Post-Irradiation Examination of High Fluence Baffle-Former Bolts Retrieved from a Westinghouse Two-Loop Downflow Type PWR

Light Water Reactor Sustainability (LWRS) Program
M3LW-19OR0402183

Date Published: July 31, 2019

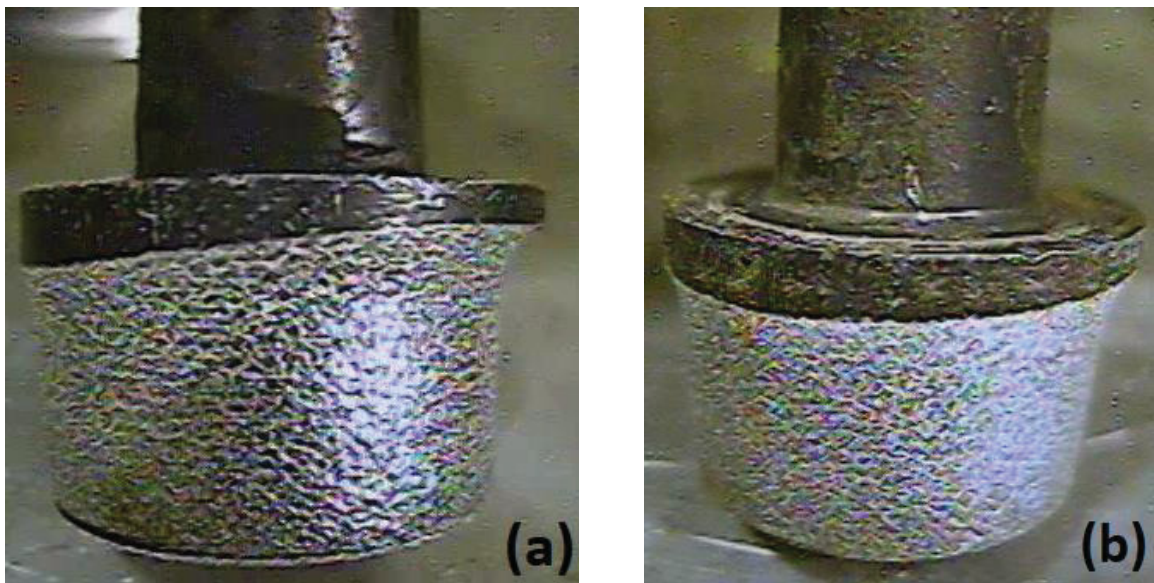
The retrieved BFBs are two of the highest fluence bolts available from the original type 347 austenitic SS bolts used in the reactor. Both bolts showed no indication of cracking during the ultrasonic inspection and in visual inspection following removal from service. However, the bolts required a lower torque for removal from the baffle structure than the original torque specified during installation. Figure 2.1 shows images of the bolt heads of two retrieved BFBs. No indication of surface cracking was observed in the transition region between shaft and head, although some surface debris scale flaked off from the bolt body. The shiny portion of the bolt head was due to electric discharge machining when the bolts were removed from the baffle wall. The ID number for the bolts follows a 4-digit code with the first number being the quadrant location in the reactor, then the associated baffle plate number, the column location of the bolt associated with the particular baffle plate number, and finally the former plate location where the bolt originated. While the exact elemental compositions of the two retrieved BFBs were not available at the time of preparation of this report, Table 2.1 shows compositions of three heats of type 347 SS used for the construction of the reactor in comparison with the material specification. The compositions of all three heats met the type 347 SS specification. Table 2.2 provides information on the range of fluences and estimated displacement damage along the length of the two bolts. The displacement damage values for the two bolts range from 15 to 41 displacements per atom (dpa) assuming a fluence to dpa conversion value of 6.7×10^{20} n/cm², E>1 MeV per dpa [2]. Other important information for the two retrieved bolts not available at the time of preparation of this report includes the irradiation temperature profile and flux both of which require more complicated modeling and calculation and they can vary within each power cycle and from cycle to cycle. Nonetheless, calculations [3] from Point Beach Unit 2, which is another Westinghouse two-loop type PWR, showed that the irradiation temperature and flux for a BFB from a region next to the bolt 4416 studied in this work varied in the range of 323-344°C and 7.5×10^{12} - 1.8×10^{13} n/cm²-sec (E>1 MeV) along the length of the bolt, respectively. It is worth noting that Point beach Unit 2 was originally a Westinghouse downflow two-loop PWR, but was converted to upflow in Nov 1986 [3].

Figure 2.1 Images of bolt heads for bolt #4412 in (a) and bolt #4416 in (b) [4]

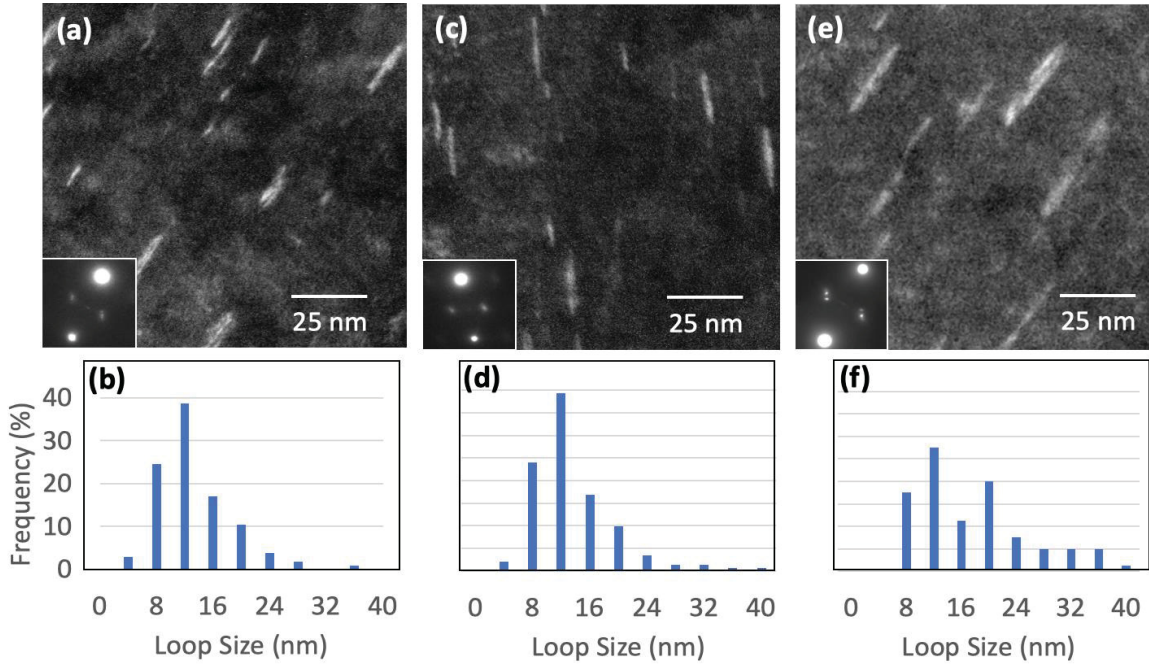
TEM characterization revealed dislocation loops in 4416 CS1, MS, and BS samples. Figure 3.1 presents the images and statistics of dislocation loops in the three samples. Similar size distributions of the loops were observed for CS1 and MS samples. The loops grew larger in the BS sample, as demonstrated by the higher frequency of loops with a diameter larger than 24 nm shown in Figure 3.1(f). By analyzing more than 80 loops per sample, obtained from different areas, the average sizes and densities of loops were calculated and listed in Table 3.1. The sample thicknesses were measured using the electron energy loss spectroscopy (EELS) technique. In Table 3.1, the uncertainties in the size data are the standard deviation; the uncertainties in the density data are the standard deviation accounting both the variances in measured densities and thickness. The changes in loop density along the bolt length profile were insignificant compared with experimental errors. Lastly, no NbC was observed in the TEM characterization which may be due to the small size of FIB-prepared samples.

Figure 3.1 DF images of dislocation loops and their size distributions for 4416 CS1, MS, and BS samples presented in (a-b), (c-d), and (e-f), respectively

Frank loops rather than network dislocations were observed in 4416 CS1, MS, and BS samples. This agrees with changes in the microstructure of austenitic SS irradiated between 300 and 400°C as reported by Chopra [2] and Maziasz [9]. The size of dislocation loops is also within but close to the high end of 4-20 nm range in the work of Bruemmer et al. [10] for austenitic SS neutron-irradiated at temperatures higher than 300°C. The observed number density of dislocation loops is lower than the reported value for types 304 and 316 SS irradiated in a boiling water reactor (BWR) at 275-300°C [11]. In general, an increase in irradiation temperature would increase the loop size while reducing their densities [12]. This confirms the irradiation temperature for bolt 4416 should be higher than 300°C. In addition, the change of irradiation temperature during different reactor cycles can lead to microstructural changes not accounted for by simply considering a constant temperature [13]. Gamma heating can also influence the variations in the temperature across the length of the bolt and over the long service exposure time, this can create variations in microstructural features at the nano- to micro-scale. However, data are still sporadic from samples examined from commercial reactors as well as from research reactors. The variations occurring in the bolts that have been seen in this work and in previous studies can be difficult to compare to each other due to uncertainty in temperatures/irradiation conditions from both research and commercial reactor test data as well as error associated with data taking. Lastly, the development of dislocation loops during irradiation can also be influenced by the material initial microstructure and reactor operating conditions. For example, the cold work could delay the growth of Frank loops [9] and the stress during service could increase the mean loop size as well as their density under neutron irradiation [14].

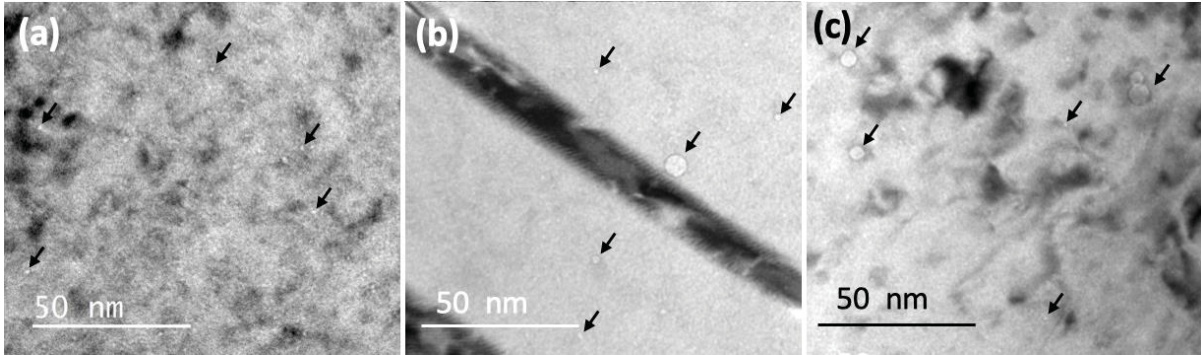
Besides dislocation loops, TEM characterization also revealed cavities in 4416 CS1, MS and BS specimens. Figure 3.2 shows cavities imaged at a focus of -400 nm and Table 3.2 summarizes the statistical results of cavities. From the bolt head towards the thread end, the average cavity size increased with a decrease in cavity density. Most cavities observed in the 4416 CS1 sample had sub-

nanometer sizes, which led to a very low swelling level, as shown in Table 3.2. On the other hand, cavities with diameters larger than 5 nm were observed in both 4416 MS and BS samples, with the latter showing a higher frequency of larger cavities. The overall swelling levels for MS and BS samples were similar and larger than that of the CS1 sample.

Figure 3.2 Cavities observed at an underfocused condition for the 4416 CS1 (a), MS (b), and BS (c) samples. Some of the cavities are marked with black arrows

Another distinctive microstructural feature after irradiation was cavity formation in 4416 CS1, MS, and BS samples as shown in Figure 3.2. The observed cavities were larger in MS and BS samples compared with the higher-dose CS1 sample, which was similar to the cavitation behavior of a cold worked type 316 SS BFB extracted from the Tihange PWR [13]. In that study, the bolt shank positions have higher irradiation temperatures in the range of 333-343°C than the irradiation temperature of the bolt head at 320°C [13]. The evolution of cavities is believed to be governed by the interactions between vacancies and gas contents of helium and hydrogen [13,15]. The coincidence in the growths of dislocation loops and cavities in the BS sample is consistent with vacancy emission from loops as an active loop growth mechanism [9], which led to a higher vacancy density in the matrix resulting in cavity growth [13]. This is also consistent with previous observations in neutron-irradiated stainless steels that the observed dislocation loops were interstitial loops [9]. Despite the cavities, swelling in 4416 CS1, MS, and BS samples was insignificant with maximum swelling of less than 0.02%. The result is in line with a compilation of swelling measurements for PWR core internal components subjected up to 80 dpa dose [2].

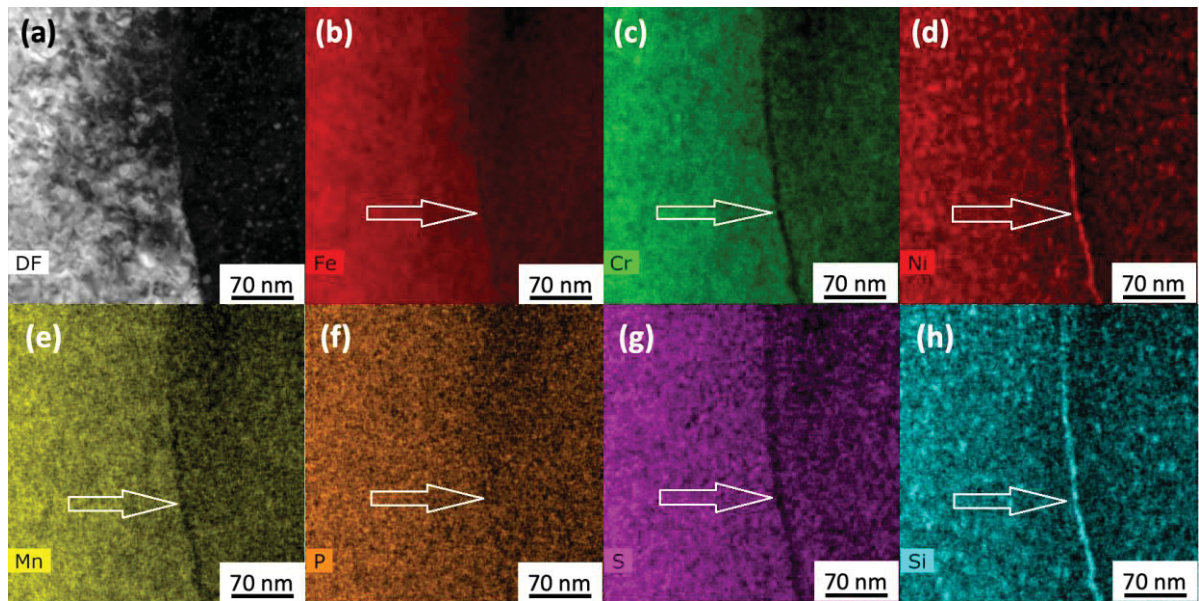
STEM/EDS-based composition maps were acquired for 4416 CS1, MS, and BS samples. As shown in Figure 3.3 to Figure 3.5, grain boundary (GB) segregation was observed in 4416 CS1 and MS, but not in 4416 BS, whereas fine precipitation was observed in all three samples. Intragranular precipitates with considerable densities showed enrichment in Ni and Si. For 4416 CS1 and MS samples, Fe, Cr, Mn, and S were observed to be depleted from GBs, while Ni and Si were observed to be enriched on GBs. The segregation of P in the CS1 sample showed a dependence on GB characters. For example, the vertical GB in Figure 3.3 did not show P segregation, whereas P segregated on the vertical GB but not the horizontal GB in Figure 3.6. For the MS sample (Figure 3.4), P segregation was observed in all studied GBs. No NbC was observed in STEM/EDS maps which may be due to the small size of FIB-prepared samples.

Figure 3.3 STEM/EDS-based composition maps for the 4416 CS1 sample. Arrows point to a GB

Radiation-induced segregation (RIS) was observed in GBs of 4416 CS1 and MS samples as shown in Figure 3.3 and Figure 3.4. The segregated elements, such as Ni and Si, and depleted elements, such as Fe, Cr, Mn, on GBs agrees with previously reported work [2]. However, RIS in GBs of the 4416 BS sample was not observed likely due to the small size of the FIB-prepared specimen. More investigation is needed to evaluate the RIS behavior in GBs of the 4416 BS sample. In addition, RIS of Ni and Si to sinks led to the formation of Ni-Si clusters in the matrix of 4416 CS1, MS, and BS samples. The possible phases for Ni-Si clusters are γ' (Ni_3Si) and G phase ($\text{M}_6\text{Ni}_{16}\text{Si}_7$)₂ which needs to be confirmed by future study. In contrast to a common belief that minor elements, such as S, should segregate to the boundary, depletion of S was observed on GBs for 4416 CS1 and MS samples in this study. Additional work is needed to understand the mechanism for S depletion on GBs. Further, P has the tendency to thermally segregate to GBs prior to irradiation. The segregation of P can be enhanced by irradiation [16-17]. However, measurements of grain boundary P segregation in neutron-irradiated SS have not yielded consistent results [2]. Indeed, in this study, P segregation on GBs was observed

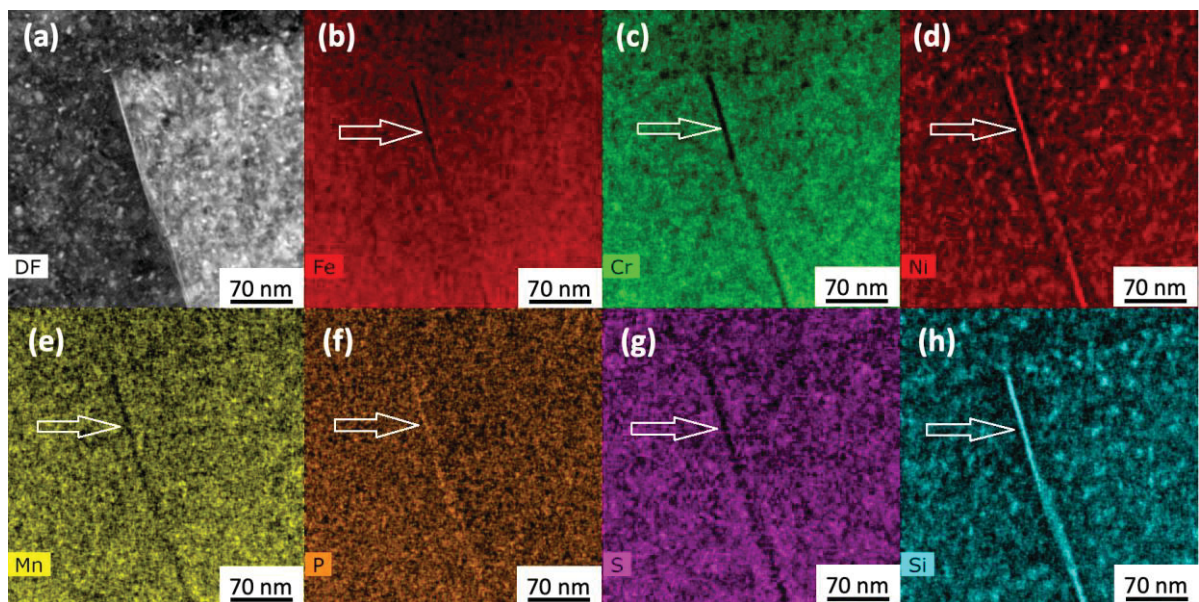
Figure 3.4 STEM/EDS-based composition maps for the 4416 MS sample. Arrows point to a GB

in the 4416 MS sample but only in one GB for the 4416 CS1 sample through the STEM/EDS survey of at least two GBs for each sample. Given the different irradiation conditions between the two samples, including but not limited to temperature, dose, gas content, stress [13, 15], and possible differences in the character of observed GBs, it is hard to determine the governing factor for P segregation via the current study. Future work to elucidate this topic will include quantification of segregation at more GBs and characterization of GB misorientation angles.

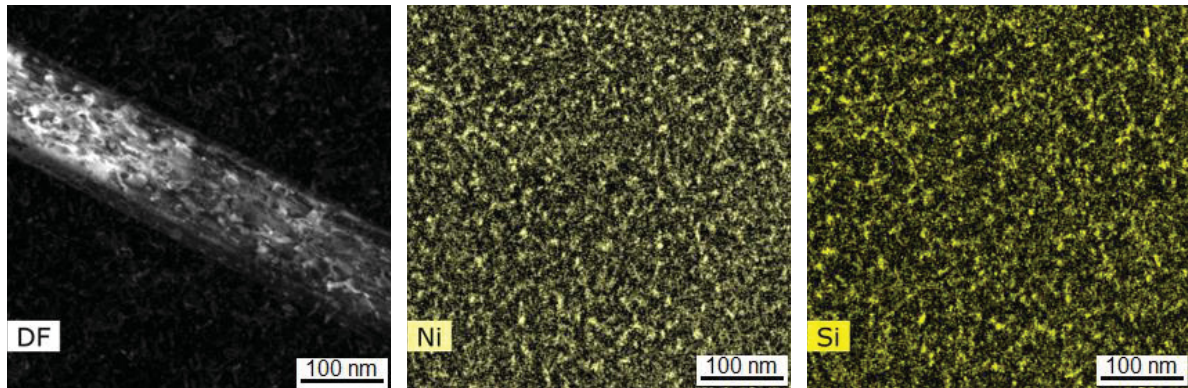
Figure 3.5 STEM/EDS-based composition maps showing Ni-Si precipitates in the 4416 BS sample

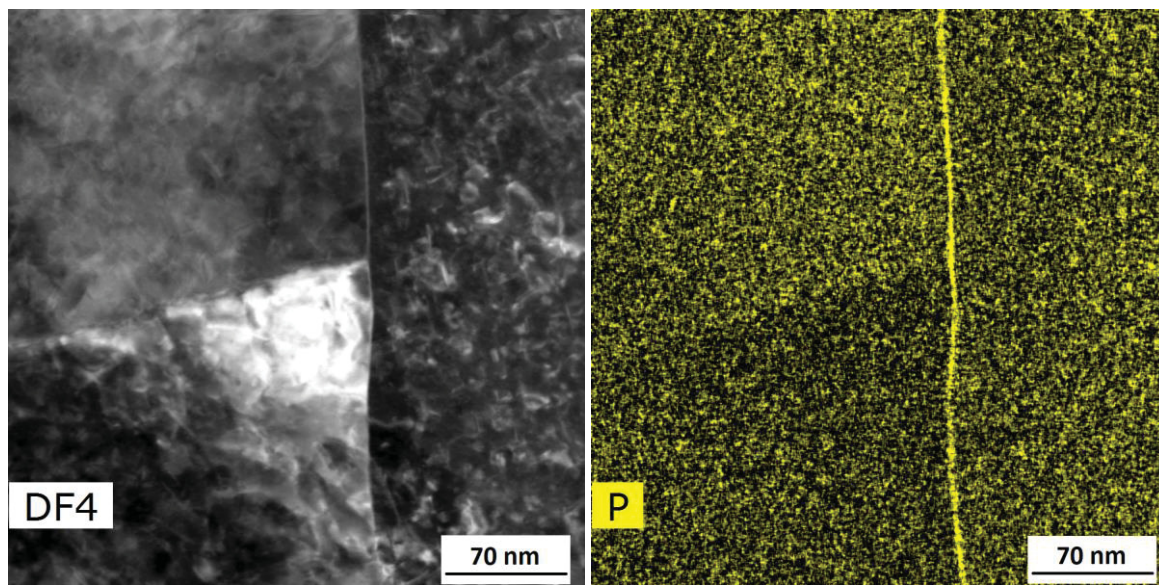
Figure 3.6 Segregation of P on the vertical GB, but not the horizontal GB of the 4416 CS1 sample

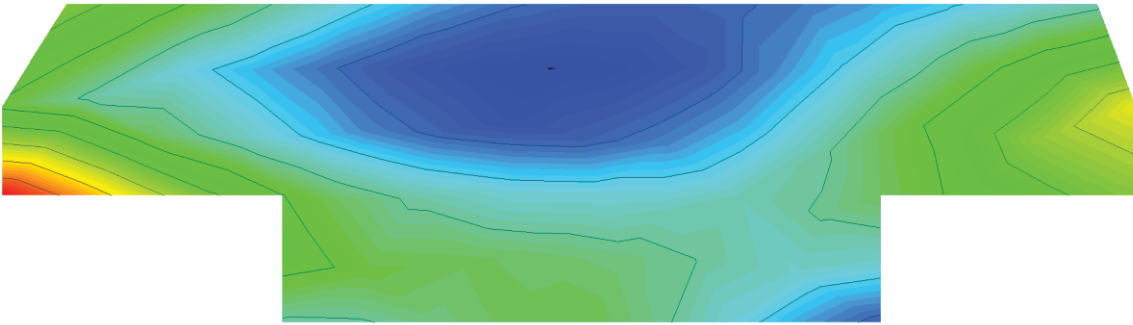
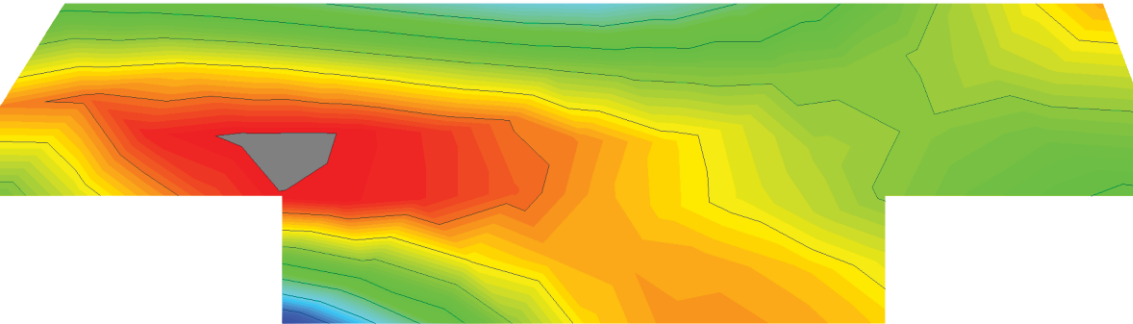
Figure 3.7 Microhardness maps for 4412 CS2 in (a) and 4416 CS2 in (b)

Microhardness results are combined with measurement coordinates to evaluate the spatial variation of hardness across the specimen surface. The results are shown in Figure 3.7 and Figure 3.8 for the bolt head thin slice and bolt shank and thread section bend bar specimens, respectively. Despite the spatial variation of hardness measurements for each specimen, no specific variation pattern was observed. Comparing hardness statistics results (Figure 3.9) reveals that for bolt 4412, hardness increased from the bolt head (high fluence region) towards the end of the thread section (low fluence region) whereas for bolt 4416, hardness variation was relatively small across the length of the bolt.

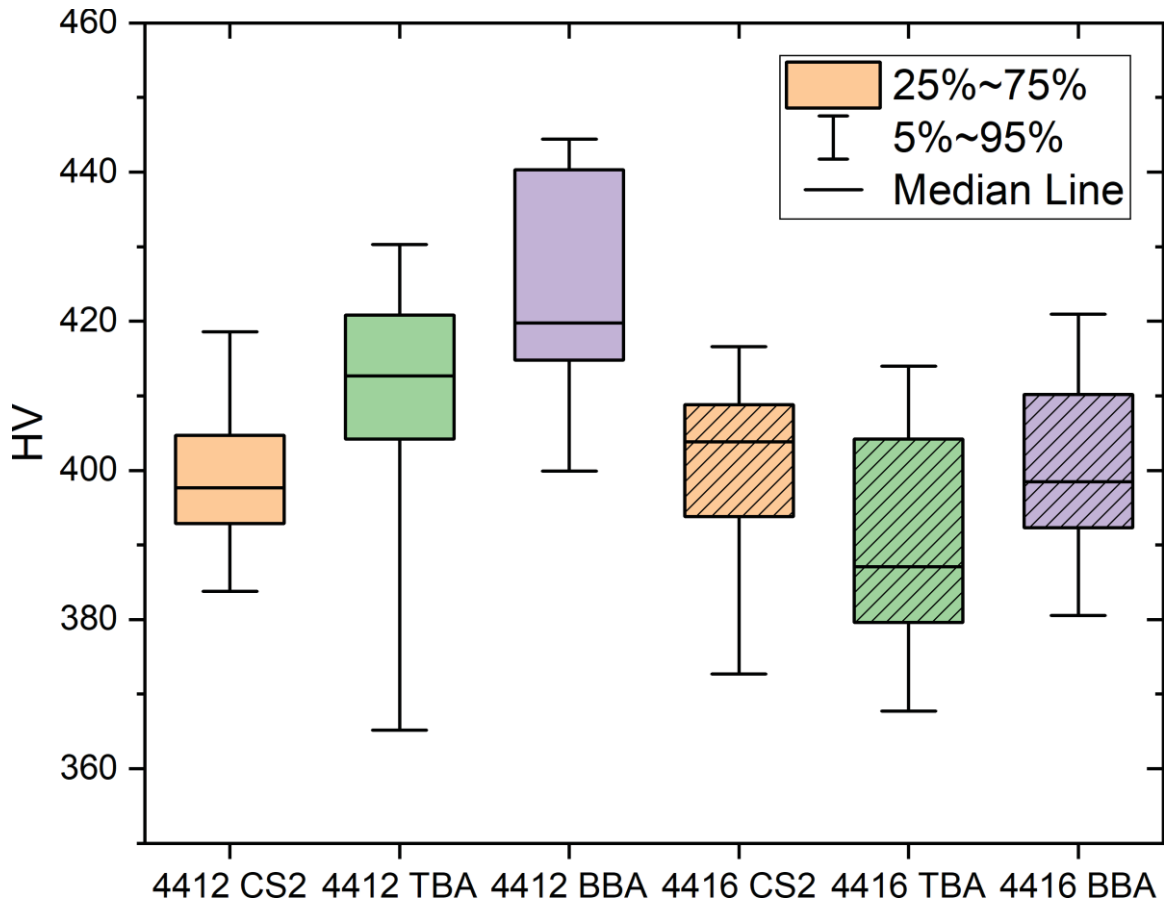
Figure 3.9 Statistics of microhardness measurements for bolts 4412 and 4416

Lastly, materials irradiation hardening behavior was evaluated by microhardness measurements. Despite the extensive characterization efforts, there was no clear effect of neutron fluence on hardness values. The spatial variation of the hardness of each specimen also did not indicate any clear trend. Based on Ref. [2], the yield strength of the 300-series SSs irradiated at approximately 300°C appears to saturate at a neutron dose of 5 dpa. BFBs studied in this work all exceeded that dose limit and hence the effect of neutron fluence on hardness values may be limited and many other factors, such as irradiation temperature, materials initial properties, in-service conditions, etc. may affect the materials irradiation hardening behavior.
