Microstructure and In-Service Degradation of Baffle-Former Bolts – In-Core Components of Light-Water Reactors

ORNL/TM-2023/3118
M3LW-23OR0402027

**MICROSTRUCTURE AND IN-SERVICE DEGRADATION OF BAFFLE-FORMER
BOLTS – IN-CORE COMPONENTS OF LIGHT-WATER REACTORS**

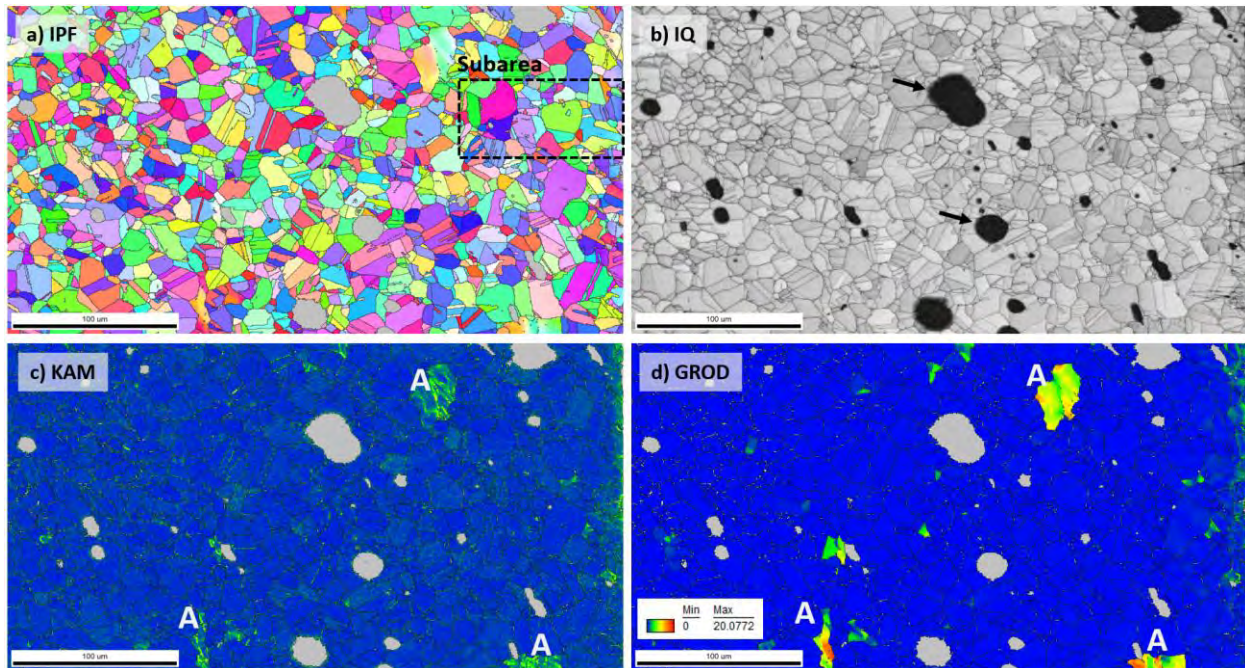
Figure 7. Microstructure of the BFB head (edge area; see Figure 3 for specimen location and orientation). A dominating recrystallized microstructure with a few abnormal grains (marked as A) can be seen. Carbon contamination spots are indicated with arrows in the IQ map. The subarea was rescanned using a smaller EBSD step, as seen in Figure 8.

Figure 7 shows the microstructure of the BFB edge area; this location is close to the edge. Analysis of the EBSD maps (especially KAM and GROD) shows mostly annealed austenite with a few abnormal grains. The general appearance of the edge area microstructure is very close to the bulk area (Figure 6). The only significant difference is the appearance of the area on the right, which contains obvious signs of plastic deformation. The layer with increased KAM and GROD values has a $\sim 15\text{--}20\ \mu\text{m}$ thickness. This may suggest that the thin near-surface layer was subjected to local loading and deformation.

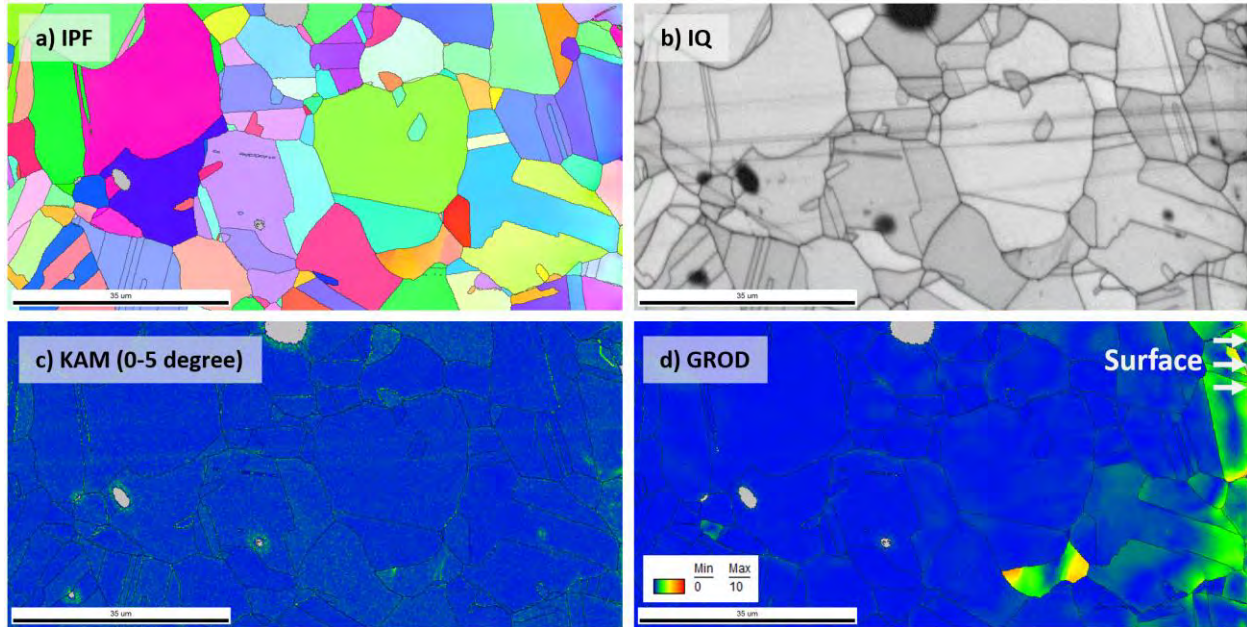
A small subarea was rescanned with a reduced EBSD step size of 125 nm, as shown in Figure 8. The presence of a thin $\sim 15\ \mu\text{m}$ deformed layer is obvious. The misorientation pattern (smooth changes in GROD, absence of hot spots typical for irradiated austenitic steel [8]) indicates that this near-surface deformation occurred before irradiation. Additionally, the deformation could occur at small damage doses of less than $\sim 1\ \text{dpa}$, which are insufficient to stimulate defect-free channel formation.

Figure 8. A magnified view of the subarea shown in Figure 7. The BFB edge (surface) is shown on the right in each image.

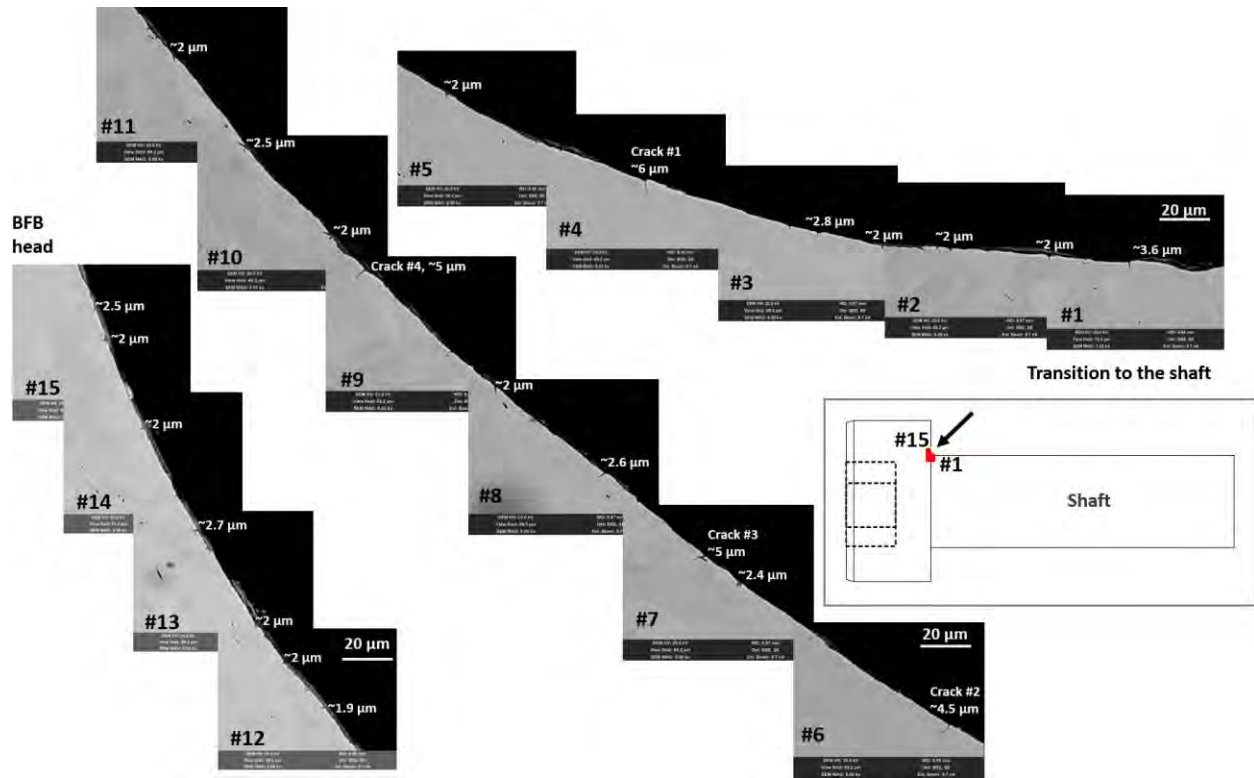
The detailed survey of the 4412-CS-1-1 specimen brought up the unexpected result depicted in Figure 10. The SEM images along the edge showed features resembling short corrosion cracks. Based on the grain contrast shown in the SEM / backscatter electron (BSE)-images, all features were related to grain boundaries. Evidence of mechanical damage was minimal, thus ruling out indents or mechanical contact with a sharp object as a cause for damage. The features are believed to be caused by corrosion and were most likely formed in-service during irradiation.

Figure 10. SEM-image collage (BSE-detector, zero-degree SEM stage tilt) showing corrosion damage distribution and depth. Image #1 (right) was taken close to the BFB shaft, and image #15 was recorded close to the BFB head.

The depths of most features from the surface varied between 2 and 3 μm , but a few exceeded $\sim 4 \mu\text{m}$. Morphology variations between these features and the histogram plot in Figure 11 suggest two types of damage: shallow pit-like objects or degraded grain boundaries 2–3 μm in depth, as well as deeper 4 $\mu\text{m}+$ features appearing as short cracks. These deep crack-like formations were in the middle of a curved area, whereas the circled area's beginning and end had only shallow degraded grain boundaries.

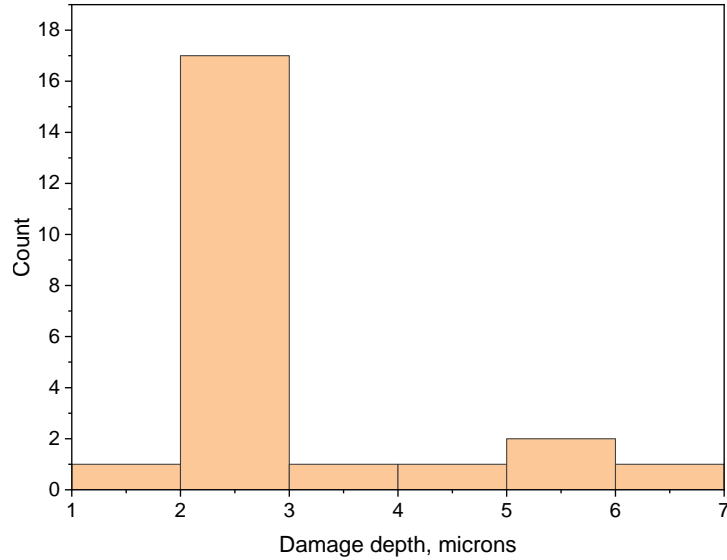
Figure 11. Number and depth of corrosion-related pits and cracks observed on the 4412-CS-1-1 specimen.

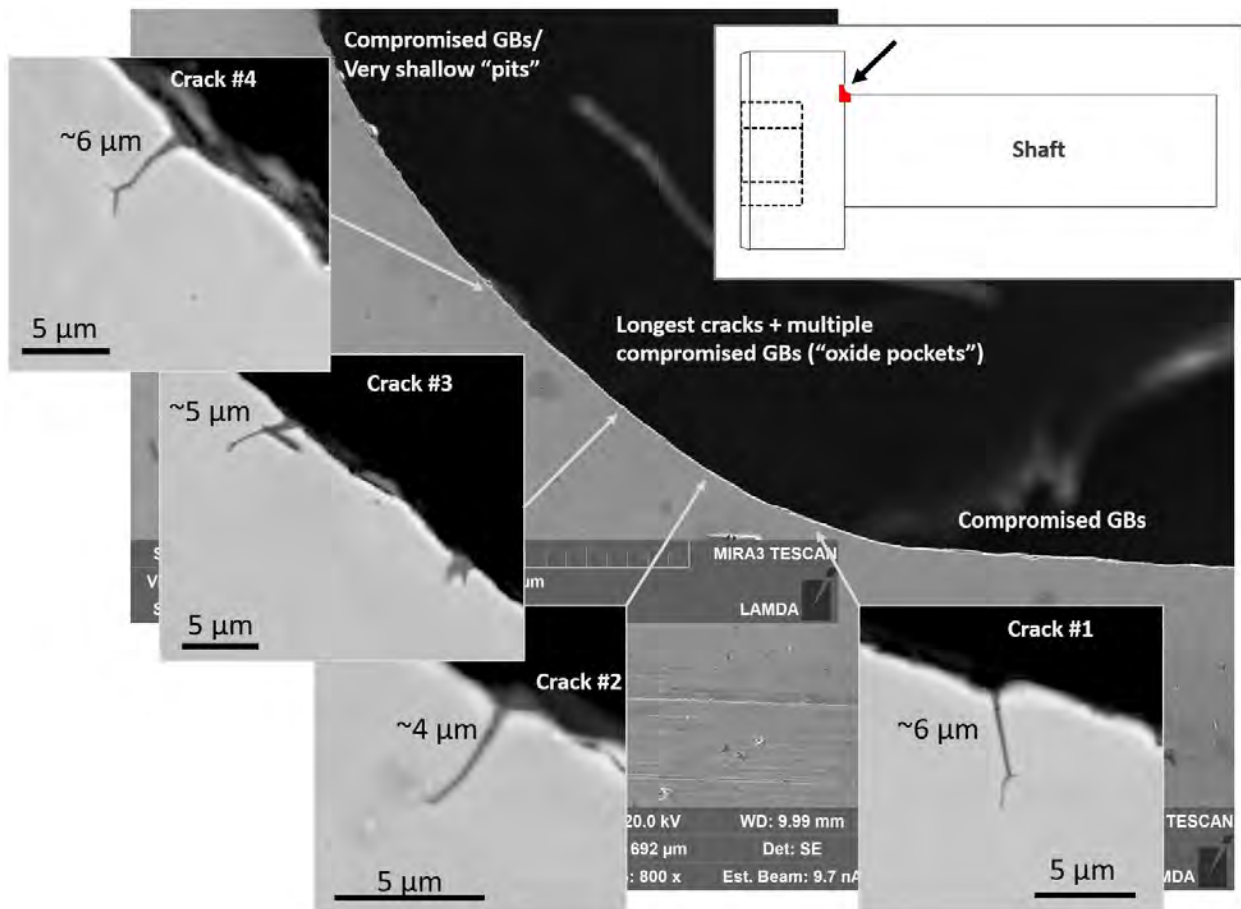
Figure 12. Identified cracks #1–#4 (objects with depths 4 μm+) located along the curved (circular) area of the BFB. Branching can be seen in cracks #1, #3, and #4. The collage combines low-magnification general view SE/SEM images with high-magnification BSE/SEM images taken for individual cracks. The inset at the top right shows the location and orientation of the area.

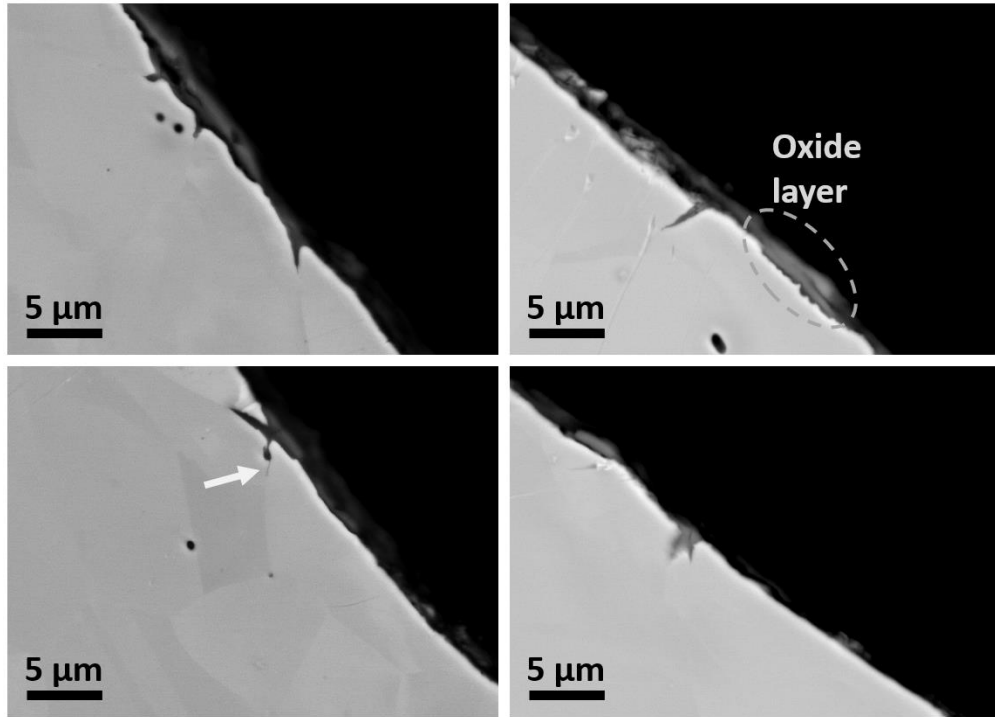
Figure 13. Enlarged view of degraded grain boundaries (SEM/BSE images). The damage penetrates at $\sim 2\text{--}3\ \mu\text{m}$ from the surface; features have triangle- or wedge-like shapes. Note the fine hair-like crack (indicated by white arrow) starting from the degraded boundary in the bottom left image. A dashed oval shows a remnant of the oxide layer.

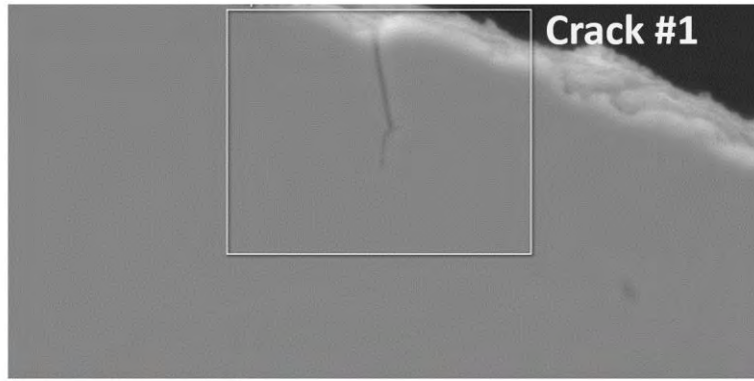
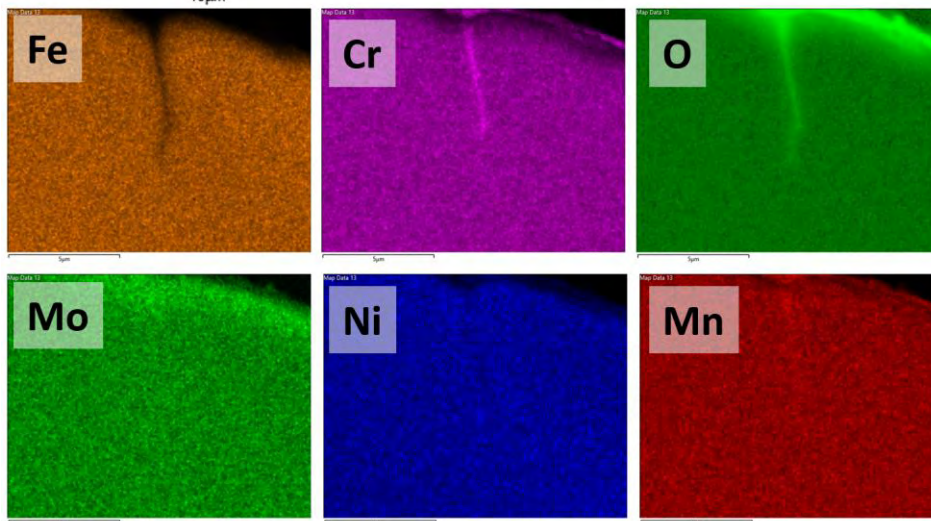
Figure 14 and Figure 15 show the results of SEM/EDS scans performed for the identified cracks. The figures show that the cracks are filled with Cr- and O-rich substances, most likely Cr-rich oxide. Mo enrichment exists in the near-surface layer and near the crack “mouth.” There is also some depletion in Ni and minor enrichment in Mn inside the cracks. Mn enrichment should be confirmed because EDS tends to overestimate Mn in austenitic steel irradiated in power reactors with thermal spectra.

Figure 14. SEM/EDS maps for Crack #1 shown in Figure 12. The crack is likely filled with Cr-rich oxide. Oxygen enrichment along the surface suggests the presence of an oxide layer.

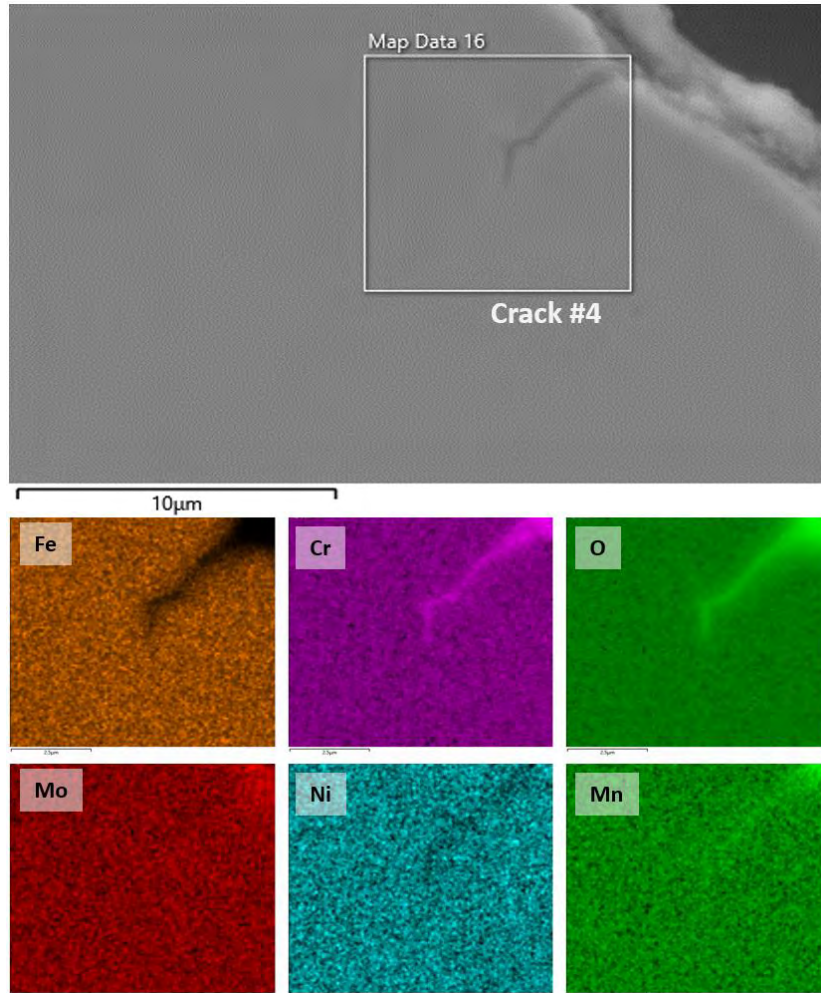
Figure 15. SEM/EDS maps for Crack #4 shown in Figure 12.
 The SEM image suggests the presence of a surface oxide layer.

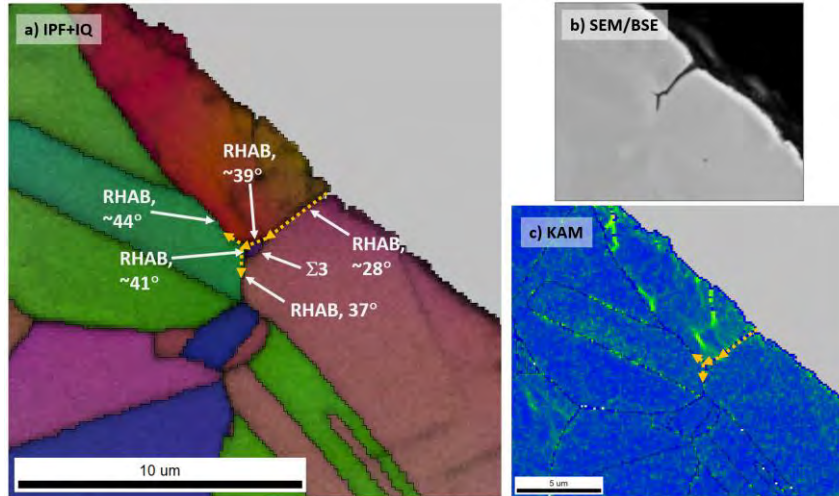
Figure 16 shows the grain's microstructure and the character of grain boundaries (misorientation in degrees and random type high-angle boundary [RHAB] or $\Sigma 3$) in the vicinity of Crack #4. The crack propagated in an intergranular fashion can be seen along grain boundaries. At triple junction points, the crack tended to branch, and new branches also formed along the GBs. Only RHABs were involved in cracking. Although there was a short $\Sigma 3$ -boundary, the crack moved along the RHAB after reaching the triple junction point, and $\Sigma 3$ was immune.

Figure 16. Grain microstructure in the vicinity of Crack #4 (Figure 12): (a) IPF+IQ, (b) SEM/BSE image, and (c) KAM map for the same location. The crack propagated in an intergranular fashion and along RHABs.

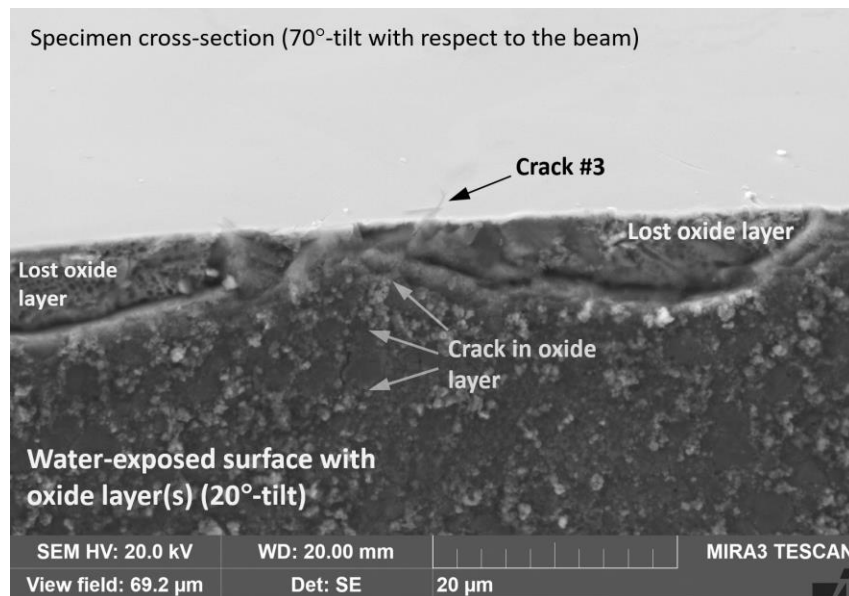
A survey of the BFB surface exposed to high-temperature high-pressure water (Figure 17) revealed a thin crack in the oxide layer. The crack in the oxide layer appears to be connected with Crack #3, as observed at the BFB cross-section.

Figure 17. Crack in the oxide layer in the vicinity of Crack #3. Note that the oxide layer was lost directly near the specimen edge (likely during specimen preparation). The water-exposed surface shows partially preserved oxide particles, (some of which were likely removed during component handling).

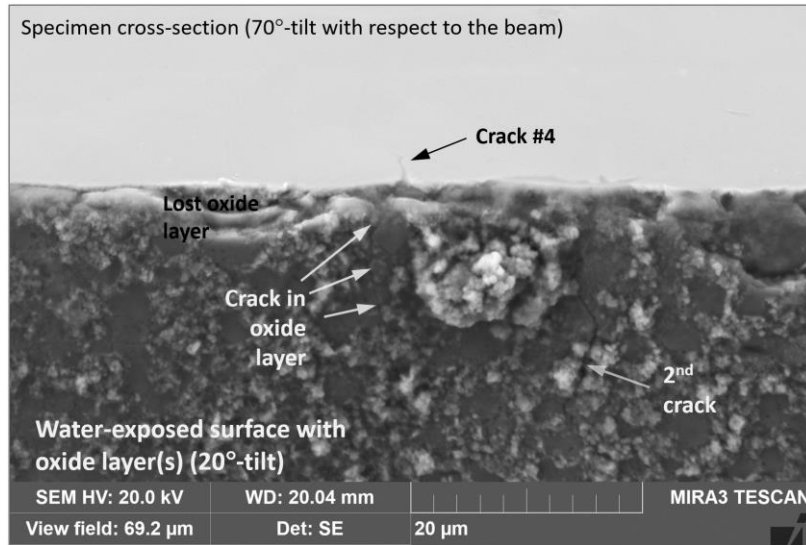
Figure 18 provides additional evidence regarding spatial correlation of corrosion cracking in the BFB, as well as cracking (likely of mechanical origin) in the oxide layer.

Figure 18. Oxide layer cracking in the vicinity of Crack #4. A second crack can also be observed, likely correlating with the degraded grain boundary.

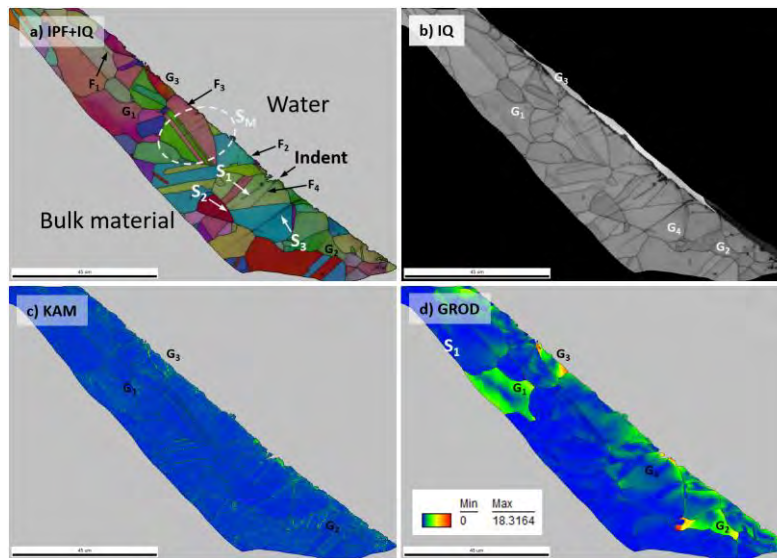
To assess this concept, a larger region around Crack #4 was scanned using EBSD, as shown in Figure 19. Based on an analysis of the EBSD maps, multiple signs of plastic deformation can be recognized, some relating to specimen preparation (i.e., scratches formed during preparation). The scratches may start and end inside the grain (see a group of scratches in area S_m and individual examples S_1 through S_3). Scratches intersect grain boundaries without changing directions. Also, the scratches do not follow (111)-plane traces (usual slip traces for fcc-materials) except in rare coincidental cases. Scratches often form in groups and appear as parallel lines.

Figure 19. EBSD dataset for the area surrounding Crack #4. Multiple signs of plastic deformation can be seen in many grains. S_M indicates the area with multiple short scratches; S_1 , S_2 , and S_3 indicate believed-to-be scratches; and F_1 through F_4 show strain-induced features.

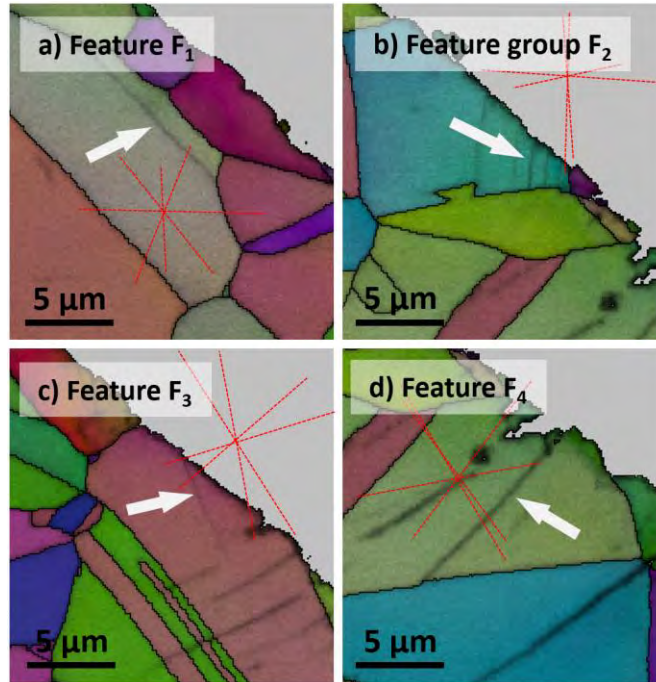
It is possible to conclude that objects F_1 through F_4 are defect-free channels formed at some point after the material reached $\sim 2\text{--}5$ dpa. The appearance of defect-free channels strongly suggests that the material reached levels of stress that were close to yield stress (YS). The exact stress level and loading conditions are unknown; channels may form at stress levels as low as ~ 0.8 YS in a routine tensile test and at ~ 0.5 YS during slow strain rate testing. Because channels exist only in some grains and the majority of grain population is channel free (i.e., no bulk deformation is observed, by analogy with [10]), slow loading may be expected at stresses comparable but still below the bulk YS.

Figure 20. Detailed view of the features F₁ through F₄ from Figure 19. Red dashed lines show projections of (111)-slip planes (possible slip traces). Good agreement in orientation can be observed between a slip plane projection and features F₁ and F₂, reasonable agreement for F₃, and a deviation of about 5° for F₄.
