# Light Water Reactor Sustainability Program

## In-service Oxidation and IASCC in High Fluence Baffle-Former Bolts Retrieved from a Westinghouse PWR

**ORNL/SPR-2024/3523**  
**M3LW-24OR0402053**

**IN-SERVICE OXIDATION AND IASCC IN HIGH FLUENCE BAFFLE-FORMER  
BOLTS RETRIEVED FROM A WESTINGHOUSE PWR**

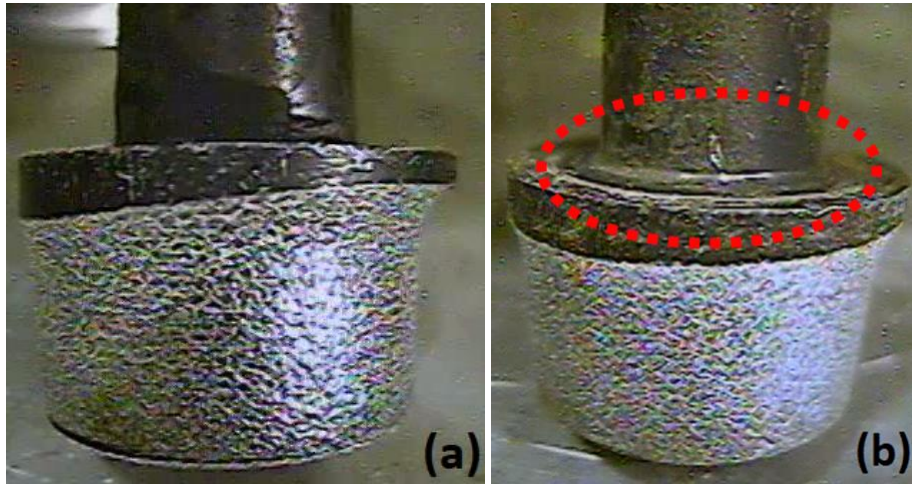
The two harvested BFBs had the highest fluence among bolts withdrawn from service in 2011. Both bolts showed no indication of cracking during the ultrasonic inspection and in visual inspection following removal from service. However, the bolts required a lower torque for removal from the baffle structure than the original torque specified during installation. *Figure 1* shows images of the bolt heads of two retrieved BFBs; no indication of surface cracking was observed in the transition region between the shaft and head, although some surface debris scale flaked off from the bolt body. The shiny gray portion of the bolt head was due to electric discharge machining (EDM) when the bolts were removed from the baffle wall. However, both bolts do still have some of the original surface that was exposed to coolant water where the bolt head intersects with the bolt shank, as circled in *Figure 1b*. The ID number for the bolts follows a 4-digit code with the first number being the quadrant location in the reactor, then the associated baffle plate number, the column location of the bolt associated with the particular baffle plate number, and finally the former plate location where the bolt originated. The composition in both atomic percent (at%) and weight percent (wt%) for both bolts as determined by APT is presented in Table 1. These bolts are within the specifications for type 316-SS with slightly elevated Cr content, but this could be due to local variations.

**Figure 1:** Images of bolt heads for bolt #4412 in (a) and bolt #4416 in (b). Surface of bolt at bolt head/shank intersection (circled) was exposed to primary water and is still intact [7]

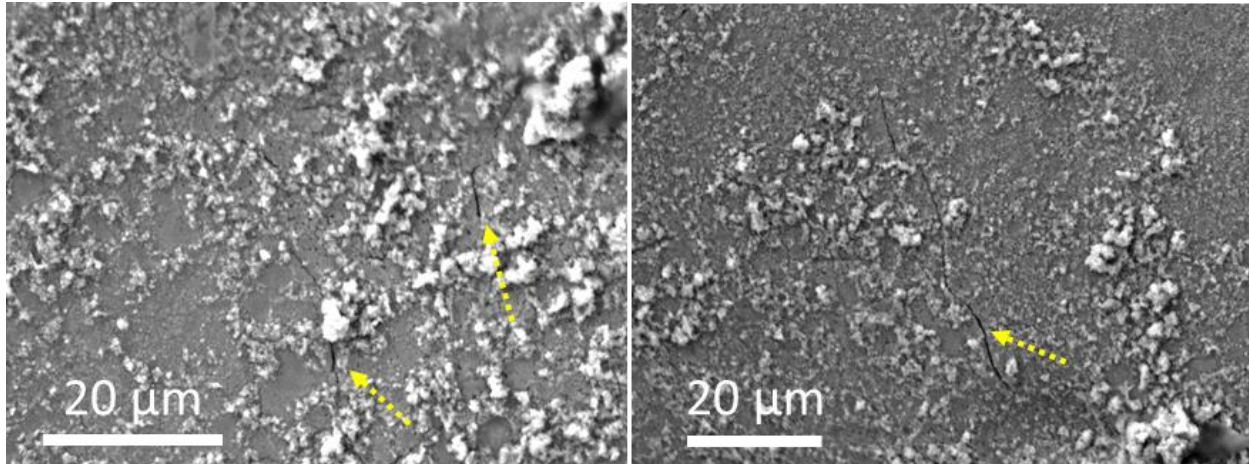
Part of the collar slice or bolt head/shank intersection region was exposed to the primary water coolant in the two-loop downflow Westinghouse PWR [13]. The CS slice in these bolts still had the exposed surface retained without excessive handling or processing damage, as shown by the SEM image of the BFB #4412 surface in Figure 3. The SEM analysis of the surface showed the oxide layer with multiple fine cracks and rough particles which are Fe-rich oxide.

**Figure 3:** Secondary electron SEM images of the surface of the head/shank transition area of BFB #4412. There are multiple small crack visible (yellow arrows) and rough Fe-rich oxide particles across surface.

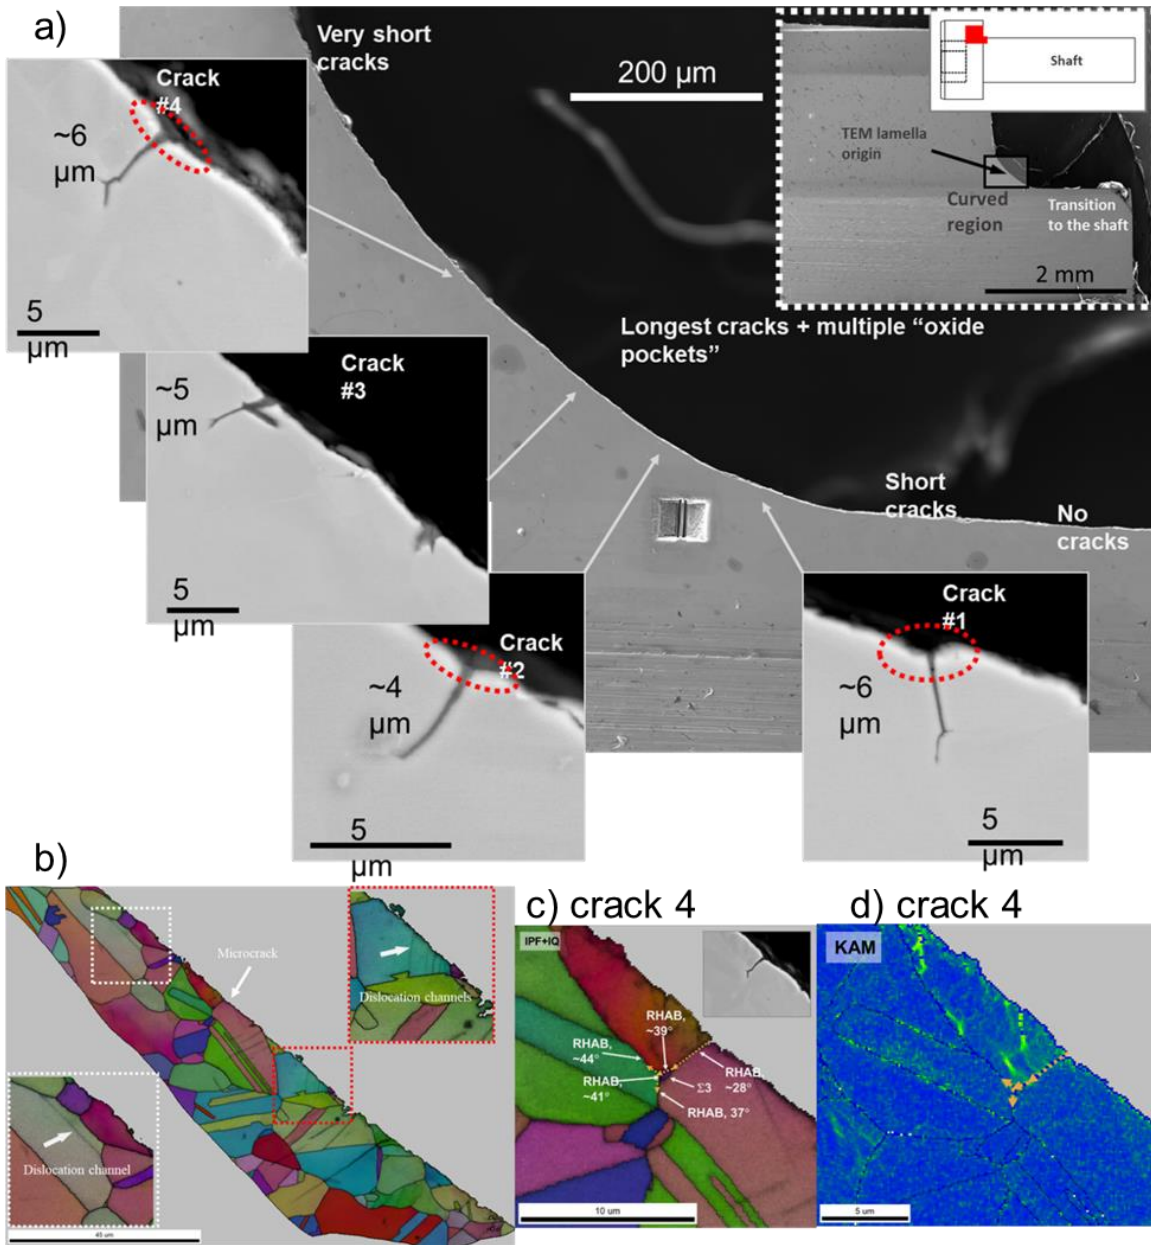
SEM analysis of the cross-section, as shown in BFB #4412 in Figure 4, demonstrated multiple small cracks along the specimen edge; all observed cracks were located inside the curved area, where stress would be highest. The longest crack reached  $\sim 6 \mu\text{m}$ . Based on the EBSD data, the corrosion crack readily propagated along random high-angle grain boundaries (RHAB) and actually splits into two different directions at a triple junction of RHABs. Special boundaries such as low-angle grain boundaries (LAGB) or twin boundaries ( $\sigma\text{-}3$  [ $\Sigma 3$ ]) appear to be immune from cracking as seen in Figure 4c, where the crack deflects and only travels along the RHAB despite hitting a triple junction of RHAB hitting a RHAB and a  $\Sigma 3$  boundary. Cracks propagated in the direction, normal to the surface suggesting the stress corrosion nature of this particular crack. In the near surface region, there is also evidence for localized deformation in the form of dislocation channels as highlighted in the EBSD maps. An oxidation environment, localized mechanical stress, and irradiation are present and make the material susceptible to IASCC. To investigate further the oxidation behavior and grain boundary attack at the cracks, targeted FIB liftouts were taken from the oxidized surface at cracks. One such liftout is shown in Figure 5 for BFB #4412. The STEM-ADF image and tKD maps in Figure 5 highlight the features that will be discussed further in full through this document: complex surface oxidation, grain boundary oxidative attack and cracking, and localized deformation in the form of dislocation channels.

**Figure 4:** SEM images from the curved section of BFB #4412 where the bolt head meets the bolt shank. Microscale cracks indicative of IASCC are found in the curved region and not in the straight regions.

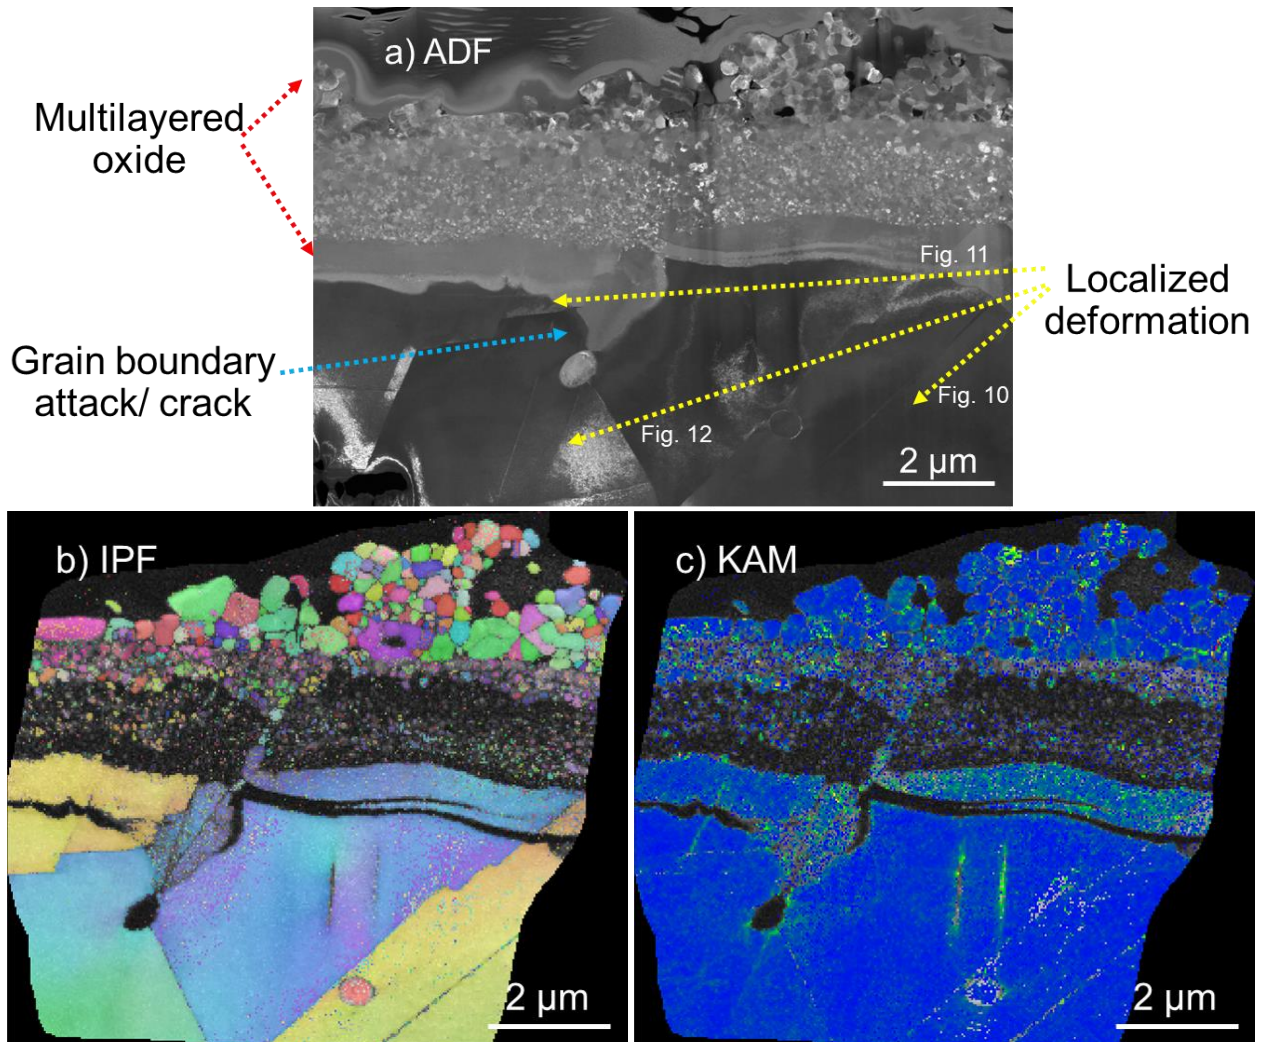
**Figure 5:** a) STEM-ADF image of liftout from BFB #4412 taken from oxidized surface near “crack #4” in Figure 4. b) tKD IPF and c) KAM maps of the same liftout. Multiple features are apparent including a multilayered oxide (red arrows), grain boundary attack (blue arrow), and localized deformation features inside the bolt (yellow arrows). These localized deformation features will be discussed in Figures 10-12.

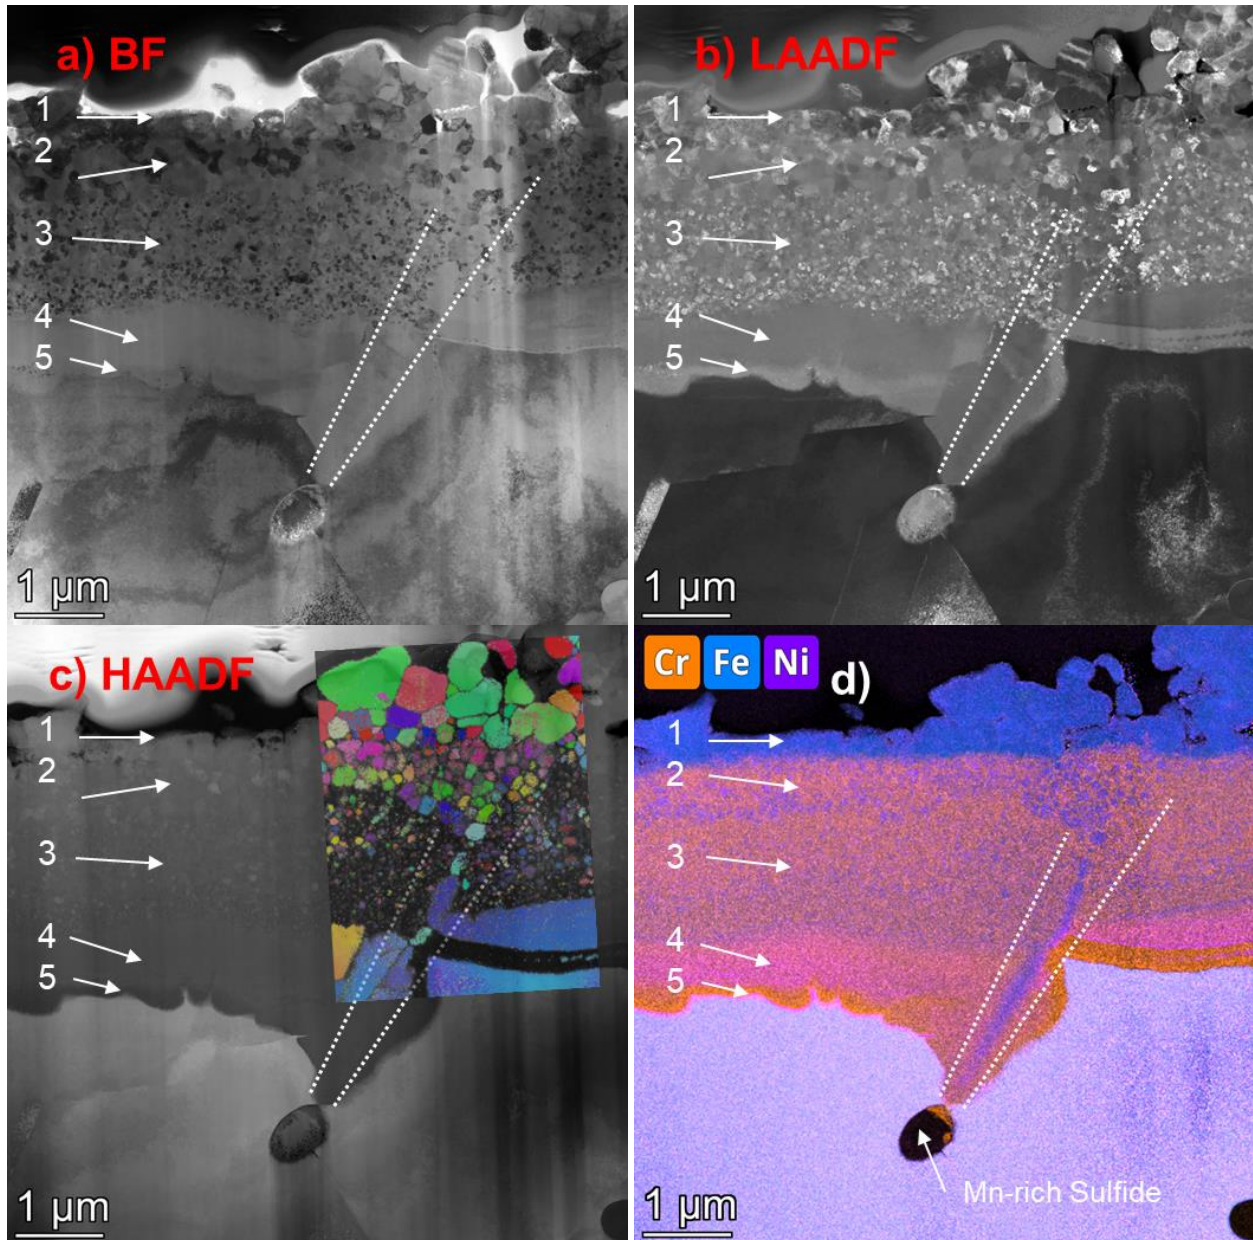
The surface oxide on the curved section of the BFBs is complex. The STEM images, tKD IPF map, and EDS map for BFB #4412 in Figure 6 highlight the five distinct layers of the surface oxide that separate themselves by composition and by grain size. Interestingly, instead of five layers, only three layers are commonly identified for corrosion and radiation-enhanced corrosion [14,15]. This finding alone signals the need for extended radiation and corrosion studies, including studying the effect of dose rate. The total oxide thickness for this BFB is  $\sim 3 \mu\text{m}$  near its thinnest point and up to  $\sim 5 \mu\text{m}$  near grain boundaries. The outer most oxide layer, denoted as layer 1, is an Fe-rich oxide with large grains  $\sim 250\text{-}500 \text{ nm}$  in size. The thickness of this layer varies from one grain thick ( $\sim 250 \text{ nm}$ ) to multiple grains but seems to be largest around grain boundaries. The second layer is an intermixed Fe/Ni-rich and Cr-rich oxide with grain sizes of  $\sim 100\text{-}200 \text{ nm}$  and a thickness of about  $600\text{-}700 \text{ nm}$ . The grains appear to be Fe/Ni-rich while the oxide boundaries are Cr-rich. The third layer is similar in composition to layer 2 but is marked by a much finer grain size of well under  $100 \text{ nm}$ . For this BFB #4412, this layer is  $\sim 1.3 \mu\text{m}$  thick. As is shown in Figure 8, this oxide layer thickness can vary substantially from bolt to bolt (only  $\sim 150\text{-}400 \text{ nm}$  for the sample taken from BFB #4416). The fourth and fifth oxide layers appear monolithic in nature but are segregated by

composition with the fourth layer being Cr/Fe/Ni-rich while the fifth layer closest to the alloy surface is depleted in Fe and Ni. Layer 5 may also be amorphous as the tKD mapping was unable to index any Cr-rich crystalline oxide. The composition gradient of each layer, 1 through 5, are shown in 1-D composition profiles in Figure 7c/d. Each of layers 4 and 5 are ~300 nm, which is about the same thickness as in BFB #4416 in Figure 8. The total thickness of the surface oxide in BFB #4416 in Figure 8 and Figure 9 is ~1.7-2  $\mu\text{m}$ , or about two-thirds the thickness of the oxide in BFB #4412. This could be due to multiple reasons, such as the following: (1) the thickness of the oxide likely can vary locally within the same bolt; (2) the radiation dose is different and could affect oxide formation; and (3) the PWR water conditions and flow could be slightly different.

**Figure 6:** a) STEM-BF, b) STEM-LAADF, c) STEM-HAADF with tKD-IPF map overlaid, and d) STEM-EDS Cr/Fe/Ni map of BFB #4412 highlighting the multilayered oxide and grain boundary attack. Numbers correspond with each oxide layer based on grain size and composition. The two near-parallel dotted lines highlight pathway along the grain boundary for Fe/Ni to out layers.

Figure 6 and Figure 7 also highlight the interesting oxidative grain boundary attack. The near-parallel dotted lines in Figure 6 highlight two features: the grain boundary oxide is enriched in Fe or conversely depleted in Cr and the grain size is much larger than the oxides in layers 3, 4, and 5 away from the grain boundary. The grain boundary acts a diffusional pathway or pipeline for Fe and Ni to move to the outer oxides, especially layer 1 which is thickest around the grain boundary. The larger grains in layer 1 and 2 along the ‘pipeline’ are all enriched in Fe and Ni as highlighted in the concentration profiles in Figure 7e/f. This is likely exacerbated by radiation-induced segregation of Ni and Si to the grain boundary and depletion of Cr at the grain boundary. This same behavior observed in BFB #4412 can also be seen in BFB #4416 as layer 3 is clearly interrupted by larger grains near the grain boundary in Figure 8 and the original grain boundary location within the oxide is enriched in Fe and Ni and depleted in Cr as shown in Figure 9. Radiation-induced segregation not only enhances grain boundary attack, but it also enhances external oxide growth.

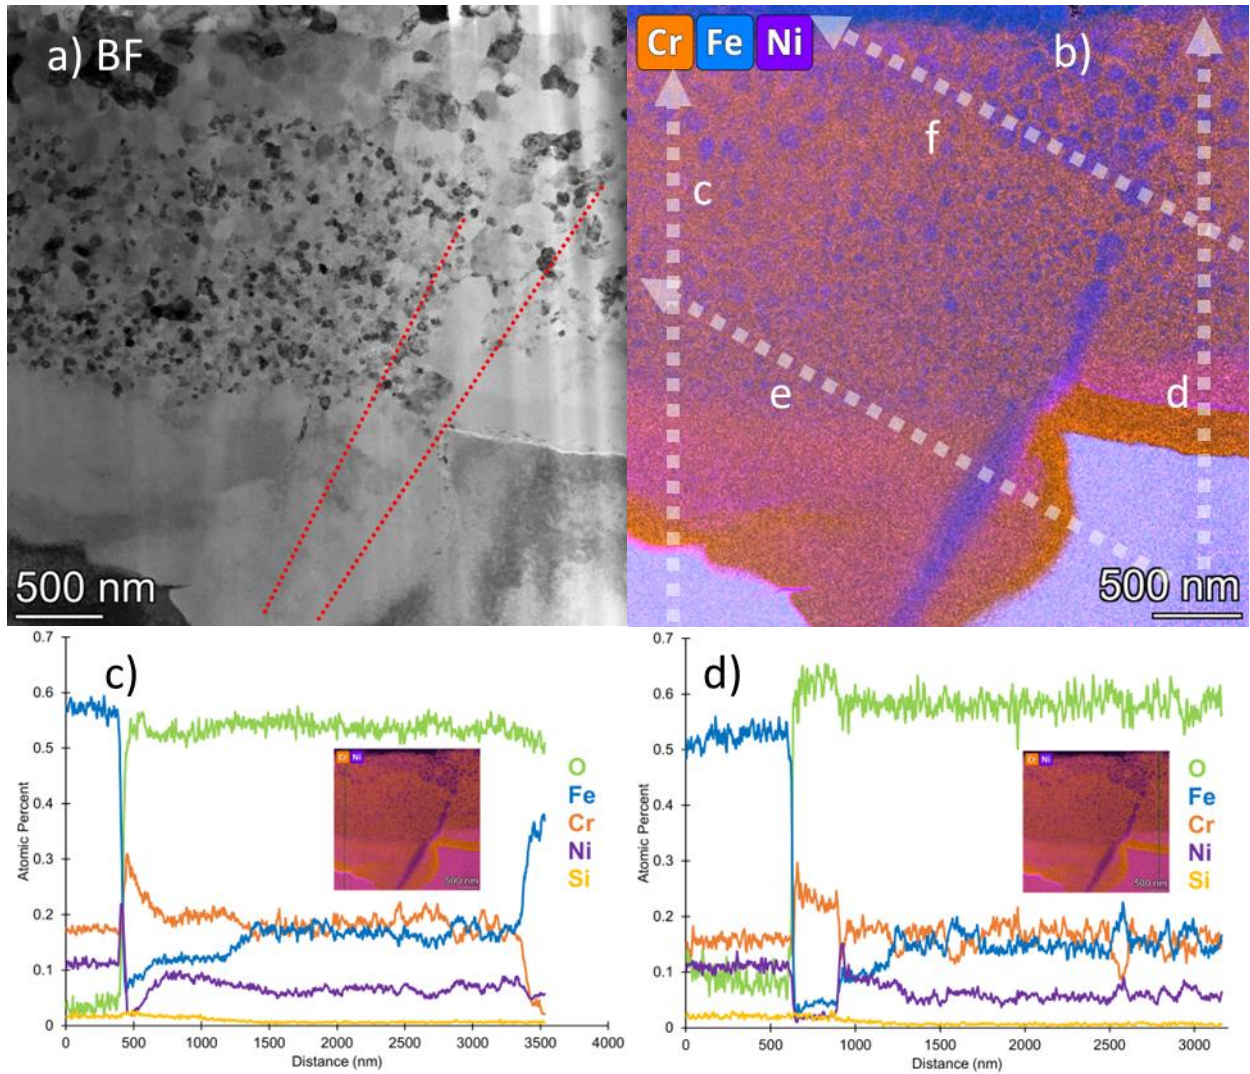
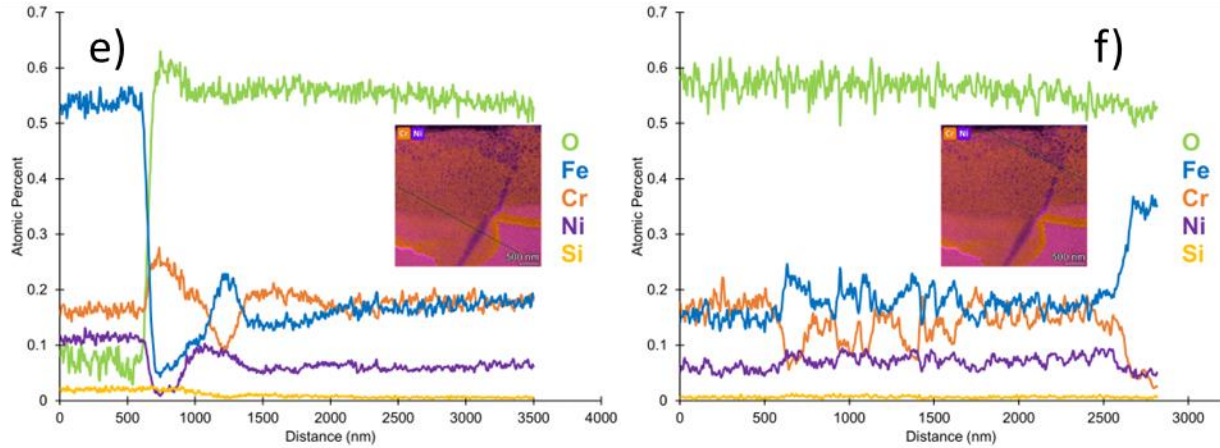
**Figure 7:** Liftout from oxide of curved region in BFB #4412. a) STEM-BF image and STEM-EDS map of Cr/Fe/Ni overlaid showing oxide and grain boundary attack. (c-f) Concentration profiles corresponding to arrows in (b).

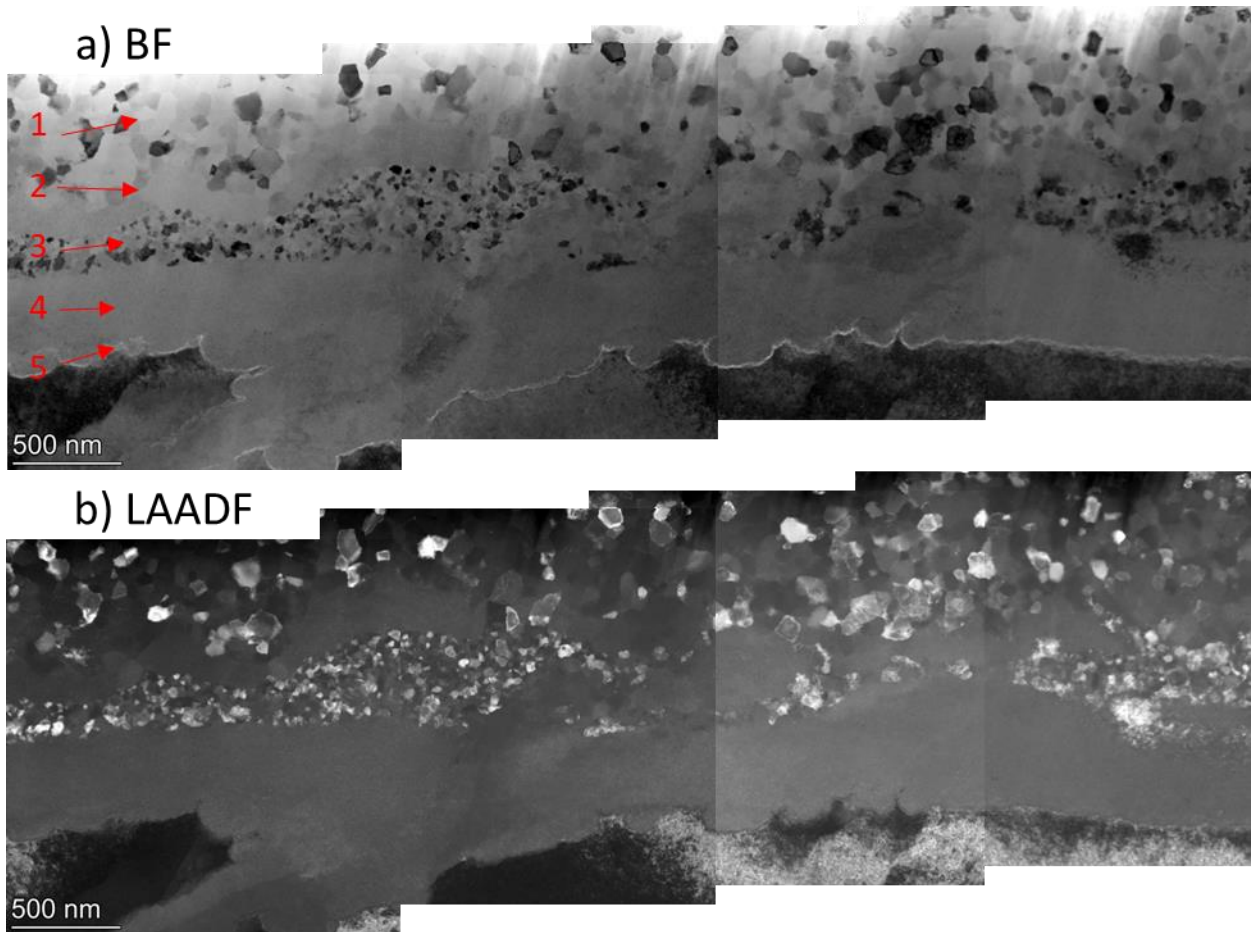
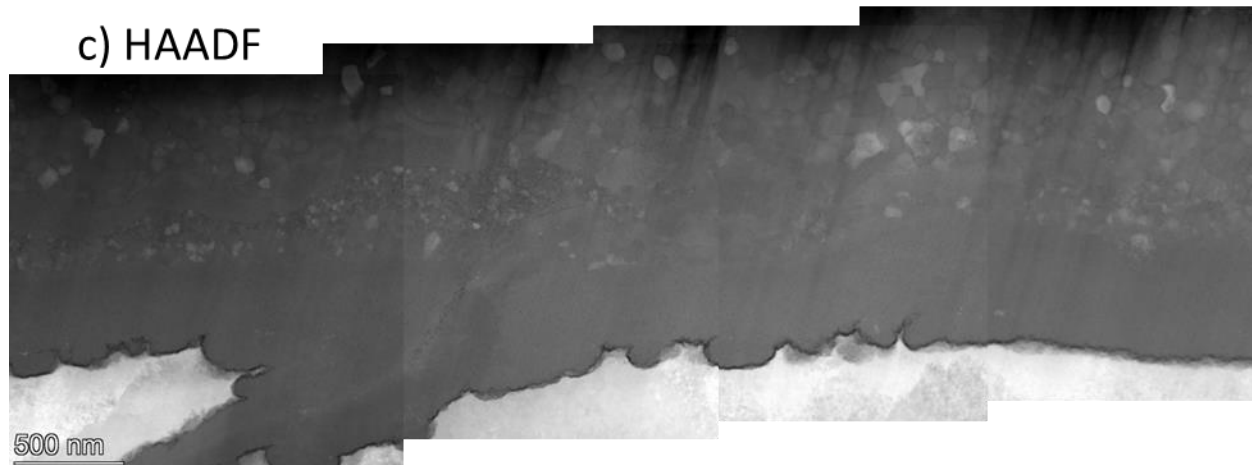
**Figure 8:** a) STEM-BF, b) STEM-LAADF, c) STEM-HAADF images stitched together of surface oxide near an oxidized grain boundary in BFB #4416 highlighting the multilayered oxide and grain boundary attack. Numbers correspond with each oxide layer based on grain size and composition.

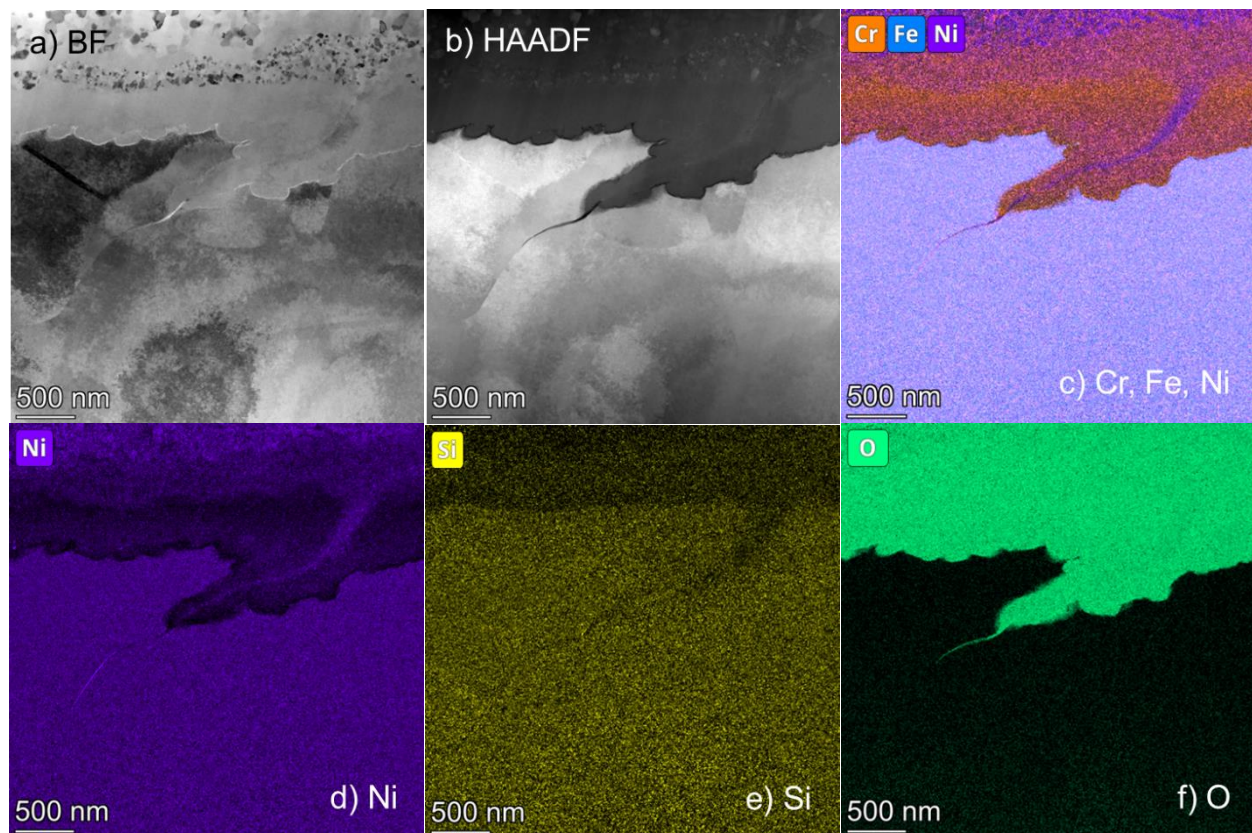
**Figure 9:** Liftout from oxide of curved region in BFB #4416. a) STEM-BF and b) STEM-HAADF images showing oxide and grain boundary attack. STEM-EDS maps of c) Cr, Fe, Ni overlapped, d) Ni, e) Si, and f) O showing segregation of Ni at grain boundary but a depletion of Si near the oxidized grain boundary.

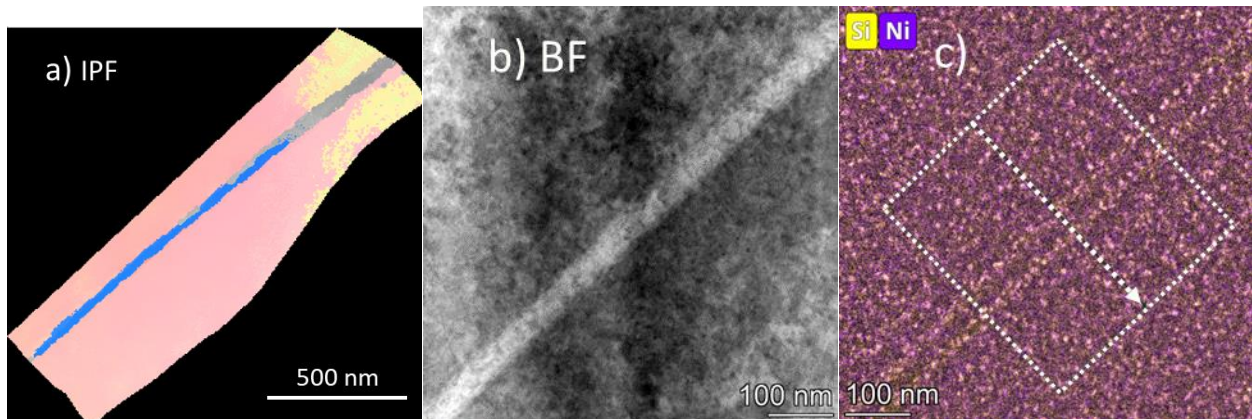
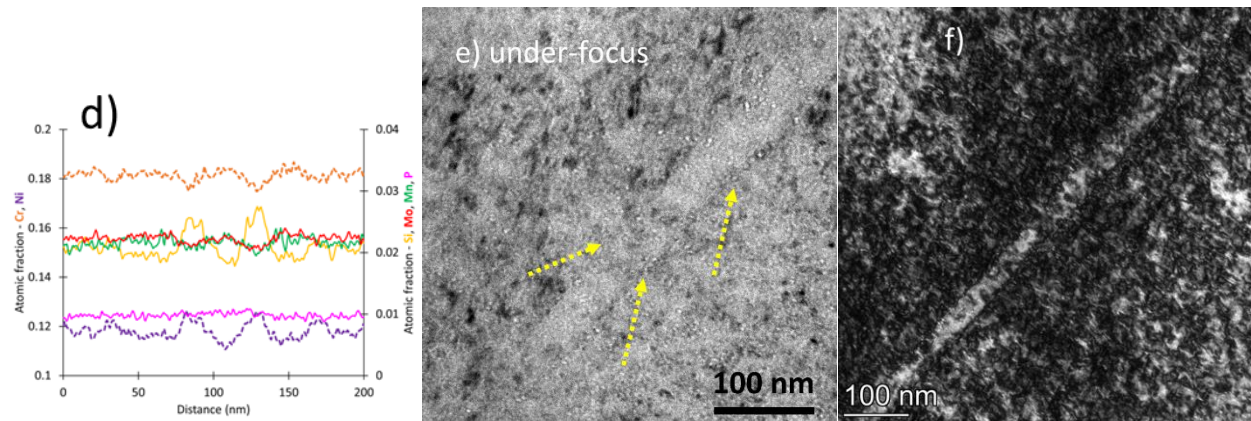
The IPF map in Figure 10a shows the channel has a twin across its length based on the misorientation being about  $60^\circ$ , indicative of a strain-induced twin with two  $\Sigma 3$  boundaries. STEM-bright field (BF), STEM-EDS analysis, and TEM-BF imaging, as shown in Figure 10b-f, were conducted at the same  $\sim 50$  nm wide feature. The most notable aspect is in the EDS map in Figure 10c showing clear segregation along channel boundaries. The surrounding matrix has a high density of Ni/Si-rich clusters, but there is an excess of clusters along the boundaries. The EDS concentration profile in Figure 10d shows the Ni/Si enrichment corresponds with a depletion of Cr, Mo, and Mn; there may be a slight enrichment of P within the channel though it is minimal. Additionally, the Ni and Si concentration between the boundaries is below that of the matrix outside the channel. The lack of precipitates between the boundaries suggests this is a defect-free dislocation channel, the result of localized deformation. There may also be a denuded zone where there is a slight reduction of Ni/Si relative to the matrix just outside the channel. Qualitatively, these results agree with previous studies on radiation-induced segregation (RIS) to  $\Sigma 3$  grain boundaries. [16–18].

The lack of precipitates inside the channel does not mean that no defects are observed within the channel. Nanoscale cavities and dislocation loops are observed within the channel in the under-focus TEM-BF images in Figure 10e and the TEM-BF image in Figure 10f, respectively. The nanocavities are in high density throughout the matrix just as reported elsewhere [8]. There appear to be fewer cavities within the channel, though it is difficult to quantify if there is a significant difference between the matrix and within the channel boundaries. However, there do appear to be cavities that build up on the channel boundaries as denoted by the dotted arrows. Similarly, the dislocation loop density appears to be much lower within the channel than in the matrix. Taken together, the total density of defects including precipitates, nanocavities, and dislocation loops are lower within the channel.

Although segregation at  $\Sigma 3$  boundaries, particularly coherent  $\Sigma 3$  boundaries, is weaker compared to random high-angle grain boundaries (RHAGBs) [17], this process cannot be dismissed. While there is evidence of twinning in the channel in Figure 10, destruction of Ni/Si-rich precipitates suggests the passage of multiple dislocations along the channel, since a single twinning event would likely be insufficient to destroy precipitates [19]. The motion of dislocations, especially through heavy or severe deformation, has been shown to dissolve precipitates [20,21] and is likely what happens here at the local scale.

**Figure 10:** a) *t*KD IPF map with 5 nm step size showing strain induced channel with deformation twin occupying most of the channel; b) STEM-BF and c) STEM-EDS Ni and Si map of same channel; d) concentration profile based on box in c) across the channel; e) under-focus TEM-BF images highlighting nanocavities including those along channel boundaries (arrows); and f) TEM two-beam BF image showing dislocation loops in matrix and channel.

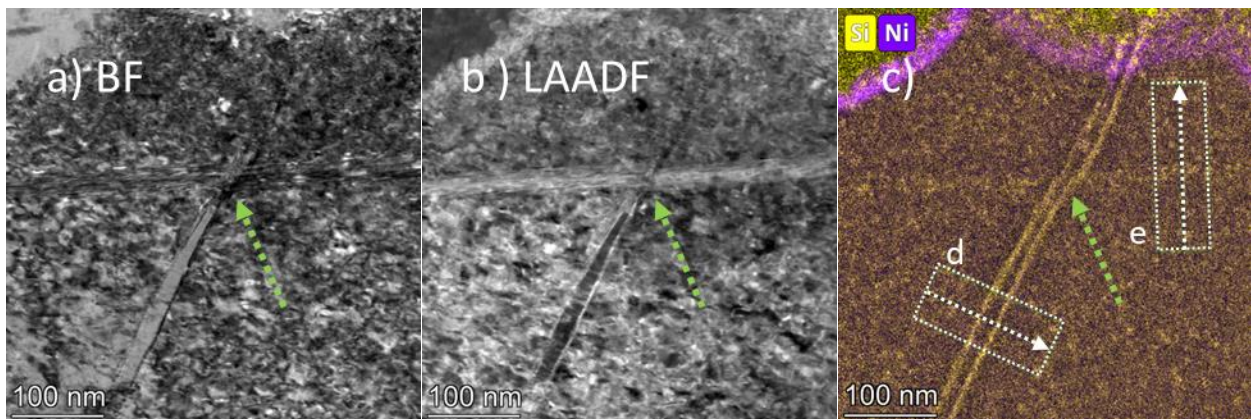
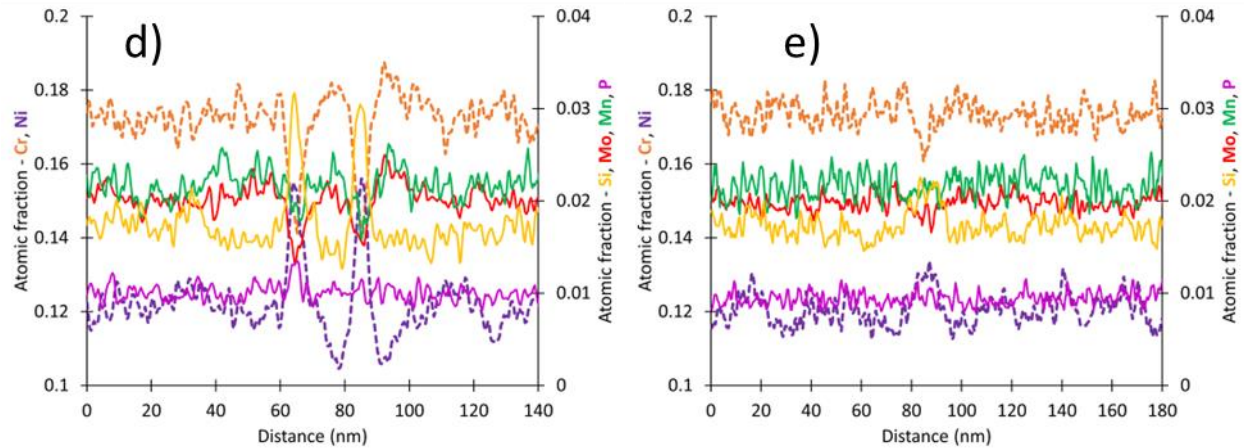
Similar STEM-EDS analyses were completed on other channel and localized defect features as well, as shown in Figure 11 and Figure 12, which are from the same liftout from BFB #4412. The region in Figure 11 shows two localized dislocation channels – the near vertical one (marked as d) and the horizontal one (marked as e). The near-vertical channel has extensive Ni/Si segregation and Cr/Mo/Mn depletion at the channel boundaries, more so than the channel boundaries in Figure 10. Two maximums in Si and Ni curves in the near-vertical channel in Figure 11d suggest strain-induced twins occupying a portion of the channel. However, instead of discrete precipitates, the segregation to the channel boundaries appears to be smooth here and reaches a much higher level than the channel in Figure 10. The BF and LAADF images show there is some but relatively low dislocation content within the channel. The horizontal channel on the other hand has elongated diffraction features as dislocations passed along it. This channel intersects with the other channel and looks like it causes channel ‘d’ to bend or be compressed slightly (the bending is pointed by dashed arrow in Figure 11). This horizontal channel does have some slight Ni/Si segregation to it as shown in the concentration profile in Figure 11 but no evidence of a strain-induced twin. The higher degree of segregation at the near-vertical channel ‘d’ boundaries also means these boundaries may likely be incoherent  $\Sigma 3$  boundaries due to being a good sink for defects and solute and comparable to RHAGBs [17]. The segregation to the non-twinned channel suggests that localized strain-induced features can serve as sinks for defects and solutes just as a dislocations and dislocation cells can [22].

**Figure 11:** a) STEM-BF, b) STEM-LAADF, and c) STEM-EDS Ni and Si map showing dislocation channel (d) with likely internal twin intersecting with another dislocation channel (e); d) concentration profile based on box in c) across the channel with twin; e) concentration profile based on box in c) across the untwinned channel

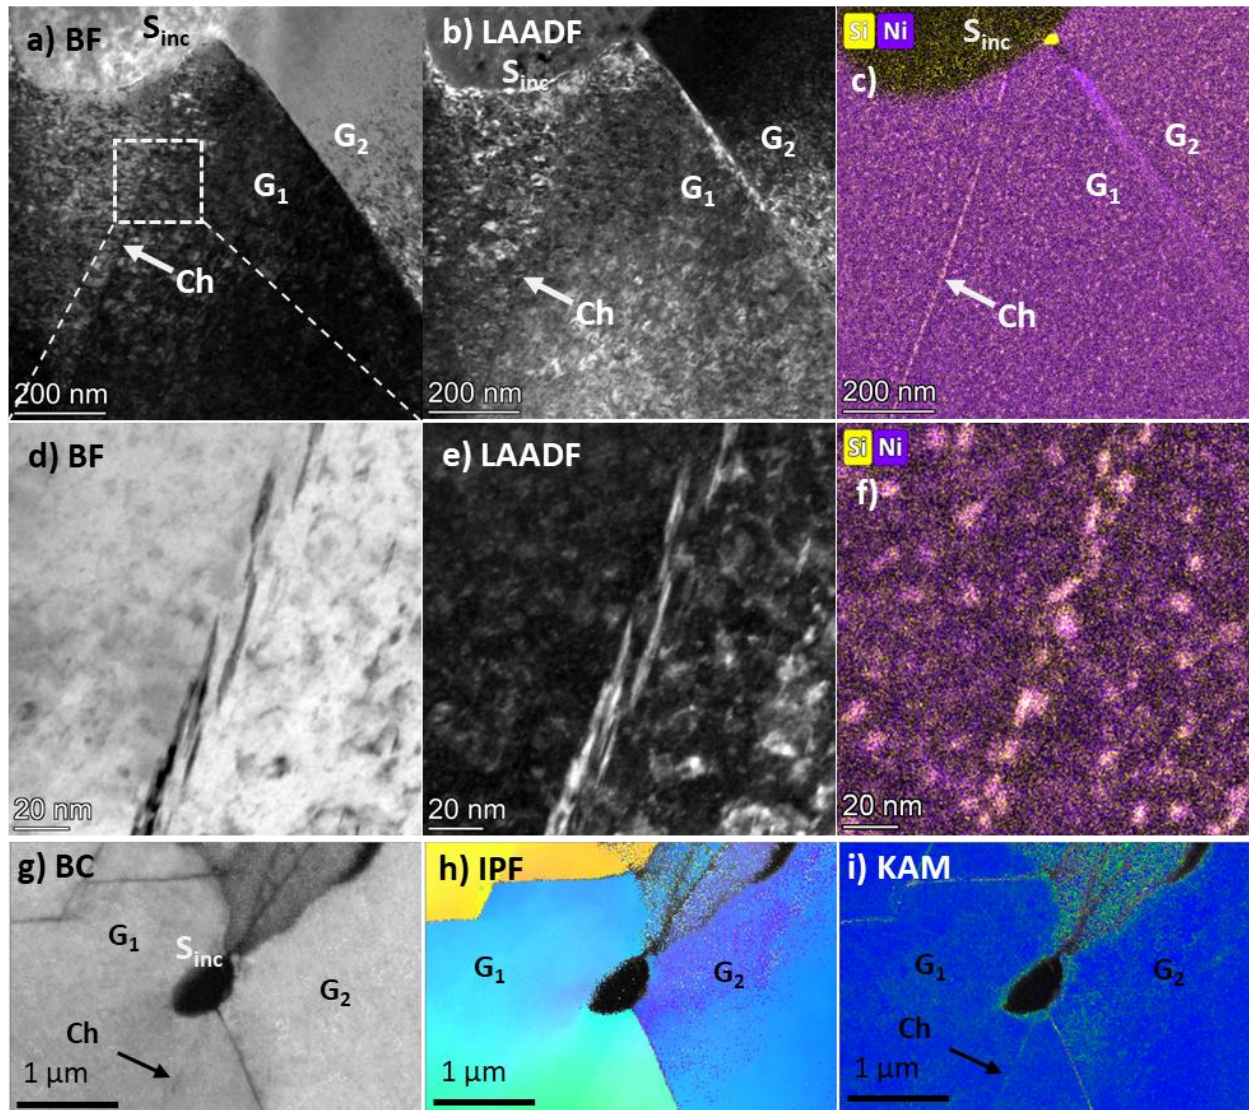
The third localized deformation feature near the sulfide inclusion from Figure 5 is characterized with tKD, STEM imaging, and STEM-EDS mapping in Figure 12. In the STEM in Figure 12a/b, one may see two grains,  $G_1$  and  $G_2$ , as well as a dislocation channel (Ch) that nearly intersects with a grain boundary at a sulfide inclusion ( $S_{inc}$ ). The grain boundary between  $G_1$  and  $G_2$  is a RHAGB. The EDS map, Figure 12c, show obvious segregation inside the channel. STEM-EDS performed at elevated magnification, Figure 12d/e, does not show evidence of twinning. One may see also much larger Ni/Si-rich precipitates but no general segregation, Figure 12f. The band contrast and IPF maps, Figure 12g/h, show minimal change across the channel, but the KAM map, Figure 12i, highlights there is increased KAM values at the channel that is similar to the grain boundary between  $G_1$  and  $G_2$ . The STEM imaging and EDS analysis in Figure 12e-f, shows the channel is similar to the horizontal channel in Figure 11 with elongated features, but it does not have any twin character. In this sense, there are not clear channel boundary walls like the twinned-channels in Figure 10 and Figure 11. This suggests that localized strain-induced features can serve as sinks for defects and solutes just as a dislocations and dislocation cells can [22].

**Figure 12:** a) STEM-BF, b) STEM-LAADF image, and c) STEM-EDS Ni and Si map of channel and grain boundary showing channel nearly intersecting with a random high angle grain boundary at a sulfide inclusion; d) STEM-BF, e) STEM-LAADF image, and f) STEM-EDS Ni and Si map zoomed in on the channel, but tilted to a kinematical condition. g, h, i) tKD band contrast, IPF, and KAM maps, respectively.
