Data Analysis of Different Nondestructive Testing Techniques to Monitor Concrete Structure Degradation due to Alkali-Silica Reaction

U.S. Department of Energy
Office of Nuclear Energy

**Idaho National Laboratory
Idaho Falls, Idaho 83415**

**INL/EXT-16-39915
Revision 0**

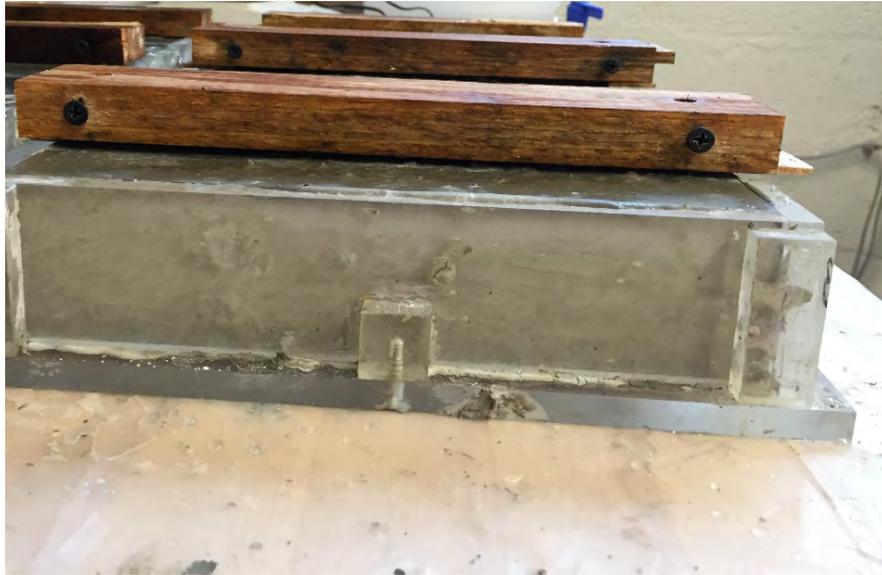
Figure 8. U bricks during curing with wood holding steel pegs in place.

The characteristic signature of ASR in damaging a concrete structure is expansion. Steel pegs were cast in the concrete bricks to provide points for repeatable measurements to be taken while the concrete was curing, as shown in Figure 8. Measurements of the bricks’ lengths were taken multiple times as the bricks were curing. Table 2 tracks the length between the two steel pegs on each of the concrete bricks as a function of curing time. The baseline brick, U1, decreased in length, especially during the first month, and length measurements of the ASR-aggressive curing bricks (U2 and U3) show slight expansion. The

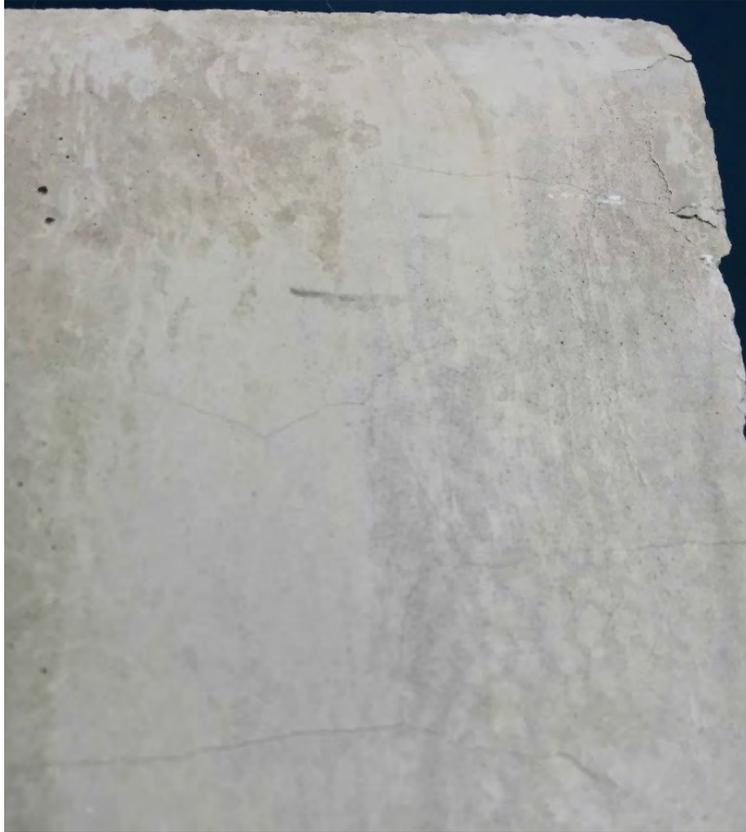
Figure 10. Hairline cracks are visible on the surface of Brick U1.

Brick U1 served as a baseline sample, which was not exposed to NaOH. However, Figure 10 shows hairline cracks visible on the surface of baseline Brick U1 after 5 months of curing, which results in an increasing shift in resonance frequency with increasing input force amplitude, as shown in Figure 11. Even though the ASR is unlikely (or insignificantly) to occur in Brick U1, the observed cracks are due to other damage mechanisms in concrete. This example demonstrates that vibration-based examination techniques have difficulty in distinguishing the cause of concrete damage; either it is from ASR or from other damage mechanisms in concrete.
