# 20 Gwd SiC Clad Fuel Pin Examination

APRIL 2014

LWRS SiC Clad Technology Development Program

Prepared by  
OAK RIDGE NATIONAL LABORATORY  
Oak Ridge, Tennessee 37831-6283  
managed by  
UT-BATTELLE, LLC  
for the  
US DEPARTMENT OF ENERGY  
under contract DE-AC05-00OR22725

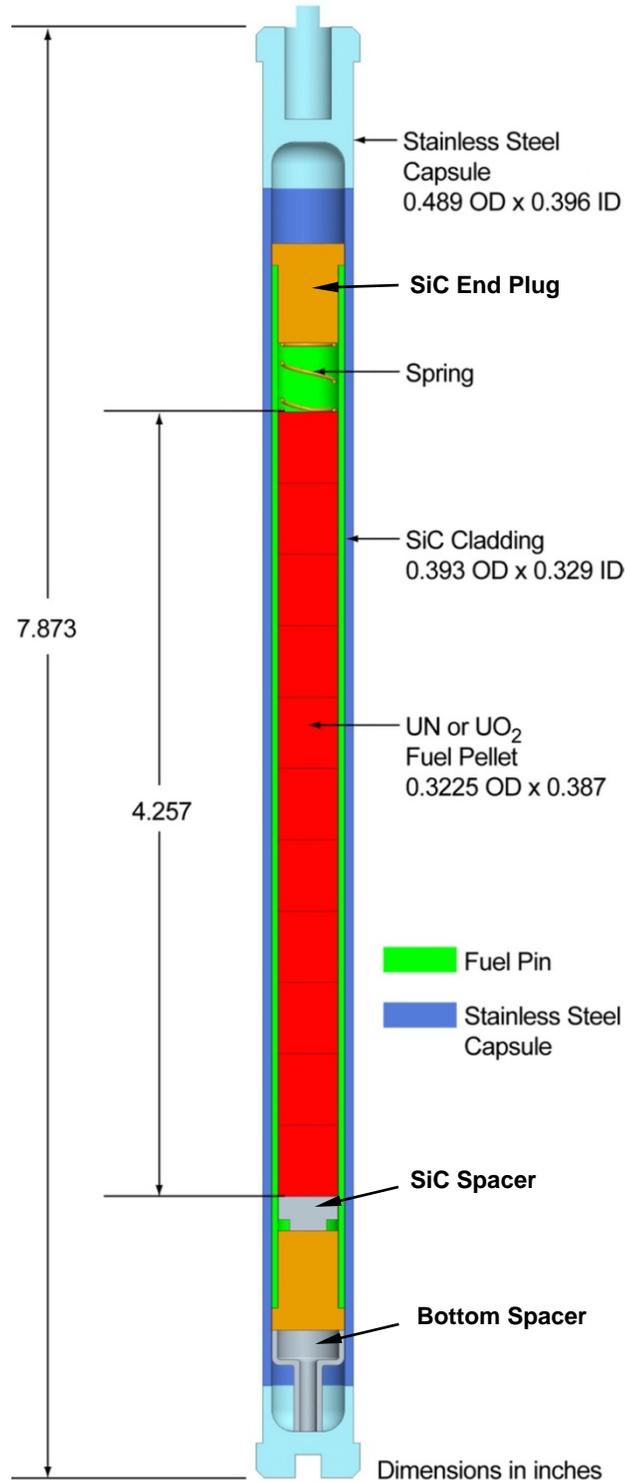
**Figure 1. Capsule and fuel pin design. Each Capsule assembly contains one fuel pin with 10 fuel pellets (11 pellets are shown in this diagram, but 10 were used in the actual irradiation)**

A UO<sub>2</sub> fuel pin, designated B4, designed to test an early SiC cladding material and end plug design was constructed and encapsulated in a stainless steel capsule for irradiation in HFIR. The stainless steel capsule was a necessary safety containment feature for irradiation in HFIR. Figure 1 is a schematic of the fuel pin and its containment. [1, 2]

The fuel pin B4 is composed of 10 UO<sub>2</sub> pellets, 4.95% enrichment, in a SiC tube with SiC end plugs cemented in place with a glassy ceramic. The fuel cladding is a triplex SiC material made up of an inner monolith of chemically vapor deposited (CVD) beta phase SiC, a middle layer of stoichiometric SiC fiber impregnated with beta phase SiC, and an outer layer of CVD beta SiC. The inside diameter of the cladding is 0.329 in., and the outside diameter is 0.393 in.

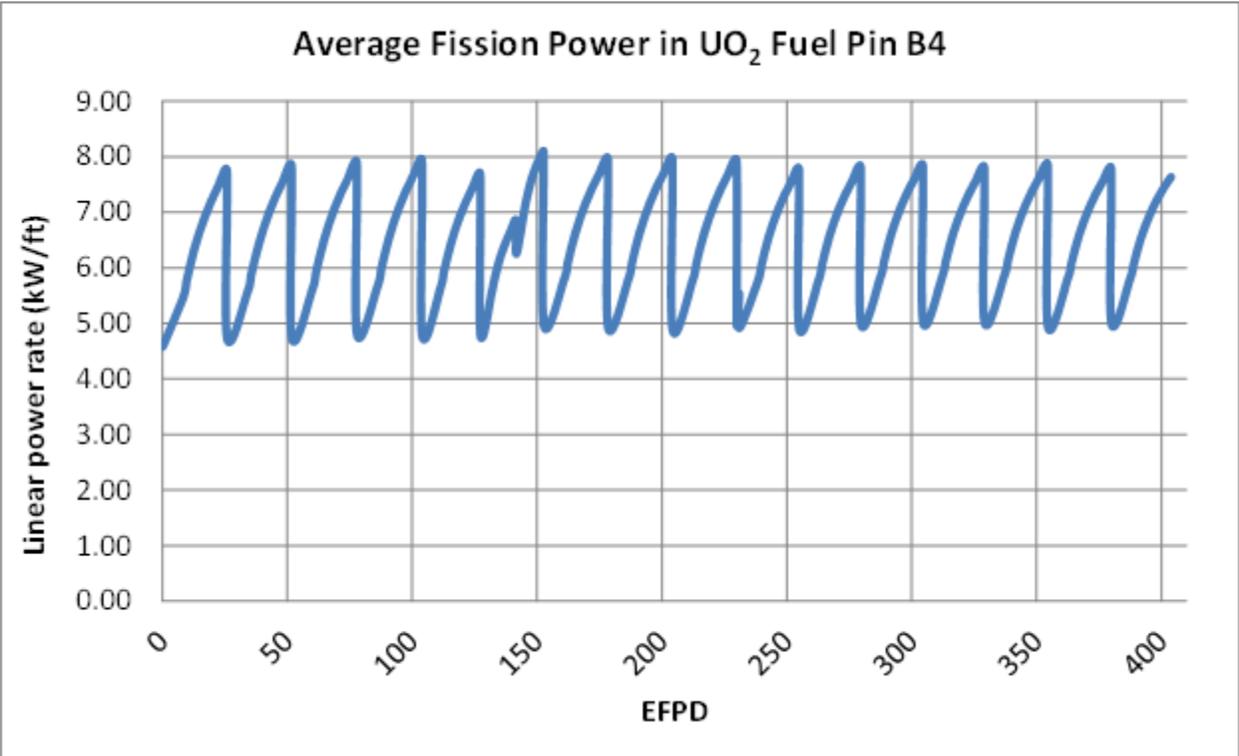
Figure 2. Fuel pin B4 fission power history.

The fuel pin capsule was irradiated for 403 full powers days in HFIR to a calculated burn-up of about 20 giga watt days per metric ton (initial) heavy metal (GWd/MTHM); it was exposed to a thermal neutron fluence of  $1.378 \times 10^{21}$  n/cm<sup>2</sup> and an average fuel pin clad operating temperature of about 380°C. The average fuel pin B4 burn-up per HFIR cycle is about 1.35 GWd/MTHM for the 16 cycles (HFIR cycle numbers 431 to 446) which totaled 403.19 fpd (34,271 MWd for HFIR core fission energy). The B4 fuel pin fission power history is approximately as shown in Figure 2.

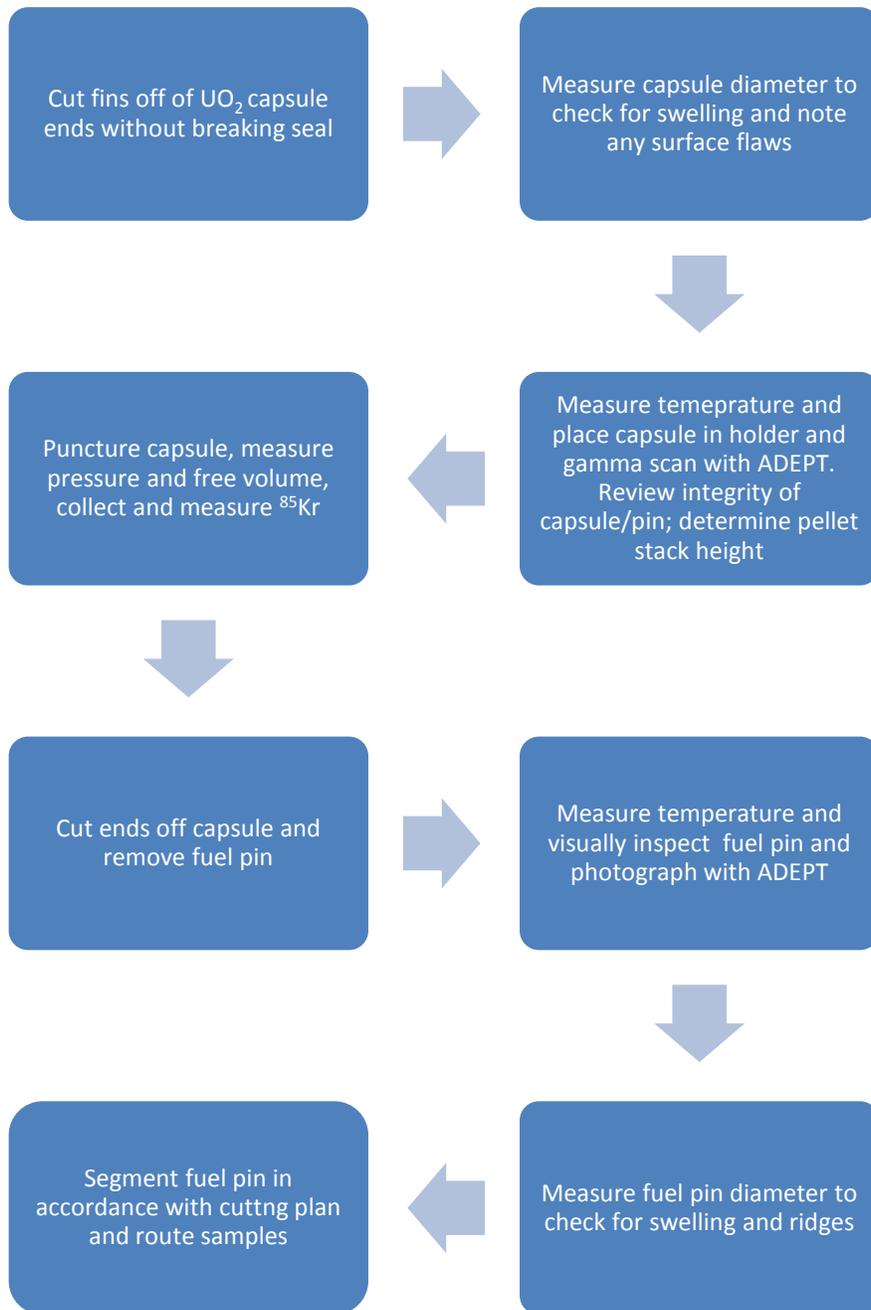
**Figure 3. Planned flow chart for PIE.**

A flow diagram of the planned PIE is shown in Figure 3. Preparation for the PIE included the design and construction of jigs and fixtures for cutting and capsule puncturing. This equipment was developed and installed without any problems.

This section presents the PIE results as outlined in the Figure 3 flowchart.

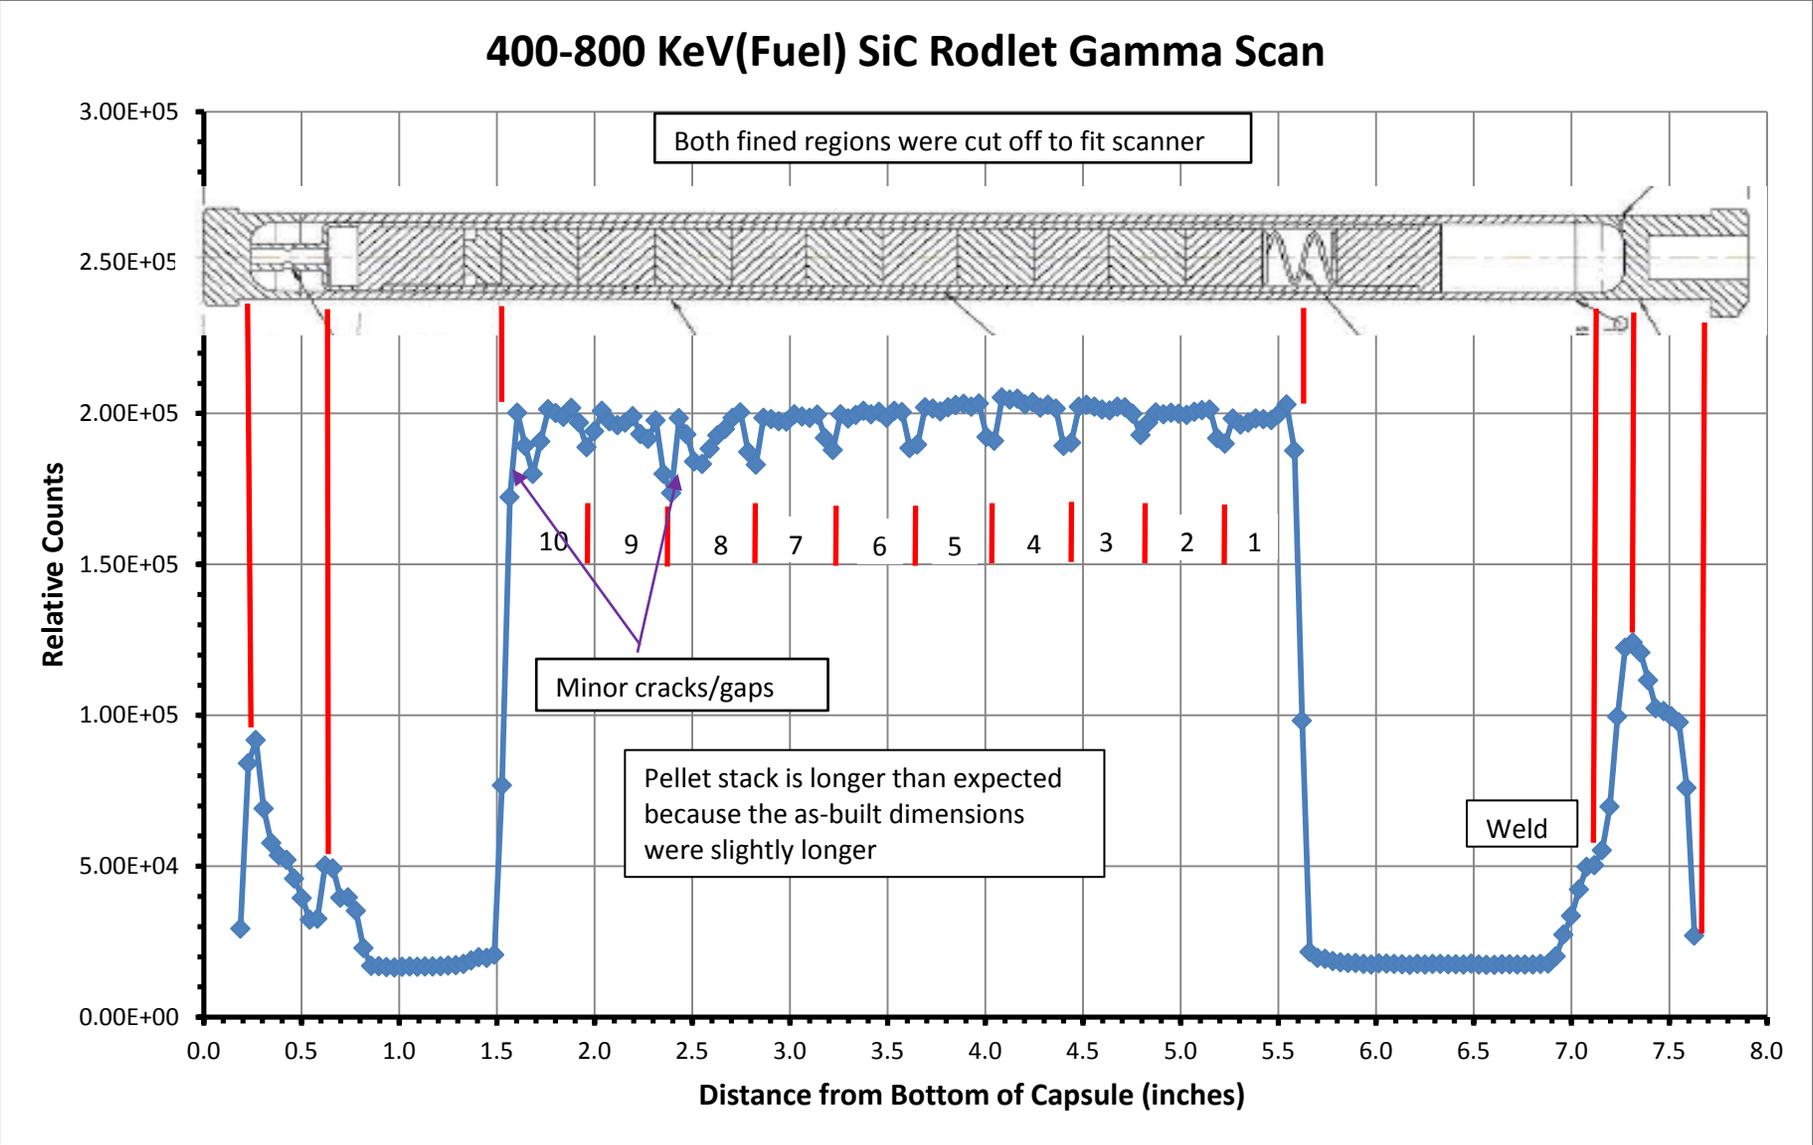
Figure 4. Low energy gamma scan of capsule showing the fuel stack.

The capsule was then placed in a holder tube for alignment in the gamma scanner and gamma scanned. The data points were taken 0.04” apart with a counting time of 60s; three energy ranges were recorded: 400 to 1600KeV, 400 to 800KeV, and 1100 to 1600KeV. The scan indicated no abnormalities with the internal components. The measured fuel stack was 4.02” and the as-build fuel stack was 3.93”; they agree within the accuracy of the gamma scan. Other than a couple of small cracks/gaps, the fuel stack was in excellent condition. The 400 to 800KeV scan is shown in Figure 4 and the 1100 to 1600KeV scan is shown in Figure 5. No information about minor swelling (< 0.04”) could be obtained from the scan.

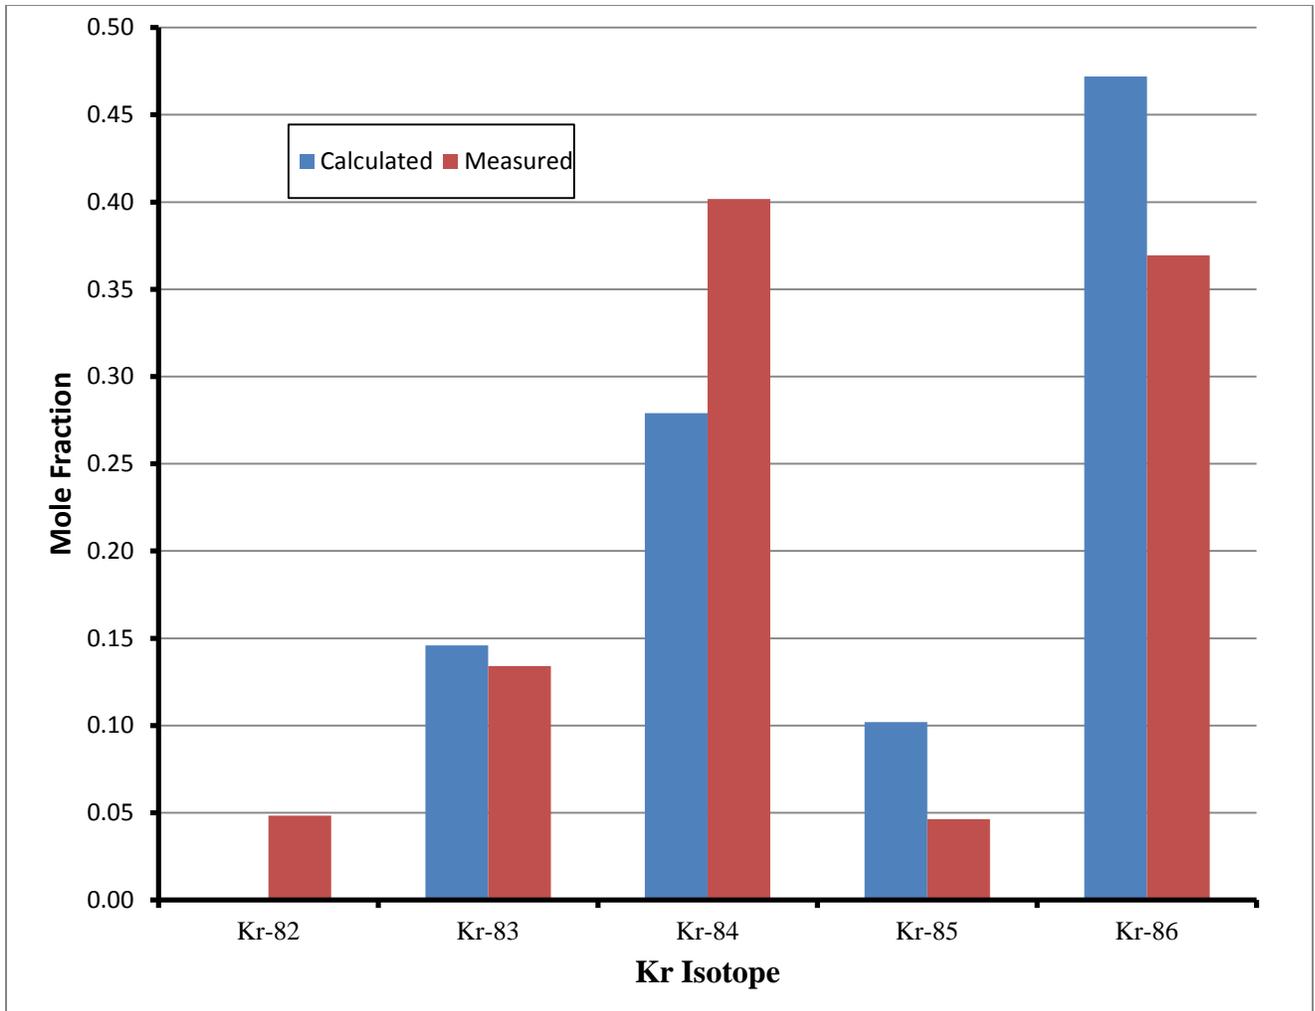
**Figure 6. Comparison of Kr isotope concentrations in the capsule gas sample.**

The measured capsule volume was 0.2 cu inches, the pressure was 28 psia, the Kr-85 inventory was  $1.2 \times 10^{-3}$  Ci, and the estimated fuel gas release fraction based on this measurement was 0.22%. The fuel pin clearly leaked an unknown amount at some time during irradiation; thus, these activity and pressure values are not representative of expectations since they involve unknown combinations of fuel release, pin volume, capsule fill gas, and capsule volume. See Table 3. Note however, that a fission gas isotope's *mole fraction* (previous paragraph) is little effected by this leakage issue because early in the irradiation the gas generation comes mostly from the fission of U-235; little comes from other (bred) isotopes which can have a different Kr/Xe ratio.

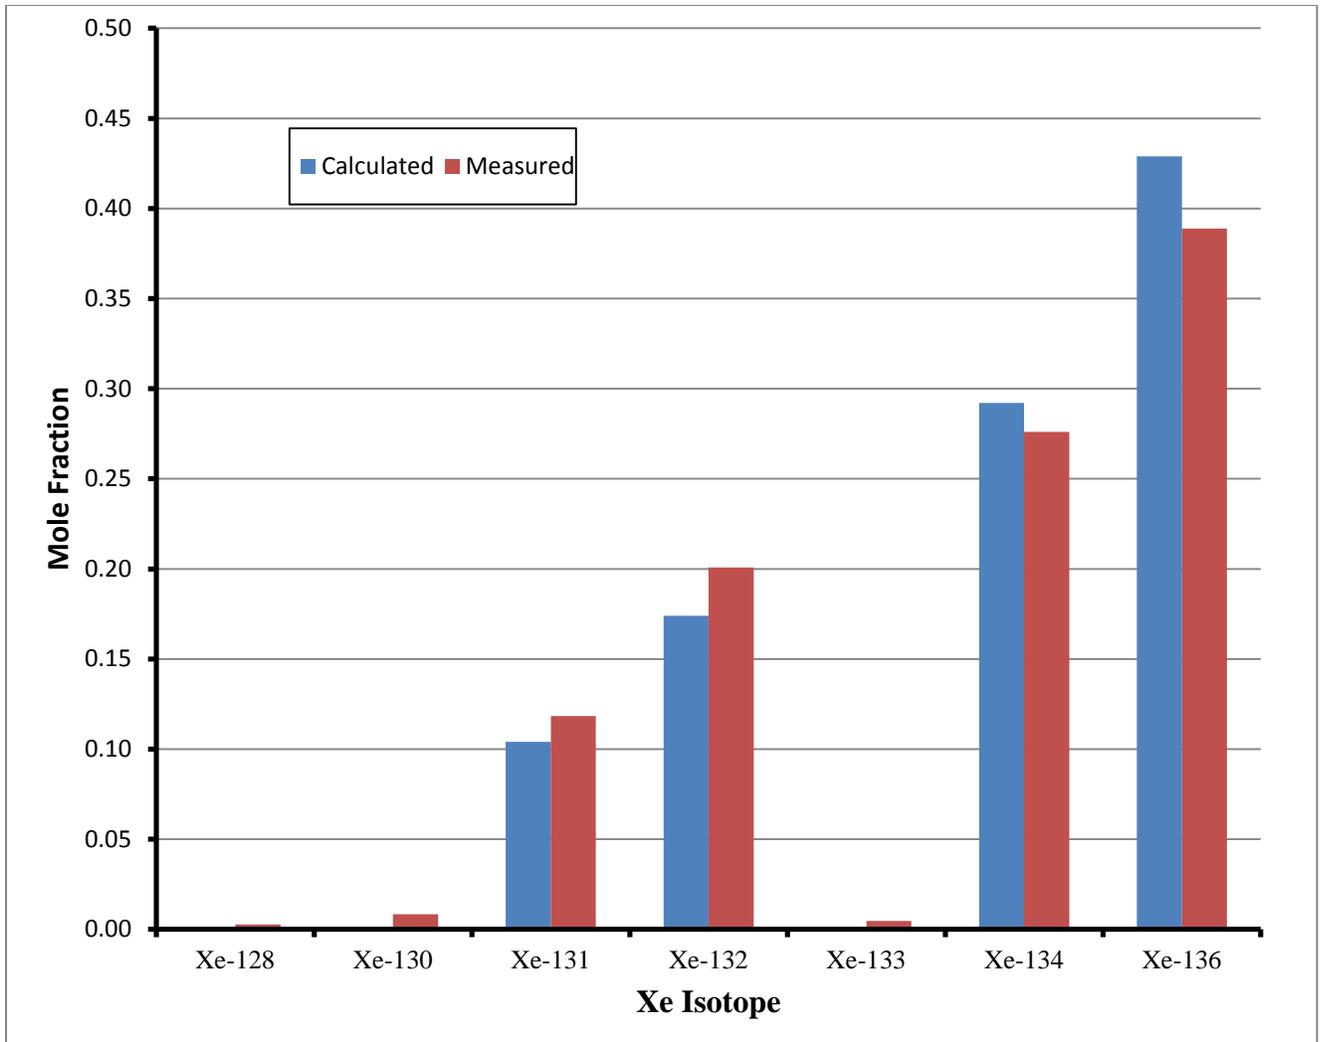
**Figure 7. Comparison of Xe isotope concentrations in the capsule gas sample.**

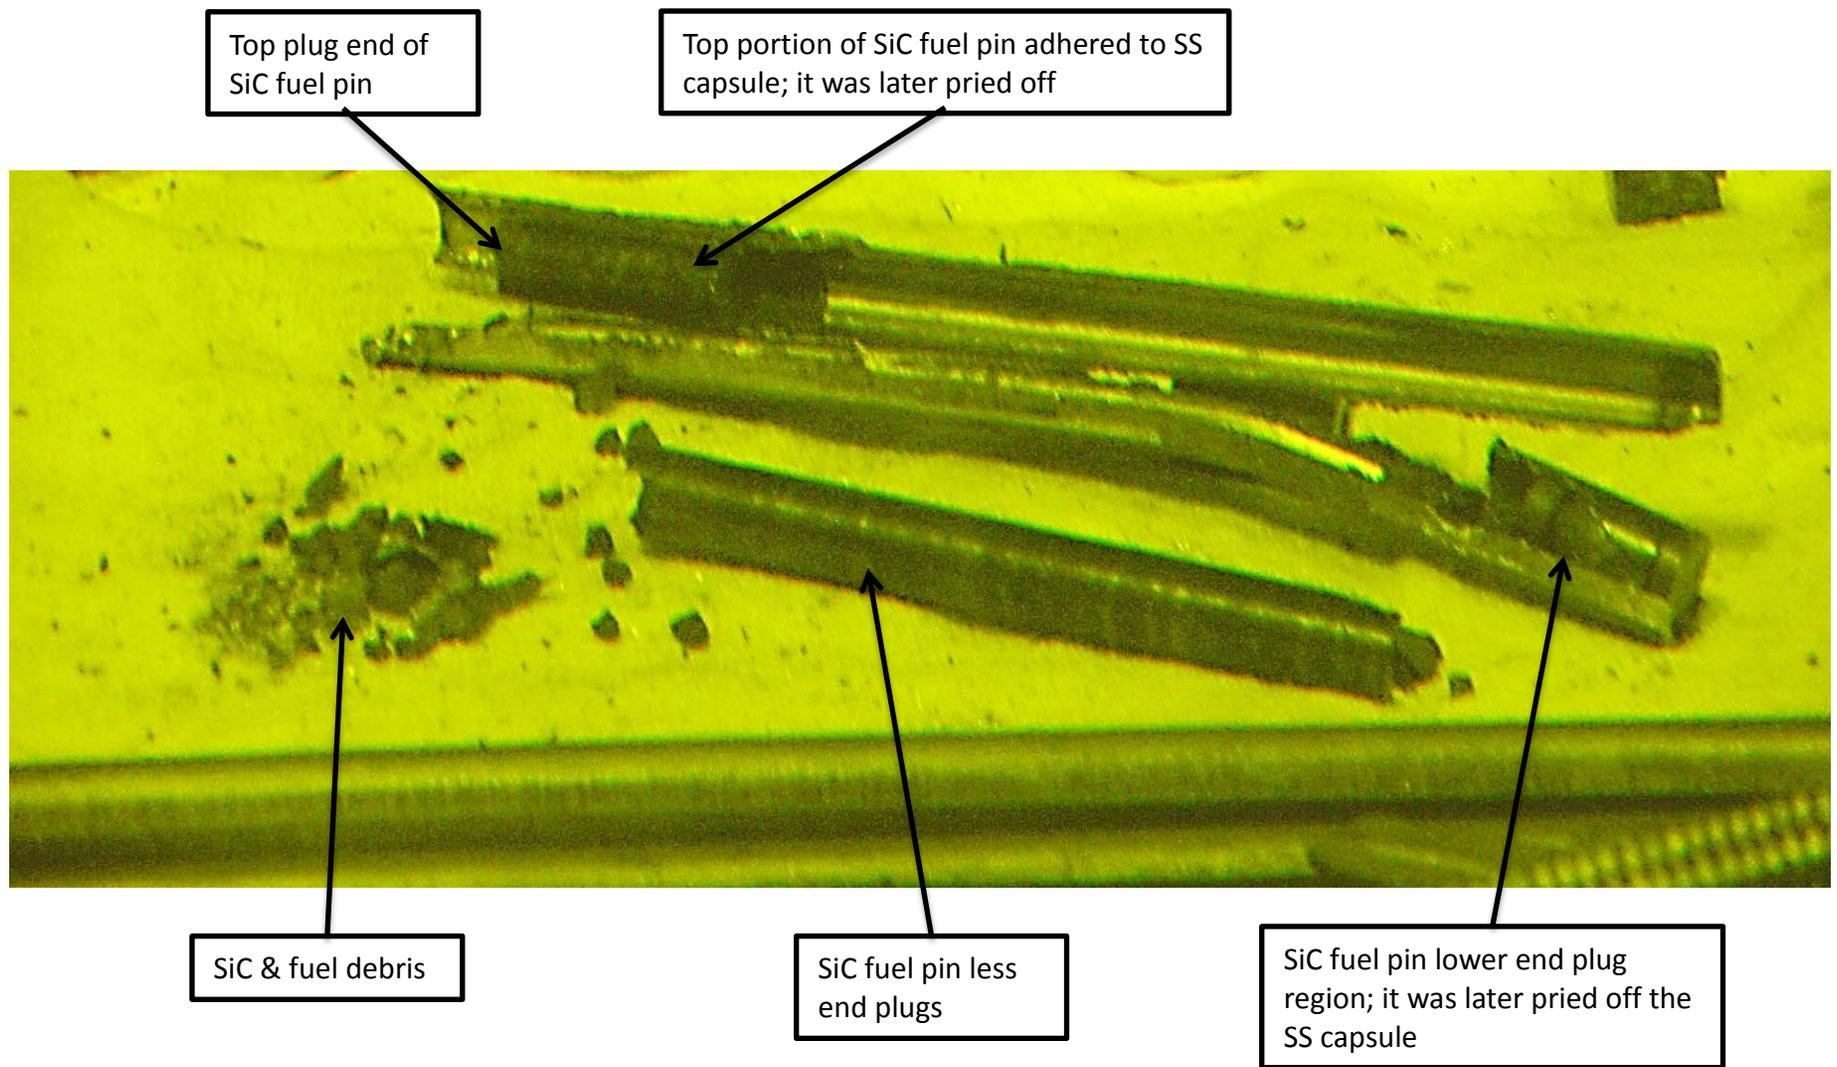
The capsule was opened by sawing off the ends to expose the fuel pin. The capsule was then placed in a push-out jig to remove the fuel pin; however, the pin could not be pushed out despite using a considerable amount of force. The capsule was finally opened by milling two longitudinal slots 180° apart along its length. The retrieved fuel pin was broken into 3 pieces along with a modest amount of debris. It is not clear when the pin broke; it could have broken during irradiation, handling, or during the milling to free it. The puncture results in the previous sections showed that there was a loss of pin seal at some point in the irradiation and handling. See Figure 8. The end plugs were stuck to the capsule inner walls and had to be pried loose. There was a considerable amount of debris; both broken SiC clad and fuel pellets pieces.

**Figure 8. The results of the fuel pin removal. Note that the fuel pin end plugs were stuck to the capsule inner walls and had to be pried loose.**

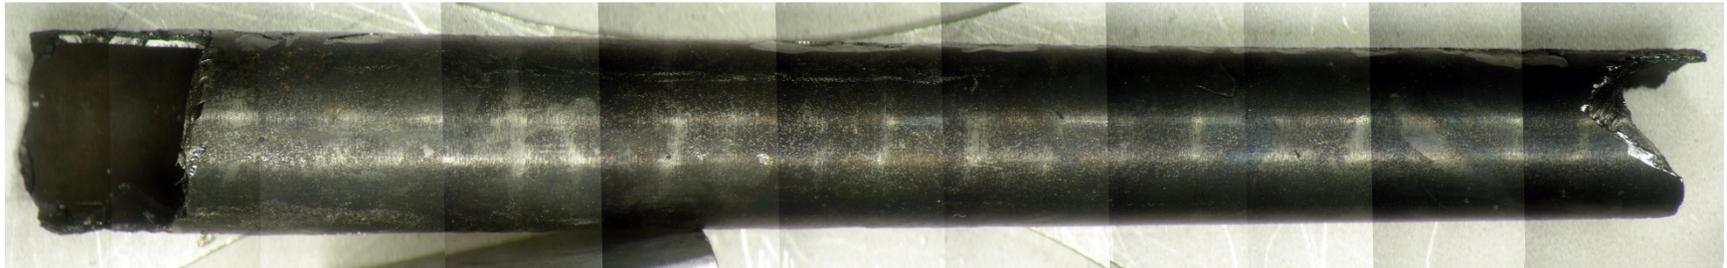
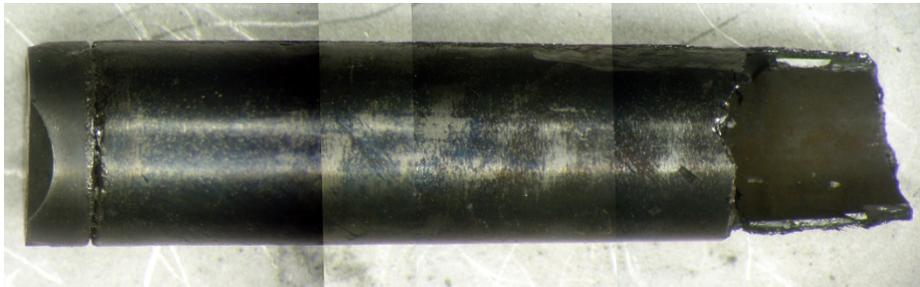
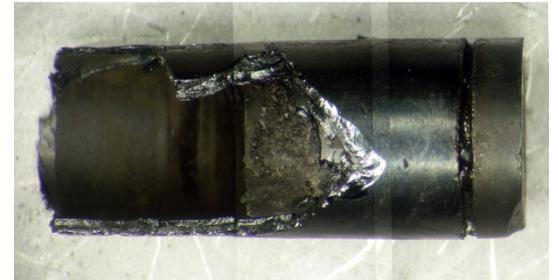
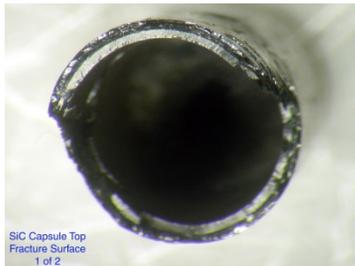
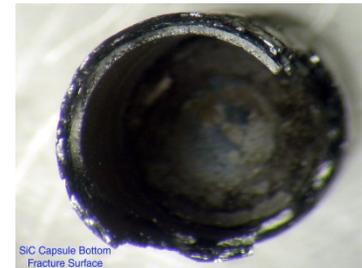
Because of the poor condition of the fuel pin the temperature was not measured for fear of spreading fuel contamination and causing further damage. Pictures were taken of the fuel pin and a portion of the capsule near the top of the fuel pin. Figure 9 shows photographs of the fuel pin. Note that the failure took place near the end plugs.

**Figure 9. Photographs of the broken fuel pin. Note that the failures took place near the end plugs.**

After opening, the fuel pin was found to be broken into 3 pieces. It is not clear whether the pin was broken during irradiation or failed during opening. It was clearly in a poor state. The fuel was loose in the clad and all of it slid out during handling; thus a MET mount with both fuel and cladding could not be obtained. No macro signs of fuel/cladding interactions were noted, but the clad swelling eliminated any hard fuel/clad contact. MET mounts showed that the clad expanded outward and that the actual construction may have been somewhat different than the nominal design.

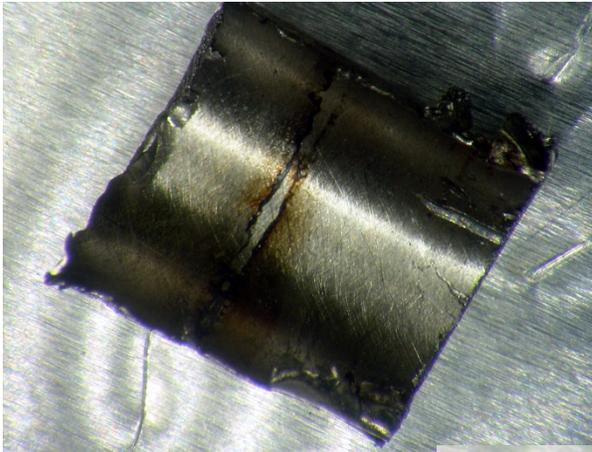
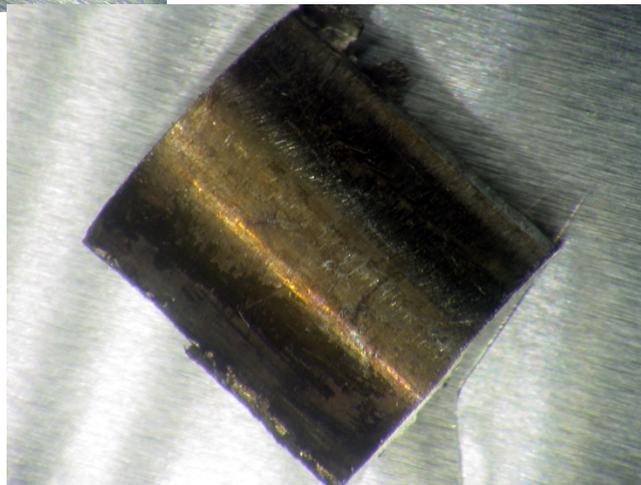
A stainless steel capsule piece near the top of the capsule was also photographed. There were no indications of any large surface build-up that might cause the capsule diameter to increase. See Figure 10.

Capsule Inner  
Surface Near Top  
of Fuel Pin

Capsule Outer  
Surface Near Top  
of Fuel Pin

**Figure 10. Photographs of capsule inner and outer surfaces near the top of the fuel pin. There are no indications of any large surface build-ups; only a mild discoloration.**

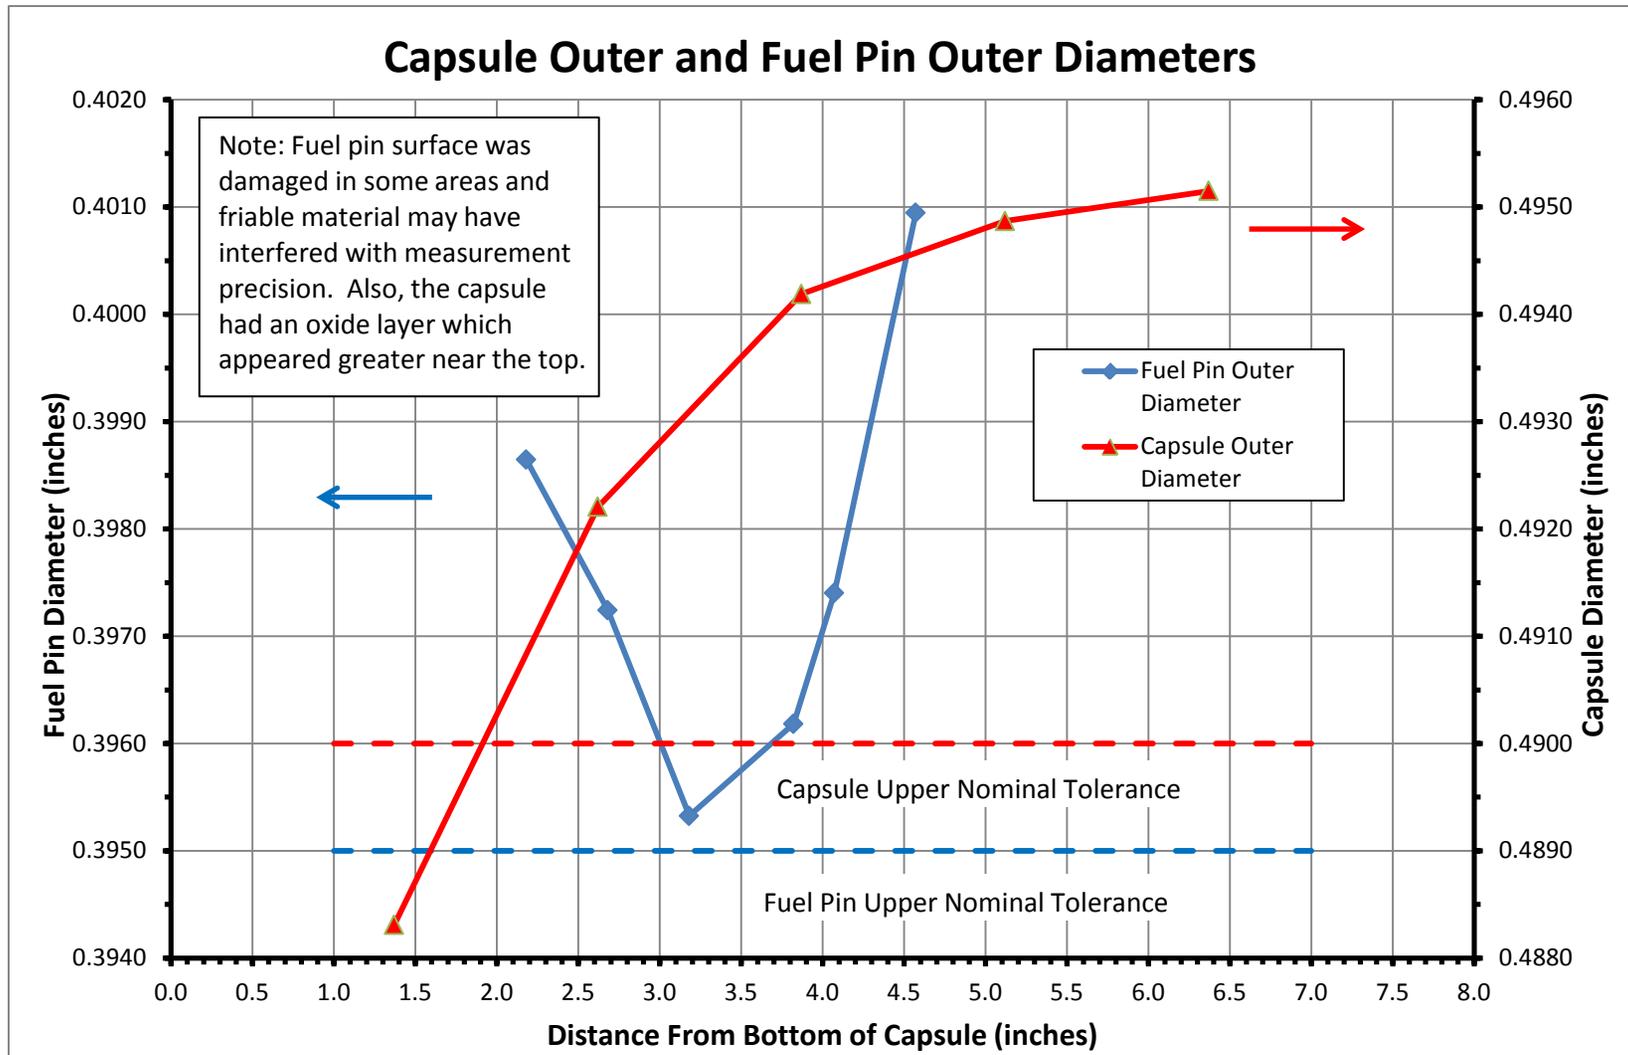
Figure 11 is a graph showing the capsule outer diameter and fuel pin outer diameter (less end plugs) showing that the greatest deviations from the nominal assembly dimensions were near the end plugs. Figure 12 is a graph of the capsule inner diameter and the fuel pin outer diameter illustrating the axial radial gap. The bottom end plug was measured at one location and the top end plug was measured at 2 locations. These measurements imply that the SiC cladding and the end plugs swelled beyond the design calculations and exerted considerable force on the capsule wall. The measurements were difficult to make because of the poor surface quality of the components; also, some relaxation (dimensional increase) of the components may have happened during disassembly, thus the apparent negative gap in some regions. Further work, beyond this PIE report, will have to be done to determine the material's behavior, the actual operating temperature, and the mechanical stresses.

**Figure 11. Outer capsule and fuel pin diameters. Note the increases near the fuel pin ends. This graph does not include the fuel pin broken off end plugs.**

The SiC clad swelled during irradiation and placed pressured on the outer stainless steel capsule as indicated by dimensional measurements; the extent of the swelling was such that the fuel pin could not be easily removed and had to be cut out. Prior to capsule opening and fuel pin retrieval, a gamma scan revealed that all the capsule and pin components were in their expected locations. Sometime during the irradiation the pin seal failed and leaked fission gas to the capsule plenum; thus, an accurate measurement of fuel fission gas release could not be obtained.

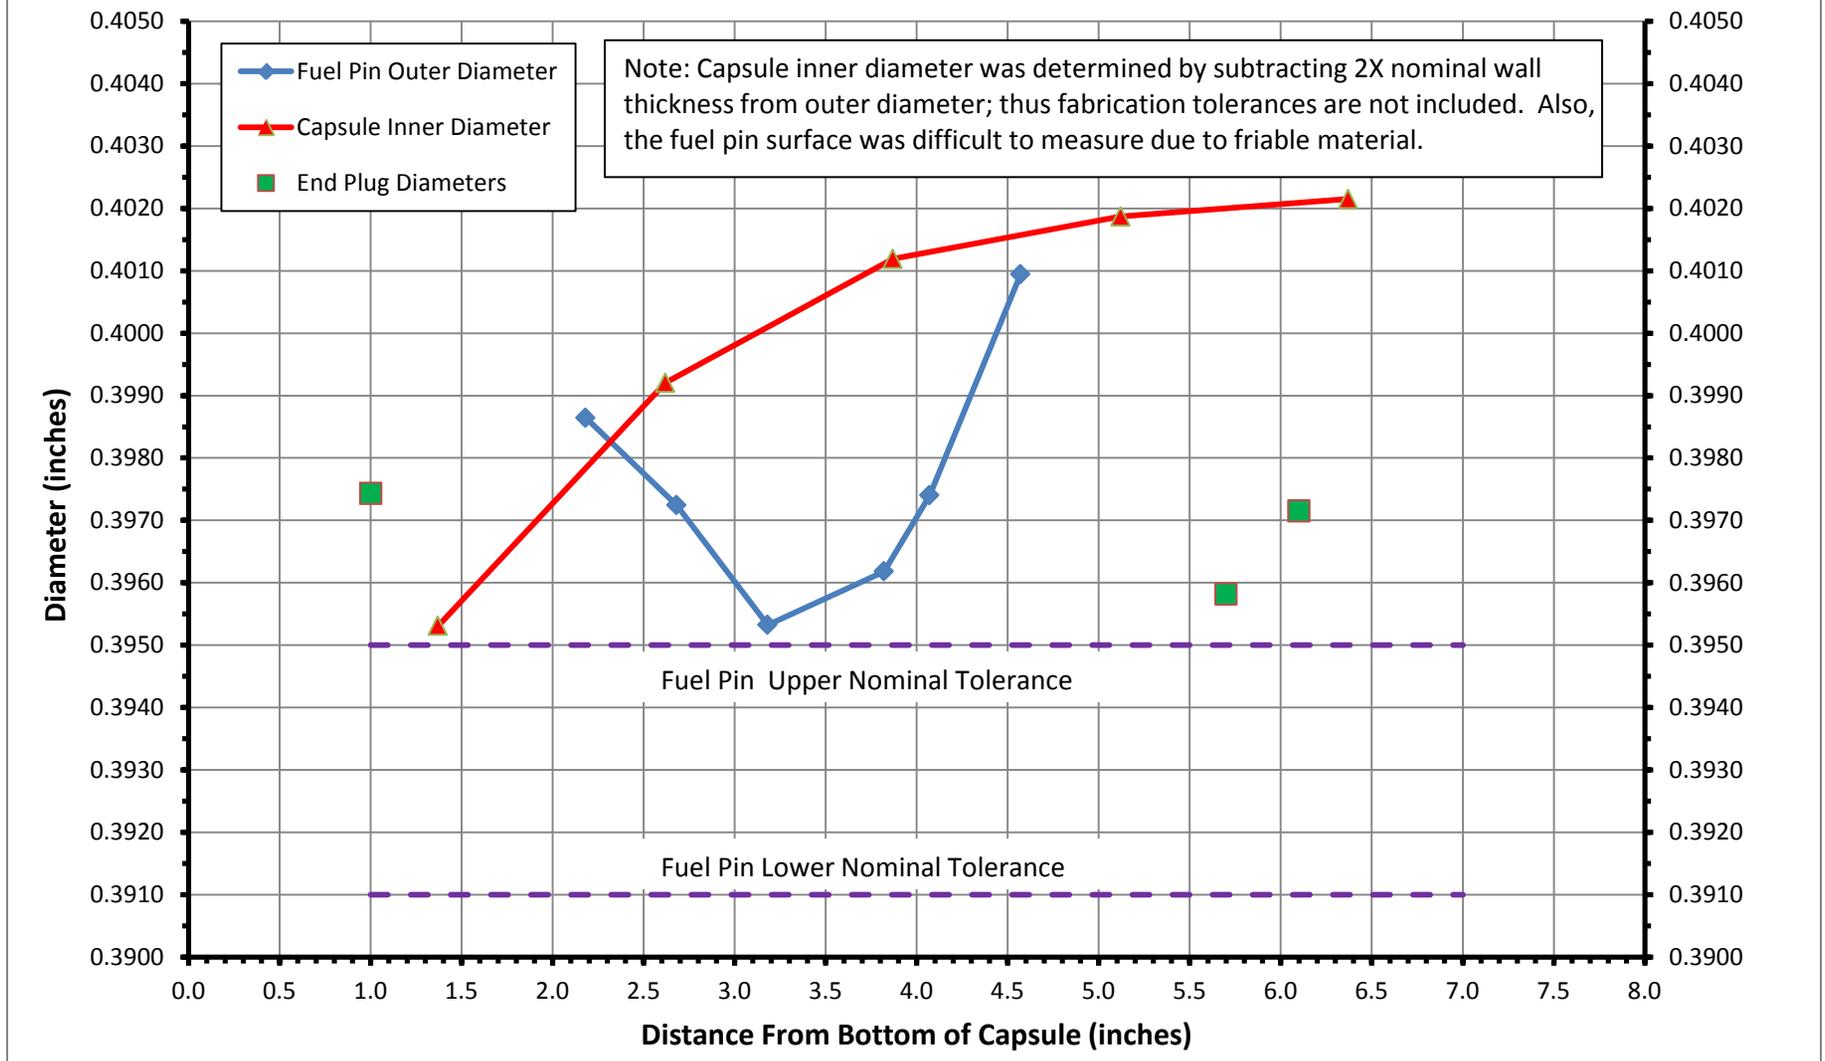
Figure 12. Capsule inner and fuel pin outer diameters illustrating gap.

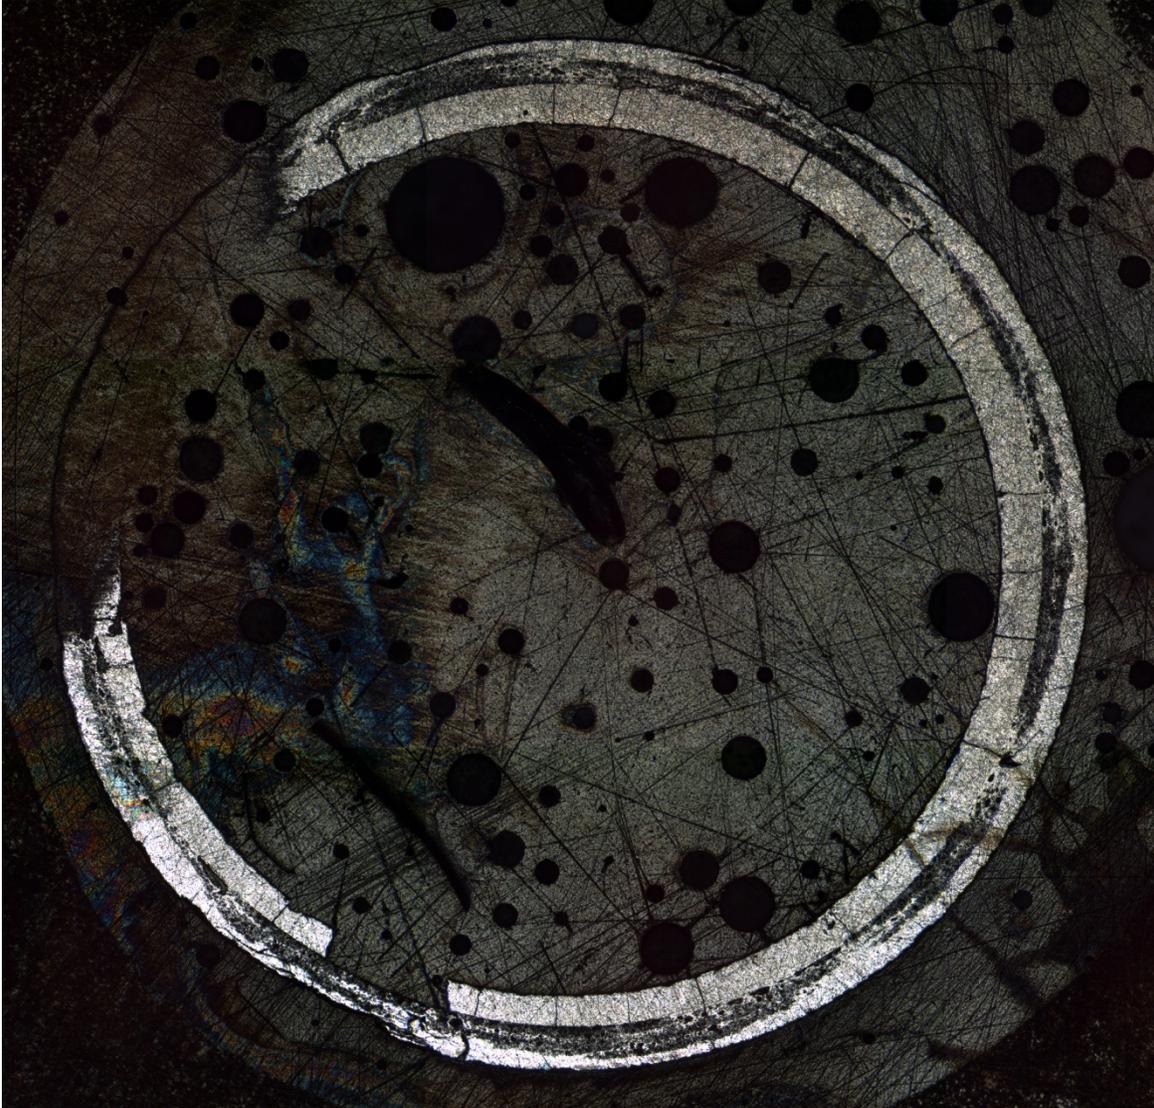
The ring MET mount is shown in Figure 13. Difficulties were encountered in polishing this mount and it is shown for qualitative purposes only. The structure of the cladding is apparent, the inner SiC layer, the fiber center, and the SiC outer layer. Resources were not sufficient for a second try.

**Figure 13. Clad ring sample about 1" from bottom. Difficulties were encountered in the preparation of this mount; however, some detail about the structure of the clad can be gleaned. Because of the poor nature of this mount, no information about the cracking is certain since the cracks may have occurred during the preparation; however, the clad was in poor condition prior to mounting so it is likely that some physical damage occurred during irradiation.**

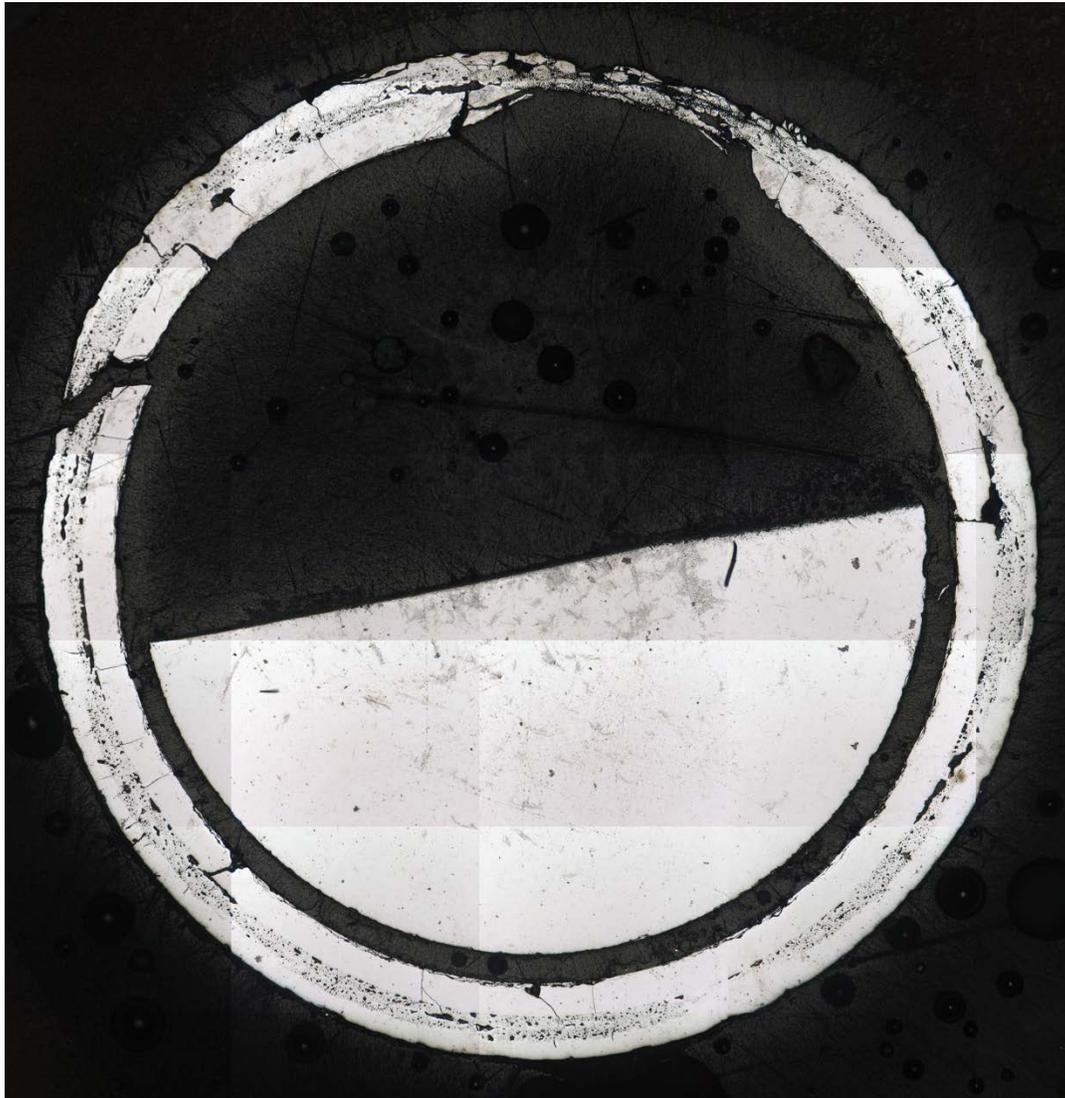
The full view top end plug MET mount is shown in Figure 14. Only half of the plug could be brought into view during the grinding and polishing; it either shifted slightly during mounting or a portion of it chipped off during cutting and grinding. The full cladding cross section is apparent; much of it is in poor condition and the fibers are not evenly distributed; see Figure 15. It is difficult to tell if the apparent porosity is actually present or due to chip out during preparation as this material was friable. Using image analysis software and the source photo for Figure 14, the diameter of the plug segment was estimated to be 0.312"; the nominal dimension is 0.322" at the 1/2 length position. The plug is tapered and ranges from 0.310 to 0.333" in diameter. This suggests that the cut was actually nearer the bottom of the plug or the plug shrank. The outer diameter of the clad at the cut point was 0.397", the nominal value is 0.393"; this number agrees well with Figure 12. The inner diameter of the clad was 0.336"; the nominal value is 0.329". The inner diameter of the composite layer was estimated at 0.364" and the outer region at 0.380". The plug sealing material is not apparent in this photo, but it may have pulled out during the grinding and polishing, thus we have no information on its detailed behavior.

**Figure 14. Cross section of top end plug and adjacent cladding. Note the poor condition of the cladding and the uneven distribution of the fibers at the 5 o'clock position. The end plug either shifted or chipped and could not be polished flat. The cement holding the plug in is not readily apparent. The black regions are epoxy; it is difficult to tell if the SiC composite has significant porosity or if these regions are due to pull-out during preparation.**

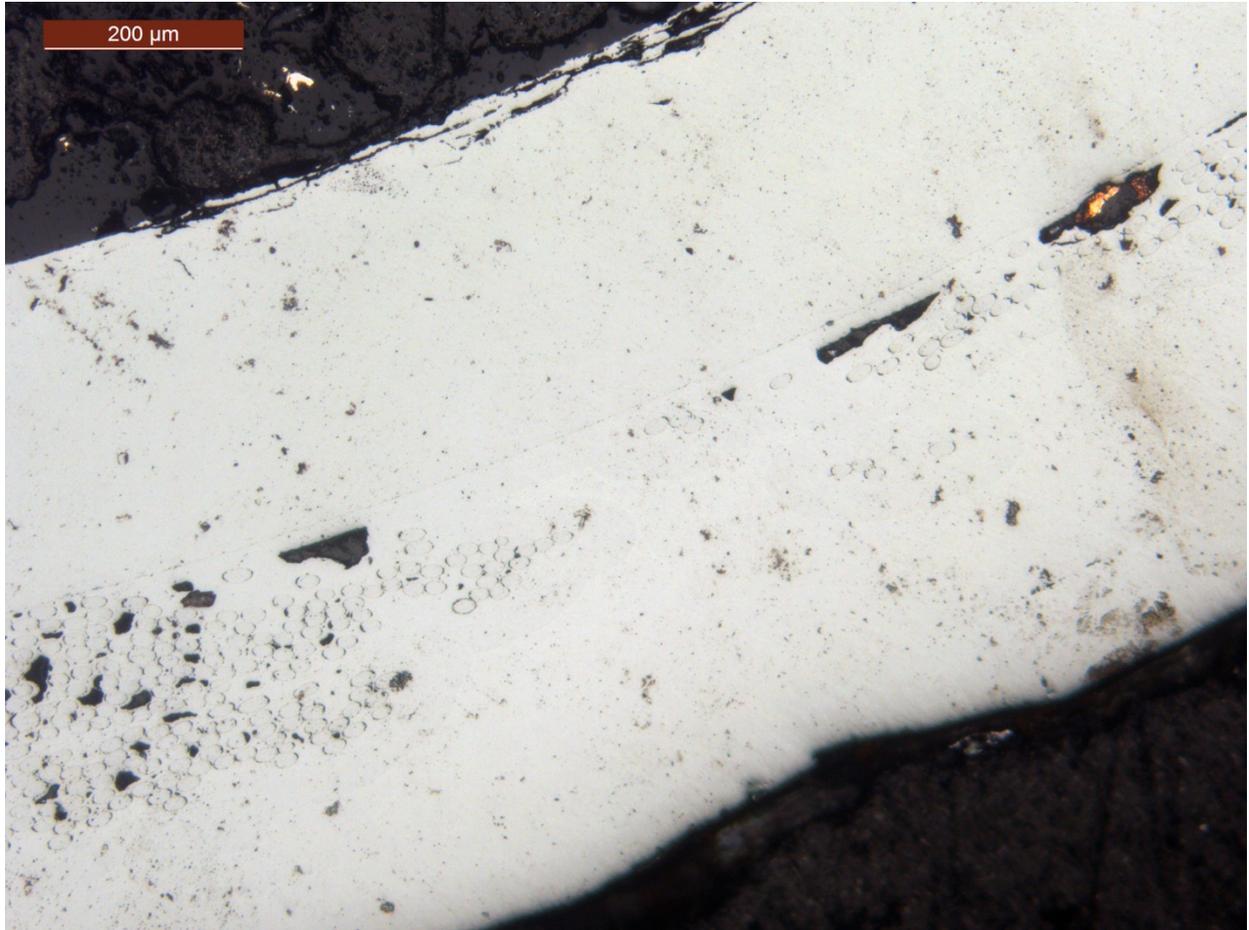
**Figure 15. Close up of cladding region at 5 o'clock (Figure 14) with low fiber count.**
