# 20 Gwd SiC Clad Fuel Pin Examination

APRIL 2014

LWRS SiC Clad Technology Development Program

Prepared by  
OAK RIDGE NATIONAL LABORATORY  
Oak Ridge, Tennessee 37831-6283  
managed by  
UT-BATTELLE, LLC  
for the  
US DEPARTMENT OF ENERGY  
under contract DE-AC05-00OR22725

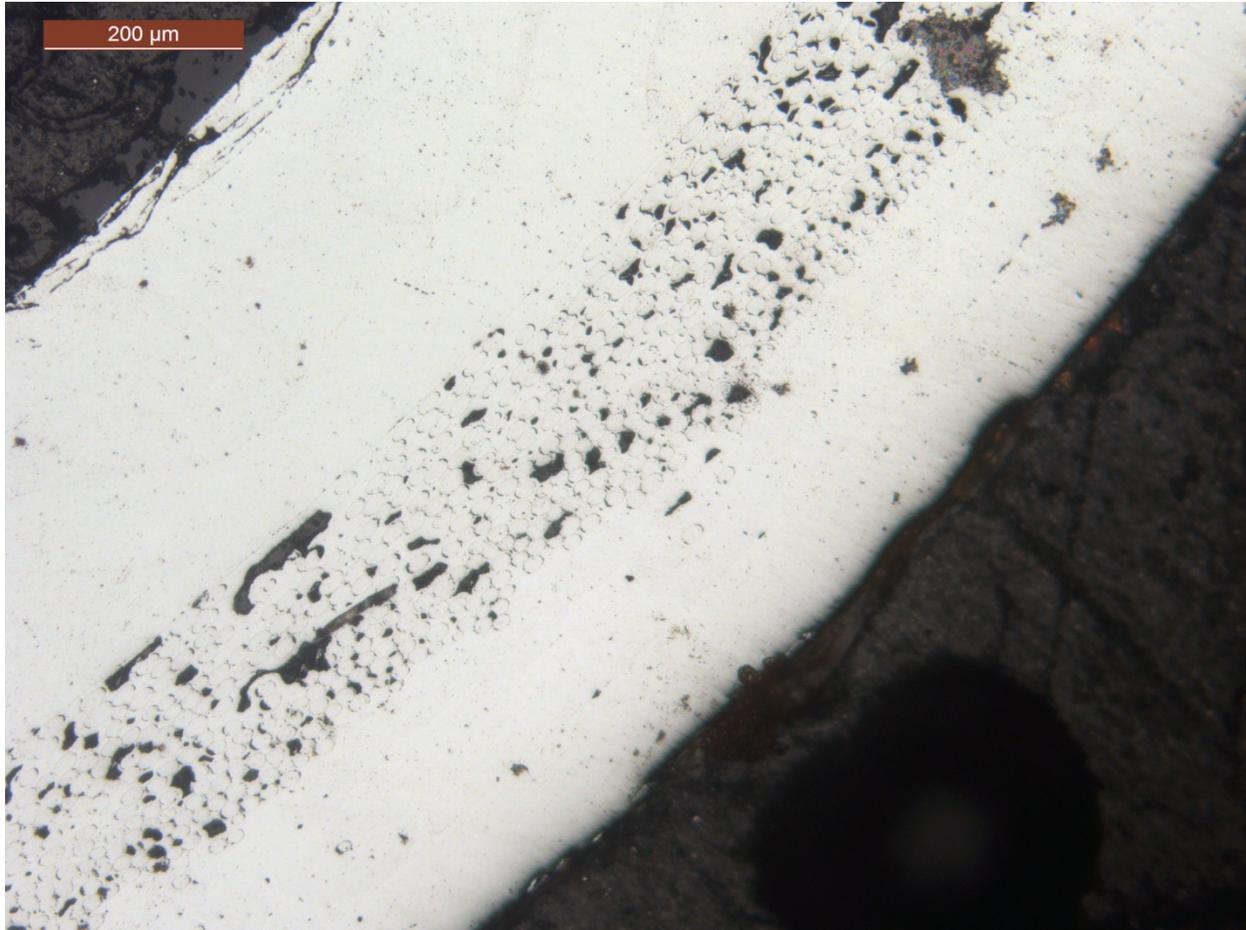
The local cladding layer regions are also of interest as they can be used to get better estimates of the layer thicknesses; see Figure 16 which shows the three regions: outer SiC seal layer, composite layer, and inner SiC seal layer. The nominal dimensions are: outer SiC seal layer 0.004" thick, the composite layer 0.014" thick, and the inner seal layer 0.014" thick. Estimates of these layer thicknesses from the MET mount, using the same image analysis software as above, are outer SiC seal layer 0.0087" thick, composite layer 0.0084" thick, and inner seal layer 0.014".

Together, these values indicate that the clad expanded outward consistent with the previous measurement, but the measured values for the layer thickness are quite different than the nominal values for the composite region and the outer SiC seal layer. Given this data and the fiber inconsistencies in Figure 15, the construction of the cladding may have been different than the nominal design. If the porosity in the composite layer is real and greater than pre-irradiation, then the expansion of the composite region may have driven the outward expansion, stressing the seal layers and cracking/breaking them. Neither mount showed signs of fuel clad interaction.

**Figure 16. Cladding region at 4 o'clock (Figure 14) showing the relative thicknesses of the three cladding regions: inner SiC seal layer, composite layer, and outer SiC seal layer.**

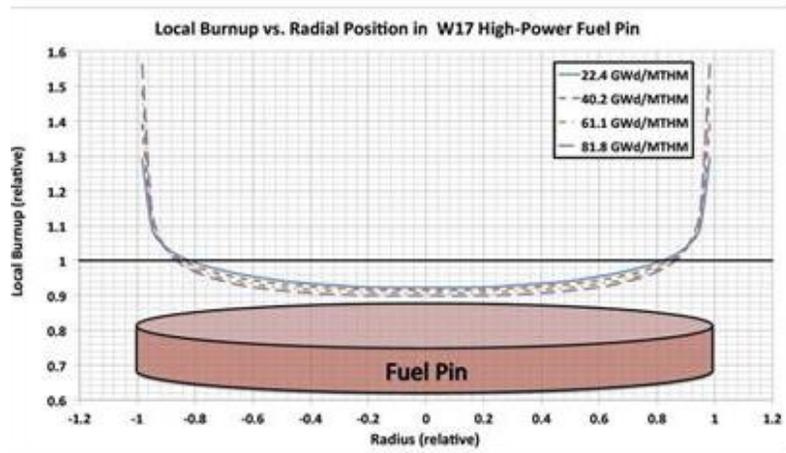
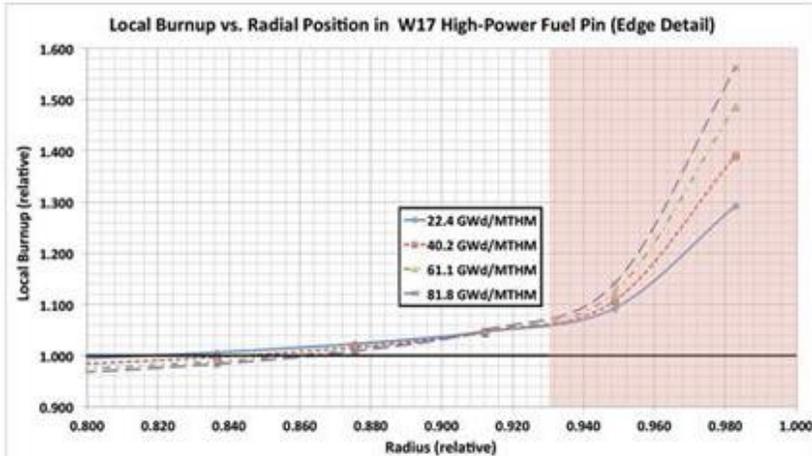
It is a known phenomenon in the irradiation of LEU UO<sub>2</sub> fuel pellets that rim effects [9, 10] result in sharp increases in burn-up levels, and Pu and Nd isotope mass fractions, in the outer annular zones of the fuel pellets. These rim effects are usually quite prominent at high fuel burnup levels, but are non-negligible at moderate burnup levels in the 20 GWd/MTHM range as seen in Figure 17 and Figure 18.

Figure 17. From Ref. 9, the rim effect in the radial fuel burn-up profile of an irradiated fuel pellet, for average pellet burn-ups from 20 to 80 GWd/MTHM. The effect is not insignificant, even for burn-up of 20 GWd/MTHM .

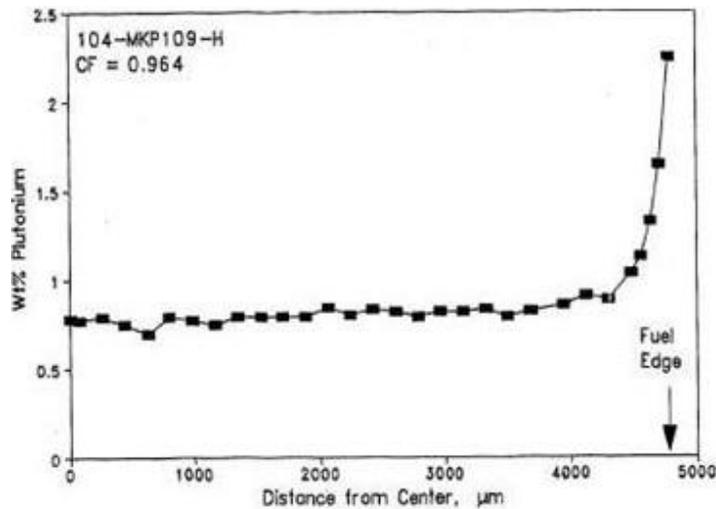
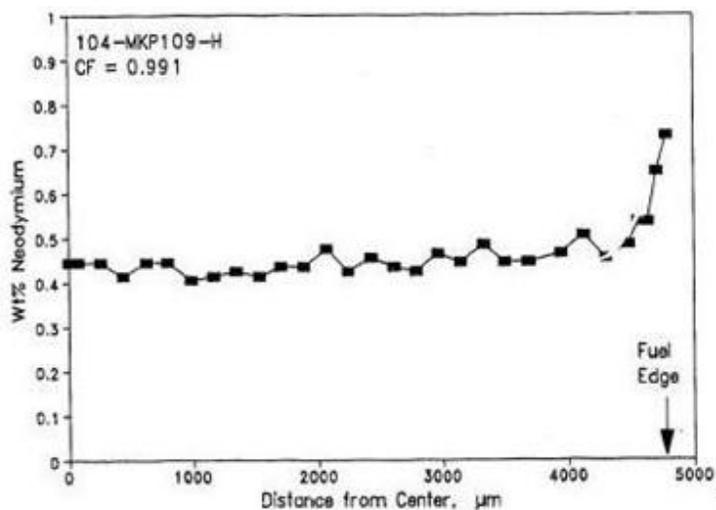
Figure 18. Plutonium and Neodymium Concentrations across the radius of a fuel pellet in the Ref. 10 measurements: Illustration of the rim effect in irradiated pellets.
