Interrogation of Alkali-Silica Reaction Degraded Concrete Samples using Acoustic and Thermal Techniques to Support Development of a Structural Health Monitoring Framework

April 2017

U.S. Department of Energy
Office of Nuclear Energy

**Idaho National Laboratory
Idaho Falls, Idaho 83415**

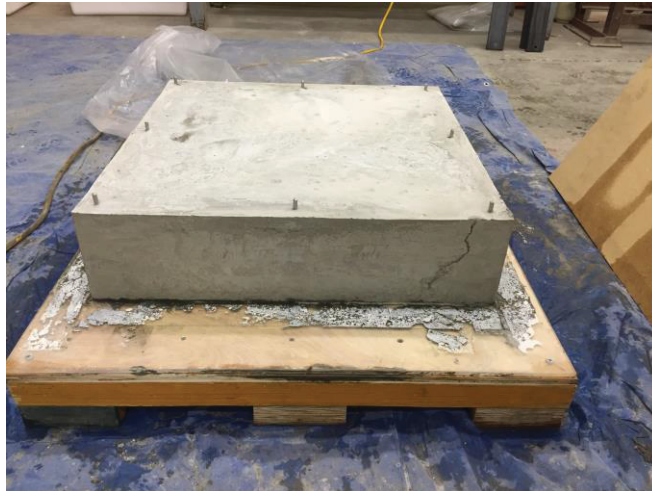
Figure 3. 2 ft × 2 ft × 6 in. dimension concrete slab.

This medium-sized slab was cast on December 21, 2015 and has dimensions of 2 ft × 2 ft × 6 in. Figure 3 shows an image of the slab immediately after the mold was removed.

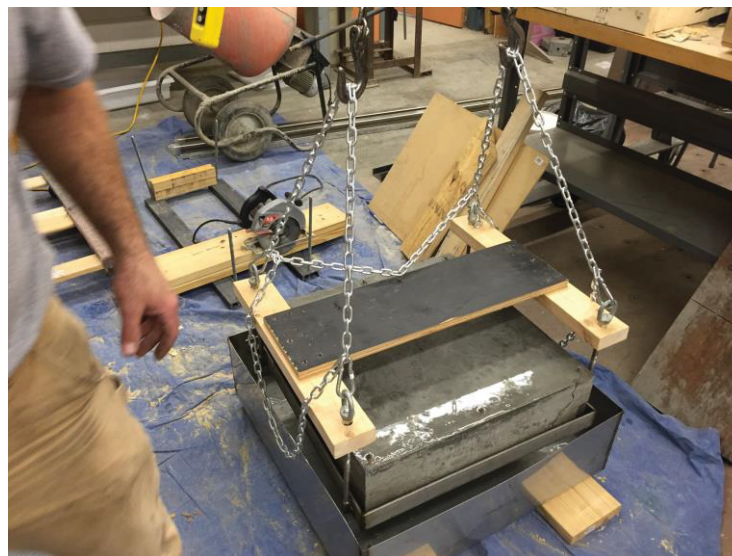
Figure 5. Slab sitting on the frame and being lowered into the tub.

3.1.2.2 Curing Tub. A stainless-steel piece of sheet metal is bent and welded along the seams to form a watertight tub with four sides. This tub is used for curing the slab. In Figure 5, the slab is being lowered into the tub by a crane located at the Laboratory for Systems Integrity and Reliability. ASR is a slow process that can take several decades to come to fruition; in the laboratory there are several things that can be done to accelerate this process. Using sodium hydroxide, NaOH, in the mix water or placing the cured concrete in a NaOH solution causes an increase in PH. Selecting highly reactive siliceous aggregates or even glass will provide an available source of silica. Lastly, curing the specimens at temperatures around 60°C has been found to accelerate ASR. The slab was cured above water in 100% humidity and 60°C in a controlled environmental chamber.

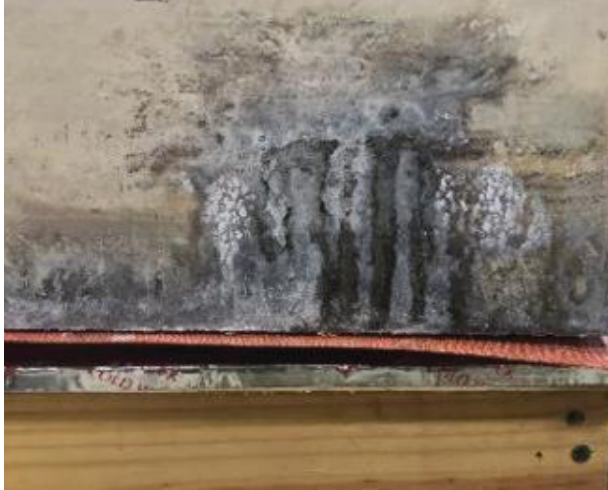
Figure 7. Damage location 1 – cracking and powder effluence.

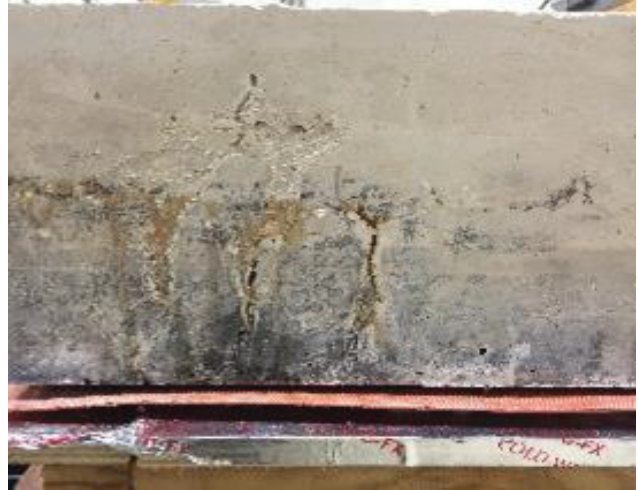
Figure 8. Damage location 2 – clear gel effluence.

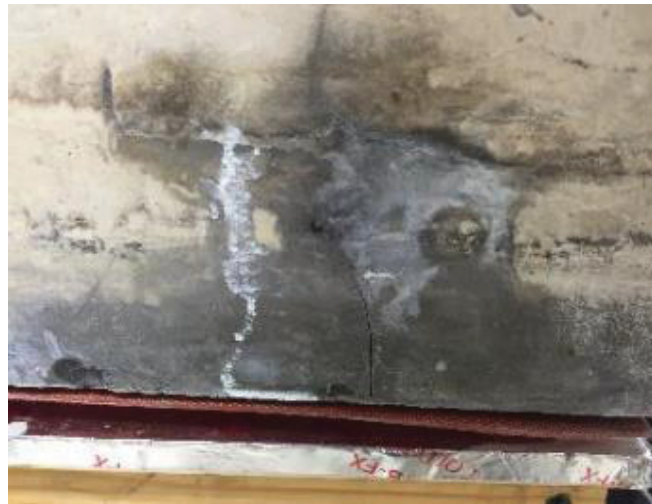
Figure 9. Damage location 3 – cracking and powder effluence.

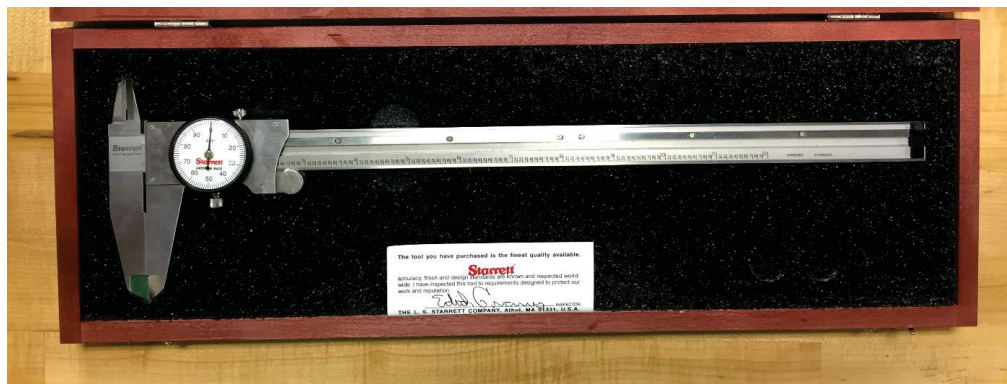
Figure 10. Calipers used for mechanical deformation measurements.

Calipers are used to take length measurements, and comparison of these measurements overtime reveals whether any deformation has occurred. The calipers shown in Figure 10 and Figure 11 have a maximum length of 1 ft and a resolution of .001 in. Steel nails were cast into the concrete samples in order to provide a reference points for length measurements.

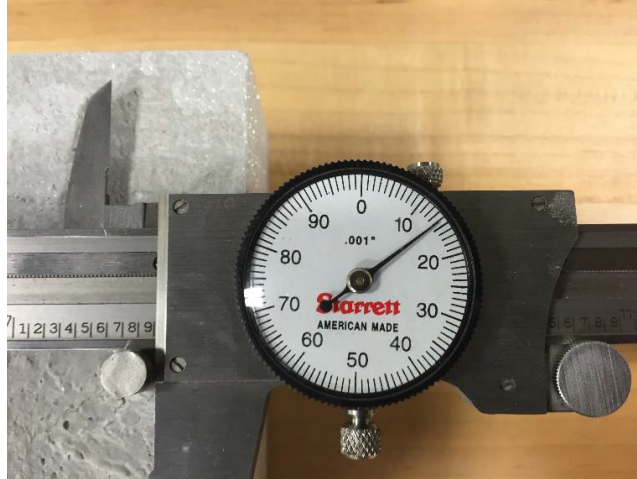
Figure 11. Calipers being used to measure the distance between nails.

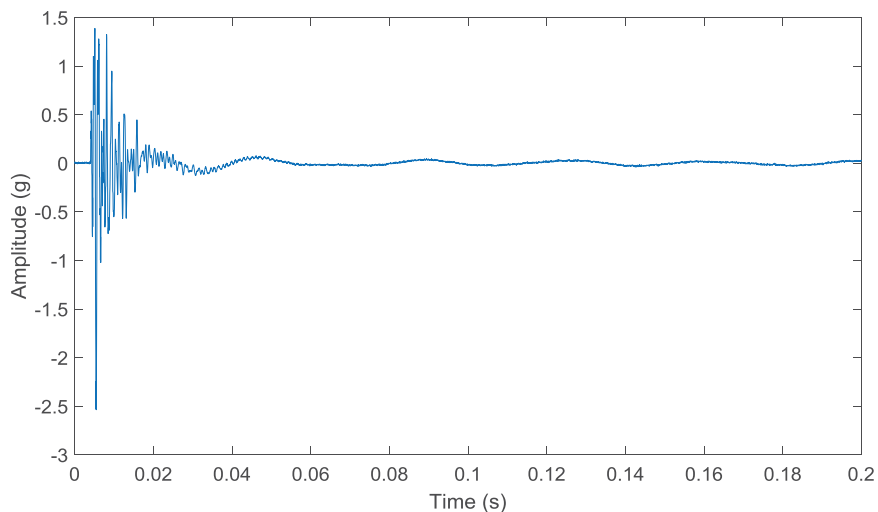
Figure 13. Vibration response of a concrete slab measured by an accelerometer after modal hammer impact.

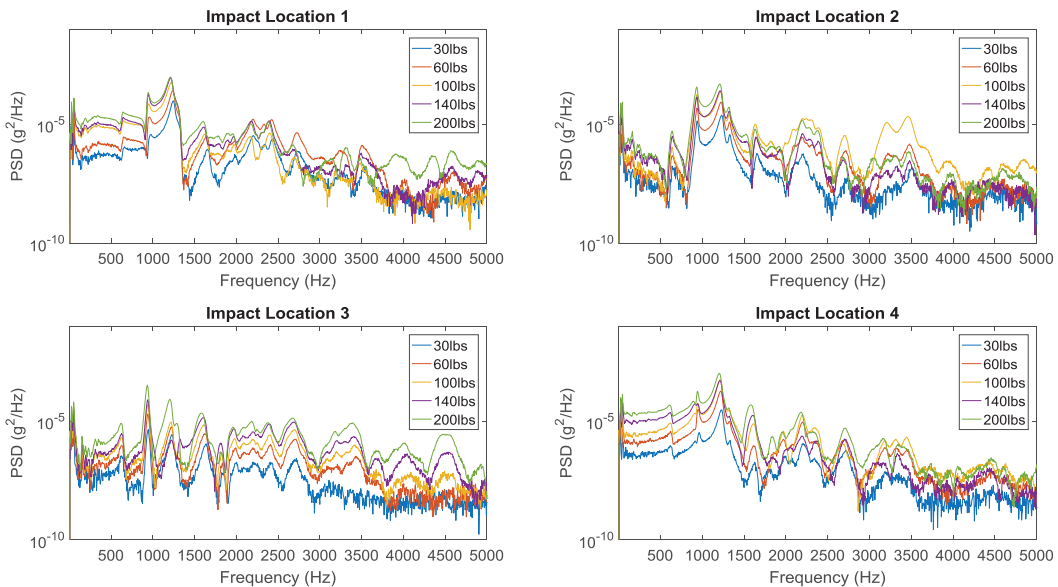
Figure 15. Power spectral distribution generated using the data collected by the accelerometer 2 data at different impact locations.

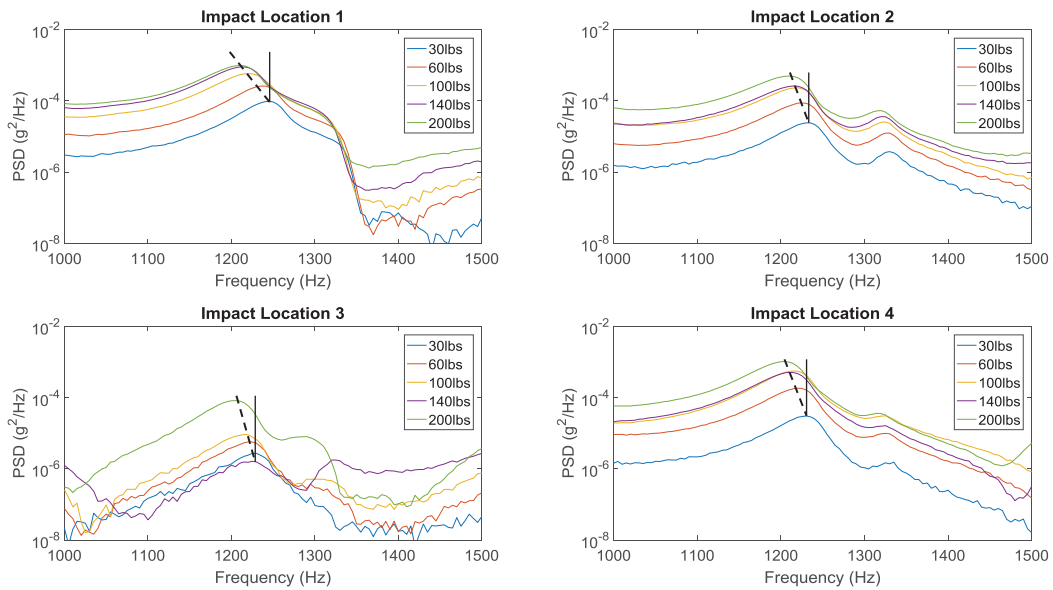
Figure 17. Accelerometer 2 frequency shift at resonant frequencies (December 2016).

From the raw PSD plots, it is difficult to say whether a shift in the resonant frequency occurred with increased impact force. In Figure 16 and Figure 17 the plots are zoomed in to the peaks (i.e., resonant frequencies), of the PSD plots. For additional ease, drawn on the figures are a solid vertical line that originates from the peak on the 30lb curve (i.e., blue) and a dashed line that goes from the peak on the 30lb curve through the peak on the 200lb curve.

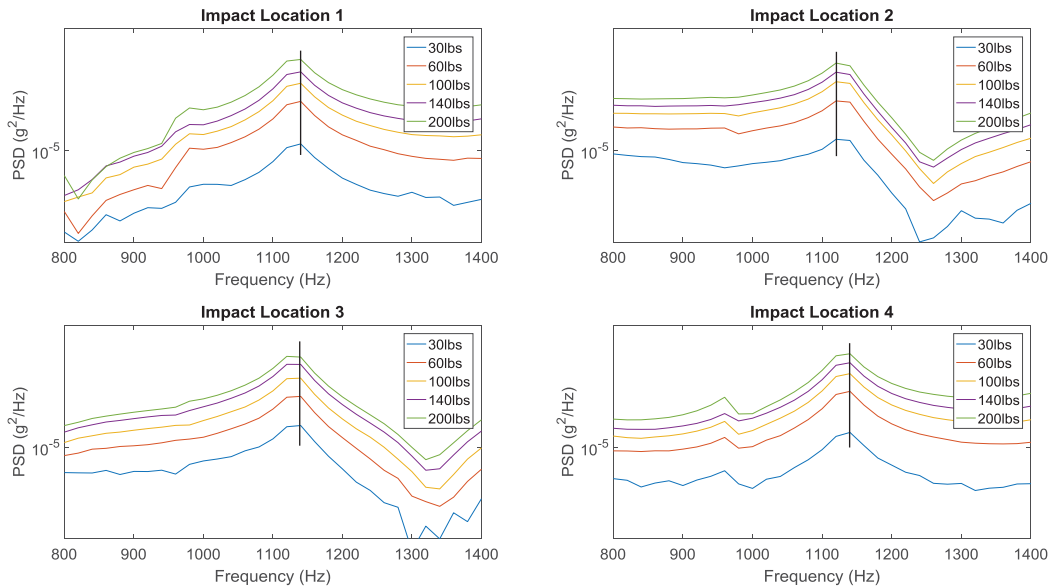
Figure 18. Accelerometer 1 zoomed into frequency shift at resonant frequency (January 2016).

The frequency response in December 2016 is compared to the frequency response of the data collected earlier in January 2016. A clear frequency shift is observed in Figure 16 and Figure 17 compared to the frequency response in Figure 18 for Accelerometer 1. Recall that concrete gains strength over time, and resonant frequency is dependent on stiffness. The data in Figure 18 is from January 2016, when the concrete had 28 days to cure, which is the standard full curing period. This is why the resonant frequency captured by accelerometer 1 for the 3rd mode is ~1140 Hz instead of ~1330 Hz. During the experiment in January 2016, data was collected for shorter time duration; hence the resolution (i.e., number of data points along the frequency axis) of Figure 18 is lower than that for the data collected in December 2016.

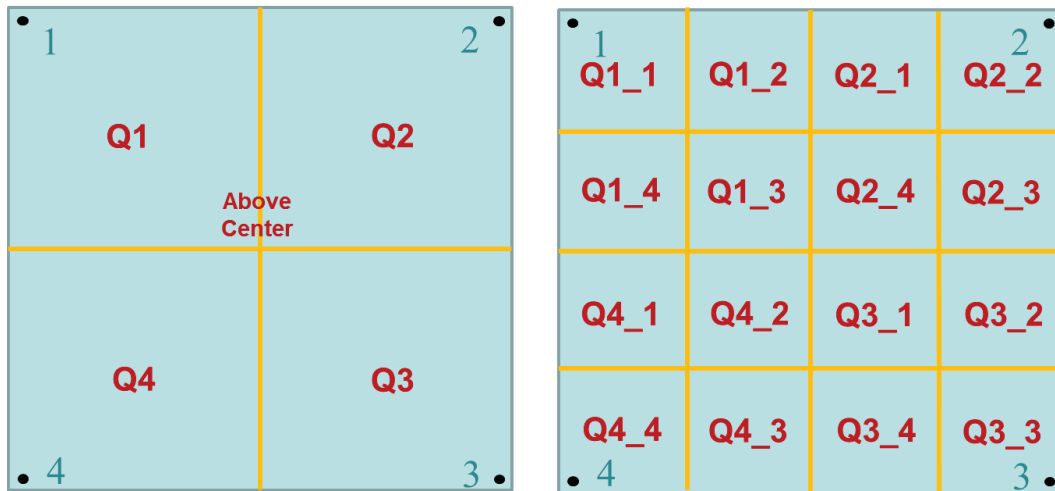
Figure 21. Testing locations for pumping actuators and probing actuators.

In this section, the pumping and probing actuator locations for various experiments are indicated by the scheme shown in Figure 21. The Q values represent the quadrants corresponding with the corner numbers as seen in Figure 6. Q1 is in the quadrant near Corner 1 and Q1_3 represents the third sub-quadrant (sub-quarter closest to Corner 3) within the first quadrant near Corner 1. Within the quadrant locations, the probe or pump was placed in the center. Seven different accelerometer configurations were used in testing, and the results for each configuration are discussed below.

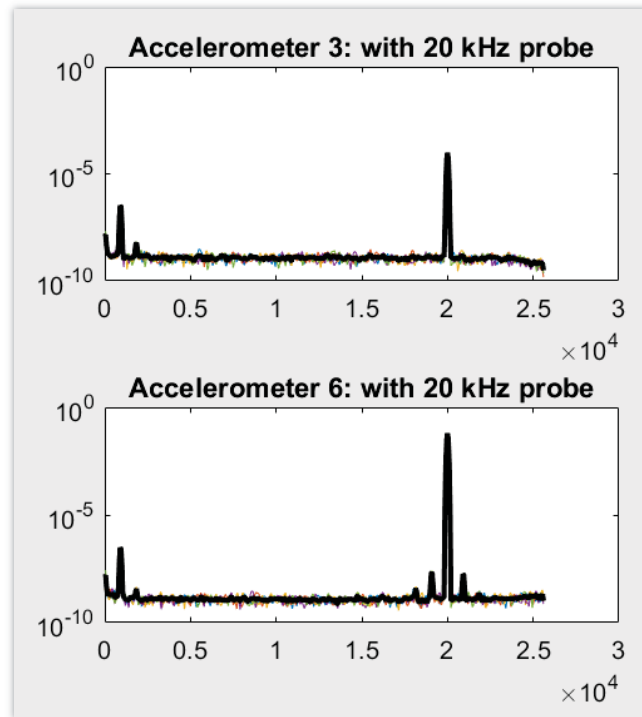
Figure 24. PSD plots used for sideband detection for 20-kHz probing frequency (amplitude = 500 mV amp) in Q4 and 920-Hz pumping frequency. Sidebands are observed at accelerometer 6 and no sidebands are observed at accelerometer 3.

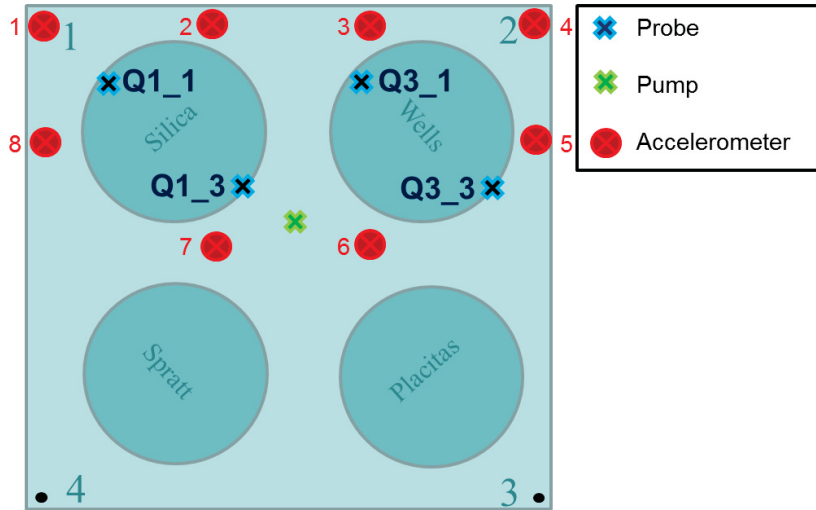
Figure 26. Schematic setup for accelerometers on the slab.

In this configuration, eight accelerometer sensors are used and their locations (red crosses) are shown in Figure 26. The pumping actuator is located 1 inch above the centerline. Probing actuator location, probing frequency, and probing excitation amplitude are varied. Figure 26 and Figure 27 show the schematic and experimental setup for this configuration respectively. Table 5 shows the results (i.e., presence or absence of sidebands) for all the probe locations, frequencies and amplitudes. The setup shown in Figure 26 and Figure 27 showed no evidence of sidebands for different combination of probe location, probing frequency and amplitude. This highlights the fact that placement of sensors and actuators impact the experimental outcomes.

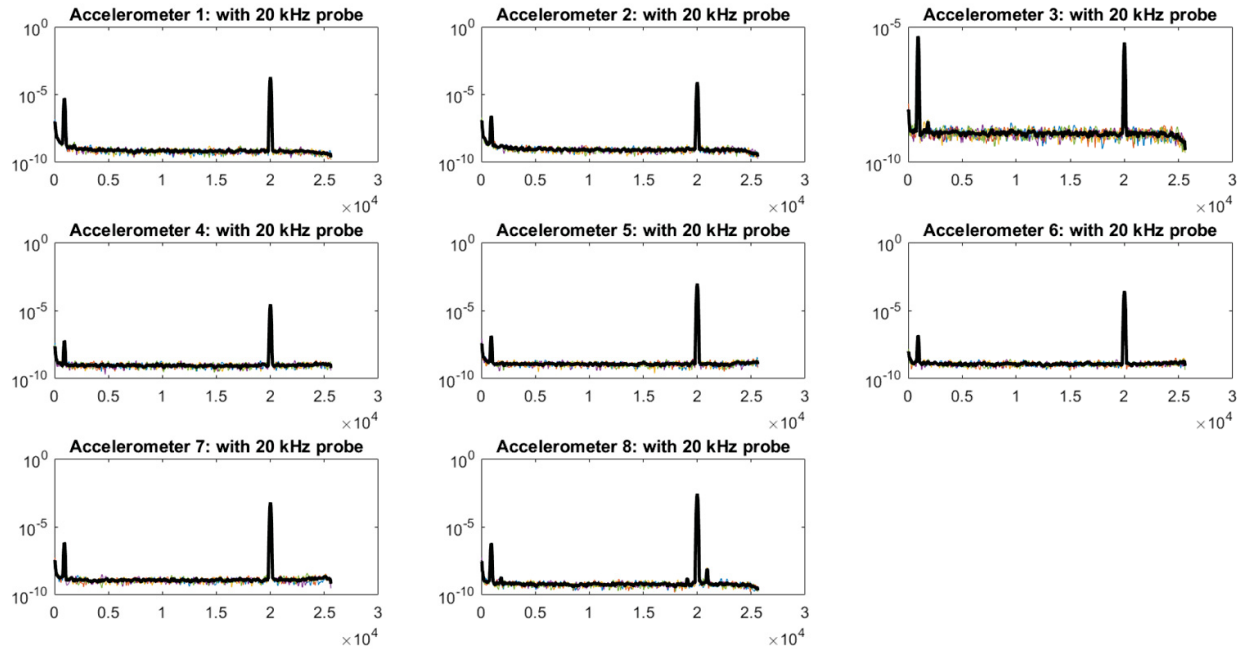
Figure 31. PSD plots used in sideband detection for the probe on Q3 with a 200 mV amp and 20-kHz probe.

Figure 29 and Figure 30, some locations of the accelerometer displayed sidebands while no sidebands were observed at others accelerometer locations. As seen in Figure 31 only one accelerometer location for the probe on Q3 with a 200 mV amp and 20-kHz frequency showed the presence of sidebands. The location of this accelerometer is located at the midpoint between Corners 2 and 3.

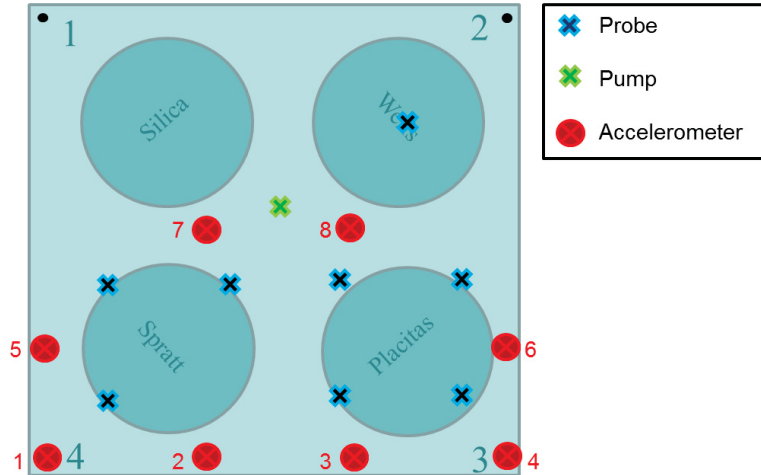
Figure 32. Schematic setup for accelerometers on the slab.

presence or absence of sidebands) for all the probe locations, frequencies, and amplitudes. For the setup shown in Figure 32, some locations of the accelerometer displayed sidebands while no sidebands were observed at other accelerometer locations. As seen in Figure 33, only one accelerometer location for the probe on Q3_1 with a 100 mV amp and 20-kHz frequency showed the presence of sidebands. The location of this accelerometer is located 6 inches above Corner 4.

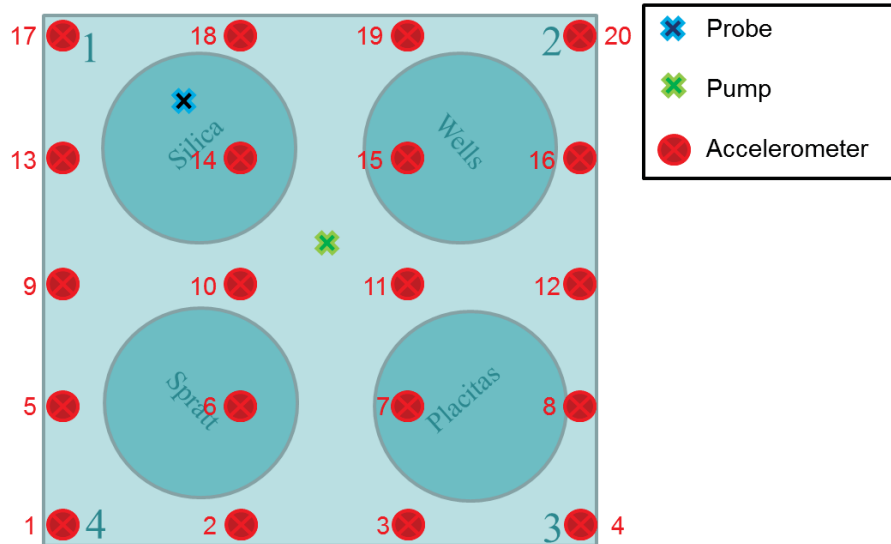
Figure 34. Schematic setup for accelerometers placed across the slab.

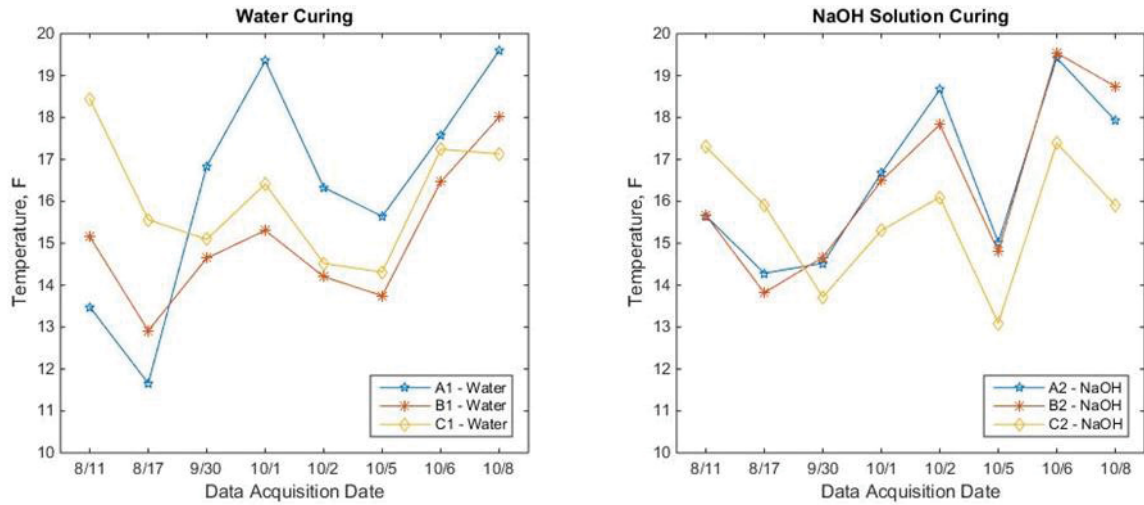
Figure 46. First peak of area-average temperature increase for water curing (left) and NaOH curing (right) for three bricks as function of image date.

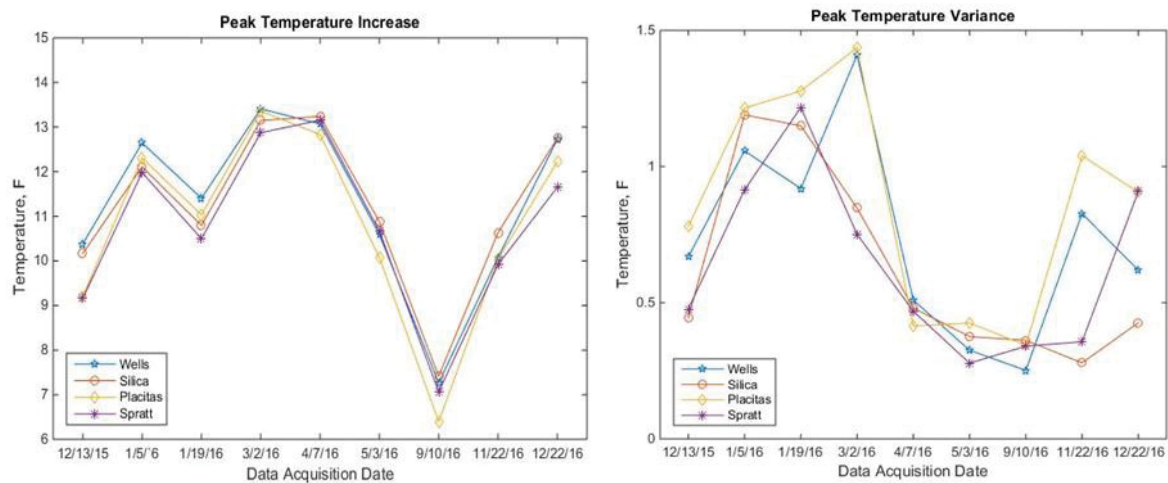
Figure 53. Peak area-average temperature increase (left) and variance (right) for four aggregate areas as function of image date.

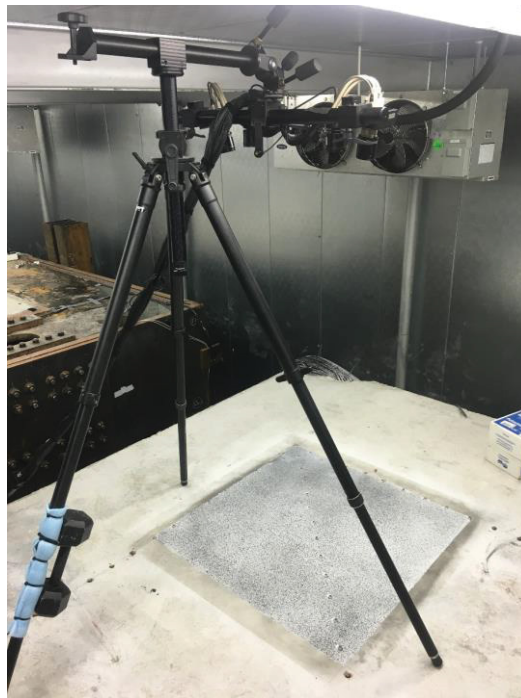
Figure 56. DIC camera support installation over the area of interest.
