# Comprehensive Characterization of Helium-Induced Degradation of the Friction Stir Weld on Neutron-Irradiated 304L Stainless Steel

**ORNL/TM-2023/3088**  
**M3LW-23OR0406013**

**COMPREHENSIVE CHARACTERIZATION OF HELIUM-INDUCED DEGRADATION  
OF THE FRICTION STIR WELD ON NEUTRON-IRRADIATED 304L STAINLESS  
STEEL**

Prepared under the direction of the  
US Department of Energy  
Office of Nuclear Energy  
Light Water Reactor Sustainability Program  
Materials Research Pathway

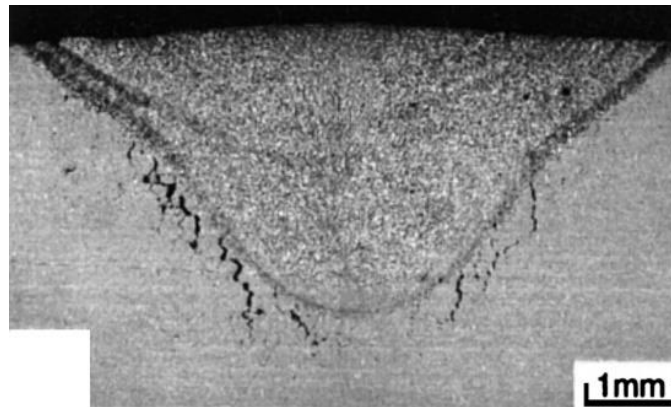
**Figure 1. Helium-induced cracks in the weld HAZ of stainless steel containing 8.3 appm helium [2].** Note many cracks exceed 1 mm in length, and the total length of macroscopic cracks is well above ~5–6 mm.

As an example, in 1986, the gas tungsten arc welding technique was used to repair the water leakage of a Savannah River National Laboratory reactor, and many cracks appeared at the HAZ after repair welding attempts. Those cracks caused the reactor’s permanent shutdown. Investigation showed that these cracks were helium-induced cracks, and helium concentration in the repaired water tank wall was about 3 appm [1]. An example of a fusion weld cross section with helium-induced cracks in the HAZ is shown in Figure

1 [2]; the helium amount was 8.3 appm. Studies have shown that elevated temperatures and the appearance of tensile stress during fusion welding cooling are two key factors in helium-induced crack formation and propagation [3].

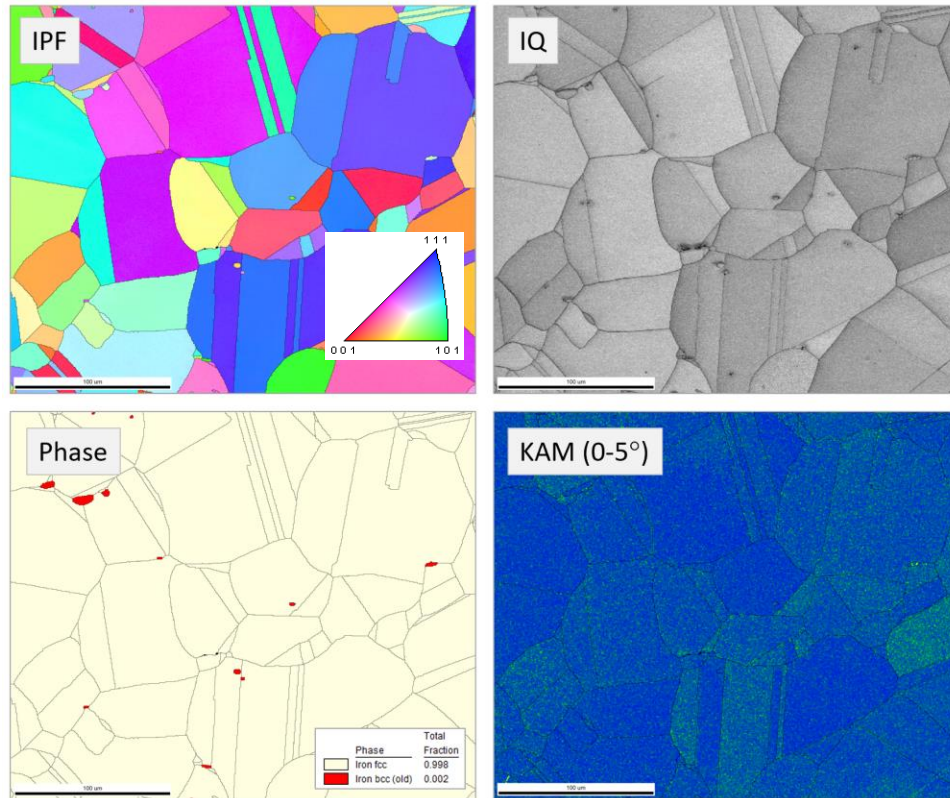
**Figure 2. Reference microstructure for 304D custom heat (24 appm boron-enriched, measured ~15.6 appm helium in another coupon with the same heat): electron backscatter diffraction (EBSD) inverse pole figure (IPF), image quality (IQ), phase, and kernel average misorientation (KAM) maps.** Visible is the annealed austenite structure with a minor amount of ferrite. Many ferrite grains have a specific elongated shape with a long axis oriented in the horizontal direction. The IQ map shows the reduced pattern quality around many ferritic grains (no such effect was observed in 304C heat); reduced Kikuchi pattern quality may suggest some element segregation effects. The KAM map reveals no plastic strain (fully annealed conditions). Amount of ferrite for this scan <0.2%–0.3%. Scan size: 300 × 250 µm; EBSD step (pitch) size: 0.5 µm.

Figure 2 shows a typical microstructure of the studied materials (304D heat) after the neutron irradiation. The well-annealed austenite structure is visible, along with multiple annealing twins. The analysis showed no pronounced texture in the austenitic matrix. A limited amount of retained ferrite (<<1%) presents in the structure with some insignificant variations between locations and heats; retained ferrite presence is typical for many 300-series steels and is believed to be irrelevant for the present work purposes. Ferrite grains sometimes appeared as bands or chains elongated in one direction—most likely, the former hot rolling direction.

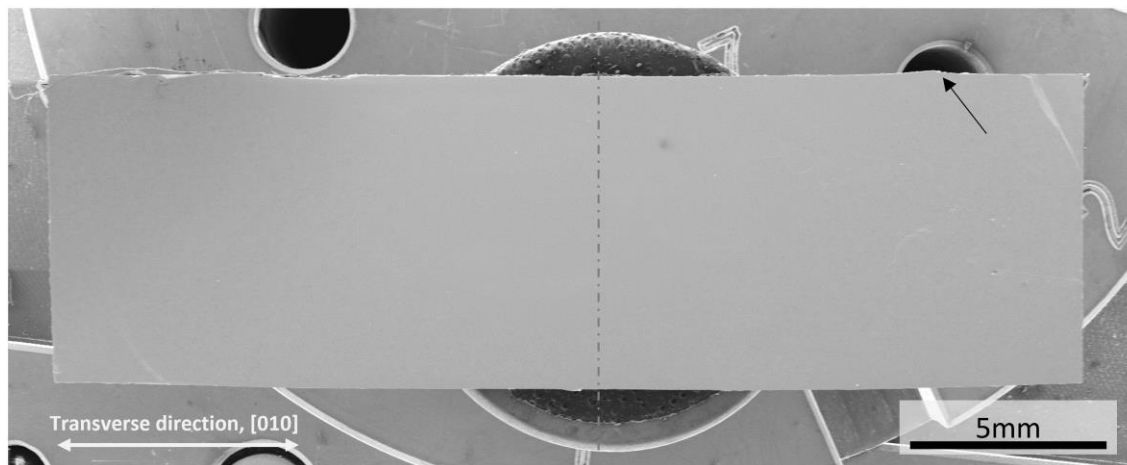
**Figure 3. Cross section of the friction stir weld performed on the 304L SS containing ~10 appm helium.** No macroscopic cracks or crack-like defects (e.g., ~0.5 mm) were observed in the SZ or TMAZ. The SEM image has some minor distortion because of the low magnification level. Left side: FSW advancing side; right side: FSW retreating side [17]

Figure 3 [17]. The scanning electron microscopy (SEM) image brightness and contrast were adjusted to highlight any potential defects such as cracks and discontinuities in the structure. As expected, macroscopic defects (e.g., approximately millimeter length) should be easy to detect at the given conditions. Image analysis reveals that it is a solid metallic surface without any visible cracks or voids.

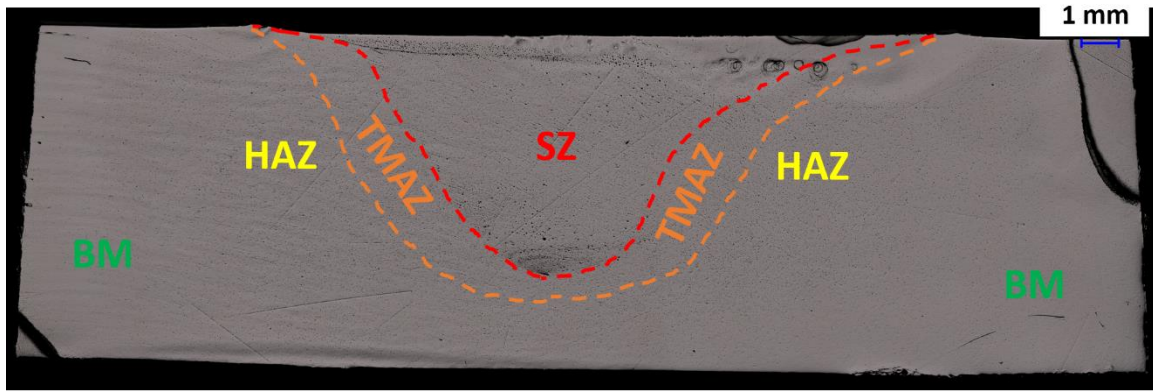
**Figure 4. Schematic of the SZ, TMAZ, HAZ, and BM in an irradiated 304L SS friction stir weld.**

The absence of etching makes the friction stir weld shape and boundary difficult to visualize. However, the schematic SZ and TMAZ shapes were plotted on the specimen cross section shown in Figure 4 by taking into account some visible features such as the edges of the undercut at the specimen surface and the root tip, the typical shape of a 304L SS friction stir weld made by the same FSW tool, and the SEM observation of the 304L SS friction stir weld specimen.

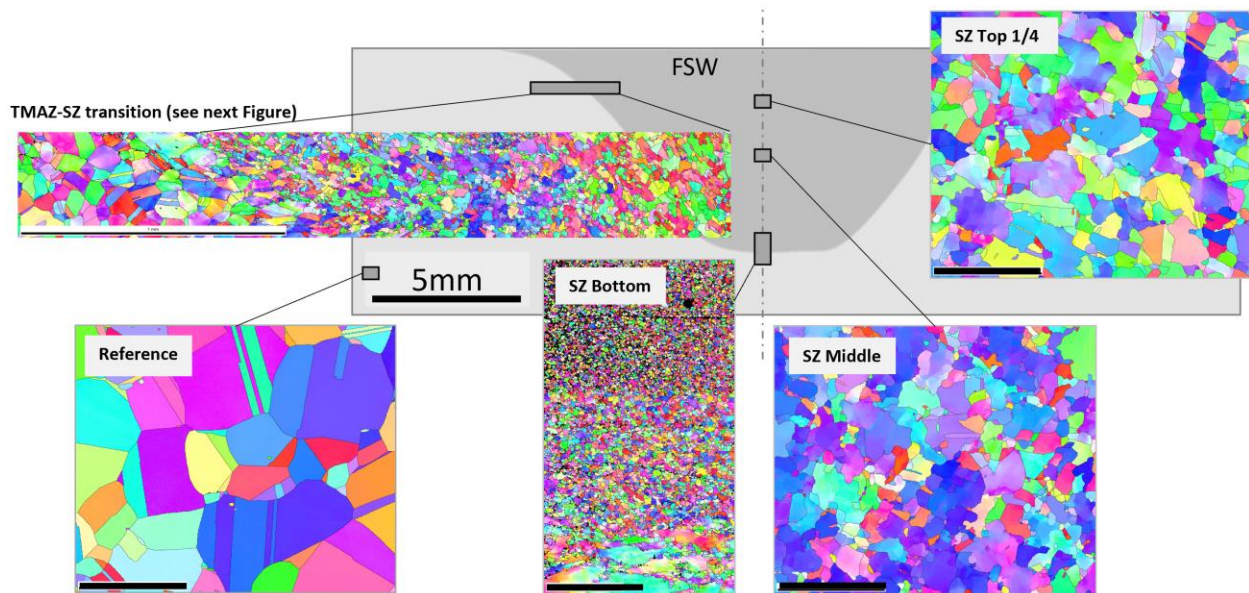
**Figure 5. Grain structures in different metallurgical zones of the 304D-5 friction stir weld.** The scale bar for grain structure transitions SEM/EBSD image (top left) is 1 mm; for all other images, the scale is 100  $\mu\text{m}$  [17].

Typical friction stir weld microstructures were observed in different metallurgical zones of the 304D-5-14 specimen, as shown in Figure 5 [17]. The SZ microstructure (two images on the right) contains roughly shaped, sometimes equiaxed grains, approximately 20–40  $\mu\text{m}$  in size. The SZ area is practically ferrite free because of the experience at elevated temperature during FSW. At the SZ root, grains in the SZ are very fine because of the low heat input in FSW, and grains become much larger in the TMAZ outside of the SZ root (middle bottom). Grain structure transitions (top left image) are clearly shown from the SZ to TMAZ and HAZ. The TMAZ features elongated grain structures without recrystallization or full recrystallization, whereas the HAZ grain shapes and sizes are close to the reference BM. The reference BM (bottom left) exhibits larger grain structures than those in the SZ.

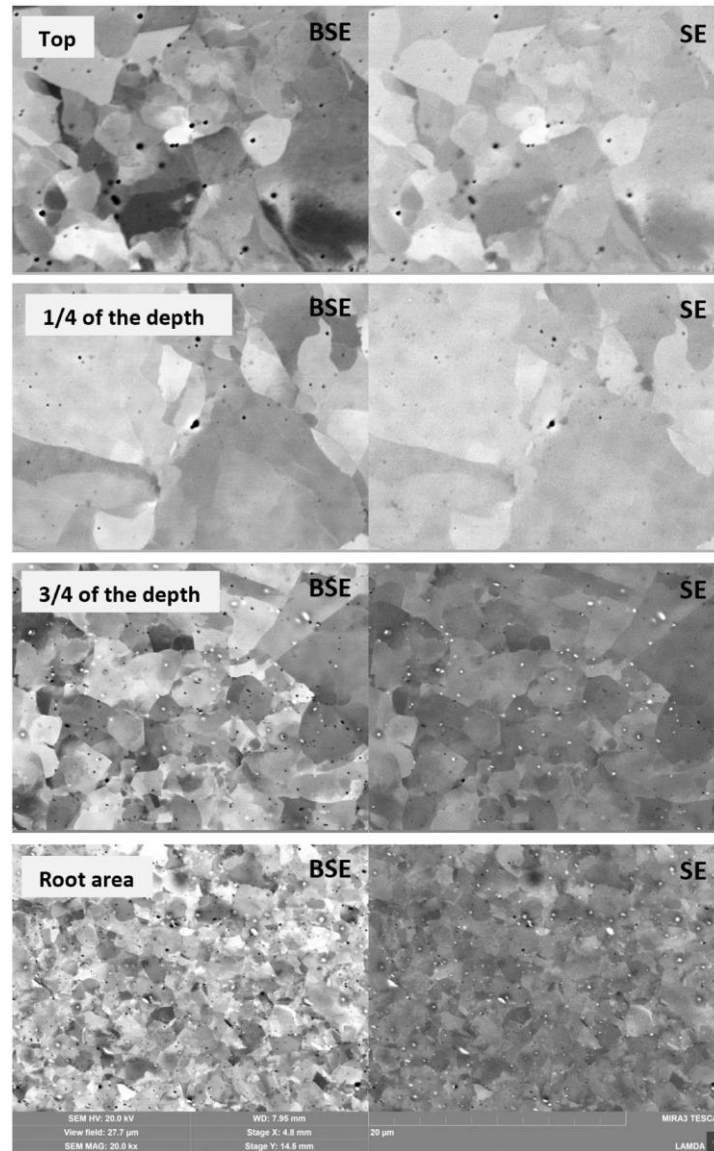
**Figure 6. SEM images along the 304D-5-14 SZ centerline [17].**

Most SEM images inside the 304D-5-14 SZ show specific void-like or bubble-like features ( $\sim 1\text{--}2\text{ }\mu\text{m}$  in size or smaller) of dark color, as shown in Figure 6 [17]. The observed features are round (likely spherical in 3D), and their sizes vary significantly. Their density also varies across the SZ, suggesting their appearance is sensitive to the local conditions. BM location revealed much smaller counts, and the

features presented differently. A significant fraction of the observed round features may be helium bubbles; however, electron energy loss spectroscopy [19] should be used to confirm.

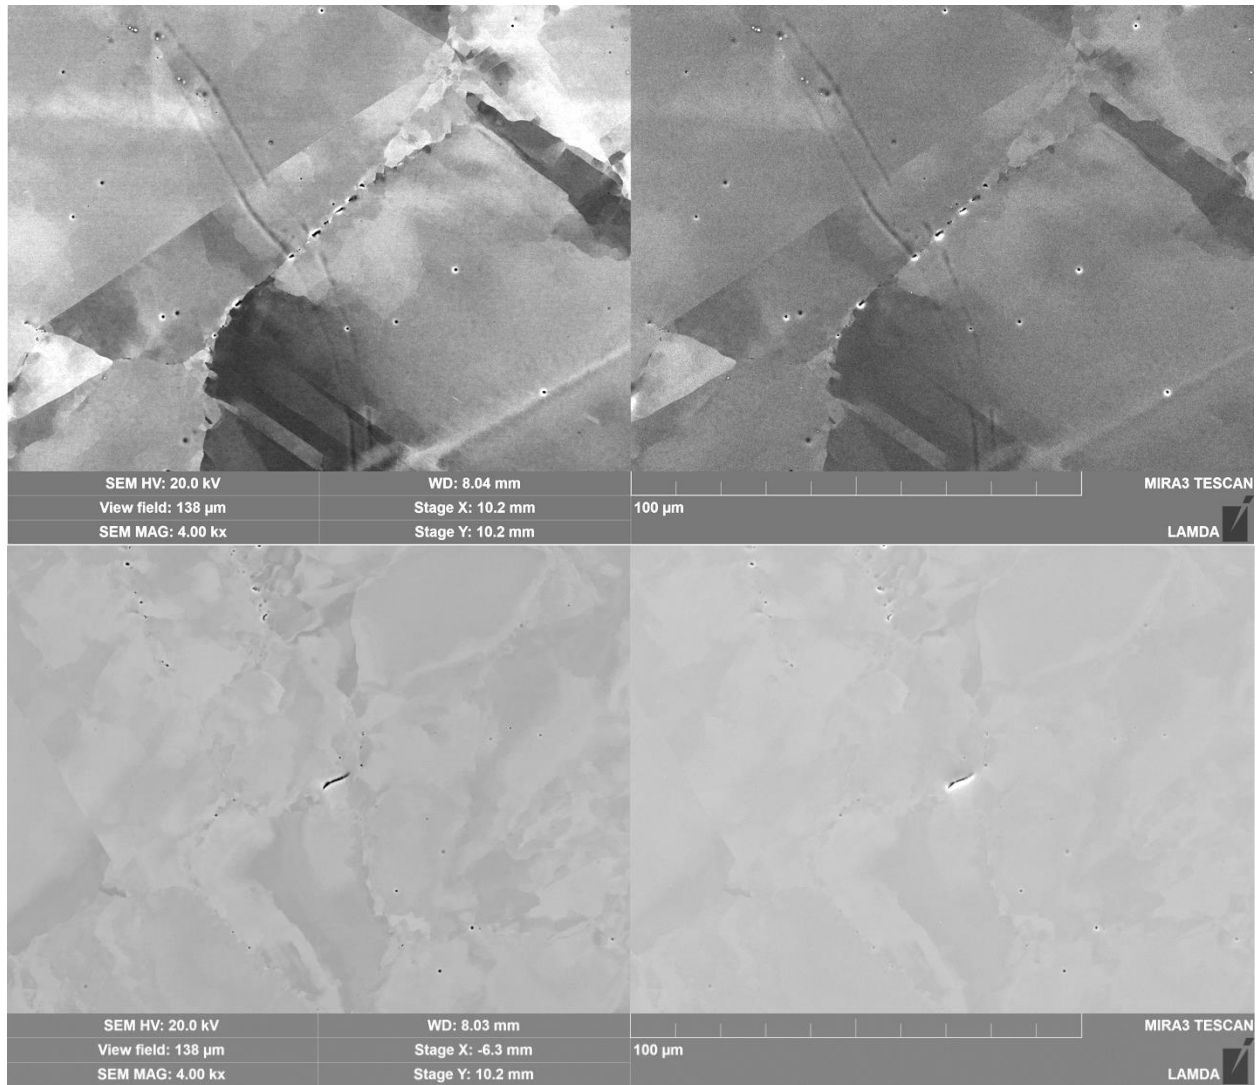
**Figure 7. Individual helium bubbles, helium bubble chains, and microcracks in the 304D-5-14 TMAZ [17].**  
 (top) Individual helium bubbles and helium bubble chains in the TMAZ on the 304D-5-14 weld advancing side. (top left) BSE image; (top right) SE image. (bottom) Individual helium bubbles and microcracks in the TMAZ on the 304D-5-14 weld retreating side. (bottom left) BSE image; (bottom right) SE image.

In the TMAZ, individual helium bubbles, helium bubble chains, and several microcracks were observed, as shown in Figure 7 [17]. Individual helium bubbles appear inside grains and on grain boundaries. The helium bubble chains and the microcracks form along grain boundaries. The compromised grain boundaries appear in a small fraction in those pictures, as shown in all images in Figure 7.

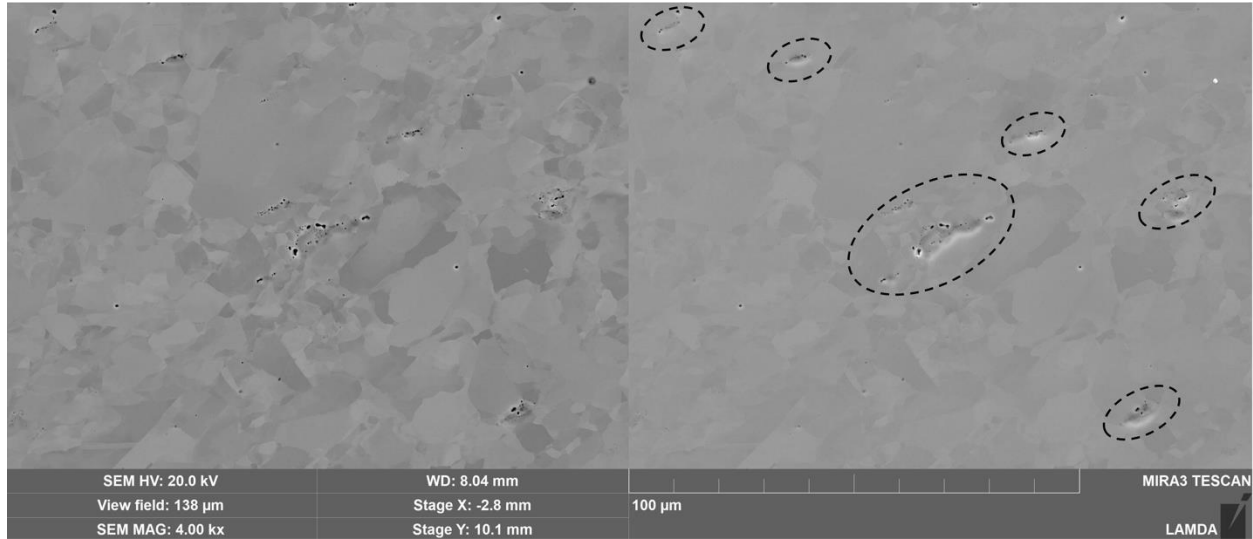
**Figure 8. Clustering of the helium-induced damage in TMAZ.** Dashed ovals at right show the clusters. (left) BSE image; (right) SE [17].

In this 304D-5-14 friction stir weld specimen, helium-induced features often formed specific clusters or “clouds” of large pores and bubbles, as shown in Figure 8 [17]. These clusters are often associated with the retained ferrite grains and preexisting metallurgical inclusions. Such features were not observed in the previously reported friction stir weld with a lower helium content (~5.2 appm).

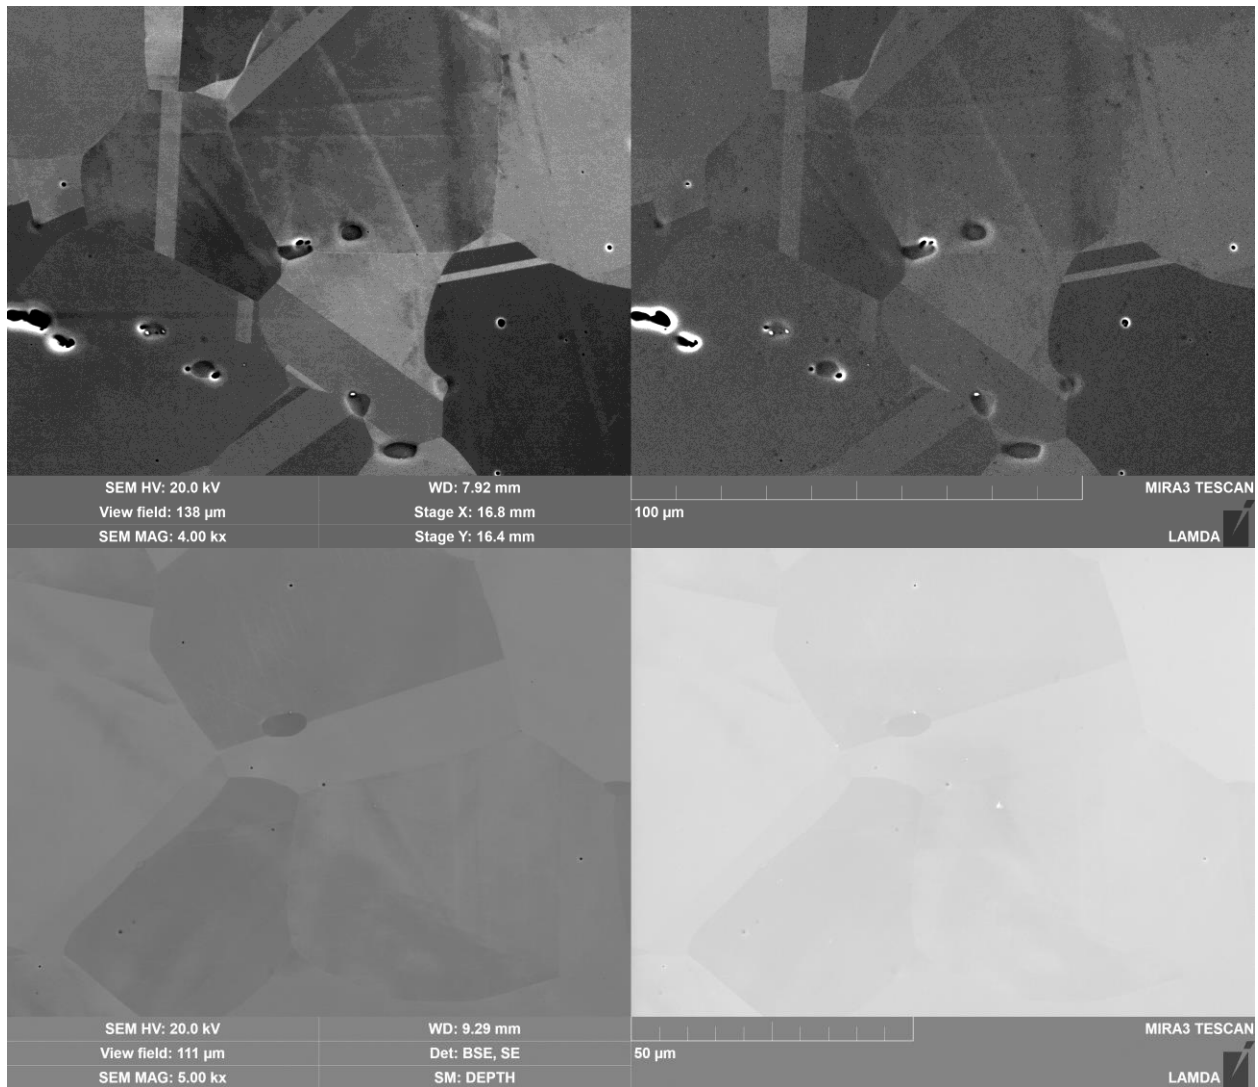
**Figure 9. SEM pictures of the 304L SS BMs contains different amount of helium [17]. (top) 304D-5-14 specimen containing ~10 appm helium. (bottom) 304C-5-14 specimen containing ~5.2 appm helium.**

BM SEM observation revealed larger voids in the 304D-5-14 specimen (~10 appm helium) than in the 304C-5-14 specimen with lower helium content (~5.2 appm). Figure 9 shows the current ~10 appm helium and the ~5.2 appm helium 304L SS BMs under SEM [17]. The helium bubble clusters or clouds in the high-helium-content 304D-5-14 specimen may be caused by the preexisting inhomogeneity of the boron distribution in the base material. Boron segregations (likely elevated boron levels in the retained ferrite and metallurgical inclusions) in turn generated inhomogeneous helium distribution during irradiation in HFIR. Such boron/helium distribution segregations are reflected in the friction stir weld microstructures. However, there could be other reasons caused the helium bubble clusters or clouds, and the boron segregation is just a hypothesis.

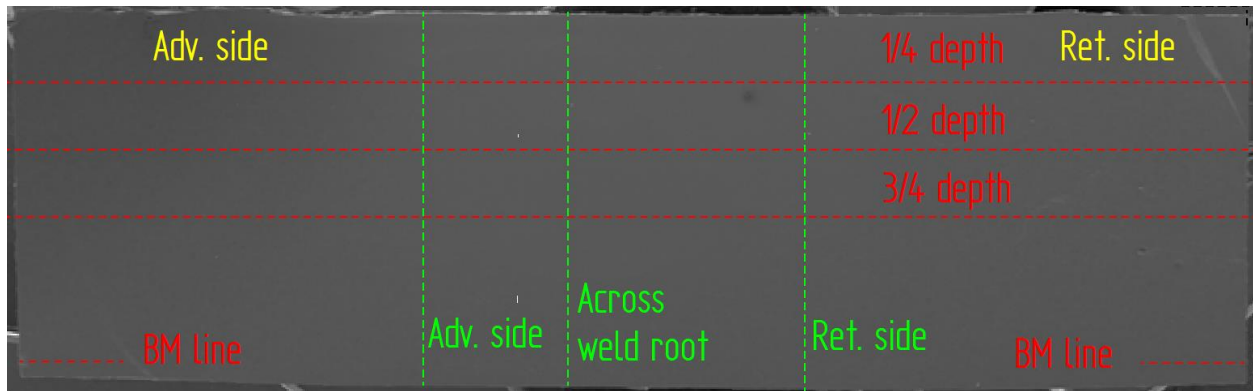
Figure 10. Vickers microhardness measurement lines.

Previous SEM characterization identified the friction stir weld shape, location, and boundaries [17]. Vickers microhardness tests were performed on the 304D-5-14 friction stir weld specimen along five horizontal lines and three vertical lines, as shown in Figure 10. The three horizontal lines cross the whole specimen, and they are one-fourth, one-half, and three-fourths of the SZ depth from the weld top surface, respectively. From left to right, the three horizontal lines start at HAZ on the friction stir weld advancing side, go through the TMAZ on the advancing side, the SZ, and the TMAZ on the retreating side, and end at the HAZ on the retreating side. The two short horizontal lines located at the bottom of the specimen left and right corners indicate the BM, and measurements from the two short horizontal lines represent the BM Vickers hardness. The three vertical measurement lines cross the specimen from top to bottom. The middle vertical line goes through the weld root tip, and the other two are on the advancing and retreating sides of the weld, respectively. From top to bottom, the three vertical lines start at the SZ, go through the TMAZ and HAZ, and end at the HAZ. The Vickers microhardness tests were performed using 200 g force, 10 s dwell time, and indentation spacing of 250 µm.

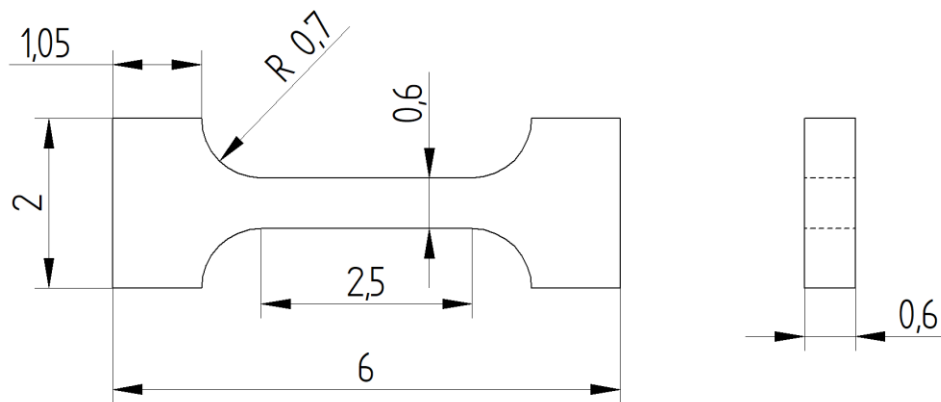
Figure 11. Miniature tensile specimen drawing (unit: mm).

The drawing of the miniature tensile specimens used in this study is shown in Figure 11. Such a small specimen can be extracted from different metallurgical zones of the metallographic specimen 304D-5-14. The miniature tensile specimen mapping on the metallographic specimen cross section is shown in Figure 12, which illustrates the long axis of the top row specimens at one-fourth SZ depth, the long axis of the second row of specimens is at five-eighths SZ depth, and the long axis of the bottom specimen is at the SZ root tip. Moreover, specimen gauge areas of the left, middle, and right specimens at the top two rows are located in the TMAZ/HAZ on the advancing side, SZ, and TMAZ/HAZ on the retreating side, respectively. The center of the bottom tensile specimen is at the SZ root tip. The specimen IDs and locations are summarized in Table 2.

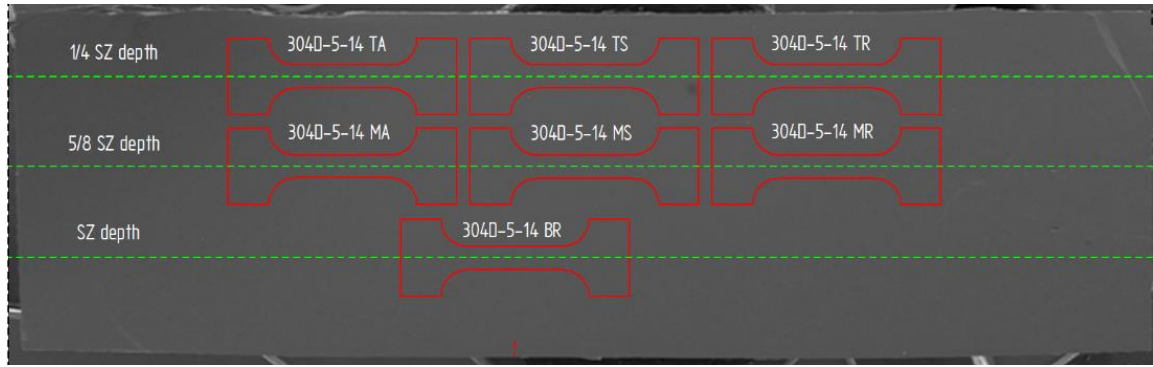
**Figure 12. Miniature tensile specimen mapping on the 304D-5-14 friction stir weld specimen.**

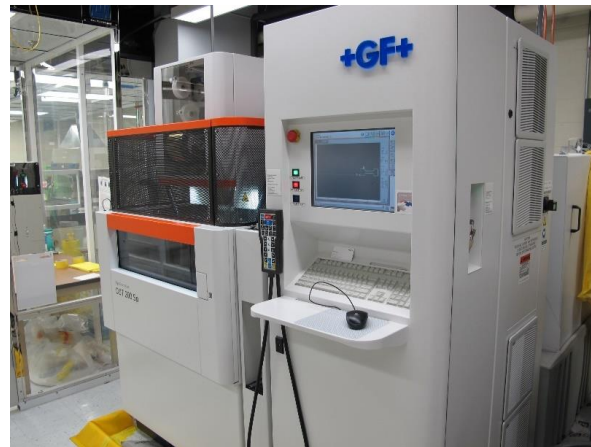
**Figure 13. The wire EDM system installed in LAMDA to manufacture specimens from radioactive material.**

The mount material was removed from the 304D-5-14 metallographic specimen after microstructure characterization and microhardness tests. Wire electric discharge machining (EDM) was used to extract miniature tensile specimens at different locations, and the wire EDM system in ORNL's LAMDA facility is shown in Figure 13. An extracted miniature tensile specimen is shown in Figure 14.

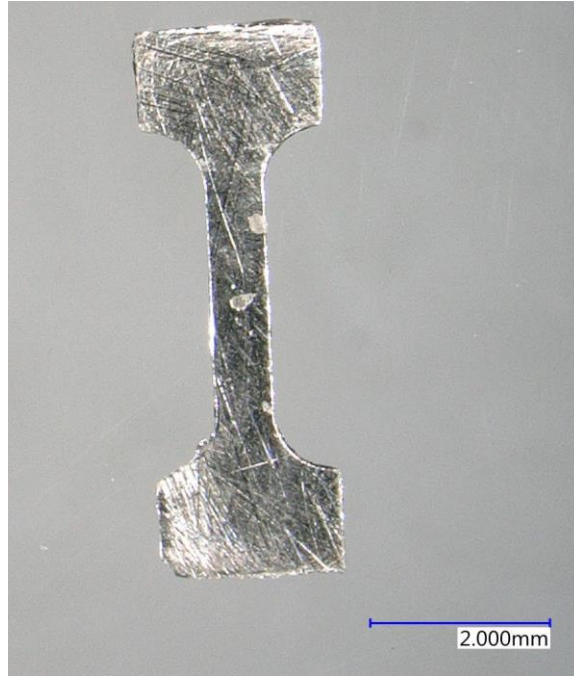
**Figure 14. Miniature tensile specimen extracted from the 304D-5-14 friction stir weld metallographic specimen.**

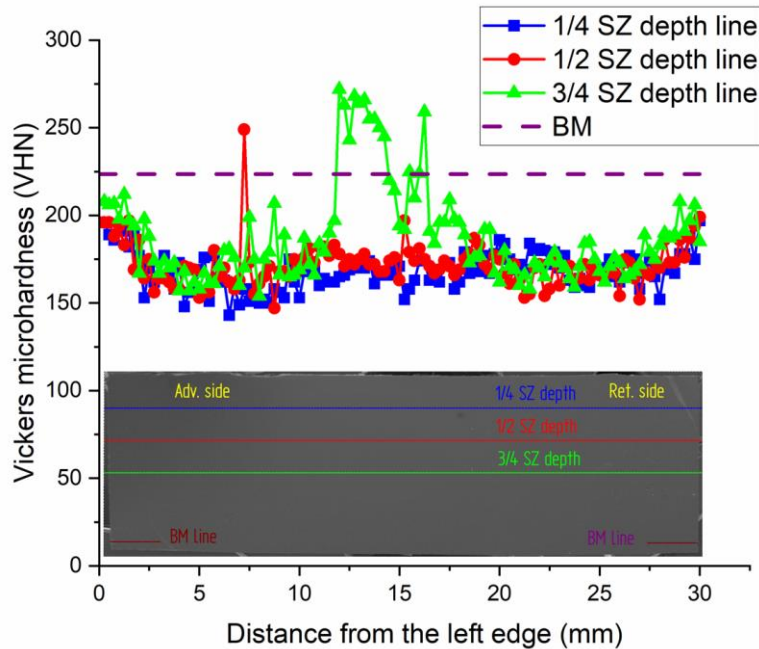
**Figure 15. 304D-5-14 friction stir weld specimen horizontal Vickers microhardness distributions.**

Microhardness distributions of the three horizontal measurement lines across the friction stir weld SZ, TMAZ, and HAZ are shown in Figure 15. The BM hardness (223.5 VHN) is indicated by a straight dashed line, with the average of measured hardness values along the two bottom lines.

Hardness values in the SZ, TMAZ, and HAZ measured along the one-fourth and one-half SZ depth were less than that of the BM, and the smallest hardness values were measured in the TMAZ/HAZ area. The hardness values in the SZ and TMAZ/HAZ along the one-half SZ depth line are slightly larger than those along the one-fourth SZ depth line. This difference could be caused by higher peak temperatures and therefore larger grain sizes at locations closer to the tool shoulder (specimen top surface), which generated the most FSW heat input. One hardness value along the one-half SZ depth is obviously larger than the other measurements along the same line and is larger than the BM hardness, but the reason for this apparent outlier remains unknown.

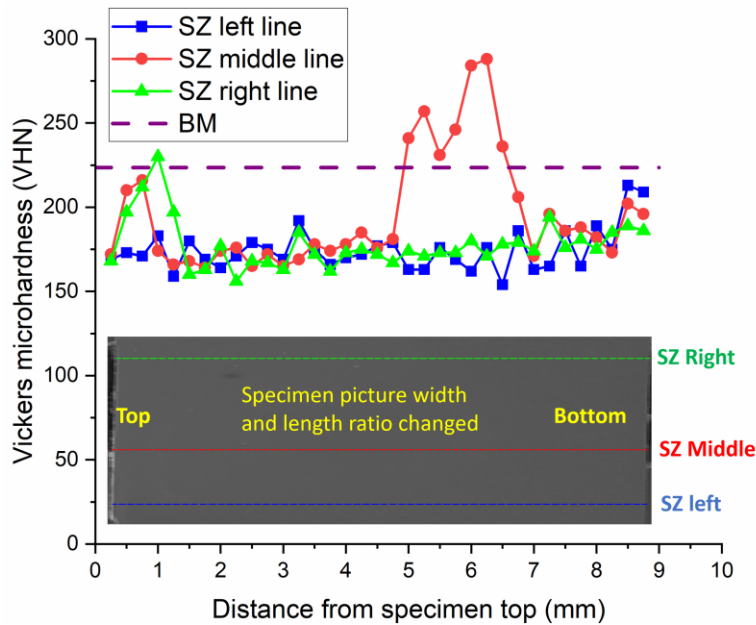
**Figure 16. 304D-5-14 friction stir weld specimen vertical Vickers microhardness distributions.**

From Figure 16, hardness increased at locations within 1–1.25 mm from the specimen top, where fine grain structures caused by excessive plastic deformation by the FSW tool shoulder were observed. Except for one measurement at this area, the SZ left and SZ right line hardness values are all smaller than that of the BM, regardless of whether the measurement was in the SZ, TMAZ, or HAZ. Furthermore, hardness values from close to the bottom started to increase toward the BM value, which meant the measuring was moving close to the FSW unaffected BM zone. For SZ middle line hardness distribution, in addition to the hardness increase near the top, significant hardness increases occurred at locations 5–7 mm away from the specimen top. These hardness increases (peak value 288 VHN) were caused by the extremely fine grain structures at the weld root area presented in Figure 5.

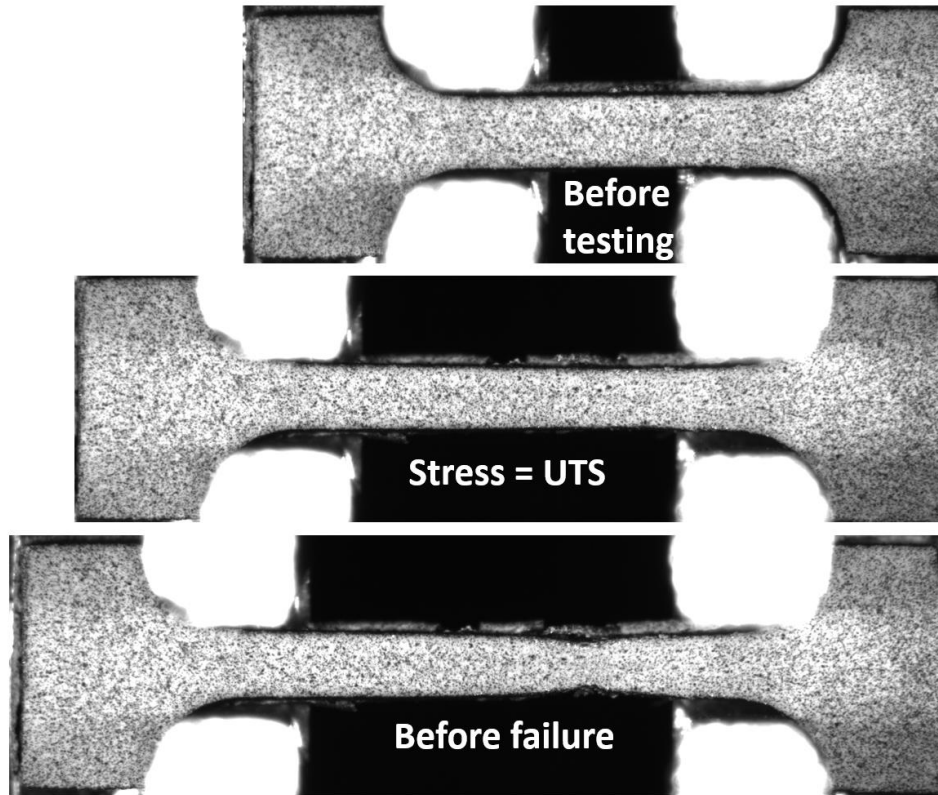
**Figure 17. 304D-5-14 MS images.** (top) Before testing, (middle) at UTS, and (bottom) before failure.

Hundreds of images were taken at different load/stress levels during each DIC tensile test. Images with a speckle pattern of miniature tensile specimen 304D-5-14 MS (five-eighths SZ depth in the SZ) at the moment before testing, at the tensile load of ultimate tensile strength (UTS) stress, and right before specimen failure are shown in Figure 17. As shown in the images, the specimen experienced significant deformation/elongation during the tensile test, and exhibited obvious necking before it broke, indicating good ductility in the SZ.

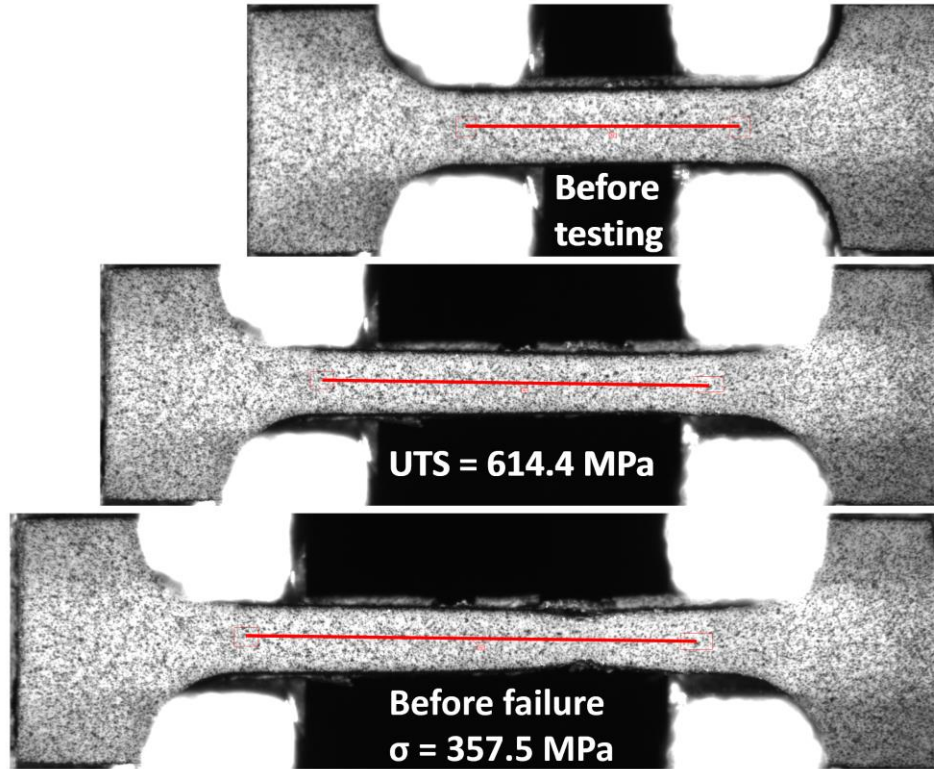
**Figure 18. 304D-5-14 MS images with digital extensometer.** (top) Before testing, (middle) at UTS, and (bottom) before specimen failure.

A 2.5 mm line was applied in the gauge area on the first image of each specimen as the digital extensometer. With the software processing, the length of the digital extensometer could be calculated for every image taken in the tensile test. Therefore, elongations, obtained from the initial digital extensometer length and its changes during the test, can be obtained at corresponding stress levels. The initial extensometer (red line in the specimen gauge area) and appearances at UTS and right before the failure of the 304D-5-14 MS specimen are shown in Figure 18. Clearly, the digital extensometer had large extension before the specimen fail.

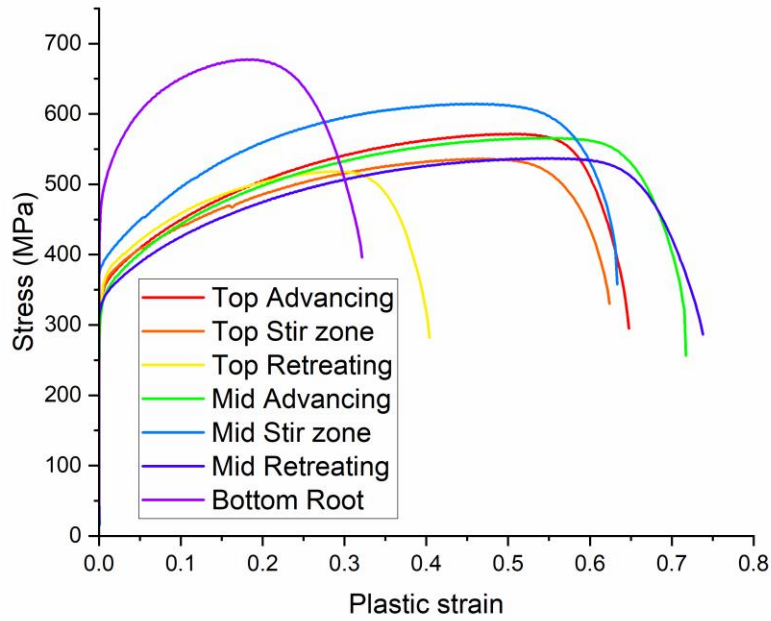
**Figure 19. 304D-5-14 tensile curves of all friction stir weld miniature tensile specimens.**

By correlating elongations obtained from the digital extensometer and recorded tensile stresses, the tensile curves and tensile properties were obtained. All tensile curves and tensile properties of the seven miniature tensile specimens are shown in Figure 19 and listed in Table 3. Despite helium bubbles in the SZ (Figure 6) and helium bubbles, bubble chains, and microcracks in the TMAZ (Figure 7), all tested specimens exhibited higher yield strength and ultimate tensile strength than ASTM minimum strength requirements of wrought 304L SS (170 MPa yield strength and 485 MPa ultimate tensile strength) [20]. Except for the specimen at the weld root (304D-5-14 BR), all specimen elongations were also higher than the ASTM minimum elongation requirement of wrought 304L SS elongation (40%) [20]. Furthermore, the extensometer length for the current experiment (2.5 mm long) is very different from that of conventional 304L SS (50 mm long). The BM tensile elongation of the irradiated 304L SS with ~5.2 appm helium was 71.3% [21]. Moreover, the uniform elongation of each tensile curve possessed a large ratio of total elongation, indicating excellent ability to remain in uniform deformation and resist necking and rapid fracture propagation. The smallest elongation (32.1%) was measured from the specimen extracted at the weld root, which also presented the highest yield strength and ultimate tensile strength. Such relatively high strength and low elongation properties were results of the superfine grain sizes in the SZ root, which caused dislocation movement difficulty in the SZ and strain localization in the TMAZ during the tensile process.

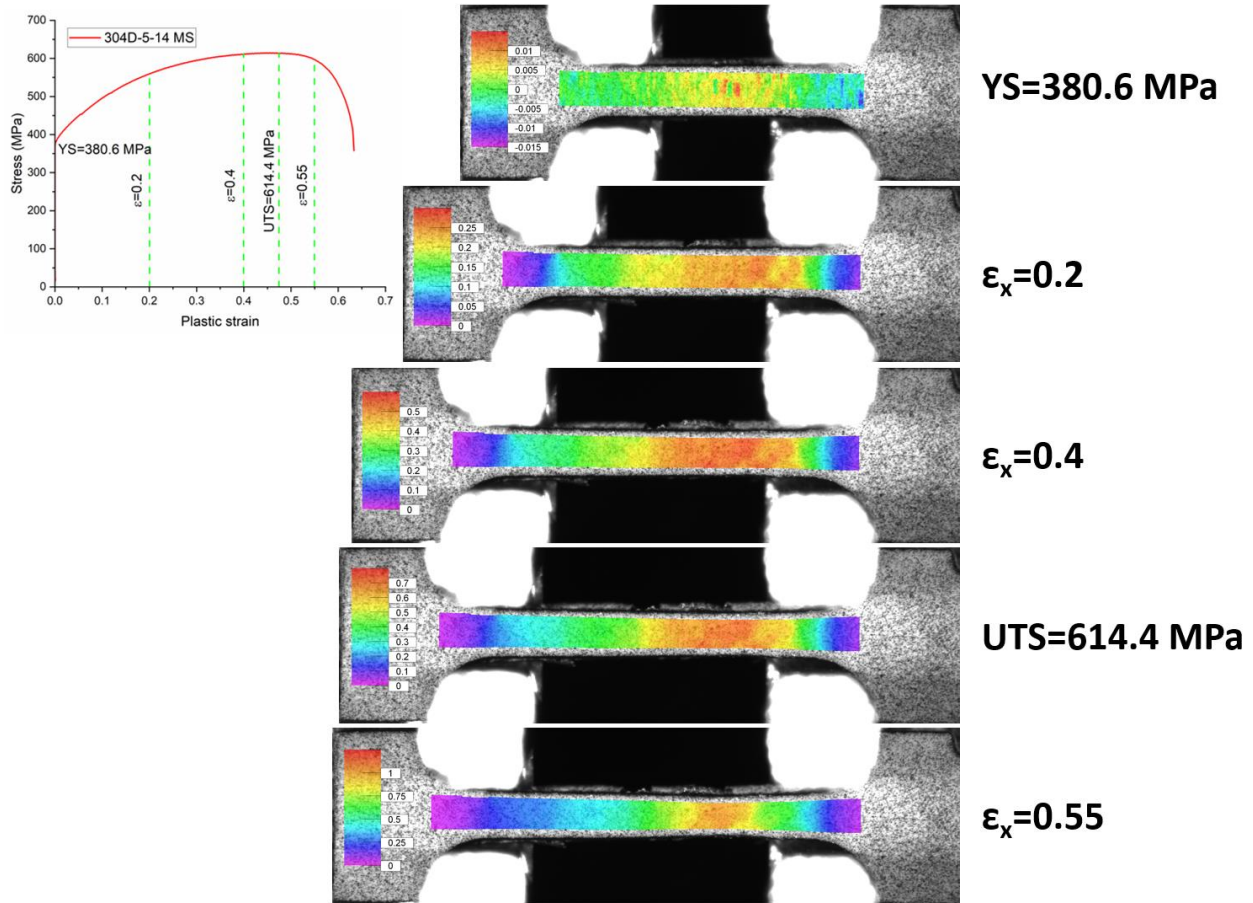
**Figure 20. Local strain  $\epsilon_x$  distribution of 304D-5-14 MS specimen at different tensile stages.**

tensile stress reached UTS, plastic strain localized in a small area of the previous wide peak strain zone, and the specimen broke at the same location by the end of tensile test.

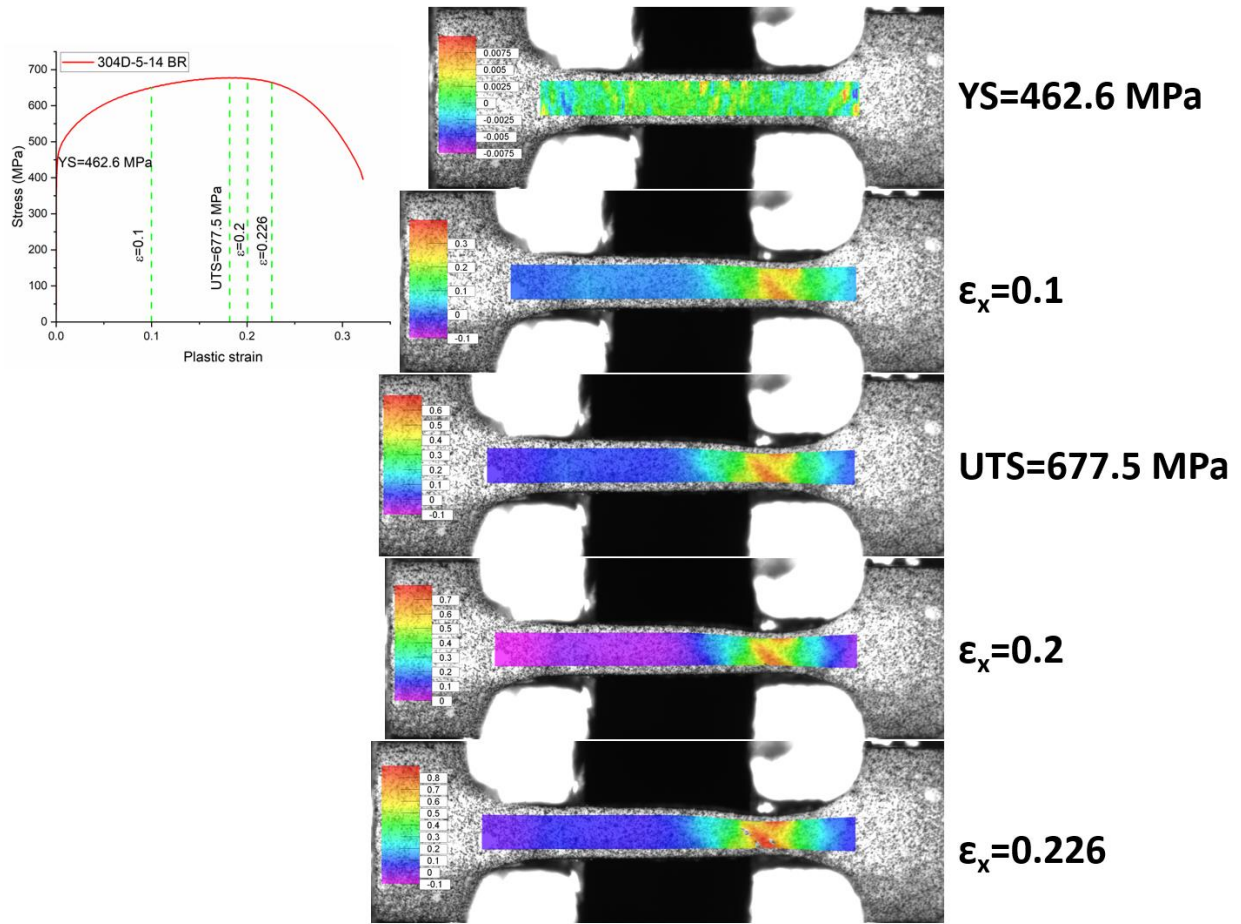
**Figure 21. Local strain  $\epsilon_x$  distribution of 304D-5-14 BR specimen at different tensile stages.**

The bottom root specimen 304D-5-14 BR strain  $\epsilon_x$  2D distributions at different tensile stages, including at yield, between yield and UTS, at UTS, and during necking, are shown in Figure 21. For the 304D-5-14 BR specimen, strain localization occurred shortly after the tensile stress reached yield and before it reached UTS because of the inhomogeneous microstructures and hardness distributions at the SZ root area. Inside the SZ root, grains are superfine with high hardness, but grains became much larger in the TMAZ right outside of the SZ root with low hardness (Figure 4, Figure 15, and Figure 16). Therefore, in the tensile test, plastic deformation was localized at the softer TMAZ soon after the tensile stress reached yield stress (YS), and specimen failed at the same location by the end of the test.

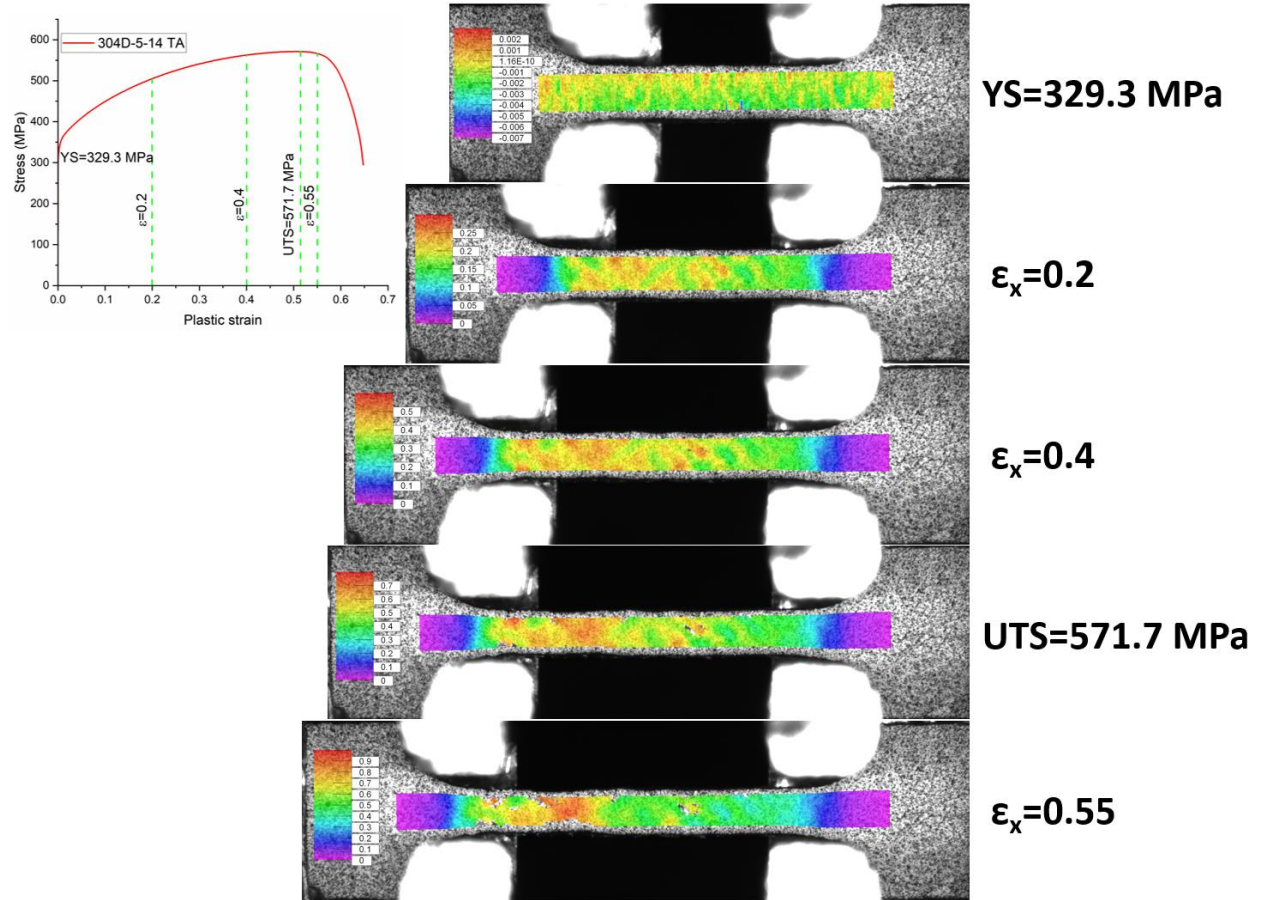
Figure 22. Local strain  $\epsilon_x$  distribution of 304D-5-14 TA specimen at different tensile stages.

The strain  $\epsilon_x$  distributions of the TMAZ/HAZ specimens at the top advancing side and the middle retreating side are shown in Figure 22 and Figure 23, respectively. Unlike the relatively uniform strain distribution of the SZ specimen (Figure 20) and the early strain localization of the bottom root specimen (Figure 21), multiple plastic strain bands, about  $45^\circ$  from the specimen gauge length directions, were present soon after the TMAZ/HAZ specimens yielded. Tensile strains inside the strain bands are much larger than those outside the strain band, although they might be within the same metallurgical zone. Those strain bands continue to exist when tensile stresses were between YS and UTS, and some strain bands even presented when the stresses reached UTS with strains larger than 0.5 in Figure 22 and Figure 23. At the UTS, the strain band widths were about 60–120  $\mu\text{m}$  for both specimens. Further studies are needed to identify the mechanism of the strain bands present, which could be related to the FSW thermal and mechanical histories in the TMAZ and HAZ, the FSW tool-determined TMAZ and HAZ geometry, and/or irradiation effects such as helium aggregation.

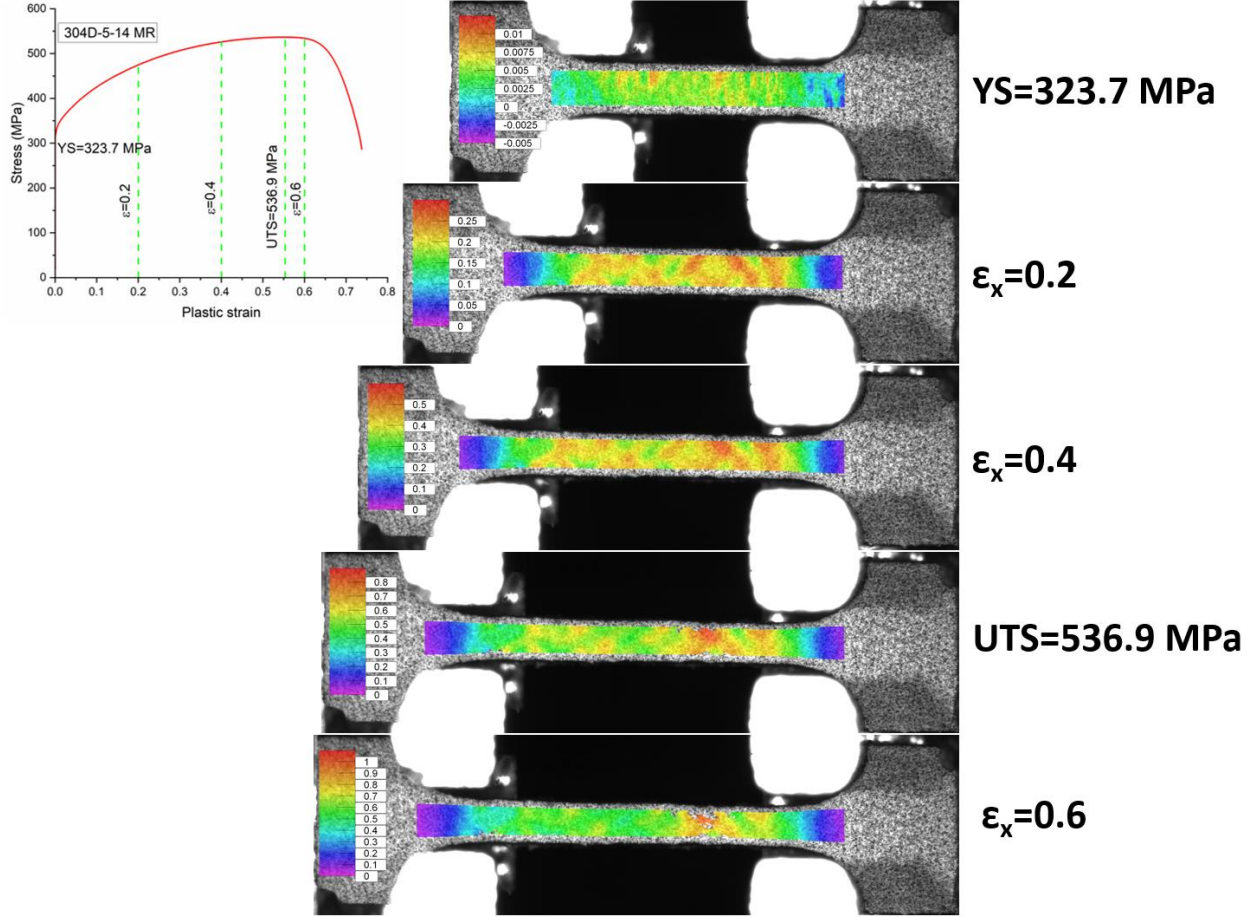
Figure 23. Local strain  $\epsilon_x$  distribution of 304D-5-14 MR specimen at different tensile stages.
