# Comprehensive Characterization of Helium-Induced Degradation of the Friction Stir Weld on Neutron-Irradiated 304L Stainless Steel

**ORNL/TM-2023/3088**  
**M3LW-23OR0406013**

**COMPREHENSIVE CHARACTERIZATION OF HELIUM-INDUCED DEGRADATION  
OF THE FRICTION STIR WELD ON NEUTRON-IRRADIATED 304L STAINLESS  
STEEL**

Prepared under the direction of the  
US Department of Energy  
Office of Nuclear Energy  
Light Water Reactor Sustainability Program  
Materials Research Pathway

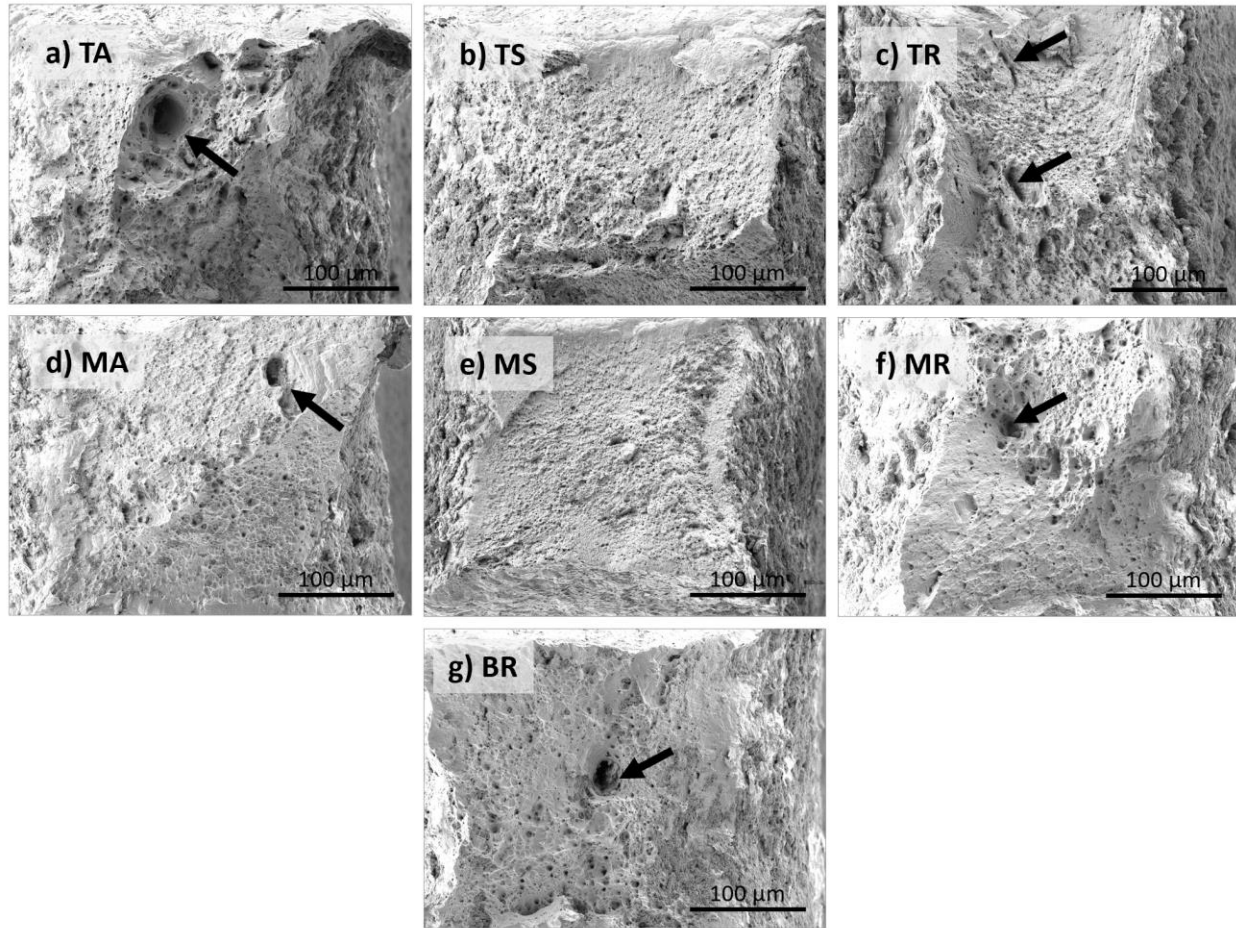
**Figure 24. Low-magnification (800×) SEM images of the fracture regions of the tested tensile specimens.** Material condition IDs and image order (e.g., “TA”) correspond to Figure 12 and Table 2. The dominating ductile fracture is visible, and minor features (indicated by black arrows) are likely related to boron-rich regions.

Figure 24 provides an overview of the fracture surface for all tested specimens. In most of the specimens, the fracture area assumes a square-like shape with dimensions roughly measuring  $300 \times 300 \mu\text{m}$ . This significantly smaller cross-sectional area ( $300 \times 300 \mu\text{m}$  compared with approximately  $600 \times 600 \mu\text{m}$  in Figure 11) and the consequent high area reduction imply the high ductility of the friction stir welded material. The fracture surface predominantly exhibits signs of ductile fracture, evident from the ductile dimples (covering the majority of the surface) or ductile shear (occupying a smaller region). Certain features, not associated with ductile fracture (e.g., deep holes, pores, and crack-like structures, highlighted by black arrows in Figure 24), were also observed. However, their frequency and overall surface area coverage were minimal, typically one or two per specimen, with the notable exception of the TR specimen, as shown in Figure 24a. The TR specimen exhibited several crack-like features.

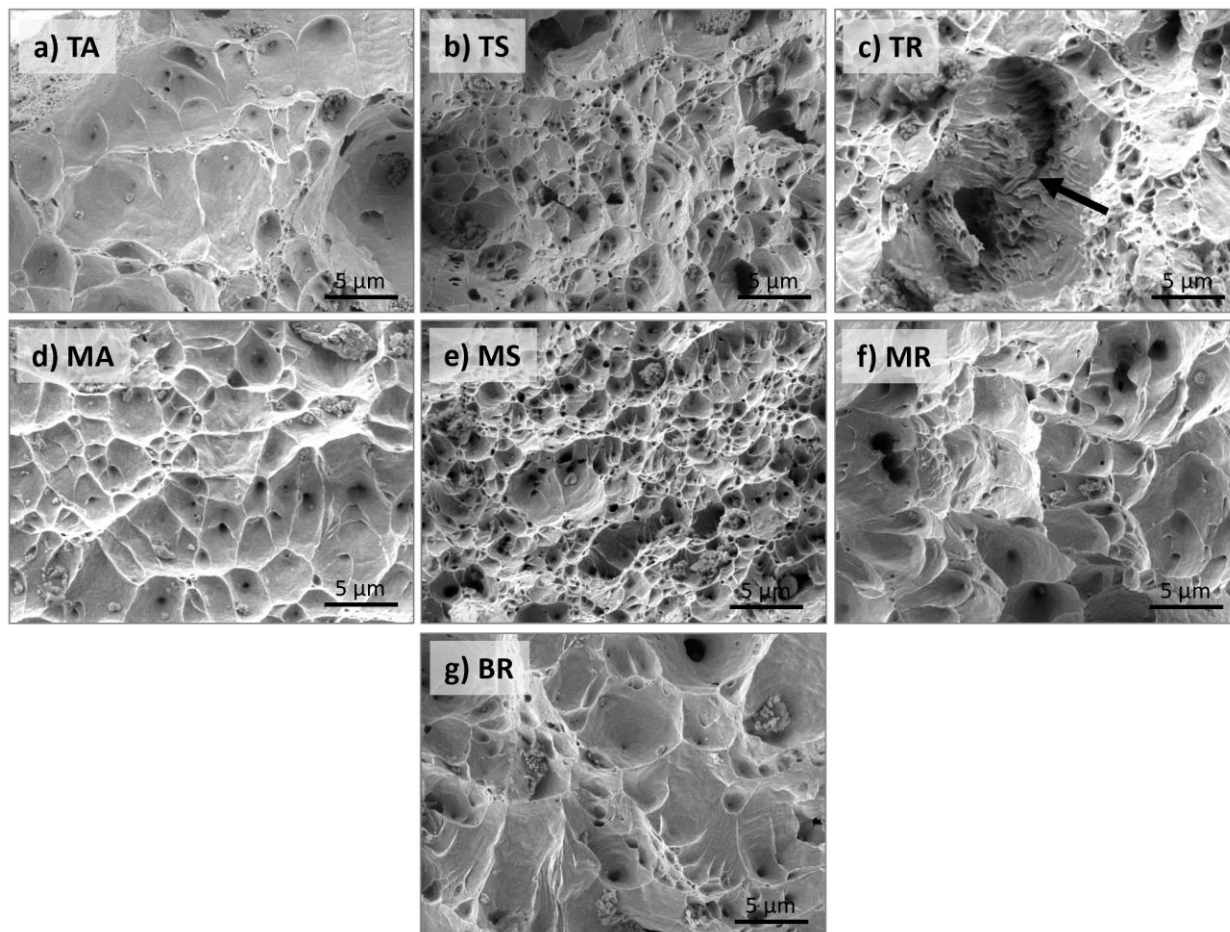
**Figure 25. High-magnification (nominal magnification 10,000 $\times$ ) SEM images of typical fracture surface appearance.** Material condition IDs are listed in Figure 12 and Table 2.

Figure 25 provides a detail view of the typical fracture surface. The dominant features are ductile dimples, which slightly vary in size based on different metallurgical locations. Although ductile dimples or ductile shear predominantly characterize the TR specimen (as shown in Figure 25c), evidence of ductile tearing is intertwined with features that are believed to be related to the initiation and growth of internal cracks (indicated by the black arrow in Figure 25c).

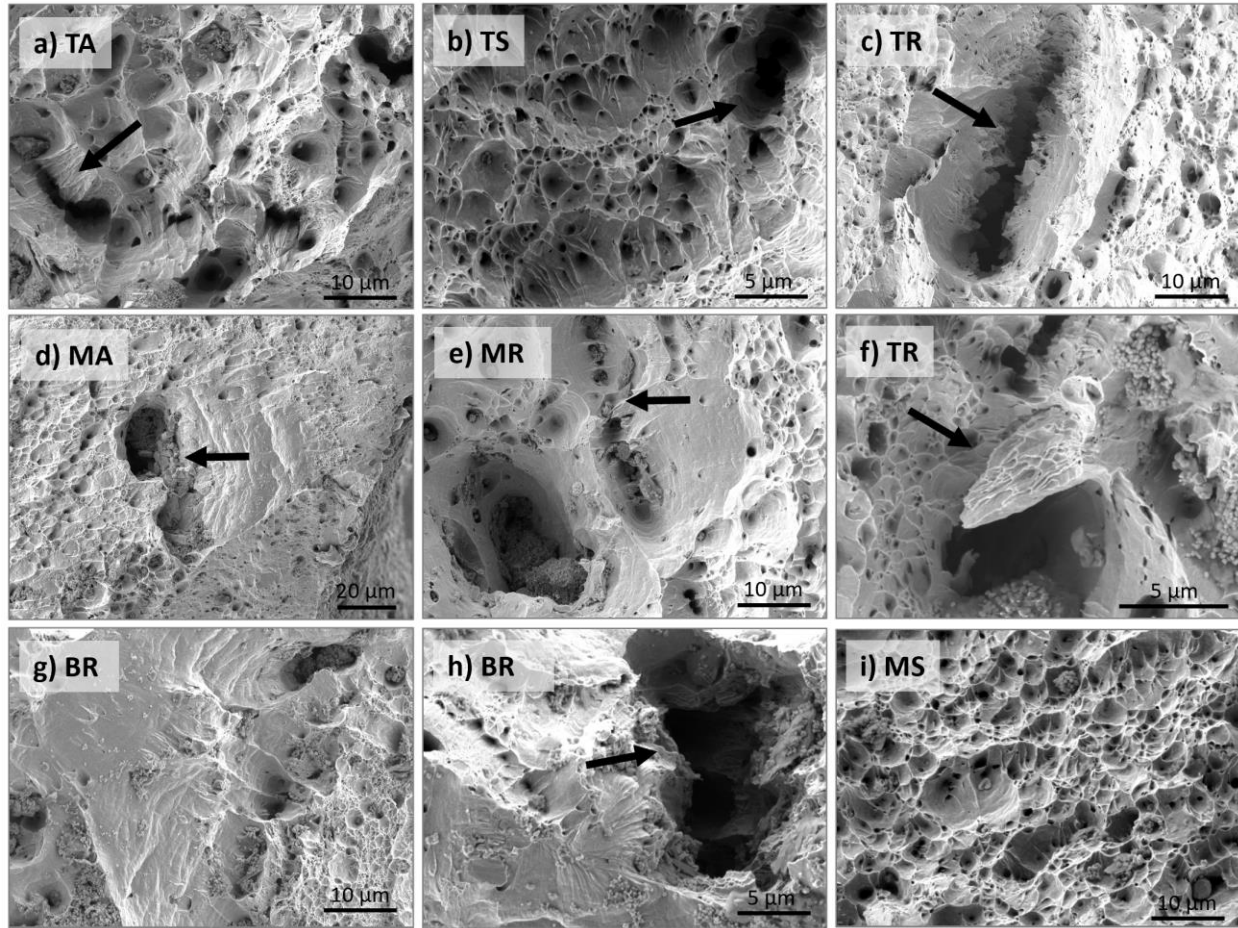
**Figure 26. Fracture surface features showing internal cracks, large pores, and cleavage-like spots. “MS”-condition image (i) represents typical the ductile fracture for comparison. Note magnification varies for some images; “TR”-condition is shown twice.**

Figure 26 displays features that are believed to be related to the presence of helium (boron)-rich regions and compromised grain boundaries. The most commonly observed features are deep, trench-like structures formed at compromised boundaries containing chains of helium bubbles, as depicted in Figure 26(a, b, c). The deep holes shown in Figure 26(d, e) potentially indicate coarse inclusions or large helium bubbles. The unique “ductile bridges” or “pillars” shown in Figure 26f underscore the intricate geometry of the internal damage. Minor cleavage areas, as shown in Figure 26g, likely correspond to helium-rich zones. Deep localized fractures, presented in Figure 26h, are relatively infrequent and are presumably due to metallurgical inclusions. In all cases, except for the TR specimen, such features constitute only a minor portion of the observed area.

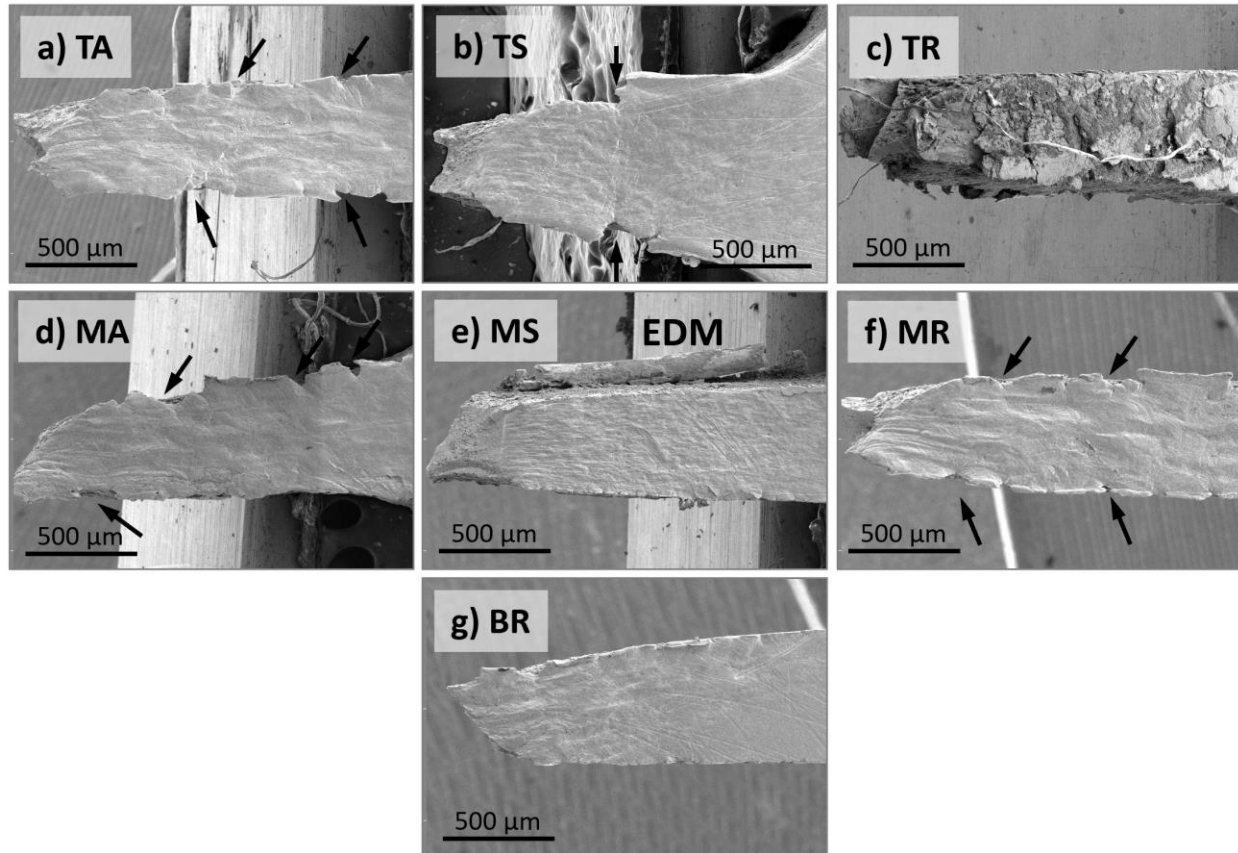
**Figure 27. Gauge portions of the tensile specimens after mechanical testing and fracture.** Black arrows mark local fracture events (mostly along the gauge edges); the “EDM”-label marks the separation and peeling-off of the EDM-induced layer. Note pronounced delayering at the surface of the TR specimen (c). Material condition IDs are given in Figure 12 and Table 2, pretest specimen geometry is shown in Figure 11.

Figure 27 illustrates the condition of the specimen gauge sections following the tensile tests and subsequent fracture. Typically, discerning both the necking and the fracture regions is easy. Intriguingly, the majority of the specimens indicate localized fracture along their edges, highlighted at specific locations by black arrows. These locations seem to be randomly distributed; they do not align into a regular zigzag or any ordered pattern, which would be characteristic of conventional strain-induced shear bands. These localized fracture spots are probably associated with helium-rich zones (Figure 9a) possibly generated in the BM production and compromised grain boundaries.

The presence of these localized fracture spots aligns with the generally erratic pattern of strain localization, as unveiled by DIC analysis (Section 3.2). Notably, both the MS and BR specimens visually exhibited no such fracture spots, likely indicating the lack of helium-rich regions.

By contrast, The TR specimen exhibited an unexpectedly poor surface quality, manifesting multiple crack formations and delamination effects, as shown in Figure 27c. To prevent the formation of debris and dislodged particles, cleaning was executed with extreme care, but some paint residue was deposited within several cracks. Although multiple cracking typically indicates premature fracture and diminished engineering ductility, the ductility for this specimen remains high, as detailed in Table 3: the total elongation value surpasses 40%. Further investigation is required to elucidate this unexpected behavior. Deformation mode may change with material volume and dimension. Actual welded component might be much more bulk, and its deformation mode and failure may not the same as observed in the small specimen.

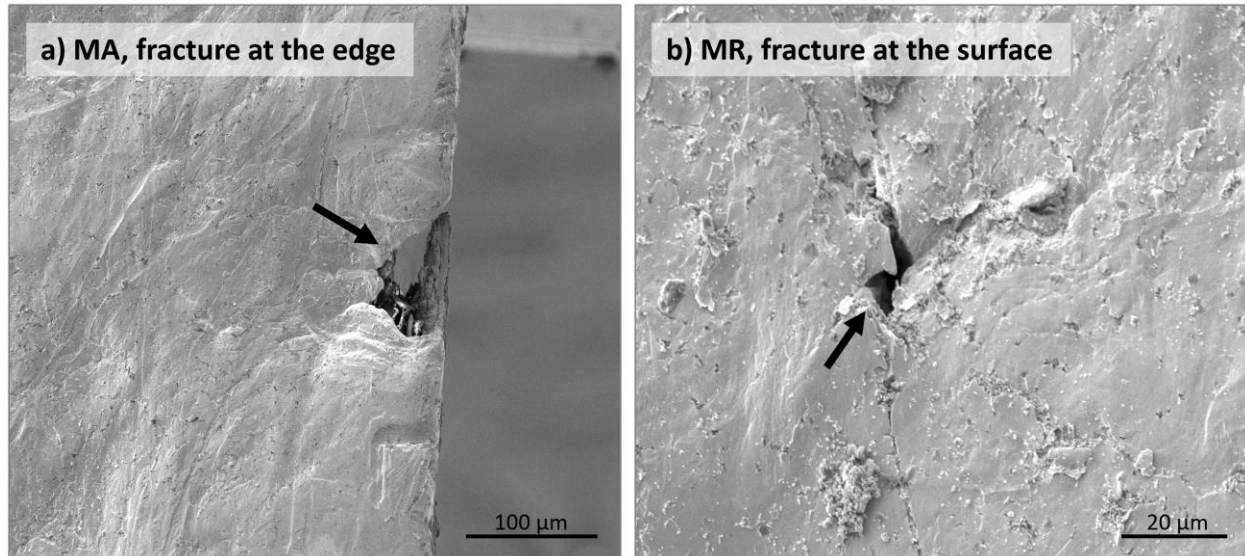
**Figure 28. Examples of localized fracture at the specimen gauges.** (a) The MA specimen, fracture at the specimen edge. (b) The MR specimen, fracture at the specimen surface, also note a thin wire-like crack. Tensile direction is vertical in this Figure.

Figure 28 shows several examples of the fracture events along the gauge. The specific appearance of these areas indicates strong variations in the material conditions. Generally ductile material (slightly deformed austenite in TMAZ) contains specific brittle “clusters” or “kernels,” easily fracturing in a brittle way.

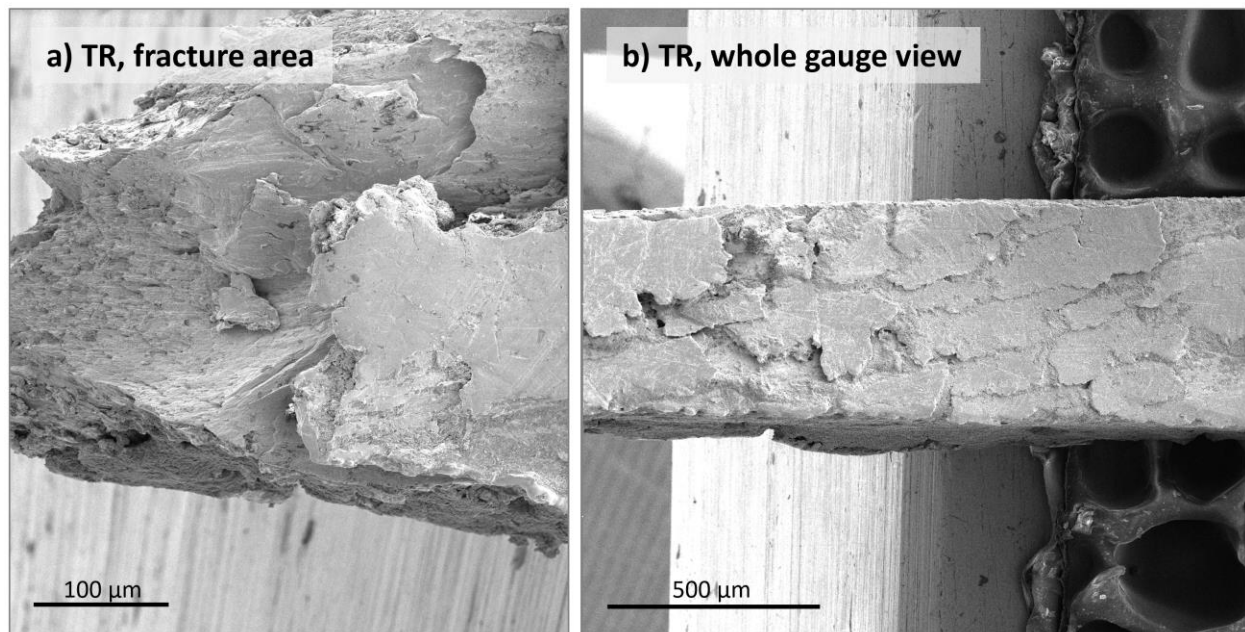
**Figure 29. Delayering and multiple cracks at the surface of the TR specimen.** This phenomenon is difficult to fully explain now.

Figure 29 shows additional images of the TR specimen, taken from a different specimen half. The figure shows a striking overlapping of pronounced ductility and ductile fracture (also shown in Figure 24 and Figure 25) and multiple delamination and, probably, cleavage processes. Such phenomena could be expected for composite materials, combining ductile/soft and brittle/hard phases or alloy components. In situ tests with an identical specimen should be performed to investigate the phenomenon in more detail.
