# Analysis of Deformation Localization Mechanisms in Highly Irradiated Austenitic Stainless Steel via In Situ Techniques

# **Analysis of Deformation Localization Mechanisms in Highly Irradiated Austenitic Stainless Steel via In Situ Techniques**

Prepared under the direction of the  
U.S. Department of Energy  
Office of Nuclear Energy  
Light Water Reactor Sustainability Program  
Materials Research Pathway

Prepared by  
OAK RIDGE NATIONAL LABORATORY  
Oak Ridge, TN 37831-6285  
managed by  
UT-BATTELLE, LLC  
for the  
U.S. DEPARTMENT OF ENERGY  
under contract DE-AC05-00OR22725

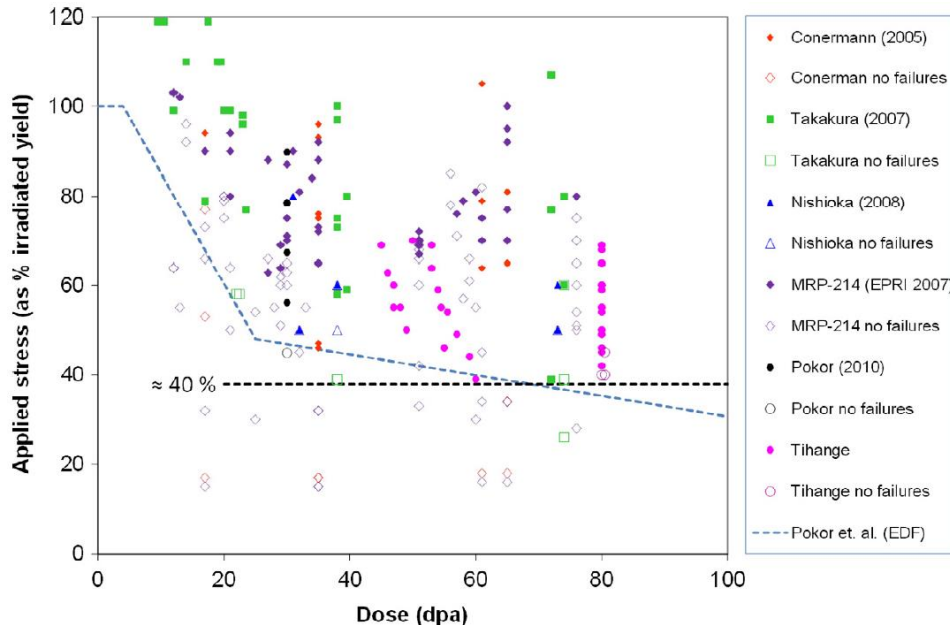
**Figure 1. Damage dose as a function of applied stress. Closed symbols represent failures; open symbols represent survived specimens. The figure was adopted from [1].**

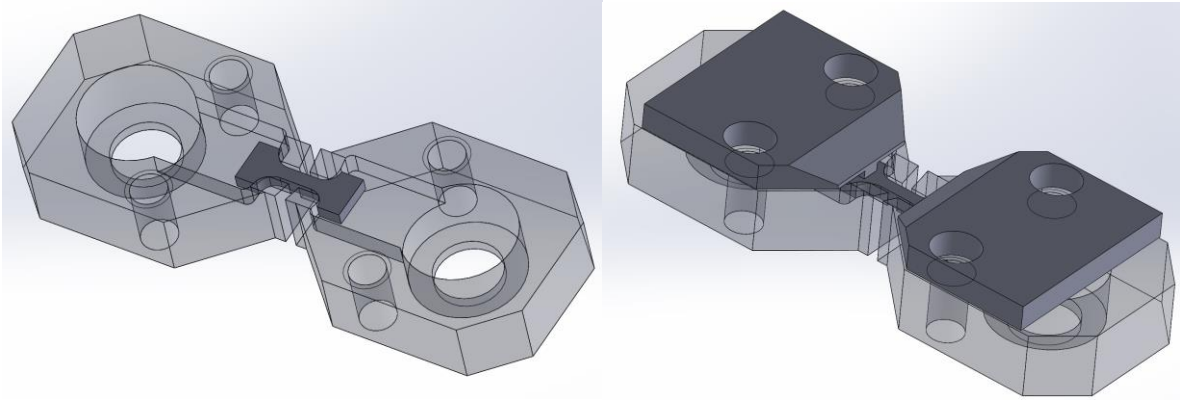
**Figure 4. Grips for the K&W tensile stage to handle the ultra-miniature specimens. (left) Specimen inside grips (shown semi-transparent. (right) full assembly with specimen holders to prevent specimen fall if the fracture occurs.**

To perform in situ mechanical tests, new grips (Figure 4) were designed for the SEM tensile stage. The grips—technically, insertions in the master K&W grips—are made of aged 718-alloy. They have sufficient carrying capacity to test materials (SS-Teeny specimen geometry) with yield strength (YS) up to  $\sim 1200$  MPa. (Irradiated austenitic steels reach YS of  $\sim 900$ – $1000$  MPa at high doses.) To keep the specimen in place, two specific thin holders were employed; they also provided additional safety, preventing the specimen from dropping off when the failure occurred.

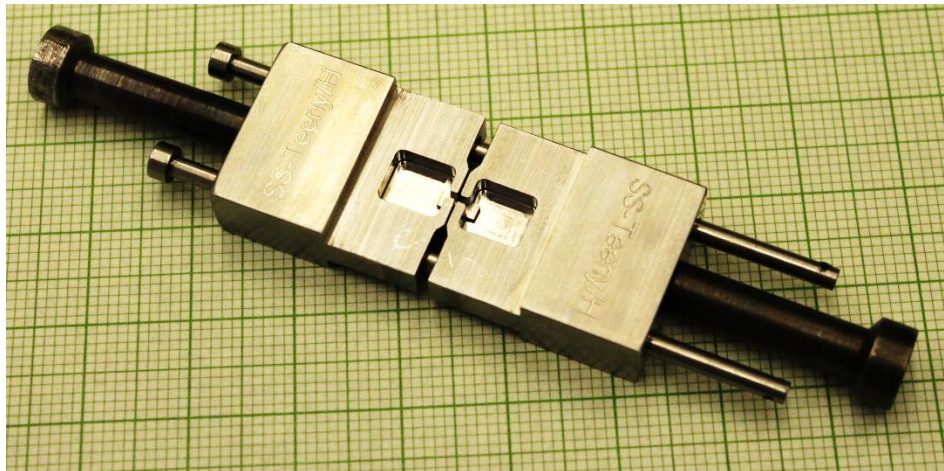
**Figure 5. Conventional tensile grips for the designed ultra-small specimens.**

Because there is a need to also perform ex situ tests, common shoulder-loading grips were designed and manufactured (Figure 5). Because material may be magnetic for out-of-SEM tests, a 17-4 PH steel was used, allowing for test temperatures up to 350–400°C.

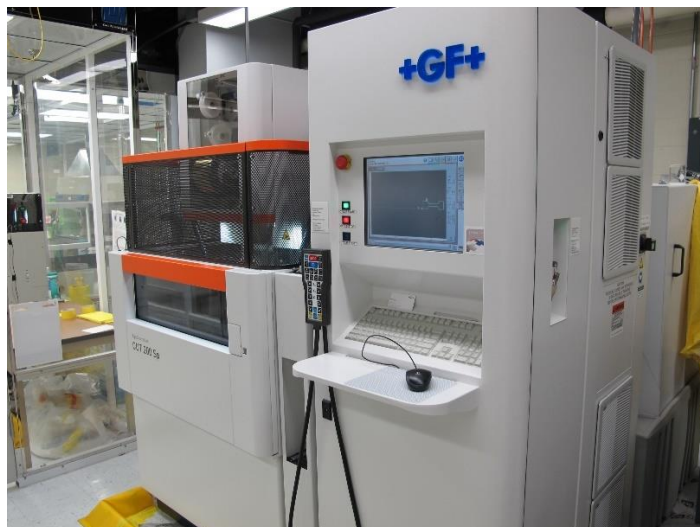
**Figure 6. EDM system installed in LAMDA to manufacture specimens from radioactive material.**

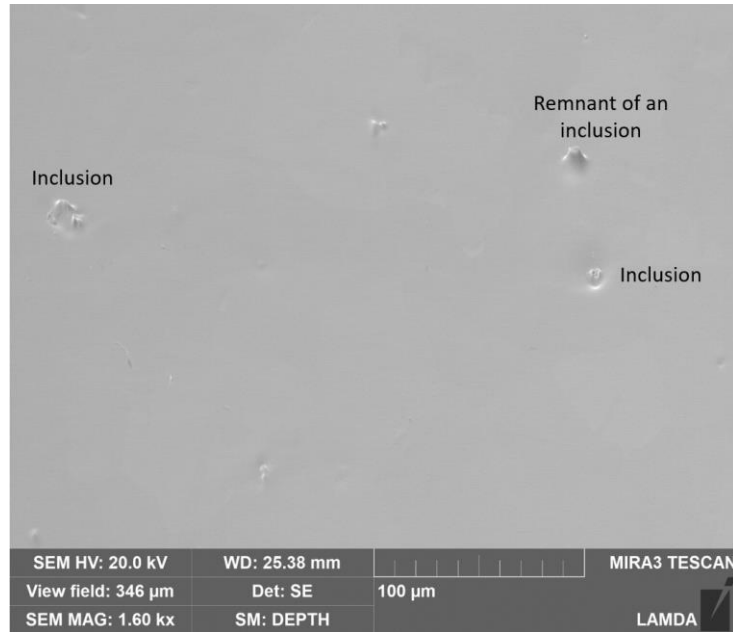
**Figure 7. A98-2-TENSILE, 69 dpa. Typical appearance of the specimen surface after electropolishing. One can see a clean metallic surface with a few scattered nonmetallic inclusions of metallurgical origin. Note the image is 70° tilted with tilt correction applied.**

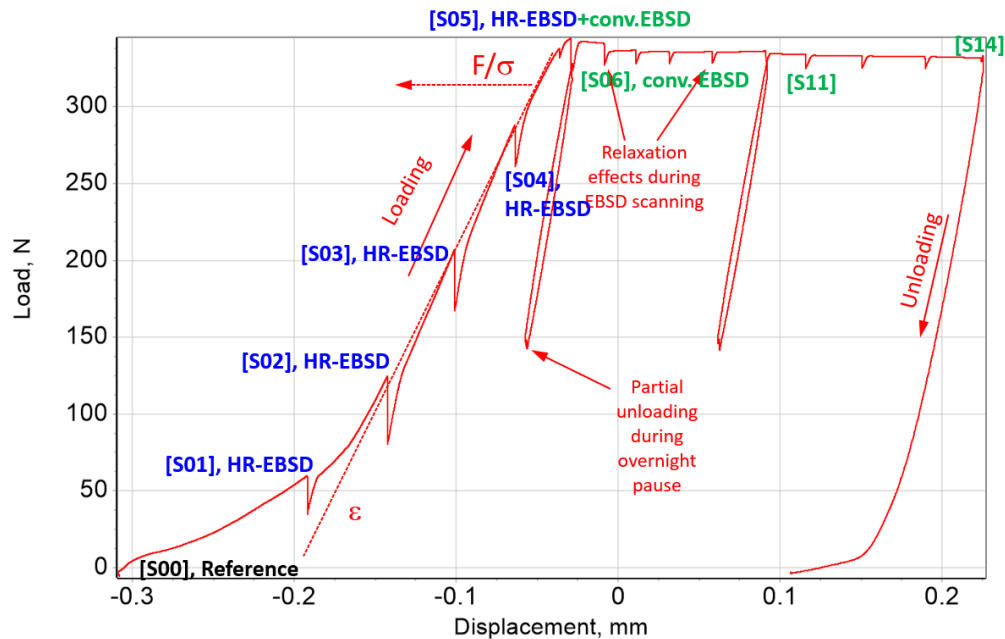
Figure 8. Scheme of a typical in situ test. S01-S14: steps of the in situ test, showing the category (or categories) of the data obtained. Specimen ID: A98-2-TENSILE, 69 dpa. The test took about 3 days at the SEM; the specimen was partially unloaded at the end of each day to minimize creep-related processes.

In the present work, by analogy with previous work [12], the specimens were deformed in several stages (Figure 8). First, the elastic strain area was explored, making stress increments of ~150–200 MPa. HR-EBSD scans were performed to study elastic in-grain stresses and strains. Once a specimen entered the plastic area, the displacement control stage was initiated with strain increments of ~1–3%. Conventional EBSD scans were performed in the plastic strain area up to strain level ~0.15–0.2 (~15–20%). After that, the pure-SEM stage occurred to track interesting features and phenomena.

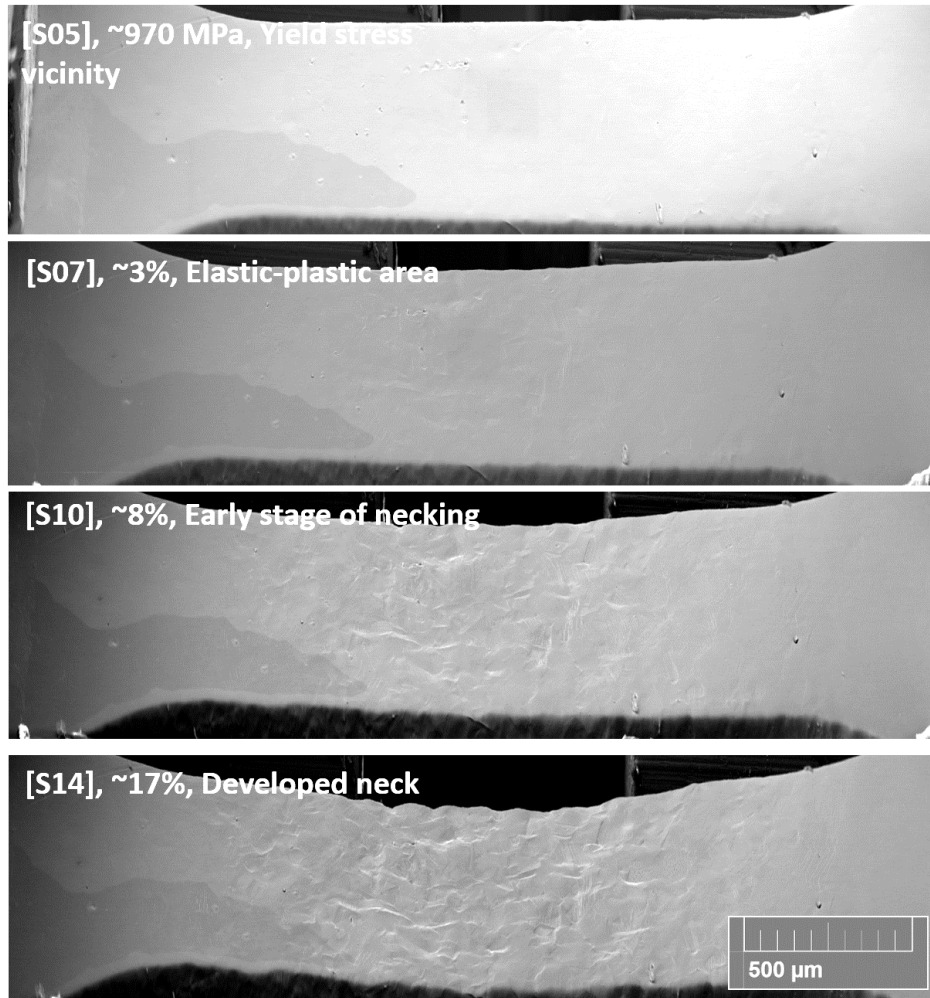
**Figure 9. A98-2-TENSILE, 69 dpa, specimen appearance at different stages of the test. Strain values are given in the “global strain” terms (defined from the tensile curve). Note that the images are 70°-tilted; also, low-magnification SEM images may show some distortion.**

Figure 9 shows the specimen appearance during the in situ test, step numbers correspond to Figure 8, and strain/stress are “global” values calculated from the tensile curve. In the elastic area and the YS vicinity (around step 5), the specimen surface is smooth and clean and free of damage. Few inclusions (of metallurgical origin) are visible at the gauge; being detrimental from the material performance point of view, the inclusions play a role of visual marks at the surface, making SEM observation and navigation

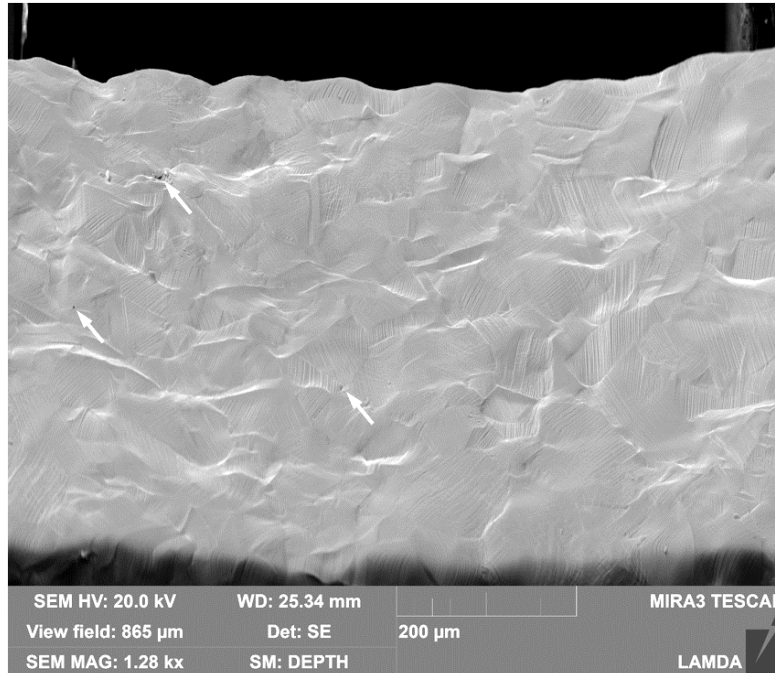
**Figure 10. A98-2-TENSILE, 69 dpa, neck at step 14 (the last step). Arrows point to a few microfracture events at the surface. A few additional fracture-related features need larger magnification (see section 4).**

easier. Maximized image contrast reveals minor carbon contamination from the SEM beam and some minor residue after electropolishing at the bottom left portion of the gauge. At small plastic strains, a weak roughness appears at the surface, reflecting plastic deformation processes. The roughness grows and becomes especially pronounced in the neck. Images taken at different magnifications show tracking features, including new cracks (Figure 10).

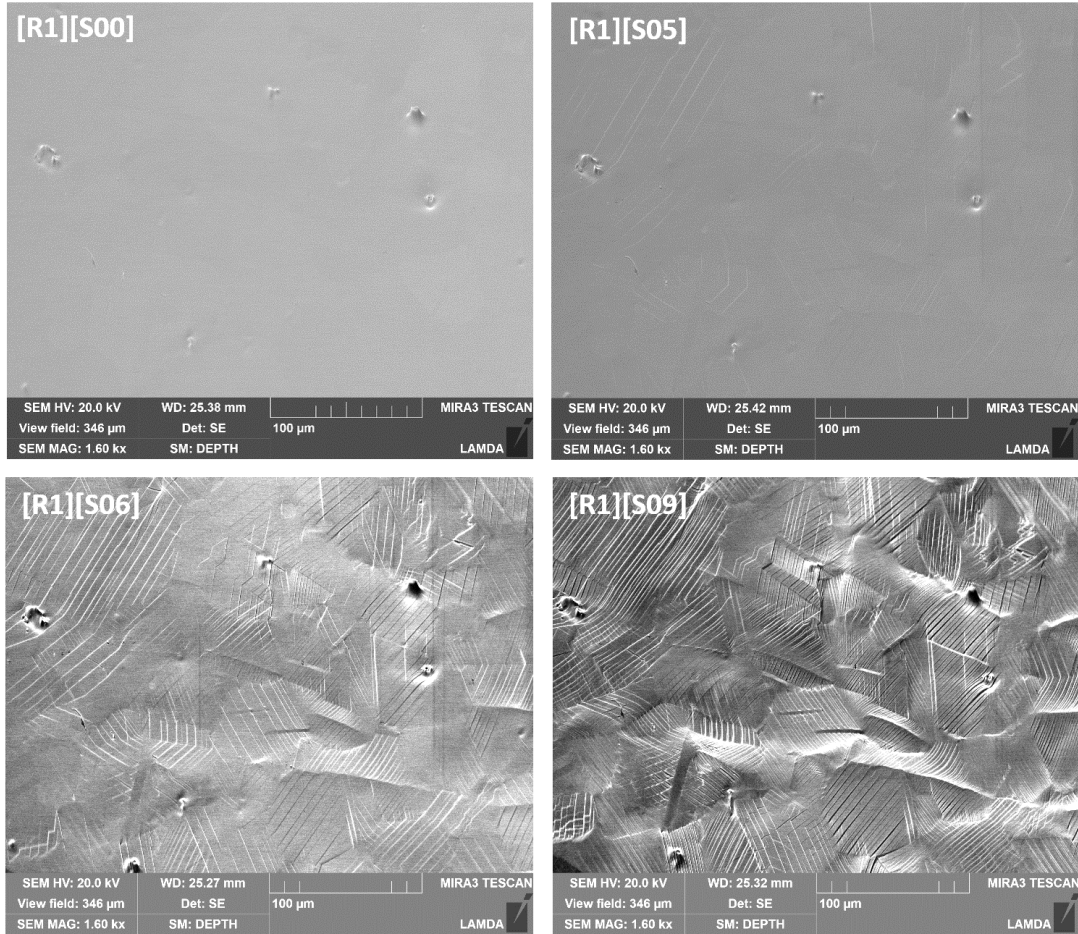
Figure 11 illustrates the changes in surface morphology during the test. A few slip lines (i.e., dislocation channels) appear in the small plastic strain area (step 5). The channels tend to appear in large grains and “soft” grains (i.e., with larger Schmidt factor) favorably oriented for slipping. Usually, one to a few channels form per grain involved in deformation, and only one slip plane—rarely two—is active per grain.

**Figure 11. A98-2-TENSILE, 69 dpa, specimen surface morphology at different stages. The same area is shown at different strain levels.**

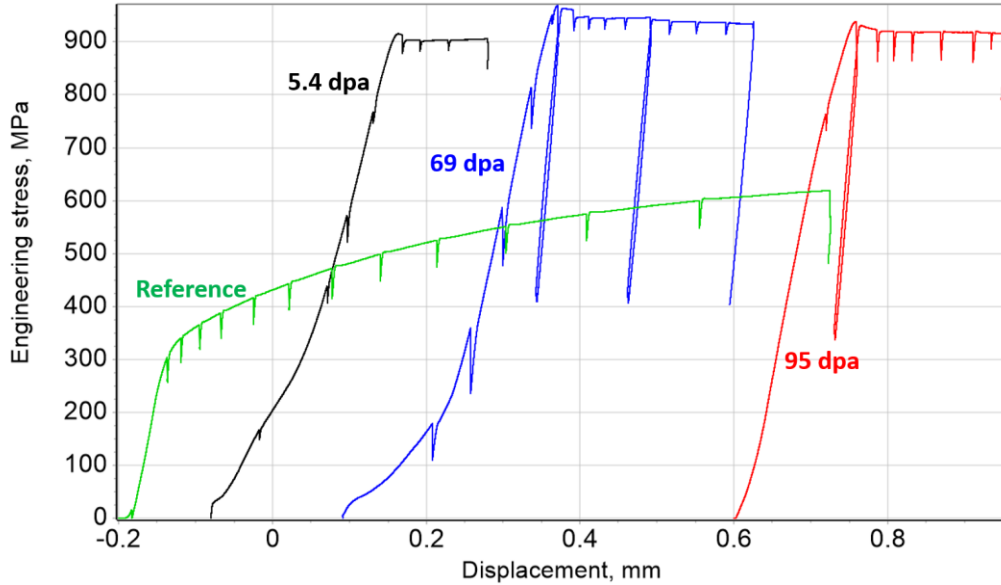
Figure 12 demonstrates tensile curves obtained during in situ tests with high-dose specimens in comparison with the curve for the reference specimen tested at the same conditions. The displacement rate during the tests was  $1.6 \mu\text{m/s}$  providing a nominal strain rate of  $0.001 \text{ s}^{-1}$ . Force drops at the curves correspond to the test interruptions to perform specimen survey and EBSD or HR-EBSD scans.

**Figure 12. Raw tensile curves in “Engineering stress [MPa] – Displacement [mm]” coordinates, recorded during in situ mechanical tests with reference and irradiated specimens. The curves are shifted along the X-axis to aid the reader. Since the tests were interrupted before fracture, full elongation (and uniform elongation for the reference specimen) cannot be determined.**

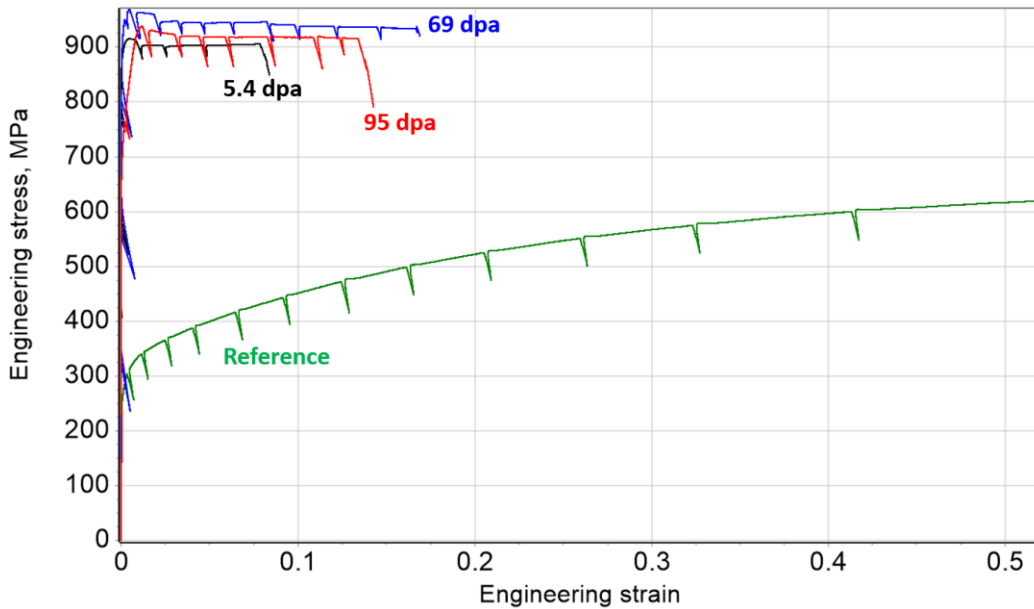
Figure 13 shows the same curves in coordinates “Engineering stress – Engineering strain” with compliance and elastic strains removed.

**Figure 13. Tensile curves in “Engineering stress [MPa] – Plastic strain [relative units]” coordinates.**

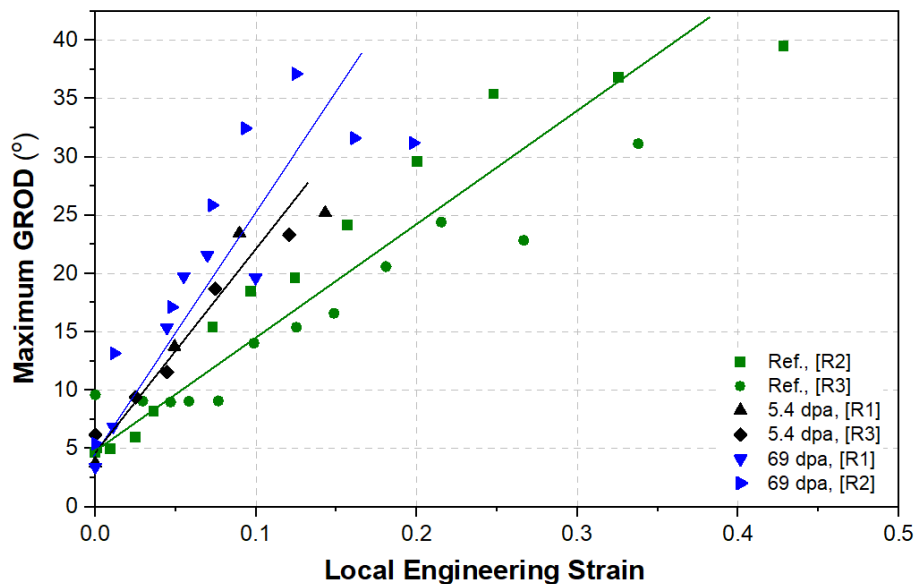
Figure 17 shows GROD value as a function of the local strains; by analogy with [12], the plot reflects the maximum GROD value ( $GROD_{max}$ ) observed within the scan. The GROD value shows how one part of the grain is bent or rotated regarding the average grain orientation; in other words, it shows the activity of dislocation sources and accumulation of geometrically necessary dislocations in the material volume.

For the nonirradiated specimen, there is a nearly linear relationship between GROD and strain up to  $\sim 0.3$  or so. It suggests that the maximum GROD value may be roughly proportional to the dislocation density and strain level. Starting at some critical strain, GROD may decrease, reflecting grain fragmentation and formation of in-grain boundaries. The irradiated specimens demonstrated a different trend: GROD increased faster, reflecting a much quicker increase in the in-grain misorientation level; the reasons behind that are not fully clear at the moment.

**Figure 17.  $GROD_{max}(\epsilon)$ : Maximum GROD value observed within an ROI as a function of the local strain. The solid lines show data trends for the tested specimens to aid the reader. 95-dpa specimen data are still being analyzed.**

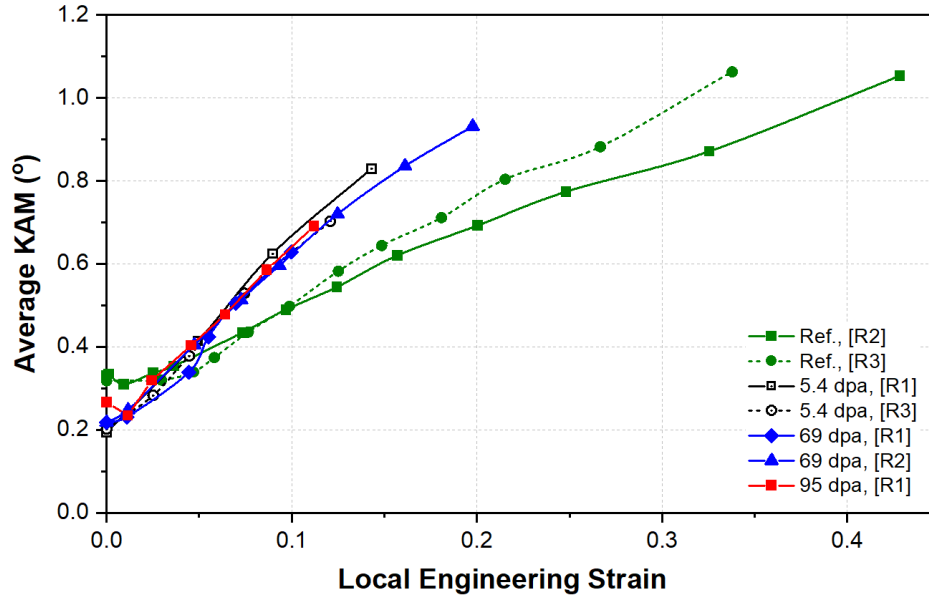
Figure 18 average shows KAM value as a function of local plastic strain for the tested reference and high-dose specimens. As discussed in [12], the average KAM parameter is often used to evaluate and quantify plastic strains. Average KAM may be connected to the density of geometrically necessary dislocations and, under some conditions, to a total dislocation density. Usually, there is a close-to-linear relationship between plastic strain level (up to strains of  $\sim 0.3$ - $0.5$ ) and KAM; a significant body of literature exists for

**Figure 18. KAM( $\epsilon$ ): Average KAM as the function of the local strain for the reference (Ref) and high-dose specimens. EBSD step size  $0.5 \mu\text{m}$  for all included scans. Note local strain levels were determined for each selected and tracked ROI, as described in [12]; because of fast necking, the irradiated and deformed specimen will have areas with different local strains. R1-R3: regions of interest. For each specimen, several ROs were selected, mapped, and tracked. However, some ROs showed no plastic strain, and some were designated for HR-EBSD scanning; such data were omitted. Data processing is not fully completed, so the plot will include more data later.**

As follows from Figure 18, a close-to-linear relationship between local strain and KAM exists for a reference specimen. The increase in the average KAM value is caused by the accumulation of geometrically necessary dislocations in the structure, and average KAM value or another similar metric may be employed to measure the strain level via a proper calibration curve [12].

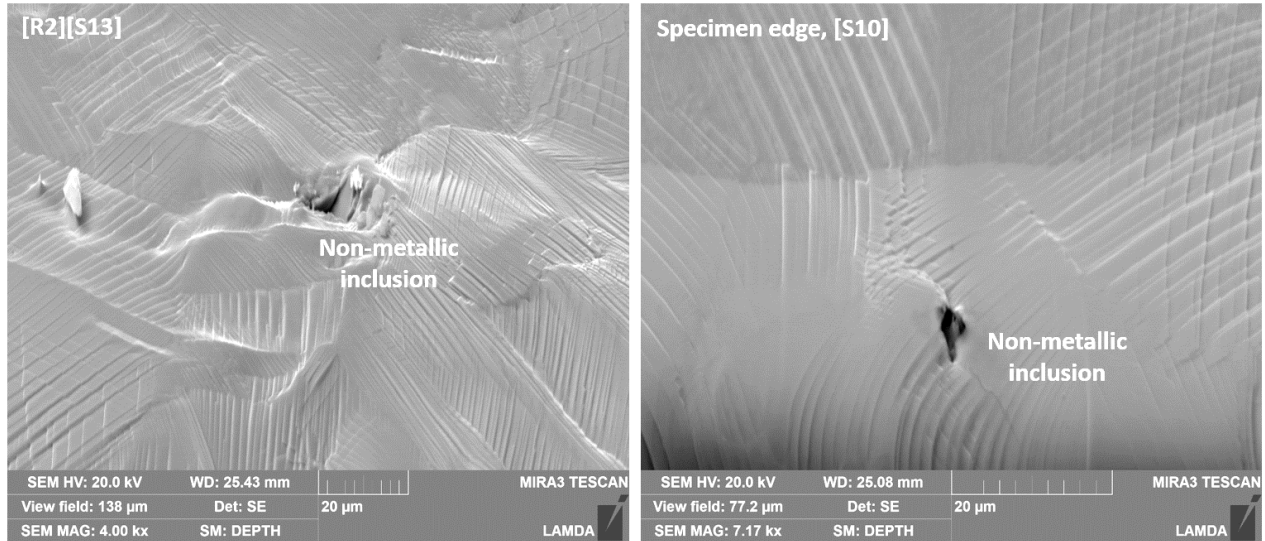
Metallurgical inclusions are apparent sources of microfracture events. Inclusion-induced cracks of  $\sim 10\ \mu\text{m}$  or so were observed in all tested specimens (Figure 19). According to the preliminary results, irradiation did not increase the size of these cracks, but they occurred at smaller local strains compared to the reference specimen.

**Figure 19. Microfracture events associated with nonmetallic inclusions. The discontinuity size was  $\sim 8\text{--}12\ \mu\text{m}$ . 69 dpa specimen (A98-2-TENSILE).**

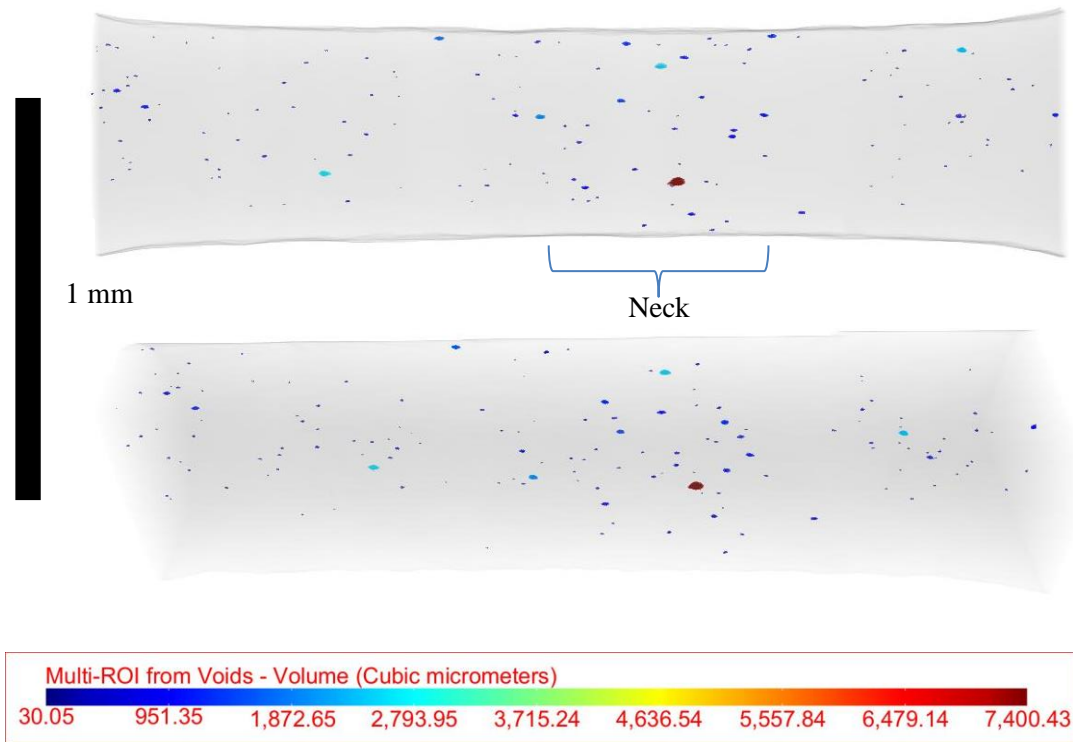
A 3D reconstructed image of the tensile sample is presented in Figure 22 from two different view angles, showing the distribution of segmented voids in 3D. The voids are colored according to the volume they occupy, as indicated on the legend.

**Figure 22. 3D representation of the reconstructed image with the discontinuities (voids and pores) segmented. The color scale corresponds to the void volume in  $\mu\text{m}^3$ . Deformed reference specimen.**

Overall, voids can be observed throughout the entire gauge section; however, larger voids are found to be concentrated within the center portion where necking has occurred. Furthermore, the voids can be seen to be elongated along the tensile direction.

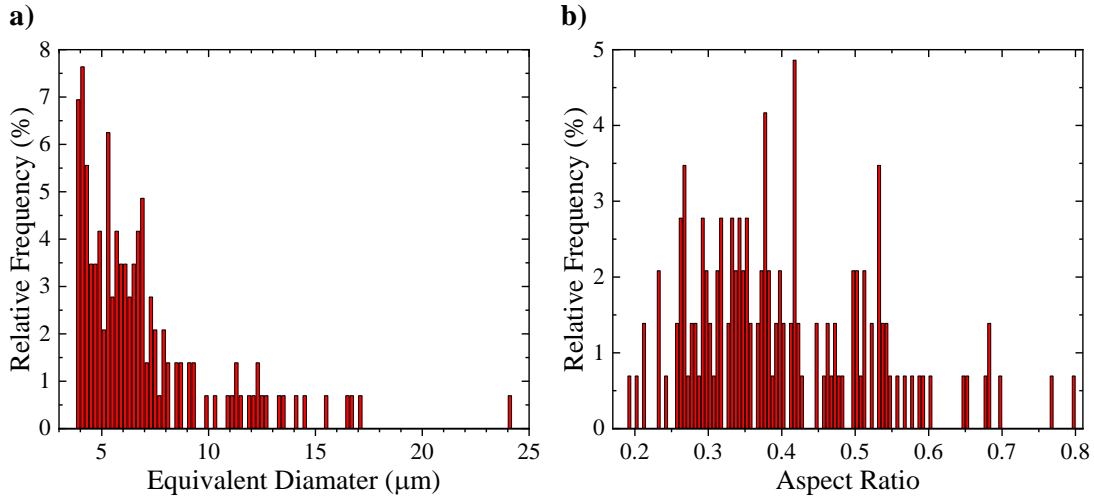
Next, quantification was performed to obtain void size and aspect ratio distributions. The results are presented in Figure 23a and b, respectively. To have a better representation of the void size, equivalent diameters were calculated from the segmented volumes assuming spherical morphology (Figure 23a). Both void nucleation and growth are captured with this approach wherein the smaller sizes correspond to newly nucleated voids, and larger sizes correspond to growth. Accordingly, most of the voids (number-wise) can be stated as belonging to the newly nucleated group. The aspect ratio distributions, on the other hand, are used to determine the void morphologies, where an aspect ratio of 1 corresponds to a perfect sphere. Following the qualitative observations, the majority of the voids are accumulated towards the lower aspect ratios ( $<0.5$ ), suggesting ellipsoidal (i.e., elongated) voids.

**Figure 23. Distribution of the void size (a) and aspect ratios (b) for the nonirradiated tensile sample.**

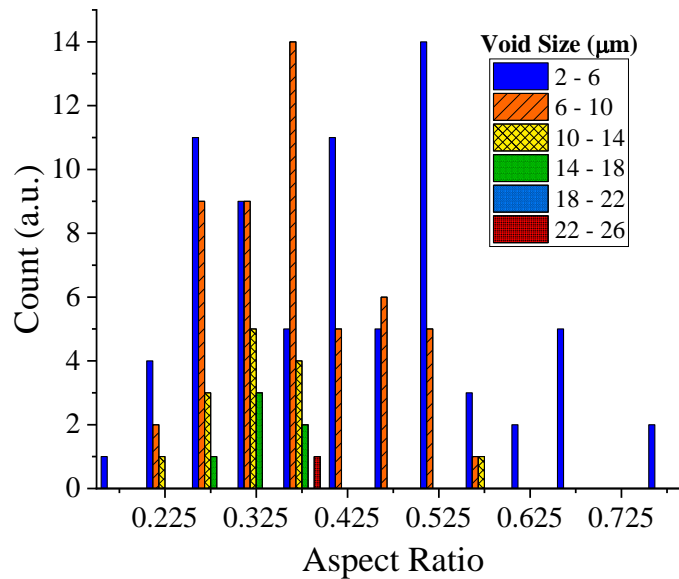
Furthermore, the relation between void size distribution and aspect ratios is presented in Figure 24. It demonstrates that as the void size grows, the aspect ratio decreases. This shows void growth by elongation (along the tensile direction in this case), leading to ellipsoidal voids.

**Figure 24. Void size distribution as a function of aspect ratios for the nonirradiated tensile sample.**

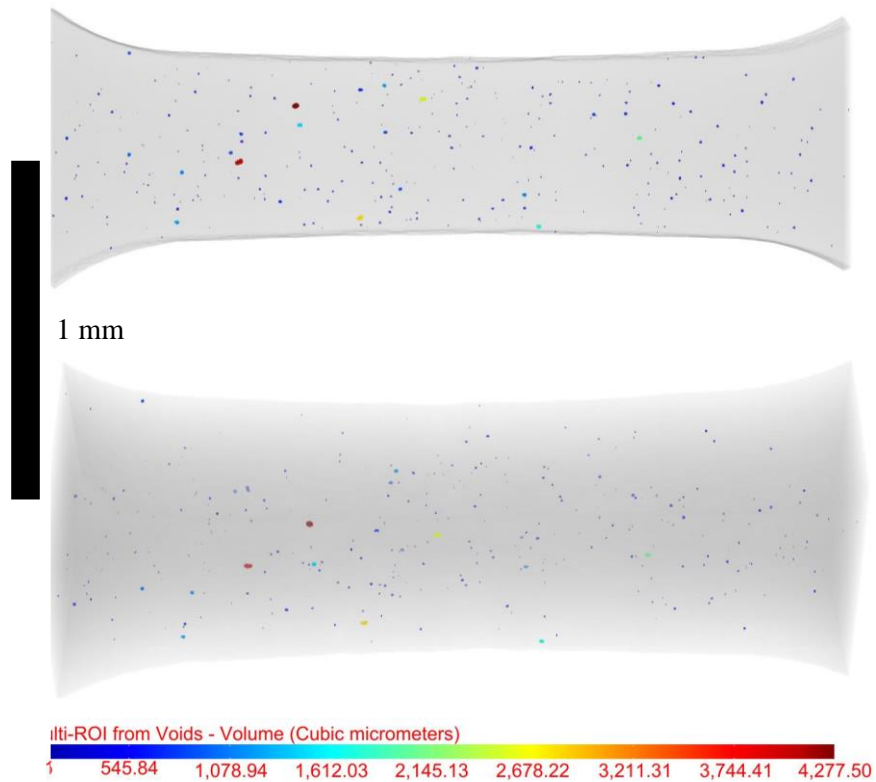
A 3D reconstructed image of the deformed tensile sample is presented in Figure 26 from two different view angles, showing the distribution of segmented voids in 3D. The voids are colored according to the volume they occupy, as indicated on the legend. Similar to the non-irradiated reference sample, the voids can be observed throughout the entire gauge section. However, the largest voids do not necessarily coincide with the neck region. Furthermore, the voids are not elongated along the tensile direction, unlike the reference sample.

**Figure 26. The 3D representation of the reconstructed image with the voids segmented. The color scale corresponds to the void volume in  $\mu\text{m}^3$ .**

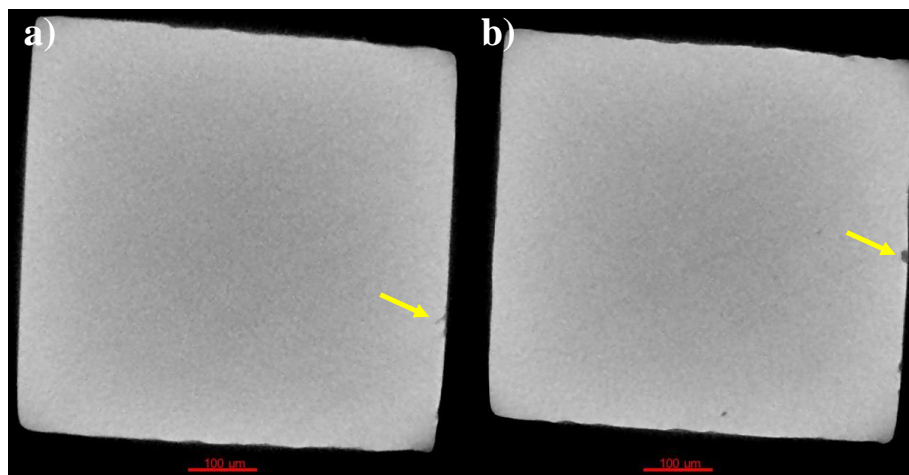
2D slice images in Figure 27 shows two discontinuities connected to the surface: possible surface crack (a) and a cavity-like feature (b). The feature, shown in Figure 27b, may correspond to the crack visible in Figure 21. Still, more detailed analysis and comparison with the SEM observations are necessary to evaluate the origin of these objects.

**Figure 27. 2D slice images of the irradiated sample a) arrow pointing to a possible surface crack b) arrow pointing to a surface cavity. Here the tensile axis is out of the plane of the paper.**

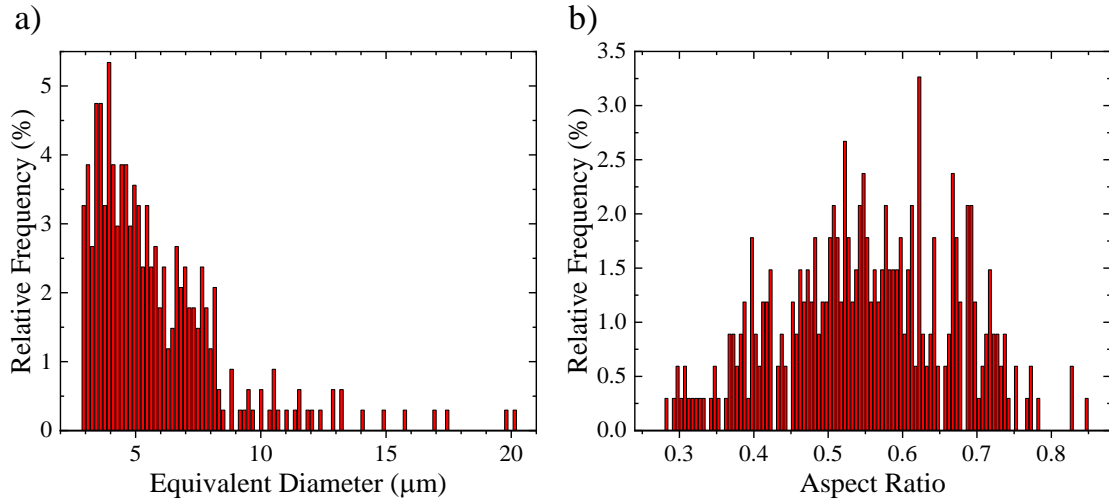
The void size and aspect ratio distributions are presented in Figure 28a and b, respectively. To have a better representation of the void size, equivalent diameters were calculated from the segmented volumes assuming spherical morphology, Figure 28a. The majority of the voids are found to be below  $\sim 5 \mu\text{m}$  equivalent diameter. The aspect ratio distributions are used to determine the void morphologies, where an aspect ratio of 1 corresponds to a perfect sphere. The aspect ratio distribution (Figure 28b) is close to a Gaussian distribution, with the majority of the voids grouped between 0.45 and 0.65.

**Figure 28. The distribution of the void size (a) and aspect ratios (b) for the irradiated A96 tensile sample.**

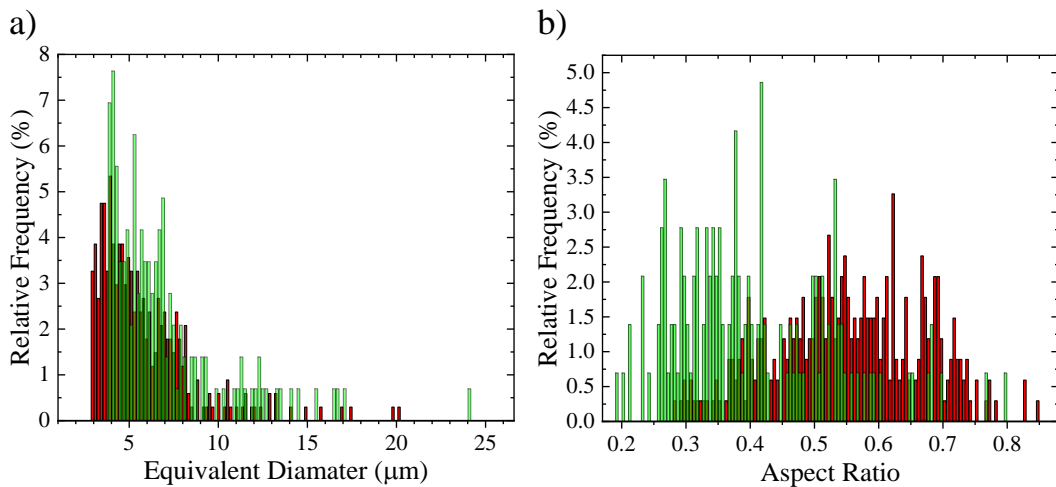
To compare the two sets of data, the quantitative results are presented together in Figure 29 where red corresponds to the irradiated A96 sample and semi-transparent green to the non-irradiated reference sample. Figure 29a shows that in the non-irradiated sample, larger voids are observed, whereas, in the irradiated sample, smaller voids are present compared to the non-irradiated sample.

**Figure 29. The distribution of the void size (a) and aspect ratios (b) for the irradiated A96 tensile sample (red) in comparison to the non-irradiated reference sample (transparent green).**

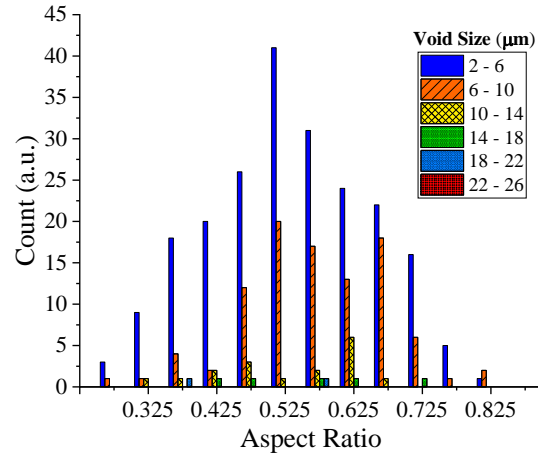
**Figure 30.** The void size distribution as a function of aspect ratios for the irradiated A96 tensile sample.
