**MICROSTRUCTURE, CORROSION AND STRESS
CORROSION CRACK INITIATION OF ALLOY 600
IN PWR PRIMARY WATER ENVIRONMENTS**

**Technical Milestone Report: M3LW-13OR0403032
March 2013**

M. J. Olszta, D. K. Schreiber, M. B. Toloczko
and S. M. Bruemmer
Pacific Northwest National Laboratory

Research Project:
**Stress Corrosion Crack Initiation of
Nickel-Base Alloys in LWR Environments**
Project Manager: S. M. Bruemmer
Pacific Northwest National Laboratory

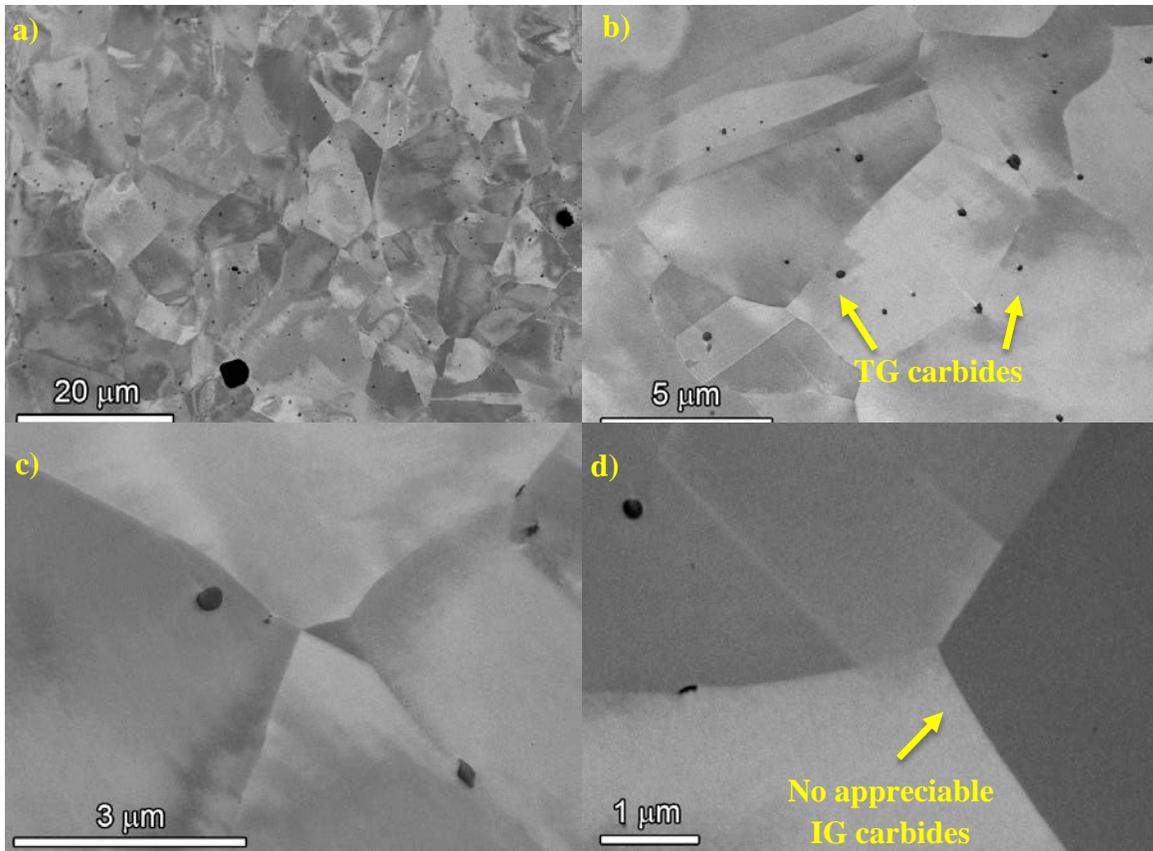
SEM backscatter electron (BSE) images in Figure 1 are presented for the alloy 600 heat 96834 steam generator tubing. The grain size of this tubing material is a rather small ~5-7 μm with the grains having an equiaxed shape and exhibiting a medium amount of strain contrast (Figure 1a). At higher magnifications (Figure 1b-d), the carbide density is observed to be low, and mostly transgranular (TG). The grain boundaries appear to have very few carbides.

Figure 1: SEM-BSE images illustrating the general microstructures in the alloy 600 heat 96834.

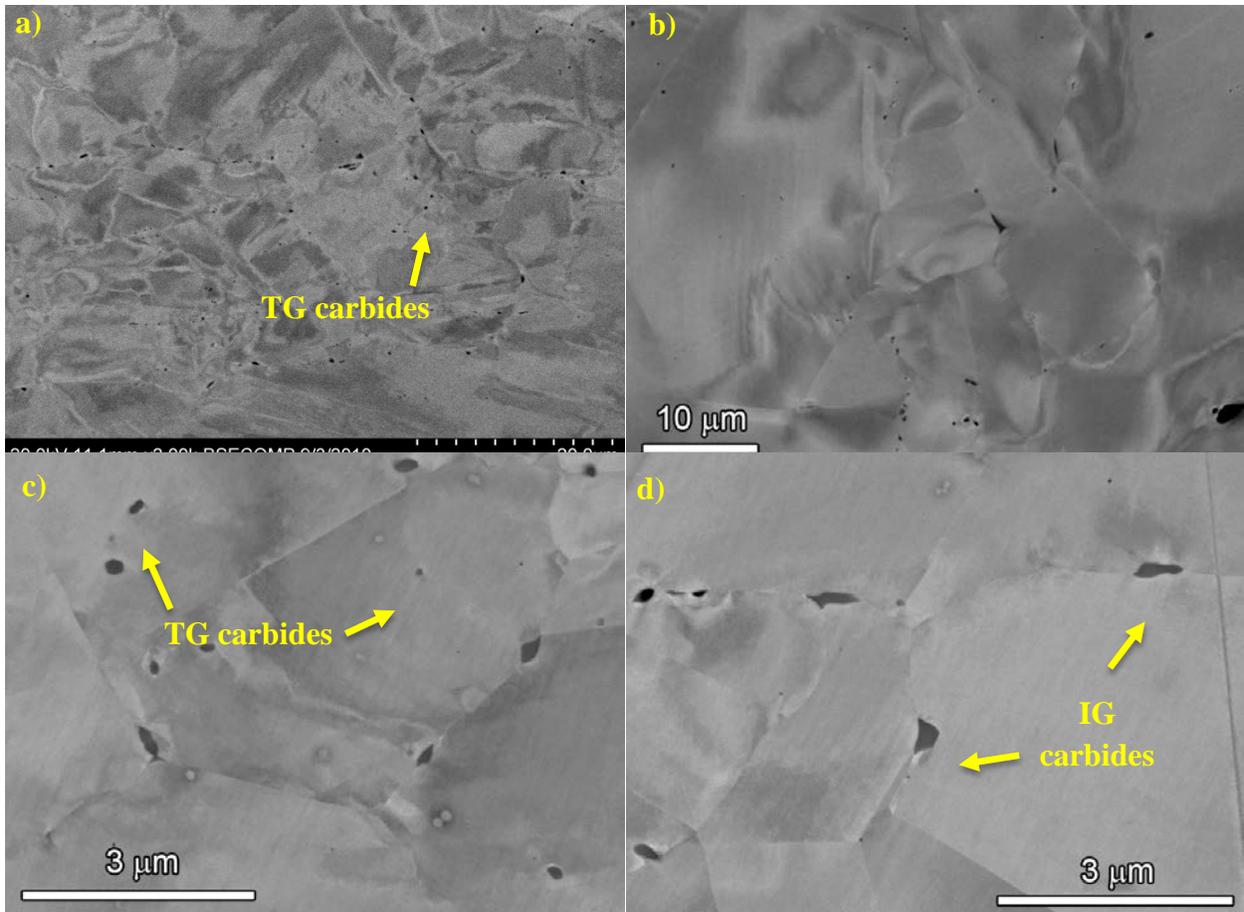
Three alloy 600 heats were received from AREVA (WF422, WF675 and NX4292XR) and are shown in Figure 2 through Figure 4, respectively. Both WF422 and WF675 exhibit an appreciable amount of strain contrast with WF422 having slightly higher contrast. From Figure 2a and 3a, the mottled contrast of the individual grains illustrates the level of strain damage. The grain shape was equiaxed with smaller ($\sim 5\text{-}7\ \mu\text{m}$ diameter) in WF422 and larger ($\sim 10\text{-}15\ \mu\text{m}$ diameter) in WF675. The grain boundary microstructure in WF422 is barely detectable because of the large amounts of strain, whereas in the WF675, although there is mottle contrast in the grains, the boundary microstructure can be determined. The grain contrast in NX4292XR is very uniform, suggesting that there is very little strain in this material. The carbide densities and microstructures for these three materials are vastly different. Both WF675 and NX4292XR have a high density of carbides, whereas WF422 has a much lower density. As seen in Figure 3a, WF675 has a high density of TG carbides with only the occasional carbide observed on grain boundaries (Figure 3d). All of the carbides in NX4292XR are IG (Figure 4), and are spaced $\sim 1\ \mu\text{m}$ apart (Figure 4d). Very few TG carbides were observed in this sample. Lastly, the carbide density in WF422 (Figure 2) is much lower than either of the other two AREVA materials. There are what appear to be both TG and IG carbides in this heat. The low density of the total carbides means that the distance between IG carbides is very high, on the order of $3\text{-}5\ \mu\text{m}$.

Figure 2: SEM-BSE images illustrating the general microstructures in the alloy 600 steam generator material, heat WF422.

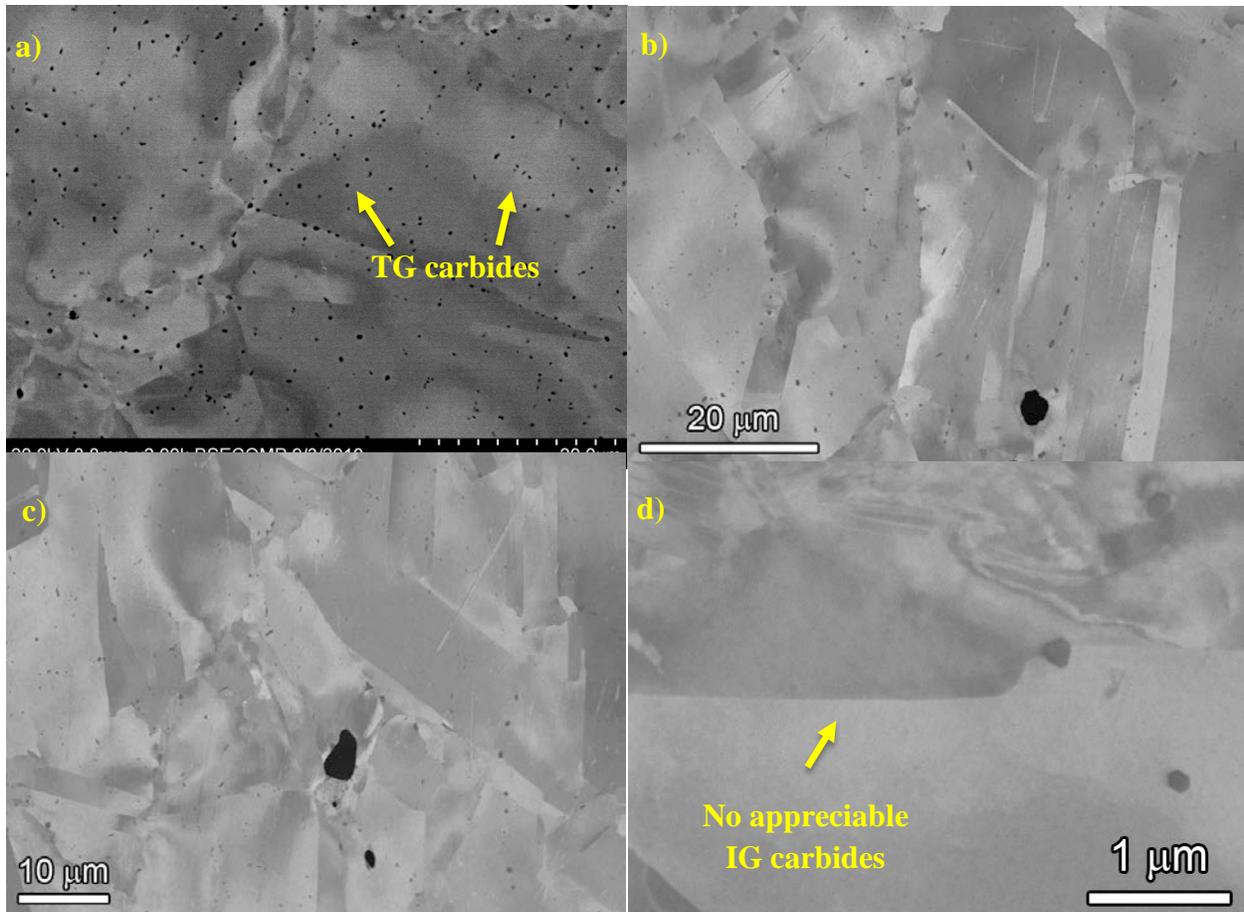
Figure 3: SEM-BSE images illustrating the general microstructures in the alloy 600 CRDM nozzle material, heat WF675.

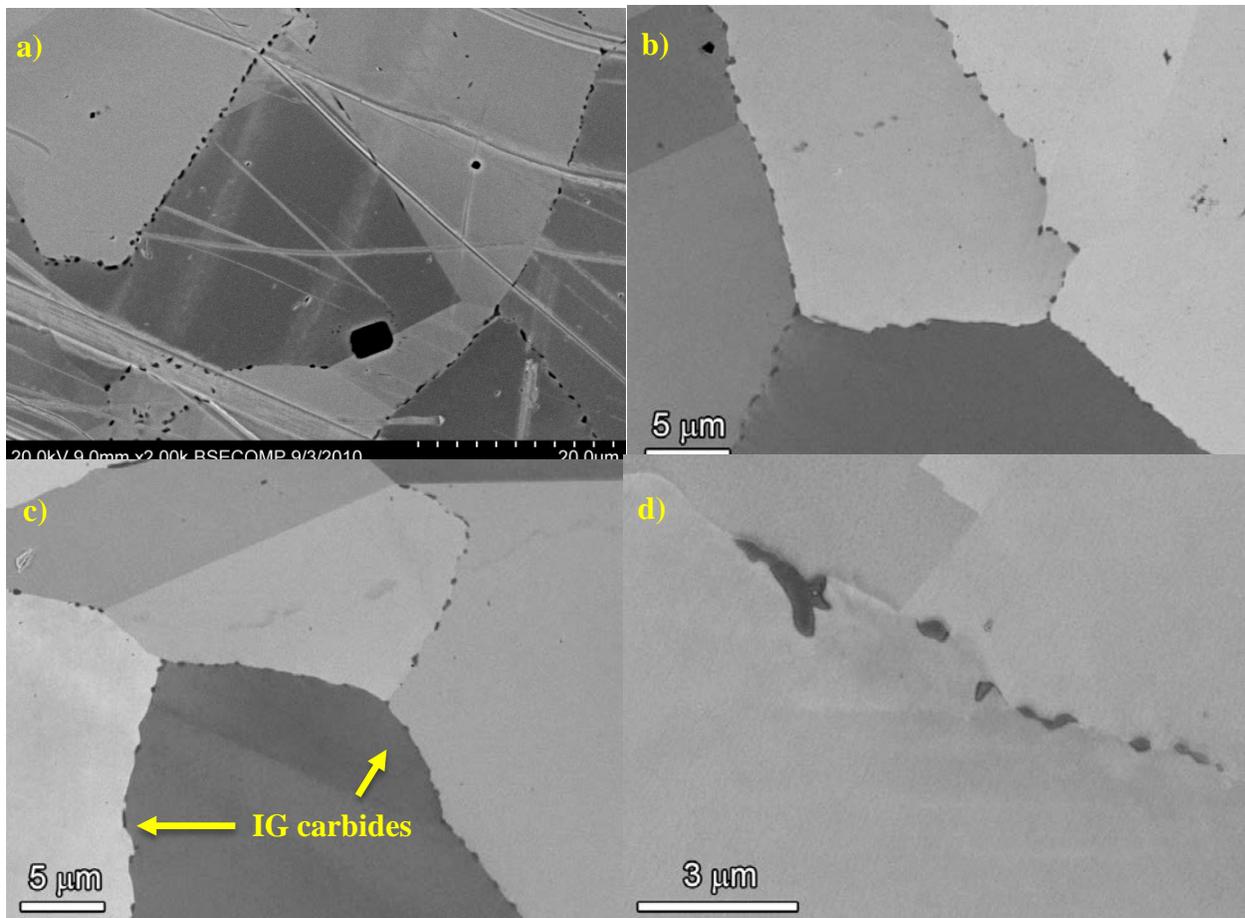
Figure 4: SEM-BSE images illustrating the general microstructures in the alloy 600 steam generator divider plate material, heat NX4292XR.

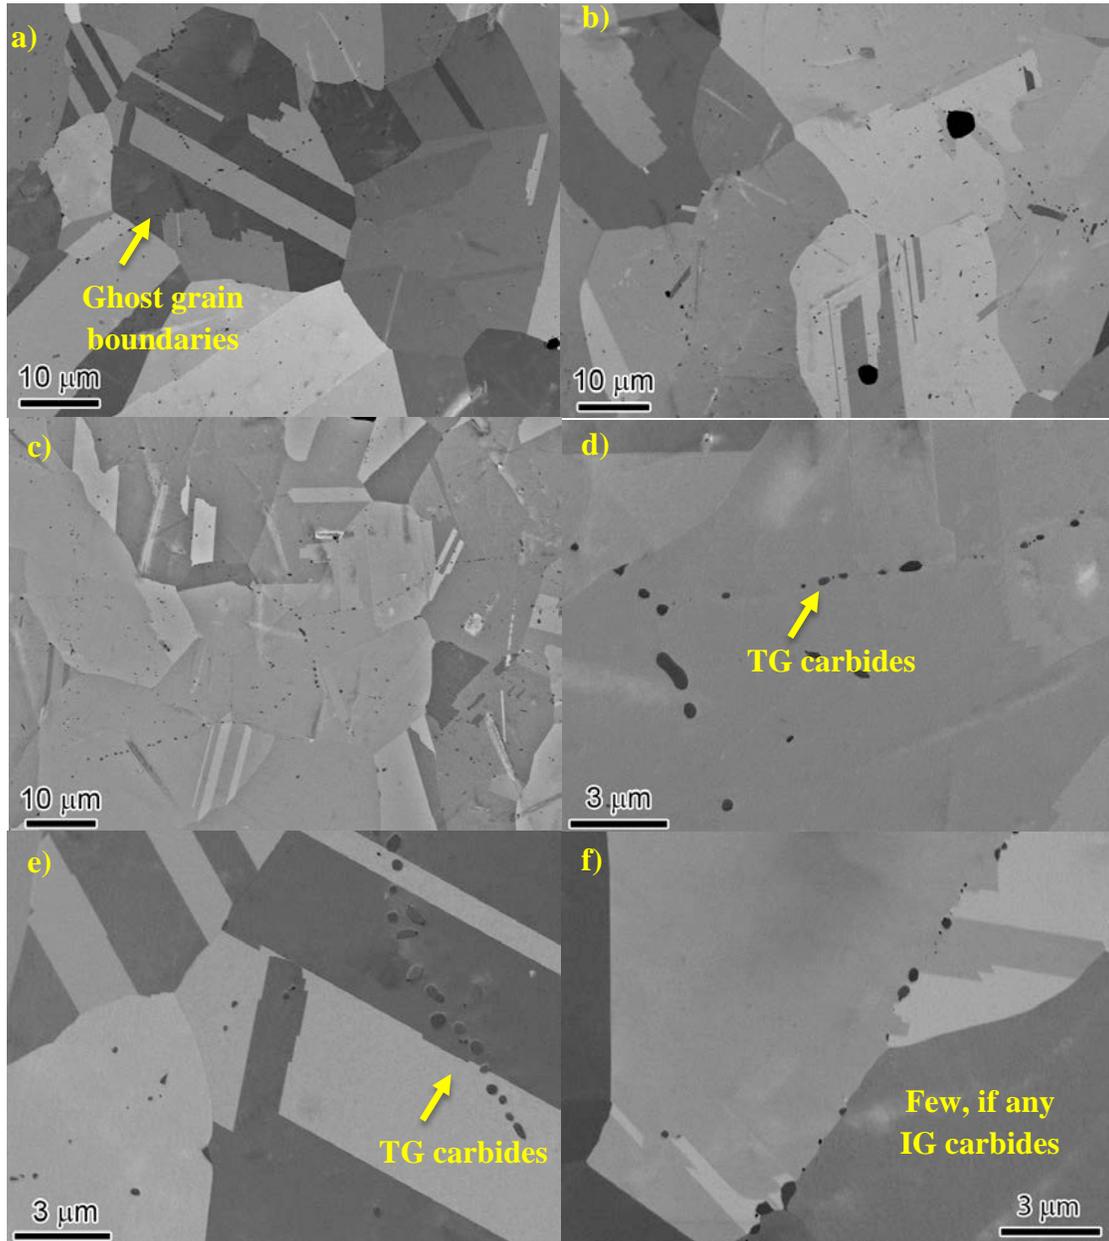
Microstructures from CRDM nozzle heats DB-7929 and DB-M3935 are shown in Figure 5 and Figure 6, respectively. Surprisingly, they have distinctly different microstructures. What is immediately apparent is the large difference in grain sizes of these two mill-annealed alloy 600 materials. The grains of DB-7929 are $\sim 15\text{-}17\ \mu\text{m}$ and equiaxed (Figure 5), whereas they are on the order of $\sim 400\ \mu\text{m}$ for DB-M3935 (Figure 6). The carbides in DB-7929 were all determined to be TG, while the carbides in DB-M3935 are all IG and spaced $500\text{-}700\ \text{nm}$ apart. The TG carbides in DB-7929 were not randomly dispersed throughout the grains but appeared to sit on ghost grain boundaries (Figure 5), most likely due to a heat treatment which transformed the grain structure to its current appearance but was not at sufficiently high temperature or a long enough time to dissolve the carbides. Of all the alloy 600 material examined, DB-M3935 had the largest grain size by an order of magnitude, suggesting an extremely high temperature final mill-anneal temperature. It was one of the few alloy 600 materials that had semi-continuous IG carbides (along with the divider plate heat NX4292XR) indicating a slower cooling from the mill-anneal temperature. It should be noted that in Figure 6c and d there are smaller ($\sim 50\ \text{nm}$)

Figure 5: SEM-BSE images illustrating the general microstructures in the mill-annealed alloy 600 CRDM nozzle material, heat DB-7929.

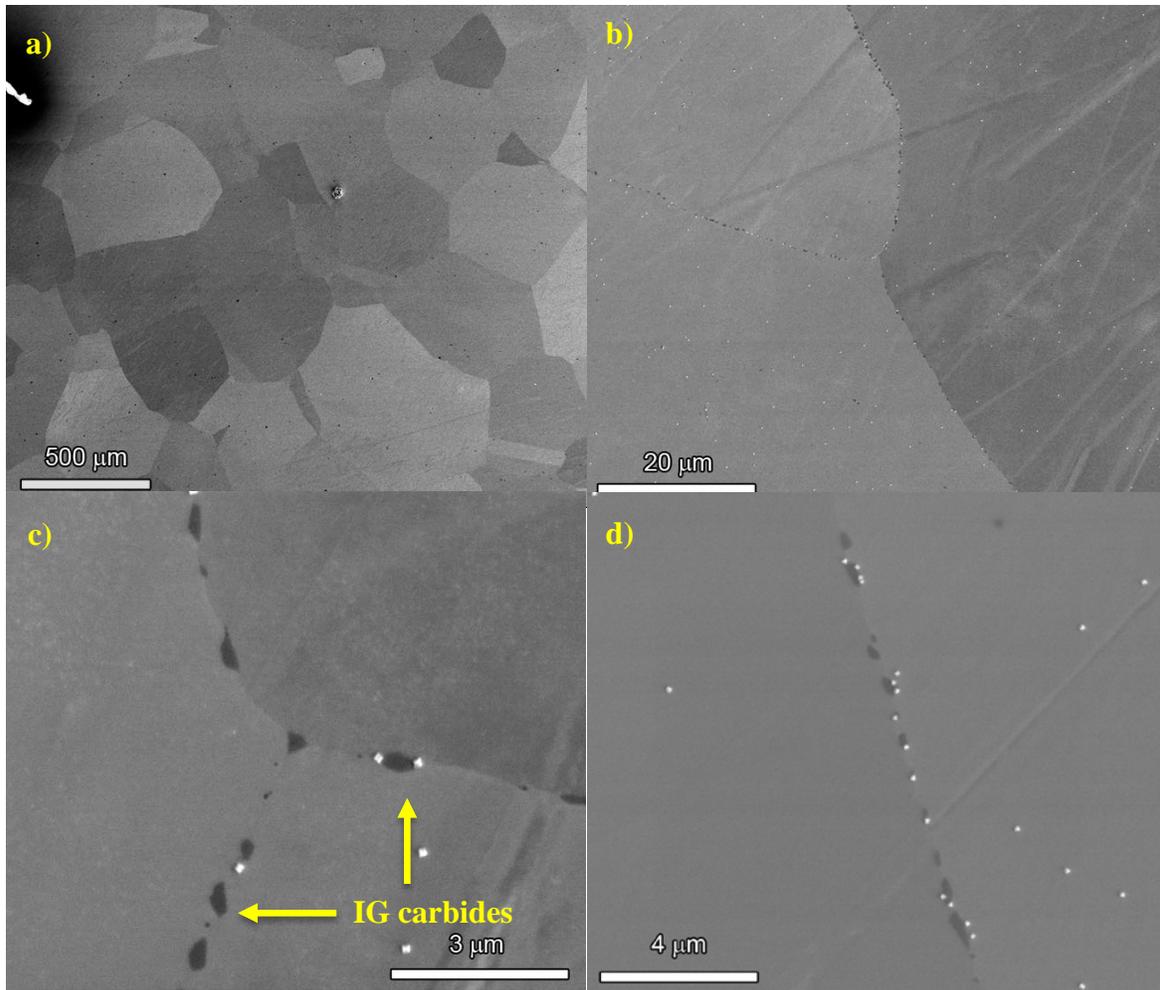
bright white particles. These are surface drying artifacts from the metallographic process and they are not a secondary phase in the microstructure. This issue has since been resolved by applying a 1% acetic acid after metallographic polishing to dissolve these deposited surface crystals. Lastly, it should be noted that there is very little strain contrast observed in either of these backscatter images, suggesting very little strain in these CRDM materials.

Figure 6: SEM-BSE images illustrating the general microstructures in the mill-annealed alloy 600 CRDM nozzle material, heat DB-M3935 Small white particles in (c) and (d) are drying artifacts from the sample preparation process.

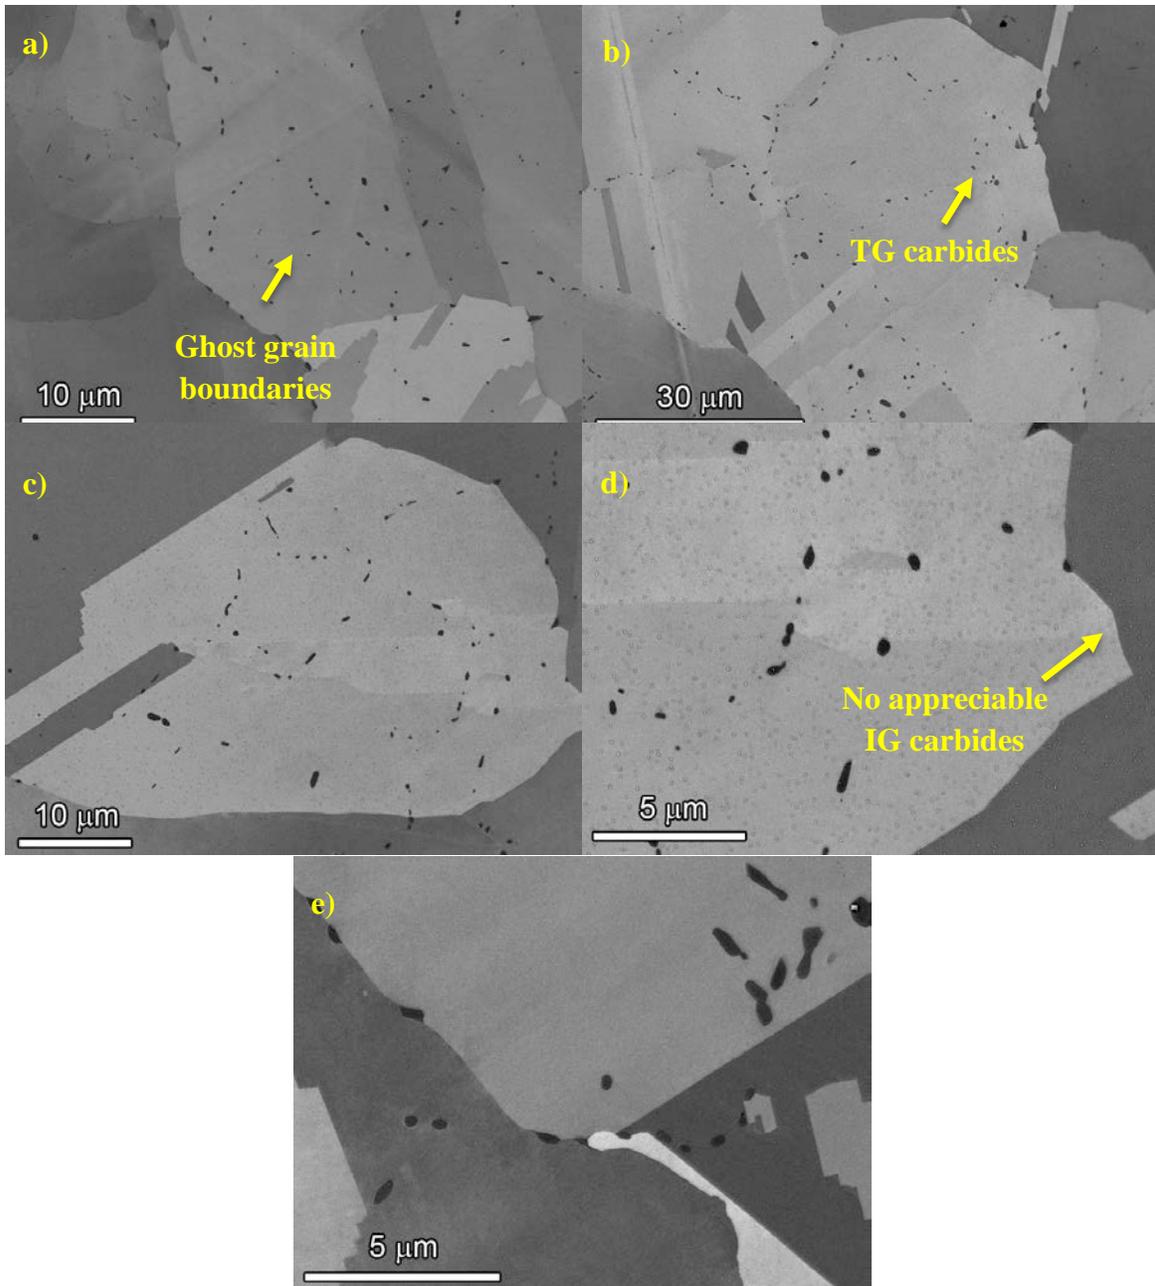
The microstructure for a third alloy 600 CRDM nozzle material (identified as NA2-N31) is illustrated in Figure 7. The sample had an equiaxed grain microstructure with grains $\sim 50\text{-}70\ \mu\text{m}$ in size. There was a high density of TG carbides (Figure 7b) along ghost grain boundaries similar to that for DB-7929 (Figure 5). Isolated IG carbides were observed, but their appearance seemed randomly spaced and may have resulted from the grain boundary intersecting a ghost boundary. Once again, there appeared to be very little strain contrast in this CRDM material.

Figure 7: SEM-BSE images illustrating the general microstructures in the alloy 600 CRDM nozzle material NA2-N31.

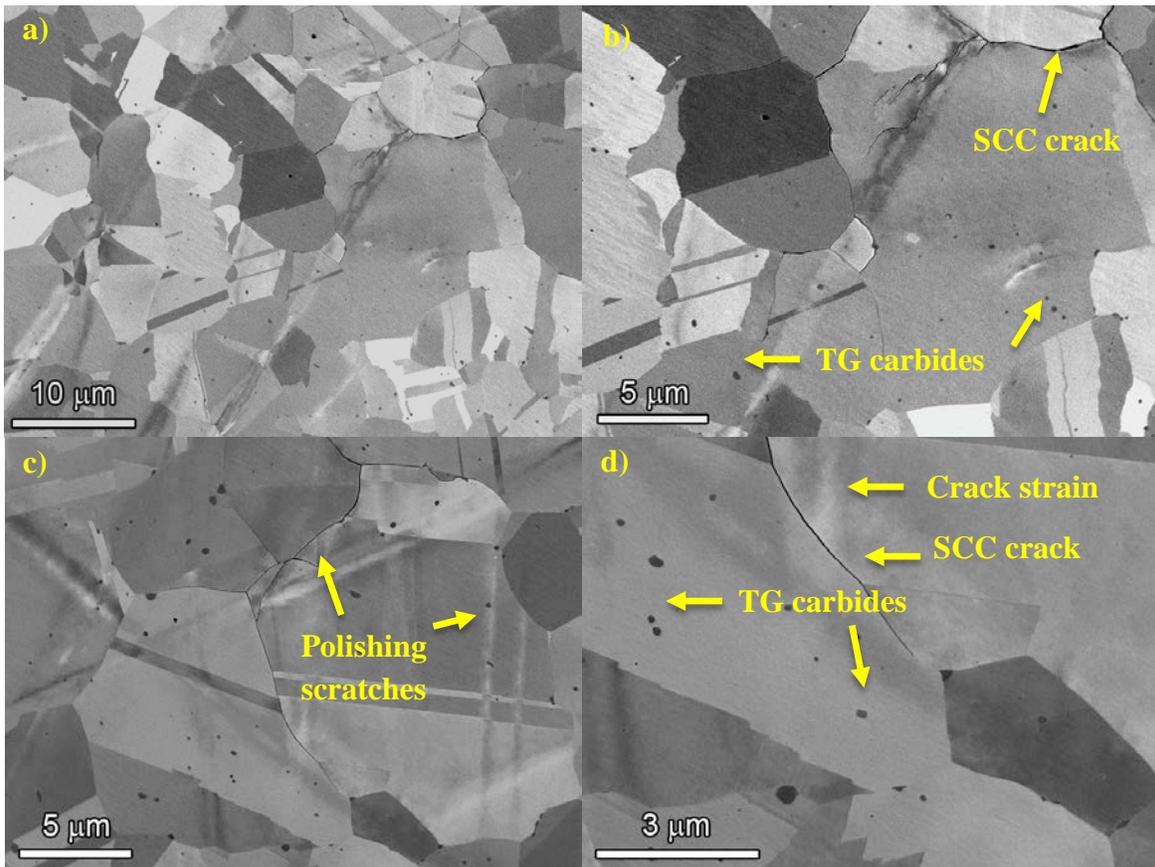
The final alloy 600 material (heat 3011) was from steam generator tubing tested in PWR secondary-side water conditions containing Pb. The micrographs illustrated in Figure 8 were taken from the cross-section of the C-ring test specimen and SCC cracks are present. The regions surrounding the cracks are still representative of the starting microstructure and hence are used for comparative purposes. If regions away from the cracks and scratches are evaluated, it is apparent that there is uniform contrast in most grains suggesting that the starting microstructure had very little strain damage. The grain size of this mill-annealed alloy 600 was about 5-10 μm , and the grains were equiaxed. A low density of TG carbides was observed through the material (Figure 8d) with only a few isolated IG carbides detected.

Figure 8: SEM-BSE images illustrating the general microstructures in the alloy 600 steam generator tubing heat 3011. Images were taken from a cross-section sample containing SCC cracks.

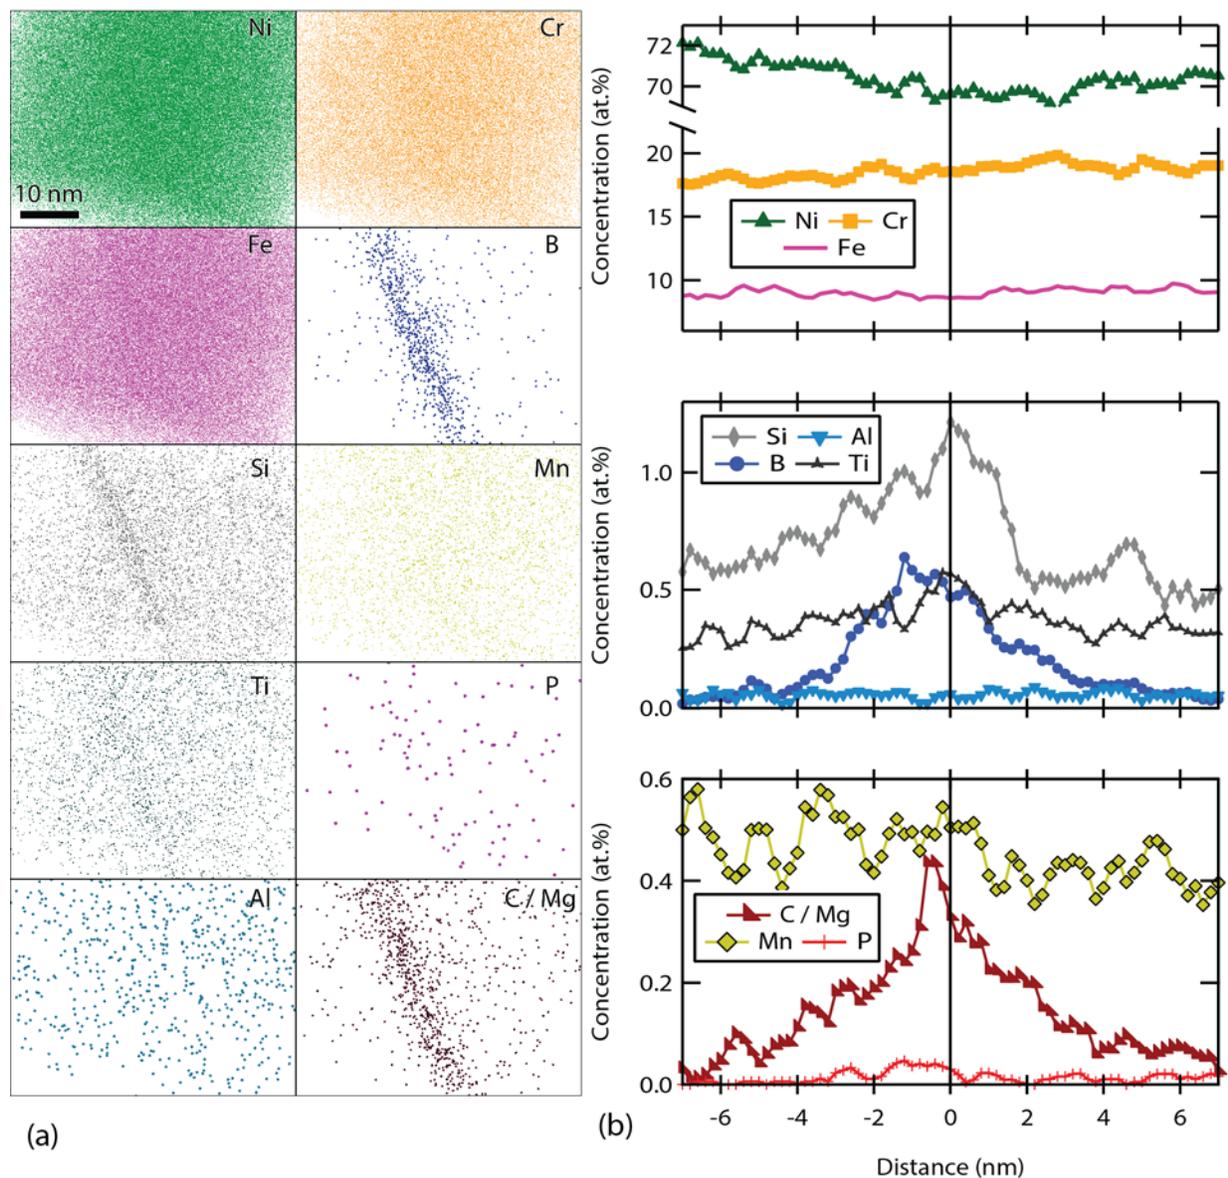
A small number of APT experiments were performed targeting general high-angle grain boundaries in heat 96834. Representative atom maps and a corresponding 1D concentration profile across the same grain boundary are presented in Figure 9. The grain boundary exhibits clear segregation of B, Si, C and Ti. Quantitatively the segregation was observed at maximum concentrations ~1.2 at% Si, 0.5 at% B and 0.4 at% C. Heat 96834 is unique among the analyzed alloy 600 grain boundaries as it is the only one that did not exhibit any measurable Cr depletion. This can be explained by the lack of any significant IG Cr carbide precipitation in the overall microstructure and may also explain the slightly higher-than-typical C concentration at the grain boundary. Furthermore no segregation was apparent for Fe, Ni, Al or Mn and only a trace amount of P was observed.

Figure 9: (a) Atom maps (10 nm image depth) and (b) corresponding 1D concentration profiles of a general high-angle grain boundary from heat 96834. Segregation is apparent for B, Si, Ti and C/Mg (convoluted signal but primarily C). No Cr depletion is apparent in this sample.

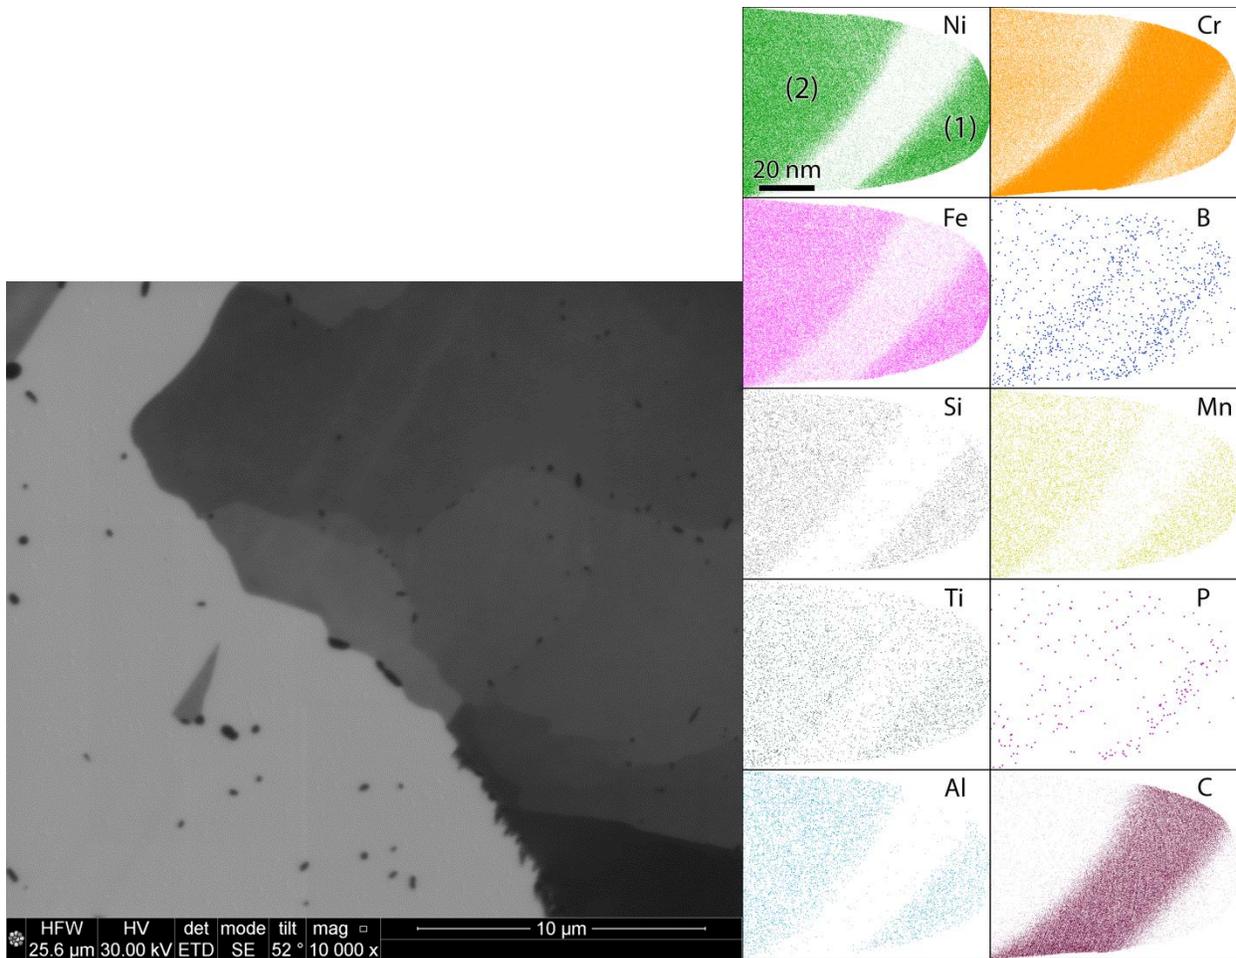
Figure 10: Typical high-magnification ion-beam image of grain boundaries in the NA2-N31 alloy 600 material. A low density of IG carbides was apparent. The rough interface along the boundary in the lower right may be suggestive of cellular carbide formation. The wavy nature of the grain boundaries presents a significant challenge to preparing grain boundary APT specimens. APT atom maps (10 nm image depth) of an IG Cr carbide. Weak B and P segregation is apparent at the carbide/metal interface.

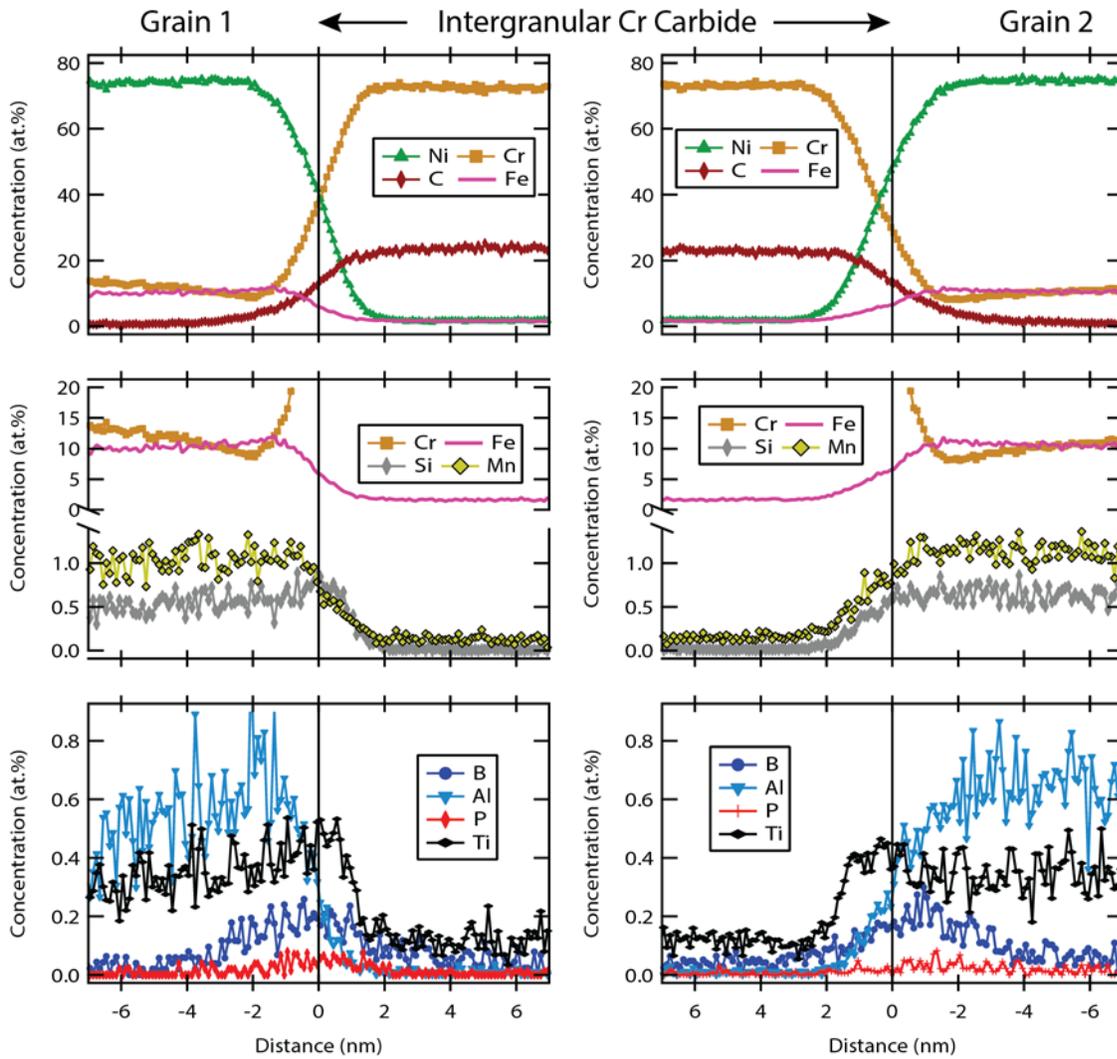
Figure 11: APT proximity histograms at the interface between the IG Cr carbide and (left) Grain 1 and (right) Grain 2. The profiles quantitatively confirm the visually apparent weak segregation of B and P and also localized Cr depletion at both metal/carbide interfaces.

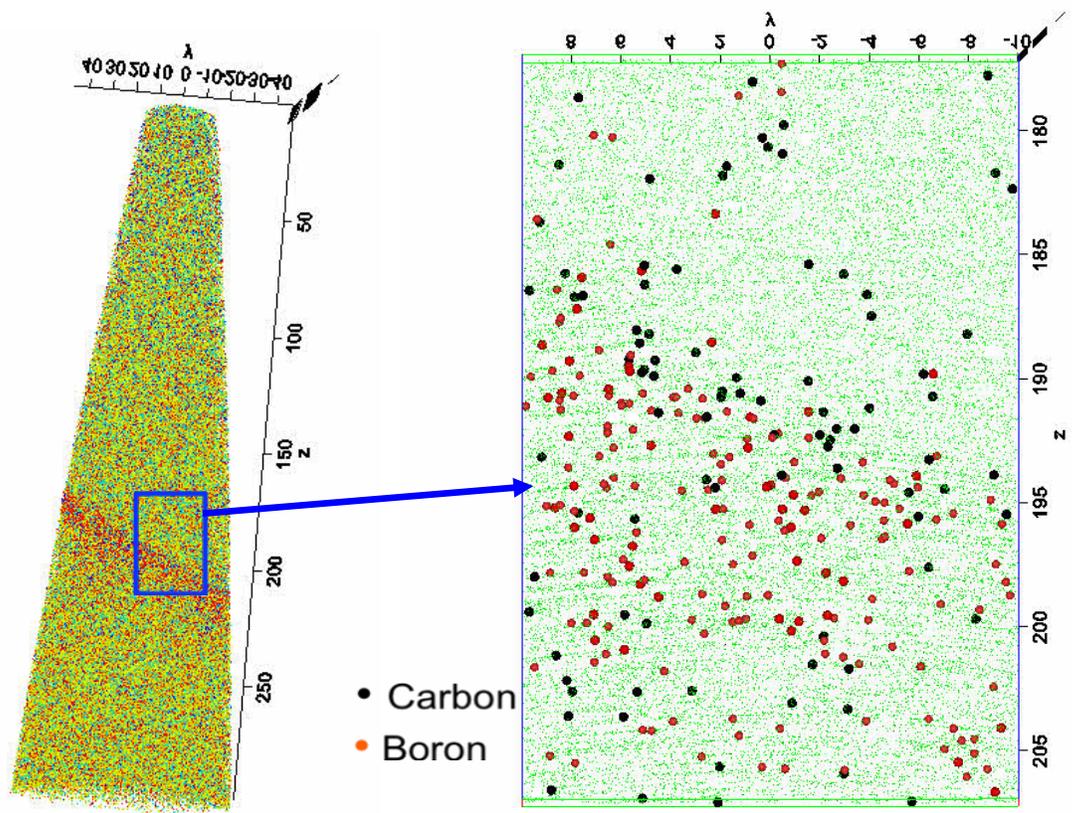
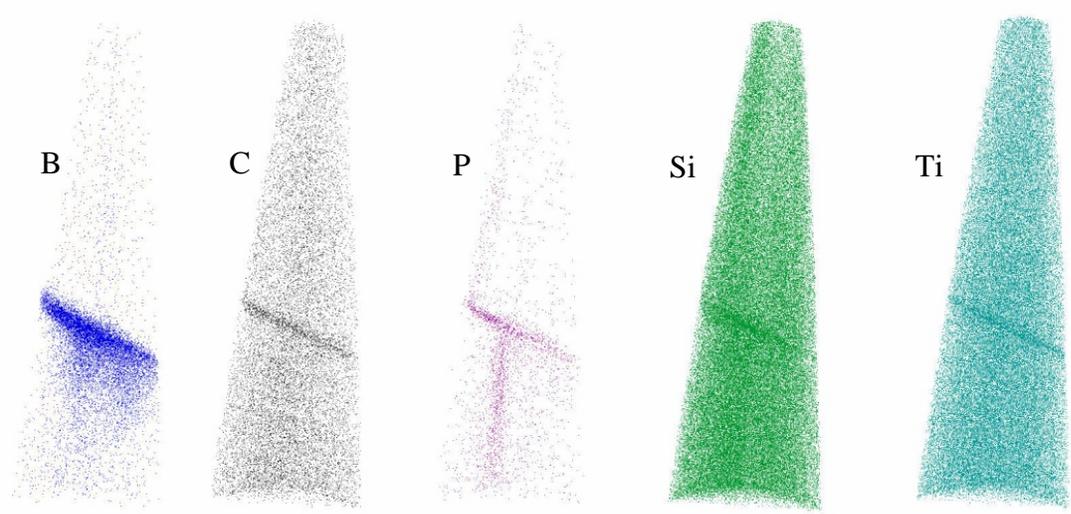
Figure 12: Atom maps from APT analysis of alloy 600 specimen NX4292XR-APT1 highlighting the grain boundary segregation of B, C, P, Si and Ti.

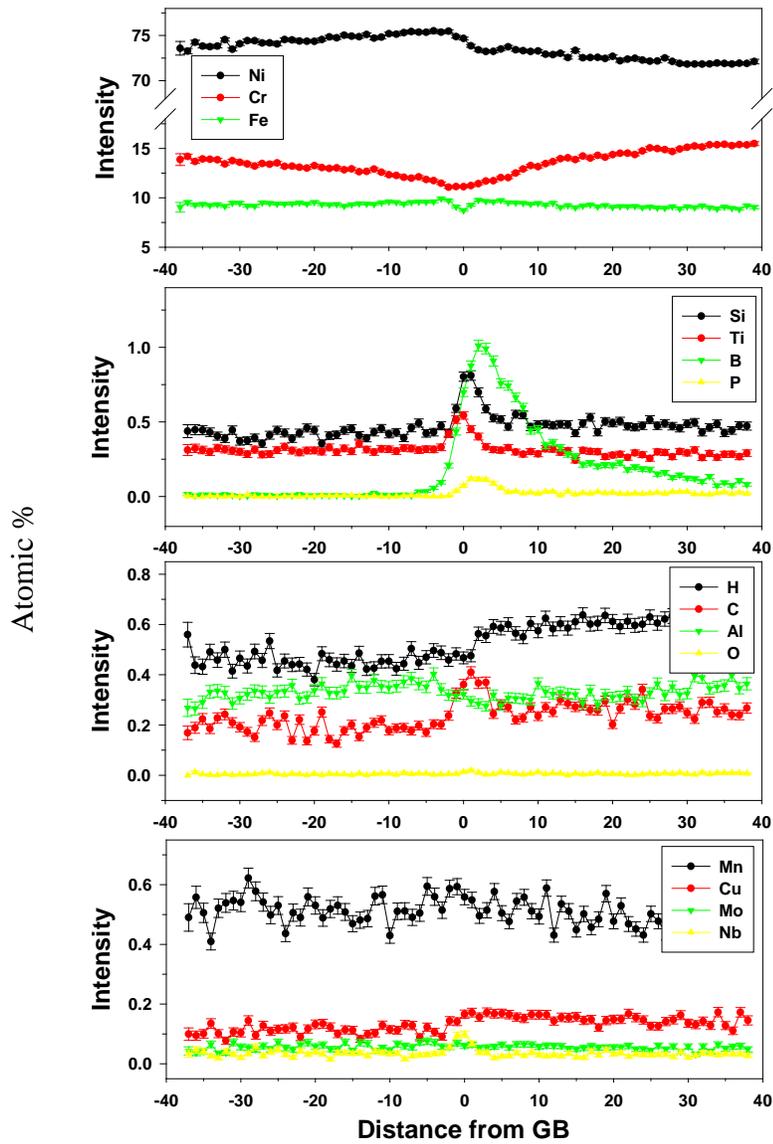
Figure 13: Concentration profiles across a grain boundary (#1) in specimen NX4292XR-APT1 from APT data using a proximity histogram. The grain boundary exhibits segregation of Si, B, P, Ti and C.

Similar to our previous APT grain boundary measurements, most segregating elements are localized at or with a nanometer of the boundary plane with B as the exception. It shows a plume below the interface in the direction of analysis and is a common artifact when analyzing grain boundaries with moderate-to-high B segregation. This can be better seen in the composition profiles plotted for many elements in Figure 13. Narrow enrichment profiles are observed for Si, Ti, P and C in comparison to the B profile. It is interesting that there appears to be a slight offset (~1-2 nm) between the Si and Ti peaks versus the P peak. This has not been consistently observed, but may suggest competitive segregation for grain boundary sites among certain elements. Chromium exhibits depletion across the boundary with a minimum concentration of ~10.7 at% and a profile width on the order of 25 nm. Iron can also be seen to show a slight depletion at the grain boundary in Figure 13 corresponding to the enrichments of Si and Ti.

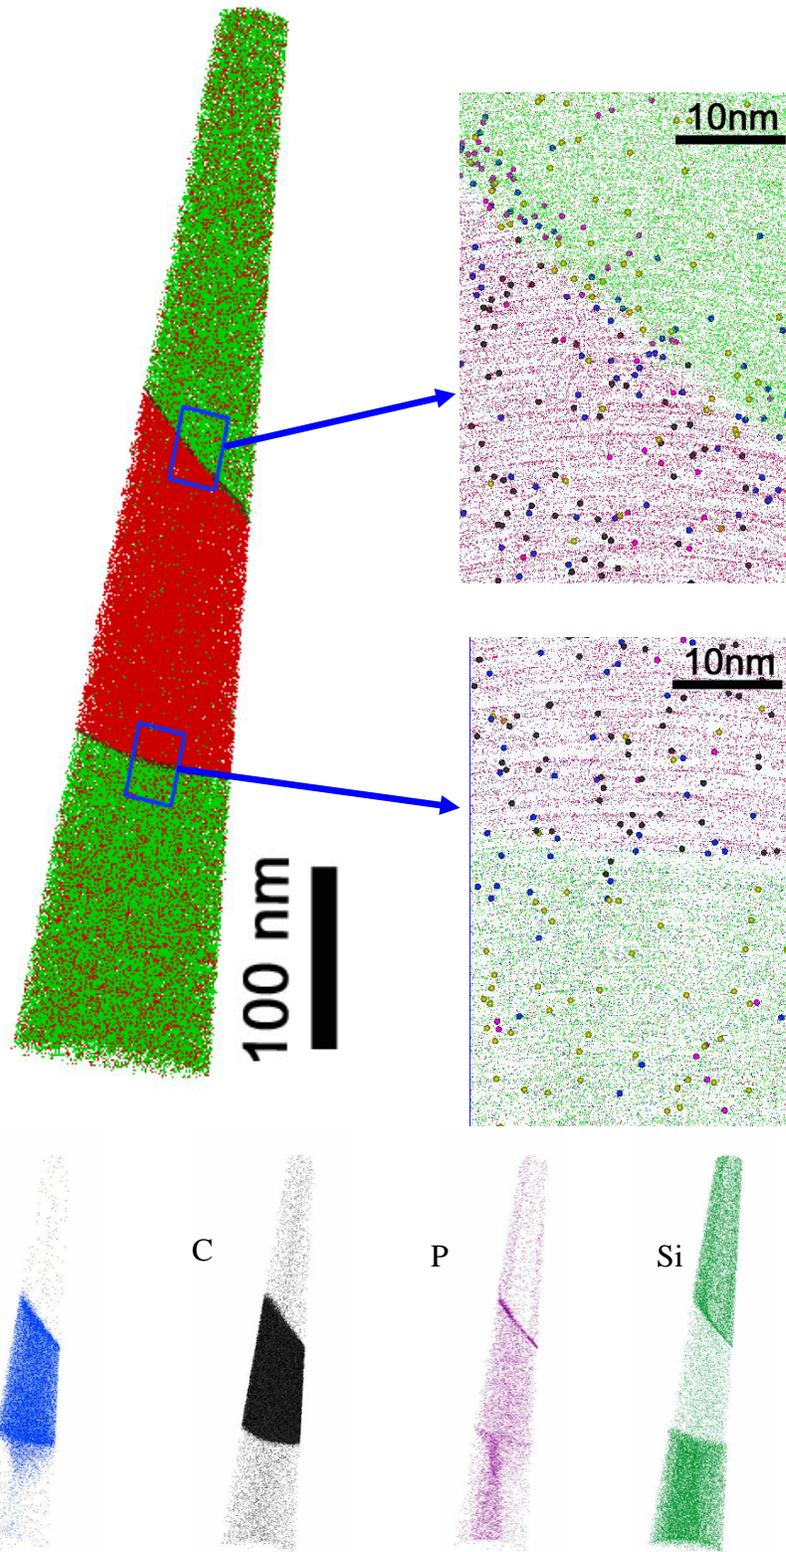
Figure 14: Atom maps from APT analysis of alloy 600 specimen NX4292XR-APT4 showing the carbide within the tip and highlighting the compositional distribution of B, C, P and Si.

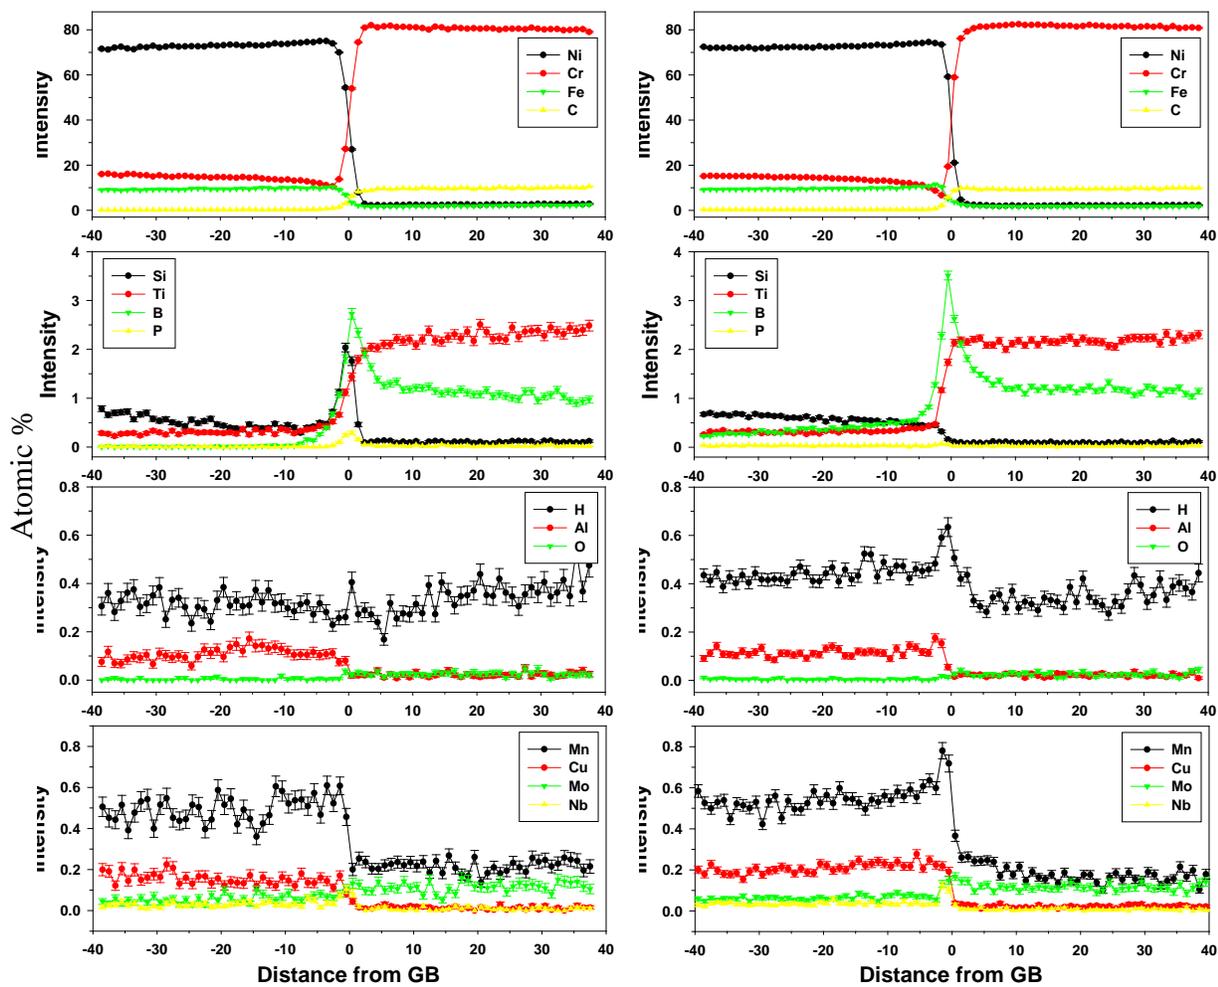
Figure 15: Concentration profiles across carbide interfaces in specimen NX4292XR-APT4 from APT data using a proximity histogram. Both interfaces exhibit significant enrichment of B while only the carbide/grain boundary interface shows Si and P segregation.

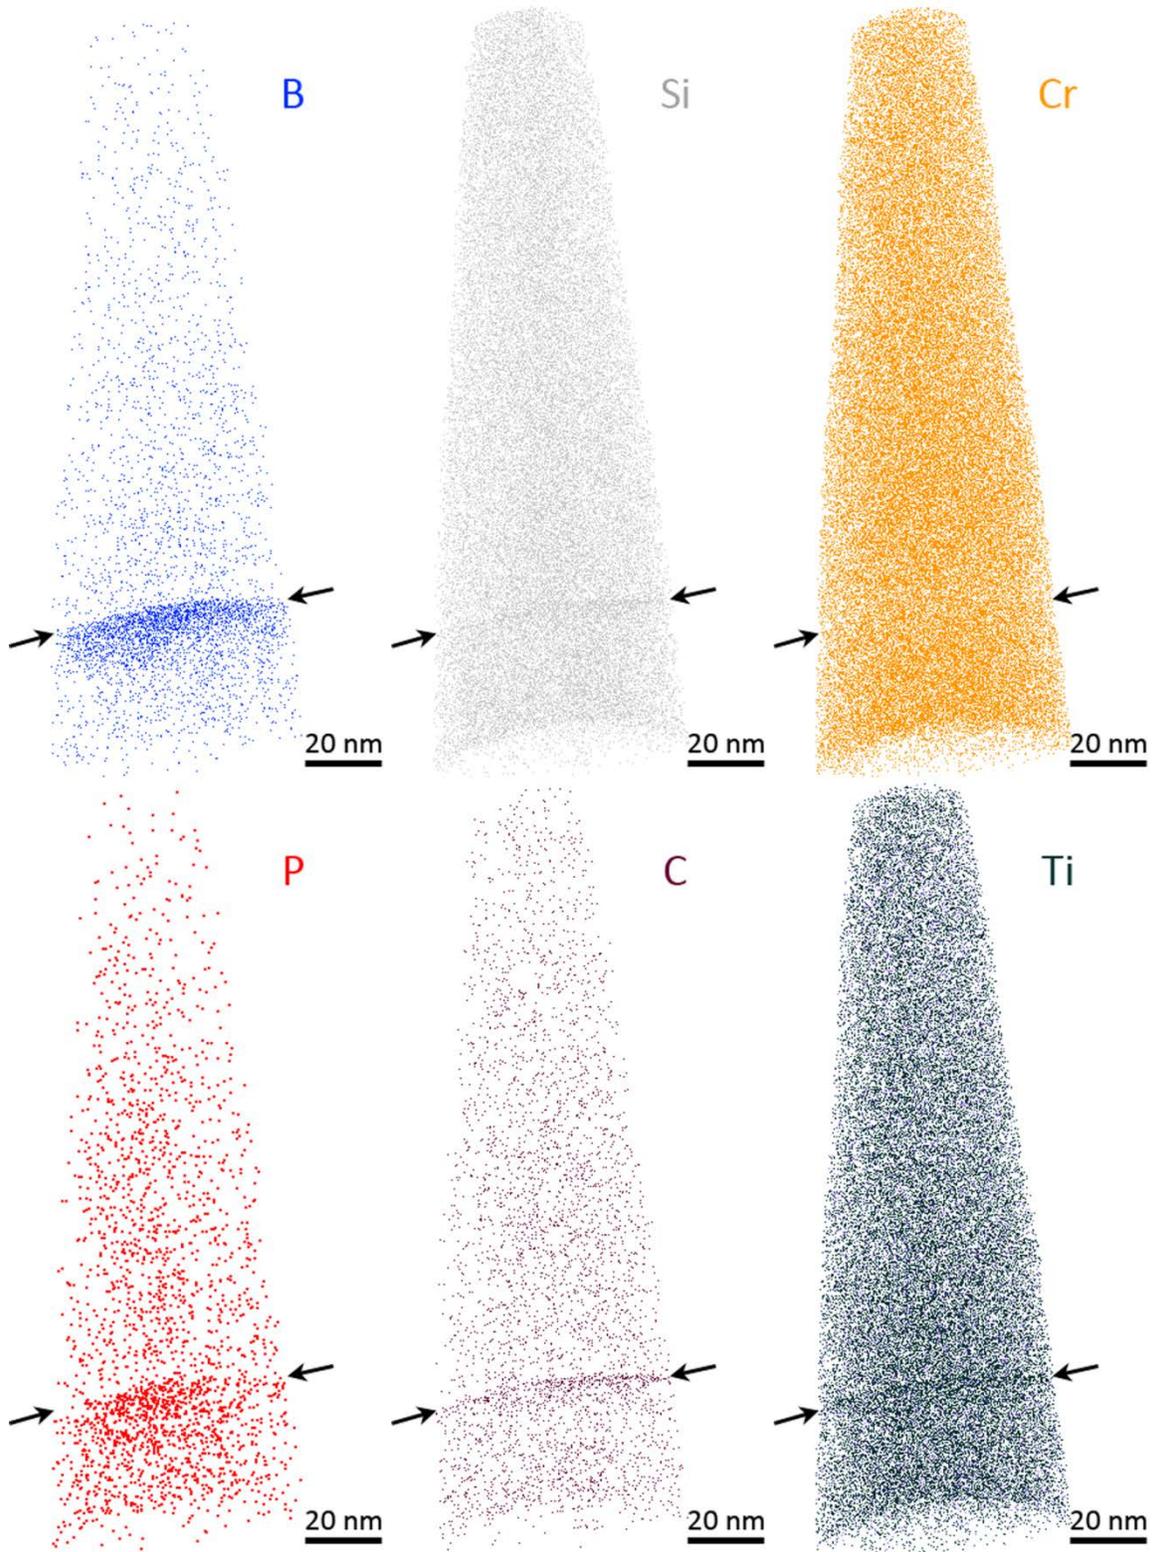
Figure 16: Atom maps from APT analysis of a metal/metal grain boundary (422-APT9) highlighting the segregation B, Si, P, C and Ti at the grain boundary. A slight depletion of Cr is also present.
