**MICROSTRUCTURE, CORROSION AND STRESS
CORROSION CRACK INITIATION OF ALLOY 600
IN PWR PRIMARY WATER ENVIRONMENTS**

**Technical Milestone Report: M3LW-13OR0403032
March 2013**

M. J. Olszta, D. K. Schreiber, M. B. Toloczko
and S. M. Bruemmer
Pacific Northwest National Laboratory

Research Project:
**Stress Corrosion Crack Initiation of
Nickel-Base Alloys in LWR Environments**
Project Manager: S. M. Bruemmer
Pacific Northwest National Laboratory

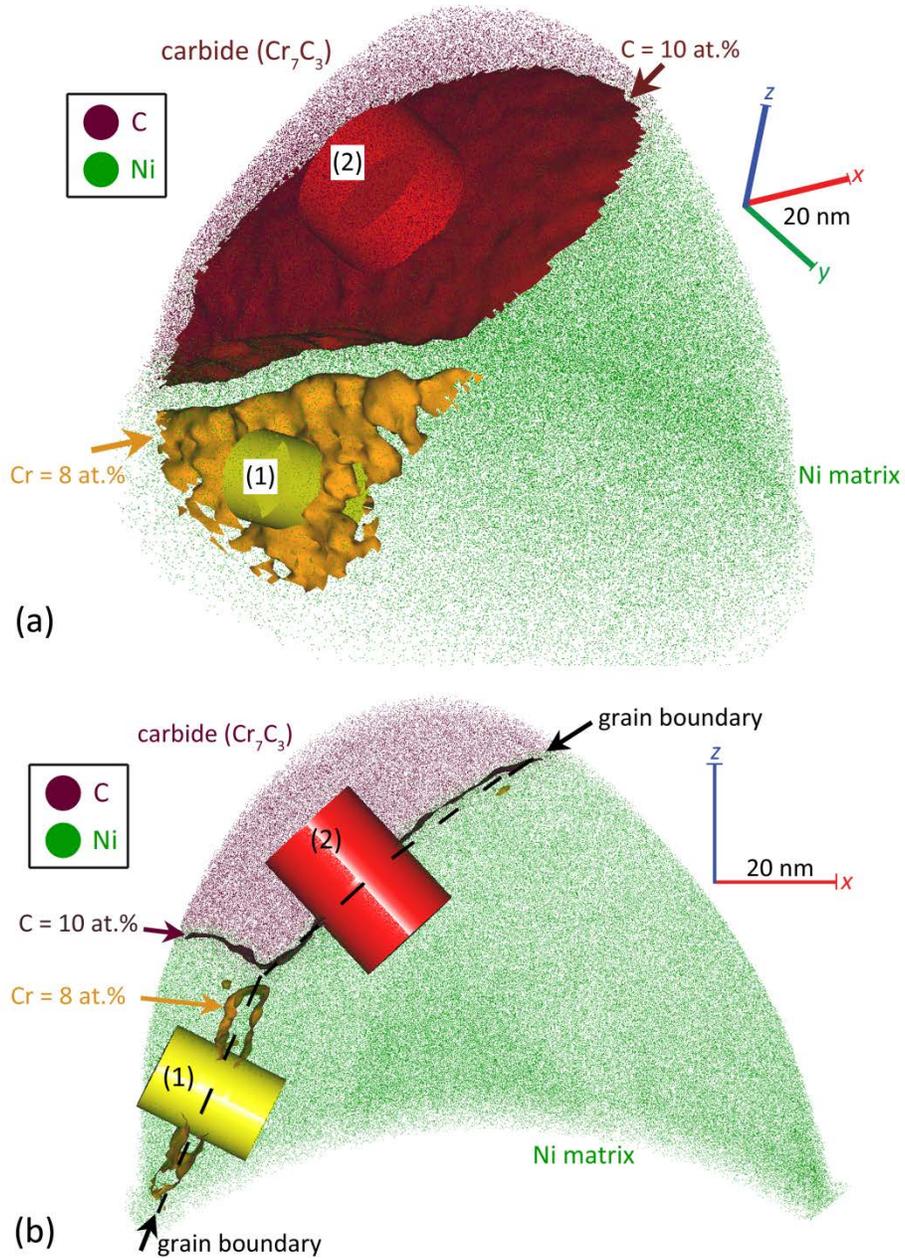
Figure 18: Top-down view (a) and side-view (b) of a grain boundary (black dashed line) from an APT reconstruction of GB2 of 422-APT2. Isoconcentration surfaces are displayed at 10 at% C (red) and 8 at% Cr (orange) to highlight the location of a Cr-rich carbide (red) and Cr-depleted, non-carbide grain boundary (orange). 1-D concentration profiles were extracted from the metal/metal [labeled yellow - (1)] and carbide/metal [labeled red - (2)] regions of the grain boundary (see Figure 19).

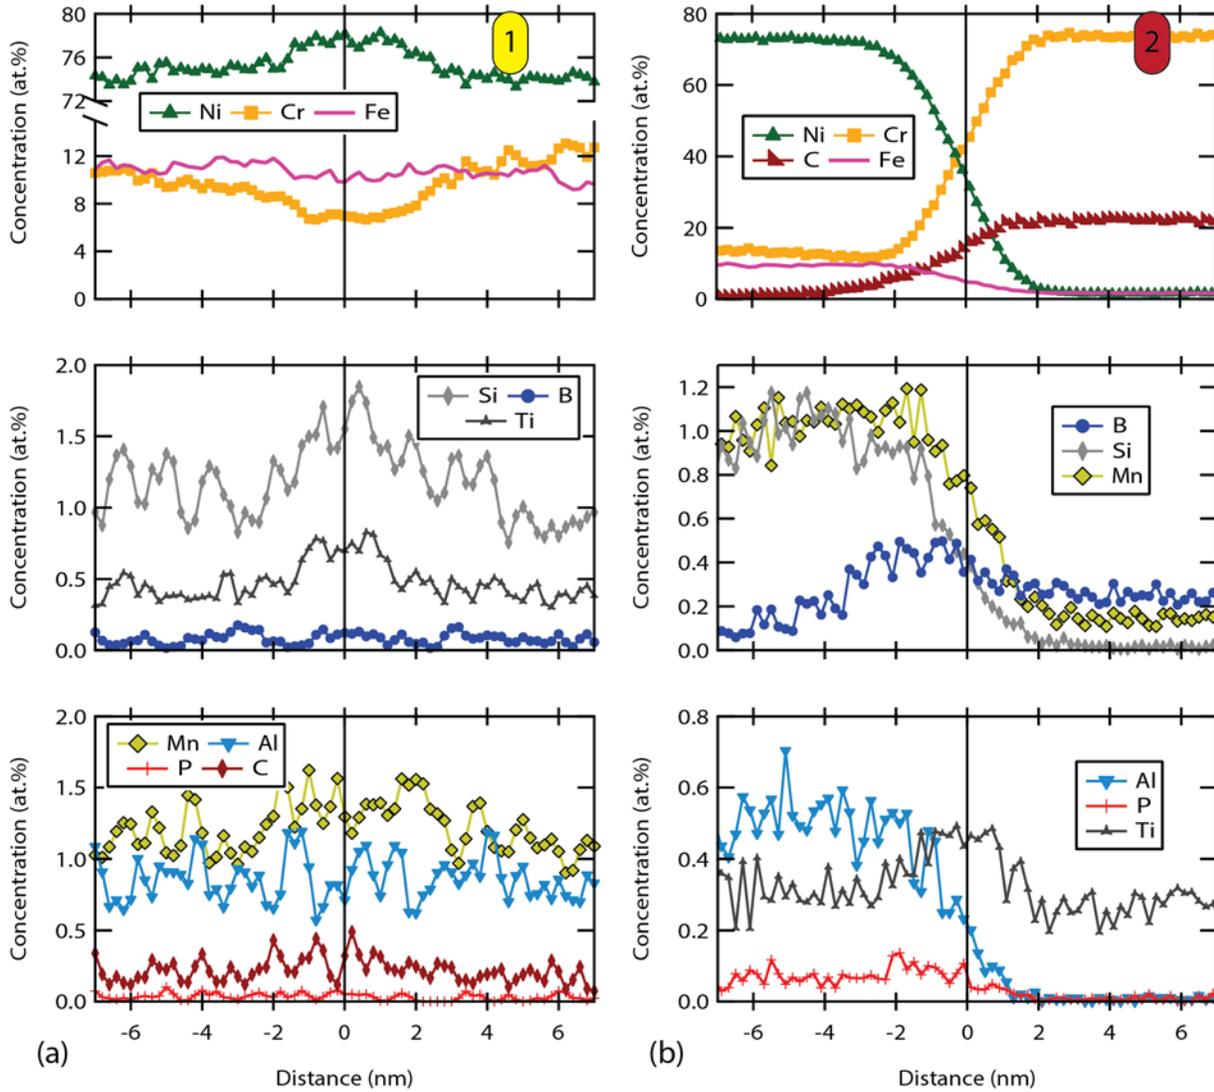
Figure 19: 1-D concentration profiles taken across the GB2 grain boundary in 422-APT2 (a) at the metal/metal and (b) at the carbide/metal grain boundary [labeled (1) and (2) respectively in Figure 18]. (a) At the metal/metal grain boundary, Si and Ti segregated, but no detectable segregation of B or P was observed. Cr is depleted to ~6 at%. (b) At the carbide/metal grain boundary interface, no Si segregation was detected, but a small amount of B excess (~0.5 at%) is observed.

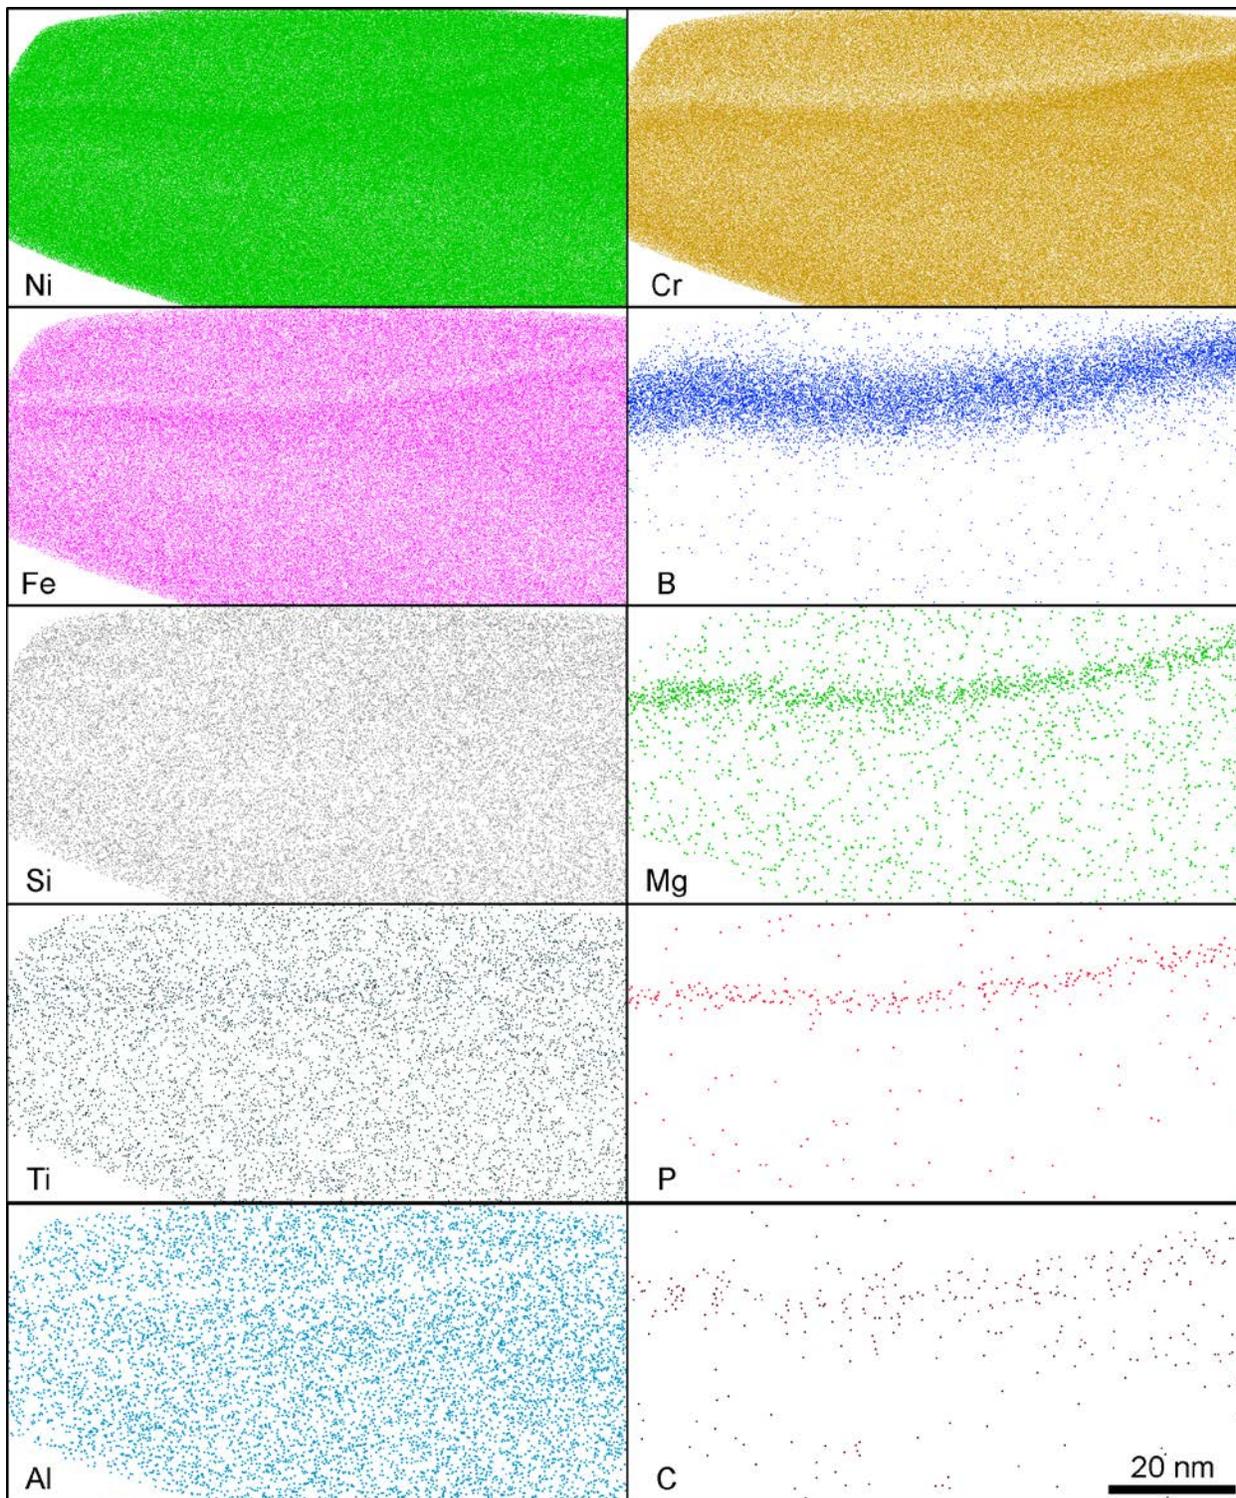
Figure 20: Atom maps (20 nm image depth) from CRDM heat DB-7929. Particularly strong segregation is apparent for B, Mg and P.

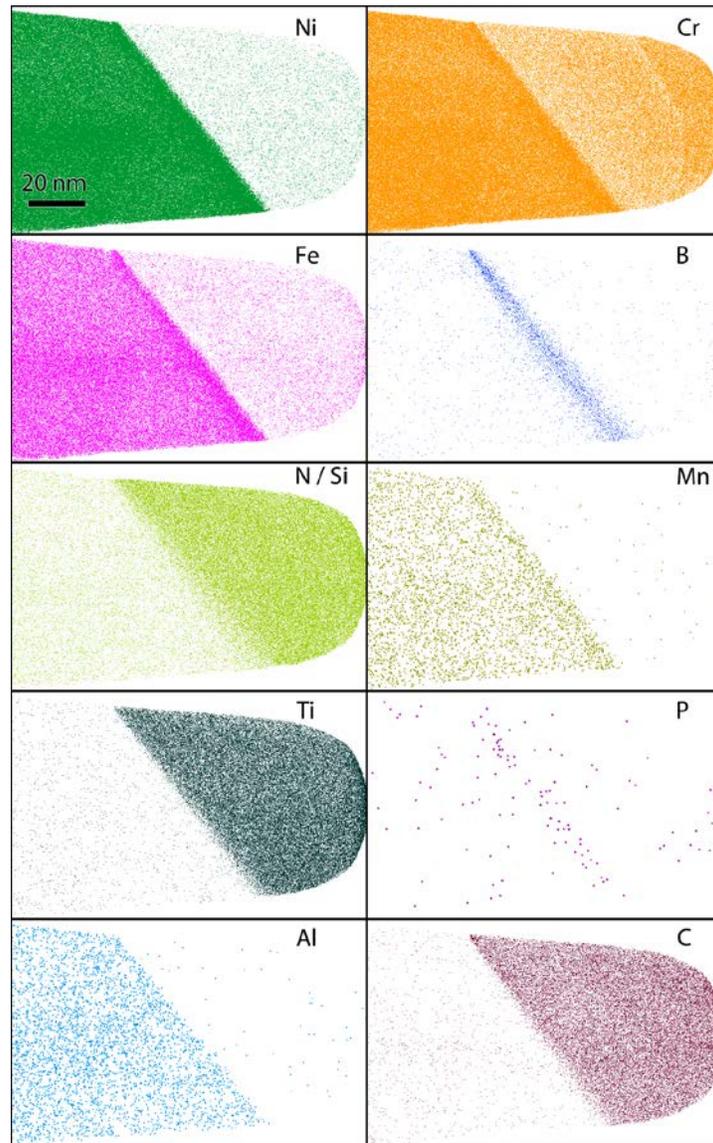
Figure 22: Atom map (10 nm image depth) of an IG Ti carbonitride in CRDM heat DB-M3935. Strong interfacial segregation is apparent for B and weak segregation for P. Note that Si and N are convoluted with one another.

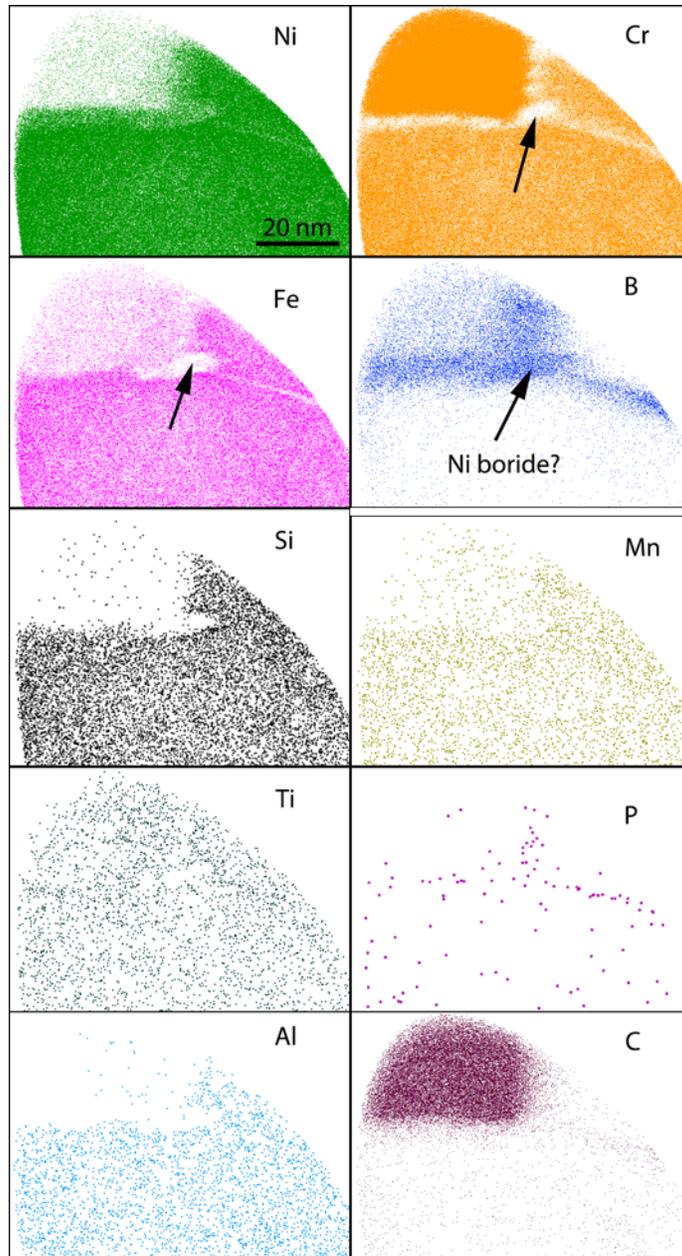
Figure 24: Atom maps from an IG Cr carbide and surrounding grain boundary in CRDM heat DB-M3935. Very strong Cr depletion and B enrichment are apparent along the grain boundary and metal/carbide matrix. Particularly strong localized B enrichment and Cr depletion is suggestive of possible Ni boride precipitations (arrowed).

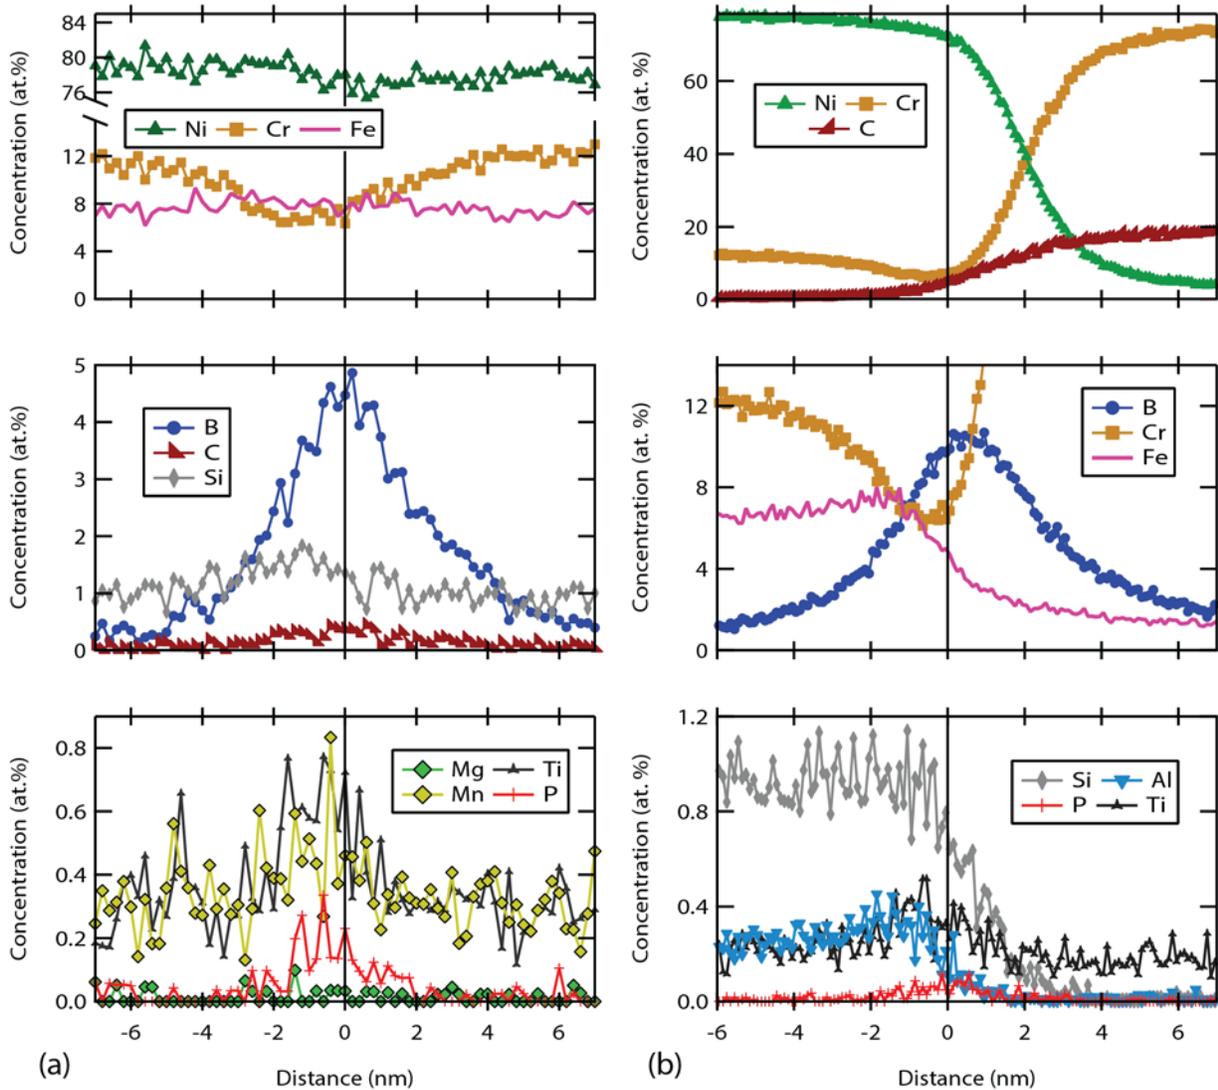
Figure 25: Concentration profiles across (a) the metal/metal grain boundary and (b) across the IG Cr carbide / metal interface in CRDM heat DB-M3935. Both types of interfaces exhibit particularly strong B segregation (5 at% and 11 at%, respectively) and Cr depletion (<8 at% each). Relatively strong P segregation is apparent at each interface (~0.2 at%) and no significant Si segregation is observed.

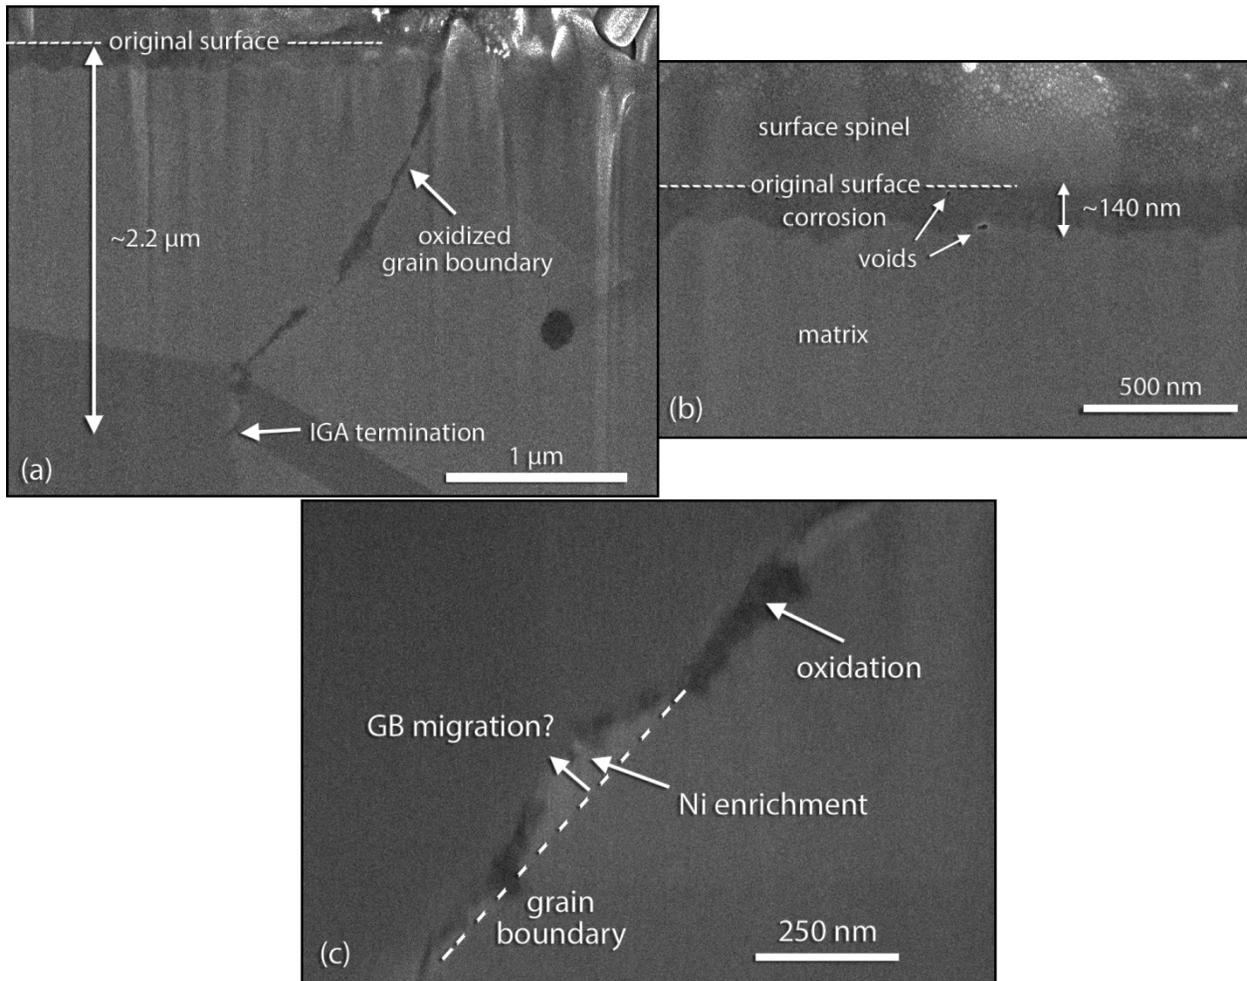
Figure 27: FIB/SEM images of corrosion exhibited in alloy 600 (heat WF422) after exposure to simulated PWR primary water (10.5 cc/kg H₂) for 3500 h at 325°C. (a) IG oxidation extended for ~3 μm with varying oxidation width. (b) High resolution SEM of the TG surface oxidation revealed a corrosion depth ~140 nm accompanied by a low density of voids. (c) High resolution SEM of the leading edge of IG attack revealed extensive Cr depletion accompanying IG oxidation. The bowing of the Ni enrichment and IG oxidation suggest grain boundary migration may be present.

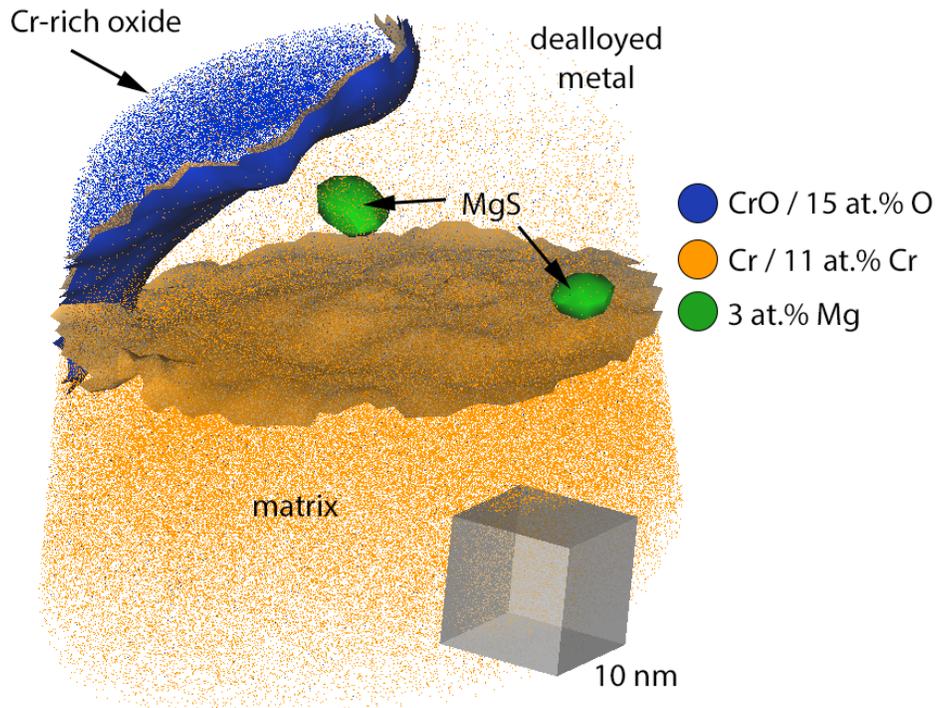
Figure 28: APT reconstruction of a shallower region of IGA. A large dealloyed region is present between the matrix and oxidized grain boundary. Two nanoprecipitates of MgS are present within the dealloyed zone and are likely not a product of the IG attack.

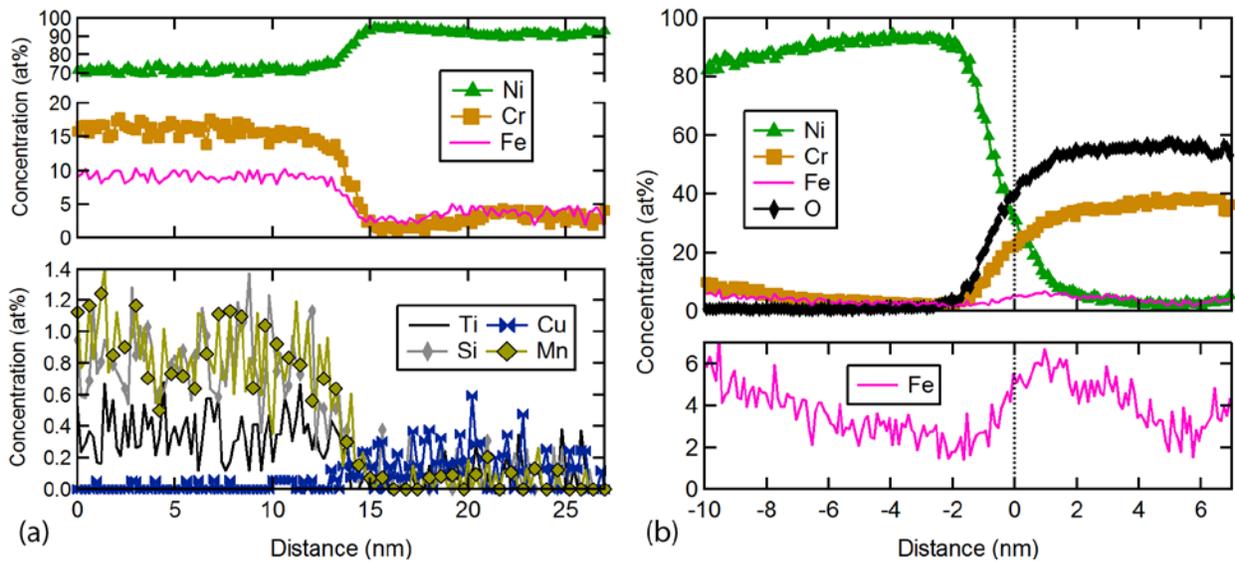
Figure 29: (a) 1-D concentration profile across the matrix/dealloyed zone interface. Cr, Fe, Mn, Ti and Si are depleted in the dealloyed zone while Ni and Cu are enriched. (b) Proximity histogram across the oxide - dealloyed zone interface. The oxide is primarily Cr_2O_3 with small concentrations of Ni and Fe. A slight enrichment of Fe at the oxide/metal interface suggests a different oxide composition, possibly MO phase.

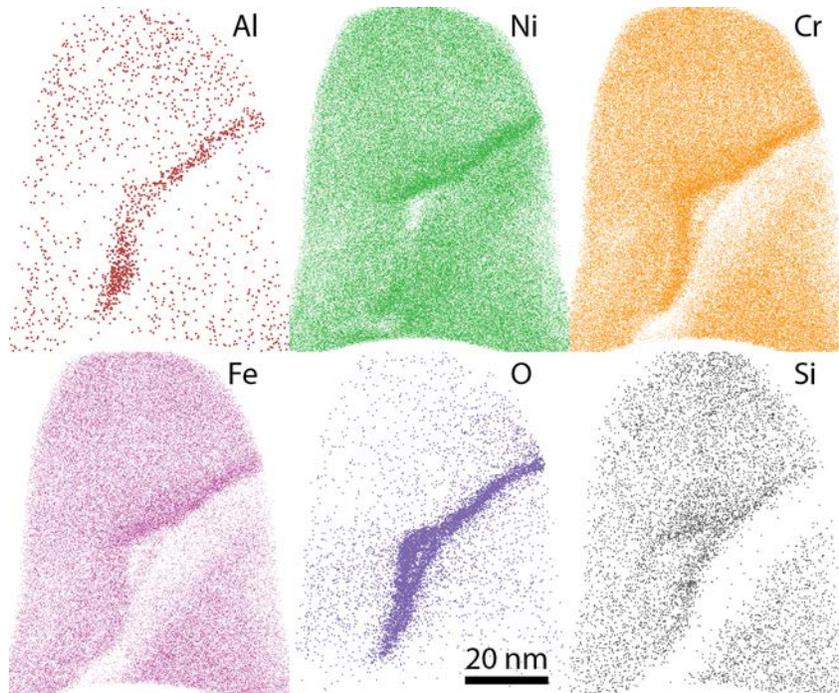
Figure 30: Cross-section atom maps of the terminal IGA in heat WF422 after re-exposure at PNNL showing Cr-rich oxides and substantial depletion of Cr, Fe and Si and grain boundary migration.

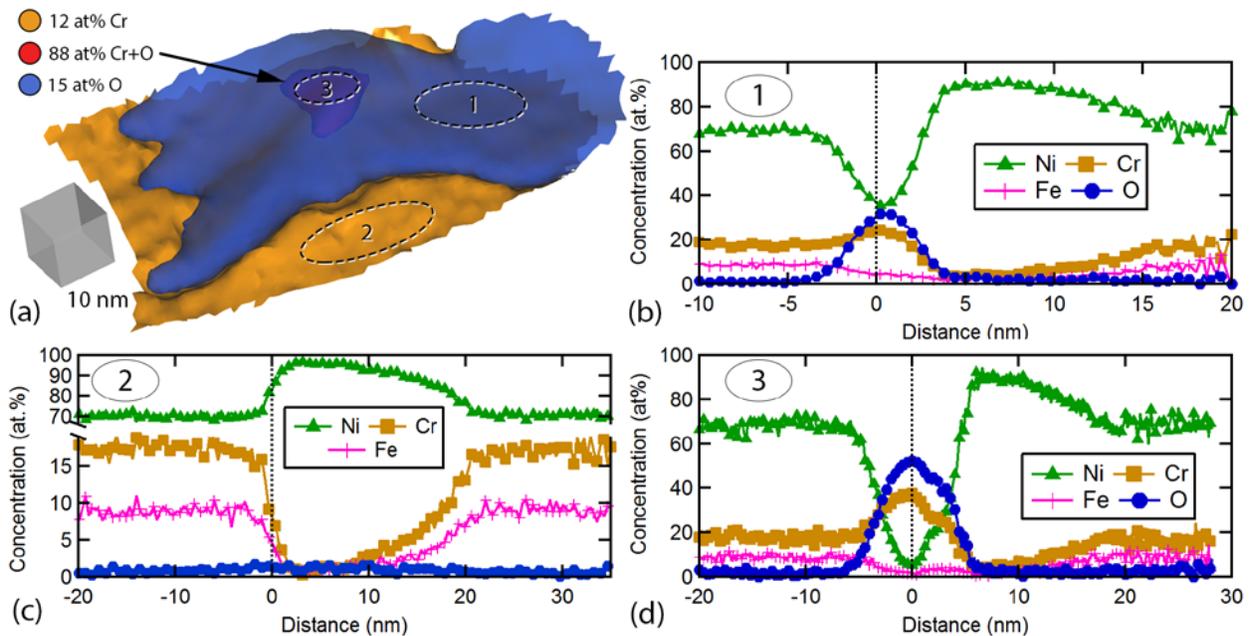
Figure 31: APT analysis of the terminal IGA in the PNNL re-exposure of alloy 600 heat WF422 at 325 °C for 3500 h. (a) Isoconcentration surfaces at 15 at% O (blue) and 12 at% Cr (orange) define the oxidized region and unoxidized portions of an attacked grain boundary. An 88 at% Cr+O isoconcentration surface (red) defines a discrete Cr₂O₃ precipitate. (b)-(d) 1-D concentration profiles extracted across the indicated regions of the grain boundary. The oxide is Cr-rich and Ni depleted and the surrounding metal is strongly depleted of Cr and Fe.

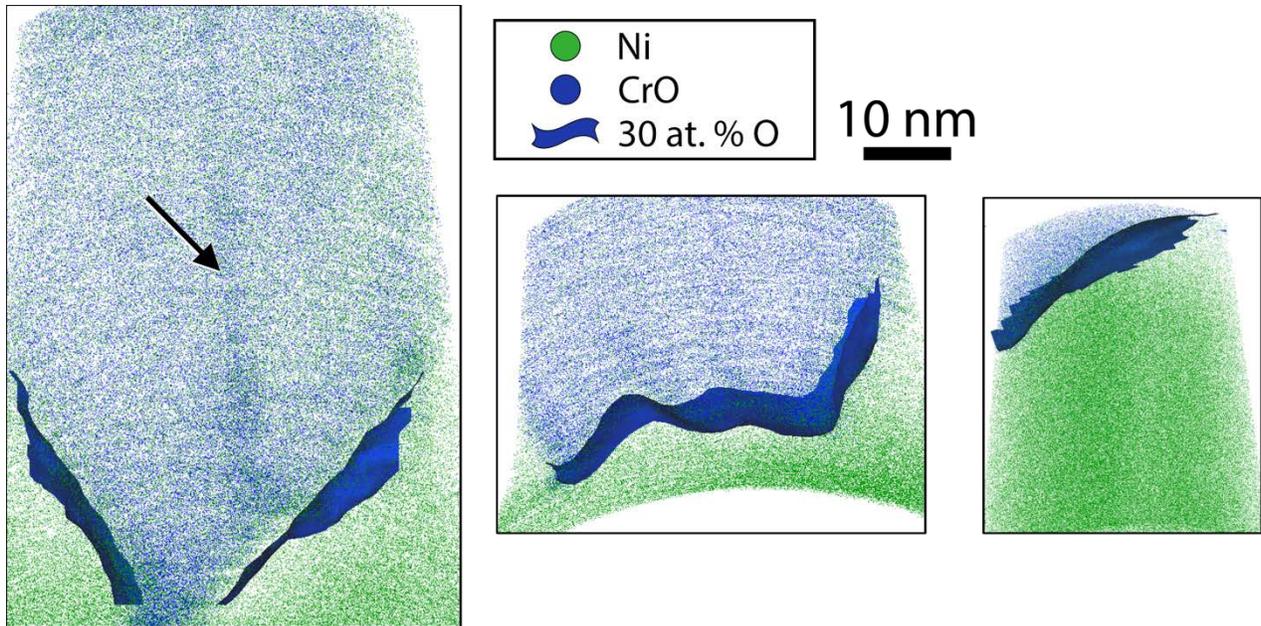
Figure 32: APT reconstructions of the metal/oxide interface from the PNNL re-exposure of WF422. The metal/oxide interface exhibited various topographies, but always terminated abruptly with no apparent O in solid solution in the metal matrix or discrete oxide formation ahead. Subtle atomic density differences in the APT reconstructions (see arrow) suggest the oxide is polycrystalline but exhibited only subtle composition fluctuations.

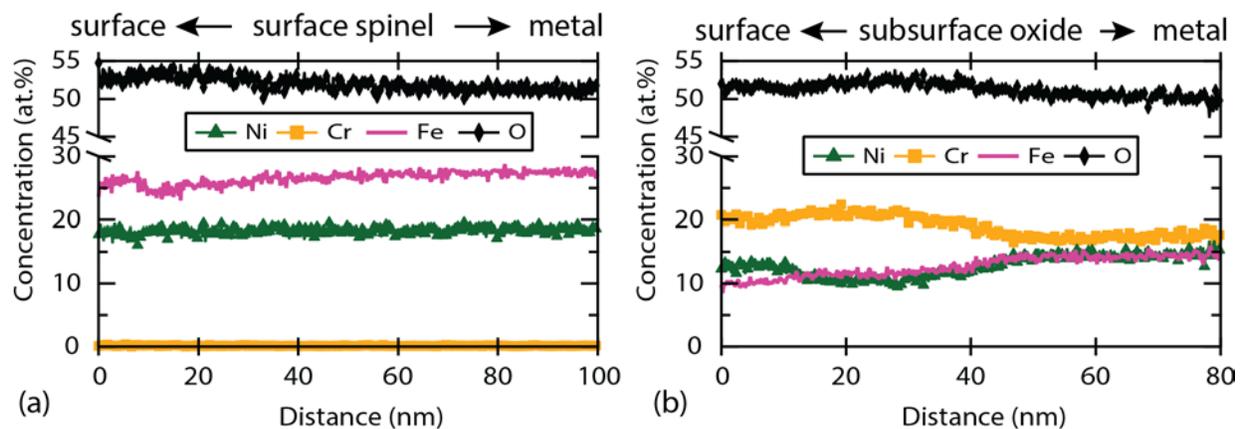
Figure 34: 1D concentration depth profiles taken from alloy 600 heat WF422 after corrosion in simulated PWR primary water at 320C for 3500 h. (a) Concentration profile taken from the external spinel oxide and (b) from the subsurface oxide. The surface spinel is comprised of a Ni-Fe spinel while the subsurface oxide is Cr rich but with varying composition.

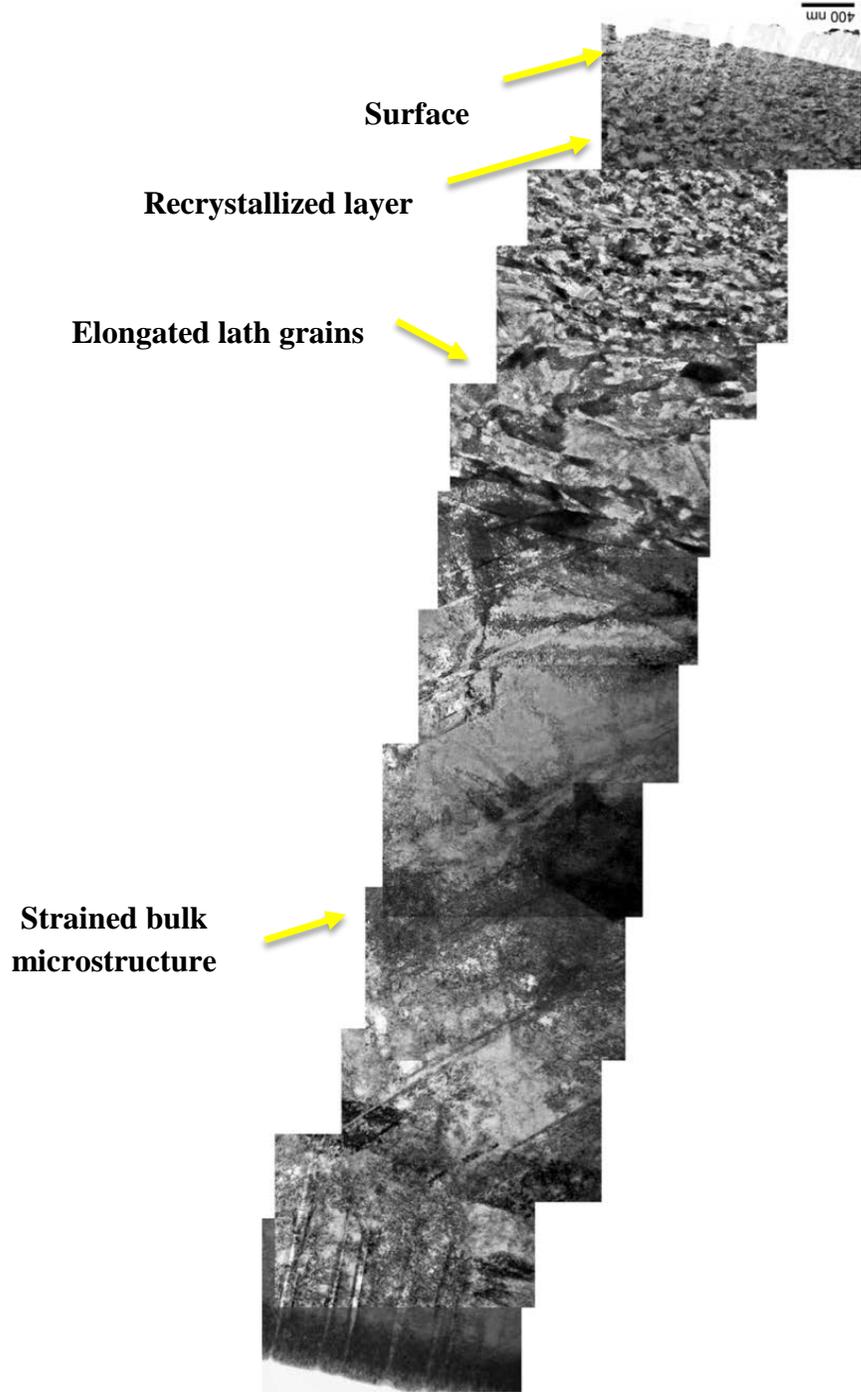
Figure 35: TEM BF montage of images taken on FIB-produced sample showing microstructural changes from the surface (nanocrystalline grains) to heavily deformed matrix at $\sim 10 \mu\text{m}$ in depth in a 304SS sample.

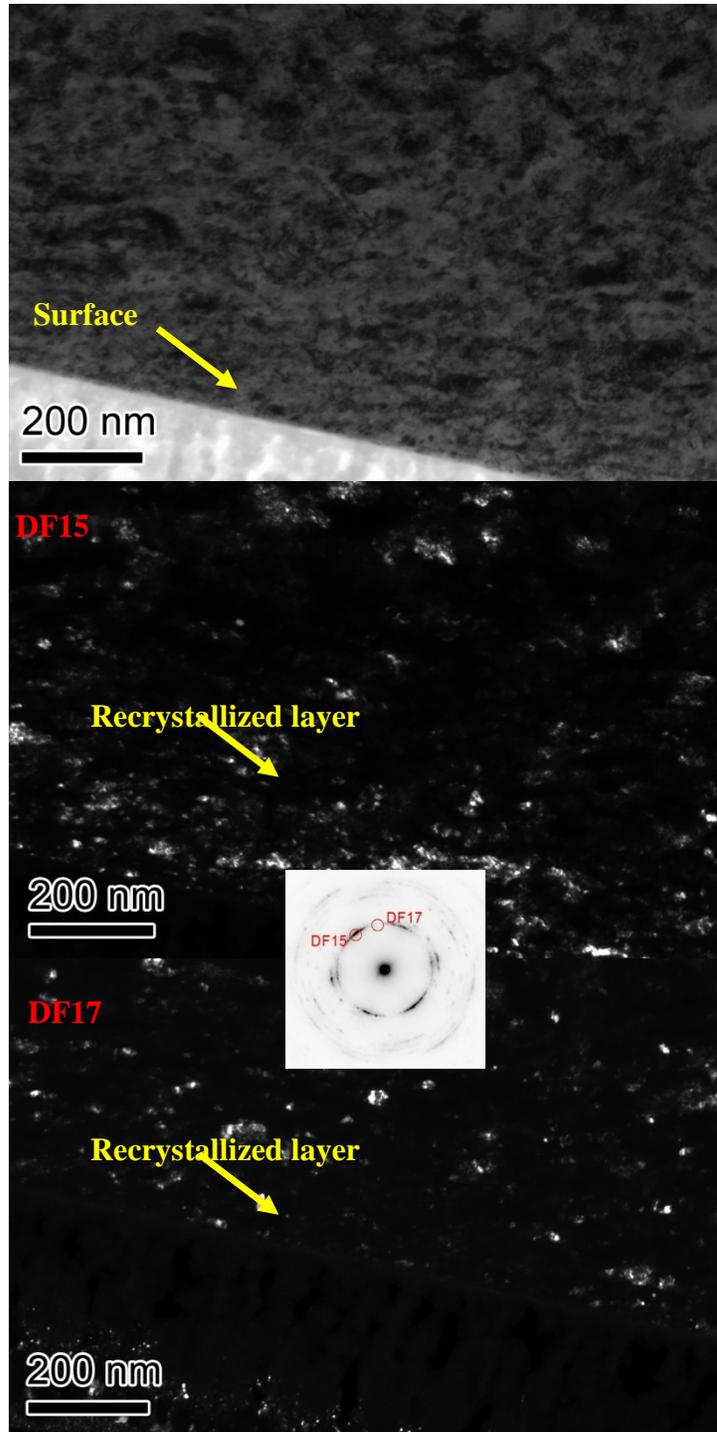
Figure 36: Brightfield (top) and darkfield TEM images illustrating the extremely fine, nanocrystalline grains near the surface. Electron diffraction pattern shows reflections used to highlight individual grains.

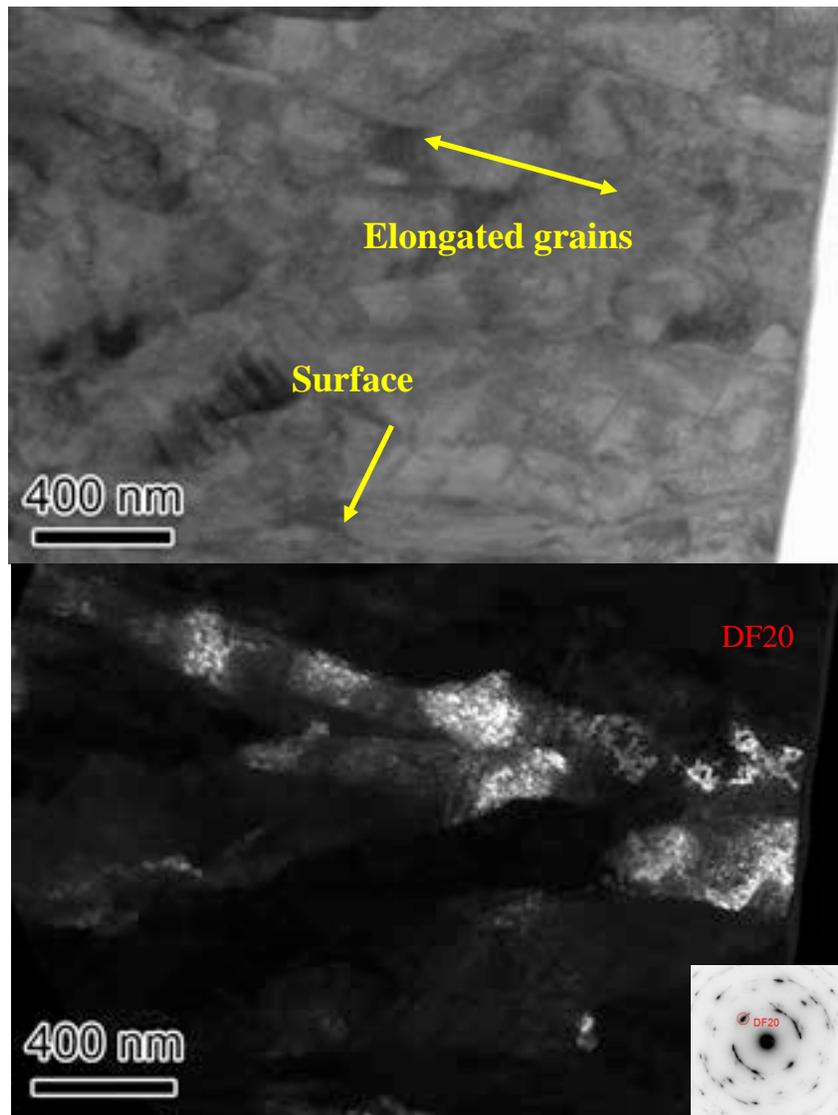
Figure 37: Bright field and dark field pair illustrating elongated metal grains $\sim 3\text{-}4\ \mu\text{m}$ from the surface of a 304SS sample.

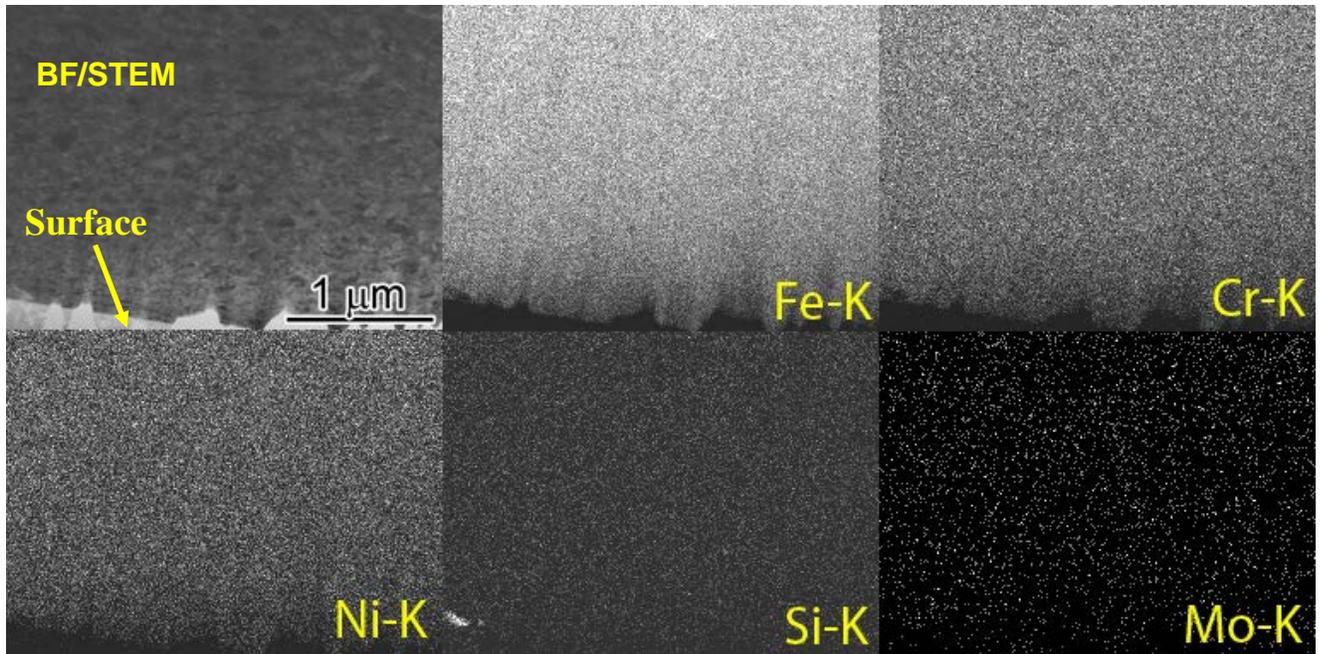
Figure 38: STEM/EDS maps of surface layer of ground 304 stainless steel surface with a recrystallized nanocrystalline surface layer. No observable segregation was found in the metal surface as well as any oxide. A small Si particle, most likely from the SiC grit paper was embedded in the surface.

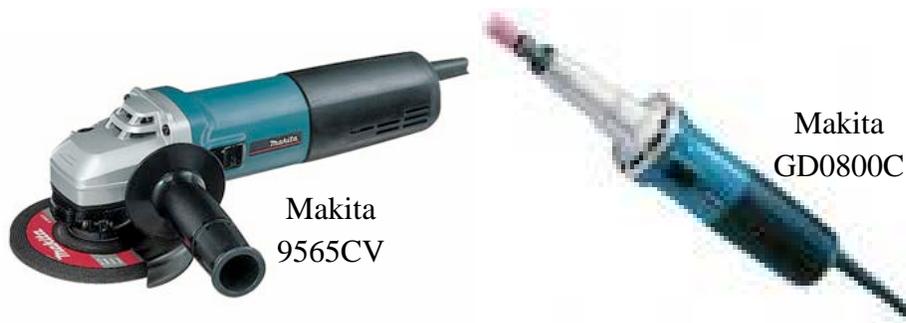
Figure 39: Representative images of the Makita 9565CV (left) and Makita GD0800C (right) used to grind the samples at Ringhals. IDs 5 and 6 were ground using the 9565CV at 11000 RPM and IDs 7 and 8 were ground with the GD0800C at 28000RPM.

As was noted in the previous section, the near-surface damage microstructures in stainless steel reactor service components could be recreated by controlled grinding in the laboratory. Investigations were continued on alloy 600 that was shipped to Ringhals. Large plates (6 in x 12 in) of alloy 600, which had been first polished to a base mirror finish (800 grit, SiC paper) at PNNL, were ground by a certified welder at Ringhals. A variety of surface preparation equipment was employed that are commonly used on LWR components during fabrication, welding and repair activities. It was indicated that these grinding conditions simulated normal surface preparation for service exposures. Table XIV indicates the grinding matrix for each of the metals, and Figure 39 illustrates the tools used in the grinding process.

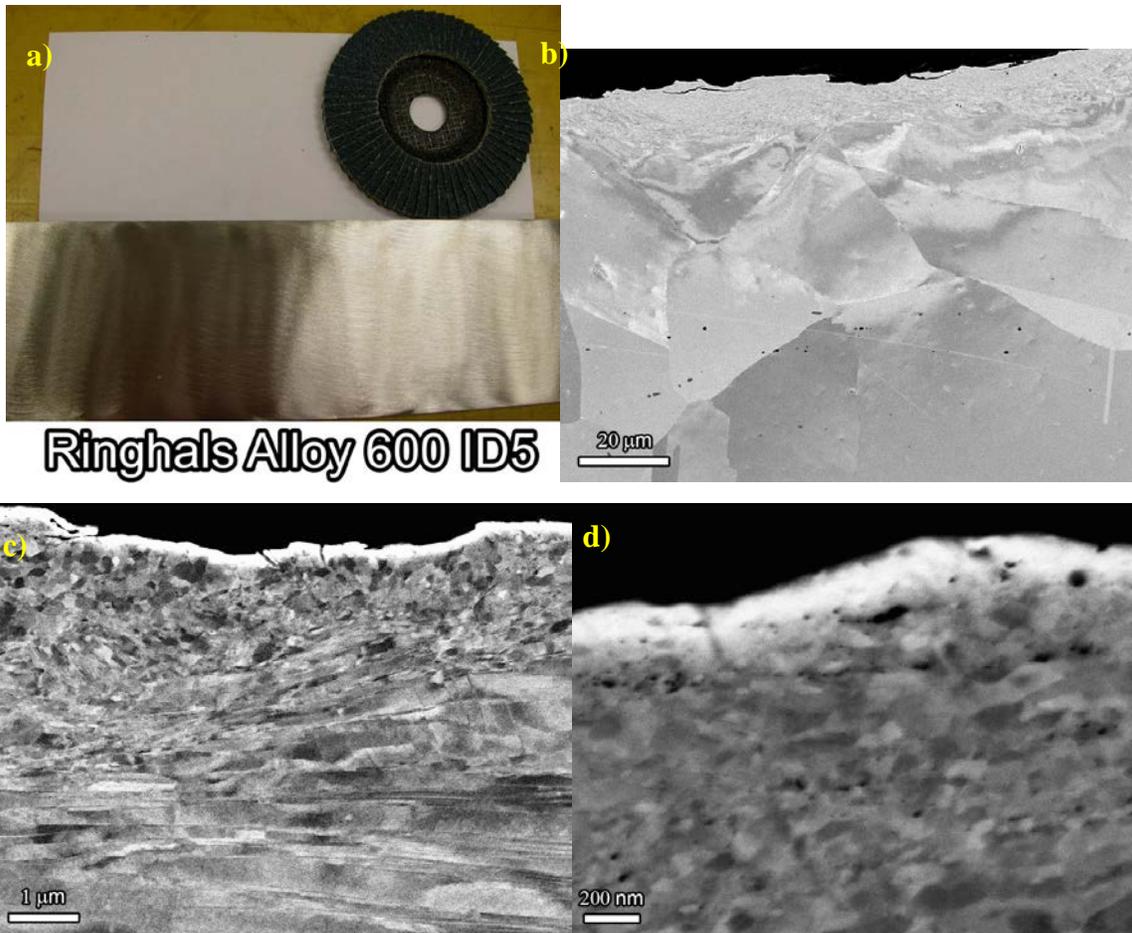
Figure 40: Alloy 600 ground using Makita 9565CV at 11000RPM and a PFERD Polifan SG-Zirkon PFC 125 Z40 SG grinding implement.

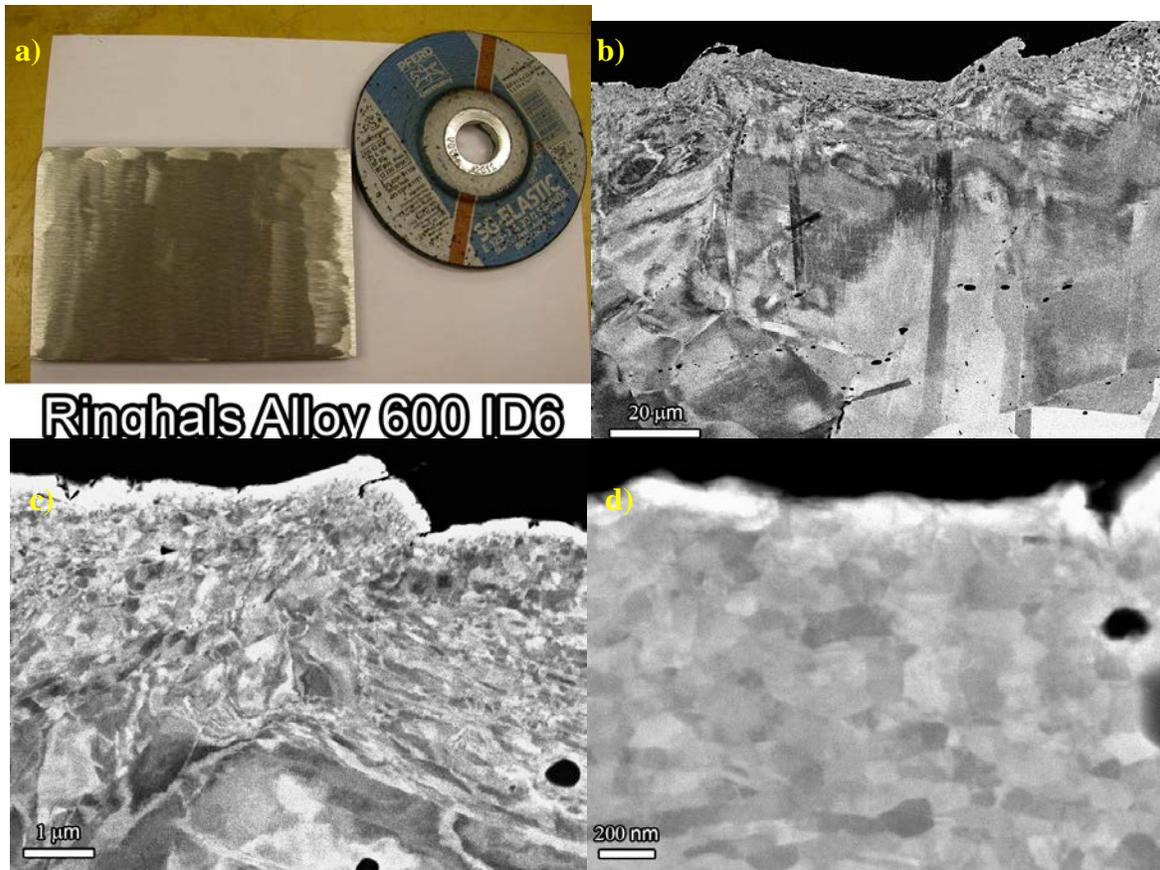
Figure 41: Alloy 600 ground using Makita 9565CV at 11000RPM and a PFERD SG-ELASTIC E 127-7 A30 N SG-INOX grinding implement.

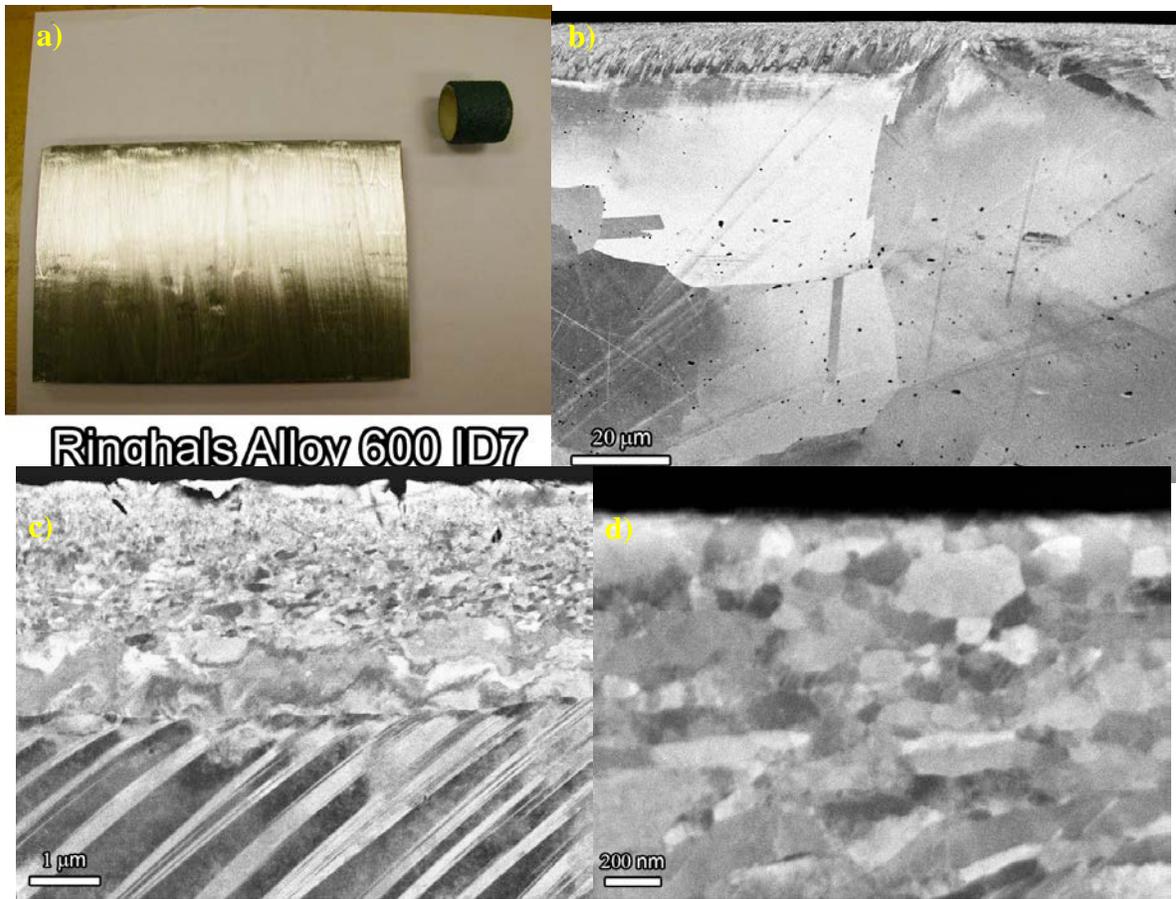
Figure 42: Alloy 600 ground using a Makita GD0800C at 28000 RPM with an abrasive sleeve Z Base-layer-cotton fabric, Zirconia alumina K-40 grain.

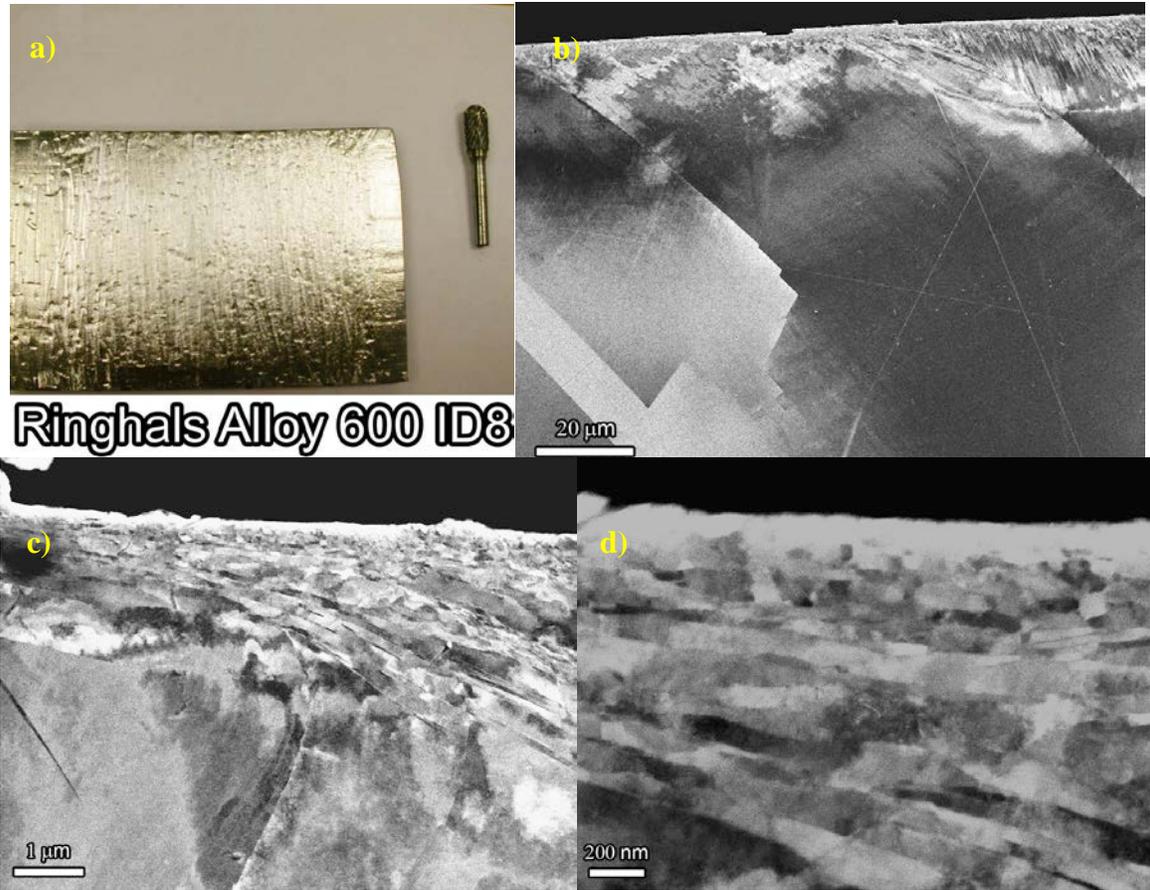
Figure 43: Alloy 600 ground using a Makita GD0800C at 28000 RPM with a PFERD, tungsten carbide burr cylindrical with radius end implement.
