**MICROSTRUCTURE, CORROSION AND STRESS
CORROSION CRACK INITIATION OF ALLOY 600
IN PWR PRIMARY WATER ENVIRONMENTS**

**Technical Milestone Report: M3LW-13OR0403032
March 2013**

M. J. Olszta, D. K. Schreiber, M. B. Toloczko
and S. M. Bruemmer
Pacific Northwest National Laboratory

Research Project:
**Stress Corrosion Crack Initiation of
Nickel-Base Alloys in LWR Environments**
Project Manager: S. M. Bruemmer
Pacific Northwest National Laboratory

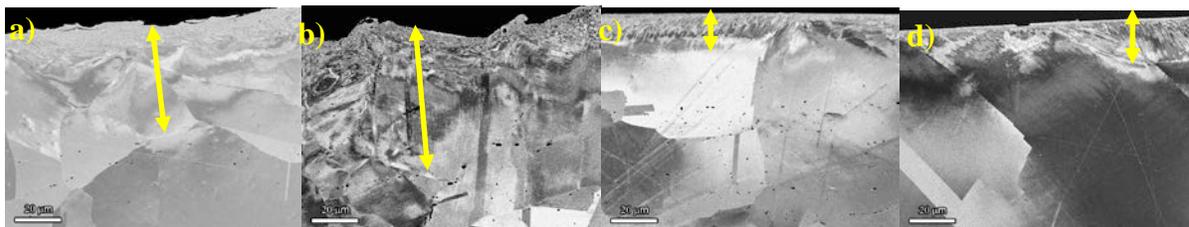
Figure 44: Low magnification SEM (BSE) cross-sectional micrographs of surfaces prepared by the Makita 9565CV (a, b) and Makita GD0800C (c, d). Arrows highlight the extent of surface damage.

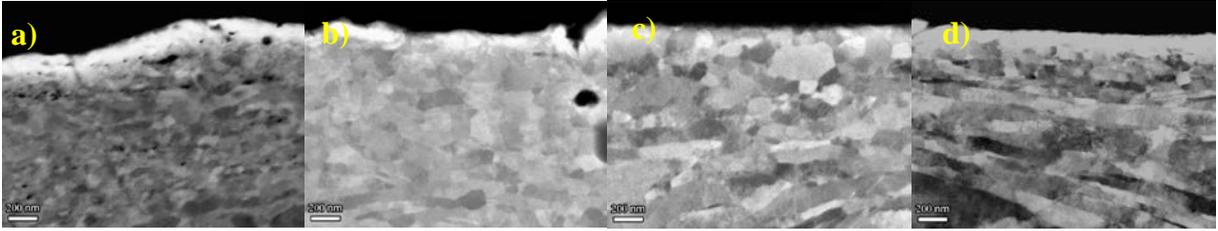
Figure 45: High magnification SEM-BSE cross-sectional micrographs of surfaces prepared by the Makita 9565CV (a, b) and Makita GD0800C (c, d) showing nanocrystalline surface layers.

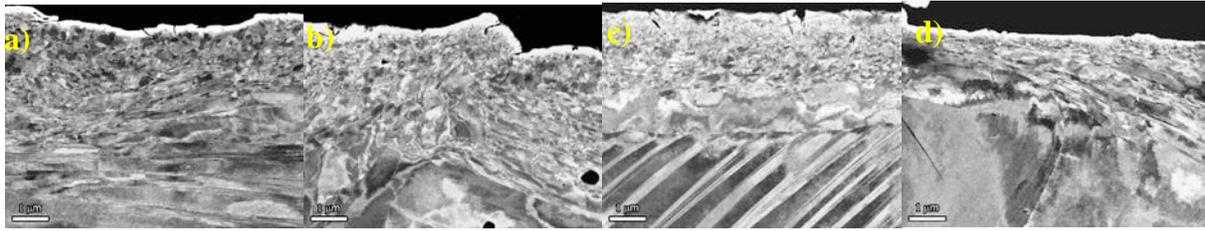
Figure 46: Medium magnification SEM-BSE cross-sectional micrographs of surfaces prepared by the Makita 9565CV (a, b) and Makita GD0800C (c, d) showing transition from nanocrystalline to lath microstructure.

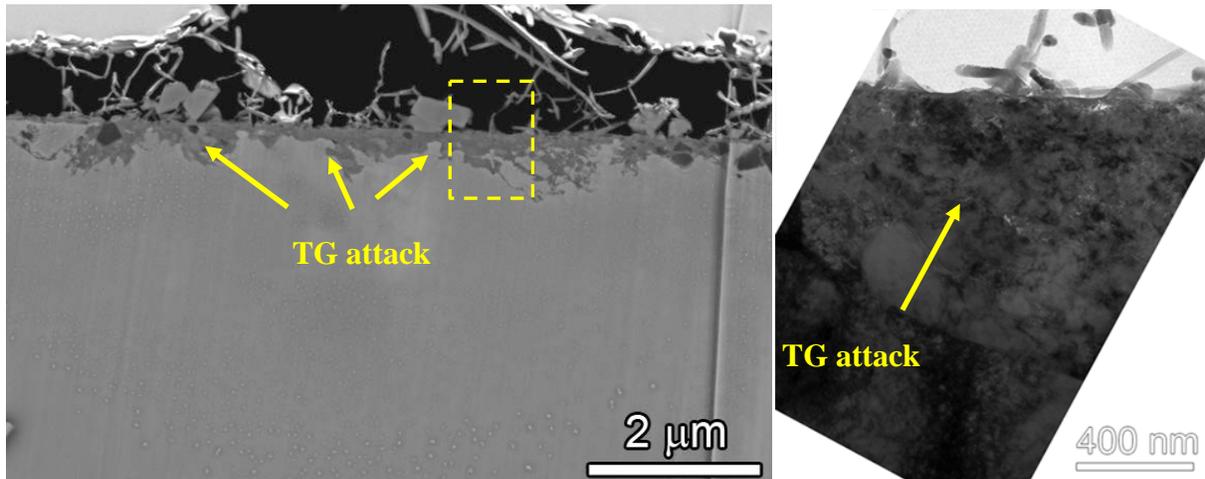
Figure 47: TEM BF and SEM (BSE) of highly polished A600 surface exposed to 1000 hr at 360°C PWR water. a) Backscatter image showing cross-section of surface and extent of attack. b) TEM underfocused BF image of dashed box region in a).

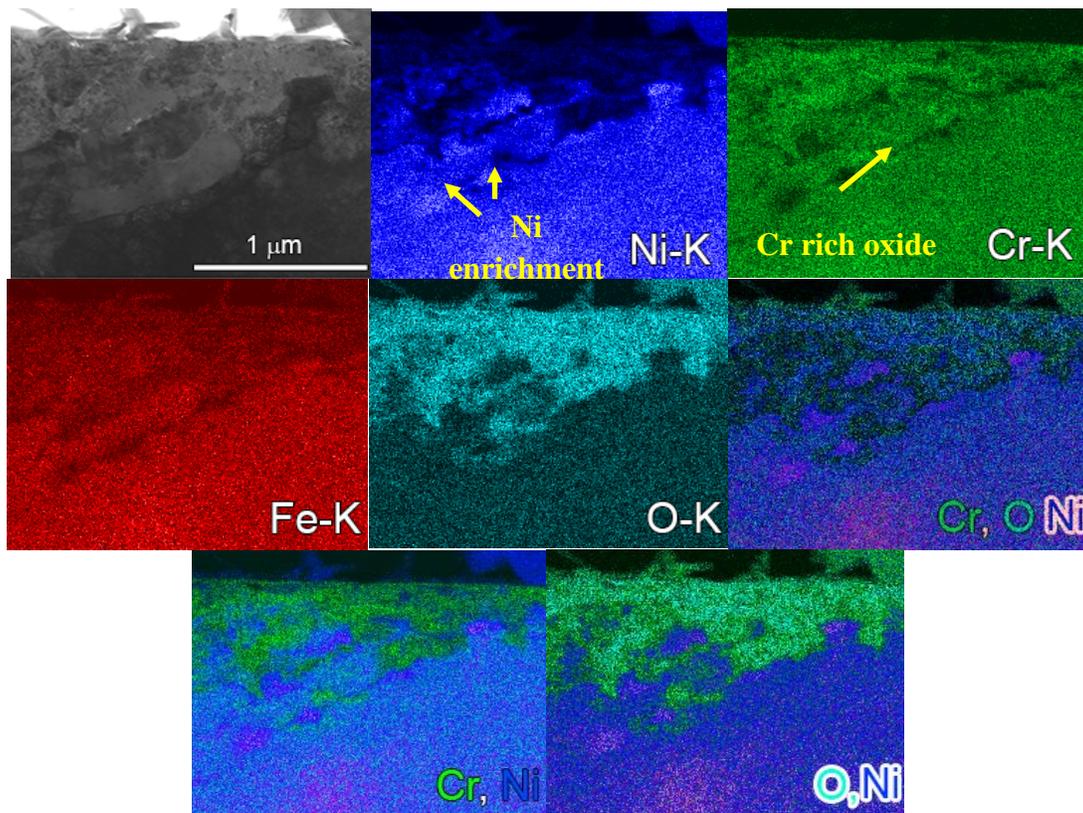
Figure 49: STEM BF/elemental maps of highly polished alloy 600 surface exposed to 1000 h at 360°C PWR water. The Ni/O difference map shows that in regions where the Ni (blue) and O (teal) form green, there is a different form of oxide than where there is predominantly teal (of which correspond well with stronger Cr signal). Similarly, in the Cr/O difference map, the two oxides are present with the Cr (green) and O (teal) overlapping to a different shade of green than in the middle of the oxide structure.

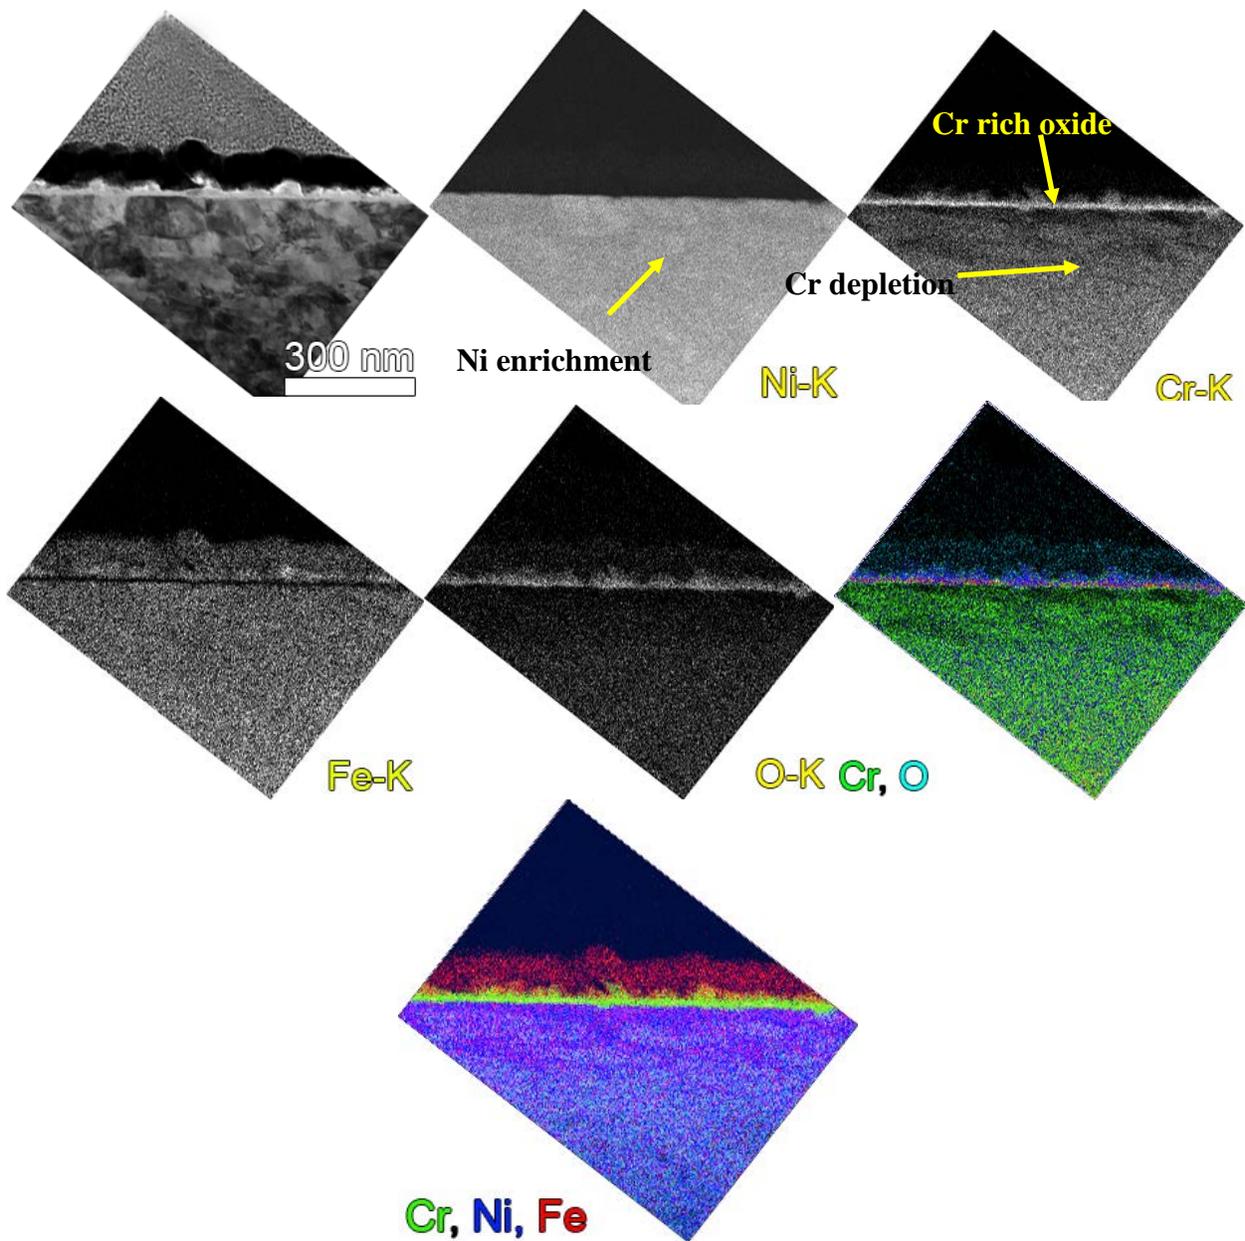
Figure 50: STEM BF/elemental maps of a ground alloy 600 surface exposed to 1000 hr at 360°C PWR water. The Cr (green)/Ni(blue)/Fe(red) difference map shows that the thin oxide layer is extremely Cr rich with very little Ni or Fe.

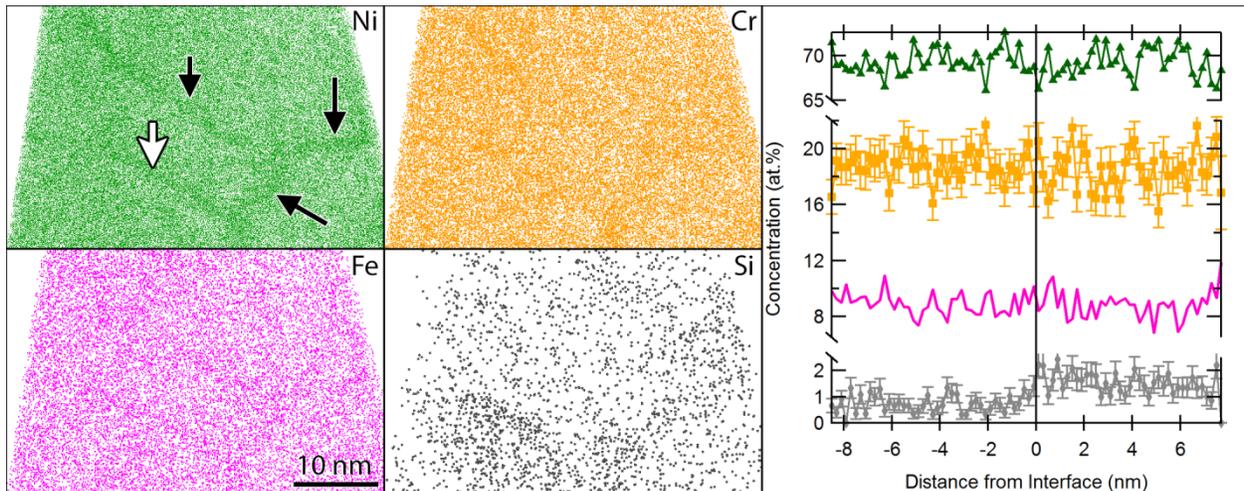
Figure 51: APT analysis of a ground and unexposed surface of WF422. The atomic density variations in the atom maps (black arrows) result from ion trajectory variability at grain boundaries. 1D concentration profiles across one such interface (white arrow) show no significant composition changes associated with the interfaces.

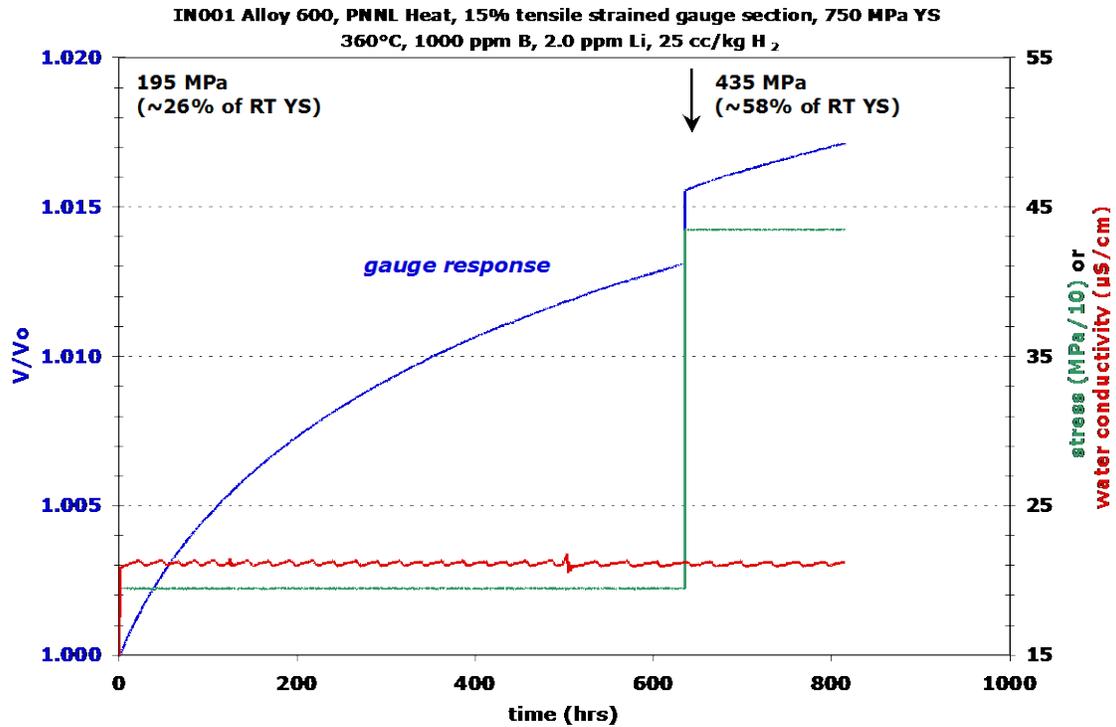
Figure 52: Normalized gauge voltage versus time plot for 15% tensile strained alloy 600 (IN001).

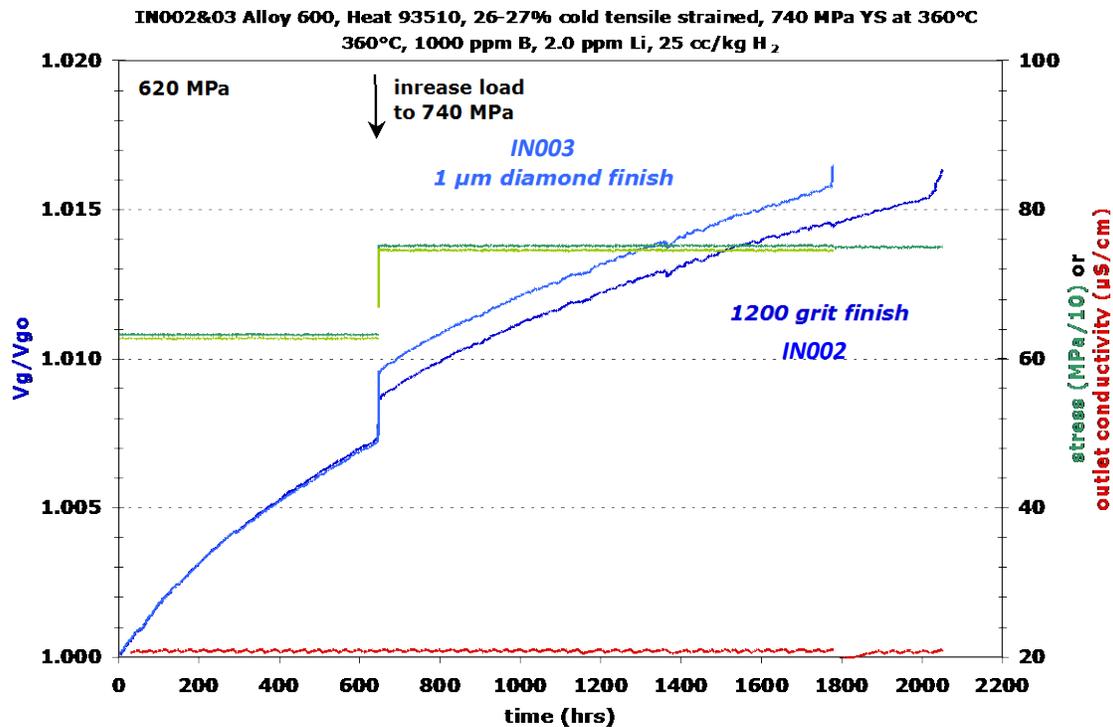
Figure 53: SCC crack initiation tests on 18% tensile prestrained alloy 600 CRDM Heat 93510.

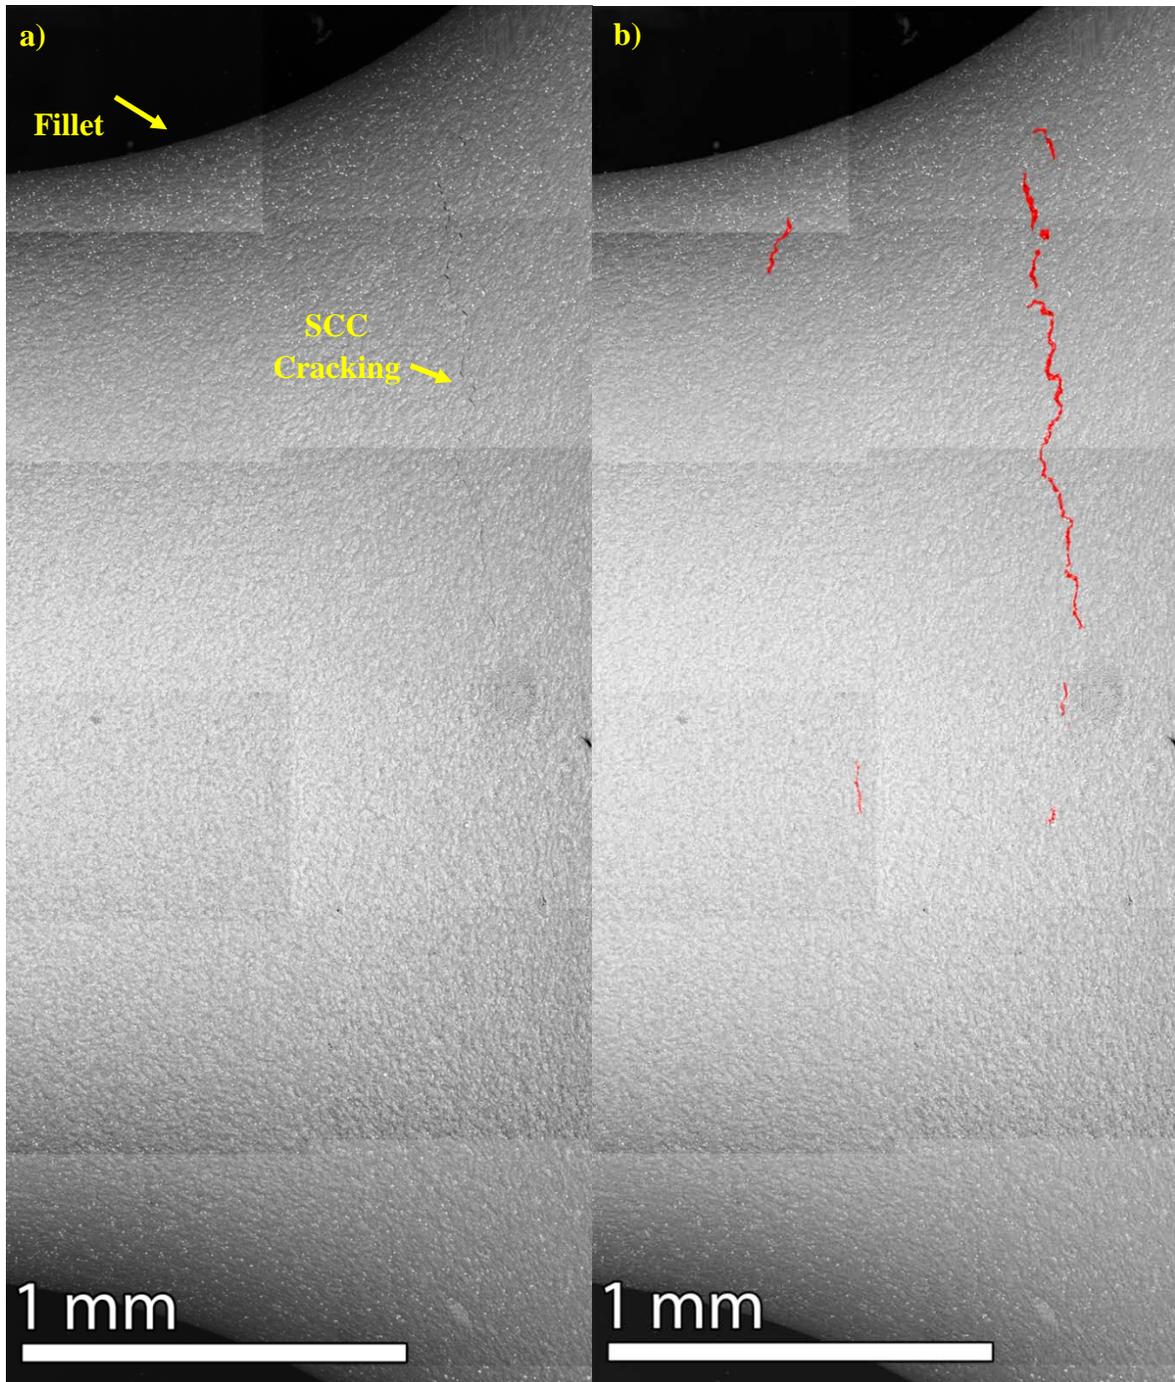
Figure 54: SEM-BSE images of the alloy 600 tensile initiation specimen IN003 surface that exhibited cracking near the fillet. Image (b) is identical image to (a), but cracks have been colored red as guide to the eye. The longest crack observed was circumferential and nearly 1 mm in length.

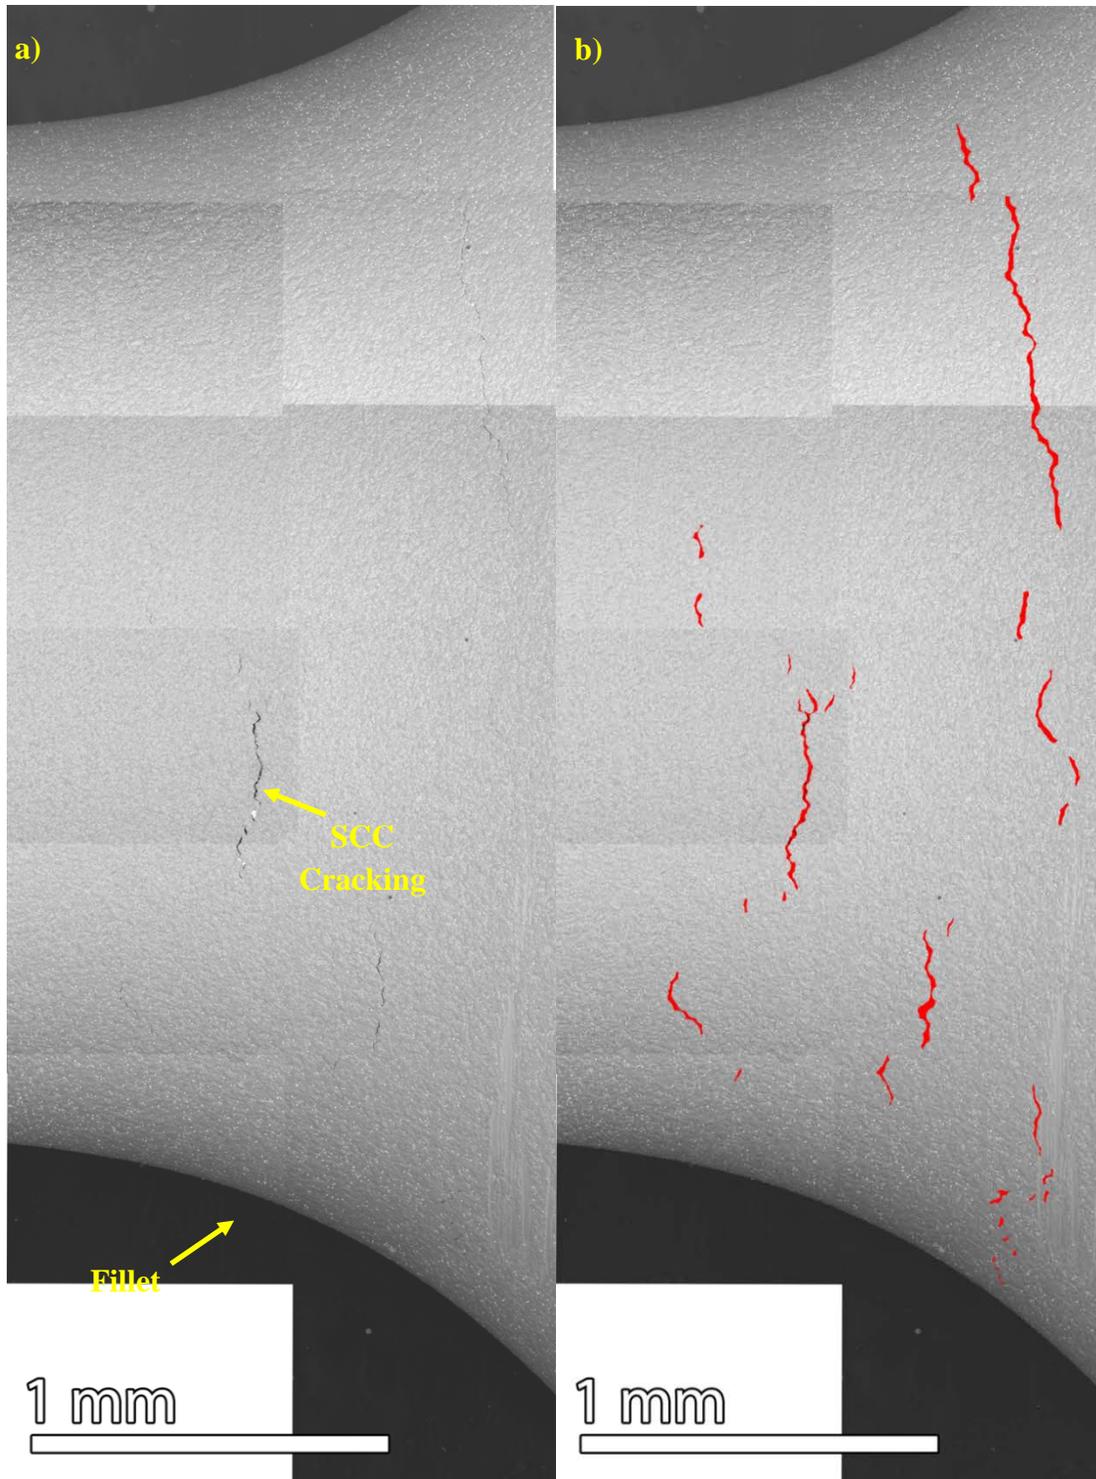
Figure 55: SEM-BSE image of the alloy 600 tensile initiation specimen IN003 (rotated 120° from Figure 54) that exhibits cracking near the fillet. Image (b) is the identical image but cracks has been colored red as guide to the eye. SCC cracks as long as ~1 mm circumferentially were observed.

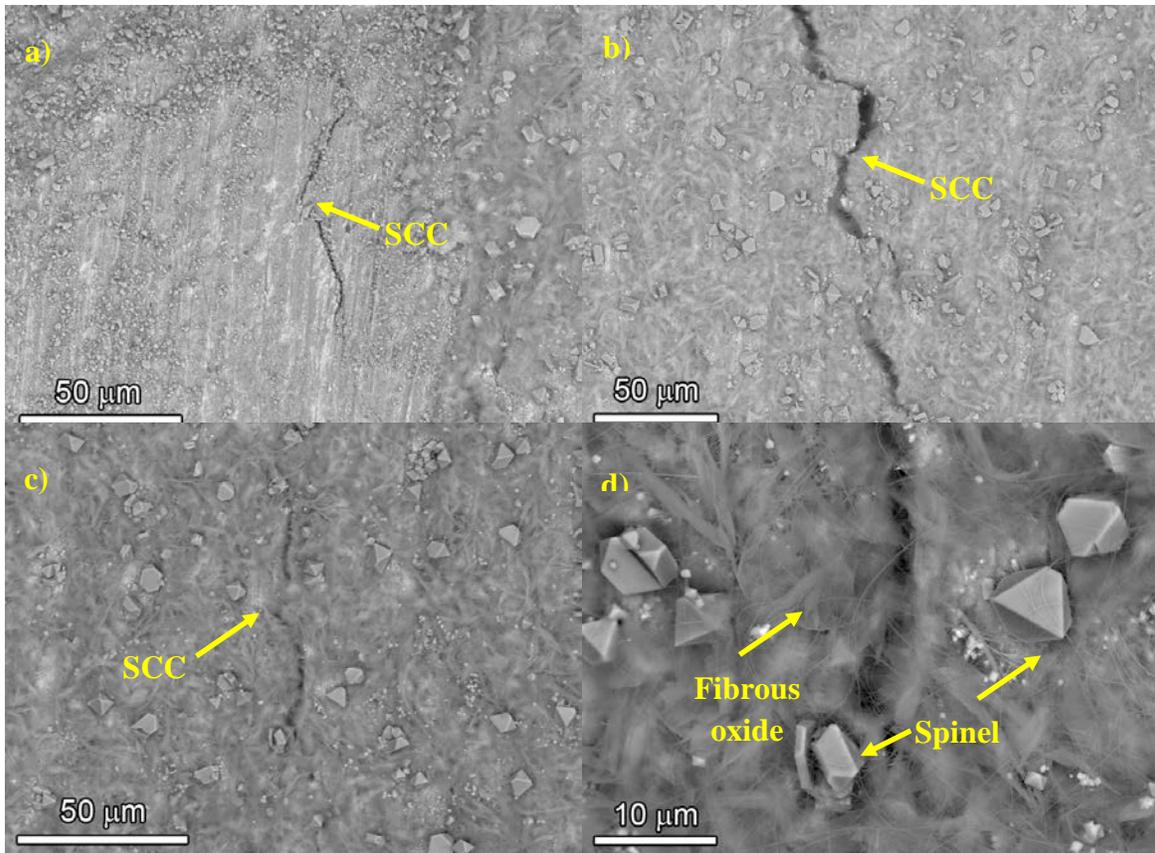
Figure 56: Low magnification SEM-BSE images of the surface of an exposed alloy 600 tensile initiation specimen IN003 illustrating various SCC cracks and surface oxides.

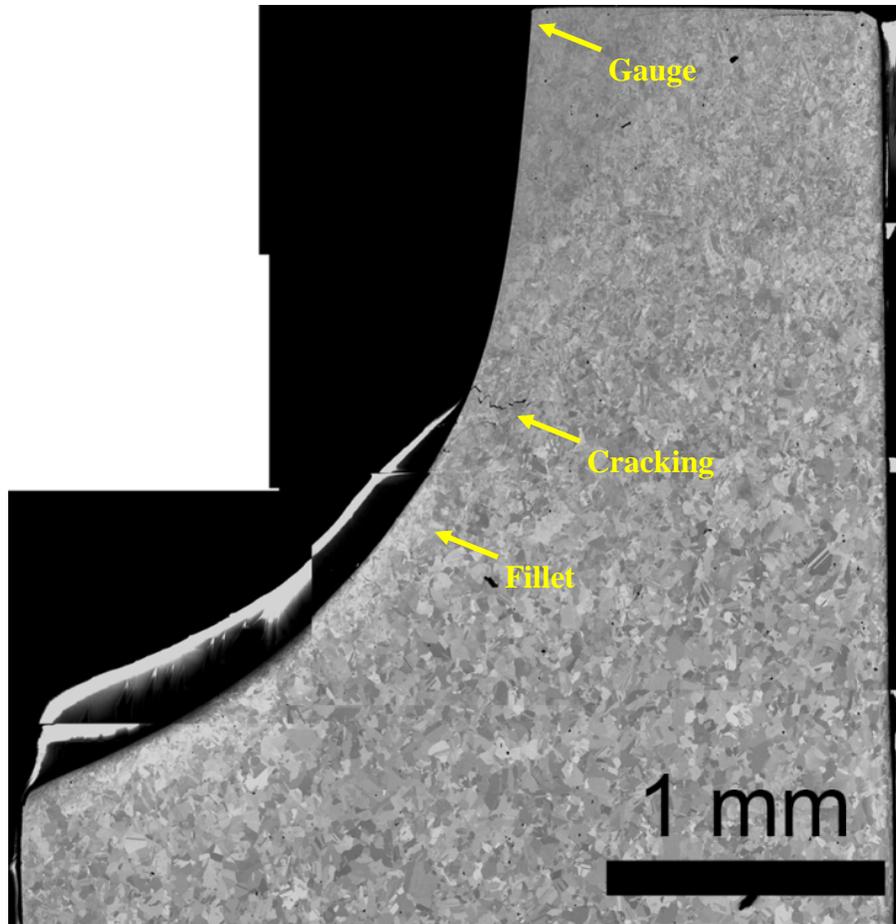
Figure 57: SEM-BSE images of a cross-section from the alloy 600 tensile initiation specimen IN003 that exhibited cracking near the fillet. Note the apparent variation in grain size between the gauge region and the fillet region.

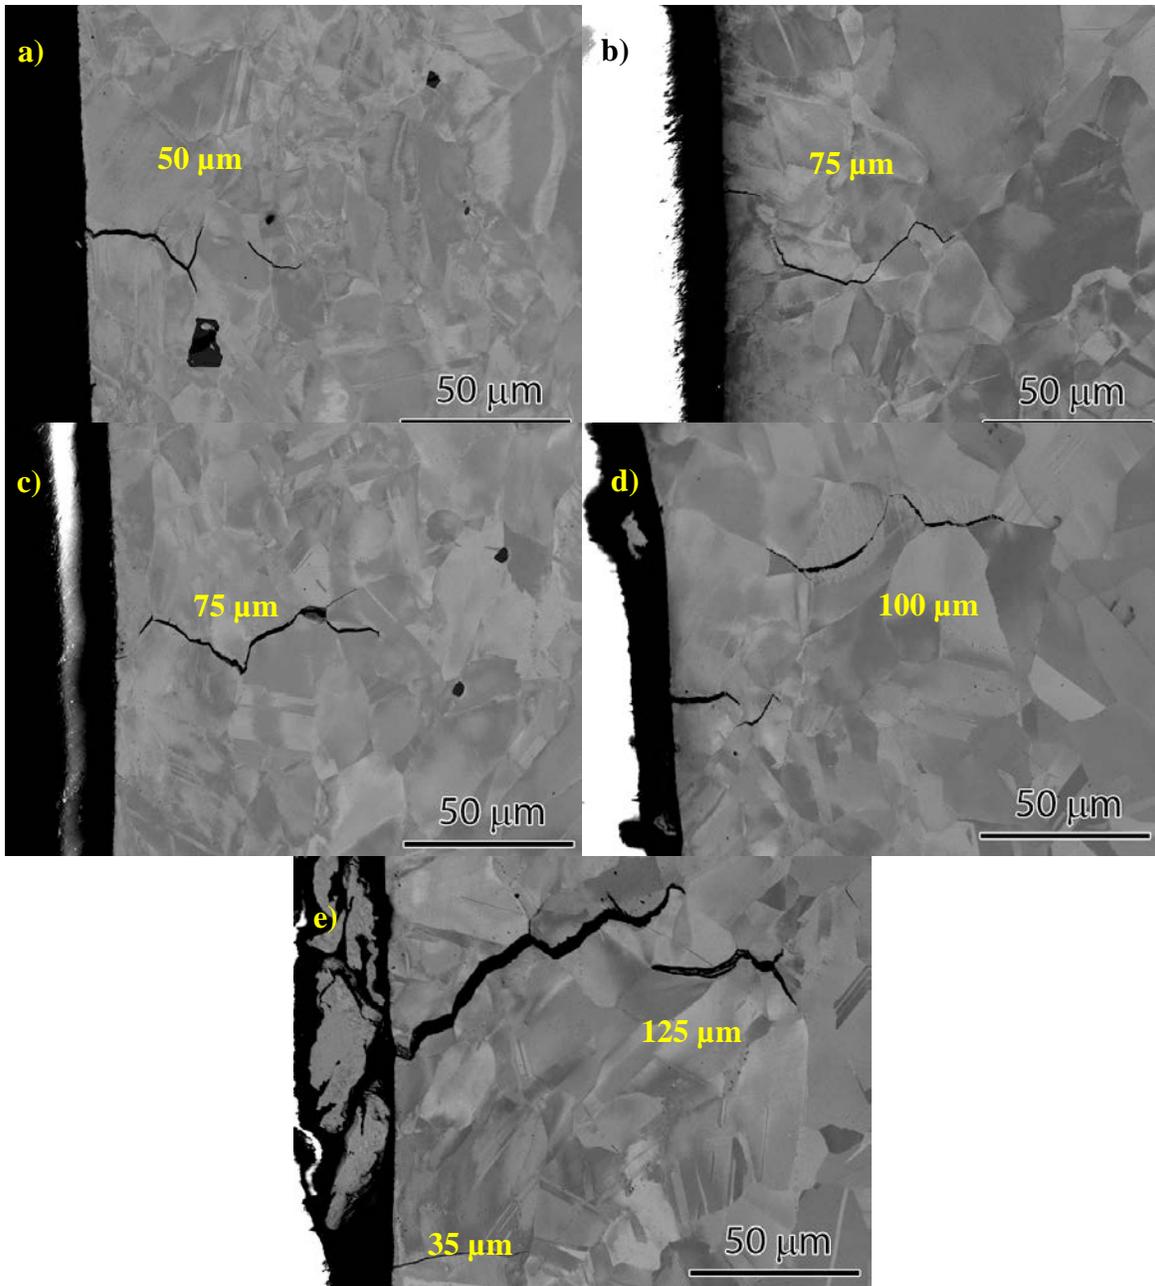
Figure 58: SEM-BSE images of a cross-section for the alloy 600 tensile initiation specimen IN003 showing deep SCC cracks initiating from the surface. Apparent crack depths are listed for each figure.

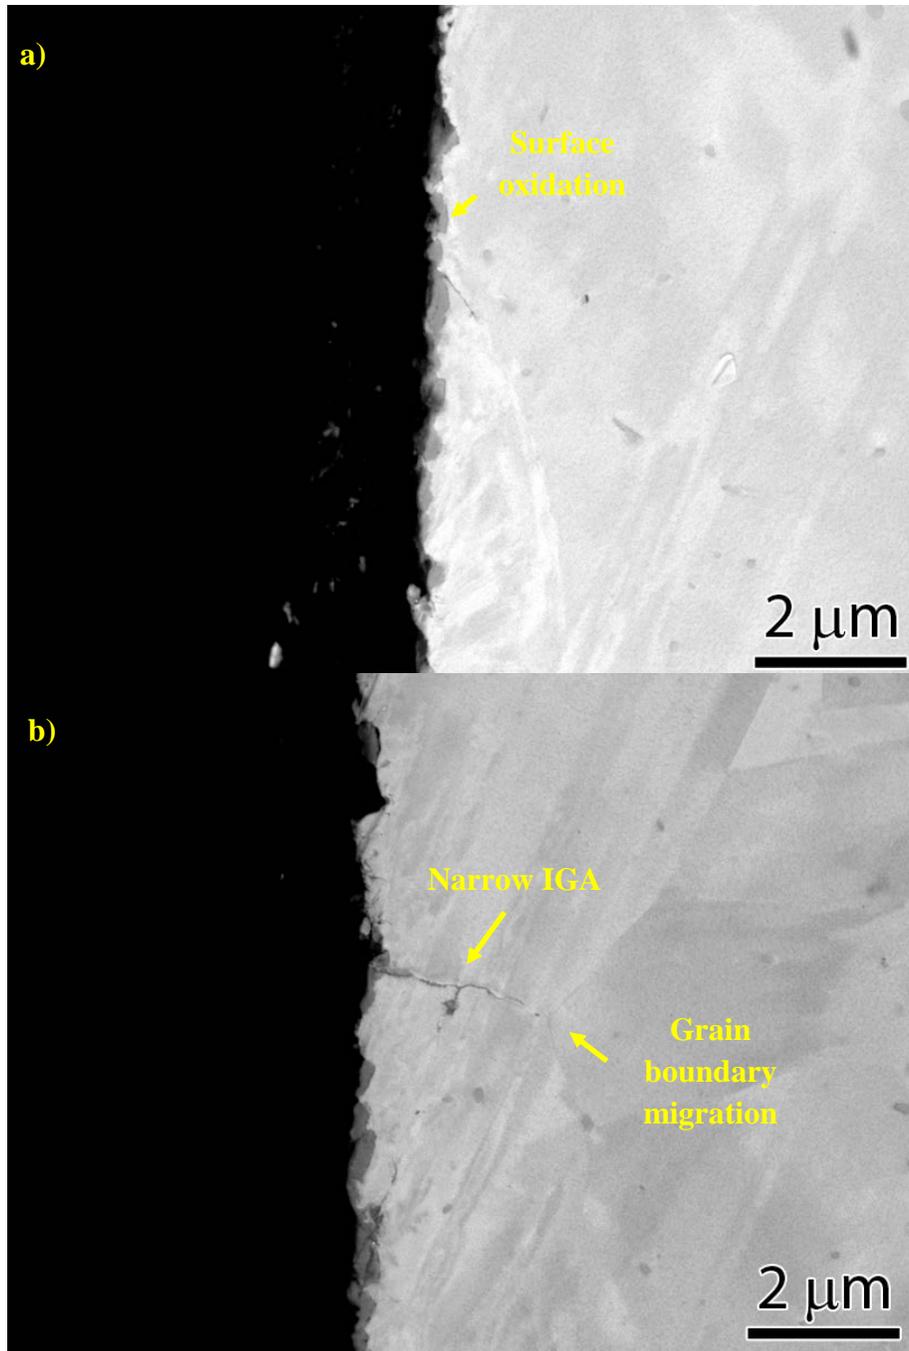
Figure 59: SEM-BSE images of a cross-section for the alloy 600 tensile initiation specimen IN003 illustrating representative TG (surface oxidation) and IG corrosion in the gauge section.

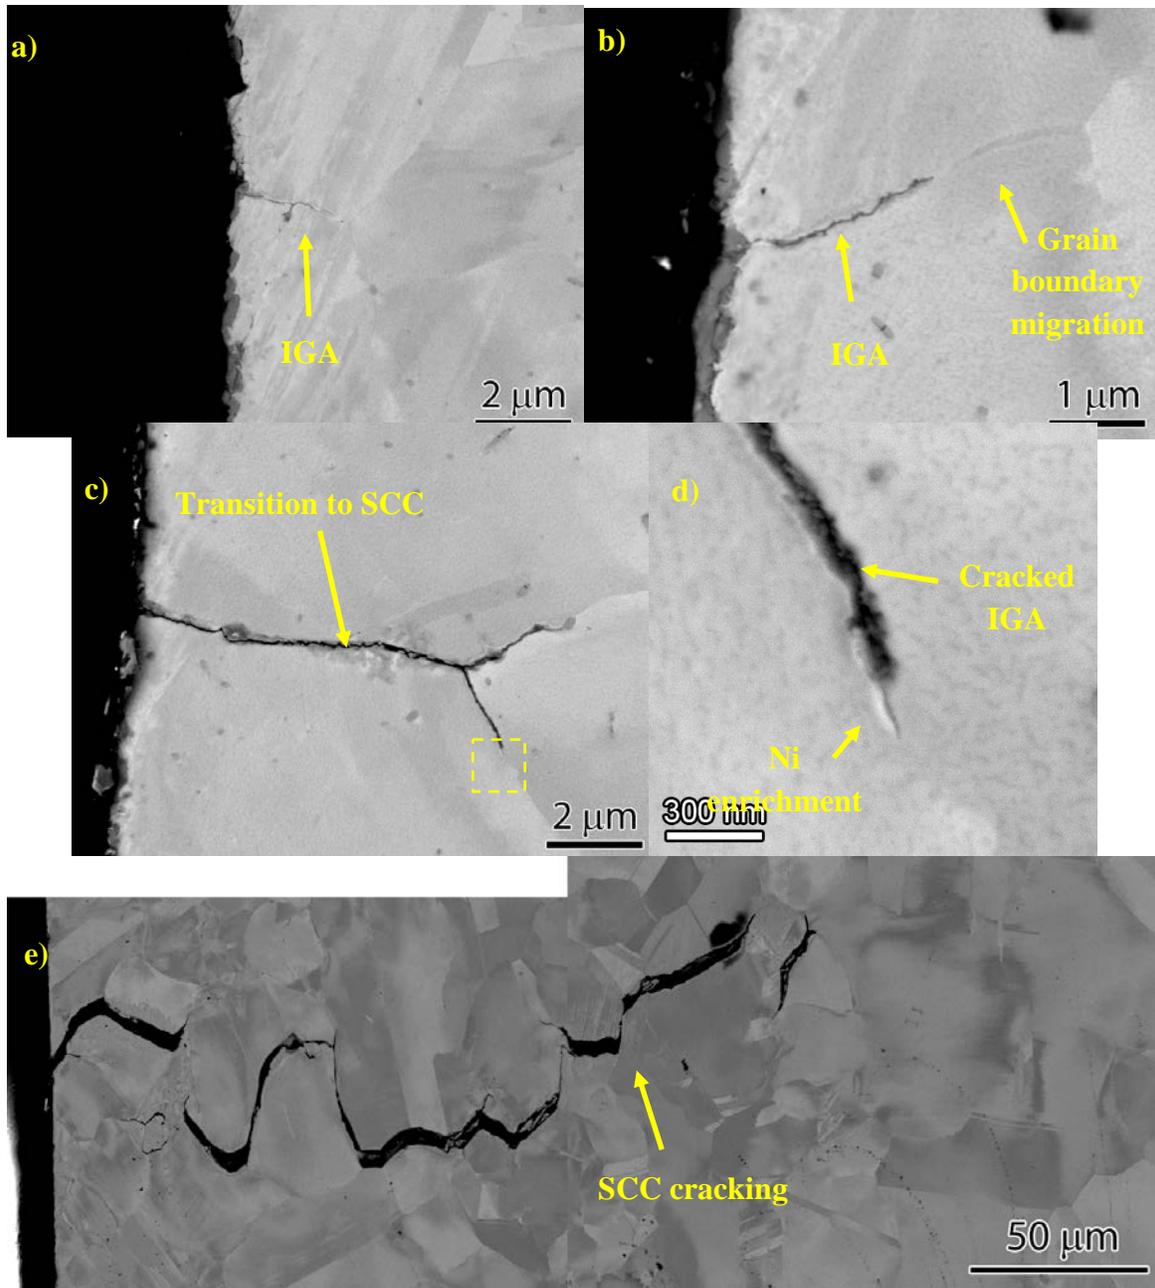
Figure 60: SEM-BSE images of the cross-section for the alloy 600 initiation specimen IN003 highlighting various stages of SCC cracking. (a,b) IG attack in gage section without cracks, (c,d) IG attack transitioning to an IGSCC crack and e) a long IGSCC crack in the fillet region.

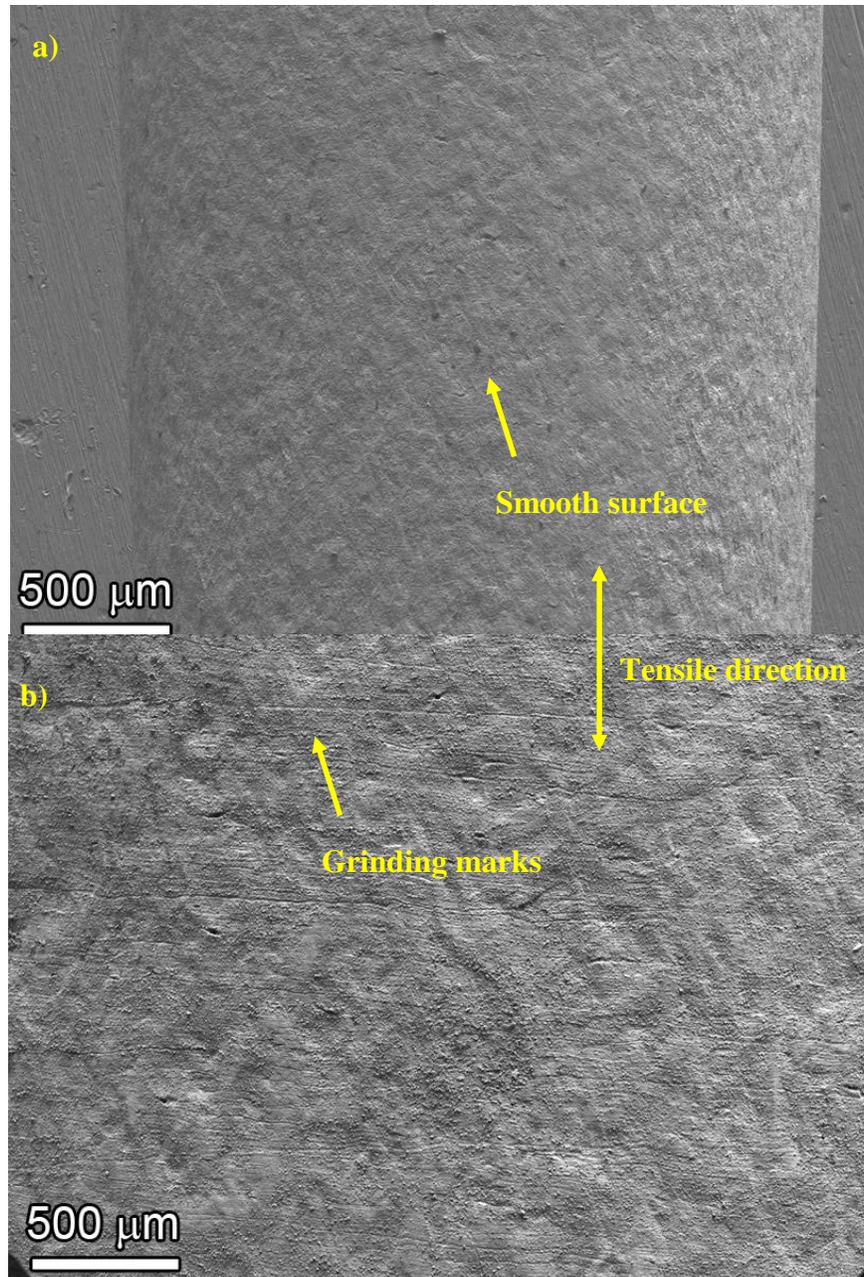
Figure 61: SEM-SE images of exposed surfaces for the alloy 600 initiation specimens that had a) highly polished gage section surface (IN003) or b) surfaces ground with 1200 grit SiC ground gage section surface (IN003).

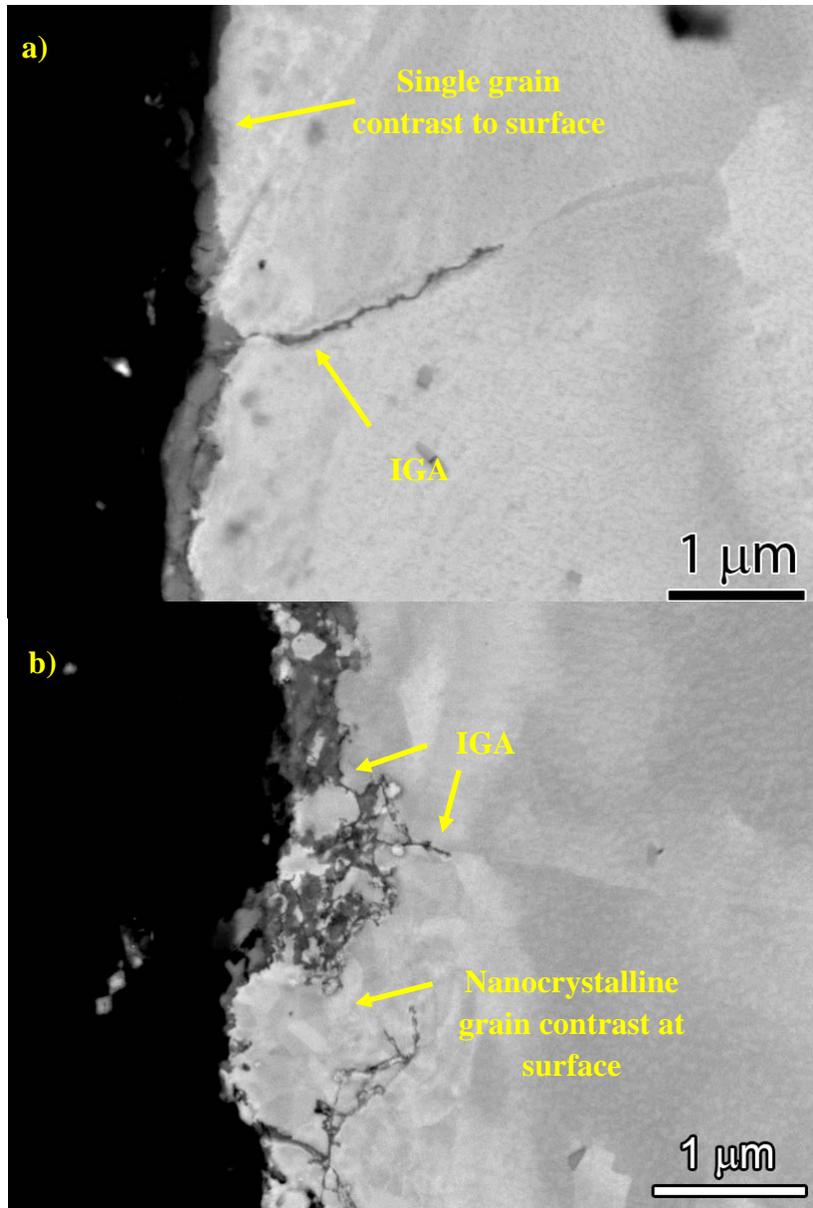
Figure 62: SEM-BSE images of cross-sections from the alloy 600 initiation specimens with surfaces of 1 μm diamond (IN003) and 1200 grit SiC (IN002) after exposure to PWR primary water.

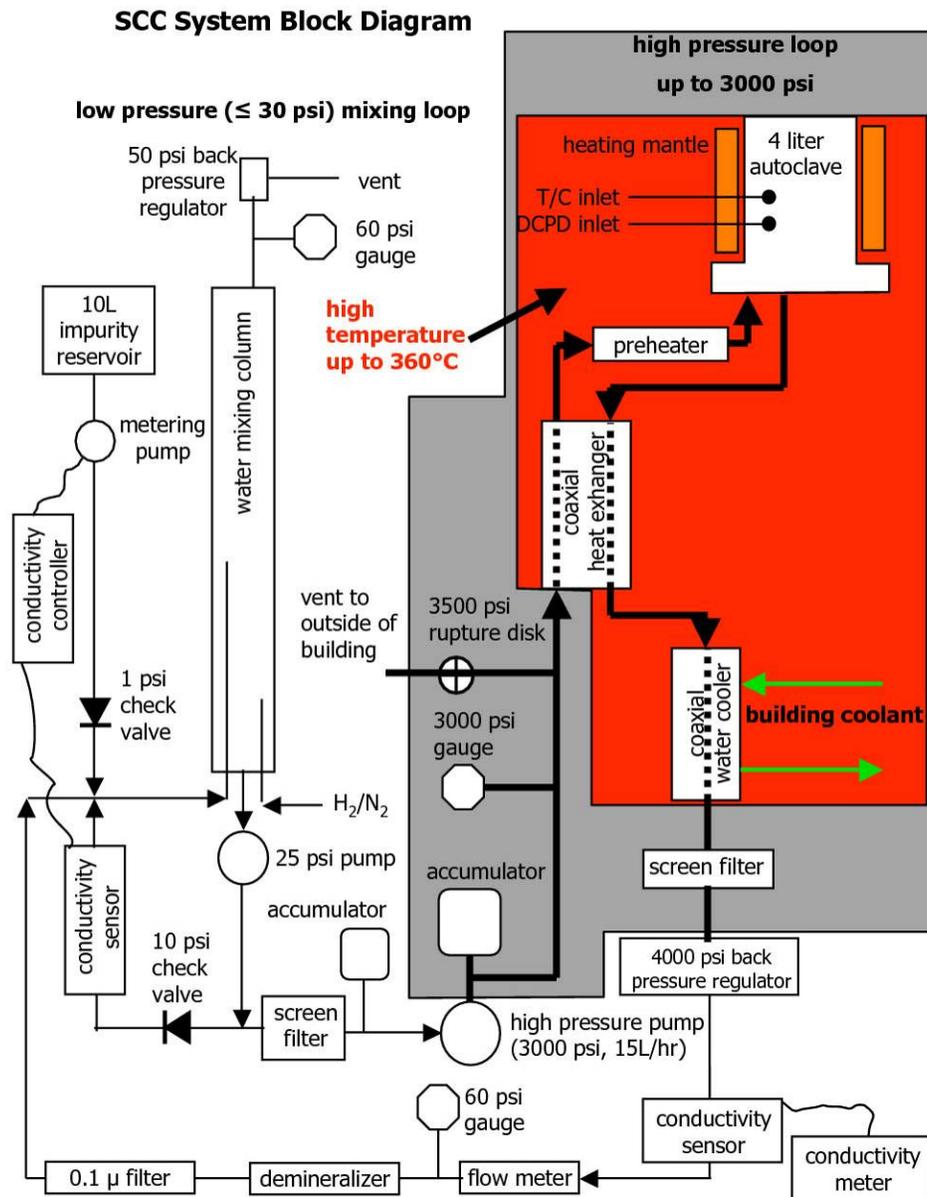
Figure 63: General water flow diagram for PNNL SCC crack-growth test systems.

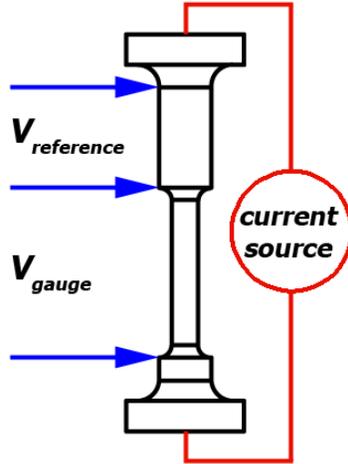
Figure 64: Schematic of final tensile geometry and DCPD measurement points.

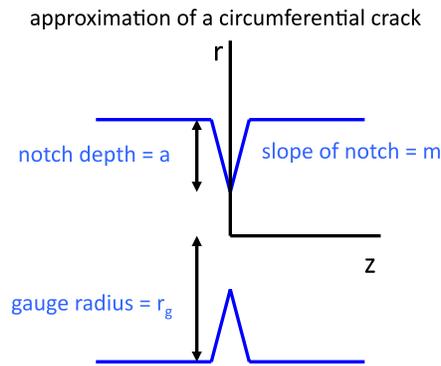
Figure 65: Sketch showing approximation of a circumferential crack.

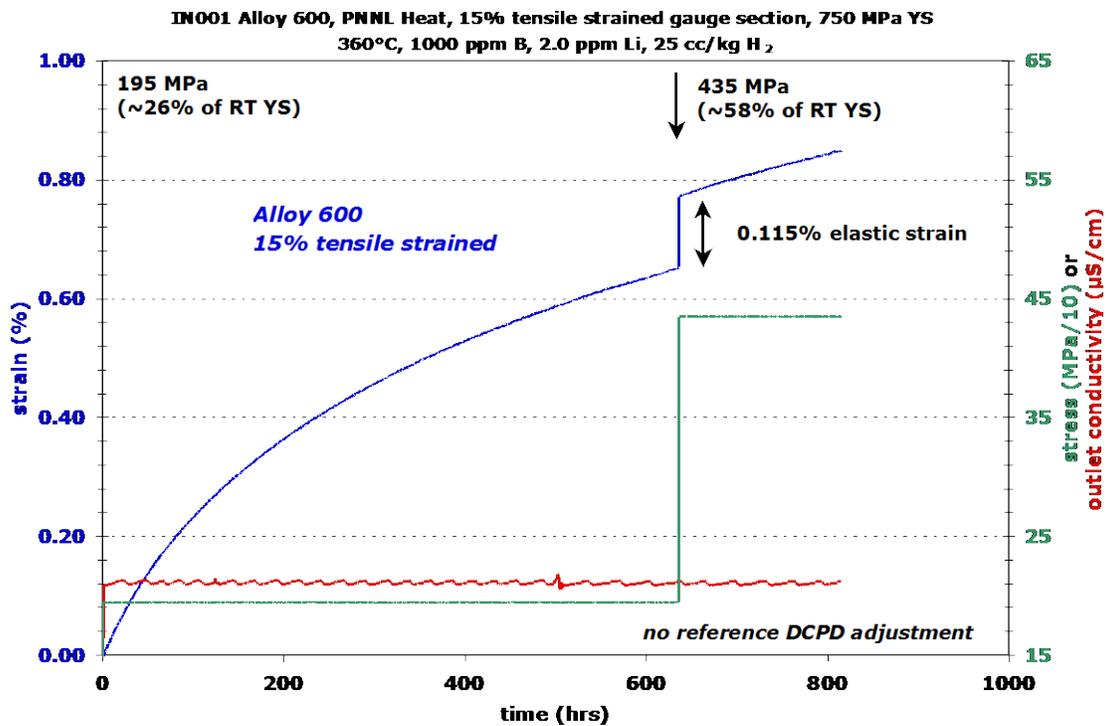
Figure 66: Unreferenced DCPD-based strain measured on 15% tensile prestrained alloy 600.

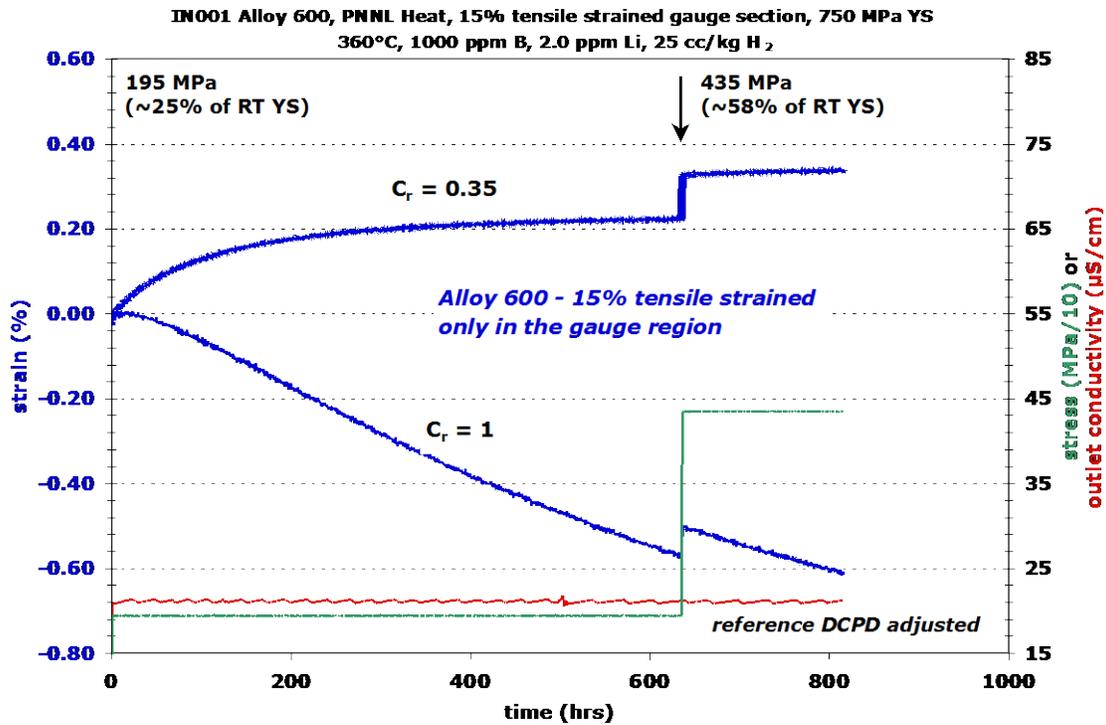
Figure 67: Referenced DCPD-based strain on alloy 600 specimen that has a plastically strained gauge region and a mill-annealed reference region. Strains are calculated from Equation 4.

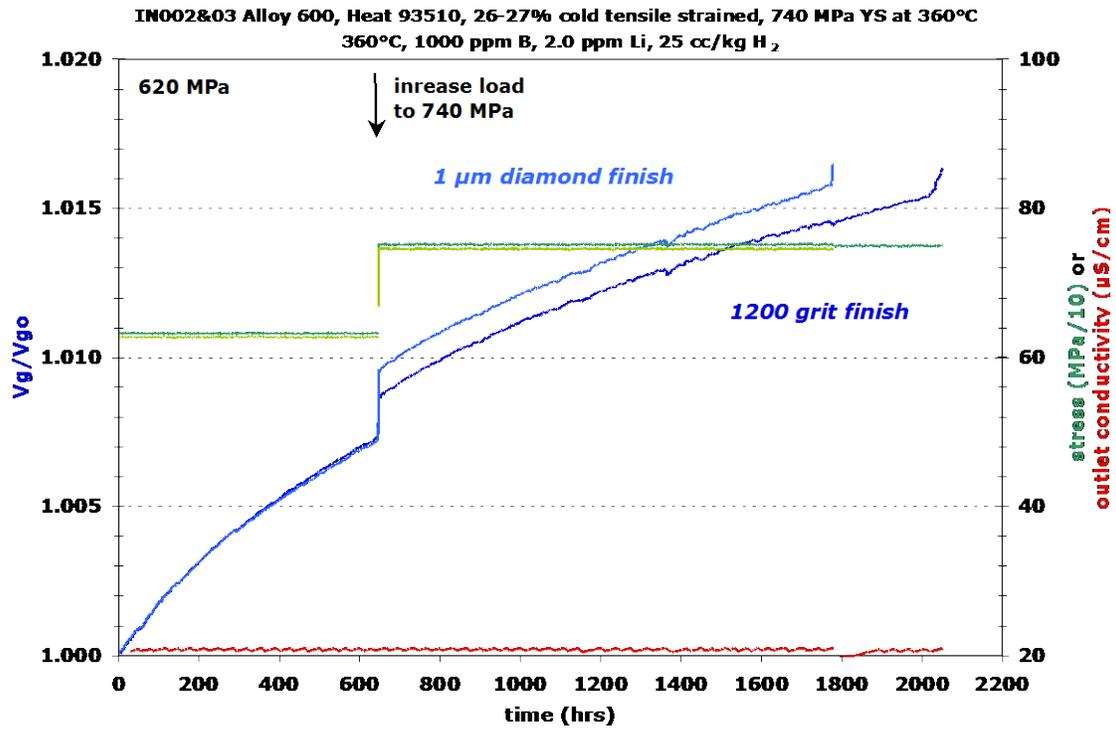
Figure 68: Normalized DCPD gauge voltage for specimens IN002 and IN003.
