**MICROSTRUCTURE, CORROSION AND STRESS
CORROSION CRACK INITIATION OF ALLOY 600
IN PWR PRIMARY WATER ENVIRONMENTS**

**Technical Milestone Report: M3LW-13OR0403032
March 2013**

M. J. Olszta, D. K. Schreiber, M. B. Toloczko
and S. M. Bruemmer
Pacific Northwest National Laboratory

Research Project:
**Stress Corrosion Crack Initiation of
Nickel-Base Alloys in LWR Environments**
Project Manager: S. M. Bruemmer
Pacific Northwest National Laboratory

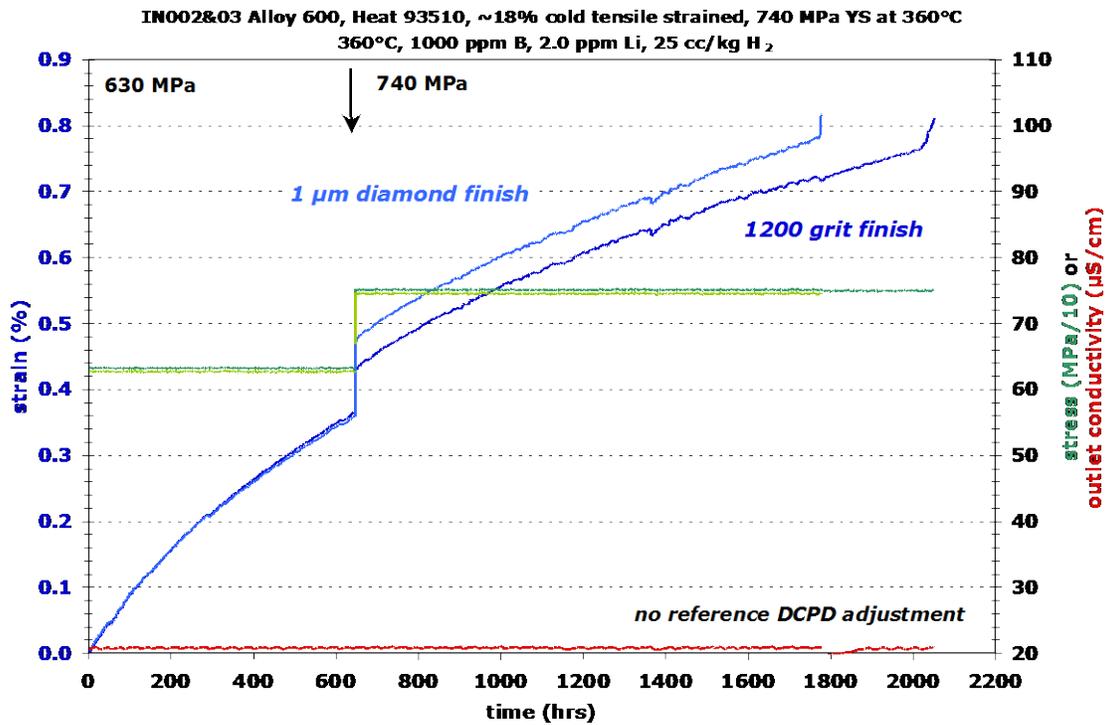
Figure 69: Unreferenced DCPD-based strain (Equation 1) for specimens IN002 and IN003.

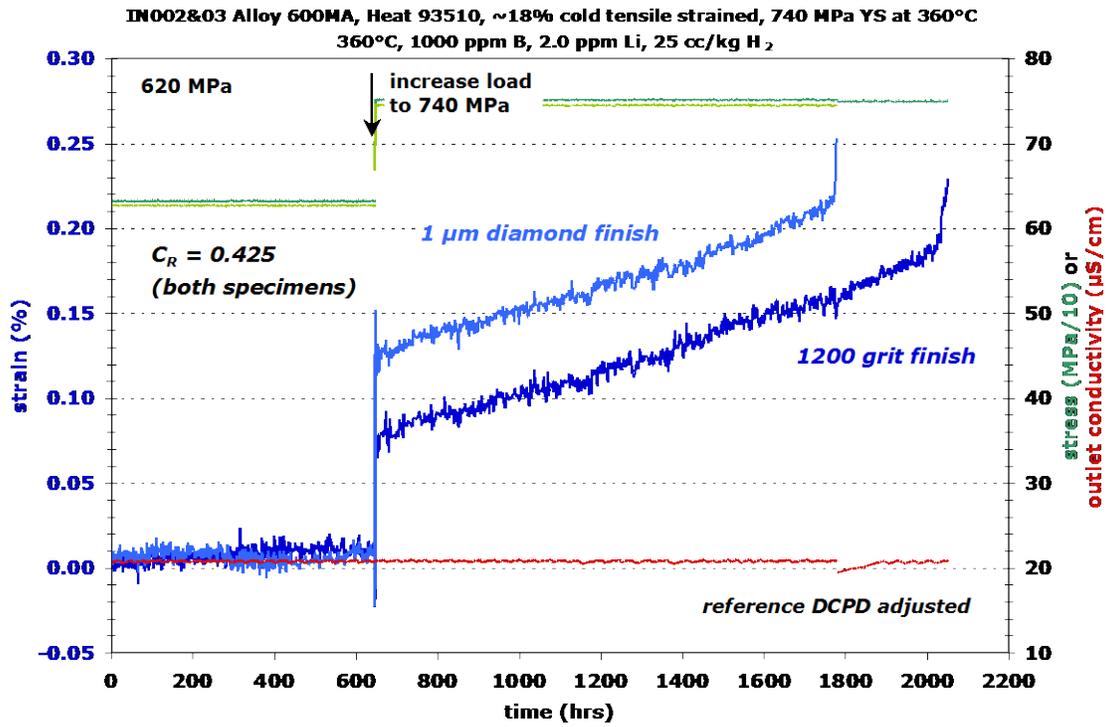
Figure 70: Referenced DCPD-based strain (Equation 4) for specimens IN002 and IN003 with $C_R = 0.425$.

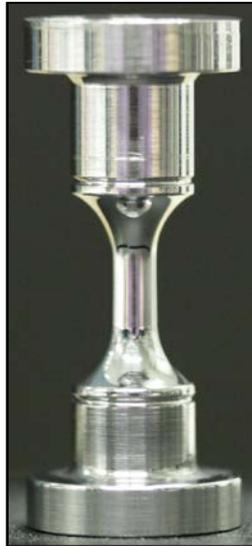
Figure 74: PNNL 1.2" tall SCC tensile initiation specimen.
