Electrochemical Microprobes Reveal Irradiation Damage in Nuclear Alloys

Materials Research Pathway

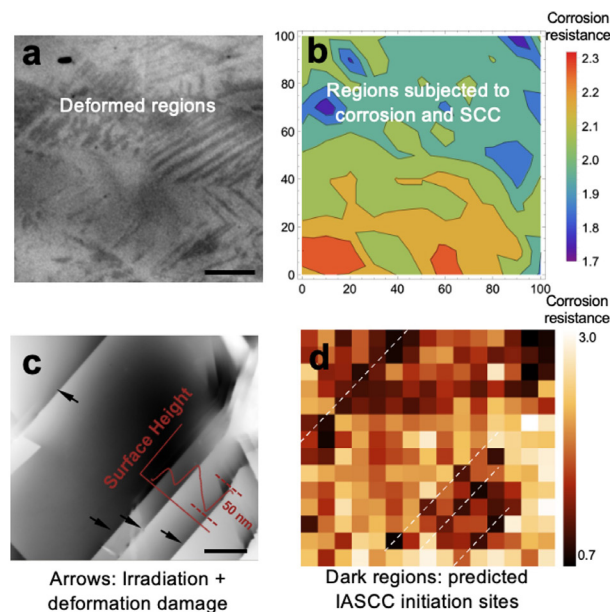
Figure 4. The scanning microprobe technique reveals: (a) strain localization; and (b) corrosion susceptibility in a deformed nuclear alloy. (c)-(d) The same technique was applied to predict IASCC susceptible regions [7] in a nuclear alloy that was deformed and damaged under irradiation. The scale bars are 20 μm in length.

In other words, it is discovered that the more an alloy has been exposed to radiation, the less resistant to corrosion it is. Therefore, the technique can be used to forecast IASCC initiation in alloys that are deformed and damaged under irradiation, as observed in Figure 4.

Currently, the team has been pushing the resolution limit of this microprobe technique to interrogate nanoscale features, such as grain boundaries and dislocation channels, as indicated in Figure 4(c) and Figure 4(d). By doing so, very early stage irradiation-induced damage and cracking can be resolved. Furthermore, due to the high-throughput and high-resolution nature of this technique, in-reactor probes to survey reactor components during maintenance shutdowns are being developed. Finally, the microprobe technique can be used to provide accurate corrosion examinations with fast turnaround times, as well as to screen next-generation nuclear alloys for new, advanced reactor designs.
