# Analysis of Localized Deformation Processes in Highly Irradiated Austenitic Stainless Steel through In Situ Techniques

**ORNL/TM-2019/1274  
M3LW-19OR0402027**

# **Analysis of Localized Deformation Processes in Highly Irradiated Austenitic Steel through In Situ Techniques**

Prepared under the direction of the  
U.S. Department of Energy  
Office of Nuclear Energy  
Light Water Reactor Sustainability Program  
Materials Research Pathway

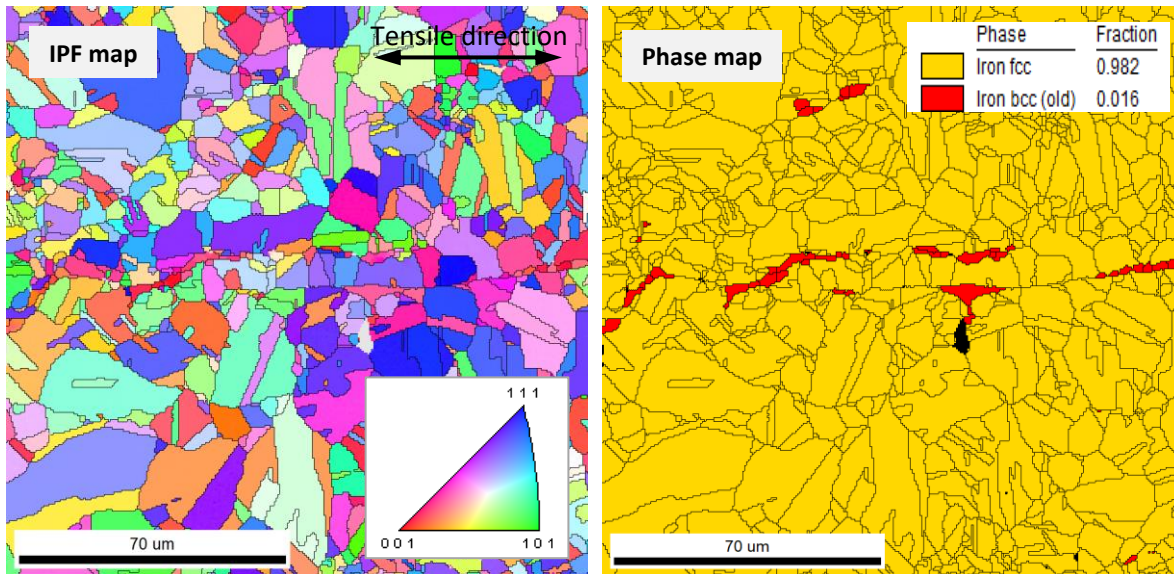
**Figure 2. Irradiated material microstructure: inverse pole figure (IPF) map (left) and phase map (right). Steel contained ~1.5–2% of retained ferrite, forming specific bands in the structure. IPF map is colored in the horizontal direction (tensile direction).**

Figure 2 shows the typical microstructure of the irradiated steel. One may see that small grains form specific clusters, surrounding large grains; the material has a bimodal grain distribution. The analysis showed no pronounced texture in the austenitic matrix.

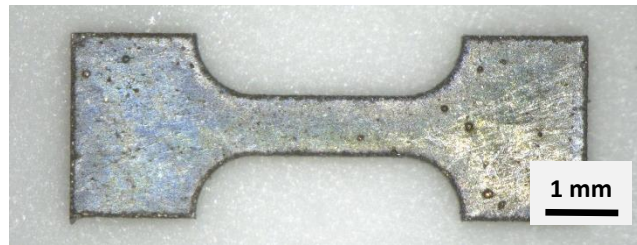
**Figure 3. EDM-manufactured miniature tensile specimen blank. Gauge dimensions: 2 mm (length)×0.8 mm (width) ×0.5 mm (thickness).**

Two identical SS-Tiny specimens (Figure 3) were tested per condition. This number was considered sufficient, as the results of the tests (i.e., nominal mechanical properties and the appearance of the tensile curves) were close for the nominally identical objects (Figure 7). Testing a larger number of specimens would be beneficial but is not feasible due to the limited time at the instrument (i.e., SEM/EBSD) and expenses associated with irradiated specimen manufacturing and preparation.

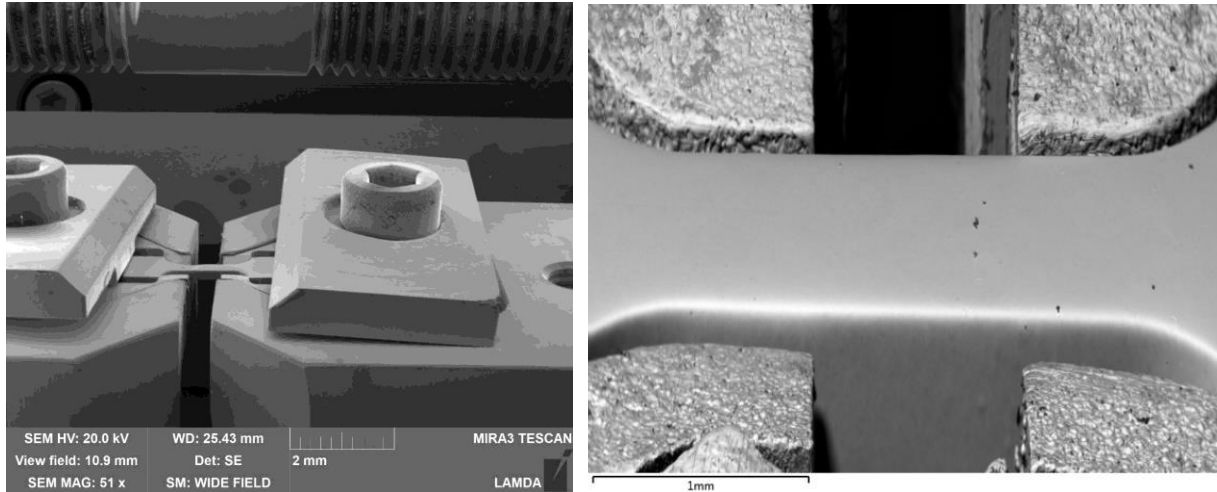
**Figure 4. A 70° tilted tensile specimen in the grips (left, no tilt correction applied) and back-scatter electron (BSE) image of the specimen surface prior to the testing (right, software tilt correction employed). The BSE image was taken by an EBSD camera on a front-scatter electron detector. One may see a flat clean object surface with few dust and debris particles.**

The specimen blank was mechanically grinded, polished, and electropolished using A2 Struer solution. After the final electropolishing step, the miniature specimen had a clean, mirror-like surface suitable for EBSD analysis. In most cases, electropolishing also removed the EDM-induced layer at the specimen side surfaces and formed slightly rounded edges (Figure 4, right).

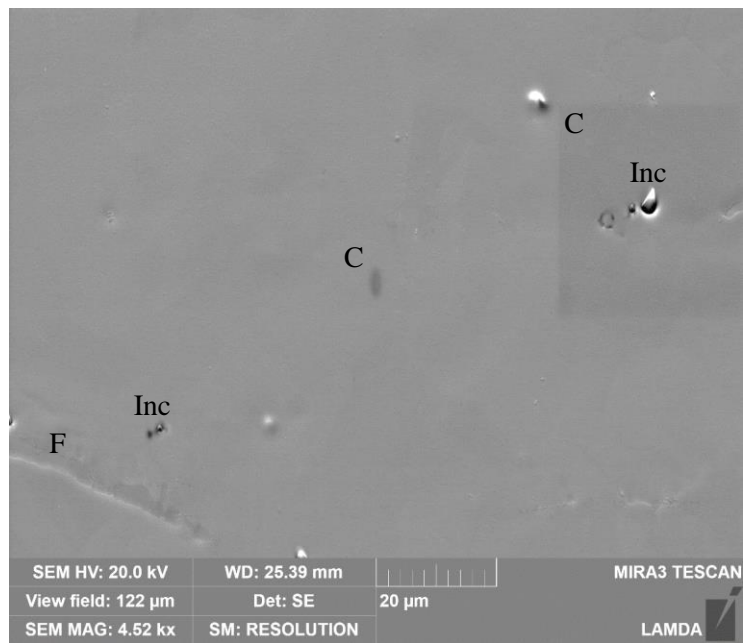
**Figure 5. Typical appearance of the electropolished surface (SE detector). One may see few inclusions (Inc), carbon contamination spots (C), and string-like inclusion of ferrite (F, which is visible due to different sensitivity to the A2 electropolishing solution). Note the image is 70° tilted with tilt correction applied.**

Figure 5 shows a secondary electron (SE) image of a typical electropolished surface. Usually, few inclusions present in the field of view, and ferrite grains (or domains) may be visible. Often, light carbon contamination appears after scanning and focusing operations instead of the plasma cleaning operation, always performed prior to and after tensile stage installation.

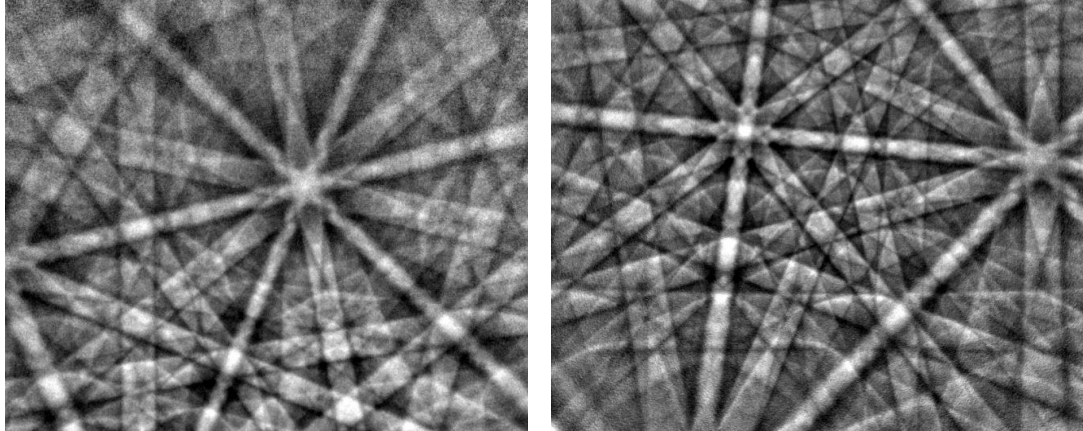
**Figure 6. Left: Typical Kikuchi pattern for nondeformed irradiated steel. Right: A pattern for nondeformed reference 304L steel.**

After electropolishing, the irradiated miniature specimens exhibited flat, damage-free, and strain-free surfaces with widely spaced inclusions. However, the recorded EBSD patterns (Figure 6) for irradiated steel always appeared to be more blurry, compared to the reference (nonirradiated) material, subjected to the same preparation. The slightly blurry appearance of the Kikuchi lines may be explained by the presence of radiation-induced defects in the lattice.

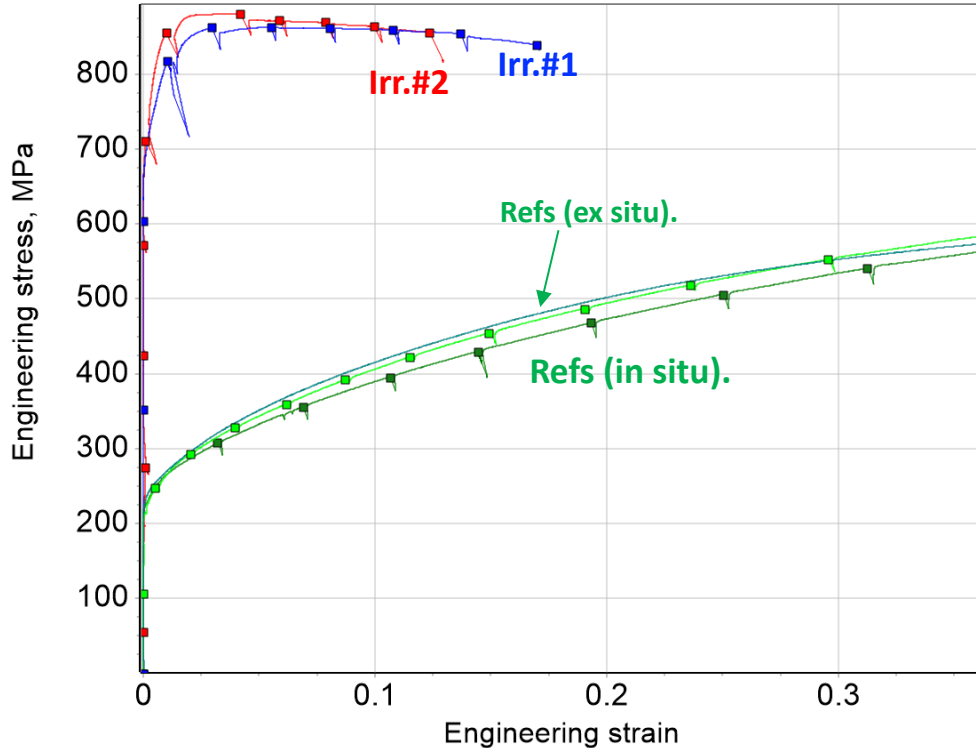
**Figure 7. Tensile curves obtained during in situ tests with nonirradiated reference specimens (Refs., green) and irradiated ones (Irr.#1 and Irr.#2, blue and red, respectively), damage dose 10.7 dpa. Square symbols show the test interruptions to perform EBSD scans. An example of the ex situ test (the same geometry specimen tested continuously, without interruptions) is also given for comparison.**

Figure 7 shows tensile curves recorded for the reference (nonirradiated) and irradiated specimens tested in situ, inside SEM. The x-axis represents nominal engineering strain, and the y-axis shows engineering stress values. During test interruptions, the load level decreased slightly due to relaxation and creep-like phenomena in the specimens, leading to appearance of the specific force drops on the tensile curves. To minimize creep-like effects, the load was reduced at  $\sim 10\text{N}$  prior to performing EBSD scans. Ex situ testing with the reference specimen (shown by the smooth curve in Figure 7) yielded the tensile results, very similar to the in situ testing case. Thus, it was assumed that the test interruptions, force drop appearance, and EBSD scans had a weak effect on the further deformation behavior of the material.

As follows from the results, the reference material was an annealed steel with a yield stress (YS~220–240 MPa), which is typical for most annealed or hot-rolled 300-series steels. Irradiation at 10.7 dpa led to a pronounced irradiation hardening (YS~750–800 MPa) and ductility decrease, and uniform elongation dropped to ~3–4%. Total elongation is difficult to estimate because the objects were not fractured during the in situ tests. Fracturing irradiated specimens inside SEM is not allowed due to radiological safety rules.

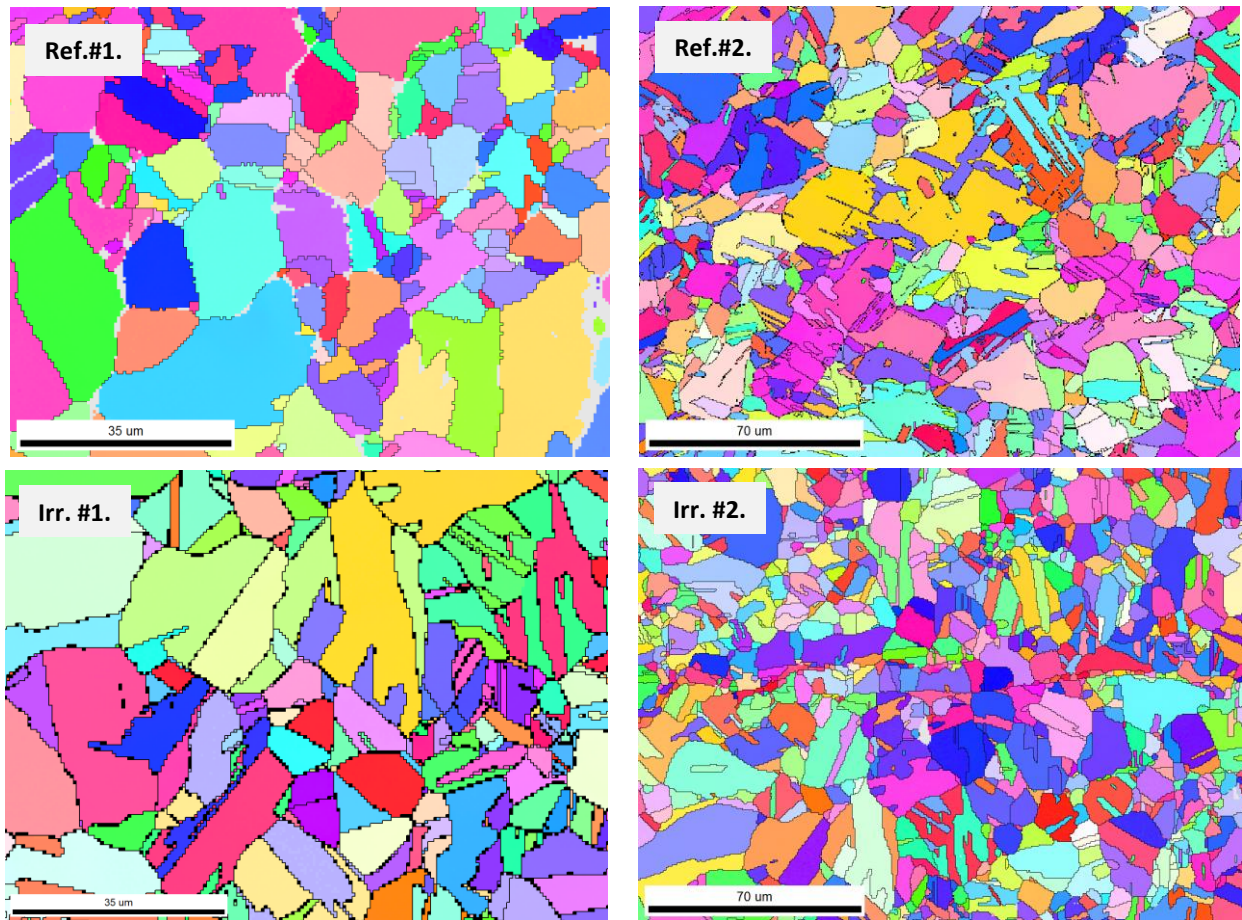
**Figure 8. Grain maps (EBSD IPF figures) of typical ROIs for the tested specimens. Note the difference in the magnification and scale for the left and right columns. One may see that grain morphology is close enough between irradiated and reference specimens.**

Figure 8 shows typical ROIs for irradiated and reference specimens. For the given material, each ROI contained up to 100–200 grains, thus providing sufficient statistics. In addition, grain orientation distribution was close to random, with very limited if any texturing.

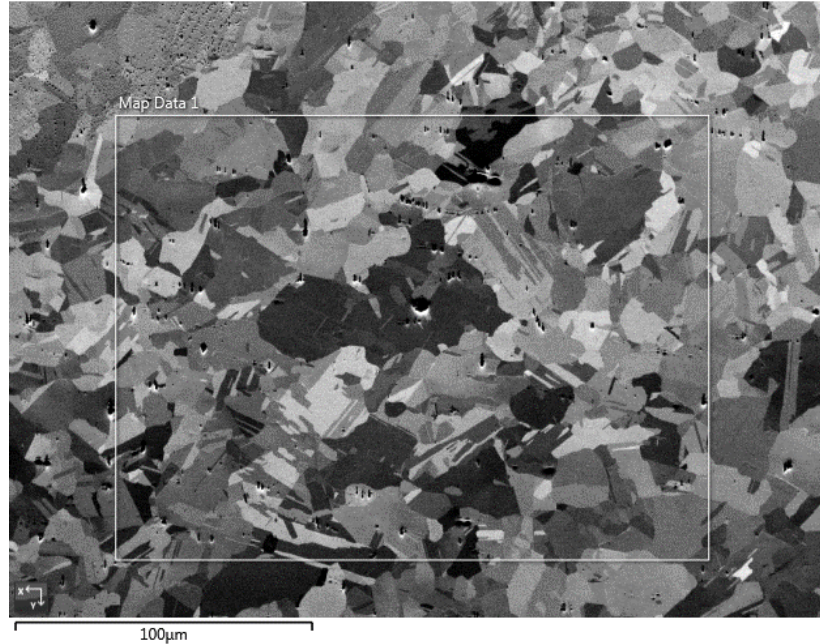
**Figure 9. BSE image of a typical ROI (reference specimen). BSE imaging is a convenient tool to evaluate grain morphology and surface quality within the potential ROI.**

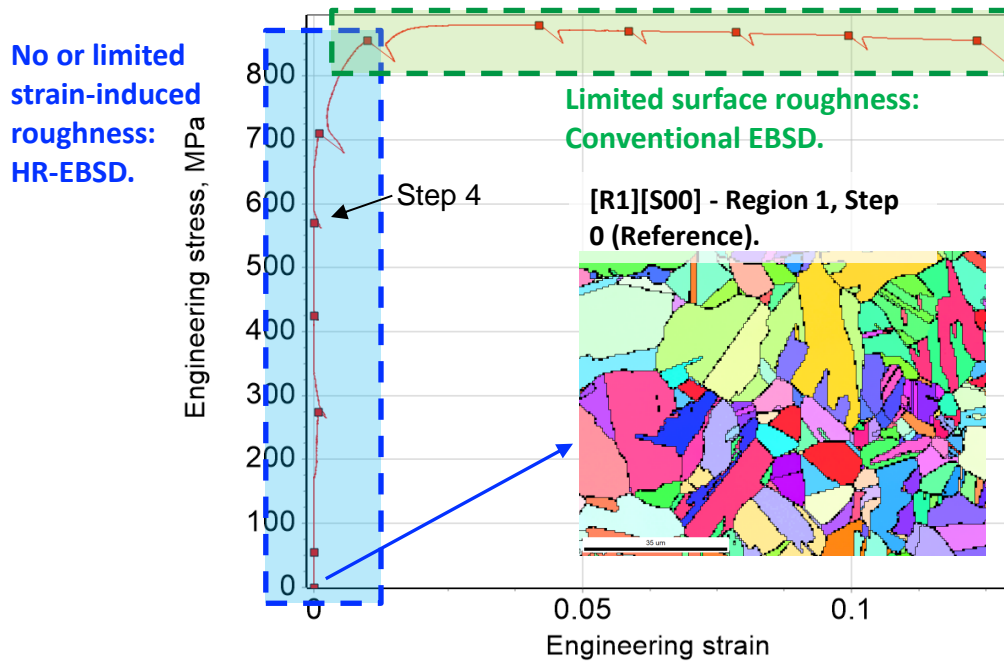
**Figure 10.** A scheme of a typical in situ test. Square symbols show stops to perform EBSD scanning. Note the same specimen may yield data for a wide range of stresses and strains.

For irradiated specimens, stress increments were ~150–250 MPa (Figure 10); once a specimen entered the plastic area, displacement control was employed with strain increments of ~0.5–2%. Conventional (relatively fast) EBSD scans were performed in the plastic strain area up to strain level of ~0.2–0.3 (~20–30%); a fraction of valid points decreases quickly with local strain increase because of surface roughness increase and slip-step evolution. (These data will be discussed later in a separate report.) As a rule, separate ROIs were selected for HR-EBSD and EBSD scans; due to its sensitivity (up to  $0.005^\circ$ ), the HR-EBSD is especially beneficial in the elastic strain area and at small plastic strains (~1–2% or 0.01 engineering strain).

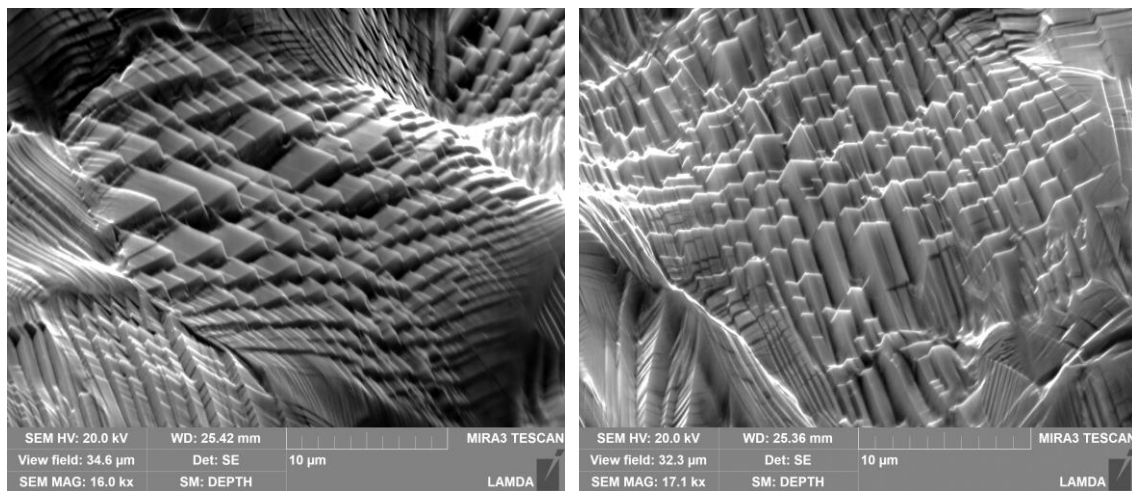
**Figure 11.** Strain-induced surface morphology in the 10.7 dpa irradiated 304L steel. Despite the interesting appearance, EBSD data interpretation is complicated at such strain levels. Note the images are 70° tilted with tilt correction applied; high-tilt angle increases the height/depth perception.

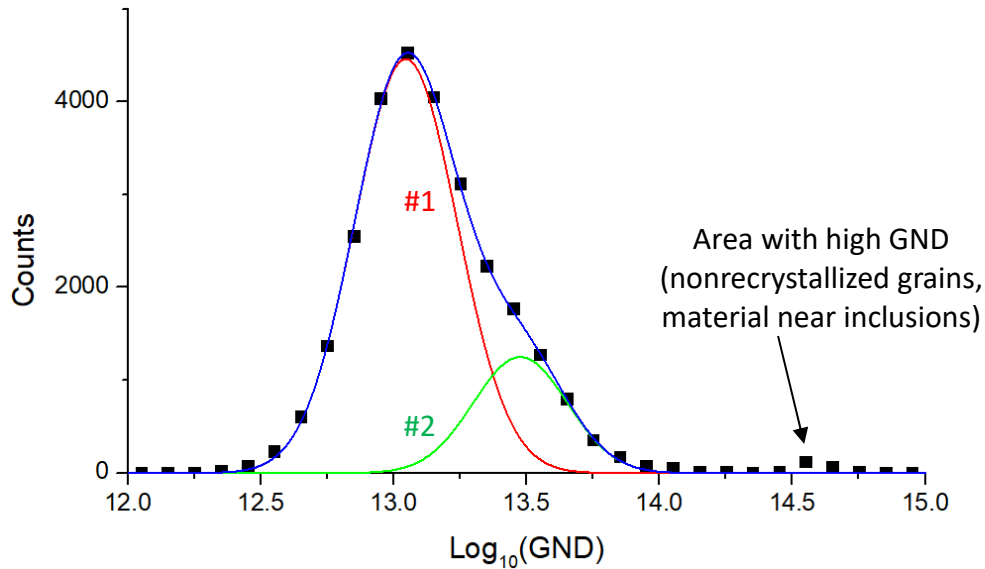
**Figure 13. Histogram of GND density distribution, presented using the logarithm scale, in the specimen prior to straining. The GND distribution may be described by two Gauss-like functions (labeled as #1 and #2), corresponding to the different types of dislocation substructures (e.g., chaotic distribution of dislocations and dislocation walls).**

The reasons for the log-normal distribution of GND density are not clear at this time. Similar trends (e.g., log-normal distribution) were observed for crystal lattice misorientations measured via conventional EBSD and for spacing between individual dislocations, measured via TEM [24]. Distributions, similar to the log-normal curves, often exist for radiation-induced defects such as Frank loops.

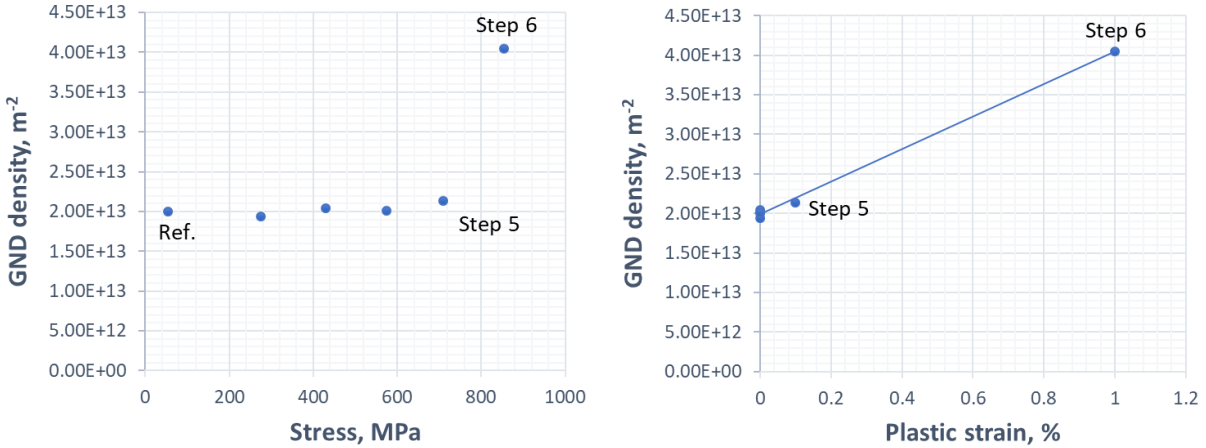
Figure 14. Average GND density for the ROI, shown in Figure 15, as a function of stress and plastic strain.

Figure 14 shows the average GND density for the selected ROI. One may see that changes in GND density are relatively weak below  $\sim 550$  MPa (step 4 and below) and that GND density grows linearly with plastic strain increase.

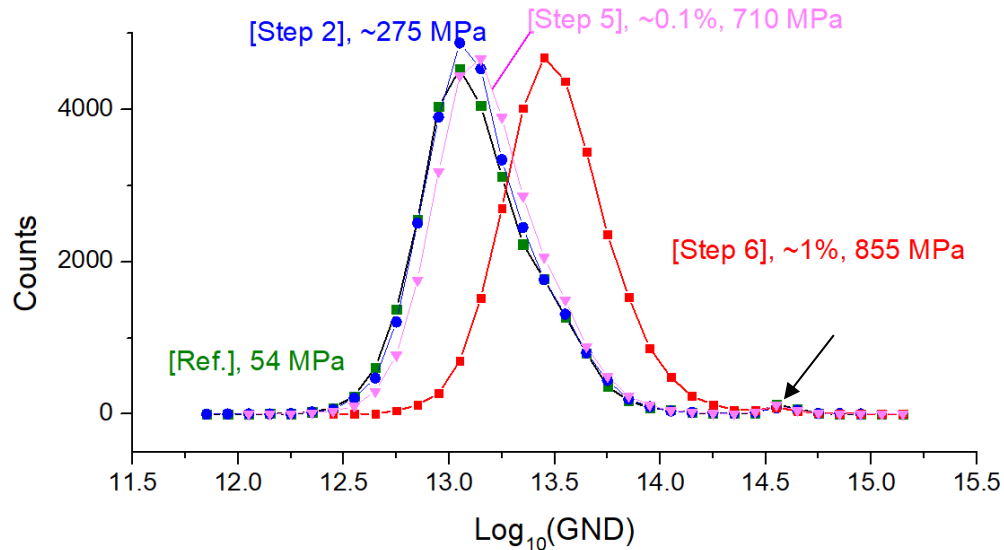
**Figure 16. Histogram of GND density at different steps of the in situ test (see the tensile curve in Figure 10). Black arrow indicates a weak increased local GND associated with hot spots; its location [ $\text{Log}_{10}(\text{GND}) \sim 14.6$ ] and amplitude were close for the analyzed stress/strain range.**

Interestingly, the HR-EBSD approach detects changes at stresses below formal yield stress (e.g., step 5 with a load level of  $\sim 710$  MPa). It means that, if a material experiences overloading or fatigue while in service, the HR-EBSD analysis may be able to quantify the defect structure and reveal changes, compared to the reference conditions.

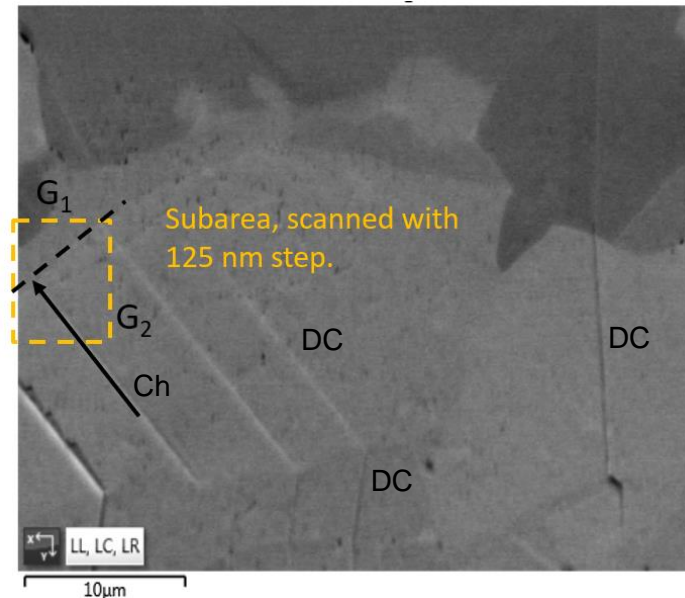
**Figure 17. Location #1. DC: dislocation channels. G<sub>1</sub>, G<sub>2</sub>: grains within the subarea scan; Ch: channel hitting the boundary between G<sub>1</sub> and G<sub>2</sub>. Dashed rectangle approximately shows the subarea scanned with 125 nm step.**

Figure 17 shows a subarea—part of the ROI, scanned at a high SEM magnification and with a smaller EBSD step size—that has few grains (G<sub>1</sub>, G<sub>2</sub>) and only one channel. (Note G<sub>2</sub> has several channels, but only one is visible in the subarea.) Grains and GBs are visible in the different areas due to orientation contrast and BSE detector usage. Defect-free channels appear as a sharp straight line within the grains. Two basic channel–GB interaction mechanisms may exist [16]: the channel may penetrate the GB (e.g.,

channels marked as DC in Figure 17) or may be arrested at the GB (e.g., channel marked as Ch in Figure 17). As expected, channel penetration should not lead to a significant increase in the stress level [16], whereas channel arrest and dislocation pileup may result in elevated stresses [1,2,16]. At this particular location (Figure 18), the channel (Ch) “hits” a 45°-inclined GB, and no GB penetration was observed (i.e., this channel is an arrested or discontinued channel, in the terms of [16]). Conventional EBSD showed only a minor  $\sim 0.5^\circ$  increase in misorientation in both grains.

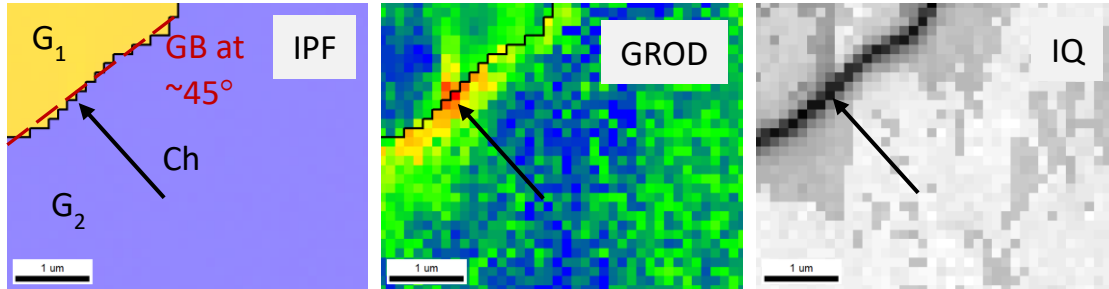
Figure 18. EBSD maps for the subarea, shown in Figure 17.

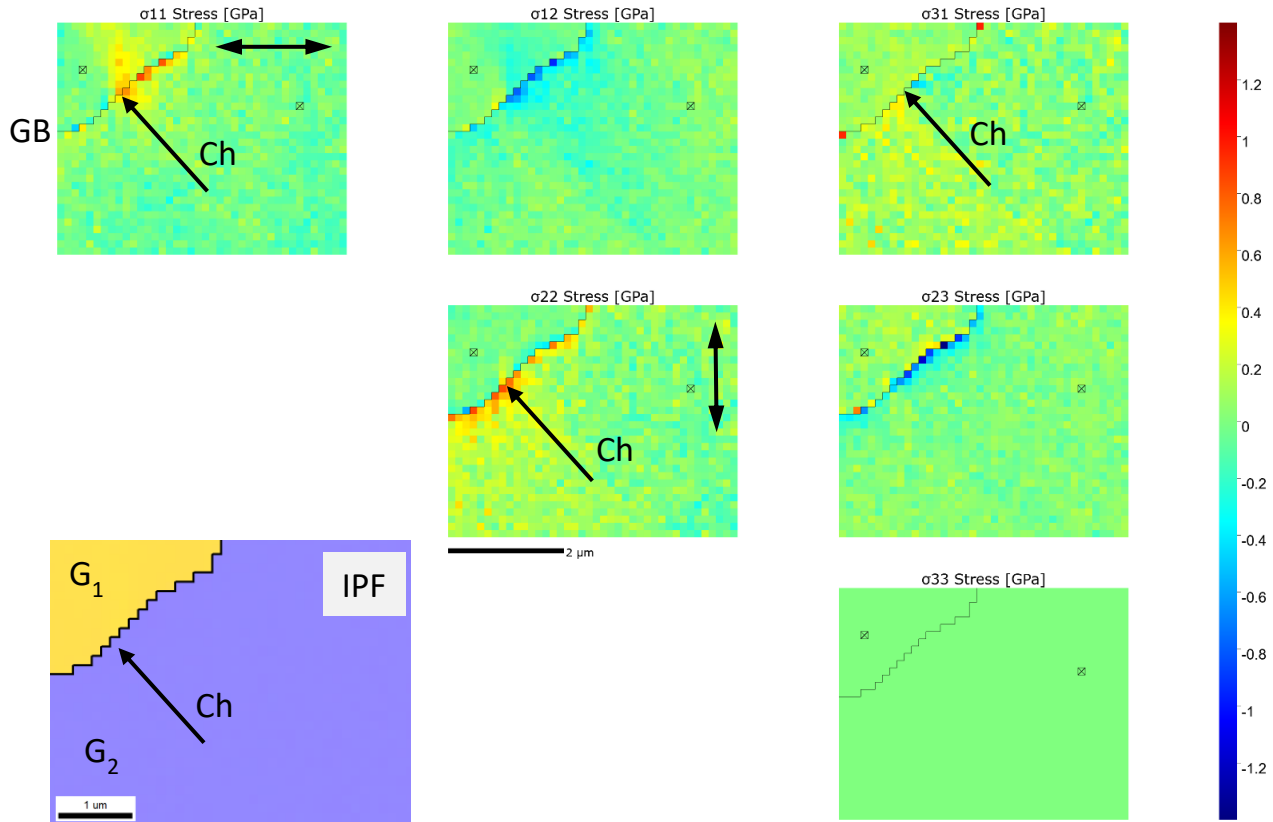
**Figure 19.** HR-EBSD maps for the channel (Ch)–grain boundary (GB) interaction (location #1, also see Figure 17 and Figure 18).  $\sigma_{11}$  shows stress in the tensile direction (horizontal).

As follows from the results, the peak  $\sigma_{11}$  stress at the channel–GB interaction point reached  $\sim 1.2$ – $1.4$  GPa; this in-grain stress increment does not include global external stress value ( $\sim 800$  MPa). The  $\sigma_{22}$  stress also was sufficiently high at  $\sim 1.2$ – $1.3$  GPa. Increased  $\sigma_{11}$  was observed in both grains, whereas a  $\sigma_{22}$  value jump was observed only in  $G_2$ . Additionally, increased  $\sigma_{11}$  has strong spatial localization: it presents only above the Ch–GB interaction location. Shear stresses (i.e.,  $\sigma_{11}$ ,  $\sigma_{31}$ ,  $\sigma_{23}$ ) also have complex distribution and change the sign near the Ch–GB interaction point.

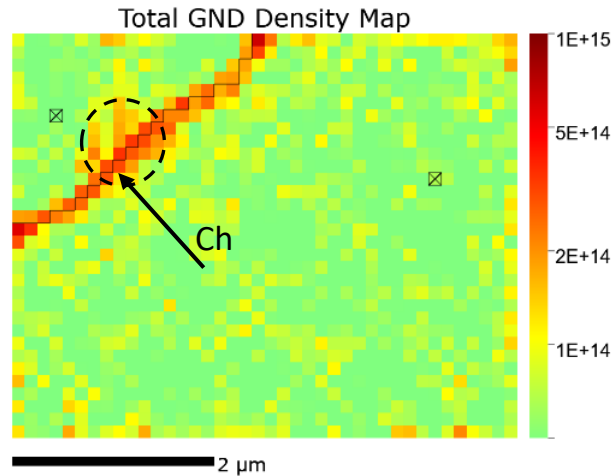
**Figure 20.** GND map for location #1. Note this map has a 125 nm step size, so it cannot be directly compared with Figure 15, which has a different EBSD step size.

compared to the surrounding volume. It may suggest the presence of dislocation pileup as well as some plastic strain in the target  $G_1$  grain, most likely, caused by relaxation of peak stresses near the channel–GB interaction point. This GND growth did not result in the formation of the defect-free channels in the target grain (Figure 17); it can be speculated that channels in the target grain ( $G_2$ ) may appear later if deformation progresses.

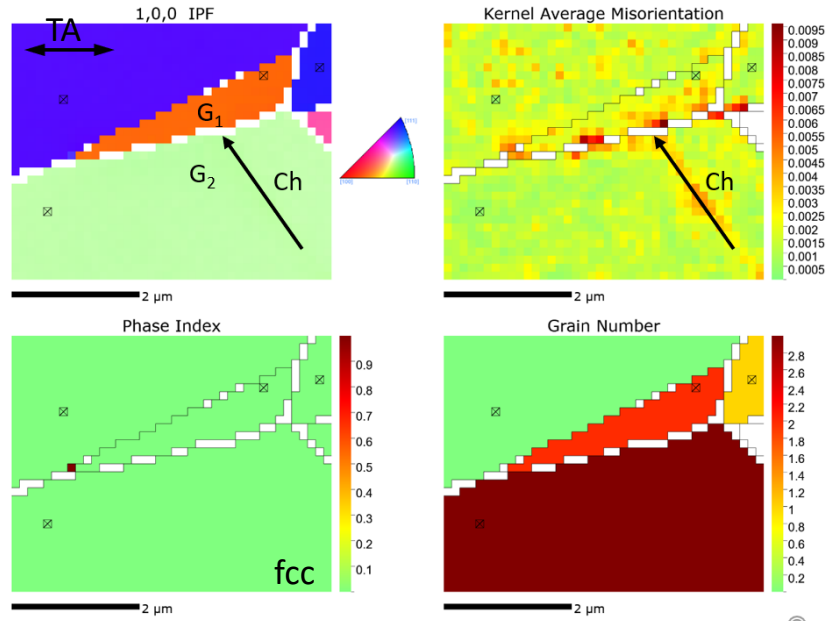
Figure 22. EBSD dataset for the case #2. TA: tensile axis. A few points located close to GBs were not indexed properly due to the partial pattern overlapping.

In this case, the dislocation channel (Ch) hits the GB at an angle of  $\sim 15^\circ$  with respect to the tensile axis. Such a configuration, according to [6,16,17], is not favorable for crack initiation; nevertheless, stress/strain and GND fields are of interest. Figure 22 shows the EBSD dataset for the selected subarea. One may see the channel (Ch) in  $G_2$ , hitting the  $G_1$ – $G_2$  GB. Only one phase presents in the field of view (i.e., fcc); see the phase index map in Figure 22. The Kernel average misorientation (KAM) map reveals strong local misorientation inside the channel, as well as at the channel–GB interaction points.

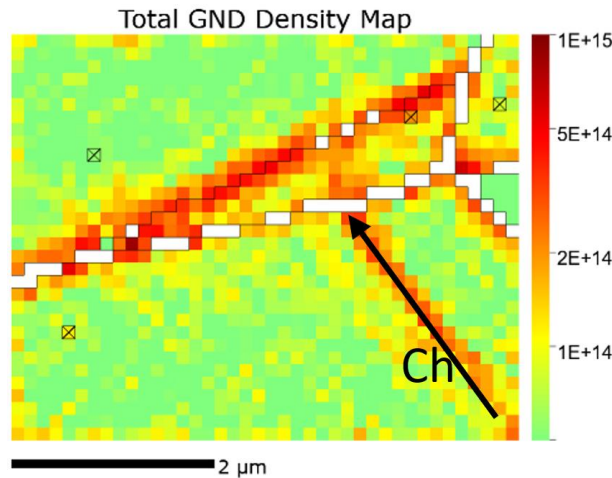
**Figure 24. GND map for the area shown in Figure 22 and Figure 23.**

Figure 24 demonstrates the GND map for the same area. One may see an increased GND density along some GBs, and, unexpectedly, also relatively high GND values inside the channel (Ch). In contrast to case #1 (Figure 20, channel without GND increase), the present channel contains a significant number of GNDs. It points to the complex character of processes inside defect-free channels, most likely not only shear but also some relative rotation of the grain portions, “bisected” by the channel.

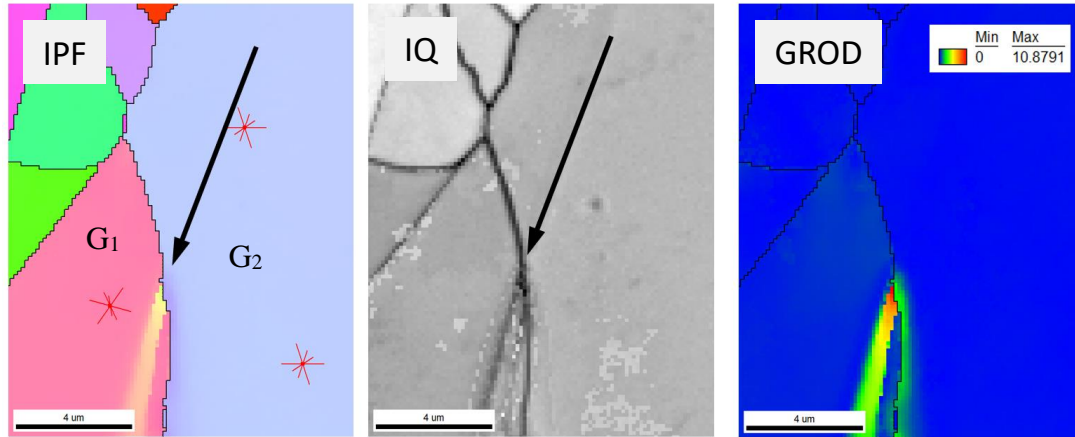
Figure 25. Conventional EBSD maps showing IPF, IQ, and GROD map for the Case #3 location.

In this case (Figure 25), the channel hits the GB, inclined at  $\sim 90^\circ$  (i.e., near-normal angle) with respect to the tensile axis. The channel–GB interaction results in penetration (in terms of [6,16]): intense plastic deformation occurs in the target grain,  $G_1$ . The penetration generates dislocation “bursts” and strong misorientation variations in  $G_1$ . These misorientations are easy to see in the grain reference orientation deviation (GROD) map (Figure 25, right) and also in the IPF map as a change in color. According to the GROD map, local in-grain misorientation may reach  $\sim 10^\circ$ , and misorientation gradients may be as high as  $\sim 10\text{--}20^\circ$  per 1  $\mu\text{m}$ .

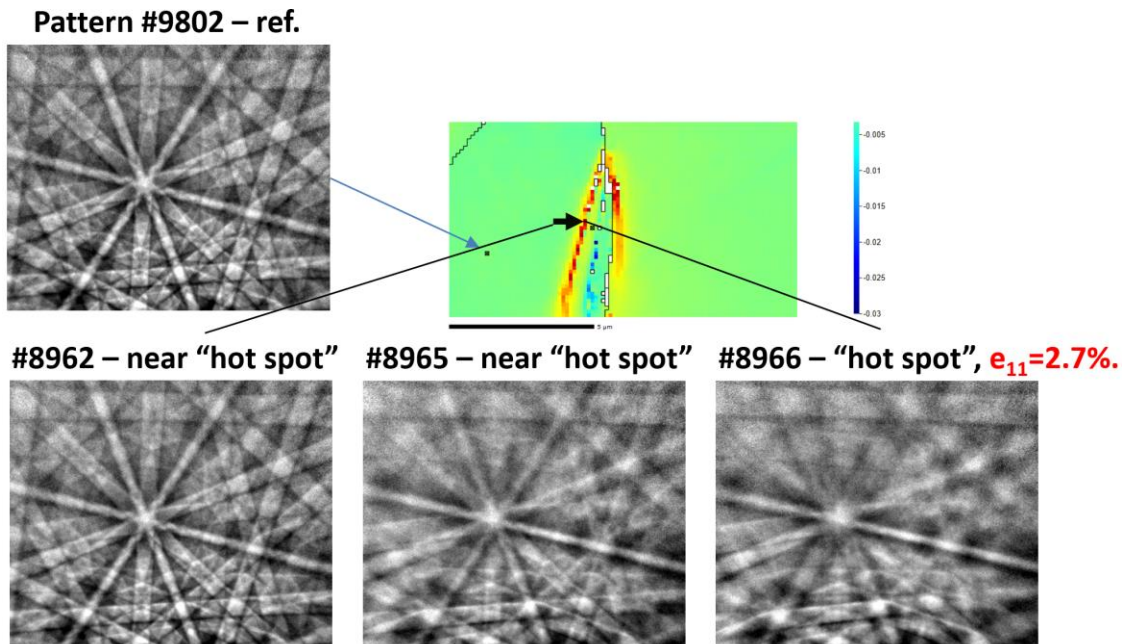
Figure 26. Pattern degradation inside strain localization areas as an issue. Pattern quality may vary drastically within one to two steps (125–250 nm).

Pattern #8962, near the hot spot, was of an acceptable quality; however, pattern #8965 (~375 nm from the previous one) showed strong degradation. The Kikuchi lines became very blurry, and weak secondary lines almost disappeared. The next pattern inside the hot spot showed further degradation. For many points inside the hot spot, the HR-EBSD analysis ran into the data processing issue, suggesting unreasonably high elastic strains in the lattice, of ~2–3%. Such points in most cases are accompanied by low values of cross-correlation function (i.e., the geometric mean of XCF peak height, the analogy of

confidence index) and can be filtered out easily. Being consistent and stable for most of the dataset, the current numerical HR-EBSD algorithms need further development and enhancement to handle strong spatial variations in the pattern quality observed in the irradiated and deformed steel. This task is difficult to handle within the framework of the present project. In general, however, the results show that HR-EBSD provides a way to study strain-induced phenomena in irradiated materials at the grain and subgrain levels.
