# Development and Initial Test Results of the In-Situ Characterization of Irradiated Materials under Deformation

**ORNL/TM-2017/111**  
**M3LW-17OR0402025**

Prepared under the direction of the  
U.S. Department of Energy  
Office of Nuclear Energy  
Light Water Reactor Sustainability Program  
Materials Aging and Degradation Pathway

Prepared by  
OAK RIDGE NATIONAL LABORATORY  
Oak Ridge, TN 37831-6285  
managed by  
UT-BATTELLE, LLC  
for the  
U.S. DEPARTMENT OF ENERGY  
under contract DE-AC05-00OR22725

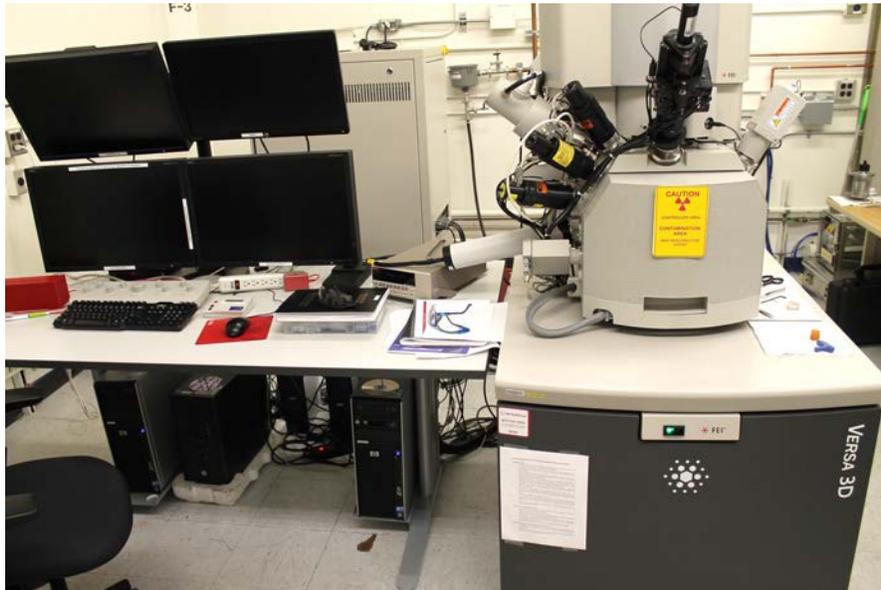
Figure 1. General view of the VERSA 3D dual beam (scanning electron microscope and ion beam).

The microscopy area of ORNL's LAMDA laboratory is equipped with two scanning transmission electron microscopes (STEM) and three dual-beam focused ion beam scanning electron microscope (FIB-SEM) instruments. One of these dual-beam FIB-SEM instruments—the FEI Versa 3D (Figure 1)—is a high-resolution imaging/analysis instrument. This particular instrument is equipped with a Schottky field emission gun (FEG), atop an electron column that can accelerate the generated electrons to energies of between 200 eV and 30 keV, with the ability to reduce the beam energy to 50 eV using beam deceleration. In imaging mode, the ultimate resolution of this instrument is 1.0 nm at 30 keV, although 0.8 nm point-to-point resolution is attainable using a STEM detector. Several electron detectors for imaging are available on this instrument, including an Everhard-Thornley secondary electron detector (ETD), an in-column secondary electron detector, a back scattered electron (BSE) detector, and a STEM detector.

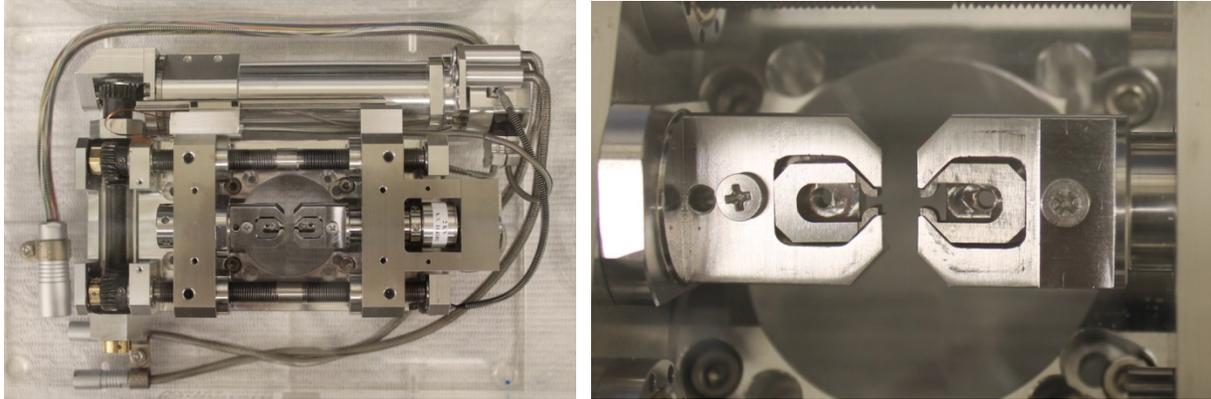
**Figure 2. Left: General view of the tensile stage (Kammrath and Weiss Technologies, Inc., Model MZ.Sb). Right: the enlarged image of the grips with holders installed for SS-J specimen geometry.**

The tensile frame (Figure 2) was delivered and installed in the VERSA SEM in December of 2016. Several trial in-situ tests conducted inside VERSA SEM demonstrated that the working distance (the distance between the sample and the electromagnetic lens) might be as small as 15.5 mm, which provides good resolution and a high-quality EBSD pattern. The tensile frame has a maximum loading capacity of 5 kN and a maximum strain rate of 50  $\mu\text{m}$  per second (3 mm per min). Two force sensors (one with a 5 kN range and one with a 2 kN range) were ordered to support testing of miniature tensile specimens for the ongoing projects and to conduct mechanical fracture tests in the future.

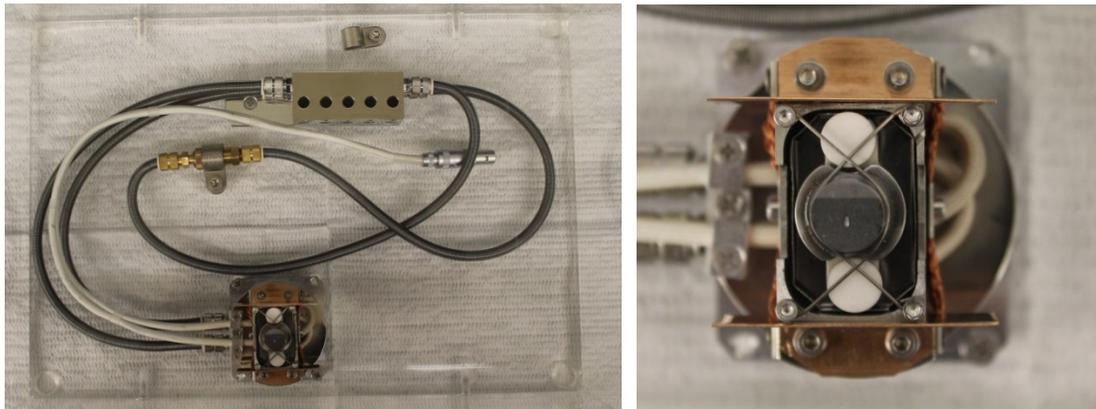
**Figure 3. General view of the heater (left) and the enlarged view of the heating element (right).**

The selected heating stage (Figure 3) allows for a maximum temperature of 800 °C in a vacuum (or 400 °C in open air, [outside the SEM]). Preliminary tests demonstrated the system's stability at elevated temperatures and low thermal inertia. However, implementing high-temperature testing will require additional careful work to ensure a uniform temperature field across the specimen gauge. Good thermal contact and uniform temperature distribution may be of concern with strain level increase during the in-situ test. Strain-induced surface roughness will likely lead to reduced thermal contact between the heater and specimen.

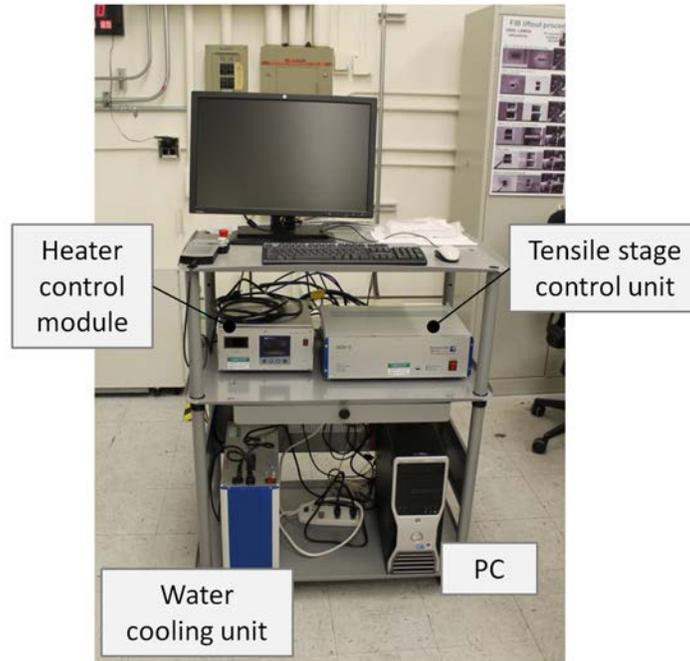
Figure 4. Tensile stage control modules located on the cart.

As shown in Figure 4, the system control units (computer, tensile stage controller, temperature controller, and water chiller) were mounted on the cart to provide a high degree of mobility.

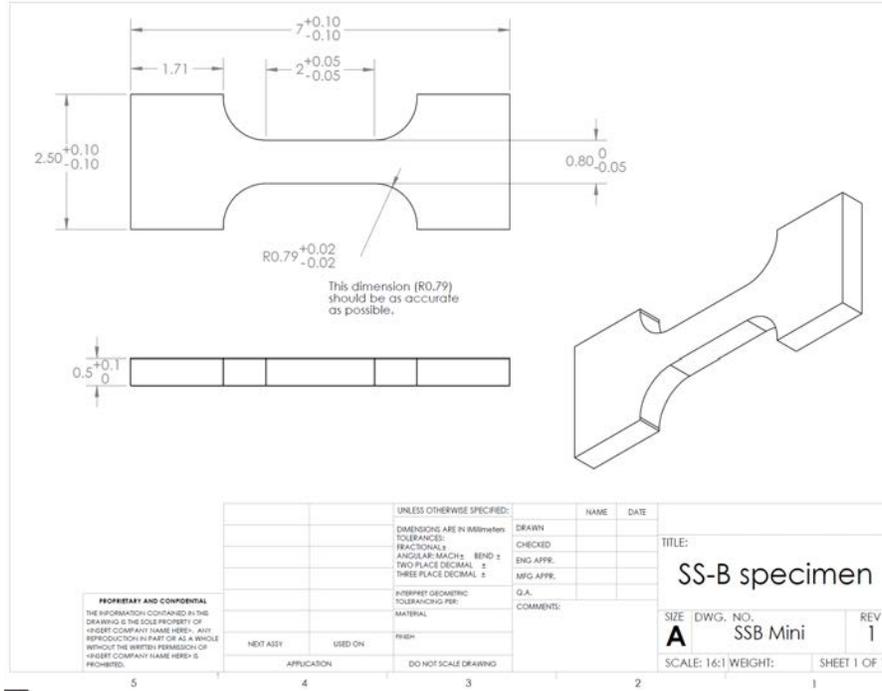
**Figure 5. Geometry and dimensions of the ultra-miniature specimen for in-situ testing.**

In most cases, the geometry of the available irradiated object does not allow for producing standard SS-3 or SS-J specimens. Taking into account the shape and dimensions of the available irradiated objects (e.g., plates of  $\sim 7 \times 3.5 \times 1$  mm), a miniature specimen design was developed for this particular case.

As expected, the geometry will accurately reproduce yield and ultimate stress values for the standard, larger specimens like SS-J. Behavior at small strain levels should be comparable to the bulk specimens with larger work volume; however, the ductility level may be smaller compared to the SS-J geometry, and the difference may depend on the strain level. This aspect will be evaluated later in detail in the future.

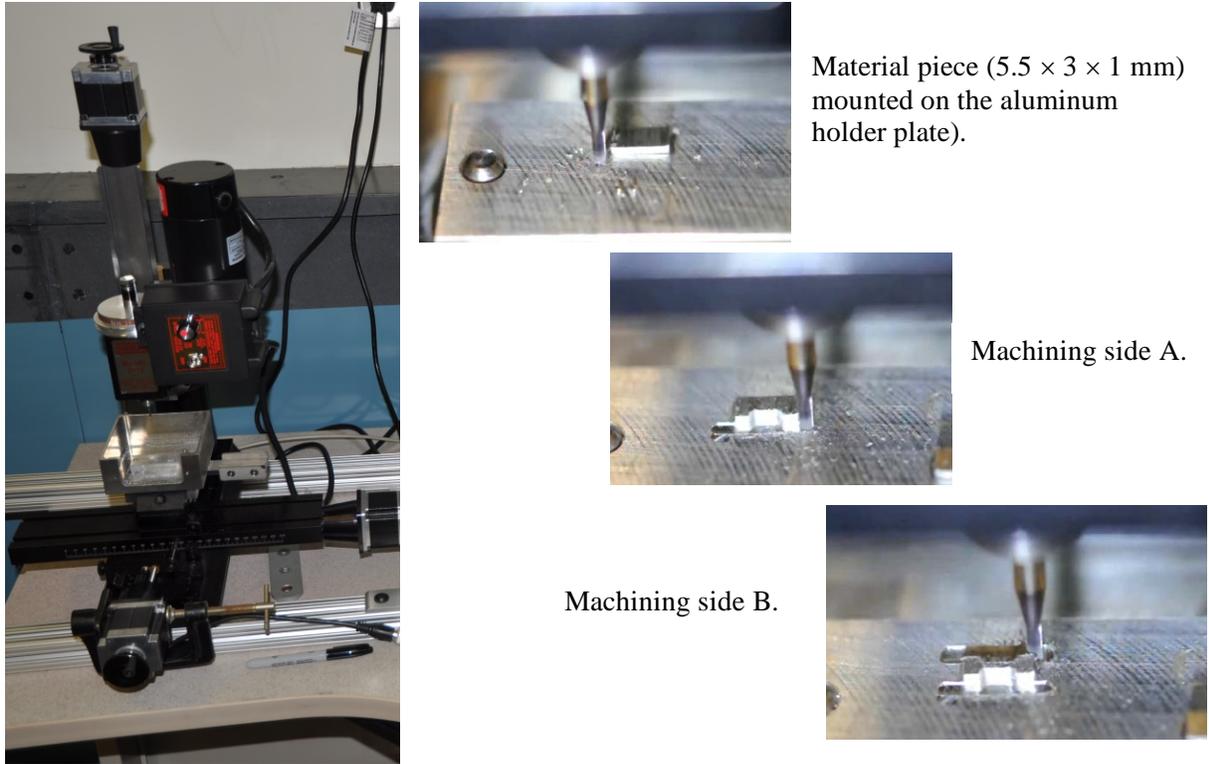
**Figure 6.** Sherline CNC milling machine, model 2010 (at the left) and specimen manufacturing steps (at the right). Images of the machining are slightly blurry because this process is performed in a water-filled container.

After research and analysis of different machines on the market, a miniature 3-axis computer numeric control (CNC) machine (Figure 6) was purchased. The system passed all necessary safety control steps, has a certification from a Nationally Recognized Testing Laboratory (NRTL) and is now undergoing initial testing. A computer-aided design (CAD) program was developed to produce a miniature rectangular “dog-bone” specimen with a gauge width of 0.9 mm and gauge length 2.0 mm (Figure 5). Total specimen length will be around 7 mm and may vary depending on the available material. According to preliminary results, specimen machining (see the movie frames in Figure 6) takes around 50–55 minutes. After machining, specimen preparation to the in-situ test may be performed using well-established procedures (mechanical grinding and electropolishing).

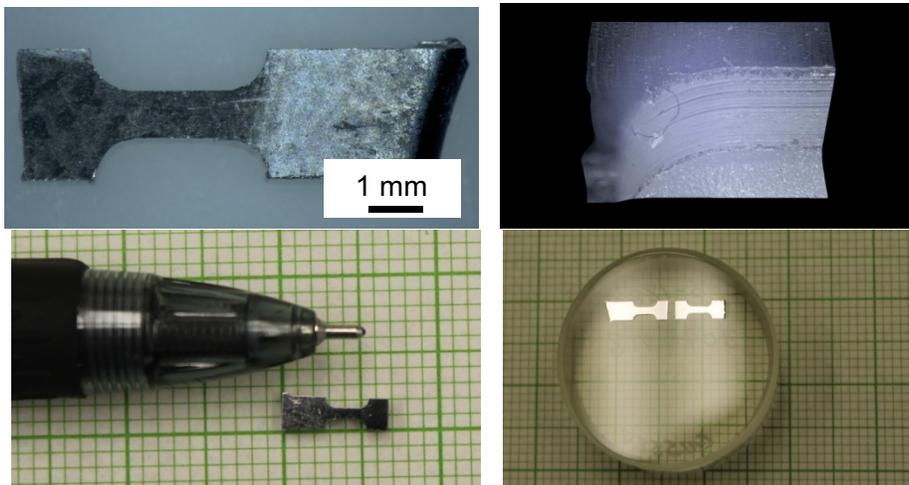
**Figure 7.** A 718-alloy miniature specimen (left), a 3D-image of typical tool marks on the specimen edge (top right), and miniature specimens mounted in epoxy (bottom right).

Several testing runs were conducted using 6061 aluminum alloy, annealed and cold-worked 304 steel, and—as a material with ultimate strength—precipitation-hardened 718 alloy. Promising results were obtained, and it was shown that a miniature tensile specimen (Figure 7) can be produced even from 718-alloy with a yield stress of around 1,200 MPa.

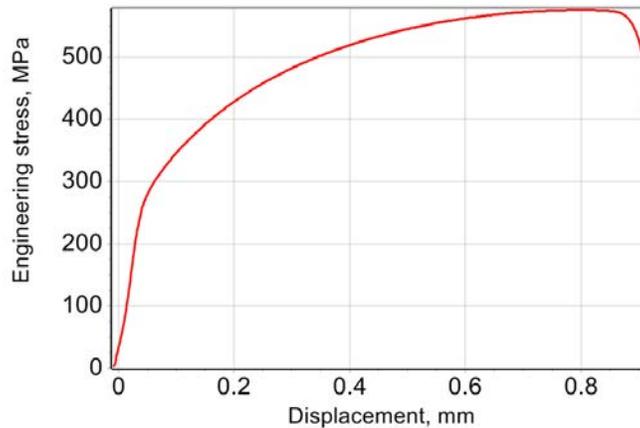
**Figure 8. The representative tensile curve for the SW'-alloy (annealed nuclear-grade 304L steel).**

Yield strength (0.2% offset) (MPa)	Ultimate strength (MPa)	Uniform elongation (%)	Full elongation (%)
253	579	69.2	81.2

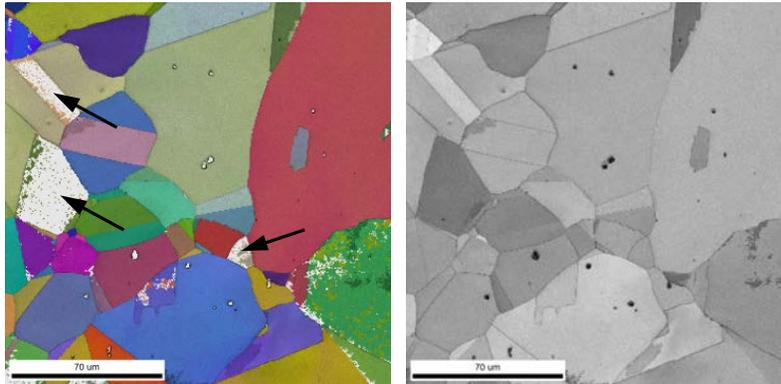
**Figure 9. EBSD IFP and image quality (IQ) maps for the reference area prior to deformation. Black arrows show non-indexed grains.**

the distance between the detector and specimen's surface increased by 15 mm. Although still within formally-allowed limits, the increased distance led to a slight decrease in quality for the EBSD data, and some grains were not indexed properly (Figure 9).

The most common EBSD strain metrics—GROD and KAM—were calculated for the reference area shown in Figure 9 and then EBSD scanned at different strain levels. The maximum GROD values (the largest increase in the grain deviation from some reference value) increased linearly with the strain level. Starting at a strain level of about 15–17%, the maximum GROD values tended to saturate because of grain fragmentation and the appearance of in-grain, high-angle boundaries within the grain. It appears that below this 15–17% strain level, the GROD maps may be used to estimate the local strain level if a sufficiently large EBSD map ( $180 \times 180 \mu\text{m}$  with ~30–50 grains) is available.

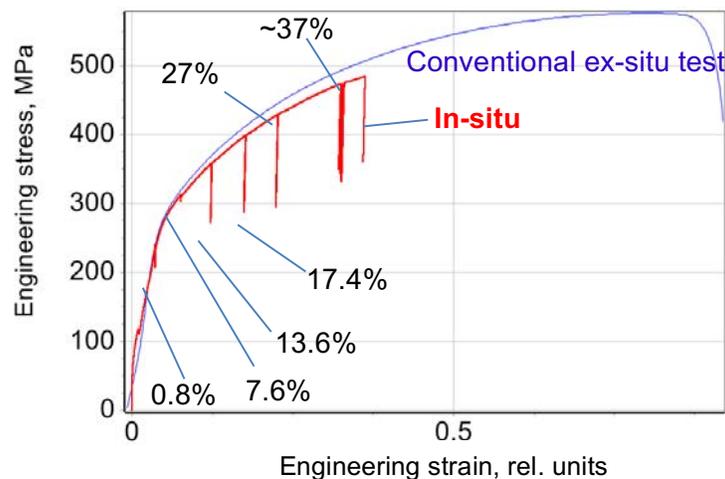
**Figure 10. The tensile curve from the in-situ test (thick red line) compared to results from the ordinary tensile test (thin blue line). Partial unloading was performed during EBSD scans to minimize the creep-related effect. For some cases, local strain levels for the area of interest are shown.**

After reference location scanning, the specimen was deformed with a strain rate of around  $5 \times 10^{-4} \text{ s}^{-1}$ . The tensile test was interrupted several times, and EBSD scans were conducted for the same area. One of the goals was to analyze the small strain range ( $<1\%$ ) to assess the possibility of detecting strain-induced changes near yield stress. Several stops were performed in the moderate-strain area ( $<20\%$ ), and finally, large strain increments were performed to establish the level of EBSD data degradation that occurs as strain increases and to determine the largest strain level achievable while still obtaining useable EBSD data. After each strain increment, the specimen was partially unloaded before the EBSD scanning to minimize the creep-related effects. Figure 10 shows tensile curves for conventional and in-situ testing.

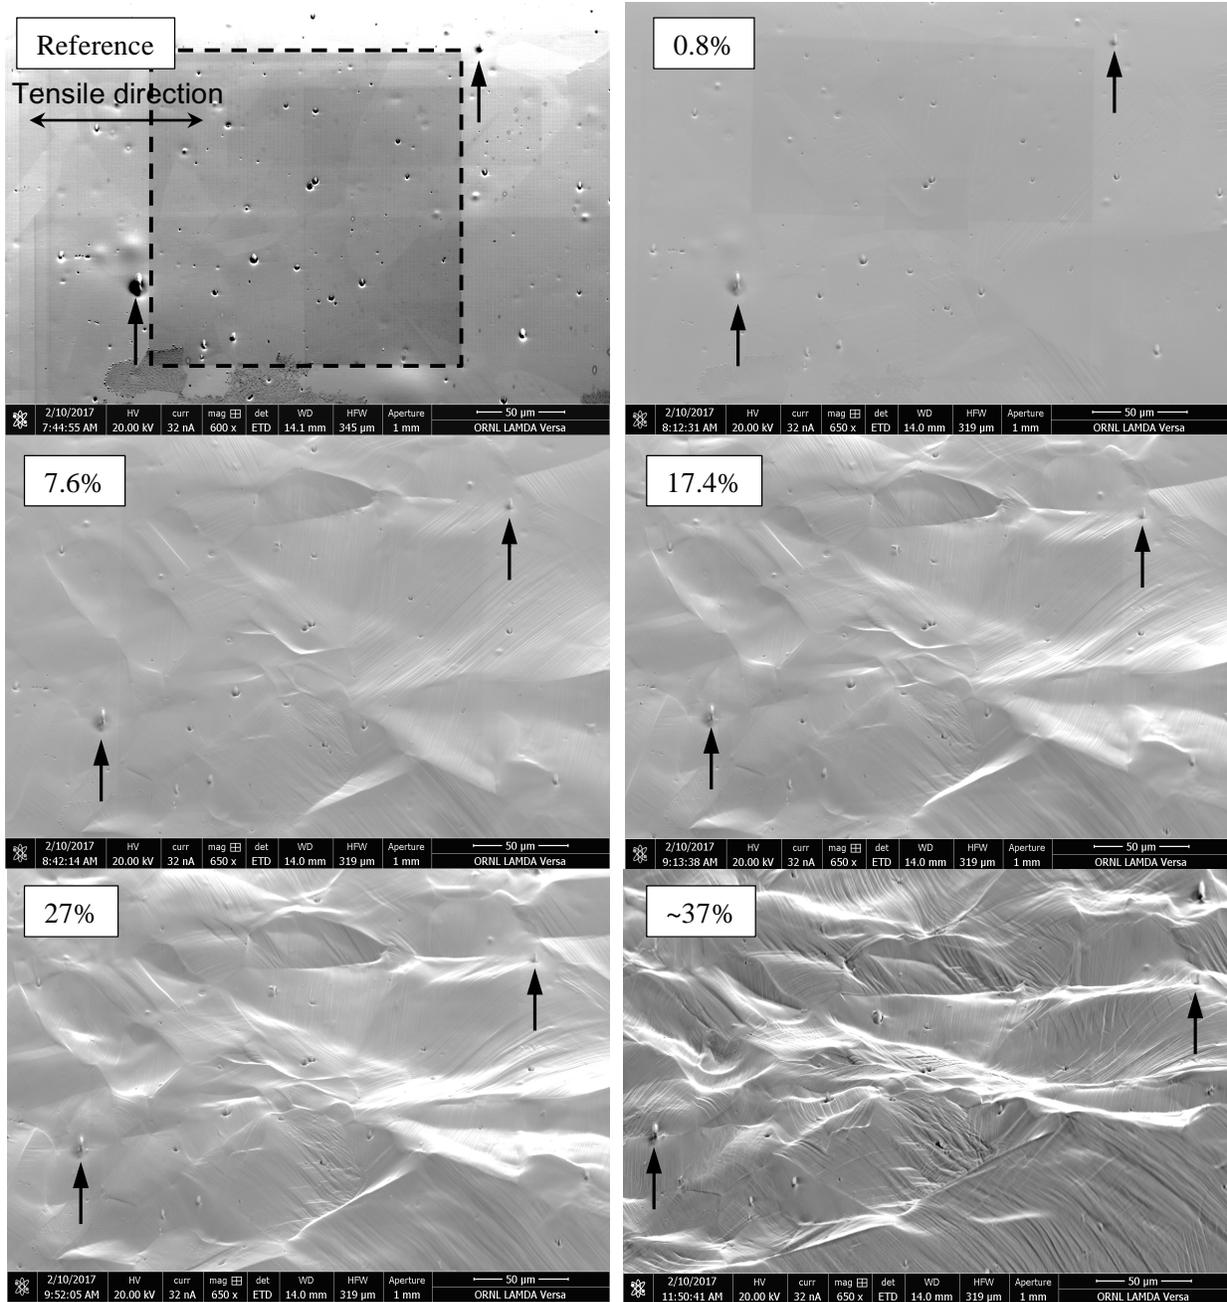
**Figure 11. SEM images taken at different strain levels.** The above images depict the surface topology evolution from single slip lines to a pronounced strain-induced relief. Black arrows track the pair of inclusions through the images. The dashed rectangle identifies the area of interest. Note that there are some variations in the magnification level.

SEM images, as shown in Figure 11, were taken for each strain level to analyze the surface evolution and to estimate the local strain level. Strain-induced surface evolution is clearly visible. While weak slip lines presented at the surface at 0.8% strain, a strong increase in the slip line density was observed at 7.6% strain, and multiple active slip systems acted in the same grain at larger strains. Grain rotation and surface relief formation became evident at a few percent of strain. Interestingly, non-metallic inclusions visible on the electro-polished surface survived up to a high strain level, which allowed for a clear and easy identification of the area of interest.

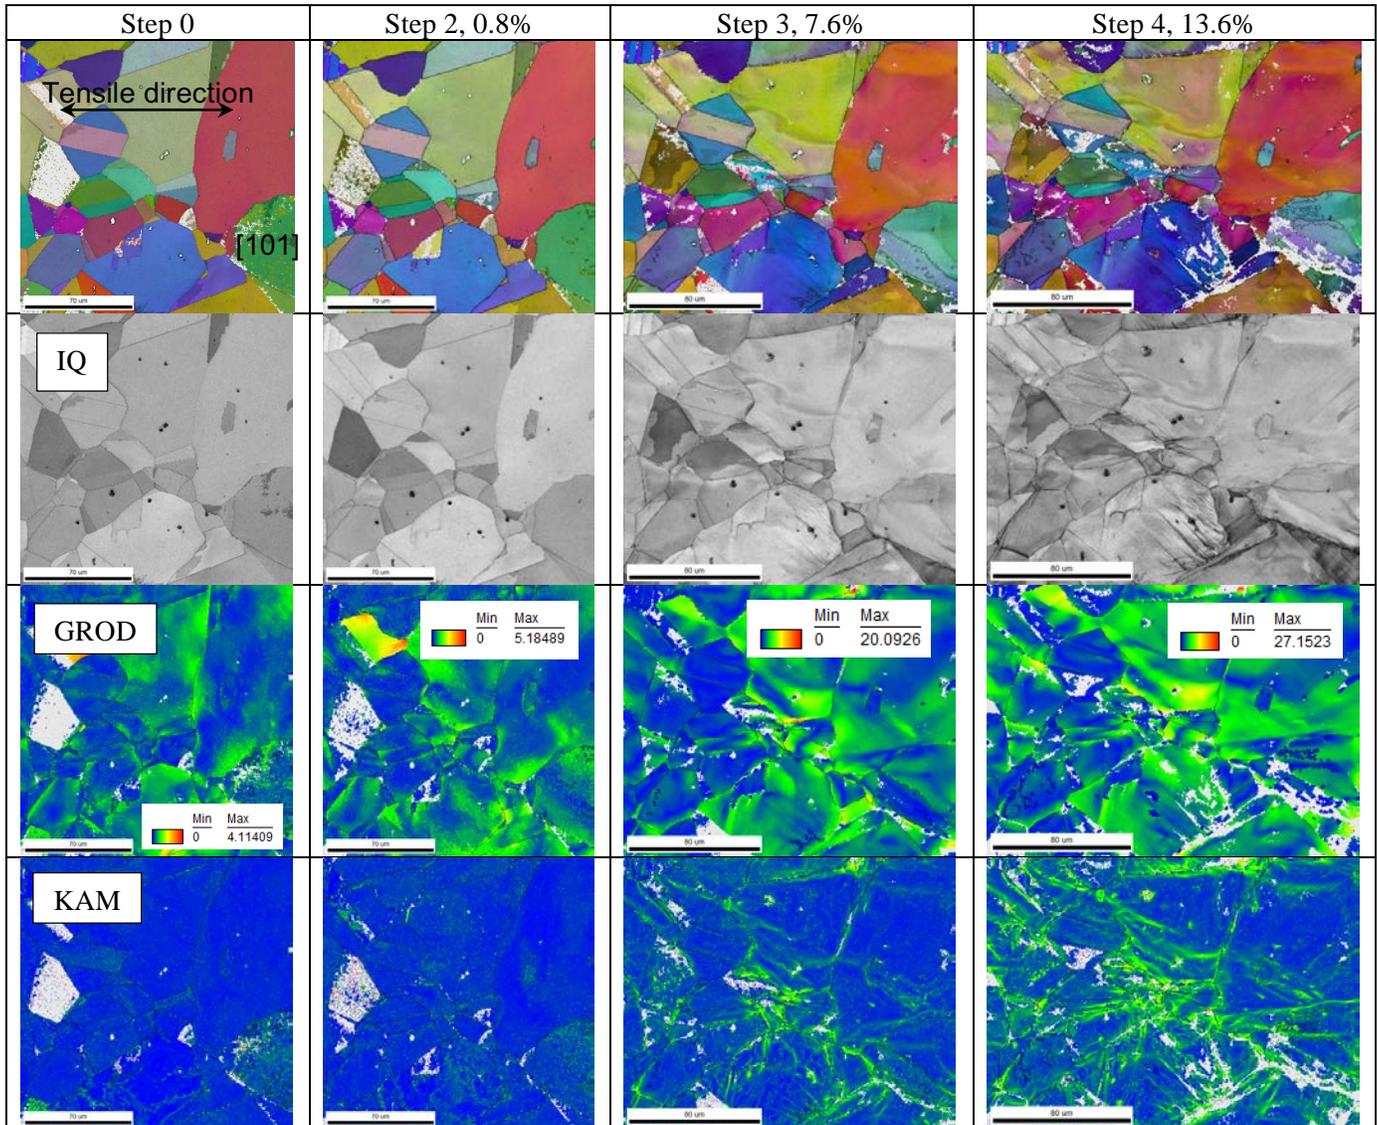
**Figure 12. Evolution of the IPF (colored in the tensile direction), IQ, GROD, and kernel average misorientation (KAM) maps for the same area at different strain levels.**

grain orientation increased significantly, which led to a strong increase in the maximum misorientation values observed in the grain reference orientation deviation (GROD) maps (from about  $5^\circ$  at 0.8% up to about  $27^\circ$  at 13.6%).

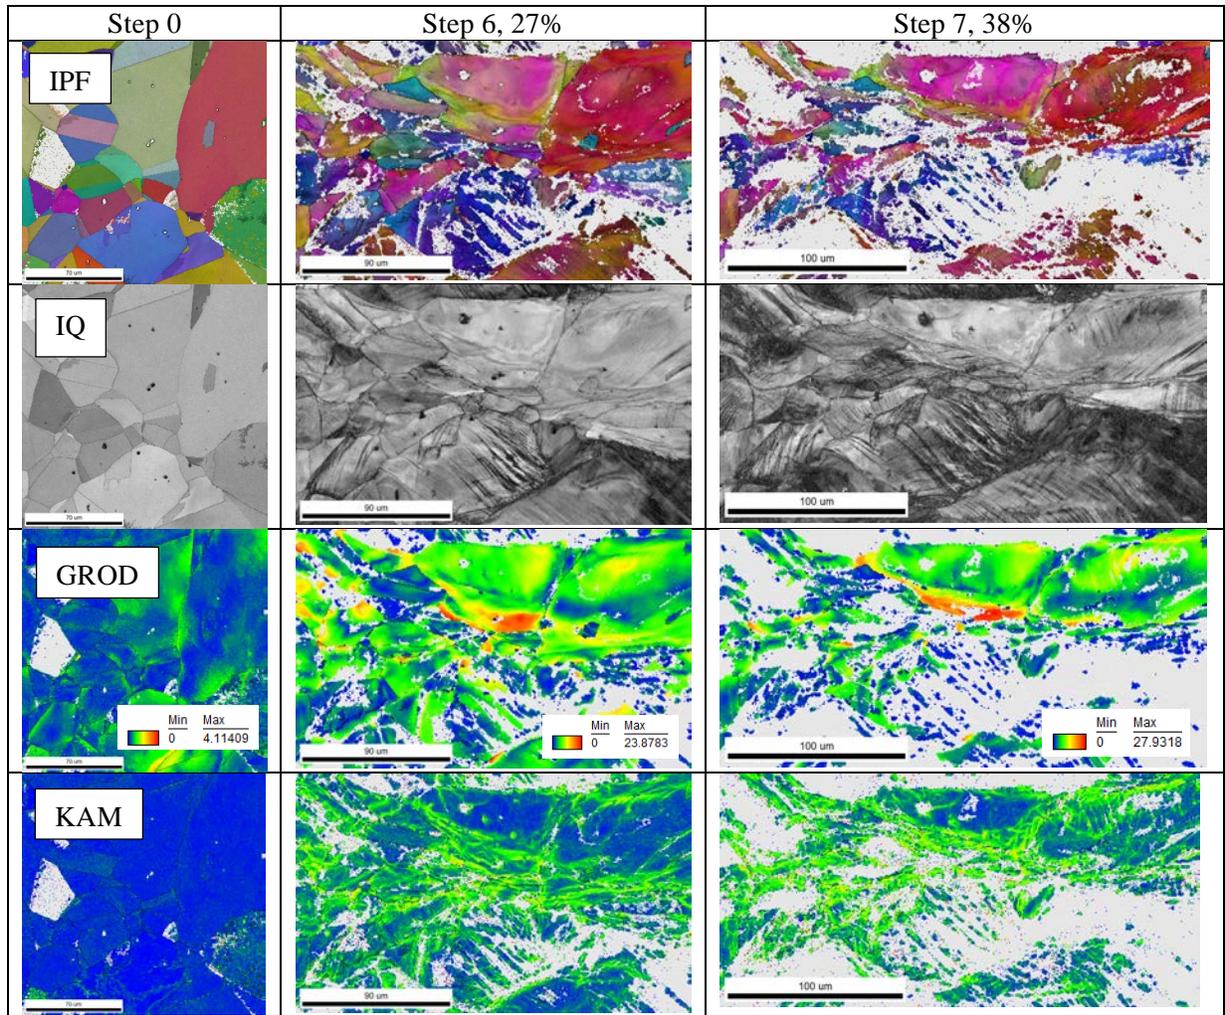
**Figure 13. Degradation of the EBSD data at large strains compared to the reference image (Step 0).** Strain values were calculated from SEM images taken at the same location using the same imaging conditions (working distance and magnification).

As the strain level increased and exceeded 20%, as depicted in Figure 13, the EBSD map quality started to degrade drastically. Many areas became invisible for the EBSD detector because of the grain rotation and strain-induced roughness. Nevertheless, many grains still appeared in the resulting maps, which provided an opportunity to analyze the large strain levels, if necessary.

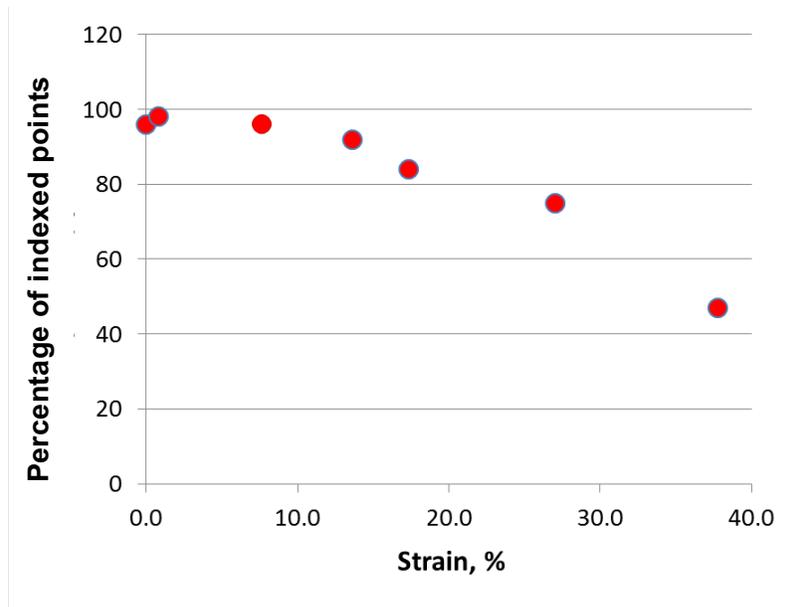
**Figure 14. EBSD data quality (fraction of “good points”) as a function of local strain level.**

Figure 14 shows the EBSD data quality (fraction of successfully indexed points) as a function of local strain level. As shown, most of the area of interest was successfully scanned (>80% of the points of interest) at strain levels below 20%. At smaller strain levels (0%–10%), grain rotation and strain-induced relief were not as pronounced, and EBSD data quality remained high.

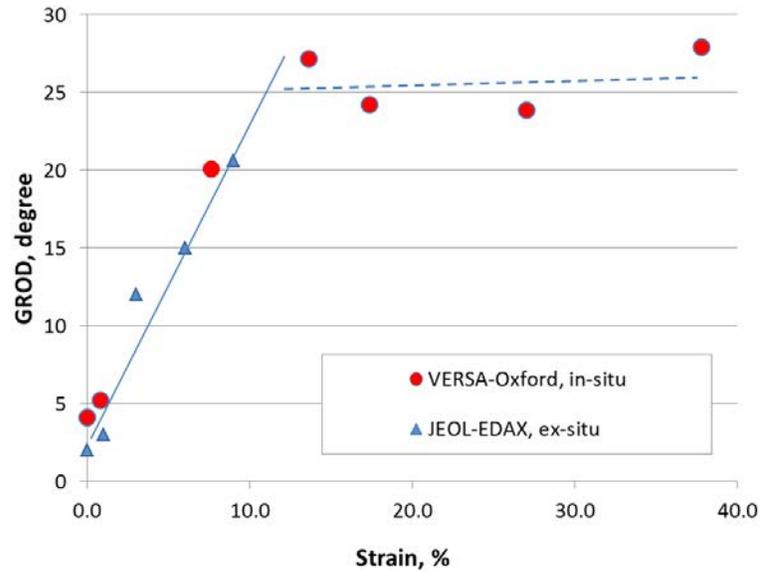
**Figure 15. GROD as a function of the strain level.** In situ data (round markers) are compared with ex-situ test data (triangles); step size was the same for both at 0.5  $\mu\text{m}$ .

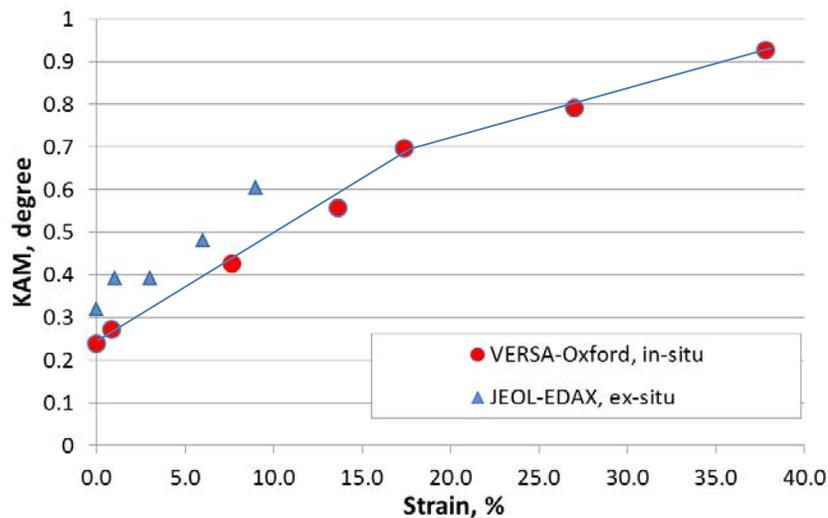
**Figure 16. Evolution of the KAM parameter as a function of the local strain level.** The in situ data (round markers) are compared to ex-situ data (triangles) obtained earlier using a different system (JEOL 6500F+ EDAX EBSD); step size was the same for both at 0.5  $\mu\text{m}$ .

The KAM value also increased linearly with the strain level up to around 20% strain (Figure 16). After that, the KAM value continued to increase but at a shallower rate/slope. The linear relationship between KAM and strain level agrees with the literature and allows for estimating the local strain values, at a given location, if the reference value and the correlation curves are known.

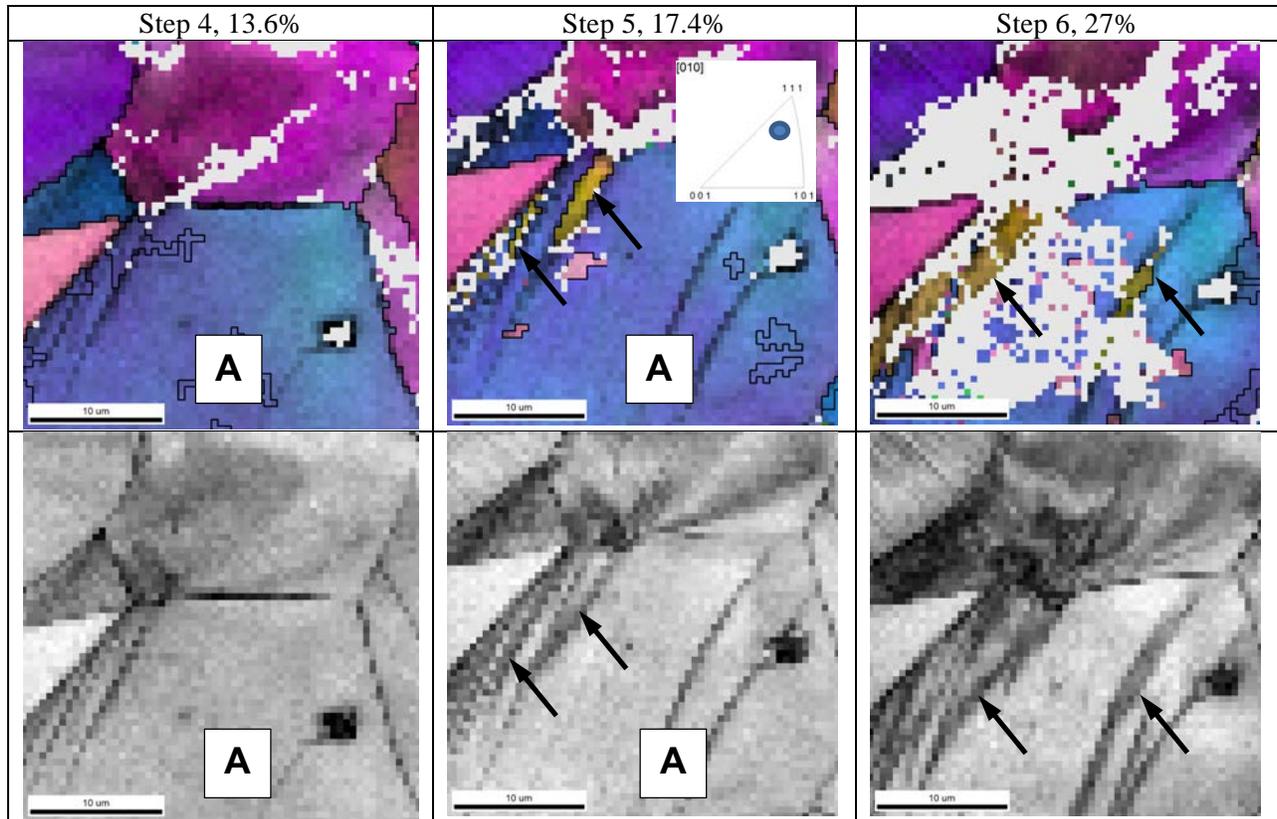
**Figure 17. Deformation twin appearance and evolution with strain increase.** Grain A was twin-free at 13.6% strain, and a clear indication of the strain-induced twin (black arrows) appeared during the next strain increment (Step 5, 17.4%). With another strain increment (Step 6, 27%), the twins grew, and an additional twin appeared in a different area. Also note the strong increase in the non-indexed point fraction.

Figure 17 shows an appearance and evolution of the deformation twin. The EBSD map (fragment of the general IPF map shown in Figure 9 and Figure 12) demonstrates the twin-free grain at 13.6% strain (left), the appearance of several strain-induced twins at 17.4% strain, and their growth coinciding with the strain level increase.

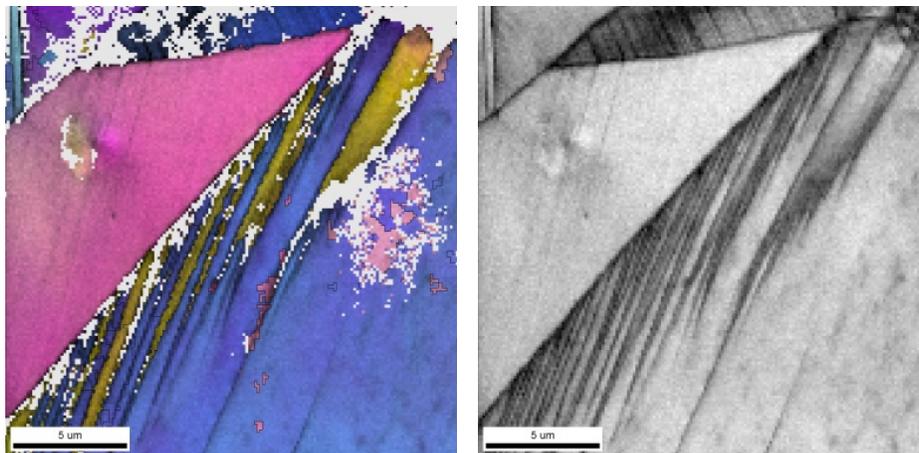
**Figure 18. EBSD data for the area shown above.** Scanning was performed at 1500 $\times$  magnification with a 125 nm pitch (Step 5, 17.4%). Shown are fine deformation twins in addition to the coarse deformation twins visible in the 0.5- $\mu$ m scan.

If necessary, any location may be scanned at higher magnification and with higher resolution to provide more details on the phenomenon of interest. An example is given in Figure 18 where a high-resolution (125 nm) scan reveals additional fine twins not visible in the scans performed with the 0.5  $\mu\text{m}$  step.

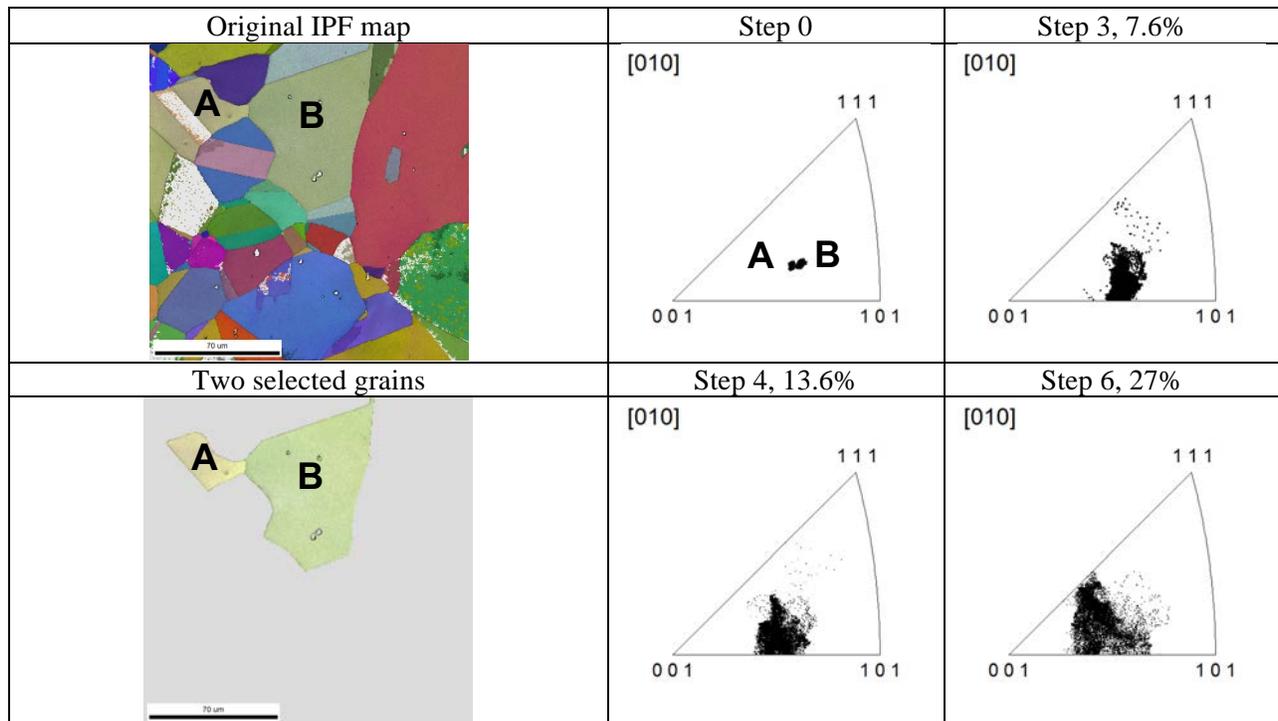
**Figure 19. An example of grain rotation behavior.** Two grains (A and B) were moved in a separate partition. During straining, there is a strong increase in the in-grain spread, but the general tendency is to rotate towards a  $[001]$ – $[111]$  line.

Figure 19 illustrates another interesting case: in-grain misorientation and grain rotation. Here, two grains (A and B depicted in Figure 19) were selected and isolated in a separate data set. The evolution of these two grains was tracked through different strain levels. Prior to straining, the grains had a very low in-grain misorientation level and orientation spread (see the unit triangles). At 7.6% strain, points belonging to the selected grains formed a specific halo around the initial location. For most points, deviation from the original orientation was within  $3^\circ$ – $5^\circ$ ; however, several points shifted up to  $10^\circ$ – $15^\circ$  forming an elongated “tail.” The grain rotation direction was fairly random at smaller strain levels; however, at larger strain levels, rotation towards the  $[001]$ – $[111]$  direction became the norm.
