# Light Water Reactor Sustainability Program

## Effect of Swelling on Irradiation- Assisted Stress Corrosion Cracking

July 2017

# **Effect of Swelling on Irradiation-Assisted Stress Corrosion Cracking**

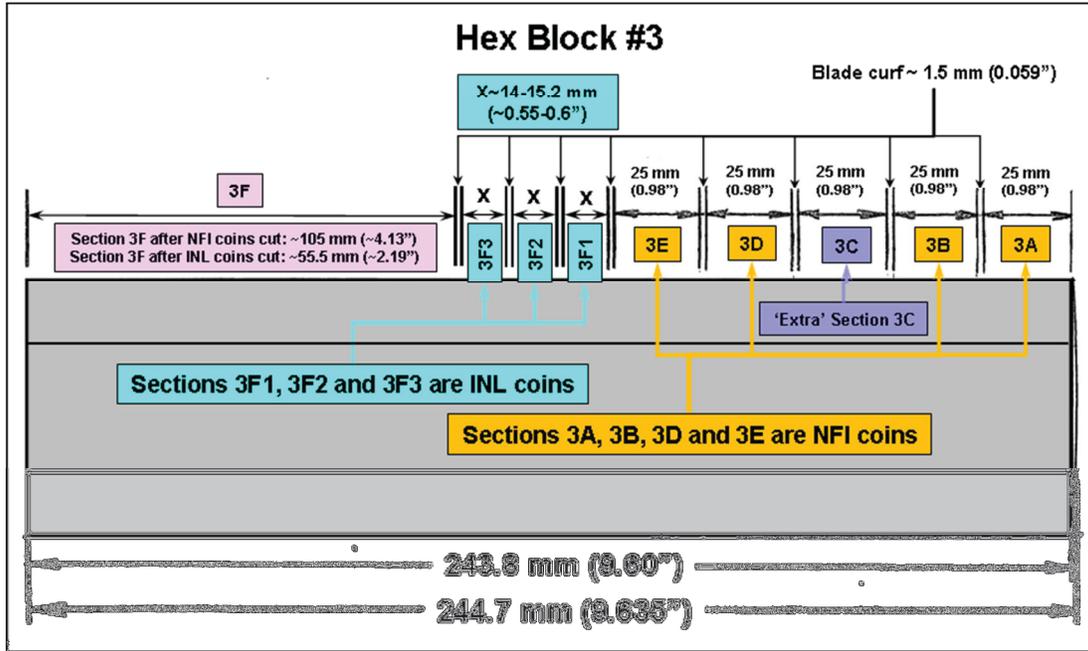
Figure 1. Schematic of Block 3 from which the material used for this study (Coin 3F3) was cut.

The material used in the study was cut from a thick hexagonal block made of American Iron and Steel Institute (AISI) 304 stainless-steel that served in one of the reflector assemblies in the Experimental Breeder Reactor II fast reactor at Idaho National Laboratory. The chemical composition was Fe-19.26Cr-8.81Ni-1.57Mn-0.43Si-0.056C-0.027P-0.03S wt%. The microstructure characterization of archive material suggests that 5% cold work was present at the center of the block prior to irradiation. The doses received and irradiation temperatures were evaluated from the temperature and dose calculated for the encasing duct using reactor physics and heat transfer calculation (Bond et al. 1999; Garner and Makenas 2006; Garner et al. 2007). This block was part of a series of five blocks that were in the reactor for 13 years: 4.5 years in Row 8 and 8.5 years in Row 16. However, 97% of the dose was received in Row 8. The material comes from Block 3, which was in the center of the core and received the highest dose (i.e., from 33 dpa for the face located toward the core center to about 22 dpa for the opposite face). As the specimens were retrieved toward the center of the block, the dose received was about 27 dpa. More specifically, the material comes from a 0.5-in.-thick coin labelled 3F3 that was initially located toward the center of Block 3 (Figure 1). The time-averaged temperature was 390°C; however, due to gradient gamma heating, there was an off-center peak in temperature inside the block (Figure 2). The maximum average temperature inside Block 3 was estimated to be about 460°C (Garner et al. 2014). This temperature gradient is expected to have led to a swelling gradient. Ultrasonic time-of-flight measurements performed on Coin 3F3 confirmed an off-center swelling peak, with a maximum at about 3.7% swelling and a minimum of less than 2% (Garner et al. 2013; Garner et al. 2014).

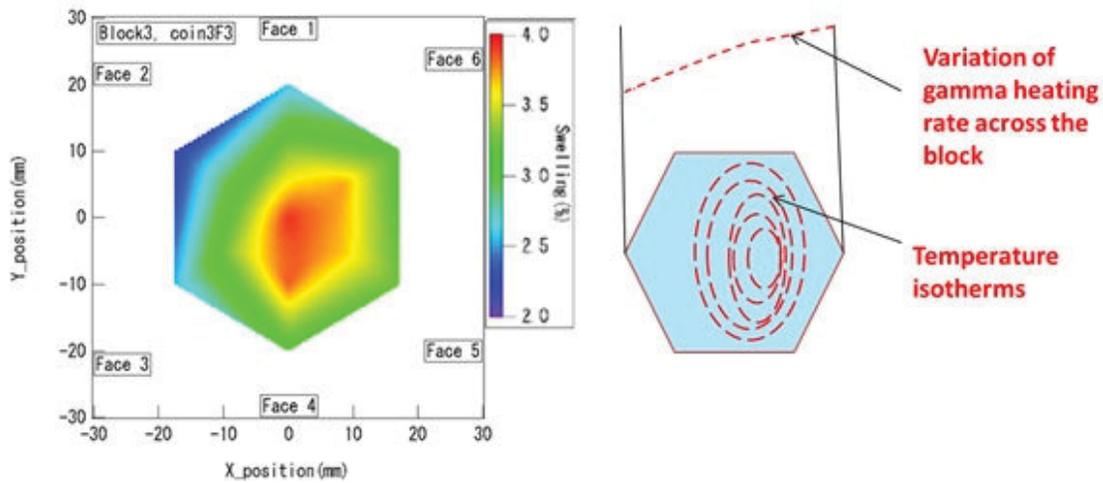
Figure 2. Temperature distribution across the block (Garner 2014 et al.).

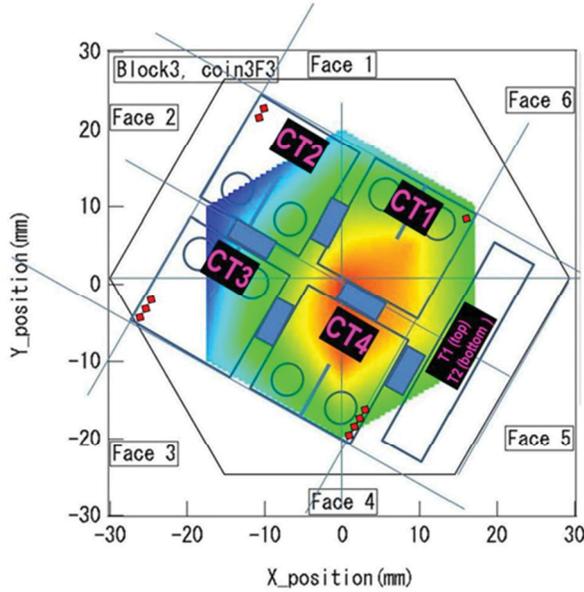
Figure 3. Locations and orientations of the four CT specimens (CT1, CT2, CT3, and CT4) as they were cut in the hexagonal coin. T1 and T2 show the locations of the tensile specimens.

Two pairs of compact tension (0.25T CT) specimens were machined. The location for machining was determined such that, for each pair of CT specimens, the cracks would grow in a material with similar swelling. Two specimens were machined so the cracks would grow in a material with 3.7% swelling, and two specimens were machined so cracks would grow in less than 2% swelling. The percent of swelling used was an estimation that was determined by ultrasonic technique. The orientation of the CTs with regard to the component was the same. Details regarding the machining steps can be found in Teyseyre (2015). The first specimens to be tested were CT1 and CT2. Their locations in the coin is shown in Figure 3. The specimens' dose rates were respectively 160 and 180 mR/hour at 30 cm.

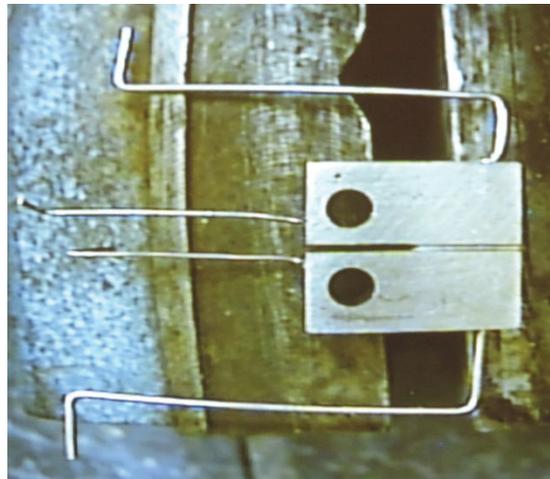
Figure 4. CT1 specimen after short current and potential lead welding was completed. Dimensions of the photograph may appear distorted, because the photograph was taken from a video monitor of the specimens.

For this project, it was decided that short leads would be connected to the specimens as part of the specimen machining. The small leads were placed so their connections to the direct current potential drop leads in the autoclave were performed without moving the specimen. A photograph of the CT1 specimen with the leads attached is presented in Figure 4.

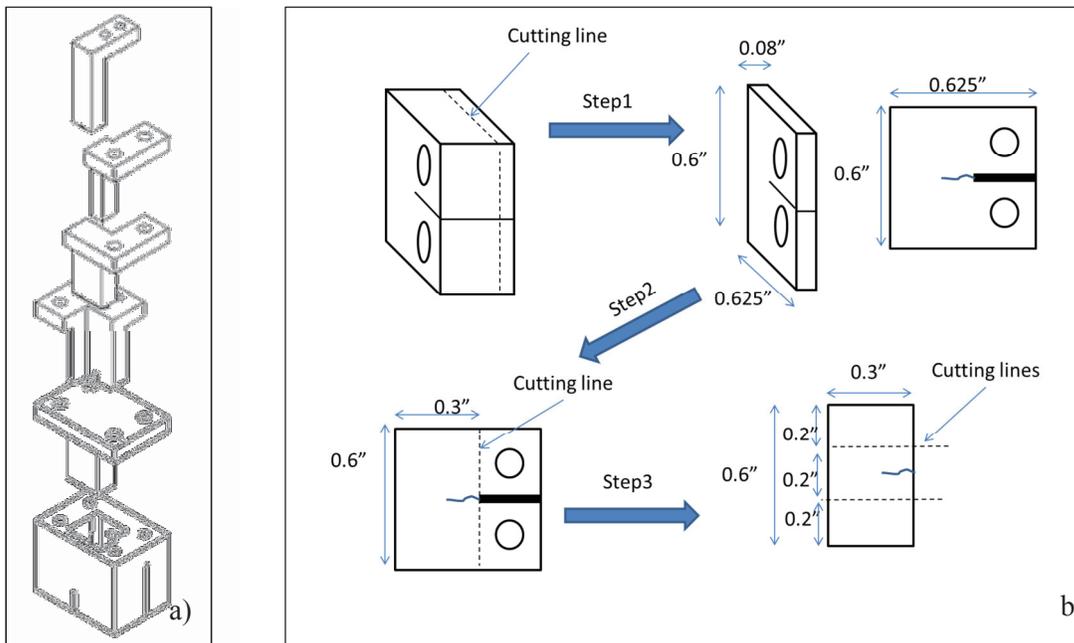
Figure 5. Schematic of the jig used to slice the 0.25T-CT specimen in the glovebox (a) and the various steps taken to slice the specimen to prepare it for post-test characterization.

Upon completion of the crack growth rate (CGR) test, the specimen was removed and placed in a specially designed jig (Figure 5) that was connected to a low-speed saw located in a glovebox. This jig allowed slicing of the specimens, as illustrated in Figure 5, with minimum exposure to the operator and high repeatability.

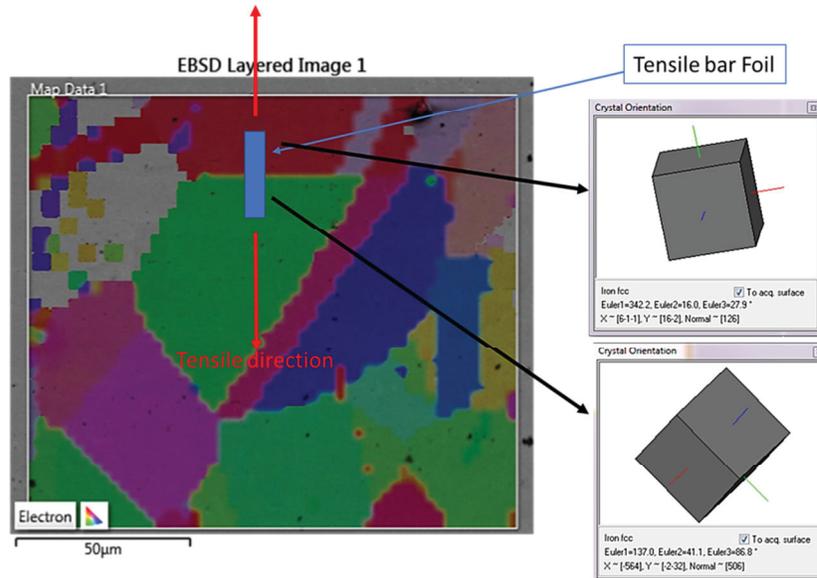
Figure 6. Illustration of the selection and indexing of grain boundary for micromechanical testing.

EBSD was used to map the grain and grain orientations of selected regions prior to sample fabrication, which allowed the tensile bars to be located within a single grain or allowed the selection of specific grain boundaries and the determination of the Schmid factor of each grain along the axis of the

tensile bars. Tensile bar selection and determination of its orientation is illustrated Figure 6. Once selected, the area of interest was removed, as illustrated in Figure 7, the orientation of the grain boundary and surrounding material was completed.

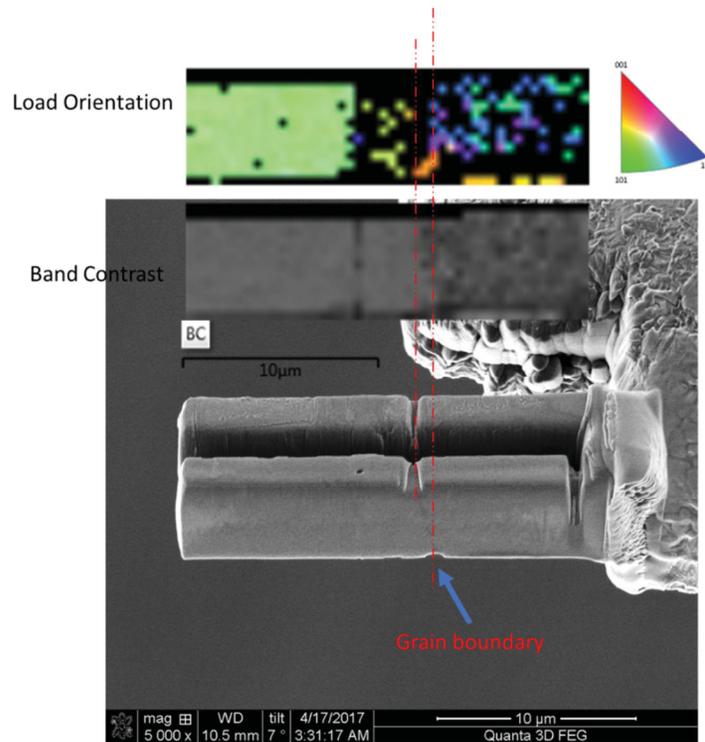
Figure 7. Preparation of a tensile bar for micromechanical testing.

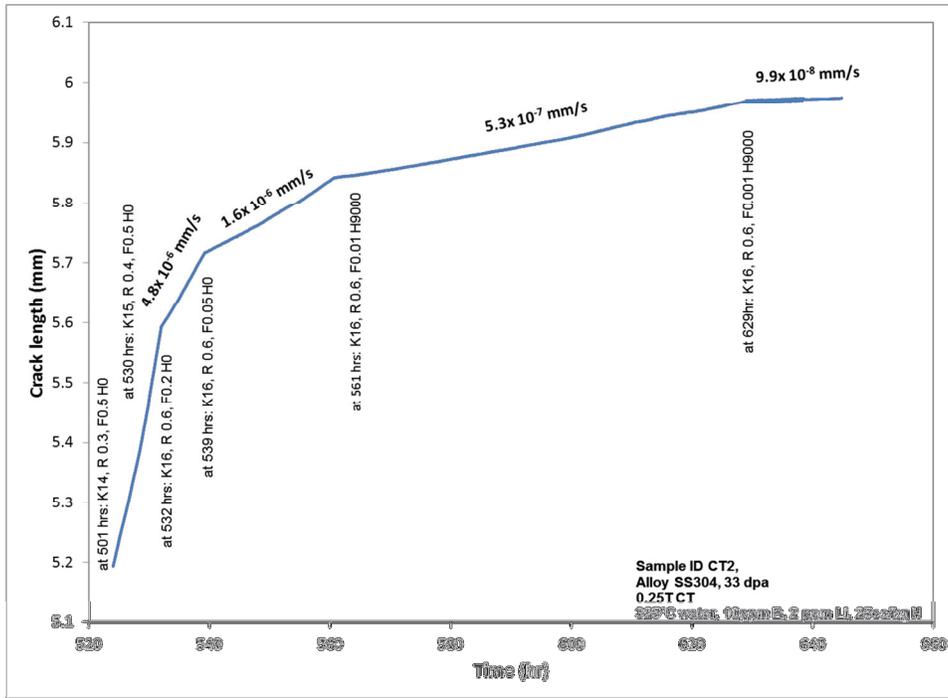
Figure 8. Initiation of the experiment, fatigue pre-crack.

The IASCC CGRs were determined for 2 and 3.7% swelling material from 0.25T CT specimens in a pressurized water reactor environment (325°C, 1,000 ppm boron, 2 ppm lithium, 25 cc/kg dissolved hydrogen). The specimen containing material with 2% swelling was tested at a nominal applied K level of 16 ksi√in. After several days in the environment to ensure stabilization of the corrosion potential, the specimen was fatigue pre-cracked at a maximum applied K of 14 ksi√in. and a loading ratio of 0.3 at a frequency of 0.5 Hz. In the following pre-cracking steps, the applied K was increased to the target test K (16 ksi√in.) as R was increased and holding time under load was applied. Table 1 summarizes the various steps used. The specimen responded well to each loading change with a stable crack propagation rate at each step (Figure 8). At about 630 hours, a long power outage caused a controlled interruption of the experiment. The experiment was restarted, and several steps were introduced to verify that the specimen was still responding to the solicitation. Loading was then transitioned to constant K (Figure 9). The CGR measured at constant K=16 ksi√in. is  $1.9 \times 10^{-9}$  mm/s (or  $1.9 \times 10^{-12}$  m/s). The applied K was then increased to 18 ksi√in. under this condition. The CGR stabilized at  $4.6 \times 10^{-9}$  mm/s (Figure 10).

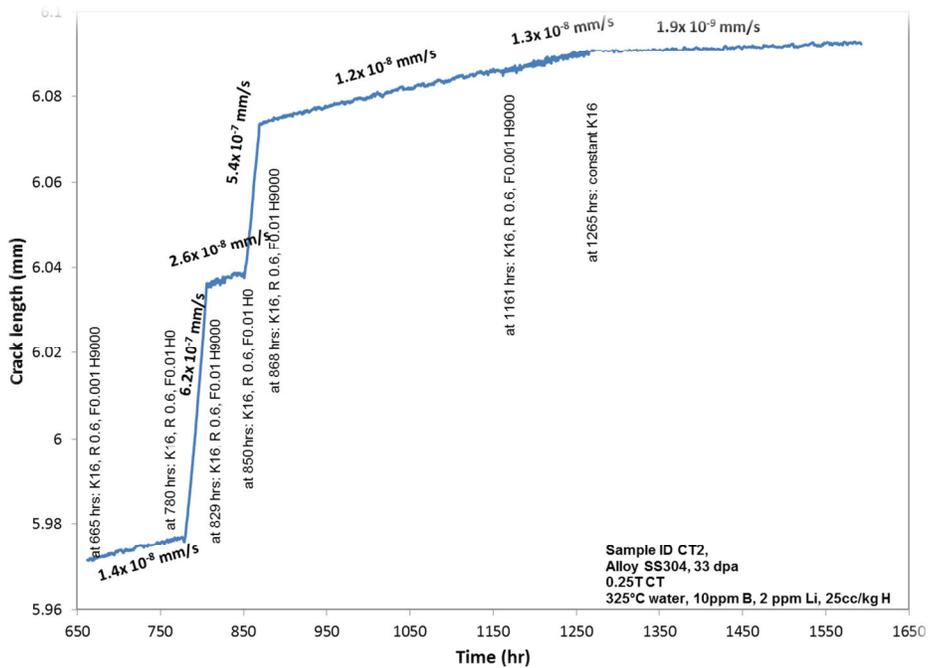
Figure 9. Second part of the experiment after restart, pre-cracking, and transition to constant K.

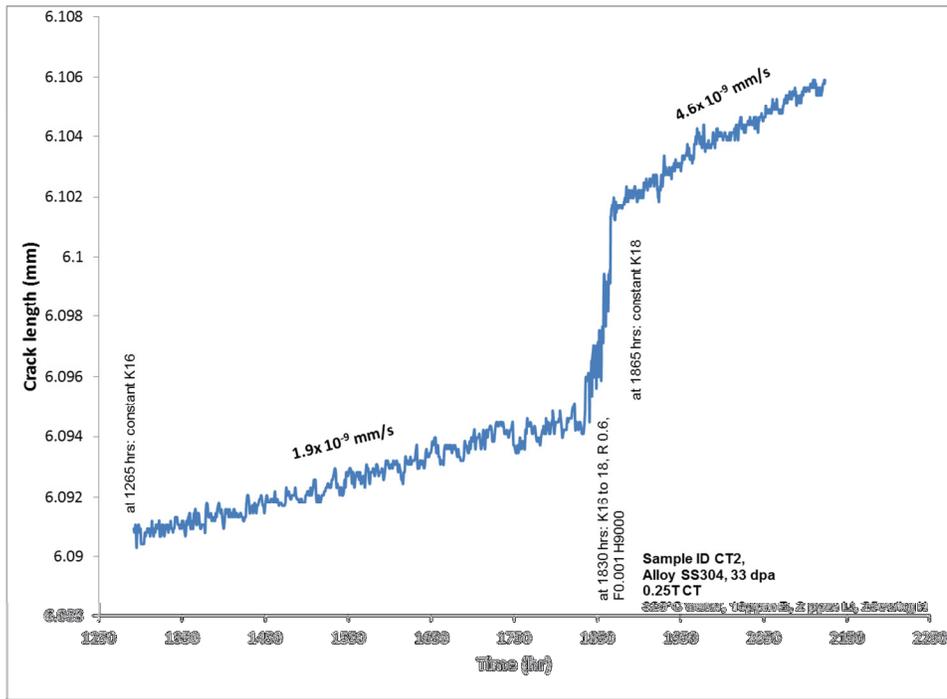
Figure 10. Crack length versus time for the 2% swelling specimen at applied  $K=16 \text{ ksi}\sqrt{\text{in.}}$  and  $18 \text{ ksi}\sqrt{\text{in.}}$ .

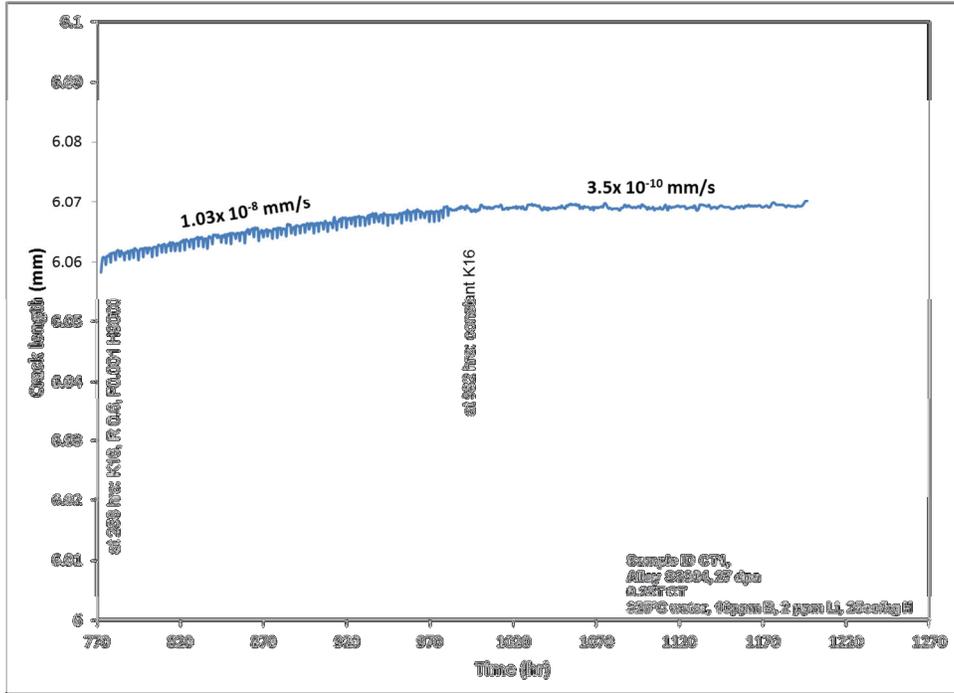
Figure 11. Crack length versus time for the 3.7 swelling specimen at applied  $K=16 \text{ ksi}\sqrt{\text{in}}$ .

The specimen containing 3.7% swelling was tested with the same approach at three different applied  $K$ :  $16 \text{ ksi}\sqrt{\text{in.}}$ ,  $18 \text{ ksi}\sqrt{\text{in.}}$ , and  $20 \text{ ksi}\sqrt{\text{in.}}$ . The evolution of crack length as a function of time is presented in Figures 11 through 13. Table 2 summarizes the different steps and associated CGRs. The CGR measured at applied  $K=16 \text{ ksi}\sqrt{\text{in.}}$  was  $3.5 \times 10^{-10} \text{ mm/s}$  to be compared with the  $1.9 \times 10^{-9} \text{ mm/s}$  measured at 2% swelling. At applied  $K=18 \text{ ksi}\sqrt{\text{in.}}$ , the CGR increased to  $9.9 \times 10^{-10} \text{ mm/s}$  to be compared with the  $4.6 \times 10^{-9} \text{ mm/s}$ . When loading increased to applied  $K=20 \text{ ksi}\sqrt{\text{in.}}$ , the crack responded with a higher CGR ( $2.17 \times 10^{-9} \text{ mm/s}$ ), which was still very low.

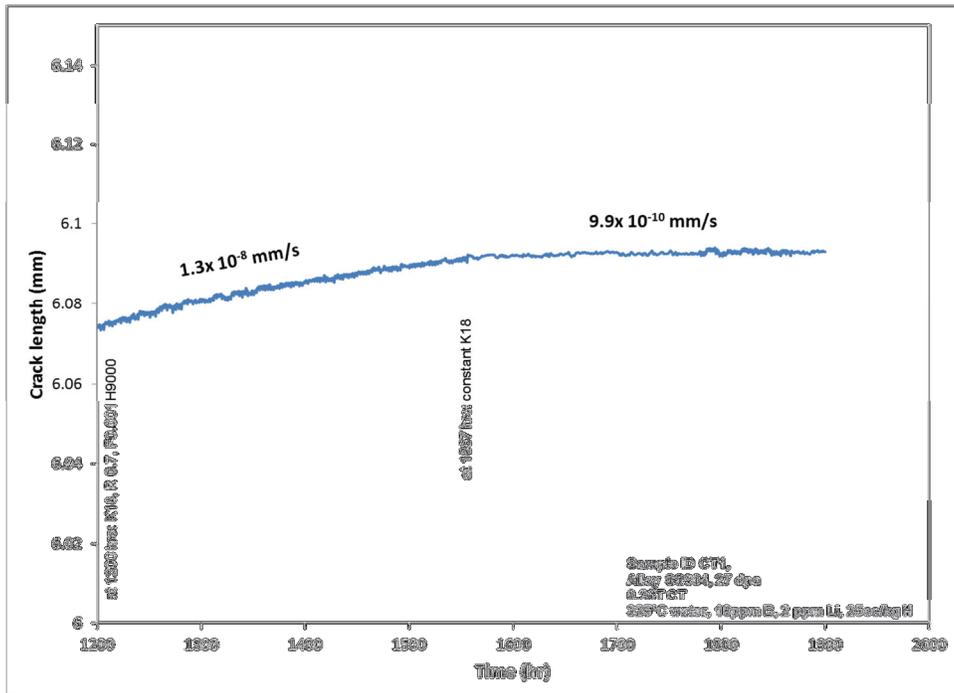
Figure 12. Crack length versus time for the 3.7% swelling specimen at applied  $K=18 \text{ ksi}\sqrt{\text{in}}$ .

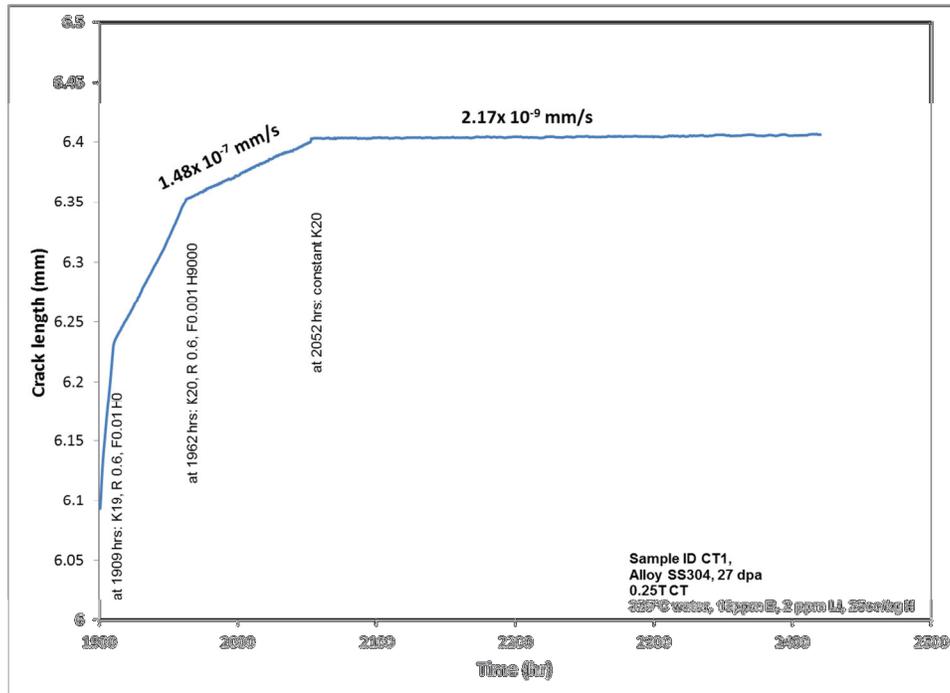
Figure 13. Crack length versus time for the 3.7% swelling specimen at applied  $K=20 \text{ ksi}\sqrt{\text{in}}$ .

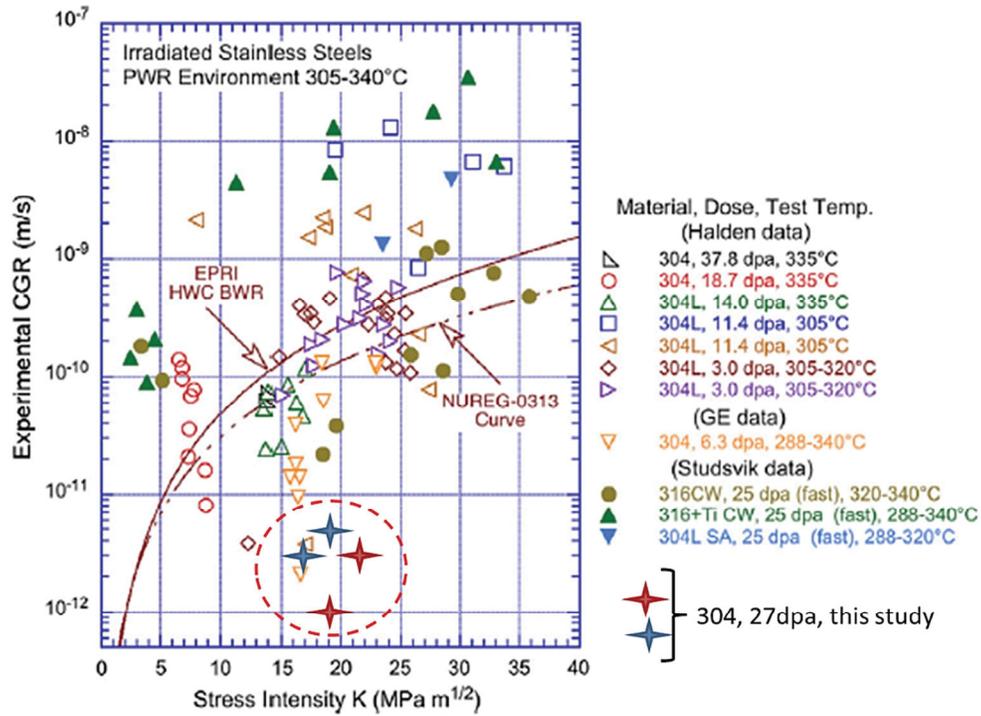
Figure 14. CGR generated in this study compared to the literature (Chopra and Roa 2011).

From information collected from NUREG/CR-7027, the CGR measured was about 1 order of magnitude below most of the data and the NUREG-0313 curve (which is about  $1 \times 10^{-10} \text{ m/s}$  at  $K=16 \text{ ksi}\sqrt{\text{in.}}$ ) (Figure 14). Despite the low CGR, it appears that higher swelling did not lead to a higher CGR.

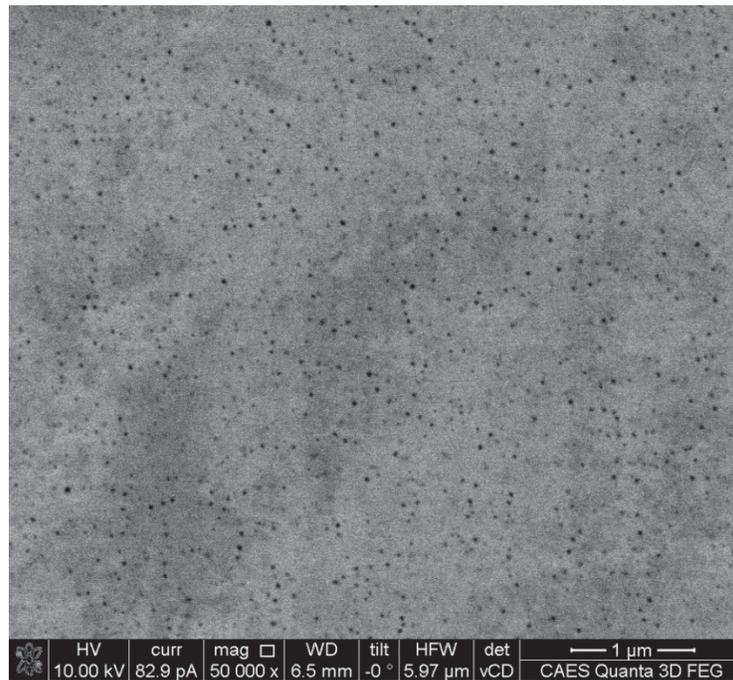
Figure 15. Imaging of voids in the material using BSE imaging.

Back-scattered electron (BSE) imaging allowed the imaging of the voids on a large area (Figure 15). Scanning the specimens away from the cracked areas permitted researchers to determine that the voids were distributed more within the grains than intergranularly (Figure 16a), with some evidence of a void denuded zone. Some grain boundaries exhibited denuded zones that may be related to local phase transformation (Figure 16b).

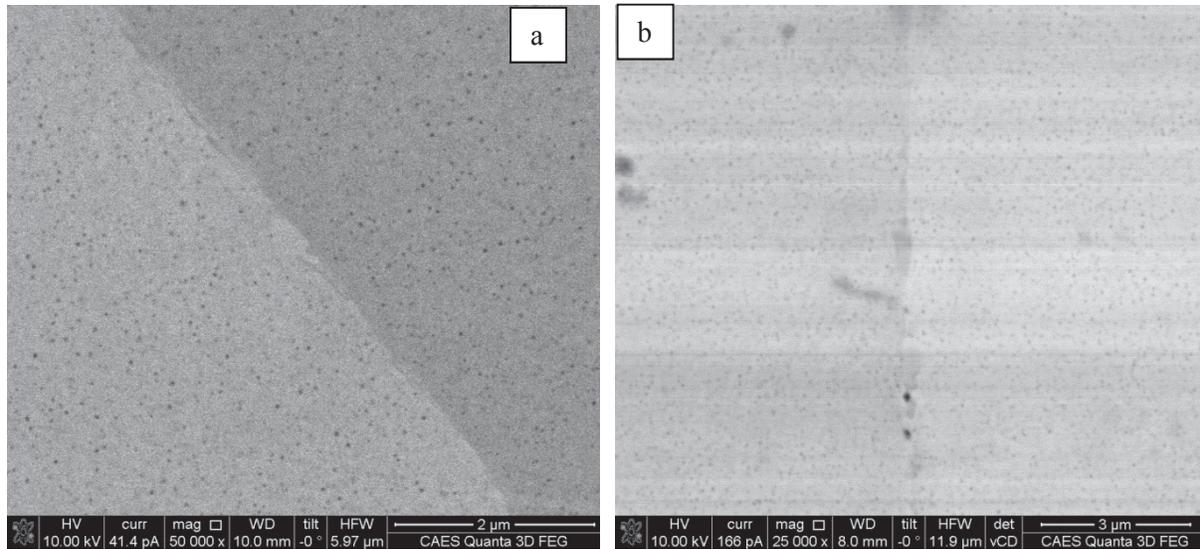
Figure 16. BSE imaging of areas containing grain boundaries.

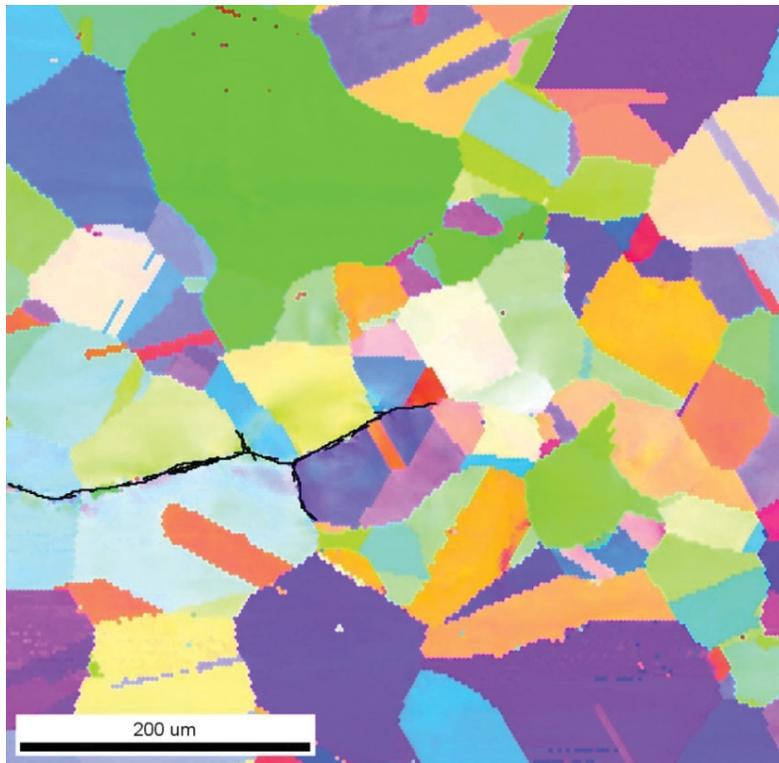
Figure 17. EBSD map and crack path during IASCC test for the 2% swelling specimen

The specimens were cross sectioned to allow the visualization of cracks. Scanning electron microscopy (SEM) and EBSD analyses confirmed the transgranular nature of the crack during the fatigue and transition to stress corrosion cracking steps and the intergranular nature of the crack during the stress corrosion cracking step. The entire cracked area was scanned. Figure 17 shows the area corresponding to the last part of the test performed with the 2% swelling specimen, which is the area where the IASCC CGRs were determined. On this two-dimensional representation, the crack was drawn above the EBSD map. One can see that the crack is branching to go around a grain that is in the path of the crack. The grain reference misorientation deviation analysis during the pre-fatigue steps (Figure 18a) and during the IASCC steps (Figure 18b) shows the presence of strain along the crack. It was not localized along the crack walls only, but pockets can be seen at localized areas in a band of about 200  $\mu\text{m}$  wide along the crack. Of interest is an evident strain localized along the grain boundary in front of the deepest crack.

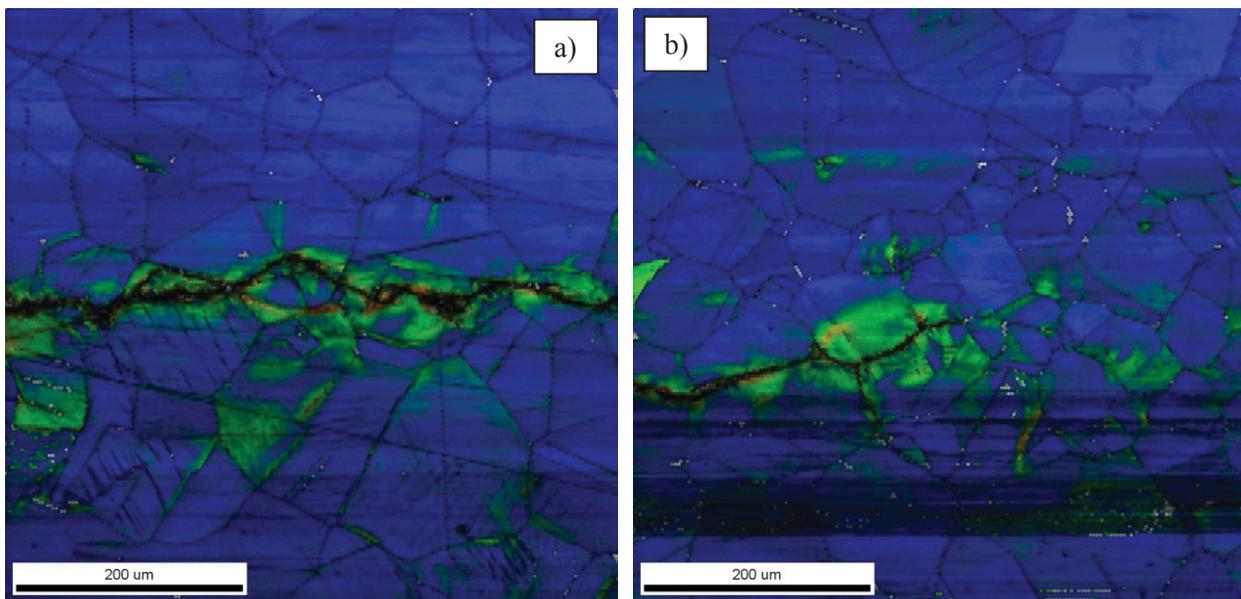
Figure 18. Grain reference misorientation deviation on crack path during fatigue (a) and IASCC test (b) for the 2% swelling specimen.

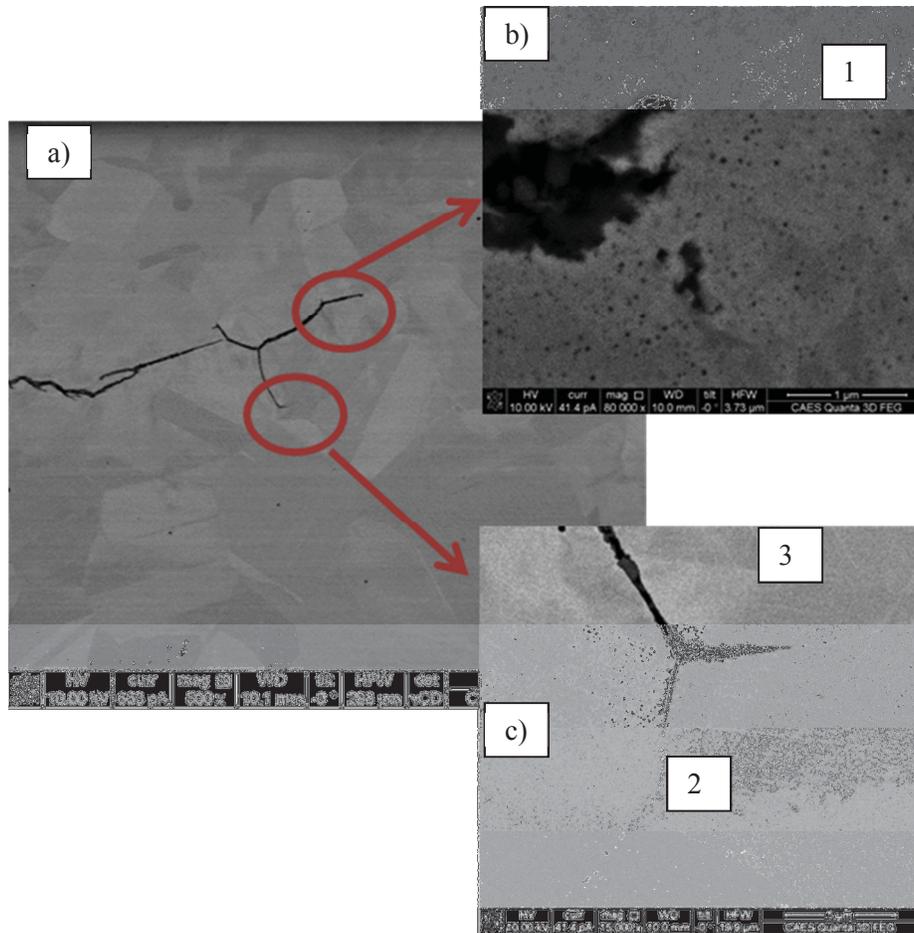
Figure 19. SEM imaging of the cracks located in the 2% swelling specimen.

SEM analysis indicated that the main crack tip (tip Number 1 corresponding to the deepest crack) seemed blunted (Figure 19b), with a large area corroded more like crevice pitting than stress corrosion cracking. In this cross section, it appears that the grain boundary located in front of the crack was a low-angle boundary that was not very susceptible to cracking. Note that strain was accumulating along this grain boundary (Figure 18b). The BSE imaging in front of this blunted crack does not reveal any particular cavity distribution. Two other side cracks, Cracks 2 and 3 as noted in Figure 19c, exhibited features that may indicate that those cracks were the active cracks during the last part of the test. However, it must be stated that such analysis was performed on a cross section, which is a two-dimensional snapshot of a phenomenon occurring in three dimensions. It is possible that the random sampling led the researchers to observe the main crack in an area where propagation was difficult, but that the observation would be different a couple of grain sizes away from this area.

The two secondary cracks exhibited interesting features ahead of the crack tip (Figure 19c). Both have phases along the grain boundary that seem denuded from voids (Figures 20 and 21). In front of Crack 2, beyond those phases appeared a series of voids along the grain boundaries. Such accumulation of voids ahead of the crack could be a precursor to cracking, but it is unclear if such accumulation was a consequence of the stress corrosion cracking test or if it was present in the material previously.

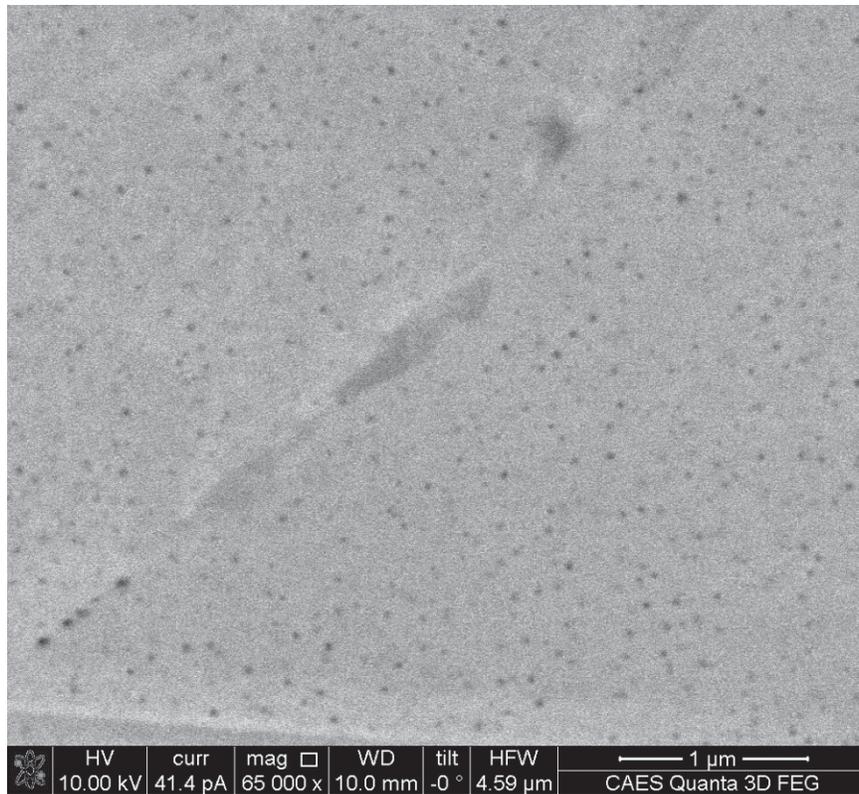
Figure 20. BSE imaging of the Crack 2 from the 2% swelling specimen.

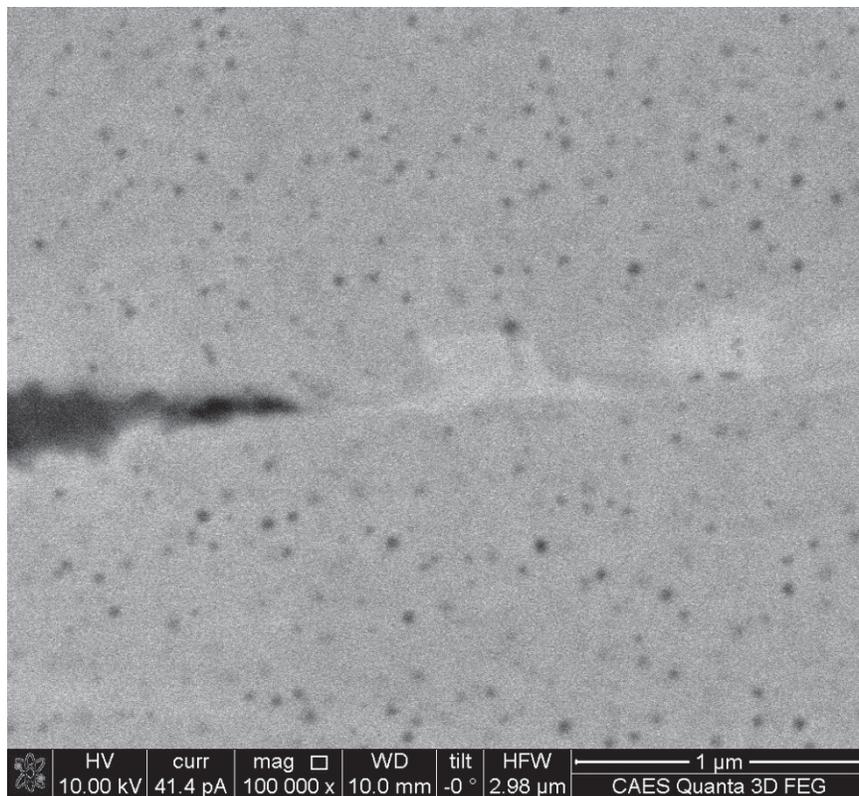
Figure 21. BSE imaging of the Crack 3 from the 2% swelling specimen.

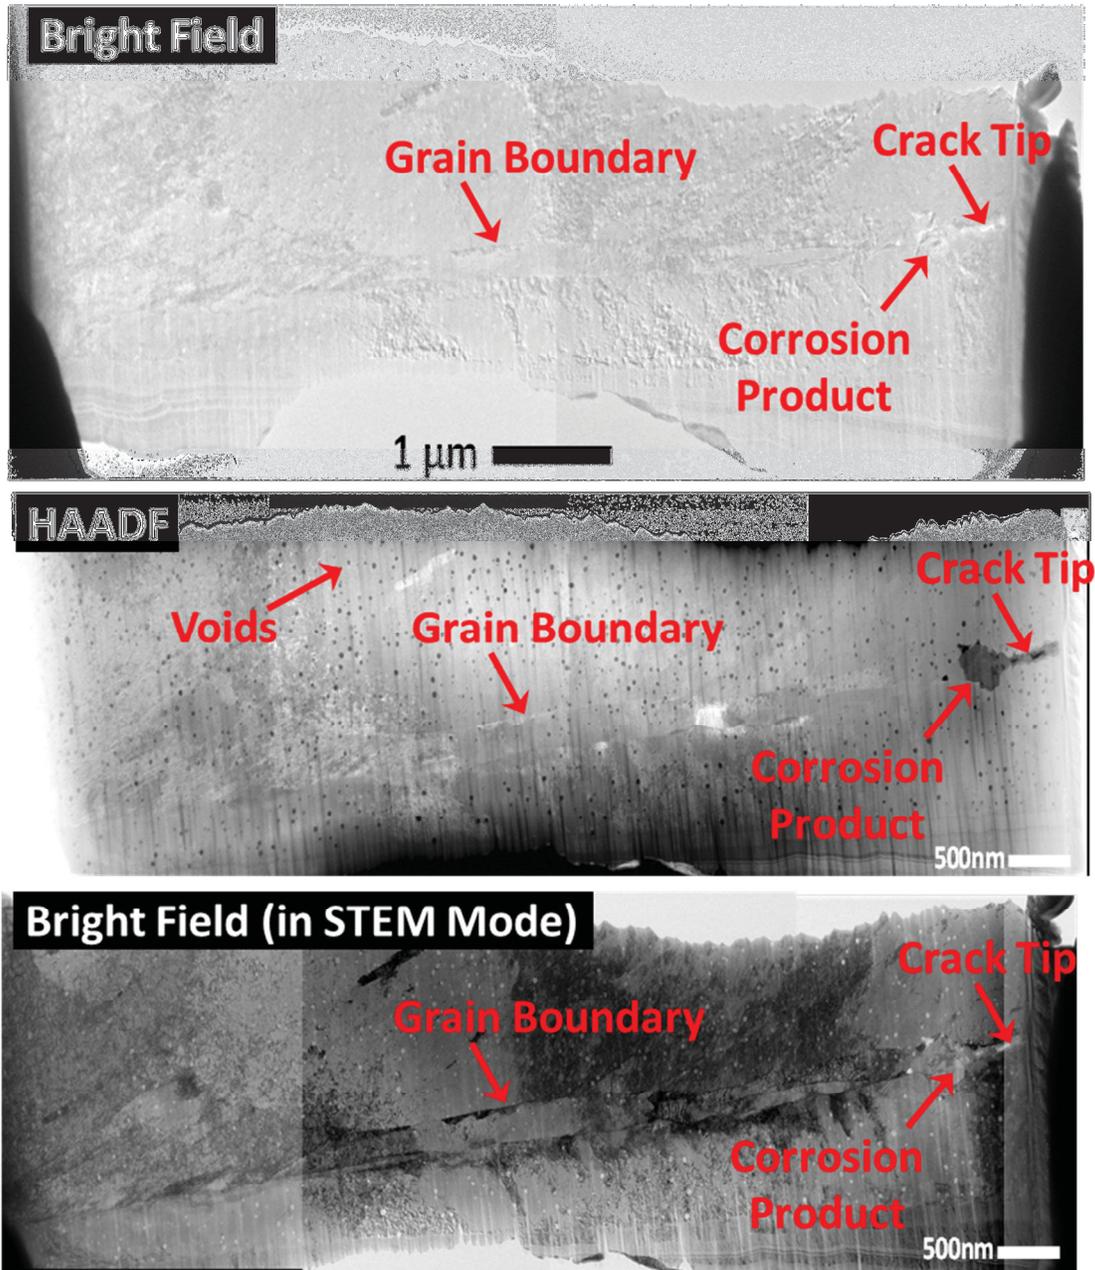
Figure 22. TEM imaging of Crack 2 from the 2% swelling specimen.

Focused-ion beam lift-out was performed to remove the crack tips and conduct transmission electron microscopy (TEM) analyses (Figure 22). The analysis of Crack 2 indicated that the crack tip was not as narrow as expected and that a pocket of corrosion products was present ahead of the crack (Figure 23). The corrosion products along the crack were mainly Fe-Ni-O, and the larger pocket of corrosion product was mainly composed of Fe-Cr-O. Ahead of this corrosion pocket was a 200-nm band that was composed of two layers with different phases (alpha and gamma) and two slightly different chemical compositions (19.7-Cr, 6.6-Ni, Fe and 12.9Cr, 4.6Ni, Fe) (Figure 24). Further the diffraction analysis (Figure 25) showed that the band was composed of both alpha and gamma phases.

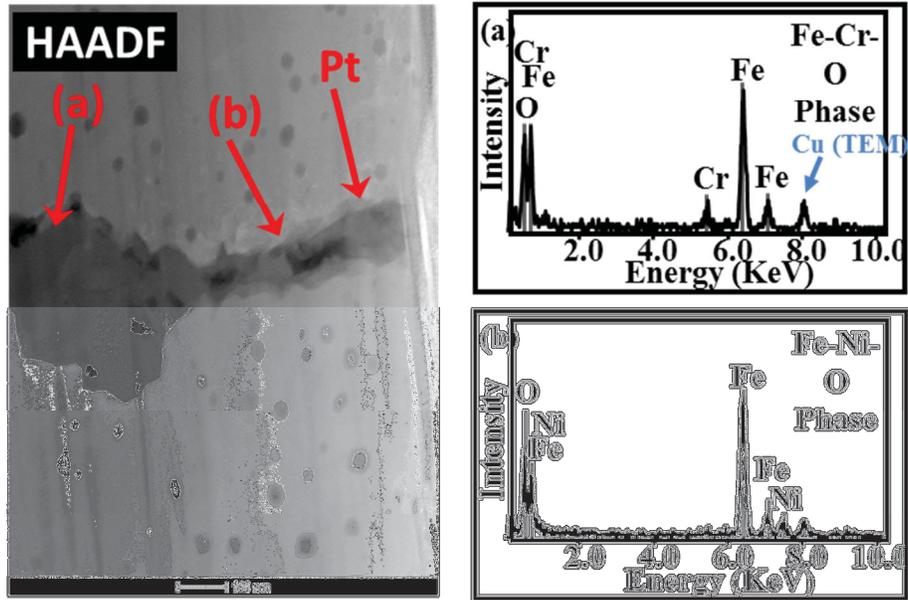
Figure 23. Actual crack tip and corroded area of Crack 2 from the 2% swelling specimen.

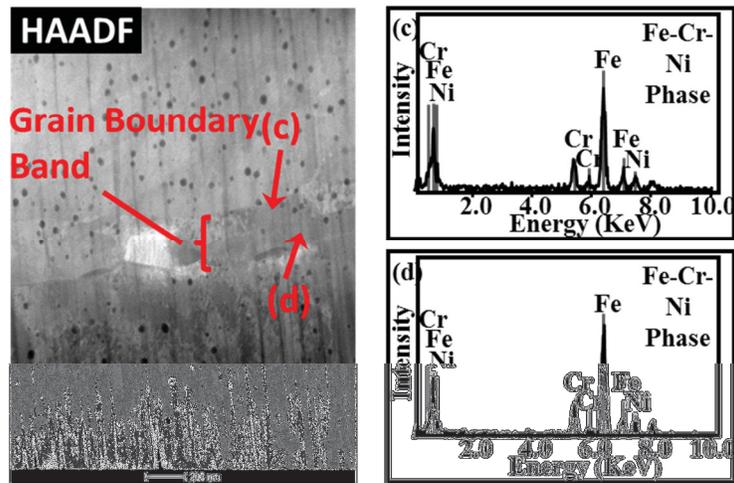
Location	Fe	Cr	Ni
	Wt.%		
(c)	74.5	19.7	6.6
(d)	82.5	12.9	4.6

Figure 24. TEM and composition analysis of the band ahead of Crack 2 from the 2% swelling specimen.

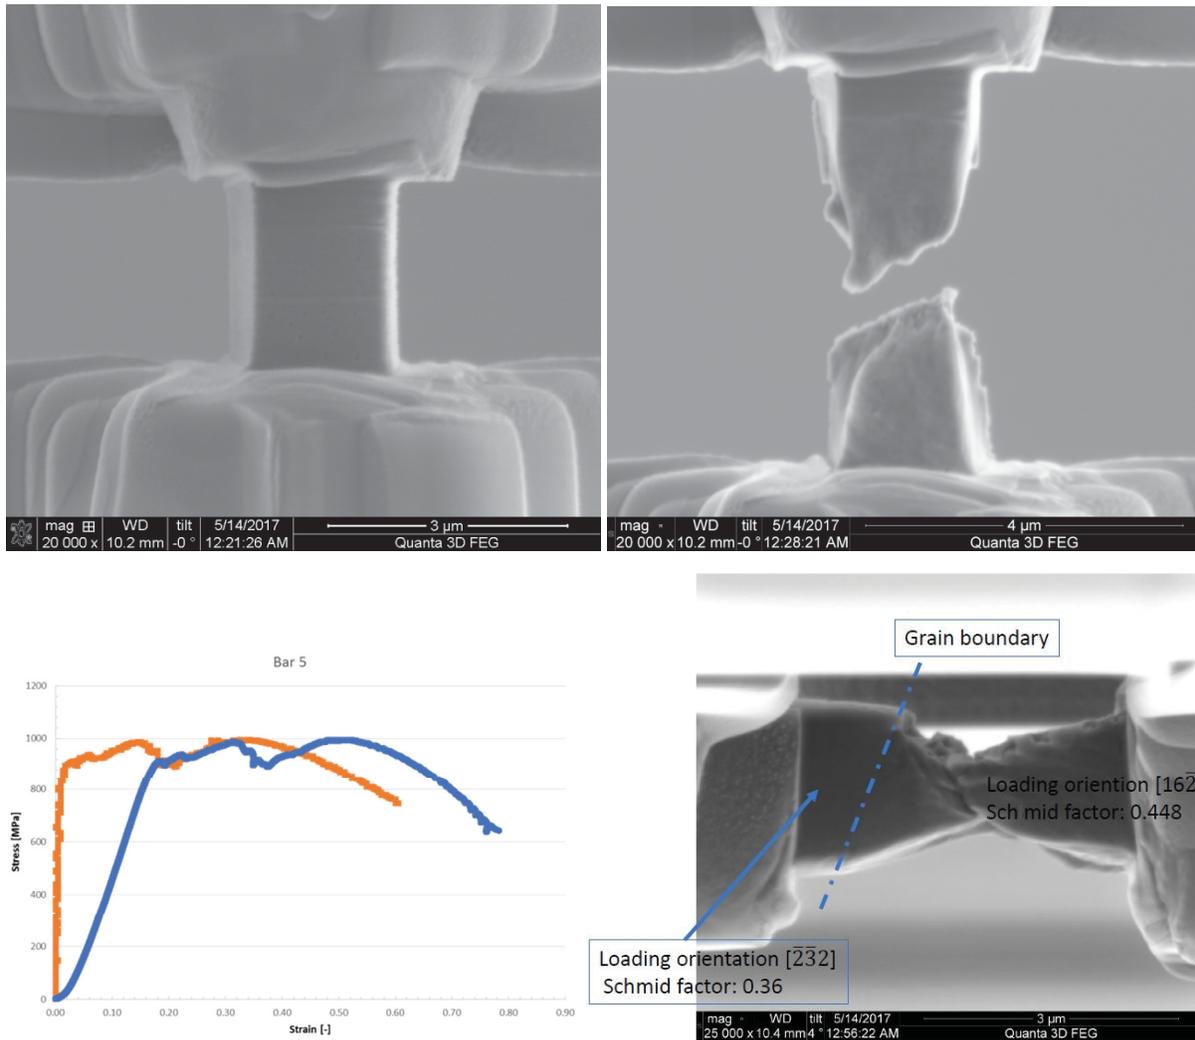
Figure 26. Tensile Bar 5 before and after tensile test.

At this writing, only the data generated with the material with 2% swelling were available. Specimens were machined either in the bulk material (monocrystal) to determine the material behavior or such that the specimen contained a single grain boundary to determine grain boundary cohesion. A total of six specimens were tested. None of the tests performed showed a failure at the grain boundary. Deformation was more pronounced on one side of the grain boundary than the other based on the respective grain orientation with regard to the tensile axis, and the specimens always failed by ductile fracture on one side of the grain boundary. Figure 26 shows Tensile Bar 5 before and after testing. Deformation clearly occurred in one grain of orientation  $[16\bar{2}]$ , and failure occurred in this grain. From the stress-strain curve generated, the yield strength was 892 MPa, and the CRSS was 418 MPa. Tensile Bar 6 was a single crystal of orientation  $[2\bar{3}2]$ . The yield strength was 1,160 Mpa, and its CRSS was 400 MPa (Table 3).

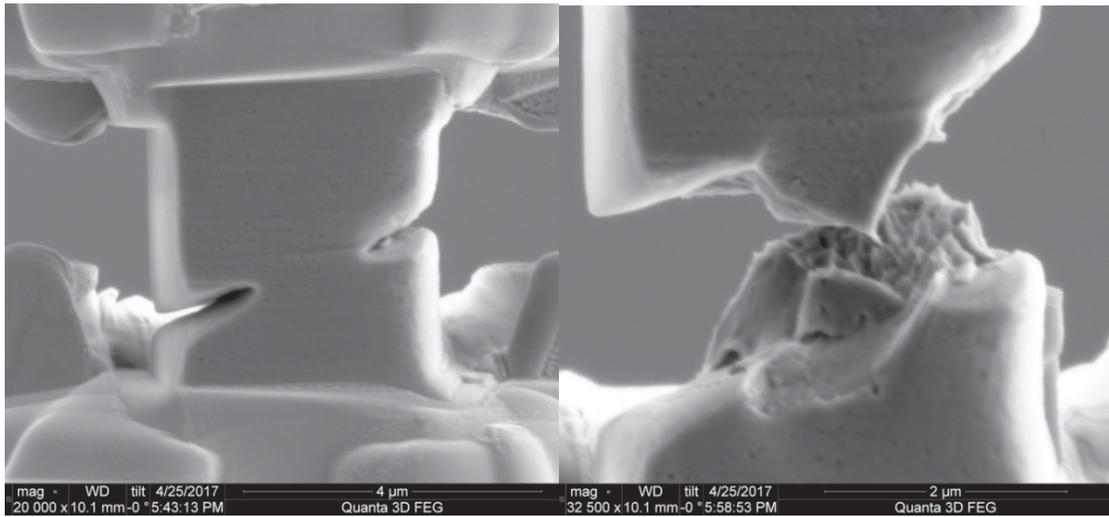
Figure 27. Notched Tensile Bar 4 before and after tensile test.

To increase the odds of measuring the cohesion of the grain boundary, notched specimens were used. Those specimens had a reduced cross section on the grain boundary area, and stress applied was higher on the grain boundary than on the surrounding matrix. An example is presented in Figure 27, which shows Tensile Bar 4 before testing, with the grain boundary aligned between the notches, and after failure where part of the fracture surface can be seen. He ion imaging of the fractured surface (Figure 28) shows that

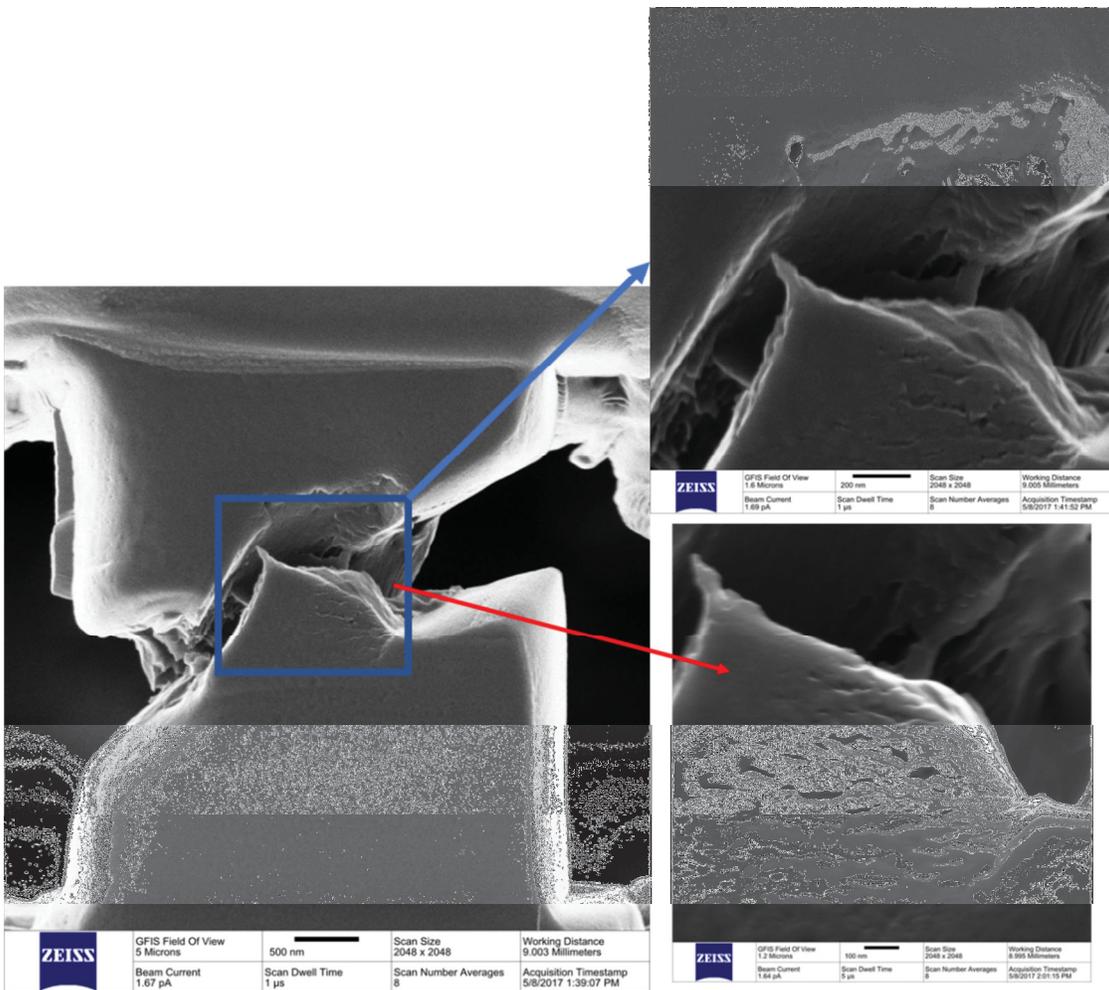
Figure 28. He ion imaging of Tensile Bar 4 after tensile test.

Failure did not occur at the grain boundary despite the localization of the notches and deformation observed within the surrounding grain.

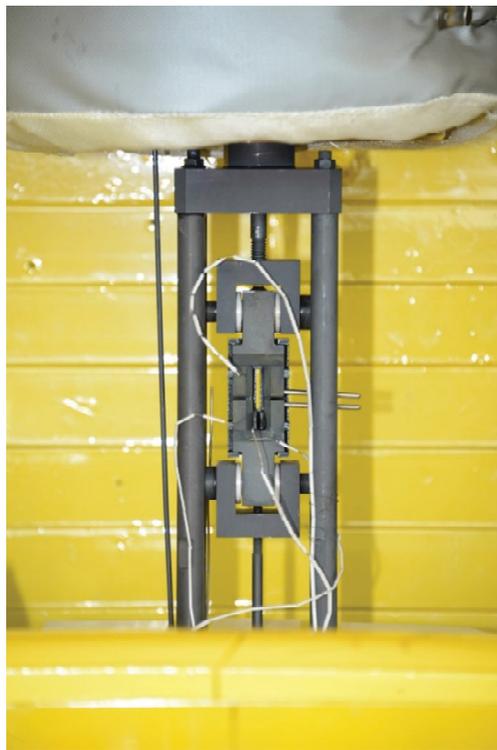
Figure A-2. Clevises and guiding jig prepared before loading the specimen.

The specimen was brought to the laboratory space in the testing facility shown in Figure A-1. The front of the shield was partially removed to allow operator access to transfer specimens. A guiding jig was placed in the autoclave for precise and quick loading of the specimens into the clevises (Figure A-2).
