# Light Water Reactor Sustainability Program

## Effect of Swelling on Irradiation- Assisted Stress Corrosion Cracking

July 2017

# **Effect of Swelling on Irradiation-Assisted Stress Corrosion Cracking**

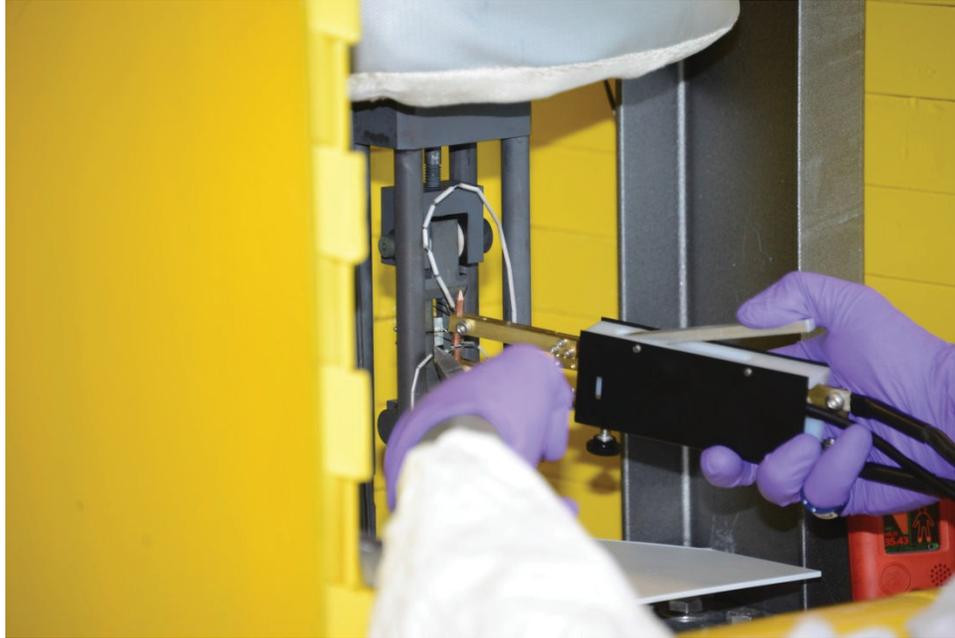
Figure A-3. The direct current potential drop leads being connected to the samples leads.

The next step consisted of welding the direct current potential drop leads to the short leads that were attached to the specimen (Figure A-3). After verifying the contact was strong enough and loading was satisfactory (Figure A-4), the autoclave body was lowered and the autoclave was sealed. The front shield was then put into place (Figure A-5).

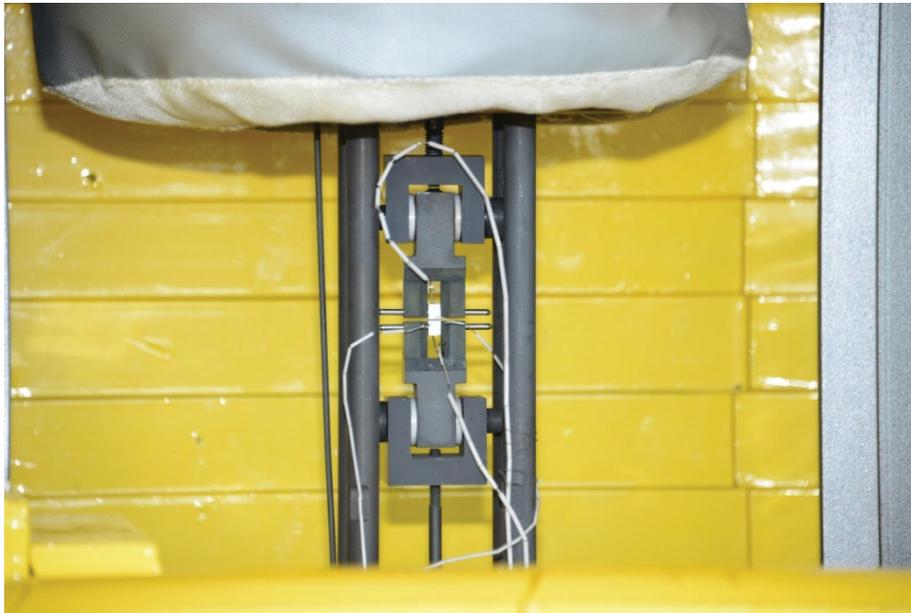
Figure A-4. Specimen loaded in the autoclave and ready to be tested.

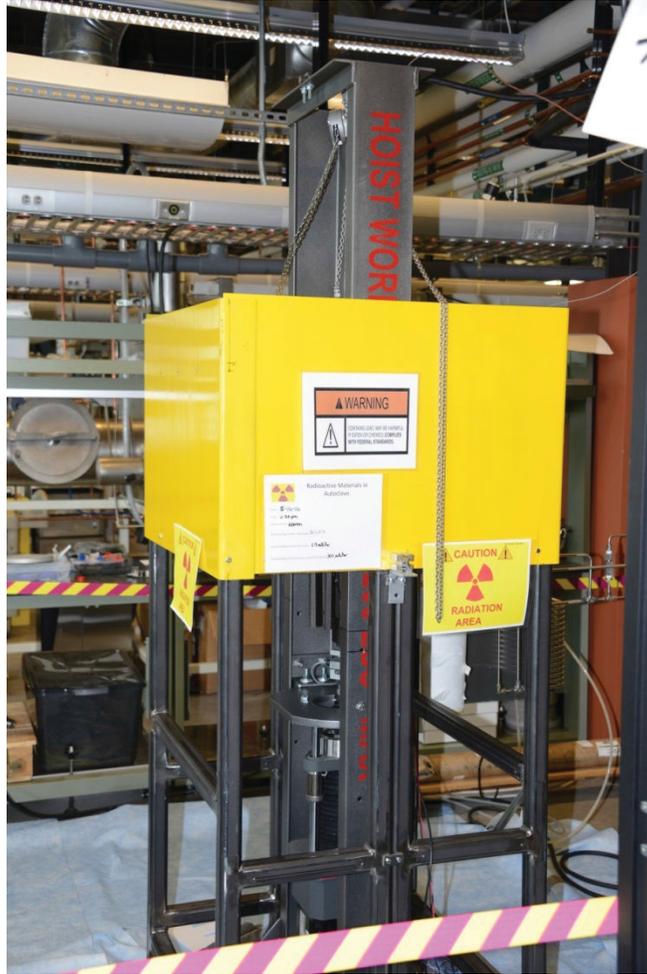
Figure A-5. IASCC testing jig with shield closed.

For radiation protection, a support frame was installed around the autoclave. This frame offered a work space for specimen handling. The frame safely supported enough lead to provide shielding, with 4 in. of lead on the walls and 2 in. of lead plus 1 in. of steel on the floor (i.e., sample loading side). The frame was not in contact with the autoclave, which prevented heat transfer for the autoclave to the lead bricks. Each of the lead bricks had been powder coated to avoid any lead oxidation and any subsequent health hazard. A 1/8-in. steel cover protected the shield walls. The front of the cover can be lowered to provide access to the lead bricks that compose the front wall and the front wall can be partially removed to allow specimen loading and unloading.

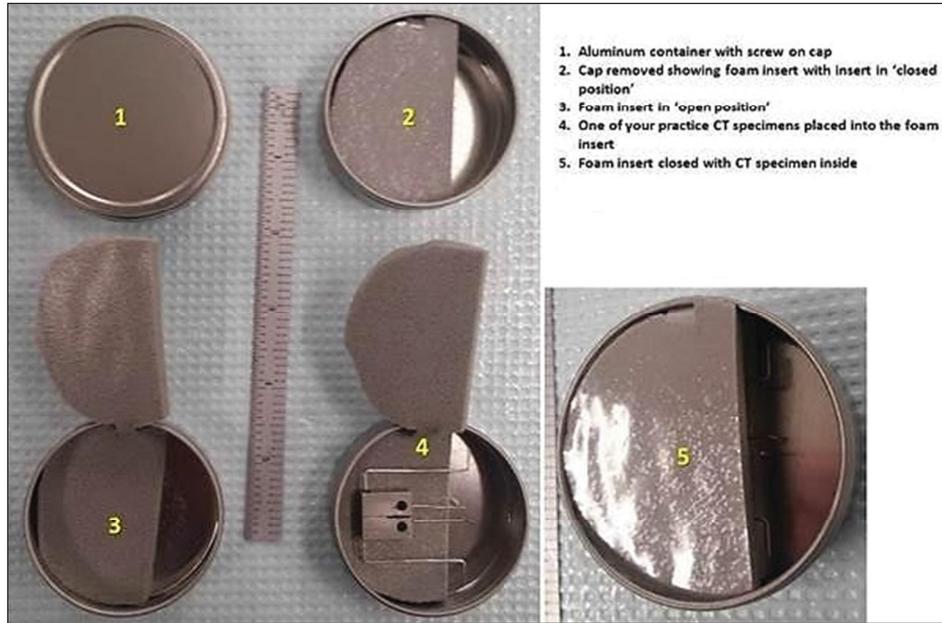
Figure A-6. Packaging of CT specimens with attached leads.

To minimize the number of manipulations (e.g., cask loading, unloading, and storage), it was decided the specimens would be shipped on a demand basis. Only two CT specimens were shipped to the building where testing was performed; the remaining specimens were stored in another facility. Each specimen was shipped in an individual aluminum container, maintaining the specimen in place between foam inserts, as shown in Figure A-6. Each can was sealed in a plastic bag.

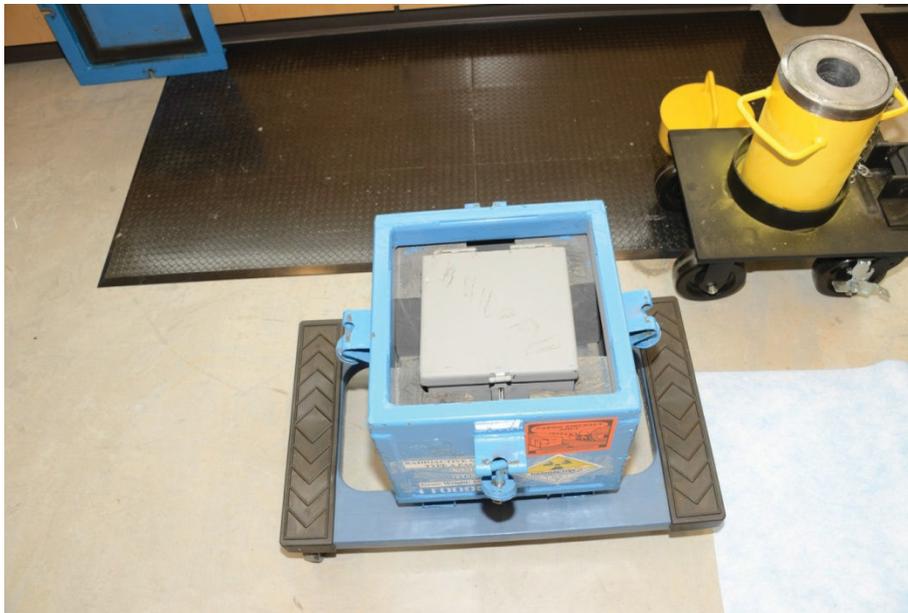
Figure A-7. The shipping container (in blue) contains the specimens. Those specimens will be transferred to the yellow lead pig for storage and transport within the testing facility.

After receipt of the shipping cask at the facility, the plastic bags containing the specimens were transferred to a lead pig (Figure A-7). The lead pig was procured for this project by the facility where the experiments were performed. The inside dimensions of the lead pig are 4 in. in diameter by 12 in. high with the lid on the unit, and the walls, lid, and bottom of the lead pig are 2 in. thick. This container was used for specimen storage and transfer to the test jig.
