## Evaluation of Localized Cable Test Methods for Nuclear Power Plant Cable Aging Management Programs

May 2016

M3LW-16OR0404022  
PNNL-25432

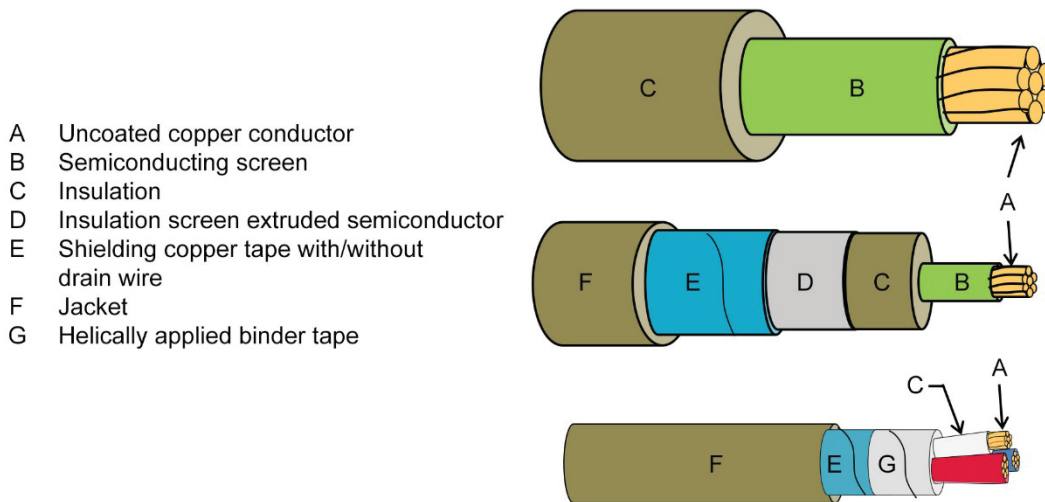
NPP cable designs typically include a conductor to carry power, instrumentation or control signals, and an insulating cover layer to isolate the conductor (Figure 5.1). They may include more than one insulated conductor within a bundle. Other components typically associated with the overall cable design include a semiconductor screen, a shield over each conductor and/or over all conductors, binder tape, and a jacket. While the insulation provides electrical isolation, in jacketed cable configurations the jacket mainly serves to provide mechanical protection during installation and sometimes fire or moisture resistance depending on the cable construction. The materials for cable components are chosen based on the use environment, such as wet, dry, radiation, or sunlit conditions, and the application such as for power or instrumentation. Conductors, made from copper, aluminum, or tin, are relatively insensitive to age and related damage. Cross-linked polyethylene (XLPE) and ethylene propylene rubber (EPR) compose the vast majority of insulation materials in the nuclear industry, with silicone rubber also being of interest. The most significant jacket materials are chlorosulphonated polyethylene (CSPE – also known as Hypalon®, registered trademark of DuPont), polychloroprene, and polyvinyl chloride (PVC). While installed cables with intact insulation may well be able to continue to provide safe operation with degraded jacket material, the tendency of jacketing materials to degrade more readily than insulation materials enables their use as lead indicators for local stress prior to insulation degradation and failure.

Figure 5.1. Configurations of typical cable designs used in NPPs.

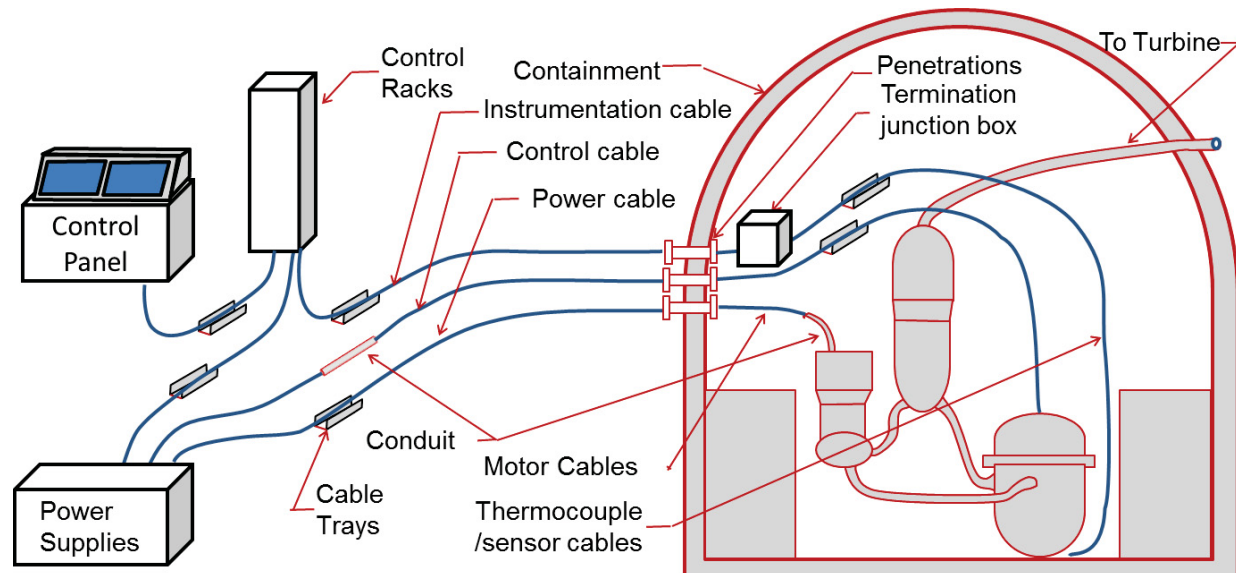
Cable layout is not designed to facilitate access and inspection of much of the cable lengths. Cable trays and conduits are designed to protect the cables from environmental stresses as well as accidental damage from workers and equipment that may be moving either inside containment, auxiliary buildings, or control buildings. While cable ends are generally accessible at termination boxes and control panels, many cables are grouped together with other cables in trays that do not necessarily follow personnel access pathways, pass through penetration pipes and conduits that may be buried in concrete, underground, or even passing through areas that may be flooded (Figure 5.2).

Figure 5.2. Typical cable layout allows access at control racks and termination junction boxes but much of the cable is protected within cable trays and conduit thereby limiting access for local inspections.

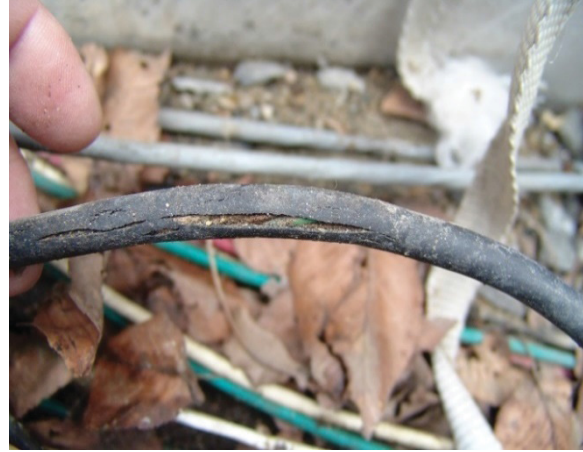
Figure 7.3. Cracked butyl jacket. Photo courtesy of EPRI.

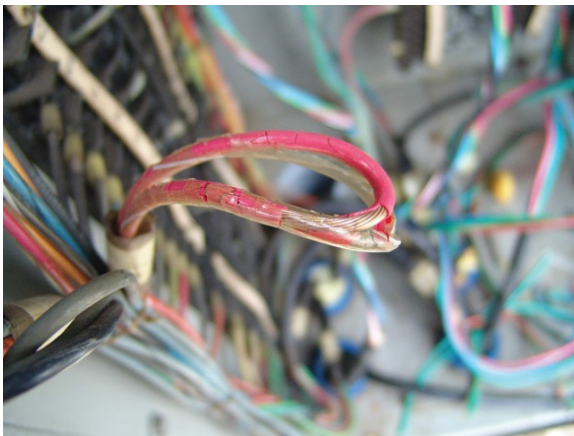
Figure 7.6. Cracks in jacket and insulation. Photo courtesy of EPRI.

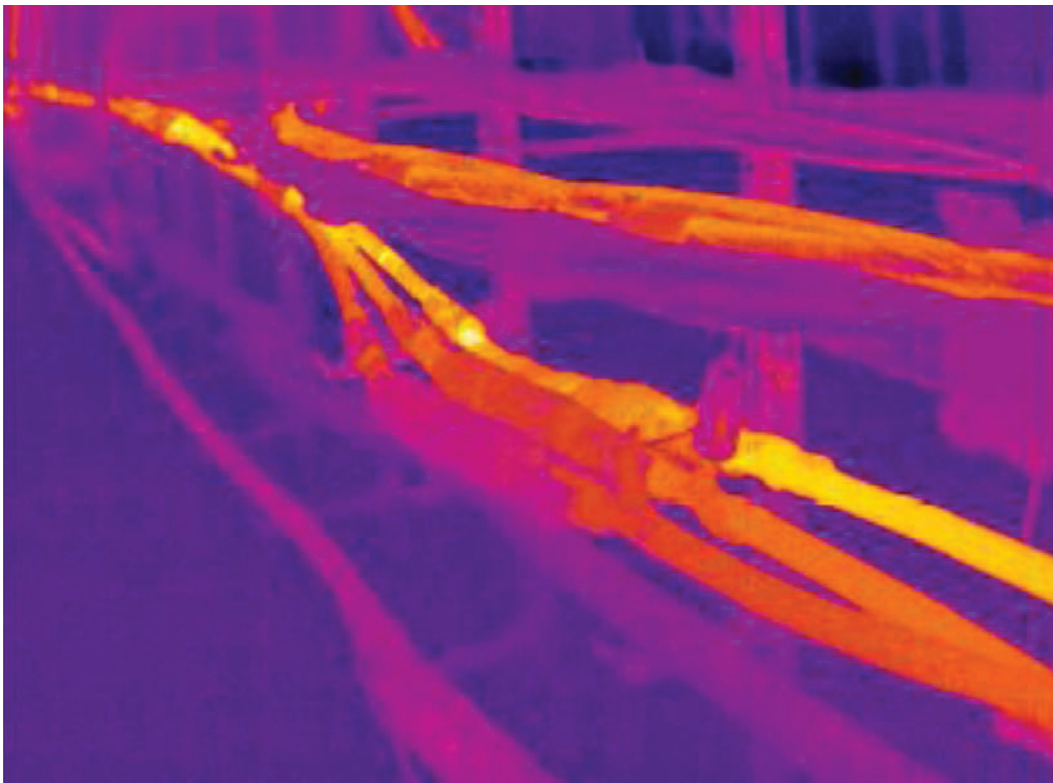
Figure 7.29. IR image – One cable and joint hotter than adjacent cables. Image courtesy of and credited to © Hydro-Québec.

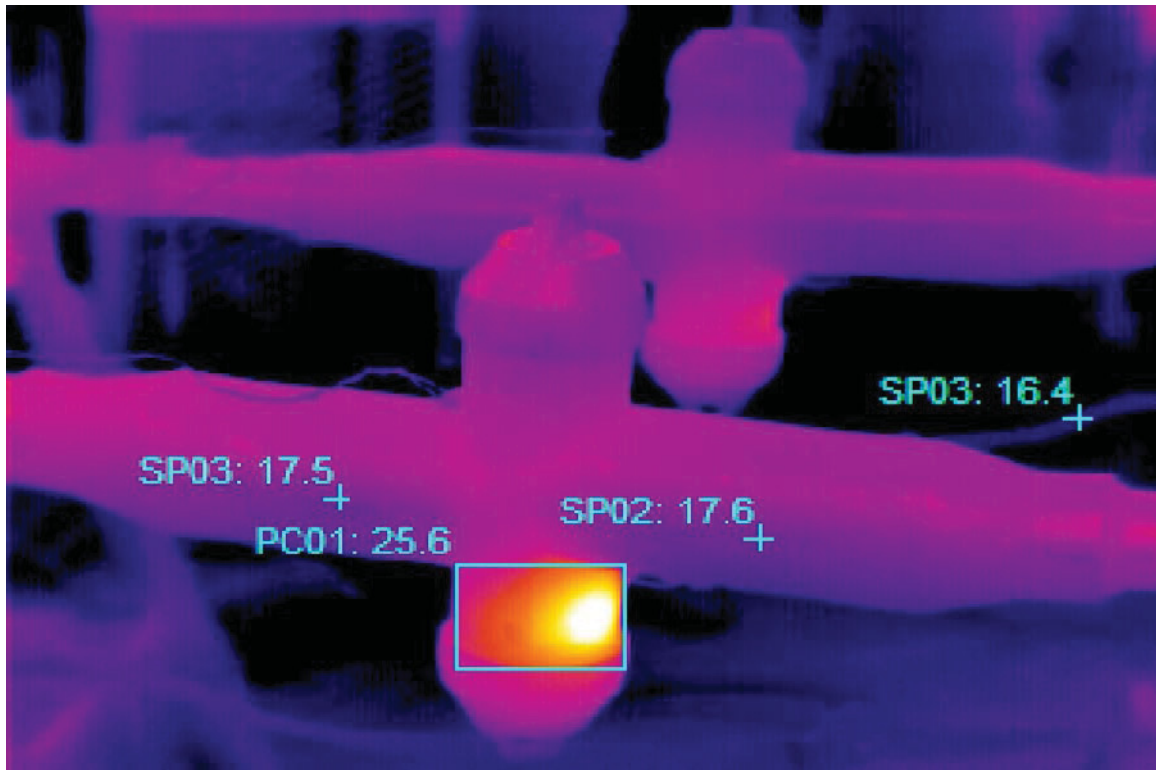
Figure 7.30. IR image – Hot spot in the bulk of insulation of a joint body (pattern 1). Image courtesy of and credited to © Hydro-Québec.

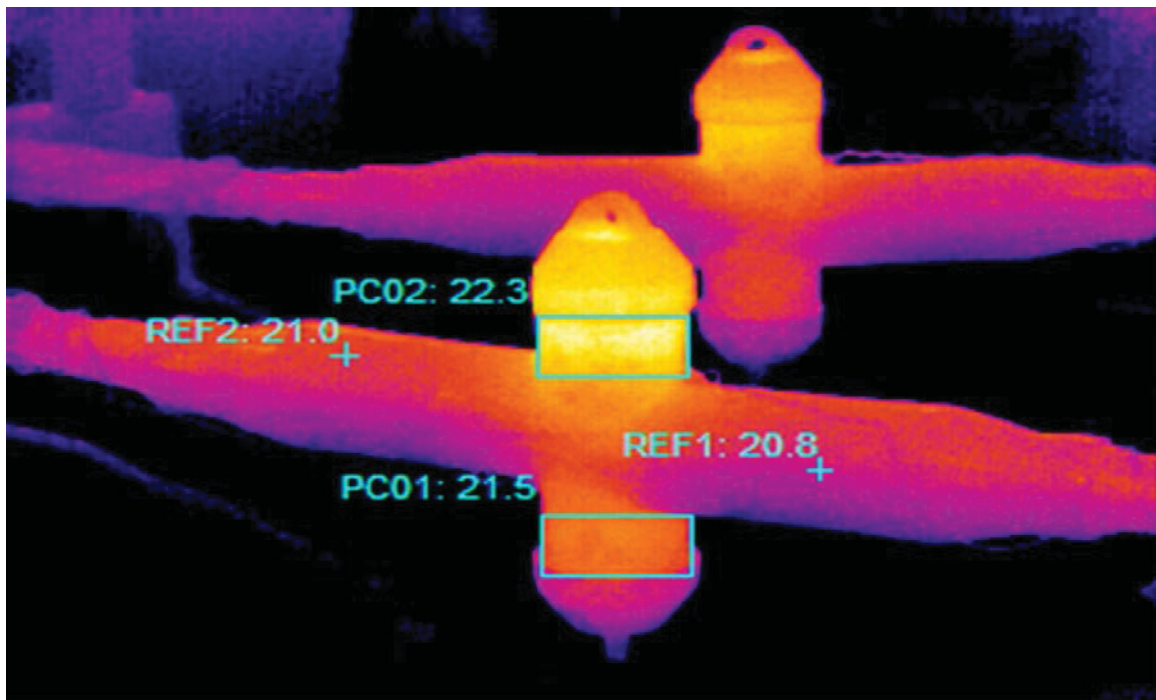
Figure 7.31. IR image – Hot spot in the bulk of insulation of a joint body (pattern 2). Image courtesy of and credited to © Hydro-Québec.

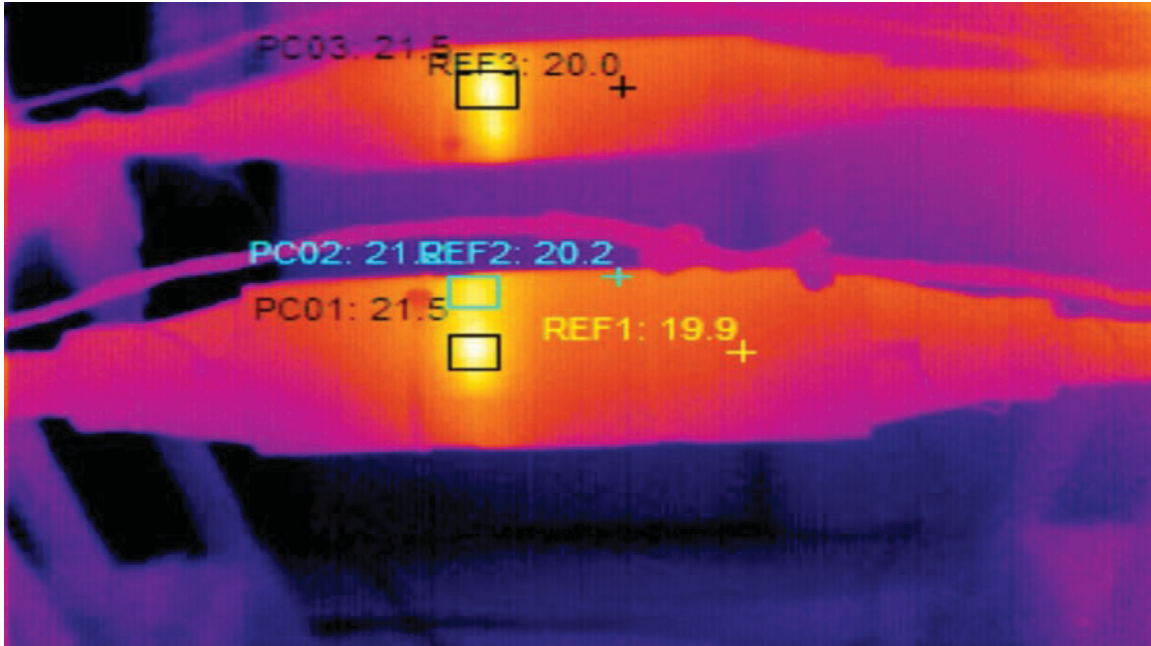
Figure 7.32. IR image – Hot spot in the bulk of insulation located at center of a cable splice. Image courtesy of and credited to © Hydro-Québec.

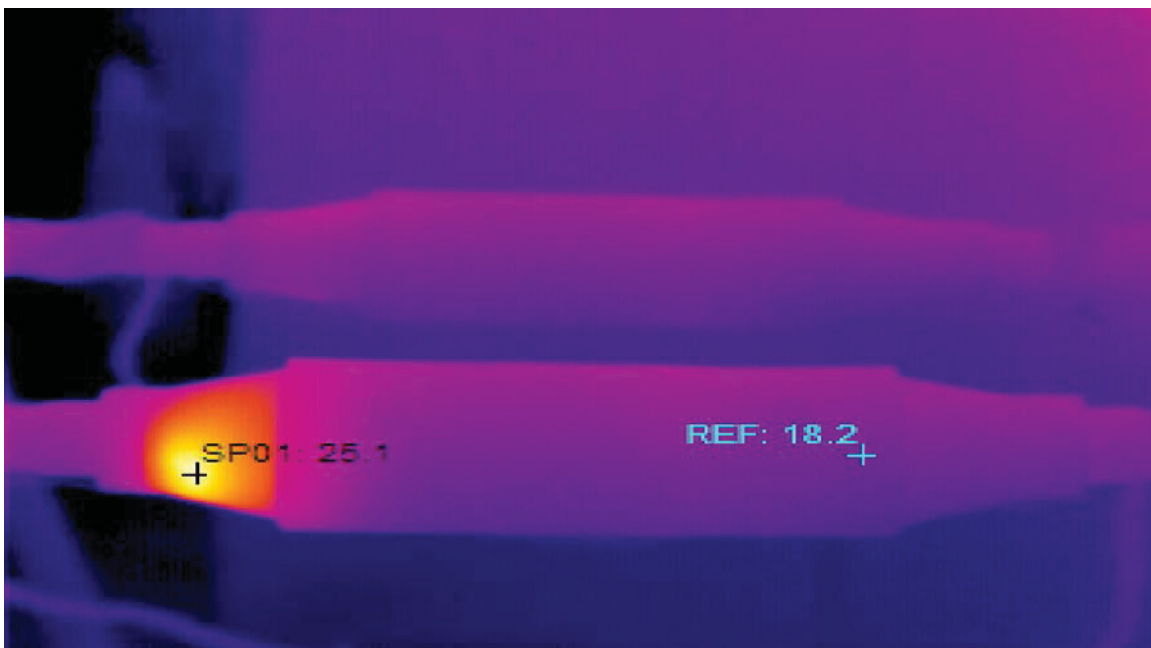
Figure 7.33. IR image – Hot spot in the bulk of insulation located on left side of cable splice. Image courtesy of and credited to © Hydro-Québec.

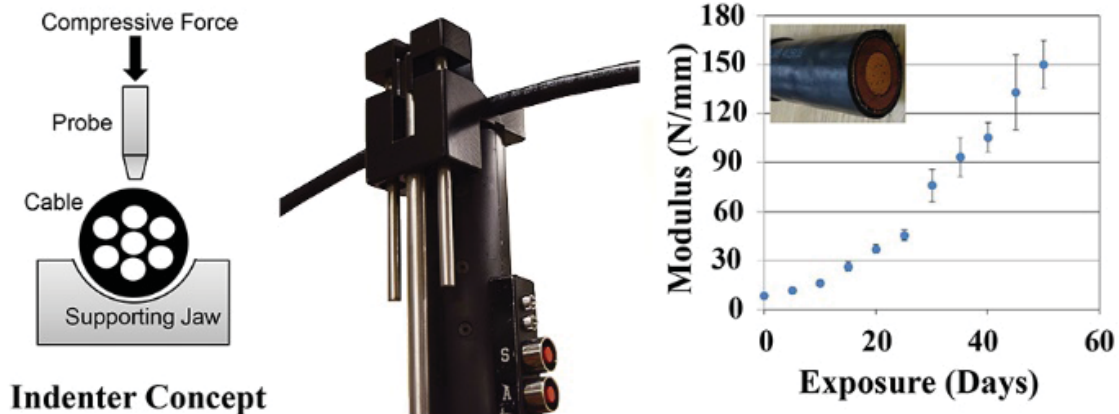
Figure 7.34. Probe, supporting jaw, and cable cross-section (*left*), instrument photo (*center*), and EPR cable modulus vs. exposure time (*right*).

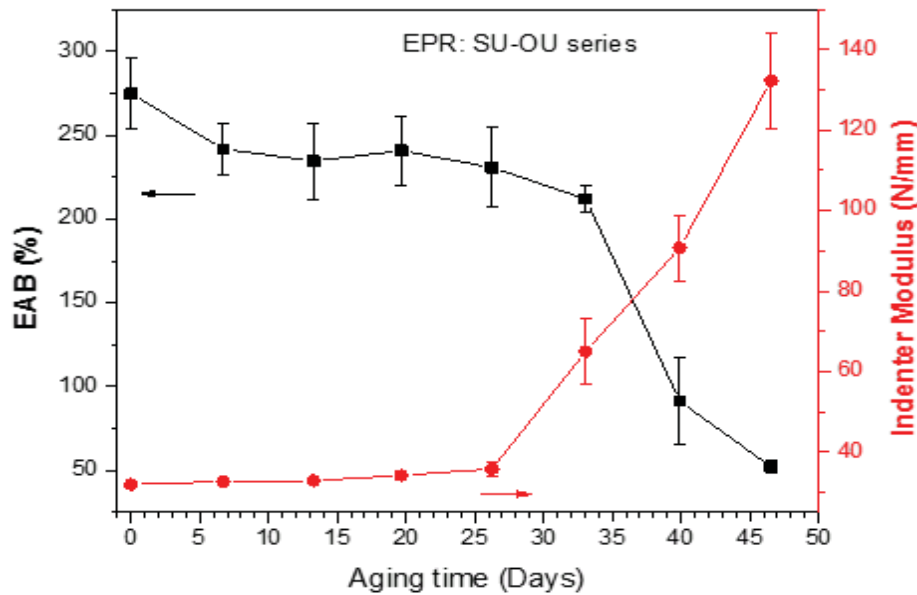
For most cable materials and particularly softer materials such as EPR, silicone rubber, and Hypalon jacket materials, the indenter modulus increases with aging and correlates well with changes in EAB (Figure 7.35). The method is less appropriate, however, for harder materials such as XLPE, some PVC formulations, or polyethylene that show smaller change in modulus with aging (IAEA 2012) or do not change significantly until the EAB is significantly degraded (EPRI 2011).

Figure 7.35. Typical EPR cable showing indenter modulus and %EAB with 1 standard deviation error bars. Note that the inflection point of both %EAB and indenter modulus occurs at the 25–30 day point, and thereafter both slope absolute values increase. Also note that %EAB is referenced to the initial sample length, not the unaged EAB.

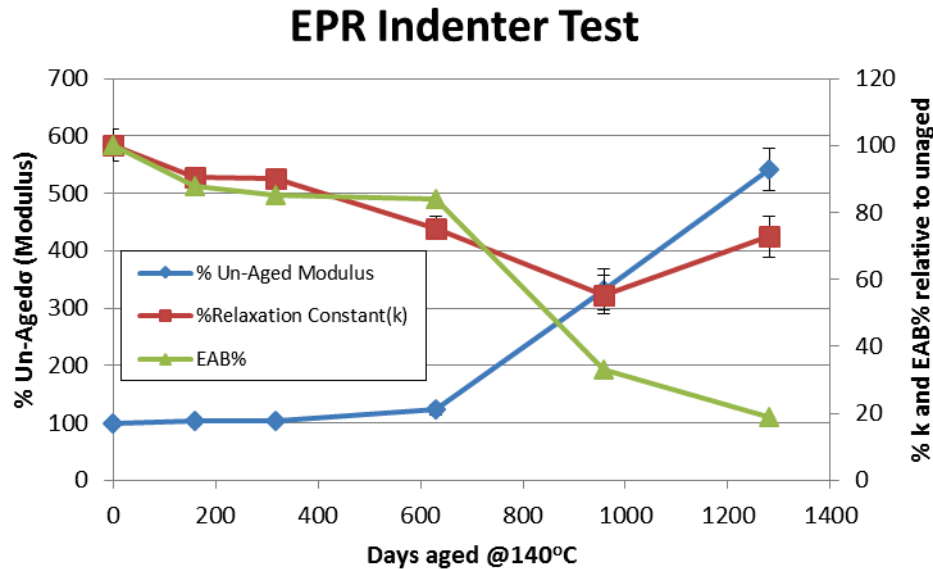
Figure 7.36. Normalized indenter modulus (left axis), plus relaxation constant ( $k$ ) and %EAB all normalized to the unaged values; i.e., each data point at 0 days = 100%.

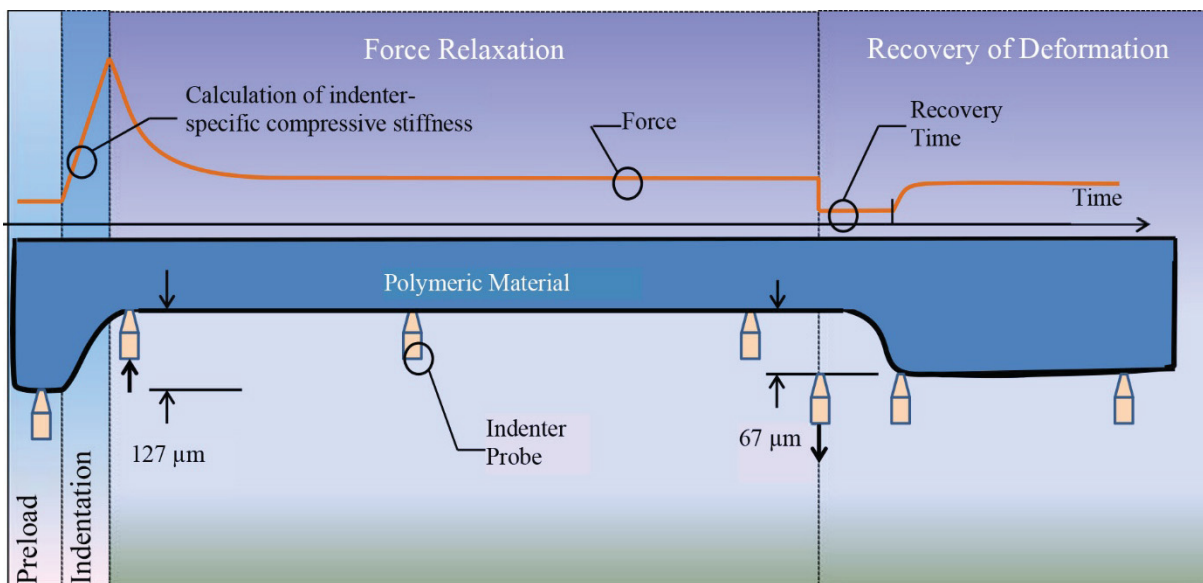
Figure 7.37. A typical test sequence showing the preload, indentation, force relaxation, and deformation recovery phases. The recovery phase is shown following a probe retraction equal to 50% of the initial indentation depth. Figure courtesy of Canadian Nuclear Laboratories.

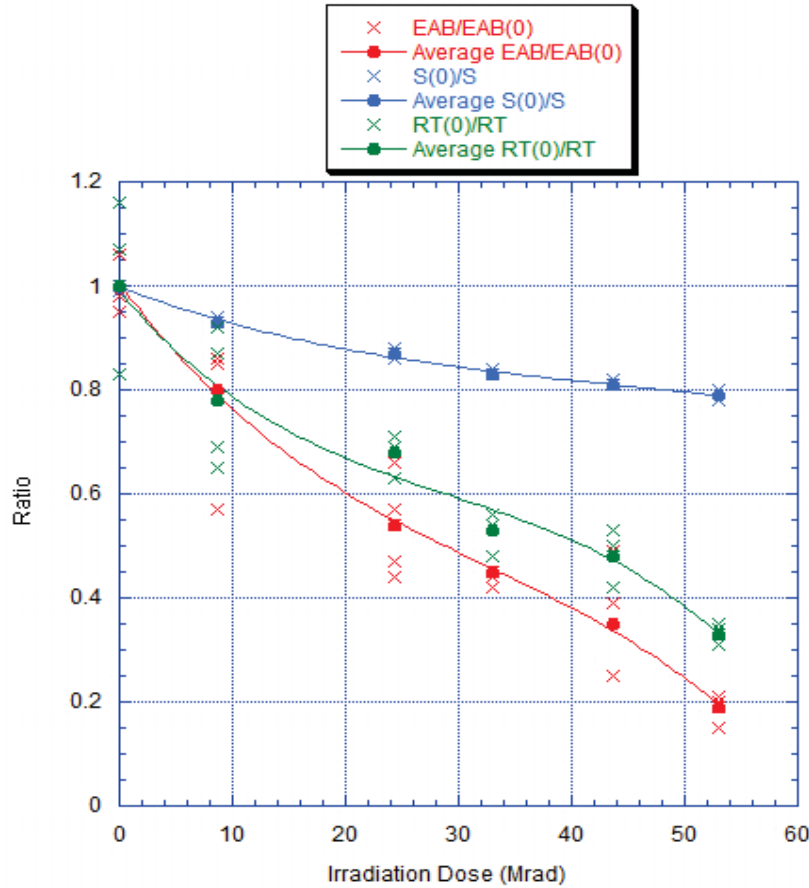
Figure 7.38. EAB and indentation results for irradiated XLPE insulation. Figure courtesy of Canadian Nuclear Laboratories.

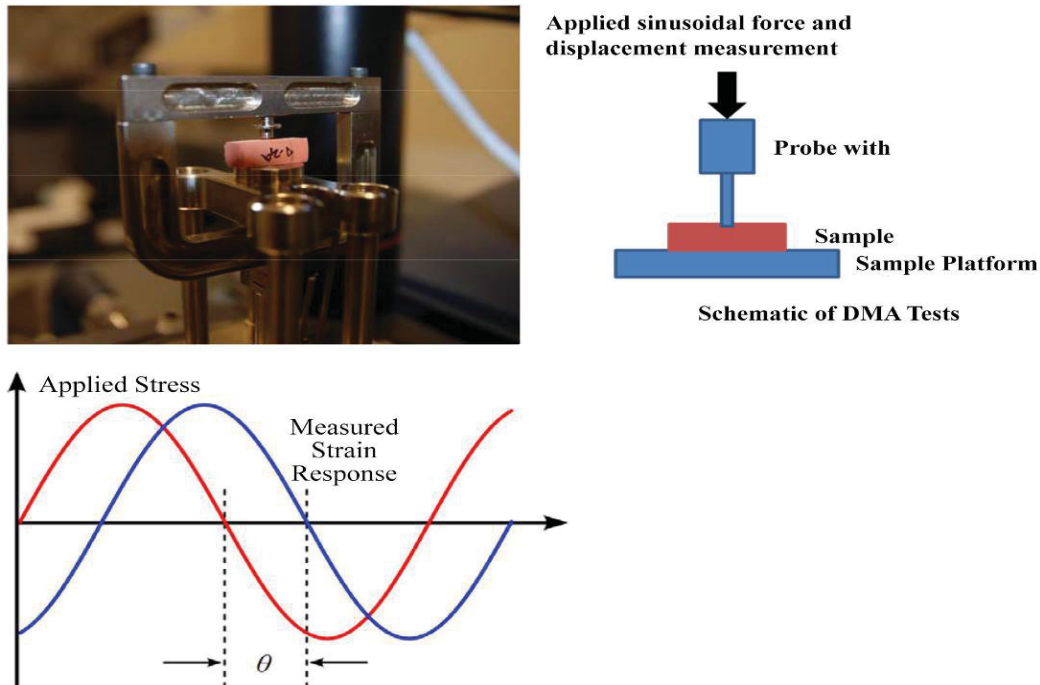
between the applied and measured conditions to calculate storage and loss moduli. The storage and loss moduli are the stored (elastic in-phase) and dampened (viscous out-of-phase) energy components, respectively. The ratio of the loss to stored moduli, measurement of energy dissipation in the material, is the  $\tan \delta$ . This can be thought of as a complex number and can be plotted as the absolute modulus magnitude and phase. The DMA was used to measure the material response to a mechanical swept-frequency stimulus from 1 to 100 Hz. A sample plot of this amplitude and phase DMA frequency response is shown in Figure 7.40 for an EPR cable that has been aged to an EAB less than 50% of its unaged condition. Note that the phase angle is quite low ( $9^\circ$ – $16^\circ$ ) placing the cable primarily in the elastic range. Moreover, there is no discernable trend or correlation for the phase variation with aging. The modulus however does seem to correlate with progressive cable thermal aging.

Figure 7.39. Image of the DMA instrument with compression tip for shear modulus and an illustration of a simple schematic and input/output waveforms for analysis.

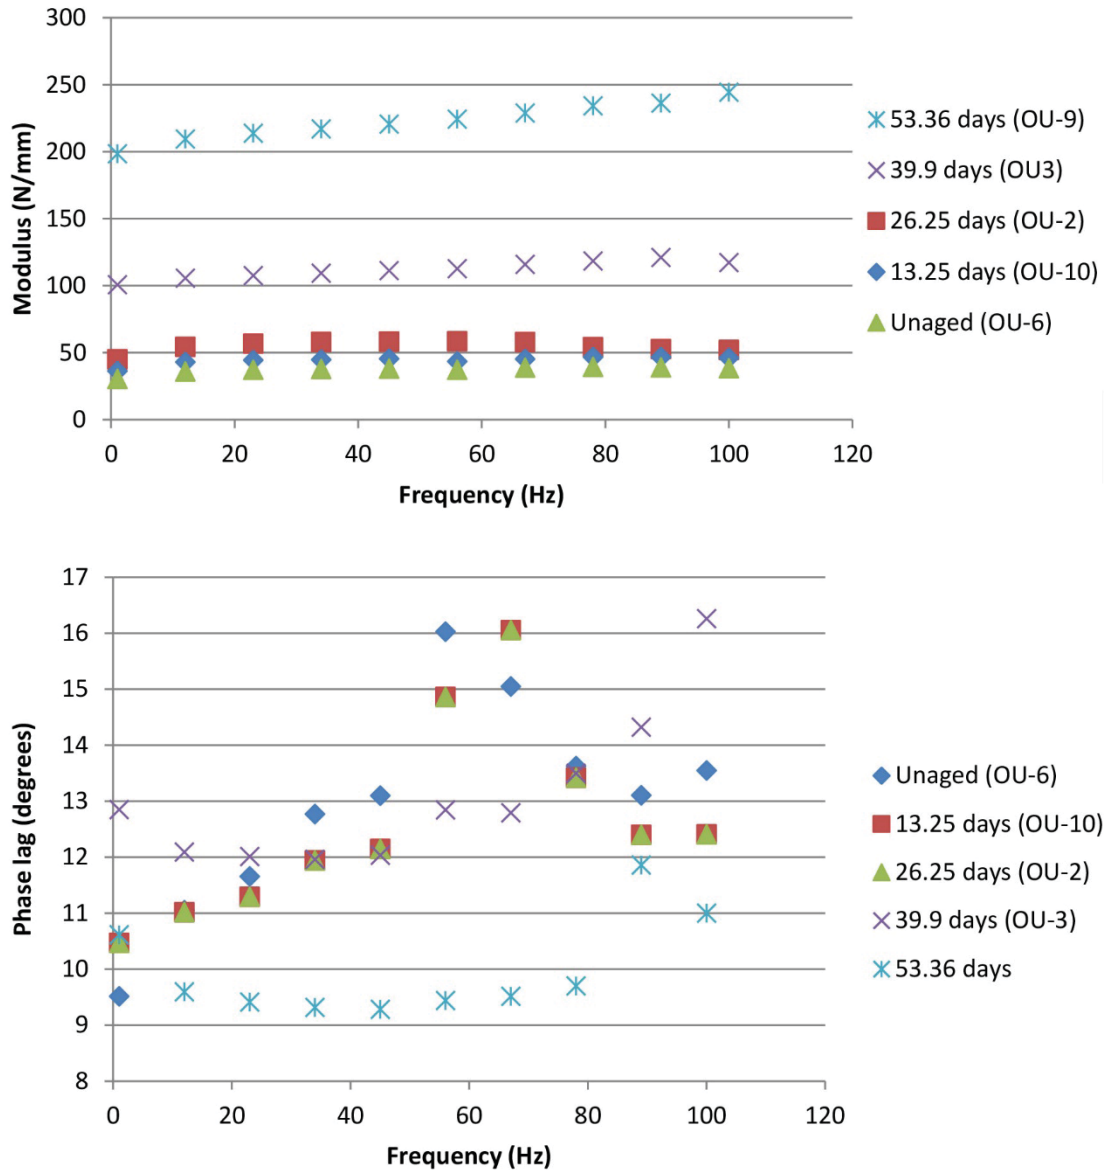
Figure 7.40. DMA modulus (*top*) and phase (*bottom*) frequency response measured for different degrees of cable aging from 0 to 53 days, which corresponded to an EAB reduction to <50% of the unaged condition.

Note that the DMA modulus units are the same as the indenter modulus,  $\sigma$ . Moreover, the low frequency data is not substantially different from the higher frequency data. The change in both the indenter and DMA moduli are shown in Figure 7.41. Both instruments show a similar trend with the cable age. There are some differences in the phase angles particularly in the 45–65 Hz range and the 100 Hz range but these differences are still relatively small. There may be some additional information in the multi-frequency DMA test, but the difficulty of performing a field measurement with the laboratory DMA is far greater than with the indenter that was designed for field applications.

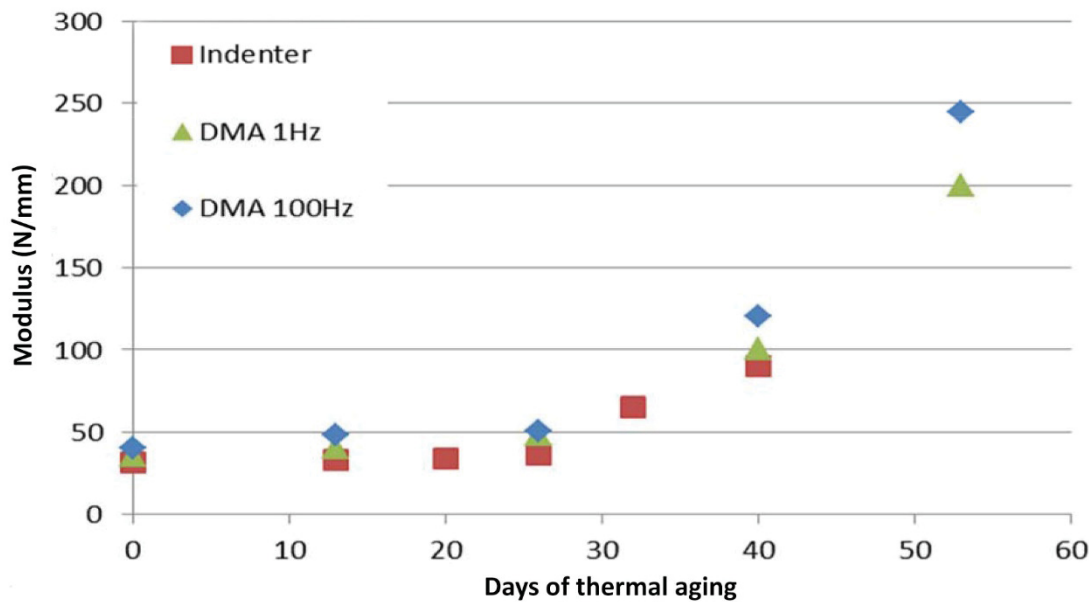
Figure 7.41. Indenter modulus plus the 1 Hz and 200 Hz DMA responses for thermally aged EPR cable at 140°C from 0 to 53 days, which corresponds to >50% reduction in %EAB.

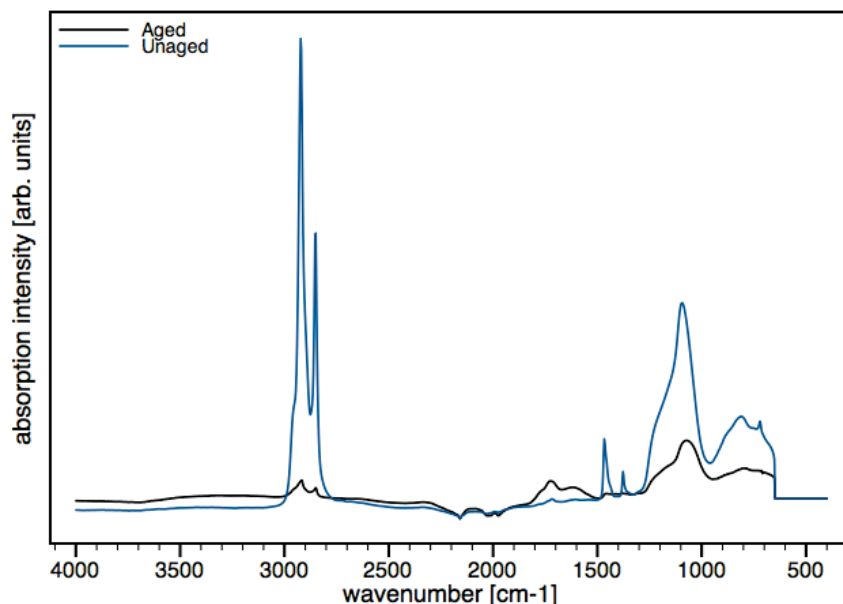
indication of polymer oxidation and that carbonyl bonds are being generated. Other wavelengths can also show aging as evidenced in Figure 7.42. This is an extreme example FTIR spectrum of aged and unaged pink EPR material. The EPR cable insulation material was milled into a powdered, particulate form and aged in a circulating air oven at 140°C to investigate chemical property changes in a form of the material easier to characterize than fully intact insulation. FTIR absorption peaks associated with unsaturated carbon bonds in the as-produced EPR (2800–3000  $\text{cm}^{-1}$ ) were observed to decrease with aging of the material at 140°C in air, and new peaks associated with carbonyl (~1700  $\text{cm}^{-1}$ ) and hydroxyl groups (3000–3500  $\text{cm}^{-1}$ ) were observed to appear. The contrasting spectra are also provided. These changes in infrared absorption with cable aging provide a method to assess the extent of cable degradation. In-situ results would be less dramatic as the influence of oxidation would be sensitive to surface proximity; however, the technique’s sensitivity to chemical changes in the material is dramatically demonstrated in this example.

Figure 7.42. FTIR spectra of aged and un-aged EPR.

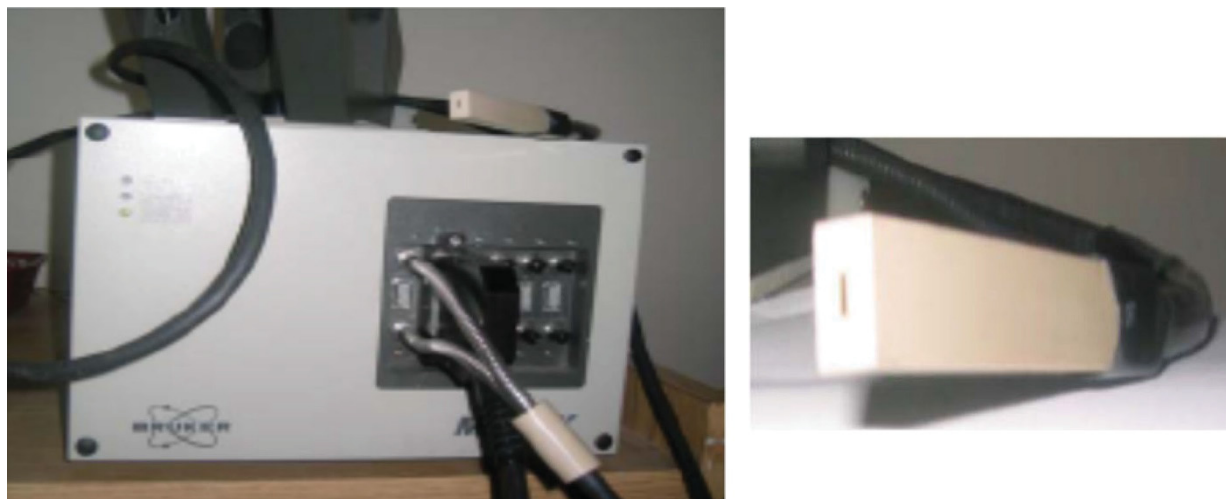
Figure 7.43. FT-NIR spectrometer (inset: the cable insulation probe). Image courtesy of NIR Technologies Inc.

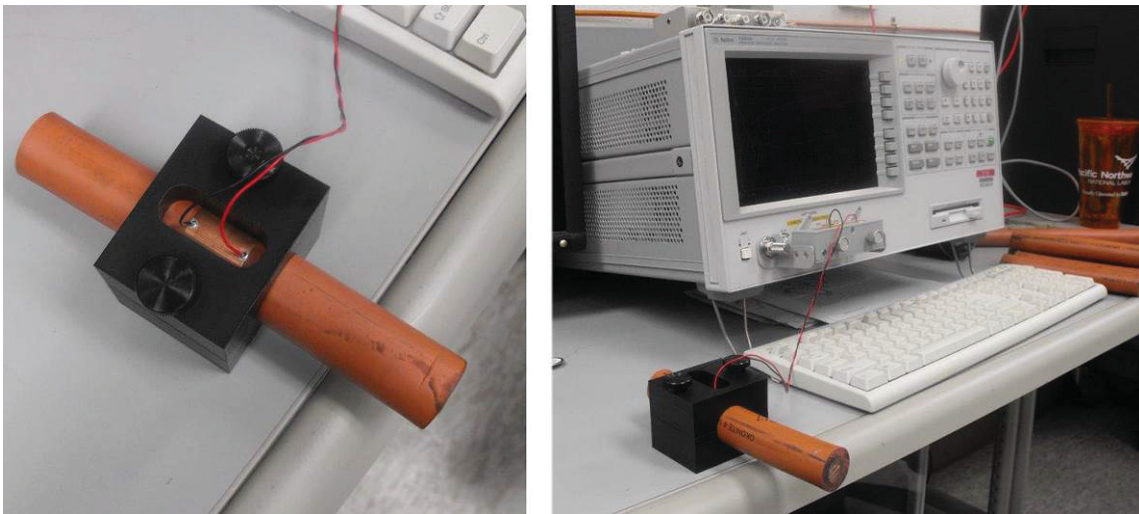
Figure 7.44. Experimental configuration for capacitance measurements showing impedance analyzer and clamshell fixture used to wrap the sensor onto the outer surface of the cable.

The interdigital sensor shown in Figure 7.44 consists of a 15-digit capacitor printed on a thin flexible polyimide substrate with an approximate width of 13 mm and length of 25 mm. Separation between the capacitor digits was 1 mm (0.004 in.). The diameter of the Okoguard 15 kV cable is approximately 25 mm (1 in.) and the capacitor was in direct contact with the EPR insulation. There was no jacket. Figure 7.45 shows the simulation model of the sensor wrapped onto the cable insulation and the electric field distribution through the cable cross section. For this design, the calculated electric field penetrated into the uppermost 1–2 mm of the cable insulation and the capacitance measurements are performed over a frequency range of 10–100 MHz. Measurements were conducted with the laboratory impedance analyzer measuring both capacitance (F) and capacitive dissipation factor (D) where D is defined as the tangent of the difference of the phase angle between capacitor voltage and current caused by dielectric losses within the capacitor.

Recent work has been published on the design of interdigital sensors that was begun for NDE of aircraft wire insulation dielectric properties to detect material degradation (Sheldon and Bowler 2014) and extended for application to cable aging management in NPPs. The idea is that the insulation material dielectric constant is affected by both thermal and radiation aging similarly to the mechanical properties that are measured by EAB and indenter modulus. Because the capacitance of the electrode in contact with the cable insulation is proportional to the material dielectric constant and independent of the applied test voltage, this type of test seems to be an approach that could be easily implemented for field testing. The test uses low-voltage excitation so no high-voltage precautions need be made prior to or during the test. Field test equipment could be made sufficiently portable to take inside a nuclear containment facility. Testing would be relatively quick for each location. PNNL has performed some laboratory validation tests using an impedance analyzer that could operate at multiple frequencies. Only single-side access to the cable is required. Although the clamp shown goes fully around the cable, the wire sensor spans less than 180° around the cable circumference Figure 7.44.

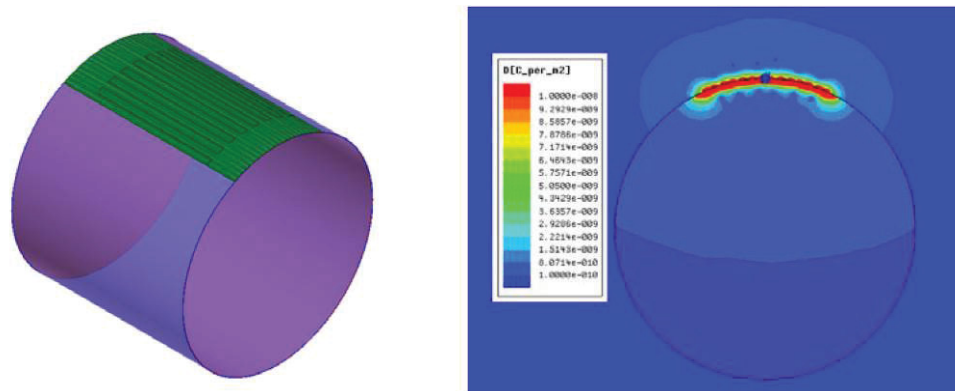
Figure 7.45. Electrostatic field simulation model of interdigital capacitive sensor and electric flux distribution inside cable insulation.

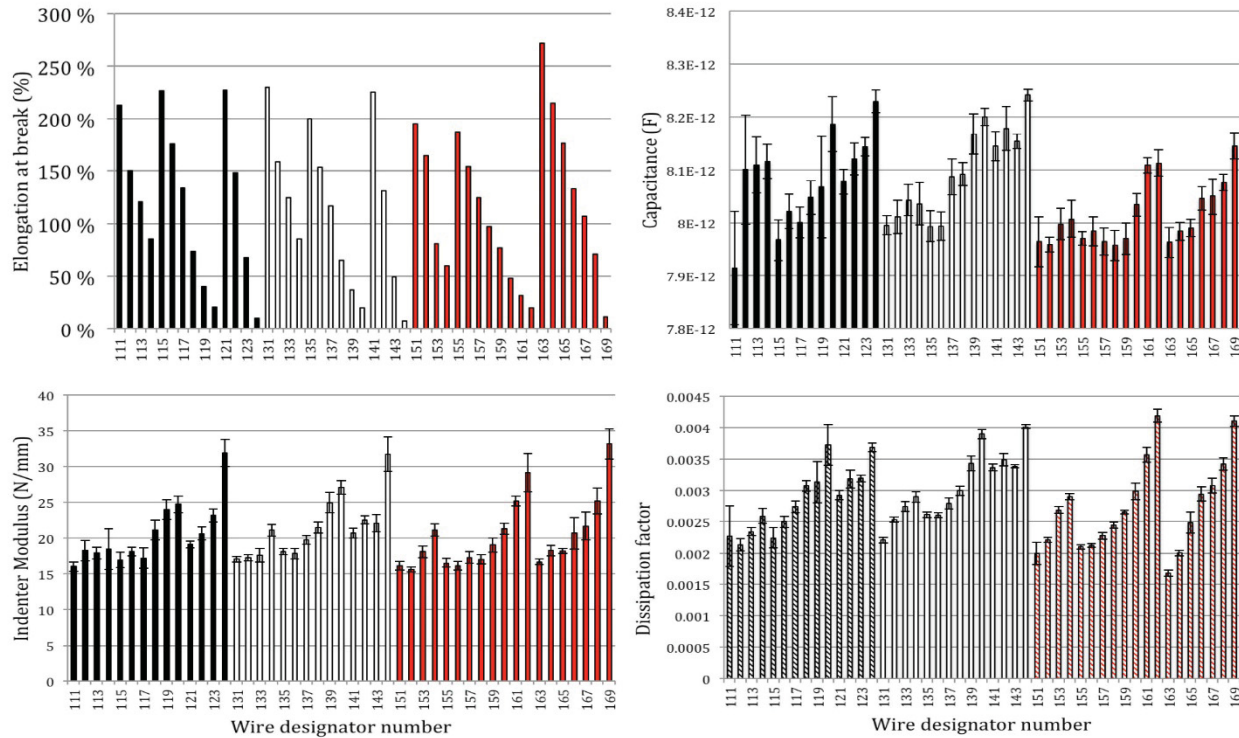
A similar arrangement was applied by researchers at Iowa State University to correlate EAB and indenter measurements with capacitance (F) and dissipation factor (D) (Arvia et al. 2014). One sample set of measured results versus thermal aging is shown in Figure 7.46. Good correlations for both indenter modulus and EAB were shown for EPR cable insulation, although these correlations vary with material, insulation color, and excitation frequency. Practical implementation of the interdigital capacitance test does not separate the effect of the jacket and the insulation, although this may be possible with further development. As of the publication date of this report, this capacitance measurement technique has not been commercialized as a field-deployable system.

Figure 7.46. EPR accelerated aging cable test response for EAB: indenter modulus ( $\sigma$ ), capacitance (F), and dissipation factor (D) (Arvia et al. 2014) © 2014 IEEE. Reprinted with permission.

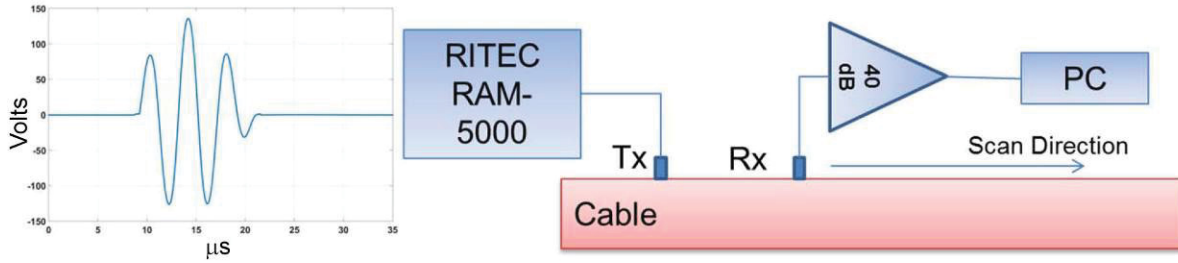
These two relations indicate that sound speed measurements may be a proxy to measuring the elastic modulus. Several studies have shown a strong correlation between aging jacket material and speed of sound for PVC sheaths and jacket material (Ikehara et al. 1998). PNNL tried to use these techniques on EPR cable samples with limited success. The EPR samples are relatively soft material with strong sound attenuation and due to signal distortion along the sound path, some variability of the sound velocity measurement was observed. To counter this, the cable was scanned as shown in Figure 7.47.

Figure 7.47. UT velocity measurement setup for EPR cable.

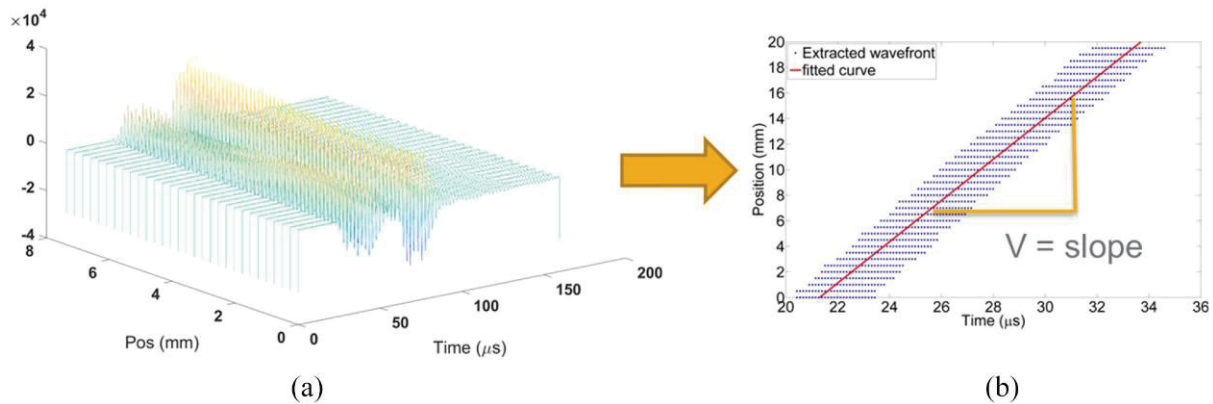
The arrival time of the transmitted waveform was difficult to pinpoint. Several advanced algorithms were attempted including auto-correlation, spatial-temporal 2-D Fourier transforms, and scanned least-squares fit regression analysis of the constant phase demarcation of the first-arrival wave packet. The regression analysis produced the most reliable repeatable velocity measurements (Figure 7.48).

Figure 7.48. Waveforms at each scan location (a) are discretized for first arrival wave-packet. This position/time plot is then subject to a regression analysis for more consistent velocity measurement (b).

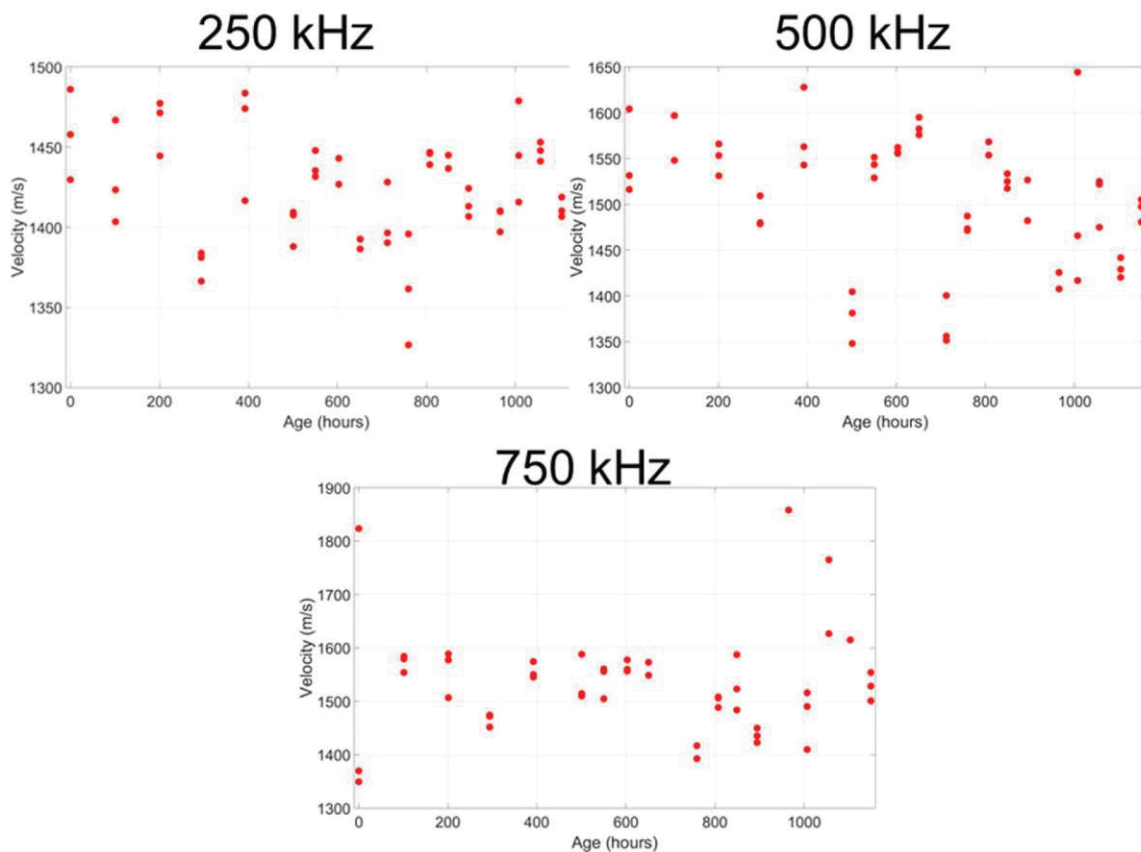
This approach was used to measure the sound velocity in a set of EPR samples exposed to up to 1200 hrs. (50 days) at 140°C (Figure 7.49). Such a period of thermal aging would be expected to reduce the EAB to below 25%. Transducer excitation frequencies of 250 kHz, 500 kHz, and 750 kHz were used. Significantly higher frequencies were rejected due to material attenuation, which limited sound propagation beyond a few inches. There was still some spread in the data but most of the measurements were relatively consistent. The sound velocity results, however, showed poor correlation with the EPR sample's thermal exposure time.

Figure 7.49. EPR ultrasound velocity as a function of accelerated thermal at 140°C aging shows poor correlation.
