# Fracture Toughness and Fatigue Crack Growth Rate Testing of Baffle-Former Bolts Harvested from a Westinghouse Two-Loop Downflow Type PWR

Light Water Reactor Sustainability (LWRS) Program  
M2LW-21OR0402053

Materials Science and Technology Division  
Oak Ridge National Laboratory

September 2021

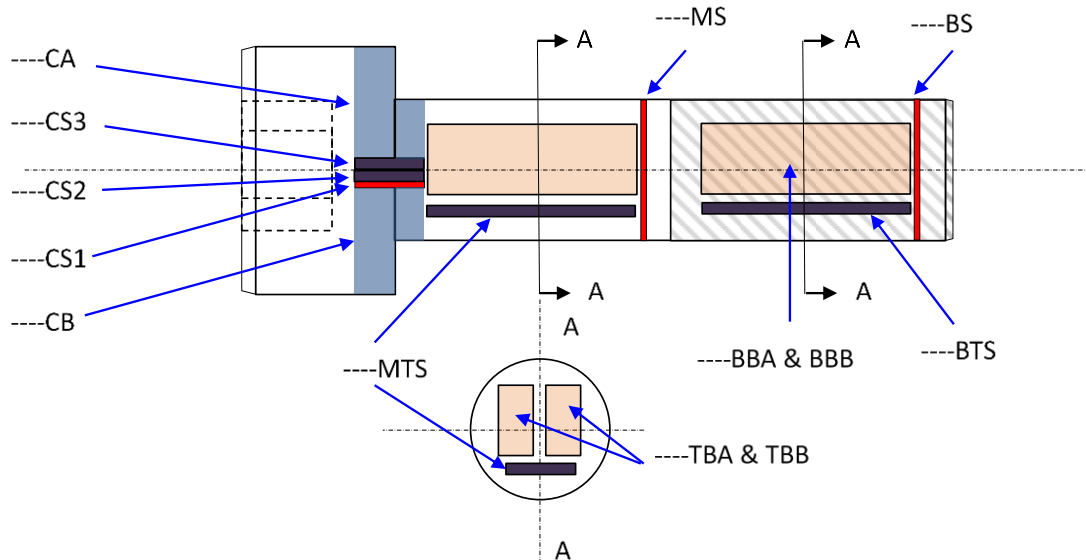
Figure 2.3 Schematic for sample IDs from machined BFBs [7]

----: bolt number, **CS**: collar slice, **CA & CB**: remaining collar materials, **MS**: middle slice, **BS**: bottom slice, **MTS**: middle thick slice, **BTS**: bottom thick slice, **TBA & TBB**: top bend bar, **BBA & BBB**: bottom bend bar

The specimen machining plan and the schematic for specimen ID are shown in Figure 2.2 and Figure 2.3, respectively. For each BFB, four bend bar specimens and seven thin slice specimens have been machined. The bend bar specimens were used in the fracture toughness and fatigue crack growth rate studies of this report, whereas the thin slice specimens are planned for subscale tensile and microstructural analyses. Specimens were machined from different fluence regions of each bolt, allowing for studies of the effect of fluence on the microstructural and mechanical properties of BFBs. Three thin slice specimens were machined from the high-stress concentration region, i.e., the transition between the bolt head and shank, of each bolt to allow for further investigation of possible crack initiation sites. The IDs of bend bar specimens characterized in this study are summarized in Table 2.3 with

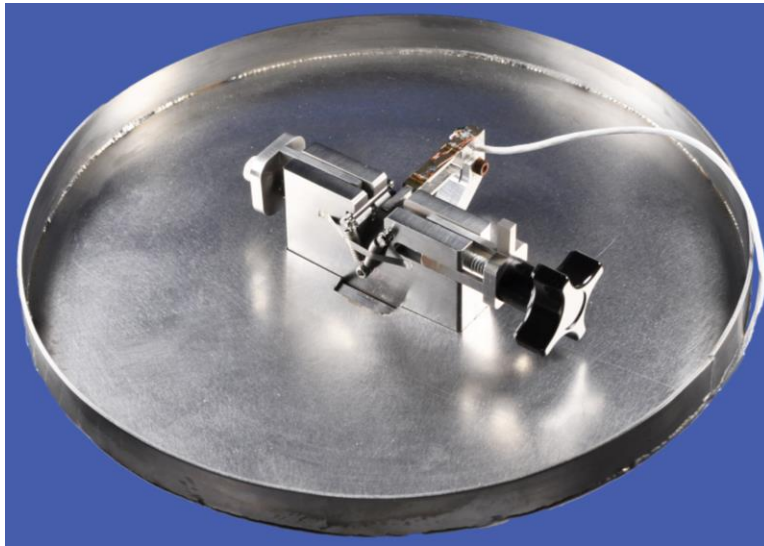
Figure 2.6 Bend bar test fixture: (a) isometric-view; (b) top-view

Due to the non-standard size of the bend bar specimen, we have designed a dedicated testing fixture to perform fracture toughness and FCGR testing. As shown in Figure 2.6, the deflection gauge attached to the specimen fixture center was used to measure the load-line displacement of the specimen. The sliding bar from the left side of the fixture was used to perform a coarse alignment of the specimen while the

threaded-hole knob from the right side was used to perform a fine adjustment of the specimen position so that the bend specimen was centered for the load pins and top indenter as shown in Figure 2.7.

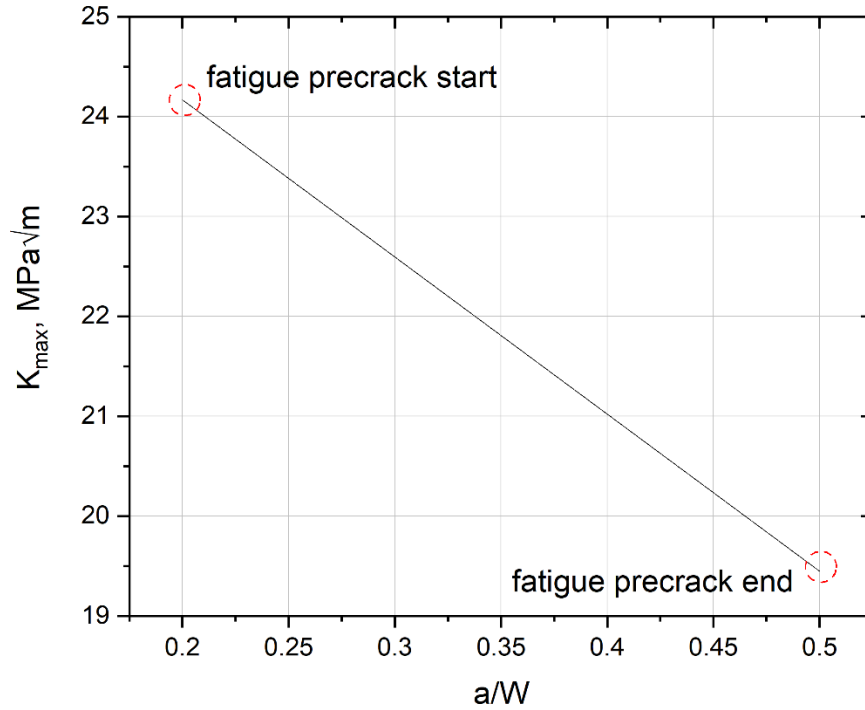
Figure 2.8  $K_{\max}$  vs.  $a/W$  relationship in the fatigue precracking prior to fracture toughness testing

Fracture toughness testing was performed according to the ASTM E1820 Standard Test Method for Measurement of Fracture Toughness [8]. Prior to fracture toughness testing, each bend bar specimen was fatigue precracked to  $a/W=0.5$  ( $a$ : crack size,  $W$ : specimen width) using a sinusoidal waveform. The fatigue frequency was at  $\sim 10$  Hz under a stress ratio  $R=0.1$ . Fatigue precracking was performed under stress intensity  $K$  control such that the maximum stress intensity  $K_{\max}$  started around  $24.17 \text{ MPa}\sqrt{\text{m}}$  and decreased linearly as the crack grew and reached  $19.45 \text{ MPa}\sqrt{\text{m}}$  at the end of fatigue precracking. Figure 2.8 shows the typical  $K_{\max}$  vs.  $a/W$  relationship in the fatigue precracking. The applied fatigue precracking stress intensity was within the allowable stress intensity limit per ASTM E1820 and also below the maximum allowable fatigue force ( $P_m$ ) given by:

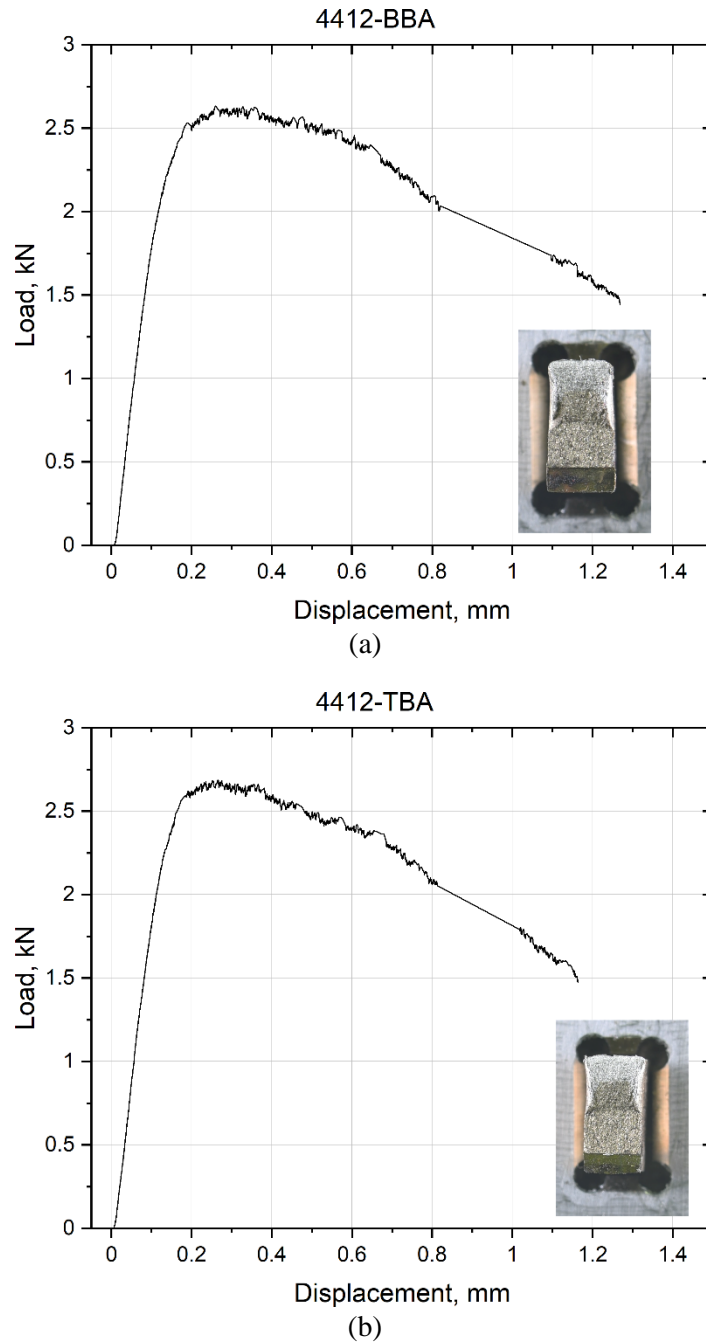
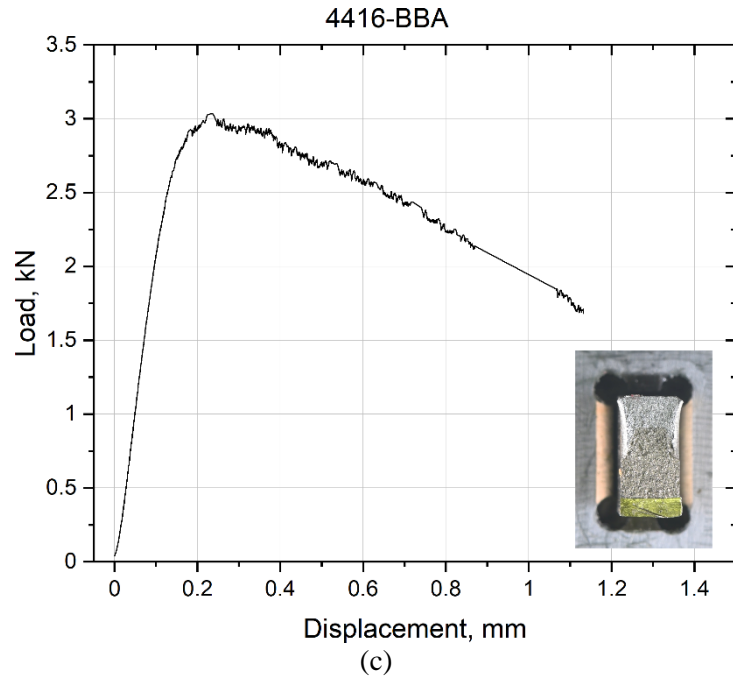
Figure 3.1 Load-displacement curves and fracture surface images for (a) 4412-BBA, (b) 4412-TBA, (c) 4416-BBA, (d) 4416-TBA.

All four bend bar specimens exhibited stable ductile crack growth in fracture toughness testing. This can be shown from the load-displacement curves and fracture surface images after testing (Figure 3.1). The load decreased smoothly after passing the maximum load and dimpled fracture morphology was observed from the fracture surface.

- 1) All four bend bar specimens exhibited stable ductile crack growth in fracture toughness testing.
- 2) The initiation fracture toughness  $J_q$  were similar and in the range of 40-60 kJ/m<sup>2</sup> for four bend bar specimens indicating the saturation of irradiation embrittlement.
- 3) Compared with the unirradiated condition, in-service neutron irradiation resulted in significant degradation of BFB fracture toughness, and the degradation was in line with current literature results.
- 4) Four bend bar specimens demonstrated similar FCGR behaviors manifested by a threshold stress intensity  $\Delta K_{th}=11-13$  MPa $\sqrt{m}$  and the stable crack growth region (i.e., Paris's law region).
- 5) The FCGR results fill the data gap of fatigue crack growth behavior of irradiated SS.

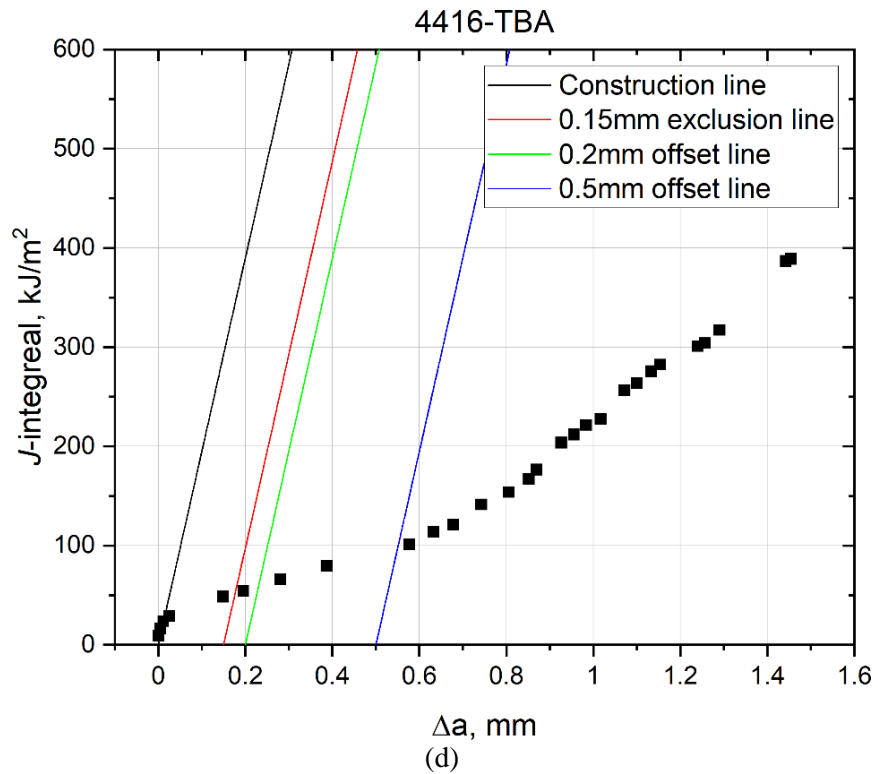
Figure 3.2 J-R curves for (a) 4412-BBA, (b) 4412-TBA, (c) 4416-BBA, (d) 4416-TBA.

The corresponding J-R curves derived from the Normalization method are shown in Figure 3.2. Among all four tested specimens, a similar trend in the J-R curve can be observed: the initiation fracture toughness  $J_q$  was fairly low; after crack initiation, the additional driving force was needed for the crack to propagate and the resistance for further crack growth significantly increased when the crack extension  $\Delta a$  reached  $\sim 0.7$  mm. This seems to contradict the results reported in Ref. [5] where most J-R curves did not show a significant increase in the slope. While further study is needed to understand the cause, possible explanations include the specimen size effect, non-standard span to width ratio, and issues with the test

fixture. However, all these factors should not affect the initiation fracture toughness determined in this study.

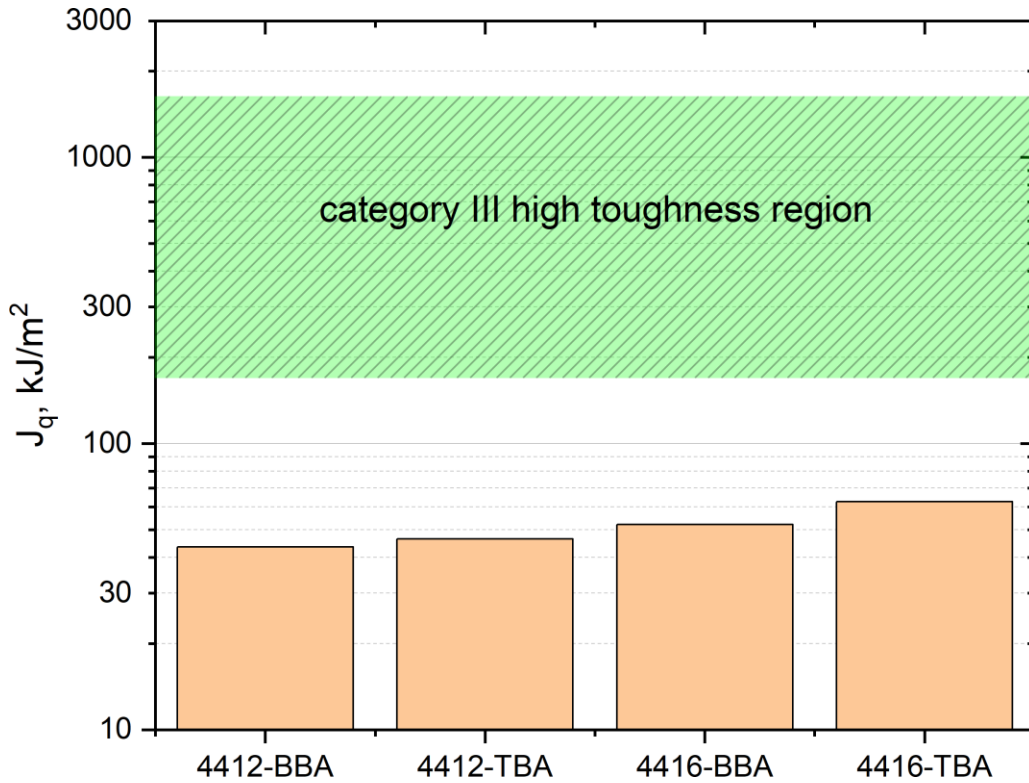
Figure 3.3 Comparison of initiation fracture toughness  $J_q$  among four tested bend bars

As shown in Figure 3.3, the initiation fracture toughness  $J_q$  of four bend bar specimens were quite similar in the range of 40-60  $\text{kJ/m}^2$  and the small difference observed is within the measurement uncertainty

in J-R curve testing. Indeed, Table 2.2 shows the lowest irradiation damage for both bolts was approximately 15 dpa which already exceeded the saturation dose level (10 dpa based on Ref. [5]) for irradiation embrittlement. It is worth noting that wrought SS materials used for making both bolts have a category III initiation fracture toughness between 169 and 1660 kJ/m<sup>2</sup> at the unirradiated condition [5] (green shaded region in Figure 3.3). Compared with the post-irradiation initiation fracture toughness, the in-service neutron irradiation resulted in significant degradation of materials fracture toughness. This is in line with reports reported for both light water reactors (LWRs) and fast reactors [5].

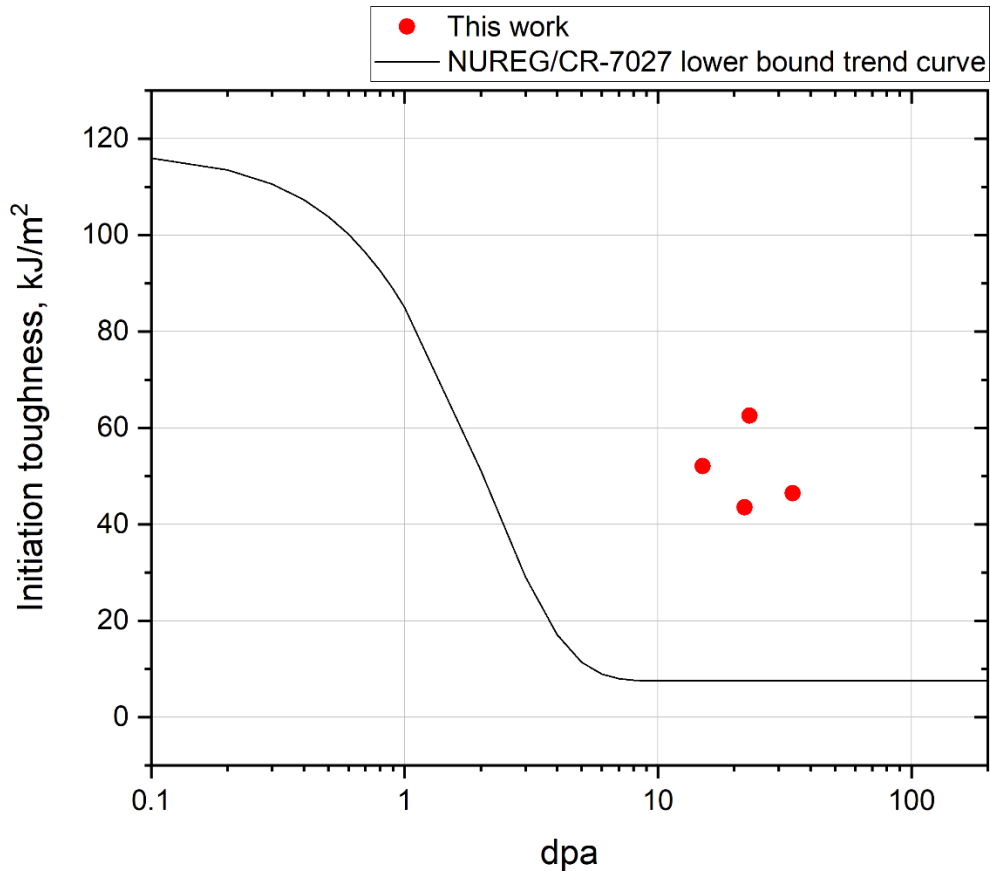
Figure 3.4 Comparison of NUREG/CR-7027 [5] low bound trend curve vs. the

Figure 3.4 evaluates if the initiation fracture toughness results in this work can be bounded by the initiation fracture toughness lower bound trend curve defined in the Nuclear Regulatory Report NUREG/CR-7027[5]. The trend curve was developed for a variety of wrought austenitic SS, cast SS, and weld metals and can represent the worst-case scenario. All data points from this work are above the trend line indicating our results are reasonable and within the lower bound of the existing database.

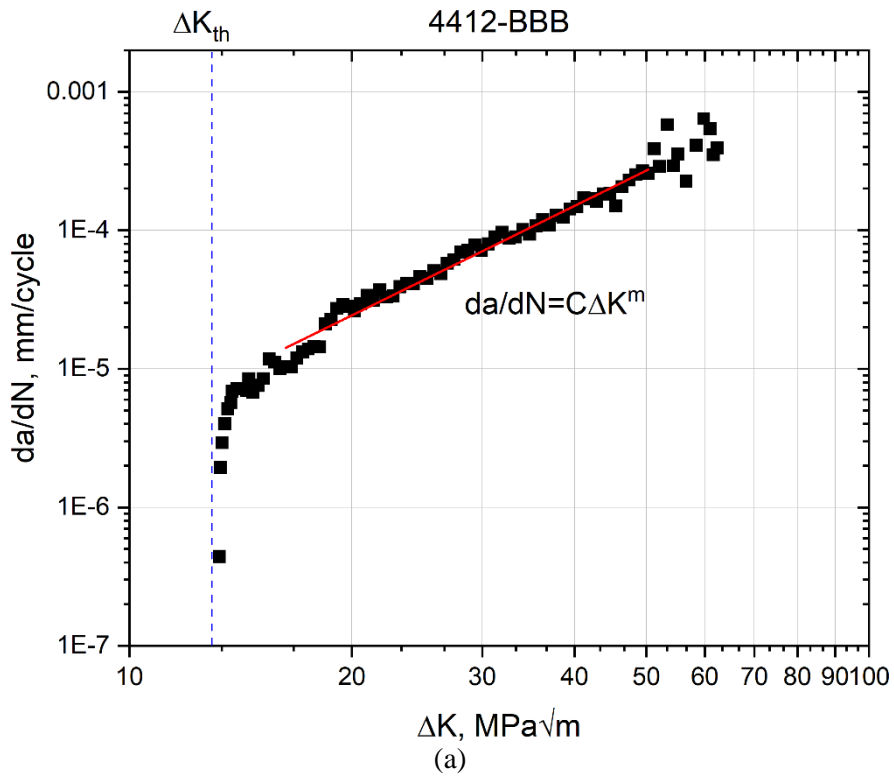
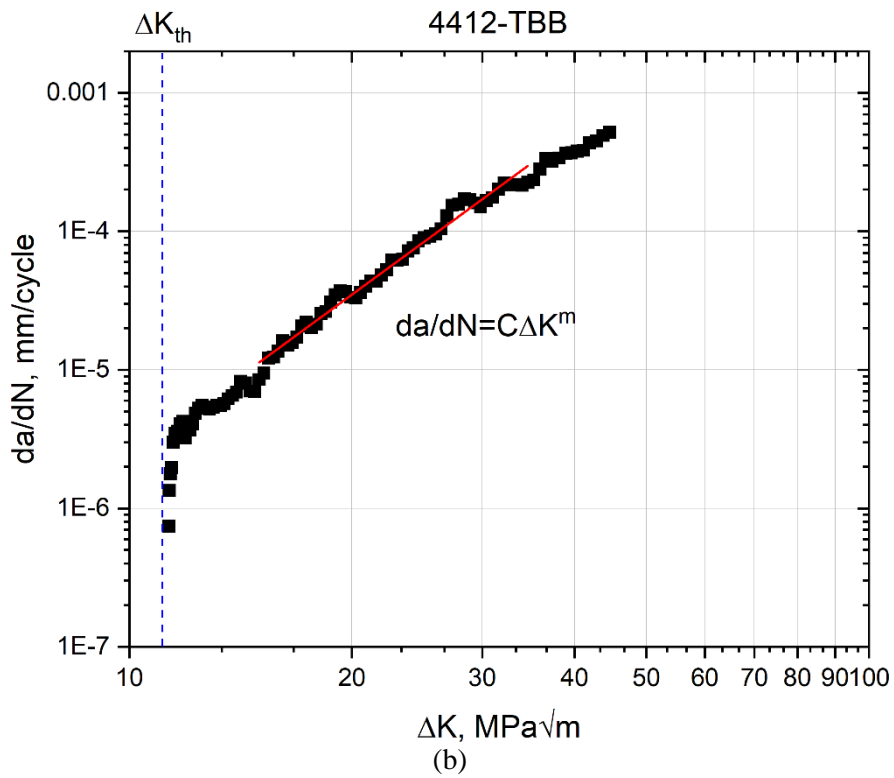
Figure 3.5 Relationship between  $da/dN$  and  $\Delta K$  for (a) 4412-BBB, (b) 4412-TBB, (c) 4416-BBB, (d) 4416-TBB.

In FCGR testing, four bend bar specimens demonstrated similar behavior. The relationships between the crack growth rate per cycle,  $da/dN$ , and the stress intensity range ( $\Delta K = K_{max} - K_{min}$ ) are shown in Figure 3.5. At around  $\Delta K_{th}=11-13 \text{ MPa}\sqrt{\text{m}}$ , crack initiated from the fatigue precracking end and started to grow. Afterward, the test gradually transitioned into Paris's law region [15], i.e.,  $da/dN=C\Delta K^m$  where  $C$  and  $m$  are materials coefficients and also depend on the testing environment, fatigue frequency, temperature, stress ratio, etc. The threshold stress intensity  $\Delta K_{th}$  and Paris's law region slope  $m$  were analyzed and summarized in Table 3.1. At the time of preparation of this report and to the best of our knowledge, the FCGR results for irradiated SS are not available in the literature. Therefore, results from our current study fill the current data gap in this area.

Specimen ID	$\Delta K_{th}$ (MPa $\sqrt{m}$ )	m	Fitting R <sup>2</sup>
4412-BBB	12.9	2.63	0.976
4412-TBB	11.1	3.91	0.984
4416-BBB	11.8	3.36	0.914
4416-TBB	11.9	4.28	0.986
