Investigation of Thermal Aging
Behavior for Harvested Crosslinked
Polyethylene and Ethylene-Propylene
Rubber Cable Insulation

Pacific Northwest National Laboratory

PNNL-27729

July 27, 2018

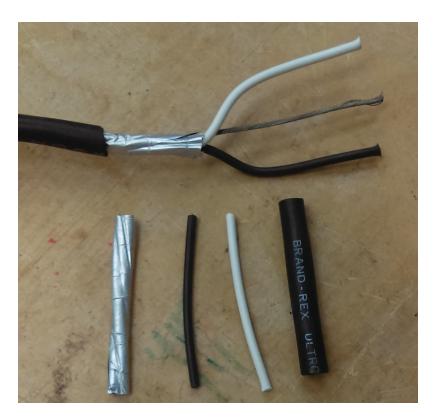
Figure 1. The Brand-Rex Ultrol 600V, shielded #16 gauge instrumentation cable

The Brand-Rex XLPE cable studied in this work, PNNL ID# XC25, was manufactured in 1986 and installed in the CR3 main feed water system in 1994. It was designated as 'maintenance rule', but not 'safety-related'. The cable jacket is labeled "BRAND-REX ULTROL INSTRUMENTATION CABLE 600V 1 SHIELDED PR #16 AWG 23XXX". As seen in Figure 1, it is constructed with a black CSPE overall jacket and two XLPE-insulated, 16-gauge conductors: one white and one black. It is 600V-rated cable, but operated at 24 VDC, with operational current of 4-20 mADC and 100% duty factor. The results described herein are for the white insulation, PNNL ID# XX28.

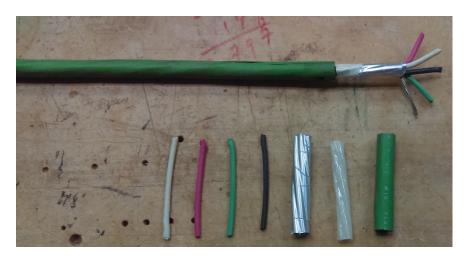
Figure 2. The Anaconda-Y 4/C #16 Flame-Guard FR-EP 600V cable components.

The Anaconda EPR cable studied in this work, PNNL ID# AC19, was manufactured in 1985 and installed in the CR3 reactor coolant system in the same year. It was designated as 'safety-related' and 'maintenance rule'. The cable jacket is labeled "ANACONDA-Y 4/C #16 FLAME-GUARD FR-EP 600V". It is constructed with a green, chlorosulfonated polyethylene (CSPE) overall jacket, seen in Figure 2, and four EPR-insulated, 16-gauge conductors: white, red, black, and green. It is 600V-rated cable, but had an operational voltage of 5 VDC and operational current less than 5 mADC with a 100% duty factor. The results described herein are for the white insulation, PNNL ID# AE21.
