## Nondestructive Evaluation Techniques for Nuclear Power Plant Concrete Structures

Materials Aging and Degradation Pathway

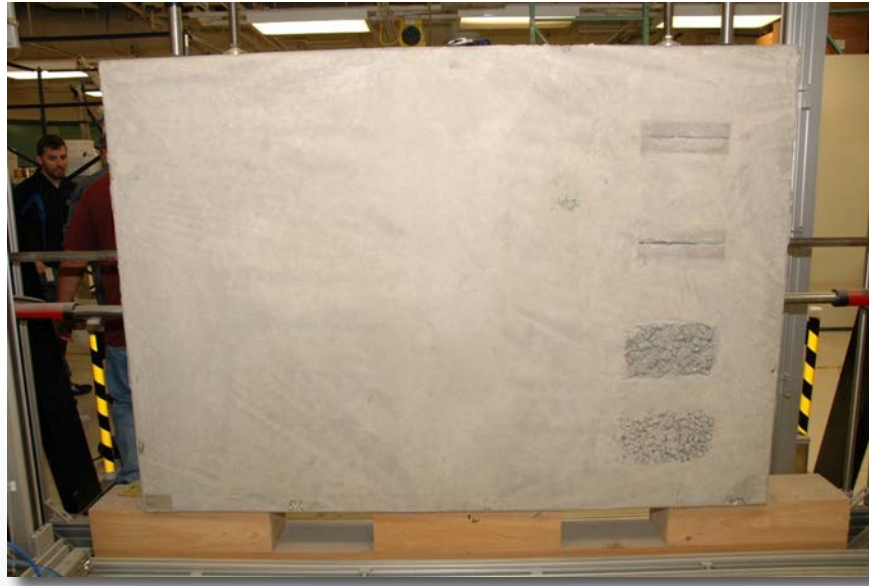
**Figure 1. Photo of the void and flaw detection block, with surface defects visible.**

One of the most common applications for NDE methods in the construction industry is in evaluating the quality of consolidation in a completed concrete structure. Movement of rebar after initial set, over/under vibration, mix segregation, and development of bleed water pockets can all lead to entrapped voids within a concrete structure and compromise its structural integrity. For these reasons, an NDE block was fabricated that contains forced honeycombing, delamination, and entrapped air around rebar, as well as simulated cracking. A photograph of the void and flaw detection block, with the surface defects visible, is shown in Figure 1.

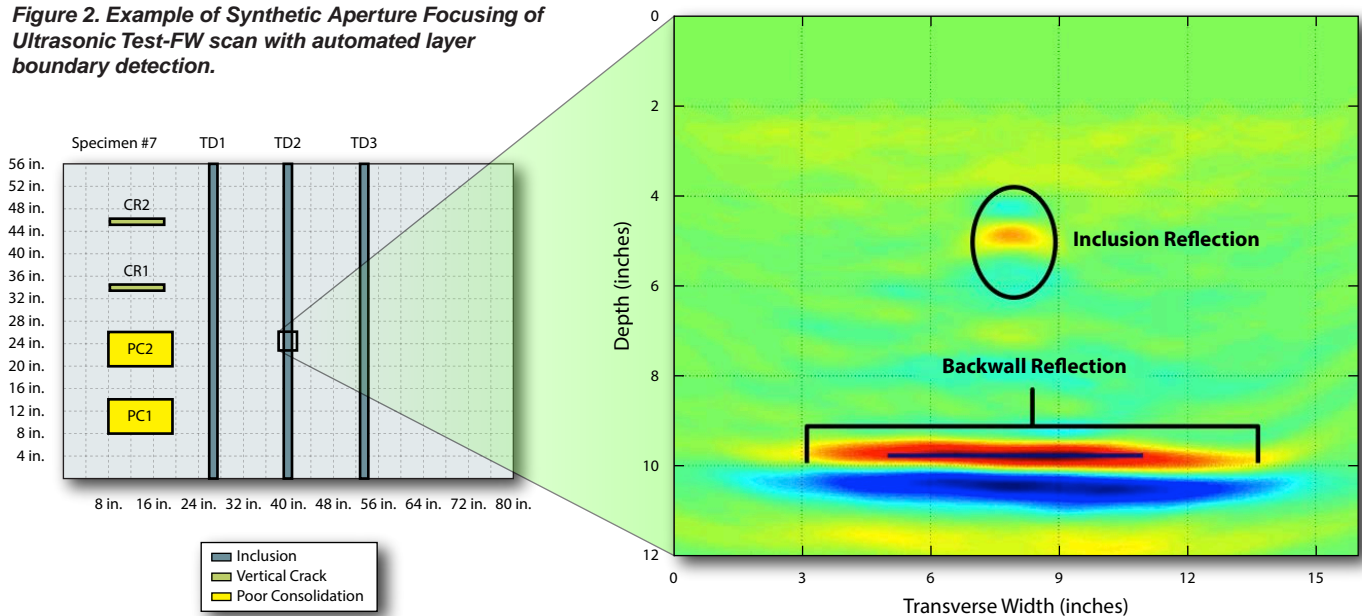
**Figure 2. Example of Synthetic Aperture Focusing of Ultrasonic Test-FW scan with automated layer boundary detection.**

Figure 2 shows an example of full waveform reconstruction (Synthetic Aperture Focusing of Ultrasonic Test-FW) from a scan taken directly over a reinforcement (see the red square for the approximate location of the scan). Peaks in intensity can be observed at the approximate thickness of the wall and at the mid-depth, corresponding to the "back wall" and reinforcement locations, respectively. The automated layer boundary detection result of 9.78 in., corresponding to the approximate thickness of the wall, is also displayed.

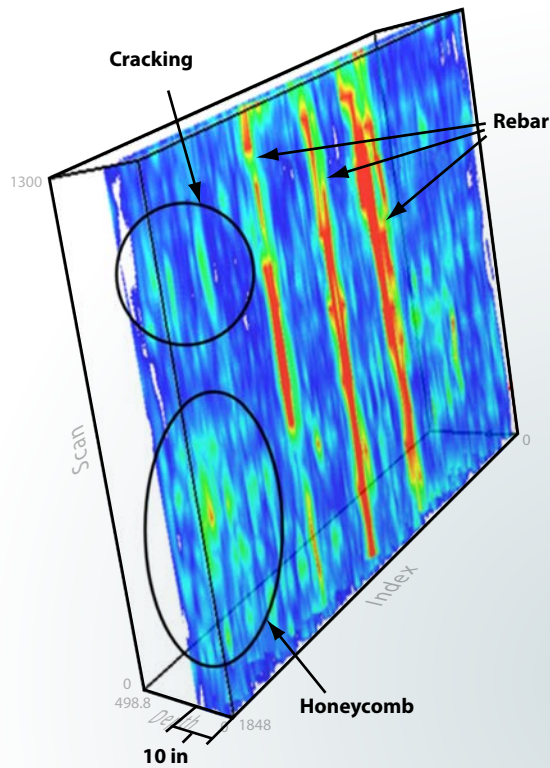
**Figure 3. Three-dimensional rendering of the void and flaw detection block.**

MIRA Tomographer Version 2 was successfully used to detect the honeycombs and cracks in the void and flaw detection block. It also detected other flaws embedded in the void and flaw detection block, but was not able to characterize them. Figure 3 illustrates the detected defects in the void and flaw detection block.

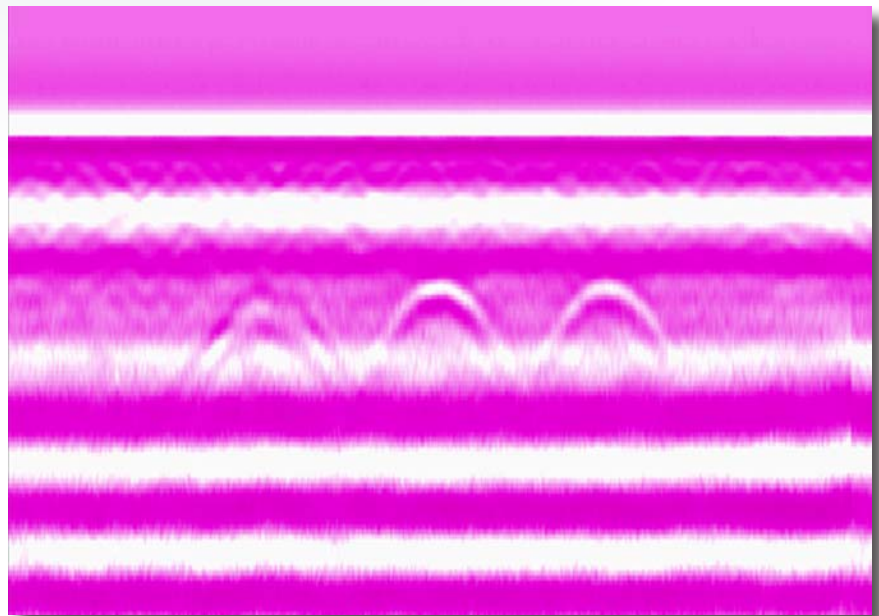
**Figure 4. Ground-penetrating radar technique line scan showing a weak reflection on the leftmost rebar due to delamination.**

radar technique scans of the void and flaw detection block revealed that radar is a generally ineffective method for detecting all but the most severe internal air voids and defects. The ground-penetrating radar technique quickly and accurately located the three reinforcing bars in the void and flaw detection block and clearly showed that one of the bars was badly out of place. The ground-penetrating radar technique also identified the two most severe intentional honeycomb defects embedded in the specimen and the artifacts from moving one of the three rebar elements, though these indications are quite subtle (Figure 4).

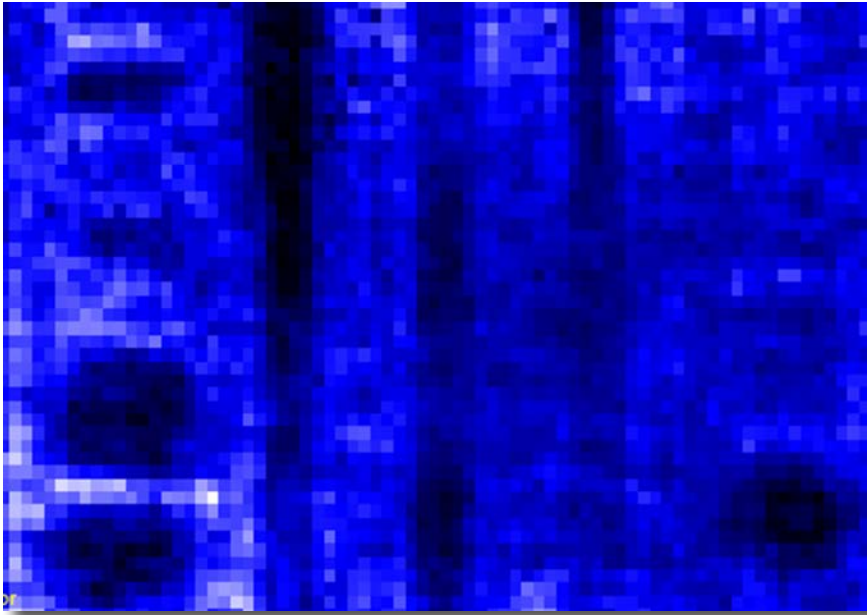
**Figure 5. Shear wave ultrasound technique image of void and flaw detection block.**

The shear wave ultrasound technique, while very slow compared to ground-penetrating radar technique, generated a series of composite images that located all rebar elements in the rebar detection block, except those directly behind the upper layer mats with no apparent dependency on the orientation of the transducer array. The ultrasound array also successfully generated a layered image of the void and flaw detection block that matched the as-built drawings of the block (see Figure 5).

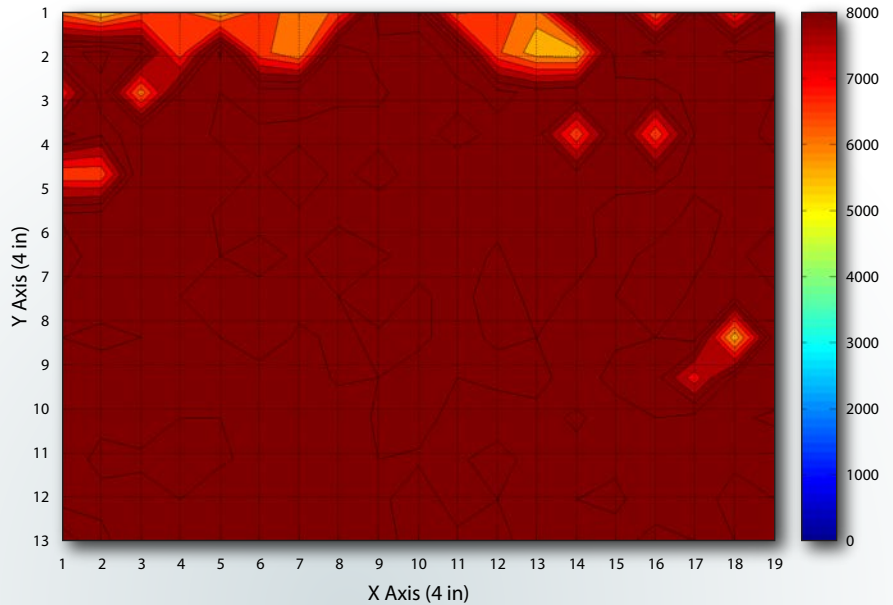
**Figure 6. Air-coupled impact-echo peak technique frequency (Hz) scan image for the rebar detection block.**

Although the air-coupled impact-echo technique is robust and relatively fast to carry out, it does not consistently reveal the presence and location of the well-bonded bars in the rebar detection block and the defects in bars and voided regions in the void and flaw detection block. It can be concluded that this method is not effective for detecting the types of defects and characteristics provided by these concrete specimens. Figure 6 and Figure 7 show the air-coupled impact-echo technique peak frequency plots for the rebar and void and flaw detection blocks, respectively. It is noted that this method is effective for detecting other types of defects such as shallow and broad delaminations.

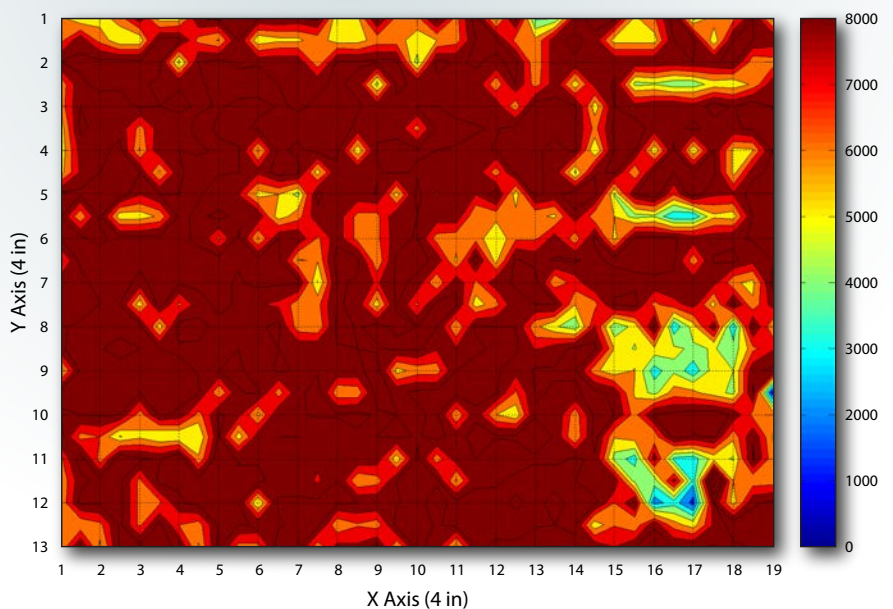
**Figure 7. Impact-echo peak technique frequency (Hz) scan for the void and flaw detection block.**

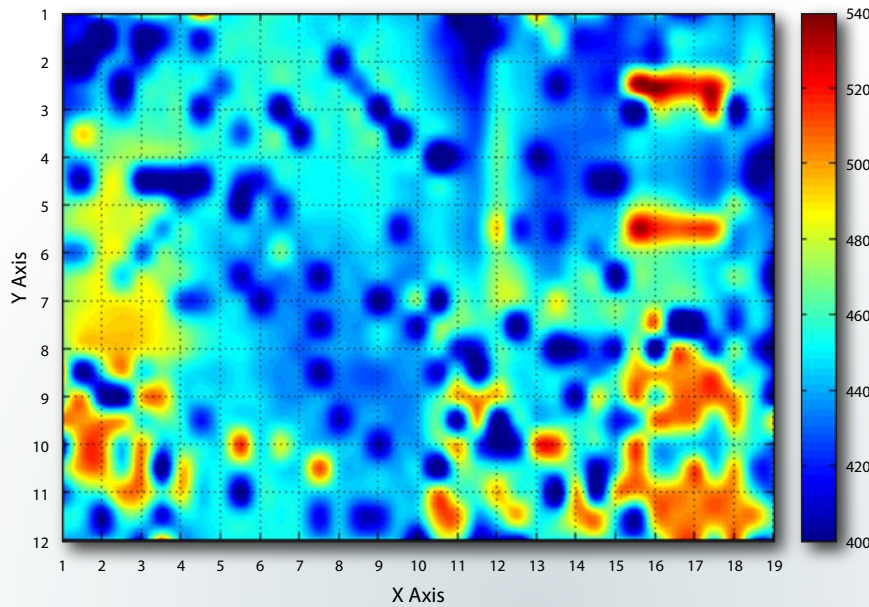
**Figure 8. Ultrasonic surface wave arrival time scan image for the void and flaw detection block.**

The air-coupled ultrasonic surface wave technique is only able to characterize the layer region near the surface to a depth of approximately 5 to 7.5 cm. The method cannot characterize deeper sections. However, the method was able to identify suspected regions of defects that lie near the surface (such as the voided concrete blocks). Note that the surface wave arrival time plot images show good distinction of the individual regions of defects on the right side of Figure 8. The deeper defects (e.g., the

poorly bonded steel bars) were not detected. The arrival time surface wave signal parameter appears to be more effective in detecting and distinguishing the size of the regions of defects than the surface wave amplitude parameter.

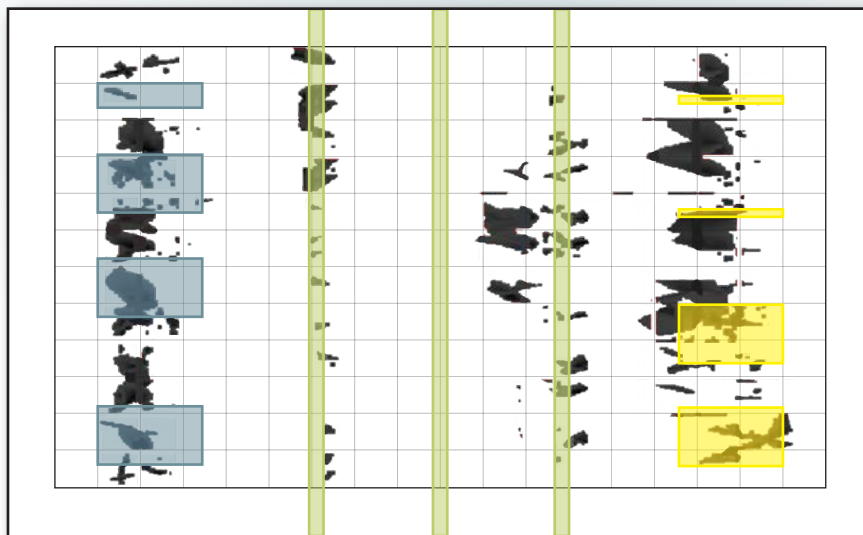
**Figure 9. Threshold (25%) binary image plots of tomographic data for the void and flaw detection block after removal of ray path artifacts.**

The semi-coupled ultrasonic tomography through-thickness ultrasonic technique appears to give the best performance in terms of identifying internal void areas and unbonded, embedded rebar, when the data are presented in a threshold binary image with transparency control (Figure 9). One drawback of this method is the need to correct the images for ray path artifacts, which can be tedious. Another drawback of the method is the data collection process, which can be time consuming and labor intensive. It can be argued that the advantages outweigh the drawbacks, because this method is the only one that can penetrate thick structures and provide good sensitivity to defects and reasonable estimation of location and size. However, the method was not able to detect the presence of well-bonded rebar.

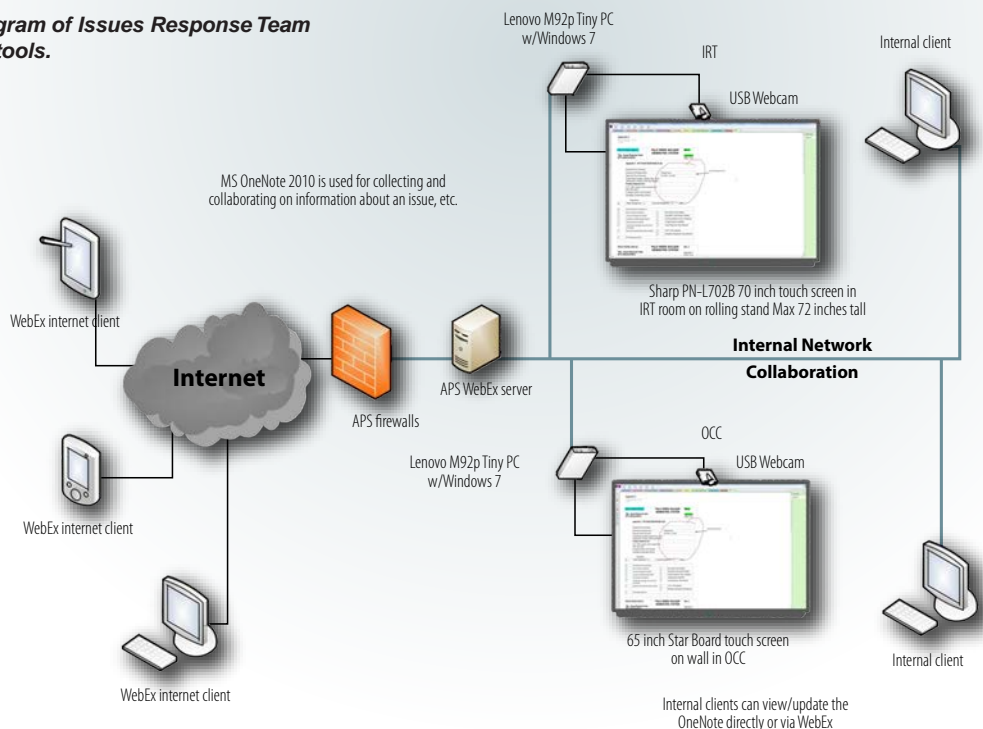
**Figure 10. Diagram of Issues Response Team collaboration tools.**

screen monitor for use in the IRT room. Video cameras for remote collaboration also were added to the IRT room and the OCC. Figure 10 provides a diagram of the hardware and software implementation.

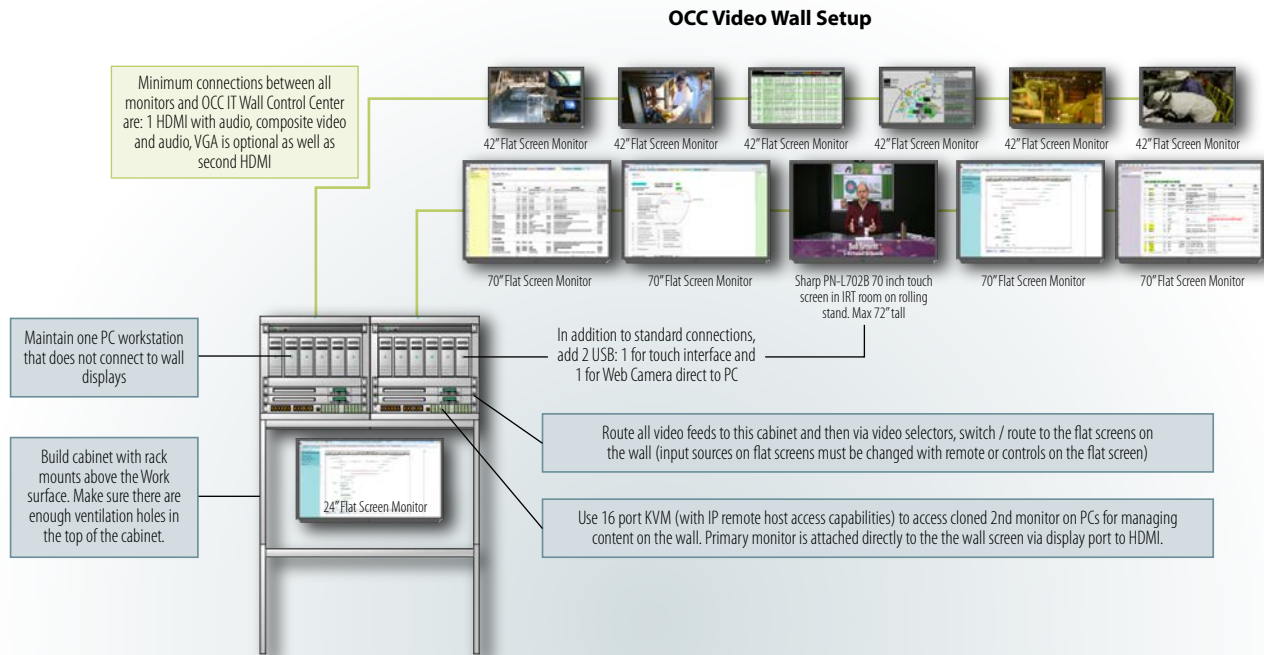
**Figure 13. Outage Control Center video wall planned for next refueling outage.**

In summary, the initial study of AOCC technology at the Palo Verde Nuclear Generating Station to support the IRT was well received. Palo Verde Nuclear Generating Station plans to permanently adopt the IRT process and technologies used during the fall 2013 refueling outage. Based on the advantages observed using the network accessible collaboration software, prior to their next refueling outage, Palo Verde Nuclear Generating Station intends to update their OCC with this technology to improve outage communication and collaboration. Figure 13 shows the planned OCC equipment upgrades.
