Linear Array Ultrasonic Test Results from Alkali-Silica Reaction (ASR) Specimens

**LINEAR ARRAY ULTRASONIC TEST RESULTS FROM ALKALI-SILICA
REACTION (ASR) SPECIMENS**

Dwight Clayton, Oak Ridge National Laboratory
Lev Khazanovich, University of Minnesota
Lucio Salles, University of Minnesota

Date Published: April 2016

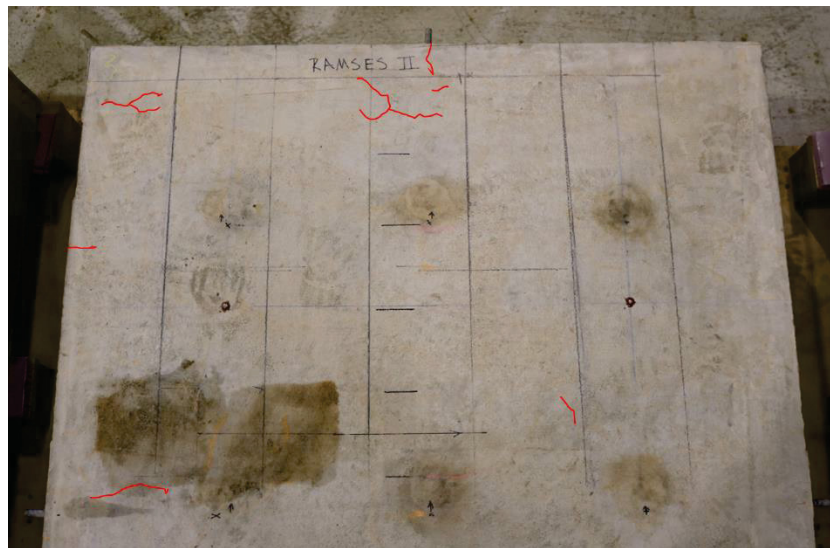
Fig. 13. Visible cracking in specimens (a) Cleopatra (south) and (b) Ramses (north)

Examination of surface cracking in all specimens confirms the damage presence on specimens Cleopatra and Ramses, as shown in Fig. 13 with cracks highlighted for greater ease of identification. The blue rectangle on Fig. 13(a) shows an enlarged section of the specimen in order for cracks to be more easily visible. Fig. 13 shows minimal visible cracking on the King Tut specimen. Specimen Nefertiti did not have any visible surface cracks.
