**STRESS CORROSION CRACK INITIATION OF COLD-WORKED
ALLOY 600 AND ALLOY 690 IN PWR PRIMARY WATER**

**Technical Milestone Report: M2LW-14OR0404023
PNNL-23712 September 2014**

Research Project:
**Stress Corrosion Crack Initiation of
Nickel-Base Alloys in LWR Environments**
Project Manager: S. M. Bruemmer
Pacific Northwest National Laboratory

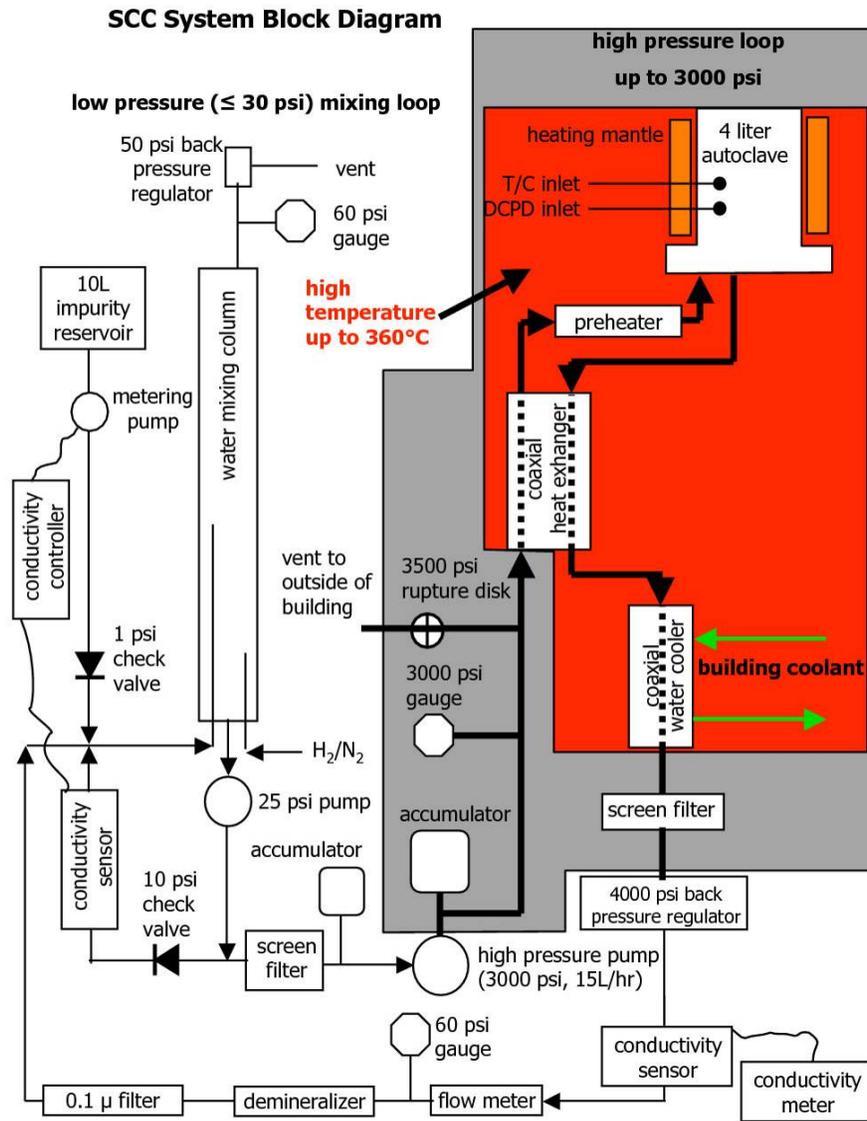
Figure 2. General water flow diagram for PNNL SCC crack-growth and initiation test systems.

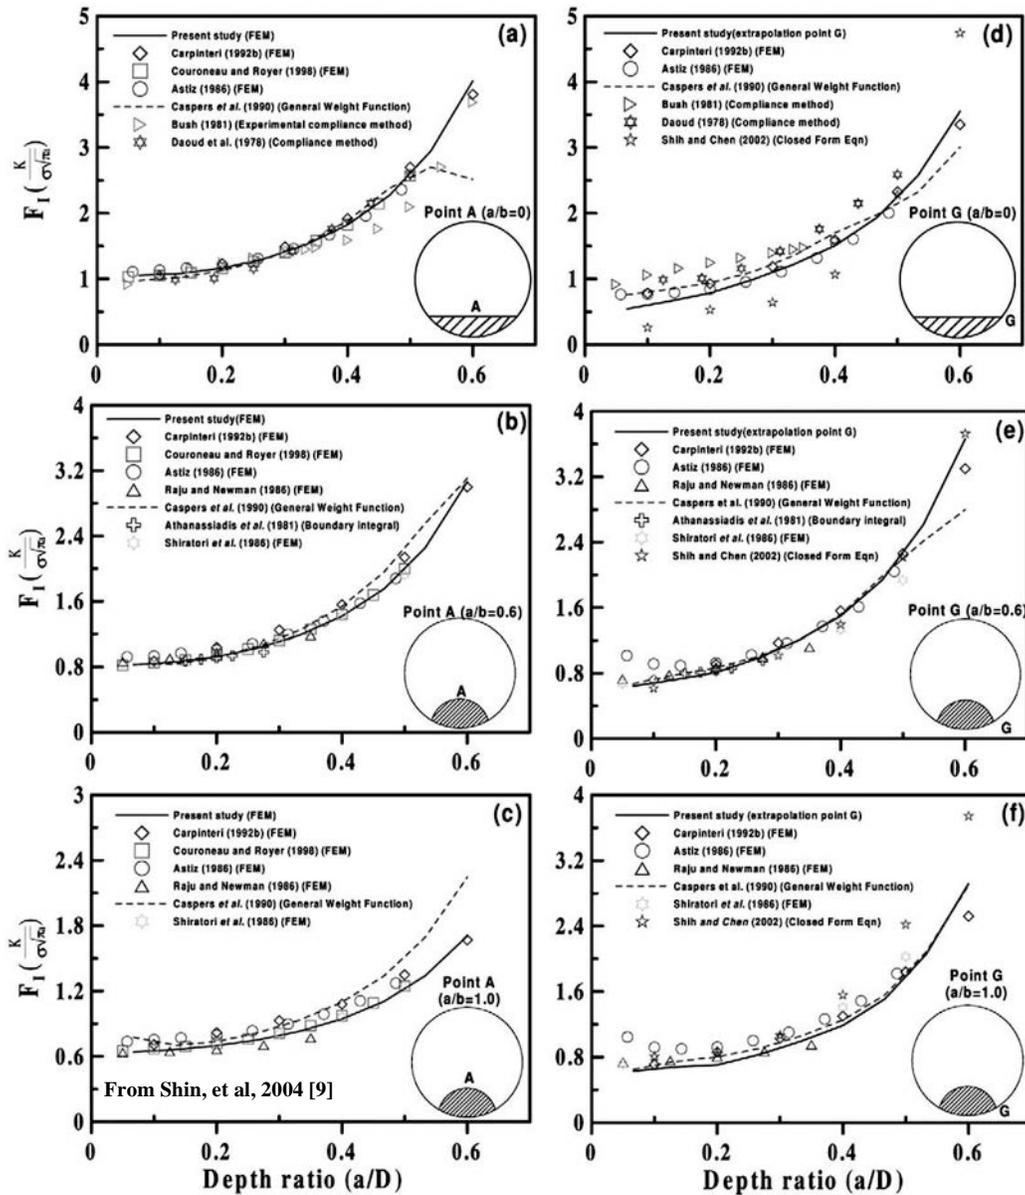
Figure 7. Dimensionless stress intensity factor at either the center or edge of the crack plotted against a/D for three different crack shapes as given by Shin [9].

F_I is typically plotted or tabulated against a/D as defined in Figure 6. One of the more concise results provided by Shin [9] in Figure 7 reveals that F_I is ~ 0.8 for likely crack shapes having a depth of $\sim 150 \mu\text{m}$ ($a/D = 0.05$).

For 20-30% cold-worked materials that have a yield strength of ~600-650 MPa, this results in a stress intensity of ~10-11 MPa \sqrt{m} . For a crack depth of ~300 μm , the stress intensity increases up to ~15-16 MPa \sqrt{m} , and becomes >20 MPa \sqrt{m} as crack depth reaches ~500 μm . SCC crack growth is thought to have a strong dependence on stress intensity within this range [11], and it is believed that one of the key contributors to conversion from a nascent crack to an actively growing SCC crack is this increase in stress intensity [12].

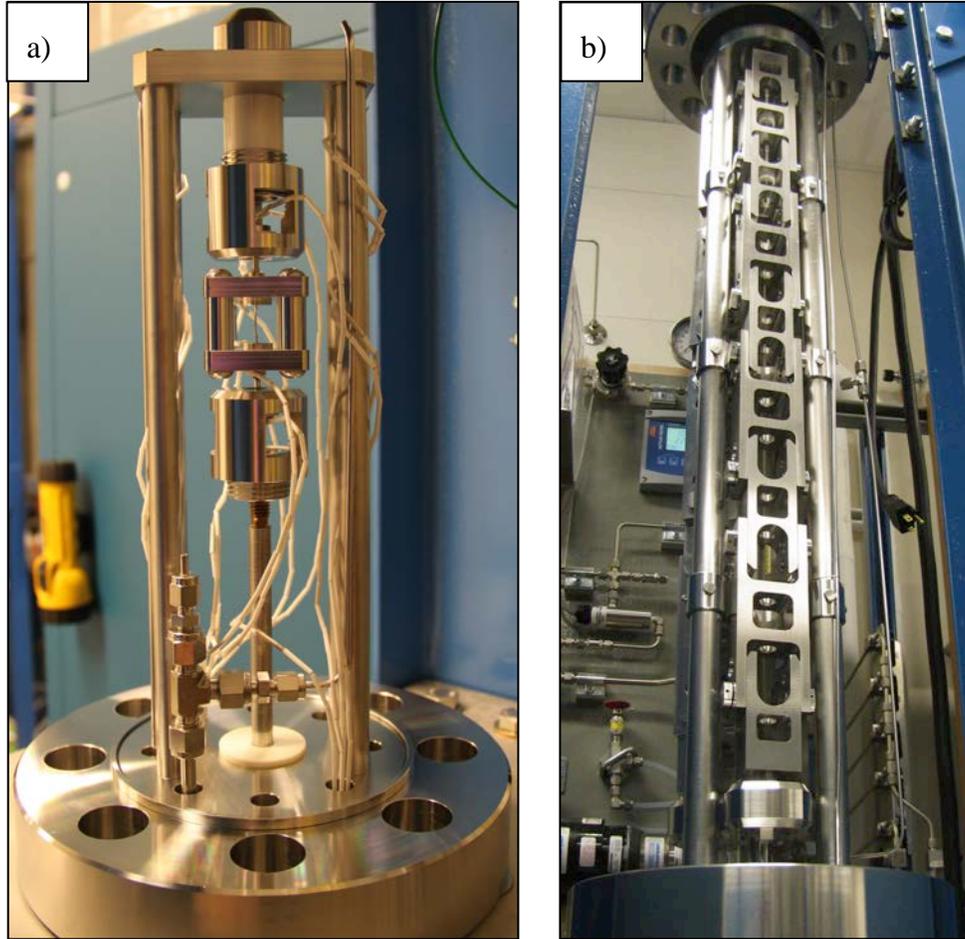
Figure 8. Crack initiation test system load trains at PNNL for (a) 1-3 specimens and (b) up to 36 specimens.

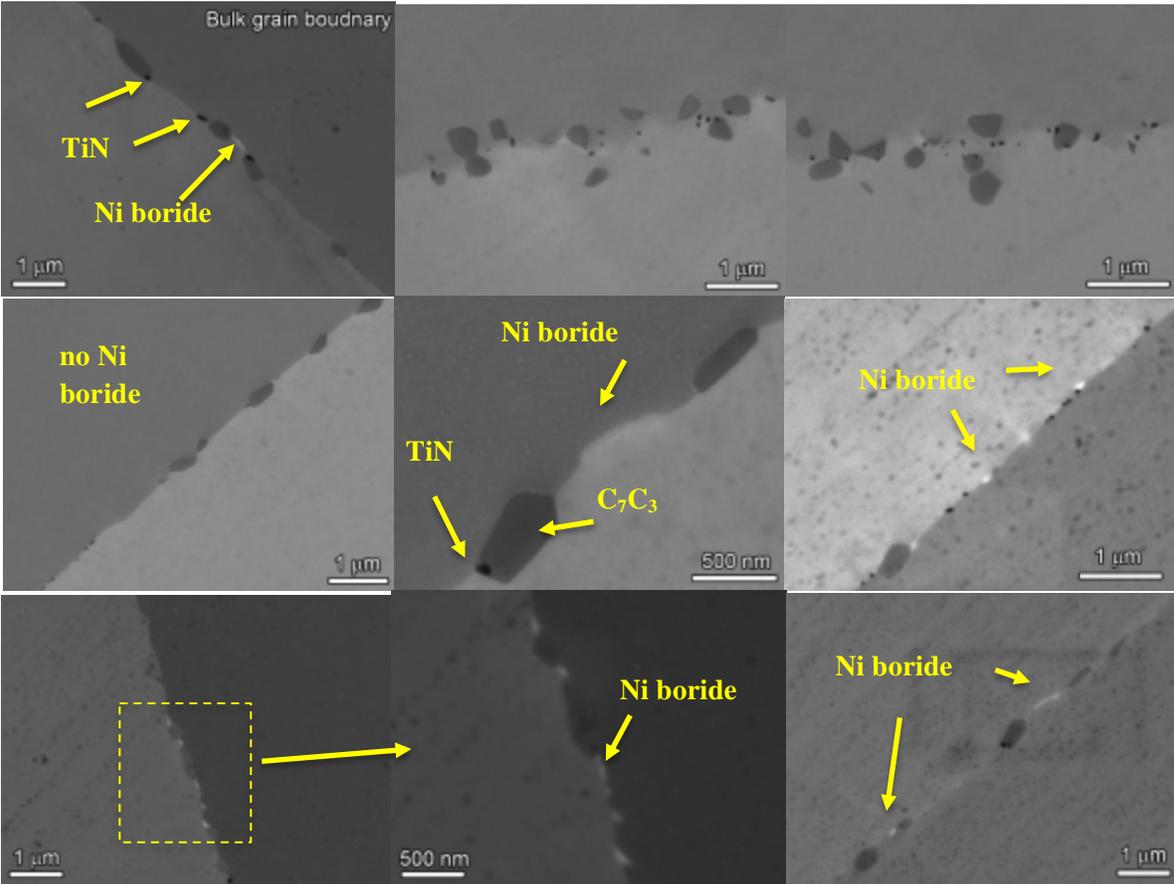
Figure 16. SEM (BSE) images illustrating the general microstructures in the mill-annealed alloy 600 CRDM heat M3935 material at higher magnification illustrating the distribution of Cr_7C_3 , TiN and Ni borides on the grain boundaries.

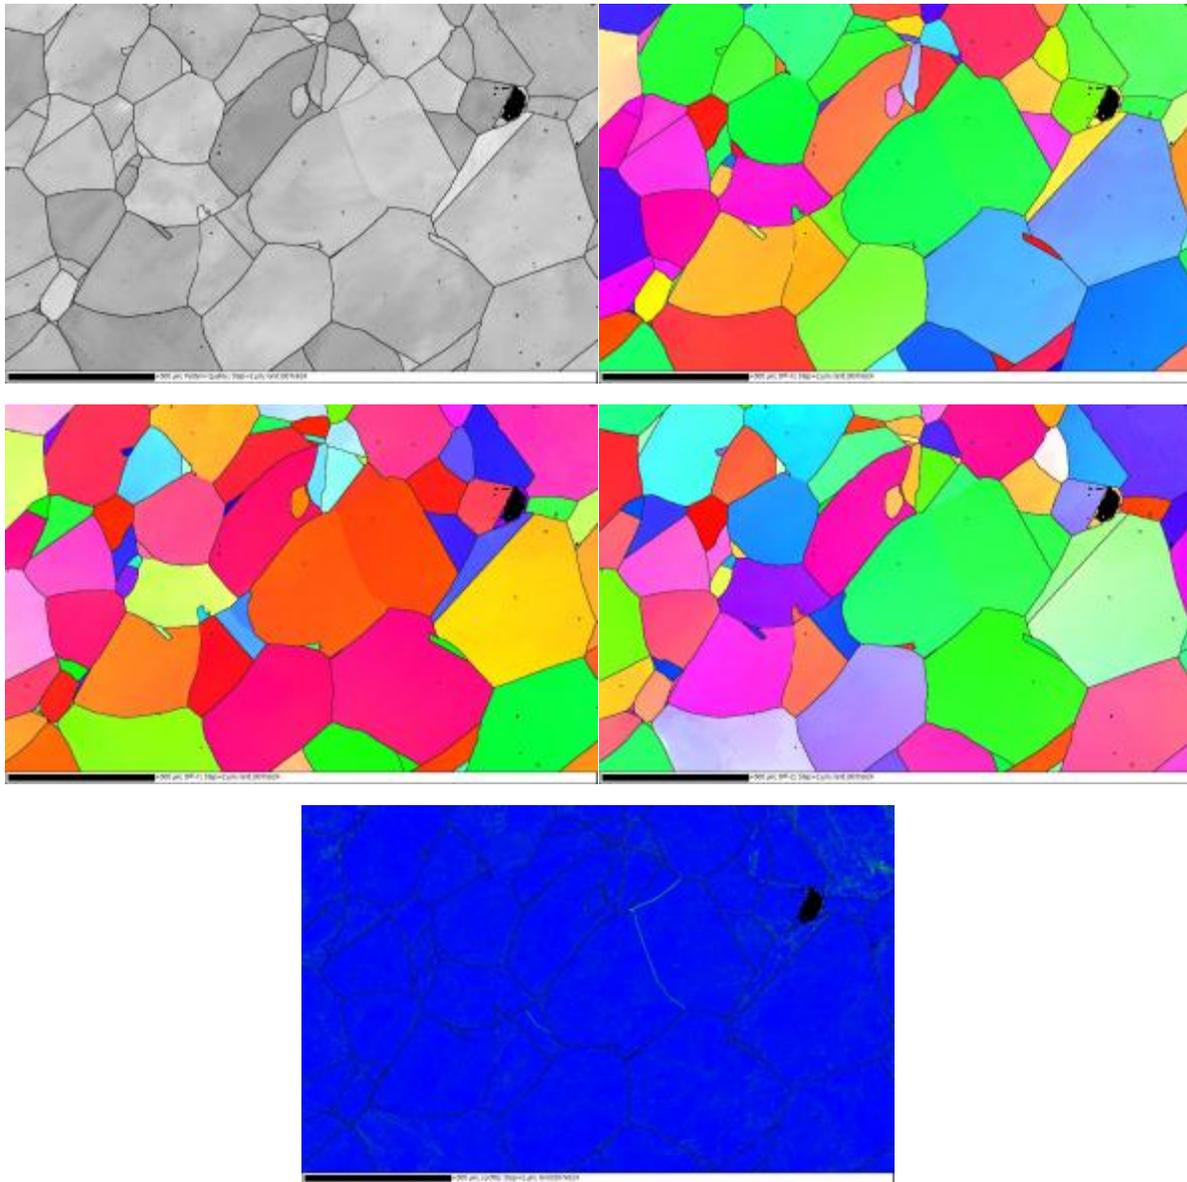
Figure 17. EBSD pattern quality map is shown in upper left image, inverse pole figure maps in upper right (X orientation), middle left (Y orientation) and middle right (Z orientation) images along with misorientation density map in bottom center for Davis Besse heat M3935.

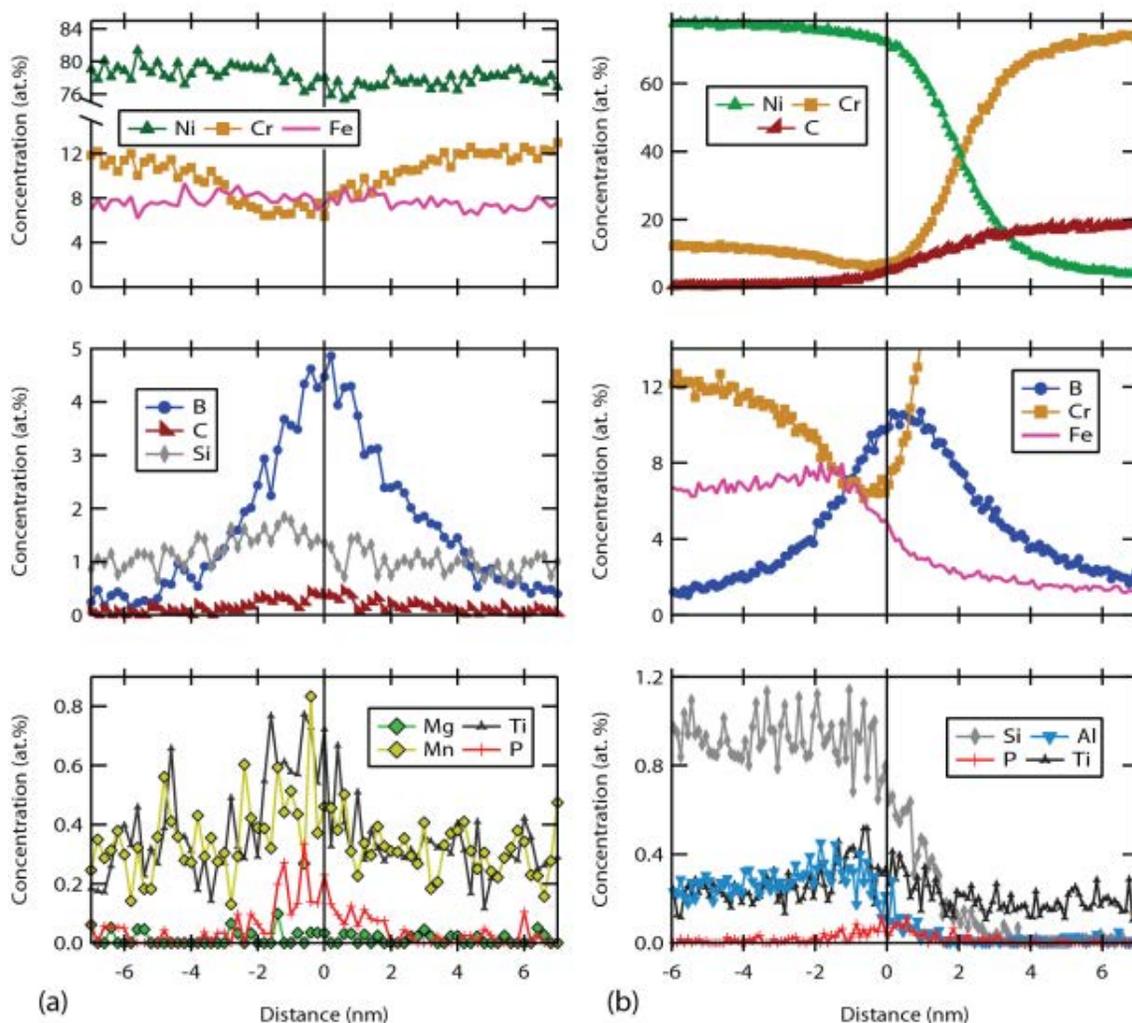
Figure 23. Concentration profiles across (a) the metal/metal grain boundary and (b) across the IG Cr carbide / metal interface in Davis Besse CRDM heat M3935. Both types of interfaces exhibit particularly strong B segregation (5 at% and 11 at%, respectively) and Cr depletion (<8 at% each). Relatively strong P segregation is apparent at each interface (~0.2 at%) and no significant Si segregation is observed.

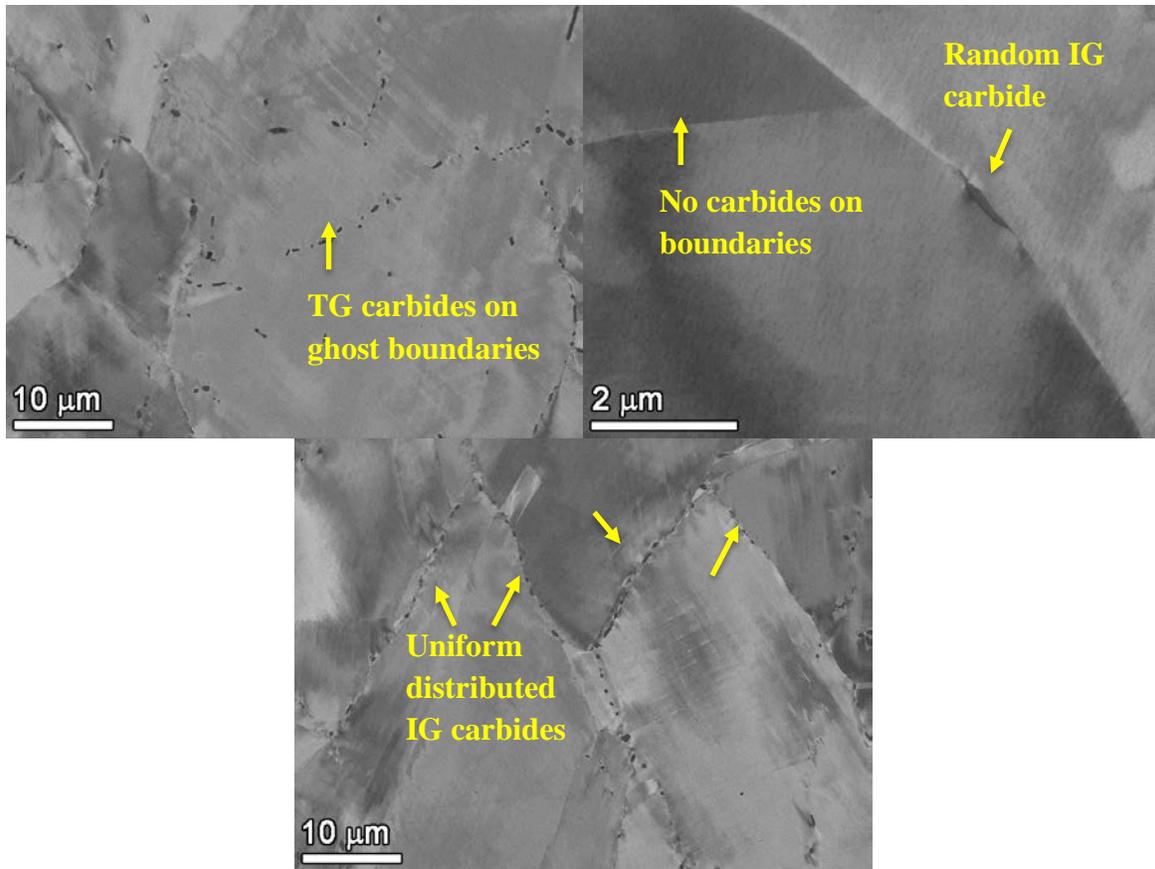
Figure 26. SEM (BSE) micrographs illustrating the microstructure of plate material NX6106XK-11 and the intergranular nature of the carbides.

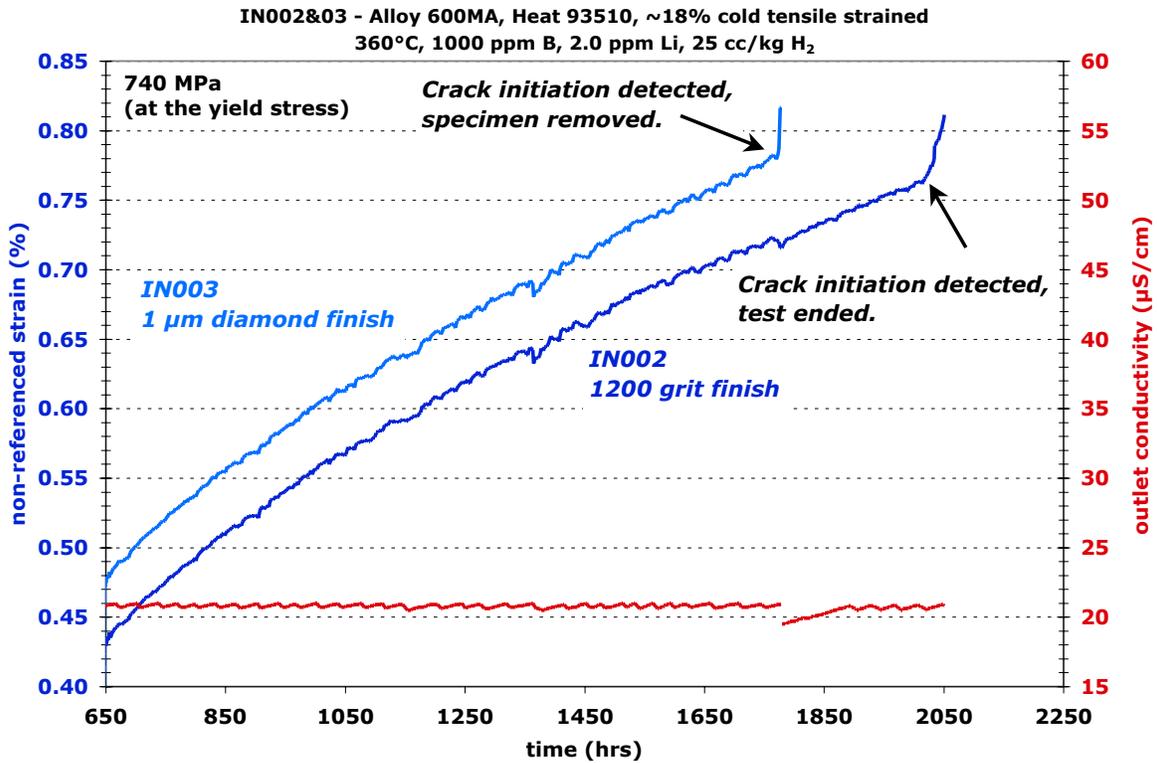
Figure 27. SCC crack initiation tests on 18% tensile prestrained alloy 600 CRDM Heat 93510.

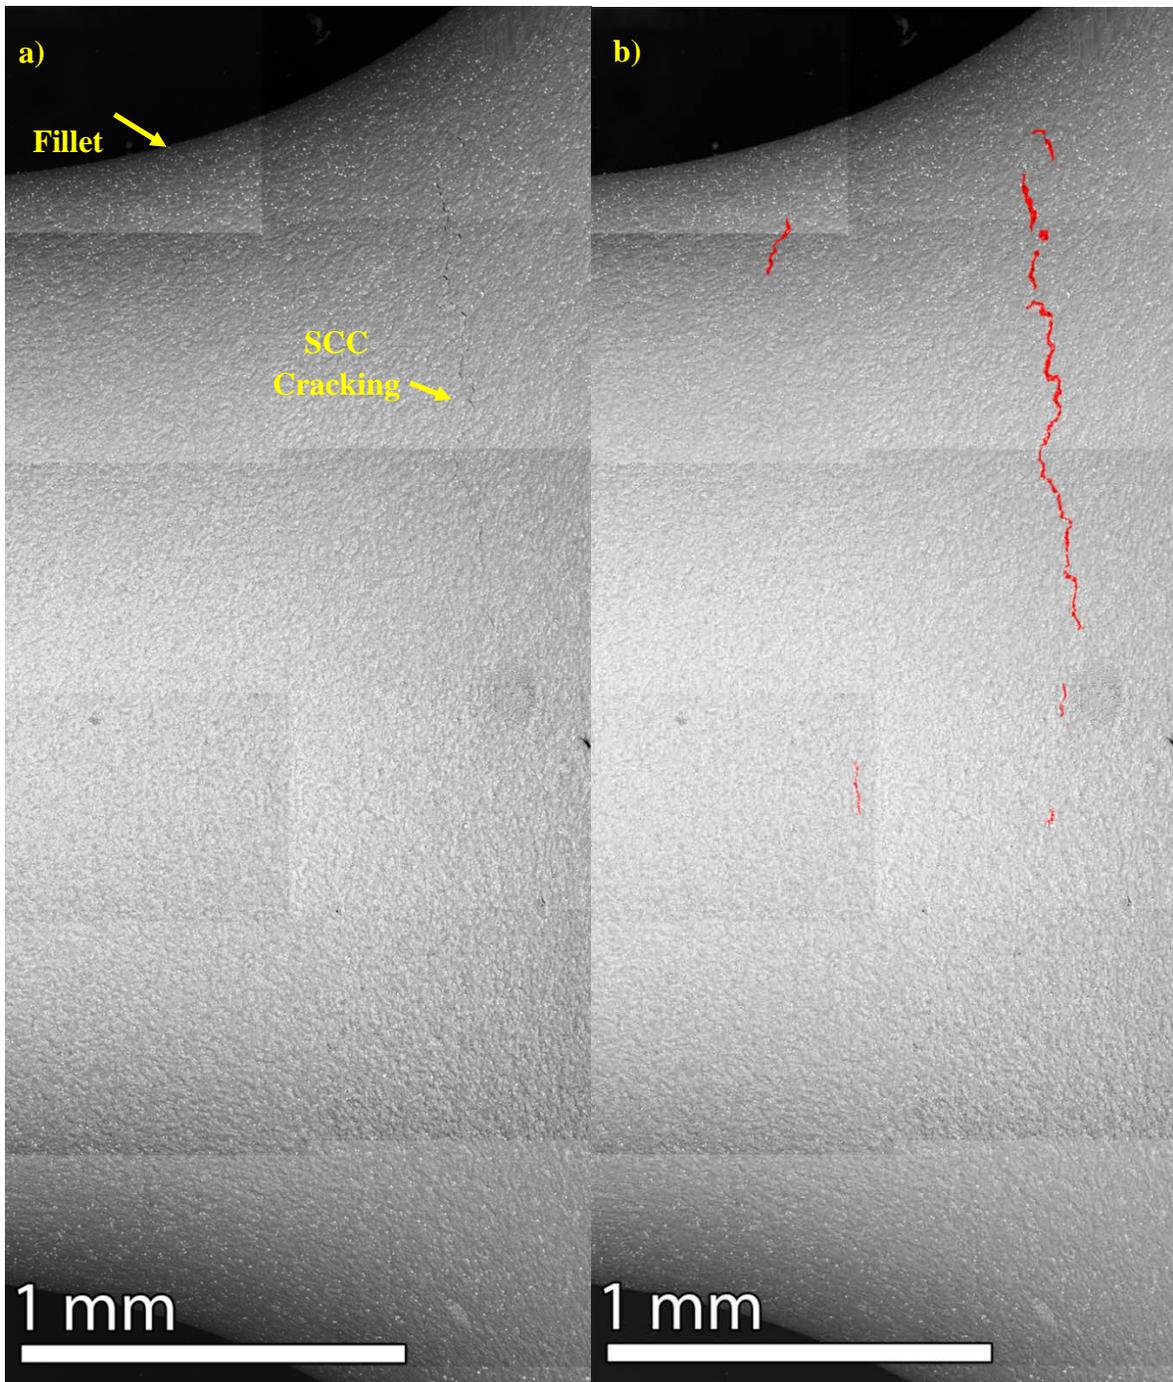
Figure 28. SEM (BSE) images of the alloy 600 tensile initiation specimen IN003 surface that exhibited cracking near the fillet. Image (b) is identical image to (a), but cracks have been colored red as guide to the eye. The longest crack observed in this region was nearly 1 mm in length.

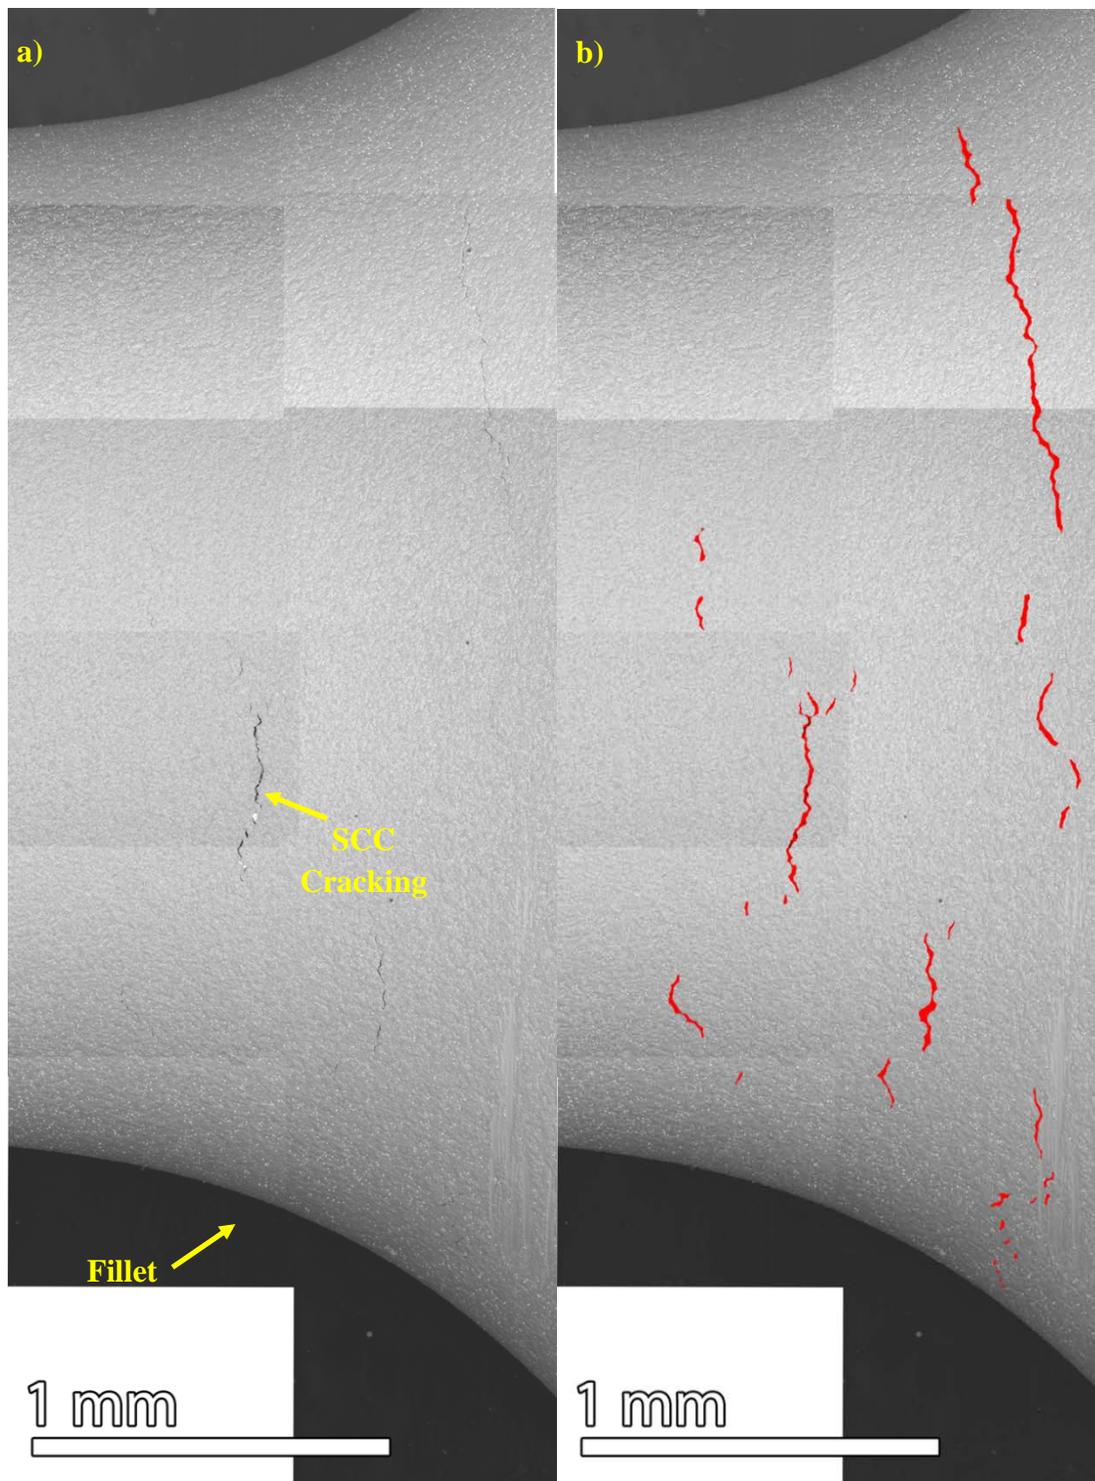
Figure 29. SEM (BSE) image of the alloy 600 tensile initiation specimen IN003 (rotated 120° from Figure 28) that exhibits cracking near the fillet. Image (b) is the identical image but cracks have been colored red as guide to the eye. SCC cracks were observed with a circumferential length as long as ~1 mm.

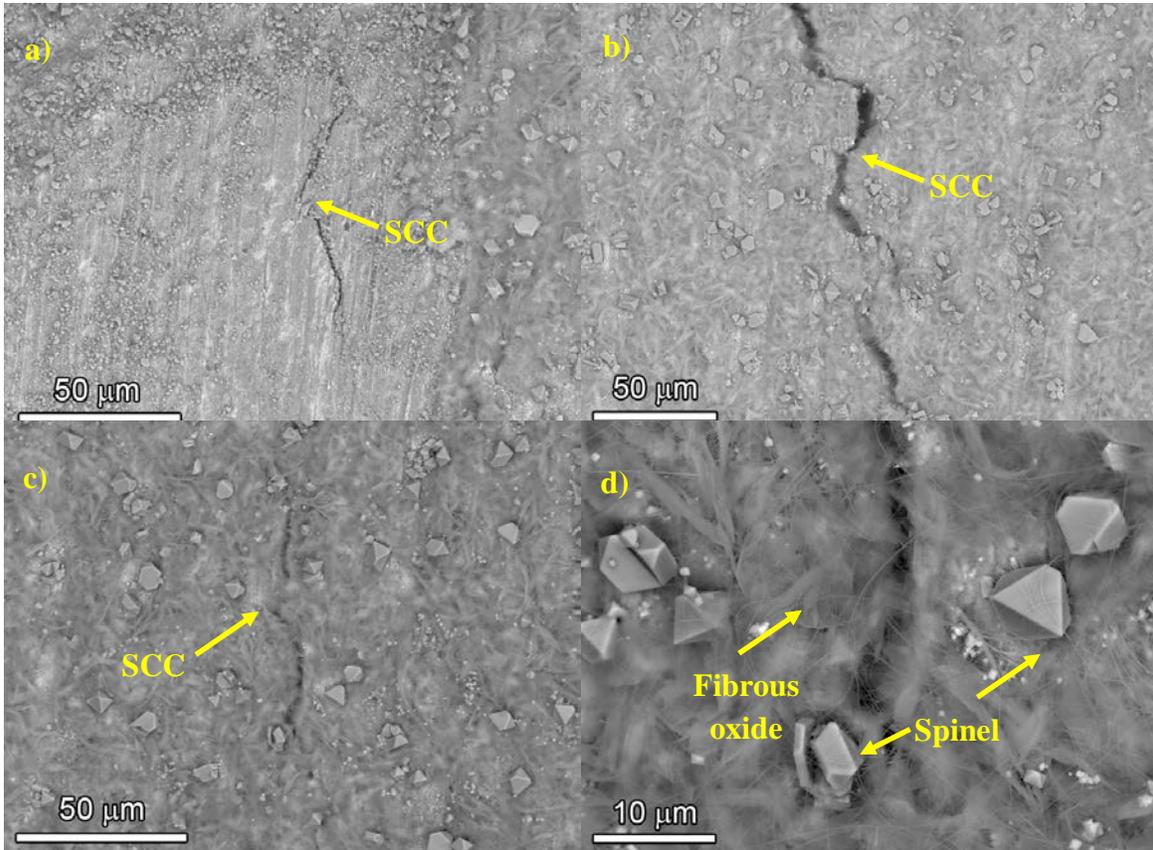
Figure 30. Low magnification SEM (BSE) images of the surface of the IN003 alloy 600 tensile initiation specimen illustrating various SCC cracks and surface oxides.

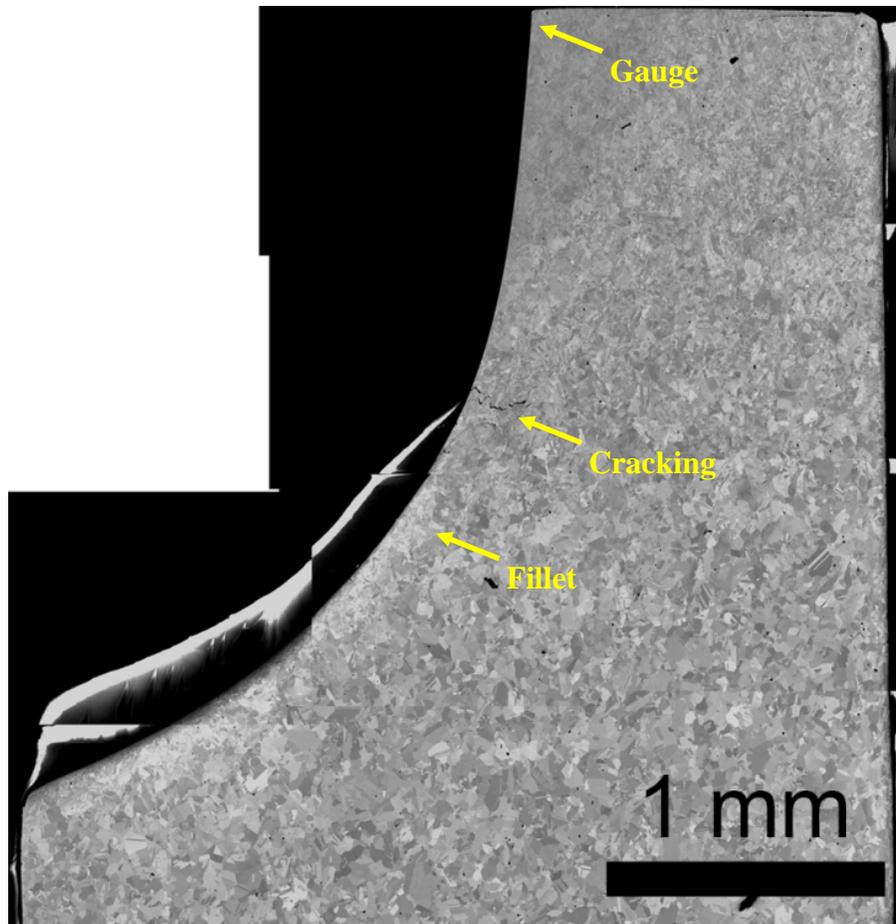
Figure 31. SEM (BSE) images of a cross-section from the alloy 600 tensile initiation specimen IN003 that exhibited cracking near the fillet. Note that strain contrast in the gauge section obscures the grain morphology.

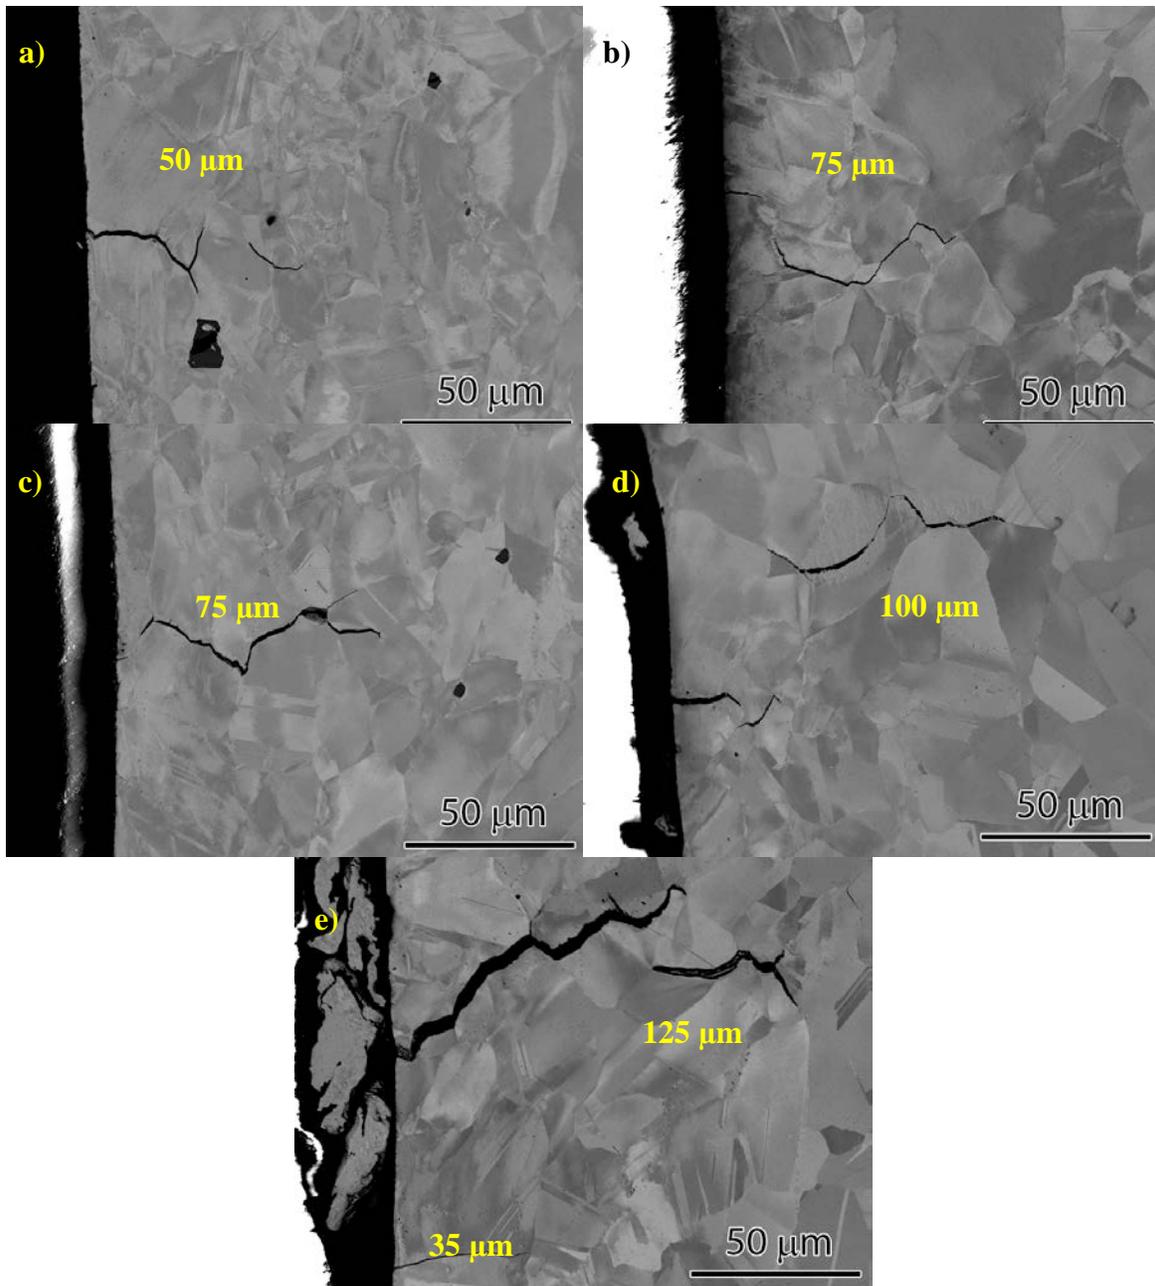
Figure 32. SEM-BSE images of a cross-section for the alloy 600 tensile initiation specimen IN003 showing deep SCC cracks initiating from the surface. Apparent crack depths are listed for each figure.

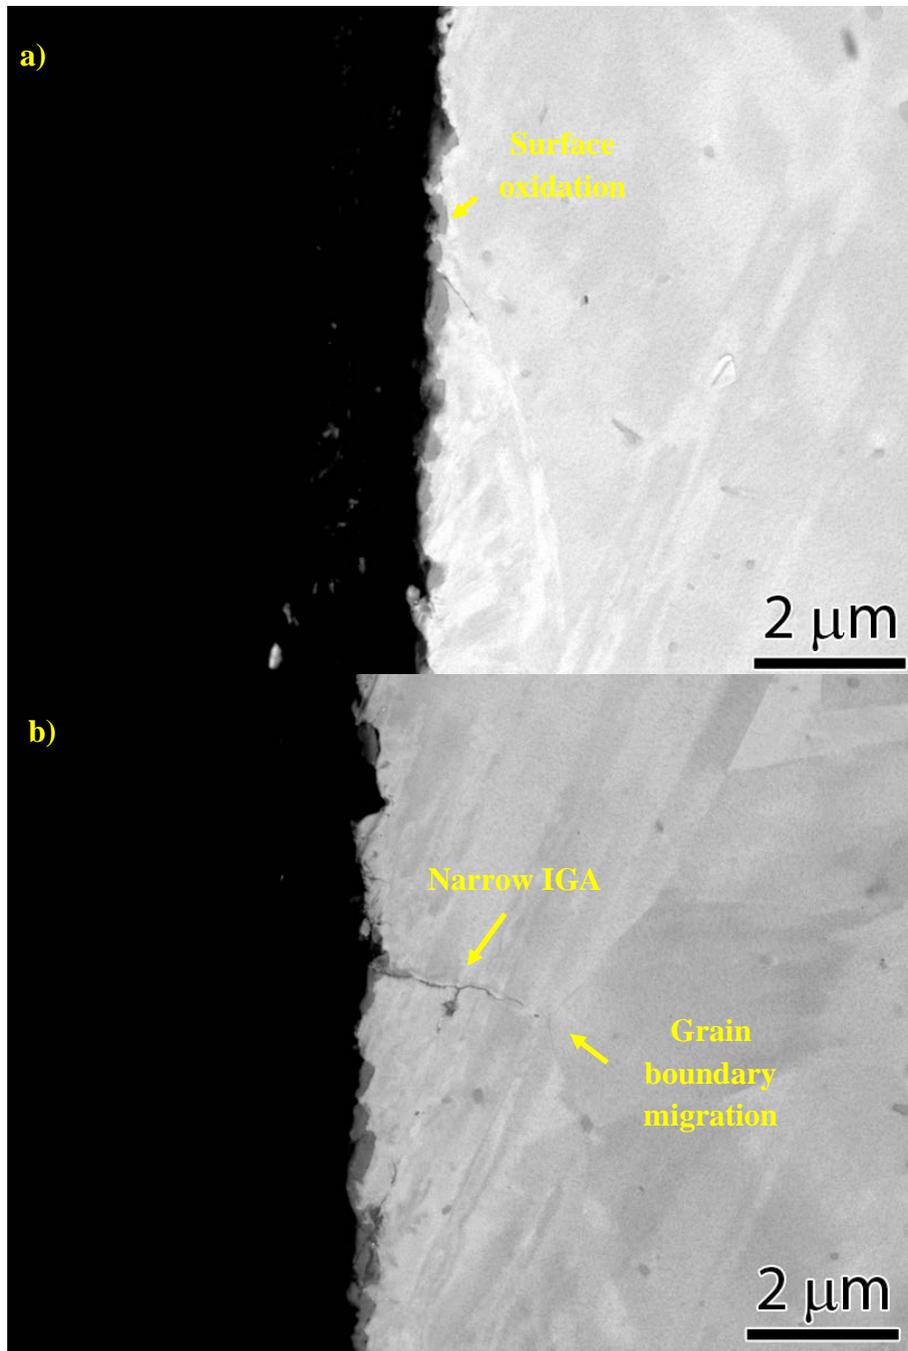
Figure 33. SEM-BSE images of a cross-section for the alloy 600 tensile initiation specimen IN003 illustrating representative TG (surface oxidation) and IG corrosion in the gauge section.

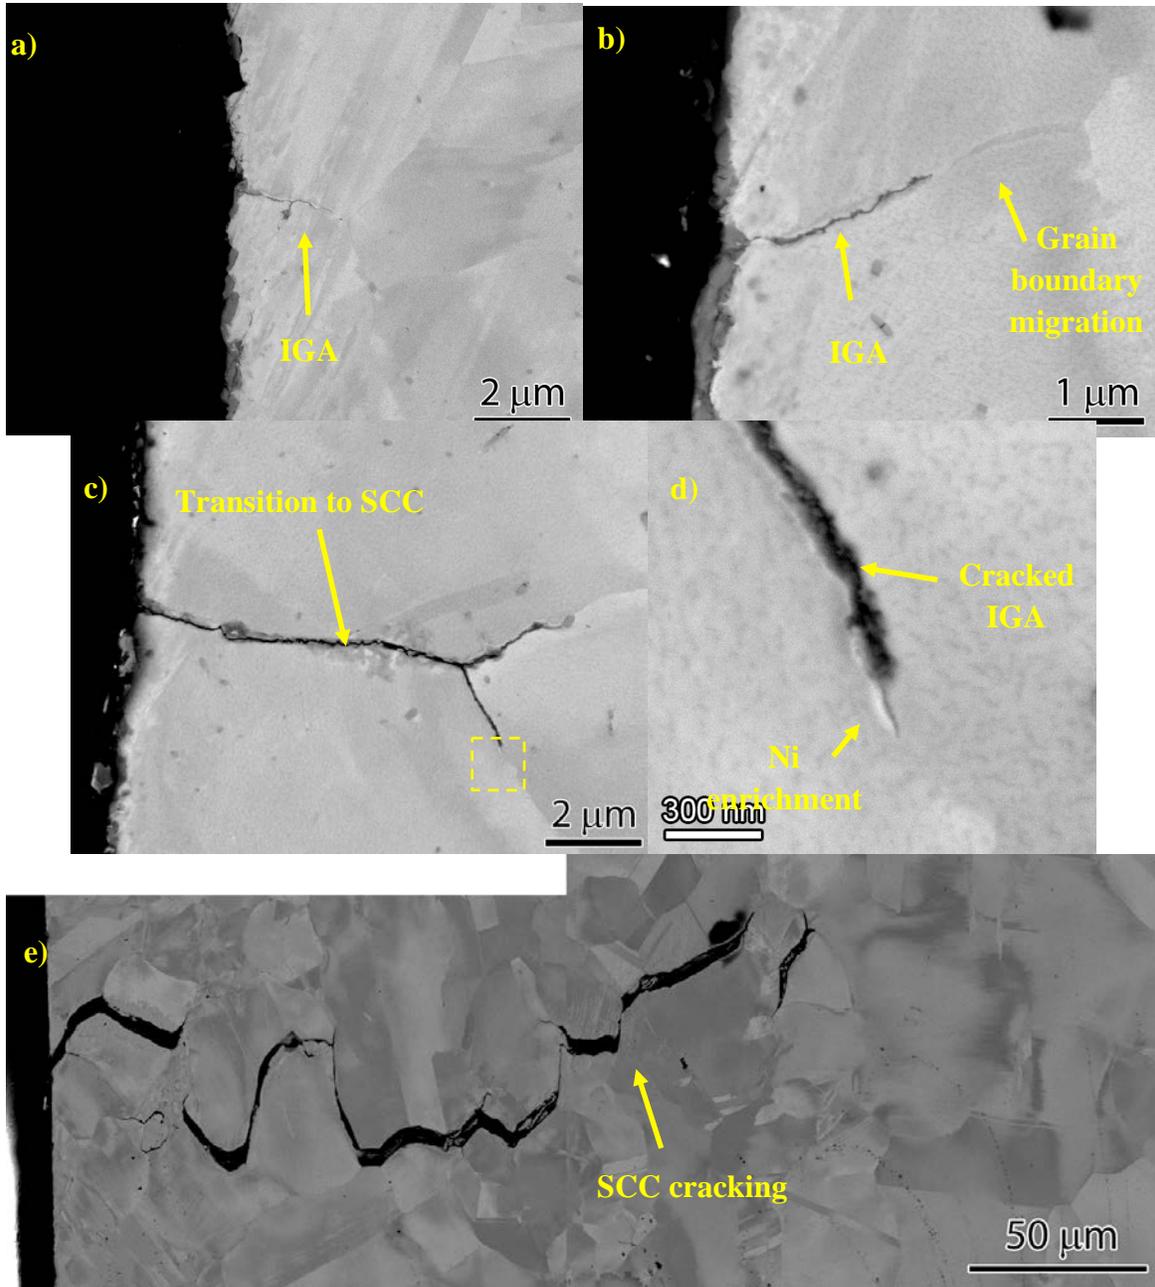
Figure 34. SEM-BSE images of the cross-section for the alloy 600 initiation specimen IN003 highlighting various stages of SCC cracking: (a,b) IG attack in gauge section without cracks, (c,d) IG attack transitioning to an IGSCC crack and e) a long IGSCC crack in the fillet region.

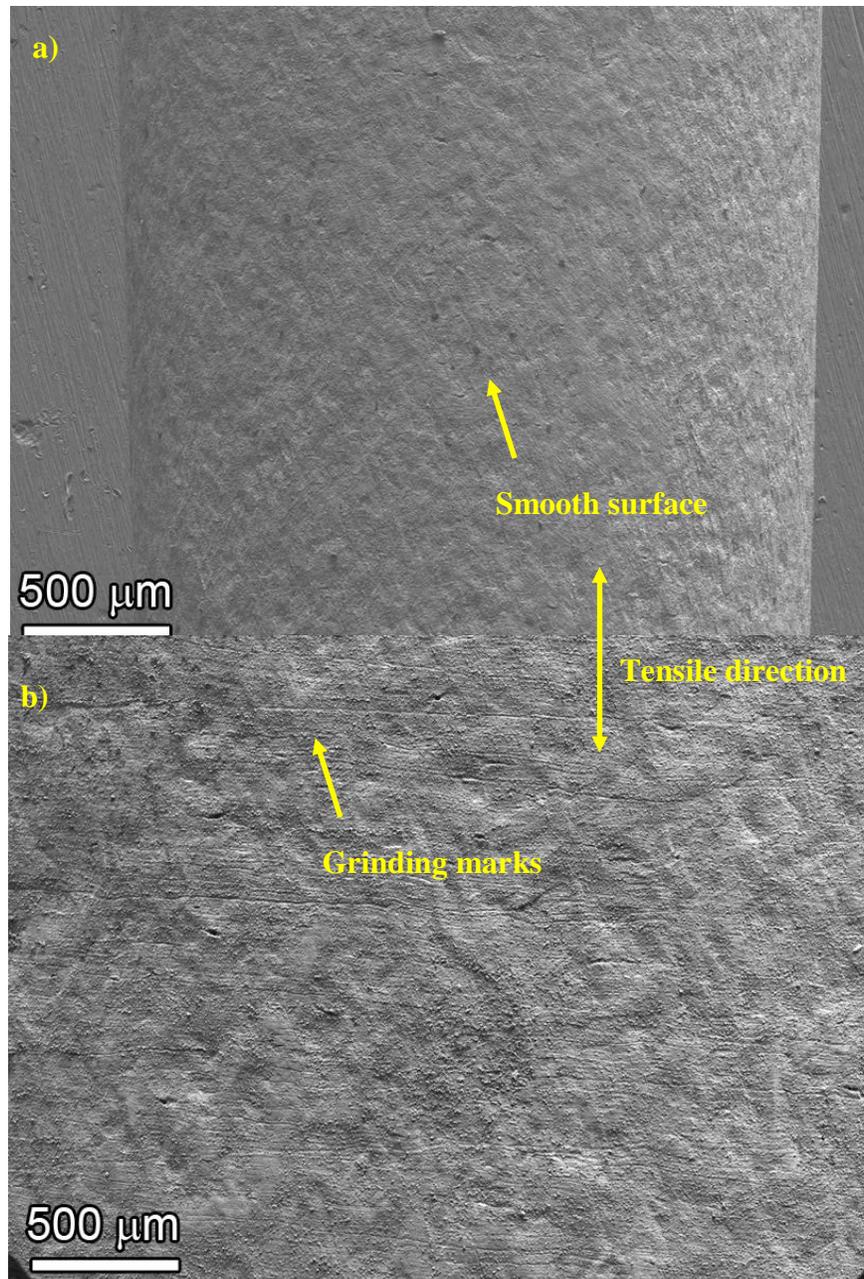
Figure 35. SEM-SE images of exposed surfaces for the alloy 600 initiation specimens that had a) highly polished gage section surface (IN003) or b) surfaces polished to 1 μm and then ground with 1200 grit SiC ground gage section surface (IN002).

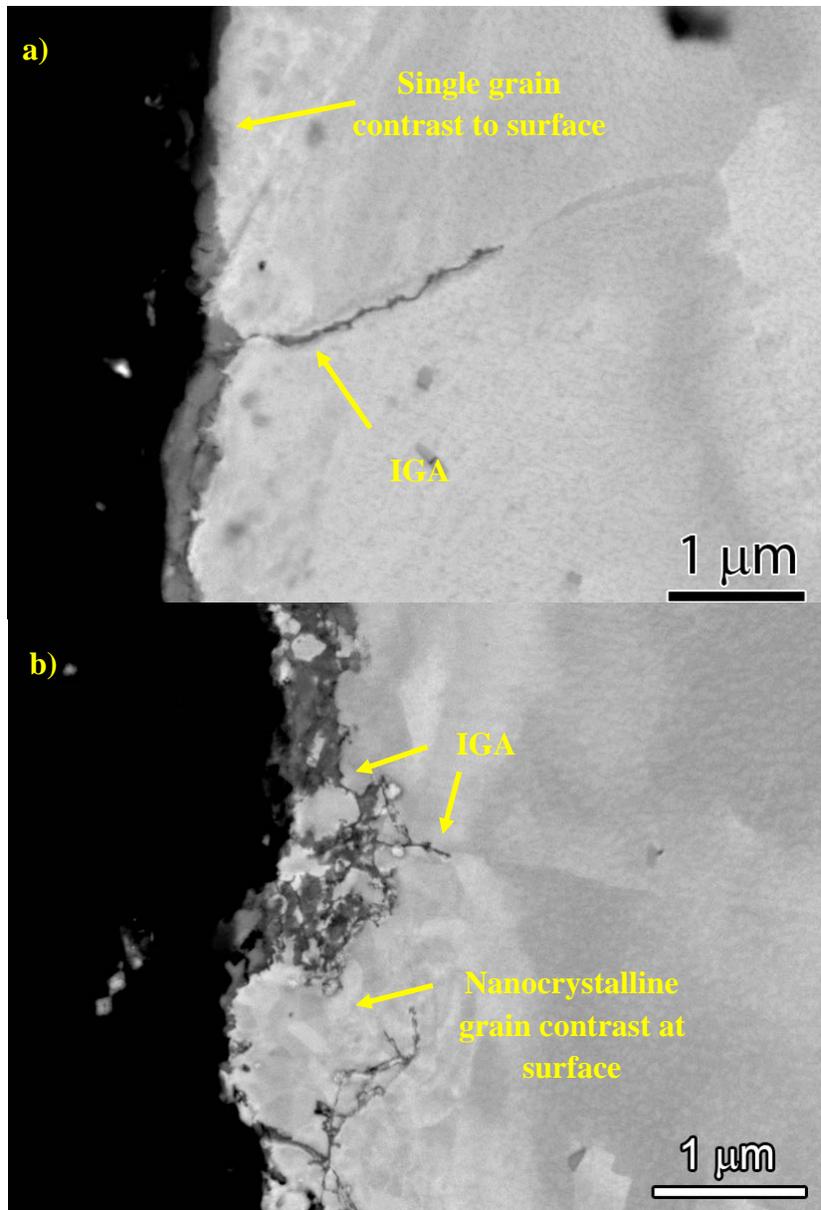
Figure 36. SEM-BSE images of cross-sections from the alloy 600 initiation specimens with surfaces of 1 μm diamond (IN003) and 1200 grit SiC (IN002) after exposure to PWR primary water.

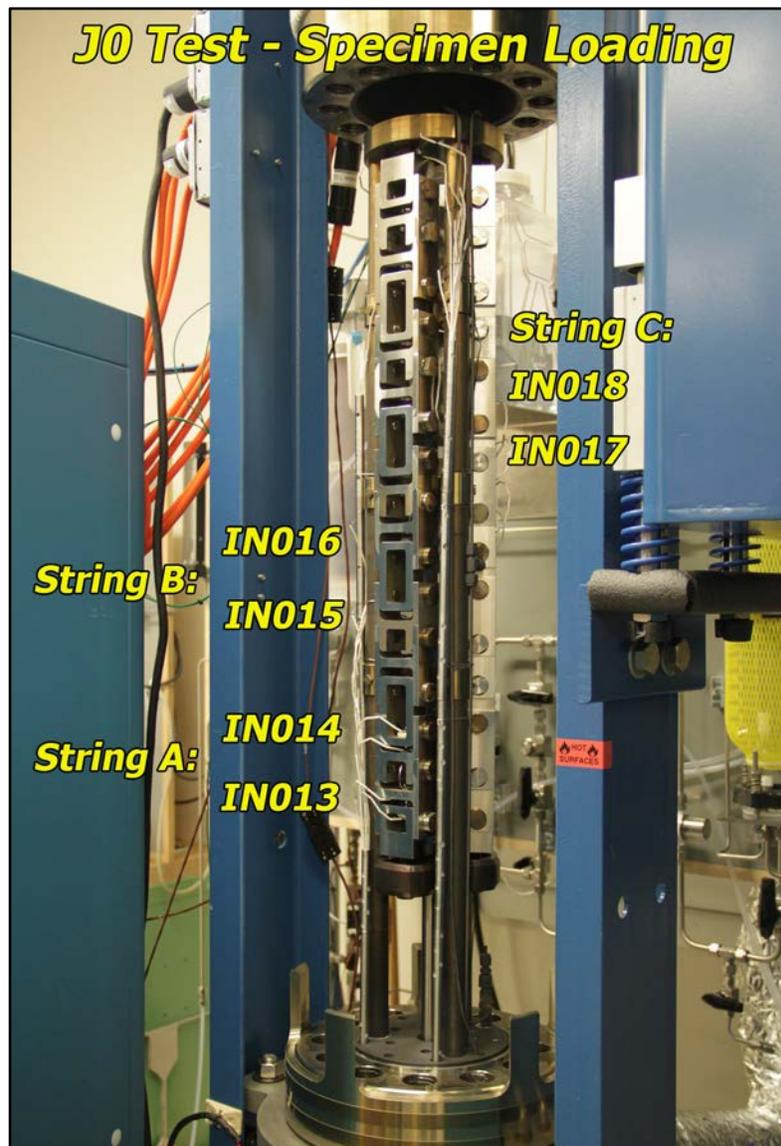
Figure 37. Load train for the LWR system #1 crack initiation test system set up for the demonstration test.

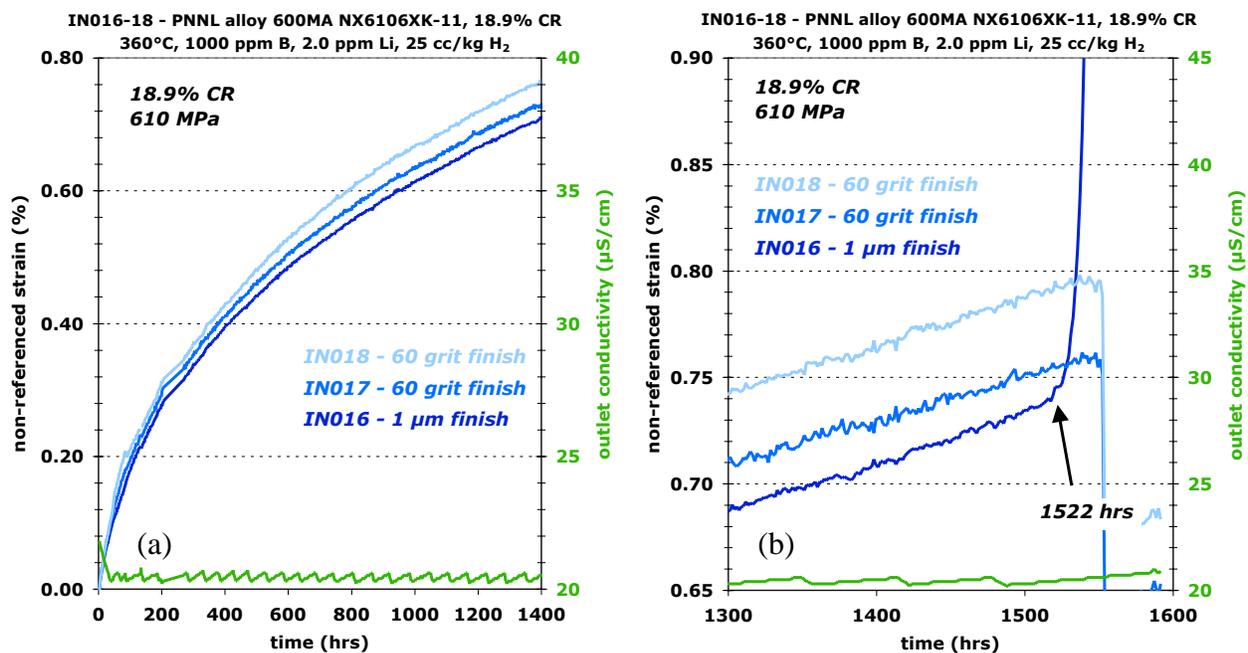
Figure 38. SCC initiation test plots for 19%CR alloy 600 specimens IN016, IN017 and IN018 during testing in 360°C PWR primary water: (a) early DCPD response and (b) observation of crack initiation and growth for the IN016 specimen.
