**STRESS CORROSION CRACK INITIATION OF COLD-WORKED
ALLOY 600 AND ALLOY 690 IN PWR PRIMARY WATER**

**Technical Milestone Report: M2LW-14OR0404023
PNNL-23712 September 2014**

Research Project:
**Stress Corrosion Crack Initiation of
Nickel-Base Alloys in LWR Environments**
Project Manager: S. M. Bruemmer
Pacific Northwest National Laboratory

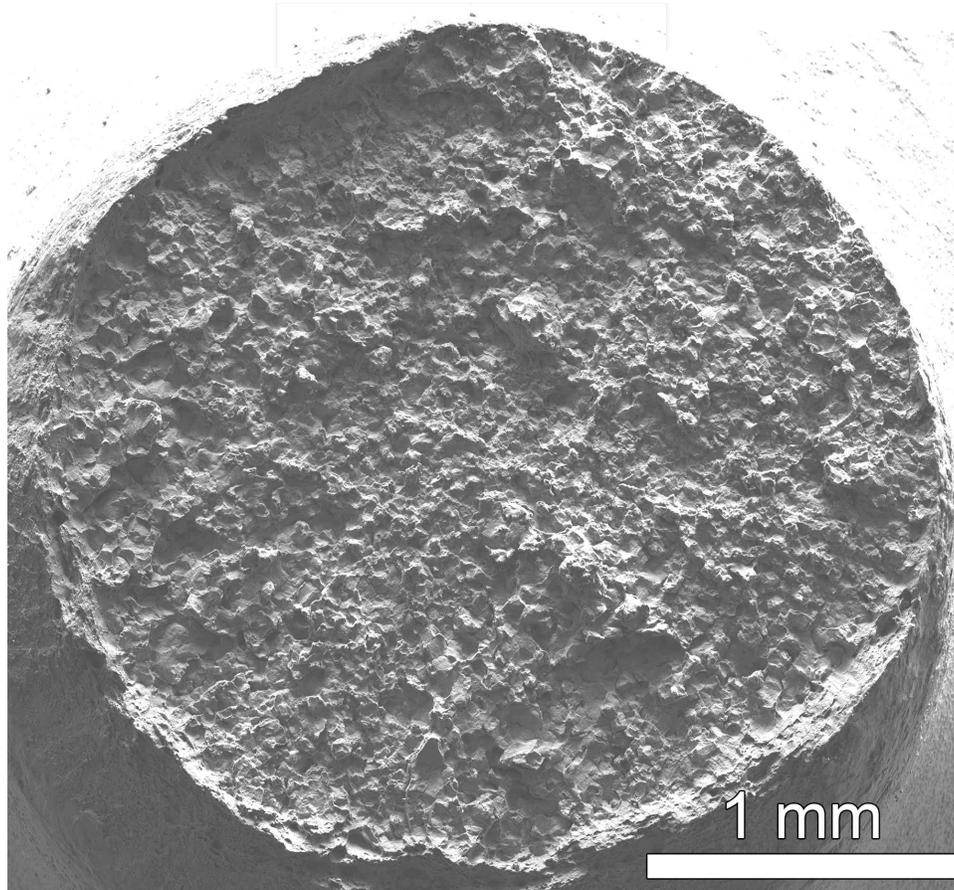
Figure 39. SEM-SE image showing IG fracture surface for 19%CR alloy 600 specimen IN016 after testing in PWR primary water.

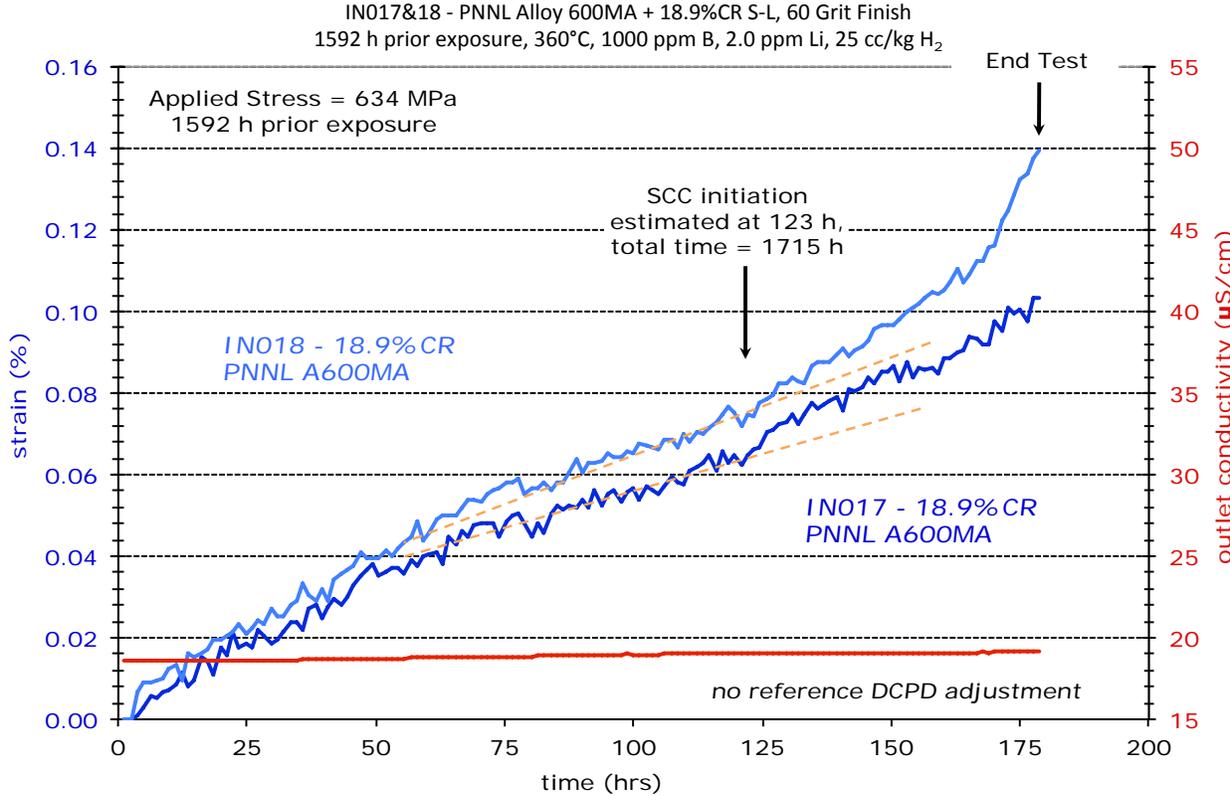
Figure 40. SCC initiation test plot for the continuing test on 19%CR alloy 600 specimens IN017 and IN018 in 360°C PWR primary water.

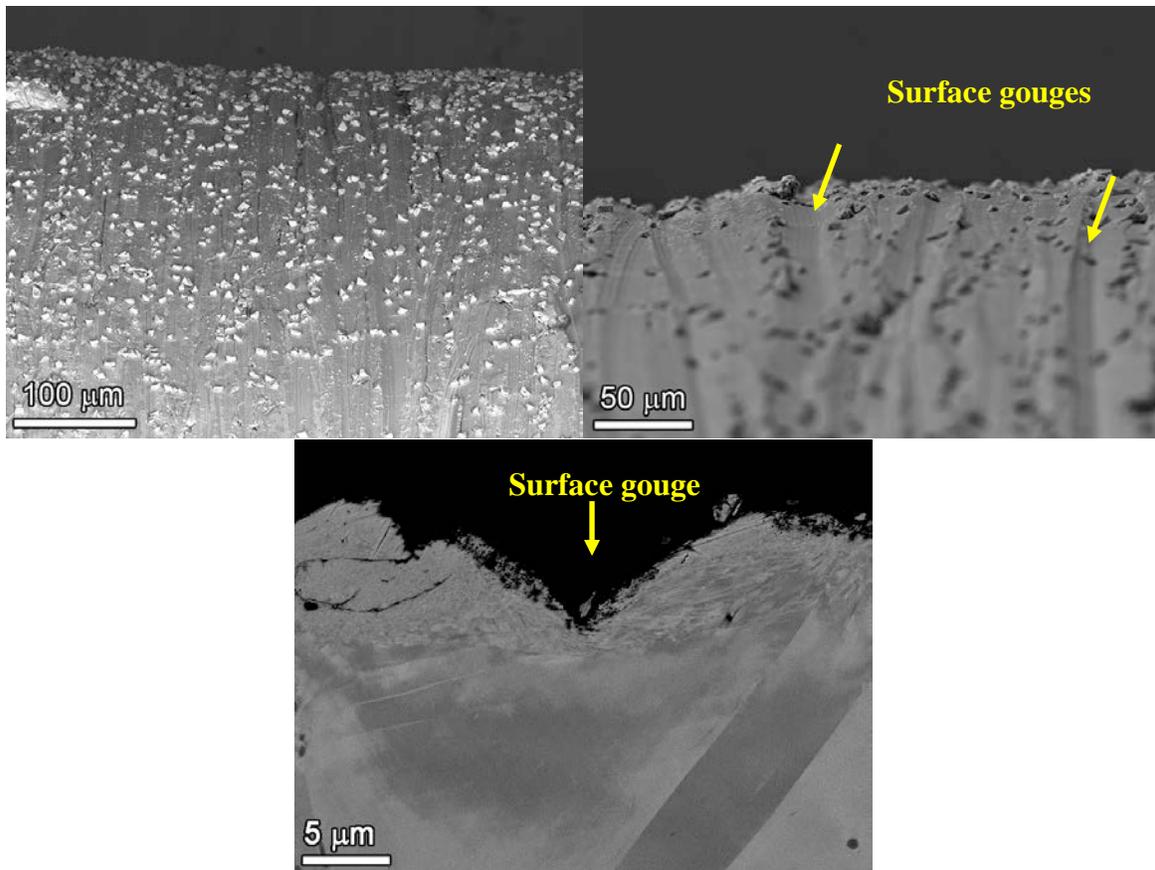
Figure 43. SEM-BSE images of IN018 gauge section in both plan view at two different angles as well as a cross-sectional example. The depth and microstructure of the gouges observed in the plan view can clearly be observed in the cross-section image to be on the order of tens of micrometers.

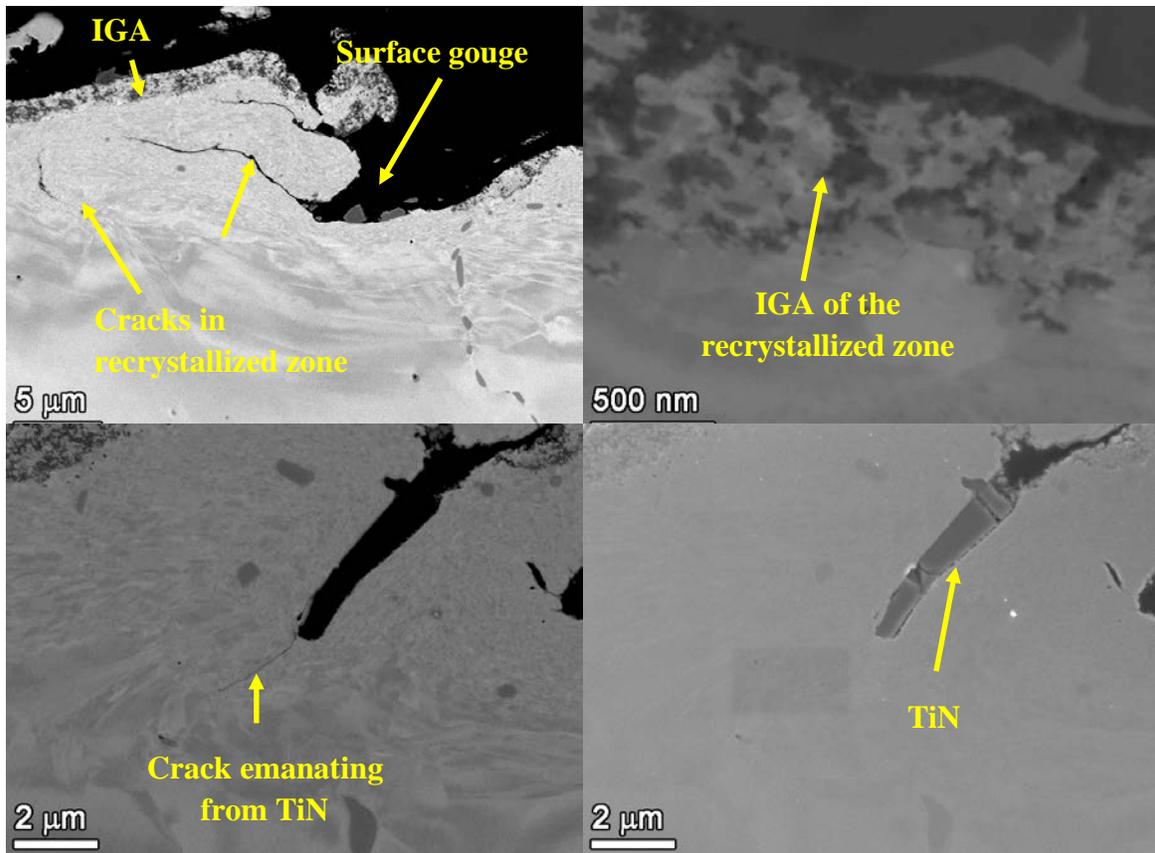
Figure 44. SEM-BSE image of the IN018 cross-section showing that the surface is comprised of a recrystallized zone of nanocrystalline grains. Once exposed, this surface slowly corrodes. Random cracking within the nanocrystalline zone was observed and was most likely imparted during grinding. Lastly, cracks were observed to emanate from TiN particles near the surface.

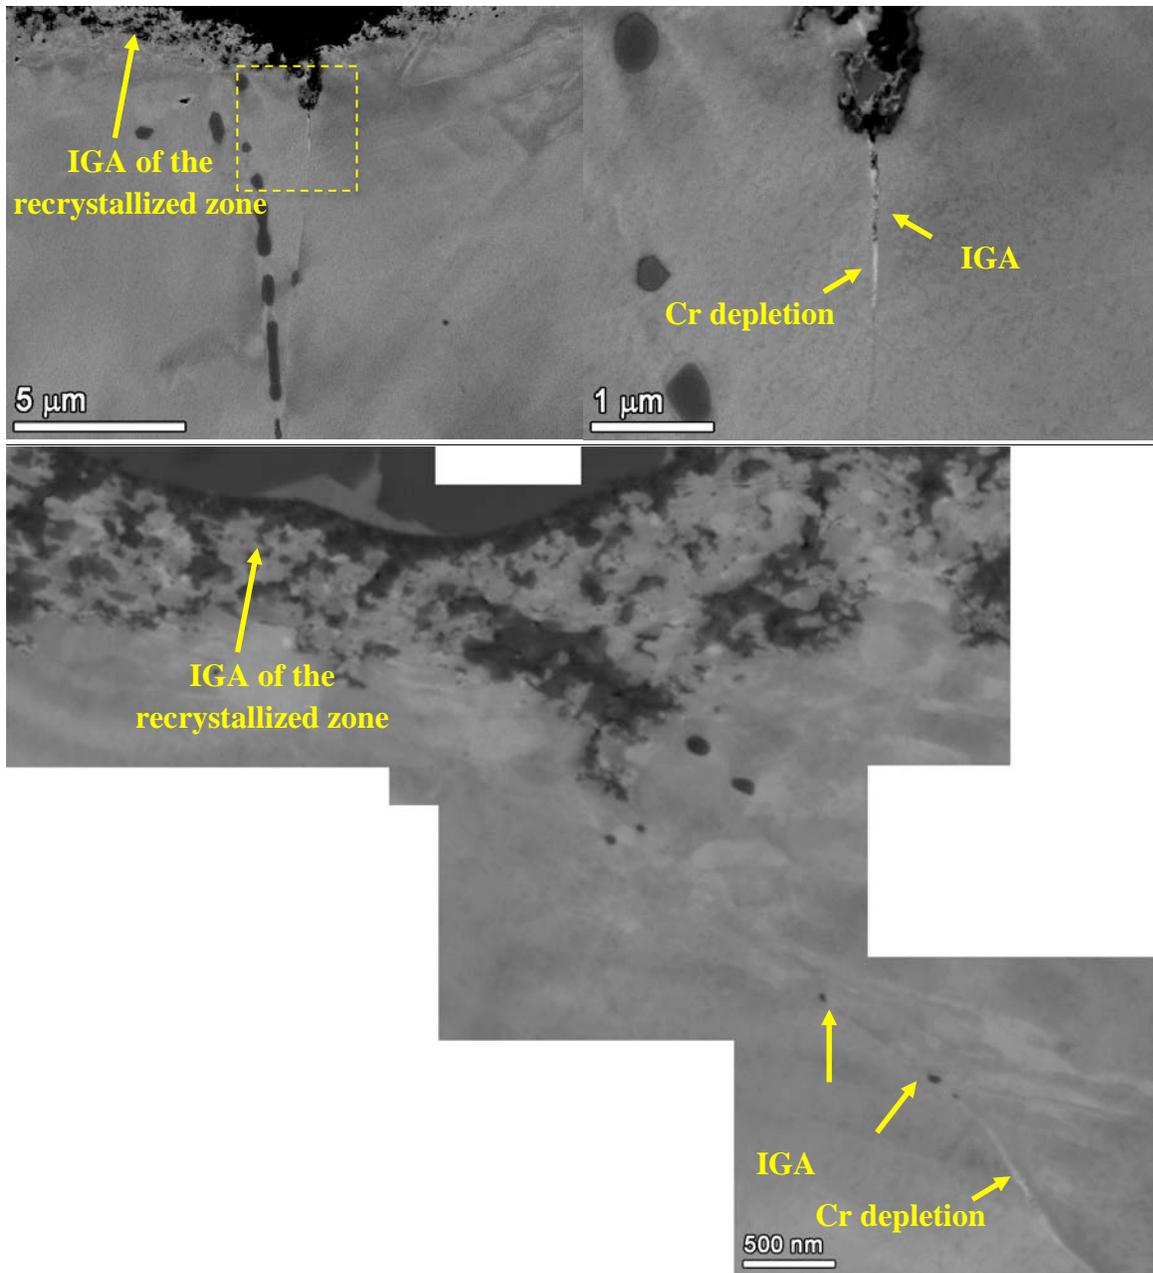
Figure 45. SEM-BSE micrographs of IN018 showing IG attack of boundaries that intersect the surface as well as a boundary below the recrystallized layer.

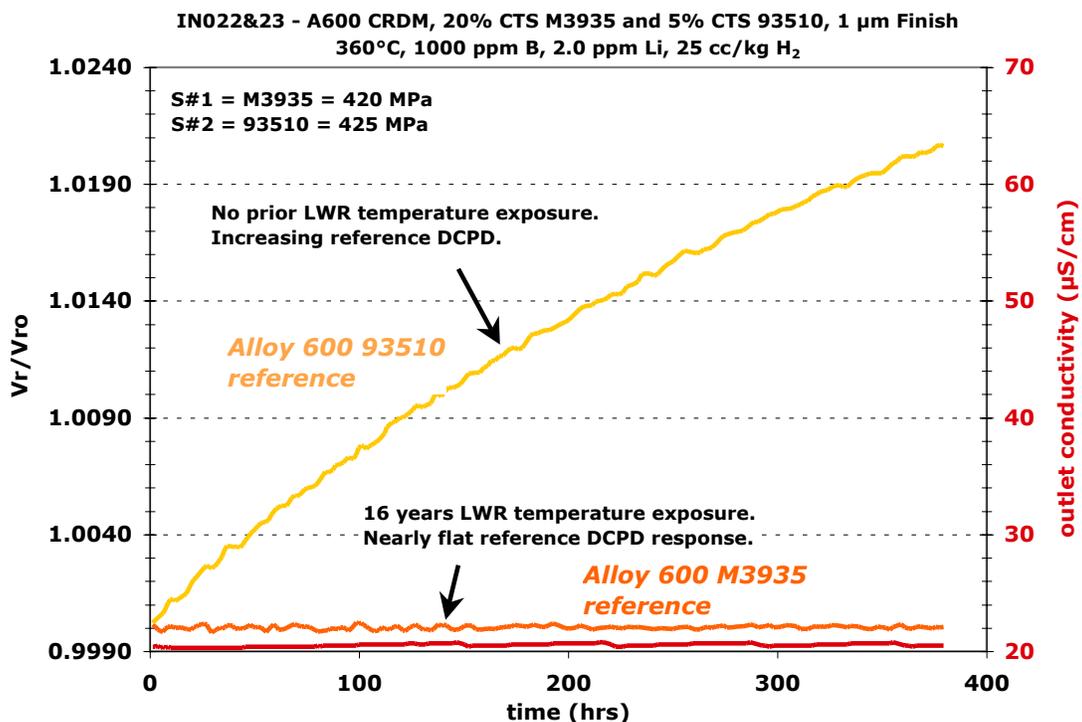
Figure 46. DCPD response for the reference locations in specimens IN022 and IN023.

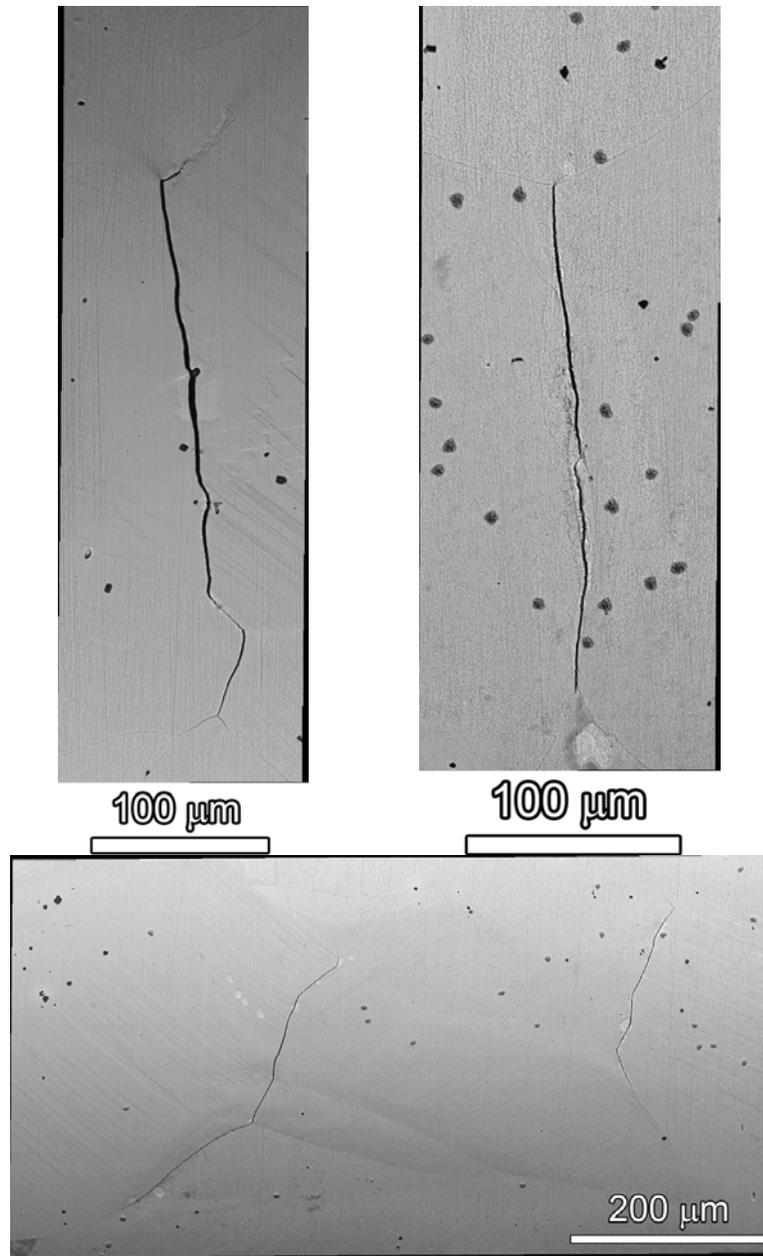
Figure 48. SEM-BSE images illustrating morphology of several large IGSCC cracks on the gauge surface of the IN022 specimen.

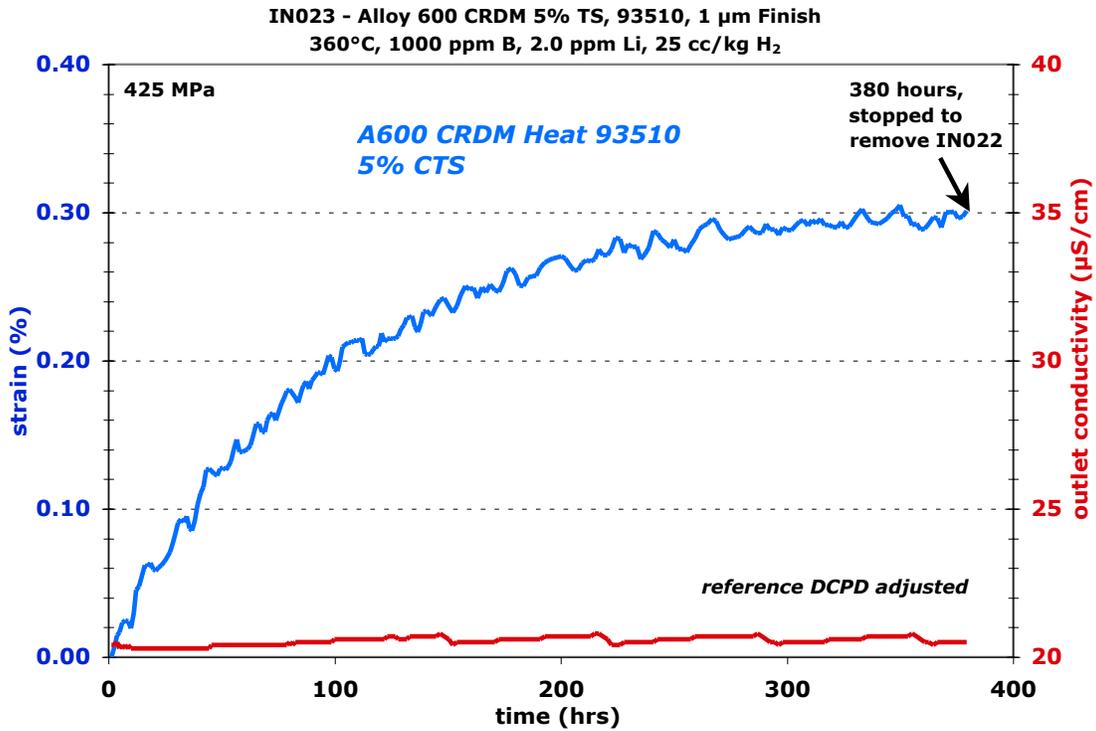
Figure 49. Strain versus time plot for specimen IN023 showing reference DCPD adjusted strains during testing in 360°C PWR primary water.

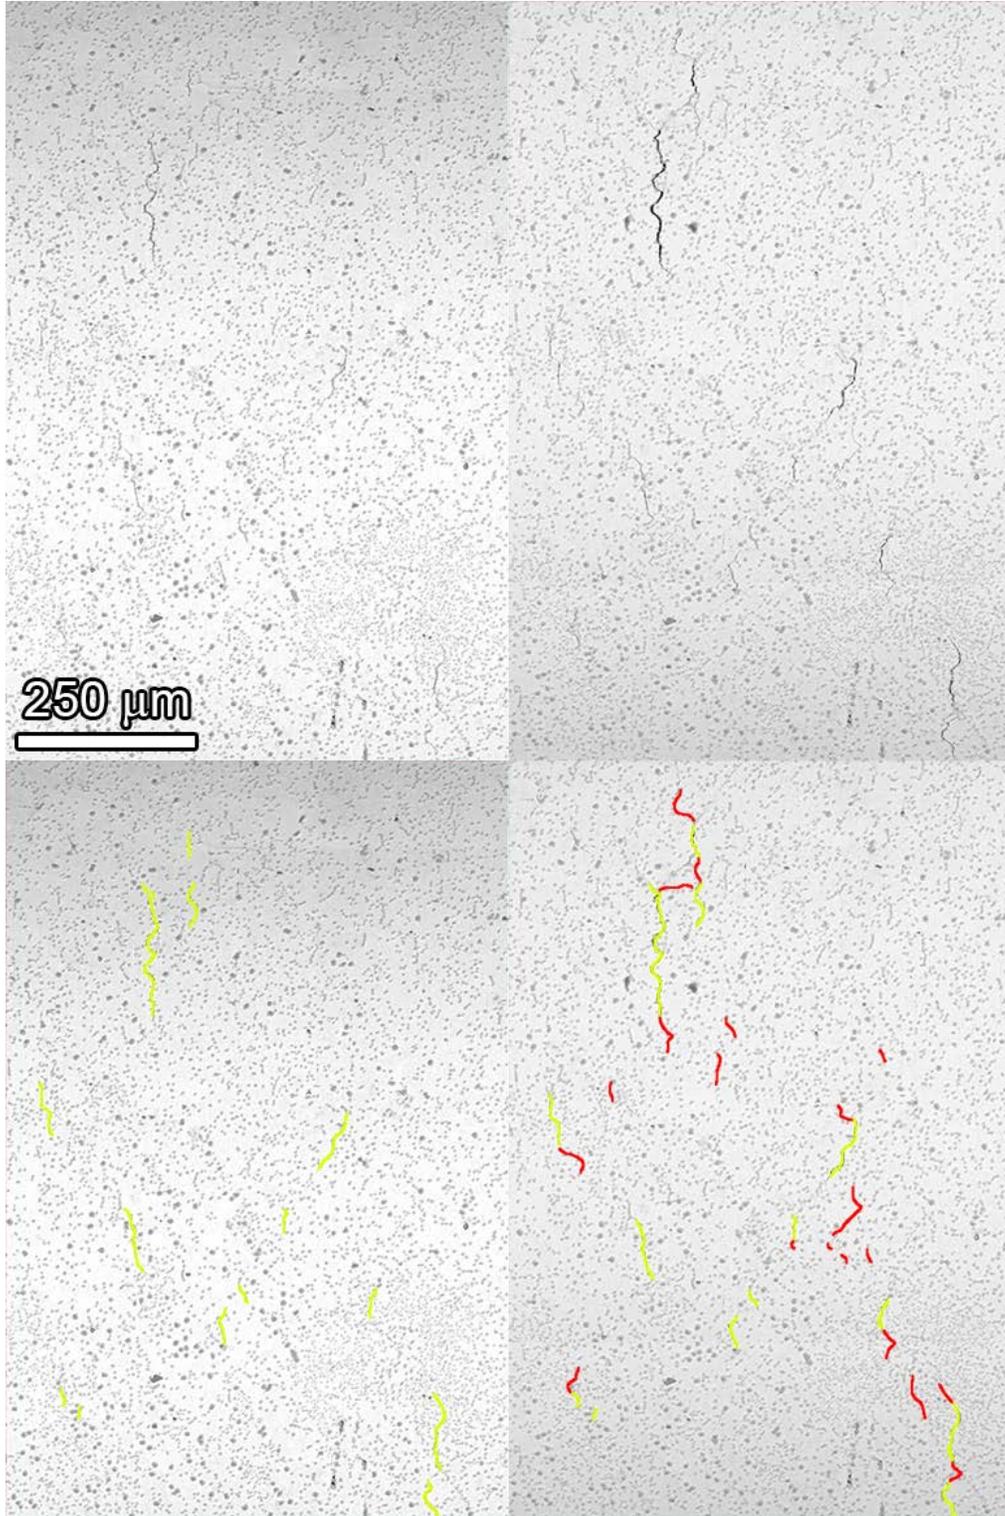
Figure 55. SEM-BSE images of IN023 Rotation #2 illustrating the sample at 1713 hours (left columns) and 2591 hours (right columns). The bottom two figures highlight the cracks in yellow present at 1713 hours and new cracks in red present at 2591 hours (red).

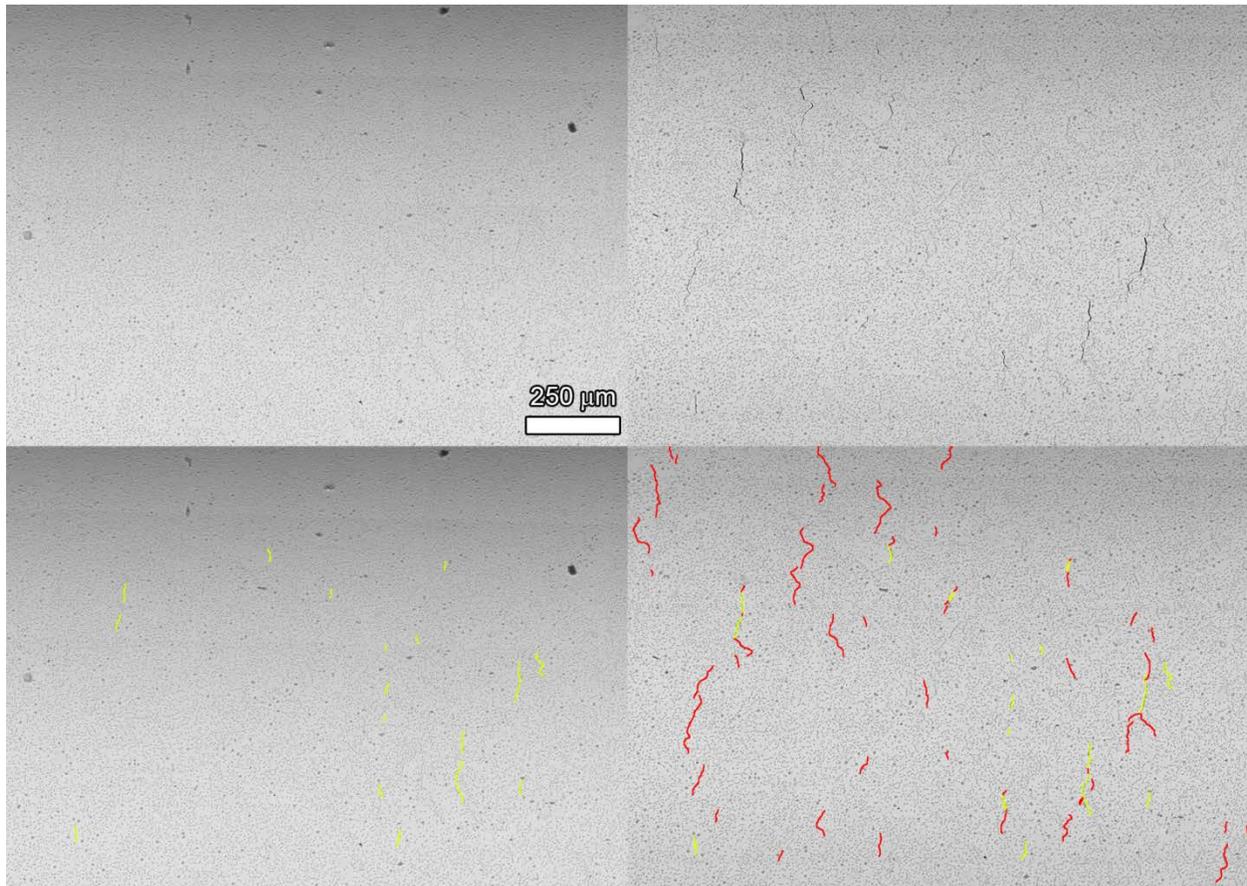
Figure 56. SEM-BSE images of IN023 Rotation 3 illustrating the sample at 1713 hours (left columns) and 2591 hours (right columns). The bottom two figures highlight the cracks in yellow present at 1713 hours and new cracks in red present at 2591 hours (red).

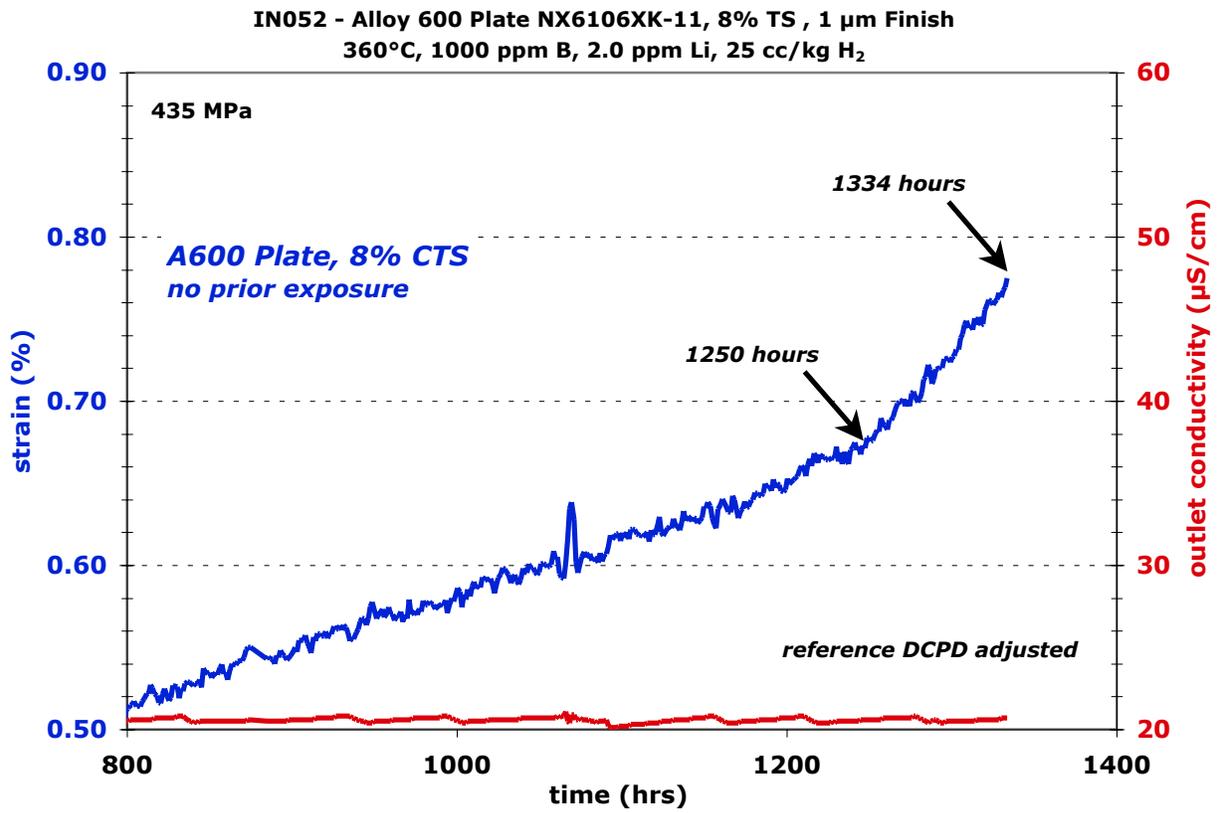
Figure 57. SCC initiation plot for the 8%TS alloy 600 specimen IN052 revealing evidence for crack nucleation at ~1250 hours.

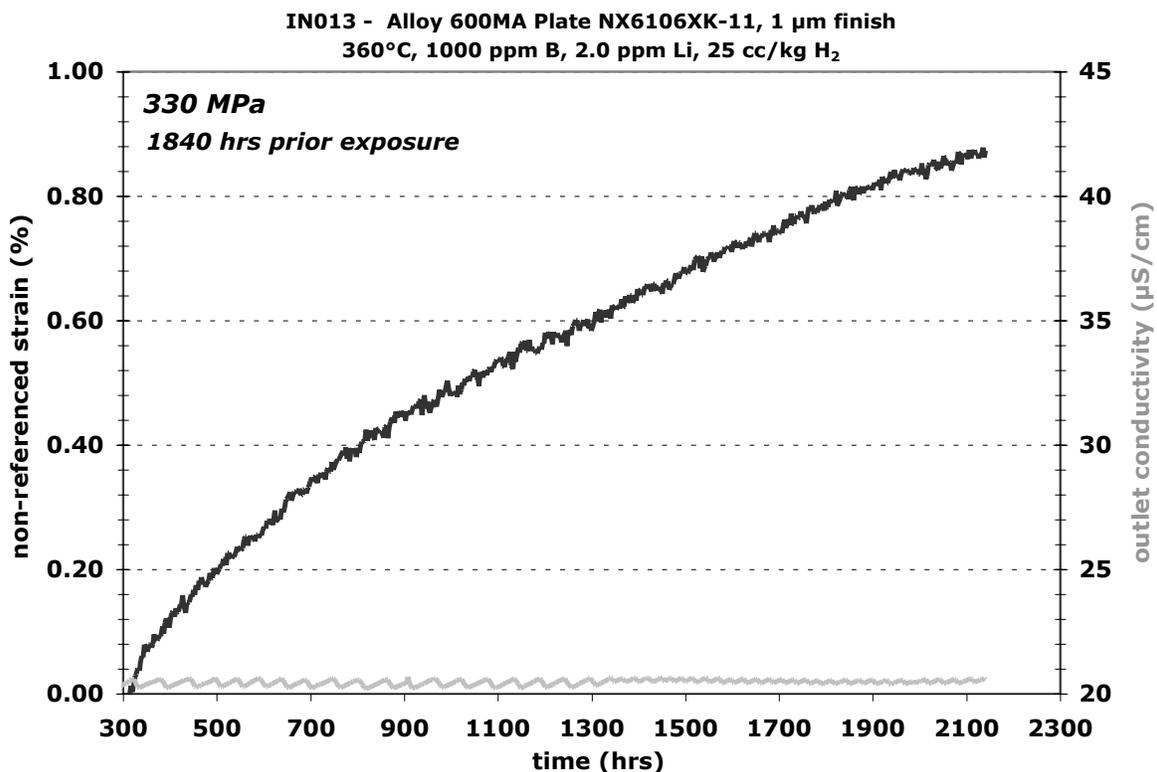
Figure 60. DCPD response for as-received alloy 600 plate specimen IN013 during its second exposure that lasted for 1840 hours giving a total exposure of 3392 hours. Neither IN014 nor IN015 were instrumented for DCPD measurement during this exposure.

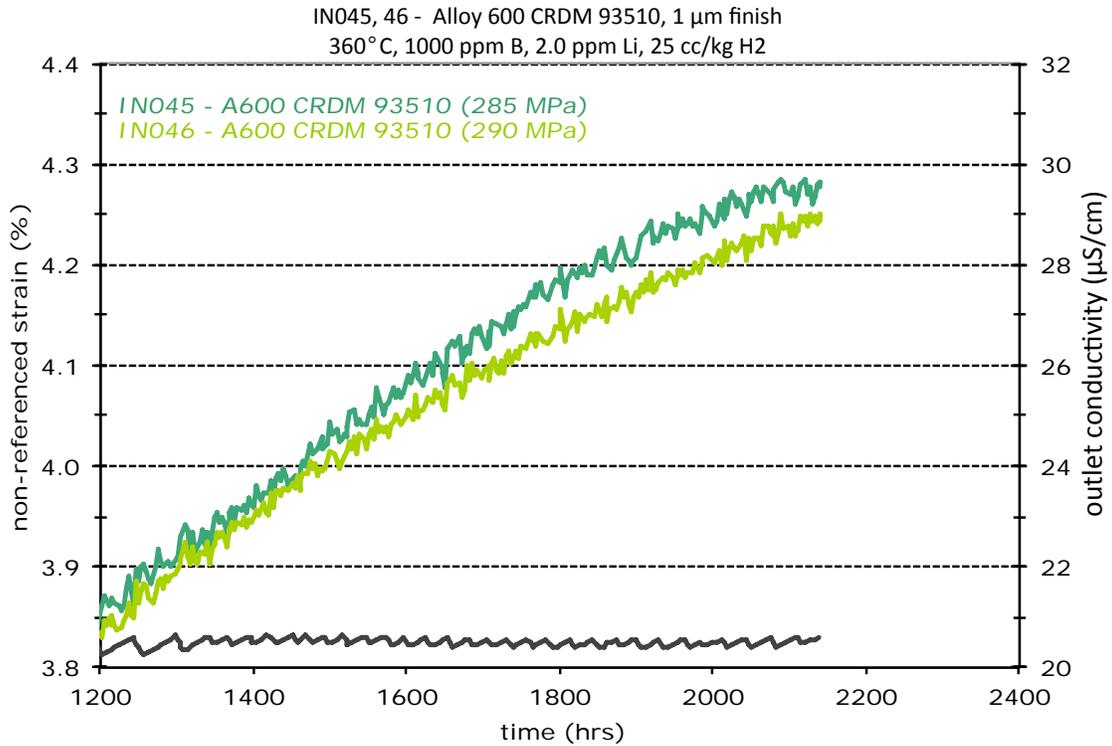
Figure 62. DCPD response for as-received alloy 600 CRDM specimens IN045 and IN046 during their first exposure in 360°C PWR primary water. IN047 was not instrumented in this exposure.

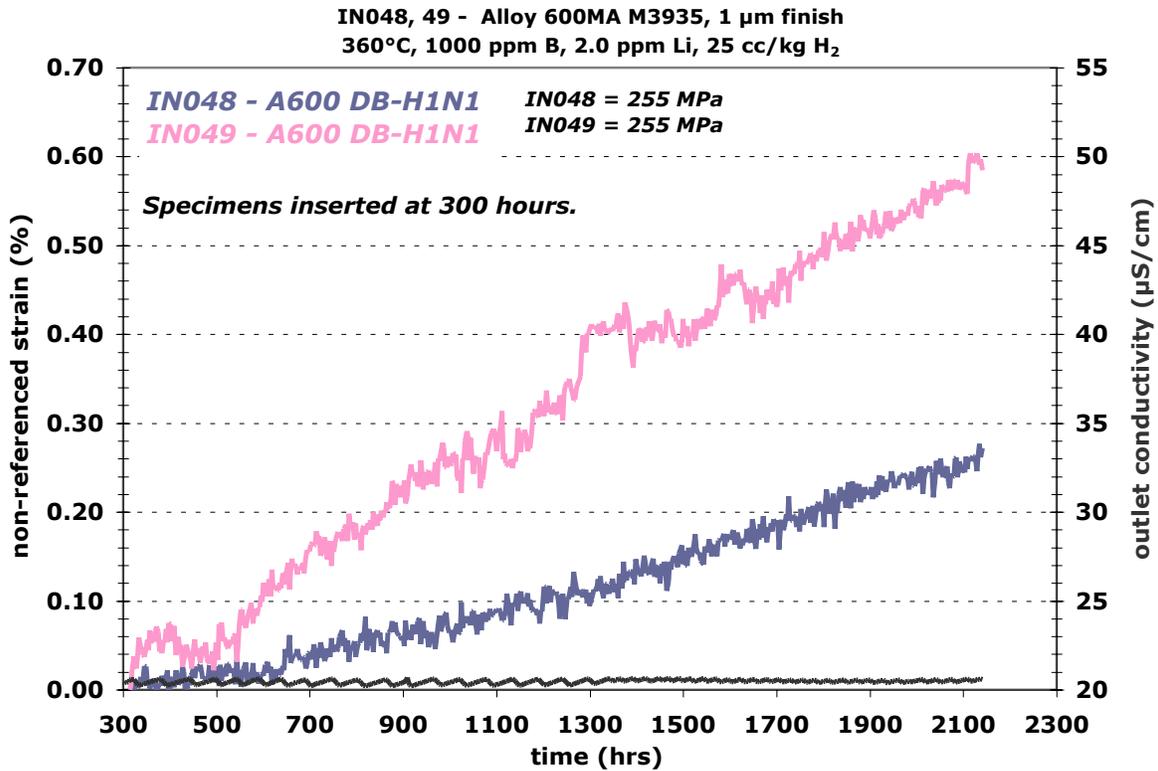
Figure 63. DCPD response for the two instrumented alloy 600 CRDM specimens from PWR service (IN048 and IN049) during their first exposure in 360°C PWR primary water for 1840 hours.

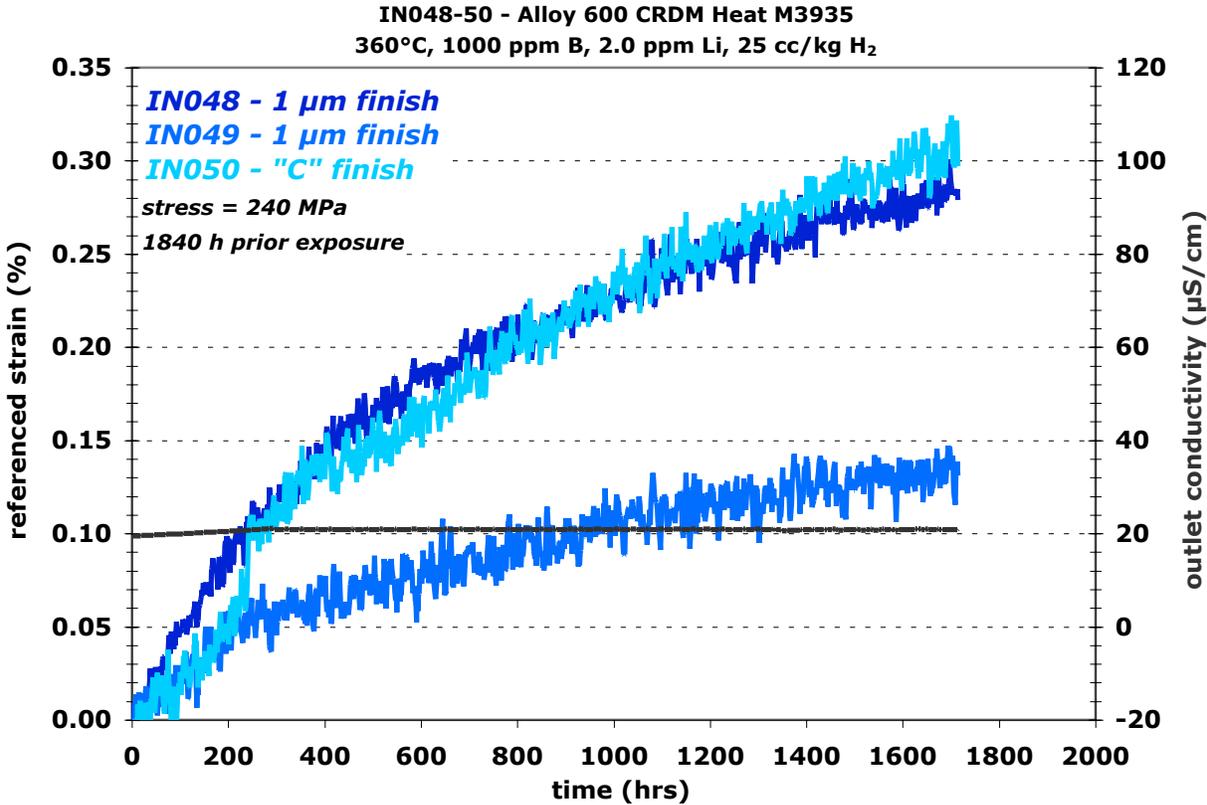
Figure 65. DCPD response for the alloy 600 CRDM specimens from PWR service (IN048, IN049 and IN050) during the ongoing second exposure in 360°C PWR primary water.

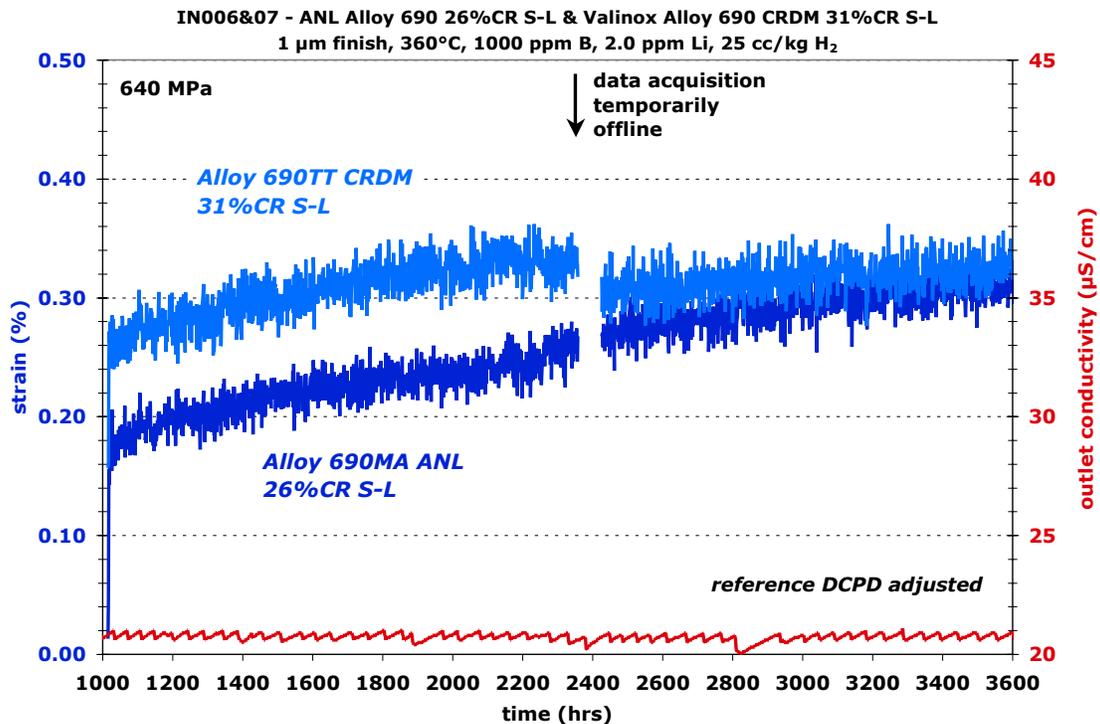
Figure 77. DCPD-based strain response for specimens IN006 and IN007 after stress increase to 640 MPa.

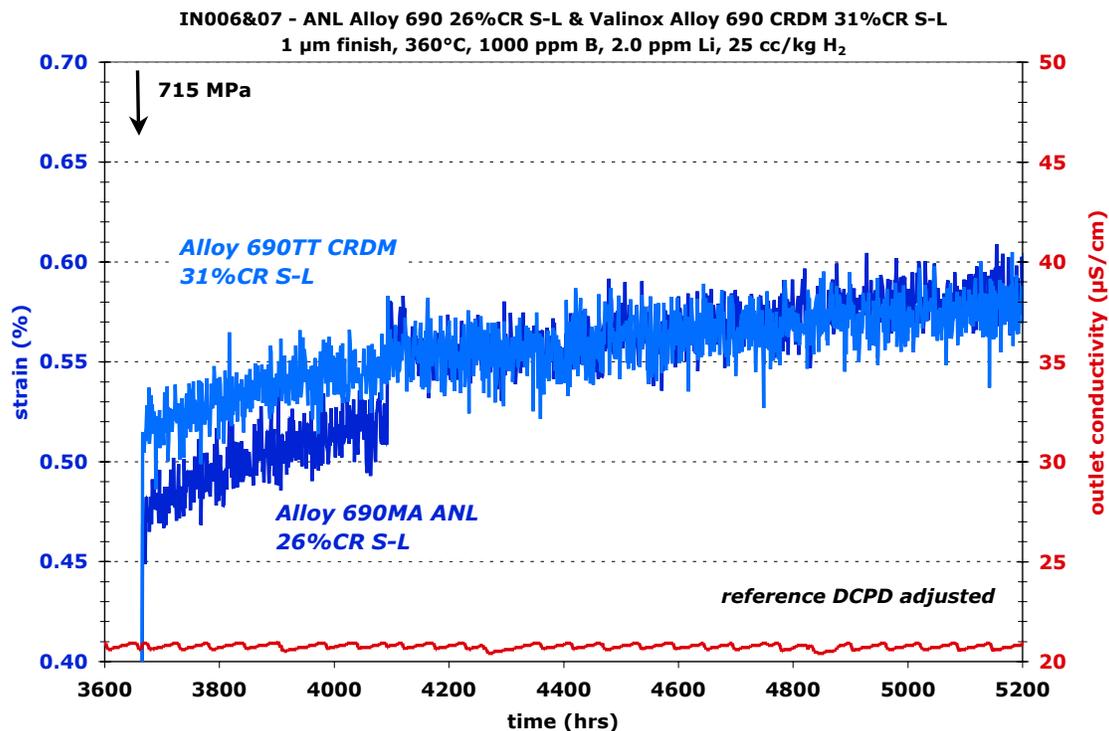
Figure 80. DCPD-based strain response of the two cold-rolled alloy 690 specimens (IN006 and IN007) from 3630 - 5200 hours after stress increase to 715 MPa.

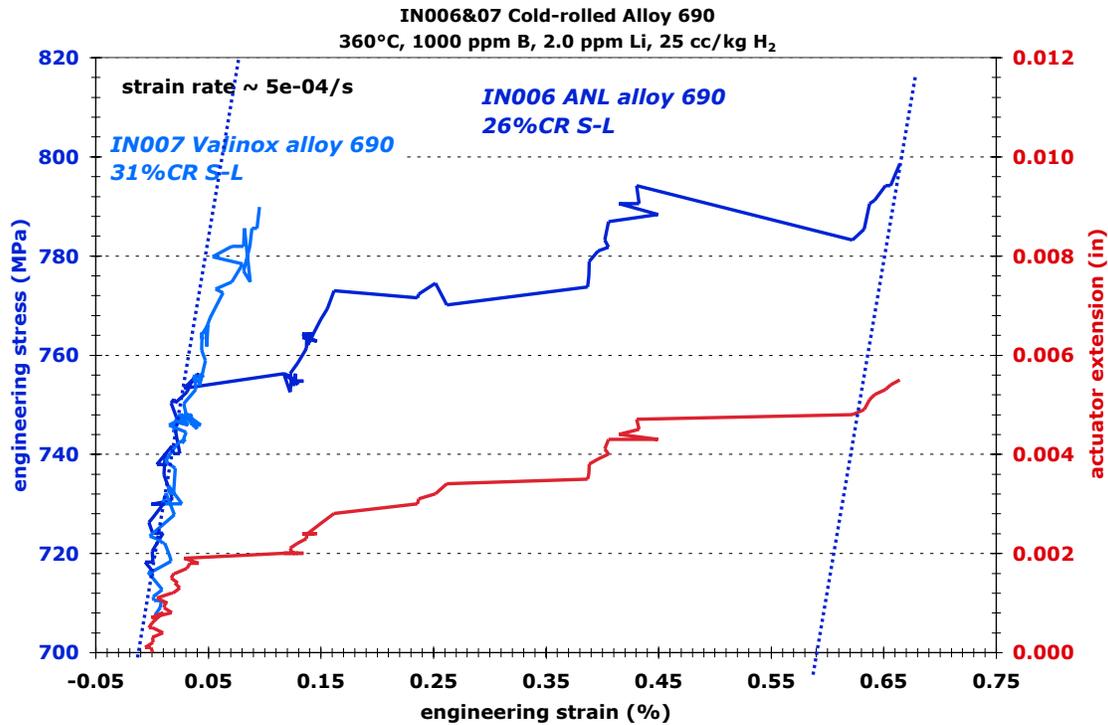
Figure 81. Tensile straining performed on the alloy 690 materials at ~5300 hours. The 26%CR plate material (IN006) underwent approximately 0.6% plastic strain while the 31%CR CRDM material (IN007) did not yield.

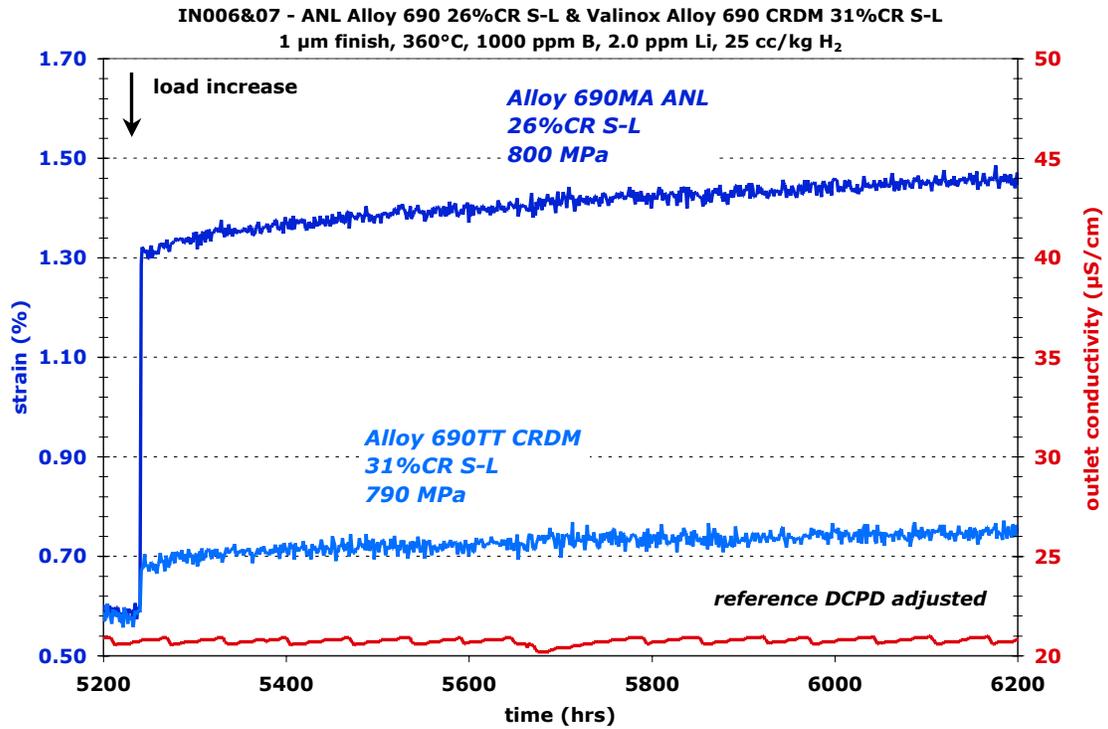
Figure 82. DCPD-based strain response for the IN006 and IN007 specimens from 5220 to 6200 hours after another load increase to 790-800 MPa.

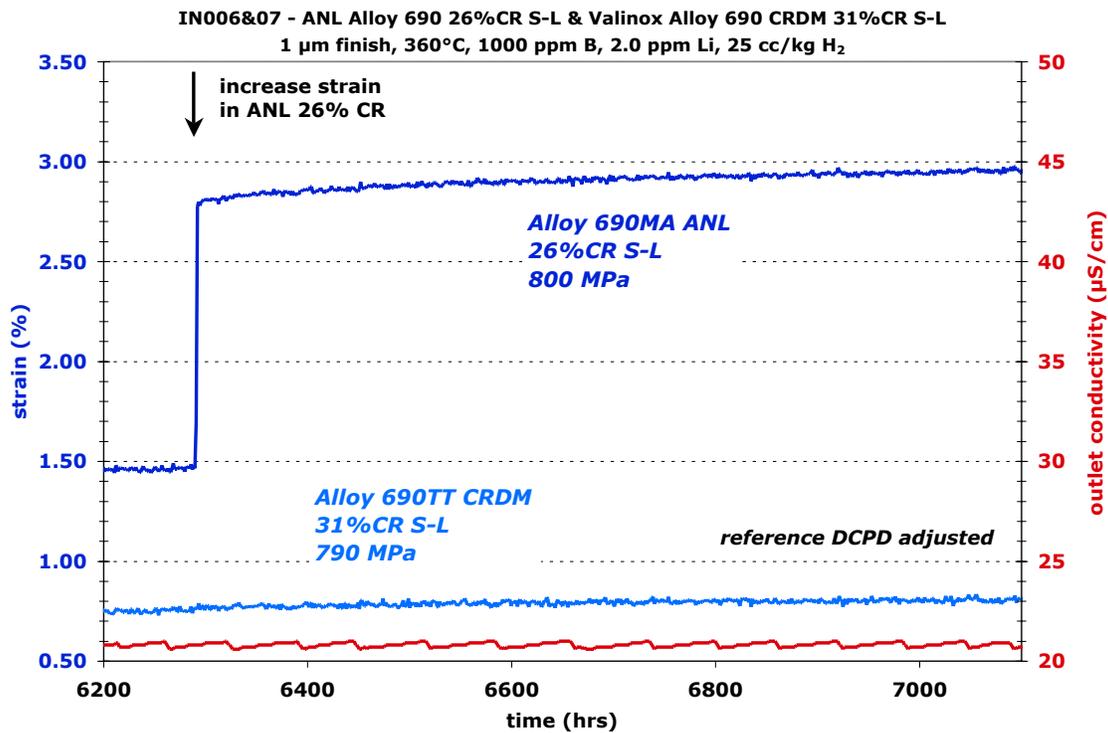
Figure 84. DCPD-based strain response of the two CR alloy 690 specimens (IN006 and IN007) from 6200 - 7100 hours after plastic deformation in plate specimen IN006.

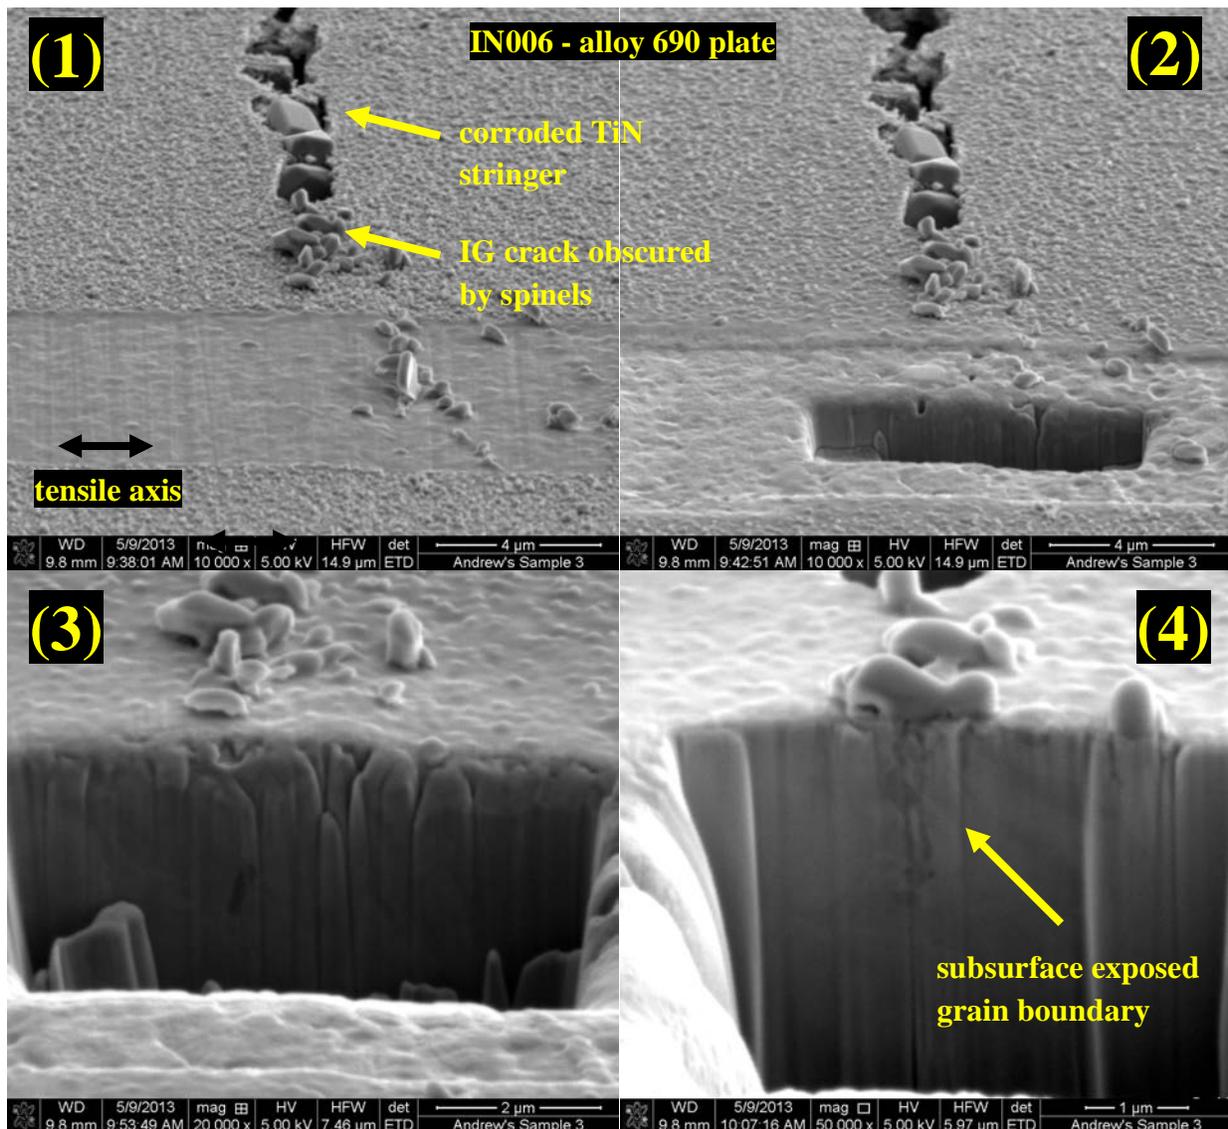
Figure 89. Step-by-step imaging of the formation of a trench into the surface of the 26%CR plate specimens (IN006) to reveal a subsurface IG crack in cross section.

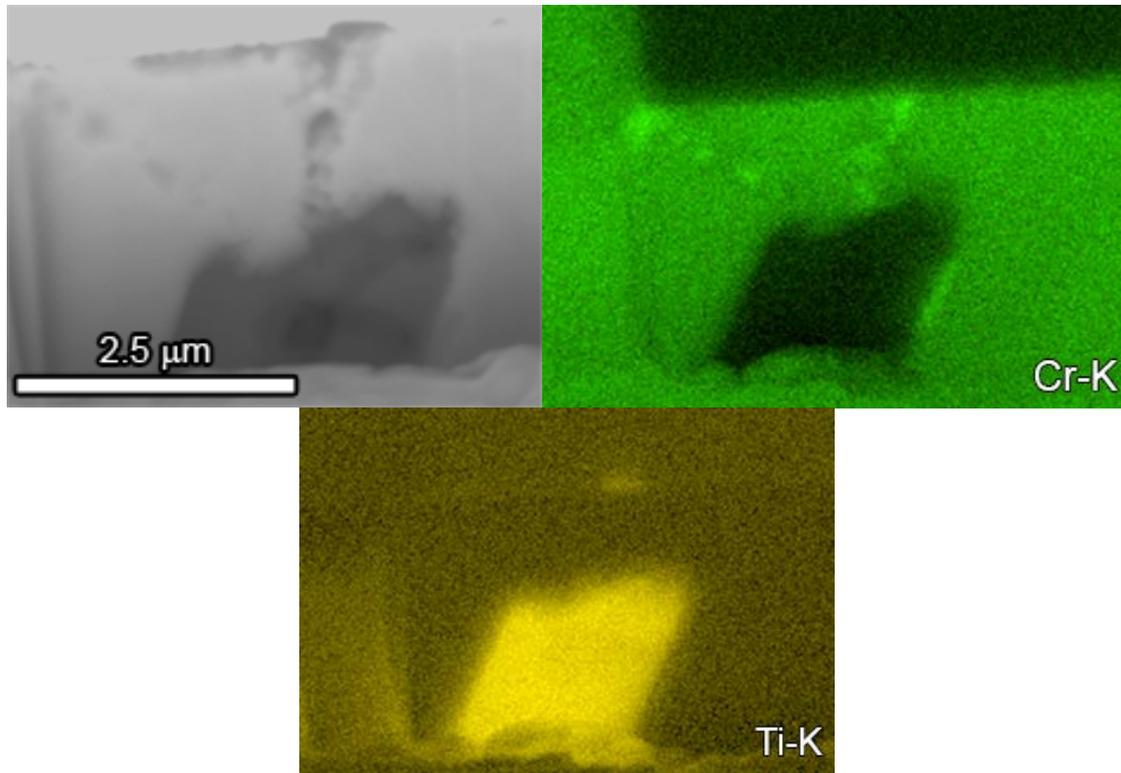
Figure 99. Near-surface grain boundary microstructure from a FIB trench in the IN007 specimen after 9144 h. Corrosion of the grain boundary is observed extending from the TiN inclusion.

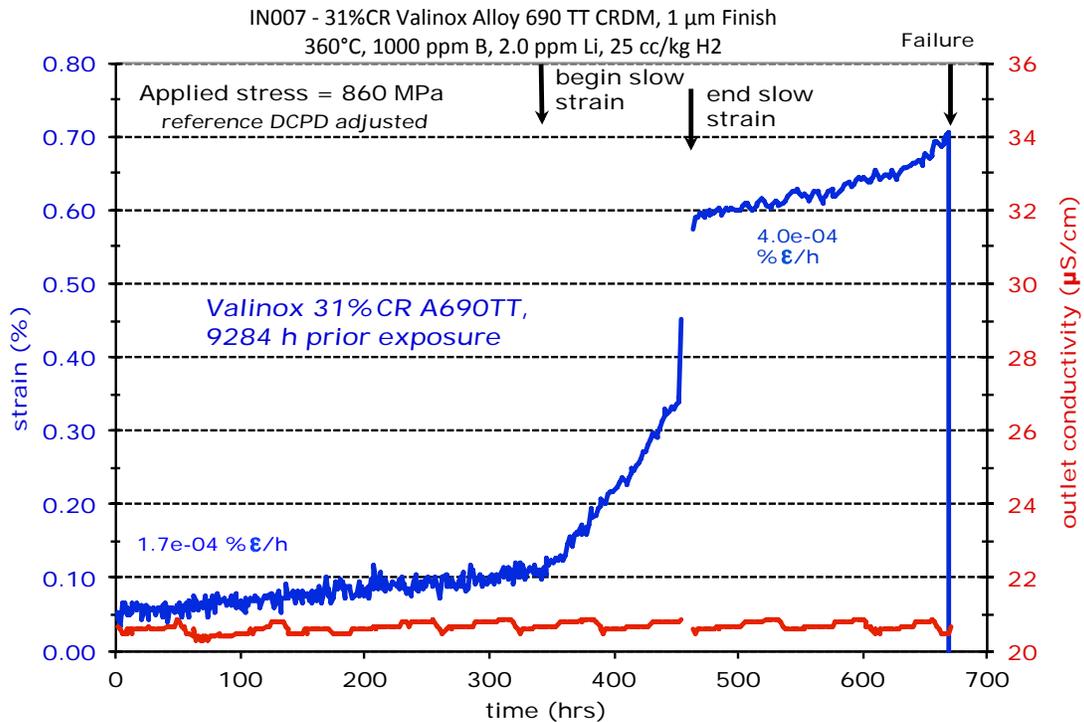
Figure 100. DCPD-based strain response of the 31%CR alloy 690 CRDM specimen IN007 after restart at the yield stress (860 MPa).
