**STRESS CORROSION CRACK INITIATION OF COLD-WORKED
ALLOY 600 AND ALLOY 690 IN PWR PRIMARY WATER**

**Technical Milestone Report: M2LW-14OR0404023
PNNL-23712 September 2014**

Research Project:
**Stress Corrosion Crack Initiation of
Nickel-Base Alloys in LWR Environments**
Project Manager: S. M. Bruemmer
Pacific Northwest National Laboratory

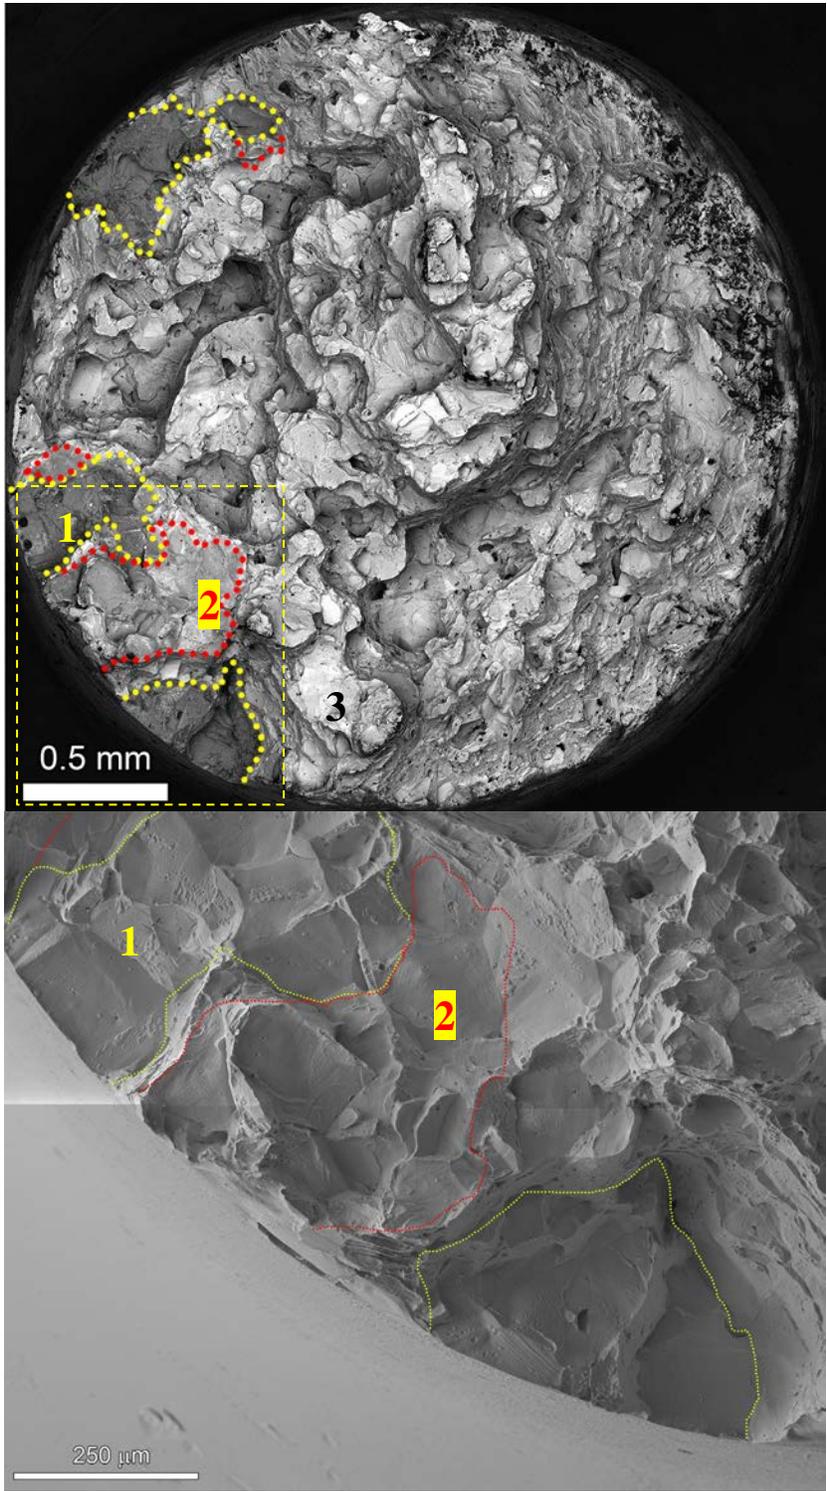
Figure 101. Low kV SEM-BSE of the fracture surface and high kV SEM-SE micrographs illustrating the fracture surface for the 31%CR CRDM specimen IN007. Several pockets of IG cracking were found where yellow is initial SCC, red is secondary SCC. Remainder of fracture surface appears to be mixture of IG and TG fracture with no apparent oxide.

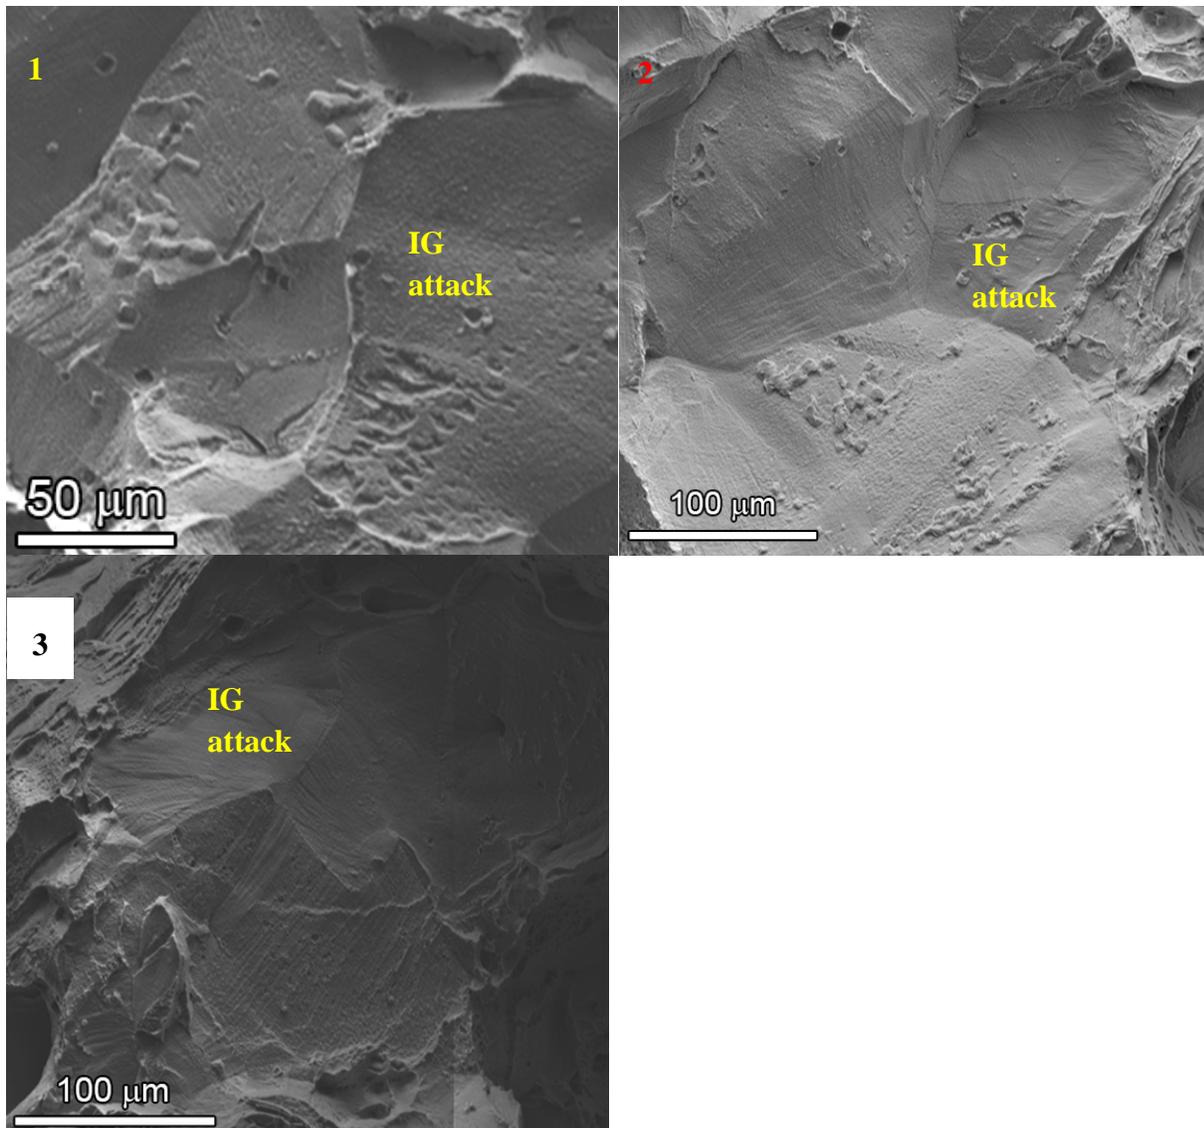
Figure 102. SEM-SE images of IG cracking of various regions denoted in Figure 101.

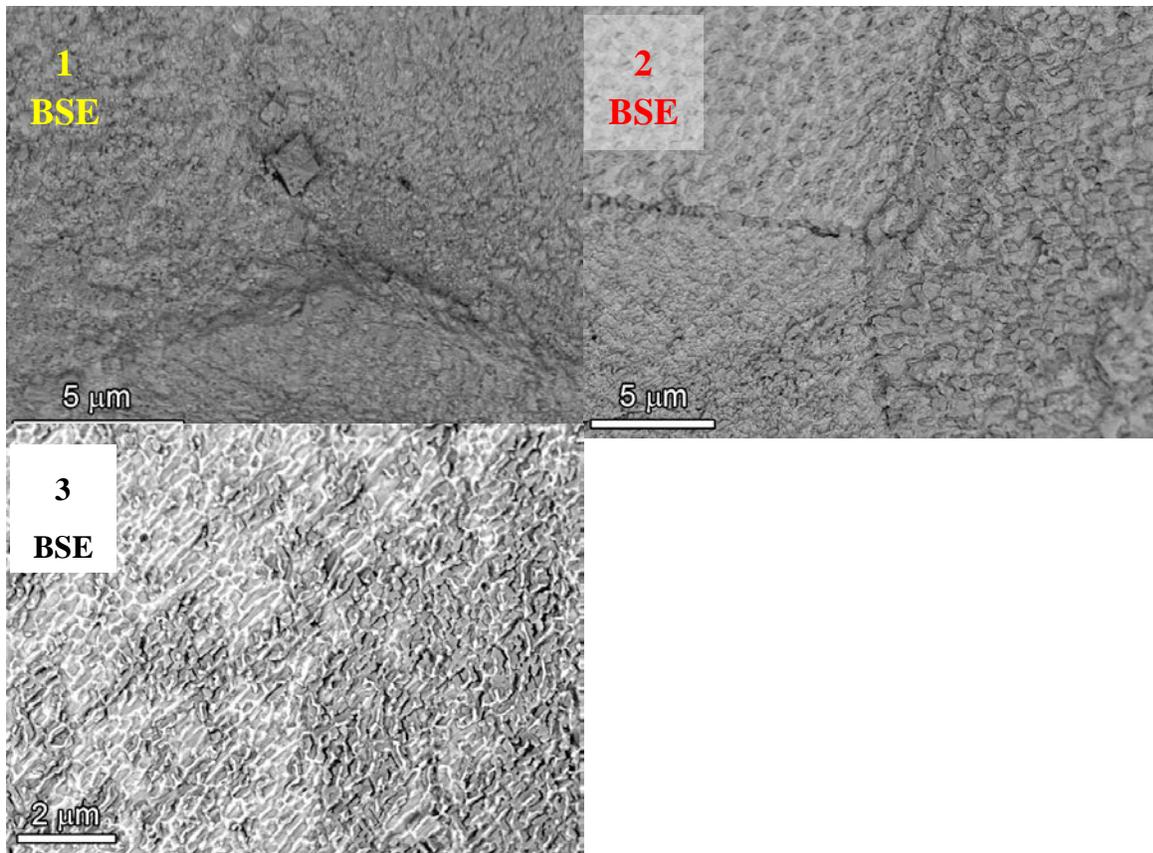
Figure 103. High magnification SEM-BSE images of IG cracking of various regions denoted in Figure 101.

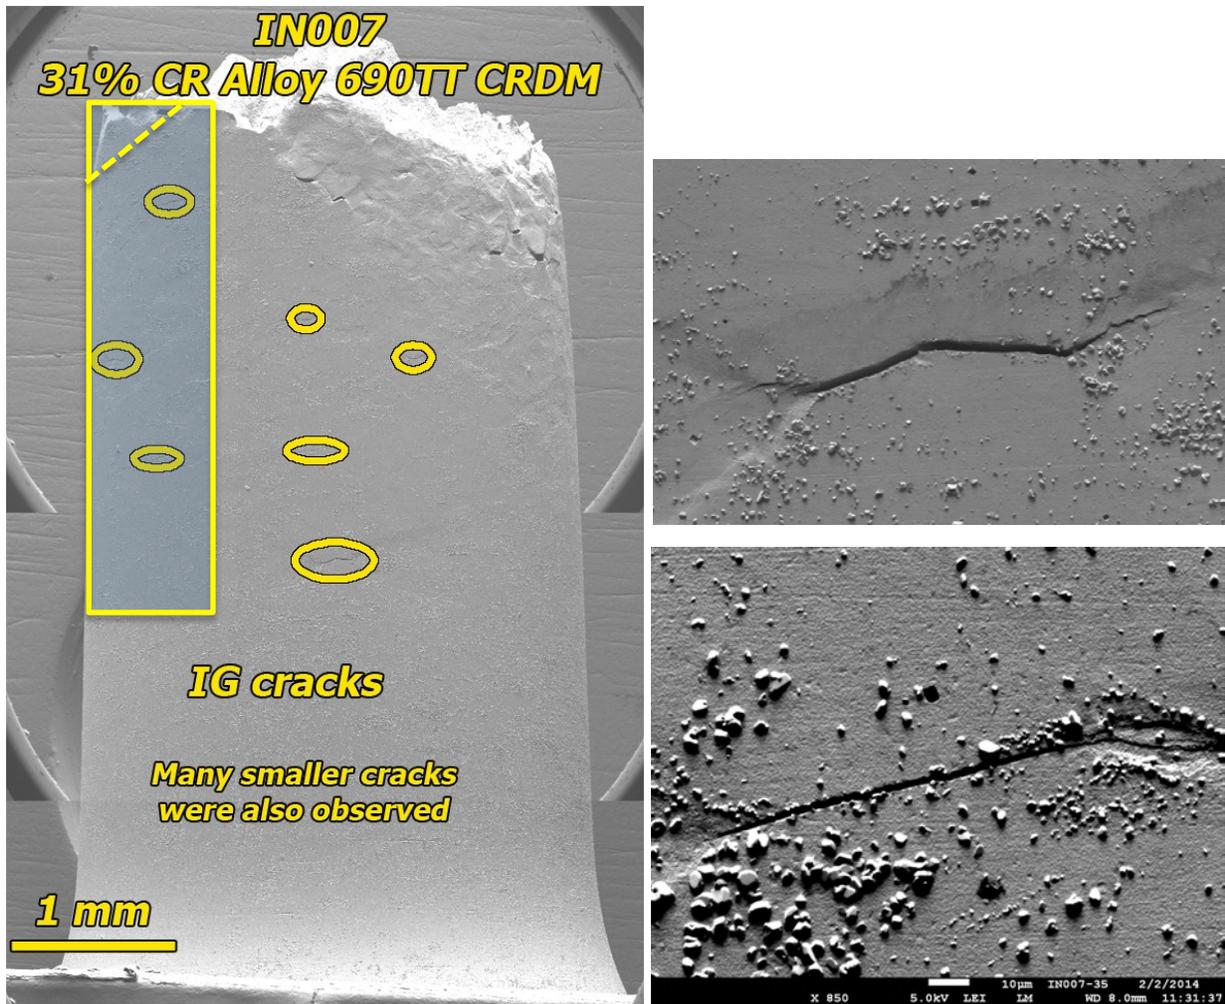
Figure 104. SEM-SE images from the gauge surface of the 31%CR CRDM specimen IN007. The yellow box indicates where a cross-section sample was prepared. The dotted line indicates a portion of the cross-section slice that was removed to due to necking damage.

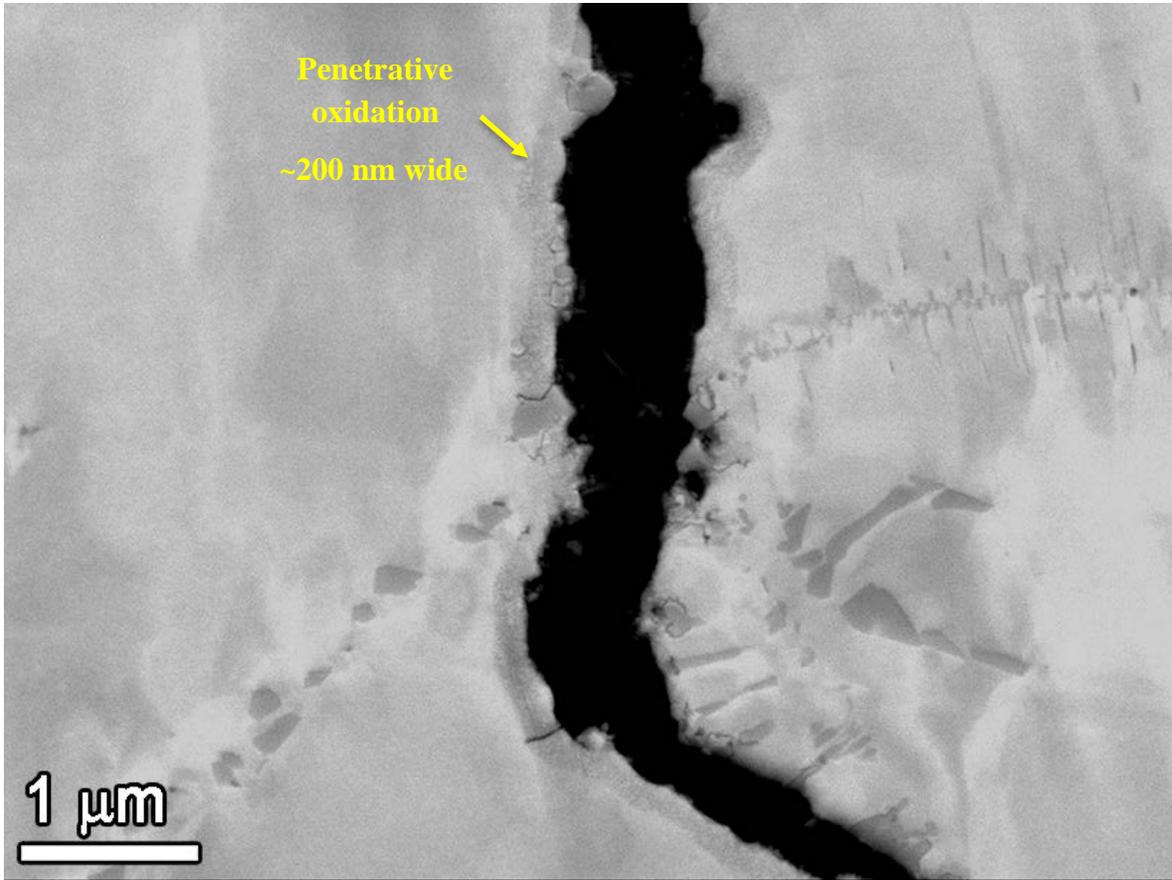
Figure 107. SEM-BSE image showing penetrative oxidation in the yellow box in Figure 106.

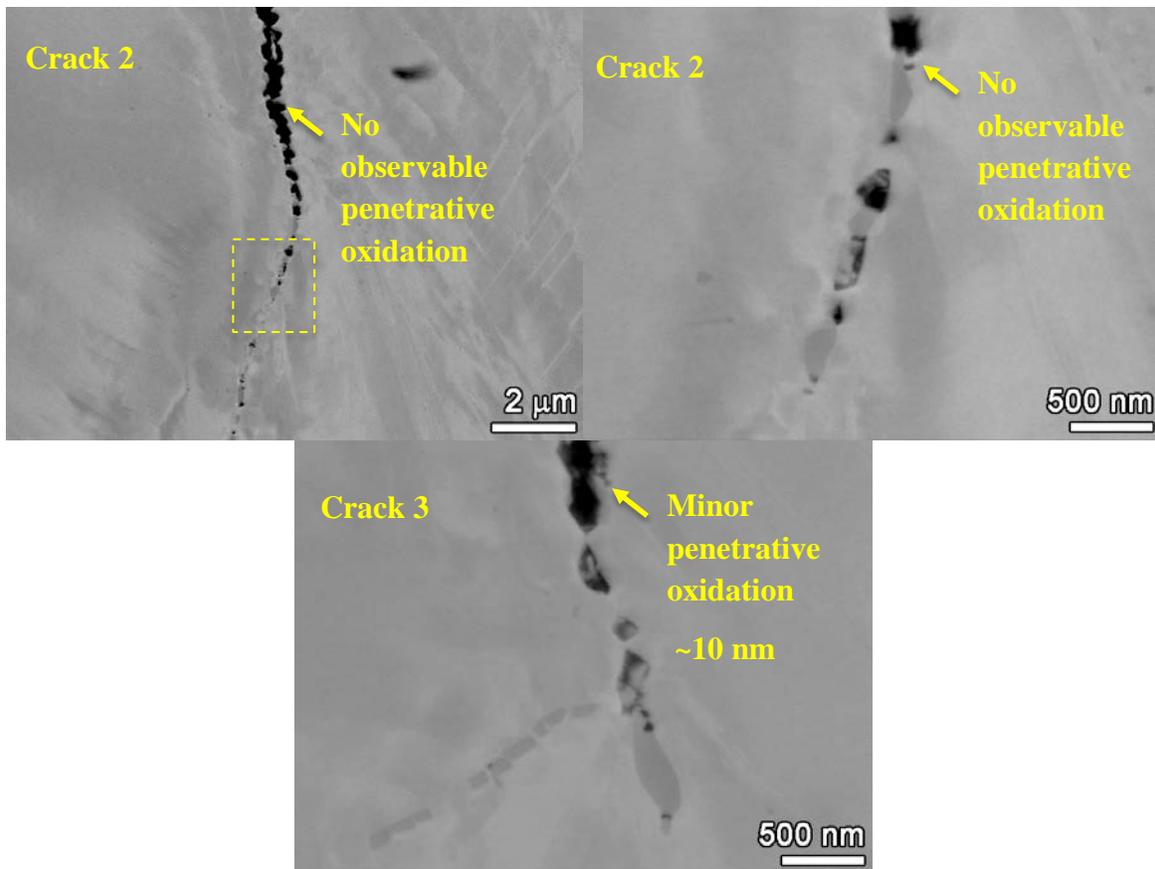
Figure 110. SEM-BSE images of crack #2 and crack #3 (see Figure 105), both of which were identified as creep cracks. No significant penetrative oxidation was observed.

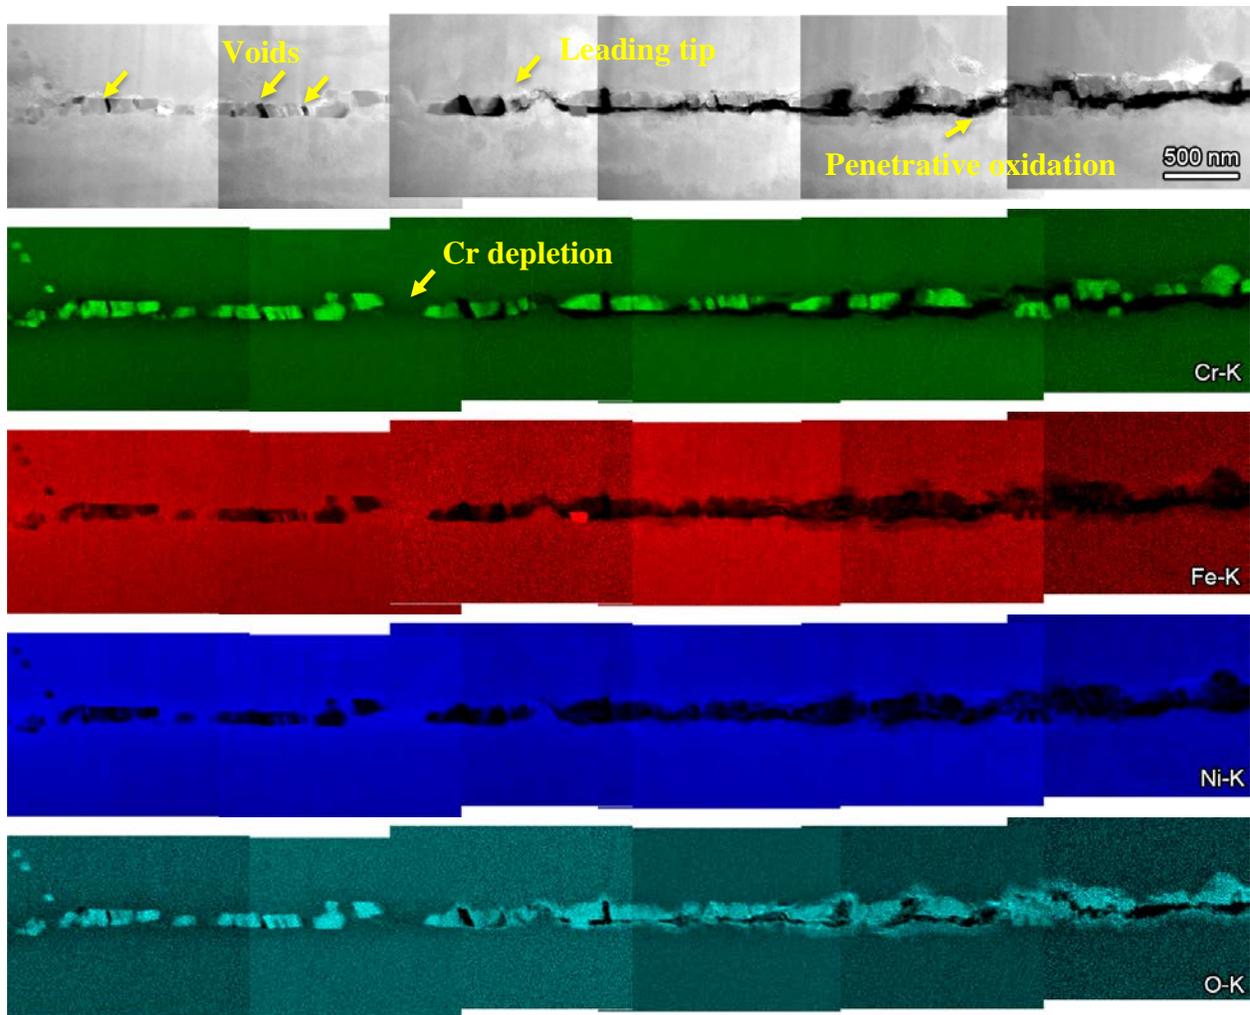
Figure 111. TEM Angular DF and EDS elemental map montages of crack #1 (see Figure 105).

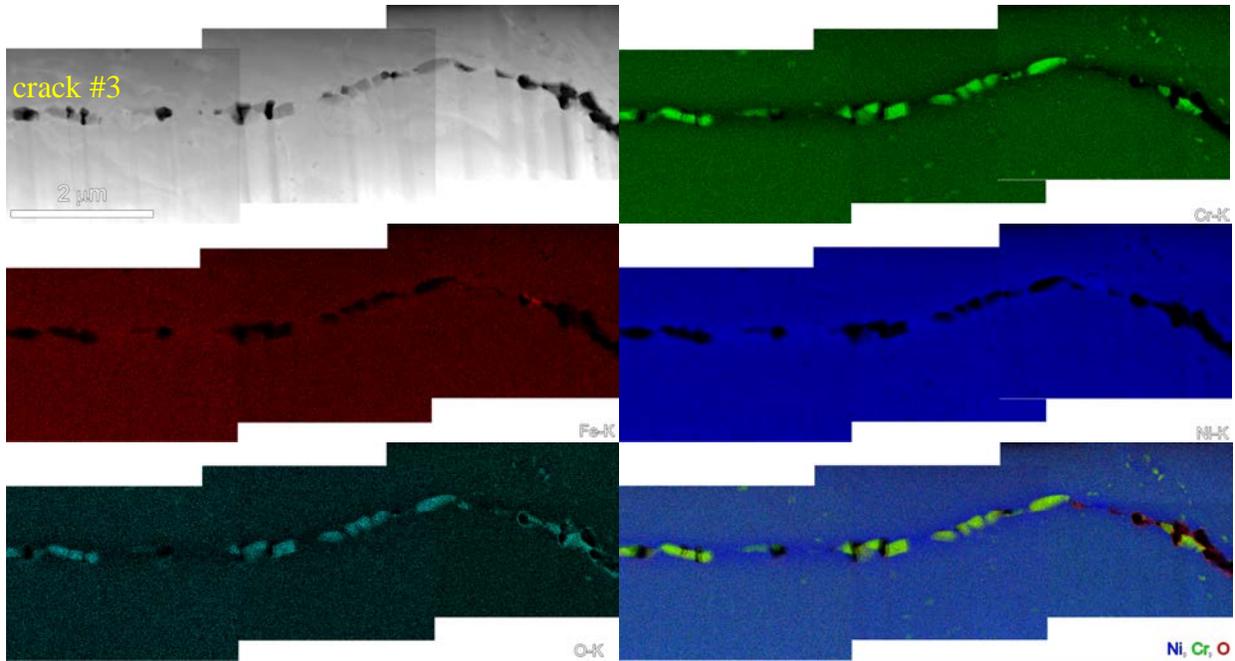
Figure 114. TEM Angular DF and EDS elemental map montages of crack #3 (see Figure 105).

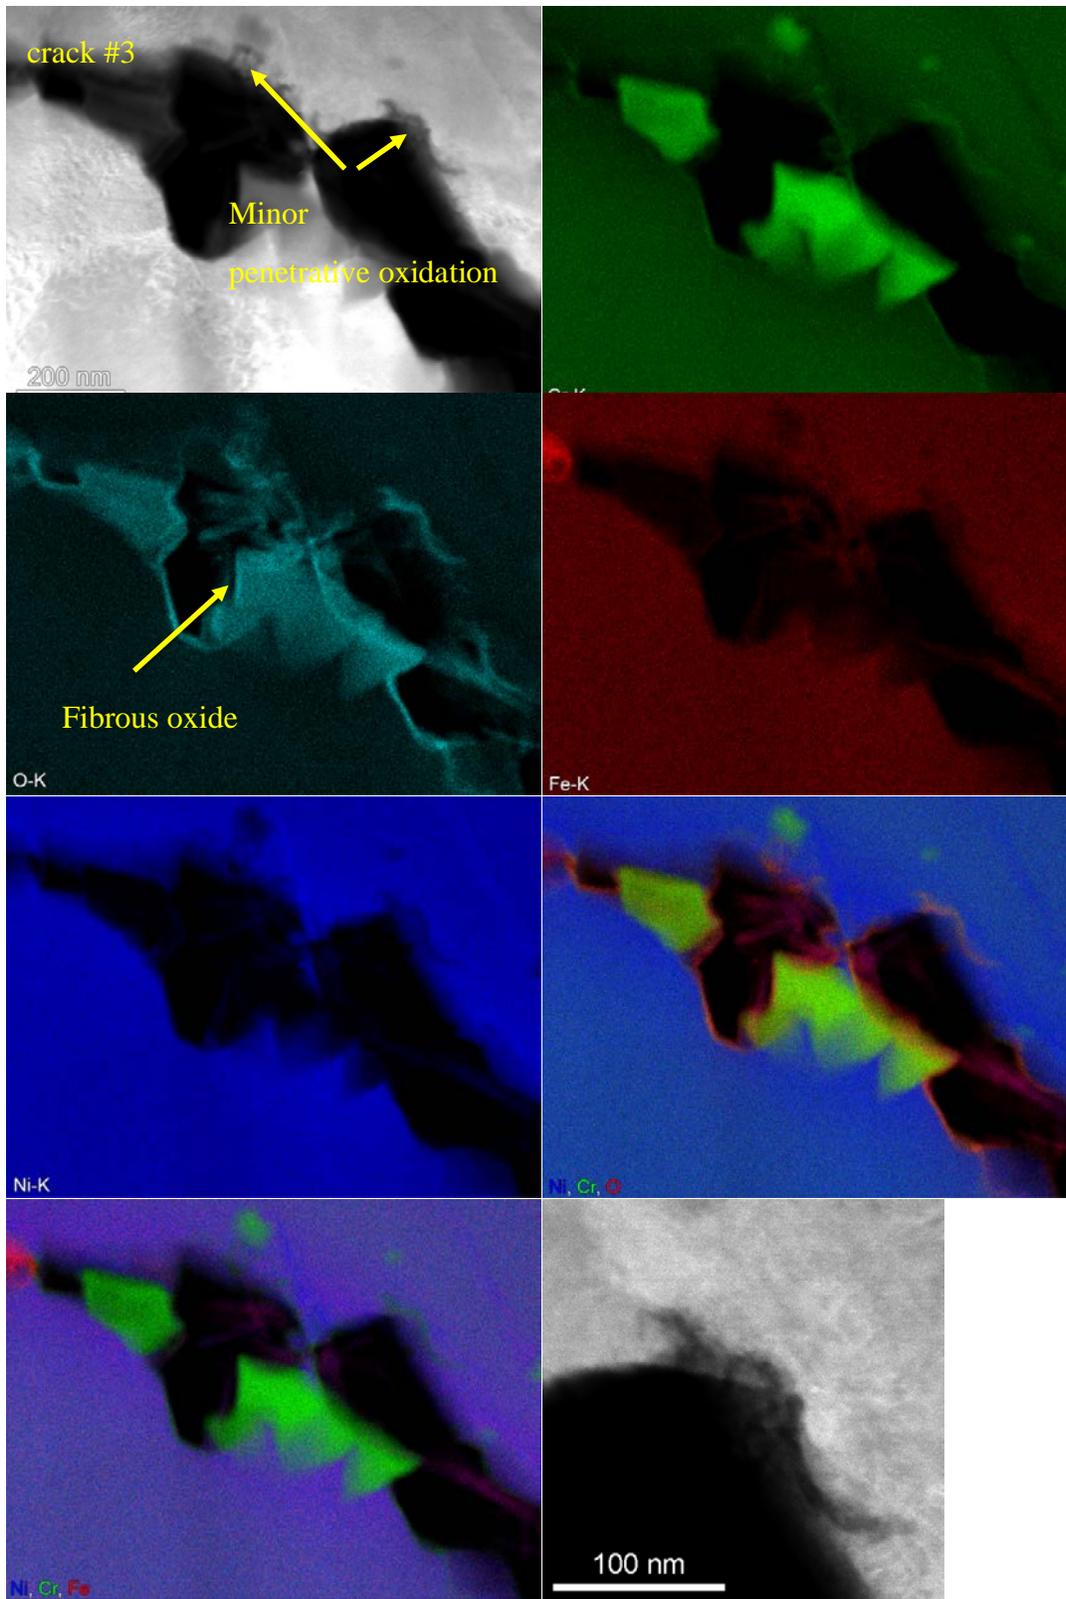
Figure 115. TEM Angular DF and EDS elemental maps of crack tip #3 (see Figure 105).

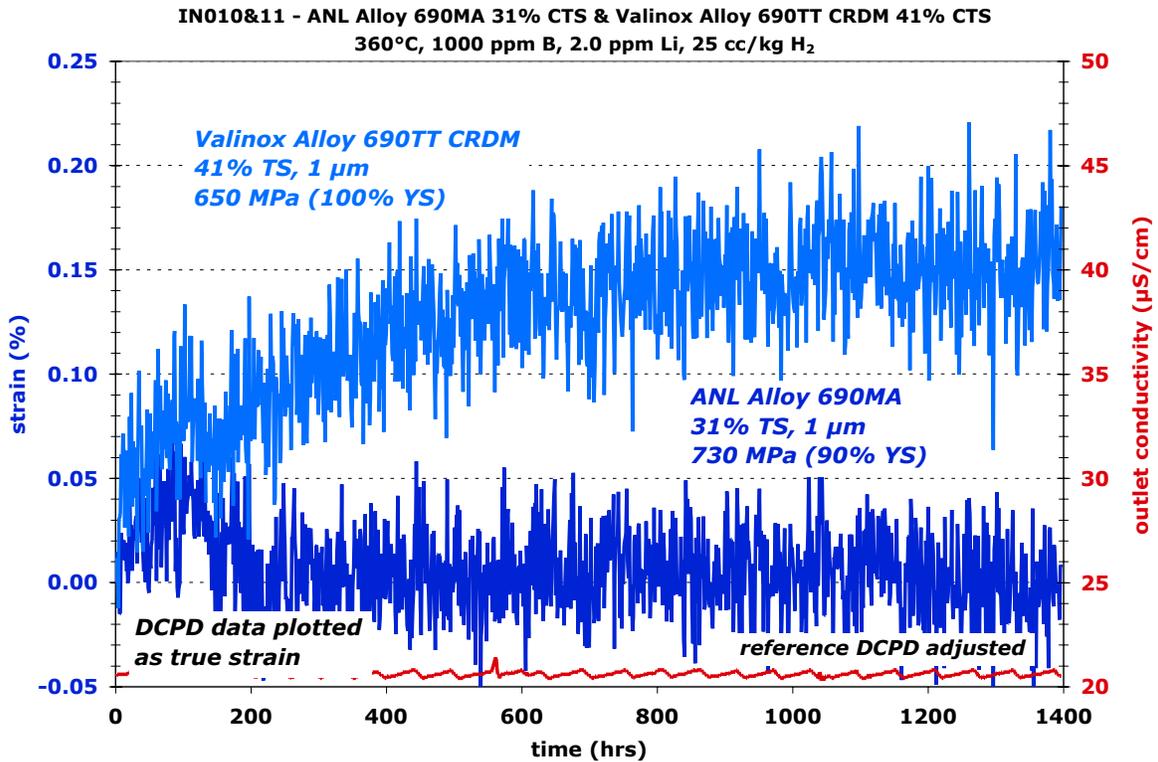
Figure 116. 31% tensile strained ANL alloy 690 plate (IN010) and 41% tensile strained alloy 690 CRDM (IN011) response during exposure in 360°C simulated PWR primary water at constant load near the yield stress.

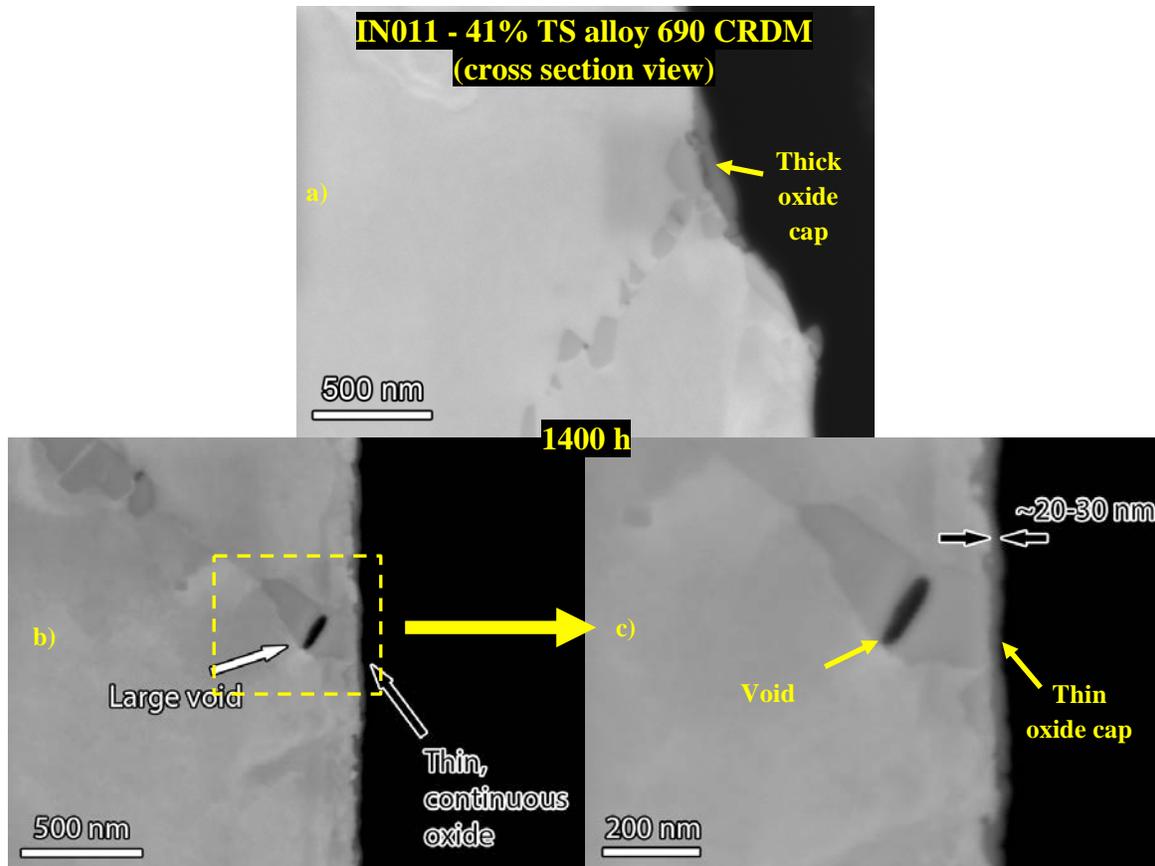
Figure 120. SEM-BSE images of the 41% tensile strained alloy 690 CRDM illustrating a thin, 20-30 nm, continuous oxide at the surface and voids between IG carbides.

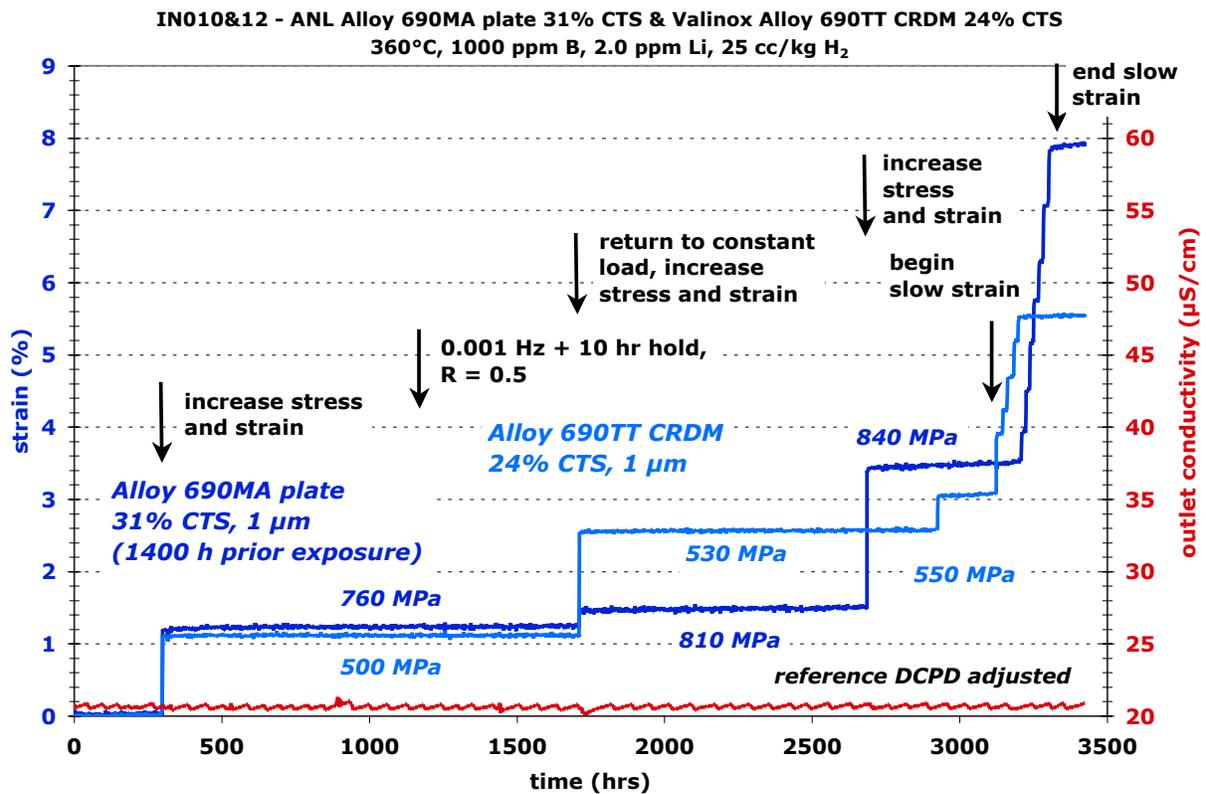
Figure 121. Overview of the entire test on the 31% tensile strained alloy 690 plate (IN010) combined with a 24% cold tensile strained alloy 690 CRDM specimen (IN012). Note that IN010 has 1400 hours of prior exposure.

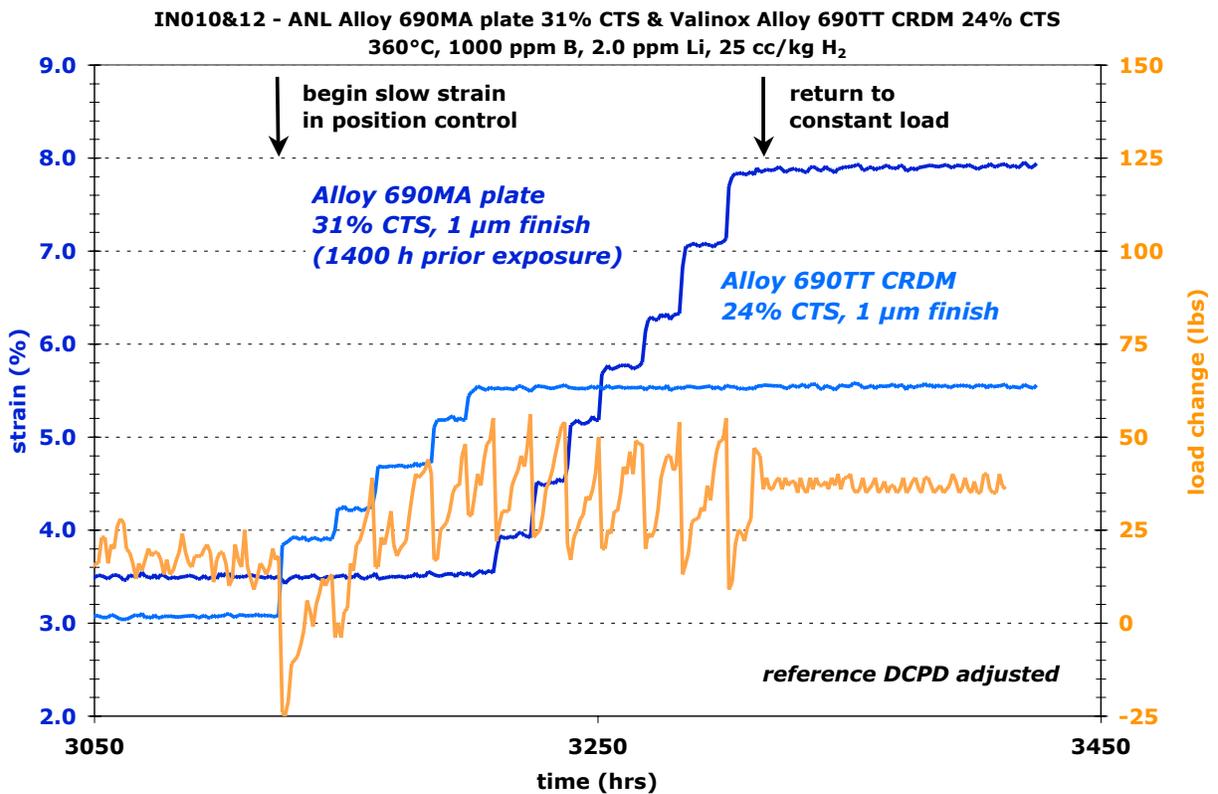
Figure 122. Slow straining response of the 31%TS alloy 690 plate (IN010) combined with a 24%TS alloy 690 CRDM specimen (IN012). Note that IN010 has 1400 hours of prior exposure.

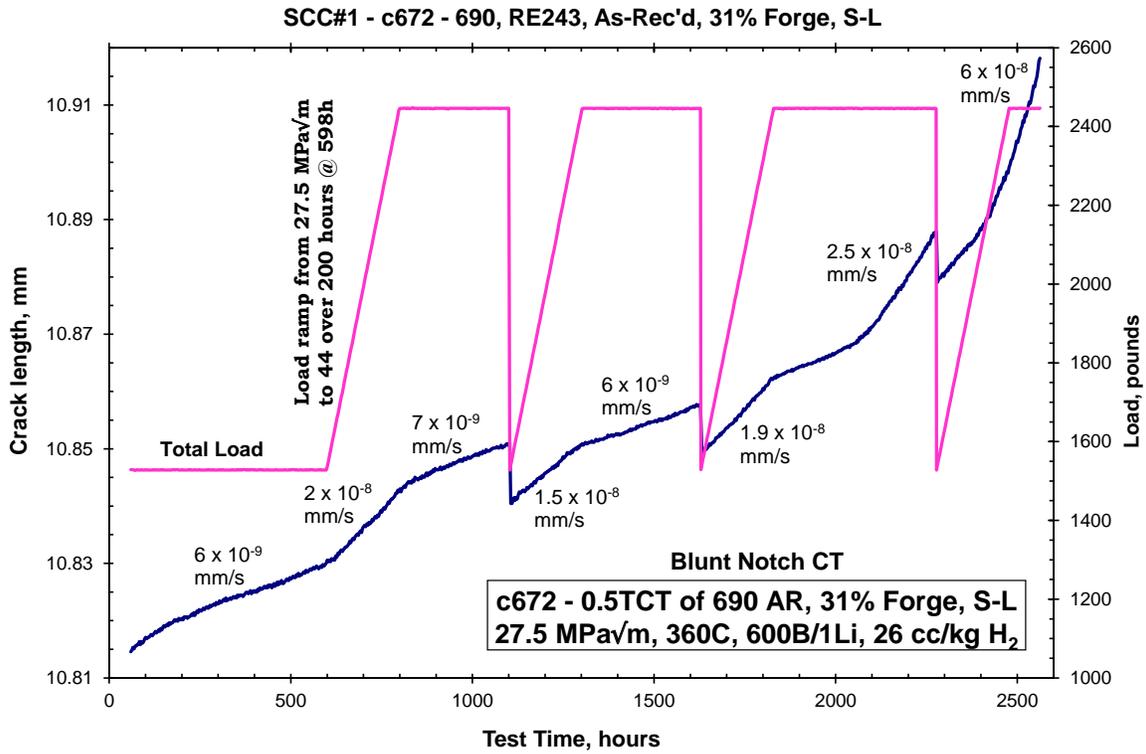
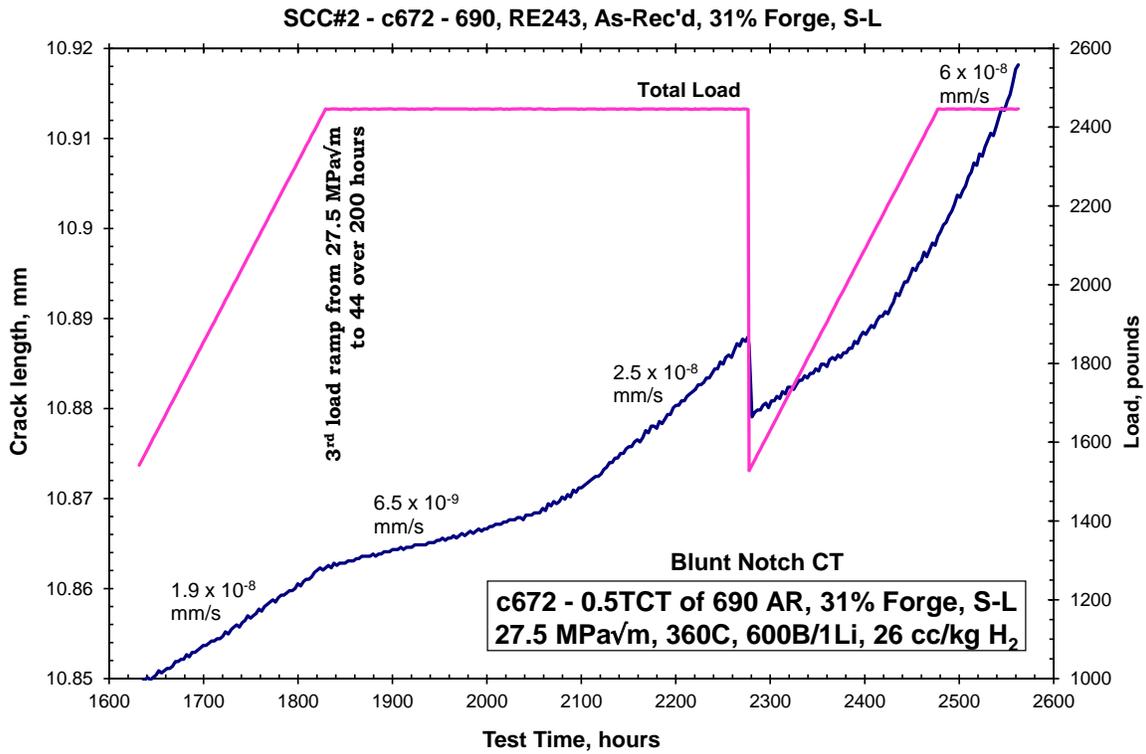
Figure 125. Crack length versus time response for the 31%CF Valinox CRDM specimen c672 blunt notch specimen.

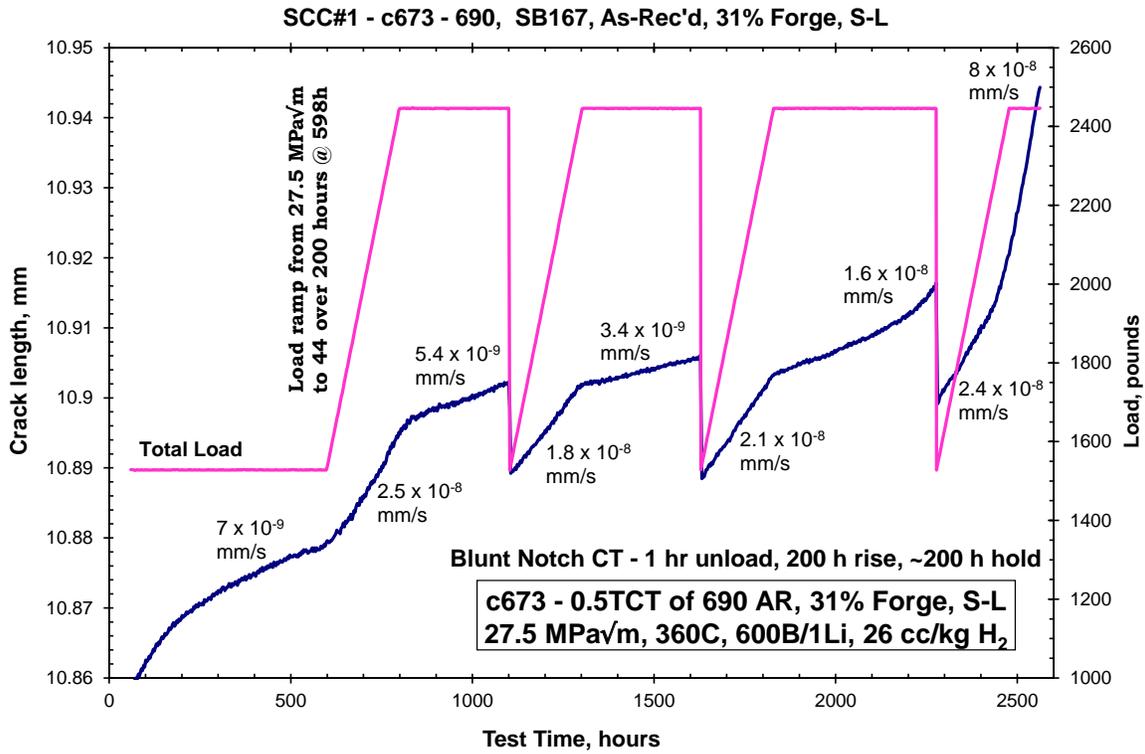
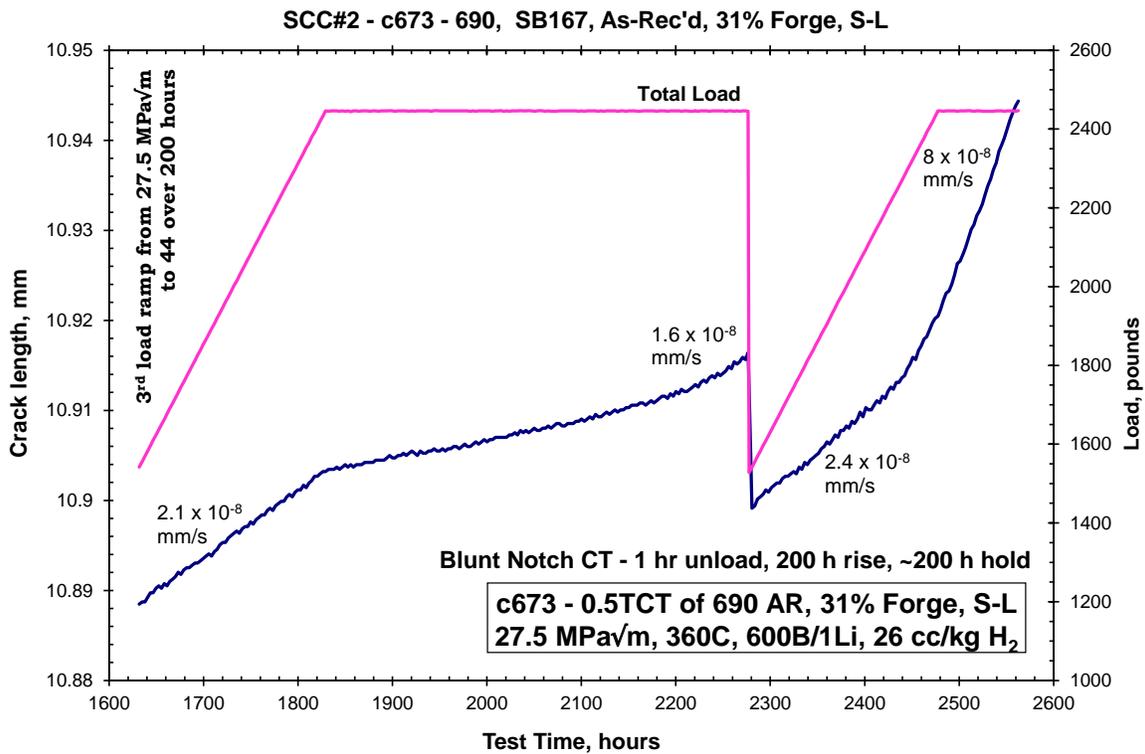
Figure 126. Crack length versus time response for the 31%CF Sumitomo CRDM specimen c673 blunt notch specimen.

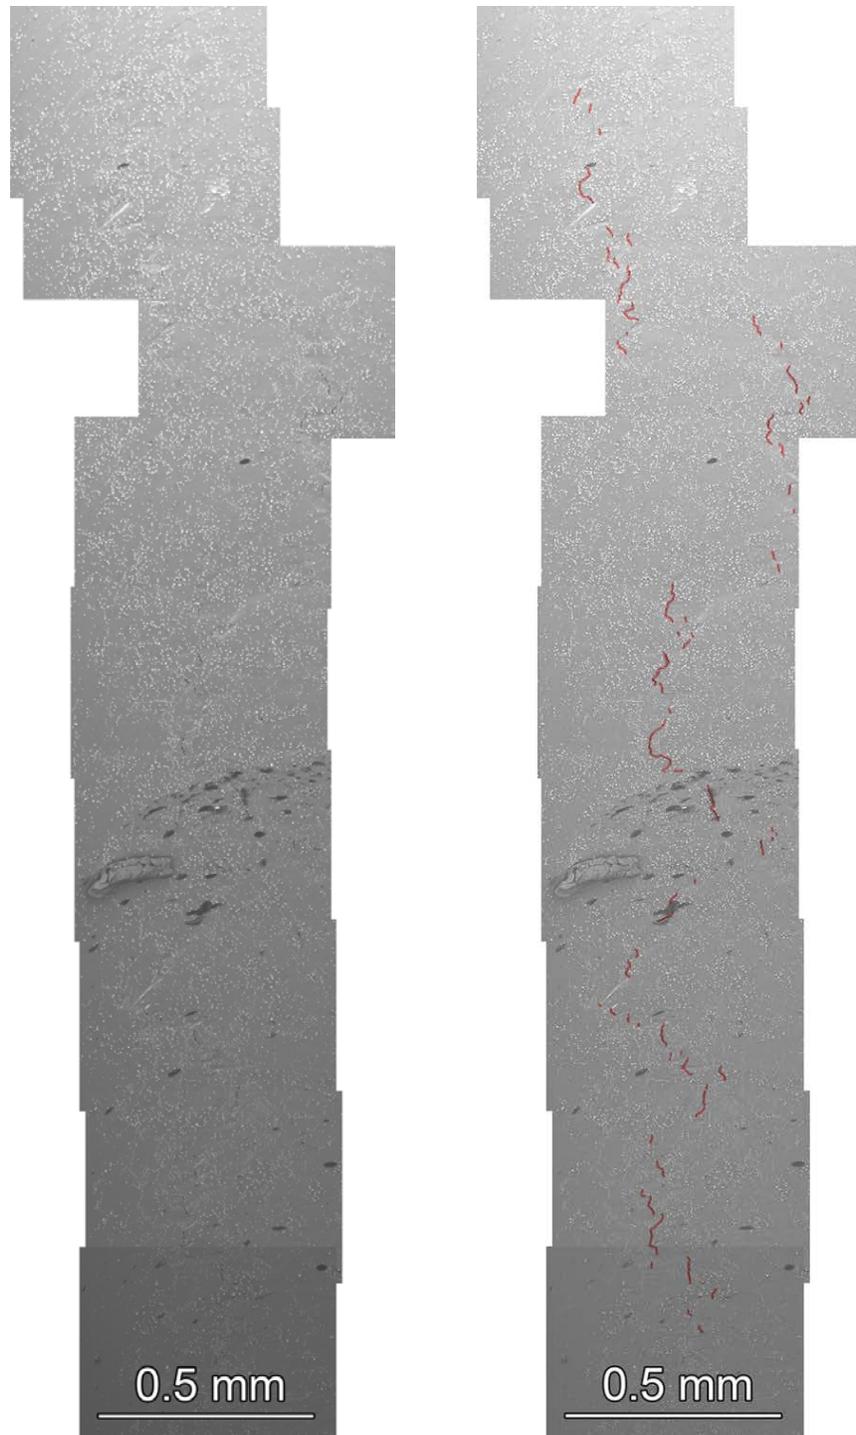
Figure 131. SEM-SE image of a portion of the 31%CF Sumitomo CRDM specimen c673 notch showing several nucleated cracks (highlighted by red marker in right image).

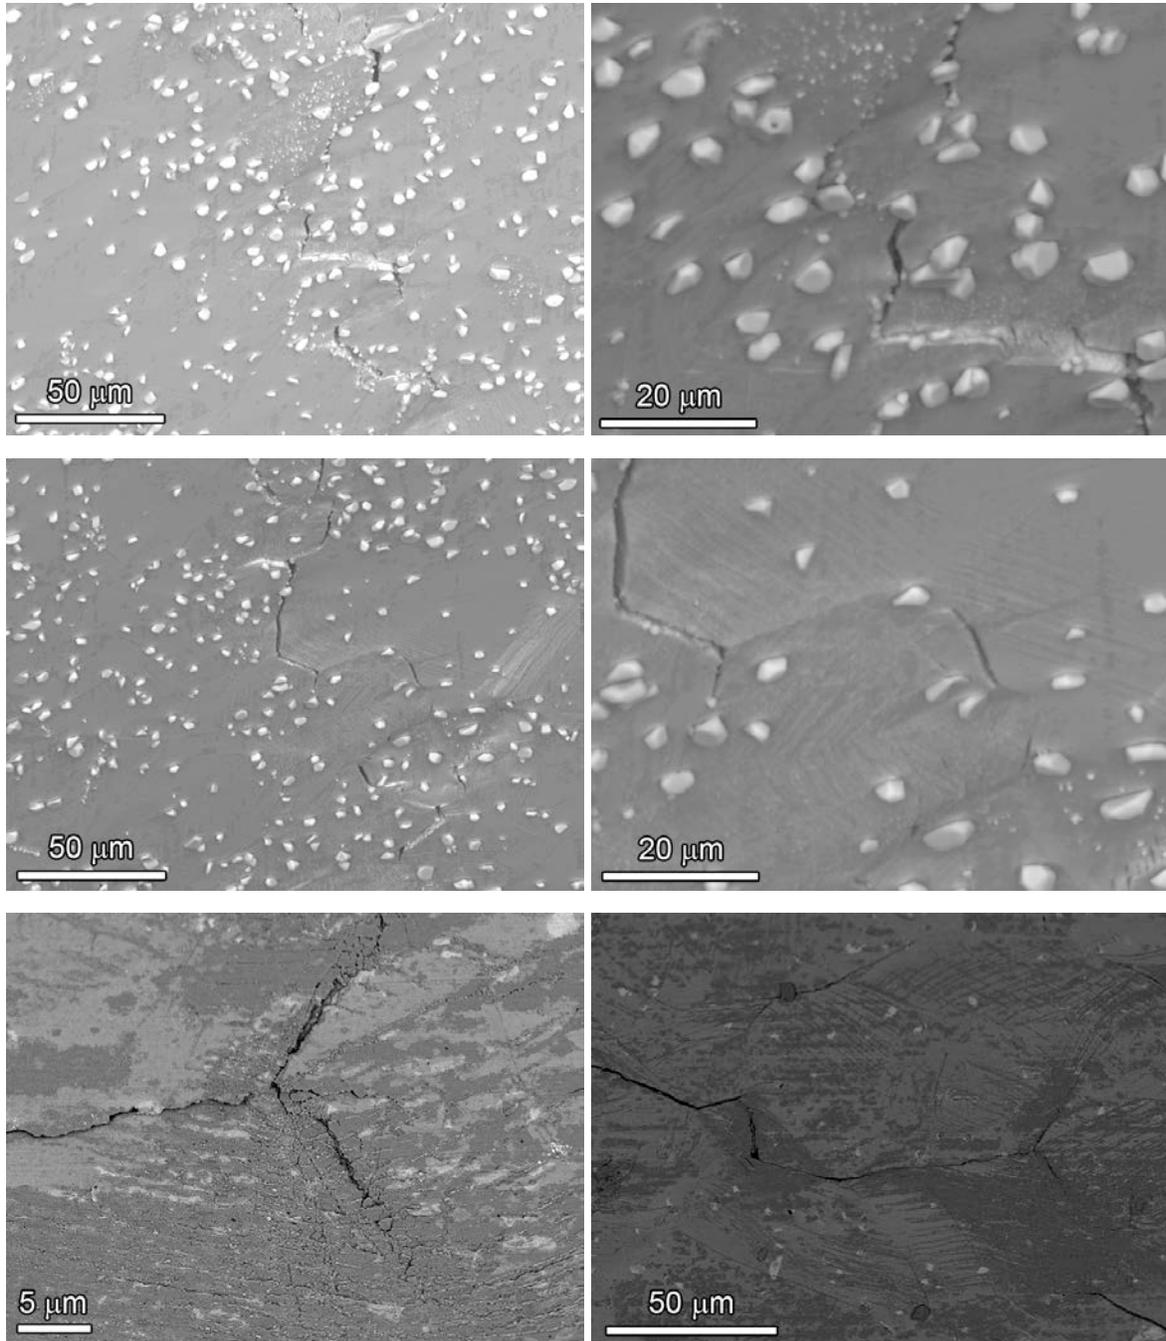
Figure 132. Higher magnification SEM images showing cracks on the notch of 31%CF Sumitomo CRDM specimen c673.

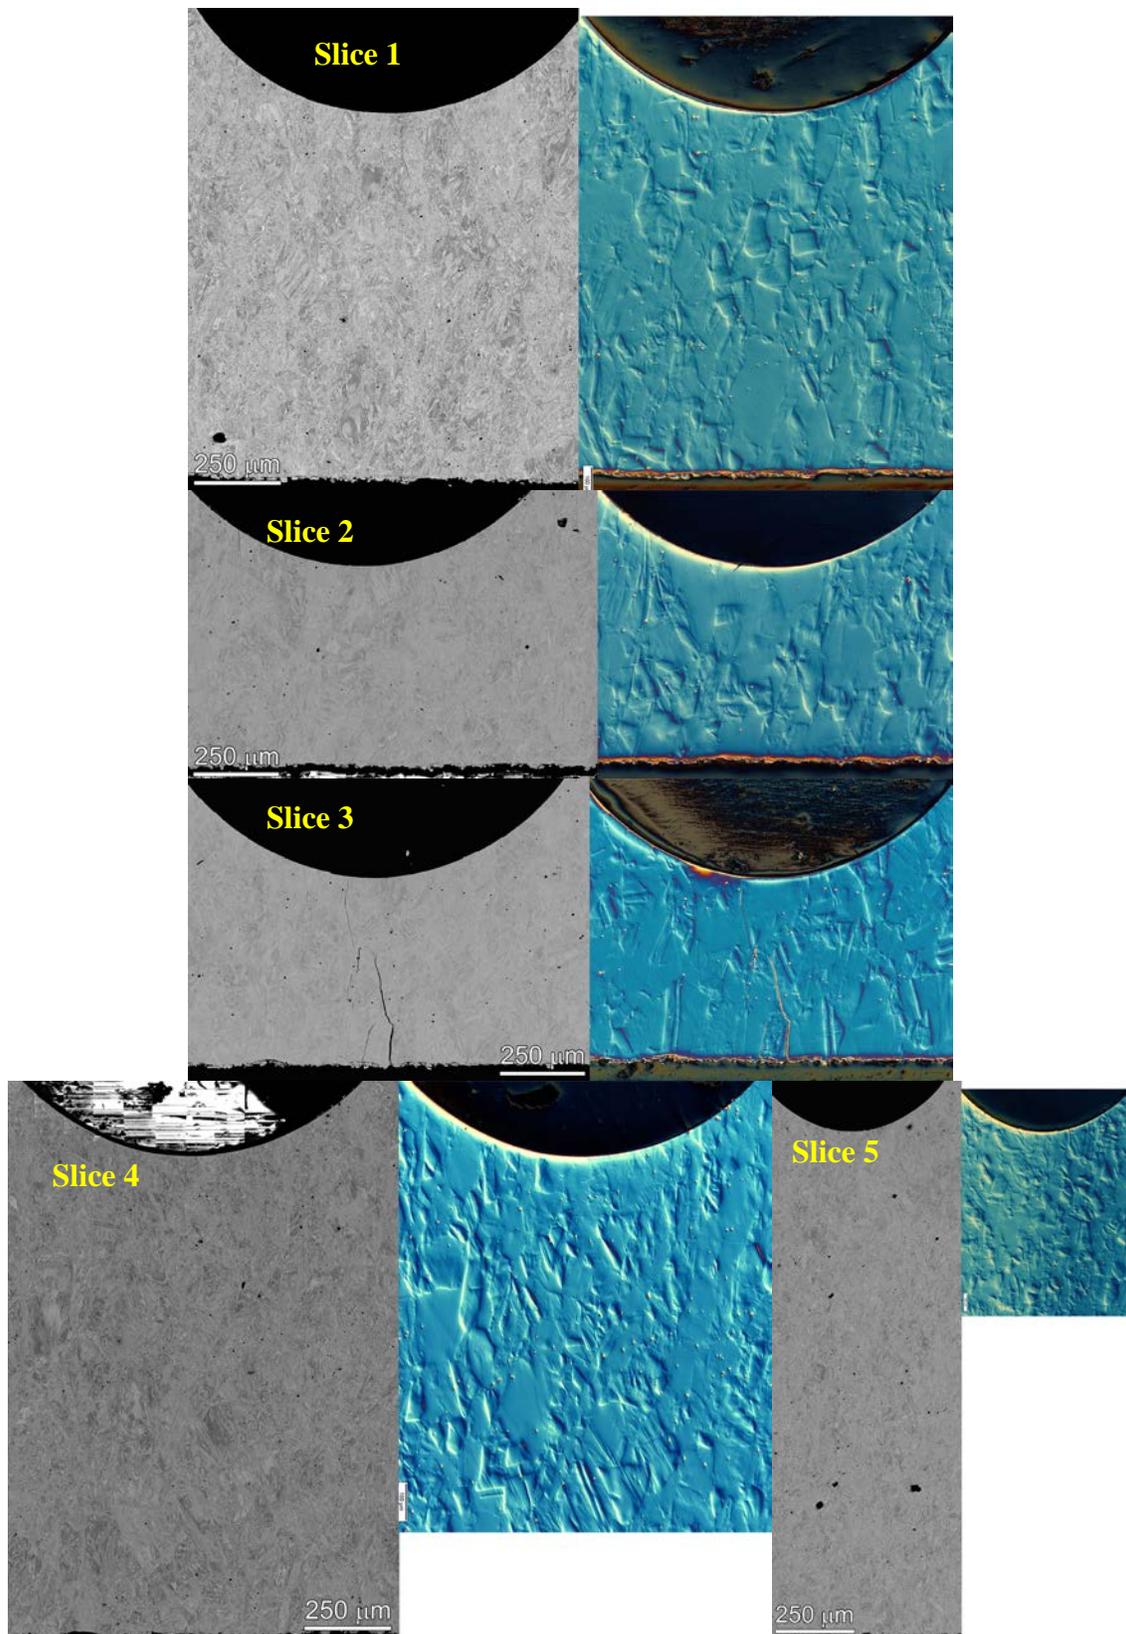
Figure 133. SEM (BSE) and optical micrographs of five slices in C672.
