**STRESS CORROSION CRACK INITIATION OF COLD-WORKED
ALLOY 600 AND ALLOY 690 IN PWR PRIMARY WATER**

**Technical Milestone Report: M2LW-14OR0404023
PNNL-23712 September 2014**

Research Project:
**Stress Corrosion Crack Initiation of
Nickel-Base Alloys in LWR Environments**
Project Manager: S. M. Bruemmer
Pacific Northwest National Laboratory

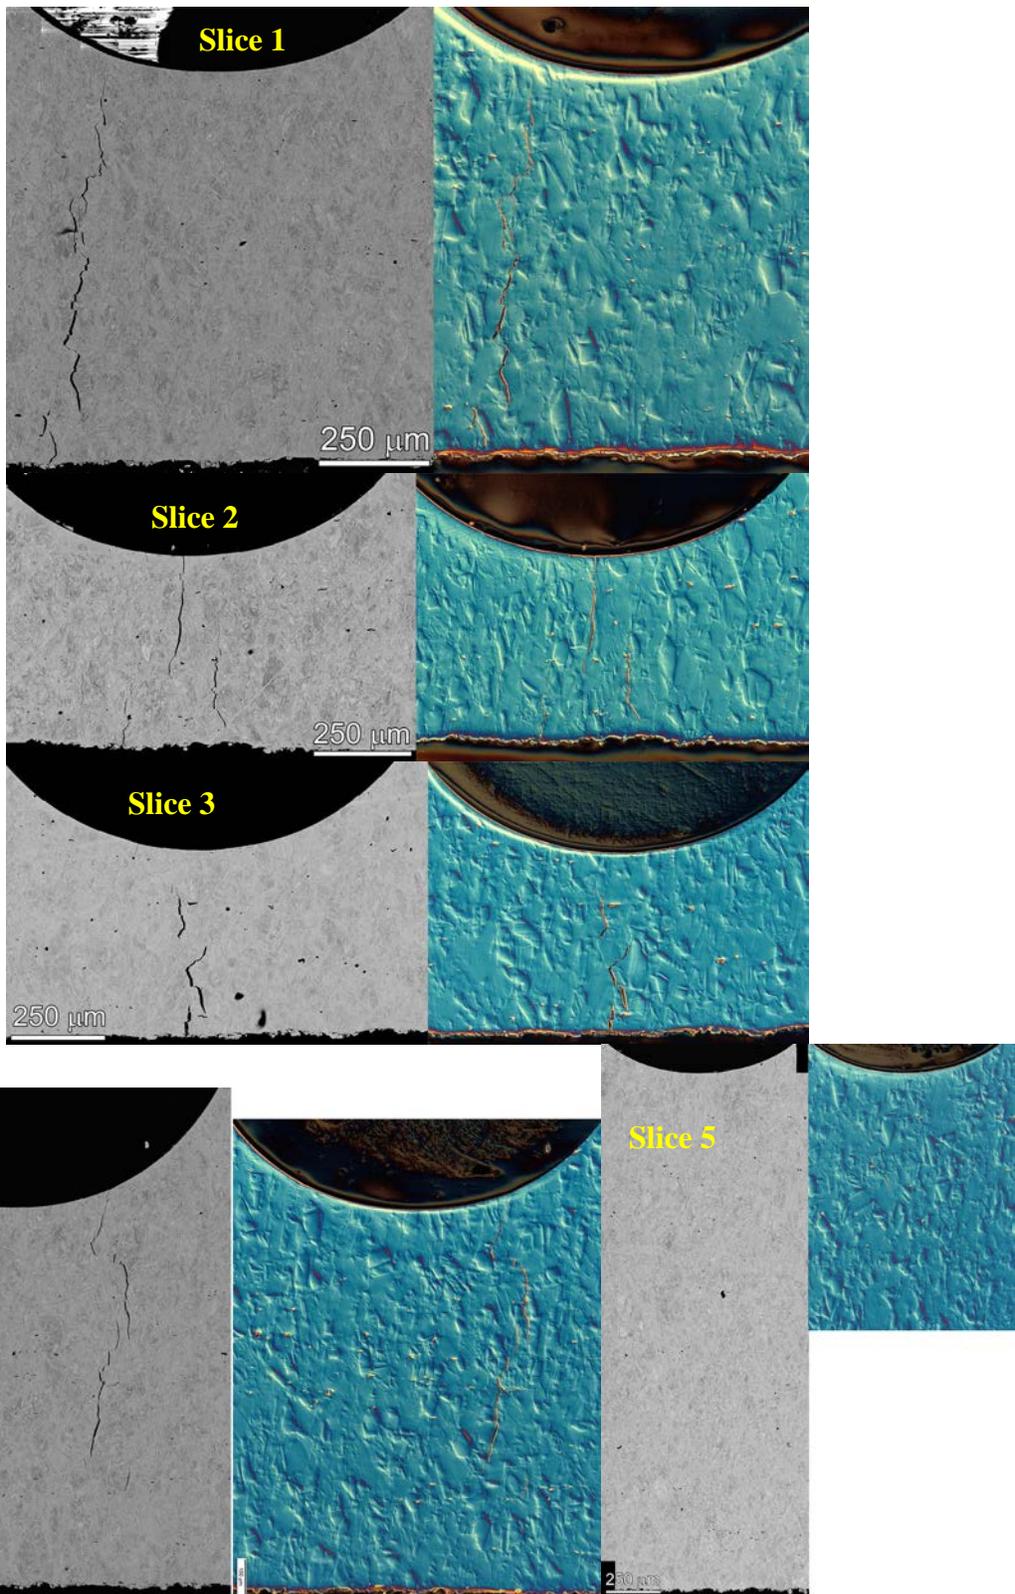
Figure 134. SEM-BSE and optical micrographs of five cross-section slices in C673.

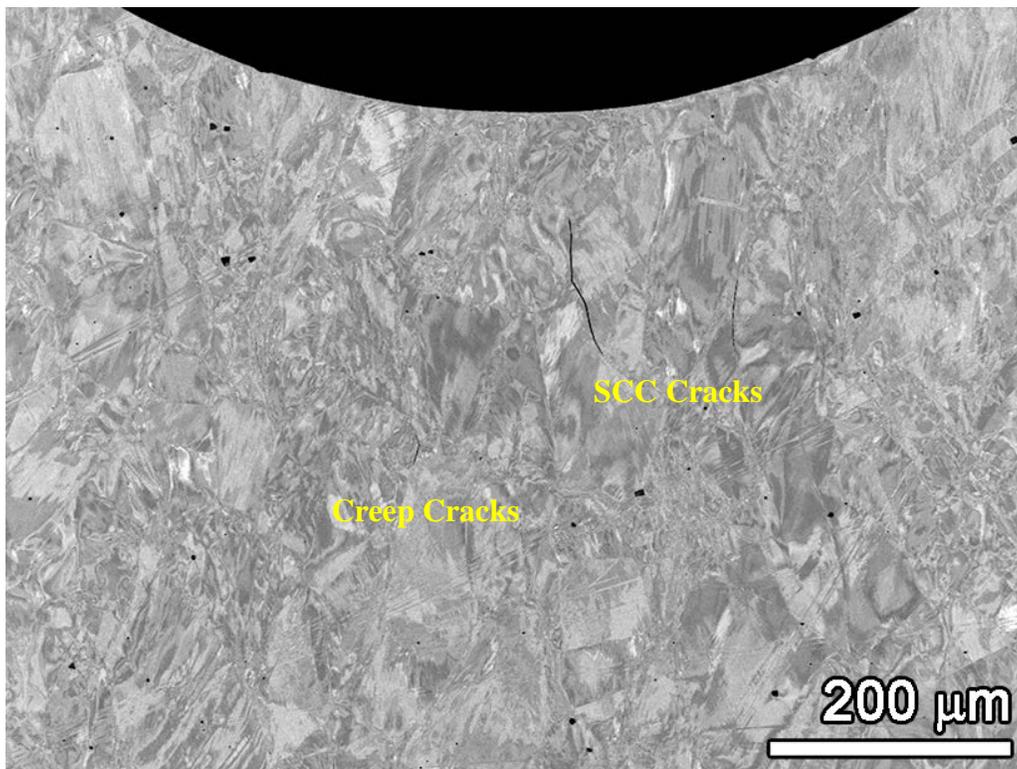
Figure 135. Blunt notch c672 cross-section slice #1 showing what are identified as SCC and creep cracks.

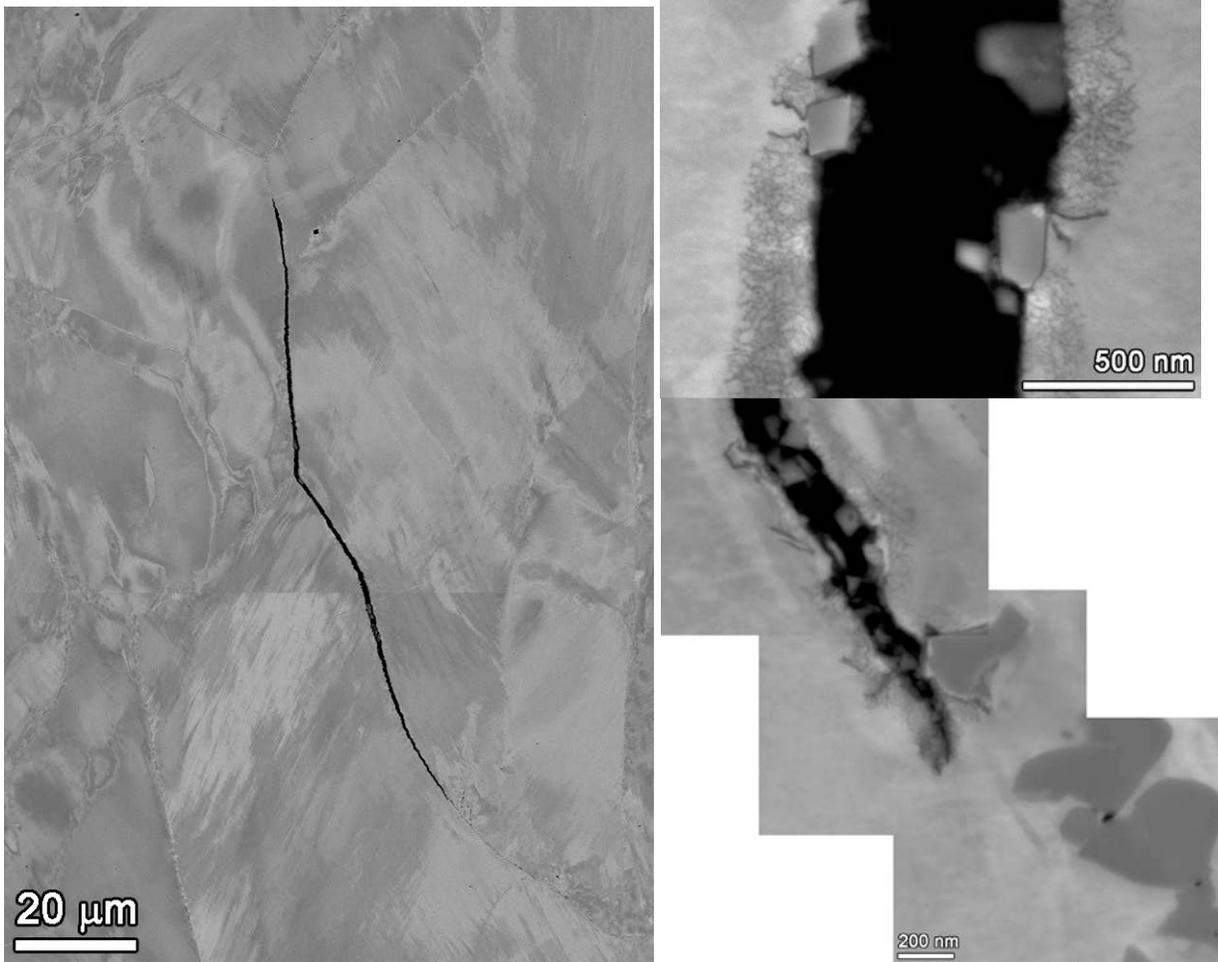
Figure 136. IGSCC crack in blunt notch specimen c672 cross-section slice #1 that clearly shows crack wall and crack tip corrosion.

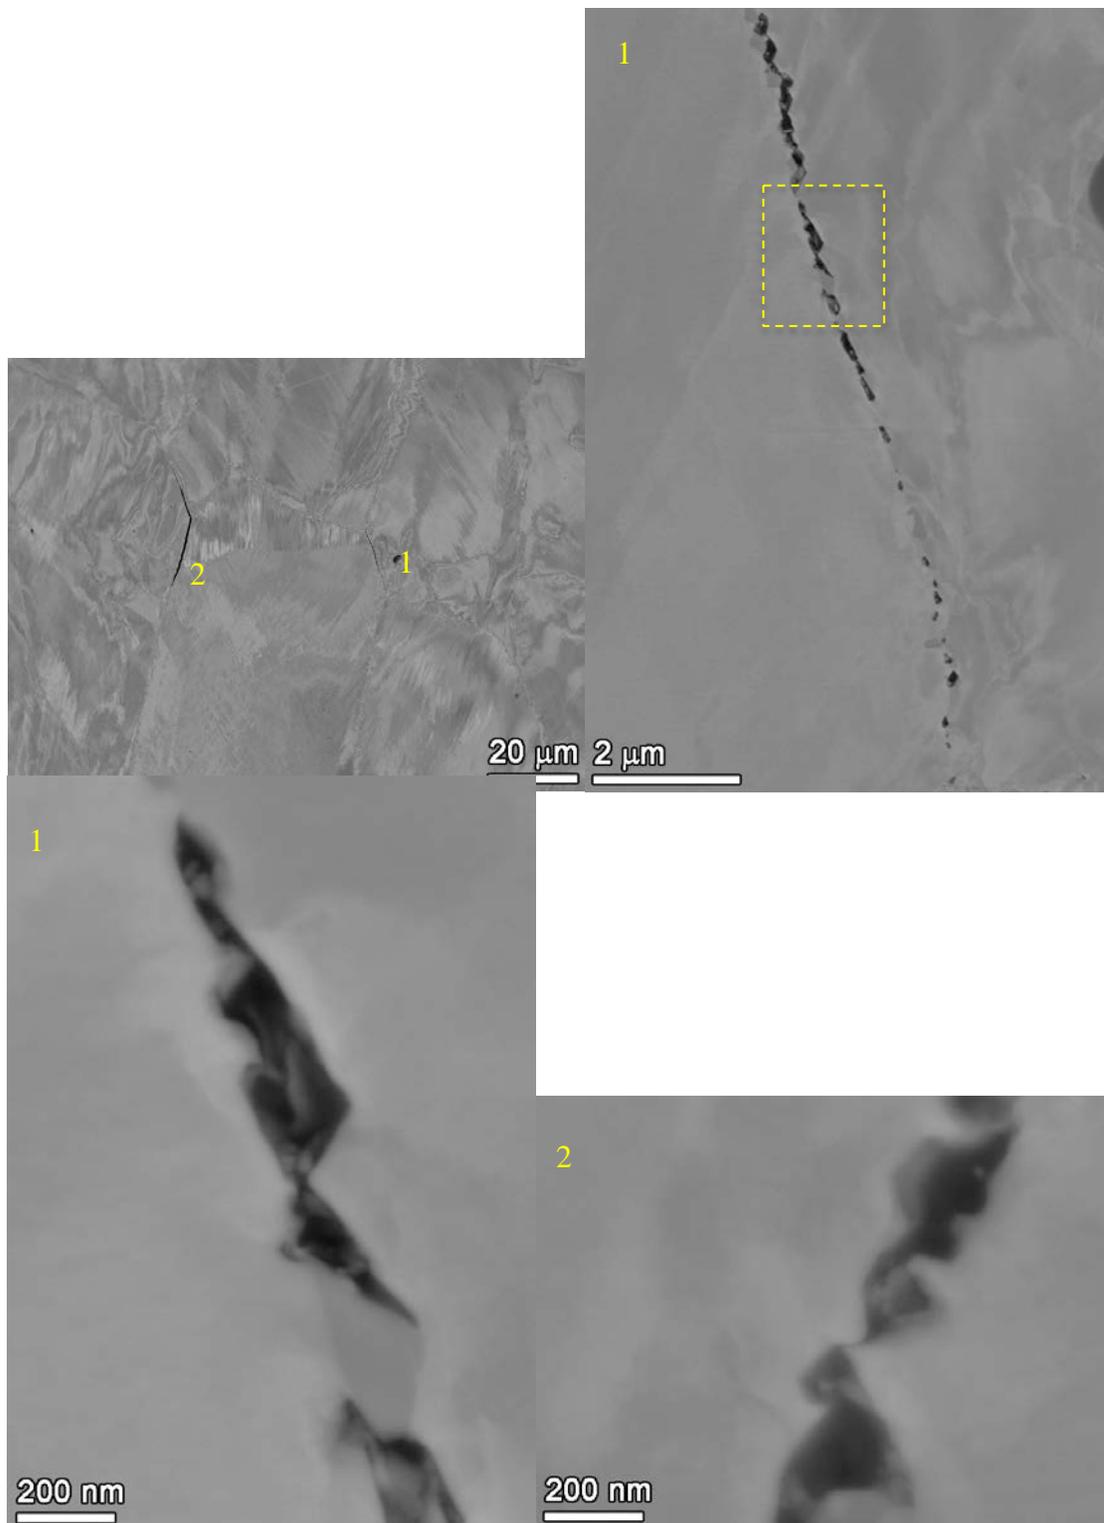
Figure 137. Apparent creep cracks in blunt notch specimen c672 cross-section slice #1 showing no evidence for corrosion or oxidation along the crack walls.

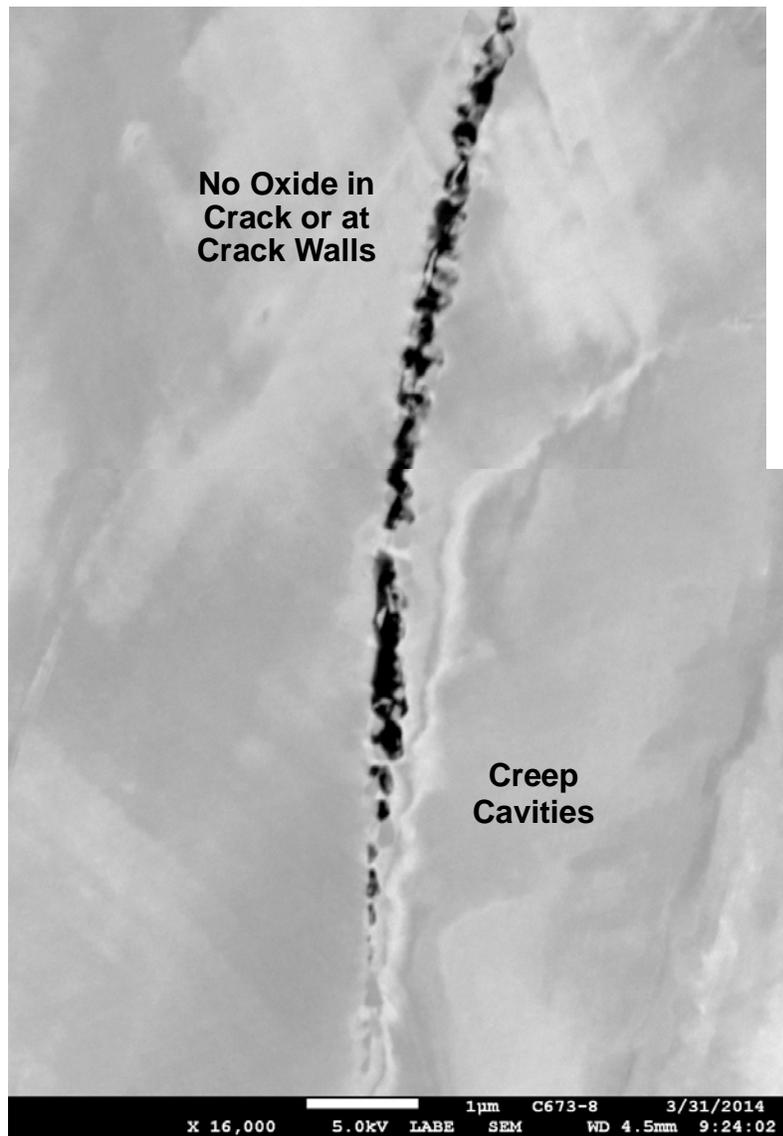
Figure 138. Example of IG creep crack and cavities in cross-section slice #2 from blunt notch specimen c672.

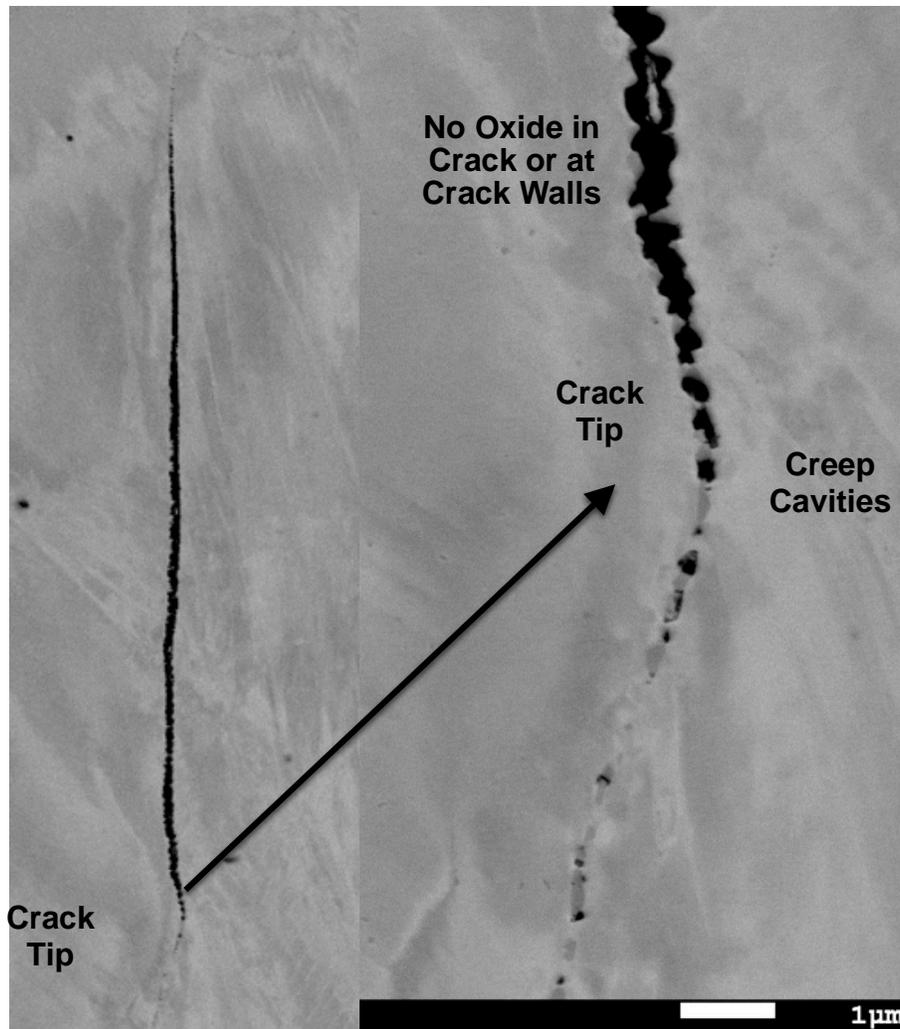
Figure 139. SEM-BSE cross-section image of c673 slice #4 showing creep crack tips. This slice had many large SCC cracks.

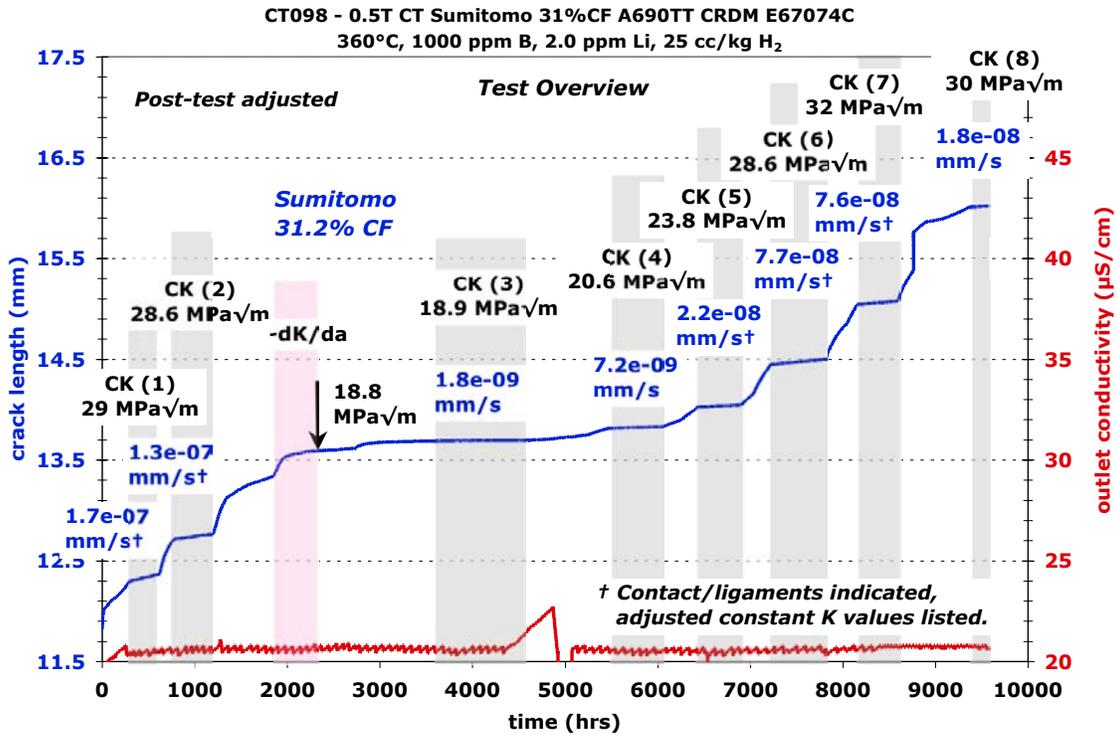
Figure 142. Overview of the entire SCC test on the 31%CF Sumitomo E67074C specimen CT098 showing crack growth rate at the different stress intensity levels.

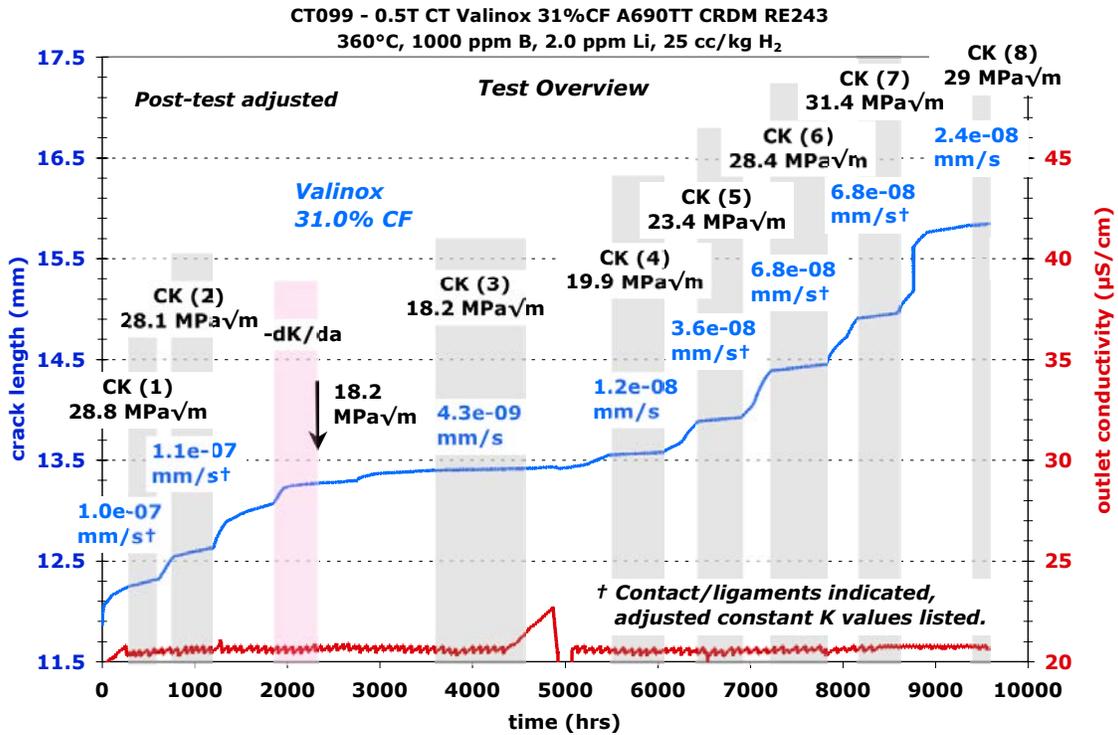
Figure 143. Overview of the entire SCC test on the 31%CF S-L/S-T Valinox CRDM RE243 specimen CT099 showing crack growth rate at each of the different stress intensity levels.
