PNNL-21692

Nondestructive Examination (NDE) Detection and Characterization of Degradation Precursors

Technical Progress Report for FY 2012

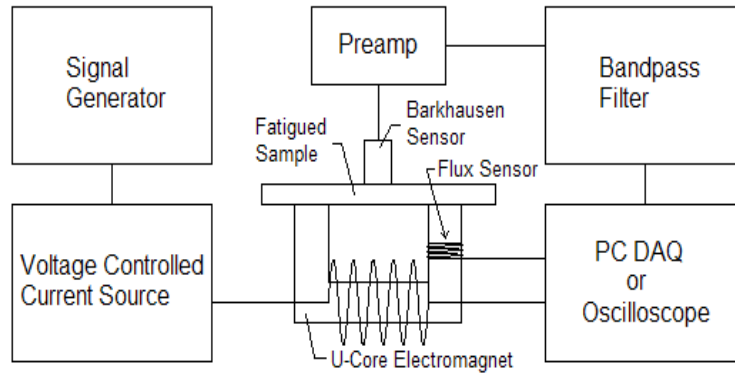
Figure 2.1. Schematic of MBN Measurement System

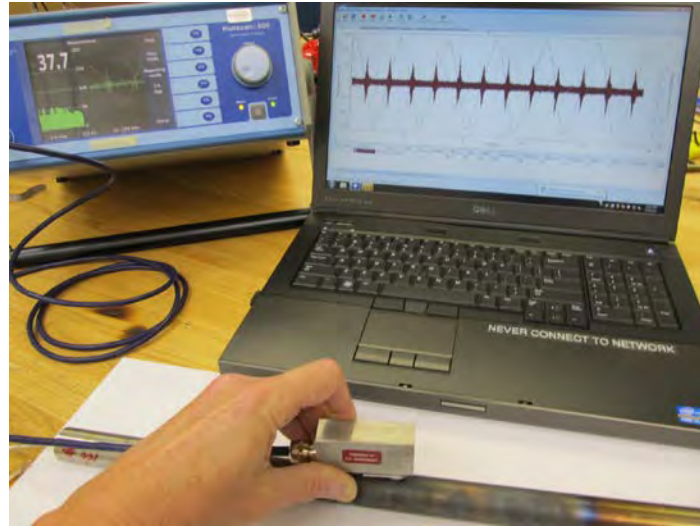
Figure 3.3. Stresstech Model 300 Rollscan with Microscan 600 Controller Software

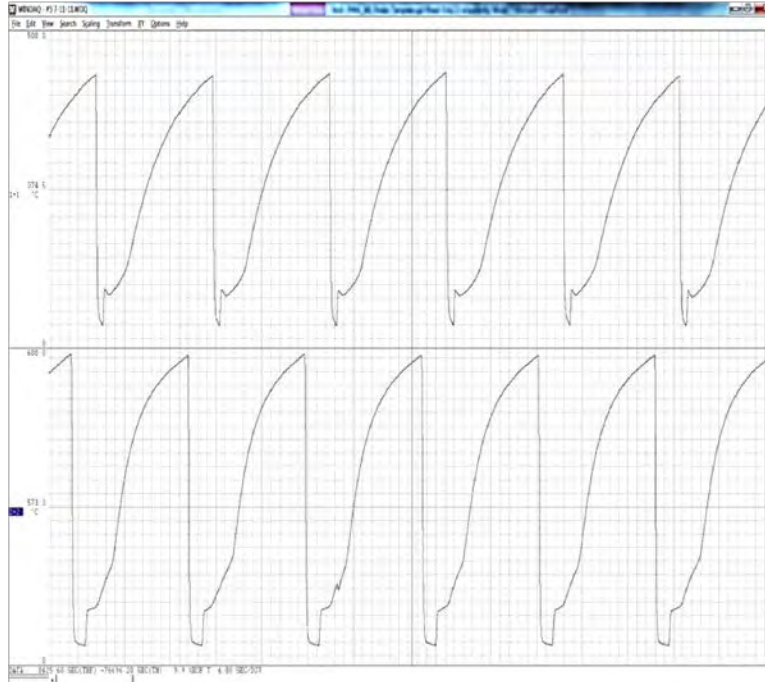
Figure 3.8. Sample of the Temperature Variation for Both Operating Stations Showing the Heating-Cooling Cycles that Develop Due to Constant Heating and Intermittent Water Jet Cooling

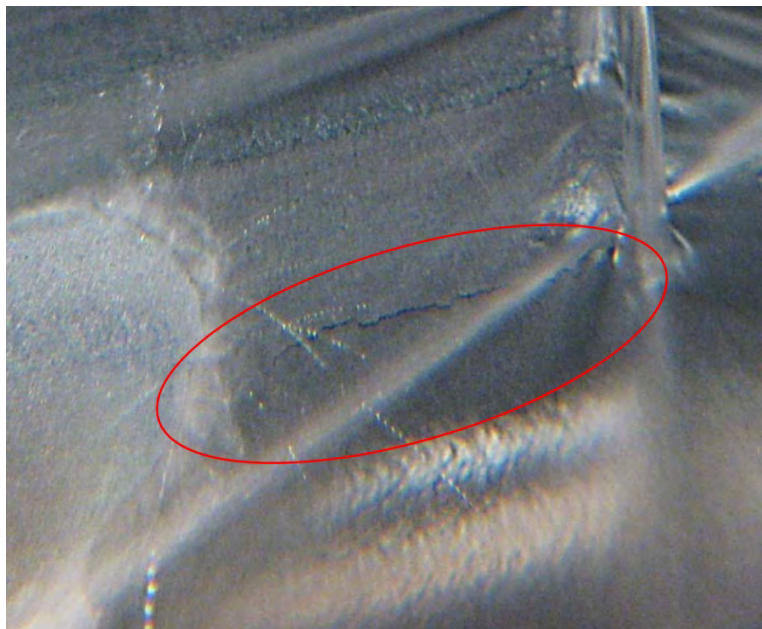
Figure 3.9. Thermal Fatigue Crack in a Specimen. The crack is generally visible only during the cooling portion of the fatigue cycle. At other times, high residual compressive stresses tend to exist, resulting in a small crack opening displacement (COD) that makes the crack difficult to visualize. The red oval is circling the thermal fatigue crack.

about 600°C to 30°C in the center portion of the heated rod for a maximum thermal fatigue stress. These settings caused a thermal fatigue crack, shown in Figure 3.9, to form after approximately 10,000 cycles.

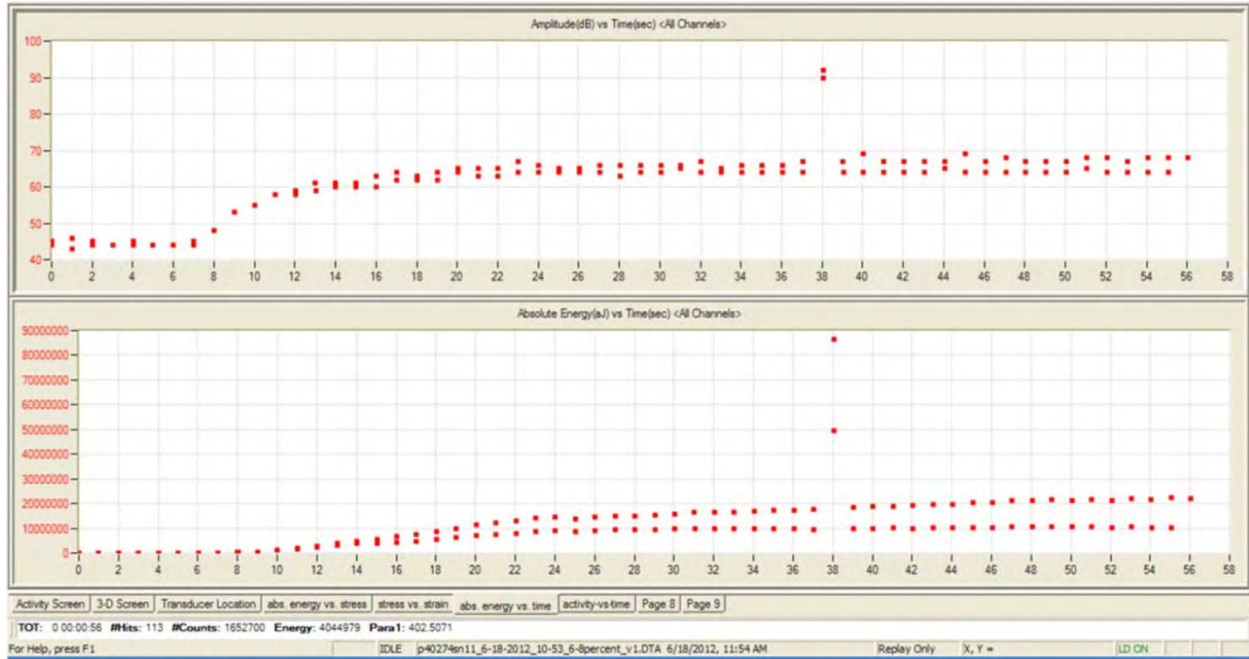
Figure 4.4. Screen Capture of the Amplitude of AE Signals (top – dB) and Absolute Energy of AE Signals (bottom – aJ) versus Time for Strain Increment from 6% to 8%

The tensile specimens were loaded in 2% strain increments until failure was reached. A significant reduction in coupling was observed (using the auto-sensor tests) at the 12%–14% strain interval, the cause of which is postulated to be deformation (cupping) of the specimen. A dry coupling material was substituted for gel couplant after this interval and consistent coupling was achieved until failure although the dry couplant resulted in approximately 6–9 dB attenuation and, therefore, a loss of sensitivity. Typical results obtained from before and after the couplant change are represented in Figures 4.4 and 4.5. Figures 4.4 and 4.5 represent amplitude of recorded hits (top – in dB) and absolute energy (bottom – aJ) versus time for strain increments from 6%–8% and 16%–18%, respectively. The amplitude and absolute energy of AE signals appears to increase with applied load, indicating the signals are perhaps caused by fretting between the load frame and specimen. No events were recorded by the AE signal processor and at this point it is unclear why the system was unable to locate the source of the signals.

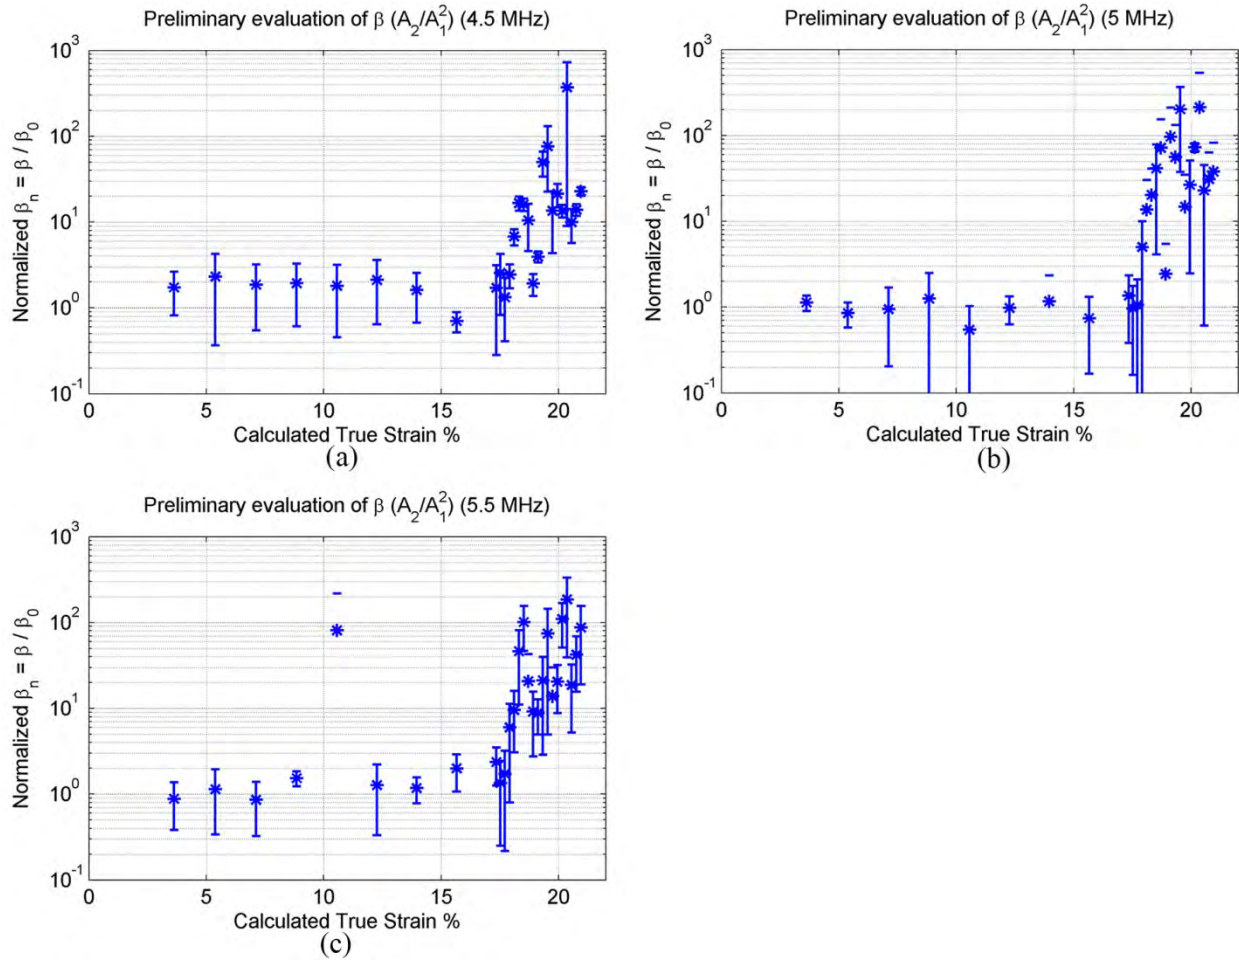
Figure 4.8. Normalized Nonlinear Parameter Computed Using Through Transmission Mode as a Function of Applied Strain, with Ultrasonic Incident Frequency (a) 4.5 MHz, (b) 5 MHz, and (c) 5.5 MHz

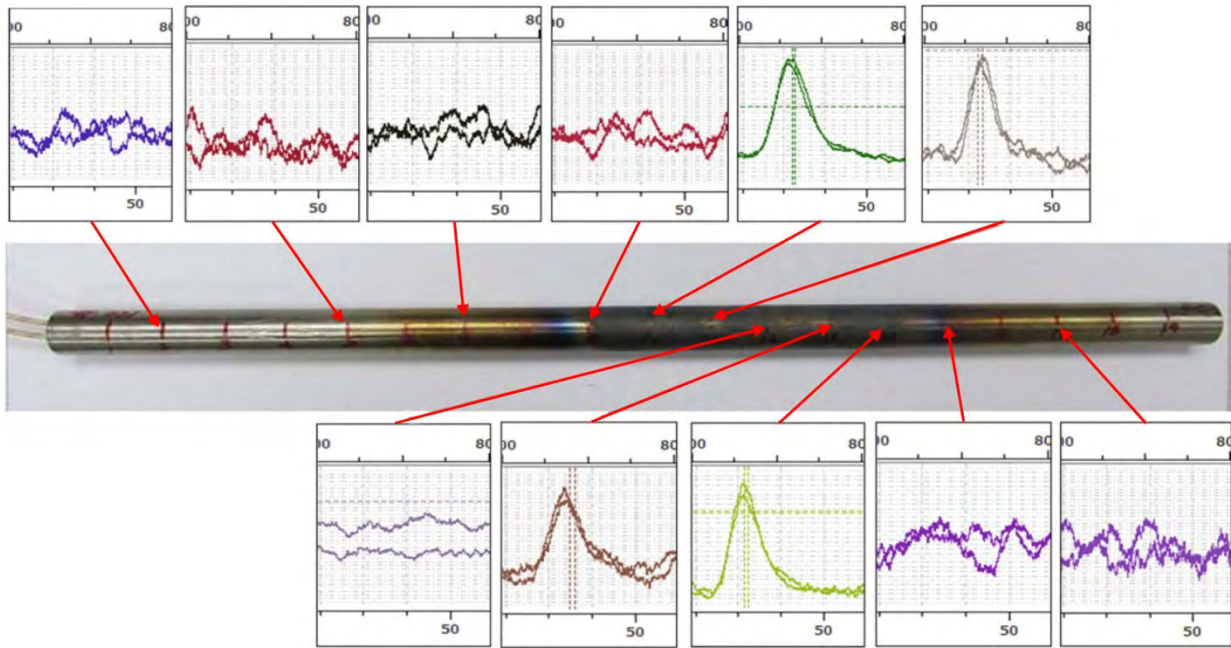
Barkhausen emissions tests show promising results as the peak signals change in the fatigued area compared to the undamaged ends of the steel rod (Figure 4.11). This indicates a potential variation in micromagnetic measurements (for 304SS) with the degree of thermal aging and fatigue damage accumulation that can potentially be exploited to measure precursors to such degradation mechanisms. However, the sensitivity of the measurements needs quantification, as does correlation of the measurements to physical damage in the material (which can be quantified using destructive analysis of the specimen).

Figure 4.11. MBN Data Taken Along the Length of a Thermal Fatigue Specimen with a Crack at the Center of the Specimen

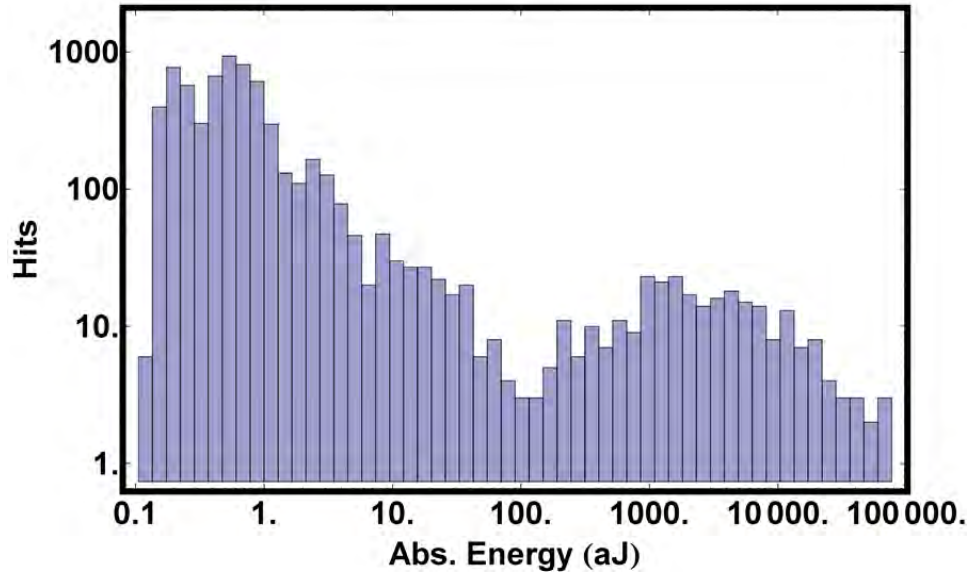
Figure 4.12. Energy Spectrum of Background Signals (< 190 kHz) Collected During Interval 1

Frequency filtering was initially applied in an attempt to separate out background AE signals by specifying a cutoff centroid frequency (f_c) of 190 kHz. Signals with f_c greater than this cutoff were attributed to degradation while signals below this cutoff were attributed to the background contributed by the environment. The absolute energy spectrum for the higher frequency signals (> 190 kHz) collected during interval 1 is shown in Figure 4.12. In addition, the AE activity is plotted over six thermal cycles in intervals 1 and 9 to observe the relationship between the emission of signals with f_c greater than and less than 190 kHz. These plots are provided in Figures 4.13 and 4.14, respectively. Finally, the activity of AE signals with $f_c > 190$ kHz is provided in Figure 4.15 in terms of hits per thermal cycle and cumulative AE hits. This information is over-laid on bars indicating the average and standard deviation of this AE activity for each cycling interval.

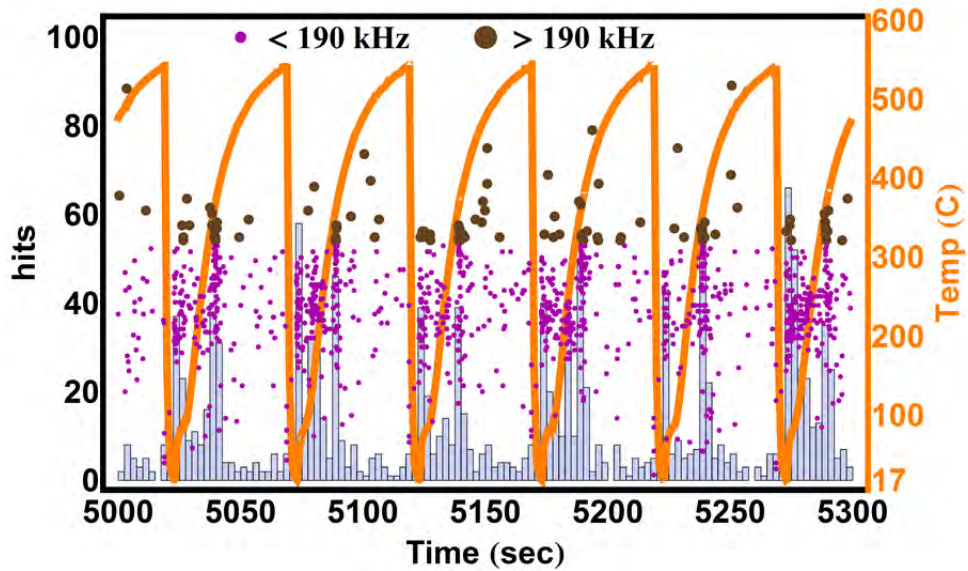
Figure 4.13. AE Activity Collected Over Six Thermal Cycles During Interval 1 Along with a Plot of the Thermocouple Signal During These Cycles; Signals with Centroid Frequency Greater Than 190 kHz are Highlighted Using Enlarged Dots

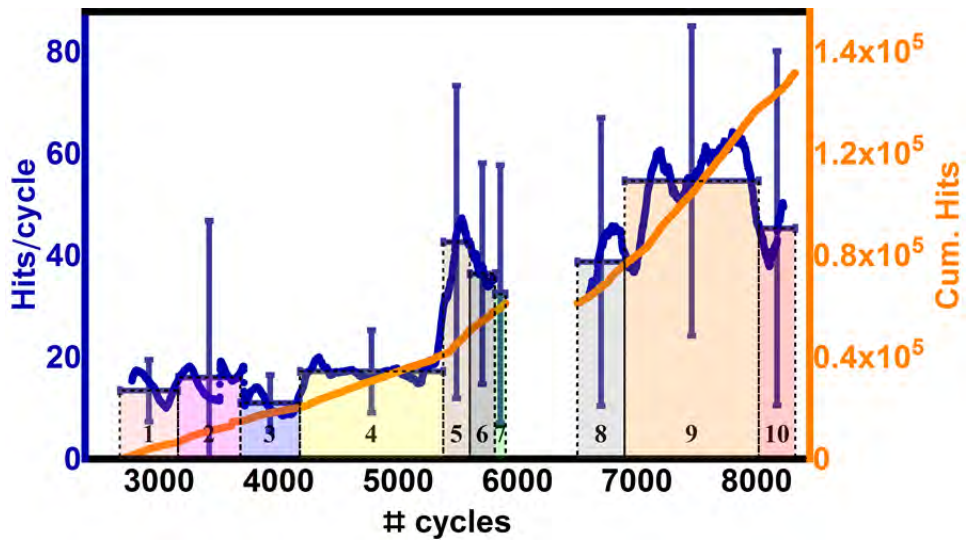
Figure 4.15. Summary of the Activity of AE Signals with Centroid Frequency Greater Than 190 kHz Over the Lifetime of the Specimen

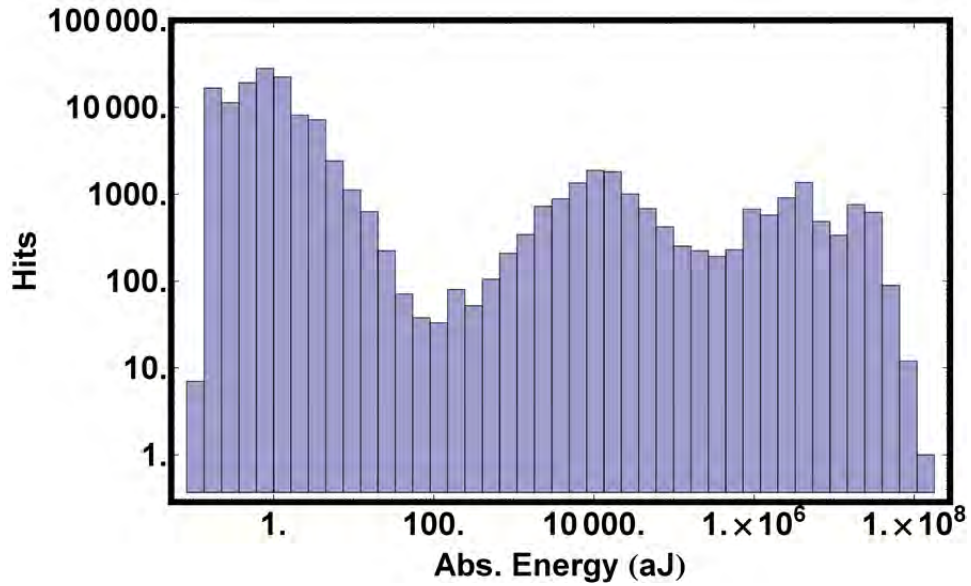
Figure 4.19. Energy Spectrum of the Remaining AE Signals in Interval 1 to Interval 10 After Removing Signals with Centroid Frequencies Greater Than 190 kHz and Energies in the Range of 5 aJ–100 aJ

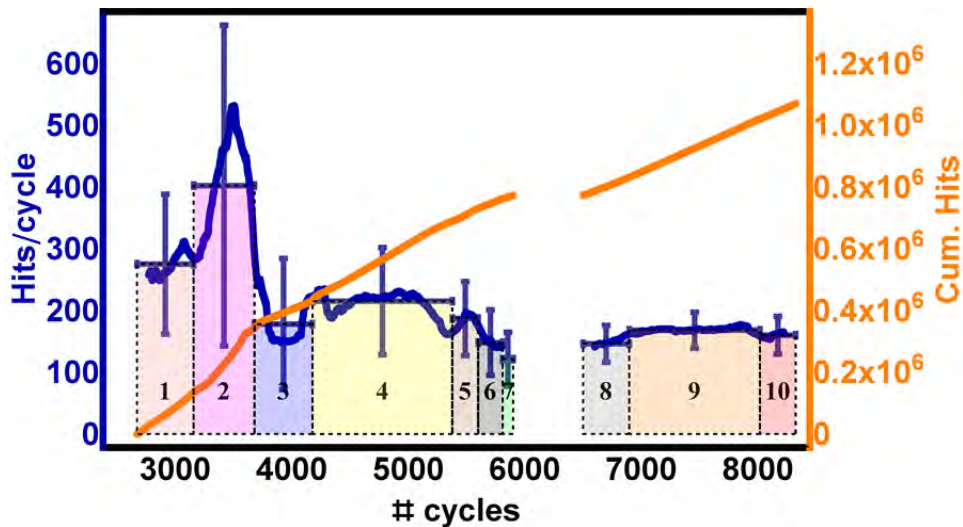
of the specimen. The activity is fairly constant over the life of the system, which is consistent with expectations for activity from a background source.

Figure 4.20. AE Activity of the Remaining Signals in Interval 1 to Interval 10 After Removing Signals with Centroid Frequencies Greater Than 190 kHz and Energies in the Range of 5 aJ–100 aJ
