**MICROSTRUCTURE, CORROSION AND STRESS  
CORROSION CRACK INITIATION OF ALLOY 600  
IN PWR PRIMARY WATER ENVIRONMENTS**

**Technical Milestone Report: M3LW-13OR0403032  
March 2013**

M. J. Olszta, D. K. Schreiber, M. B. Toloczko  
and S. M. Bruemmer  
Pacific Northwest National Laboratory

Research Project:  
**Stress Corrosion Crack Initiation of  
Nickel-Base Alloys in LWR Environments**  
Project Manager: S. M. Bruemmer  
Pacific Northwest National Laboratory

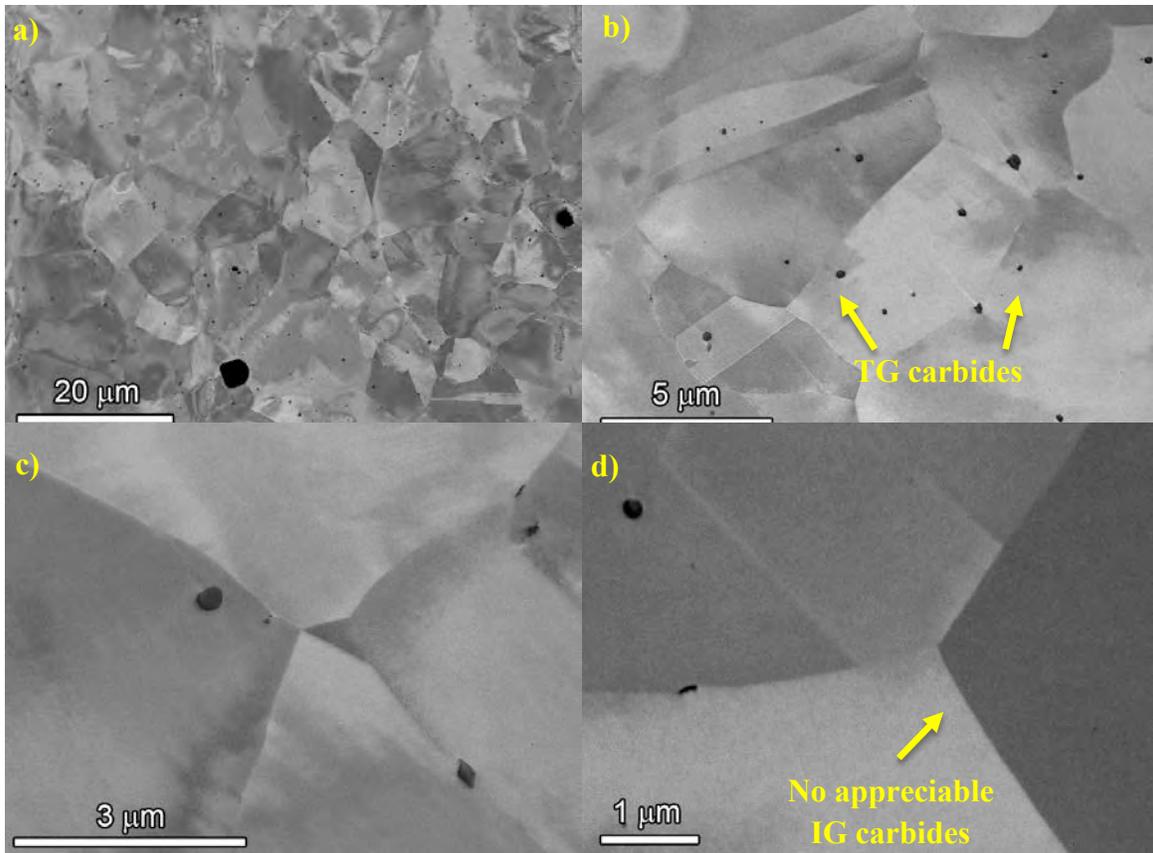
SEM backscatter electron (BSE) images in Figure 1 are presented for the alloy 600 heat 96834 steam generator tubing. The grain size of this tubing material is a rather small ~5-7  $\mu\text{m}$  with the grains having an equiaxed shape and exhibiting a medium amount of strain contrast (Figure 1a). At higher magnifications (Figure 1b-d), the carbide density is observed to be low, and mostly transgranular (TG). The grain boundaries appear to have very few carbides.

Figure 1: SEM-BSE images illustrating the general microstructures in the alloy 600 heat 96834.

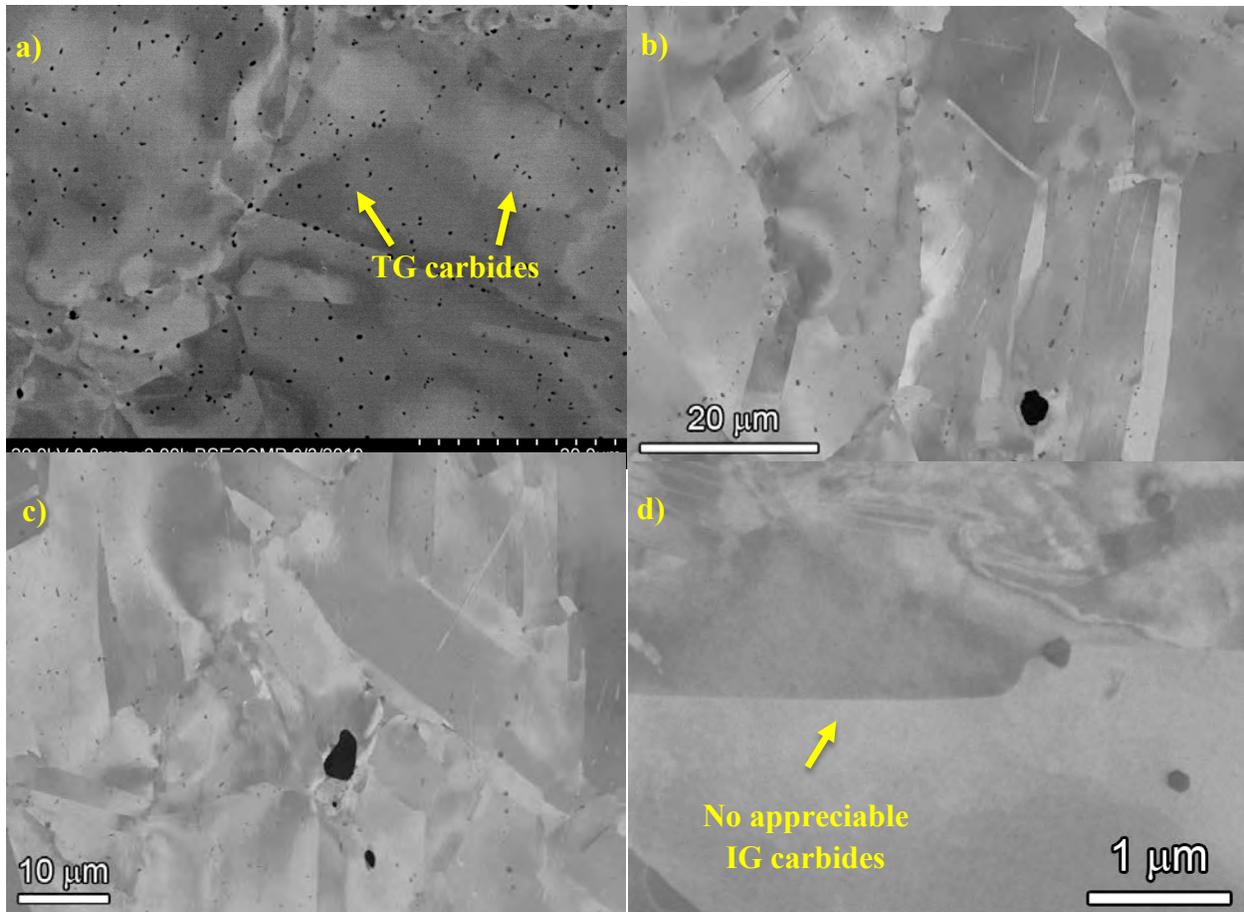
Figure 3: SEM-BSE images illustrating the general microstructures in the alloy 600 CRDM nozzle material, heat WF675.

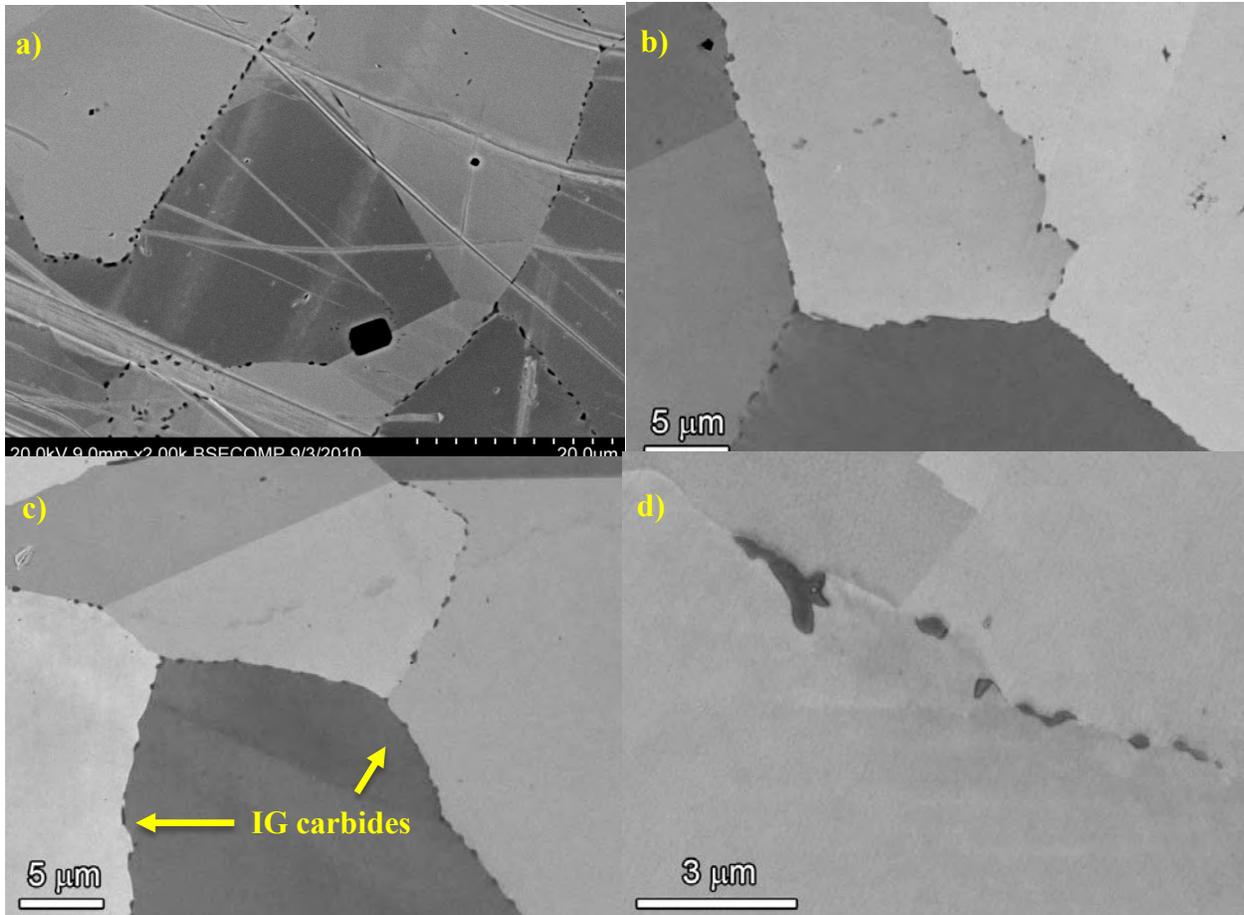
Figure 4: SEM-BSE images illustrating the general microstructures in the alloy 600 steam generator divider plate material, heat NX4292XR.

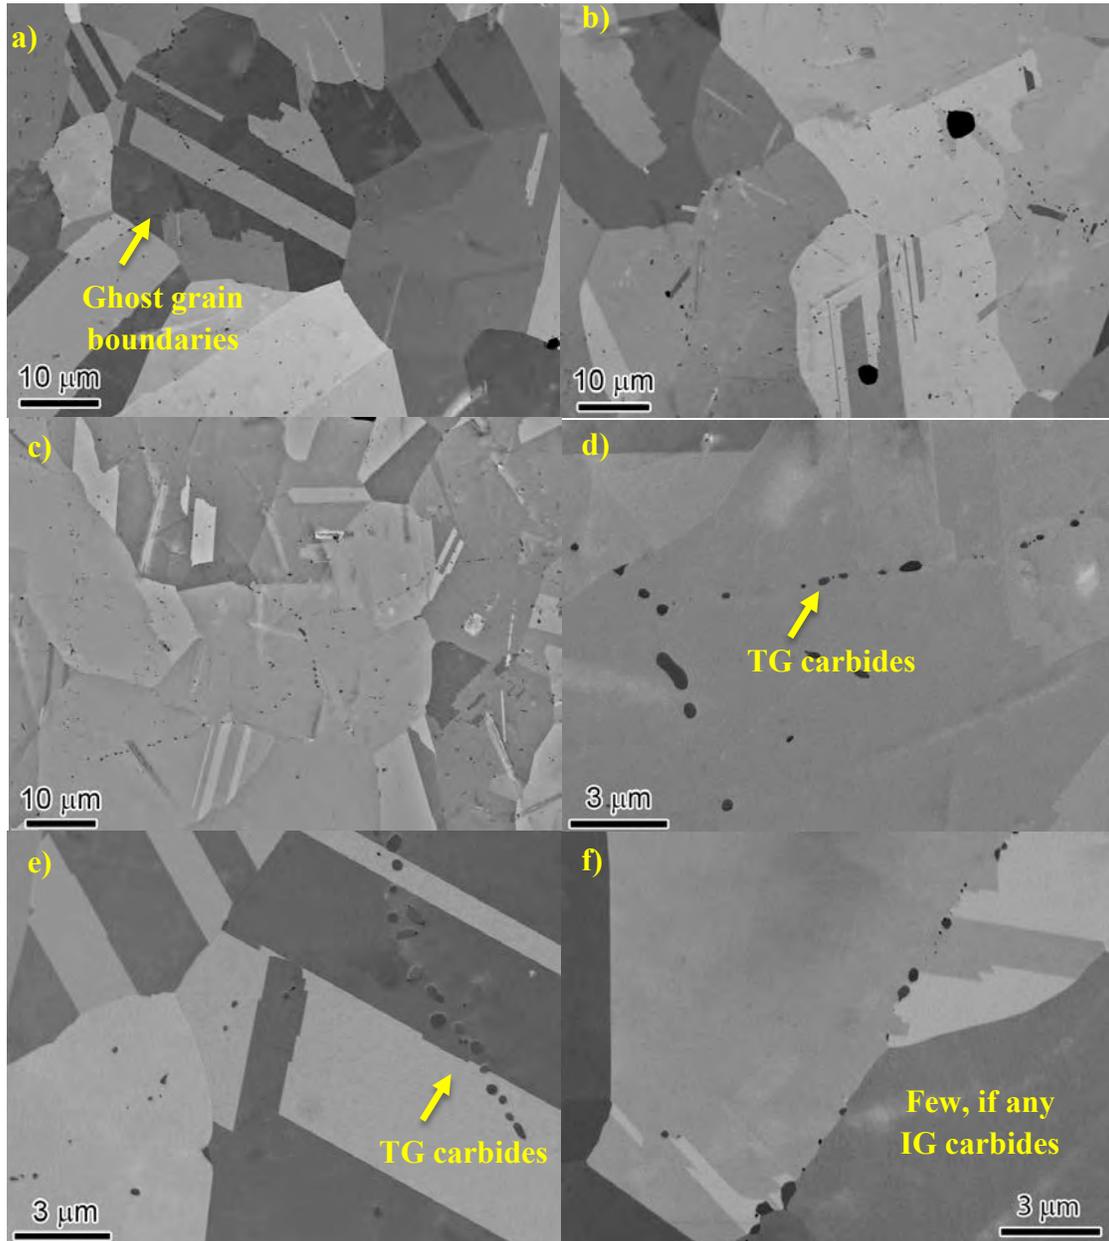
Microstructures from CRDM nozzle heats DB-7929 and DB-M3935 are shown in Figure 5 and Figure 6, respectively. Surprisingly, they have distinctly different microstructures. What is immediately apparent is the large difference in grain sizes of these two mill-annealed alloy 600 materials. The grains of DB-7929 are  $\sim 15\text{-}17\ \mu\text{m}$  and equiaxed (Figure 5), whereas they are on the order of  $\sim 400\ \mu\text{m}$  for DB-M3935 (Figure 6). The carbides in DB-7929 were all determined to be TG, while the carbides in DB-M3935 are all IG and spaced  $500\text{-}700\ \text{nm}$  apart. The TG carbides in DB-7929 were not randomly dispersed throughout the grains but appeared to sit on ghost grain boundaries (Figure 5), most likely due to a heat treatment which transformed the grain structure to its current appearance but was not at sufficiently high temperature or a long enough time to dissolve the carbides. Of all the alloy 600 material examined, DB-M3935 had the largest grain size by an order of magnitude, suggesting an extremely high temperature final mill-anneal temperature. It was one of the few alloy 600 materials that had semi-continuous IG carbides (along with the divider plate heat NX4292XR) indicating a slower cooling from the mill-anneal temperature. It should be noted that in Figure 6c and d there are smaller ( $\sim 50\ \text{nm}$ )

Figure 5: SEM-BSE images illustrating the general microstructures in the mill-annealed alloy 600 CRDM nozzle material, heat DB-7929.

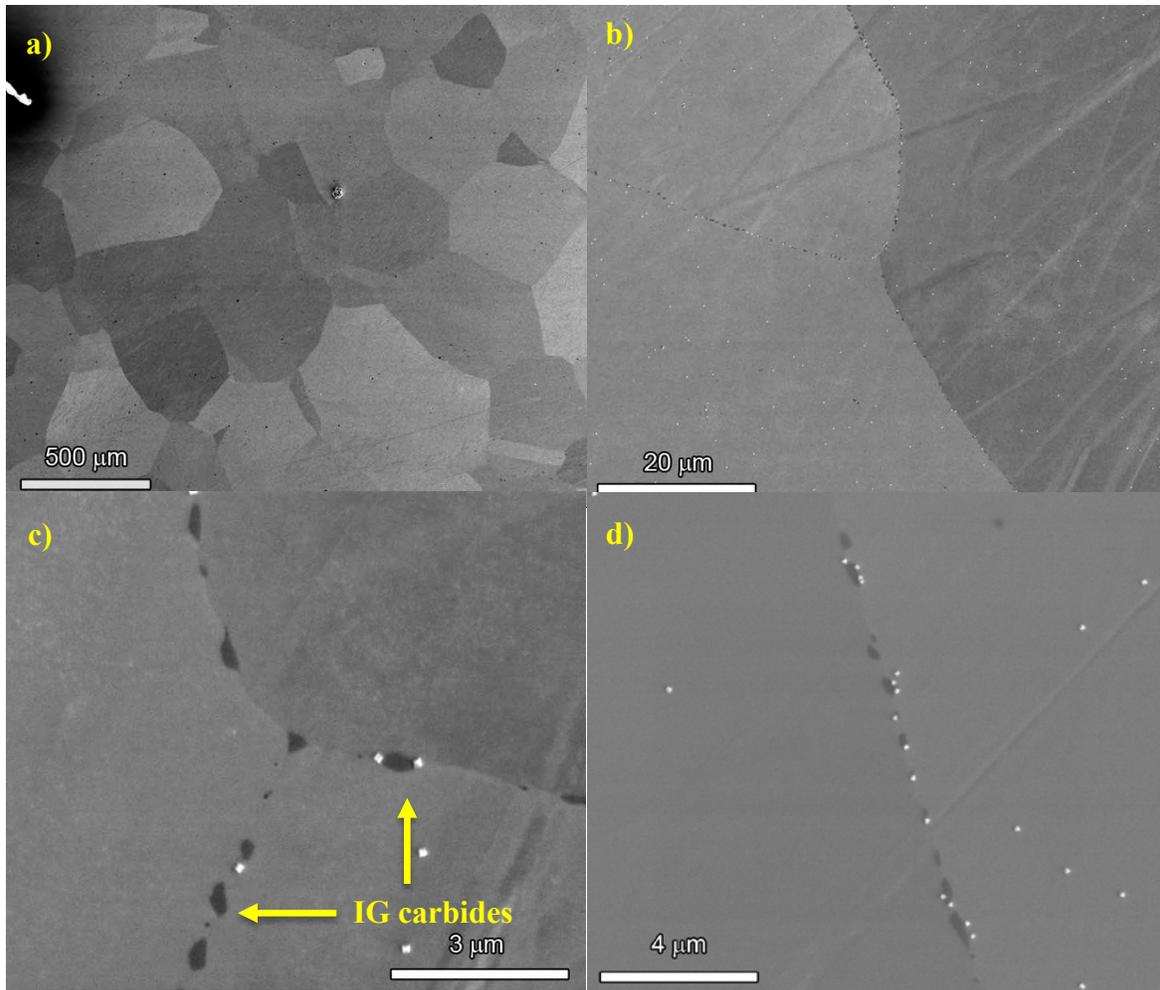
bright white particles. These are surface drying artifacts from the metallographic process and they are not a secondary phase in the microstructure. This issue has since been resolved by applying a 1% acetic acid after metallographic polishing to dissolve these deposited surface crystals. Lastly, it should be noted that there is very little strain contrast observed in either of these backscatter images, suggesting very little strain in these CRDM materials.

Figure 6: SEM-BSE images illustrating the general microstructures in the mill-annealed alloy 600 CRDM nozzle material, heat DB-M3935 Small white particles in (c) and (d) are drying artifacts from the sample preparation process.

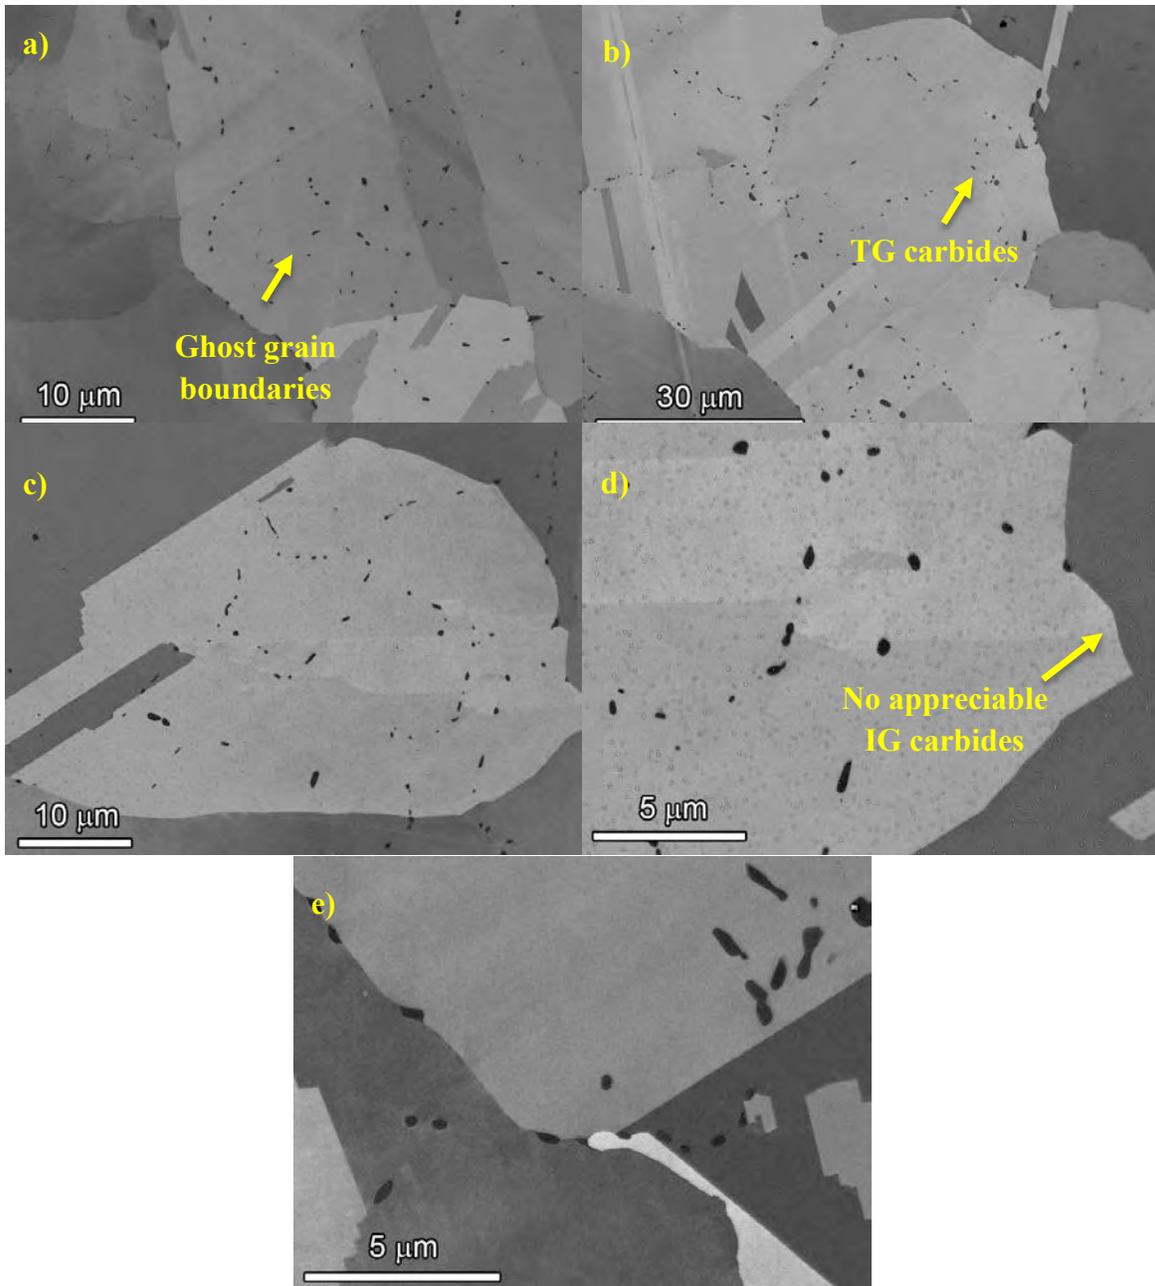
The microstructure for a third alloy 600 CRDM nozzle material (identified as NA2-N31) is illustrated in Figure 7. The sample had an equiaxed grain microstructure with grains  $\sim 50\text{-}70\ \mu\text{m}$  in size. There was a high density of TG carbides (Figure 7b) along ghost grain boundaries similar to that for DB-7929 (Figure 5). Isolated IG carbides were observed, but their appearance seemed randomly spaced and may have resulted from the grain boundary intersecting a ghost boundary. Once again, there appeared to be very little strain contrast in this CRDM material.

Figure 7: SEM-BSE images illustrating the general microstructures in the alloy 600 CRDM nozzle material NA2-N31.

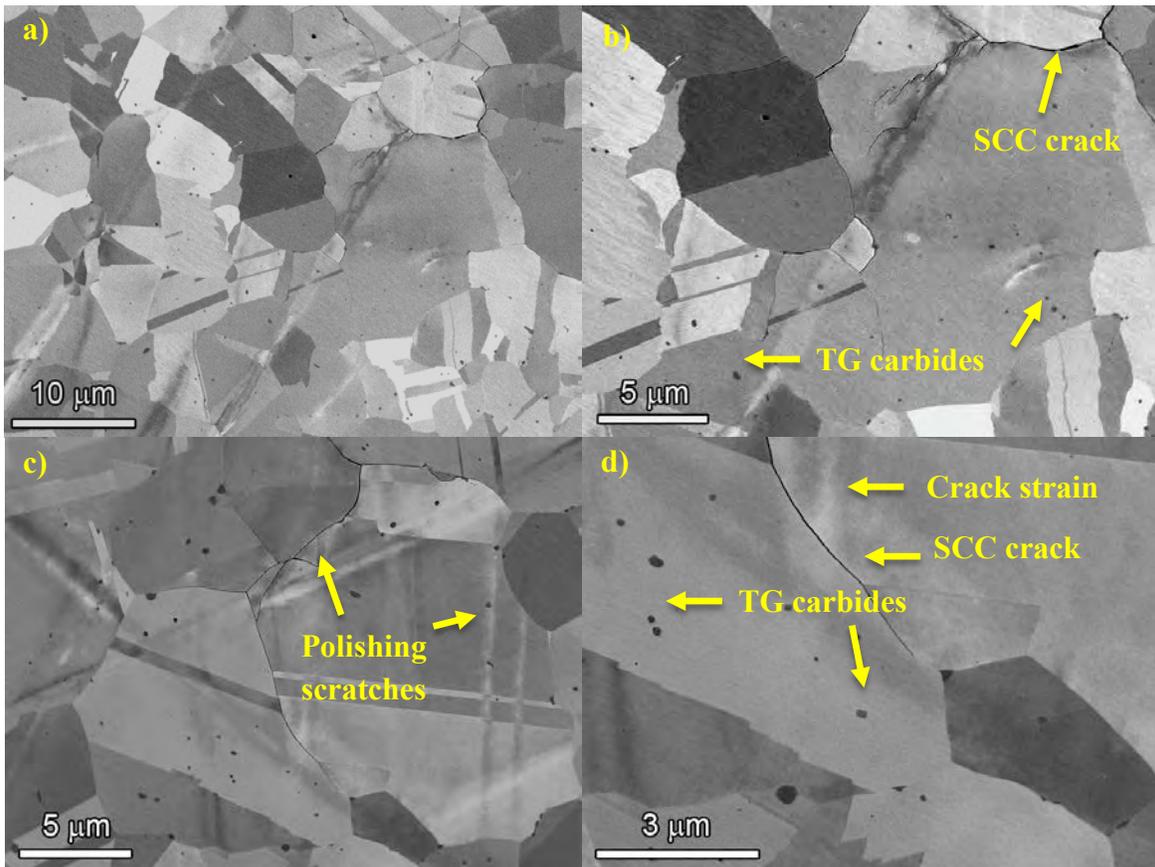
The final alloy 600 material (heat 3011) was from steam generator tubing tested in PWR secondary-side water conditions containing Pb. The micrographs illustrated in Figure 8 were taken from the cross-section of the C-ring test specimen and SCC cracks are present. The regions surrounding the cracks are still representative of the starting microstructure and hence are used for comparative purposes. If regions away from the cracks and scratches are evaluated, it is apparent that there is uniform contrast in most grains suggesting that the starting microstructure had very little strain damage. The grain size of this mill-annealed alloy 600 was about 5-10  $\mu\text{m}$ , and the grains were equiaxed. A low density of TG carbides was observed through the material (Figure 8d) with only a few isolated IG carbides detected.

Figure 8: SEM-BSE images illustrating the general microstructures in the alloy 600 steam generator tubing heat 3011. Images were taken from a cross-section sample containing SCC cracks.

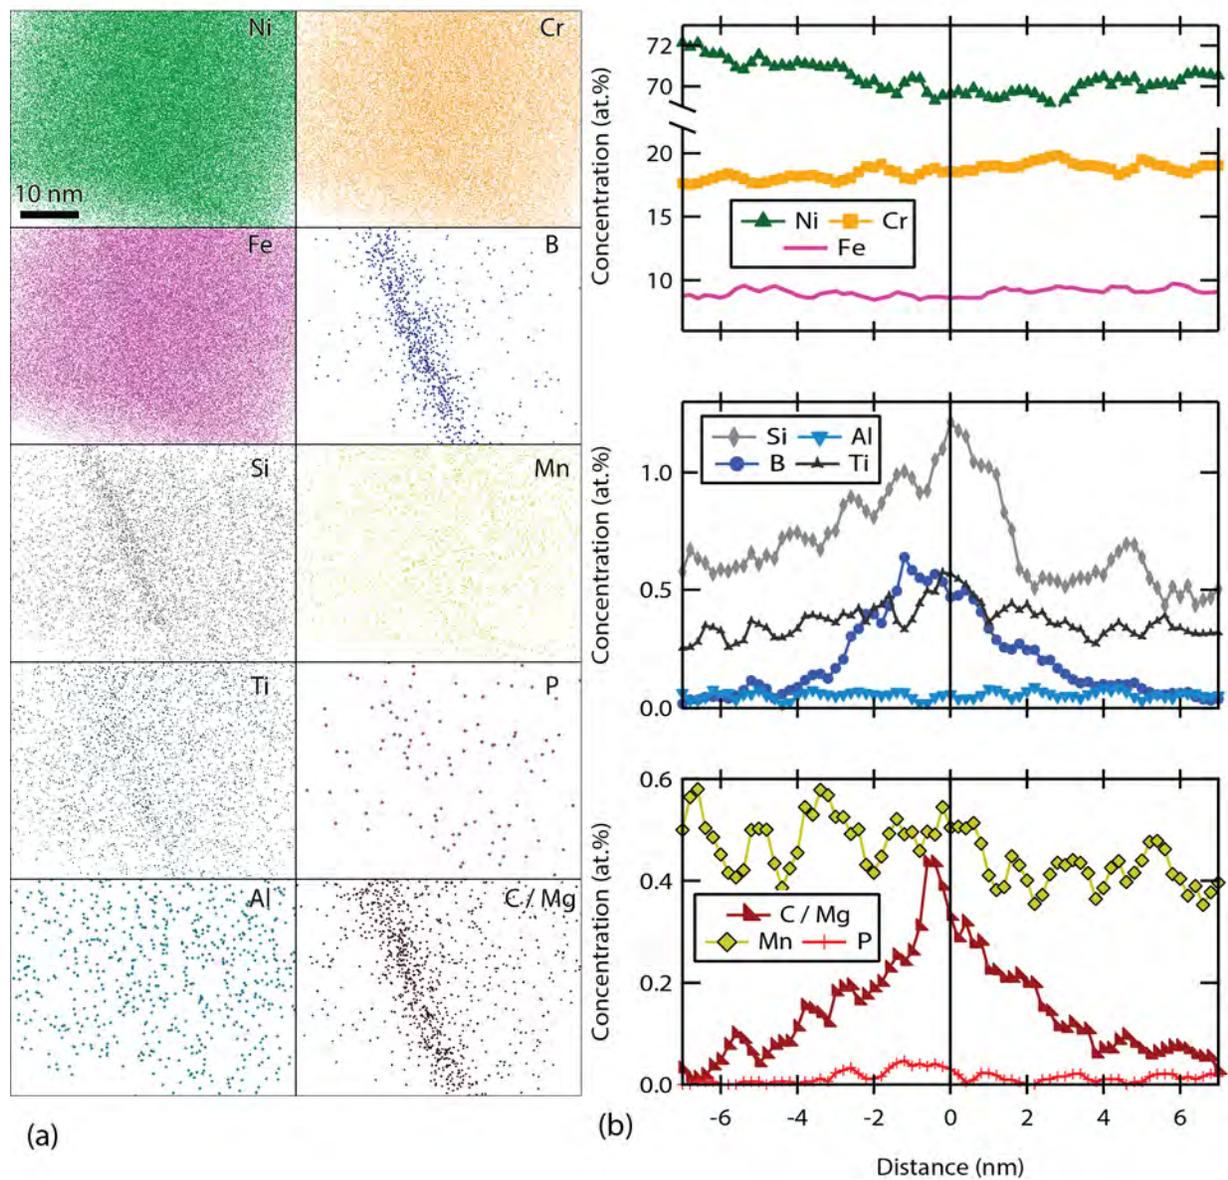
A small number of APT experiments were performed targeting general high-angle grain boundaries in heat 96834. Representative atom maps and a corresponding 1D concentration profile across the same grain boundary are presented in Figure 9. The grain boundary exhibits clear segregation of B, Si, C and Ti. Quantitatively the segregation was observed at maximum concentrations ~1.2 at% Si, 0.5 at% B and 0.4 at% C. Heat 96834 is unique among the analyzed alloy 600 grain boundaries as it is the only one that did not exhibit any measurable Cr depletion. This can be explained by the lack of any significant IG Cr carbide precipitation in the overall microstructure and may also explain the slightly higher-than-typical C concentration at the grain boundary. Furthermore no segregation was apparent for Fe, Ni, Al or Mn and only a trace amount of P was observed.

Figure 9: (a) Atom maps (10 nm image depth) and (b) corresponding 1D concentration profiles of a general high-angle grain boundary from heat 96834. Segregation is apparent for B, Si, Ti and C/Mg (convoluted signal but primarily C). No Cr depletion is apparent in this sample.

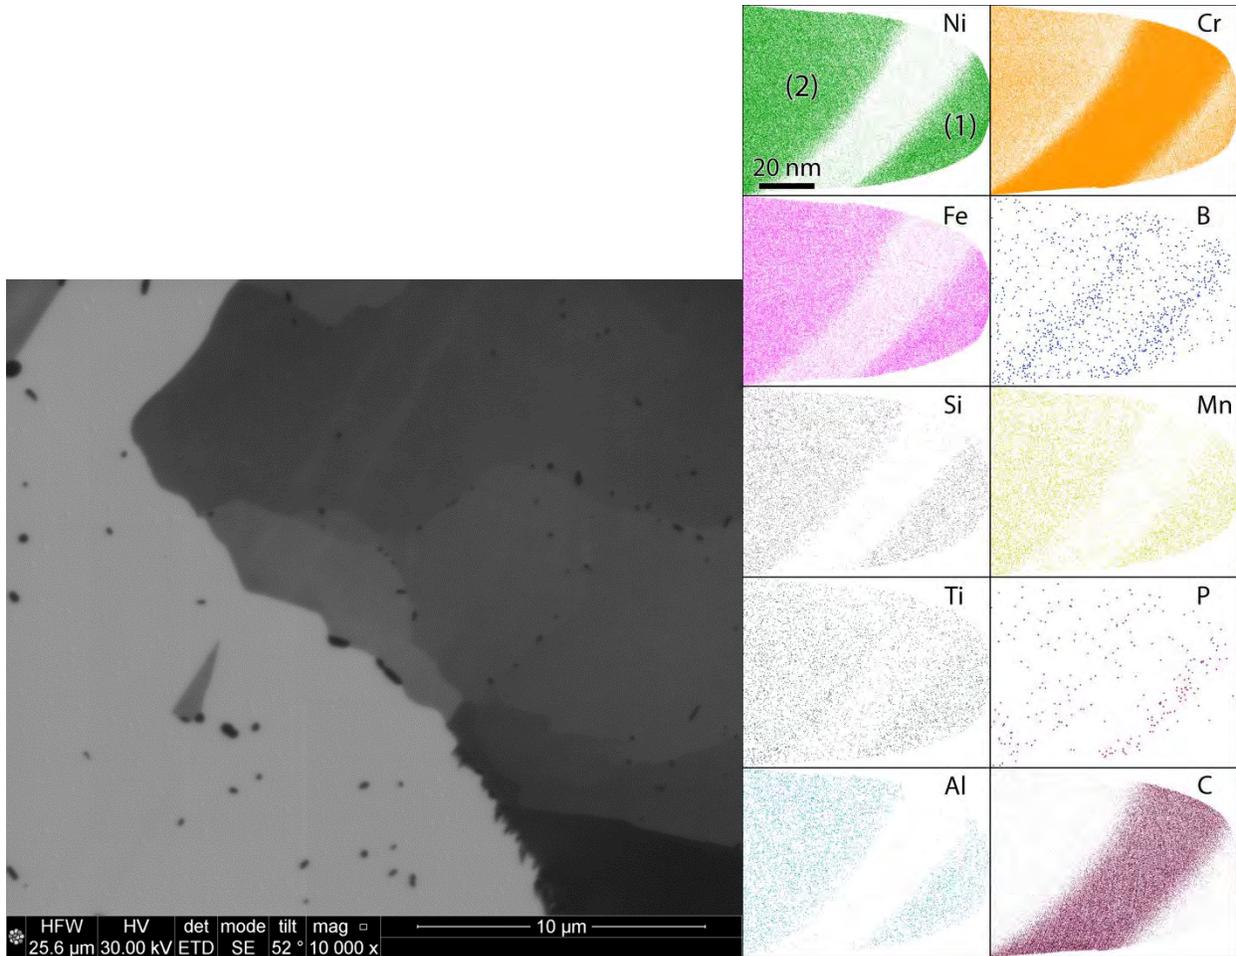
Figure 10: Typical high-magnification ion-beam image of grain boundaries in the NA2-N31 alloy 600 material. A low density of IG carbides was apparent. The rough interface along the boundary in the lower right may be suggestive of cellular carbide formation. The wavy nature of the grain boundaries presents a significant challenge to preparing grain boundary APT specimens. APT atom maps (10 nm image depth) of an IG Cr carbide. Weak B and P segregation is apparent at the carbide/metal interface.

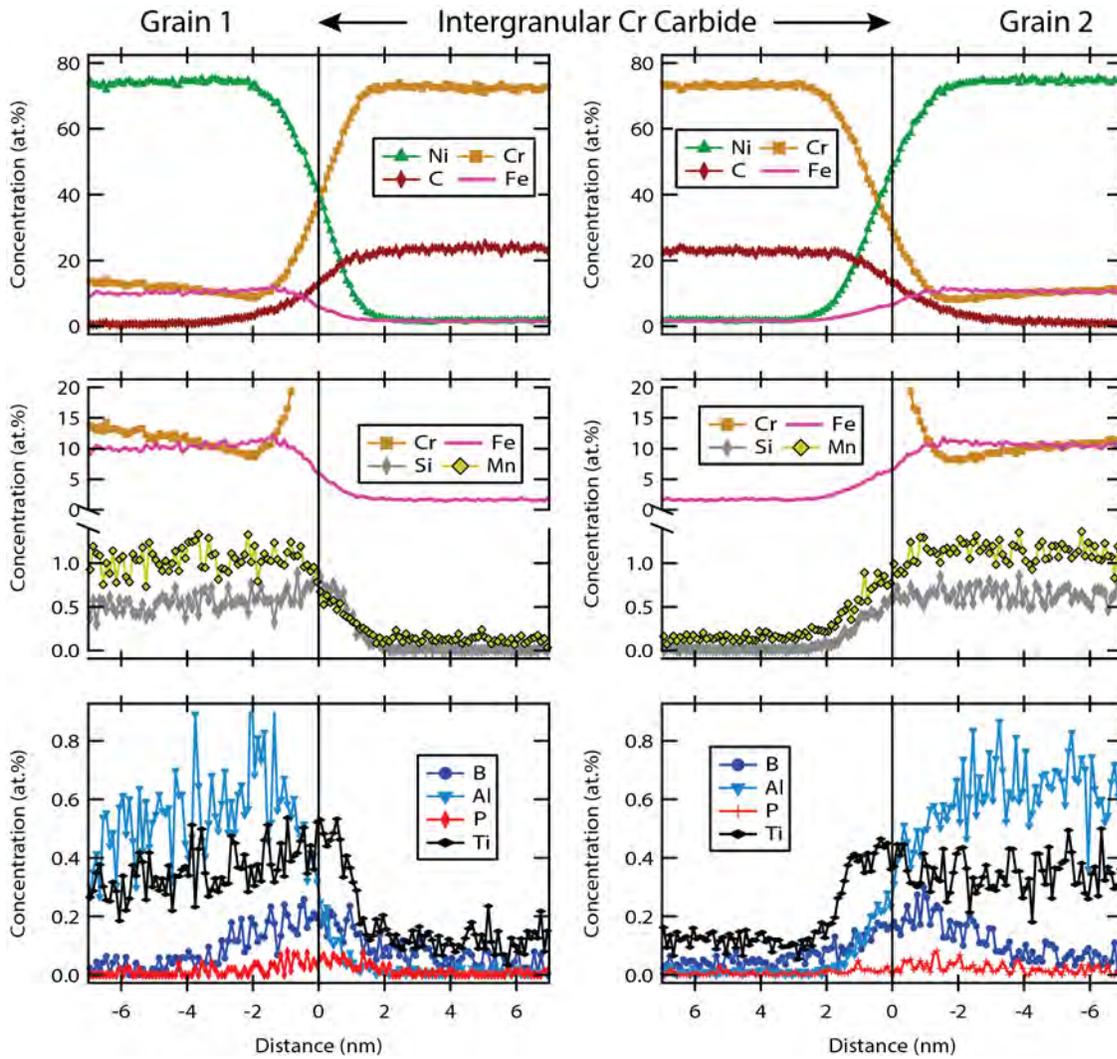
Figure 11: APT proximity histograms at the interface between the IG Cr carbide and (left) Grain 1 and (right) Grain 2. The profiles quantitatively confirm the visually apparent weak segregation of B and P and also localized Cr depletion at both metal/carbide interfaces.

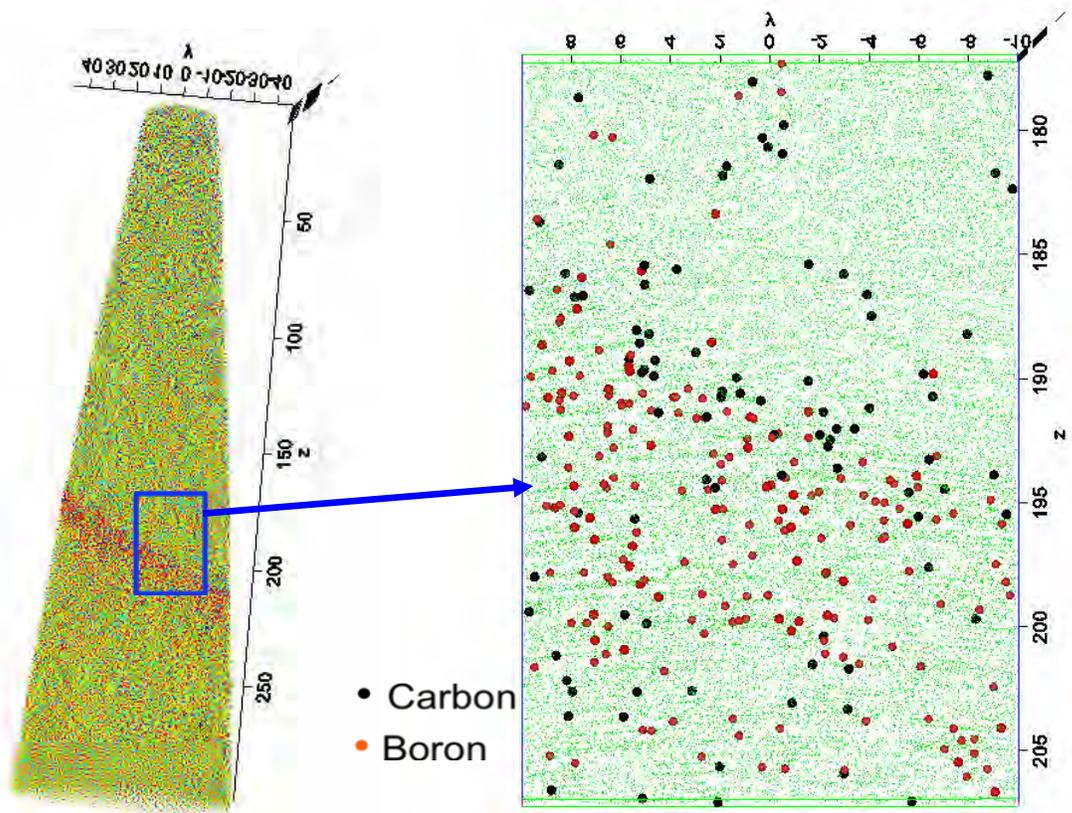
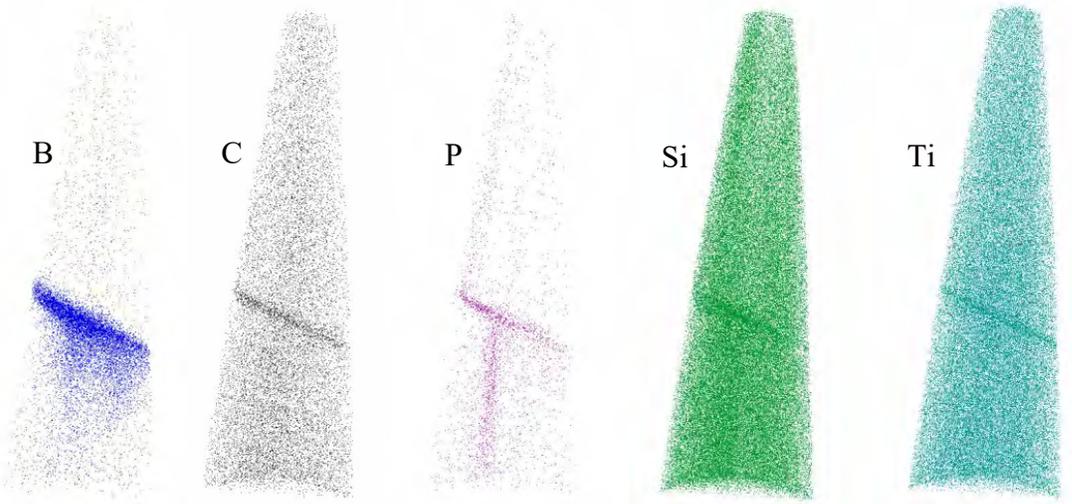
Figure 12: Atom maps from APT analysis of alloy 600 specimen NX4292XR-APT1 highlighting the grain boundary segregation of B, C, P, Si and Ti.

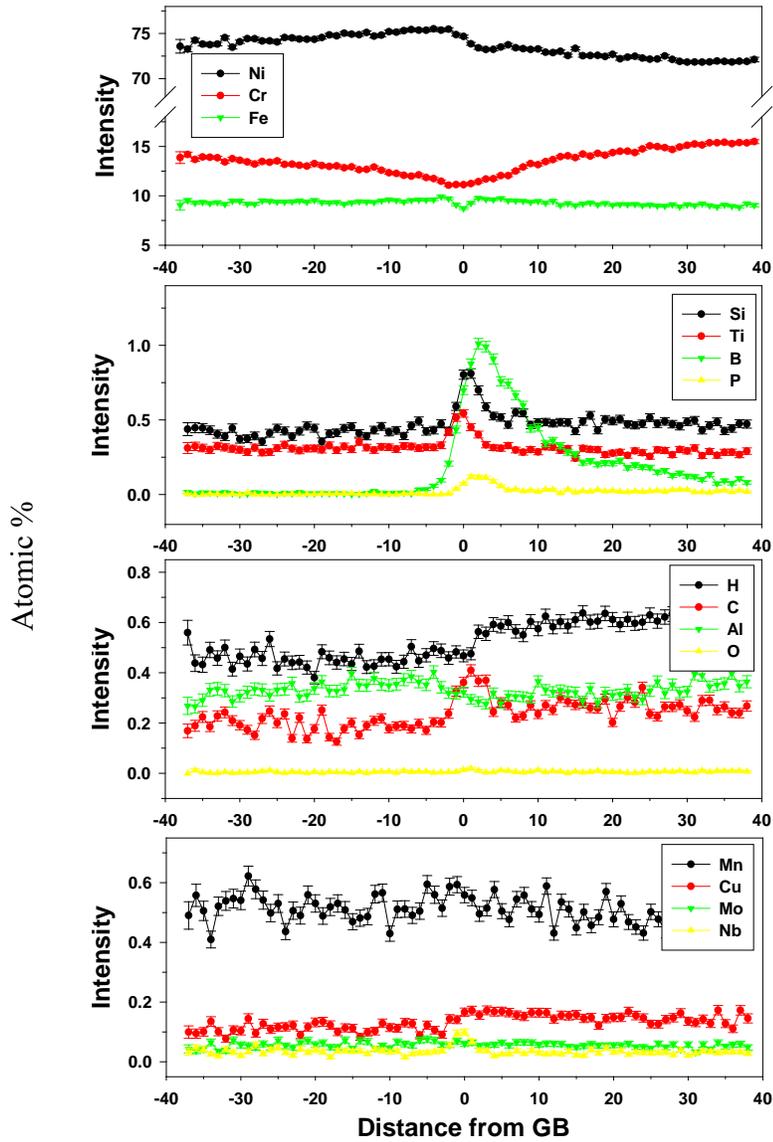
Figure 13: Concentration profiles across a grain boundary (#1) in specimen NX4292XR-APT1 from APT data using a proximity histogram. The grain boundary exhibits segregation of Si, B, P, Ti and C.

Similar to our previous APT grain boundary measurements, most segregating elements are localized at or with a nanometer of the boundary plane with B as the exception. It shows a plume below the interface in the direction of analysis and is a common artifact when analyzing grain boundaries with moderate-to-high B segregation. This can be better seen in the composition profiles plotted for many elements in Figure 13. Narrow enrichment profiles are observed for Si, Ti, P and C in comparison to the B profile. It is interesting that there appears to be a slight offset (~1-2 nm) between the Si and Ti peaks versus the P peak. This has not been consistently observed, but may suggest competitive segregation for grain boundary sites among certain elements. Chromium exhibits depletion across the boundary with a minimum concentration of ~10.7 at% and a profile width on the order of 25 nm. Iron can also be seen to show a slight depletion at the grain boundary in Figure 13 corresponding to the enrichments of Si and Ti.

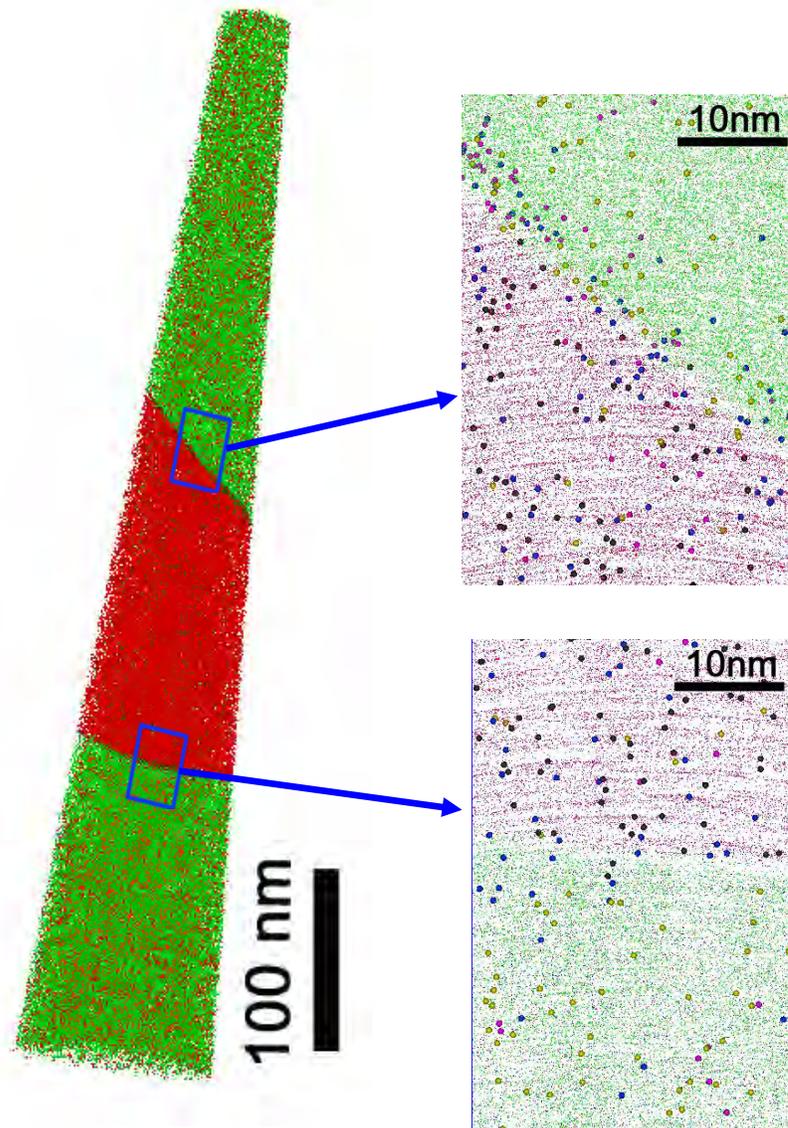
Figure 14: Atom maps from APT analysis of alloy 600 specimen NX4292XR-APT4 showing the carbide within the tip and highlighting the compositional distribution of B, C, P and Si.

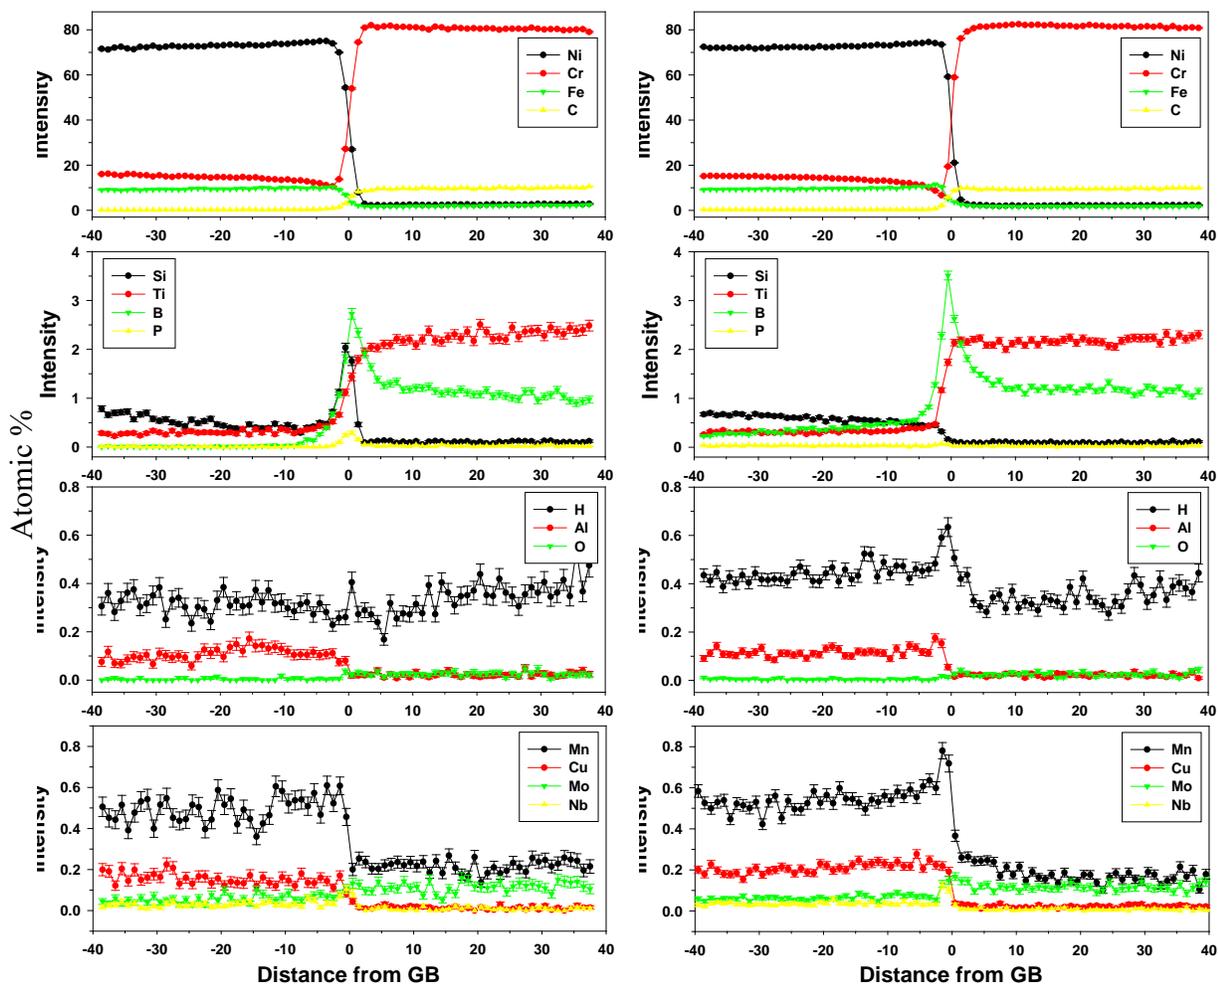
Figure 15: Concentration profiles across carbide interfaces in specimen NX4292XR-APT4 from APT data using a proximity histogram. Both interfaces exhibit significant enrichment of B while only the carbide/grain boundary interface shows Si and P segregation.

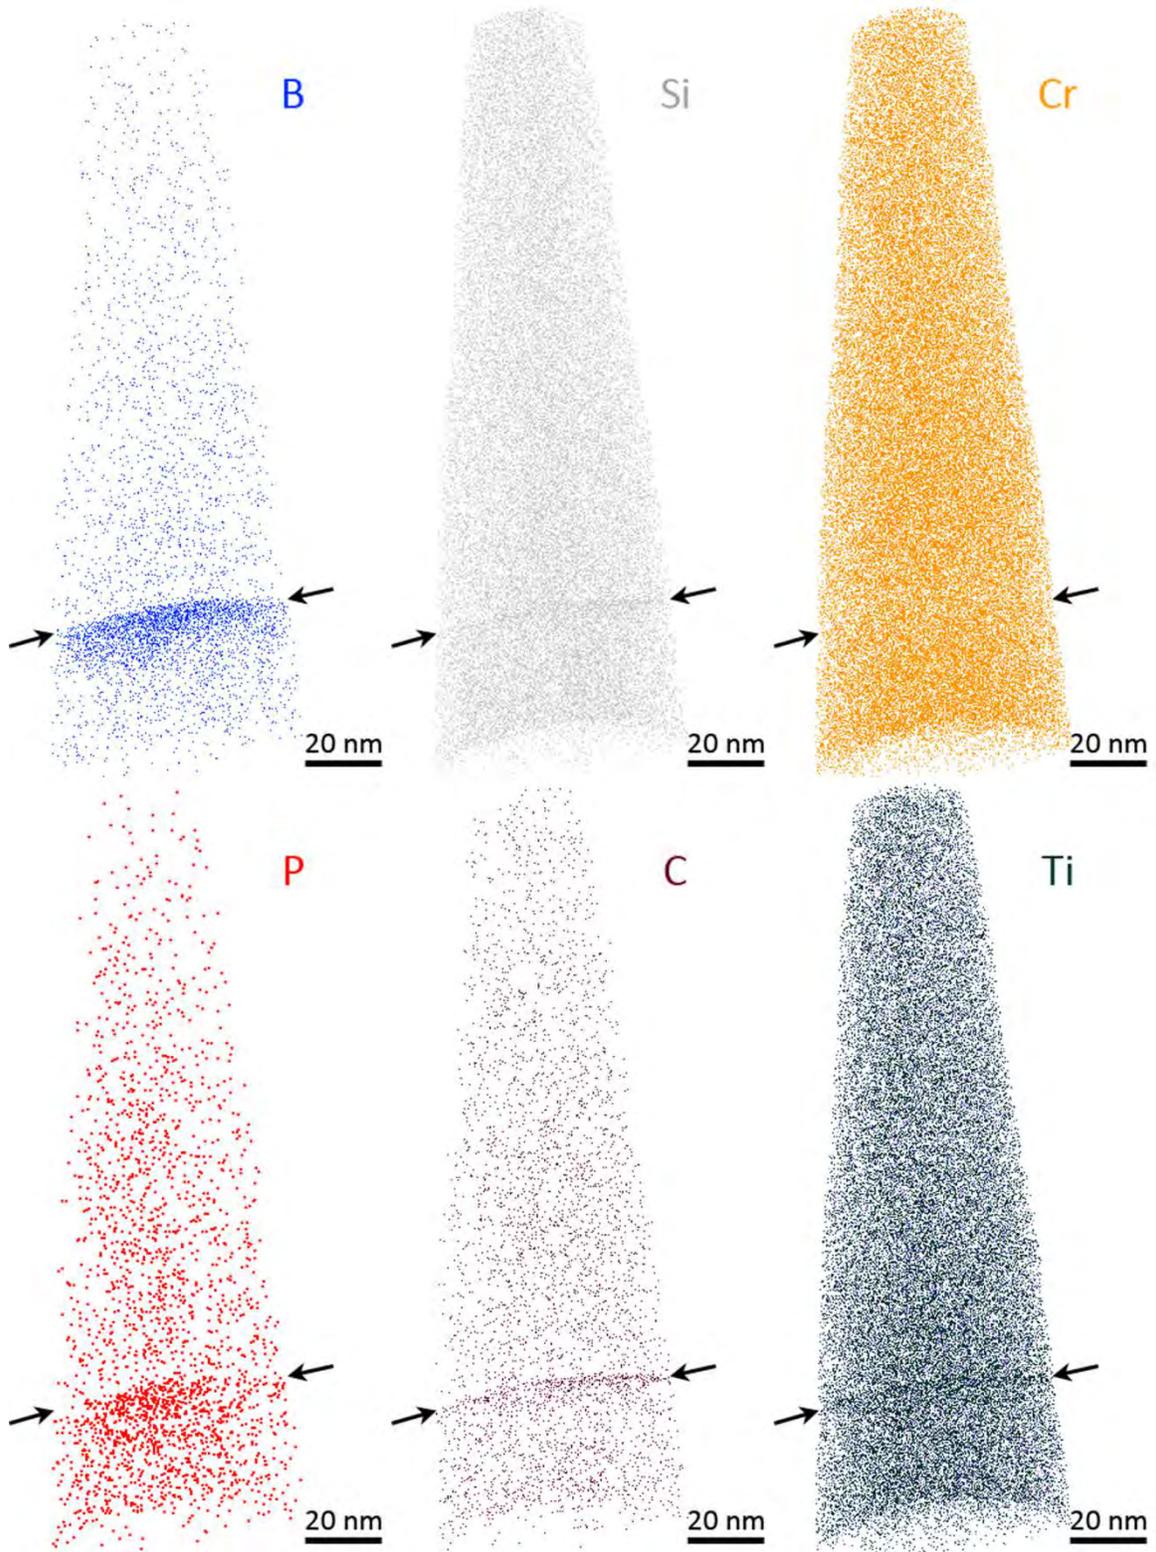
Figure 16: Atom maps from APT analysis of a metal/metal grain boundary (422-APT9) highlighting the segregation B, Si, P, C and Ti at the grain boundary. A slight depletion of Cr is also present.

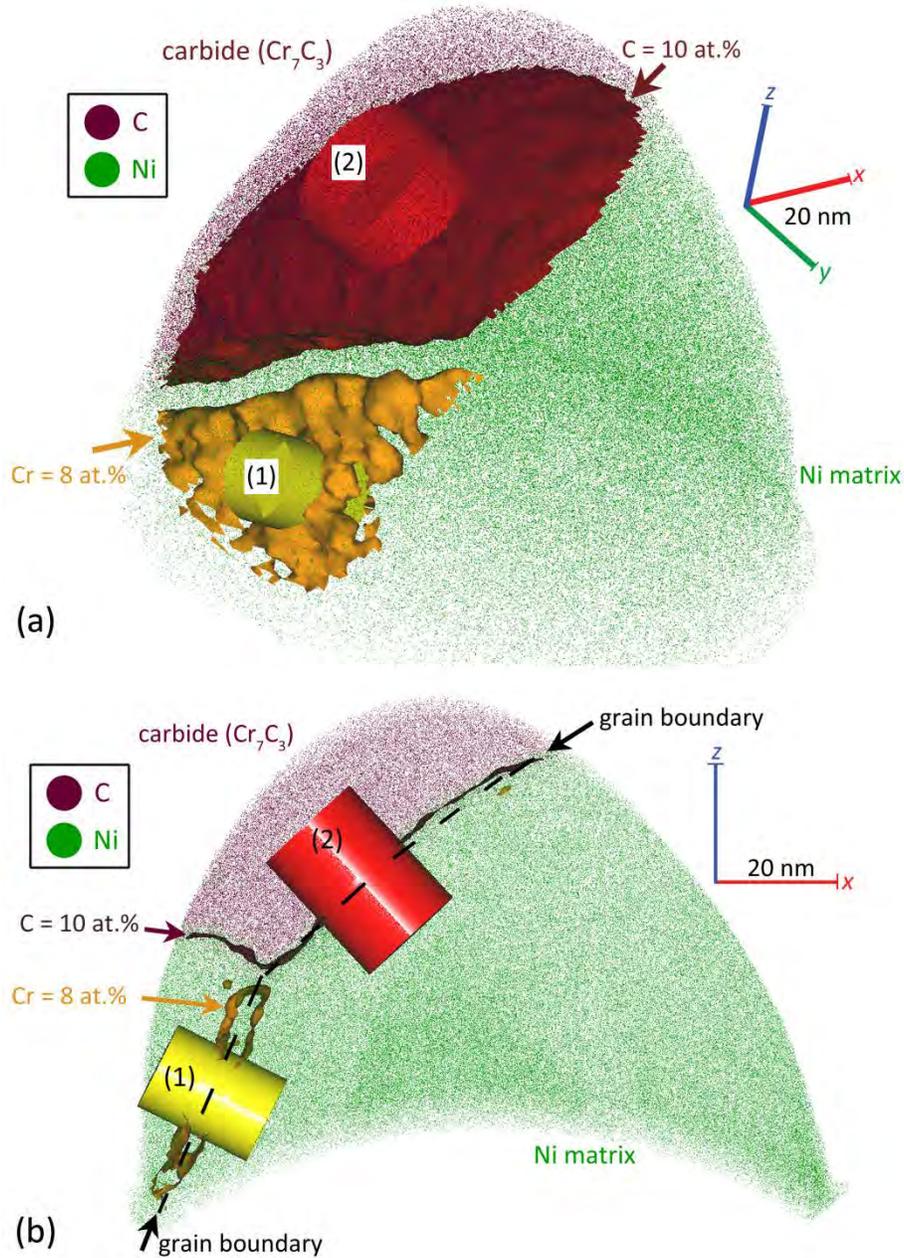
Figure 18: Top-down view (a) and side-view (b) of a grain boundary (black dashed line) from an APT reconstruction of GB2 of 422-APT2. Isoconcentration surfaces are displayed at 10 at.% C (red) and 8 at.% Cr (orange) to highlight the location of a Cr-rich carbide (red) and Cr-depleted, non-carbide grain boundary (orange). 1-D concentration profiles were extracted from the metal/metal [labeled yellow - (1)] and carbide/metal [labeled red - (2)] regions of the grain boundary (see Figure 19).
