**MICROSTRUCTURE, CORROSION AND STRESS  
CORROSION CRACK INITIATION OF ALLOY 600  
IN PWR PRIMARY WATER ENVIRONMENTS**

**Technical Milestone Report: M3LW-13OR0403032  
March 2013**

M. J. Olszta, D. K. Schreiber, M. B. Toloczko  
and S. M. Bruemmer  
Pacific Northwest National Laboratory

Research Project:  
**Stress Corrosion Crack Initiation of  
Nickel-Base Alloys in LWR Environments**  
Project Manager: S. M. Bruemmer  
Pacific Northwest National Laboratory

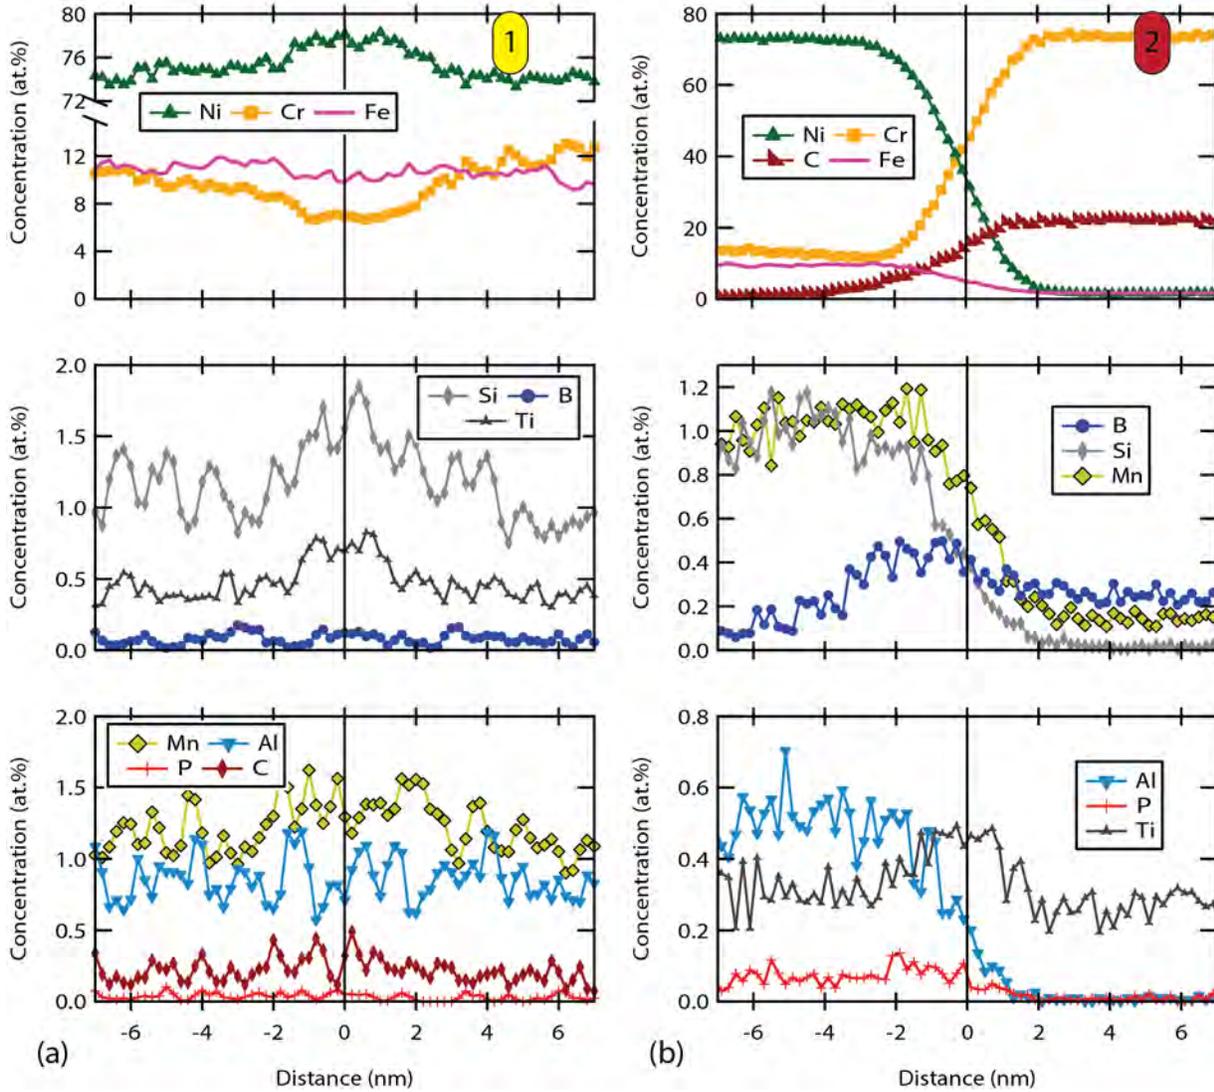
Figure 19: 1-D concentration profiles taken across the GB2 grain boundary in 422-APT2 (a) at the metal/metal and (b) at the carbide/metal grain boundary [labeled (1) and (2) respectively in Figure 18]. (a) At the metal/metal grain boundary, Si and Ti segregated, but no detectable segregation of B or P was observed. Cr is depleted to  $\sim 6$  at%. (b) At the carbide/metal grain boundary interface, no Si segregation was detected, but a small amount of B excess ( $\sim 0.5$  at%) is observed.

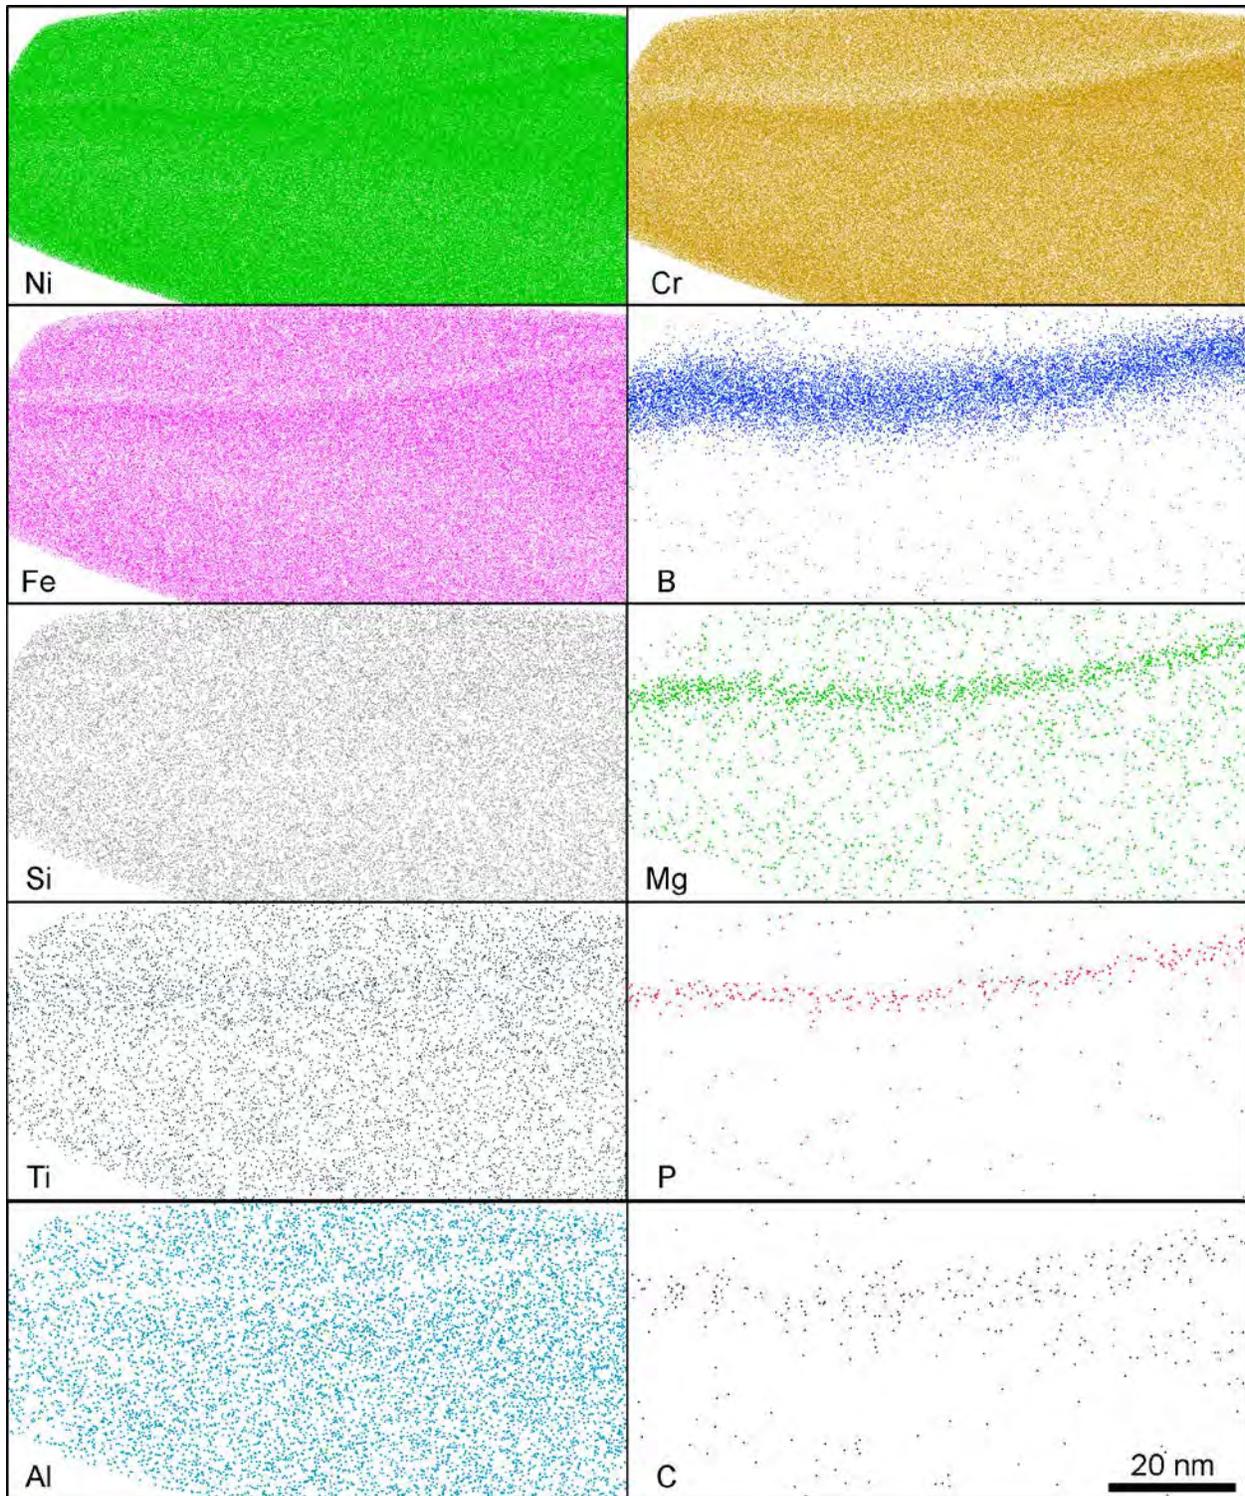
Figure 20: Atom maps (20 nm image depth) from CRDM heat DB-7929. Particularly strong segregation is apparent for B, Mg and P.

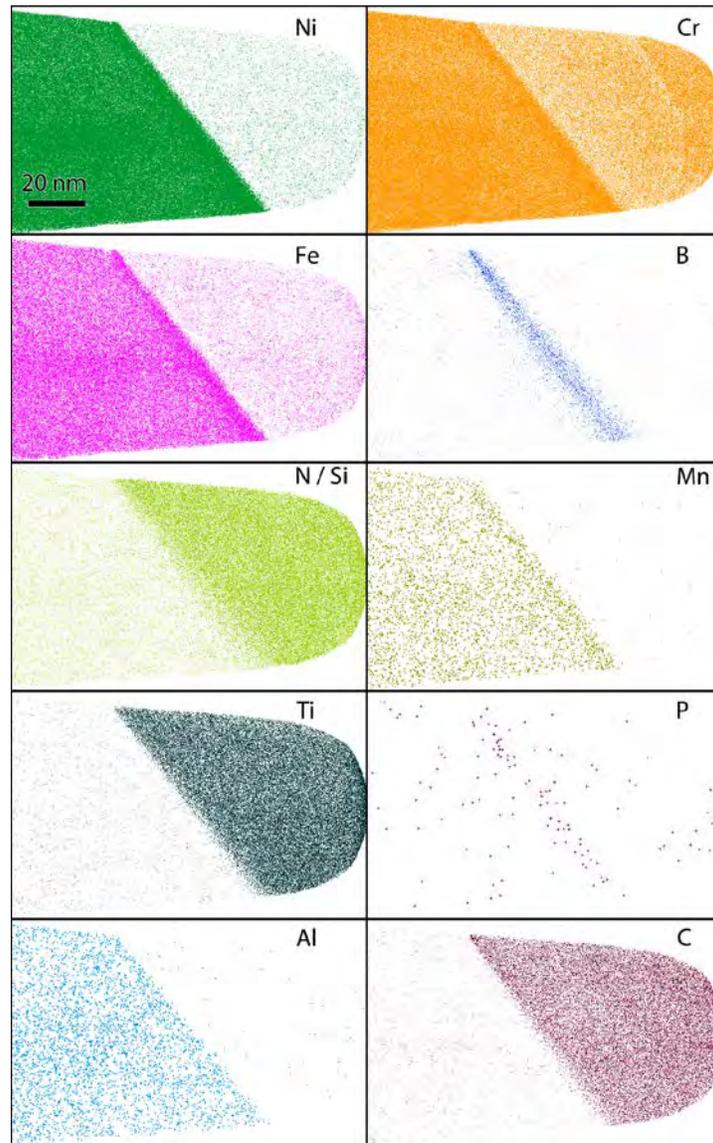
Figure 22: Atom map (10 nm image depth) of an IG Ti carbonitride in CRDM heat DB-M3935. Strong interfacial segregation is apparent for B and weak segregation for P. Note that Si and N are convoluted with one another.

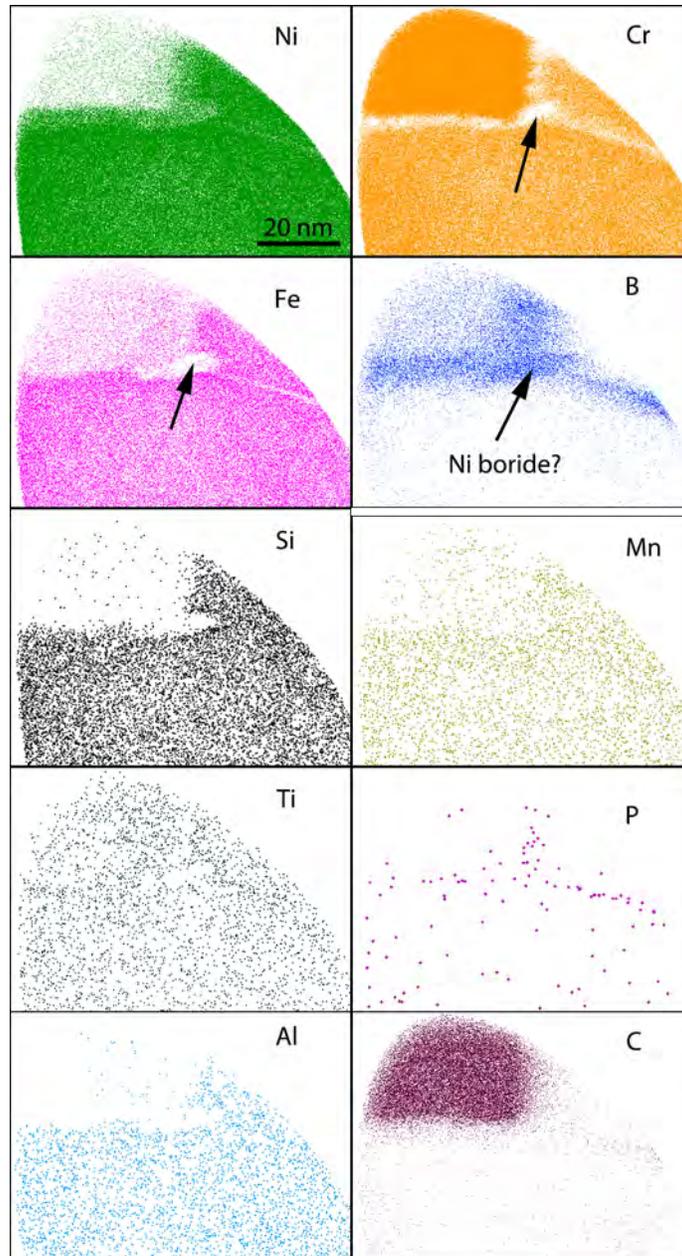
Figure 24: Atom maps from an IG Cr carbide and surrounding grain boundary in CRDM heat DB-M3935. Very strong Cr depletion and B enrichment are apparent along the grain boundary and metal/carbide matrix. Particularly strong localized B enrichment and Cr depletion is suggestive of possible Ni boride precipitations (arrowed).

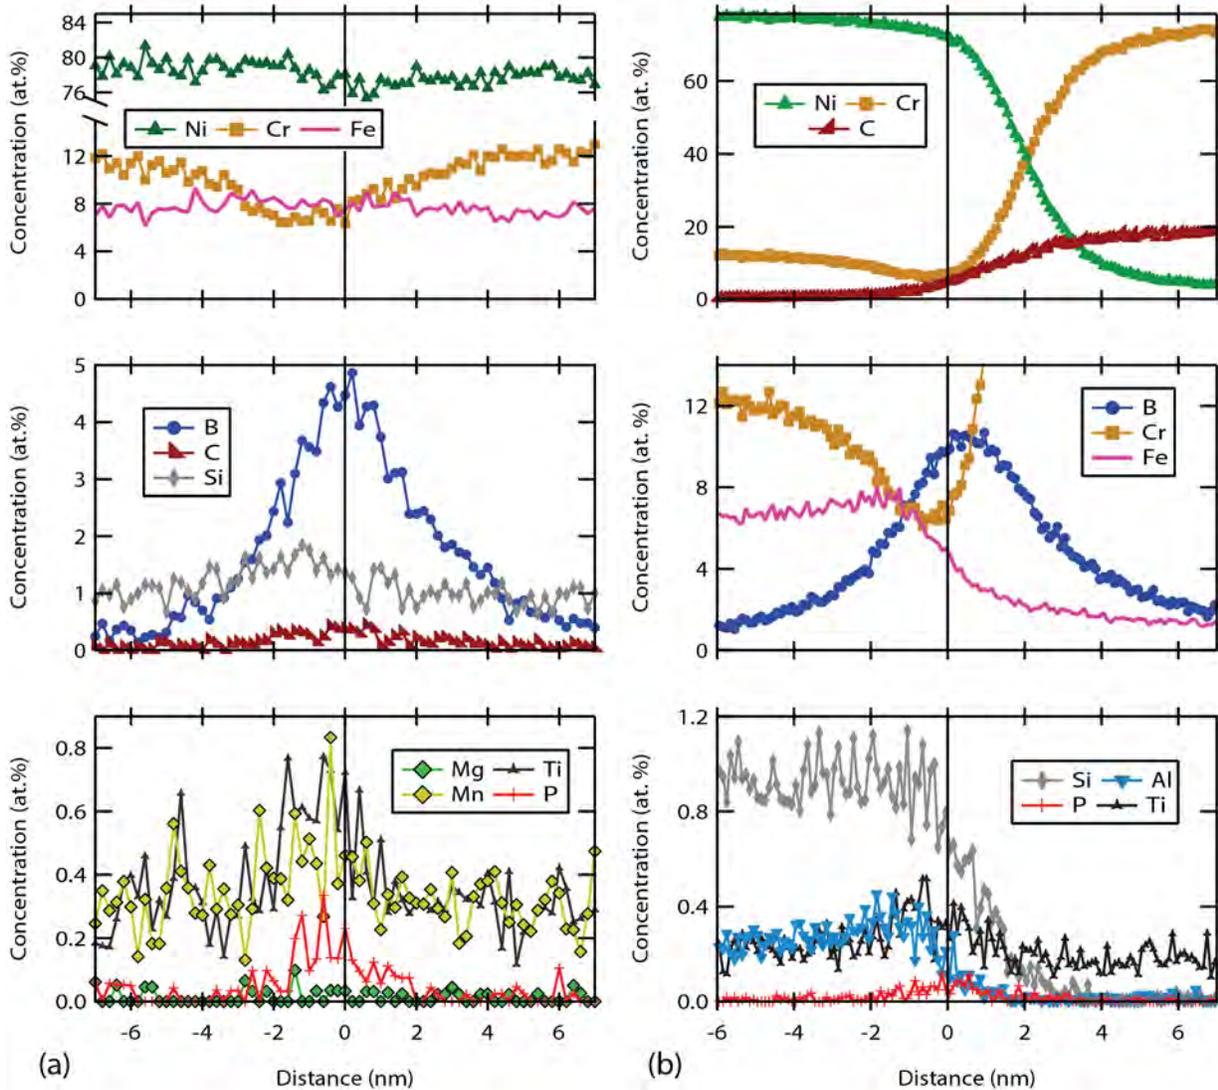
Figure 25: Concentration profiles across (a) the metal/metal grain boundary and (b) across the IG Cr carbide / metal interface in CRDM heat DB-M3935. Both types of interfaces exhibit particularly strong B segregation (5 at% and 11 at%, respectively) and Cr depletion (<8 at% each). Relatively strong P segregation is apparent at each interface (~0.2 at%) and no significant Si segregation is observed.

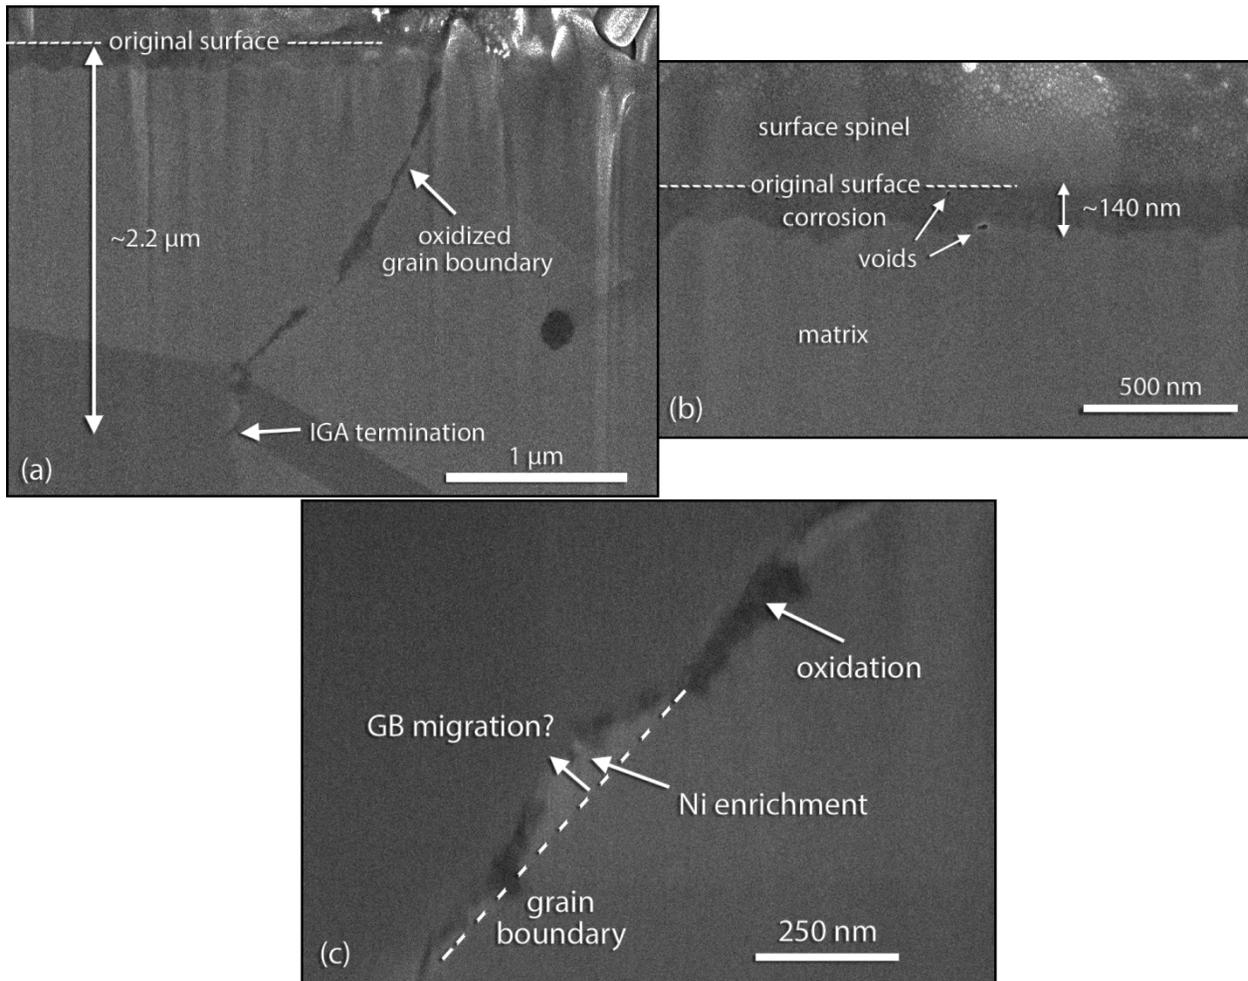
Figure 27: FIB/SEM images of corrosion exhibited in alloy 600 (heat WF422) after exposure to simulated PWR primary water (10.5 cc/kg H<sub>2</sub>) for 3500 h at 325°C. (a) IG oxidation extended for ~3 μm with varying oxidation width. (b) High resolution SEM of the TG surface oxidation revealed a corrosion depth ~140 nm accompanied by a low density of voids. (c) High resolution SEM of the leading edge of IG attack revealed extensive Cr depletion accompanying IG oxidation. The bowing of the Ni enrichment and IG oxidation suggest grain boundary migration may be present.

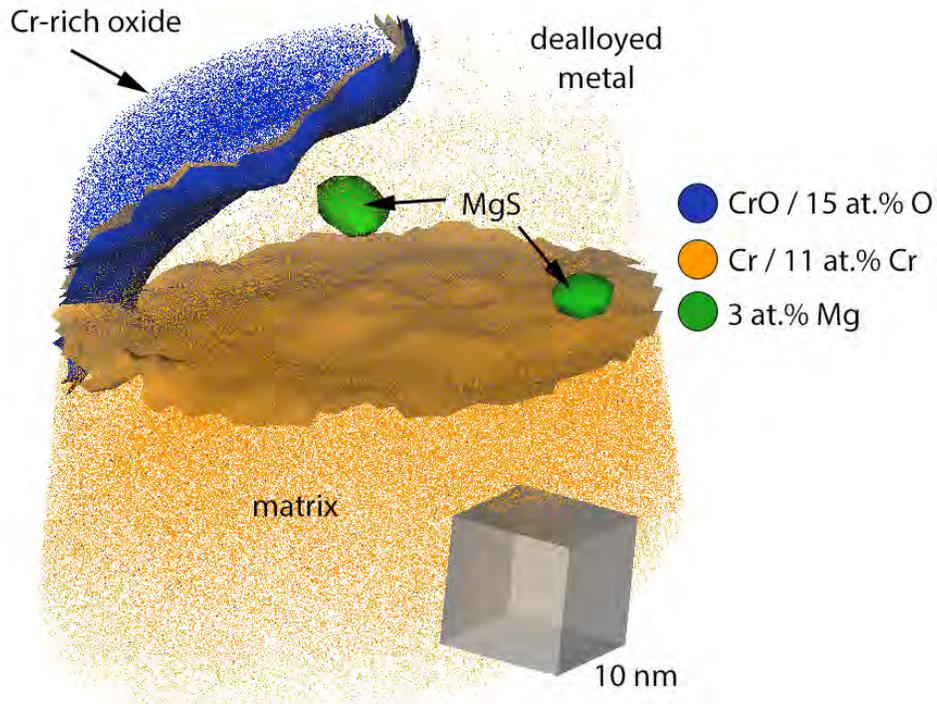
Figure 28: APT reconstruction of a shallower region of IGA. A large dealloyed region is present between the matrix and oxidized grain boundary. Two nanoprecipitates of MgS are present within the dealloyed zone and are likely not a product of the IG attack.

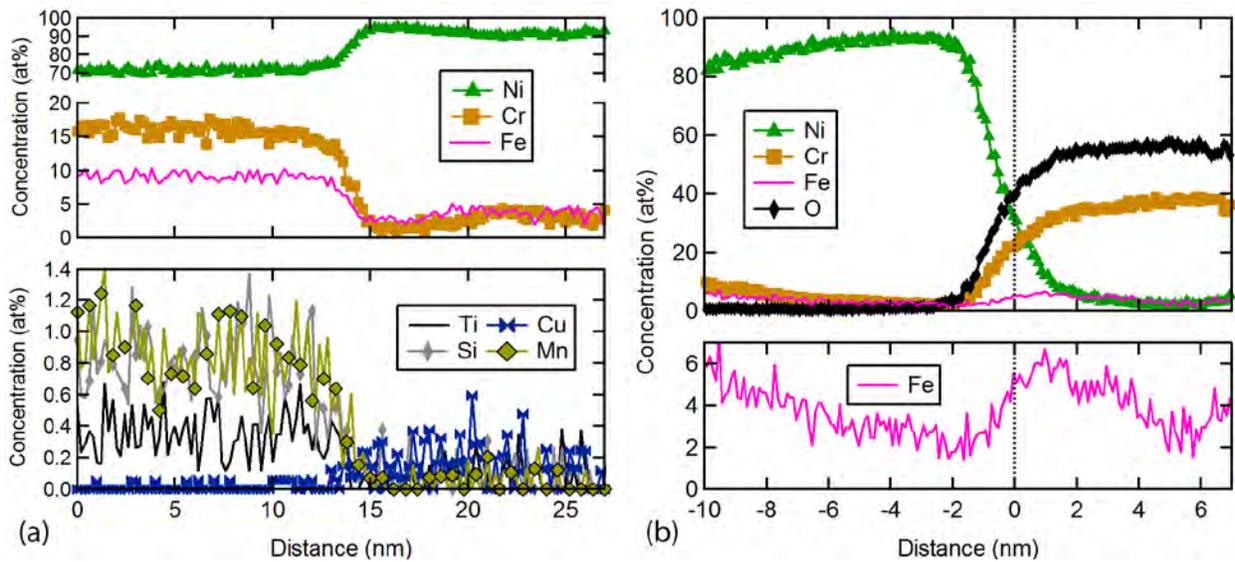
Figure 29: (a) 1-D concentration profile across the matrix/dealloyed zone interface. Cr, Fe, Mn, Ti and Si are depleted in the dealloyed zone while Ni and Cu are enriched. (b) Proximity histogram across the oxide - dealloyed zone interface. The oxide is primarily  $\text{Cr}_2\text{O}_3$  with small concentrations of Ni and Fe. A slight enrichment of Fe at the oxide/metal interface suggests a different oxide composition, possibly MO phase.

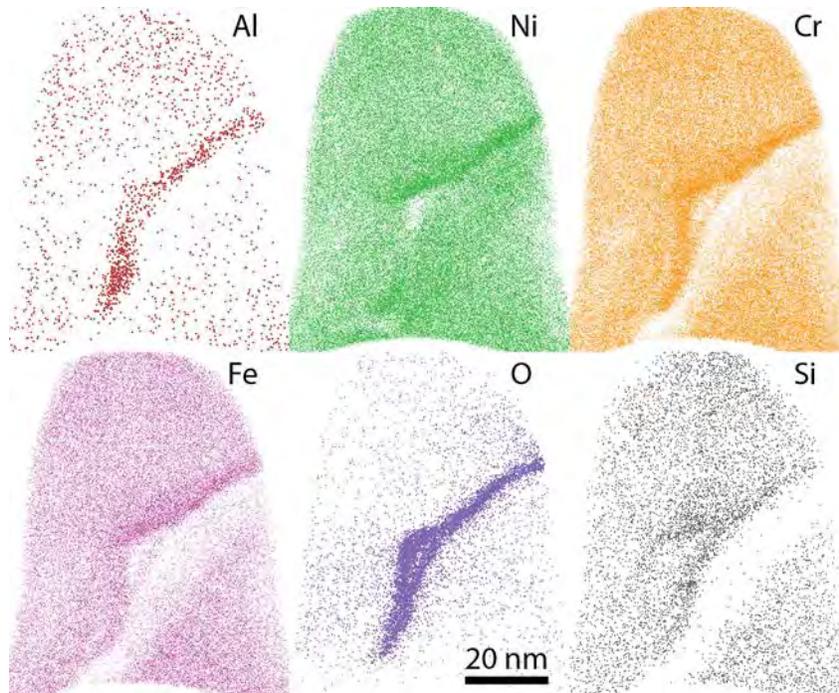
Figure 30: Cross-section atom maps of the terminal IGA in heat WF422 after re-exposure at PNNL showing Cr-rich oxides and substantial depletion of Cr, Fe and Si and grain boundary migration.

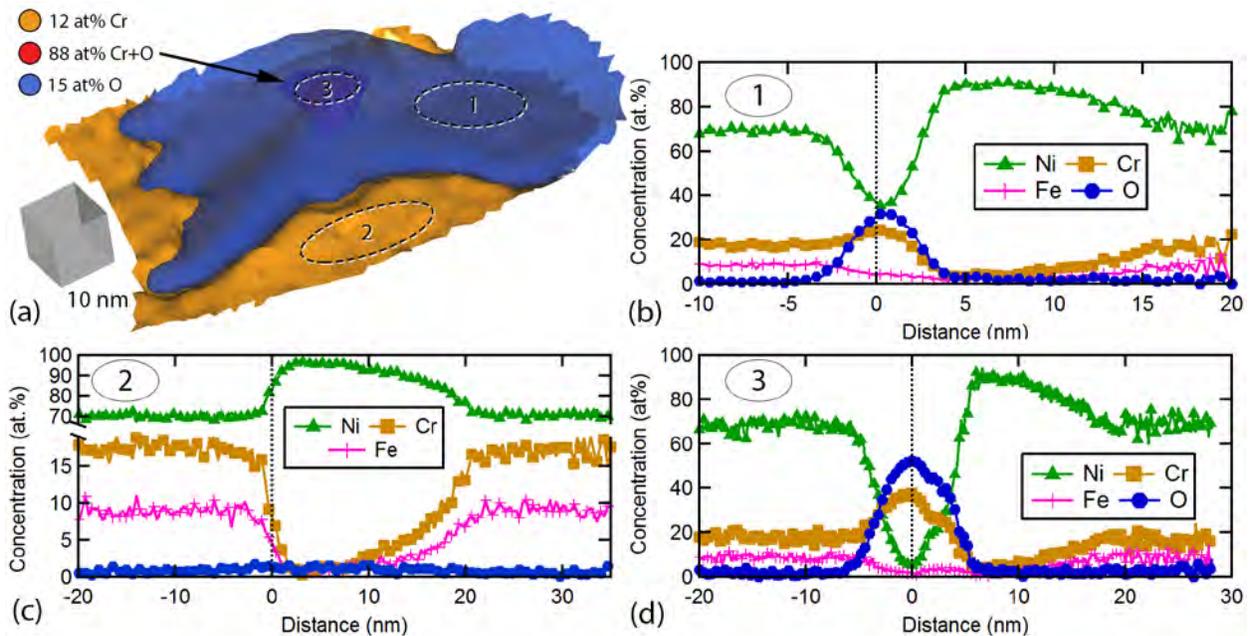
Figure 31: APT analysis of the terminal IGA in the PNNL re-exposure of alloy 600 heat WF422 at 325 °C for 3500 h. (a) Isoconcentration surfaces at 15 at% O (blue) and 12 at% Cr (orange) define the oxidized region and unoxidized portions of an attacked grain boundary. An 88 at% Cr+O isoconcentration surface (red) defines a discrete Cr<sub>2</sub>O<sub>3</sub> precipitate. (b)-(d) 1-D concentration profiles extracted across the indicated regions of the grain boundary. The oxide is Cr-rich and Ni depleted and the surrounding metal is strongly depleted of Cr and Fe.

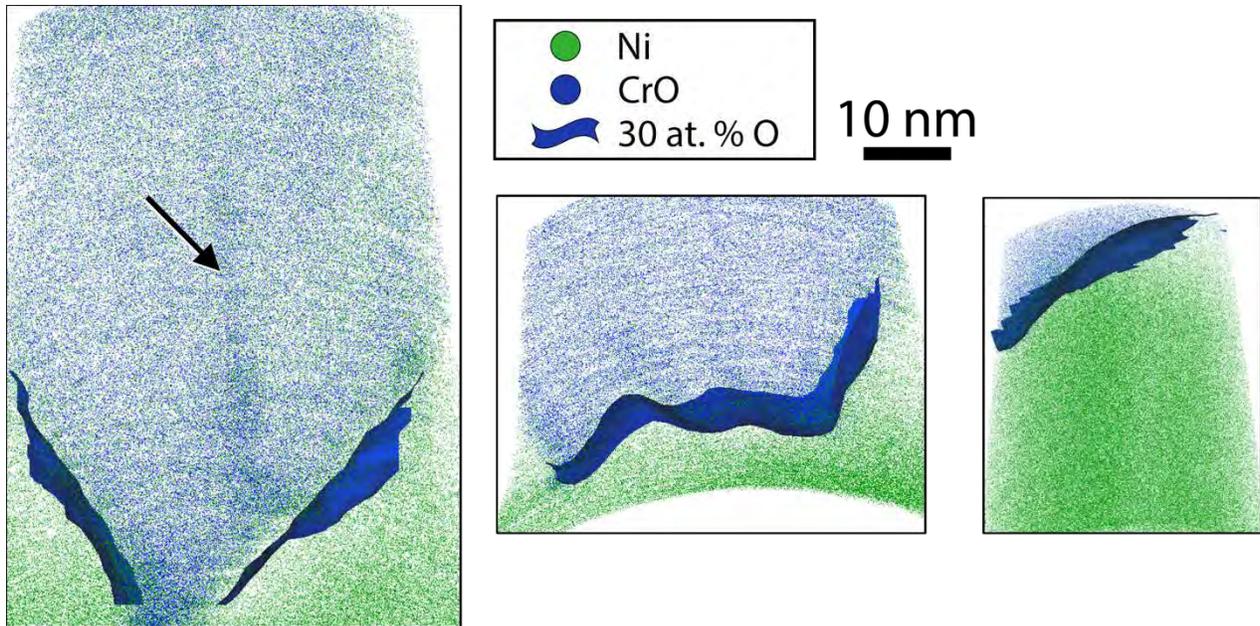
Figure 32: APT reconstructions of the metal/oxide interface from the PNNL re-exposure of WF422. The metal/oxide interface exhibited various topographies, but always terminated abruptly with no apparent O in solid solution in the metal matrix or discrete oxide formation ahead. Subtle atomic density differences in the APT reconstructions (see arrow) suggest the oxide is polycrystalline but exhibited only subtle composition fluctuations.

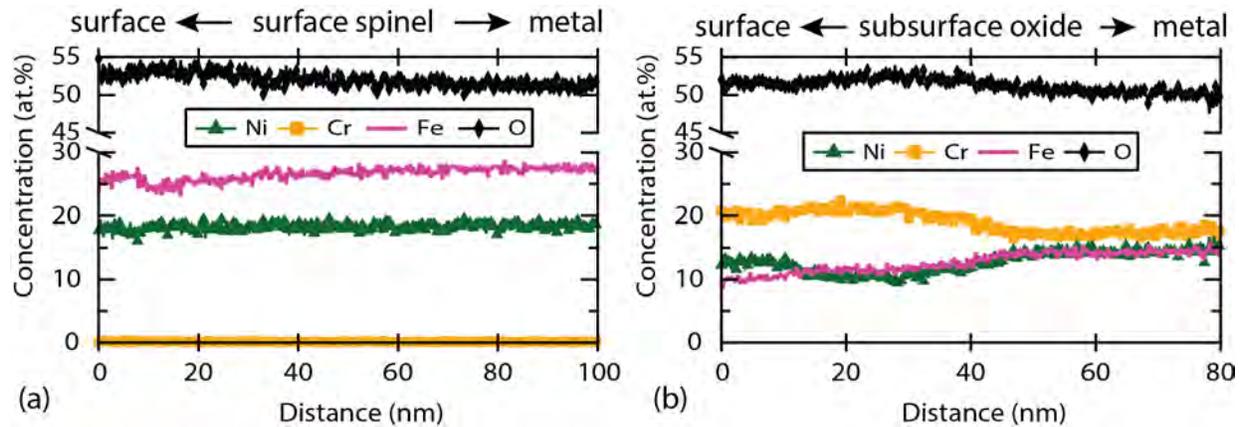
Figure 34: 1D concentration depth profiles taken from alloy 600 heat WF422 after corrosion in simulated PWR primary water at 320C for 3500 h. (a) Concentration profile taken from the external spinel oxide and (b) from the subsurface oxide. The surface spinel is comprised of a Ni-Fe spinel while the subsurface oxide is Cr rich but with varying composition.

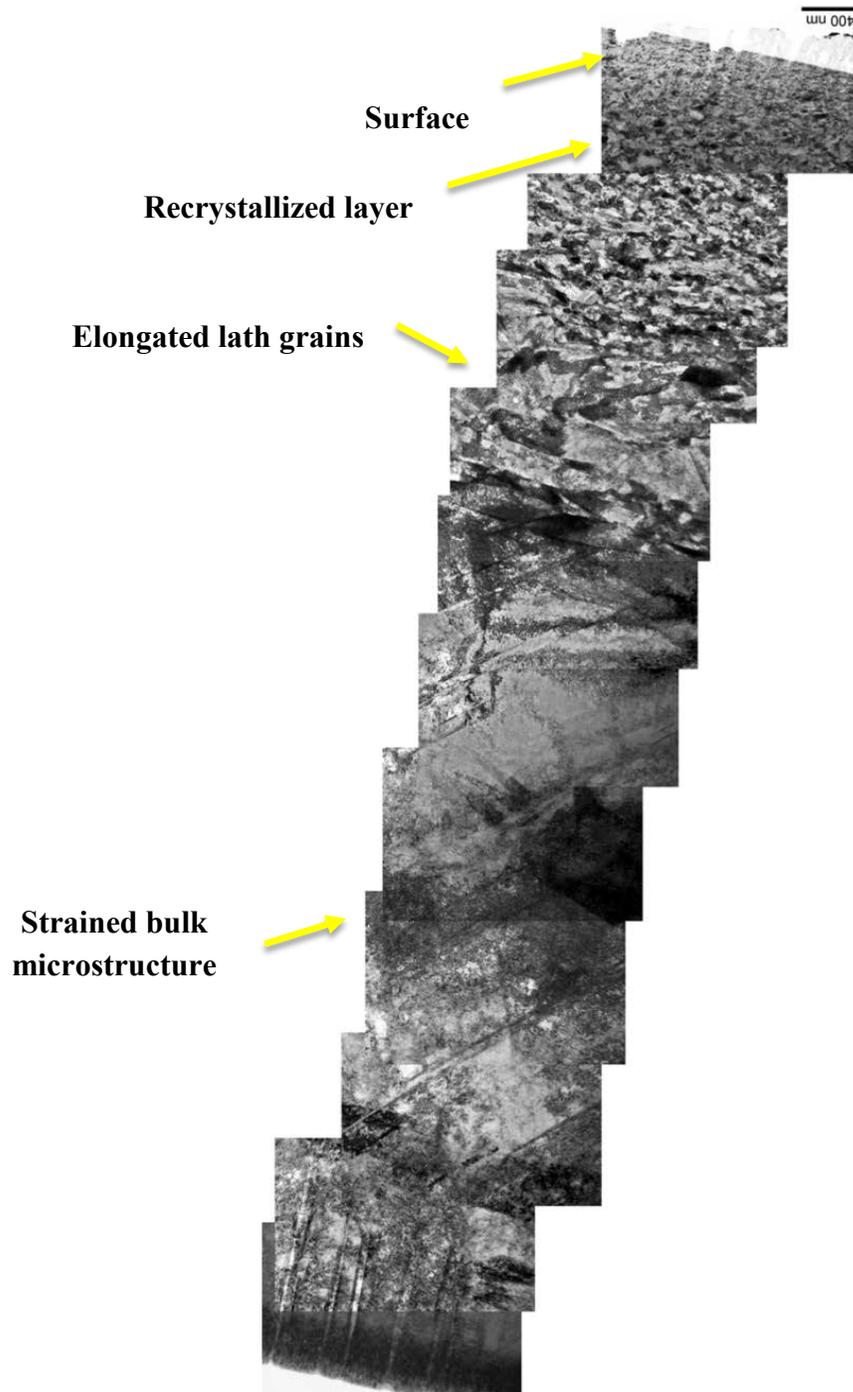
Figure 35: TEM BF montage of images taken on FIB-produced sample showing microstructural changes from the surface (nanocrystalline grains) to heavily deformed matrix at  $\sim 10 \mu\text{m}$  in depth in a 304SS sample.

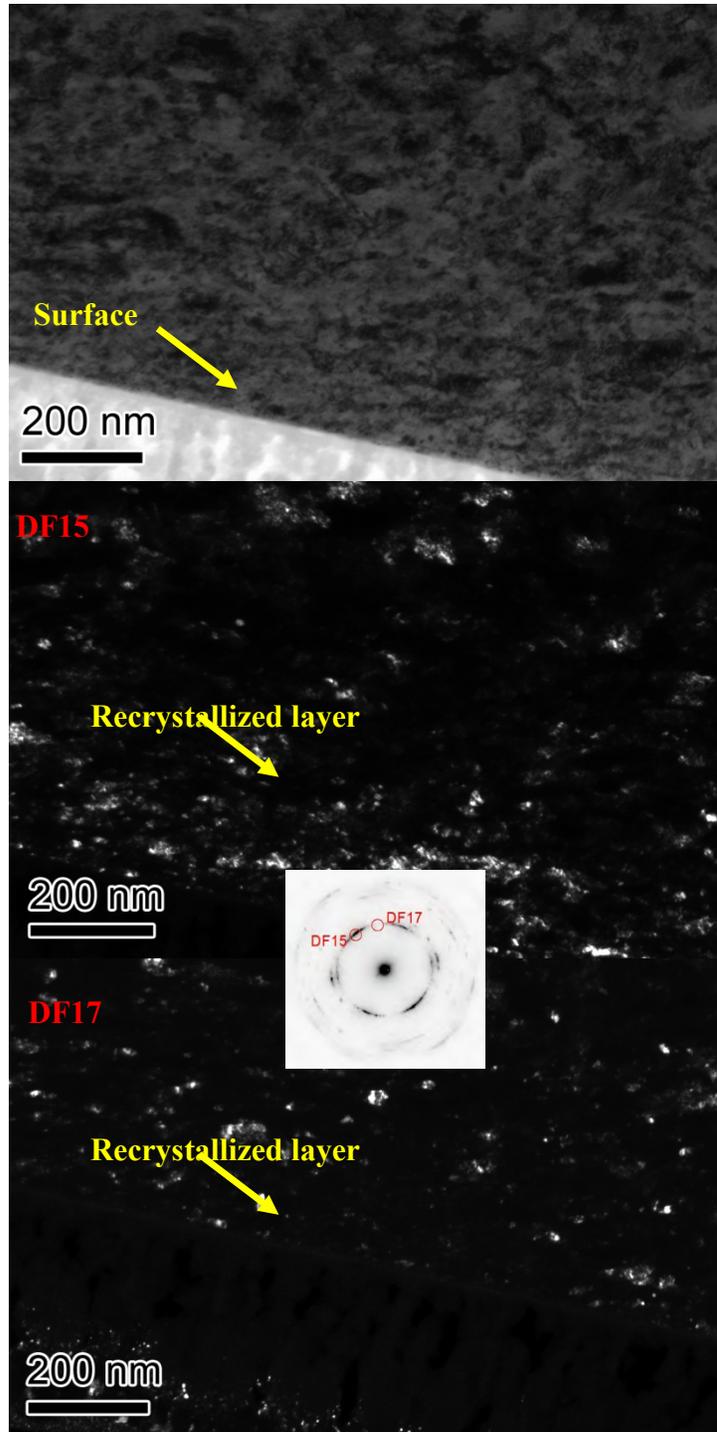
Figure 36: Brightfield (top) and darkfield TEM images illustrating the extremely fine, nanocrystalline grains near the surface. Electron diffraction pattern shows reflections used to highlight individual grains.

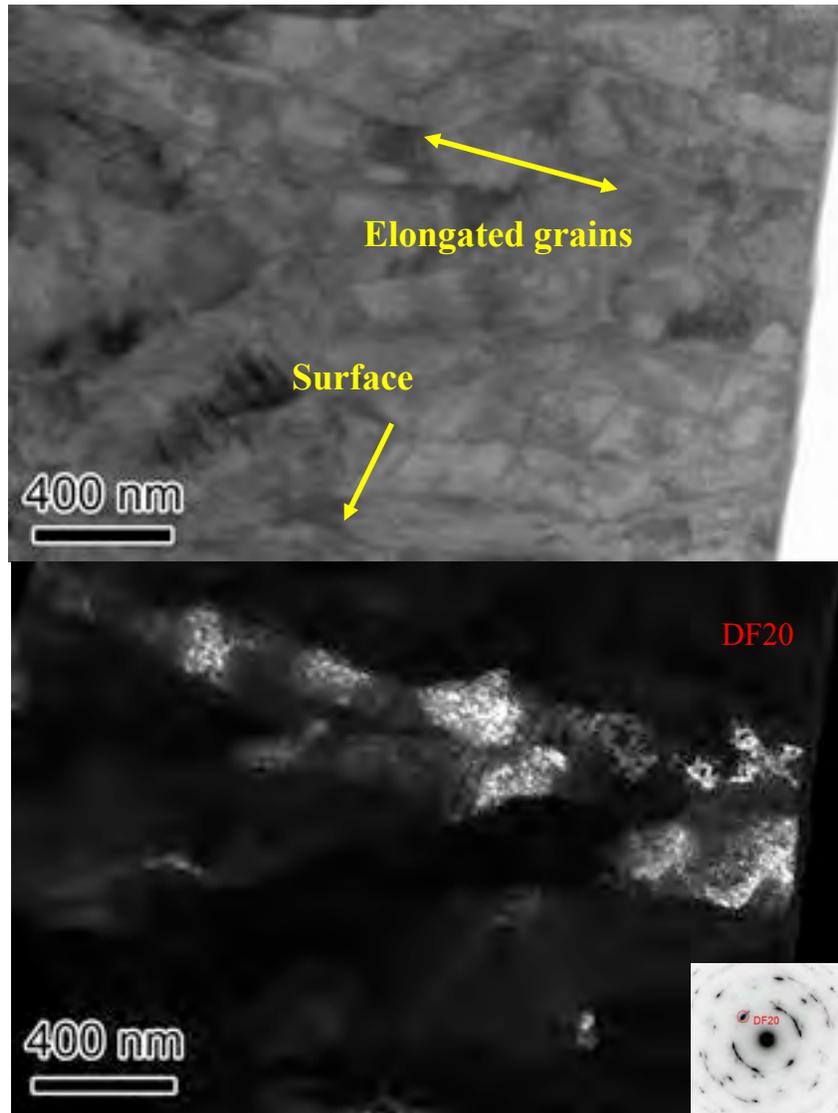
Figure 37: Bright field and dark field pair illustrating elongated metal grains  $\sim 3\text{-}4\ \mu\text{m}$  from the surface of a 304SS sample.

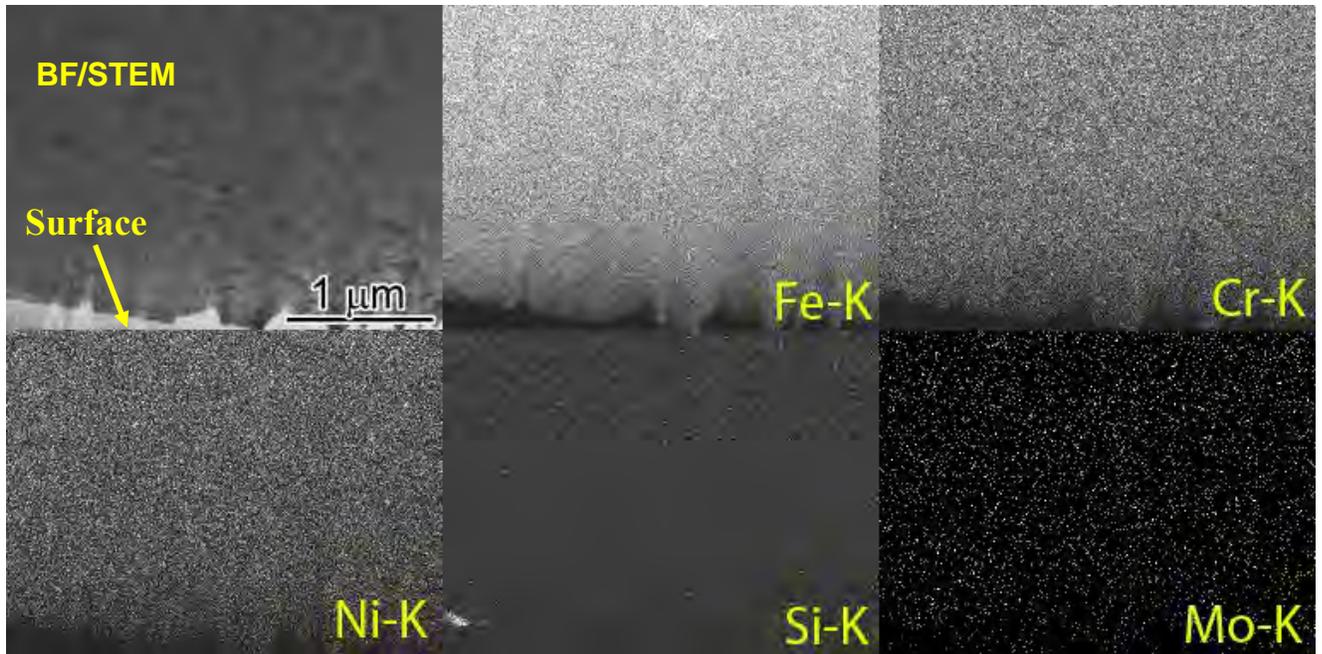
Figure 38: STEM/EDS maps of surface layer of ground 304 stainless steel surface with a recrystallized nanocrystalline surface layer. No observable segregation was found in the metal surface as well as any oxide. A small Si particle, most likely from the SiC grit paper was embedded in the surface.

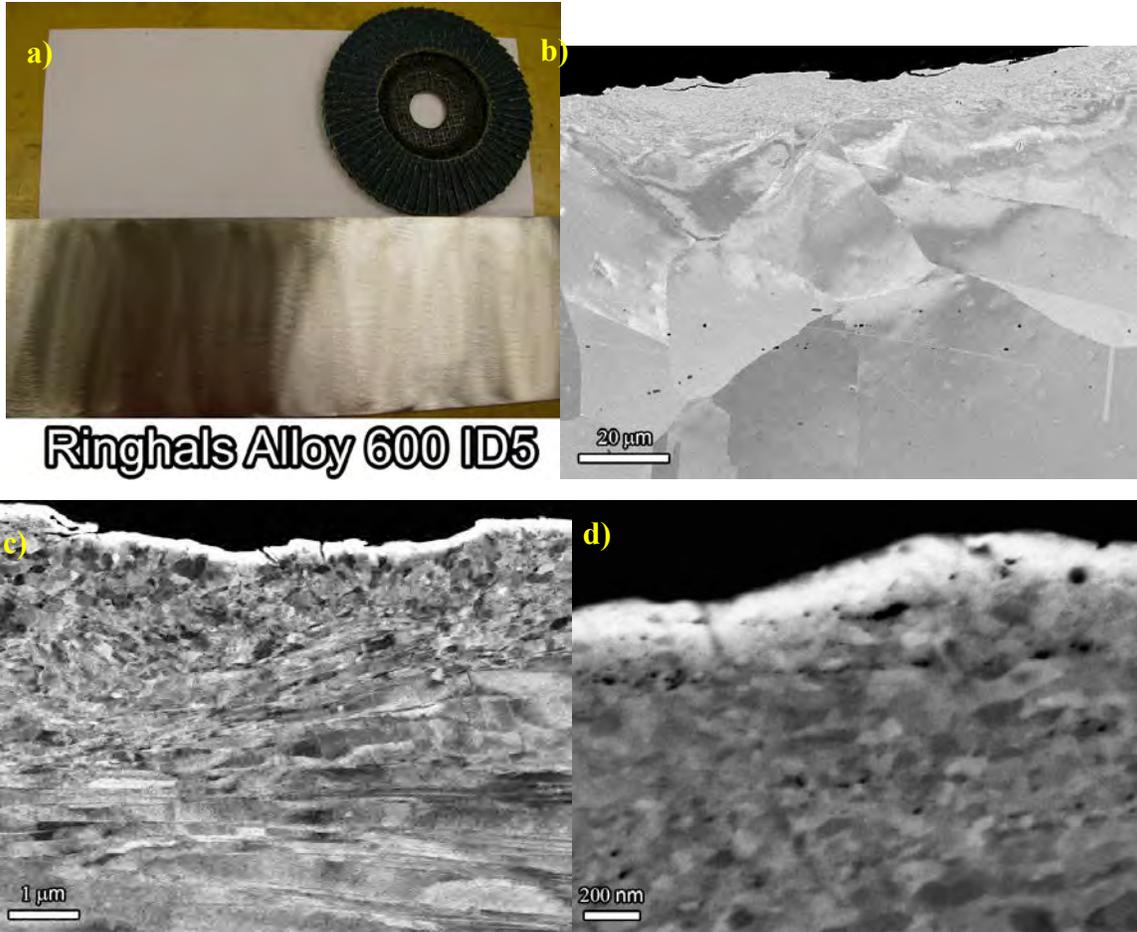
Figure 40: Alloy 600 ground using Makita 9565CV at 11000RPM and a PFERD Polifan SG-Zirkon PFC 125 Z40 SG grinding implement.

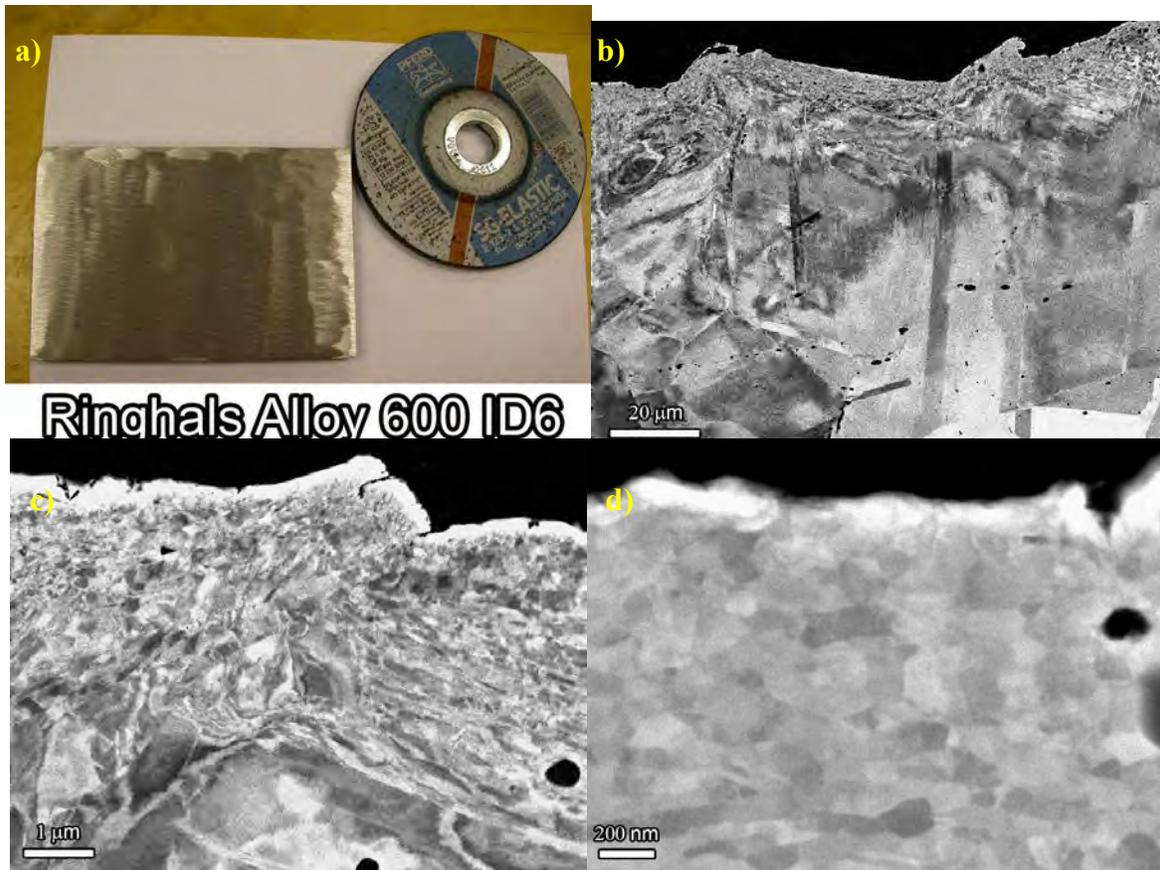
Figure 41: Alloy 600 ground using Makita 9565CV at 11000RPM and a PFERD SG-ELASTIC E 127-7 A30 N SG-INOX grinding implement.

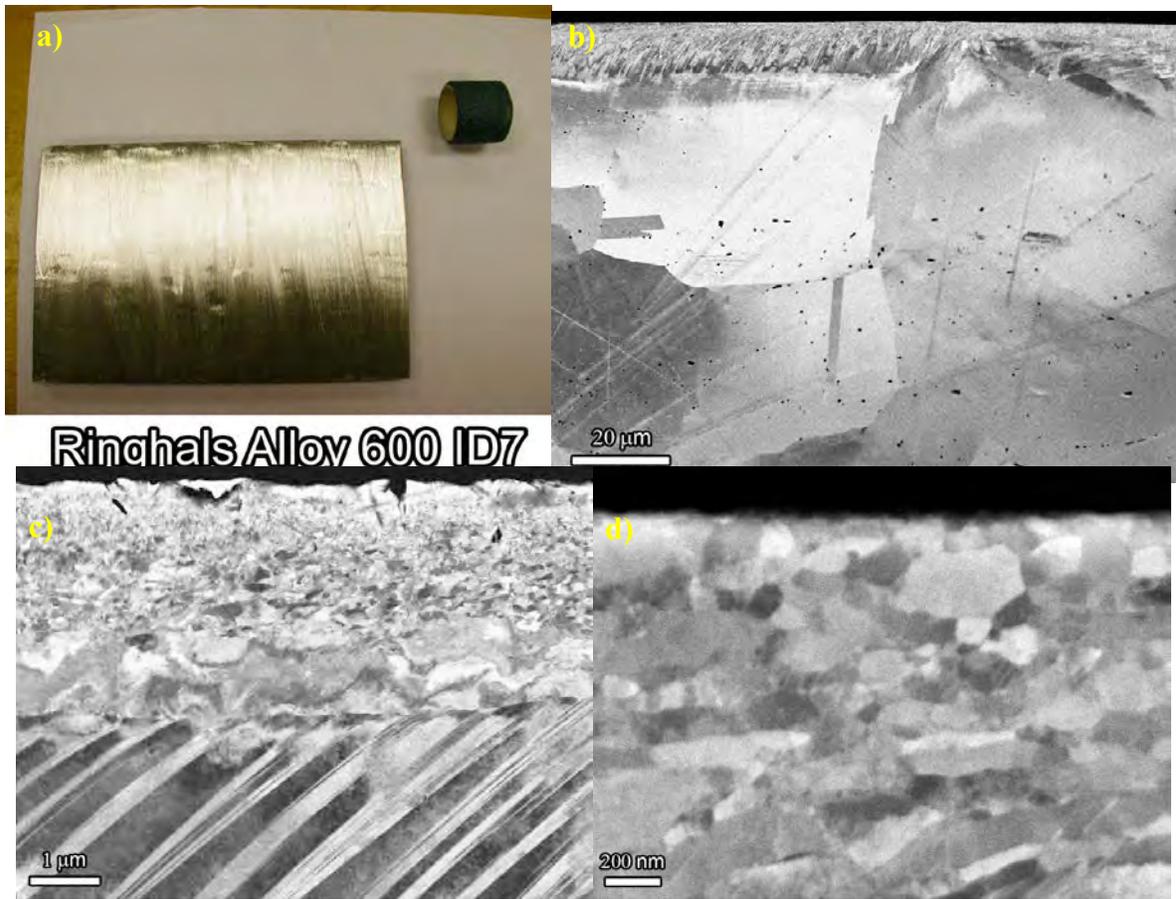
Figure 42: Alloy 600 ground using a Makita GD0800C at 28000 RPM with an abrasive sleeve Z Base-layer-cotton fabric, Zirconia alumina K-40 grain.

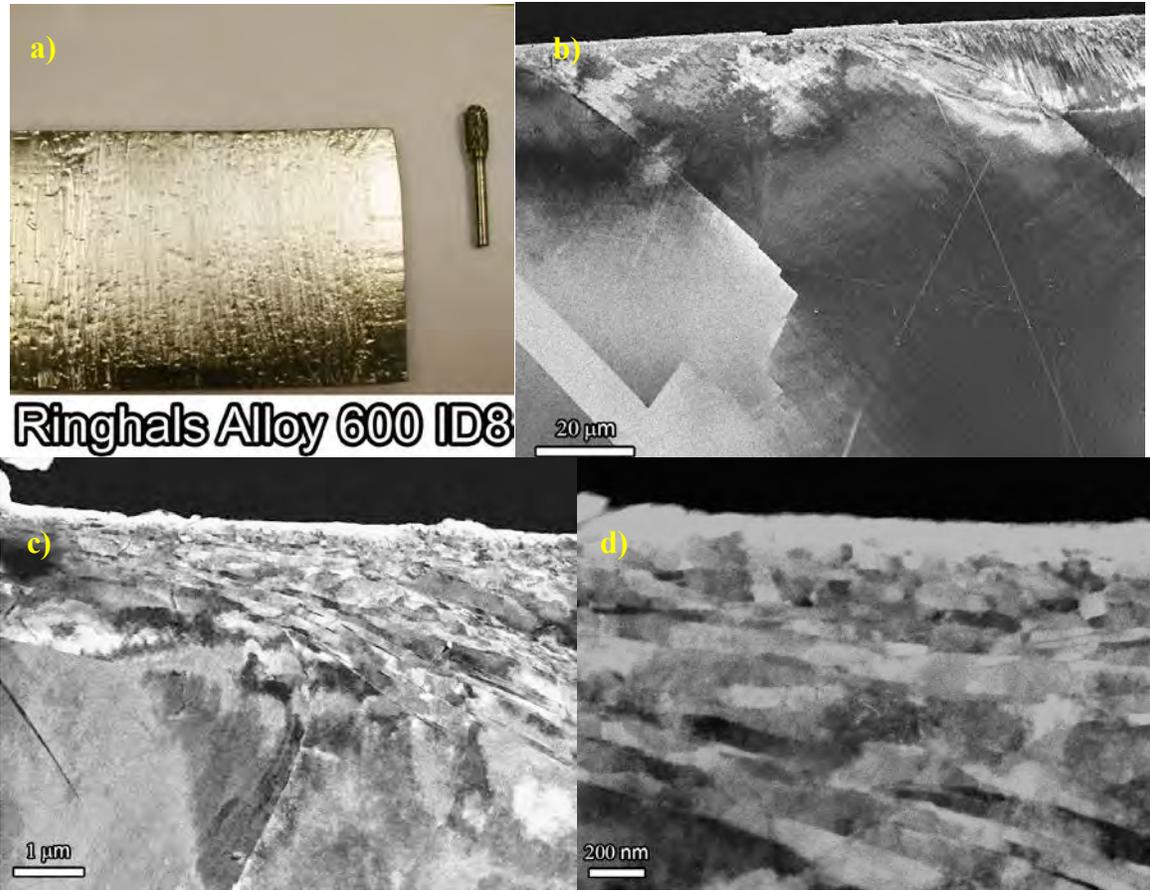
Figure 43: Alloy 600 ground using a Makita GD0800C at 28000 RPM with a PFERD, tungsten carbide burr cylindrical with radius end implement.

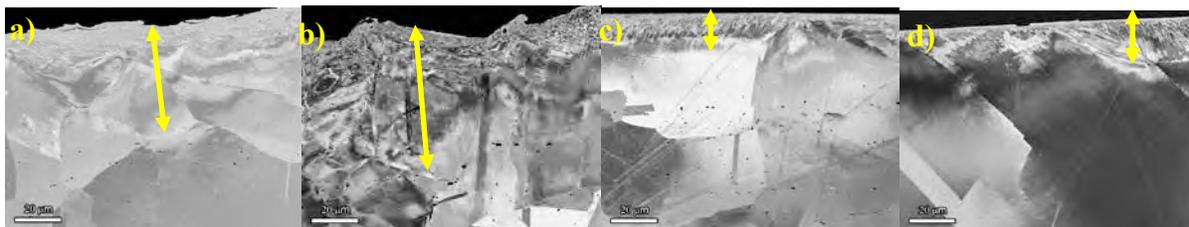
Figure 44: Low magnification SEM (BSE) cross-sectional micrographs of surfaces prepared by the Makita 9565CV (a, b) and Makita GD0800C (c, d). Arrows highlight the extent of surface damage.

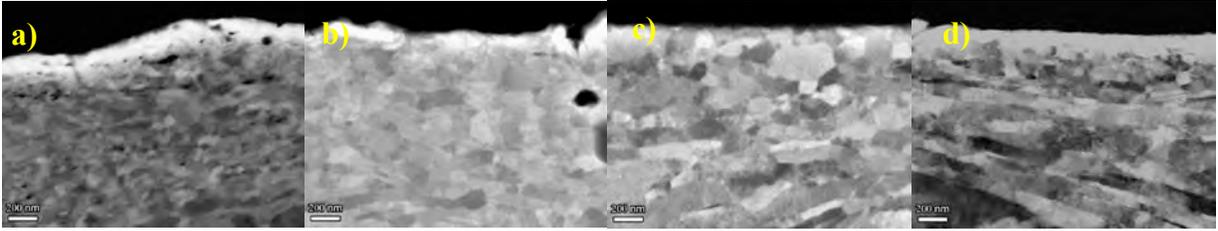
Figure 45: High magnification SEM-BSE cross-sectional micrographs of surfaces prepared by the Makita 9565CV (a, b) and Makita GD0800C (c, d) showing nanocrystalline surface layers.

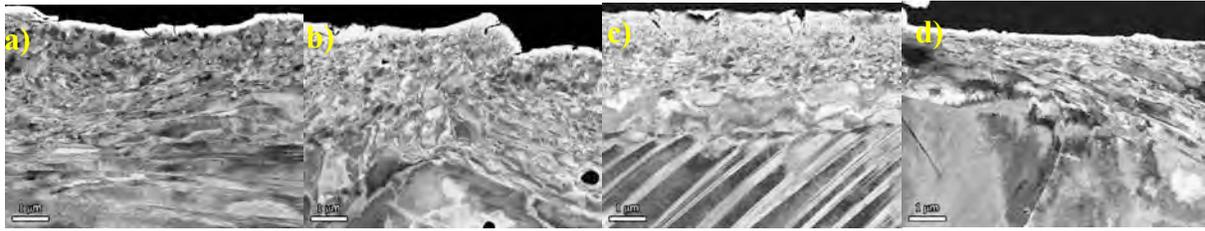
Figure 46: Medium magnification SEM-BSE cross-sectional micrographs of surfaces prepared by the Makita 9565CV (a, b) and Makita GD0800C (c, d) showing transition from nanocrystalline to lath microstructure.

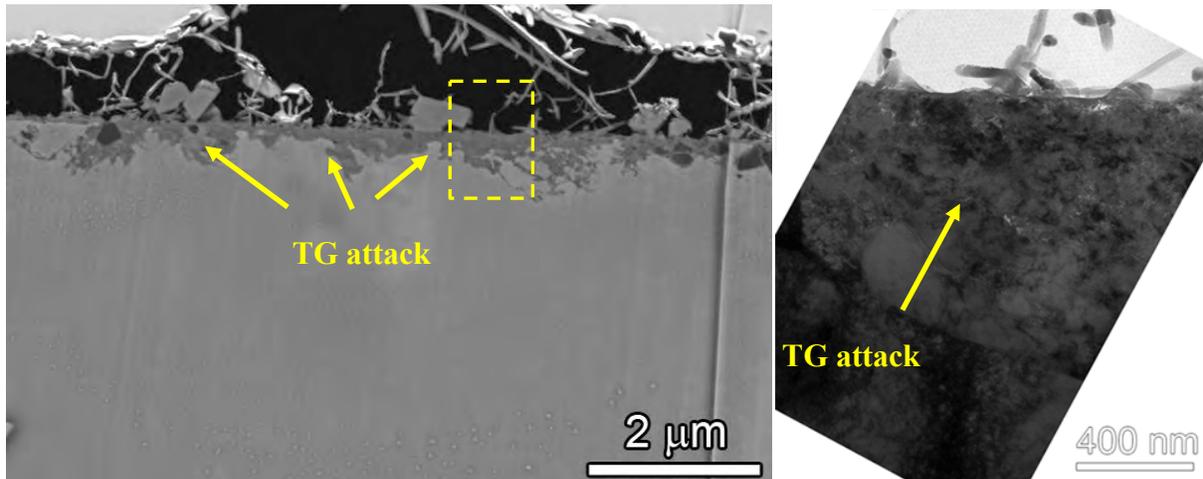
Figure 47: TEM BF and SEM (BSE) of highly polished A600 surface exposed to 1000 hr at 360°C PWR water. a) Backscatter image showing cross-section of surface and extent of attack. b) TEM underfocused BF image of dashed box region in a).
