**MICROSTRUCTURE, CORROSION AND STRESS  
CORROSION CRACK INITIATION OF ALLOY 600  
IN PWR PRIMARY WATER ENVIRONMENTS**

**Technical Milestone Report: M3LW-13OR0403032  
March 2013**

M. J. Olszta, D. K. Schreiber, M. B. Toloczko  
and S. M. Bruemmer  
Pacific Northwest National Laboratory

Research Project:  
**Stress Corrosion Crack Initiation of  
Nickel-Base Alloys in LWR Environments**  
Project Manager: S. M. Bruemmer  
Pacific Northwest National Laboratory

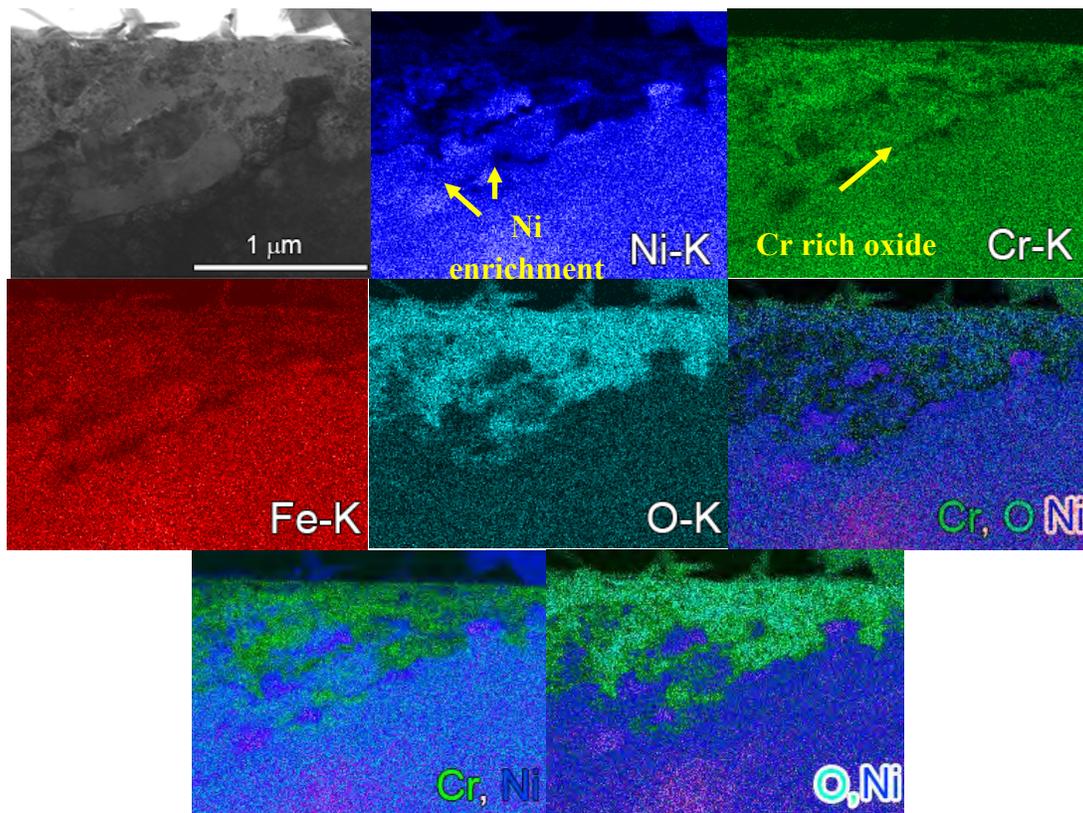
Figure 49: STEM BF/elemental maps of highly polished alloy 600 surface exposed to 1000 h at 360°C PWR water. The Ni/O difference map shows that in regions where the Ni (blue) and O (teal) form green, there is a different form of oxide than where there is predominantly teal (of which correspond well with stronger Cr signal). Similarly, in the Cr/O difference map, the two oxides are present with the Cr (green) and O (teal) overlapping to a different shade of green than in the middle of the oxide structure.

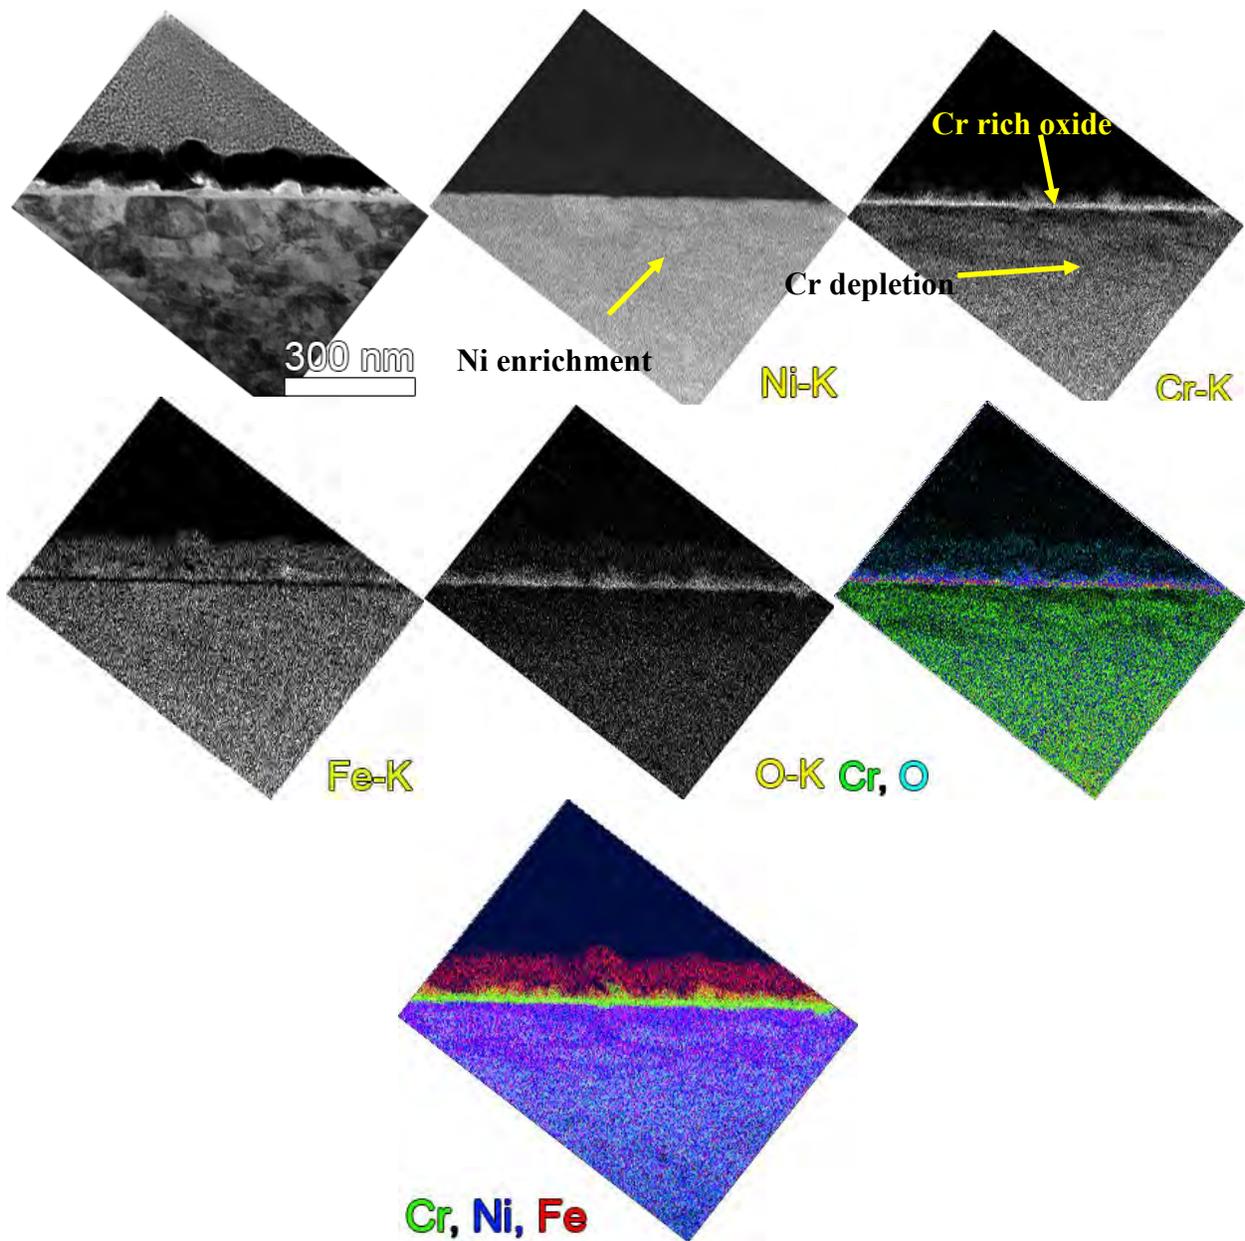
Figure 50: STEM BF/elemental maps of a ground alloy 600 surface exposed to 1000 hr at 360°C PWR water. The Cr (green)/Ni(blue)/Fe(red) difference map shows that the thin oxide layer is extremely Cr rich with very little Ni or Fe.

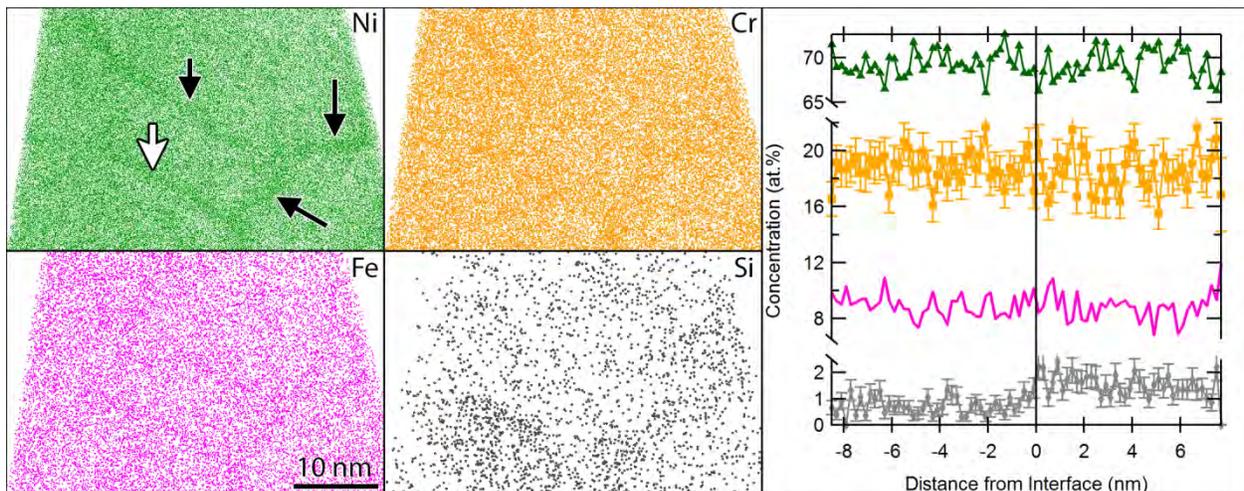
Figure 51: APT analysis of a ground and unexposed surface of WF422. The atomic density variations in the atom maps (black arrows) result from ion trajectory variability at grain boundaries. 1D concentration profiles across one such interface (white arrow) show no significant composition changes associated with the interfaces.

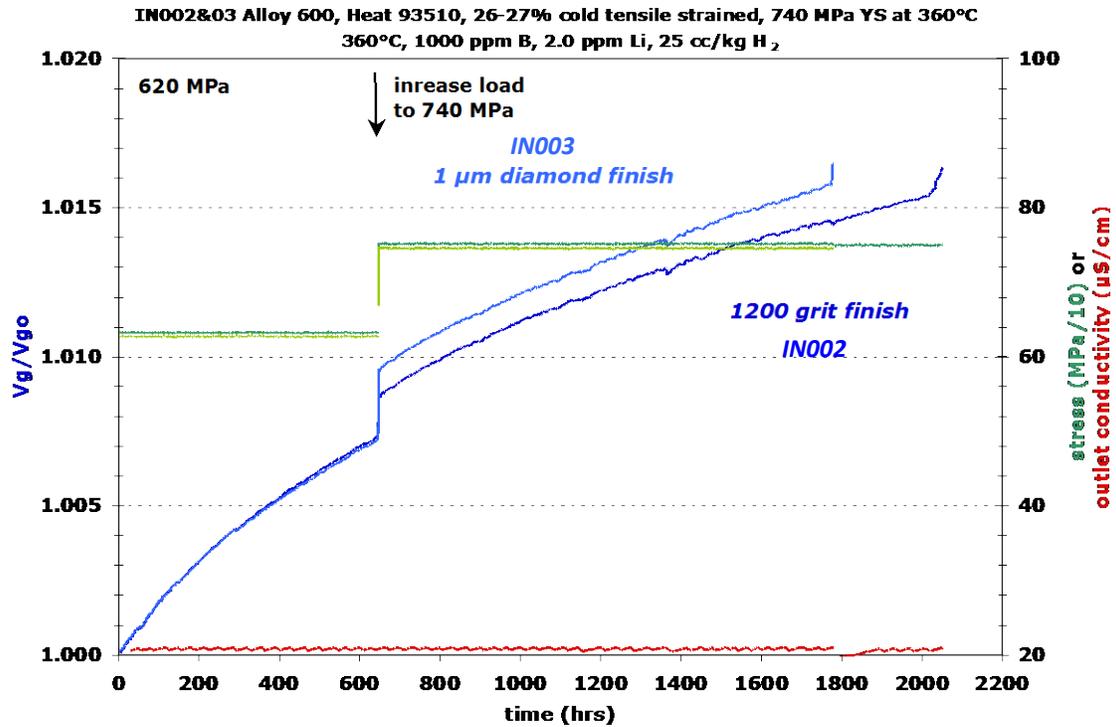
Figure 53: SCC crack initiation tests on 18% tensile prestrained alloy 600 CRDM Heat 93510.

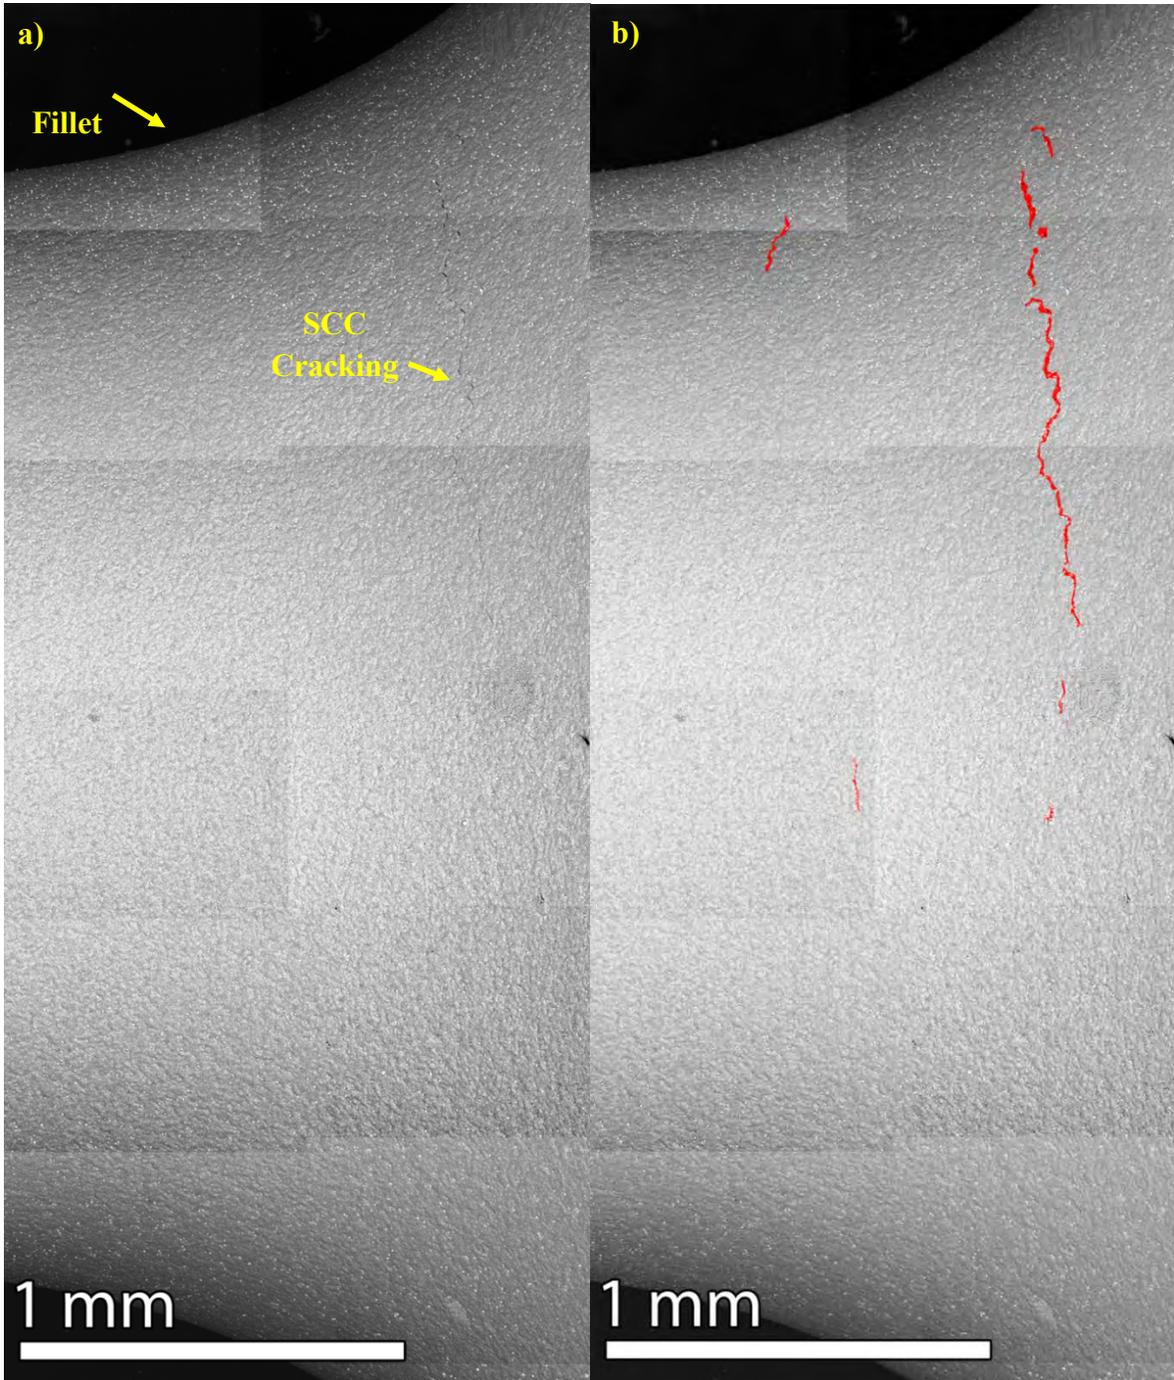
Figure 54: SEM-BSE images of the alloy 600 tensile initiation specimen IN003 surface that exhibited cracking near the fillet. Image (b) is identical image to (a), but cracks have been colored red as guide to the eye. The longest crack observed was circumferential and nearly 1 mm in length.

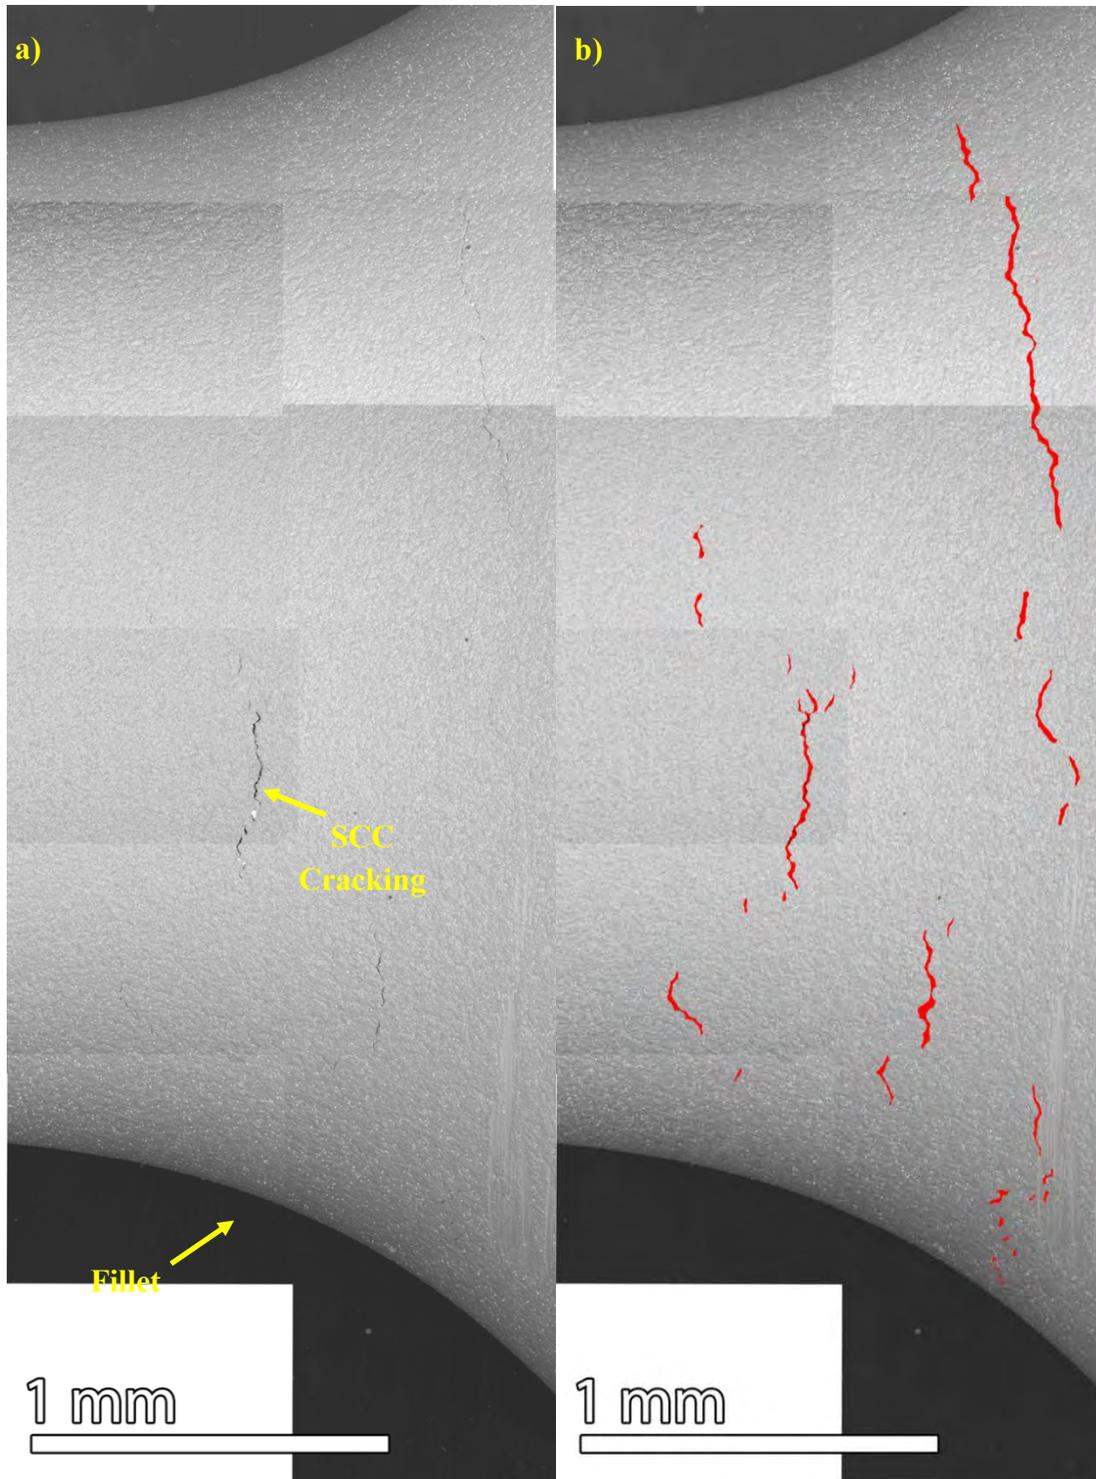
Figure 55: SEM-BSE image of the alloy 600 tensile initiation specimen IN003 (rotated 120° from Figure 54) that exhibits cracking near the fillet. Image (b) is the identical image but cracks has been colored red as guide to the eye. SCC cracks as long as ~1 mm circumferentially were observed.

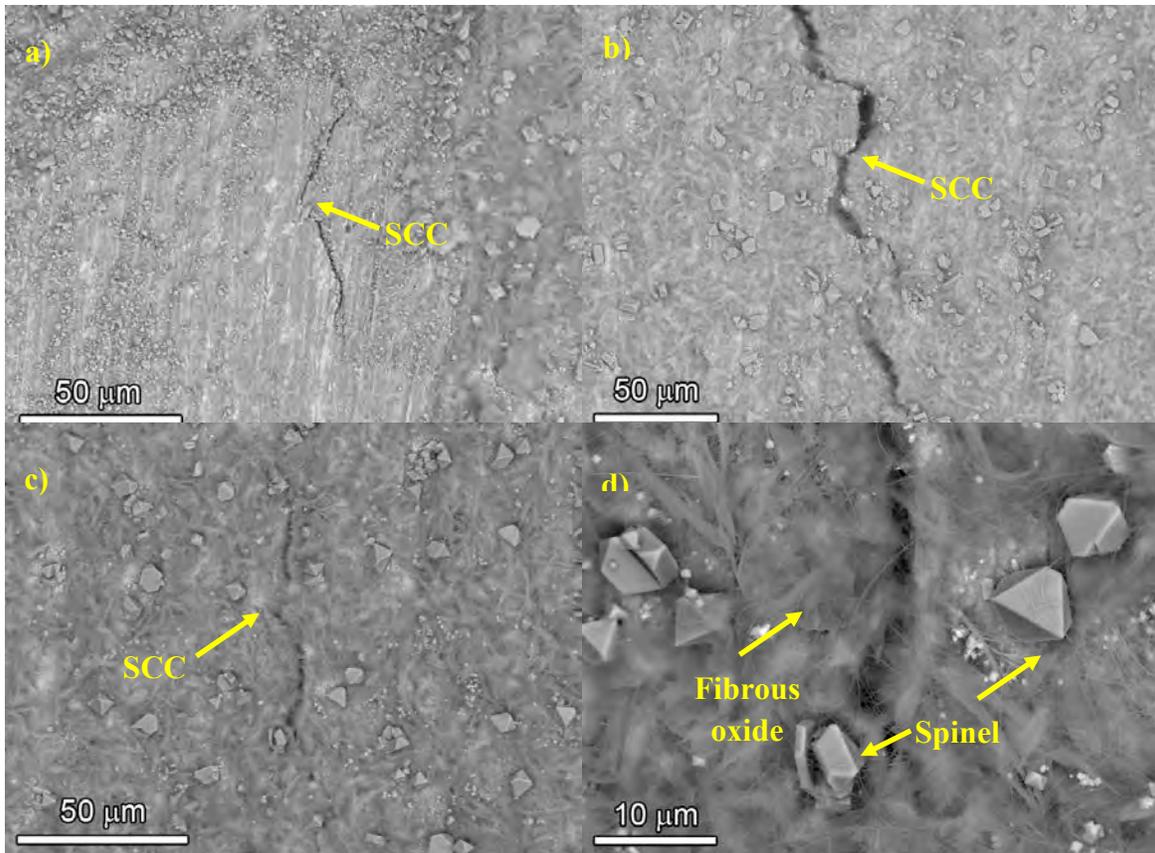
Figure 56: Low magnification SEM-BSE images of the surface of an exposed alloy 600 tensile initiation specimen IN003 illustrating various SCC cracks and surface oxides.

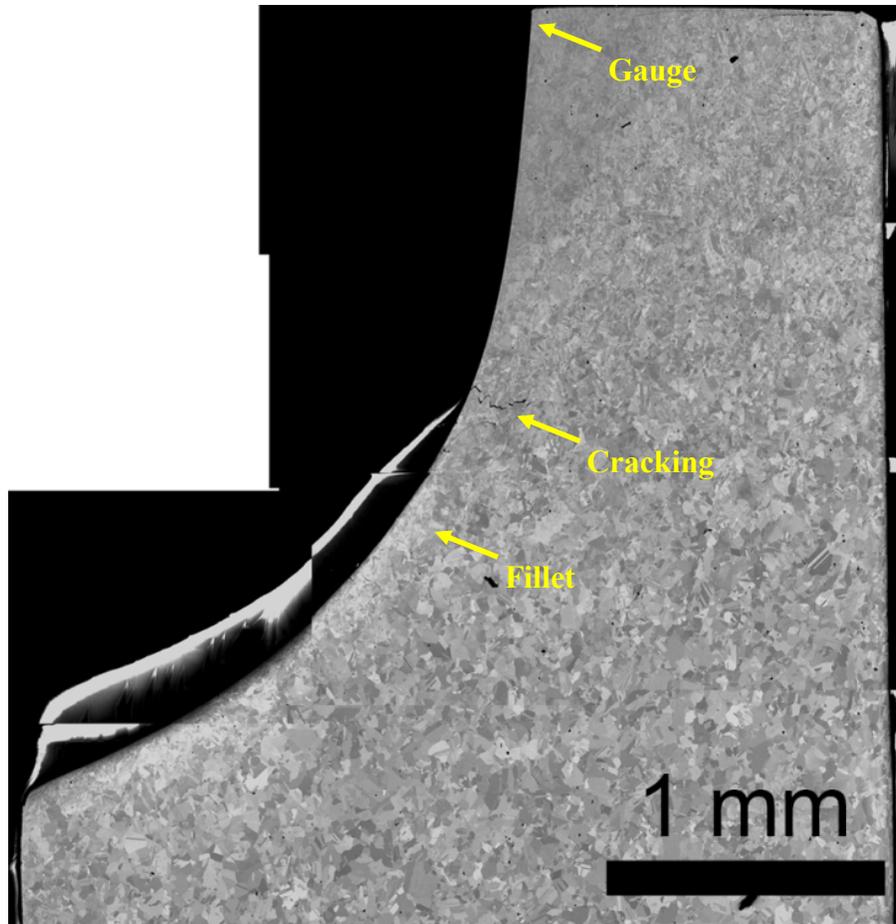
Figure 57: SEM-BSE images of a cross-section from the alloy 600 tensile initiation specimen IN003 that exhibited cracking near the fillet. Note the apparent variation in grain size between the gauge region and the fillet region.

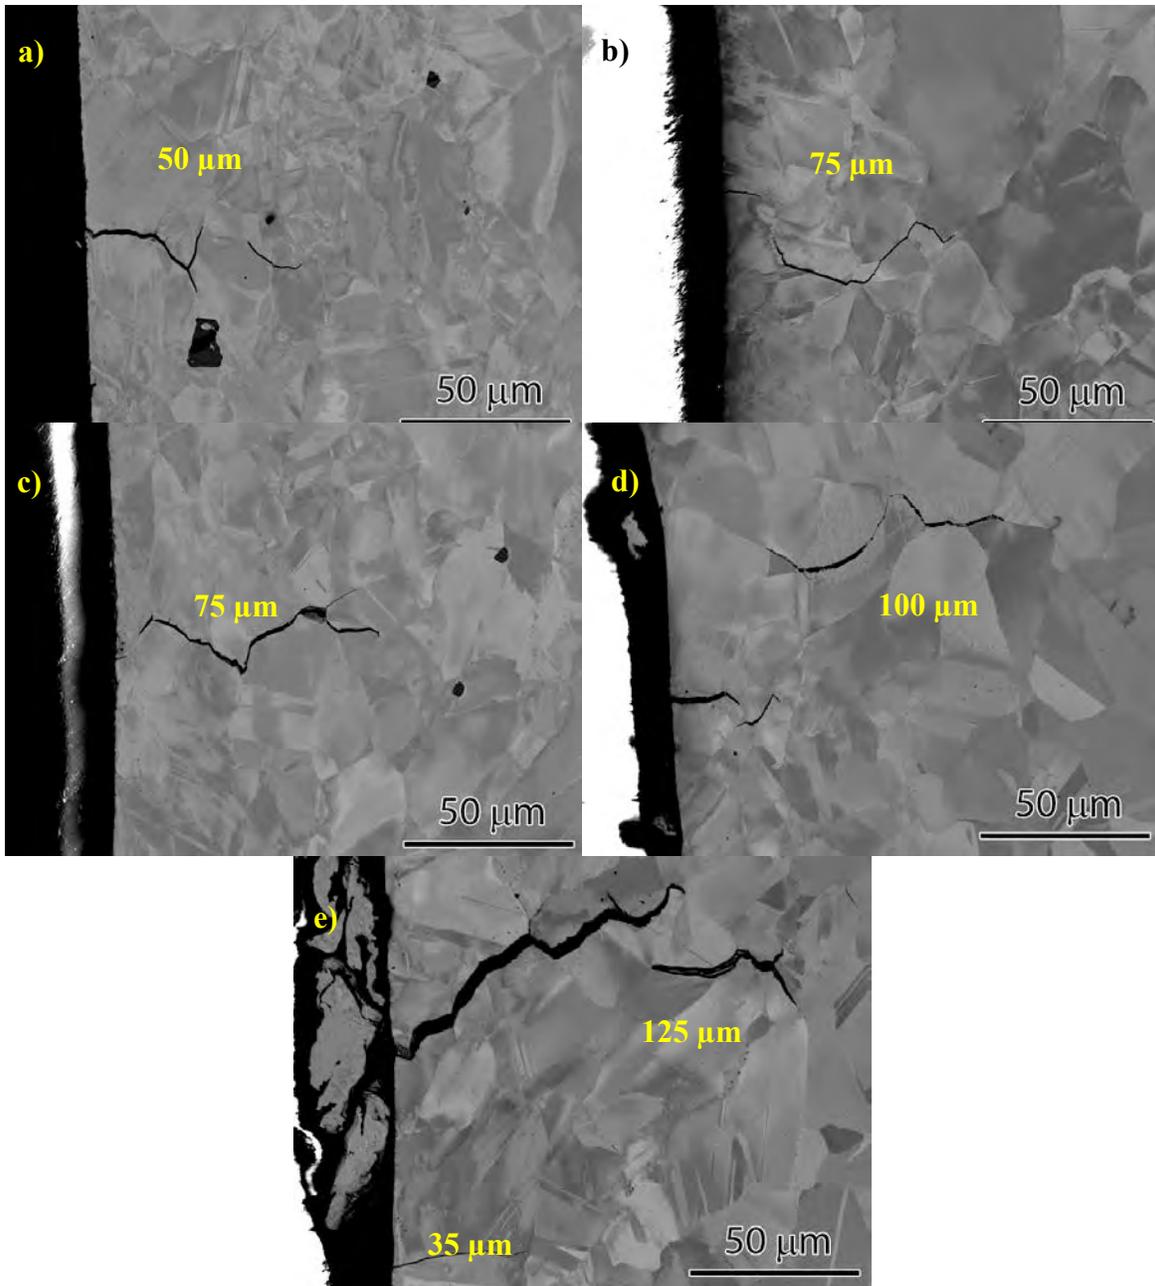
Figure 58: SEM-BSE images of a cross-section for the alloy 600 tensile initiation specimen IN003 showing deep SCC cracks initiating from the surface. Apparent crack depths are listed for each figure.

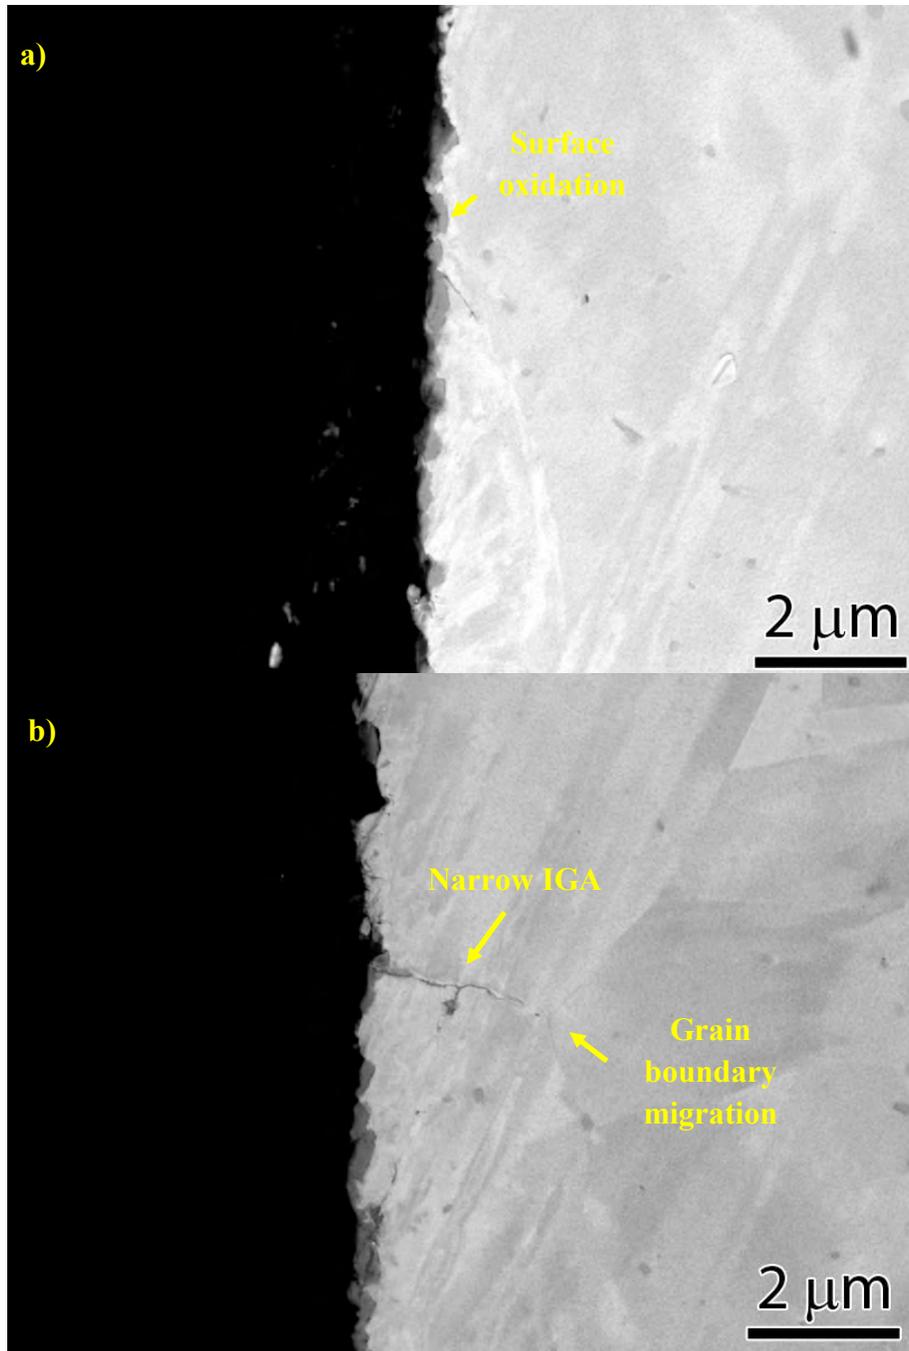
Figure 59: SEM-BSE images of a cross-section for the alloy 600 tensile initiation specimen IN003 illustrating representative TG (surface oxidation) and IG corrosion in the gauge section.

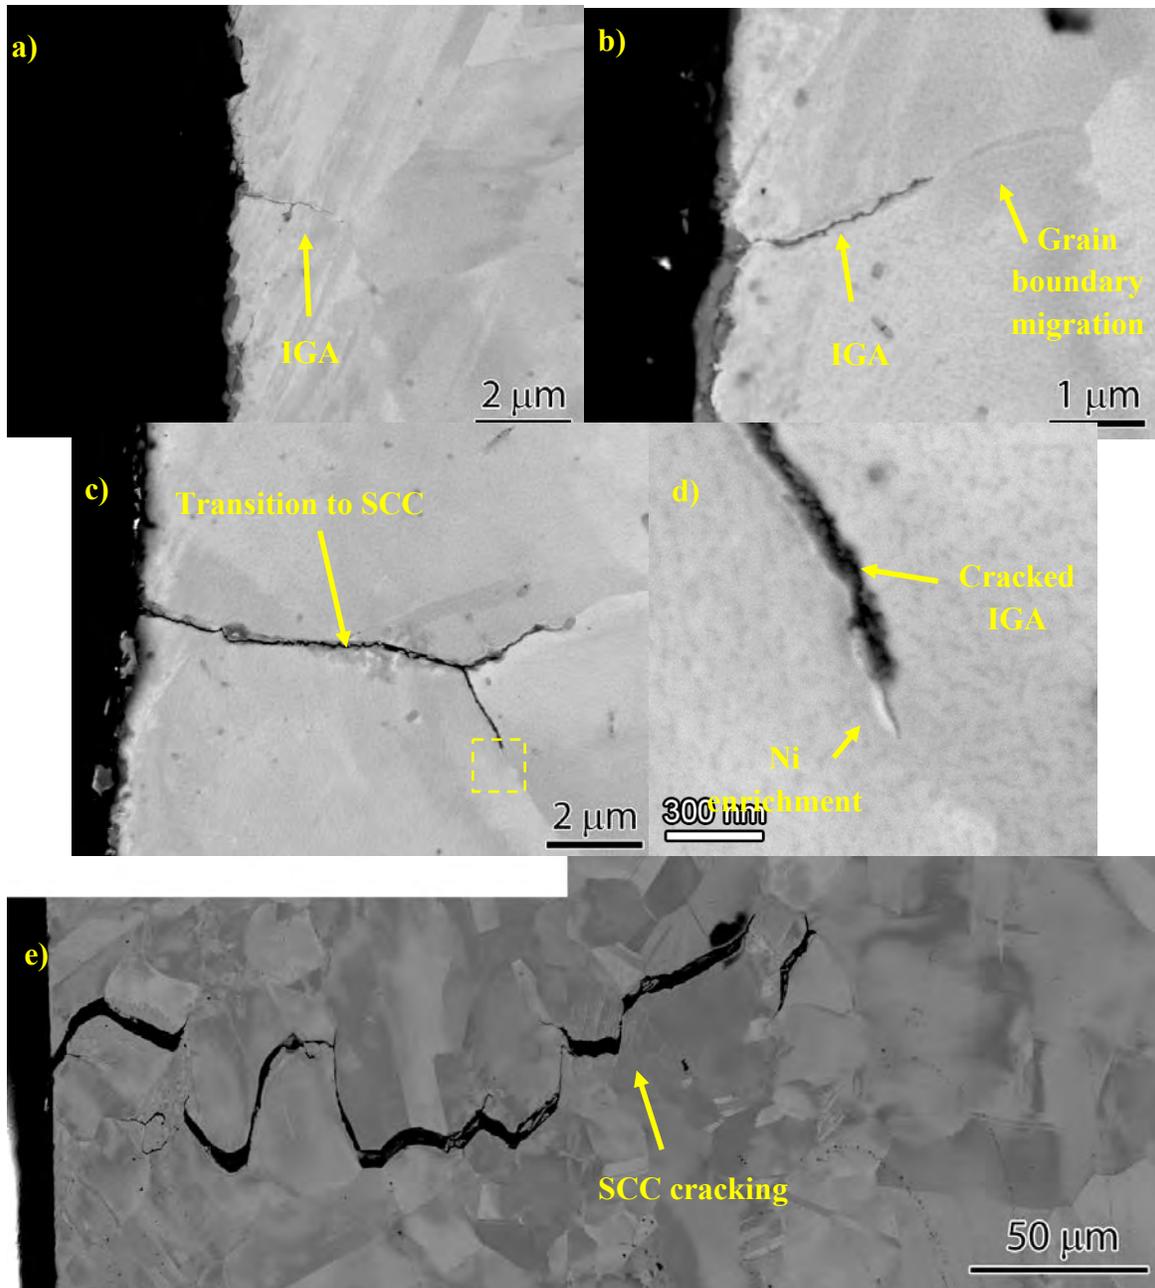
Figure 60: SEM-BSE images of the cross-section for the alloy 600 initiation specimen IN003 highlighting various stages of SCC cracking. (a,b) IG attack in gage section without cracks, (c,d) IG attack transitioning to an IGSCC crack and e) a long IGSCC crack in the fillet region.

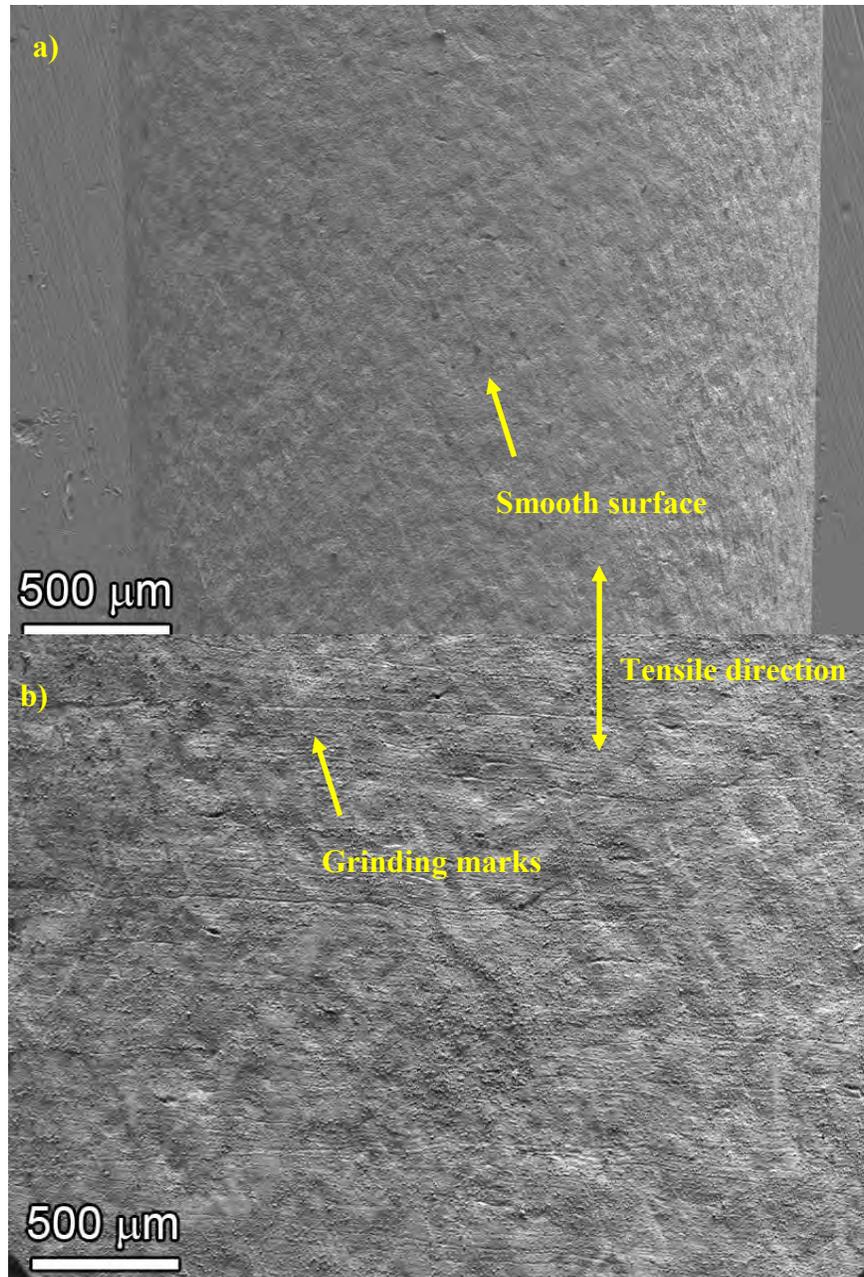
Figure 61: SEM-SE images of exposed surfaces for the alloy 600 initiation specimens that had a) highly polished gage section surface (IN003) or b) surfaces ground with 1200 grit SiC ground gage section surface (IN003).

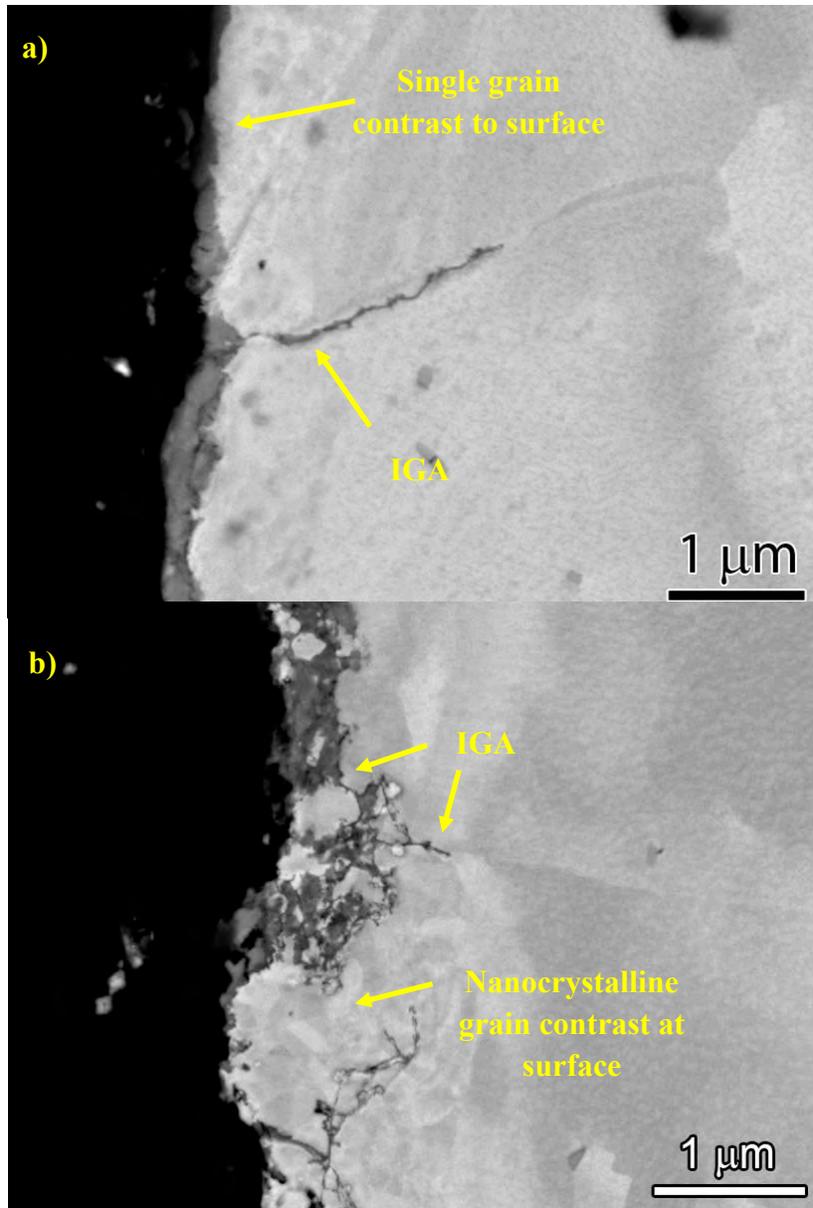
Figure 62: SEM-BSE images of cross-sections from the alloy 600 initiation specimens with surfaces of 1 μm diamond (IN003) and 1200 grit SiC (IN002) after exposure to PWR primary water.

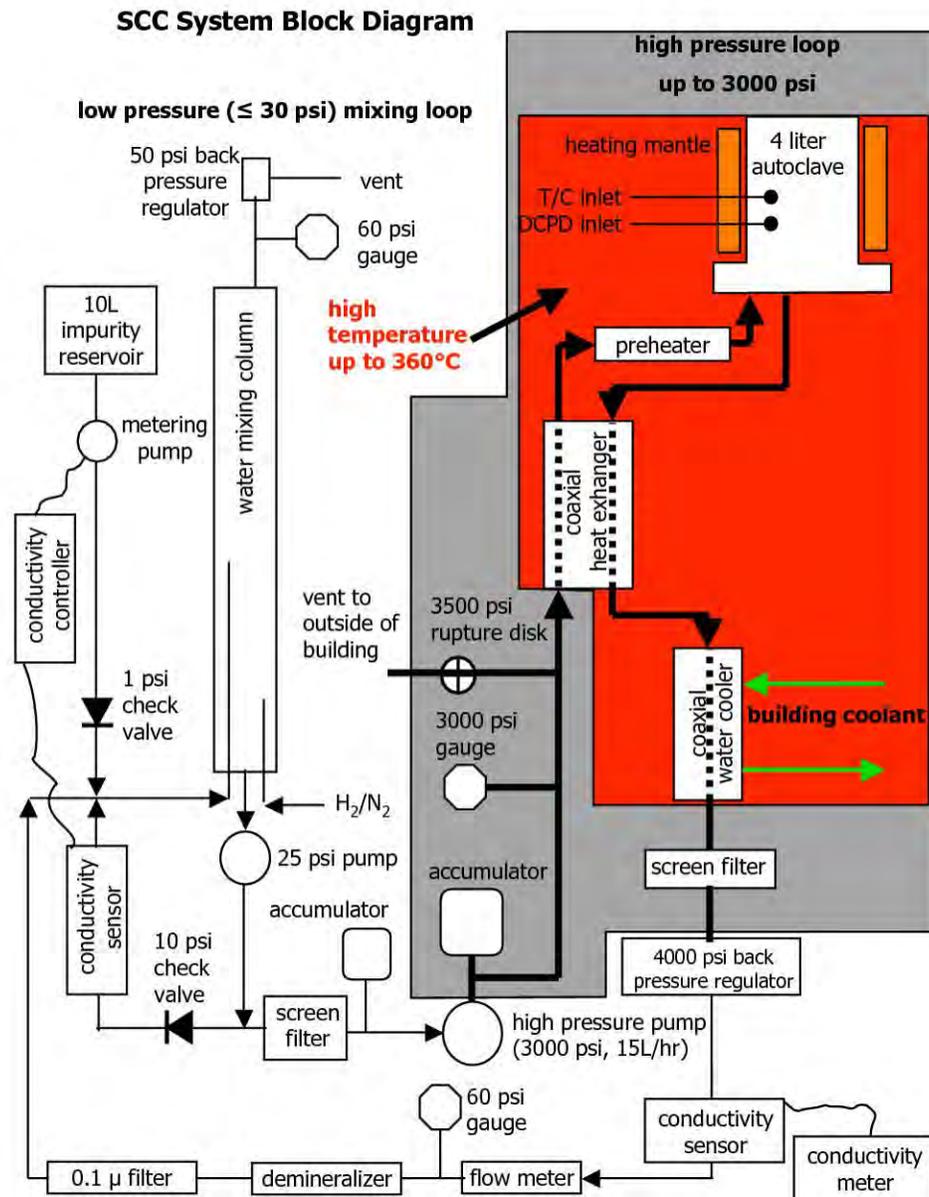
Figure 63: General water flow diagram for PNNL SCC crack-growth test systems.

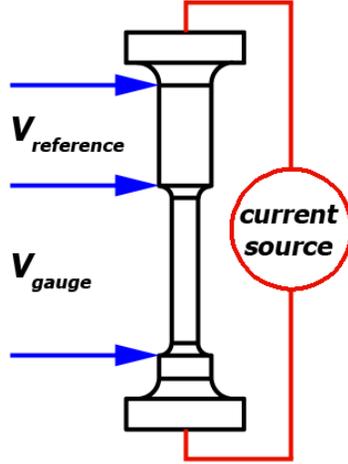
Figure 64: Schematic of final tensile geometry and DCPD measurement points.

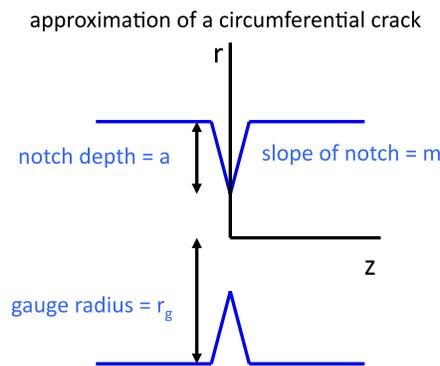
Figure 65: Sketch showing approximation of a circumferential crack.

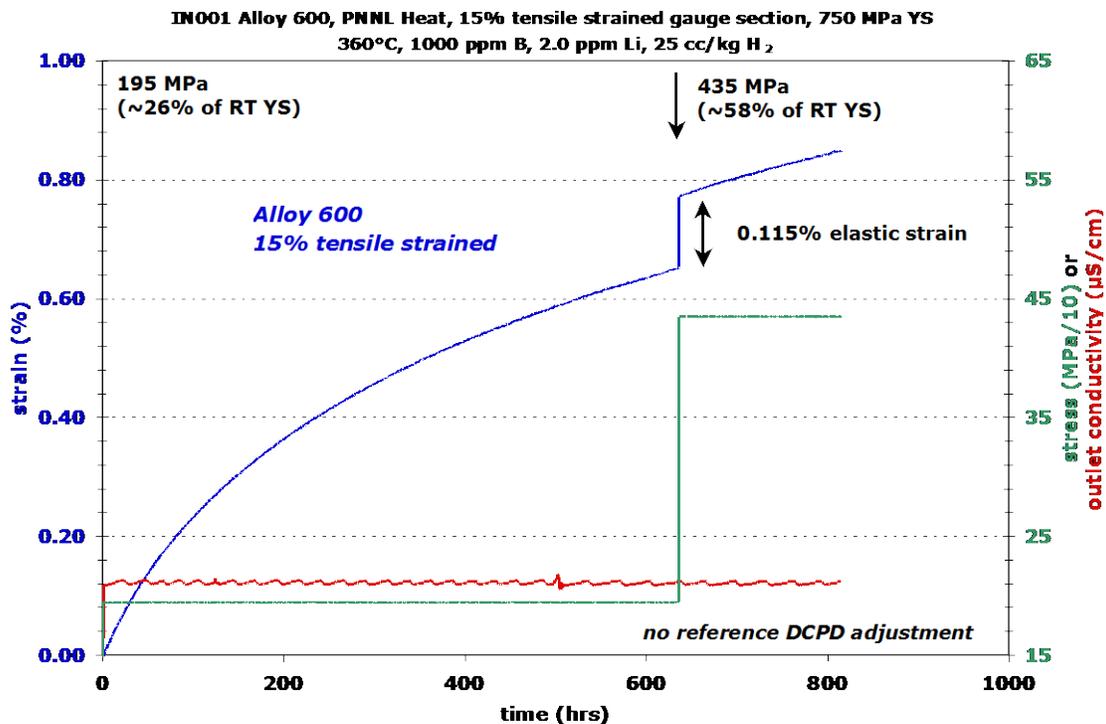
Figure 66: Unreferenced DCPD-based strain measured on 15% tensile prestrained alloy 600.

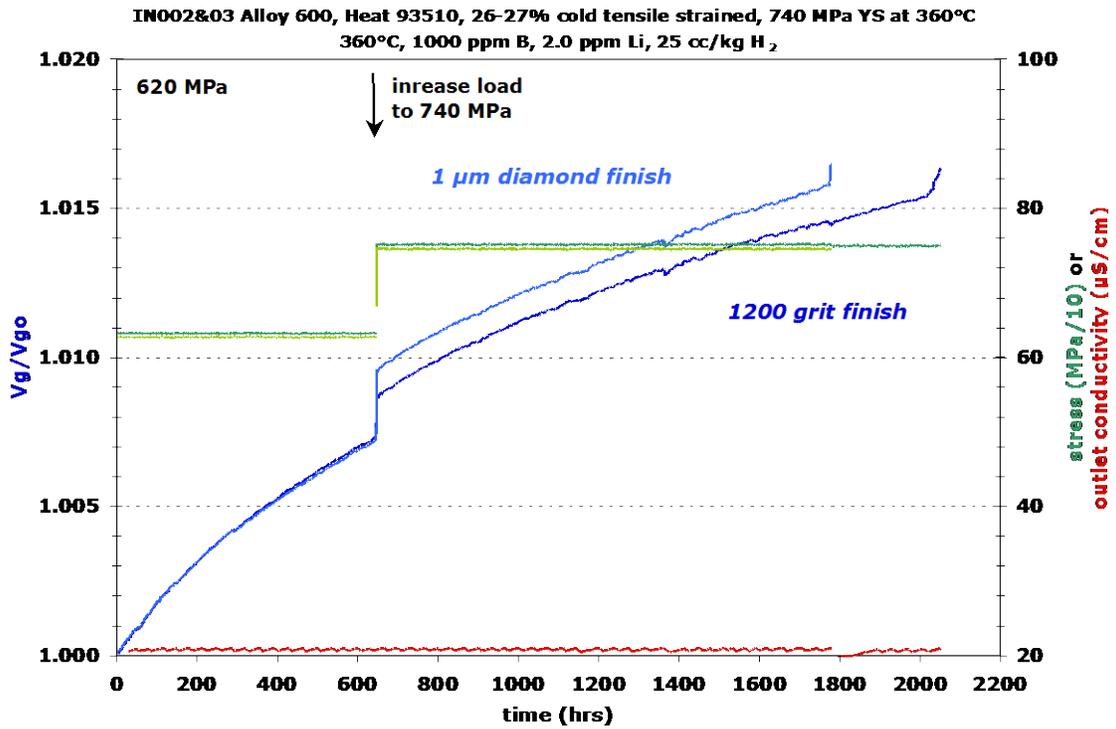
Figure 68: Normalized DCPD gauge voltage for specimens IN002 and IN003.

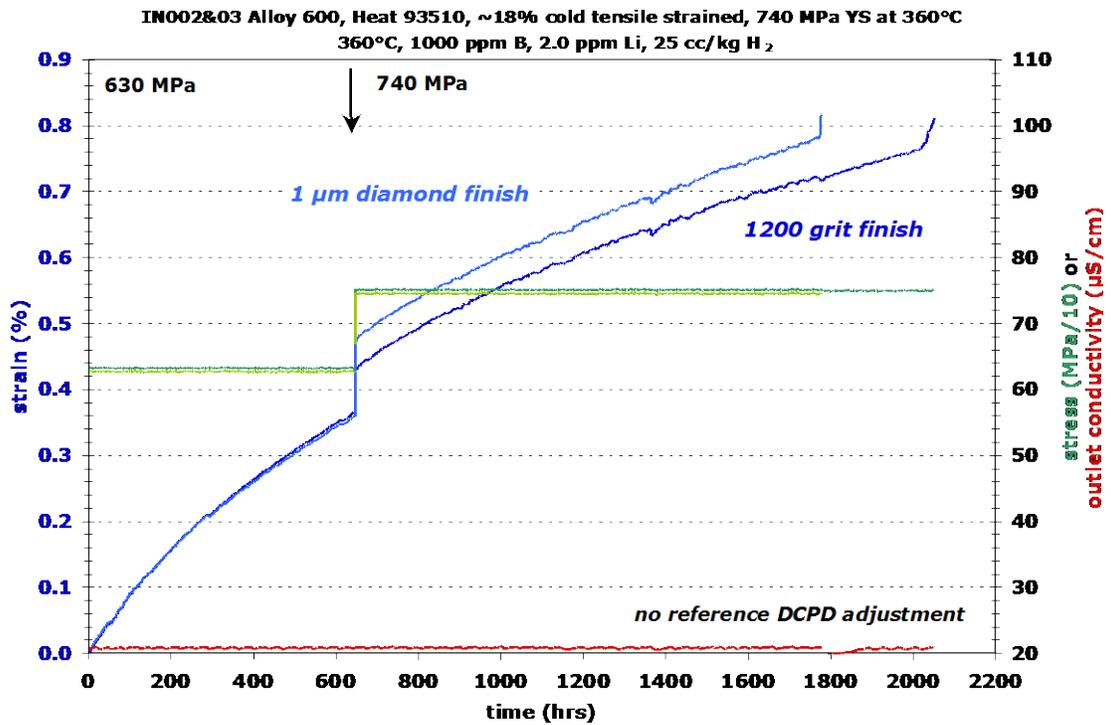
Figure 69: Unreferenced DCPD-based strain (Equation 1) for specimens IN002 and IN003.

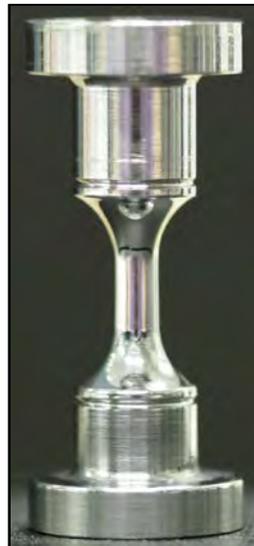
Figure 74: PNNL 1.2" tall SCC tensile initiation specimen.
