***PNNL Presentations on SCC Initiation
at the 2017 EPRI Alloy 690/152/52
Research Collaboration Meeting
Milestone Report: M3LW-18OR0402032***

Light Water Reactor Sustainability R&D Program

ICG-EAC Alloy 600 PWSCC Initiation Round Robin Testing at PNNL

Update on Alloy 690 SCC Initiation Research at PNNL

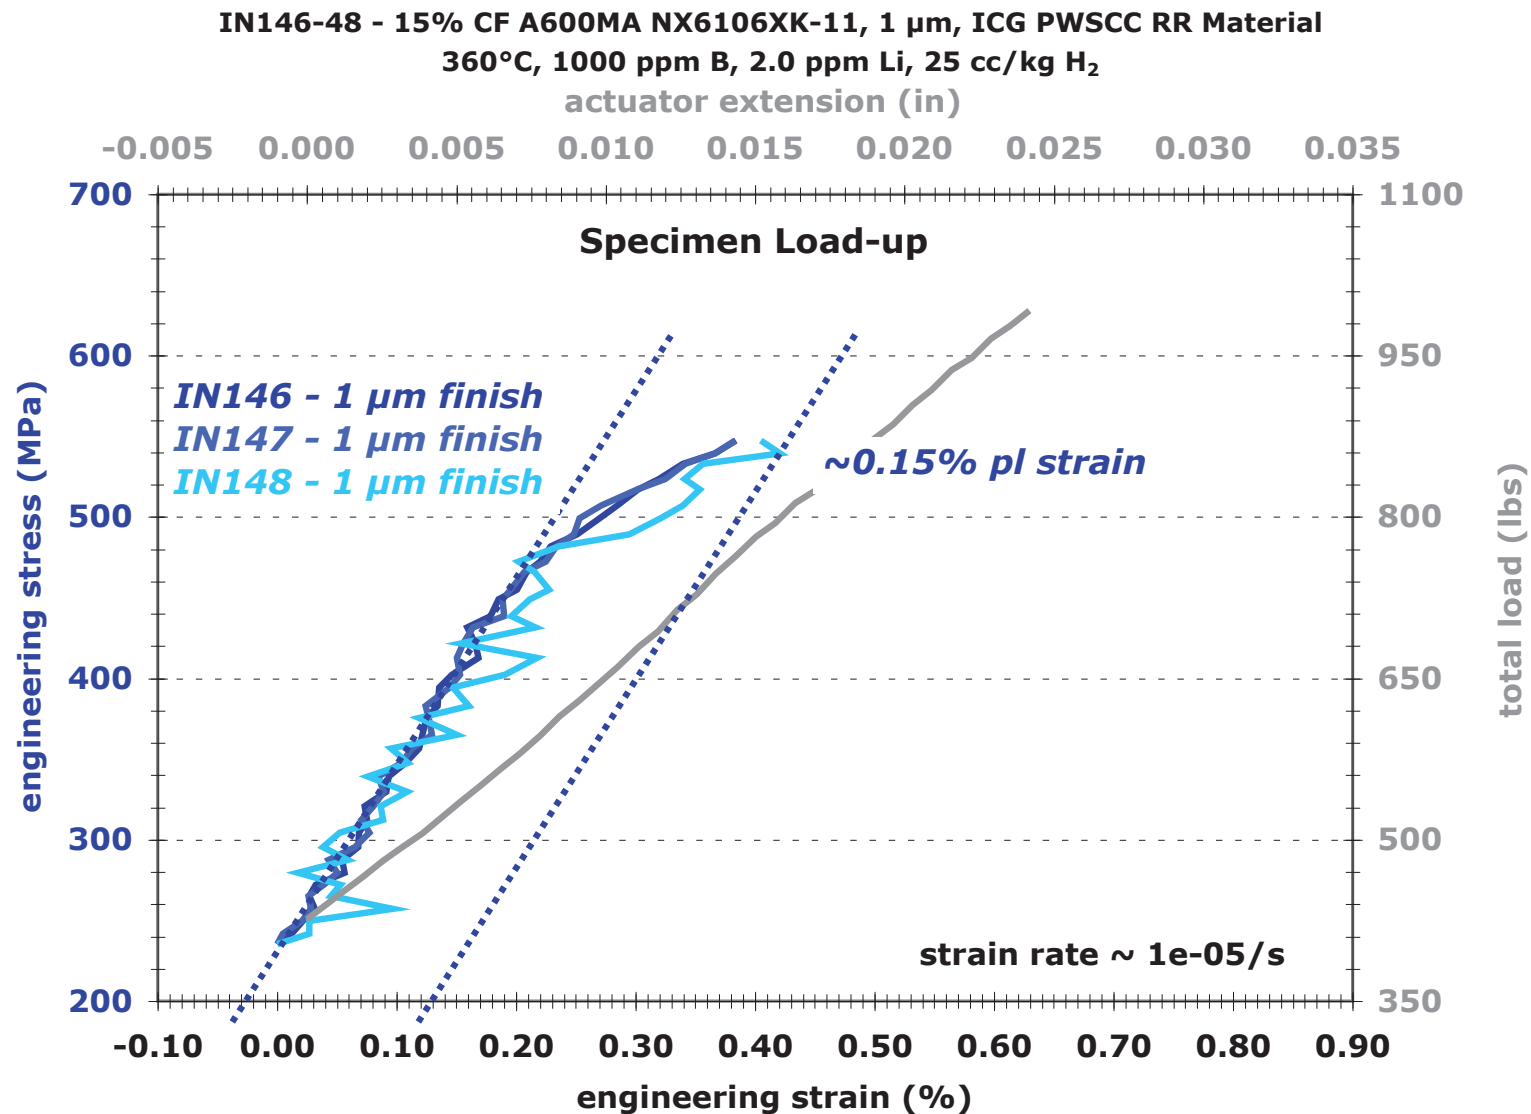
Load-up of NX6106XK-11 Round Robin Specimens

- All three specimens behaved identically during tensile loading to reach the yield strength.
- Loading stopped at 0.12-0.15% plastic strain = **550 MPa**.
- 1 hour to reach full load.

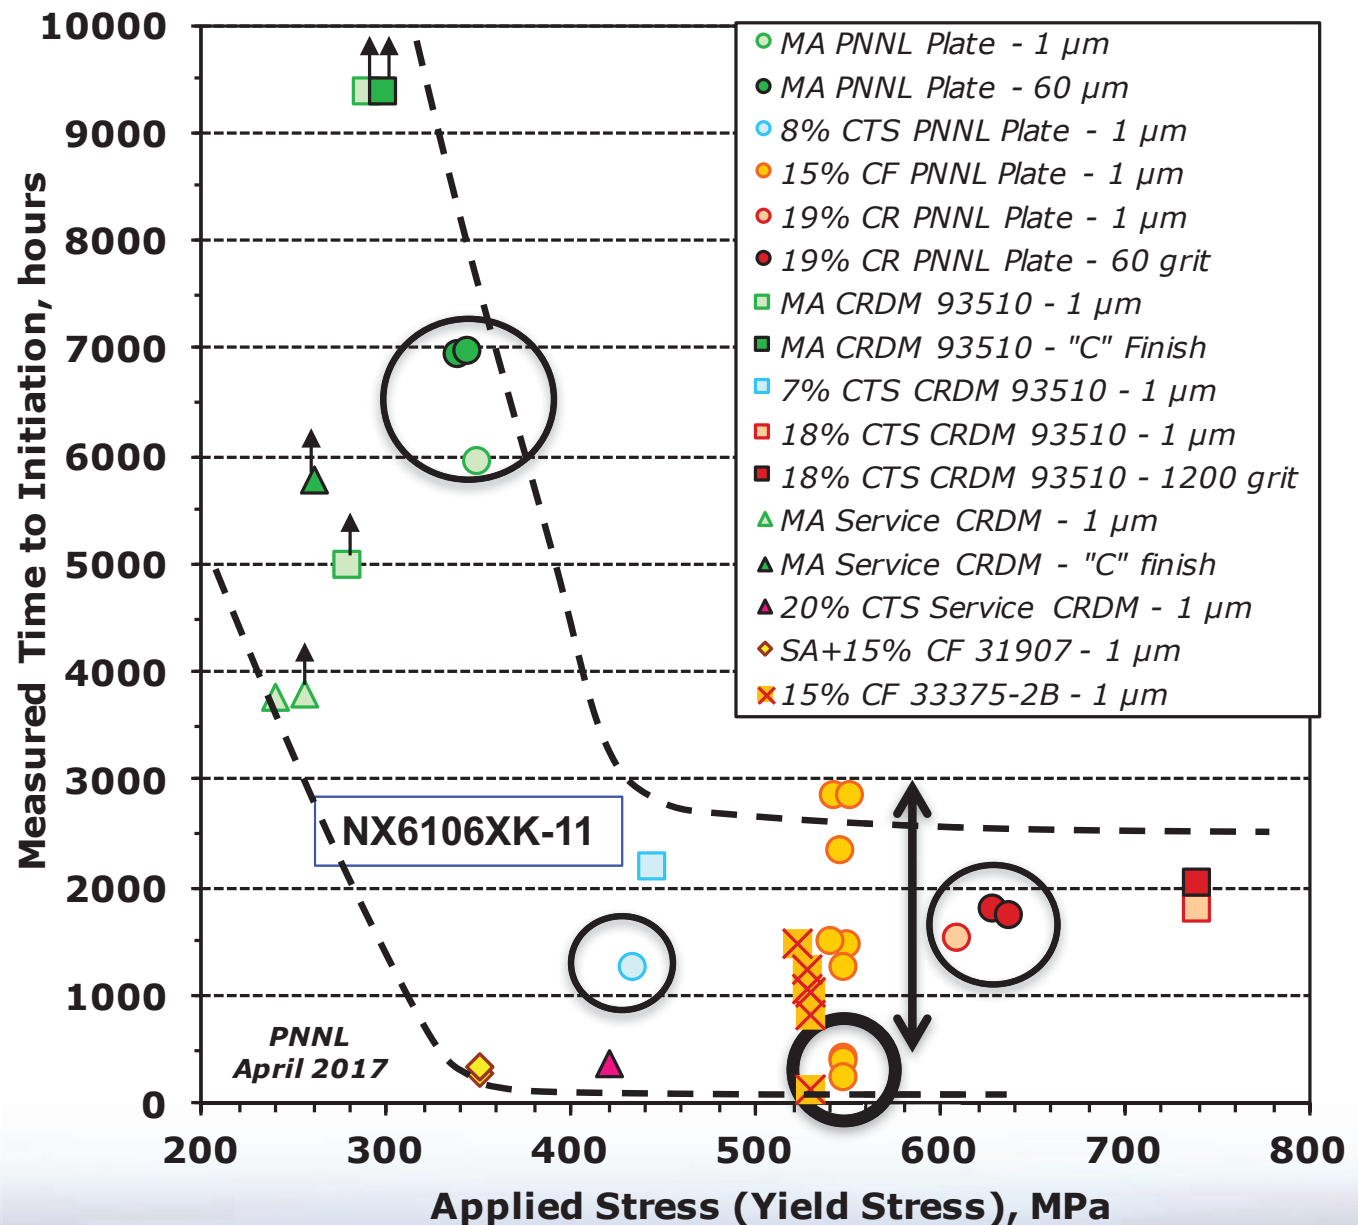
SCC Initiation Measurements on PNNL Plate

- *NX6106XK-11: lower RR initiation times than previous tests may result from differences in microstructure, cracking observed along large elongated grains in RR tests.*
- Additional tests on 15%CF PNNL material from different plate location revealed longer (>5X) crack initiation times.***

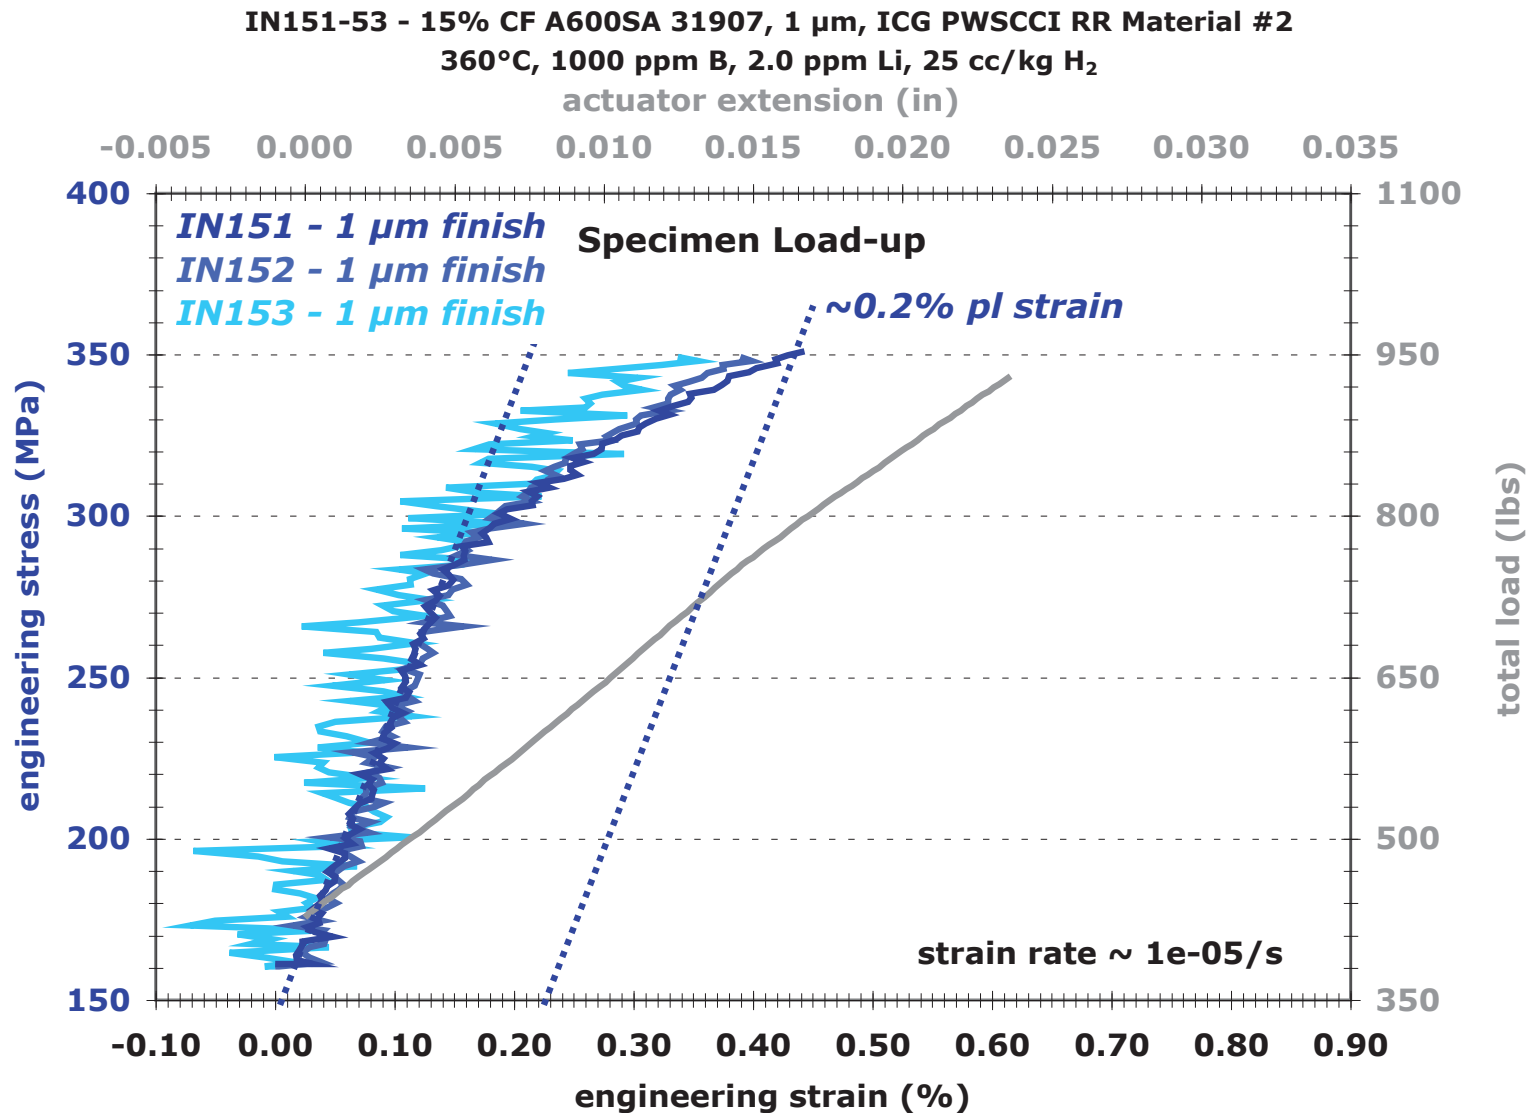
Load-up of 31907 Round Robin Specimens

- All three specimens behaved nearly identically during tensile loading to reach the yield strength of the specimens.
- Loading was stopped at 0.1-0.2% plastic strain = **350 MPa**. Note lower YS than for 15%CF plate
- 1 hour to reach full load.

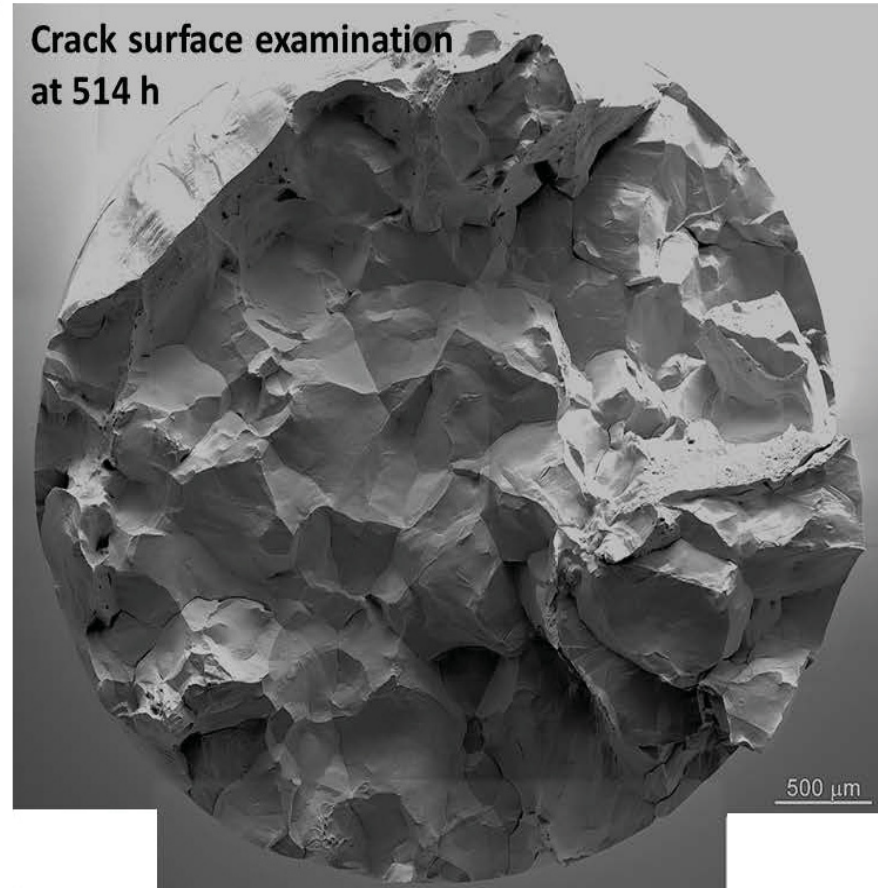
IN152 (SA+15%CF Alloy 600 heat 31907, 360°C, initiation at 354 h)

Gauge surface examination at 352 h

Crack surface examination at 514 h

- *Full thickness IGSCC failure occurred in ~160 hours after DCPD-detected initiation.*

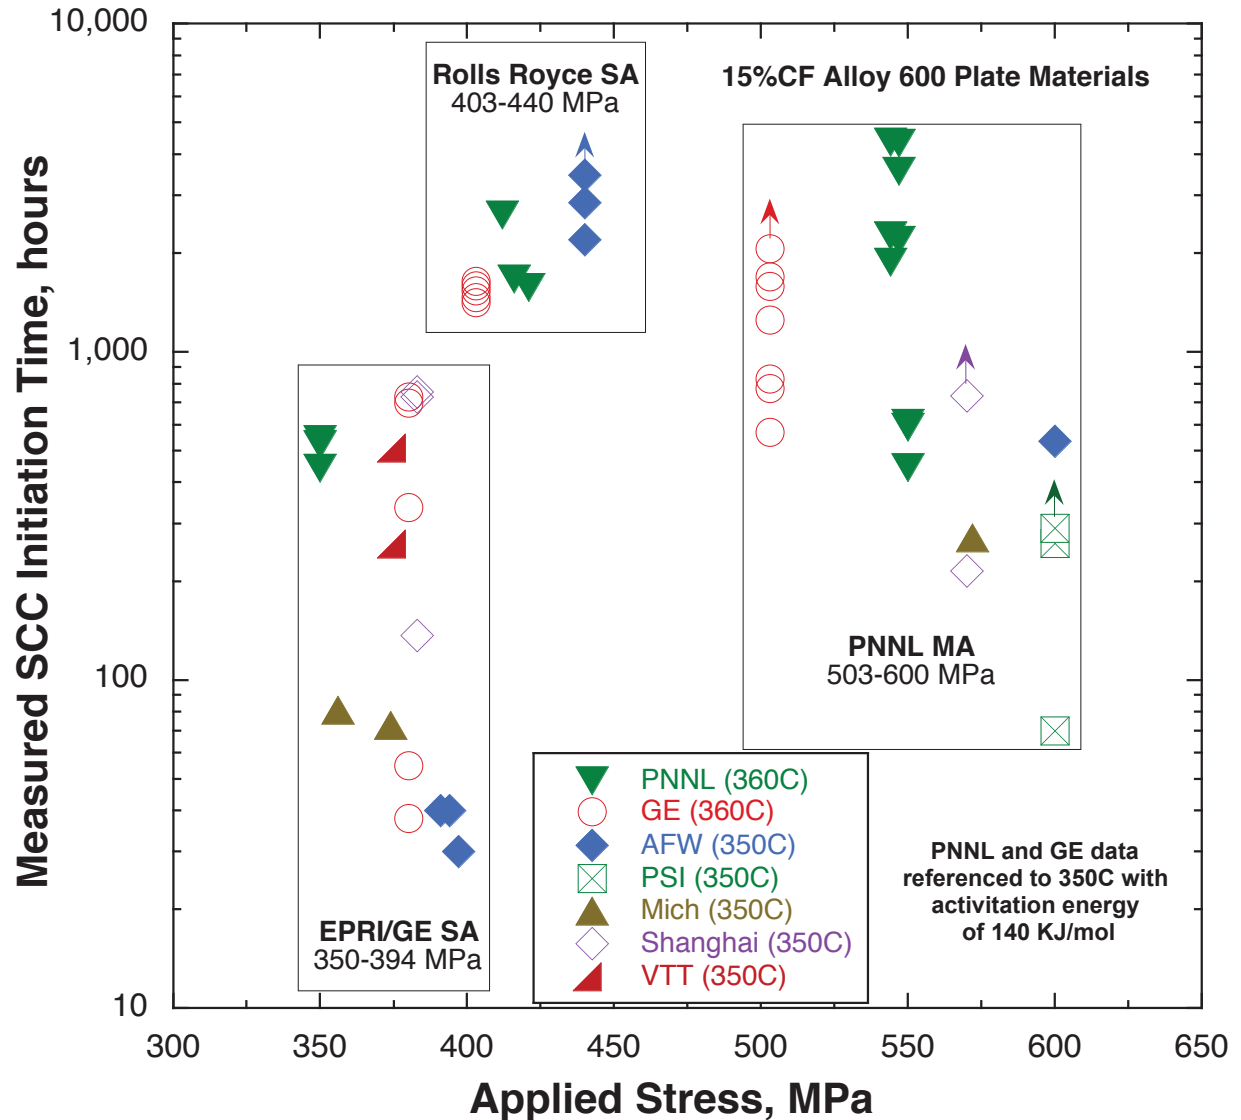
Preliminary Comparison to Other Labs

- *NX6106XK-11: range in SCC initiation times from 200-4000 hours may result from inhomogeneous microstructure.*
- *31907: range in SCC initiation times from 30-700 hours, lower initiation times at lower applied stress. Higher SCC susceptibility in this low C heat may result from higher creep rate.*
- *Heat 11415: longer SCC initiation times for this higher C heat, limited data but more consistent.*

Data as of June 2017

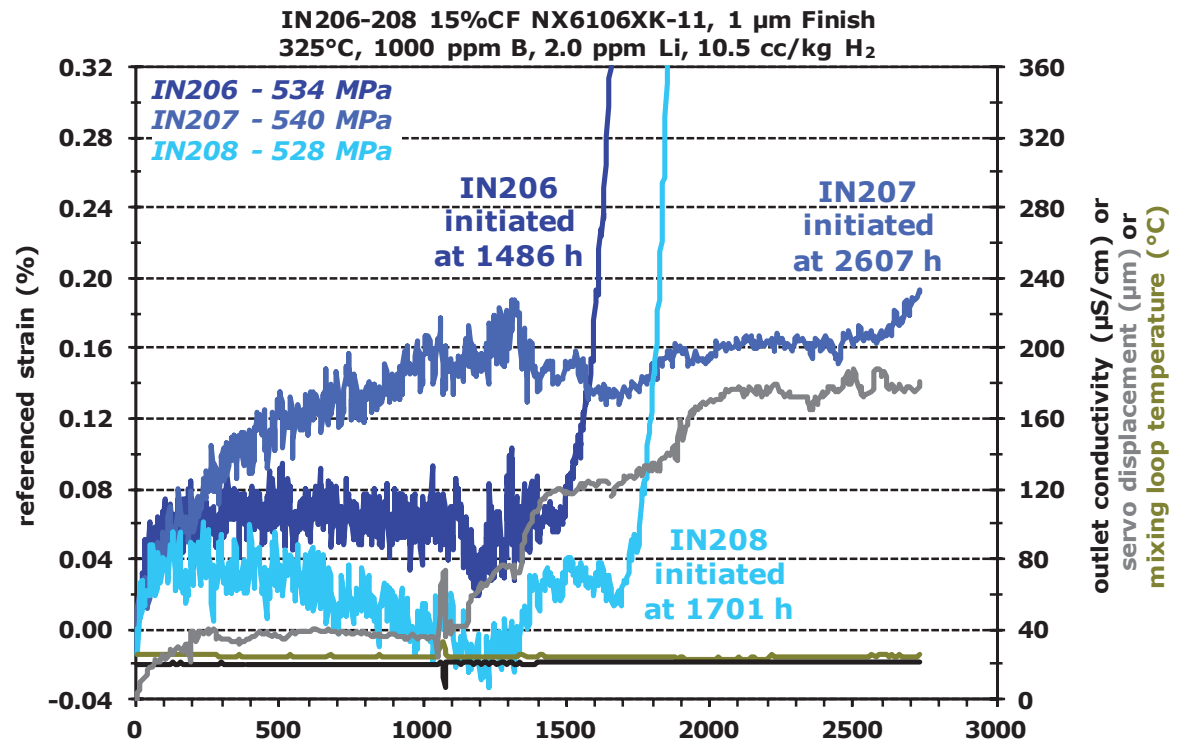
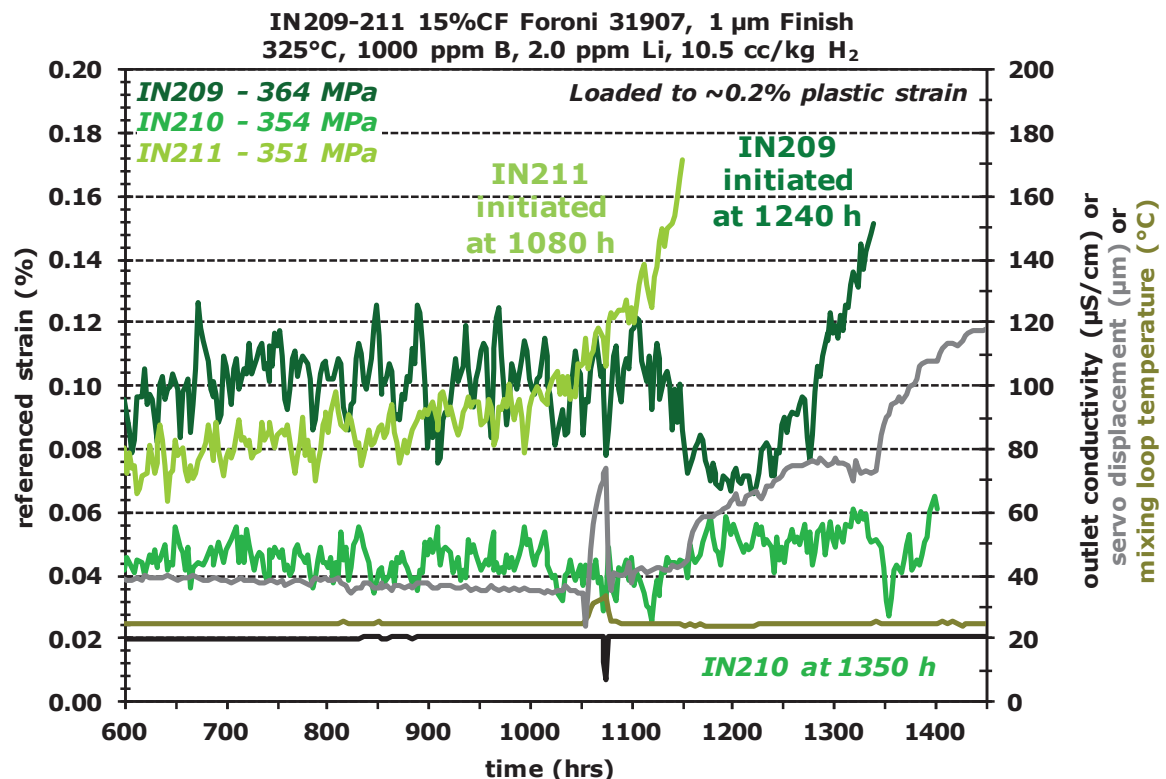
SCC Initiation Response at 325°C

- 15%CF PNNL MA plate initiated at 1486, 1701 and 2607 hours.
- 15%CF EPRI/GE SA plate initiated at 1080, 1240 and 1350 hours.
- General response is consistent with the 360°C behavior with EPRI/GE heat more susceptible.
- SCC initiation times at 325°C are ~4X longer than measured at 360°C.

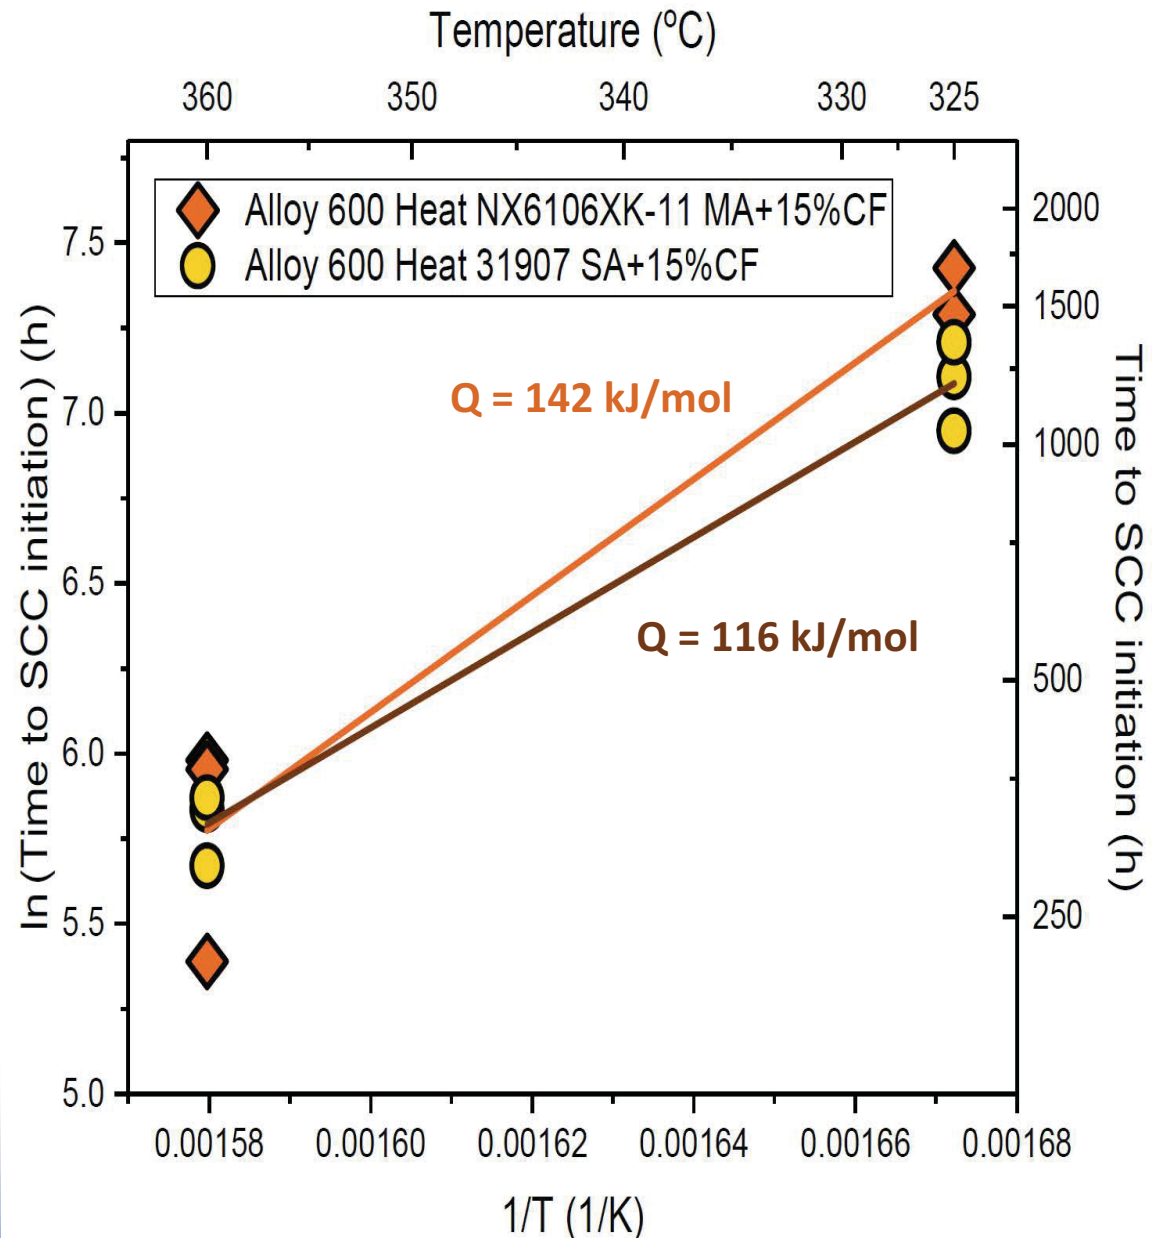
Estimated Thermal Activation Energy of SCC Initiation Determined for Cold-Worked Alloy 600

- SCC initiation tests performed in 325°C and 360°C simulated PWR primary water at the Ni/NiO stability ECP.
- Measured SCC initiation times reveal estimated activation energies of ~116 kJ/mol for the 15%CF EPRI/GE SA600 plate and 142 kJ/mol for the 15%CF PNNL MA600 plate materials. Reasonably consistent with prior reported values by KAPL.
