Pre-Irradiation Testing and Analysis to Support the LWRS Hybrid SiC- CMC-Zircaloy-4 Unfueled Rodlet Irradiation

January 2013

The purpose of this report is to provide the details of selected cold characterization tests conducted at the Idaho National Laboratory (INL). The specific set of characterization tests included those identified for prototype testing to ascertain neutron irradiation readiness. These tests support rodlet design activities and validate methods for examining chemical, mechanical and physical properties of the mock-up hybrid fuel rodlet design and component materials. The hybrid fuel rodlet design is being investigated under the Light Water Reactor Sustainability (LWRS) program for further development and testing of a possible advanced LWR nuclear fuel cladding design.

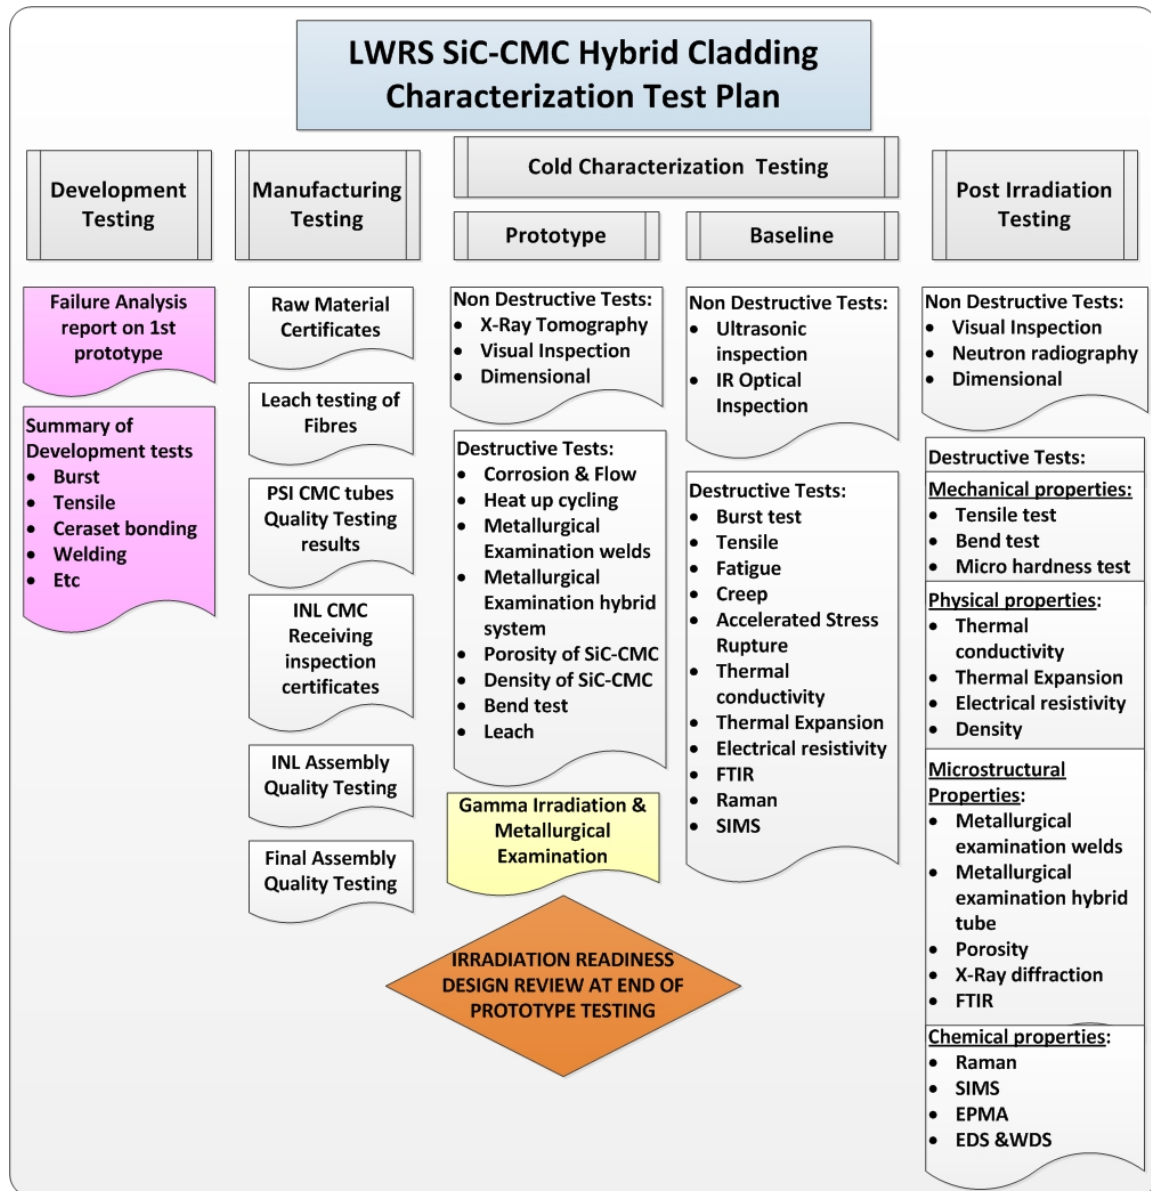
Figure 1. Figure showing the LWRS SiC-CMC hybrid cladding characterization test plan [2].

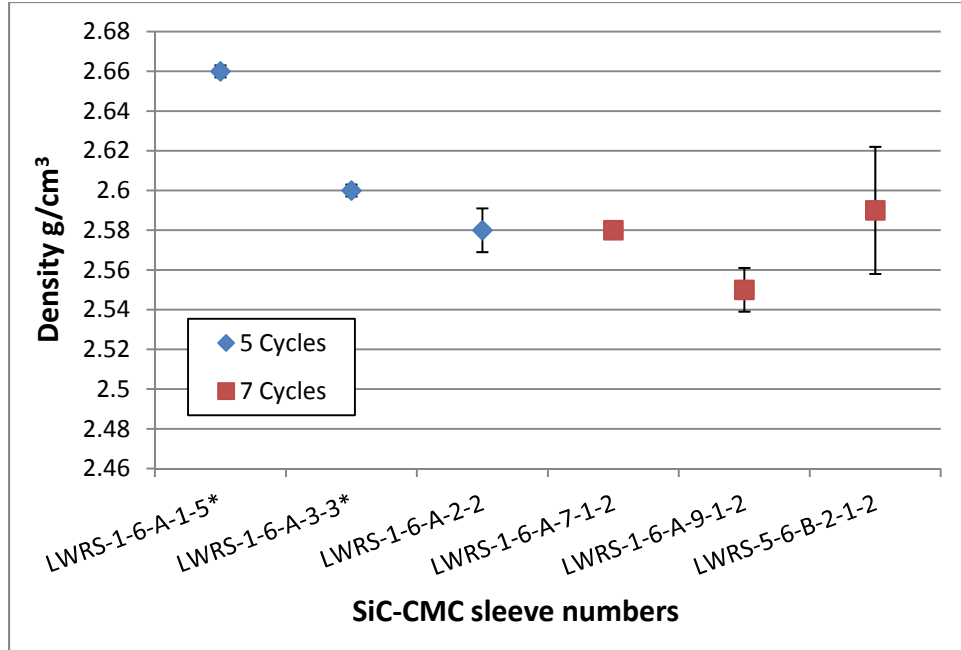
Figure 5. Density values of representative SiC-CMC sleeve samples presenting to show no significant difference between the 5 and 7 processed PIP cycles.

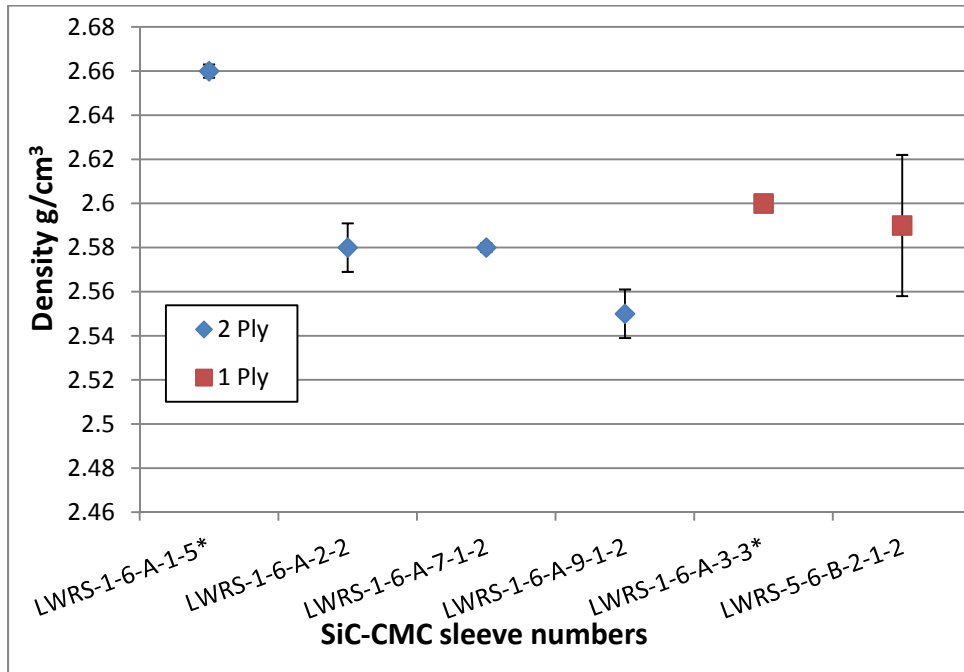
Figure 6. Density values of representative SiC-CMC sleeve samples presenting to show no significant difference between the 1 and 2 ply braided SiC-CMC tubes.

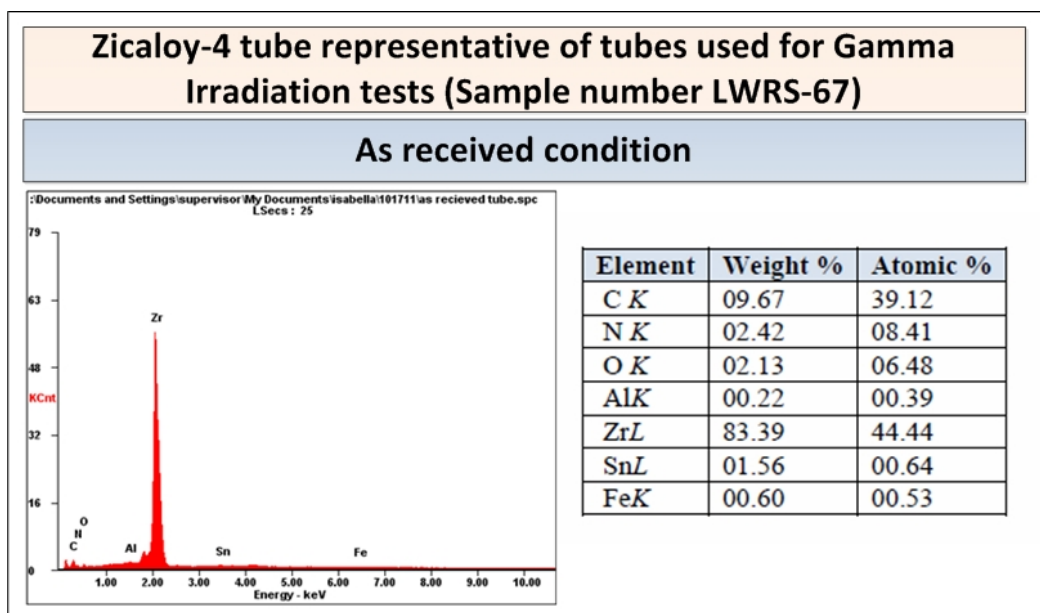
Figure 10. SEM-EDS analysis of the Zr-4 tube used for the gamma irradiation tests (sample number LWRS-67).

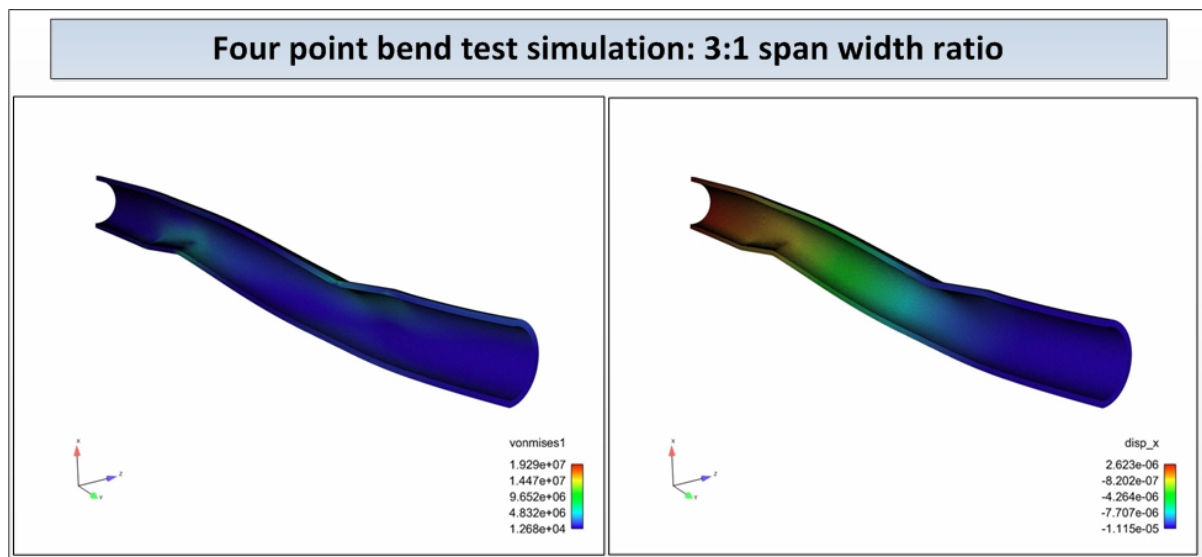
Figure 12. Initial simulation results presenting the elastic case during a four point bend test with a 3:1 load span width on Zr-4. The simulation was completed on half of the sample length.

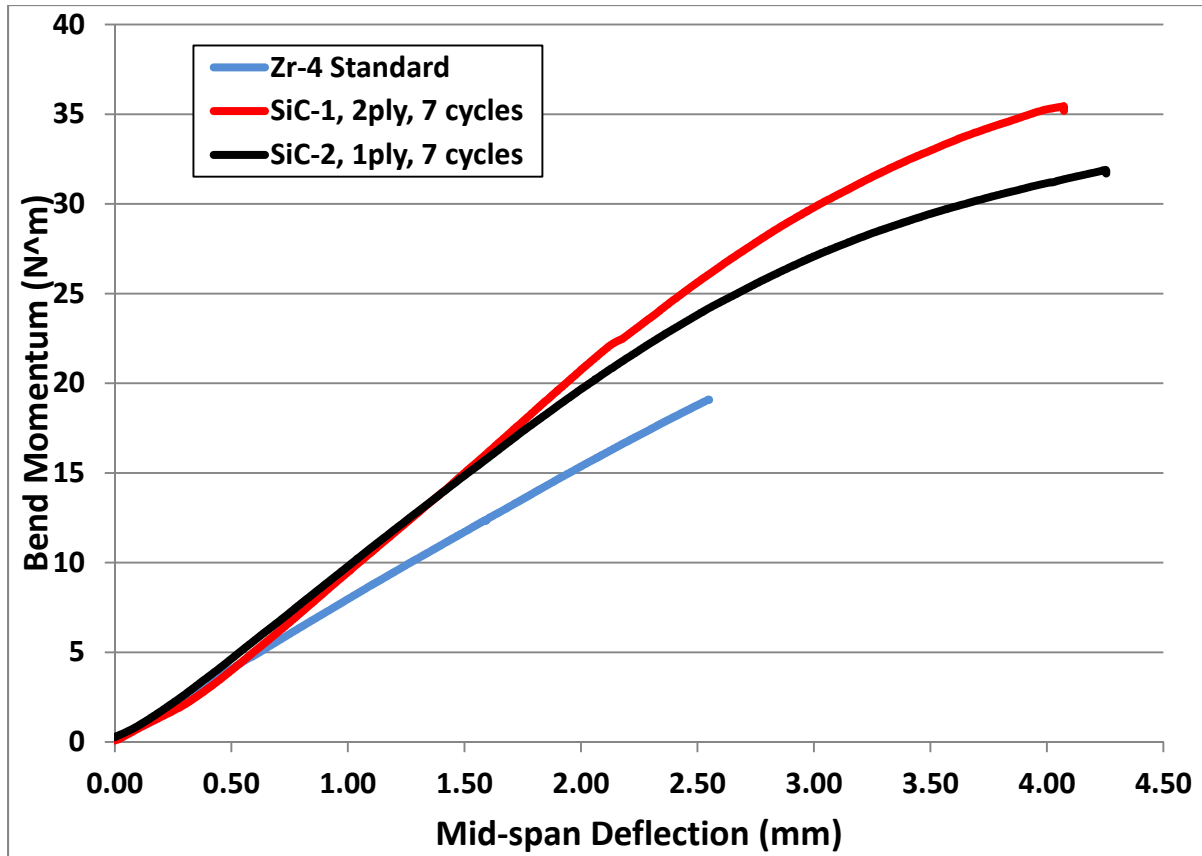
Figure 16. Bend test results of the mock-up samples showing bending momentum vs mid-span deflection. The 2 ply SiC-CMC hybrid mock-up sample exhibits the highest bend momentum.

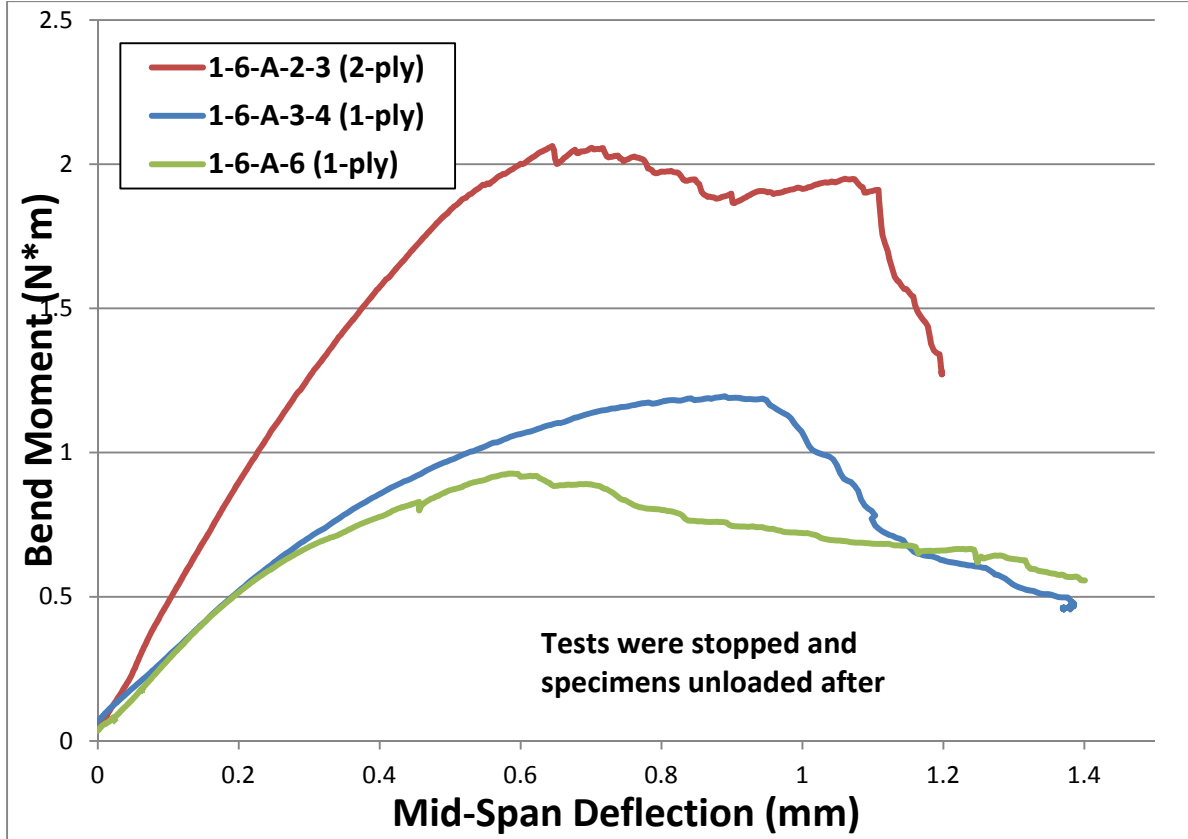
Figure 20. Bend test results of the two identical fabricated 5 cycles, 1 ply (LWRS-1-6-A-3-4 and LWRS-1-6-A-6) in comparison with the 5 cycles, 2 ply (LWRS-1-6-A-2-3) SiC-CMC sleeves, showing the higher bend moment of the 2 ply SiC-CMC.
