Light Water Reactor Sustainability Program

FY 2023 Progress on Stress Corrosion Crack Testing of Ni-Base Alloys in PWR Primary Water

August 2023

U.S. Department of Energy
Office of Nuclear Energy

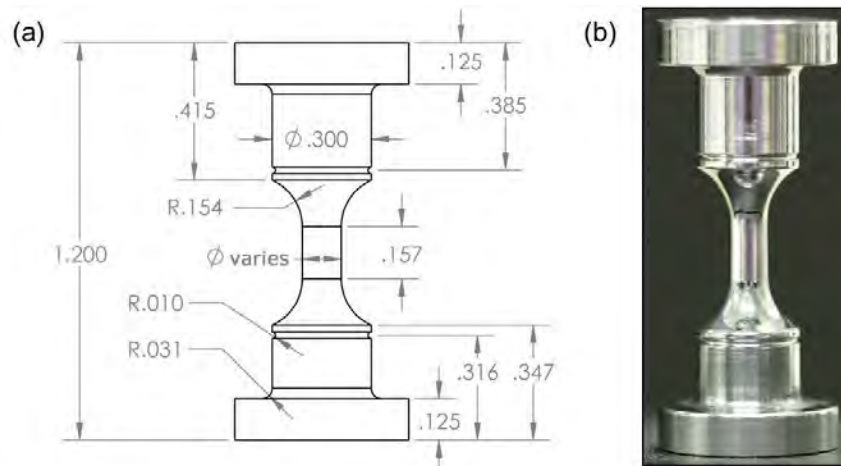
30.4 mm (1.2-inch) tall uniaxial tensile specimens are used for the tests (Figure 1). All specimens have an identical gauge length of 4 mm. A precision servo-electric load control system applies the load on the loading string(s) using a target load of 4670 N (~1050 lbs). Different stress levels can be achieved by varying the gauge diameter in the specimens loaded in the same string, allowing multiple specimens to be tested at their yield stress (YS) or any other target stress. For most specimens, a 1 μm surface finish was prepared to facilitate the examination of precursor damage and cracks on the surface.

Figure 1. PNNL initiation specimen design. The gauge diameter is selected based on material strength and can vary from 2.75-4.5 mm (0.11-0.18 inches). The gauge length is set at 4.0 mm (0.157 inches). Overall height is 30.5 mm (1.2 inches). Illustrated dimensions are in inch units.

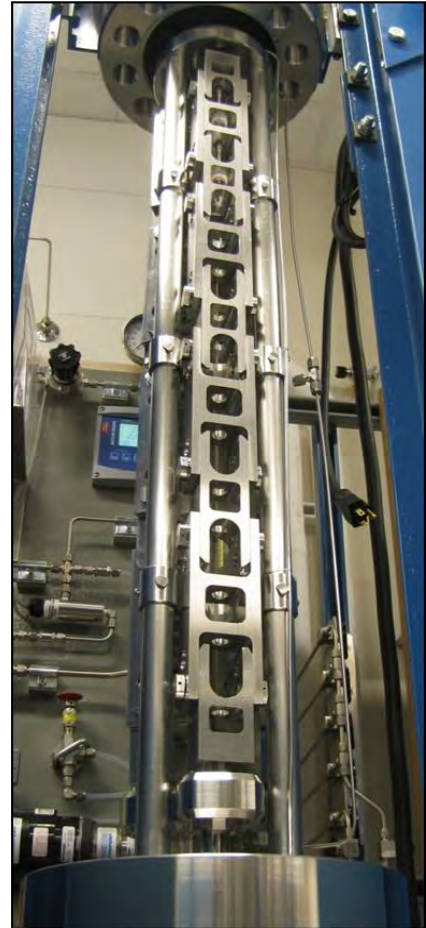
**(b) 36-Specimen
SCC Initiation System**

Figure 2. The load trains used at PNNL in the (a) medium-size SCC initiation test system with a capacity of testing up to 6 fully instrumented specimens and the (b) large-size SCC initiation test system with a capacity of testing up to 24 instrumented specimens and up to 36 specimens in total.

Figure 2 shows the load train and DCPD instrumentation for the serially loaded SCC initiation specimens set up at PNNL. Currently, two medium-size SCC initiation systems and one large SCC initiation system are being used under the scope of LWRS. The two medium-size systems each can test up to 6 fully instrumented specimens, and the large SCC initiation system allows 36 specimens to be tested simultaneously with up to 12 specimens instrumented. The KOH vs. LiOH SCC initiation testing on Alloy 82 utilized one medium-size LWRS test system. This test system was first filled with KOH-based water chemistry. After the completion of the SCC initiation testing in the KOH water chemistry, the system was cleaned following a procedure similar to what is described for on-the-fly water chemistry change during SCC crack growth testing in Section 2.2.2.4. A control study of SCC initiation in the target LiOH-based water chemistry was then performed on the same Alloy 82 material. KOH was used at a concentration that provides the same pH as LiOH (neutral pH at 310°C). Six specimens were tested in each water chemistry. To acquire results within a practical timeframe, the tests were performed with accelerant factors in temperature and dissolved hydrogen level. A higher temperature (360°C) than in service (325°C) was used for these tests. In addition, a dissolved hydrogen concentration was selected that corresponds to an electrochemical corrosion potential at the Ni/NiO stability line, where the SCC initiation susceptibility is believed to be the highest for Ni-base alloys.

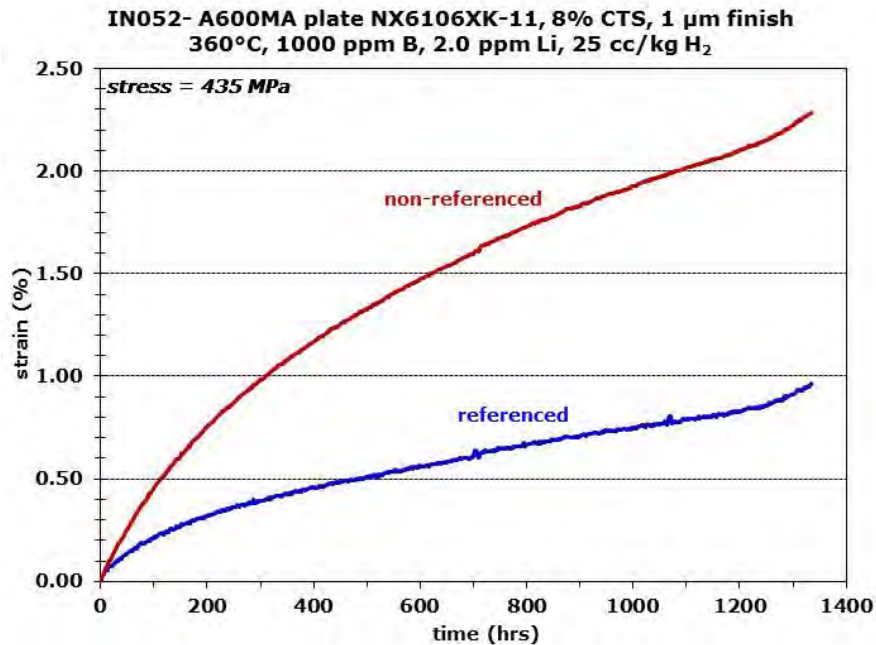
Figure 4. Non-referenced and referenced DCPD strain response for IN052, an 8% CW specimen from Alloy 600MA plate heat NX6106XK-11.

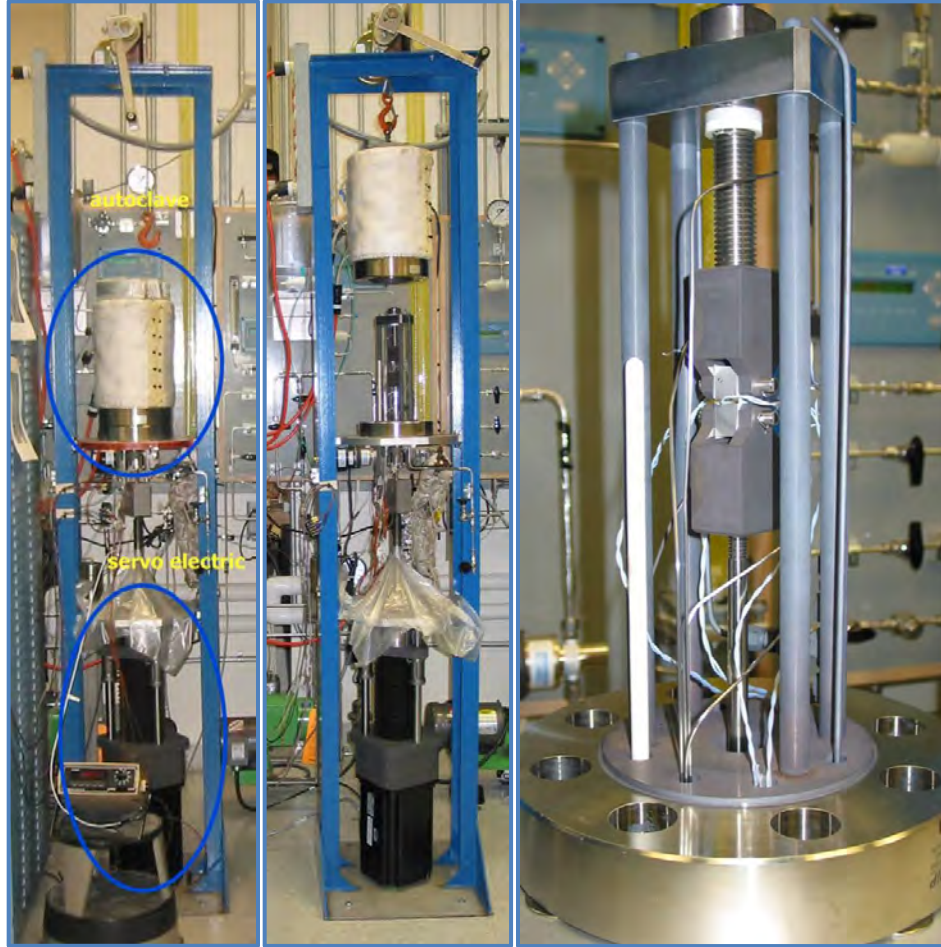
Figure 5. The typical SCCGR test system used at PNNL.

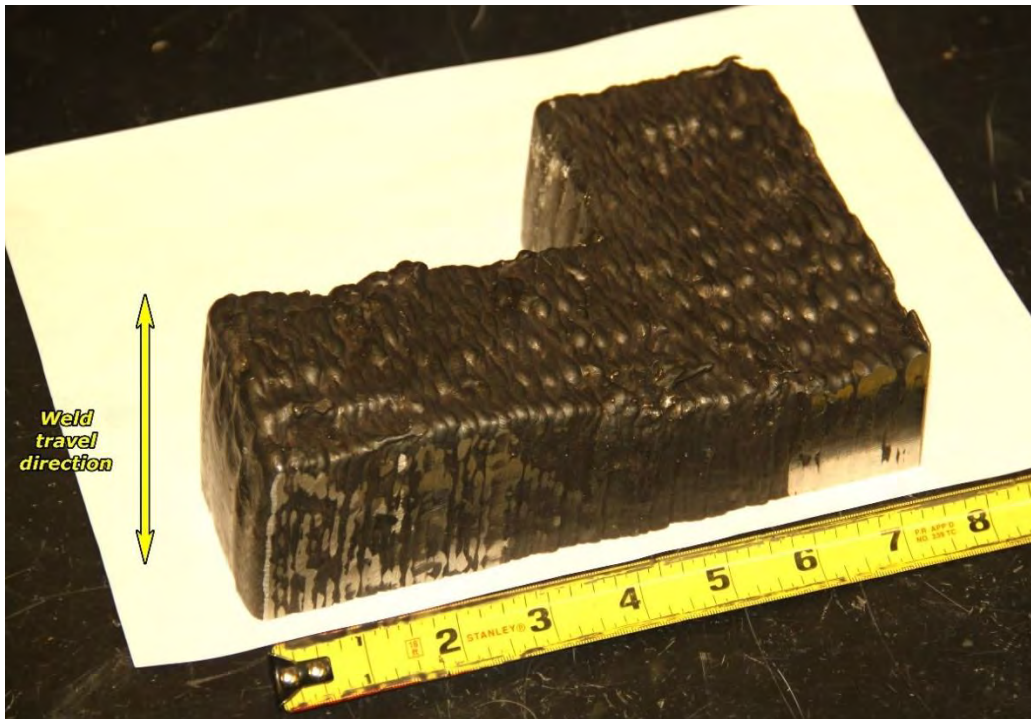
Figure 8. The as-received Alloy 82H (Heat 21719-2) block for this study.

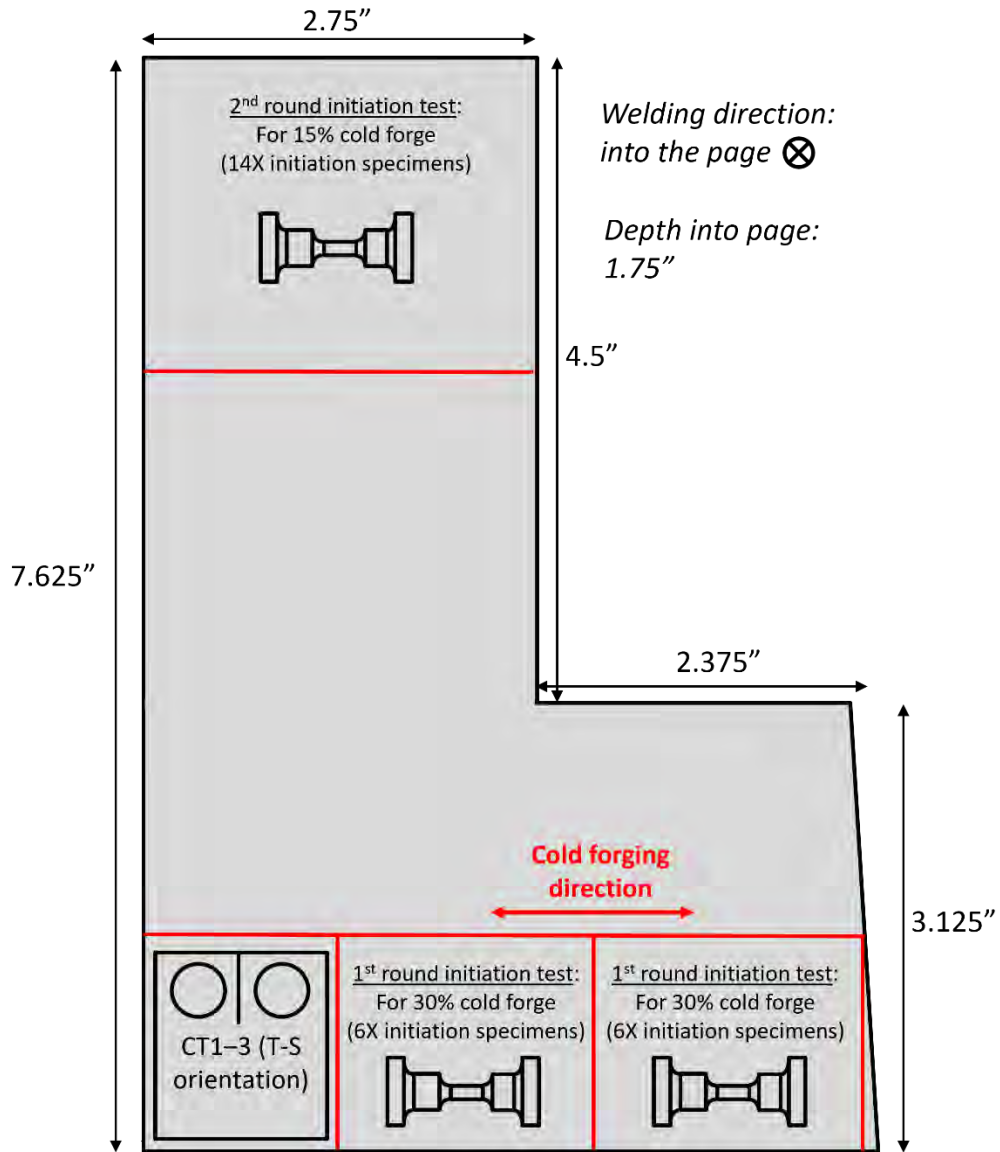
Figure 9. Schematic of the A82 block cutting plan for specimen preparation.

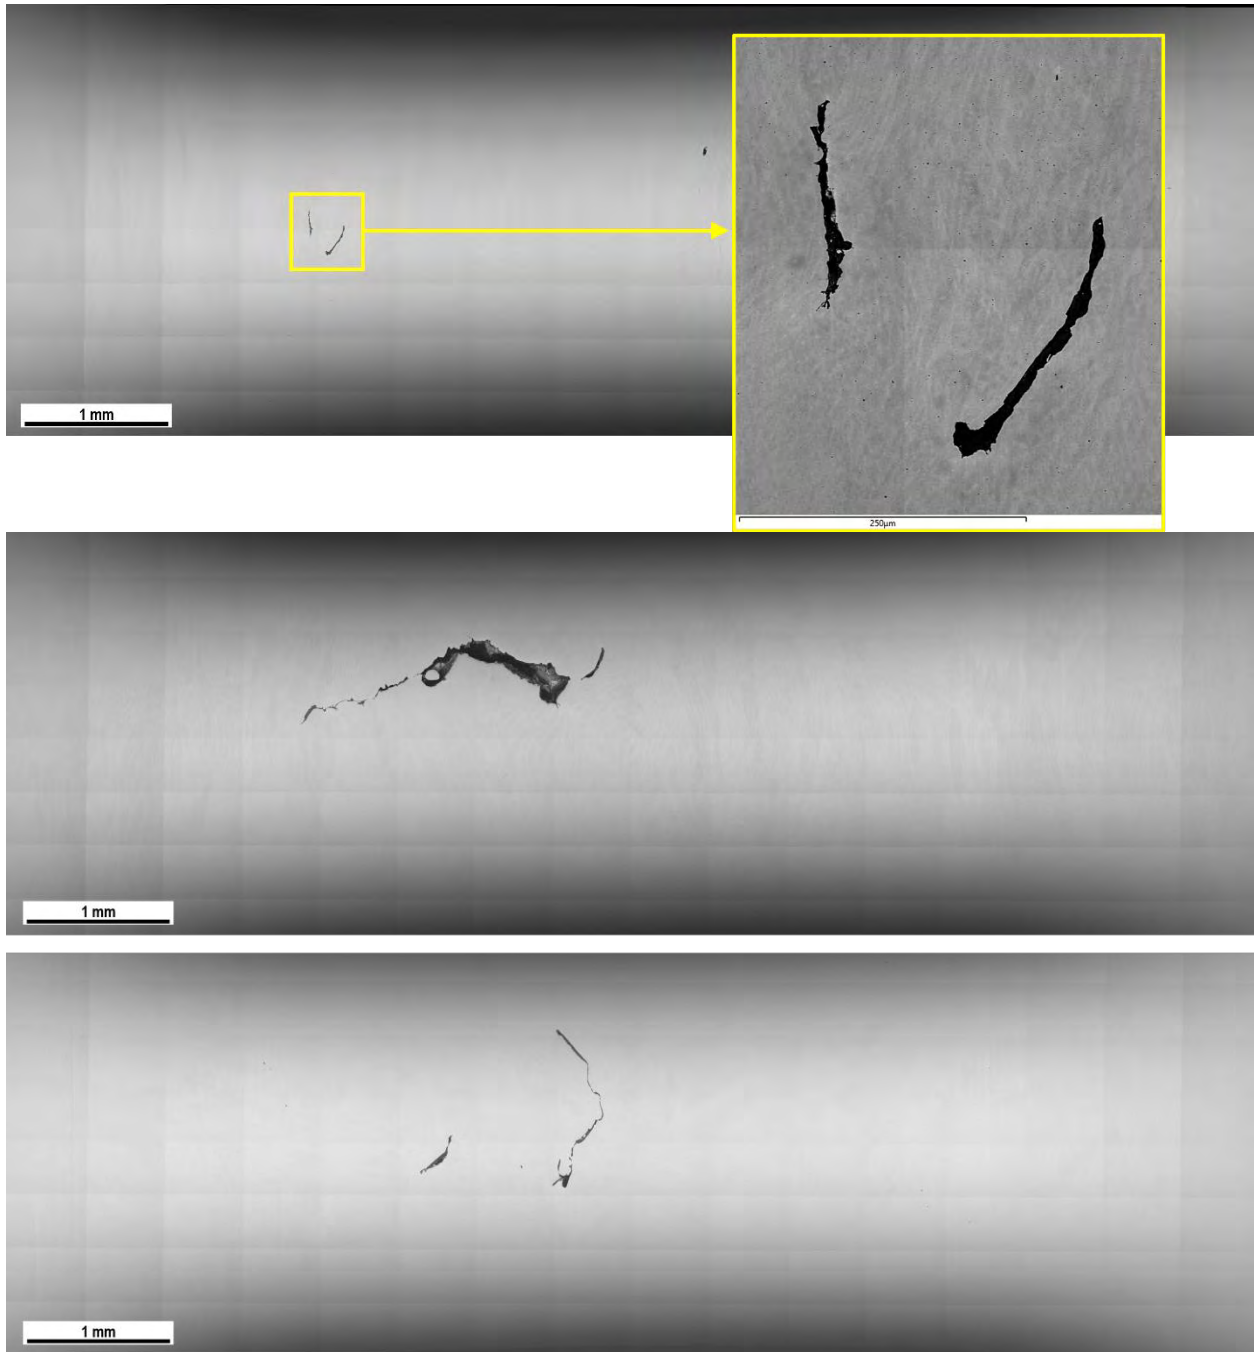
Figure 10. Examples of pre-existing welding defects observed on the gauge surface of several 30% CF Alloy 82 initiation specimens after they were polished to a colloidal silica finish.

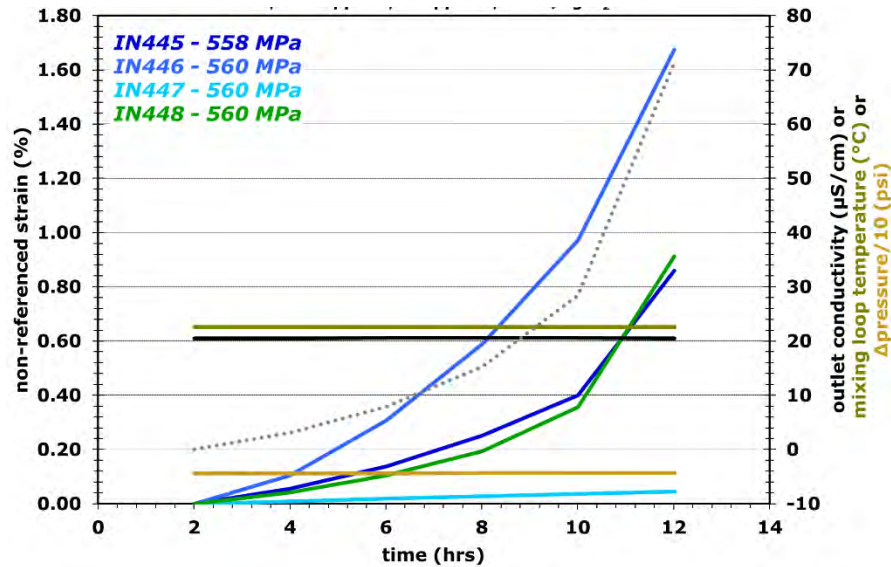
Figure 11. Non-referenced DCPD strain response of the four 30%CF Alloy 82 specimens IN445-48 tested at material yield stress in 360°C PWR primary water containing 1500 ppm B and 2.2 ppm Li.

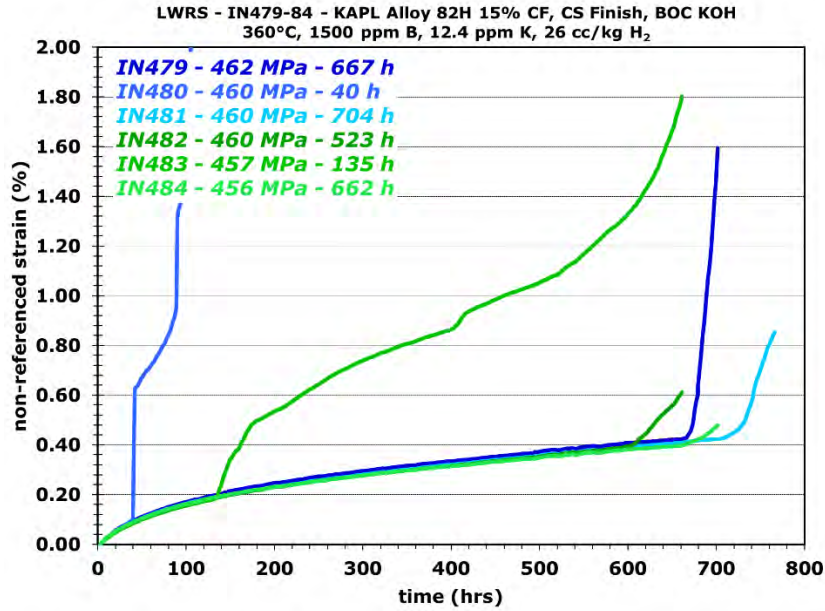
Figure 14. Overall non-referenced DCPD strain response of the six 15%CF Alloy 82 specimens IN479-84 tested at material yield stress in 360°C PWR primary water containing 1500 ppm B and 12.4 ppm K. The SCC initiation time of each specimen is marked in the legend.

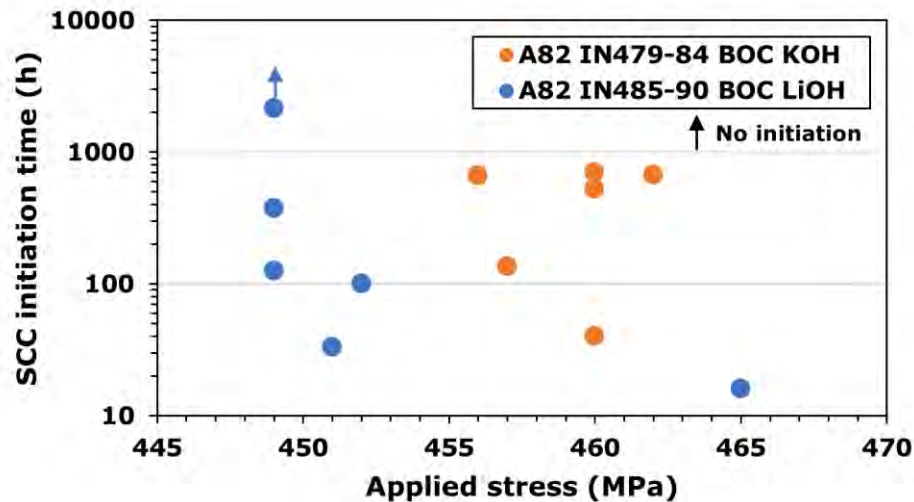
Figure 17. SCC initiation time of all the tested 15%CF Alloy 82 specimens as a function of applied stress.

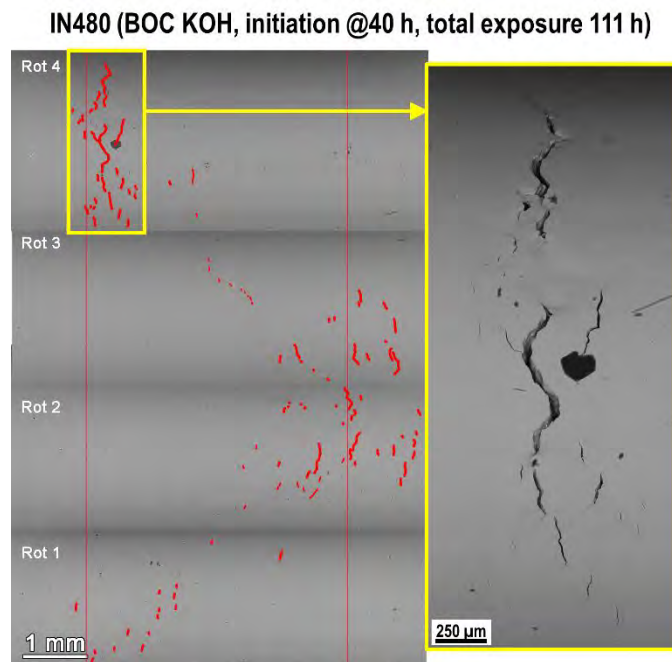
Figure 18. Post-test SEM-BSE montage of the first initiated 15%CF Alloy 82 specimen IN480 in 360°C PWR primary water with 1500 ppm B and 12.4 ppm K.

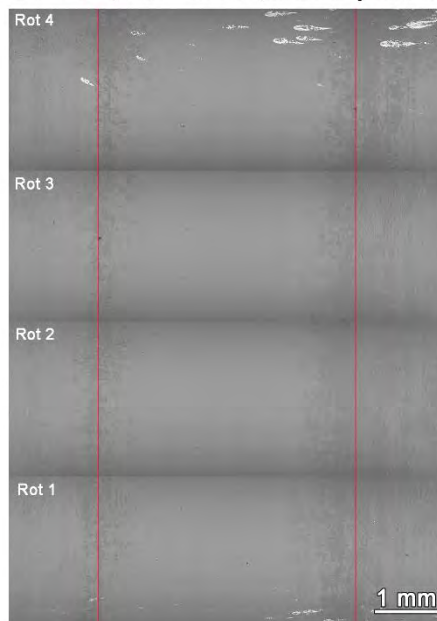
IN490 (BOC LiOH, no initiation, total exposure 2152 h)

Figure 29. Post-test SEM-BSE montage of the non-initiated 15%CF Alloy 82 specimen IN490 in 360°C PWR primary water with 1500 ppm B and 2.2 ppm Li.

The post-test surface morphology of the six initiated Alloy 82 specimens IN485–90 tested in the BOC water chemistry containing 1500 ppm B and 2.2 ppm Li are presented in Figures 24–29. These specimens are also reported in order of increasing SCC initiation time, and the loading direction was parallel to the axial direction of the specimens. As shown in Table 4, four out of the six specimens initiated within 150 hours of exposure. IN485 and IN487 reached >0.8% plastic strain during loading and were the first two to show macroscopic SCC initiation after only two to three days in test. They were removed within a half day to one day after DCPD detected SCC initiation, and both showed wide-opened primary cracks close to 1 mm long (Figures 24 and 25). A higher density of cracks was observed in IN486 (Figure 26) and IN489 (Figure 27), which initiated between 100 and 132 hours but stayed in test for another ~200 hours before removal. IN488 initiated at 374 hours and generally showed similar cracking morphology as IN486 and IN489 (Figure 28). Interestingly, the last specimen IN490 underwent 5–50X longer exposure time than the first five specimens but not a single crack was observed on its gauge surface after the test ended. A thicker layer of spinel oxide was formed on the fillet region because of the longer exposure and rougher surface finish (Figure 29).

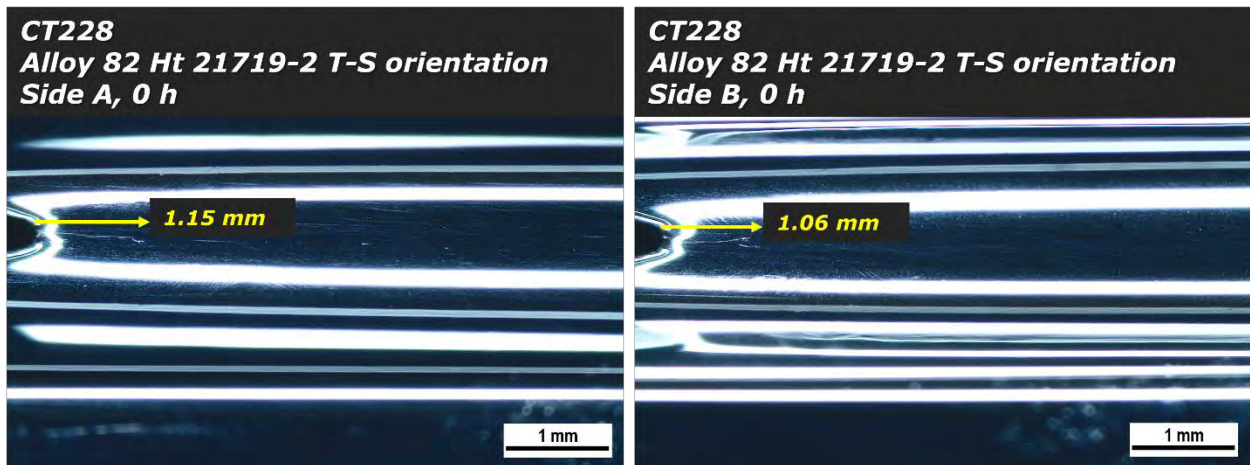
Figure 30. Optical micrographs of the polished side grooves of the 30%CF Alloy 82 specimen CT228. The length of the precrack produced by air fatigue is marked in both side grooves.

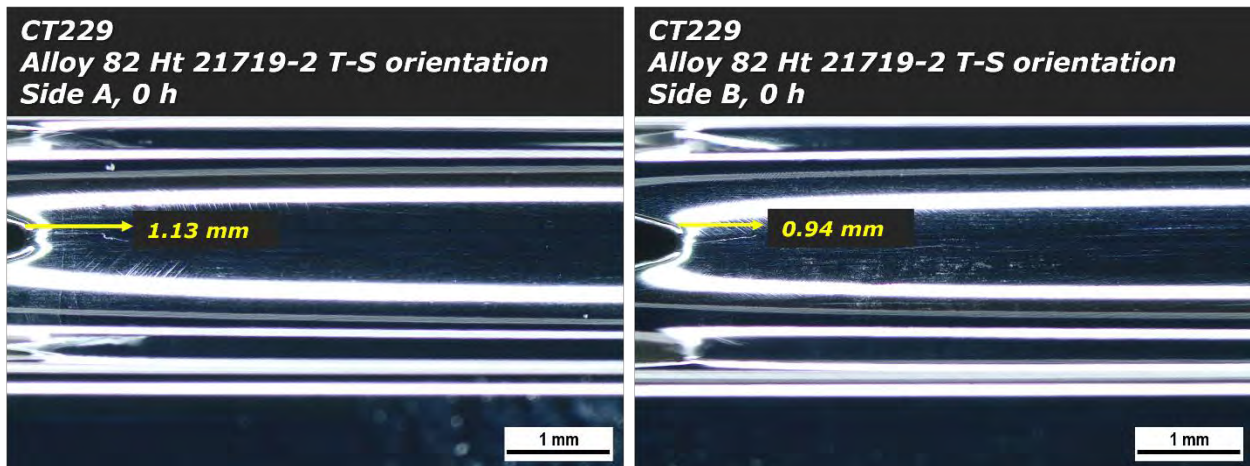
Figure 31. Optical micrographs of the polished side grooves of the 30%CF Alloy 82 specimen CT229. The length of the precrack produced by air fatigue is marked in both side grooves.

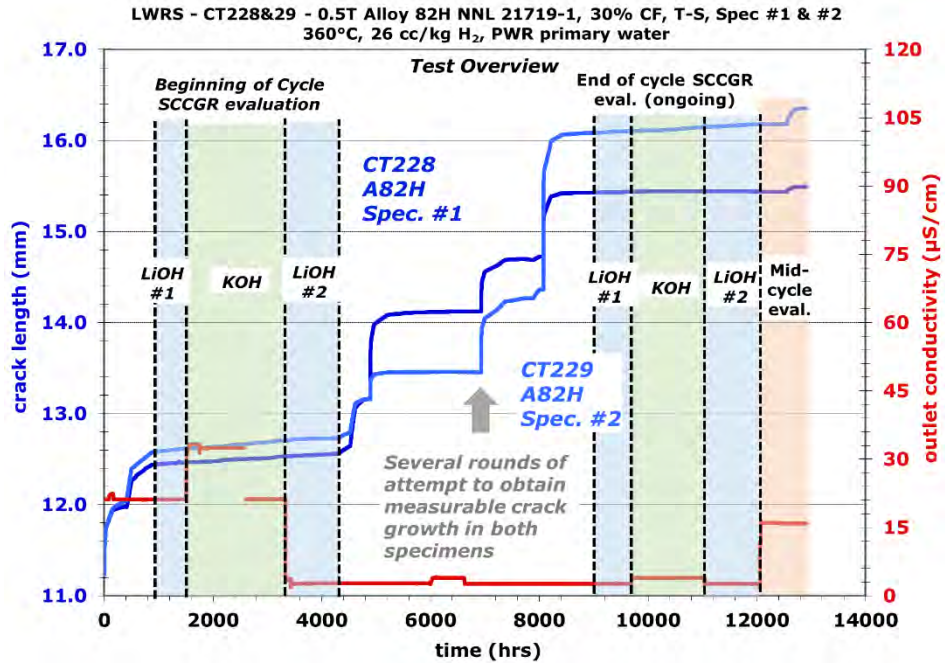
Figure 32. Test overview of crack growth response in the two Alloy 82 specimens CT228 & 229 tested in T-S orientation. The effect of KOH vs. LiOH on the SCCGR of both specimens was evaluated in 360°C simulated PWR primary water at a constant stress intensity of 30 MPa√m.

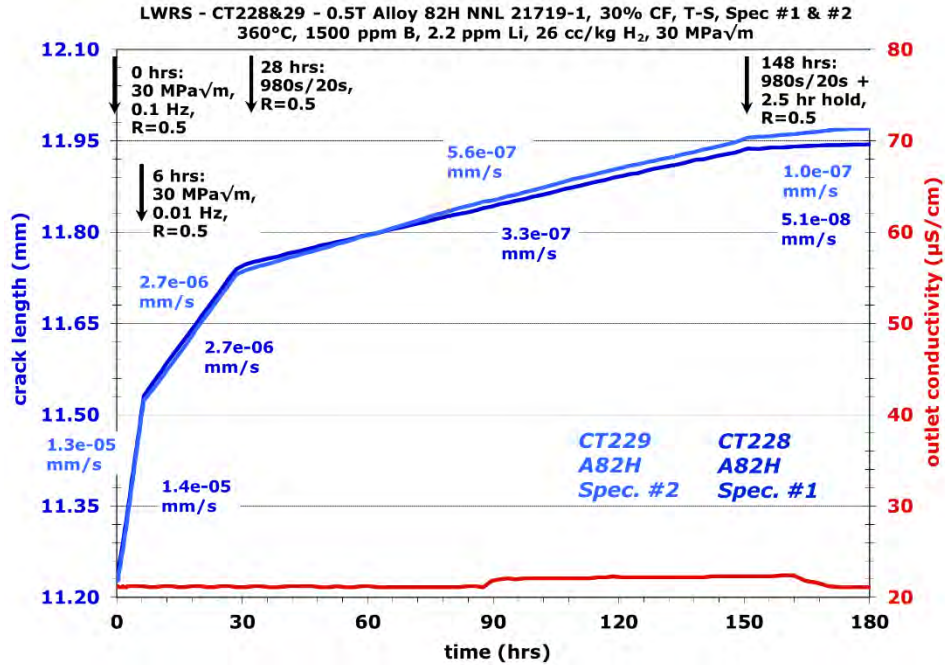
Figure 33. Crack growth response of CT228 & 229 during the initial cyclic loading transition steps in 360°C simulated PWR primary water.

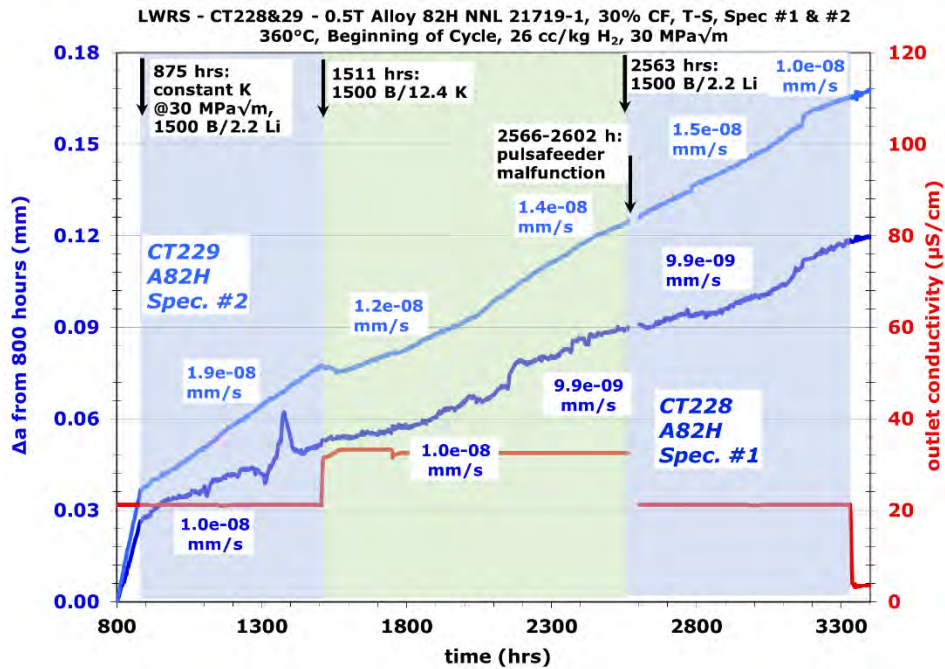
Figure 34. SCCGR response of CT228 & 229 in 360°C PWR primary water BOC chemistry with on-the-fly changes between LiOH and KOH. The concentrations of B, Li, and K in the plot are shown in ppm.

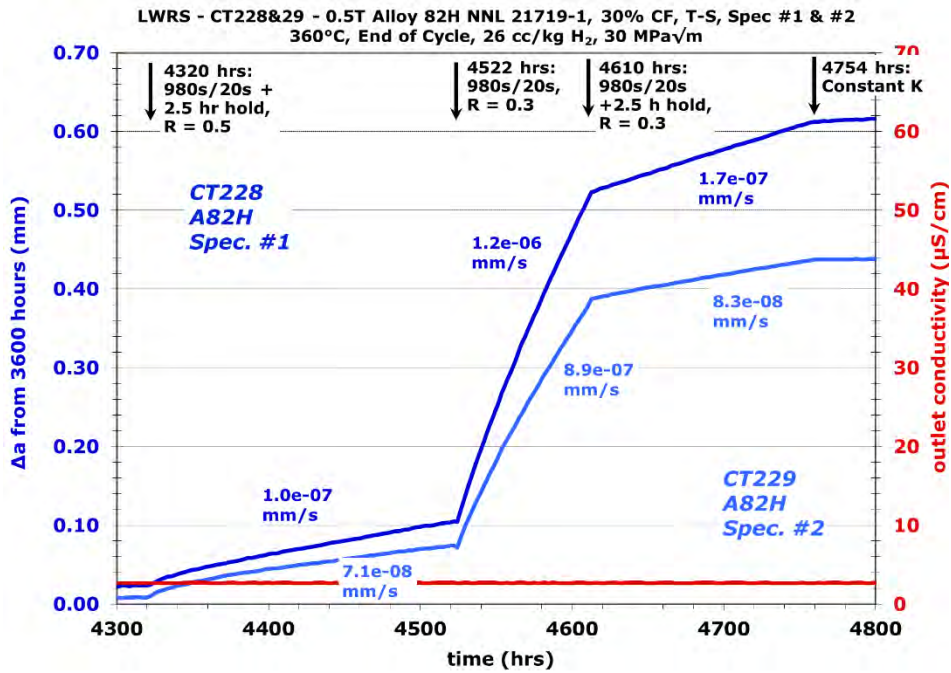
Figure 36. Crack growth response of CT228 & 229 during the first attempt to adjust crack growth behavior after the water chemistry change from BOC LiOH to EOC LiOH.

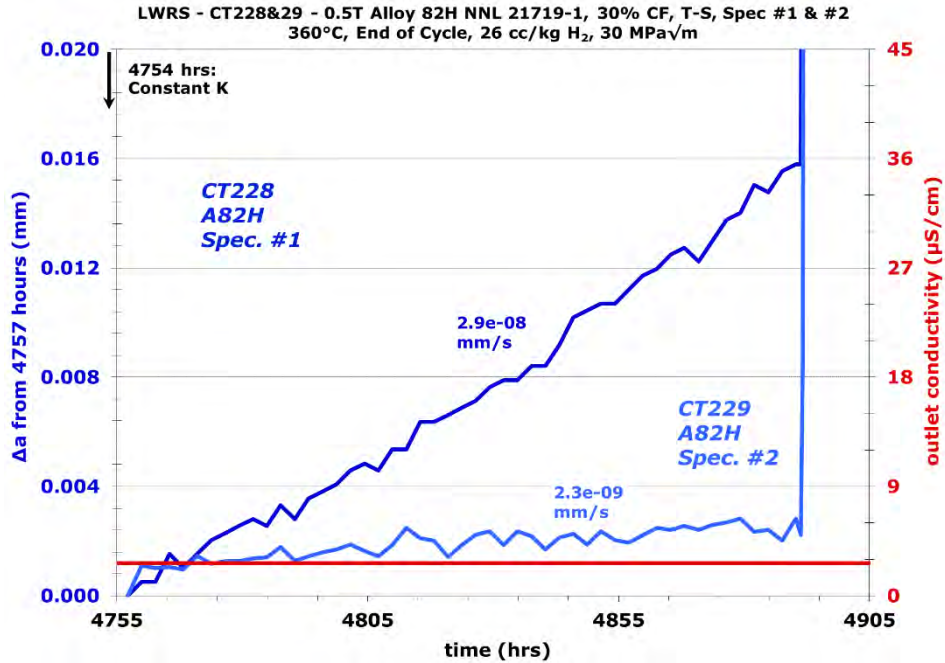
Figure 37. The 2nd attempt to measure SCCGR response of CT228 & 229 in 360°C PWR primary water EOC LiOH water chemistry.

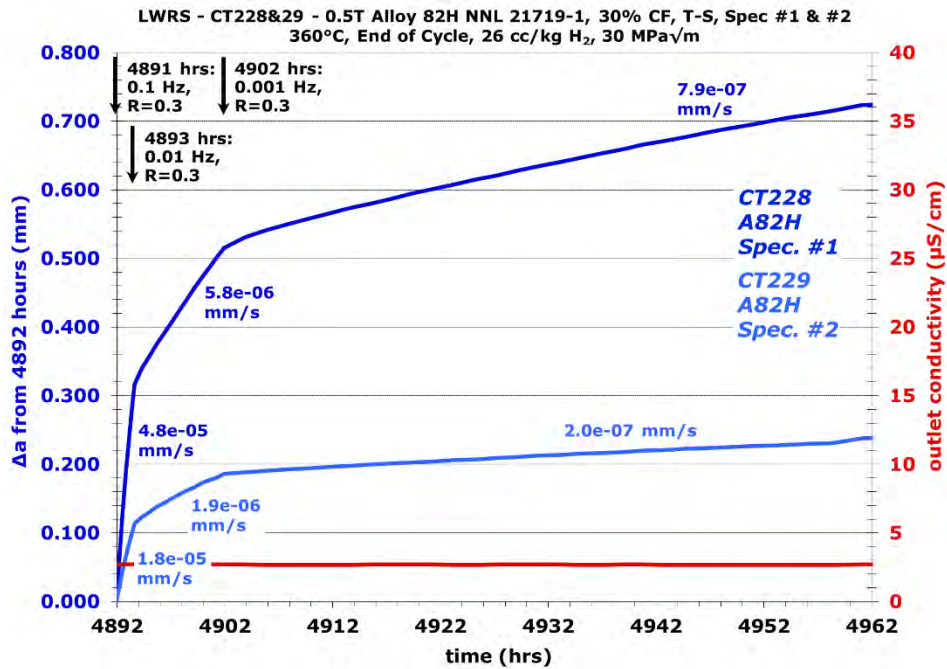
Figure 38. Crack growth response of CT228 & 229 during the second attempt to adjust crack growth behavior in the EOC LiOH water chemistry.

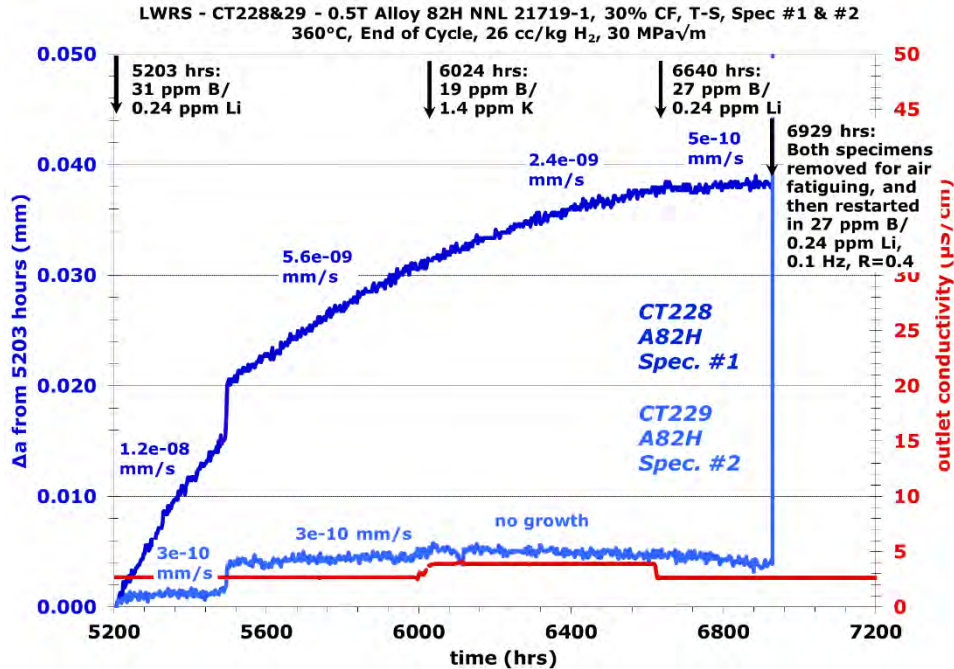
Figure 39. The 2nd attempt to measure the SCCGR response of CT228 & 229 in 360°C PWR primary water EOC water chemistry with on-the-fly changes between LiOH and KOH.

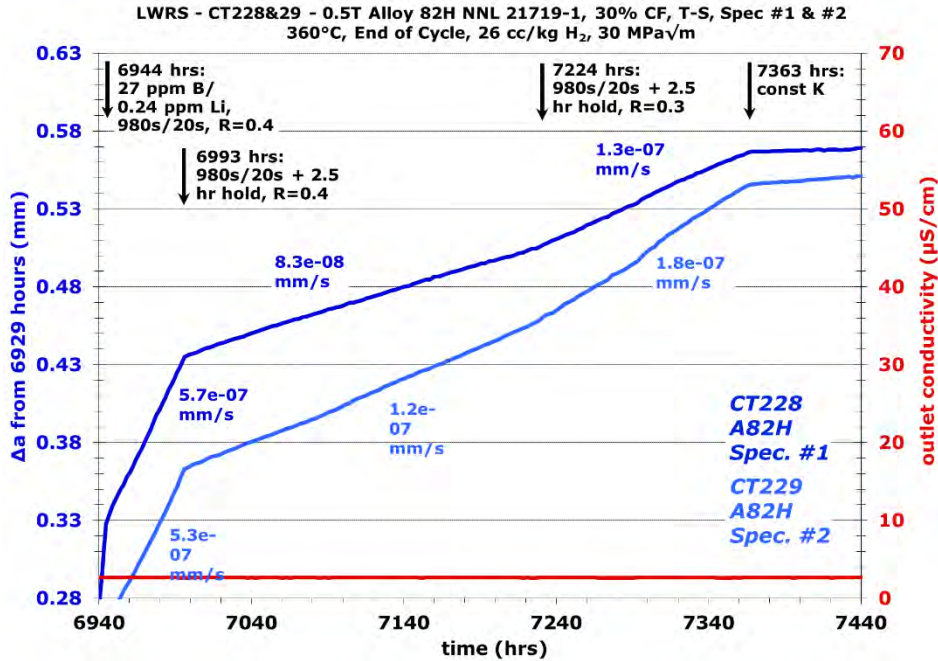
Figure 42. CGR response of CT228 & 229 in transition steps after the specimens were fatigued in air for the 1st time to adjust the crack length.

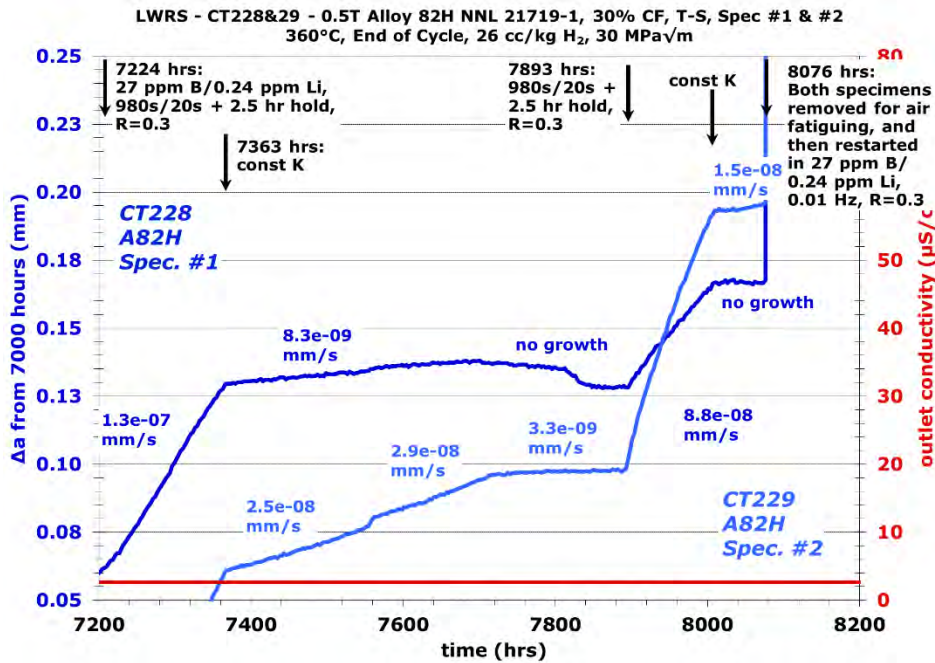
Figure 43. The 3rd attempt to measure the SCCGR response of CT228 & 229 in 360°C PWR primary water EOC LiOH water chemistry.

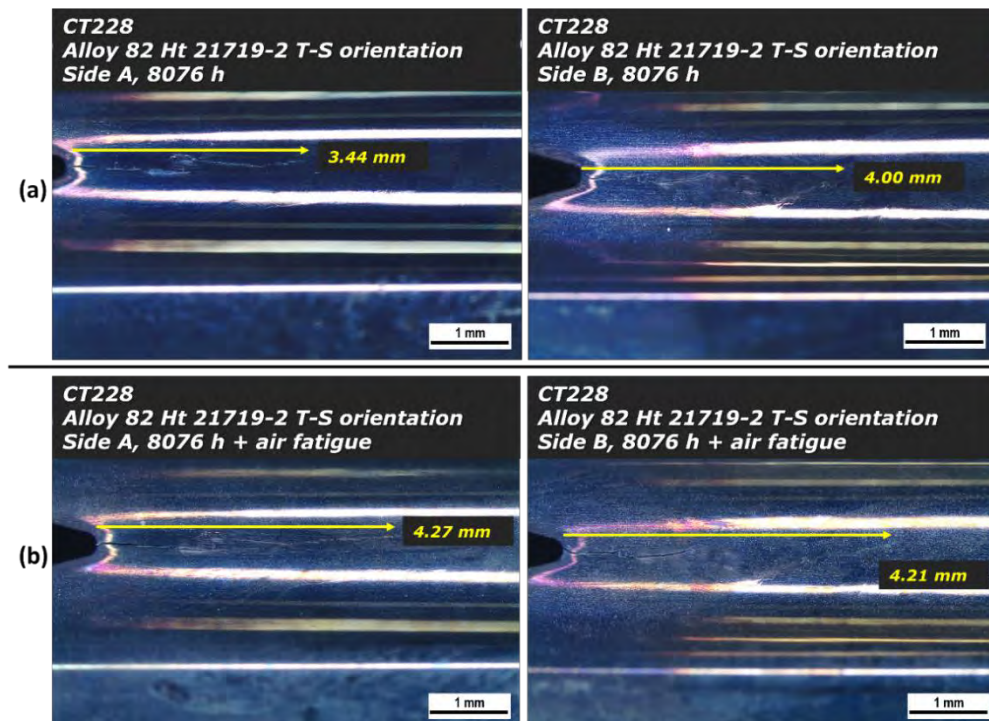
Figure 44. Crack length measurement in the side grooves of CT228 after 8076 hours of testing in 360°C simulated PWR primary water: (a) immediately after the specimen was removed from testing and (b) after additional fatigue in air to grow the crack in the specimen.

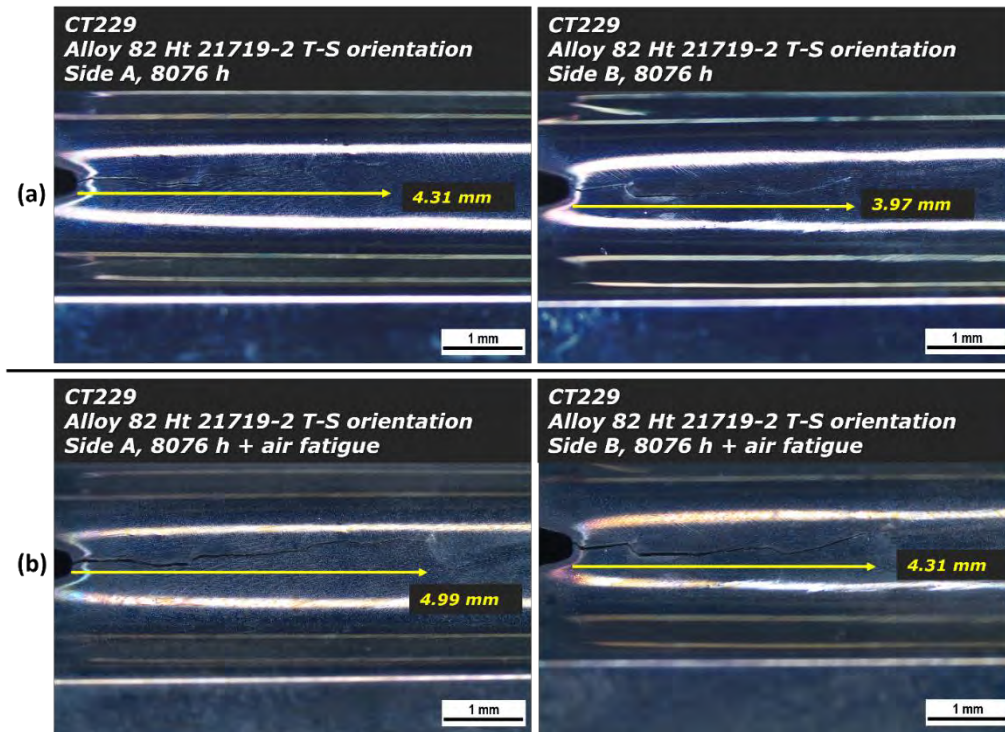
Figure 45. Crack length measurement in the side grooves of CT229 after 8076 hours of testing in 360°C simulated PWR primary water: (a) immediately after the specimen was removed from testing and (b) after additional fatigue in air to grow the crack in the specimen.

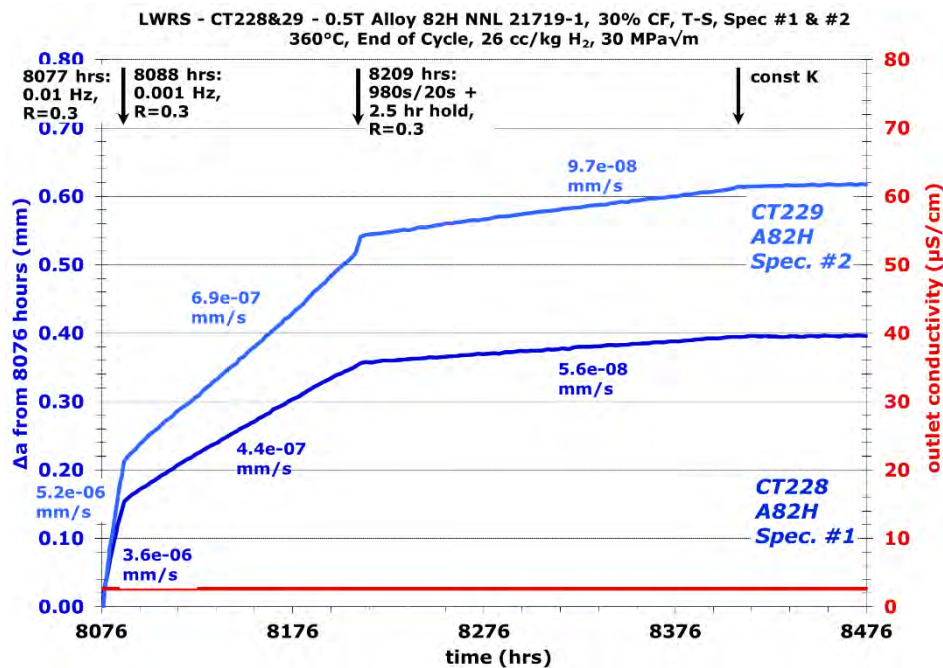
Figure 46. CGR response of CT228 & 229 in transition steps after the specimens were fatigued in air for the 2nd time to adjust the crack length.

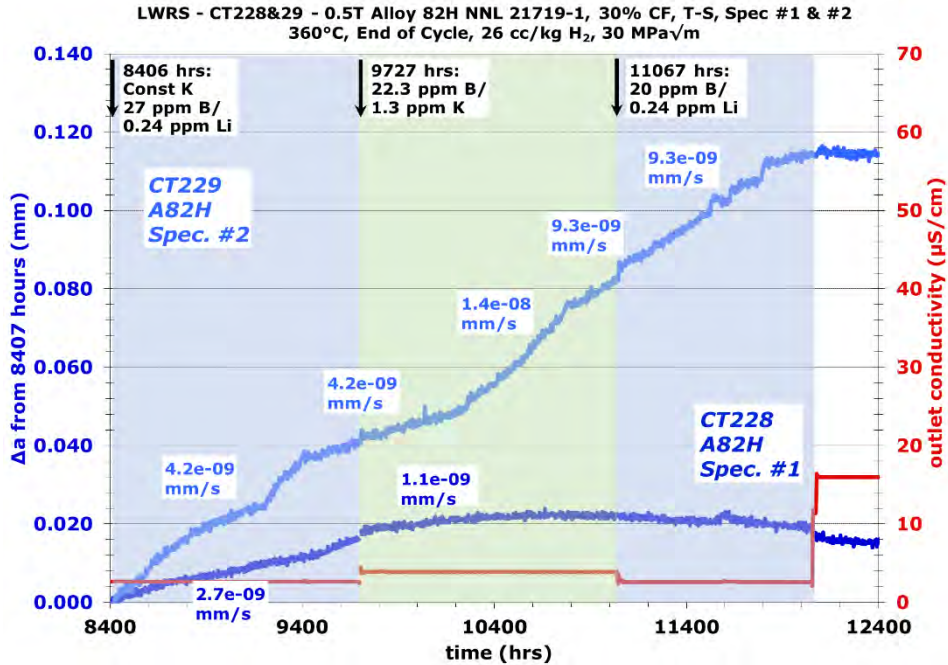
Figure 47. SCCGR response of CT228 & 229 in 360°C PWR primary water EOC chemistry with on-the-fly changes between LiOH and KOH.

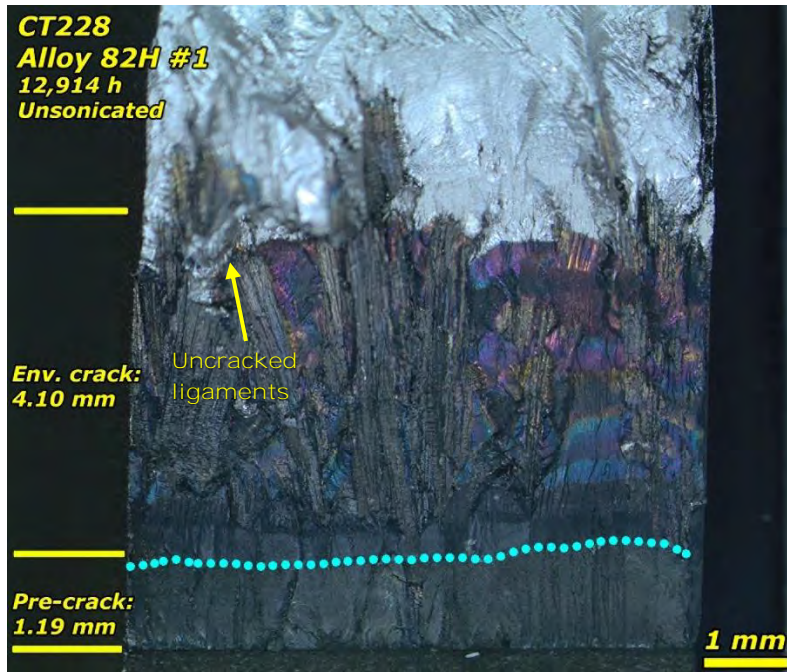
Figure 49. Post-test optical image of the crack growth surface in the 2/3-thickness slice of CT228. The extent of the fatigue pre-crack is highlighted by the blue dotted line. The average pre-crack length and environmental crack length are marked in yellow on the left.

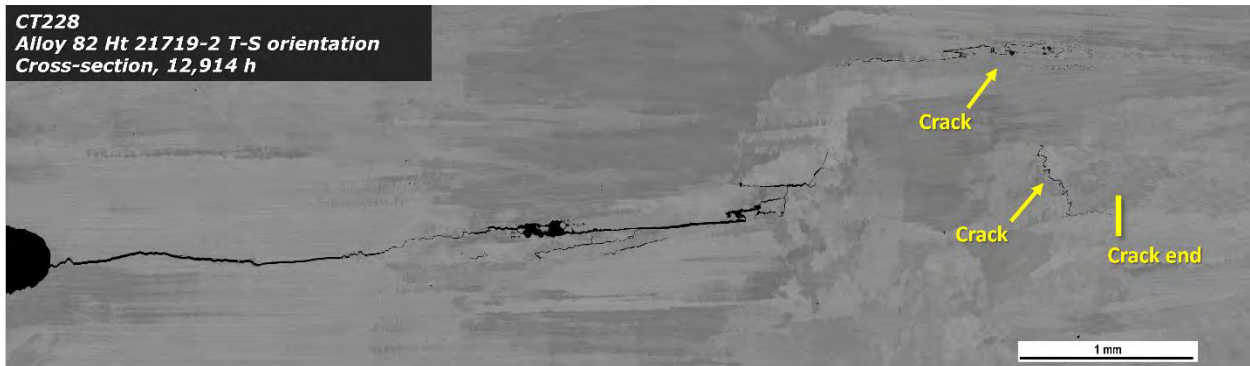
Figure 50. Post-test SEM BSE image showing the crack morphology in the cross-section of the 1/3-thickness slice sectioned from CT228.

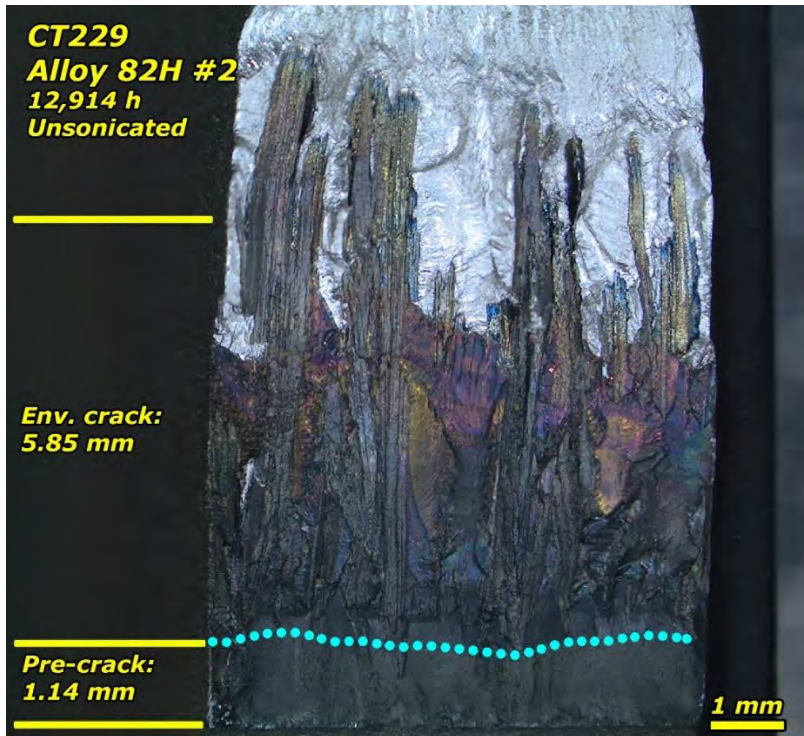
Figure 51. Post-test optical image of the crack growth surface in the 2/3-thickness slice of CT229. The extent of the fatigue pre-crack is highlighted by the blue dotted line. The average pre-crack length and environmental crack length are marked in yellow on the left.

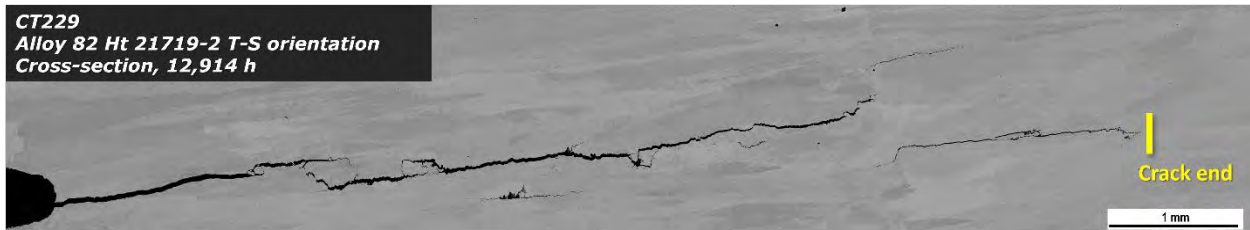
Figure 52. Post-test SEM BSE image showing the crack morphology in the cross-section of the 1/3-thickness slice sectioned from CT229.

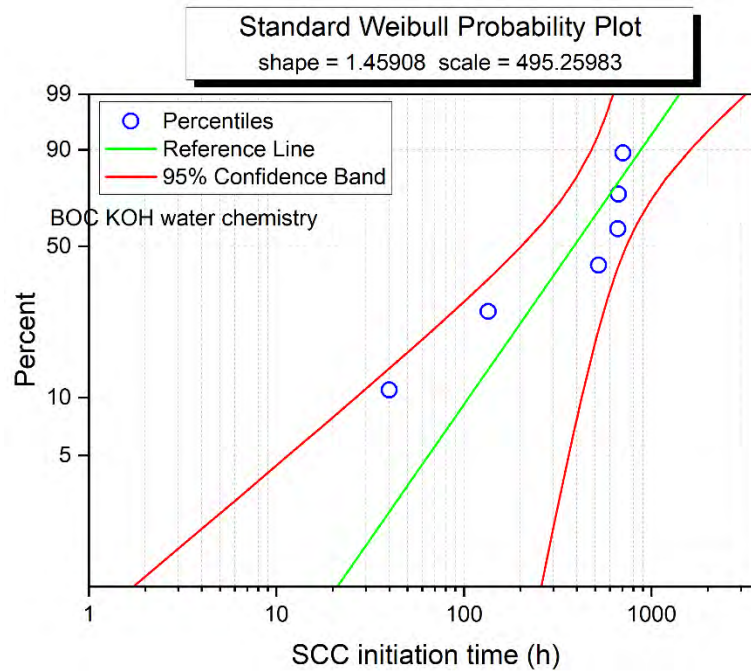
Figure 53. Standard Weibull analysis (cumulative failure vs. hours) with a 95% confidence interval based on the SCC initiation times acquired on Alloy 82 at yield stress in 360°C water with 1500 ppm B and 12.4 ppm K. All six specimens have initiated and are considered failures in this analysis.
