Light Water Reactor Sustainability Program

FY 2023 Progress on Stress Corrosion Crack Testing of Ni-Base Alloys in PWR Primary Water

August 2023

U.S. Department of Energy
Office of Nuclear Energy

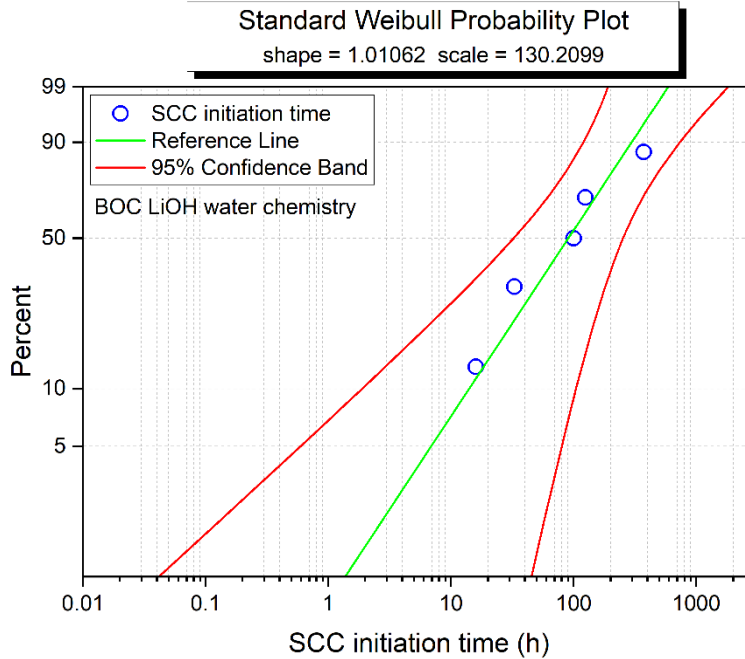
Figure 54. Non-censored (standard) Weibull analysis (cumulative failure vs. hours) with a 95% confidence interval based on the SCC initiation times acquired on Alloy 82 at yield stress in 360°C water with 1500 ppm B and 2.2 ppm Li. This fit only takes into account the five initiated specimens as failures. The non-initiated sample is excluded from this analysis.

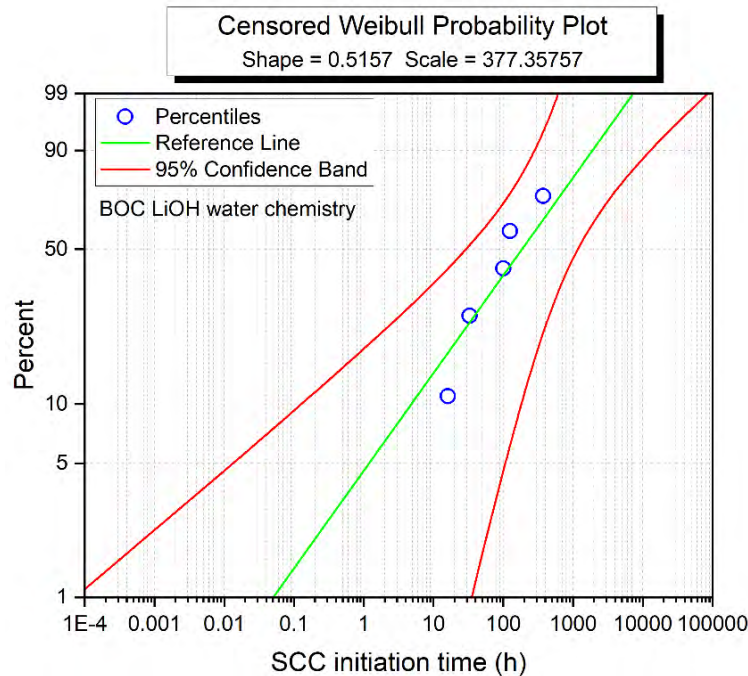
Figure 55. Censored Weibull analysis (cumulative failure vs. hours) with a 95% confidence interval based on the SCC initiation times acquired on Alloy 82 at yield stress in 360°C water with 1500 ppm B and 2.2 ppm Li. Five out of the six specimens have initiated and are considered failures in this analysis. This censored analysis also accounts for the one non-failure event.

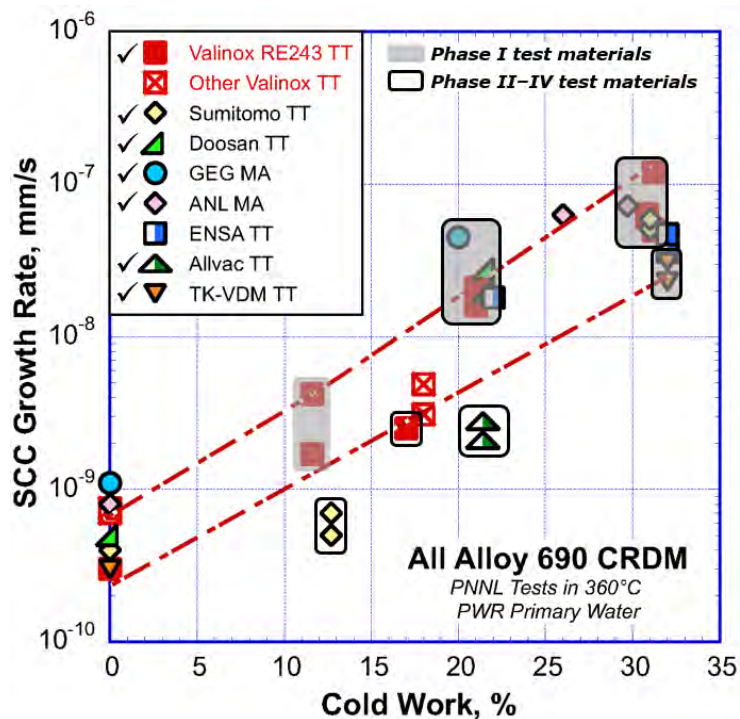
Figure 57. SCCGR response of TT/MA Alloy 690 materials at $\sim 30 \text{ MPa}\sqrt{\text{m}}$ acquired from the NRC SCC crack growth program [7, 22]. The heat and cold work levels selected for SCC initiation evaluation at each stage were checked in the label box and circled in the plots.

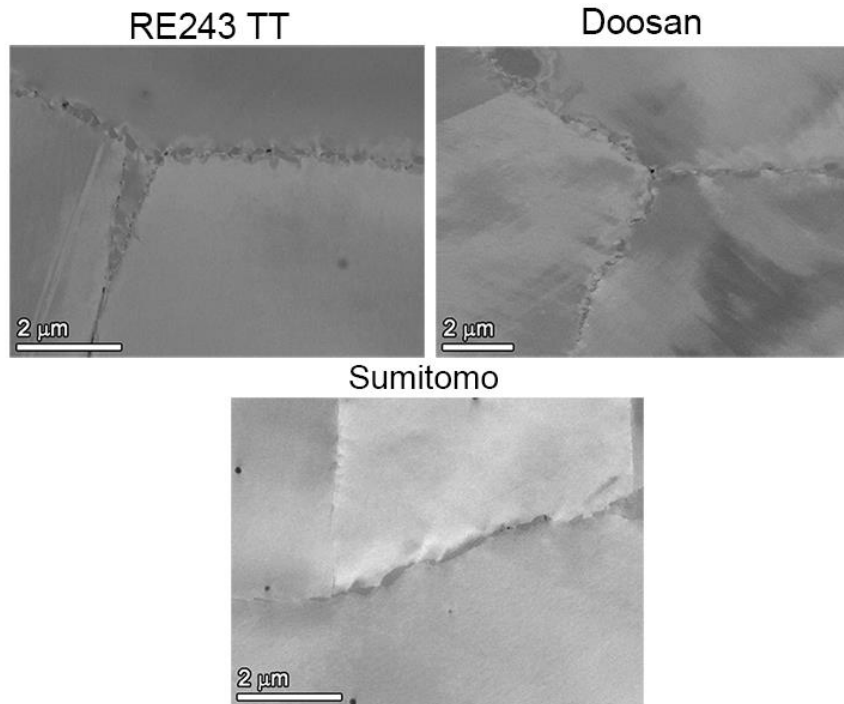
Figure 58. SEM-BSE images illustrating the GB microstructures for the three Alloy 690TT CRDM materials in the as-received condition.

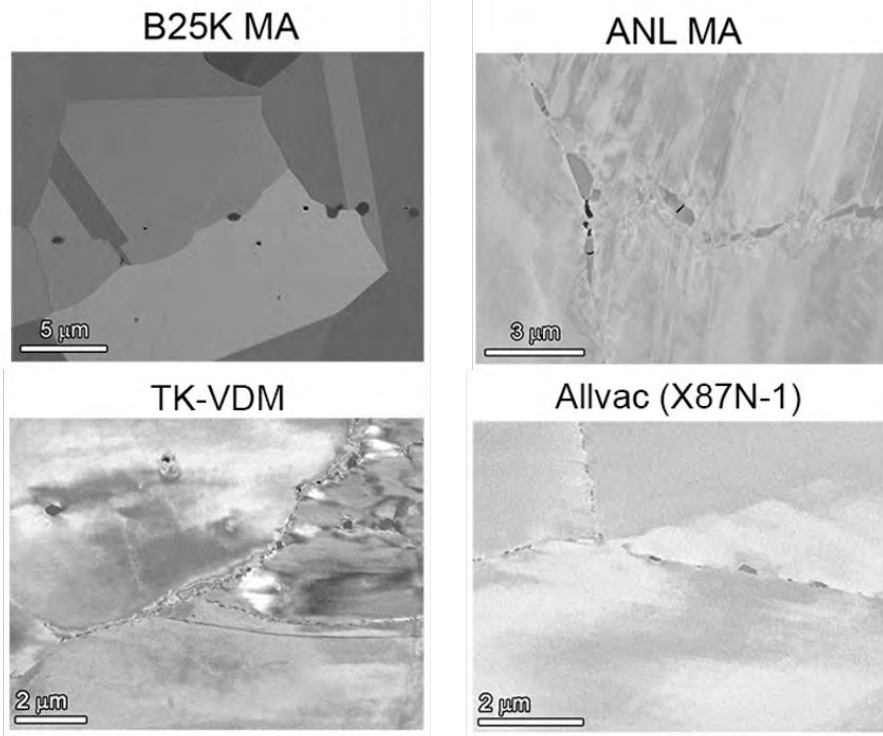
Figure 59. SEM-BSE images illustrating differences in the GB carbide microstructures for each of the four Alloy 690 plate/bar materials in the as-received condition.

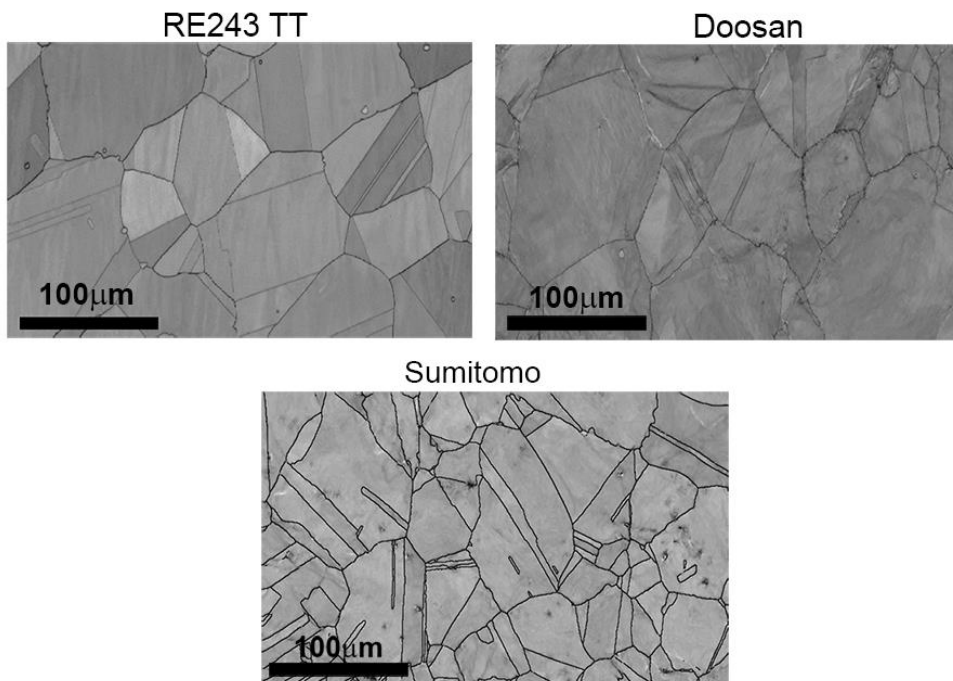
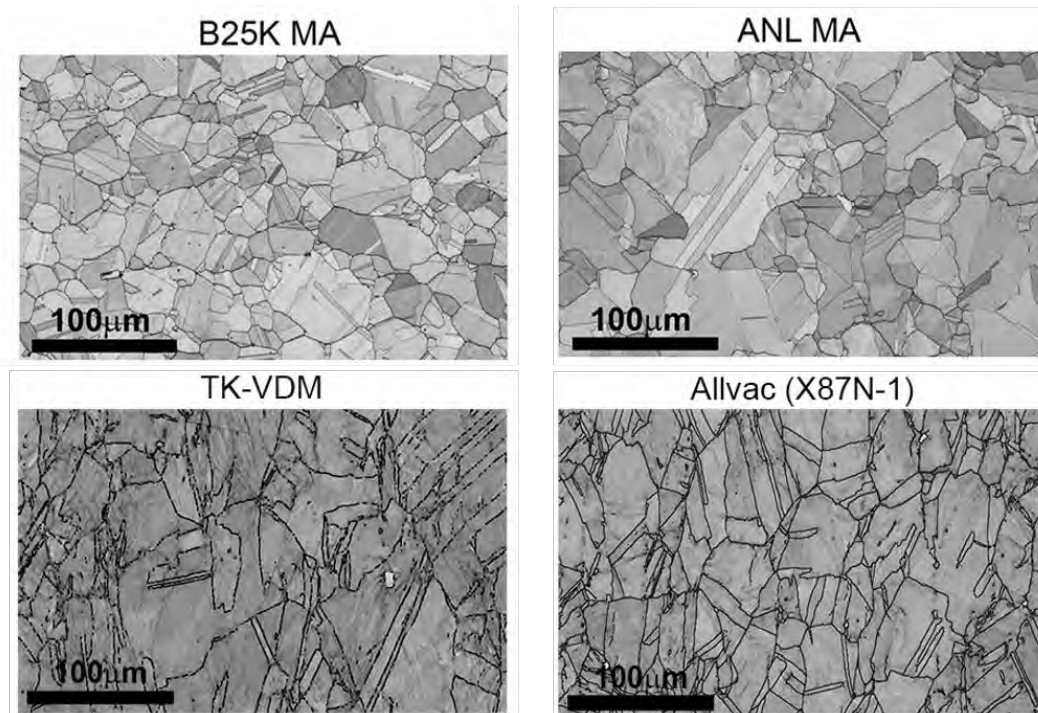
Figure 60. EBSD pattern quality maps showing the general microstructure and grain size for the seven Alloy 690TT/MA materials in the as-received condition.

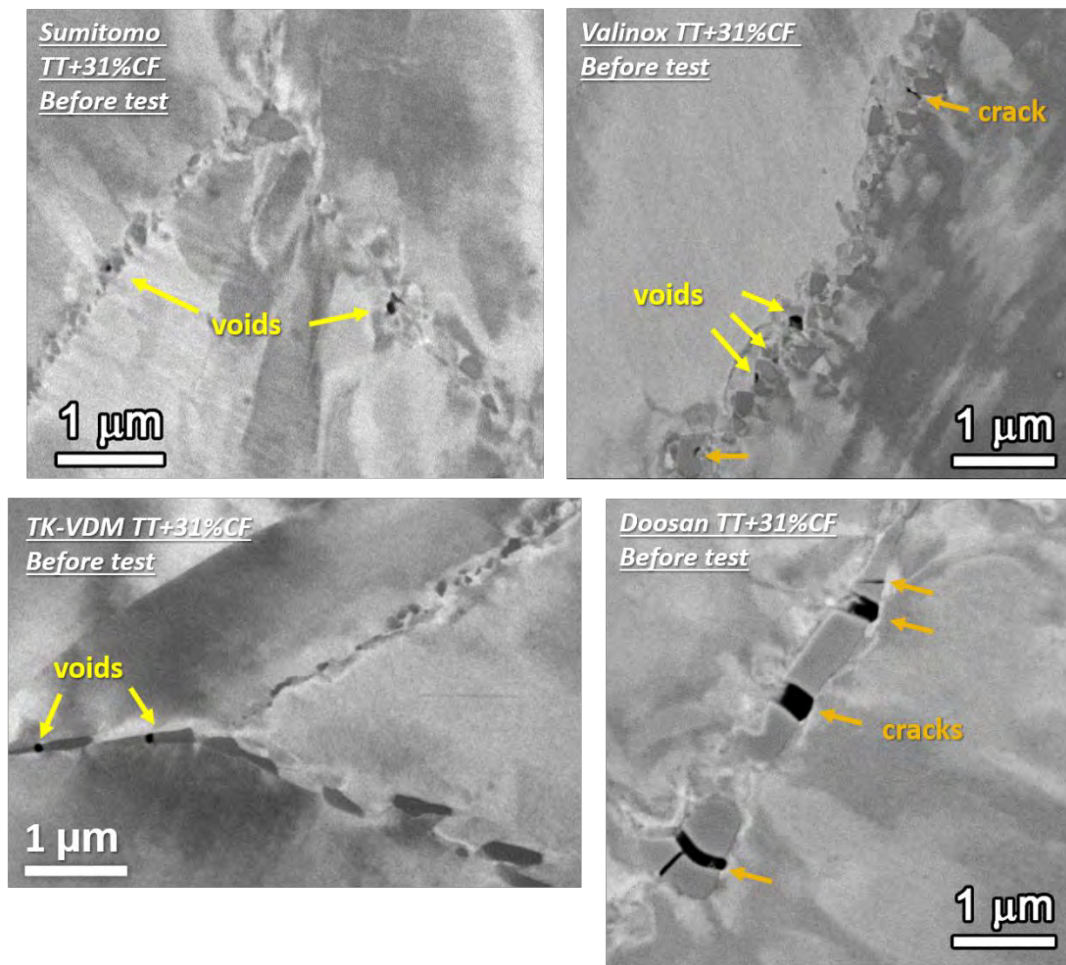
Figure 61. SEM-BSE images illustrating the permanent damage (highlighted by arrows) induced by cold work in four 31%CF Alloy 690TT materials. All images are shown at the same scale.

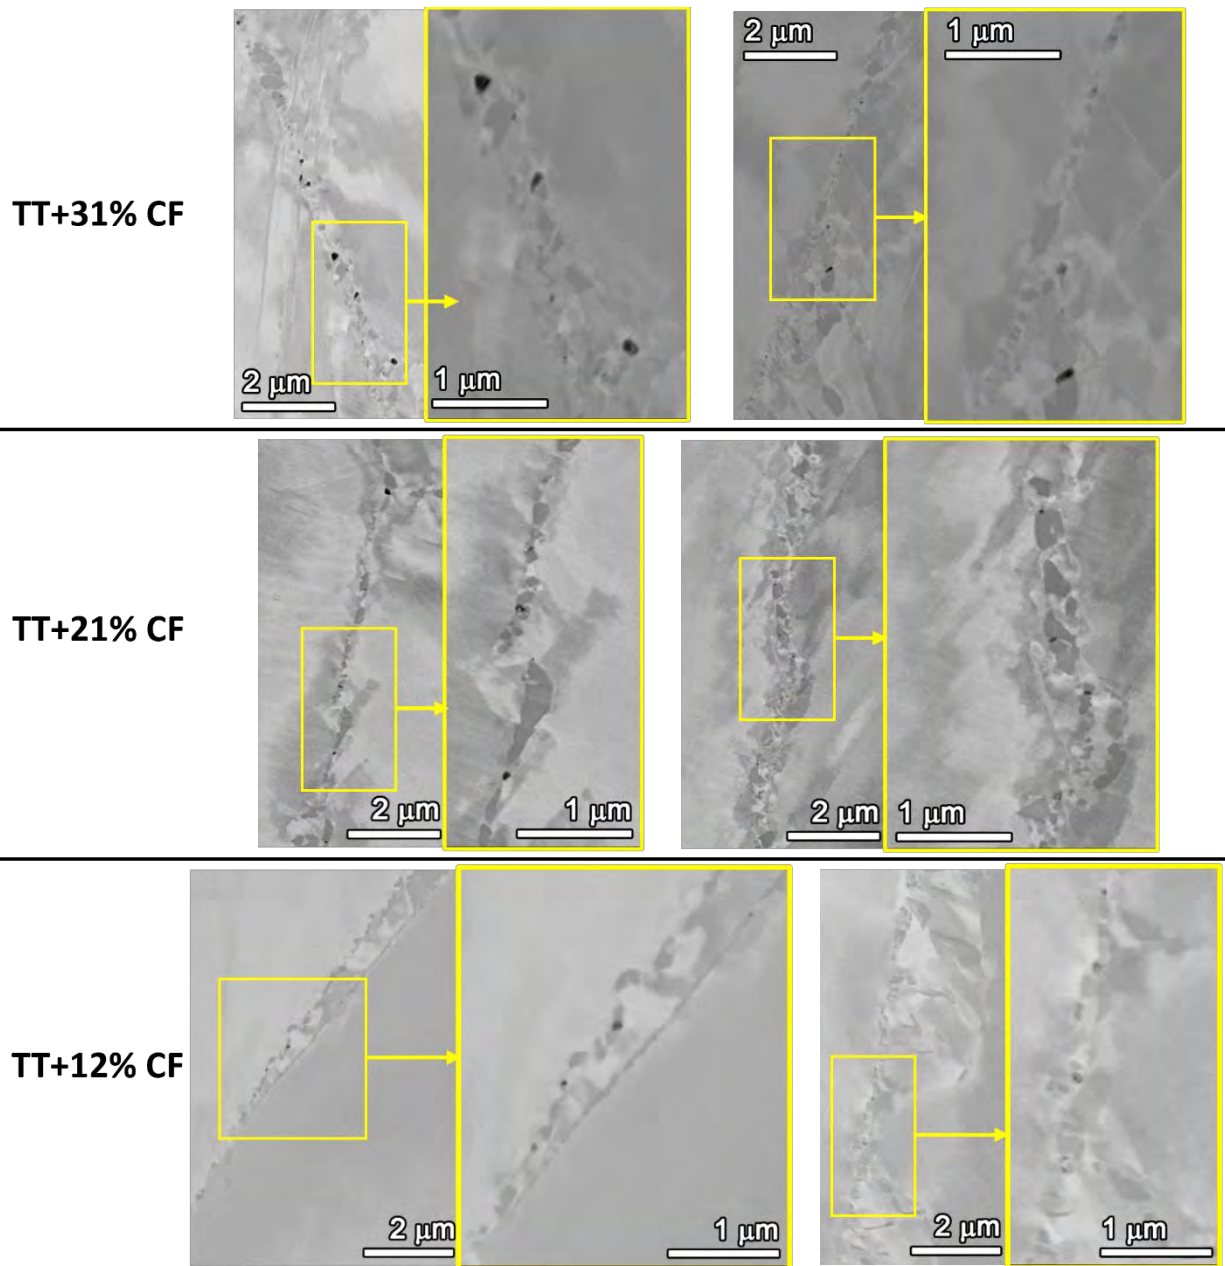
Figure 62. Representative pre-existing defect distribution in the thermally treated Valinox CRDM material cold forged to 12, 21, and 31% reduction in thickness.

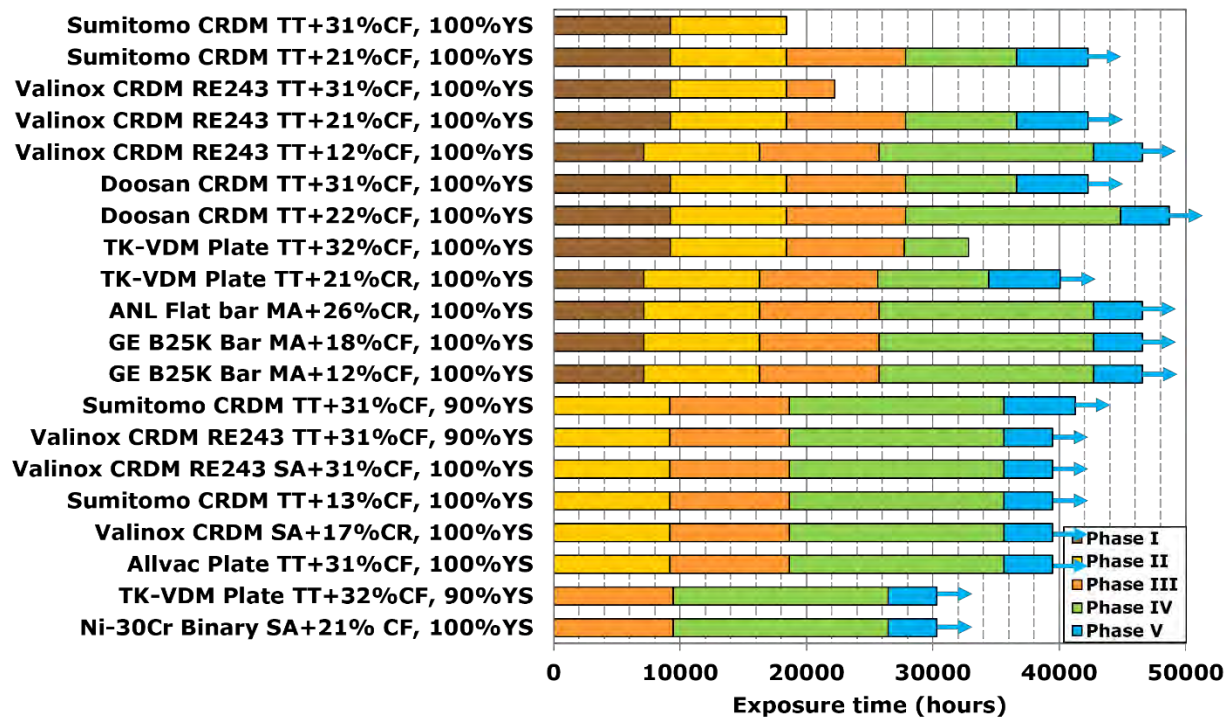
Figure 63. Up-to-date exposure time of the CW Alloy 690 materials evaluated in the long-term SCC initiation testing under LWRS. The arrows suggest that the test is ongoing as of August 2023 for the specified material and cold work conditions.

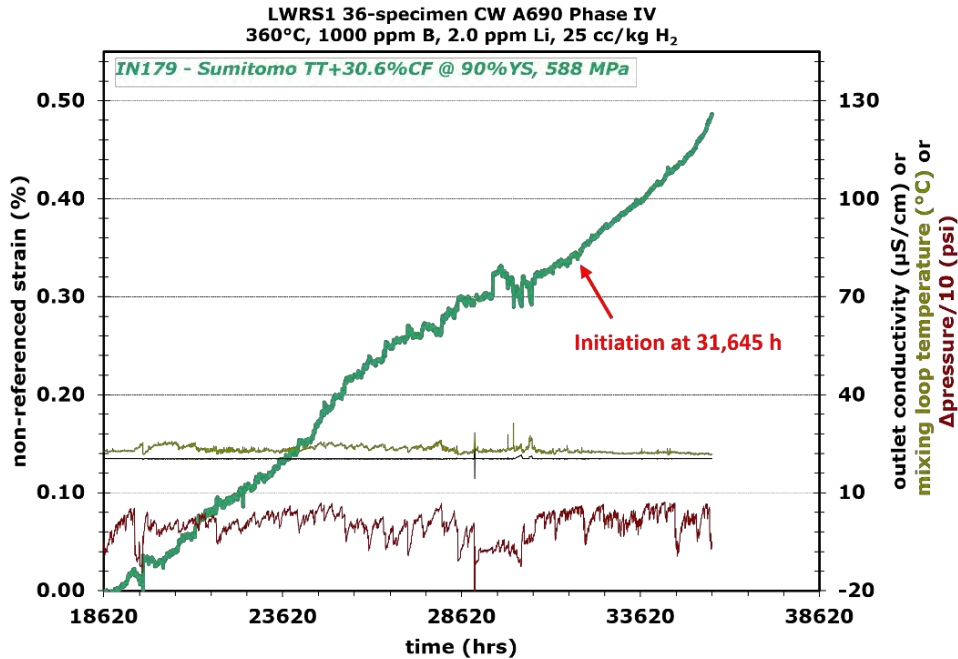
Figure 64. Non-referenced DCPD strain response during the Phase IV exposure, indicating macroscopic crack initiation in the Sumitomo CRDM TT+31%CF specimen IN179 tested at 0.9 YS initiated after 31,645 hours of exposure in 360 °C PWR primary water.

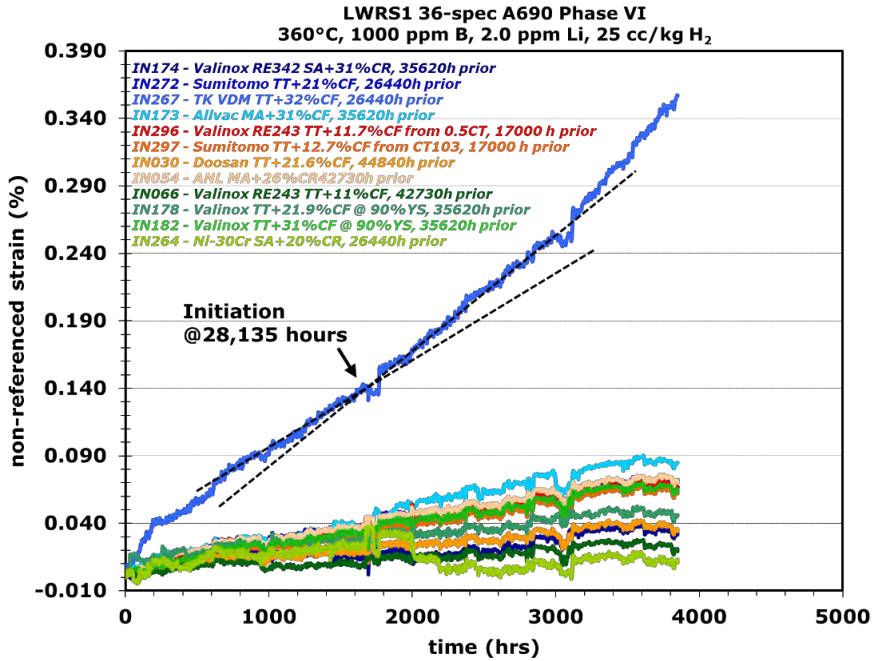
Figure 65. Overall non-referenced DCPD strain response during the Phase V exposure for all the specimens monitored in the LWRS1 (36-specimen) SCC initiation test system in 360 °C PWR primary water. The test is ongoing as of August 2023. Specimens are all being tested at materials yield stress unless otherwise specified.

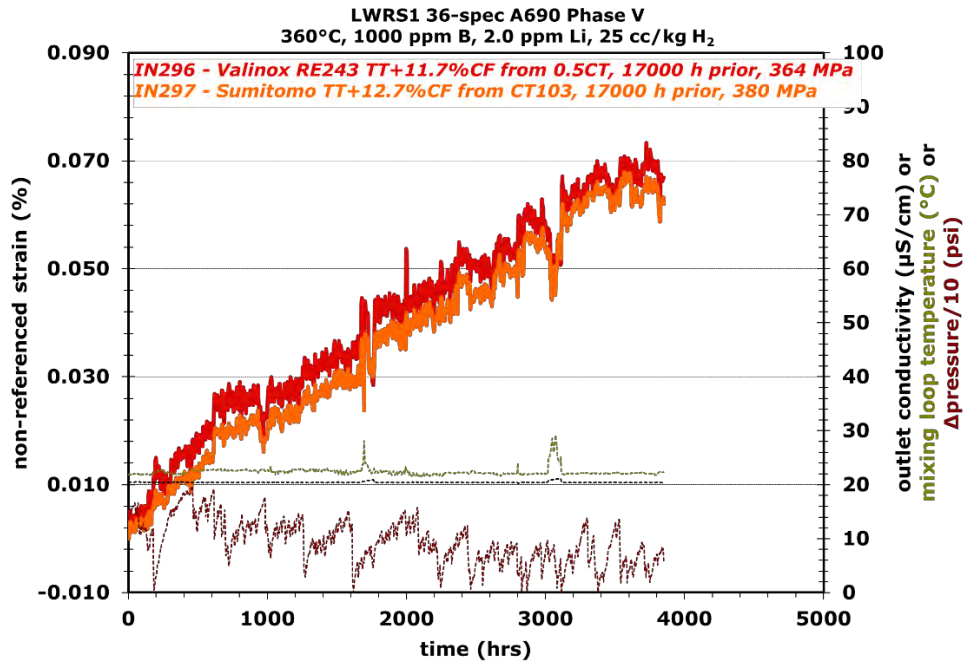
Figure 69. Non-referenced DCPD strain response during the Phase V exposure for the specimens introduced in Phase IV and monitored in the LWRS1 (36-specimen) test system in 360 °C PWR primary water. The test is ongoing as of August 2023.

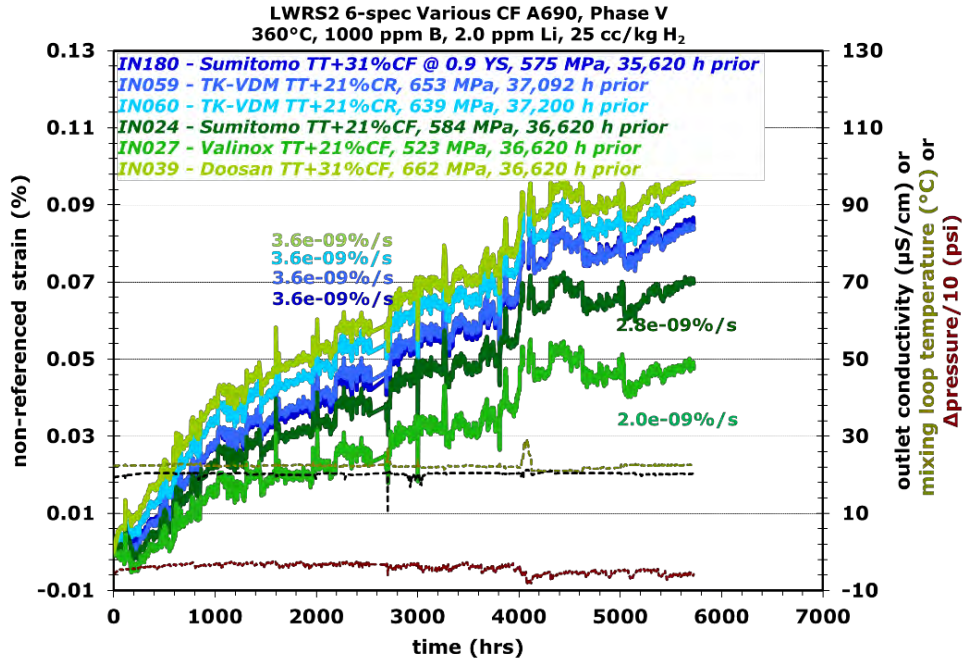
Figure 70. Overall non-referenced DCPD strain response during the Phase V exposure for all the specimens monitored in the LWR2 (6-specimen) SCC initiation test system in 360 °C PWR primary water. The test is ongoing as of August 2023.

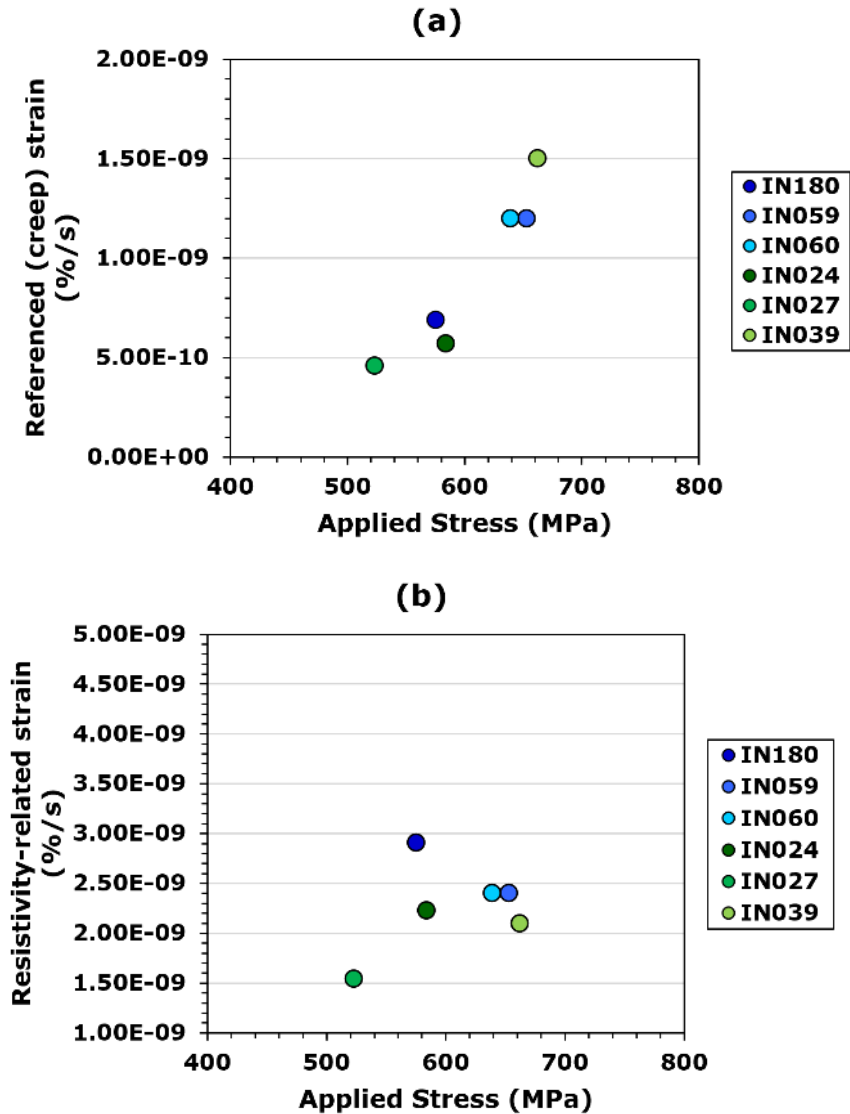
Figure 72. (a) Creep strain rates and (b) resistivity evolution as a function of applied stress of the six specimens tested in LWRS2. The strain rates were calculated based on their DCPD response up to ~5830 hours of exposure during Phase V. The test is ongoing as of August 2023.

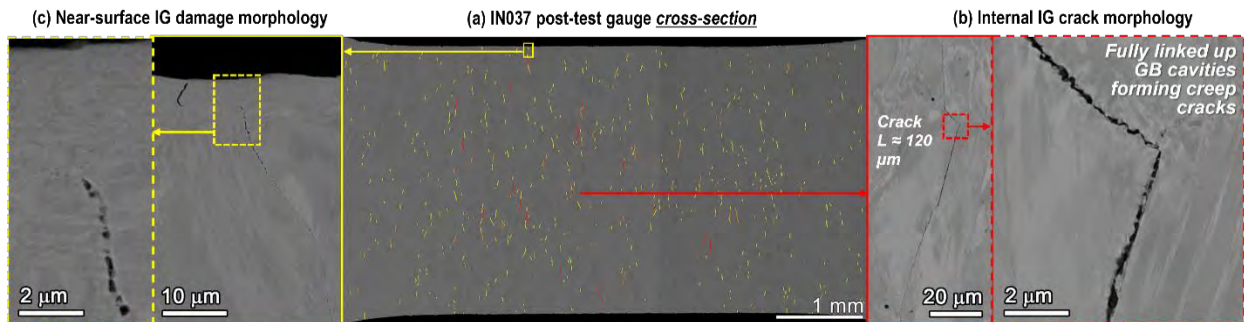
Figure 73. SEM-BSE images of (a) the gauge cross-section of the TT+31% CF Valinox CRDM specimen IN037 removed after DCPD detected crack initiation. Aggregations of GB cavities are highlighted in yellow and continuous IG cracks in red, with higher magnification IG damage examples (b) inside the specimen and (c) near the surface.

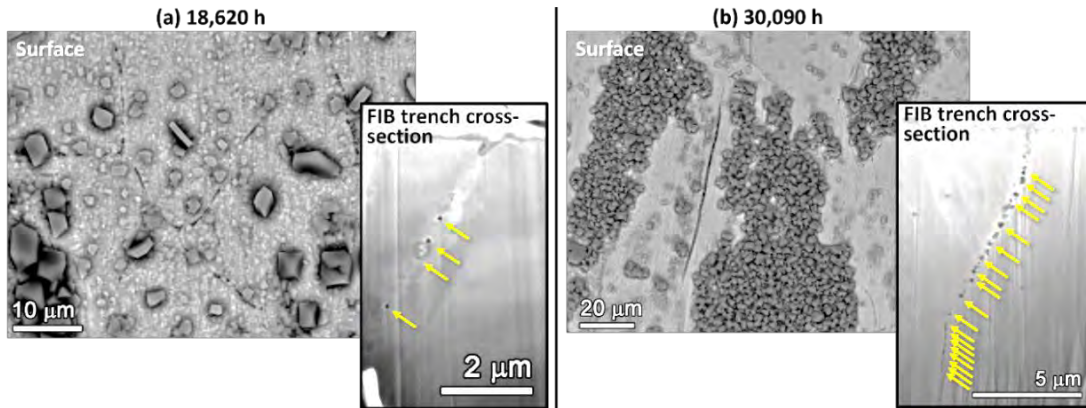
Figure 74. SEM-BSE images of the representative surface and cross-section morphology of IG damage found in the TT+31% CF Sumitomo CRDM specimen IN179 after 2.1 (left) and 3.4 (right) years of exposure in 360°C simulated PWR primary water. GB cavities are highlighted in yellow in the FIB trench cross-sections.

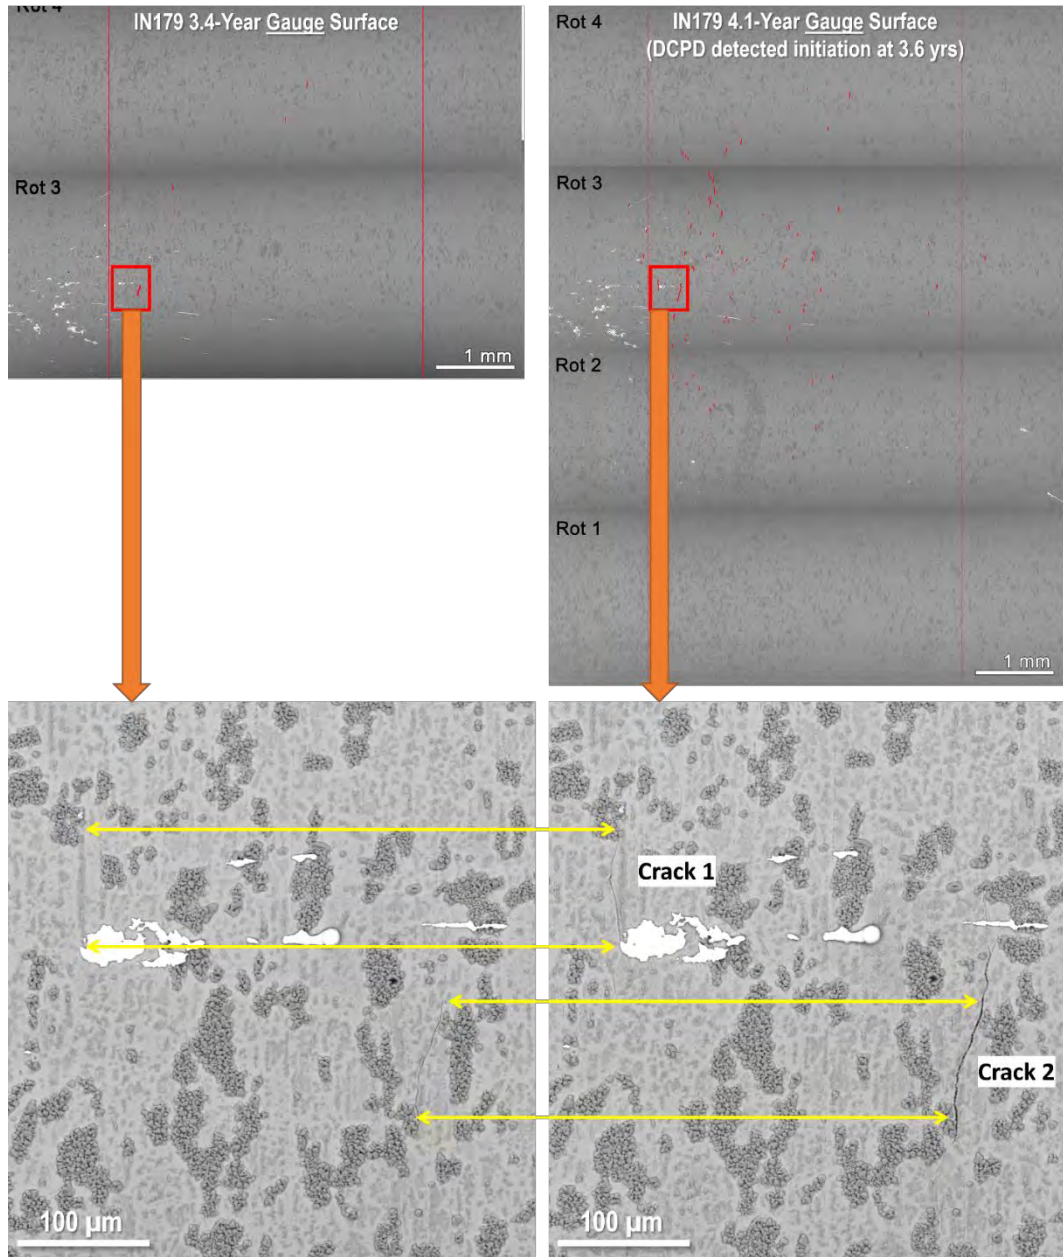
Figure 75. SEM-BSE montage images of the evolution of surface-breaking IG cracks (highlighted in red) found on the gauge surface of the TT+31% CF Sumitomo CRDM specimen IN179 before (left) and after (right) DCPD detection of crack initiation.

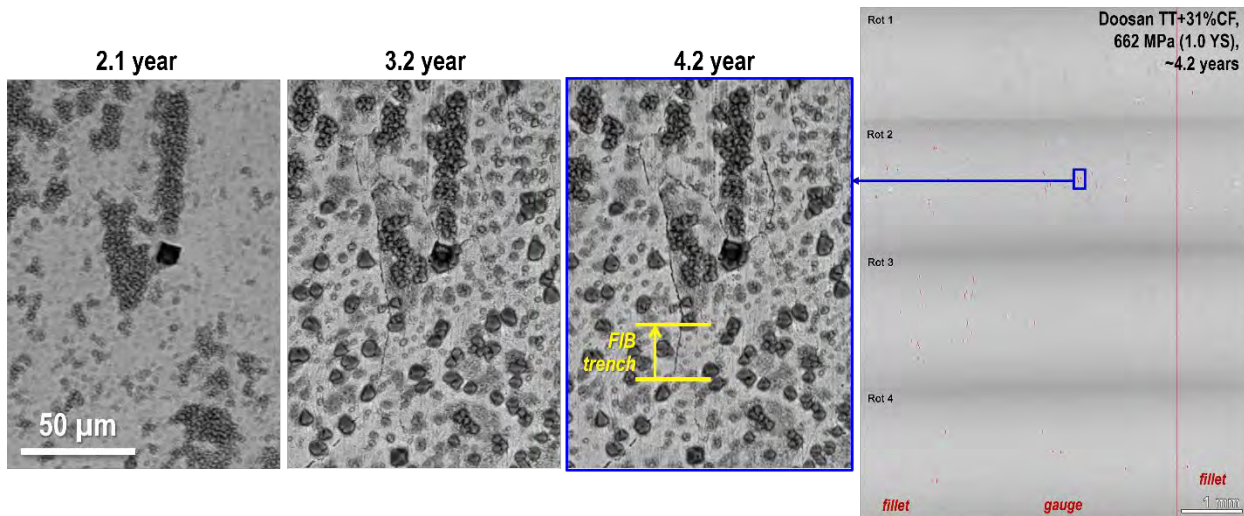
Figure 76. SEM-BSE montage images of the IG cracks (marked in red) observed on the TT+31% CF Doosan CRDM specimen IN039 after 4.2 years of exposure in 360°C simulated PWR primary water (right). The surface morphology evolution of the IG crack found after 4.2 years at the marked site is also presented (left).

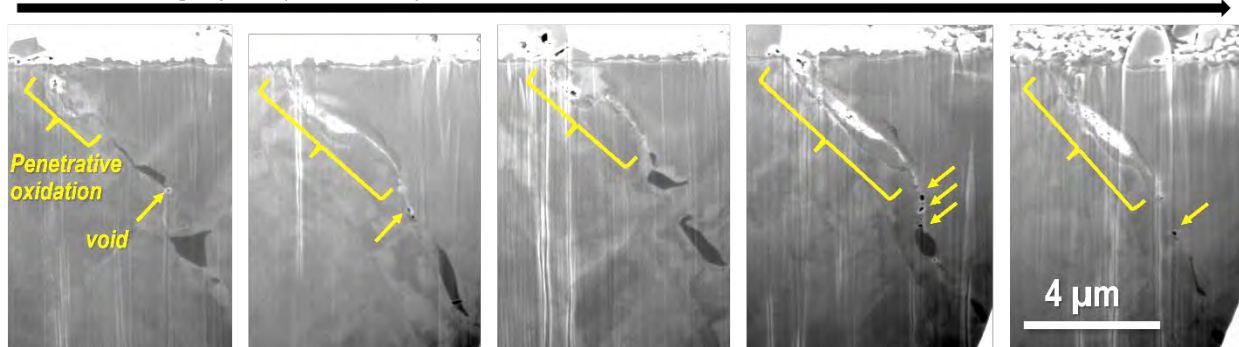
Figure 77. Low-kV FIB-SE images taken during FIB serial milling on the IG crack highlighted in Figure 76 in the TT+31% CF Doosan CRDM specimen IN039 after 4.2 years of exposure at 100% yield stress in 360°C simulated PWR primary water.

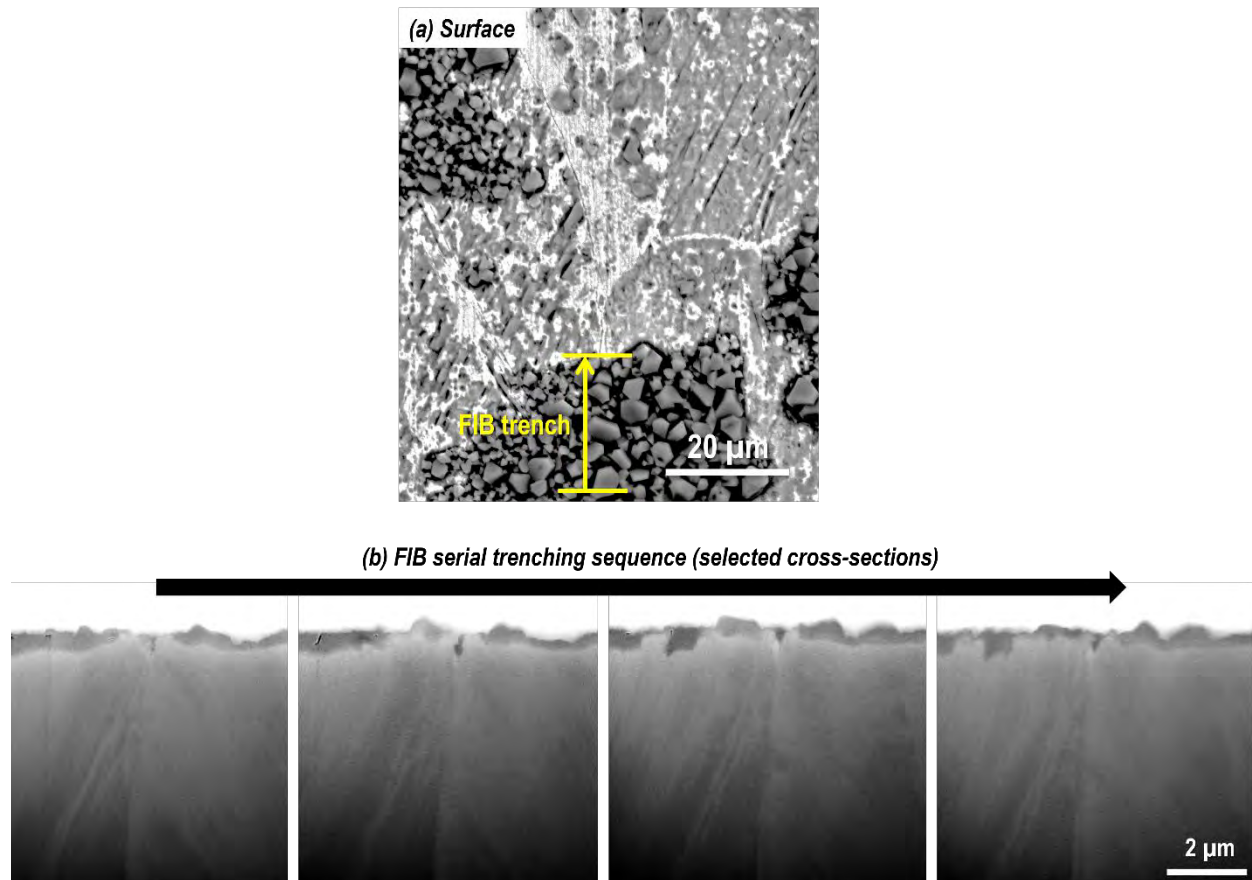
Figure 78. (a) SEM-BSE image of representative surface morphology of the HAGBs in the SA+31%CF Valinox CRDM specimen IN175 after 4.1 years of exposure at 100% yield stress in 360°C simulated PWR primary water. (b) Low-kV FIB-SE images taken during FIB serial milling on a segment of HAGB highlighted in (a).

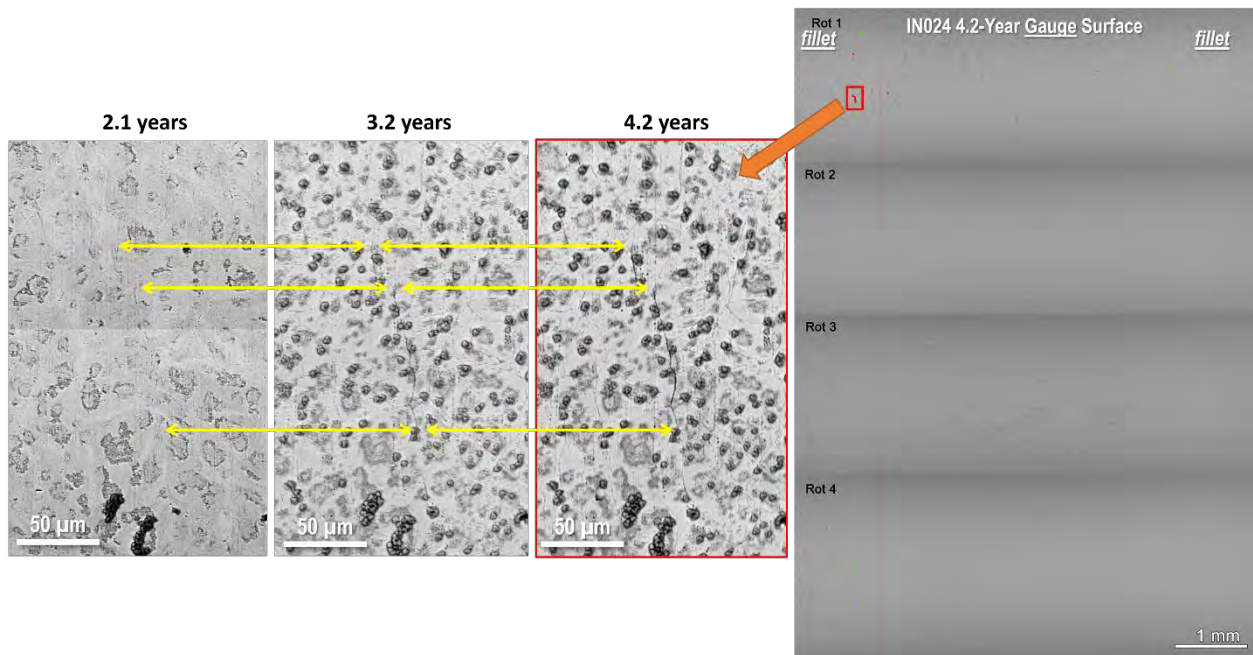
Figure 79. Distribution of surface-breaking IG cracks (marked in red) and possible cracks (marked in green) observed on the gauge surface of the TT+21% CF Sumitomo CRDM specimen IN024 tested at 100% YS after 4.2 years of exposure in 360°C simulated PWR primary water (upper right). Higher-magnification SEM-BSE images are also shown for the evolution of IG damage on a selected site from 2.1–4.2 years of exposure.

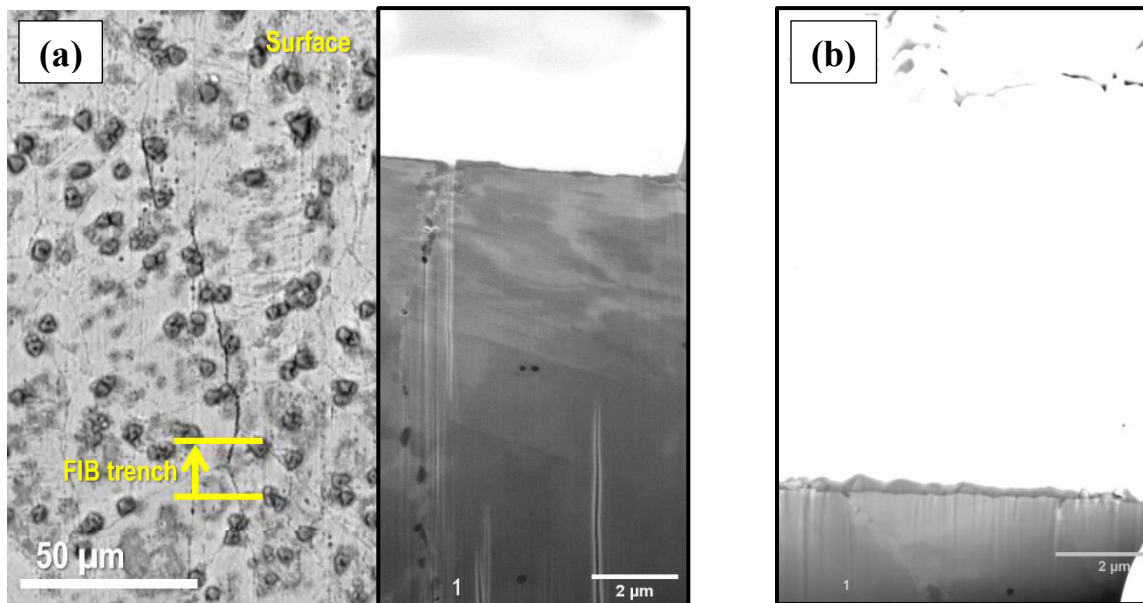
Figure 80. Low-kV FIB-SE images taken during FIB serial milling on (a) the IG crack identified in Site 1 in Figure 81 and (b) a random HAGB without surface-breaking crack in the gauge section of the 1 μm finish, TT+21%CF Sumitomo CRDM specimen IN024 tested at 100% YS after Phase IV (4.2 years) exposure in 360°C simulated PWR primary water.
