# Light Water Reactor Sustainability Program

## Progress in Characterizing Naturally- Aged Nuclear Power Plant Cables

May 2016

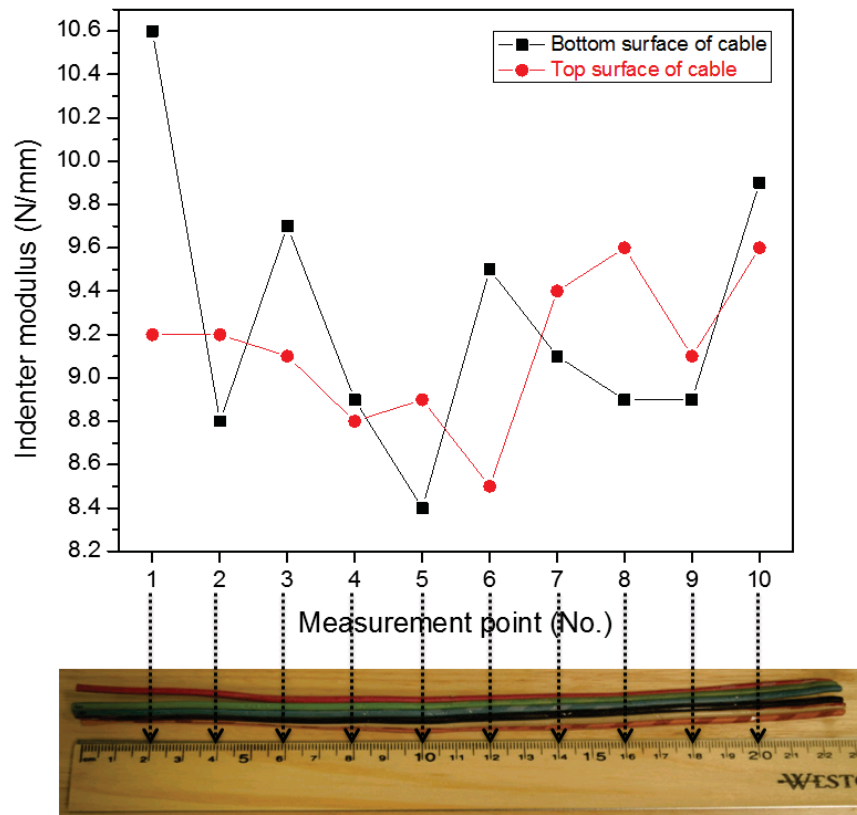
Figure 9. IM results as a function of location along individual conductors

The indenter modulus of each of the individual jacketed insulated conductors was measured prior to removal of the metal conductor strands. Figure 12 shows IM values along individual conductors and Figure 13 show average IM values for several color-coded conductors.

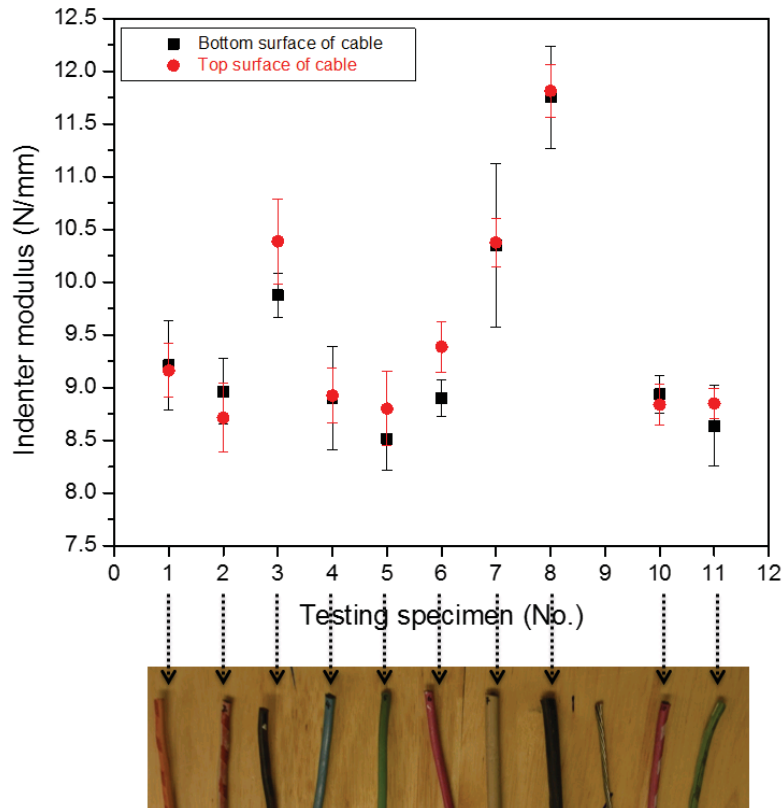
Figure 10. Average IM results of some of outer ring conductors

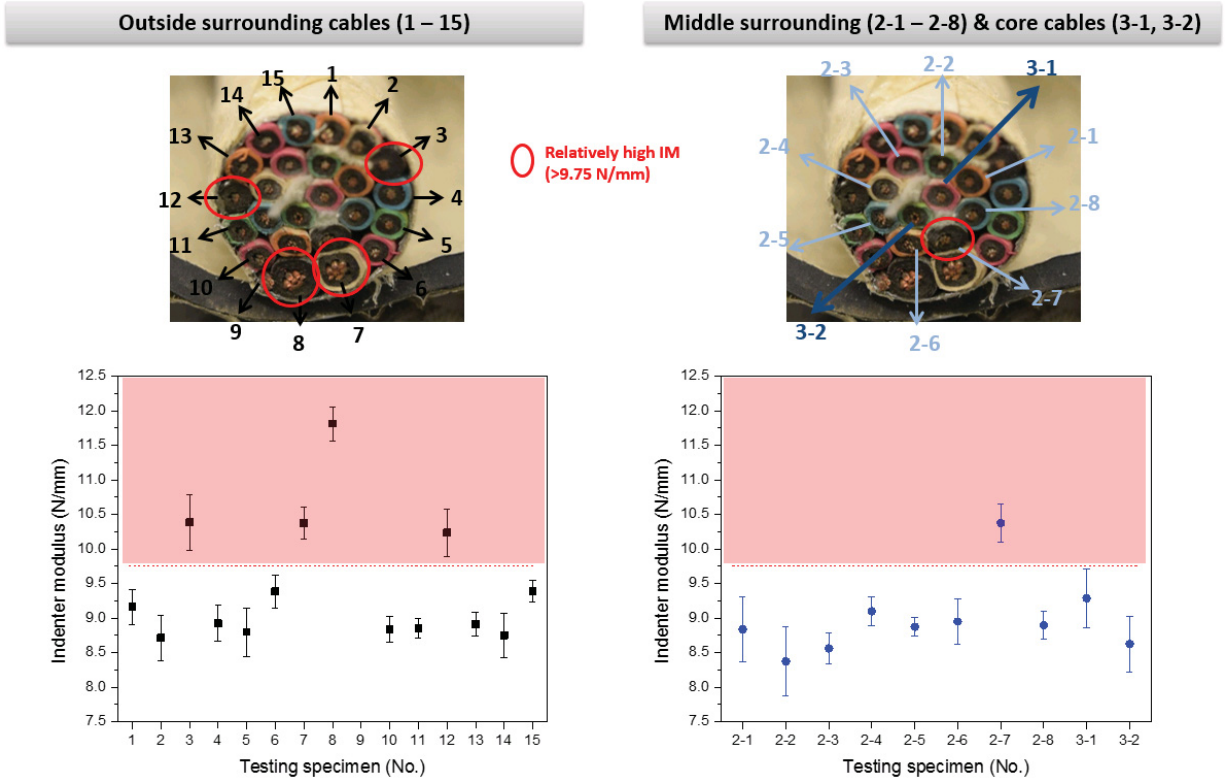
Figure 11. Average IM values for conductors with high IM values indicated

It is noted in Figures 14 and 15 that certain of the individual conductors exhibit reproducible differences in IM and density. The two larger, 12 gauge conductors, for instance, express higher IM and lower density values compared to the other conductors. These differences may be due to formulation or construction differences. The conductors with black colored individual jackets, 3 and 12, feel stiffer and

consistently measure as higher IM. The conductors with orange colored individual jackets registered lower density, but only for those in the outer ring, 1 and 13, not for those in the middle ring, 2-1 and 2-6.

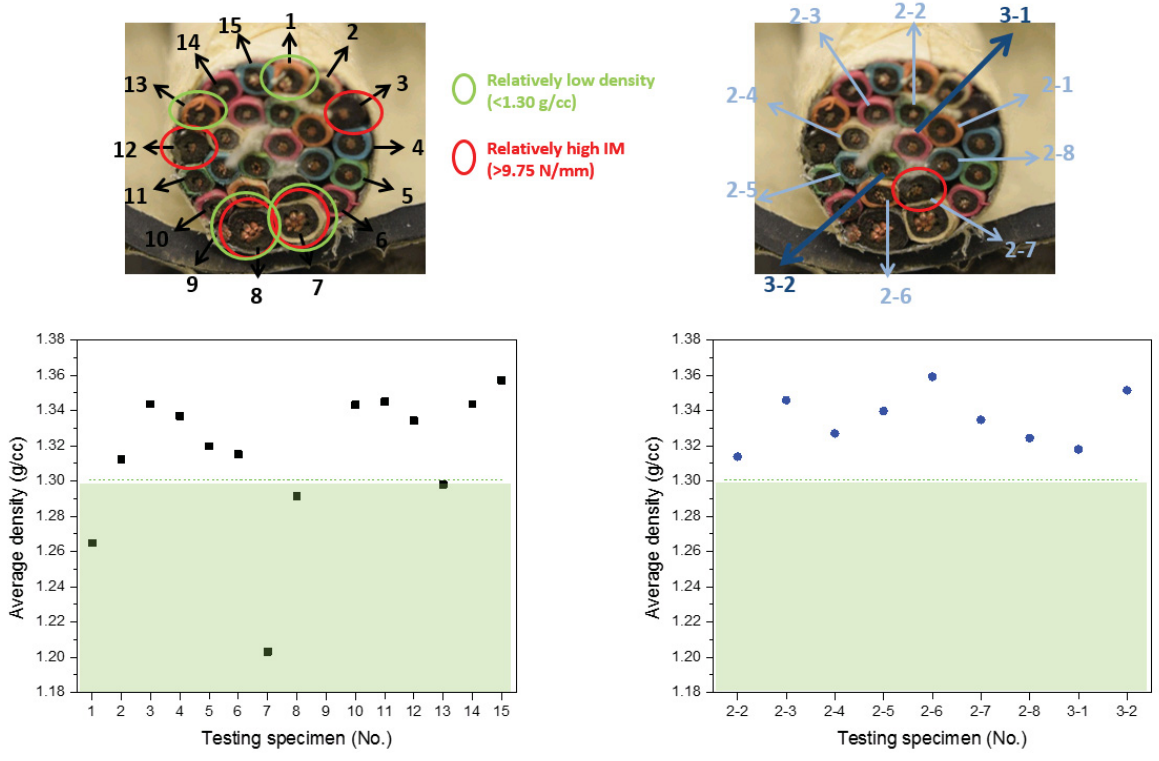
Figure 12. Individually jacketed insulation densities with low density values indicated

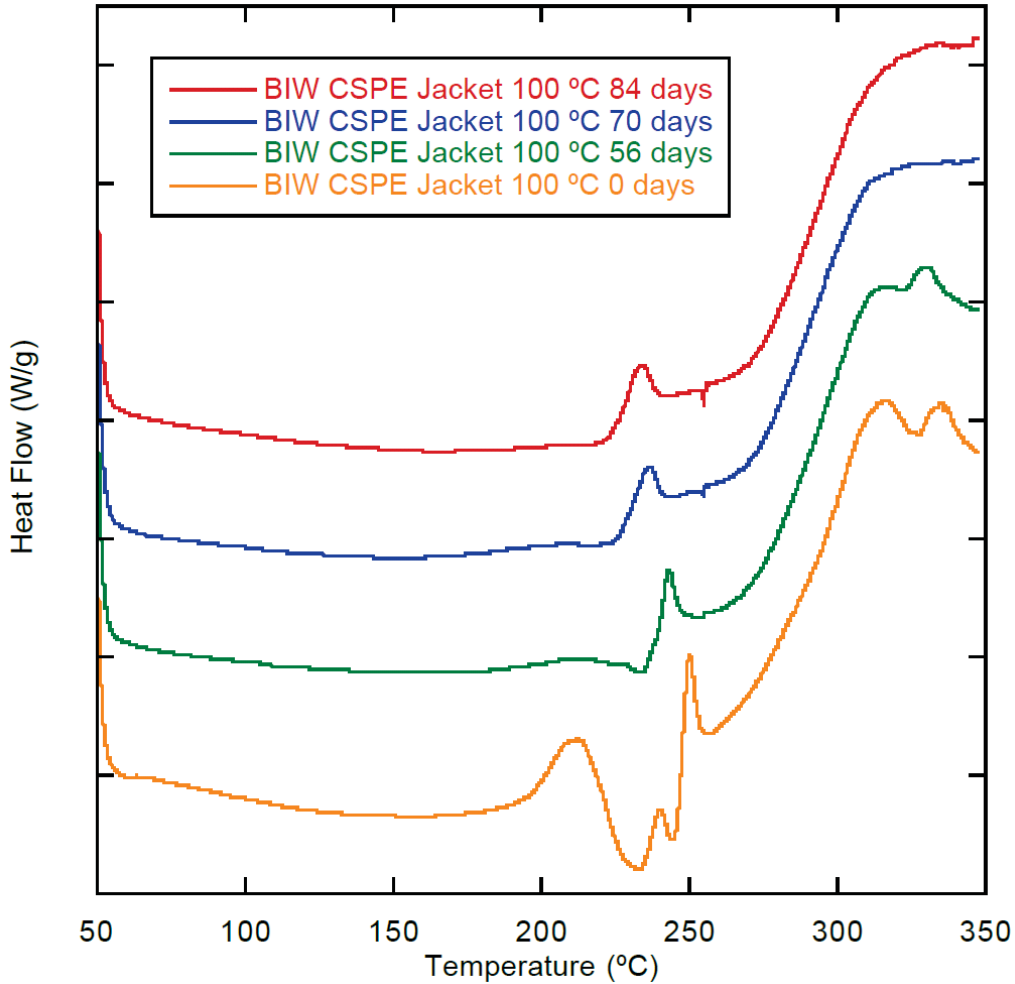
Figure 17. OITP curves for a series of samples exposed at 100°C for 0, 56, 70, and 84 days

Portions of the CSPE jacket were exposed to additional laboratory thermal aging by the laboratory of Dr. Robert Duckworth at ORNL. OITP analysis of these samples show changes with aging, as seen in Figure 20. Note OITP curve feature locations are summarized in Table 5.

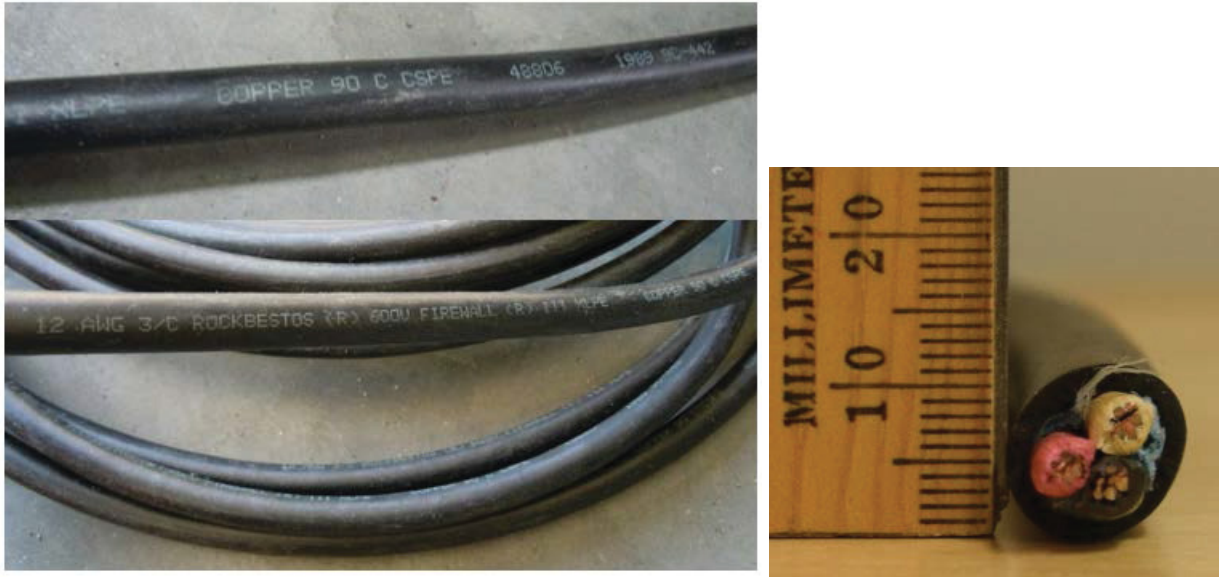
Figure 18. ROCKBESTOS® 600V FIREWALL® III XLPE cables and cross-section

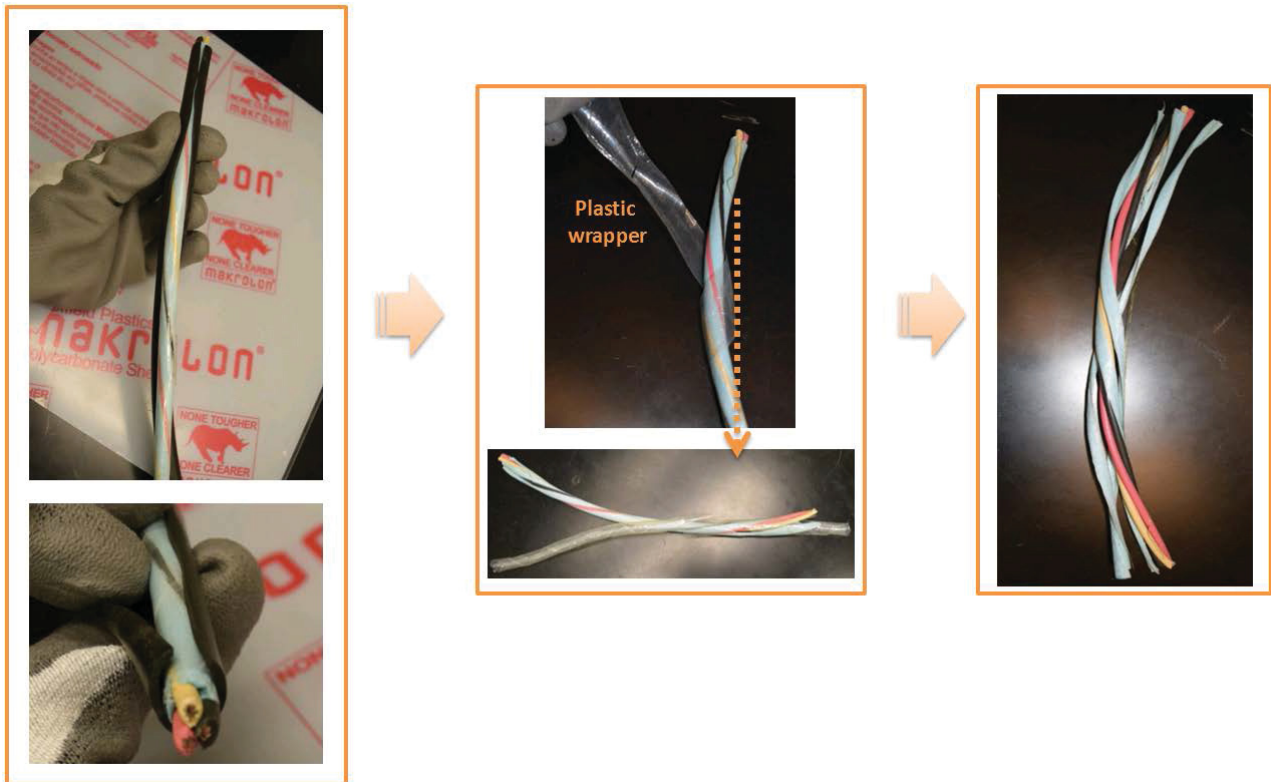
Figure 22. The FWIII cable consists of a CSPE jacket, 3 conductors, and no shield

Construction of the unshielded, three conductor FWIII cable is observed in Figures 25 and 26.
