SCC Initiation in Alloy 600 and Alloy 690

*Presentations at the EPRI Alloy 690/152/52
Collaborative Research Meeting*

PNNL Status on ICG-EAC PWSCC Initiation Round Robin Testing

Grain Boundary Damage Evolution and SCC Initiation in Cold-Worked Alloy 690 Exposed to High-Temperature PWR Primary Water

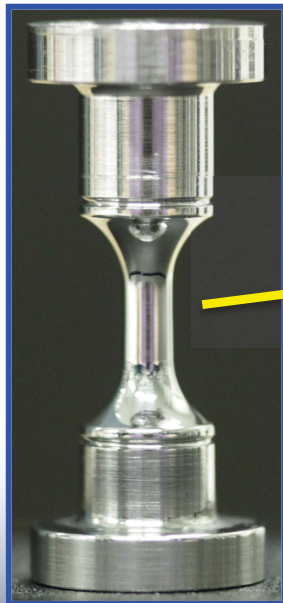
**1.2" Tall SCC
Initiation Specimen**

- Tensile specimen: uniform, easily determined stress and strain.
- PNNL 1.2" length matches the height of a 0.5T CT specimen.
- Optimized geometry for DCPD-based detection of initiation
 - Short gauge length and small diameter accentuate DCPD initiation signal.
 - Small gauge dimensions allow complete documentation by SEM.
 - DCPD reference resistivity measured directly on the specimen.
- A range of surface finishes or notches can readily be applied.

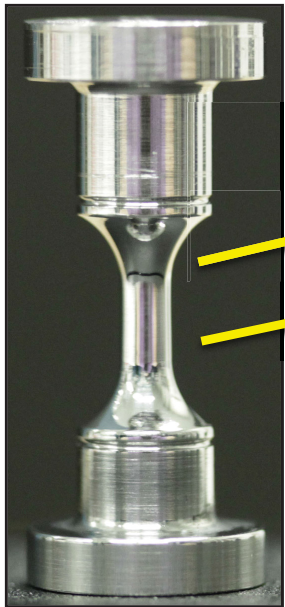
**1.2" Tall SCC
Initiation Specimen**

- *Based on PNNL SCC CGR test systems.*
- *Two systems that can test up to 6 specimens.*
- *One 36 specimen system with up to 12 specimens instrumented for initiation.*
- *All use DCPD for in-situ detection of crack initiation.*

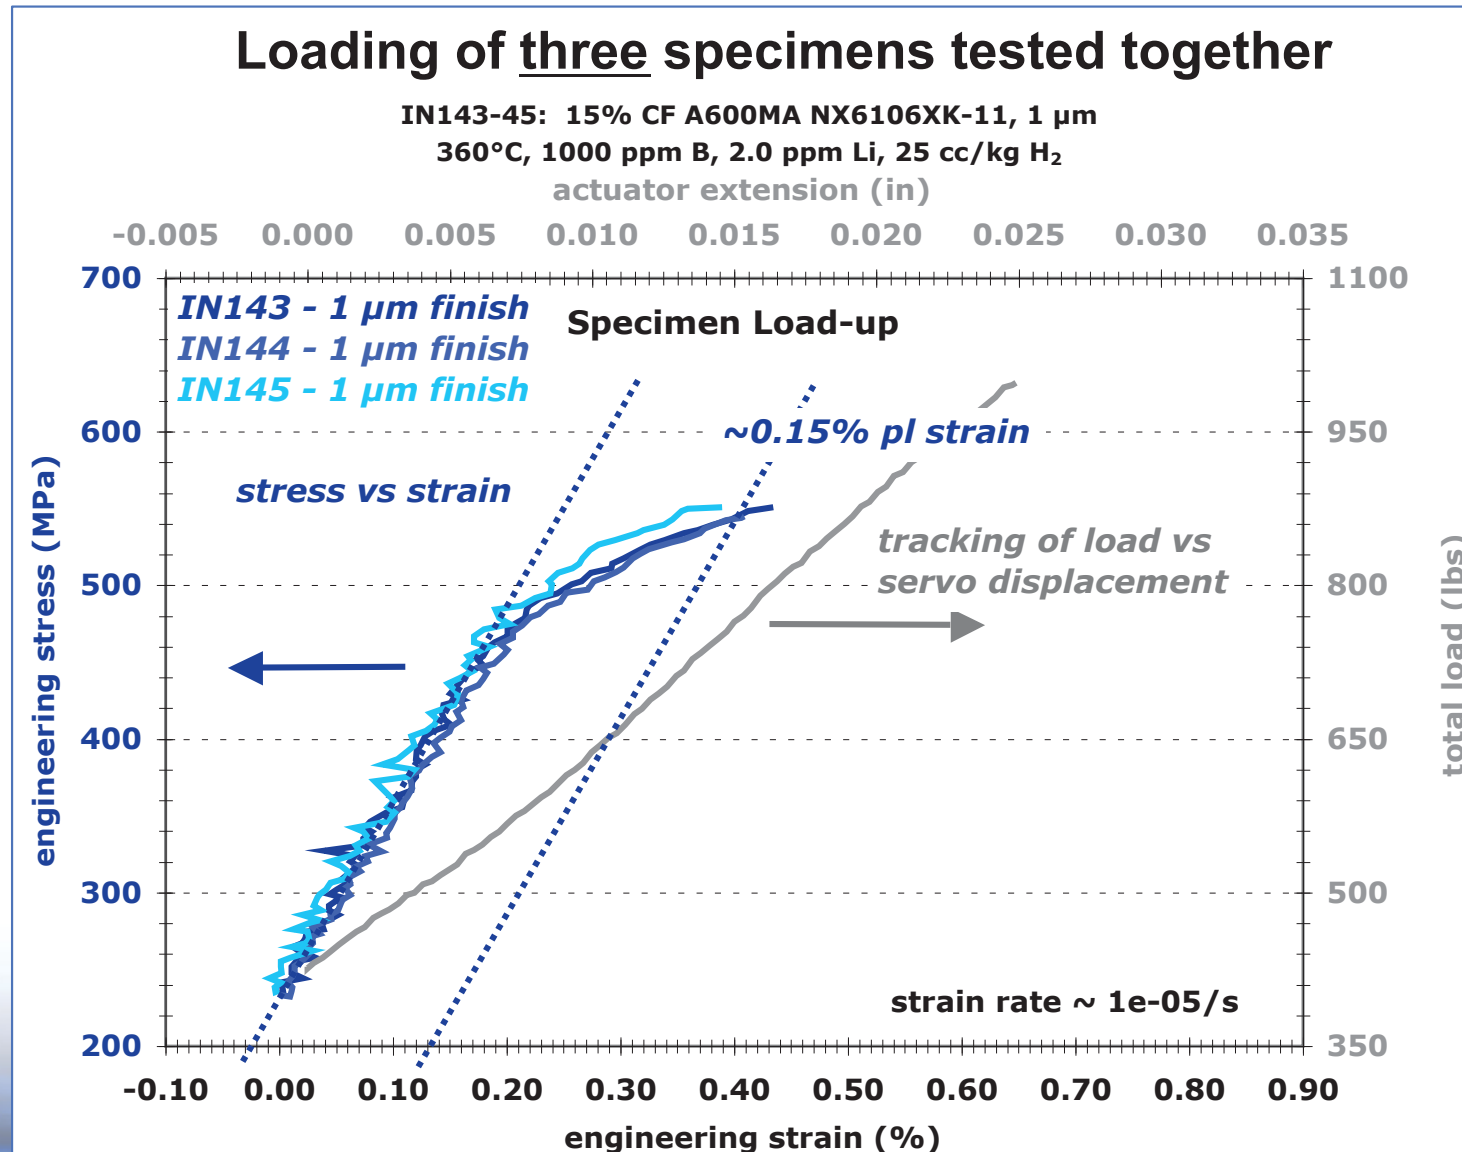
- Gauge section is typically polished to a $1\ \mu\text{m}$ finish to facilitate detection of cracking via surface and cross section examinations.
- Testing typically conducted at the yield strength of the material.
- Confirmation of yield determined by monitoring stress versus strain (from DCPD) at a displacement rate of $\sim 1 \times 10^{-5}\ \text{s}^{-1}$ (~ 1 hour to load).
- Loading typically stopped at $\sim 0.1\text{-}0.2\%$ plastic strain.

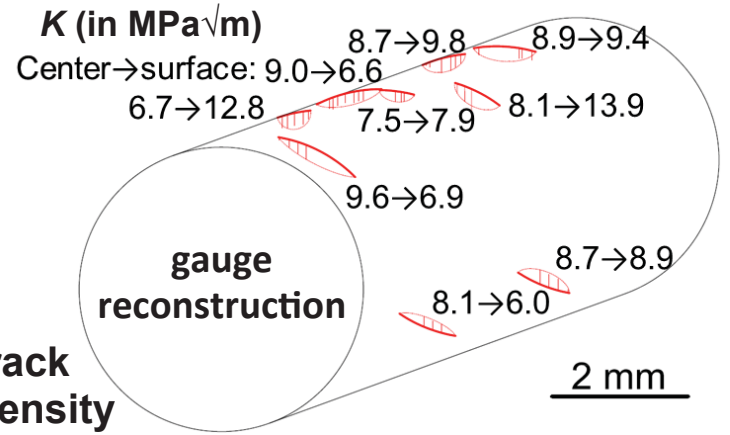
Reconstruction of crack shape and stress intensity

primary SCC crack

200 μm deep

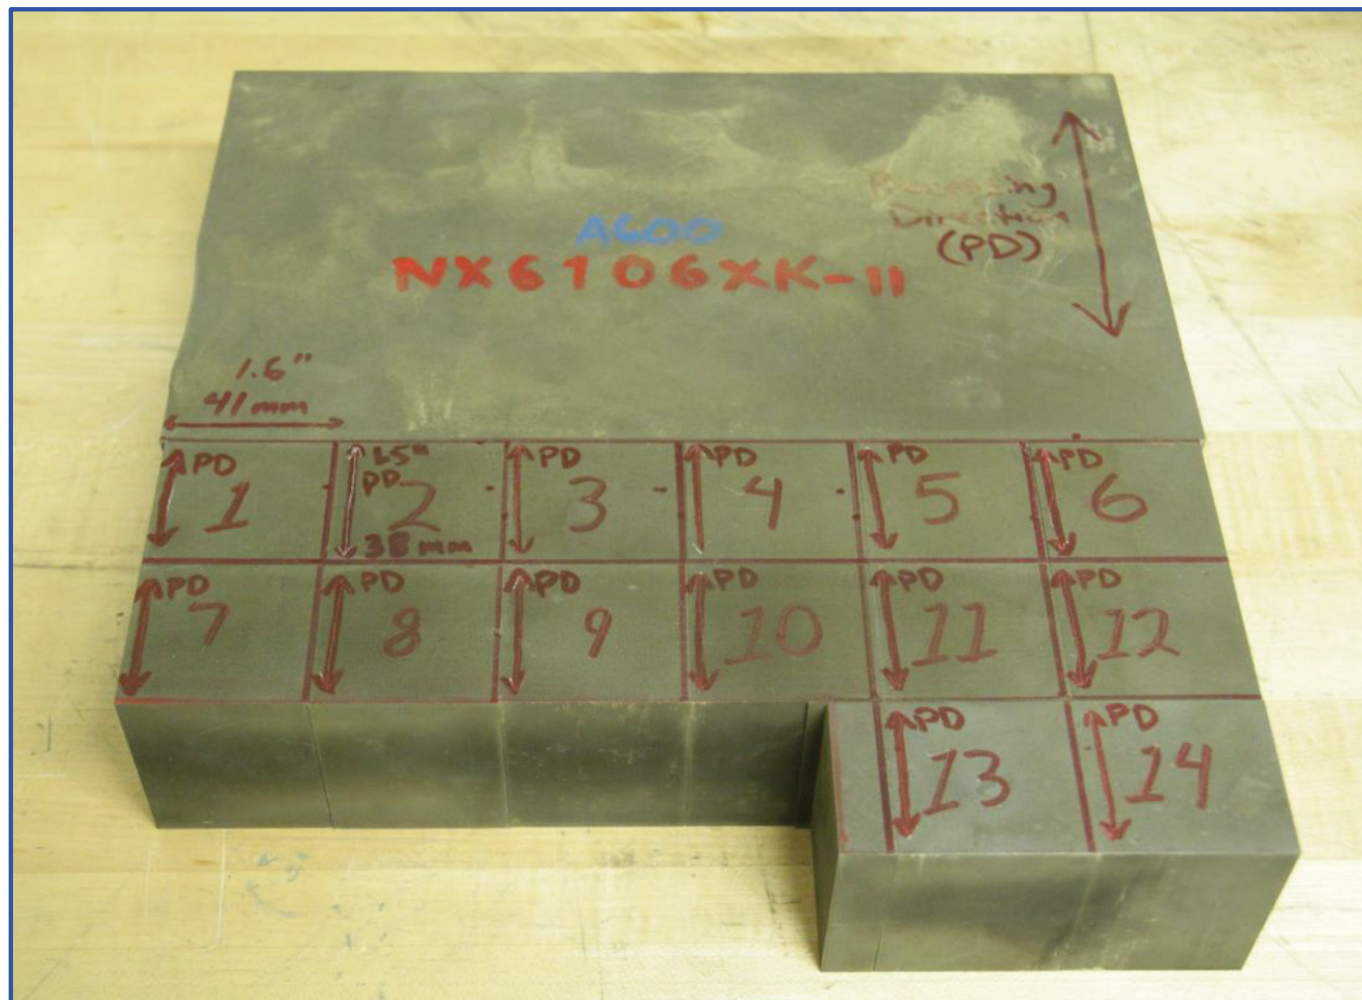
Orientation of Specimens from Plate

- Plate material was cut into 1.5" long x 1.6" wide x 2" tall blocks.
- Blocks were numbered, and forging and mill processing direction (PD) were indicated on each block.
- Blocks were 15% cold-forged at GE Global by Peter Andresen.
- Forging and banding planes set to be coincident.

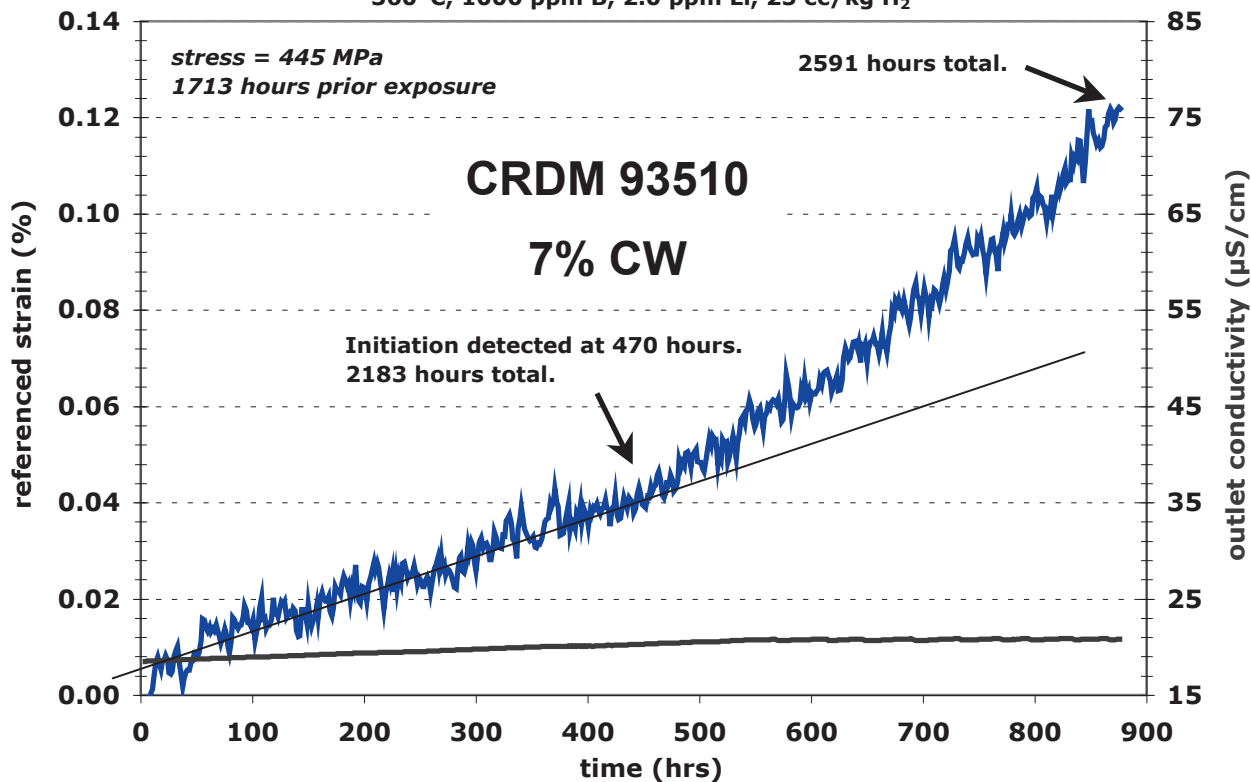
IN023 - A600 CRDM Heat 93510, 7% TS, 1 μm Finish
 360°C, 1000 ppm B, 2.0 ppm Li, 25 cc/kg H₂

Moderately cold-worked materials exhibit a transition to higher indicated strain rate over many days.

Slower evolution likely a combination of susceptibility and applied stress.

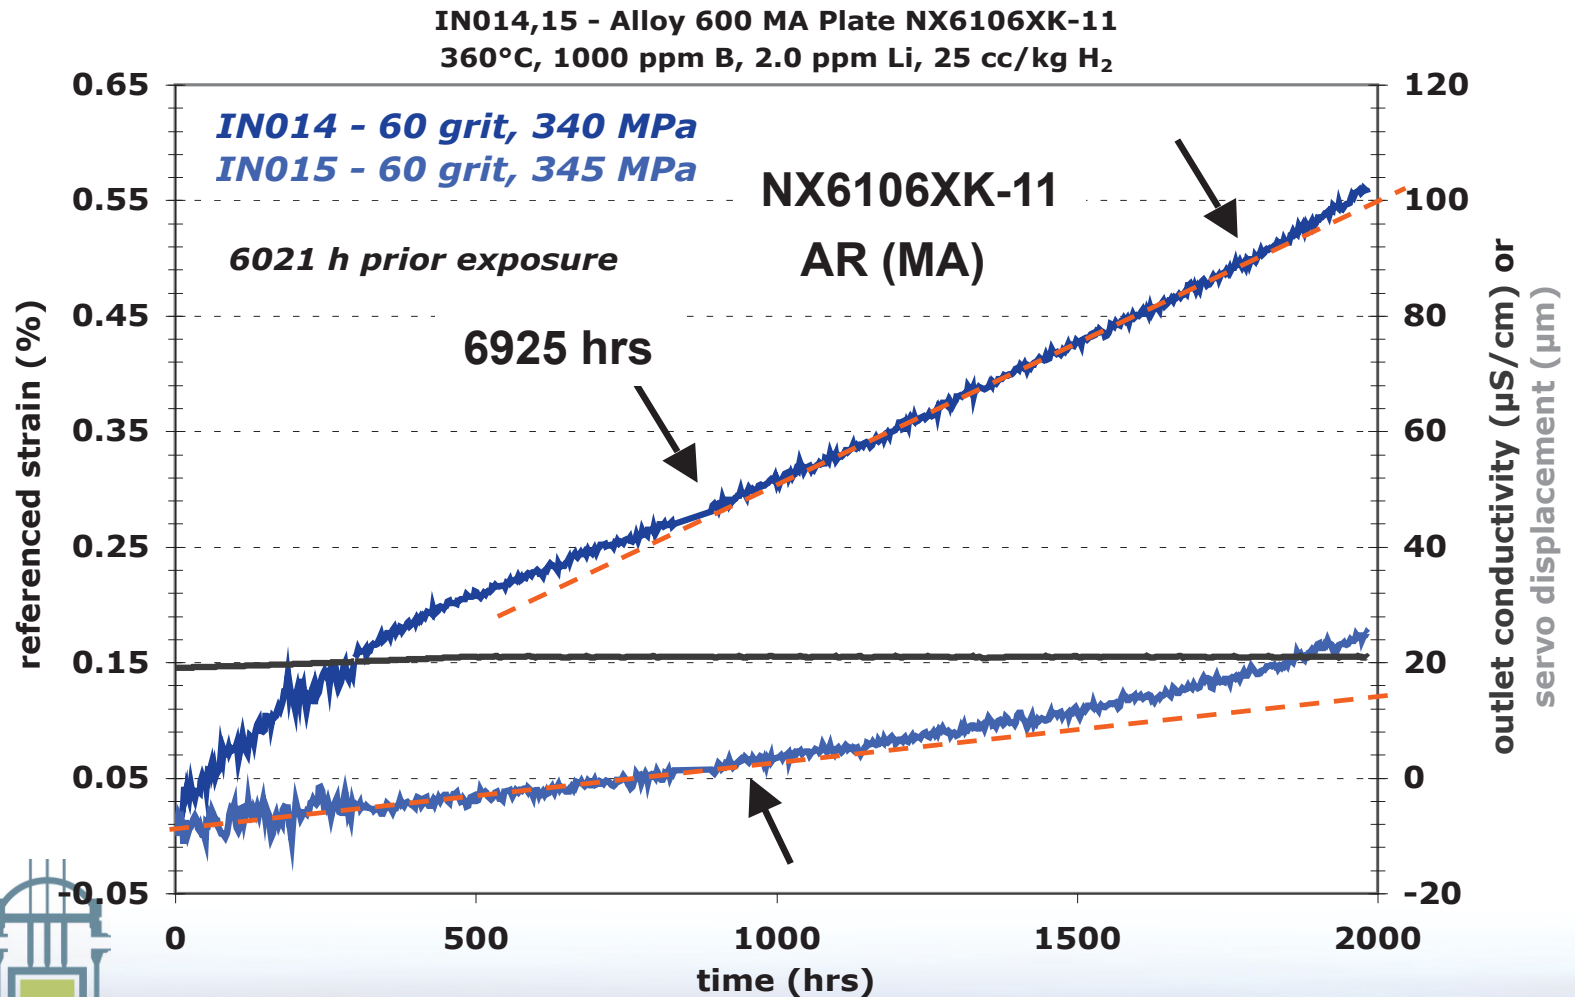
As-Received, Non-Cold Worked Material

- Transition to higher indicated slope is even more gradual in non-CW, low strength materials. Similar variability in SCC initiation response with CW/strength observed for other alloy 600 heats.

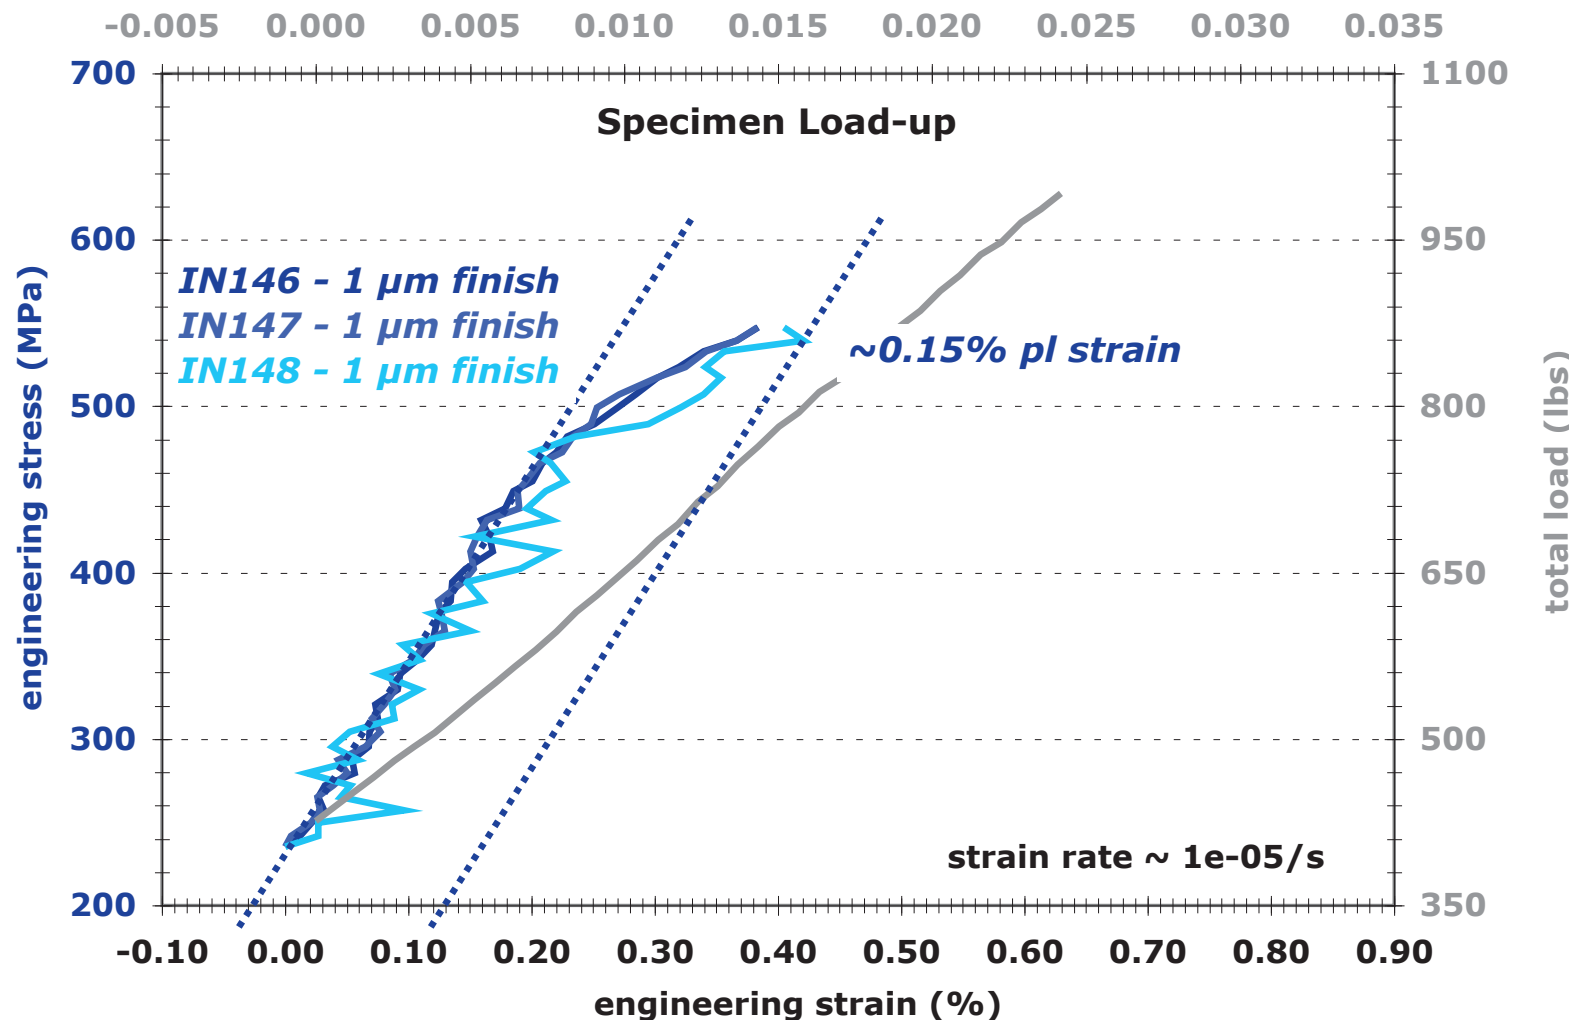
Load-up of NX6106XK-11 Round Robin Specimens

➤ All three specimens behaved identically during tensile loading to reach the yield strength.

➤ 1 hour to reach full load.

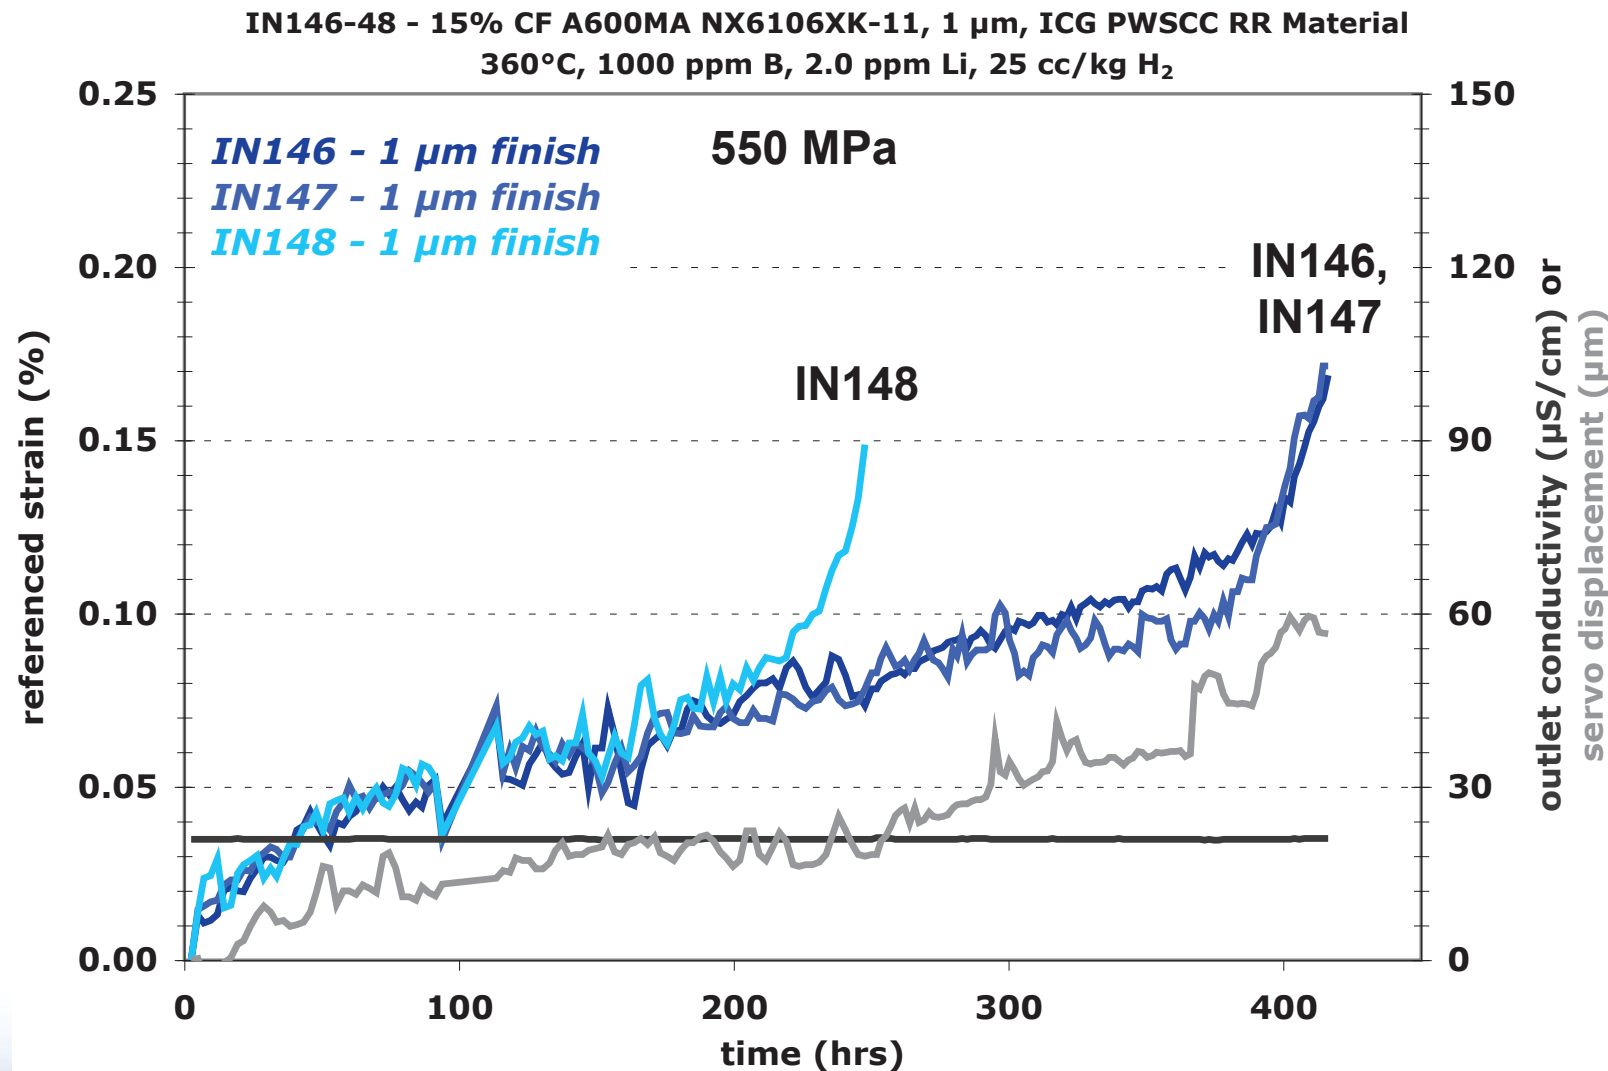
Initiation of NX6106XK-11 Round Robin Specimens

- Well behaved response, but unexpectedly low SCC initiation time for all three specimens.
- SCC initiation times of 219, 385 and 396 hours.
- Well below prior tests on this plate heat in the cold-worked condition.

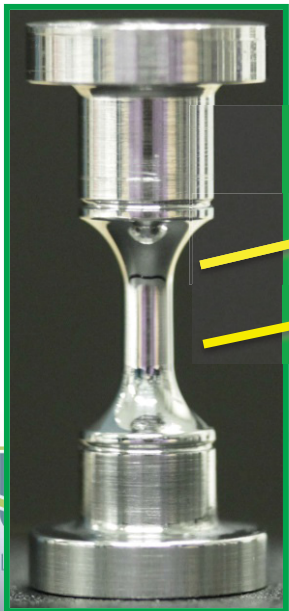
**2-6 Specimen SCC
Initiation System**

SCC initiation test systems assembled with in-situ DCPD crack detection.

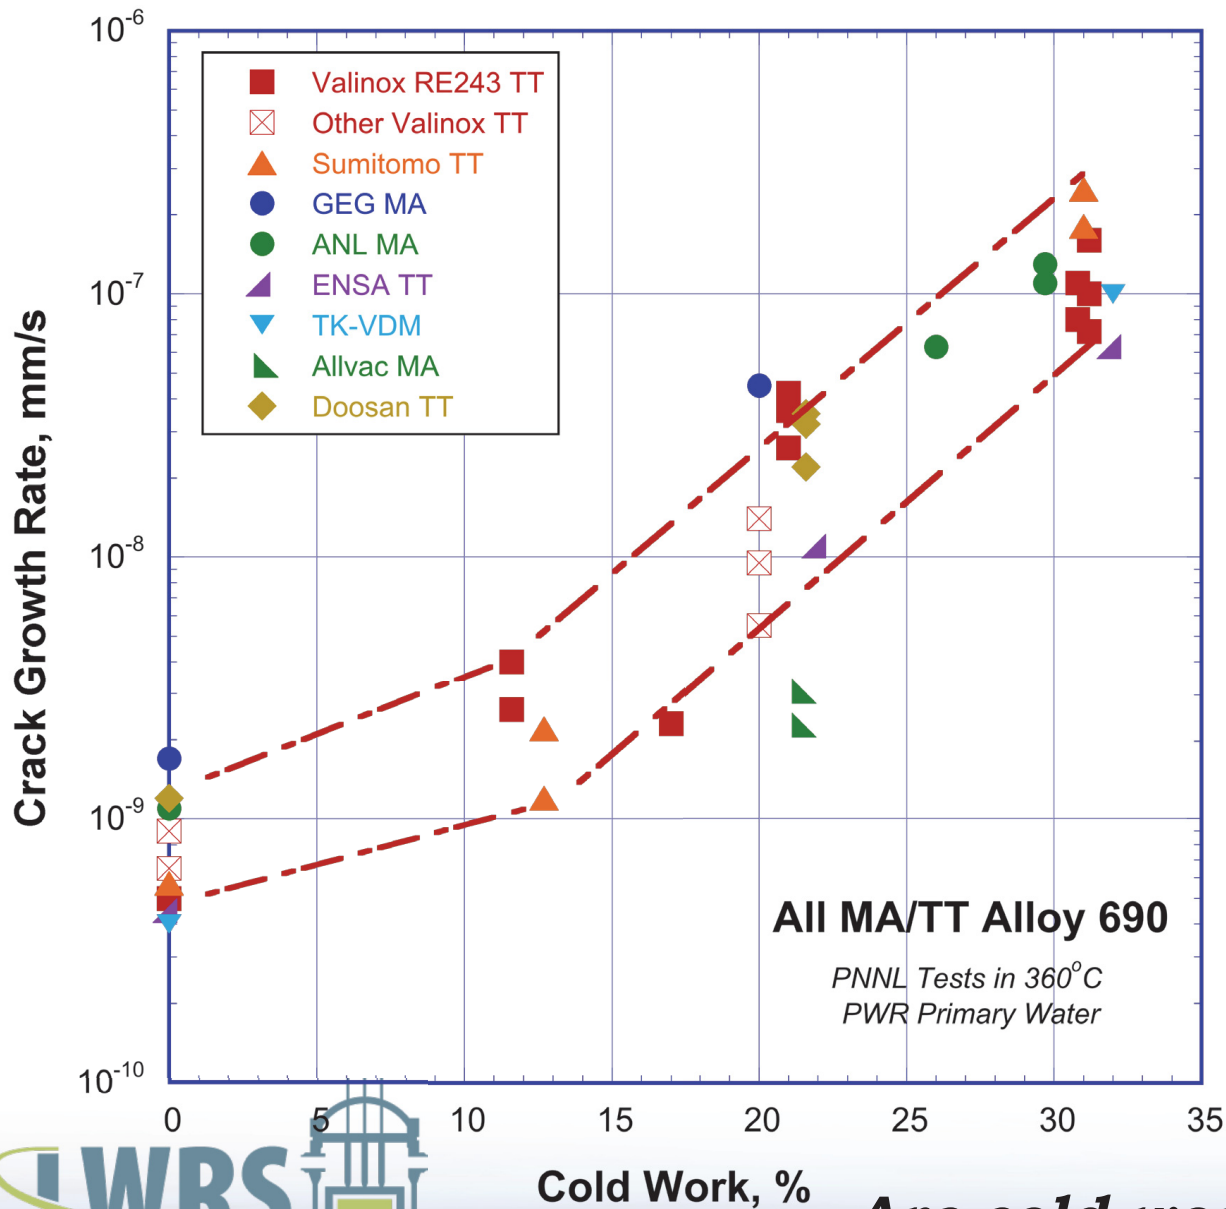
Summary of PNNL Alloy 690 Measurements of SCC Growth Rates

Consistent increase in measured SCC growth rates as a function of cold work for alloy 690 materials in the as-received MA or TT condition.

Data on these heats suggest a transition in SCC susceptibility for materials cold worked to >15% reduction. High SCC growth rates for many heats at ~30% cold work.
