**STRESS CORROSION CRACK INITIATION MECHANISMS OF  
NICKEL-BASE ALLOYS IN SIMULATED PWR PRIMARY WATER**

**Technical Milestone Report: M3LW-18OR0402033  
May 2018**

Z. Zhai, M. B. Toloczko, M. J. Olszta, K. Kruska, D. K. Schreiber and S. M. Bruemmer  
Pacific Northwest National Laboratory

Research Project:  
**Stress Corrosion Crack Initiation of  
Nickel-Base Alloys in LWR Environments**  
Project Manager: S. M. Bruemmer  
Pacific Northwest National Laboratory

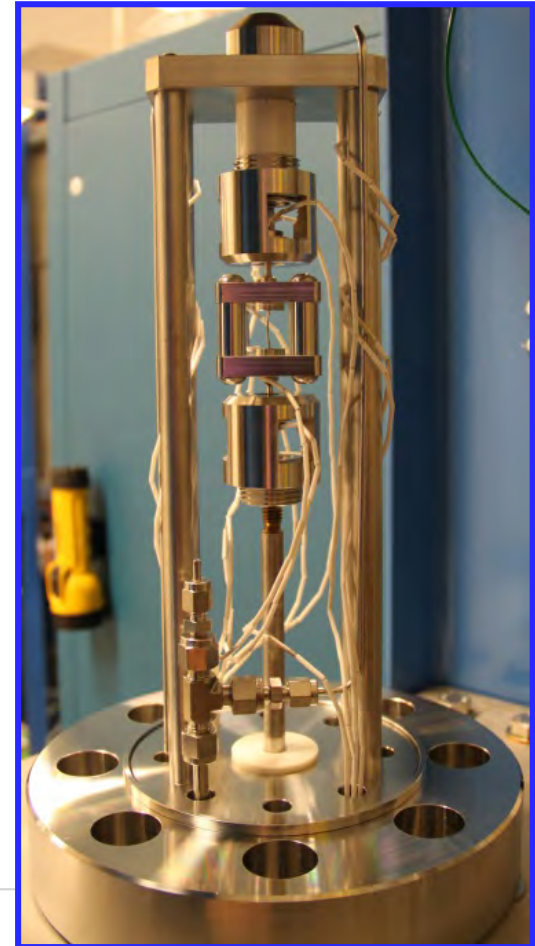
PNNL 2-3 Specimen  
SCC Initiation System
