**SUMMARY OF STRESS CORROSION CRACK INITIATION
MEASUREMENTS AND ANALYSES ON ALLOY 600 AND ALLOY 690**

**Technical Milestone Report: M2LW-15OR0402034
September 2015**

Research Project:
**Stress Corrosion Crack Initiation of
Nickel-Base Alloys in LWR Environments**
Project Manager: S. M. Bruemmer
Pacific Northwest National Laboratory

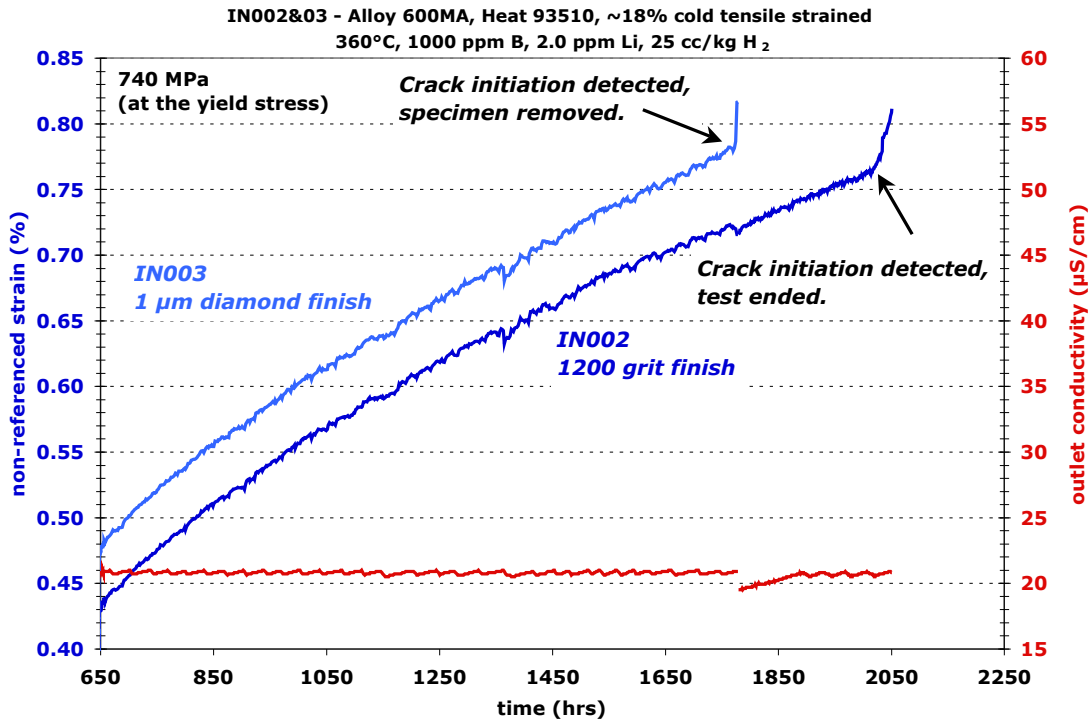
Figure 14. SCC initiation response of two ~18%CTS alloy 600 plate specimens showing a smooth but sharp transition to a higher indicated strain rate.

SCC nucleation was readily detected by DPCD in the highly CW specimens that exhibited a smooth but very rapid transition to a higher indicated apparent strain rate over a period of 10's of hours (recognizing that the higher strain rate is due to rapid crack growth rather than crack extension). An example is shown in Figure 14 for two 18%CTS specimens. More lightly CW materials exhibited a more gradual transition to a higher indicated strain rate with the change taking place over 100's of hours as can be seen for a 7%CTS specimen in Figure 15. However, AR materials exhibited some complexity in DCPD response. As with the CW materials, some AR materials such as two NX6106XK-11 plate specimens with a ground surface have exhibited a very gradual upward trend in referenced strain rate (Figure 16). The IN014 plate specimen began showing an increasing response at ~6925 hours with this transition to higher strain rates continuing over the next ~1000 hours. In the final 1000 hours of the test, the DCPD indicated strain rate increased by 60%. The IN015 plate specimen exhibited a transition in DCPD response at ~7480 hours, and over the final ~500 hours of the test, the DCPD indicated strain rate increased by ~170%. Other AR materials have exhibited a distinctly different response that consisted of a step change in referenced strain as shown in Figure 17 for a 1 μm finish service CRDM material (M3935). The cause for this step change response is still under investigation, and whether a specimen that exhibits a step change in response will eventually also show an increasing strain rate has yet to be studied at PNNL. However, researchers at KAPL have observed some specimens exhibiting a step change in strain that was eventually followed by an increasing strain rate [8]. This response for the AR materials is discussed further later.

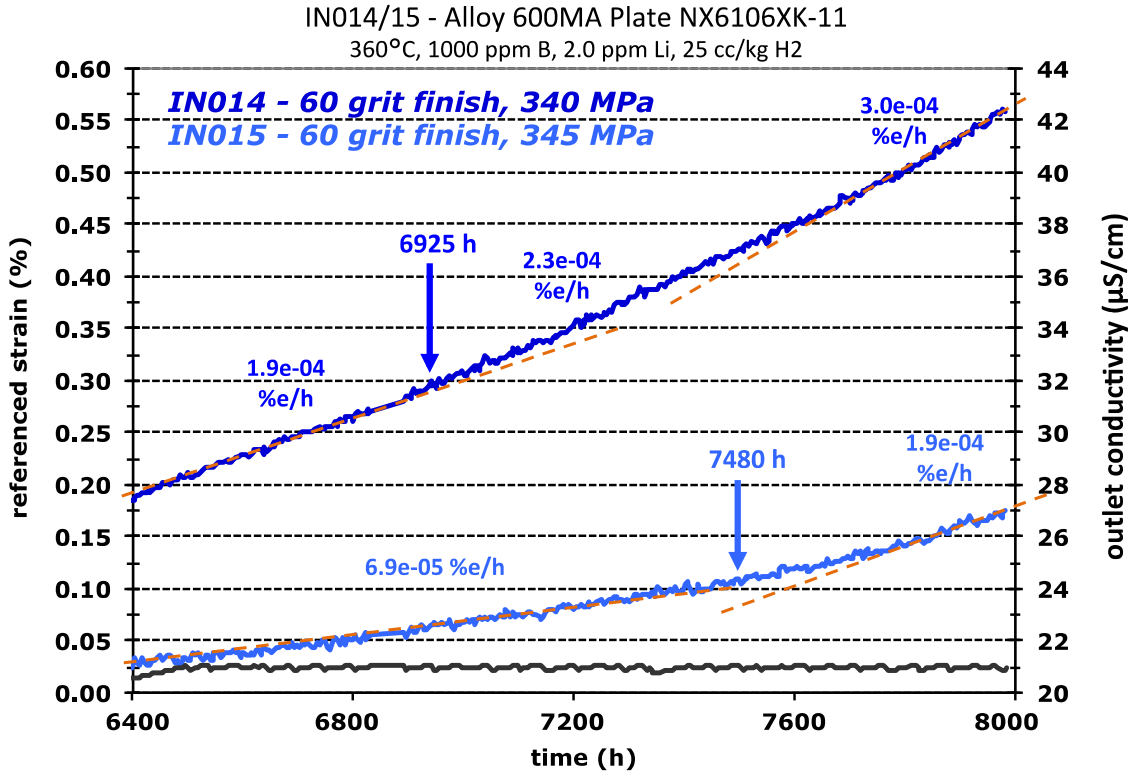
Figure 16. Observed DCPD response of two AR alloy 600 plate specimens with the estimated time of SCC initiation identified by arrows at the first change in slope.

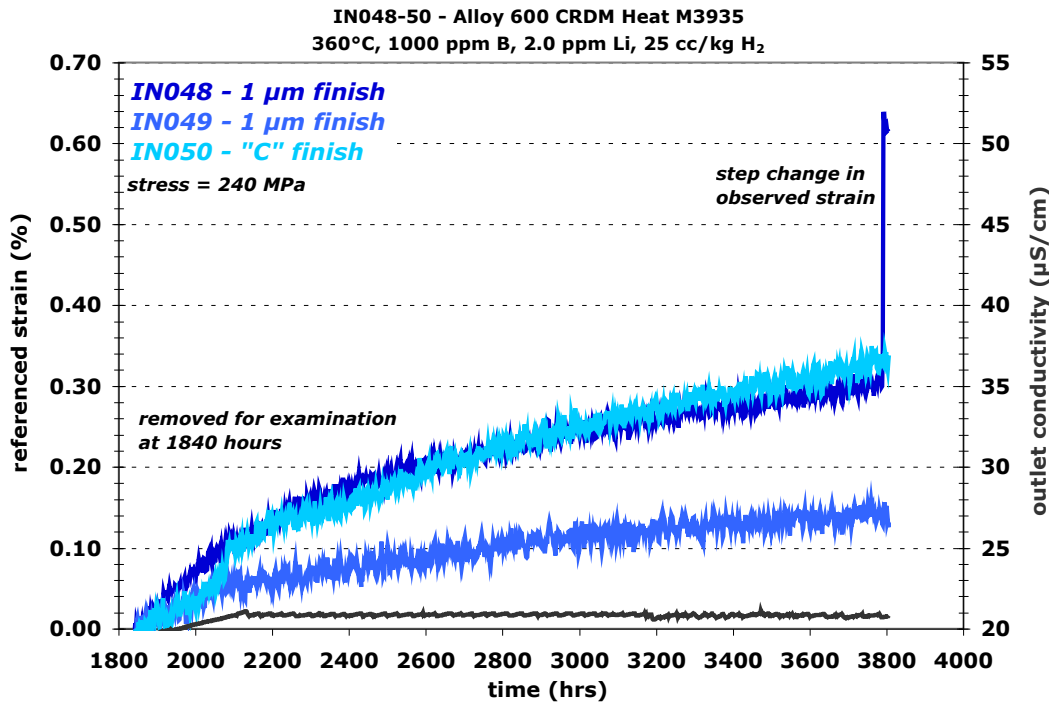
Figure 17. Observed DCPD response of AR alloy 600 CRDM (M3935) specimens.

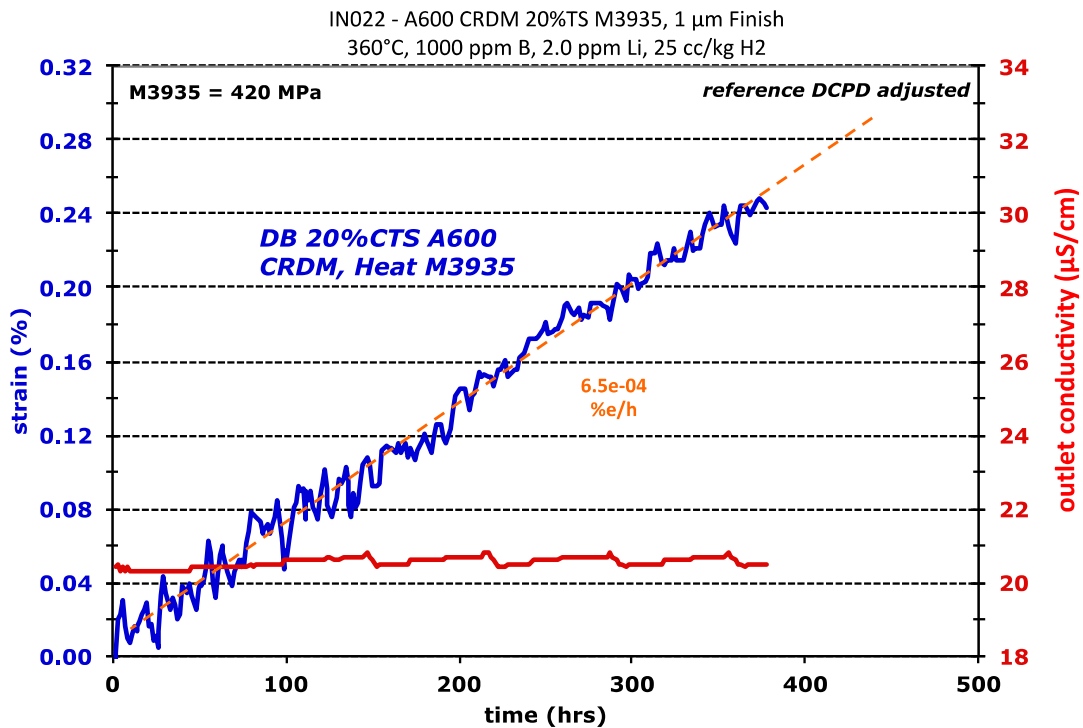
Figure 18. DCPD response of the 20%CTS service CRDM specimen IN022.

SCC initiation times are summarized in Table 4. As noted in the table, two tests were stopped before a clear indication of SCC initiation by DCPD. The 20%CTS service CRDM specimen (IN022) was stopped early due to a higher than expected indicated strain rate from the very start of the test (Figure 18). This MA material exhibited very high SCC crack growth susceptibility in the AR, non-CW condition [5,6]. Post-test analysis of the SCC initiation specimen revealed significant cracking with the primary crack having a peak depth of 350 μm , comparable to that for other CW specimens that showed clear DCPD-indicated crack initiation. This suggests that either SCC initiation detection was imminent or that crack nucleation and growth occurred almost immediately from the start of the test. Based on the crack depth observations, the time at which the test was stopped (385 h) was considered to be a reasonable estimate of the SCC initiation time. The other specimen that was stopped before an indication of SCC initiation was a specimen made from the service CRDM material in the AR condition (IN049). This specimen is nominally identical to IN048 that underwent a step-change in DCPD response. The decision was made to discontinue testing IN049 so that its crack morphology could be compared to IN048. Comparative examinations of these two specimens are ongoing with the most current results presented later.

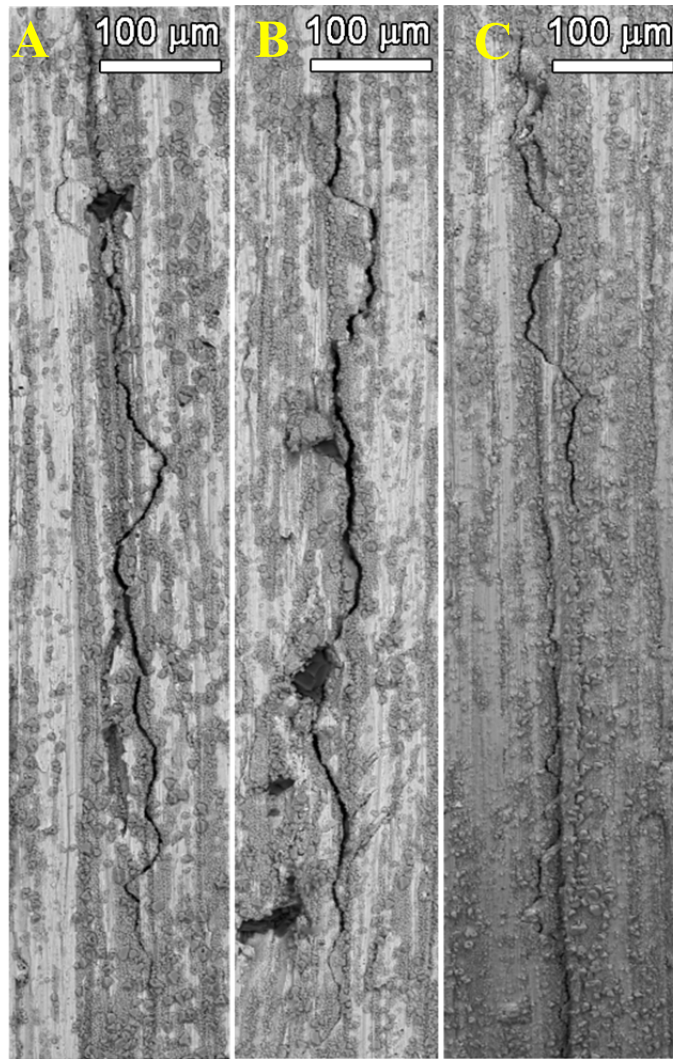
Figure 25. SCC cracks observed on the surface of IN014 (AR plate specimen) after 8008 h of exposure: (a) Large cracks are highlighted in red on the BSE montage images of part of the gauge surface, and (b) corresponding morphology of cracks A, B and C marked in (a).

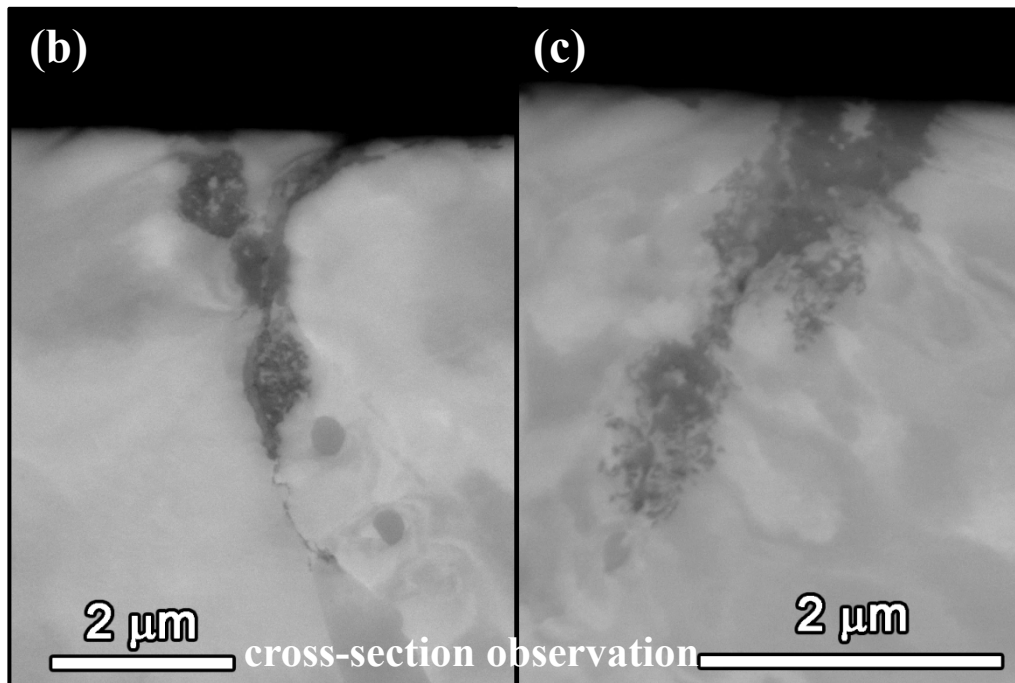
Figure 29. SEM-BSE images of typical morphology of IGA and small crack (identified by arrows) along with few larger cracks observed on the IN013 surface (a). Shallow depths for IGA and small surface cracks are illustrated in cross-section (b,c).

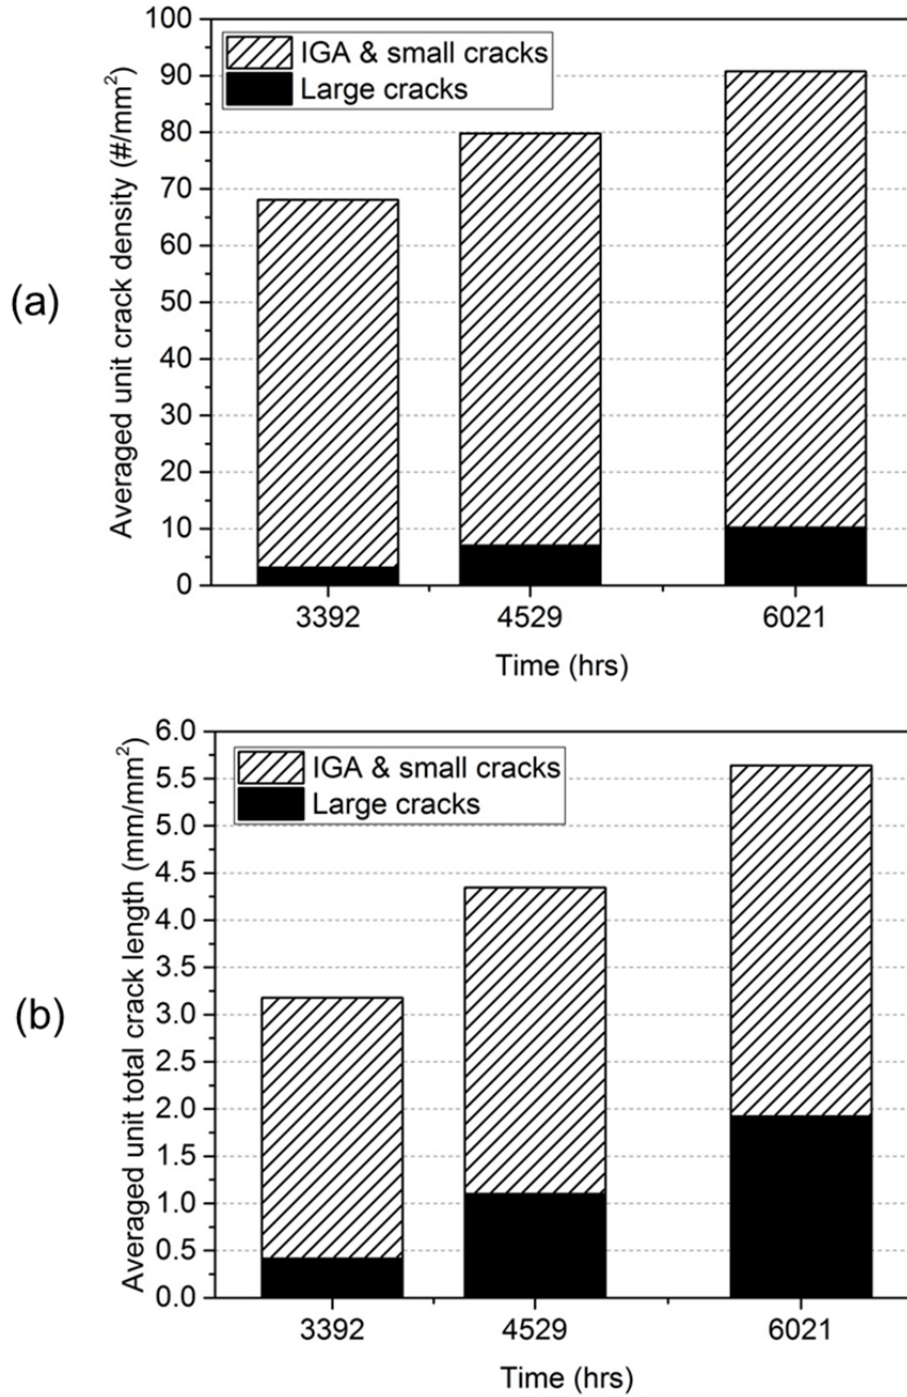
Figure 36. Time evolution of (a) the average unit number density ($\#/mm^2$) and (b) the average unit total crack length (mm/mm^2) on the gauge section of MA plate 1.

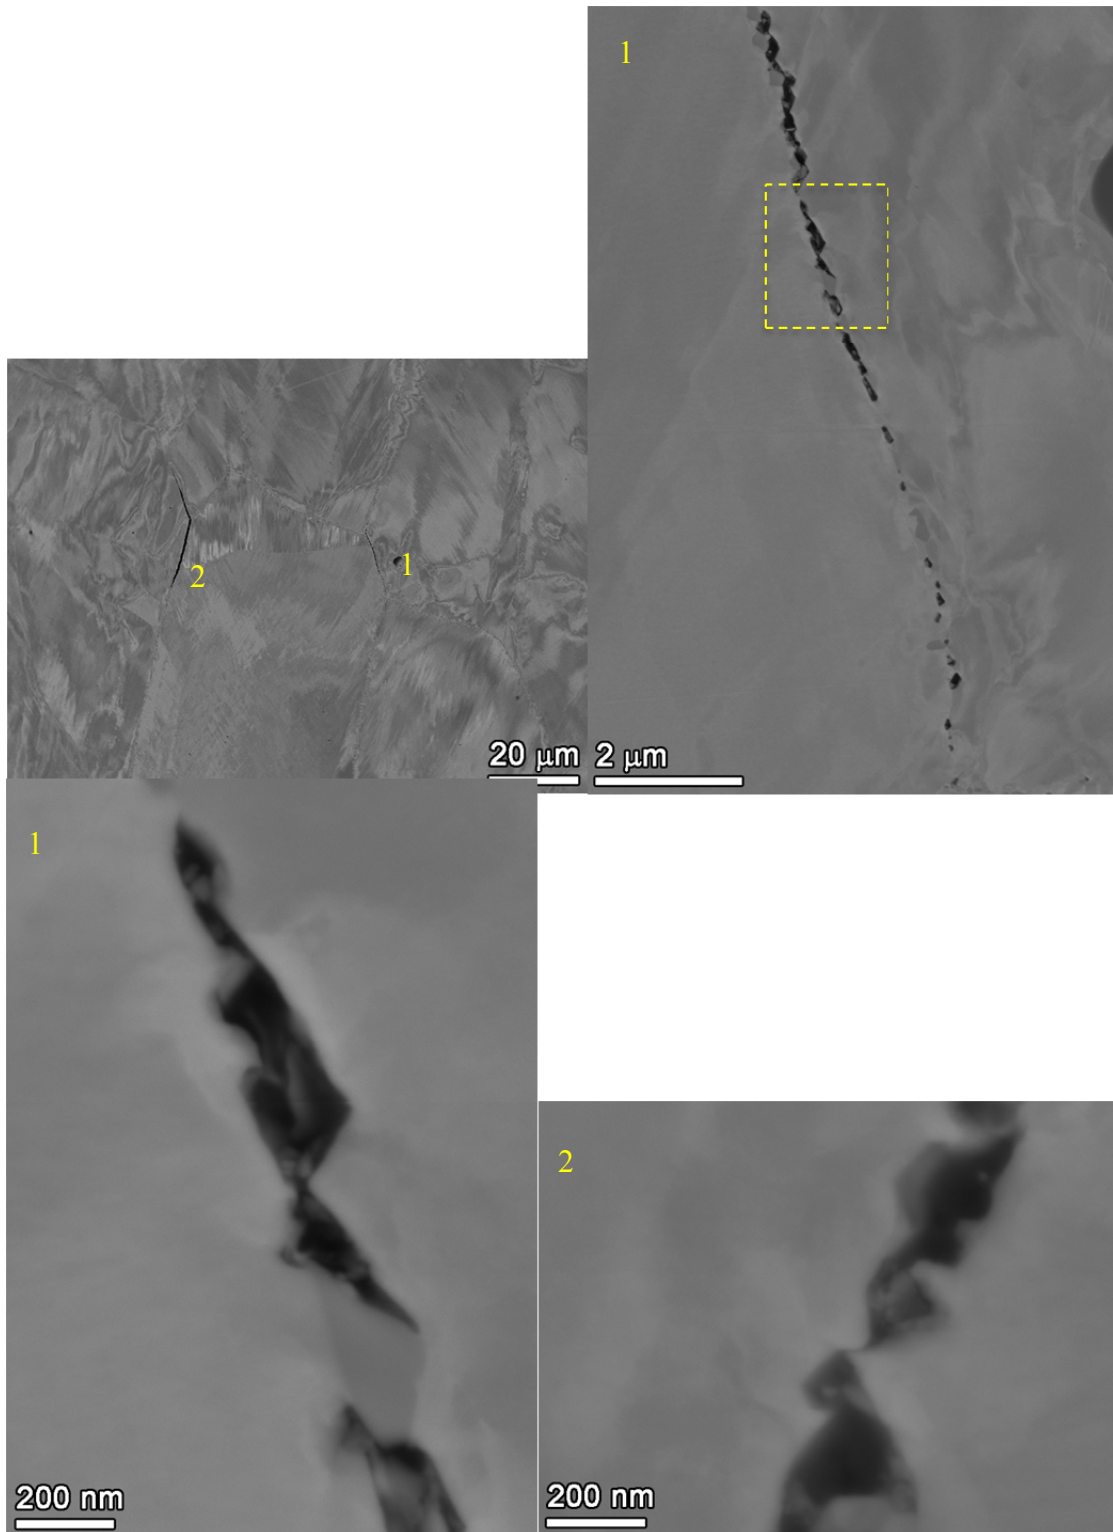
Figure 68. Apparent creep cracks in blunt notch specimen c672 cross-section slice #1 showing no evidence for corrosion or oxidation along the crack walls.

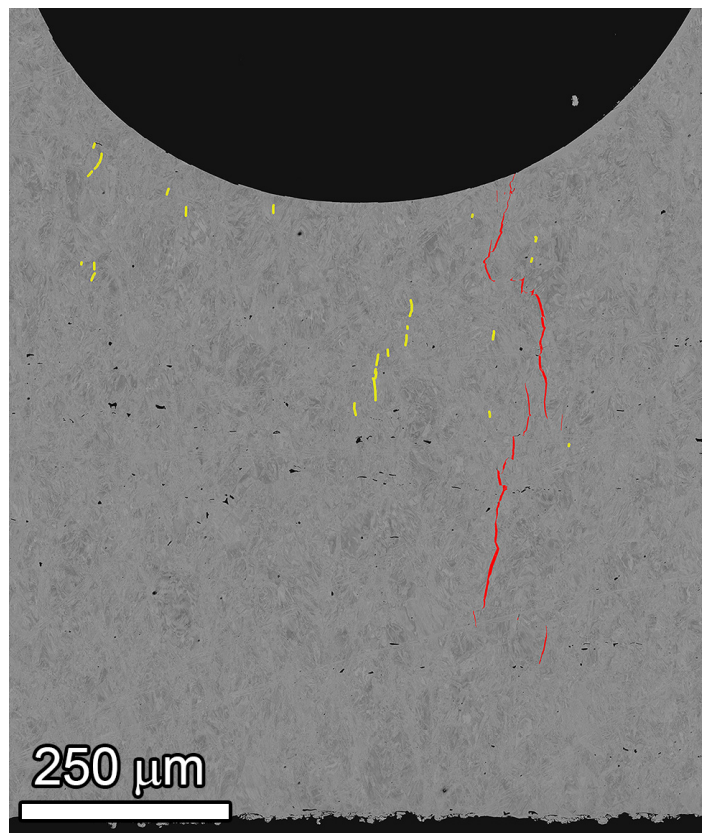
Figure 72. SEM-BSE image of c673 cross-section slice #4 showing cracks identified as SCC (red) and creep (yellow).

The EDM sectioning and polishing approach to investigate crack morphologies is illustrated for specimen c703 in Figures 76-79. An area of the surface containing cracks along what appears to be incoherent twin boundaries is shown in Figure 76 along with cross-section locations examined after the 1st and 2nd polishing sequences. These locations intersect the twin boundaries (A and B) and a grain boundary (C). The subsurface features in the 1st polish location are presented in Figure 77(a) where an approximately 70 μm long crack is present at the twin boundary location A1. The crack starts at ~ 20 μm below the surface for the cross-section, but exhibits significant corrosion/oxidation along the crack walls and must be an SCC crack connected to the notch surface. This can be better resolved in Figure 77(b) at higher magnification for the twin boundary crack along with a series of cavities along the adjacent high-energy grain boundary. The IG cavities are thought to have occurred during one or more of the strain ramps. At the 2nd polish location, the SCC crack can be seen to extend to the surface confirming water ingress into the crack causing the observed crack wall corrosion structures. More detailed SEM examinations revealed evidence for cavities associated with the SCC crack. In addition, a series of creep cavities are present ahead of the corroded SCC crack tip. Small creep cracks are also identified across the notch on c703 as shown in Figures 81 and 81. Similar to c672, most of the creep cracks are located at a distance >100 μm below the surface.

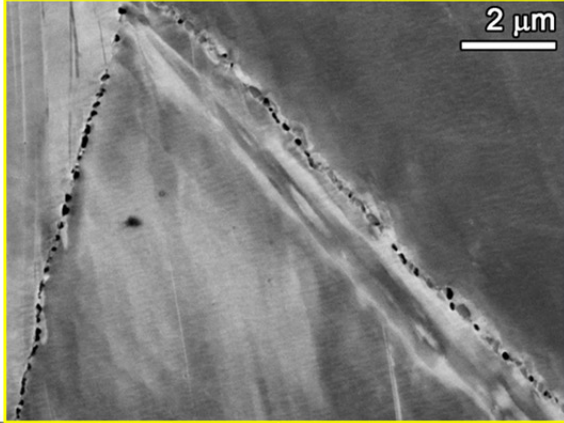
Figure 80. SEM examinations revealing creep cracks in the cross-section of serial polish #1 for the c703 blunt notch specimen.
