Light Water Reactor Sustainability Program

Vibration-based Techniques for Concrete Structural-health Monitoring

March 2019

U.S. Department of Energy
Office of Nuclear Energy

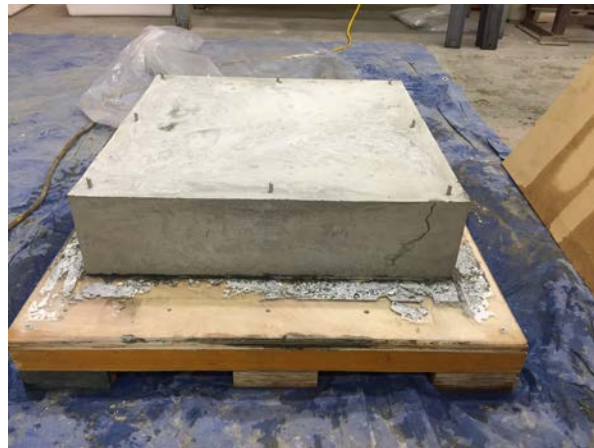
Figure 2. 2 ft × 2 ft × 6 in. dimension concrete slab (Vanderbilt University).

A medium-sized concrete slab of dimensions of 2 ft × 2 ft × 6 in. was cast on December 21, 2015 and cured at Vanderbilt University. The details of the casting and curing process of this specimen are discussed in detail in a report by Mahadevan et al. (2016). Figure 2 shows an image of the slab immediately after the mold was removed.

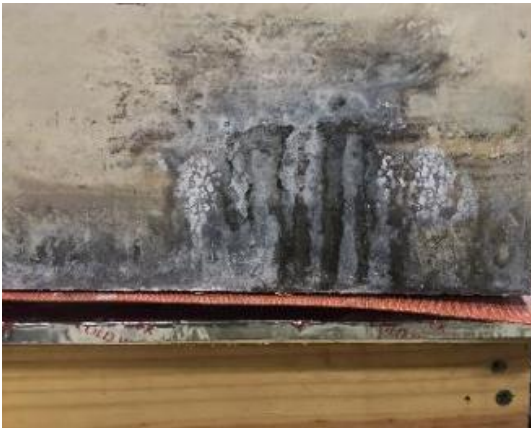
Figure 4. Damage Location 1: cracking and powder effluence.

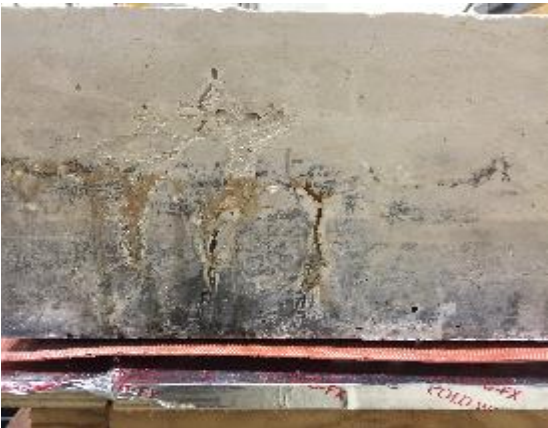
Figure 5. Damage Location 2: clear gel effluence.

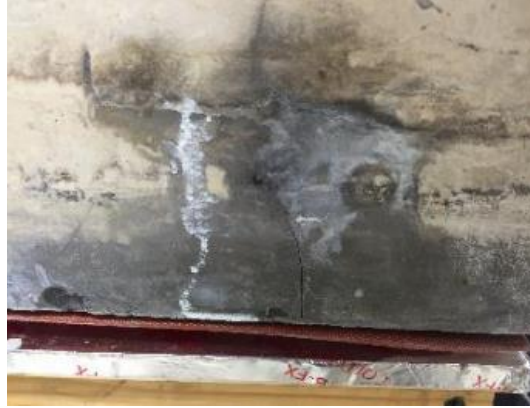
Figure 6. Damage Location 3: cracking and powder effluence.

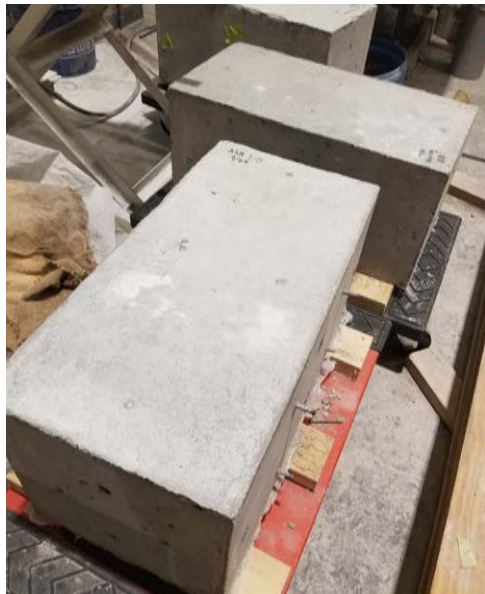
Figure 8. Specimen cast at University of Nebraska-Lincoln.

Four concrete blocks of dimensions of $2 \times 1 \times 1 \text{ ft}^3$ were cast and cured in accelerating conditions at The University of Nebraska-Lincoln, Omaha (Figure 8). Similar to the Alabama samples, the Nebraska specimens used conventional concrete mixtures prepared in a rotating drum mixer. The aggregates were distributed throughout the blocks. All four specimens contained 25 mm coarse aggregates known to be susceptible to ASR (reactive) combined with a non-reactive crushed dolomite/calcite fine aggregate. All four specimens contained a reactive crushed green schist from North Carolina. All four specimens contained a low-alkali cement ($0.46\% \text{ Na}_2\text{O}_{\text{eq}}$), while three contained added sodium hydroxide (NaOH) to boost the alkali loading to 5.25 kg/m^3 to accelerate ASR. Here, the three samples treated with NaOH will be referred as reactive and the sample not treated with NaOH will be referred to as non-reactive. Two specimens were reinforced with rebar, one specimen has rebar only in one direction while another specimen has rebar in two directions. The Nebraska concrete specimens are labeled as, Nebraska - Control, Nebraska – non-reinforced, Nebraska – reinforced 1-D, and Nebraska – reinforced 2-D.

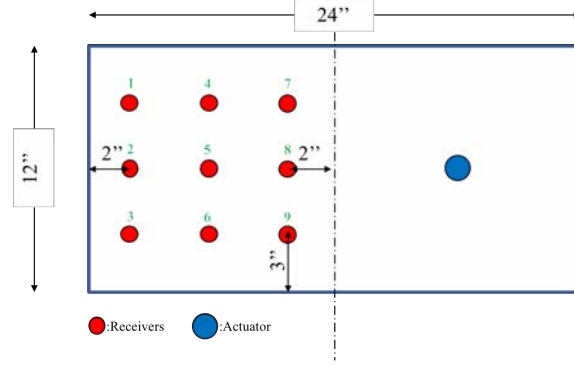
Figure 10. Locations of the accelerometers and the waveform actuators.

The locations of the accelerometers and the actuator for the single-frequency tests are shown in Figure 10. For the sake of illustration, for single-frequency experiment, we placed accelerometers on one half of the sample and performed 100 tests for each of the specific settings. Each test lasted for 1.5 seconds duration.

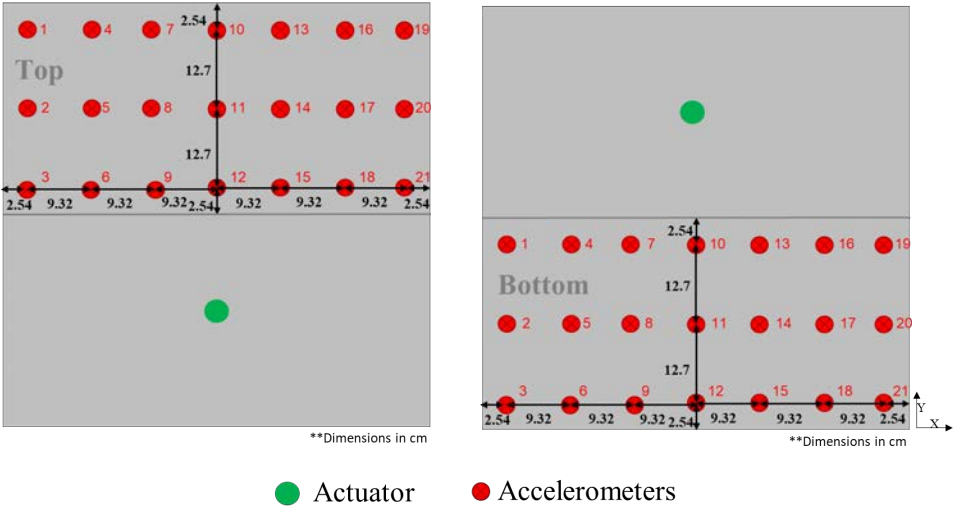
Figure 12. Locations of the accelerometers on one half.

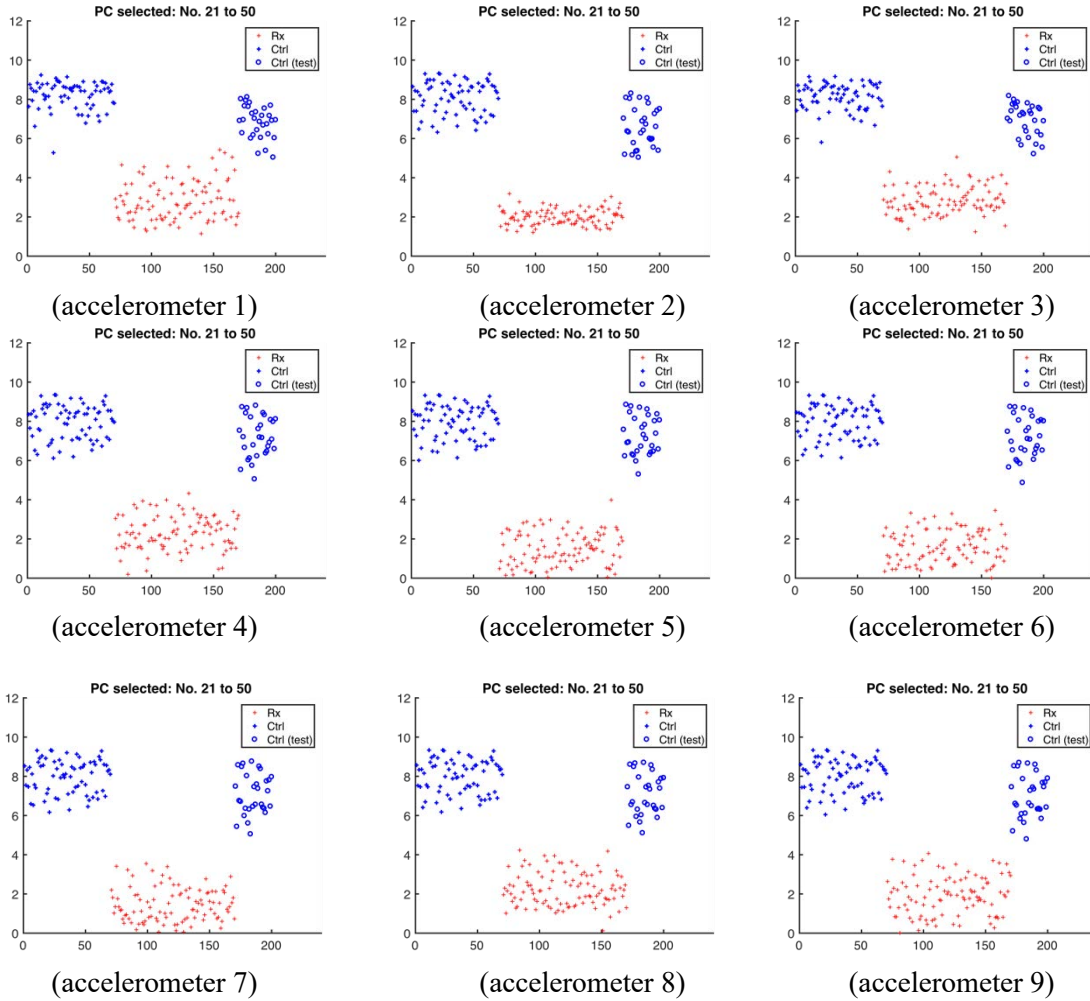
Figure 15. SVD-based features of Alabama samples with North Carolina aggregates (x-axis: dataset number; y-axis: SVD-based feature value). Blue – non-reactive aggregate; Red – reactive aggregate.

The results are shown in Figure 15 and Figure 16. Blue plus signs represent the feature values for the 70% control samples; red plus signs represent the values for the reactive samples, and blue circles represent the values for the 30% control validation samples. It is seen that the feature values for the reactive samples were much lower than those for the control samples, and the differences were significant enough to make damage detection clear.

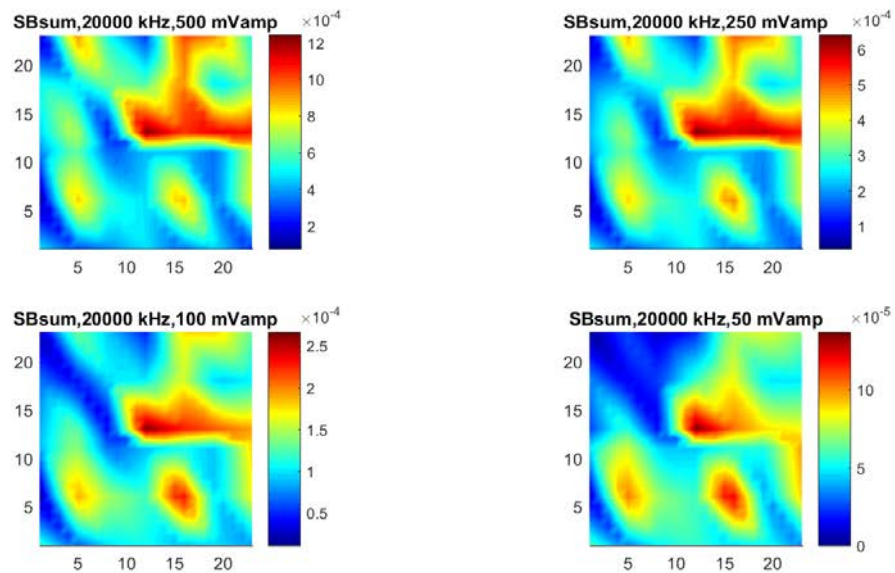
Figure 25. SBSum data in the LS of acceleration given a 500 mV pump of 920 kHz, and 500, 250, 100, and 50 mV probes of 20 kHz for all five pump and probe locations.

In this section, we report the results of VAM tests performed on the Vanderbilt University slab. Parameters for this testing are described in Section 2.3.3. The pump and the probe actuators were placed at the center of each quadrant and the center of the slab (as shown in Figure 23), where blue and green circles represent the pump and probe actuators, respectively. We conducted VAM tests using the parameters noted for each quadrant, collected the acceleration time series data at each accelerometer location, computed the corresponding LS, and obtained the SBSum metric. Next, we plotted the variation of the SBSum metric over each quadrant using linear interpolation of the SBSum metric obtained at accelerometer locations. We juxtaposed damage maps for the four quadrants in order to obtain a damage map for the entire slab. Figure 24 and Figure 25 shows damage maps for three probing frequencies.

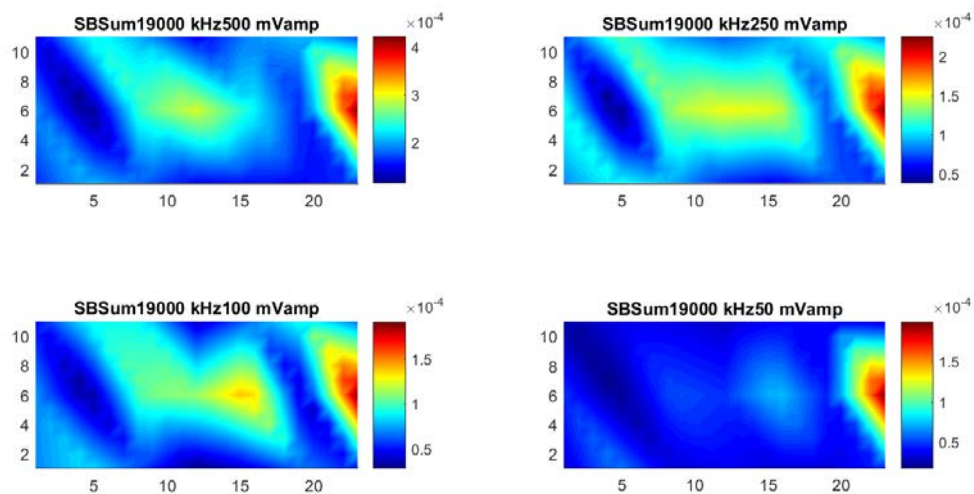
Figure 28. SBSum surface diagram for the Colorado control (non-reactive) sample with a 2240 Hz and 500 mV pump and a 21 kHz probe of various amplitudes.
