Light Water Reactor Sustainability Program:

Zion Unit 1 Reactor Pressure Vessel Sample Acquisition: Phase 2 and Phase 3 Status Report

Zion Unit 1 Reactor Pressure Vessel Sample Acquisition: Phase 2 (Cutting Blocks) and Phase 3 (Machining Test Specimen) Status Report

Milestone Report: M3LW-16OR0407014

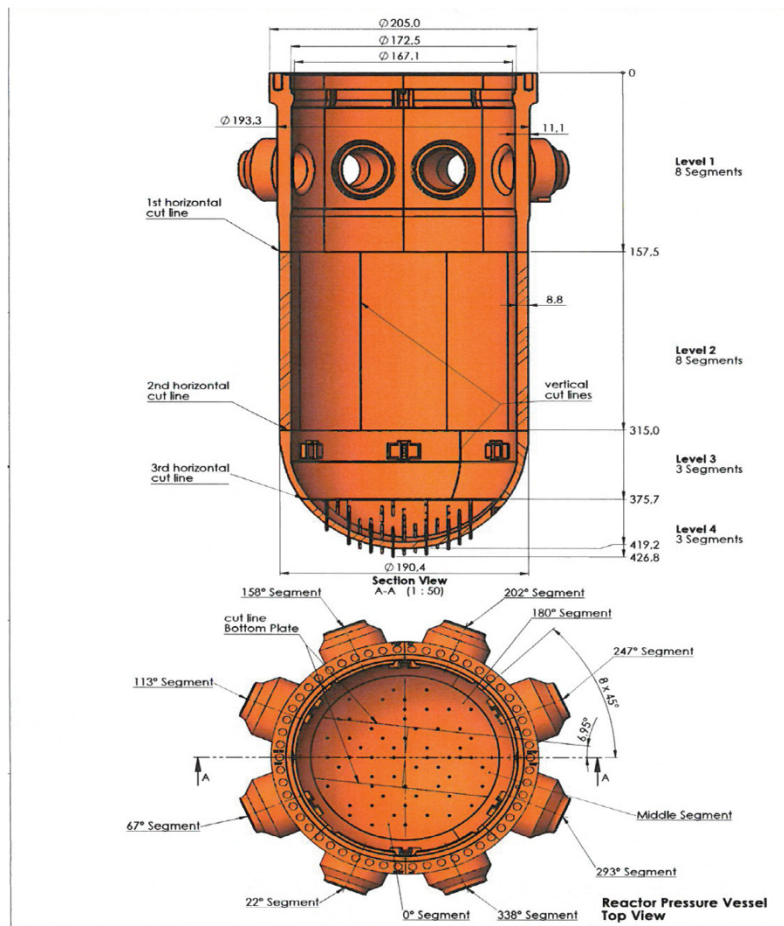
Figure 2. The 2014 RPV Segmentation Plan for the Zion Unit 1 vessel. The black lines are the proposed cut plan. There are eight vertical cuts in the nozzle region and eight vertical cuts in the Level 2 intermediate and lower shell area [11].

Segmentation Plan: Based on information provided by Mr. Dan E. Pryor, Manager, Reactor Vessel Segmentation, Zion Solutions, the vessel was cut, using an oxy-propylene torch into 17 segments over four levels as shown in figure 2. Level 1, which includes the inlet and outlet nozzles, was cut into eight 45° segments of 157.5" (400 cm) in height. Level 2 was also cut into eight 45° segments of 157.5" (400 cm) in height and 72.9" (185.2 cm) in length as measured from end to end of the outer diameter. Because the vessel could not be rotated 22.5° after the nozzle segments were cut due to the location of the overhead bridge, the level 2 segments, which include most of the intermediate shell and a portion of the lower shell and the well-characterized WF-70 beltline weld, the vertical cuts were made along the same lines as the vertical nozzle cuts, i. e., at the two vertical welds of the intermediate shell, directly above the vertical welds of the lower shell, and in the middle of the peak circumferential flange. Moreover, four segments (1, 2, 7, and 8) also contained the well-characterized base metal B7835-1 in the upper shell (Figure 2, Figure 3, and Figure 4). The beltline pieces cut from the vessel are 8.8 inches thick including a 3/16th inch stainless steel cladding on the internal surface. Each piece weighs approximately 28,000 lbs. (12,727 kg).

Harvest ORNL BW1 RPV Segment: Verifying that the RPV did not rotate a few degrees after cutting and removal of the nozzle shell segments, harvest one segment (Segment 1, Figures 2, Figure 3, and Figure 4) containing base metal B7835-1 and a section of the WF-70 beltline weld (between the lower and the intermediate shells). The right edge (as viewed from the outer wall) of this segment begins at the 0° position / WF-4 vertical weld. This segment is paired with Segment 5 to provide shielding during shipping.

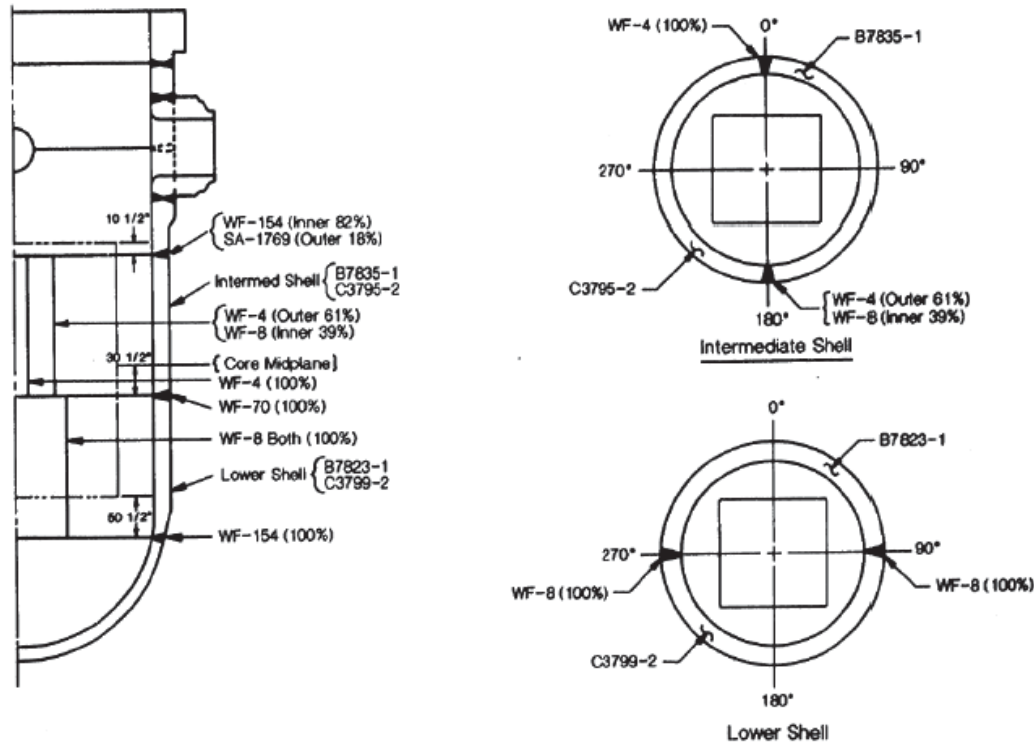
Figure 3. Location of materials (weld and base metal) used in the fabrication of the Zion Unit 1 beltline (intermediate shell to lower shell), two vertical welds above the beltline, and base metal heats [12].

Plan Scope: ORNL BW1 RPV (Segment 1), which was harvested from the Zion Unit 1 NPP and includes the WF-70 beltline weld and base metal B7835-1 (Figure 2, Figure 3, and Figure 4) shall be cut into blocks (**Fig. 6**) varying in length from approximately 5.7 x 2.0 x 8.5 inches to 7.6 x 3.0 x 8.5 inches to 11.25 x 3.0 x 8.5 inches. Three types of blocks shall be cut and are designated as “C,” “F,” and “CF.” The “C” block is designated for machining Charpy V-notch, SS-3 tensile specimens and coupons for chemical and microstructural characterization. The “F” block is designated for machining compact tension specimens for Fracture toughness testing. The “CF” block is designated for alternating rows of Charpy and compact tension specimens for Fracture toughness testing.

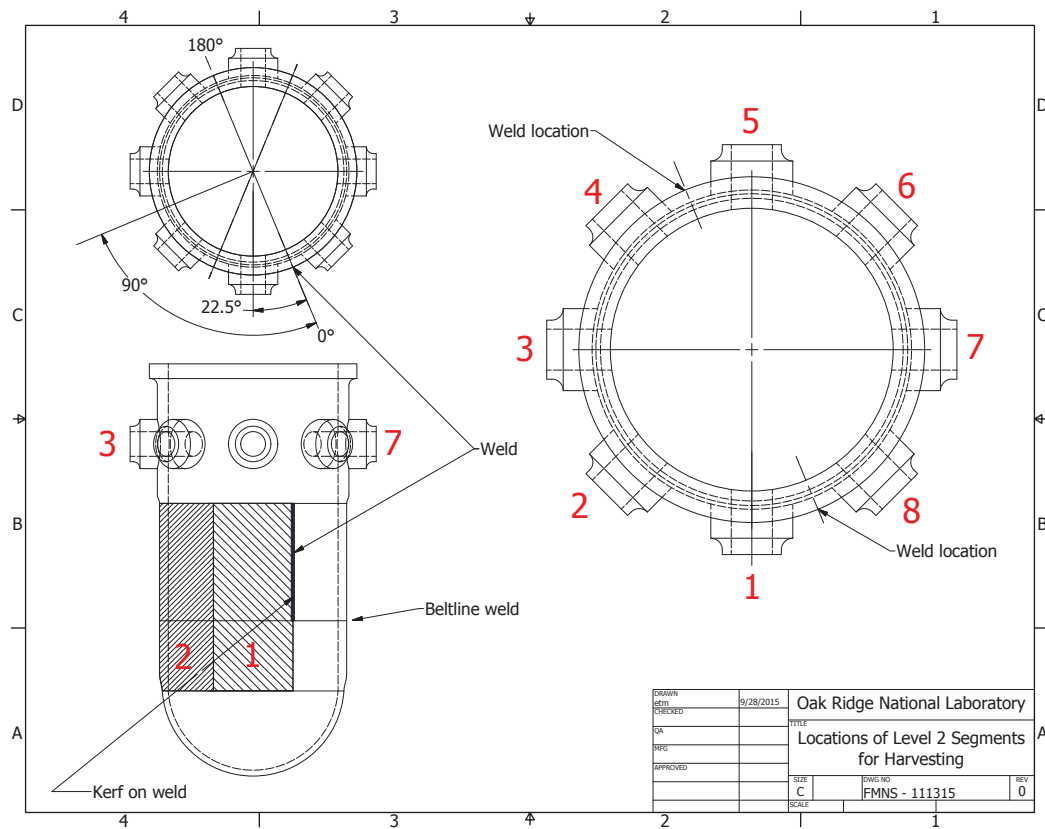
Figure 4. Identification of Level 2 segments (1, 2, 5, and 6) collected as part of process to harvest Segment 1. Segment 1 (as well as Segments 2, 7, & 8) contains the well-characterized base metal B7835-1 (intermediate shell) and a section of the well-characterized WF-70 beltline weld [11].

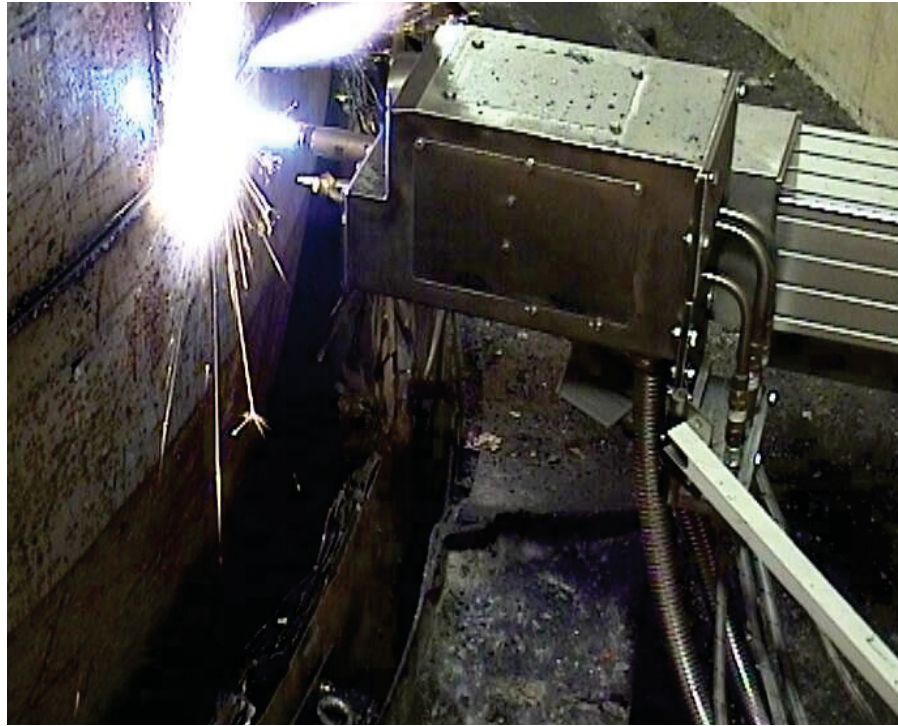
Figure 5. Vertical cut using an oxy-propane torch of a Zion Unit 1 RPV Level 2 Segment [11].

- The beltline weld was located on the outer wall of the RPV and photographic evidence of the location of the segment provided.
- Segments, ~ 13' x 6' (157.5" x 72.9" x 8.8") of the RPV extending from just below the circumferential weld between the nozzle section and the intermediate shell to just above the circumferential weld between the lower shell and the bottom plate were cut using an oxy-propane torch (Figure 5). The selected segment, Segment 1, contains base metal B7835-1 and a section of the WF-70 beltline weld. The right edge (as viewed from the outer wall of the RPV) begins at the 0° / WF-4 vertical weld.

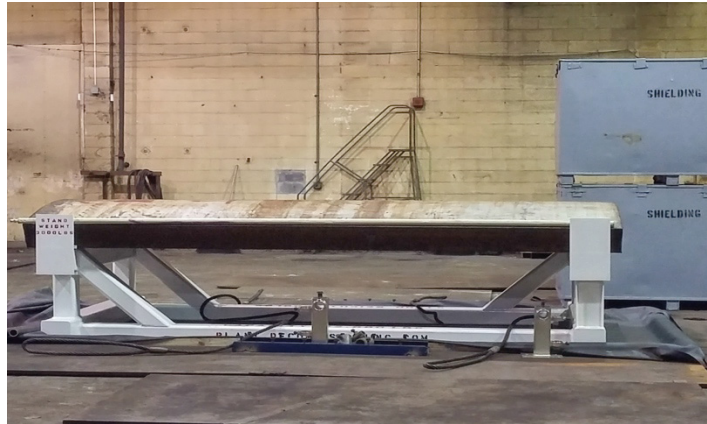
Figure 7. Segment 1 on the cutting frame at the Energy Solutions MPF.

Upon implementation of the “Block Cutting” contract (Zion RPV Phase 2), the box containing Zion Unit 1 RPV Segments 1 and 5 was opened and the ~ 14 ton, 45° ORNL Beltline Weld Segment 1 was lifted and transferred from the rail car to the designated MPF C-zone cutting location by crane, placed on the cutting stand (Fig. 7) for cutting into blocks and the activity verified. At the conclusion of the work, the uncut portion of Segment 1 along with the cutting waste will be stored in the steel box containing Segment 5 and placed into the railcar with the box containing Segments 2 and 6 for eventual shipment as waste to Clive, Utah. The cut blocks will, in turn, be shipped to a third party vendor to be machined into test specimens and coupons for eventual laboratory testing.

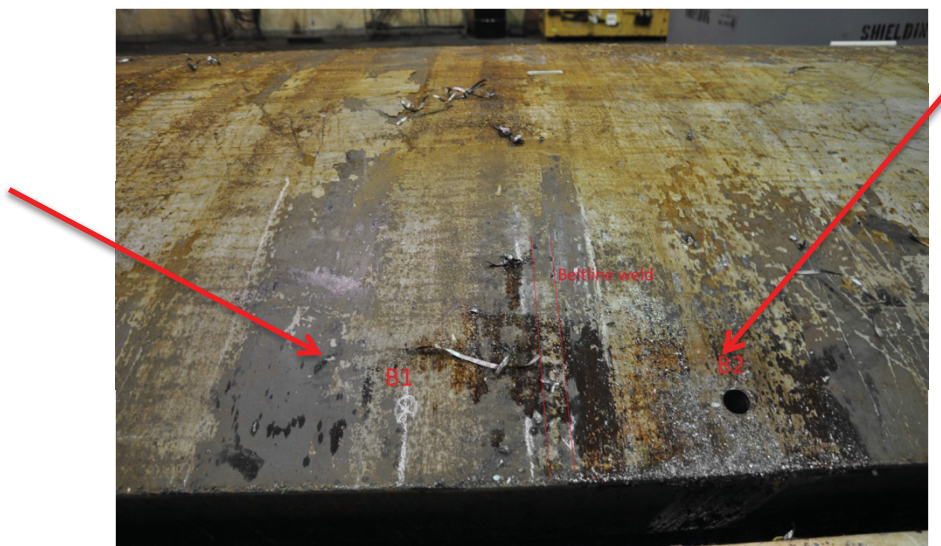
Figure 8. Location of holes for wire saw to cut a fresh section to identify beltline weld.

The process of cutting the blocks from the well-characterized beltline weld and base metal above the weld began with locating the exact position of the beltline weld and a determination of the slope across the outer diameter of the segment. Due to the high probability that the oxy-propane flame cut along the vertical direction may have obscured the weld, two 1” holes were drilled approximately 6” above and below the estimated position of the beltline weld and 2.75” from either edge of the segment (Figs 8 and 9) and a wire saw placed through the holes to cut out two small sections in order to provide fresh surfaces to locate the exact position of the weld and to determine what the slope (if any) of the weld line is on the segment. Following the removal of the two small sections, chemical etching, using a 10% Nital (nitric acid / alcohol) solution, revealed the weld cross-section and position (Fig 10) approximately 2” below the estimated position.

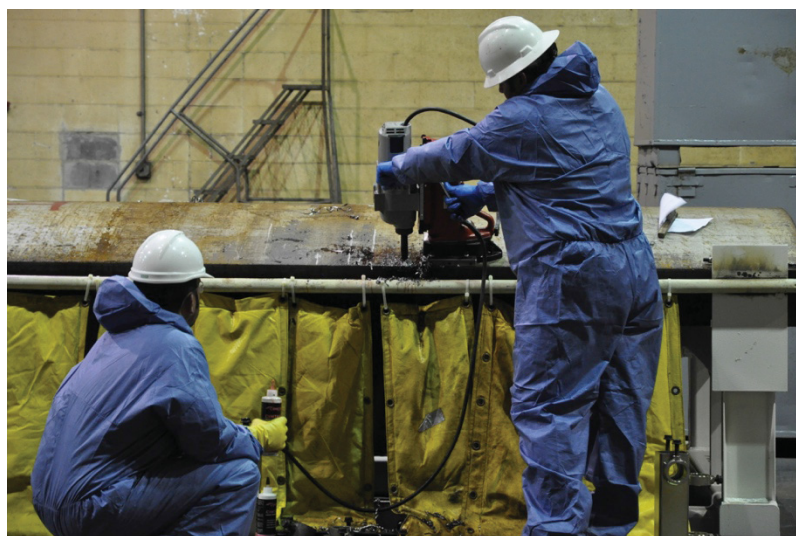
Figure 9. Drilling holes for wire saw to cut fresh surfaces to identify the beltline.

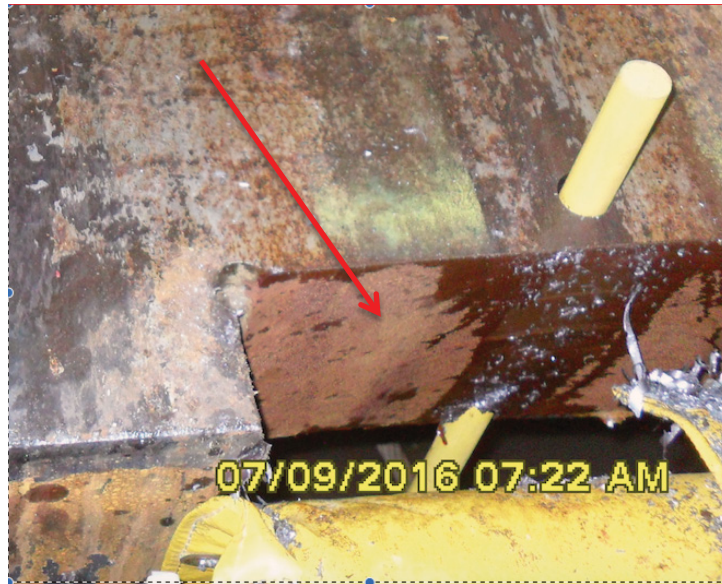
Figure 10. With small section removed from the flame cut edge, chemical etching revealed the location of the beltline weld.

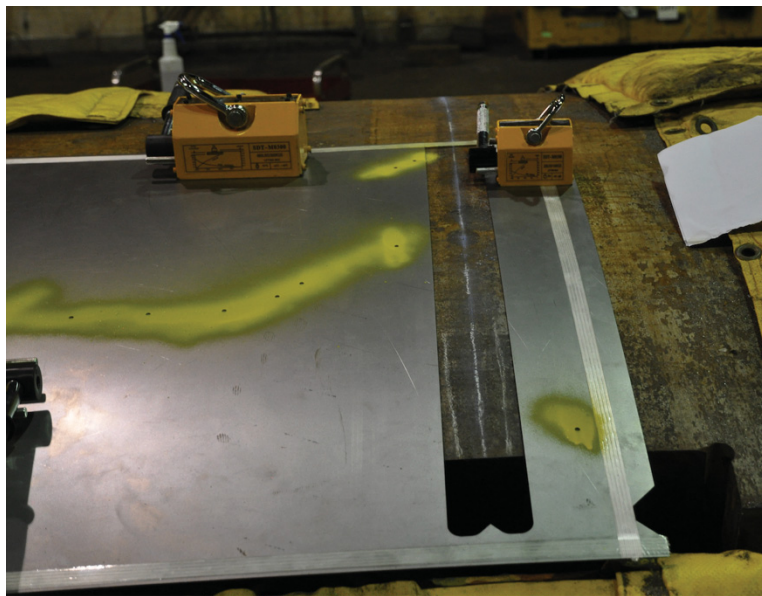
Figure 11. Thin-metal template, with the holes marked for transference to the RPV segment, was aligned with the beltline weld (chalk line). The holes will be used to thread the wire saw to cut the blocks.

Once the position and slope were determined, a thin metal template was placed over the segment and aligned with the beltline weld (Fig. 11). The template was designed based on the location of the blocks relative the beltline weld and base metal as seen in Fig. 6 and included the location of cut lines for the blocks that includes the kerf and the location of 13 holes as seen in Fig. 12. The holes were used for inserting the diamond wire to cut the 2 beltline weld and 5 base metal blocks from Segment 1 as shown in Fig. 13. With the completion of Cut 11 (Fig. 12), the CF block was removed from Segment 1 (Fig. 14) using a lift magnet in a similar manner as shown in Fig. 15. Similarly, the remaining blocks were successfully cut and lifted out from Segment 1 (Figs. 16-19) by the end of the shift on September 22, 2016. The target shipping date to the machining vendor (Phase 3 / Zion RPV harvesting project) is the week of October 17th.

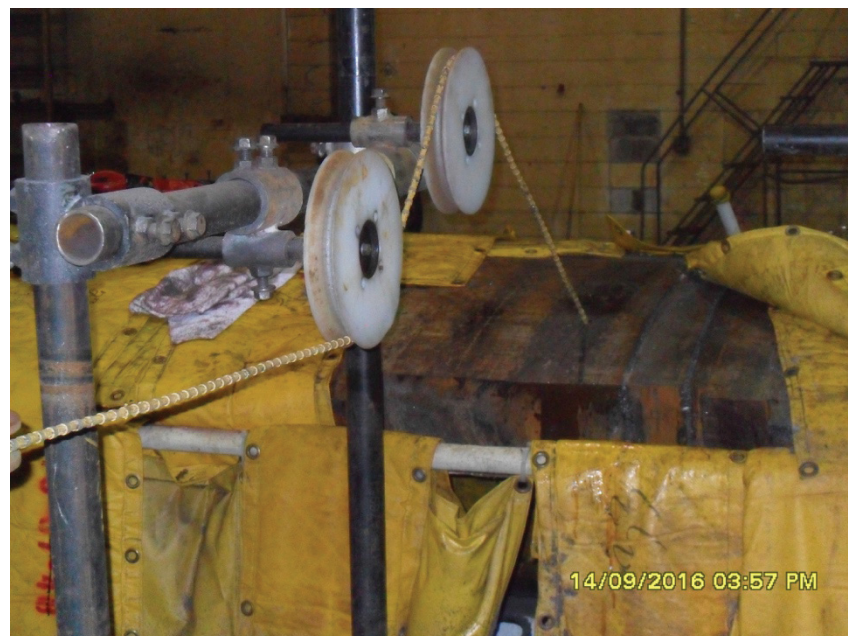
Figure 13. Wire saw cuts parallel to the beltline weld.

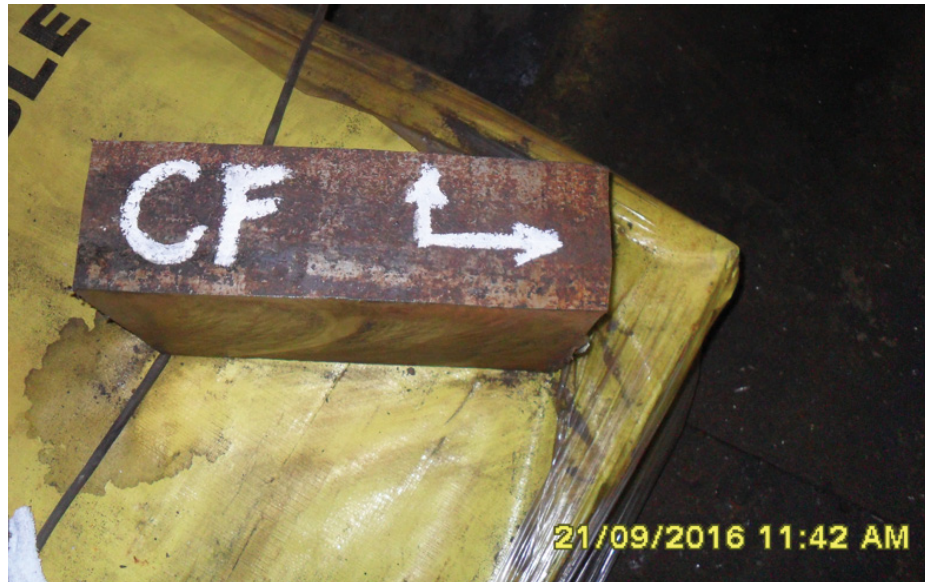
Figure 14. CF block with orientation marked (Y axis is perpendicular to the beltline weld with the arrow pointing to the top of the segment and the X axis is parallel to the beltline weld with the arrow pointing to away from the high fluence edge).

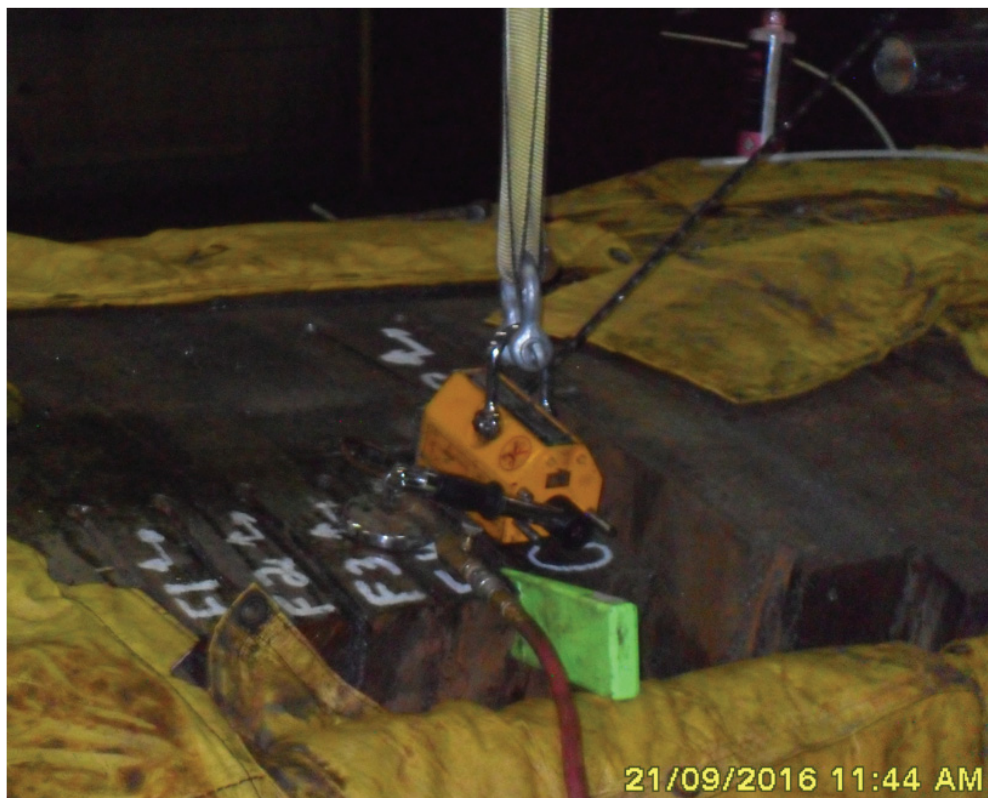
Figure 15. Lift magnet used to remove the cut blocks.

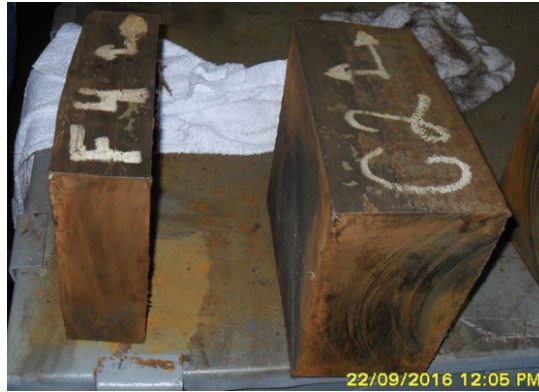
Figure 16. F4 and C2 blocks with orientations marked.

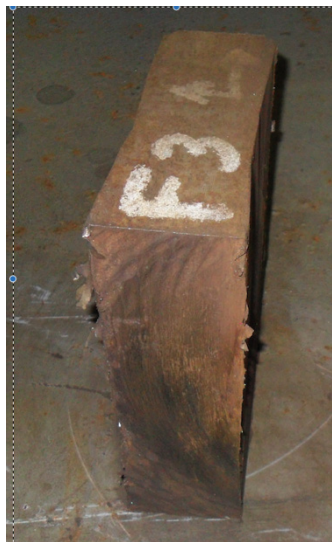
Figure 17. F3 block with orientation marked.

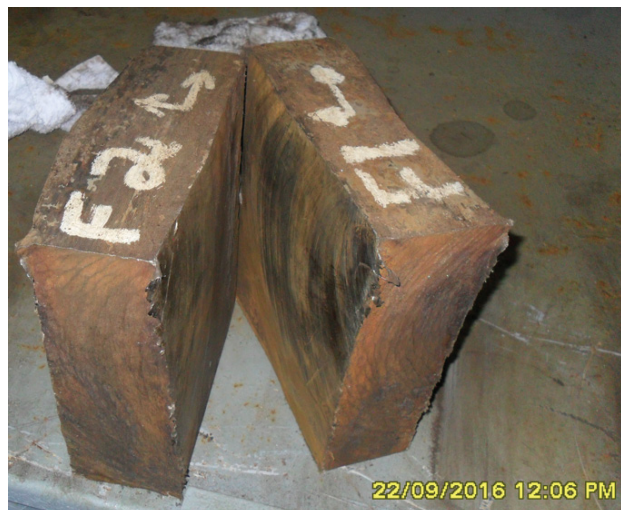
Figure 18. F1 and F2 blocks with orientations marked.

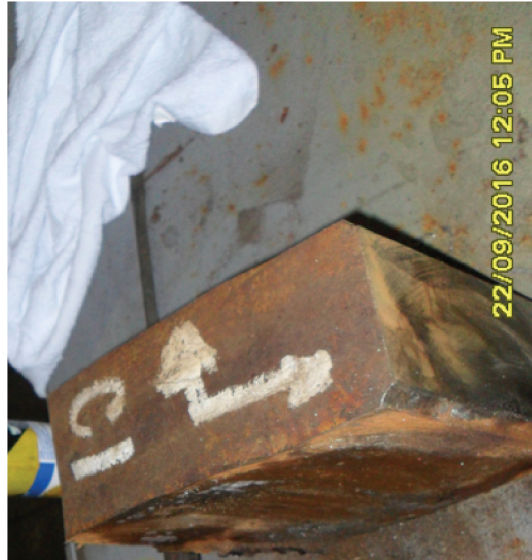
Figure 19. C1 block with orientation marked.

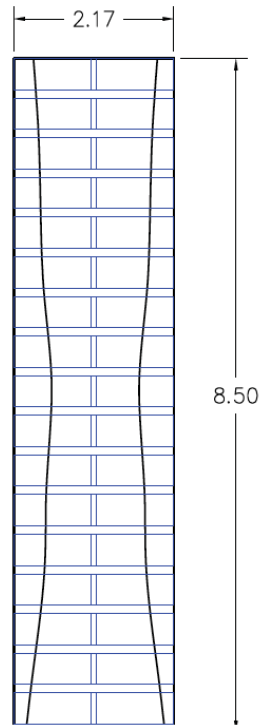
Specimens centered in weld

Figure 20. Detailed C1 block layout for Charpy Specimens. Figure derived from reference [2].

Summary of samples to be machined from one “C” block (base metal)

239 = [(17x15)-16] Charpy specimens

128 = (16 x 8) SS3 tensile specimens

64 = (2 x 2 x 16) coupons (for microstructural characterization)
