Light Water Reactor Sustainability Program

Status Update on the Long-Term Crack Initiation Testing of Alloy 690 and Its Weld Metals in PWR Primary Water

Pacific Northwest National Laboratory

June 2024

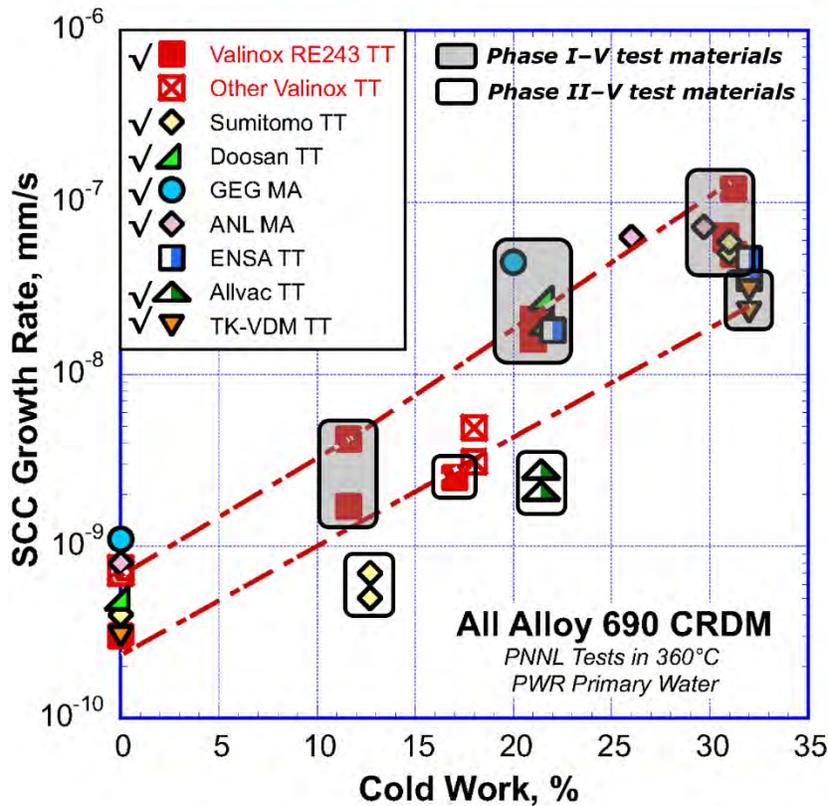
Figure 2. SCCGR response of TT/MA Alloy 690 materials at $\sim 30 \text{ MPa}\sqrt{\text{m}}$ acquired from the NRC SCC crack growth program [14, 15]. The heat and cold work levels selected for SCC initiation evaluation at each stage were checked in the label box and circled in the plots.

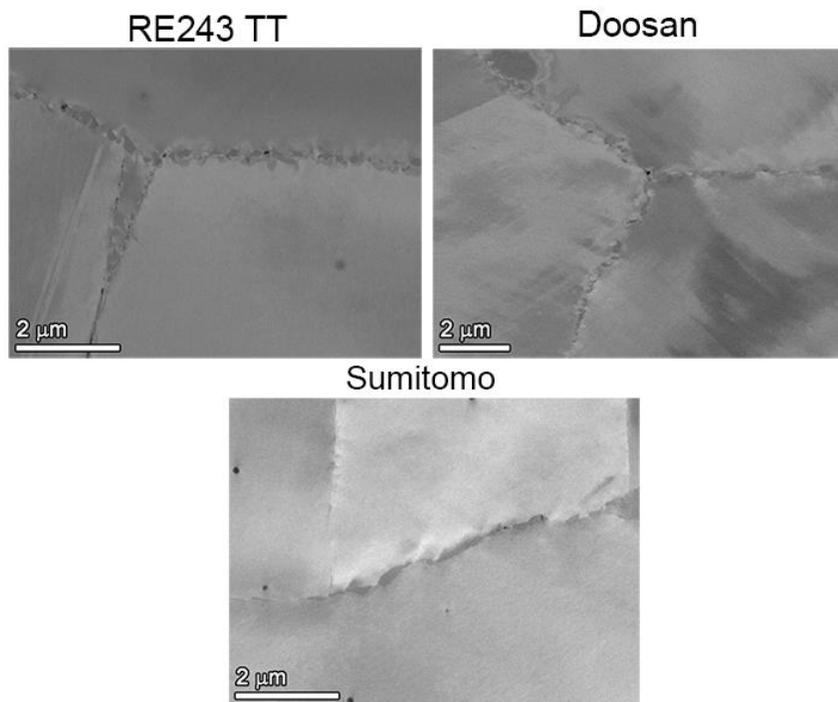
Figure 3. SEM-BSE images illustrating the GB microstructures for the three Alloy 690TT CRDM materials in the as-received condition.

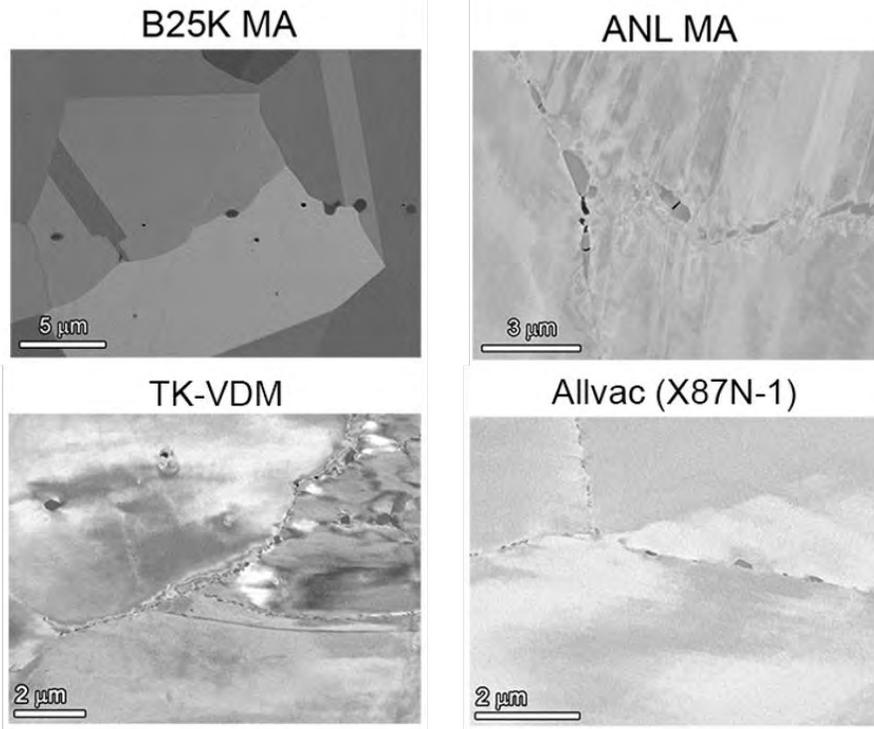
Figure 4. SEM-BSE images illustrating differences in the GB carbide microstructures for each of the four Alloy 690 plate/bar materials in the as-received condition.

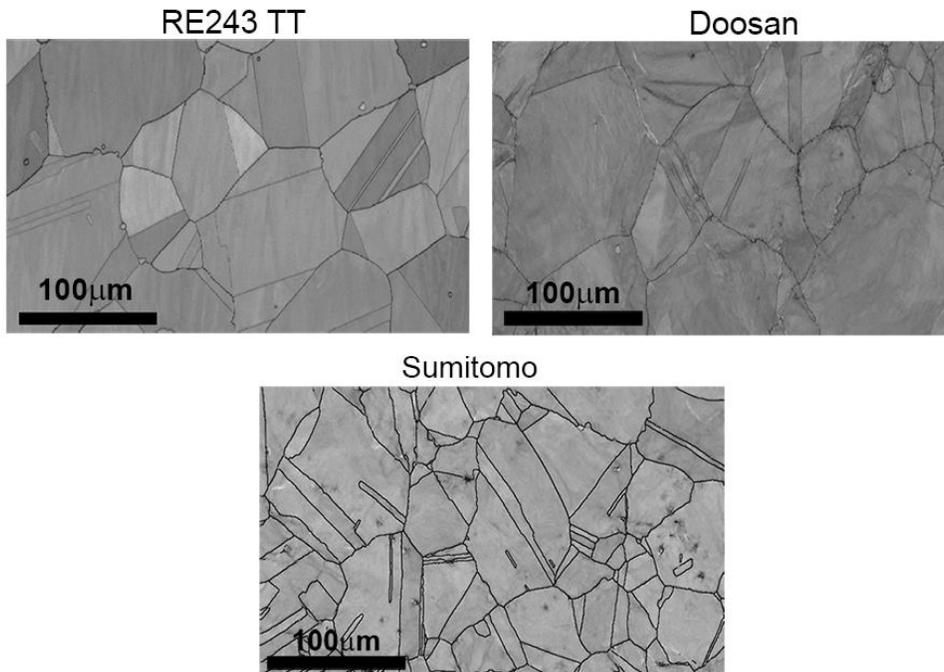
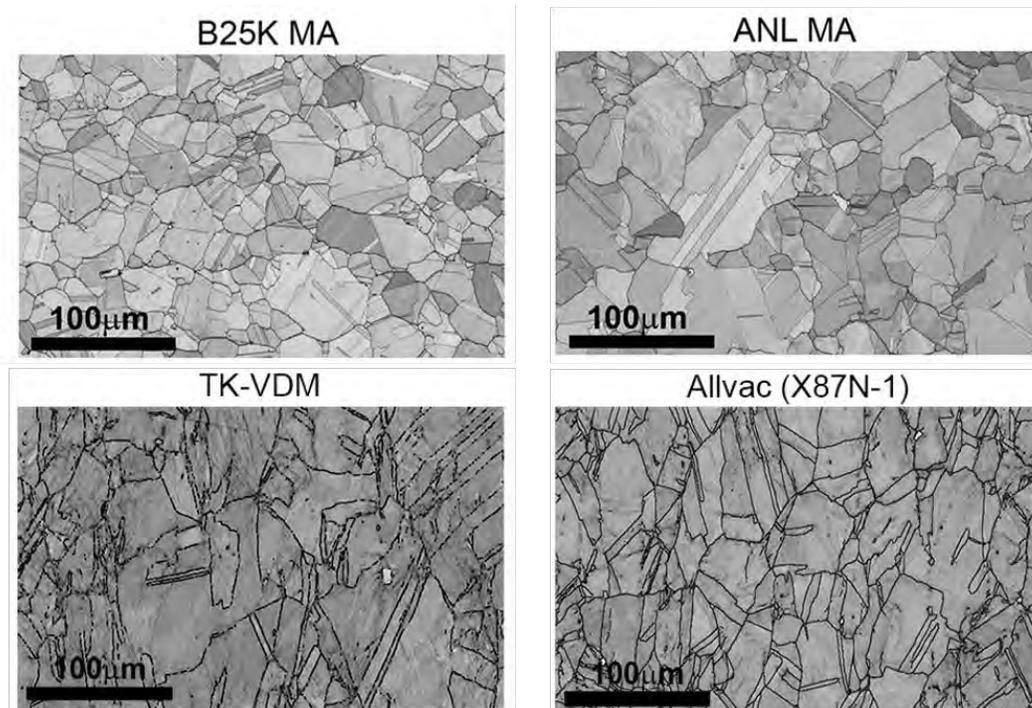
Figure 5. EBSD pattern quality maps showing the general microstructure and grain size for the seven Alloy 690TT/MA materials in the as-received condition.

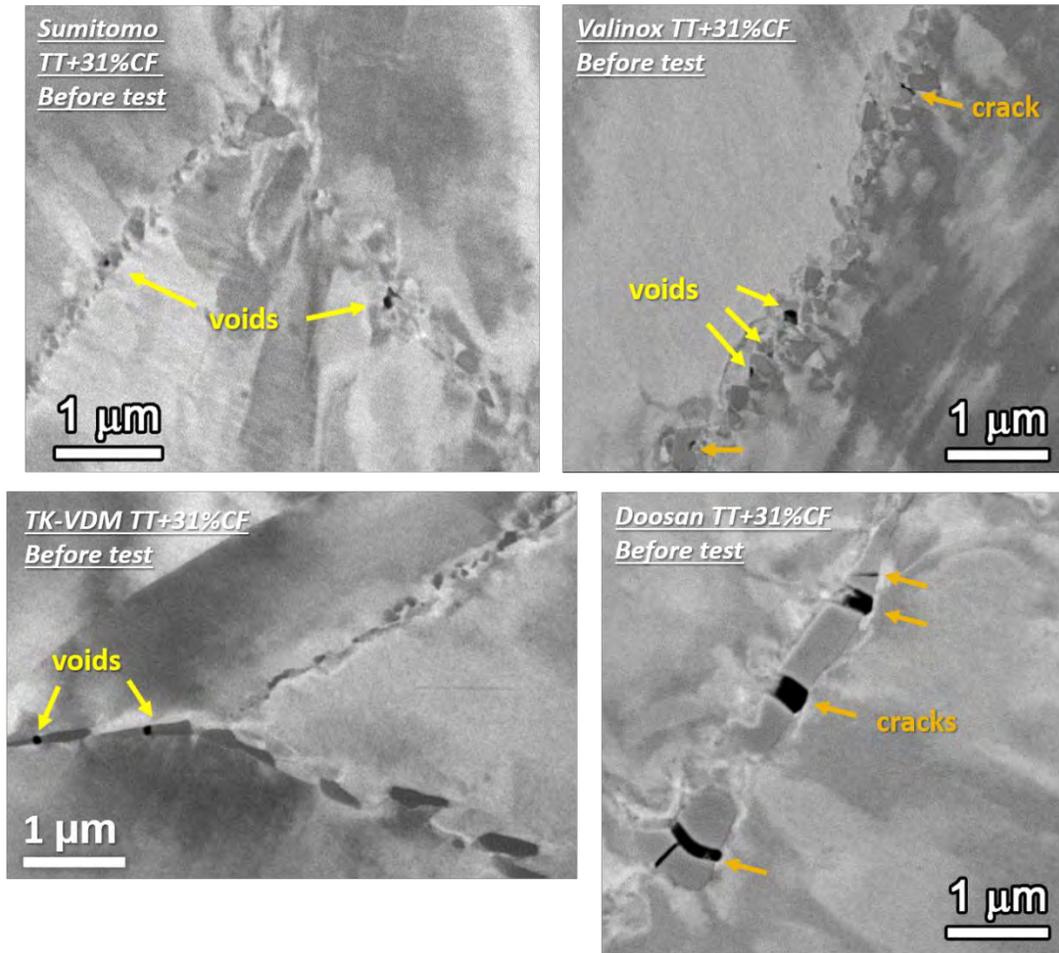
Figure 6. SEM-BSE images illustrating the permanent damage (highlighted by arrows) induced by cold work in four 31%CF Alloy 690TT materials. All images are shown at the same scale.

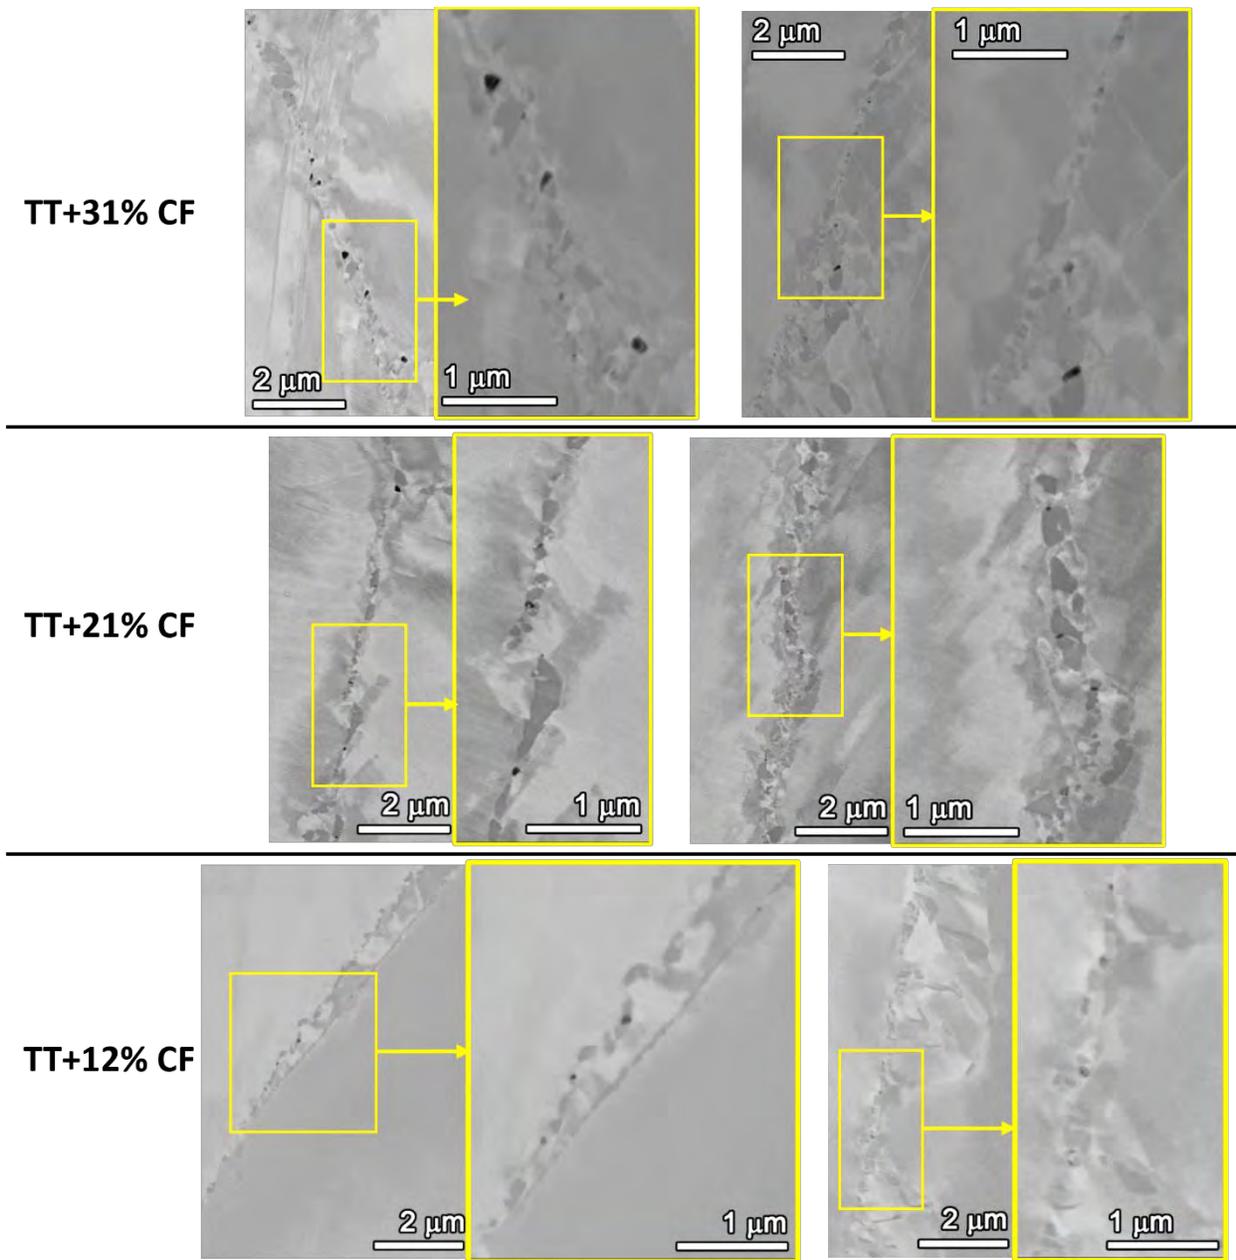
Figure 7. Representative pre-existing defect distribution in the thermally treated Valinox CRDM material cold forged to 12, 21, and 31% reduction in thickness.

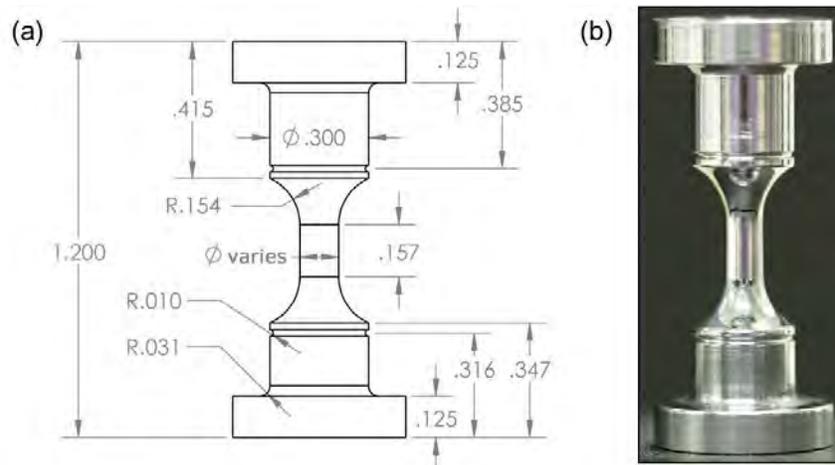
Figure 8. PNNL initiation specimen design. The gauge diameter is selected based on material strength and can vary from 2.75-4.5 mm (0.11-0.18 inches). The gauge length is set at 4.0 mm (0.157 inches). Overall height is 30.5 mm (1.2 inches). Illustrated dimensions are in inch units.

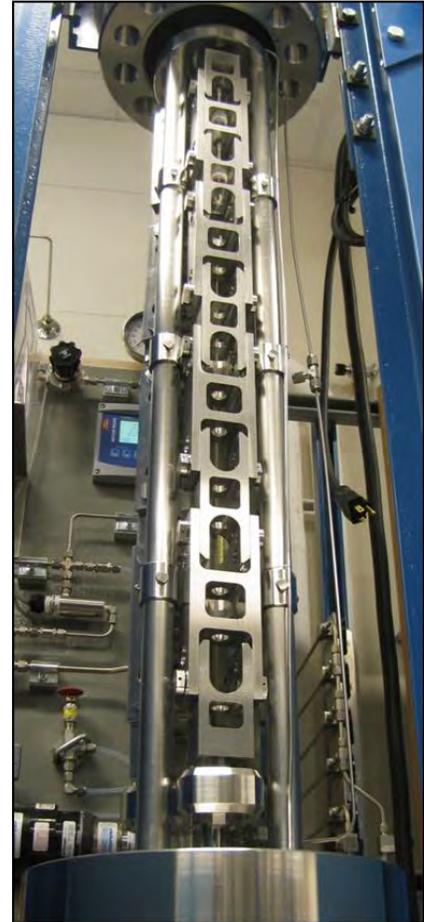
(b) 36-Specimen
SCC Initiation System

Figure 9. The load trains used at PNNL in the (a) medium-size SCC initiation test system with a capacity of testing up to 6 fully instrumented specimens and the (b) large-size SCC initiation test system, i.e., LWRS1, with a capacity of testing up to 12 instrumented specimens and up to 36 specimens in total.

Figure 9 shows the load train and DCPD instrumentation for the serially loaded SCC initiation specimens set up at PNNL. Currently, one large SCC initiation system (denoted as LWRS1 hereafter) and two medium-size SCC initiation systems (denoted as LWRS2 and LWRS3 hereafter) are being used under the scope of LWRS. LWRS1 allows 36 specimens to be tested simultaneously with up to 12 specimens instrumented. LWRS2 and LWRS3 each can test up to 6 fully instrumented specimens. A reversing DCPD technique developed by General Electric [16] was adapted for online monitoring of SCC initiation behavior based on original work by NNL [17]. Details of the PNNL approach were provided in previous publications [1, 18].

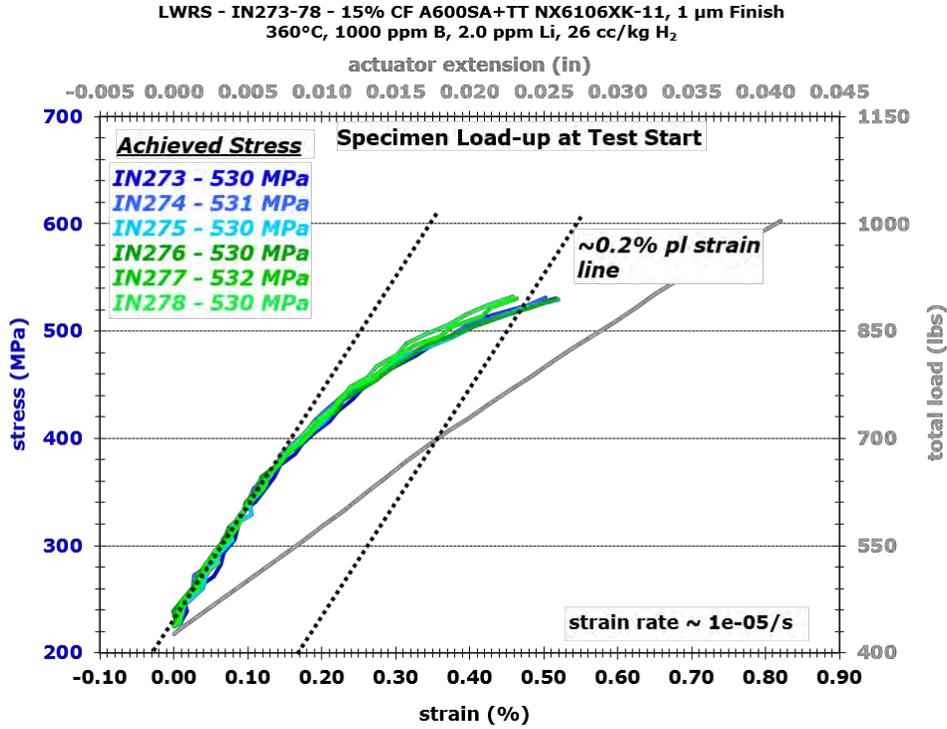
Figure 10. Example of stress versus strain plot during the initial loading of tensile specimens for SCC initiation testing. The displacement in the actuator and the total load are plotted in the secondary x (upper) and y (right) axes, respectively.

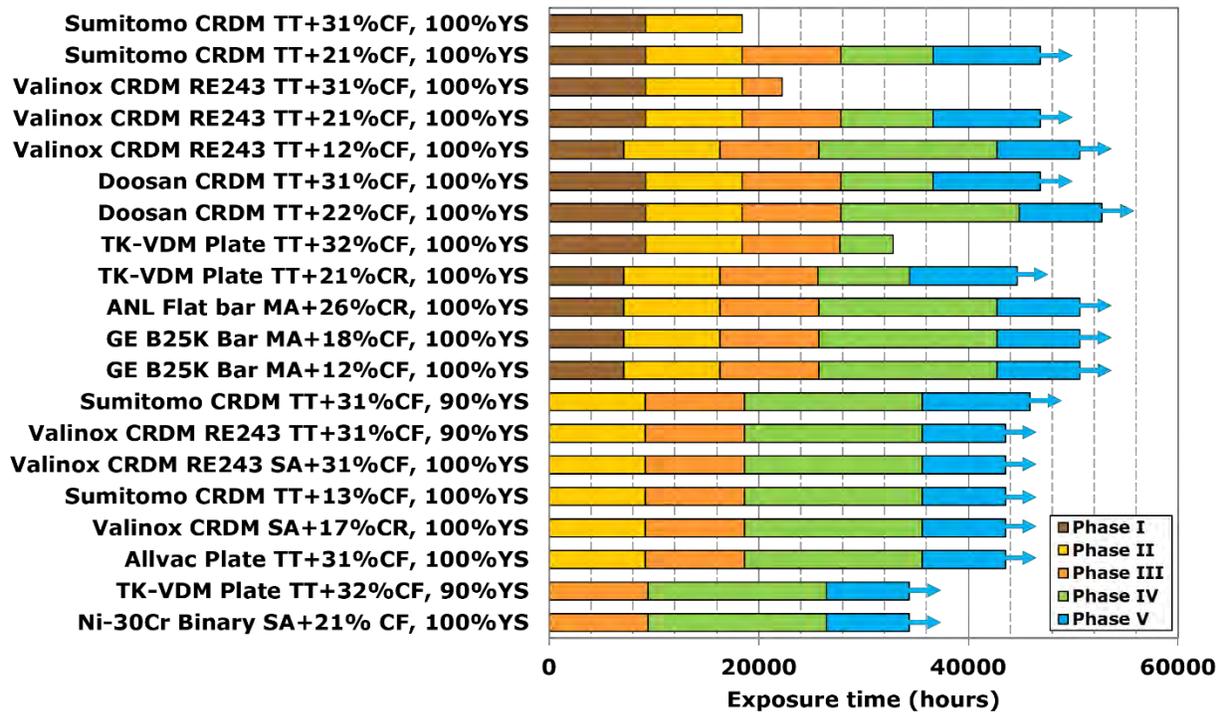
Figure 12. Up-to-date exposure time of the CW Alloy 690 materials evaluated in the long-term SCC initiation testing under LWRS. The arrows suggest that the test is ongoing as of June 2024 for the specified material and cold work conditions.

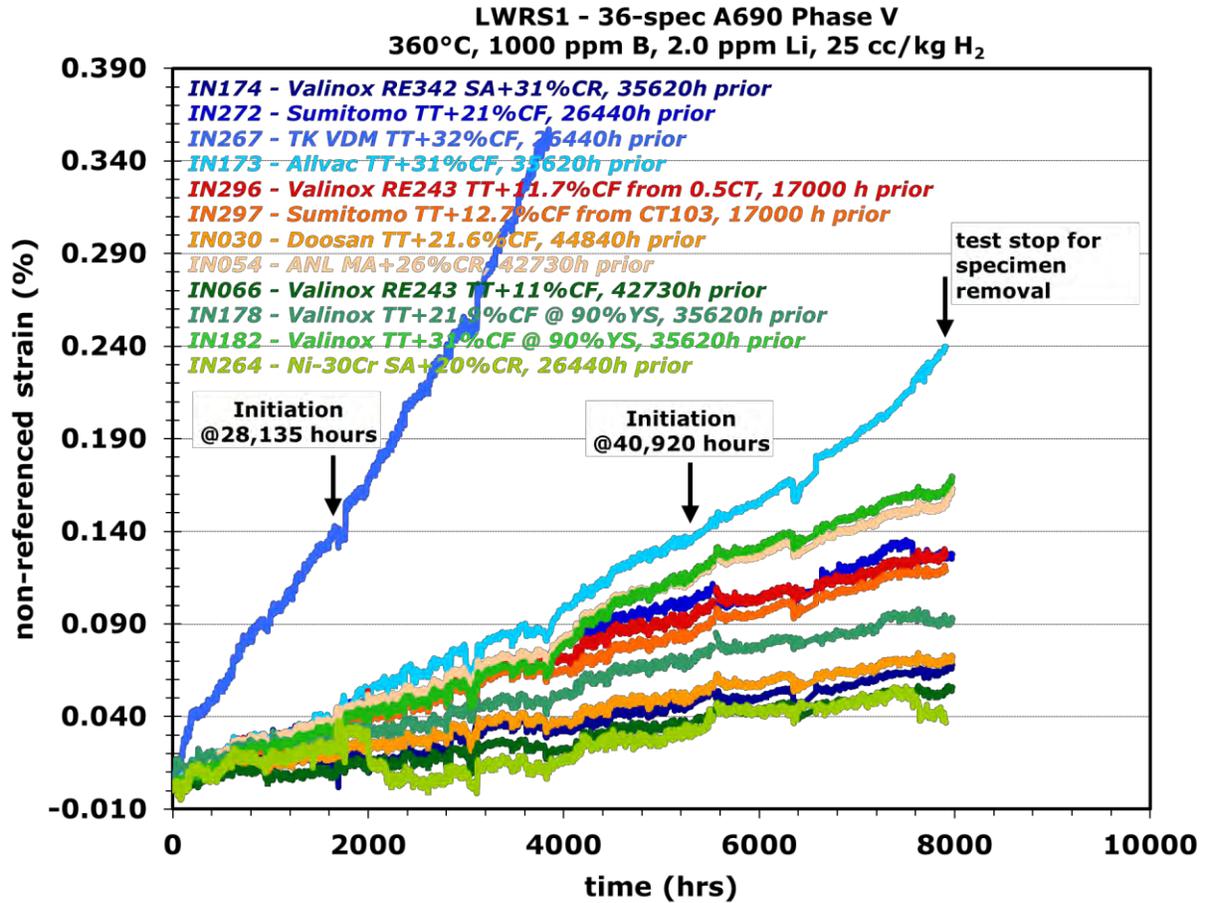
Figure 13. Overall non-referenced DCPD strain response during the Phase V exposure for all the specimens monitored in the LWRS1 SCC initiation test system in 360 °C PWR primary water by the time the test was stopped in April 2024. Specimens were all tested at materials yield stress unless otherwise specified.

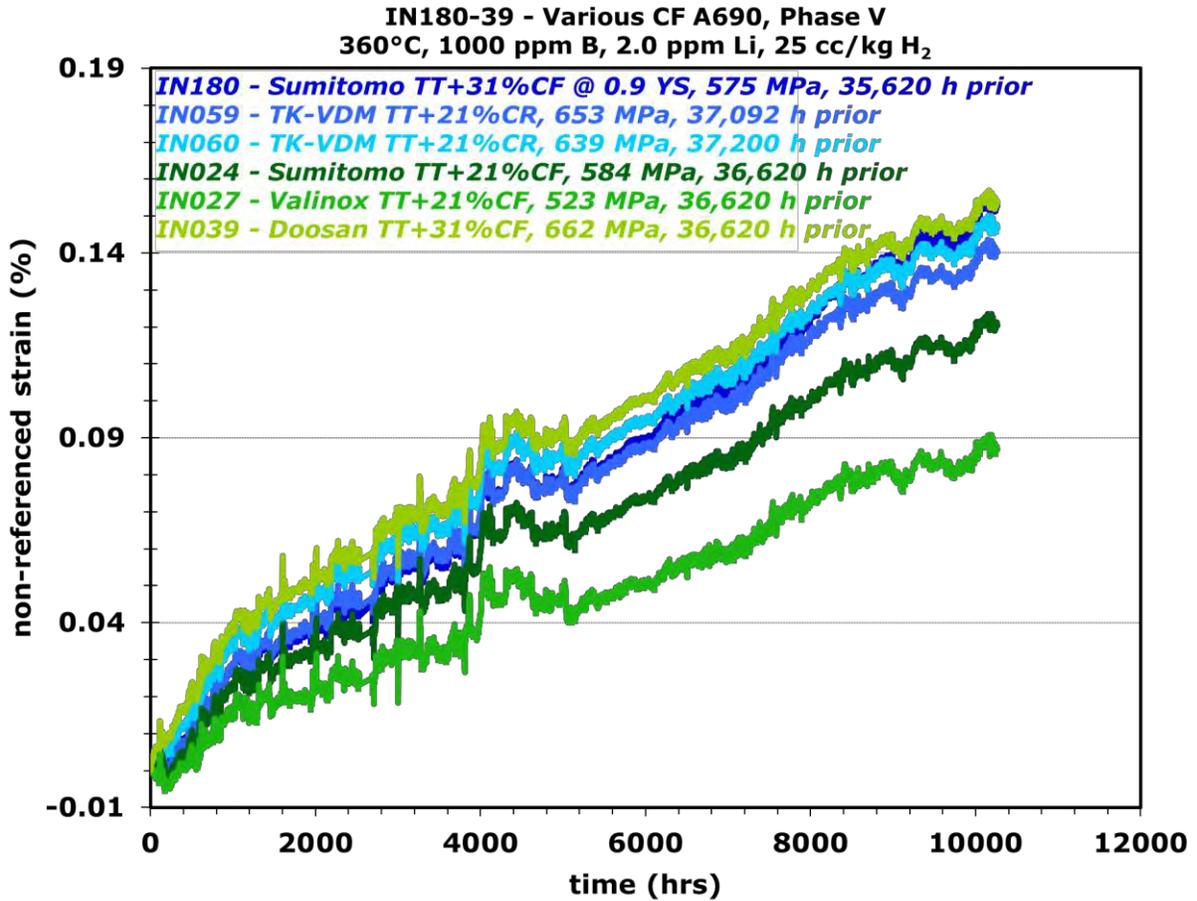
Figure 14. Overall non-referenced DCPD strain response during the Phase V exposure for all the specimens monitored in the LWRS2 (6-specimen) SCC initiation test system in 360 °C PWR primary water by the time the test was stopped in April 2024. Specimens were all tested at materials yield stress unless otherwise specified.

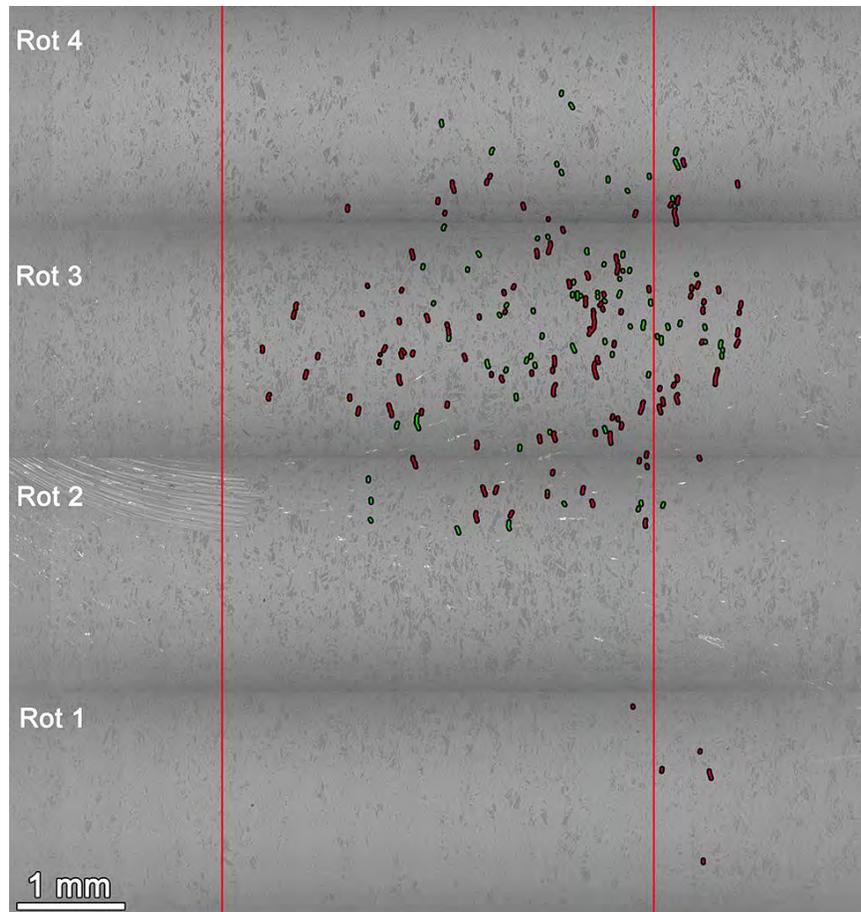
Figure 15. SEM-BSE montage image of the Allvac TT+31%CF specimen IN173 removed after 43,527 hours of exposure in 360°C simulated PWR primary water upon DCPD detection of crack initiation. The gauge section of the specimen is between the two red lines marked in the image. Obvious cracks and possible cracks are highlighted in red and green, respectively.

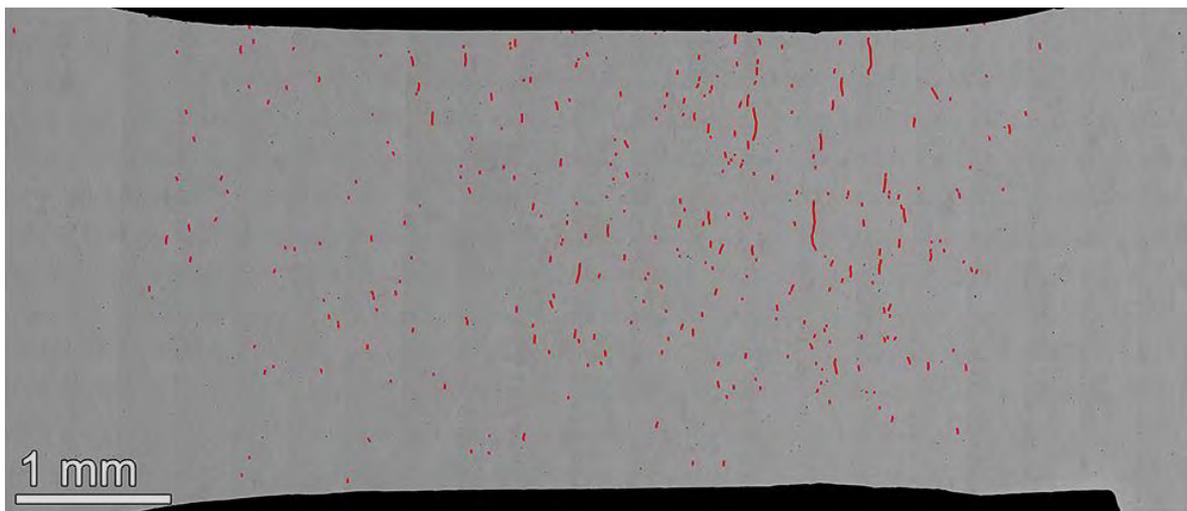
Figure 16. SEM-BSE montage image of the cross-section of the Allvac TT+31%CF specimen IN173. Continuous and semi-continuous IG damage are highlighted in red.

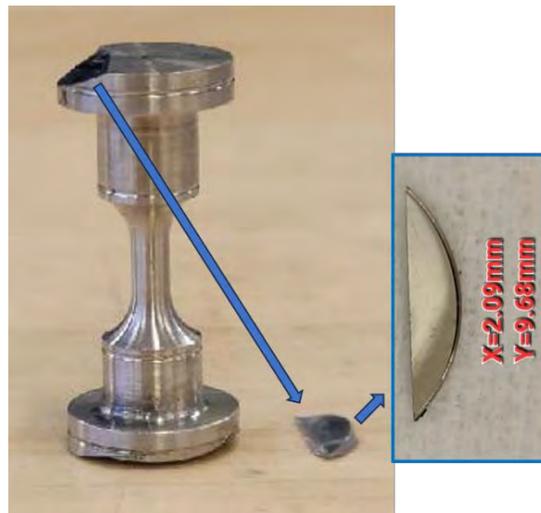
Figure 17. Photos showing the wedge samples cut off from initiation specimens for SXR D analysis.

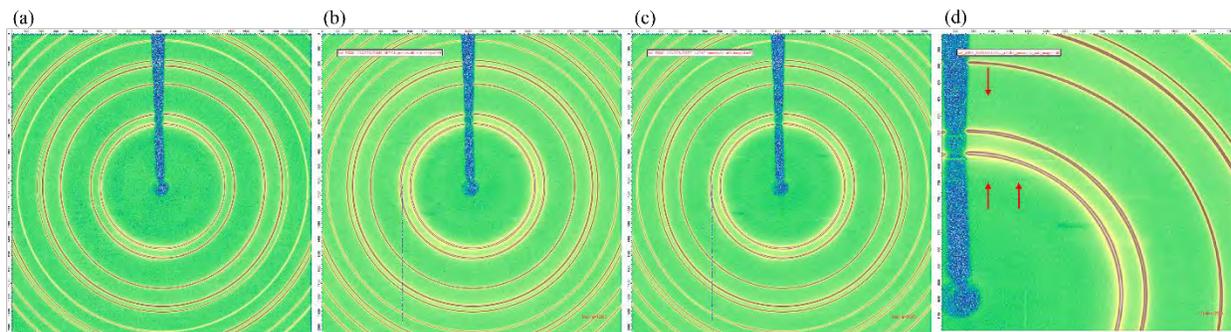
Figure 18. 2D XRD patterns for Doosan TT+31%CF specimens (a) IN039, (b) IN040, and (c) IN041 exposed for 5.3, 2.1, and 1.1 years in 360°C simulated PWR primary water. Panel (d) shows a magnified view of the region with “spotty” peaks for the MX and M₂₃C₆ particles.

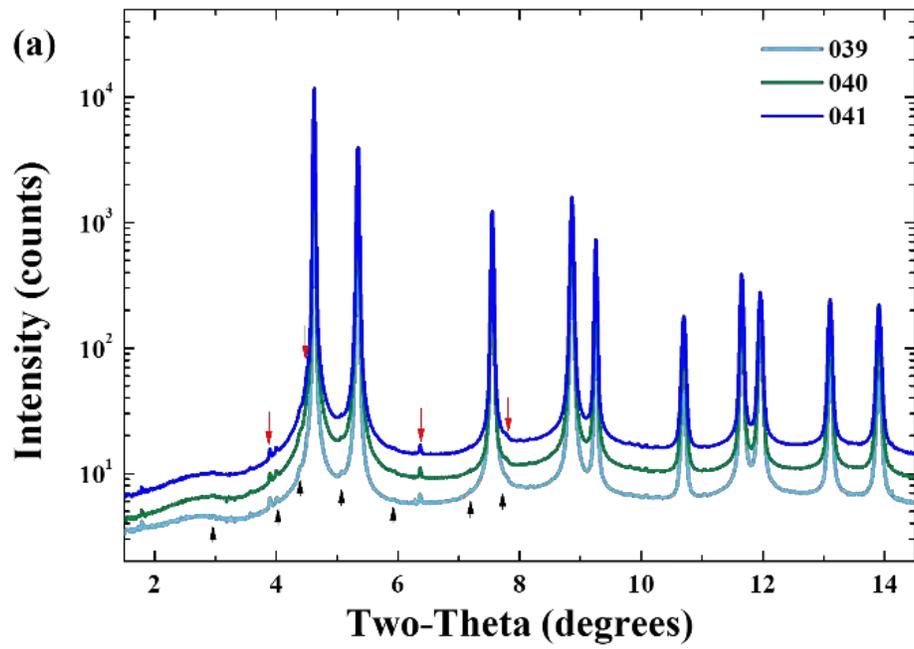
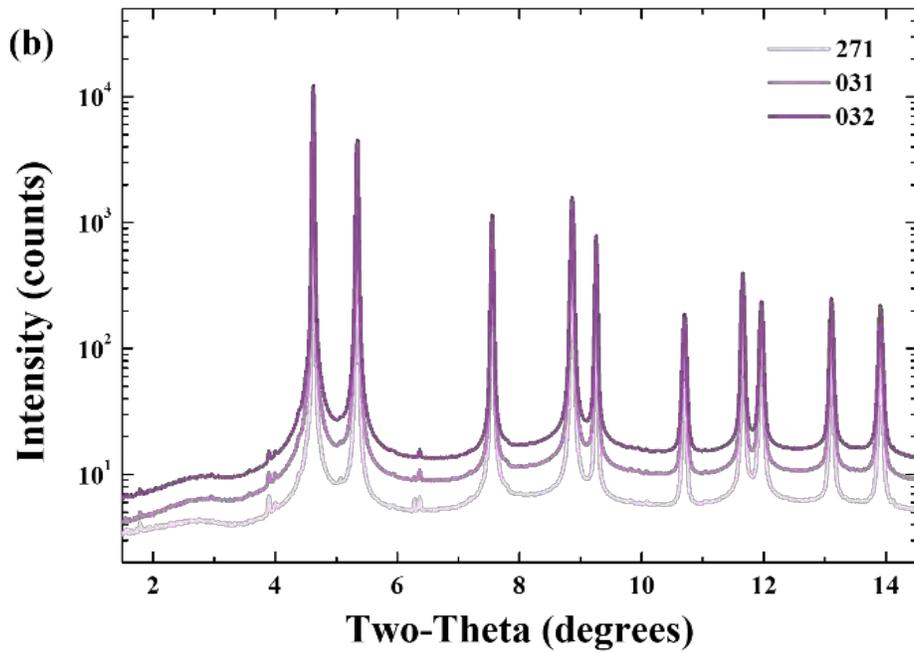
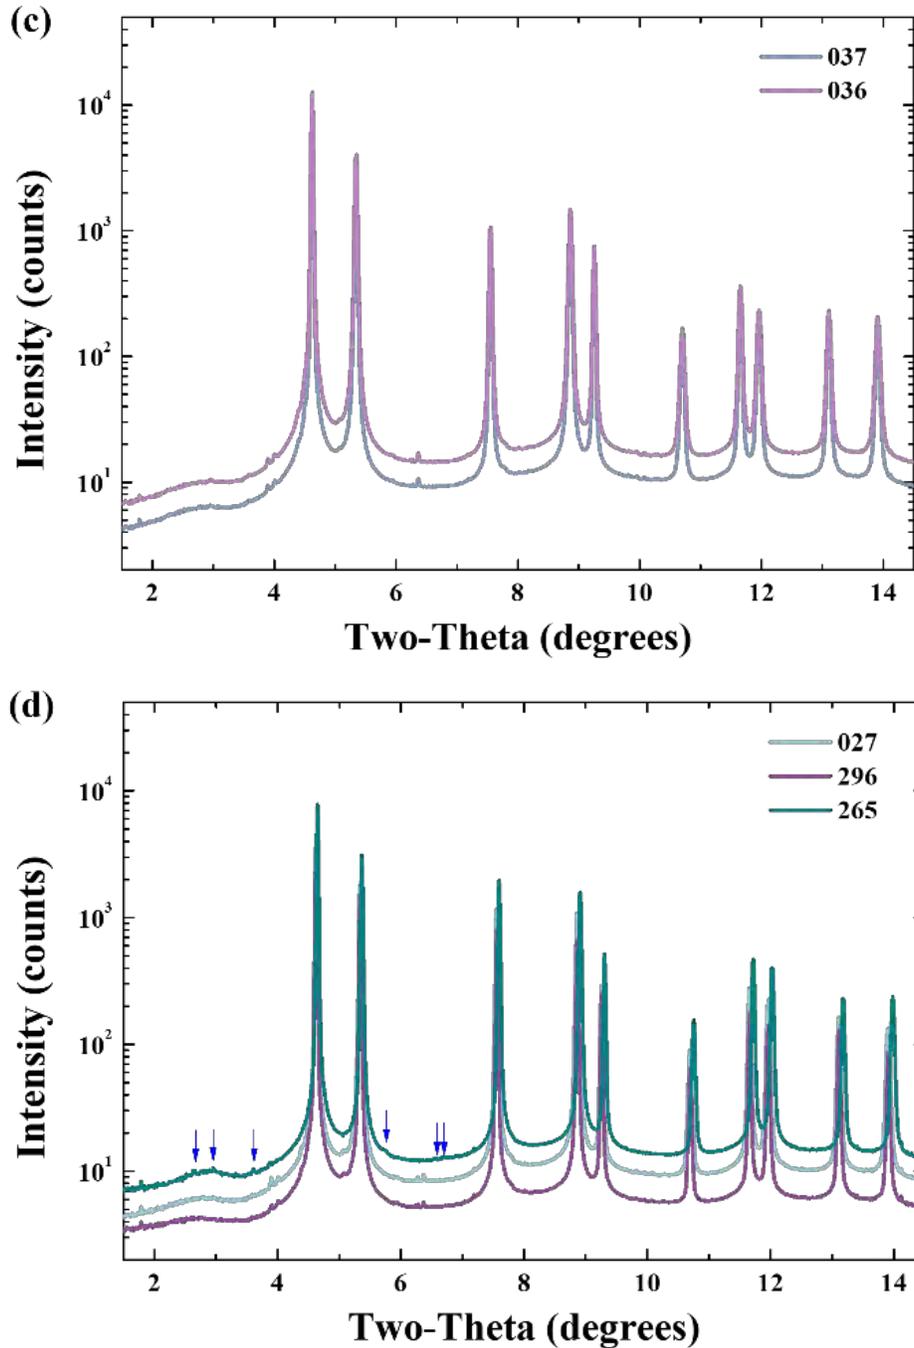
Figure 19. Reduced XRD patterns for all measured specimens previously exposed in 360°C simulated PWR primary water: (a) Doosan TT+31%CF specimens exposed for 5.3 (IN039), 2.1 (IN040), and 1.1 (IN041) years, (b) Doosan TT+21%CF specimens exposed for 3.9 (IN271), 2.1 (IN031), and 1.1 (IN032) years, (c) Valinox TT+31%CF specimens exposure for 2.5 (IN037) and 2.1 (IN036) years, (d) Valinox TT+21% specimens IN027 exposed for 5.3 years, Valinox TT+12%CF IN296 exposed for 2.8 years, and Ni-30Cr SA+20%CF specimen IN265 exposed for 3.9 years. Black and red arrows indicate the minor Cr_{23}C_6 and TiN phases. Note the 265 specimen has subtle features close to the peaks expected for Immm Ni_2Cr phase, as indicated by blue arrows.

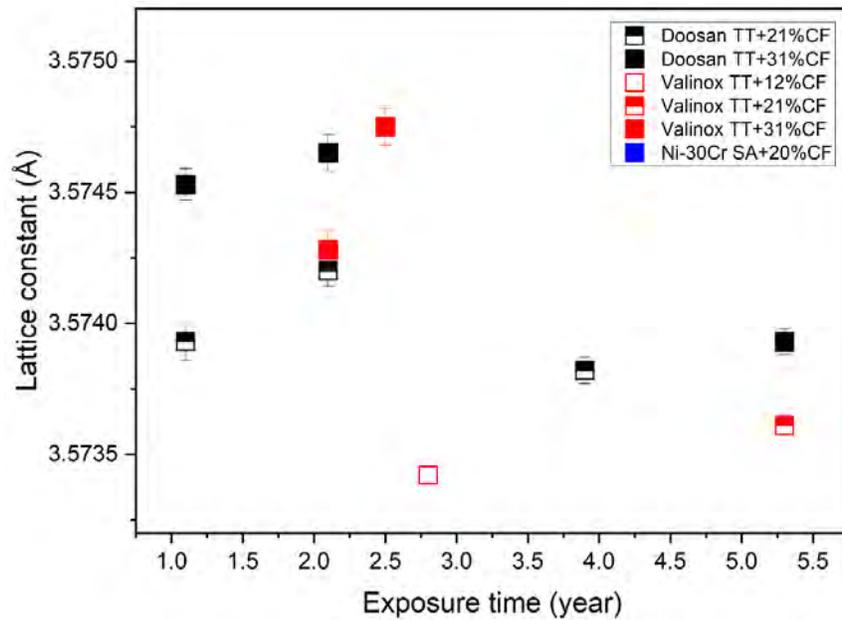
Figure 20. Lattice constants measured in all specimens grouped by heat and material condition and as a function of exposure time. The Ni-30Cr SA+20%CF specimen has a very different lattice constant so is not shown in this figure to better visualize the difference among the other specimens.

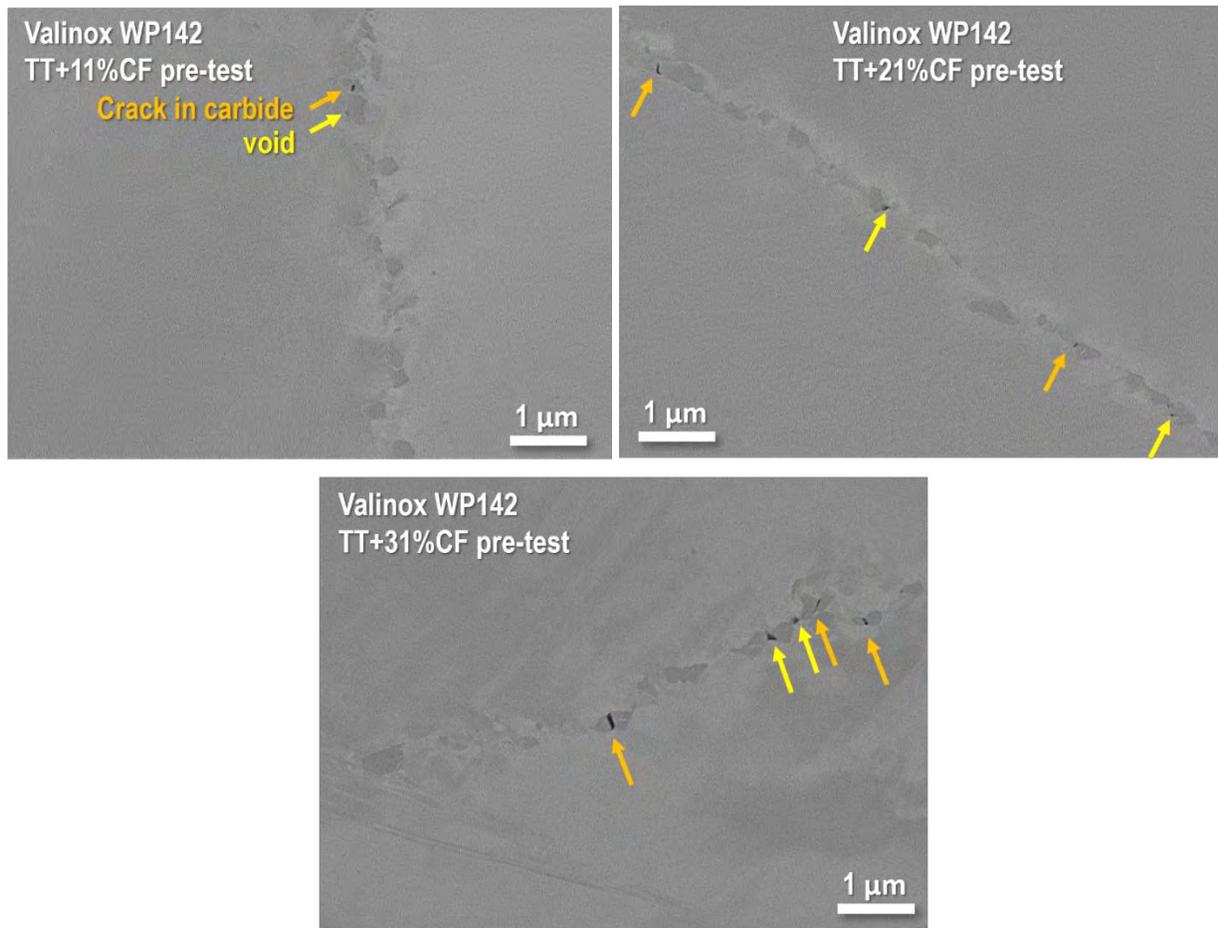
Figure 21. Cold forging-induced defects at GBs in the 11%, 21%, and 31% CF Valinox WP142 Alloy 690TT materials.

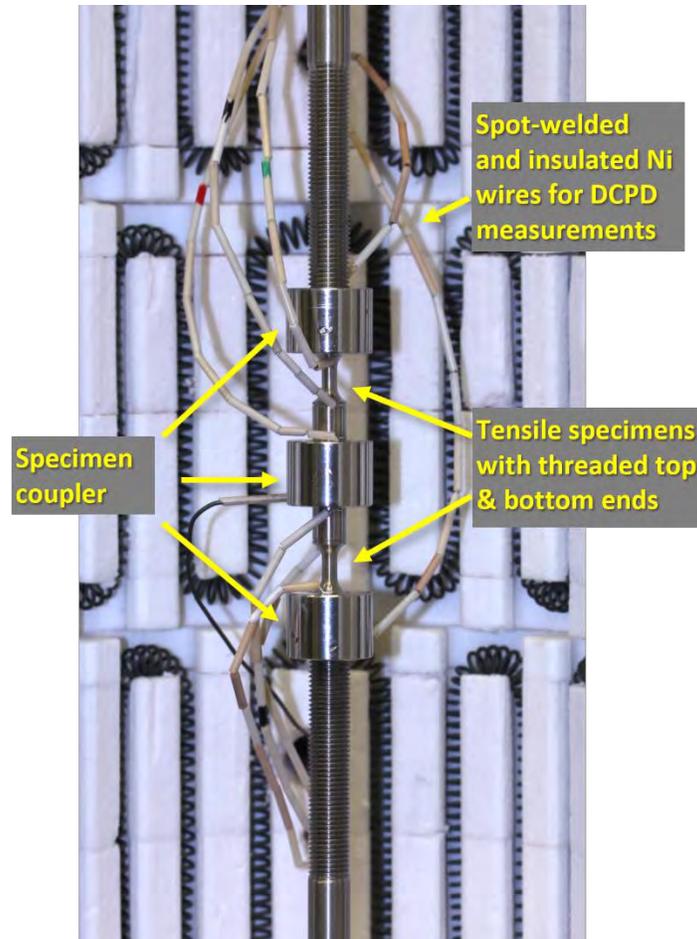
Figure 23. Setup of the PNNL threaded tensile specimen DCPD shakedown test.

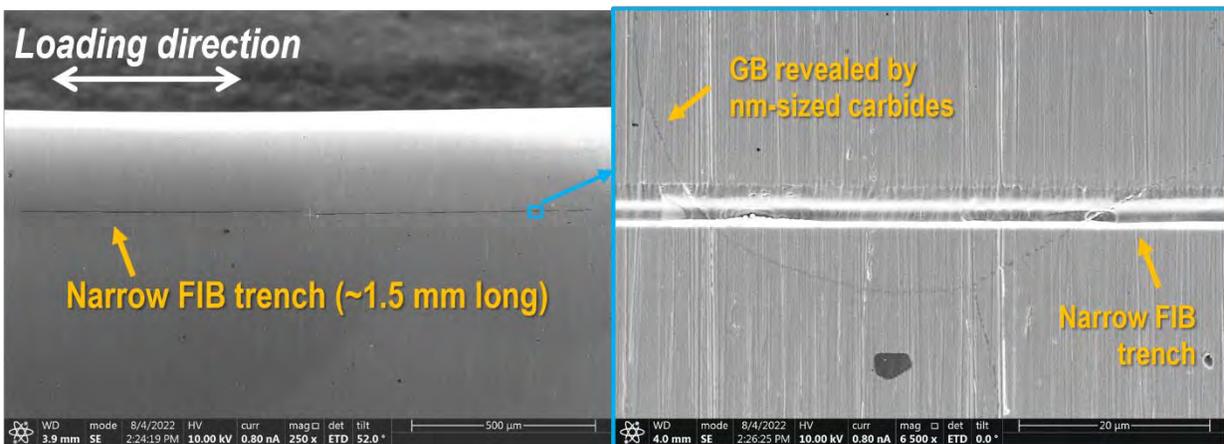
Figure 24. Example of the narrow FIB trench made in the gauge section of the creep specimens prior to the test to serve as a fiducial mark for post-test GB sliding measurement. The trench is around 1.5 – 2 mm long and less than 5 μm wide.

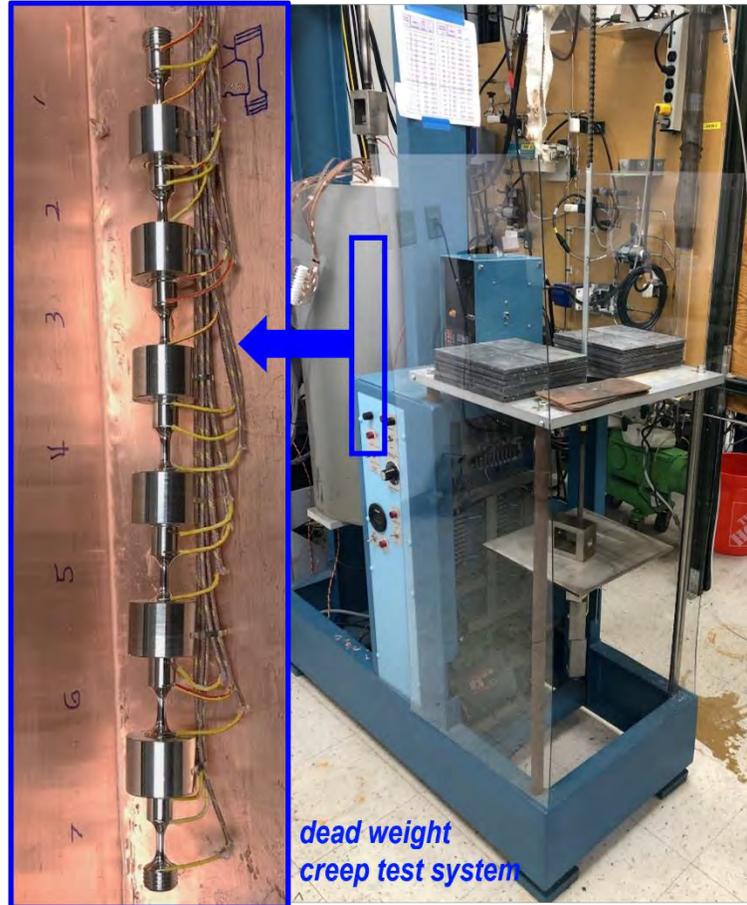
Figure 25. Deadweight creep test system at Lucideon M+P showing the furnace and the lever arm (partial view) with dead weights (right), and the load train inside the furnace containing seven specimens with instrumentation wires spot welded to each specimen for in-situ DCPD monitoring of creep rates and crack initiation (left).

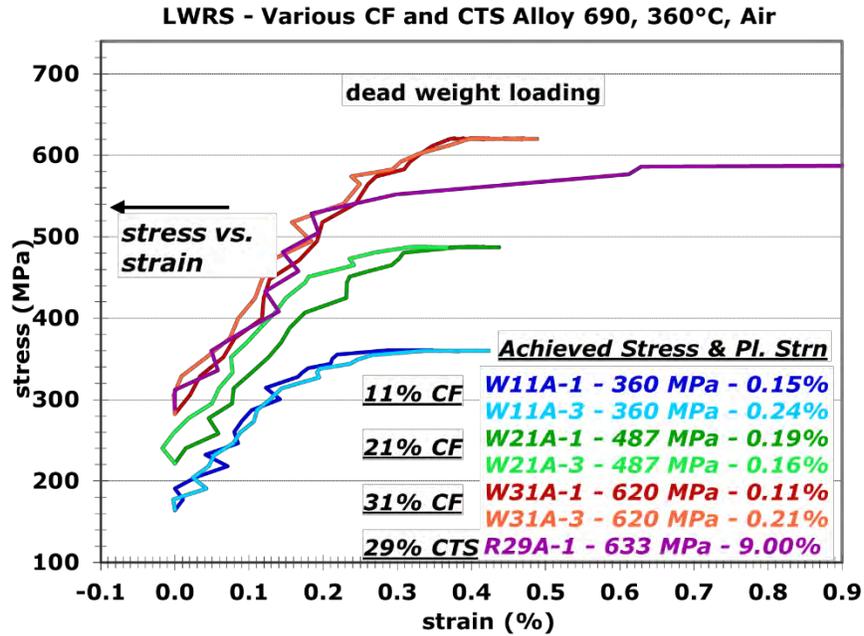
Figure 26. Example of stress versus strain plot during the initial loading of seven specimens in the 360°C creep test in air.

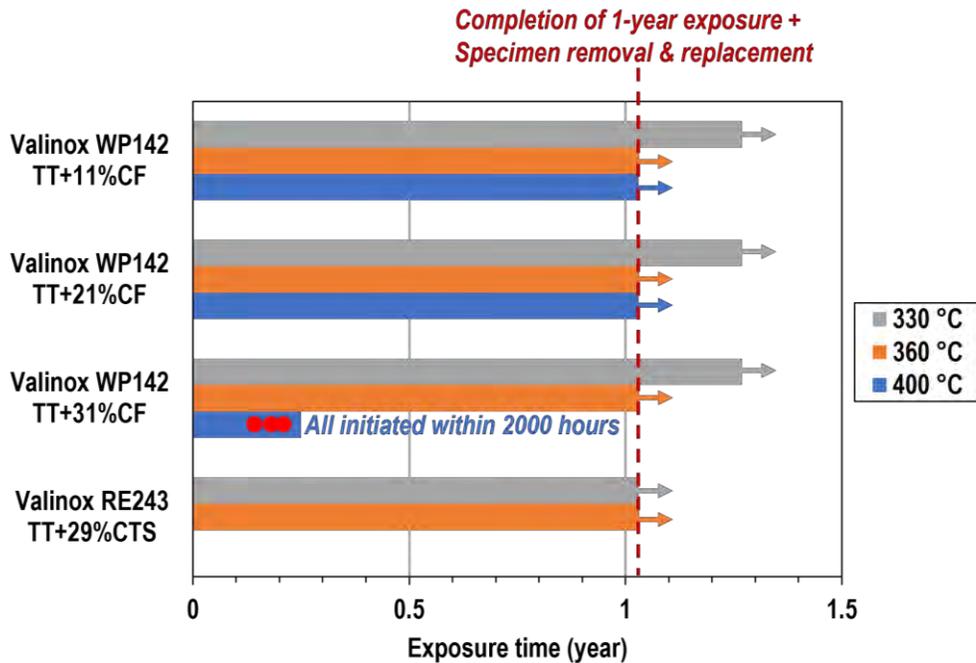
Figure 27. Test progress on specimens with the longest exposure at each temperature.

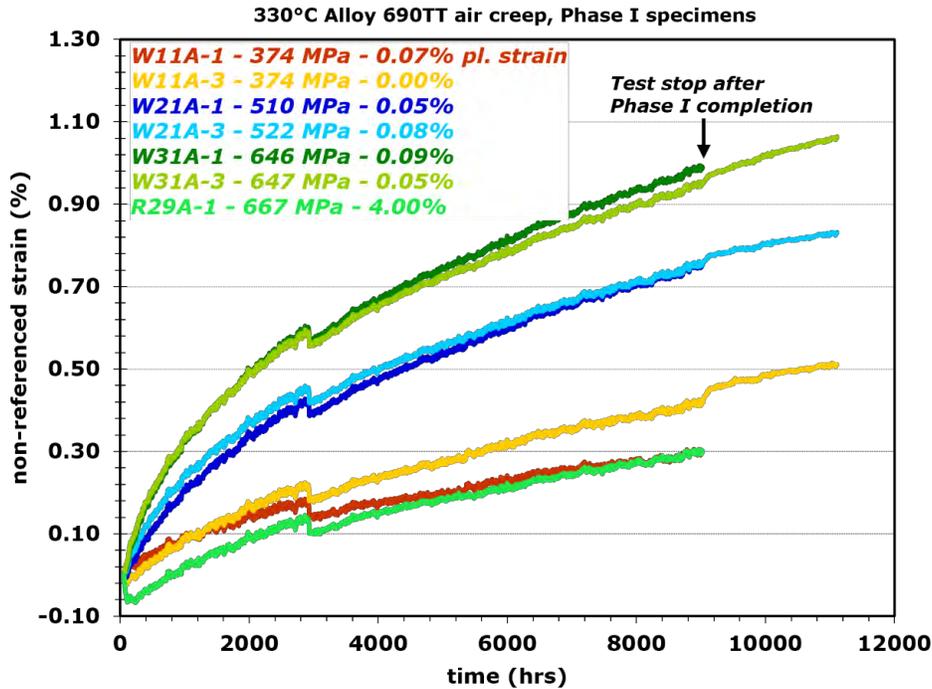
Figure 28. Overall non-referenced DCPD strain response of the seven Alloy 690TT specimens tested in 330°C air during the 1st year exposure, and the three specimens stayed in test for Phase II testing. This test is ongoing as of June 2024.

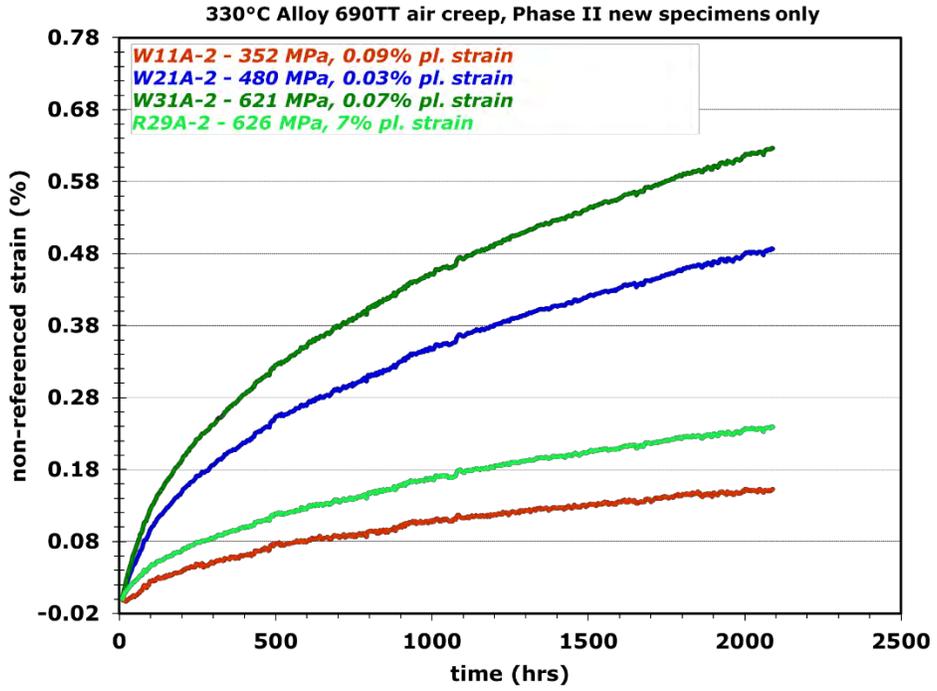
Figure 29. Overall non-referenced DCPD strain response of the four new Alloy 690TT specimens added to the Phase II testing in 330°C air. This test is ongoing as of June 2024.
