Light Water Reactor Sustainability Program

Status Update on the Long-Term Crack Initiation Testing of Alloy 690 and Its Weld Metals in PWR Primary Water

Pacific Northwest National Laboratory

June 2024

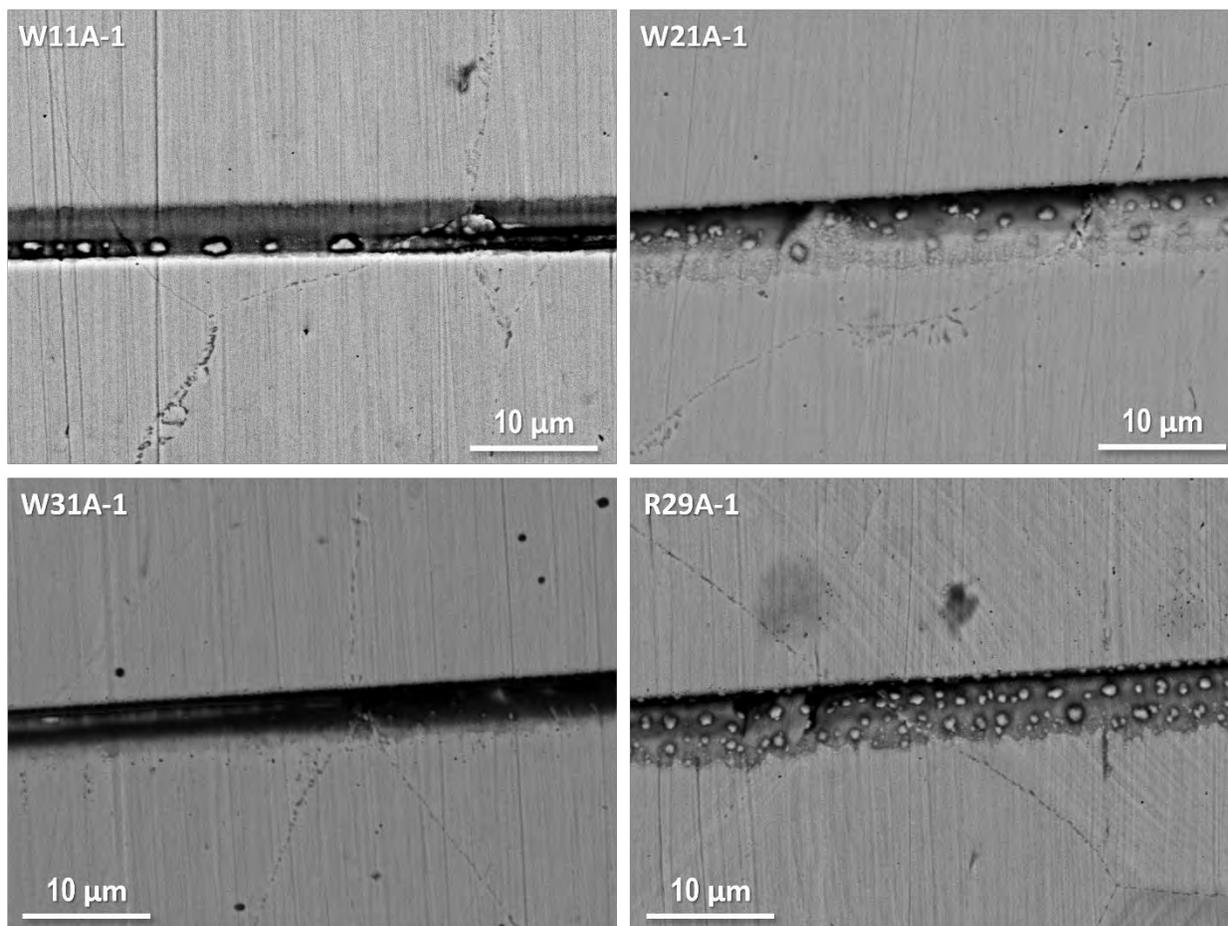
Figure 30. Representative grain boundary morphology crossing the FIB trenches in the creep specimens tested in 330°C air after 9022 hours of exposure.

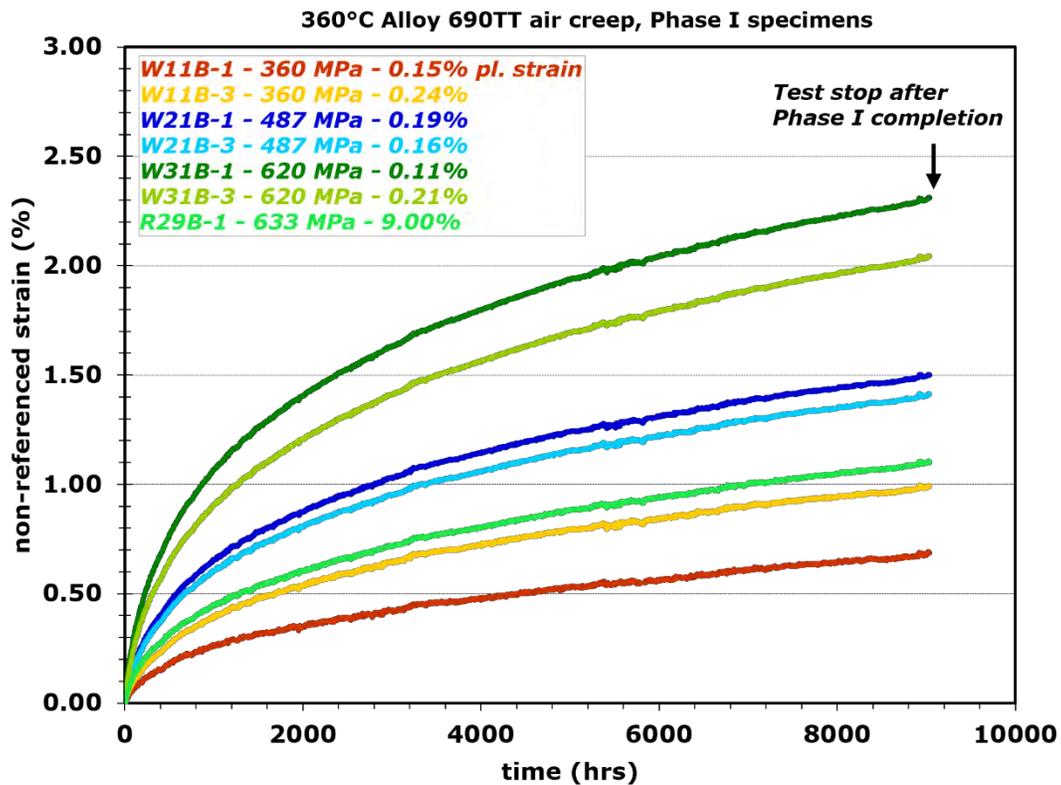
Figure 31. Overall non-referenced DCPD strain response of the seven Alloy 690TT specimens tested in 360°C air during Phase I exposure.

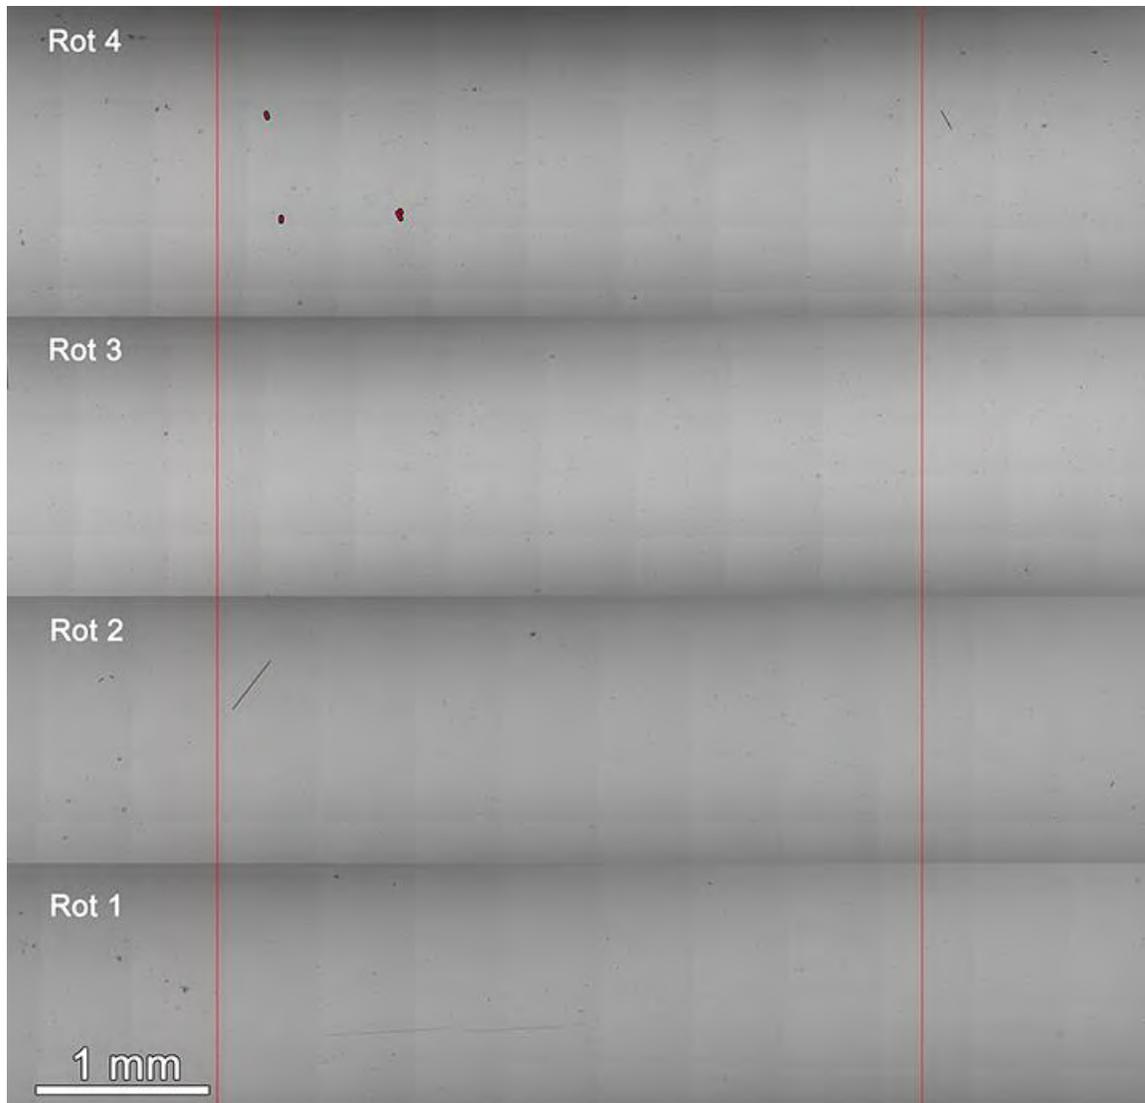
Figure 32. SEM-BSE montage image of the Valinox WP142 TT+31%CF specimen W31B-1 tested in 360°C air after 9038 hours. The gauge section of the specimen is between the two red lines marked in the image. Obvious cracks are highlighted in red.

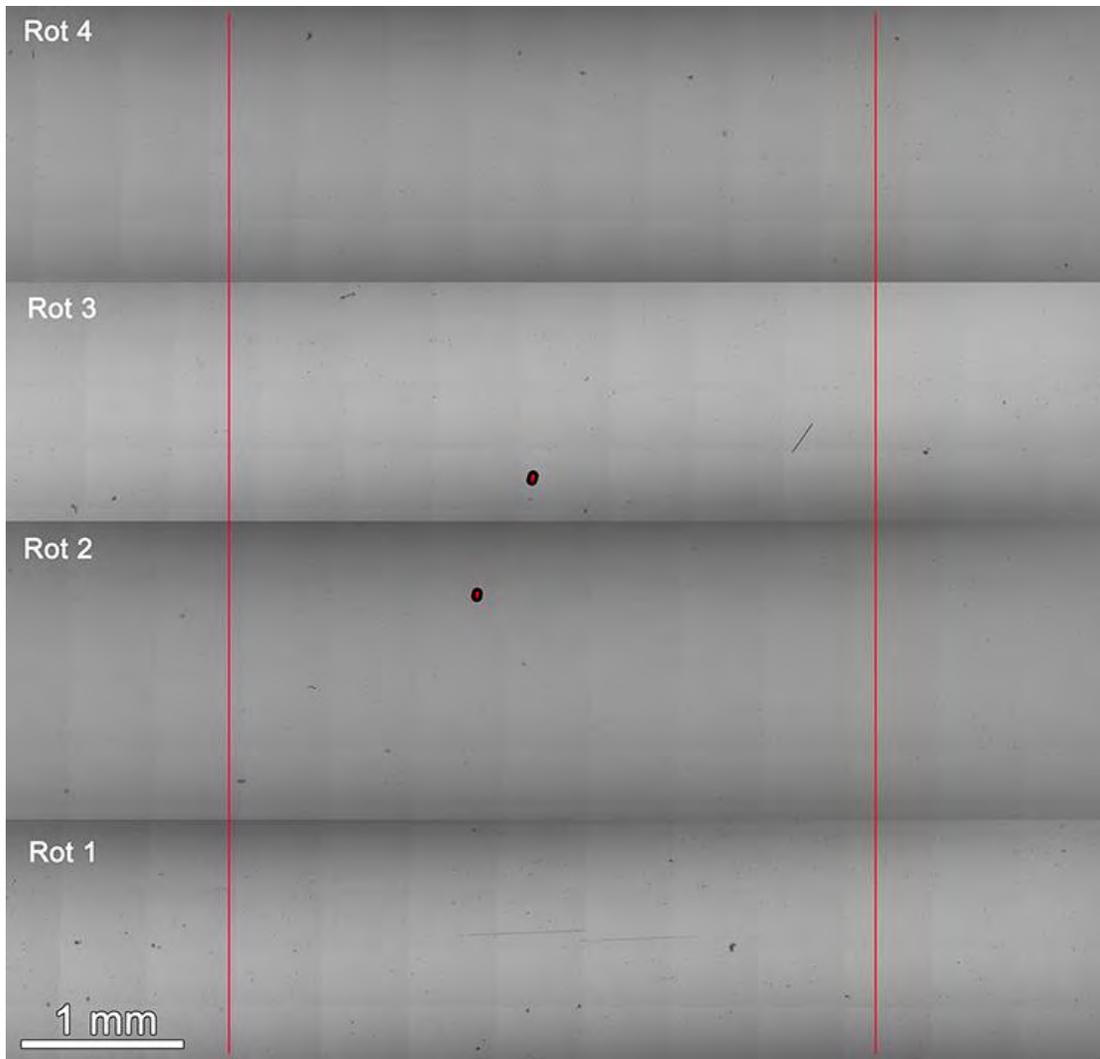
Figure 33. SEM-BSE montage image of the Valinox WP142 TT+31%CF specimen W31B-3 tested in 360°C air after 9038 hours. The gauge section of the specimen is between the two red lines marked in the image. Obvious cracks are highlighted in red.

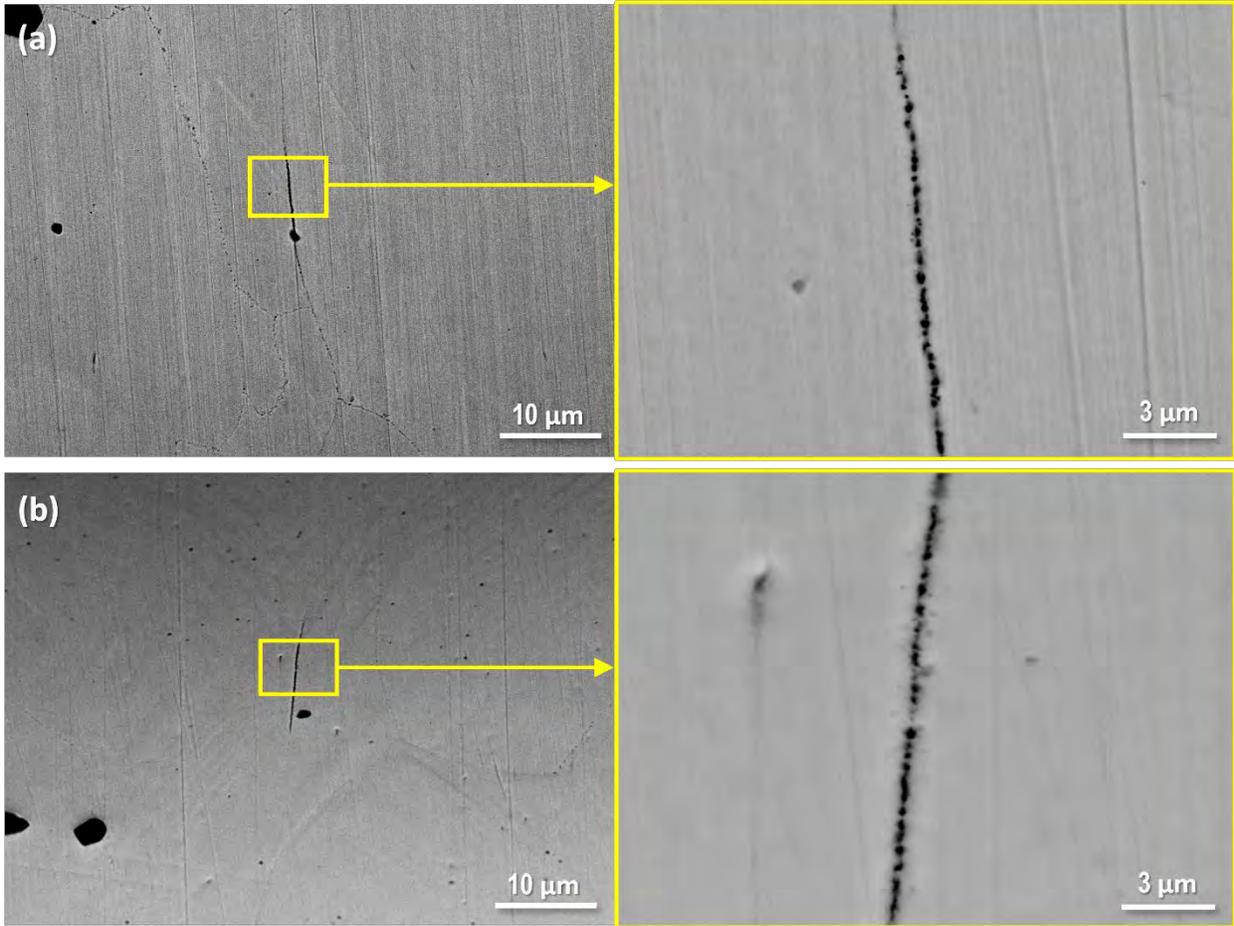
Figure 34. SEM-BSE images on representative IG cracks found on the surface of the two Valinox WP142 TT+31%CF specimens (a) W31B-1 and (b) W31B-3 tested in 360°C air after 9038 hours.

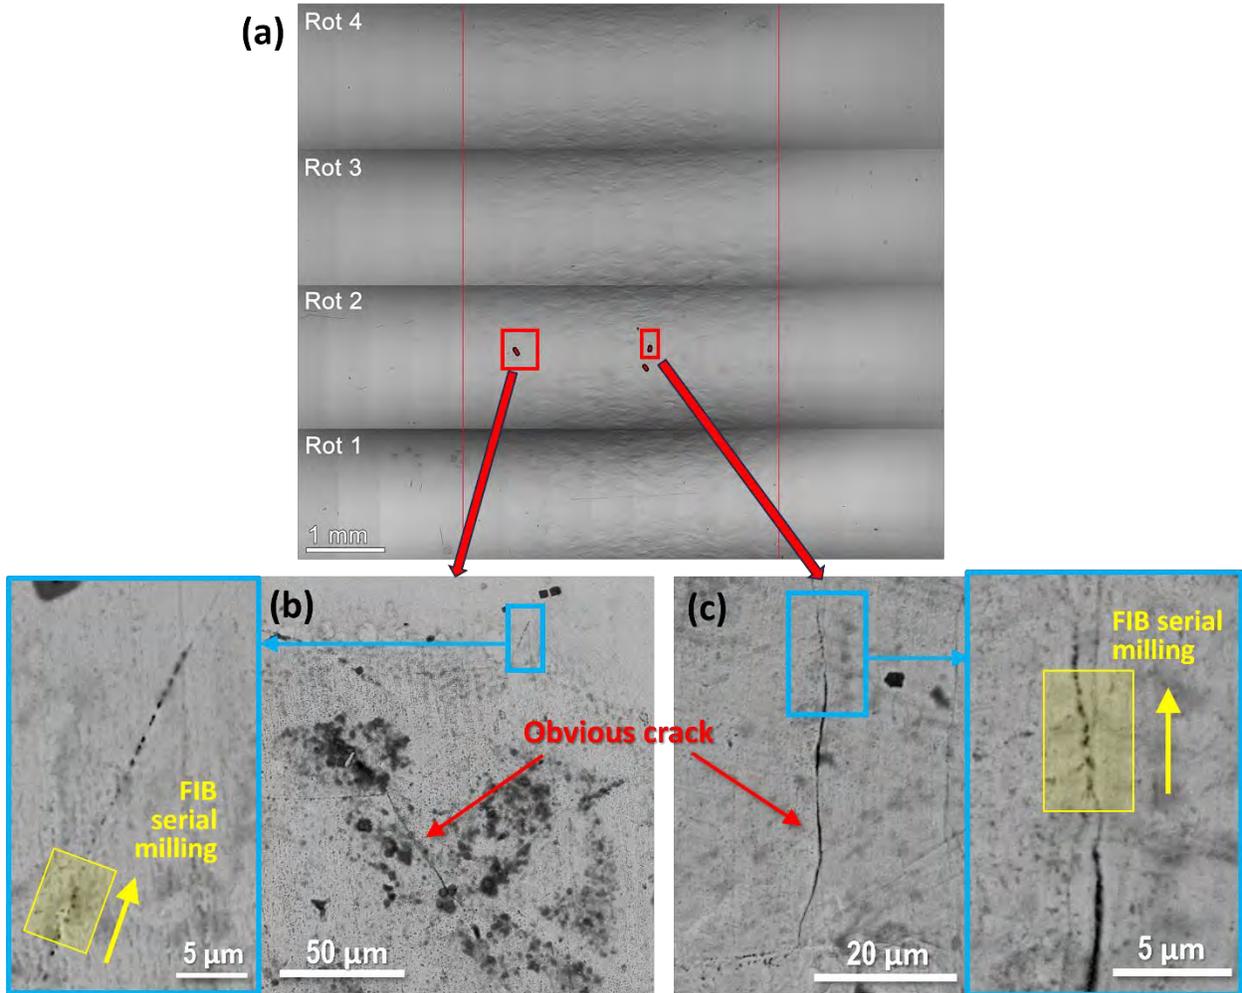
Figure 35. (a) SEM-BSE montage image of the surface morphology of the Valinox RE243 TT+29%CTS specimen R29B-1 tested in 360°C air after 9038 hours. The gauge section of the specimen is between the two red lines marked in the image. IG cracks identified on the surface are highlighted in red. Zoom-in images of two cracks are presented in (b) and (c). The region where FIB serial milling was performed is marked.

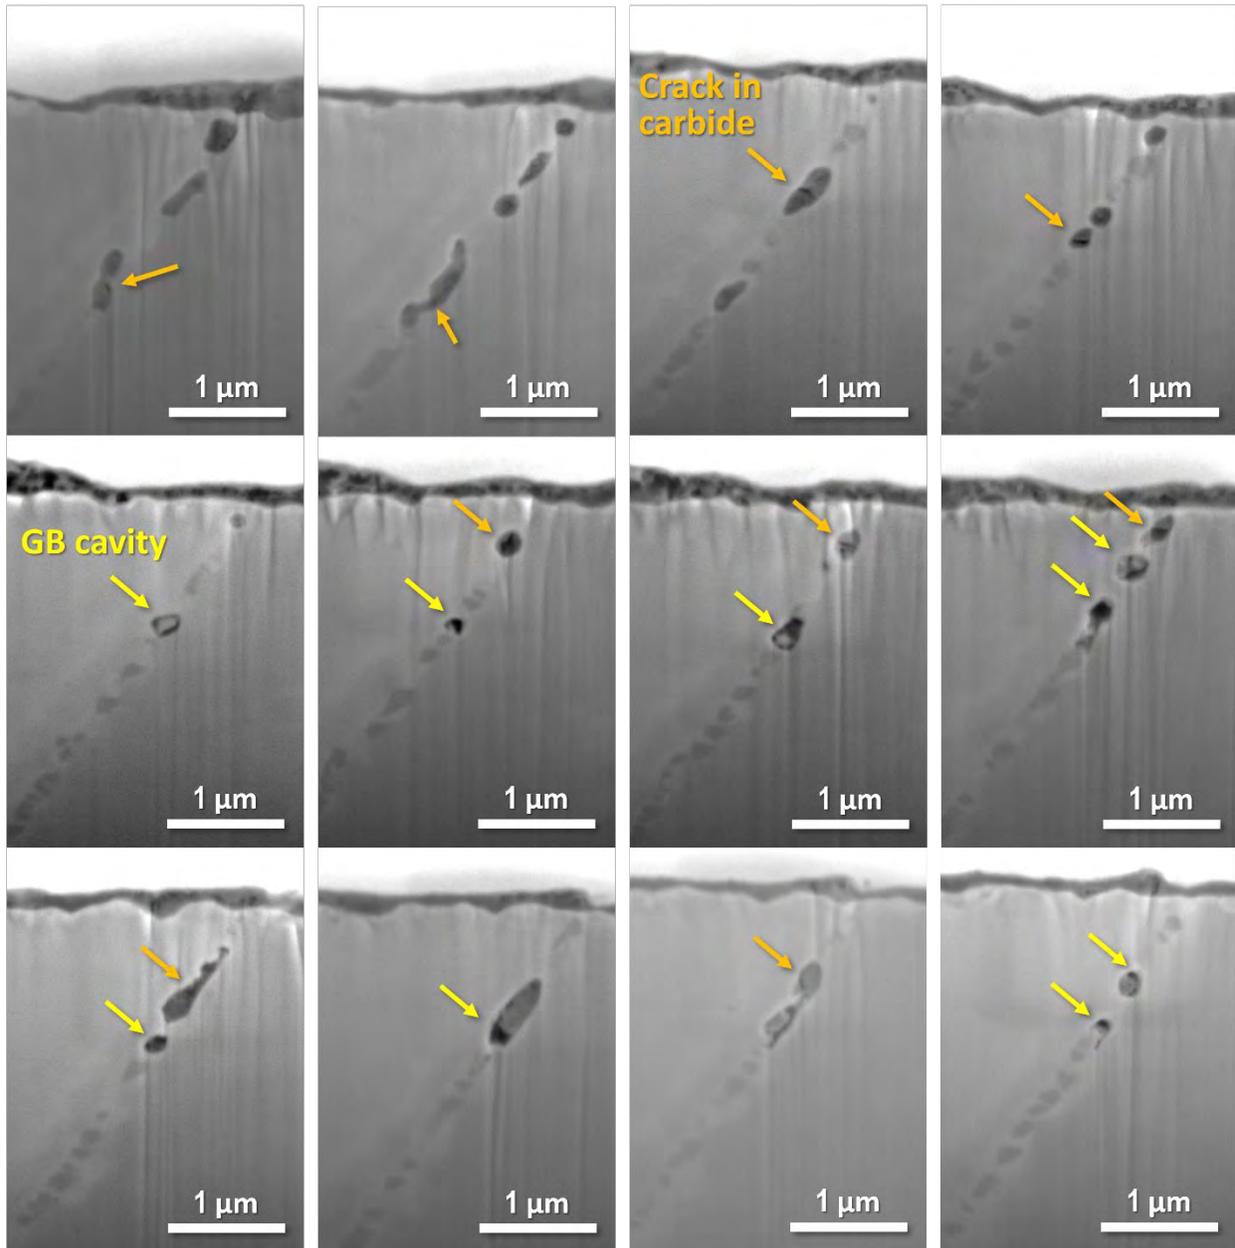
Figure 36. Examples of IG oxide morphology in cross-sections revealed during FIB serial milling on the possible crack marked in Figure 35(b).

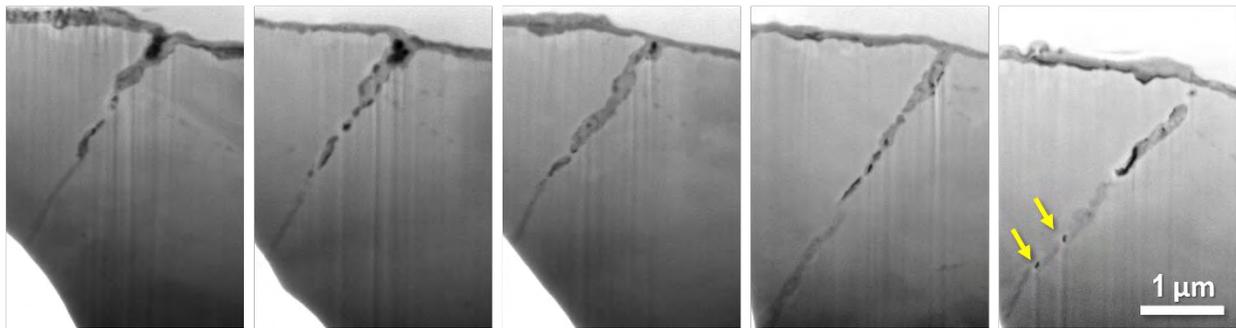
Figure 37. Examples of IG oxide morphology in cross-sections revealed during FIB serial milling on the obvious crack marked in Figure 35(c).

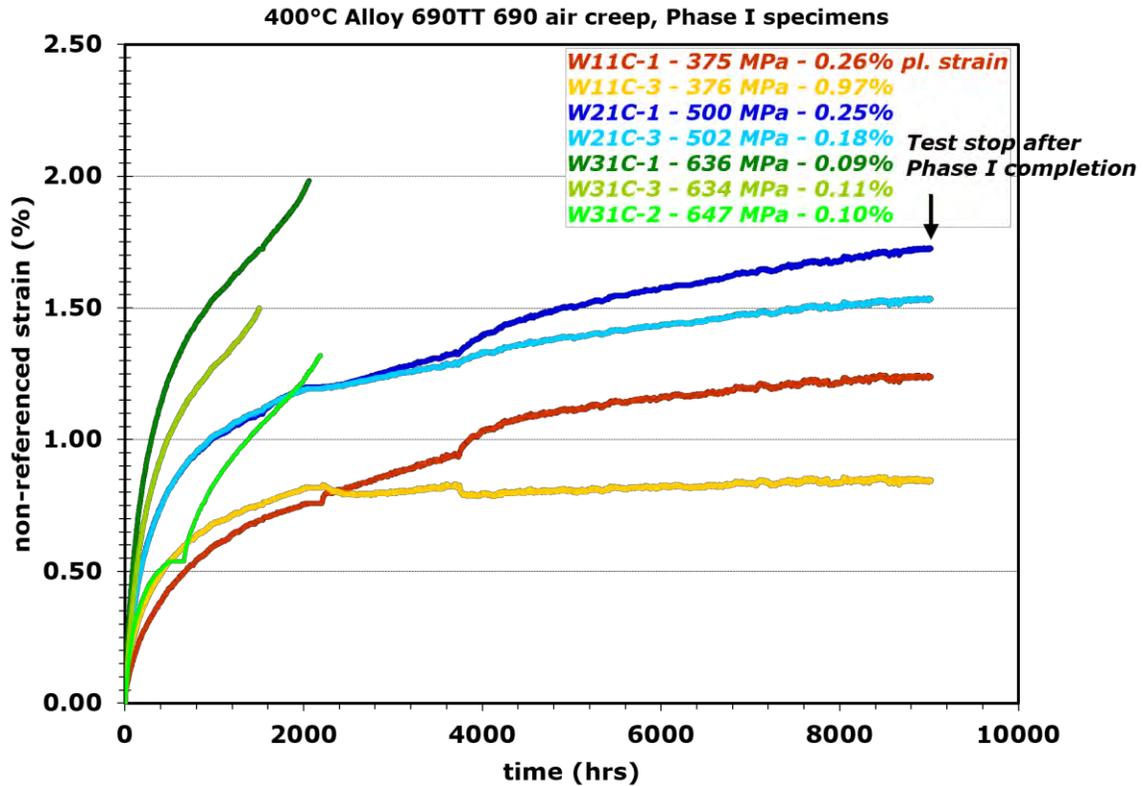
Figure 38. Overall non-referenced DCPD strain response of the seven Alloy 690TT specimens tested in 400°C air during Phase I exposure.

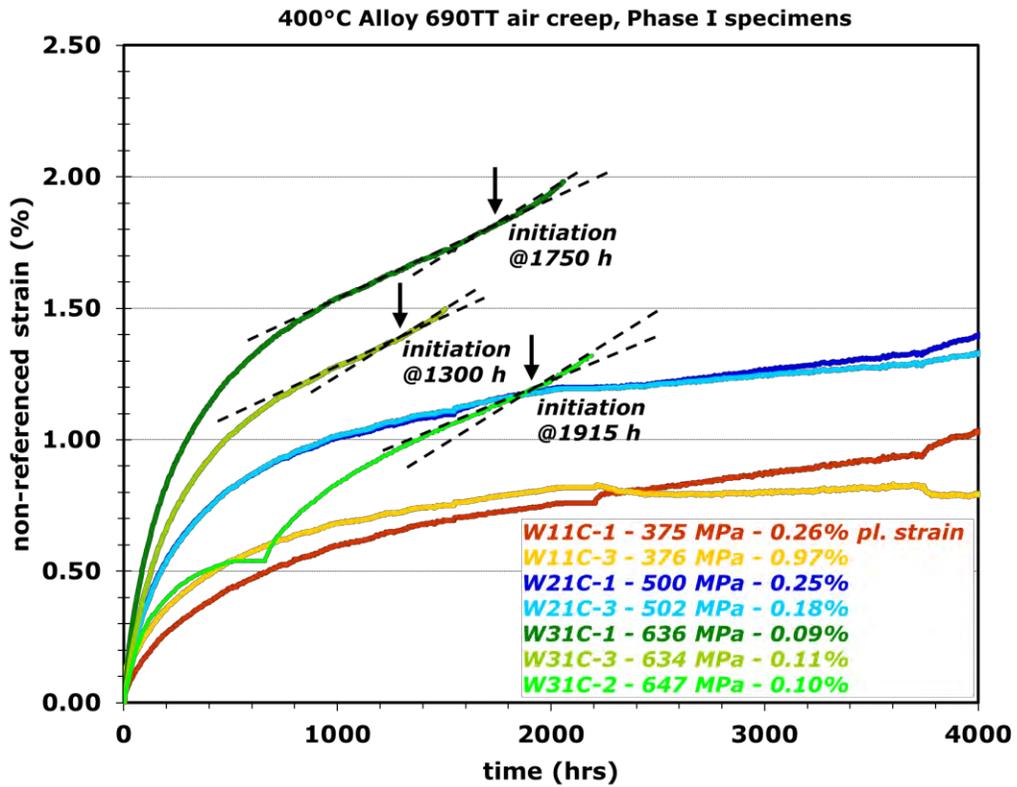
Figure 39. A closer look at the three Alloy 690 WP142 TT+31%CF specimens' non-referenced DCPD strain response among the seven Alloy 690TT specimens tested in 400°C air during Phase I exposure.

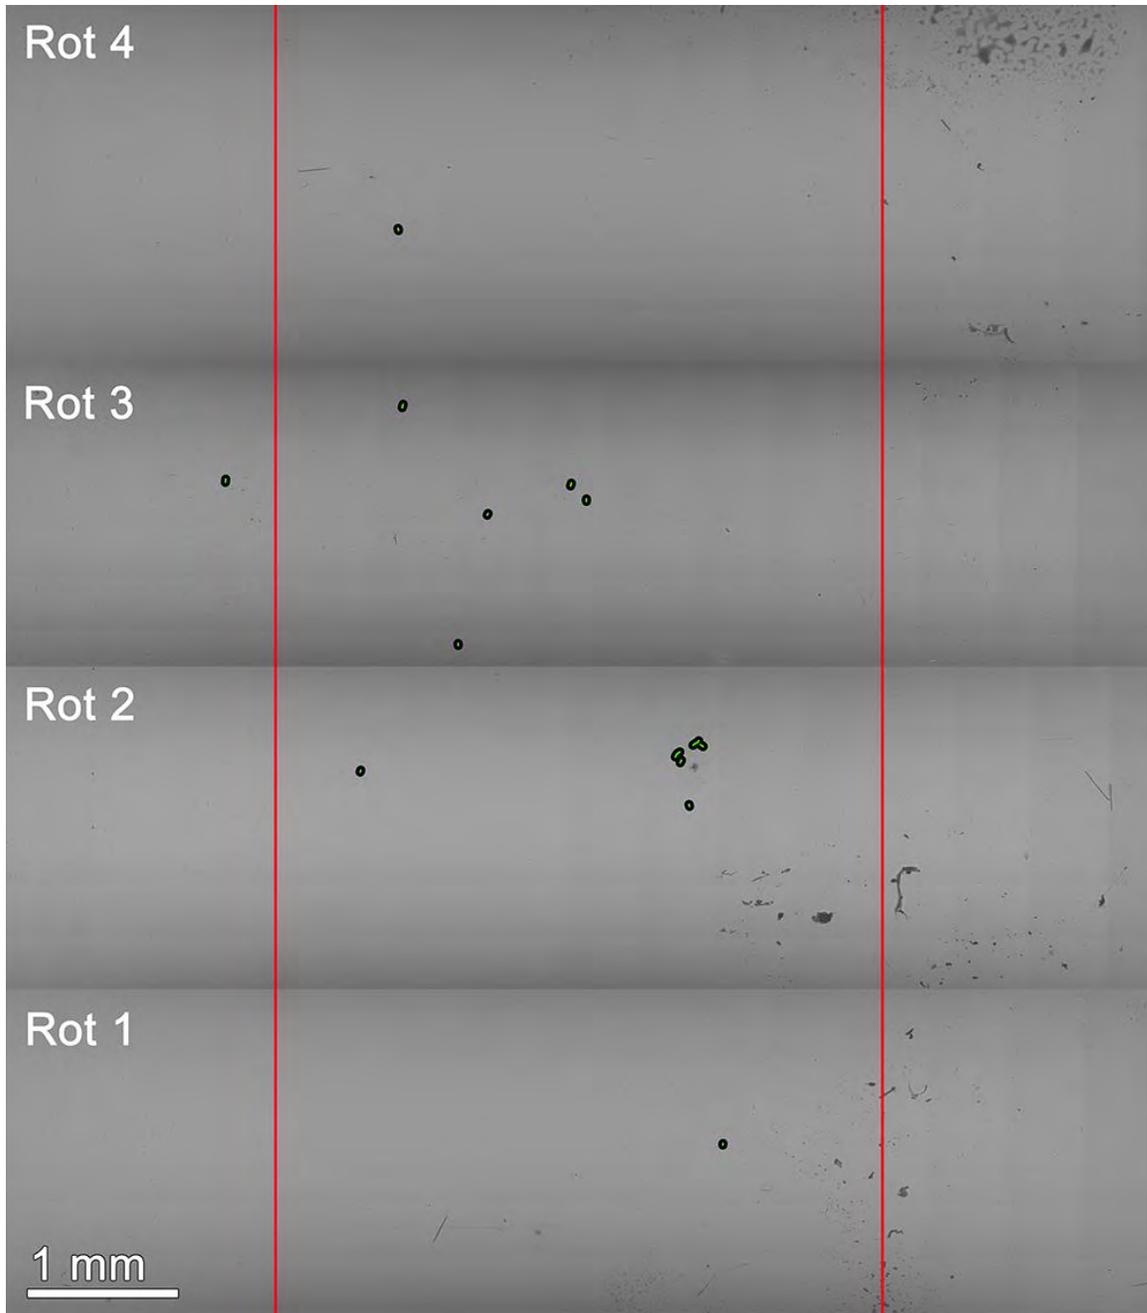
Figure 40. SEM-BSE montage image of the Valinox WP142 TT+11%CF specimen W11C-1 tested in 400°C air after 9021 hours. The gauge section of the specimen is between the two red lines marked in the image. Possible cracks are highlighted in green.

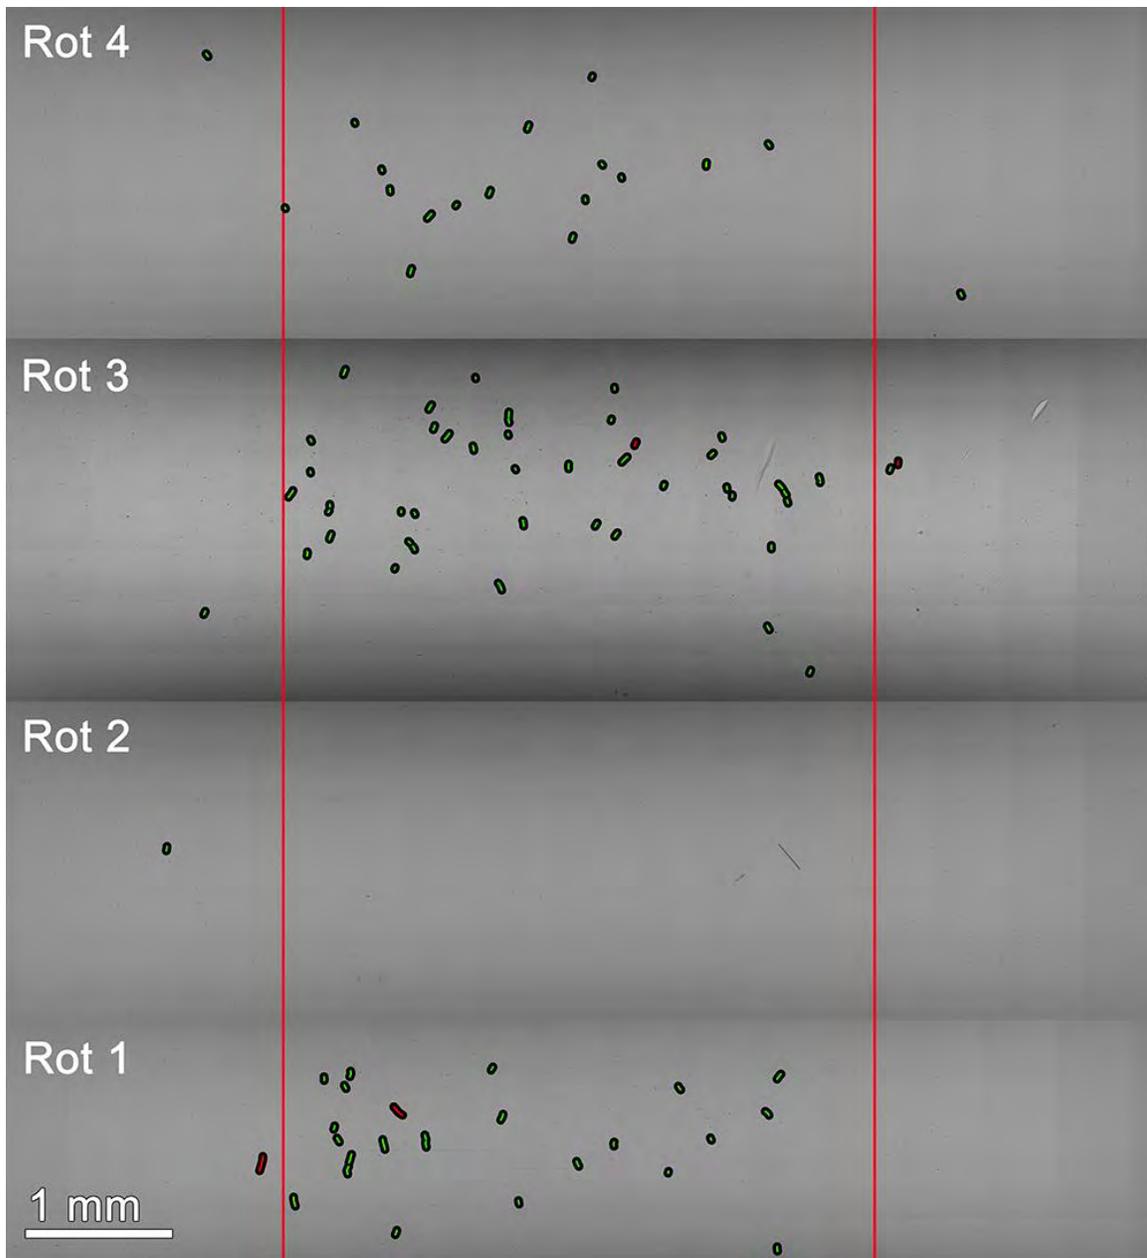
Figure 41. SEM-BSE montage image of the Valinox WP142 TT+11%CF specimen W11C-3 tested in 400°C air after 9021 hours. The gauge section of the specimen is between the two red lines marked in the image. Obvious cracks and possible cracks are highlighted in red and green, respectively.

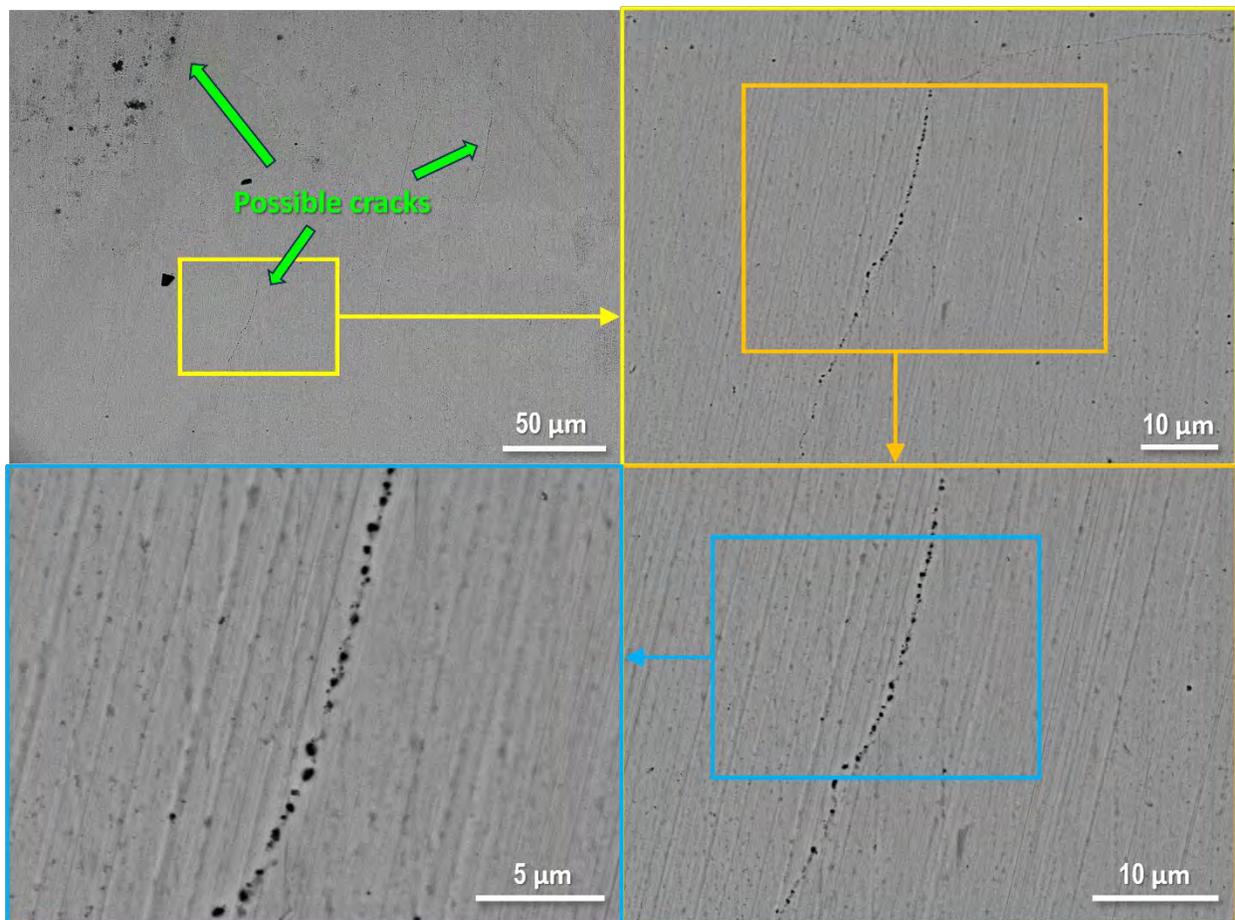
Figure 42. SEM-BSE images showing the morphology of typical possible cracks found in the Valinox WP142 TT+11%CF specimen W11C-3 tested in 400°C air after 9021 hours.

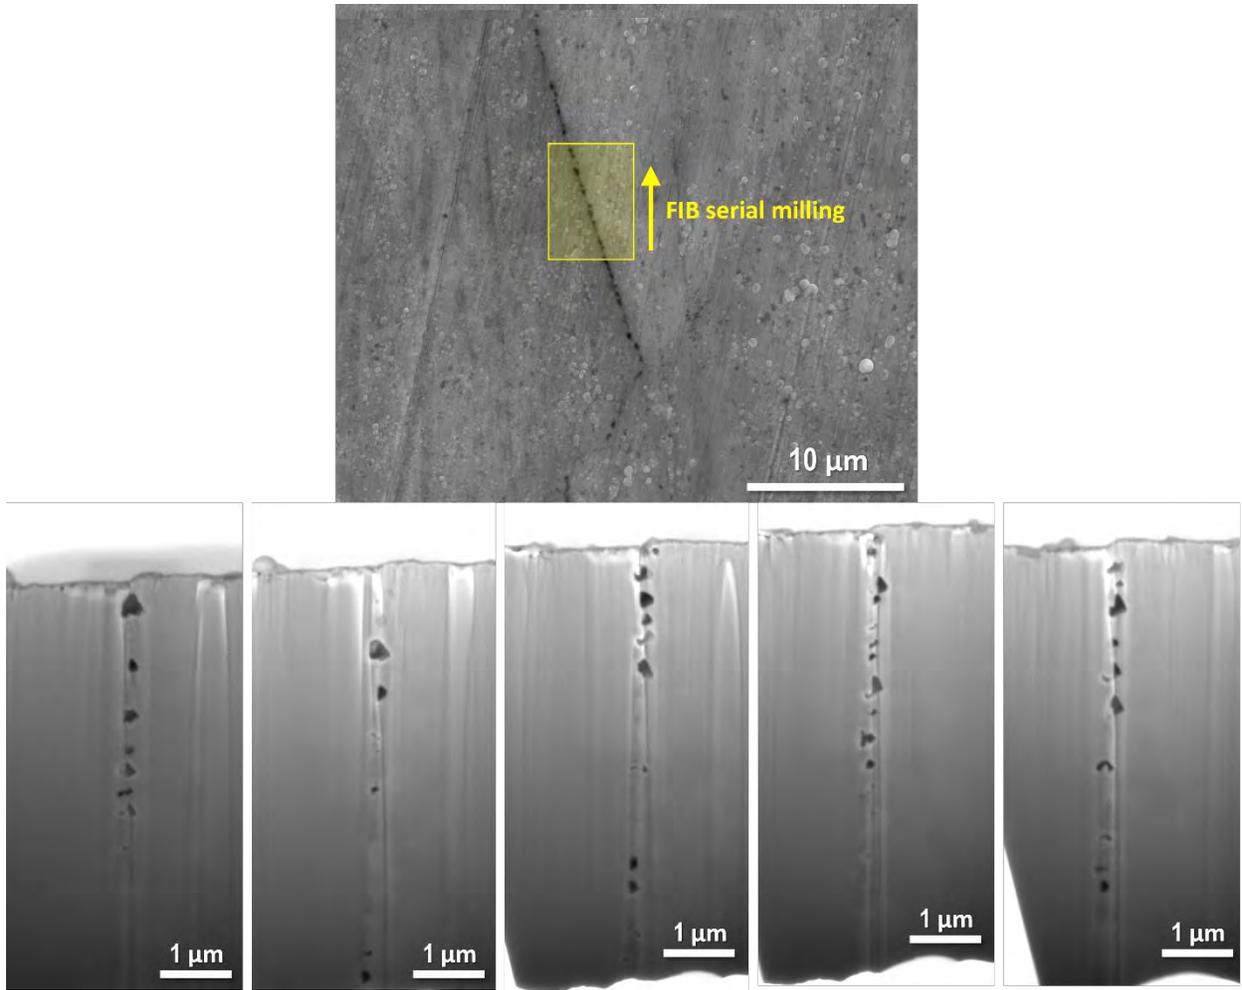
Figure 43. Examples of GB cavities in cross-sections revealed during FIB serial milling on a randomly chosen possible crack found on the surface of the Valinox WP142 TT+11%CF W11C-3 tested in 400°C air after 9021 hours.

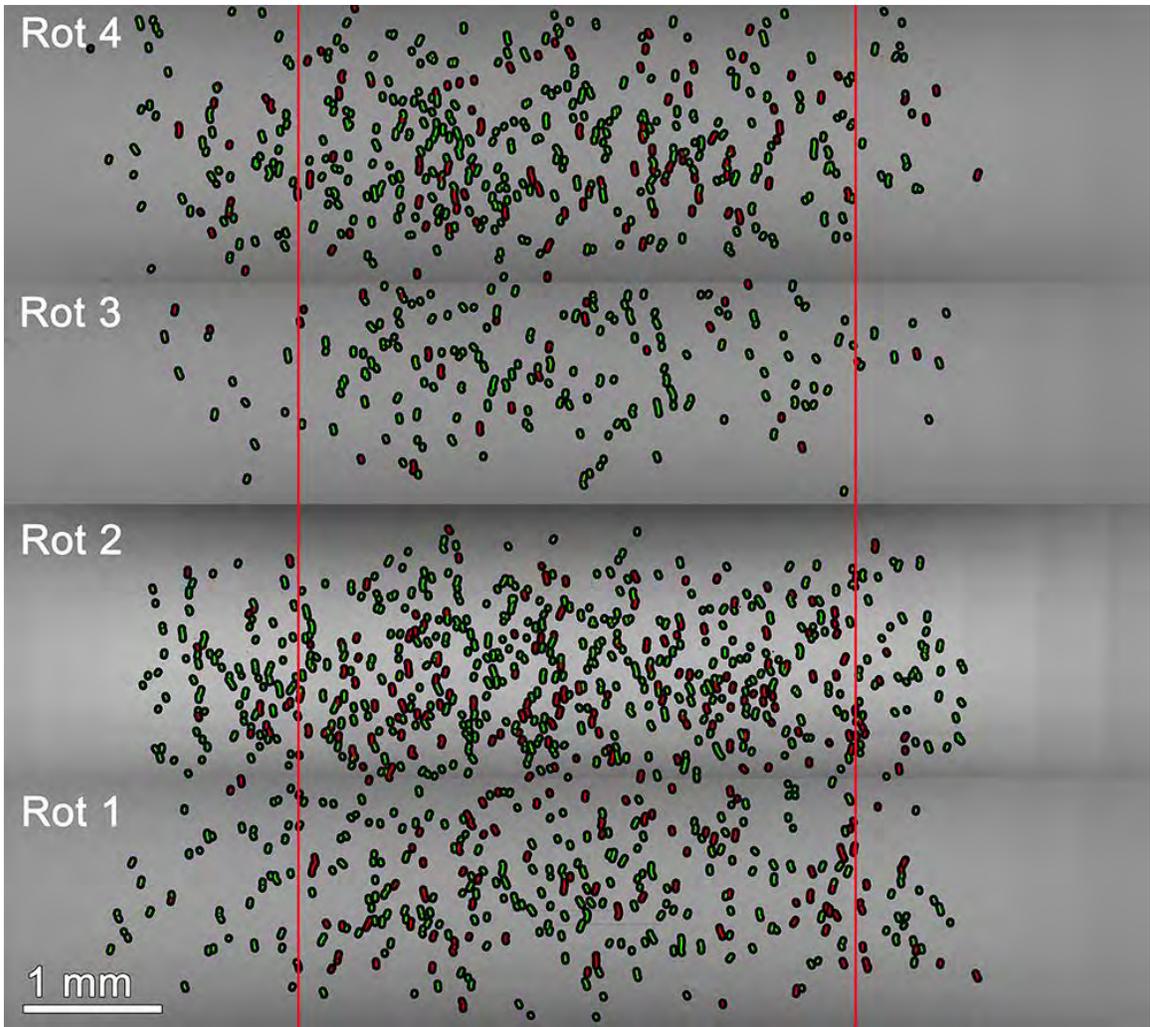
Figure 44. SEM-BSE montage image of the Valinox WP142 TT+21%CF specimen W21C-1 tested in 400°C air after 9021 hours. The gauge section of the specimen is between the two red lines marked in the image. Obvious cracks and possible cracks are highlighted in red and green, respectively.

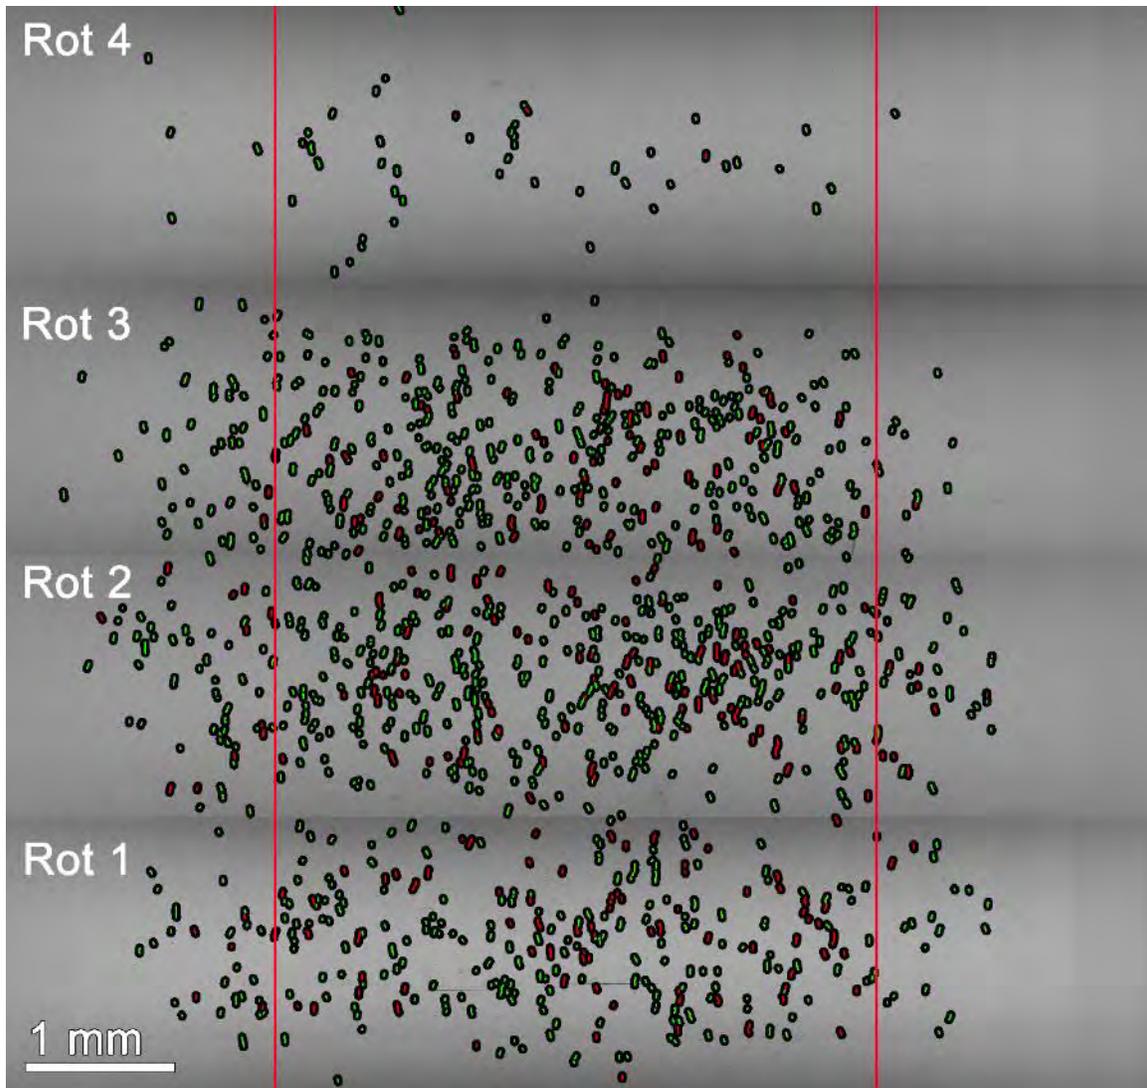
Figure 45. SEM-BSE montage image of the Valinox WP142 TT+21%CF specimen W21C-3 tested in 400°C air after 9021 hours. The gauge section of the specimen is between the two red lines marked in the image. Obvious cracks and possible cracks are highlighted in red and green, respectively.

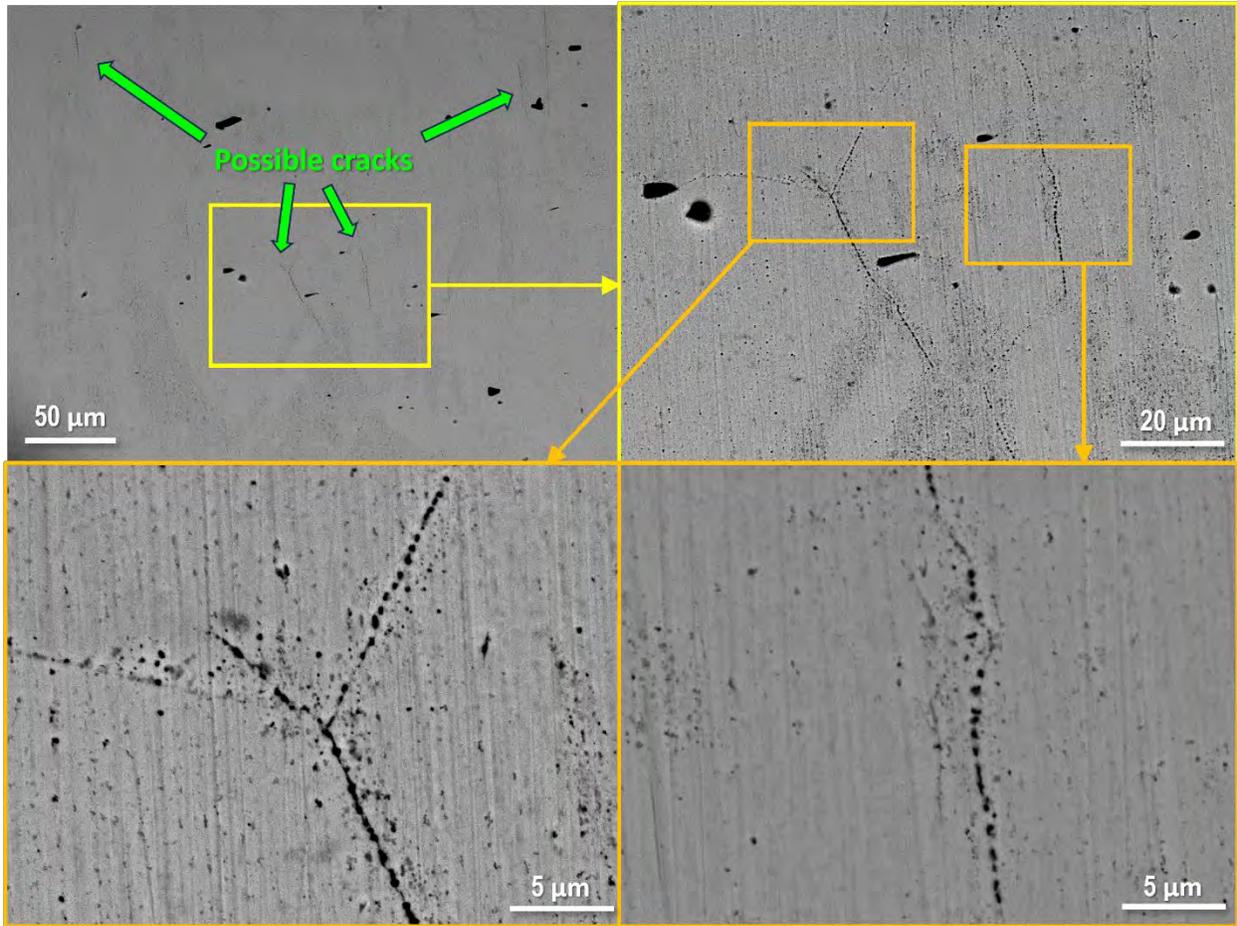
Figure 46. SEM-BSE images showing the morphology of typical possible cracks found in the Valinox WP142 TT+21%CF specimen W21C-3 tested in 400°C air after 9021 hours.

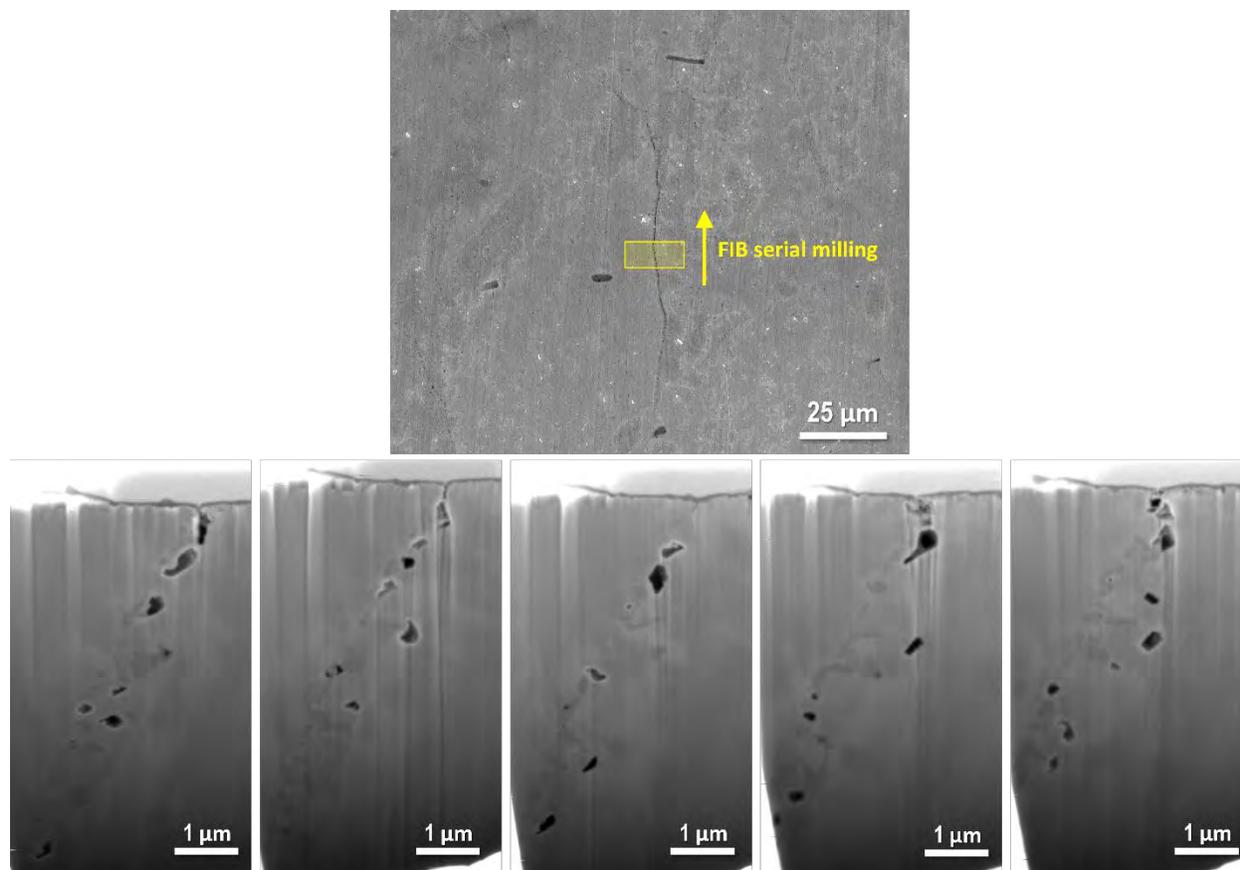
Figure 47. Examples of GB cavities revealed in cross-sections during FIB serial milling on a randomly chosen possible crack found on the surface of the Valinox WP142 TT+21%CF W21C-3 tested in 400°C air after 9021 hours.

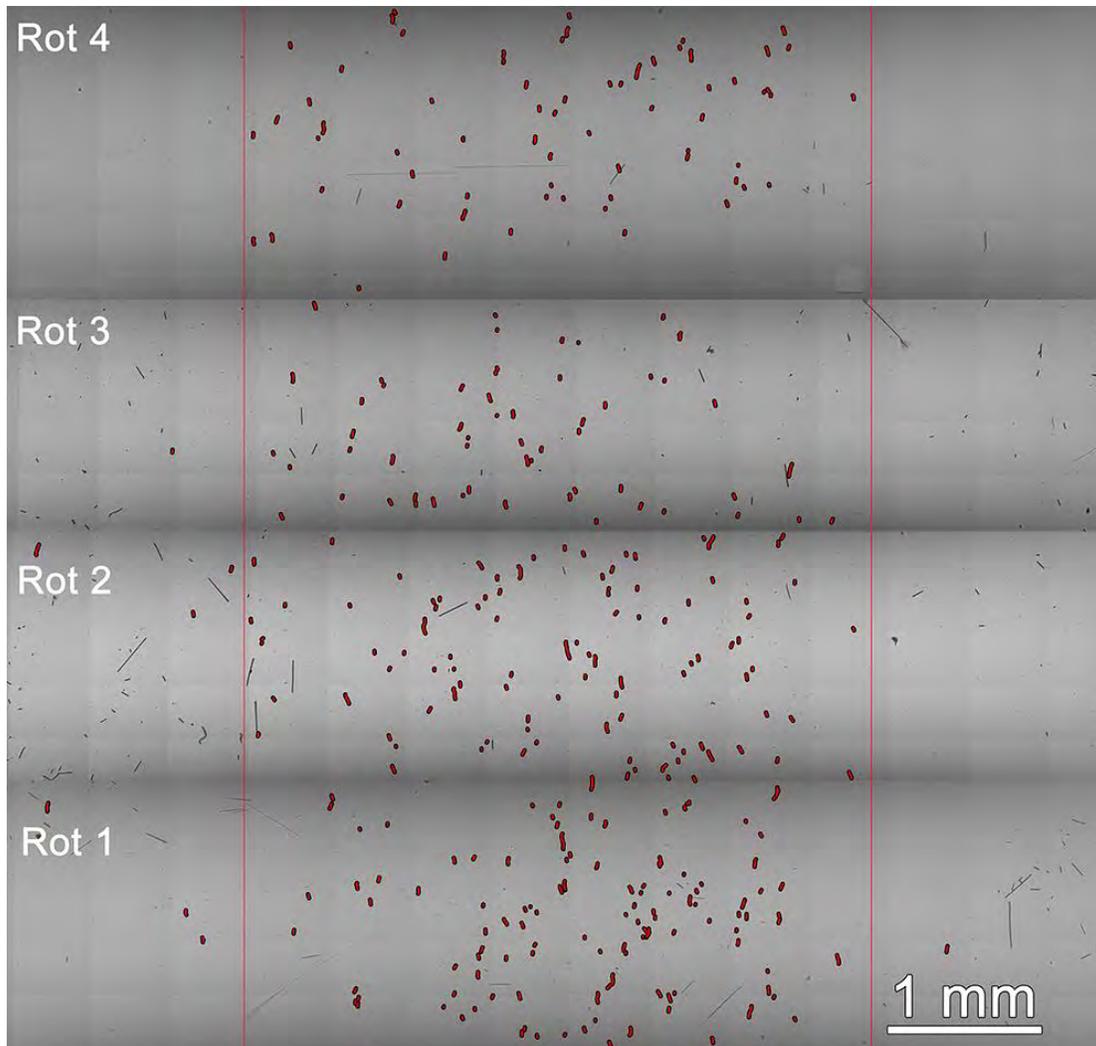
Figure 48. SEM-BSE montage image of the Valinox WP142 TT+31%CF specimen W31C-1 tested in 400°C air after 9021 hours. The gauge section of the specimen is between the two red lines marked in the image. Obvious cracks are highlighted in red. Possible cracks are not marked because the density is too high.
