Light Water Reactor Sustainability Program

Status Update on the Long-Term Crack Initiation Testing of Alloy 690 and Its Weld Metals in PWR Primary Water

Pacific Northwest National Laboratory

June 2024

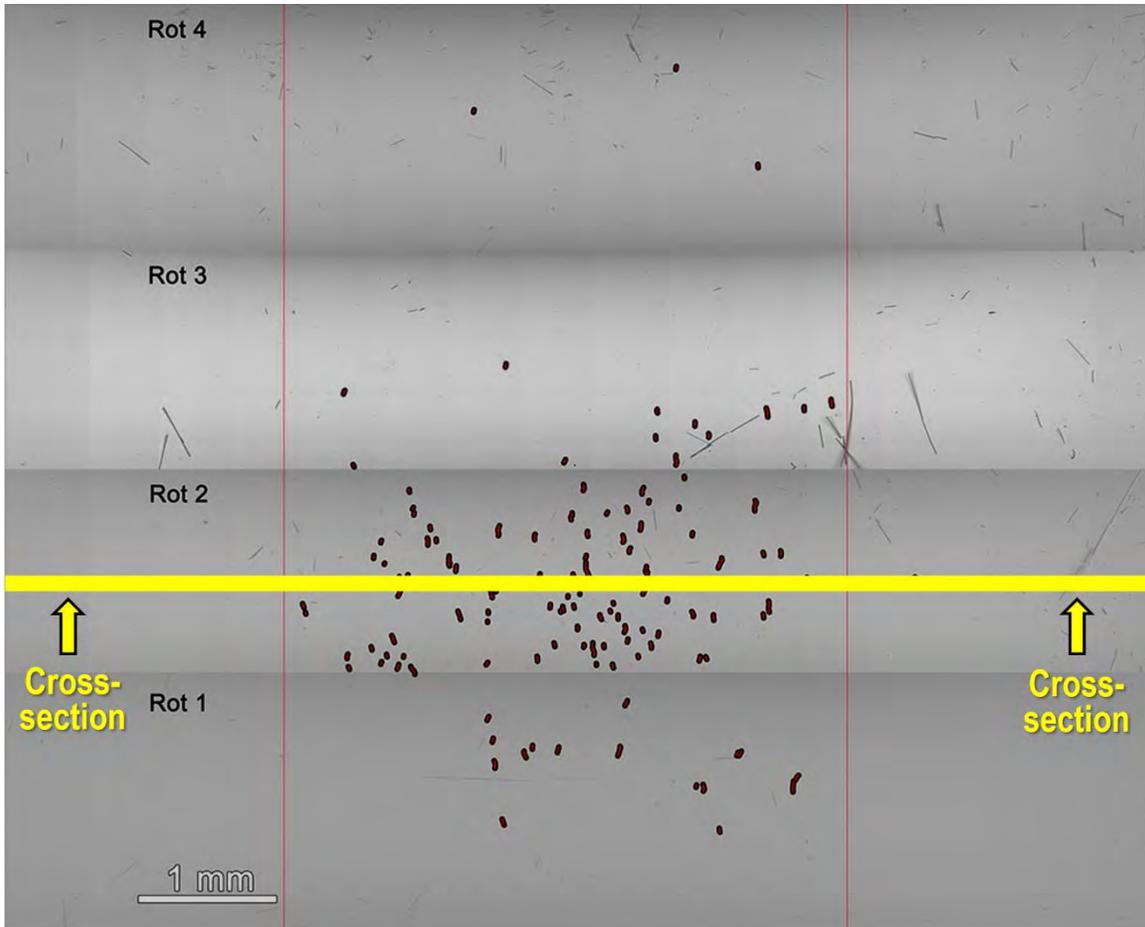
Figure 49. SEM-BSE montage image of the Valinox WP142 TT+31%CF specimen W31C-2 tested in 400°C air after 9021 hours. The gauge section of the specimen is between the two red lines marked in the image. Obvious cracks are highlighted in red. Possible cracks are not marked because the density is too high. The location where the specimen was cross-sectioned is also marked.

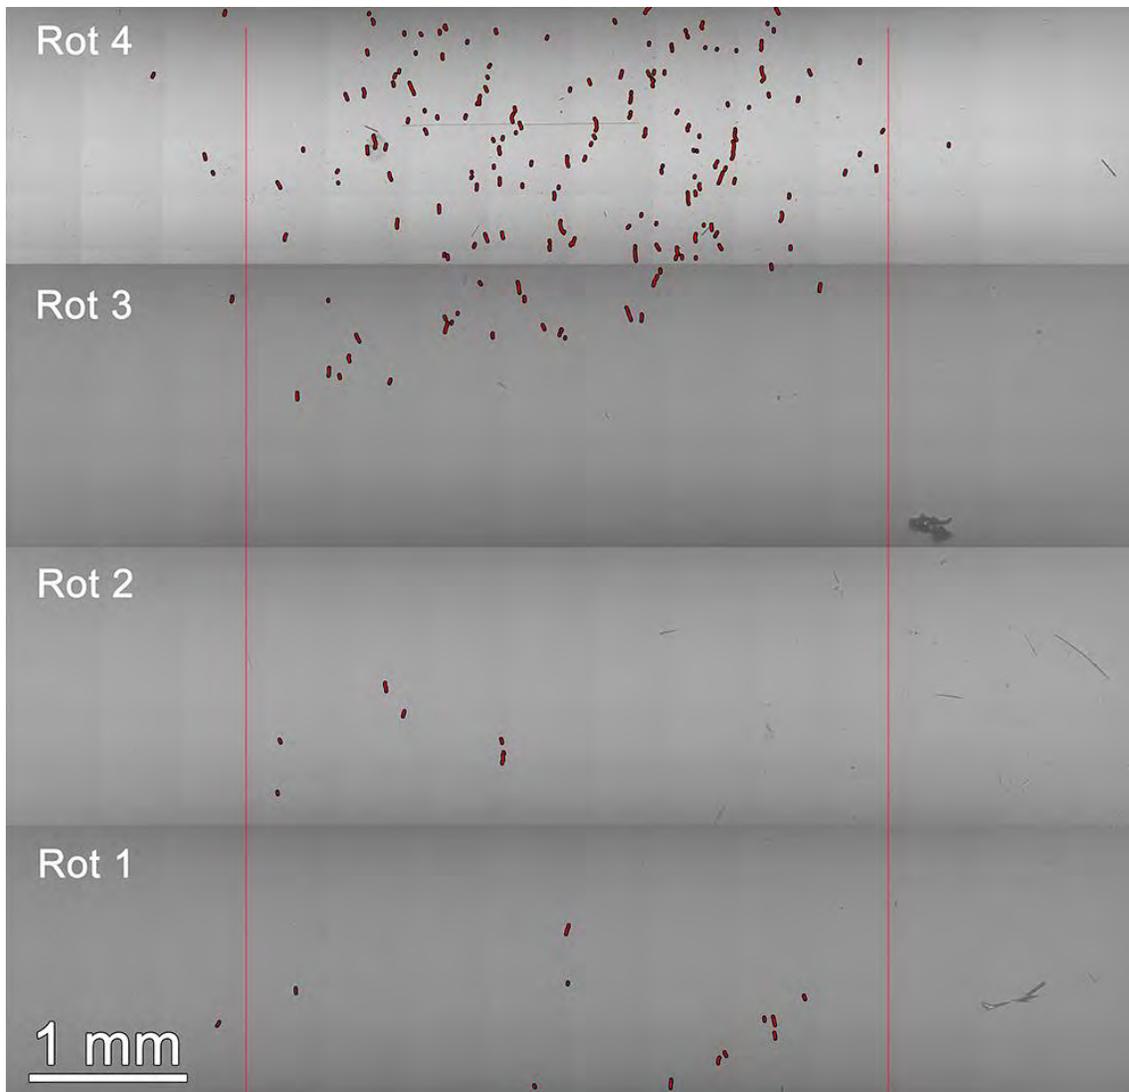
Figure 50. SEM-BSE montage image of the Valinox WP142 TT+31%CF specimen W31C-3 tested in 400°C air after 9021 hours. The gauge section of the specimen is between the two red lines marked in the image. Obvious cracks are highlighted in red. Possible cracks are not marked because the density is too high.

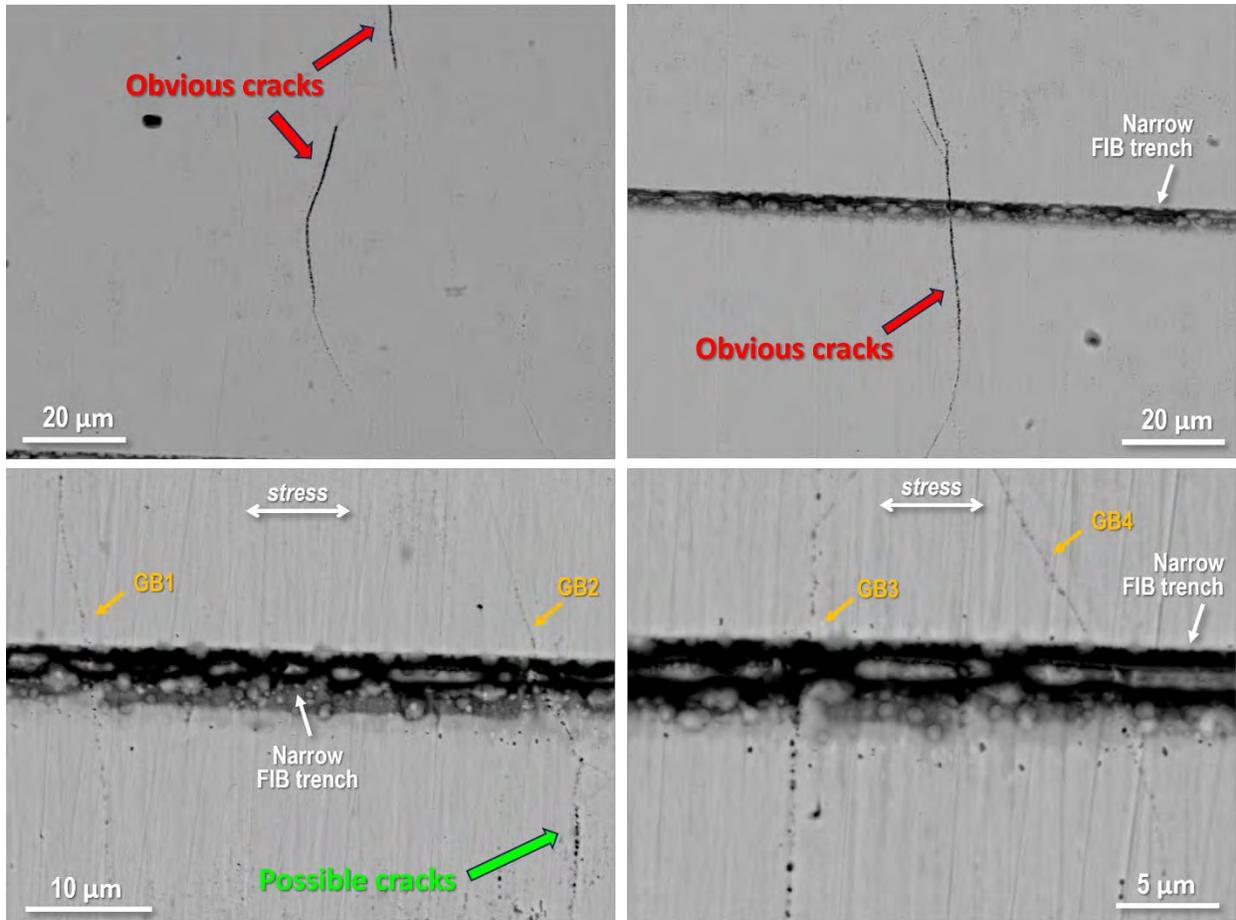
Figure 51. SEM-BSE images showing the morphology of typical obvious and possible cracks found in the Valinox WP142 TT+31%CF specimen W31C-3 tested in 400°C air after 9021 hours.

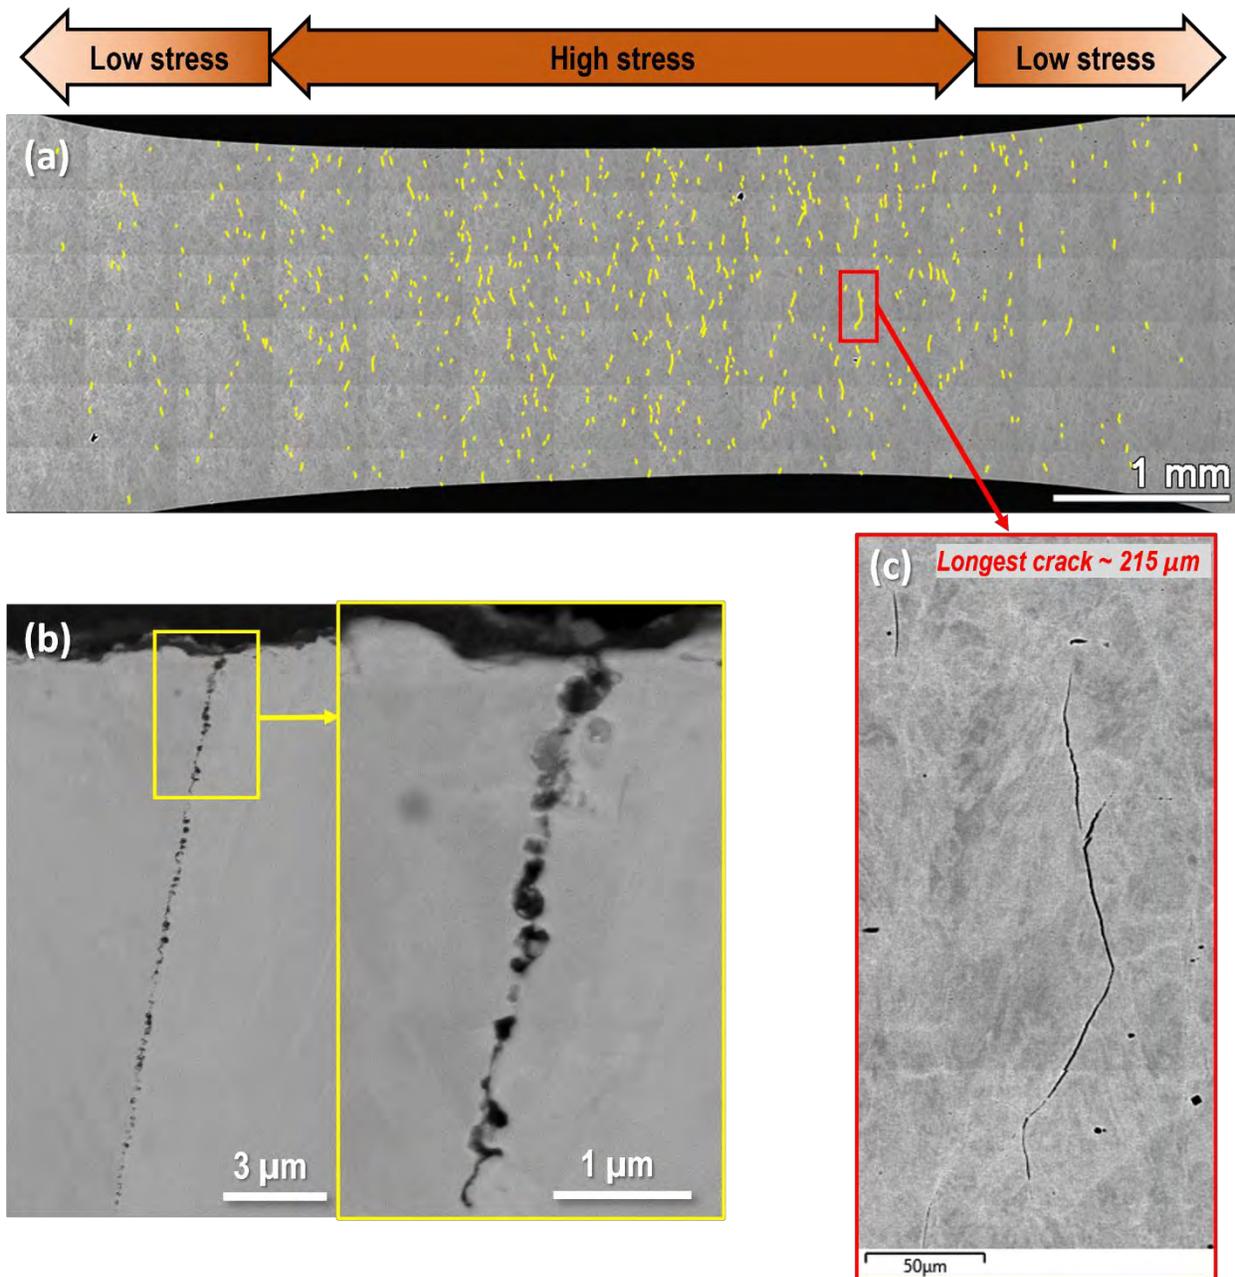
Figure 52. (a) SEM-BSE montage image of the cross-section of the Valinox WP142 TT+31%CF specimen W31C-2 tested in 400°C air after 9021 hours. Continuous and semi-continuous IG damage are highlighted in yellow. (b) Representative morphology of IG cracks intersected the specimen surface. (c) The longest IG crack found in this cross-section with a total length of ~215 μm.

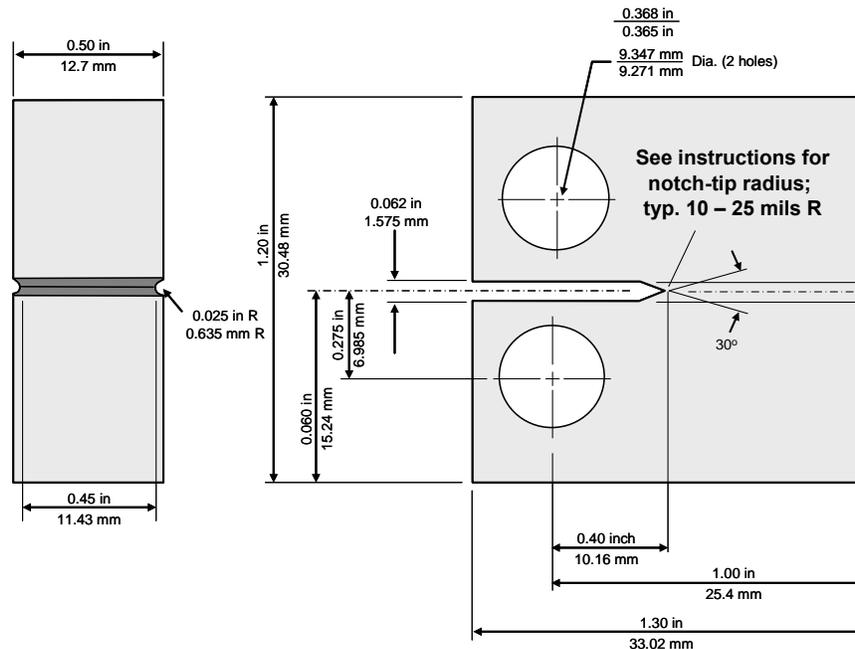
Figure 53. Dimensions of the 0.5T BNCT specimen. The notch radius is ~0.75 mm for all specimens.

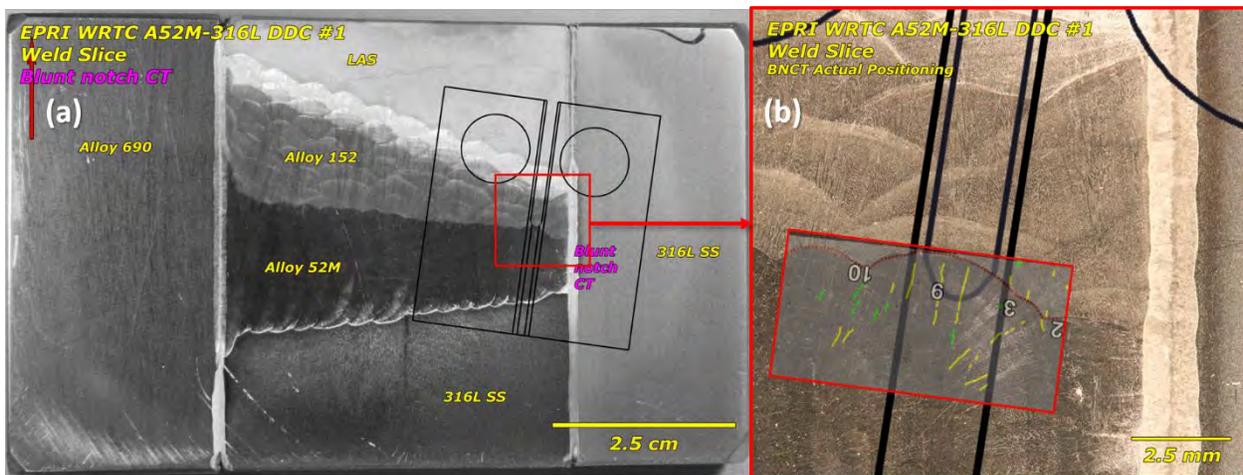
Figure 54. (a) Micrograph illustrating the blunt notch position for CT148, the EPRI WRTC 52M-316L V-groove weld with DDC specimen. (b) A zoom-in micrograph of the location of the notch with respect to pre-test SEM characterizations of DDC distributions (obvious cracks marked in yellow and possible cracks marked in green) in this weld.

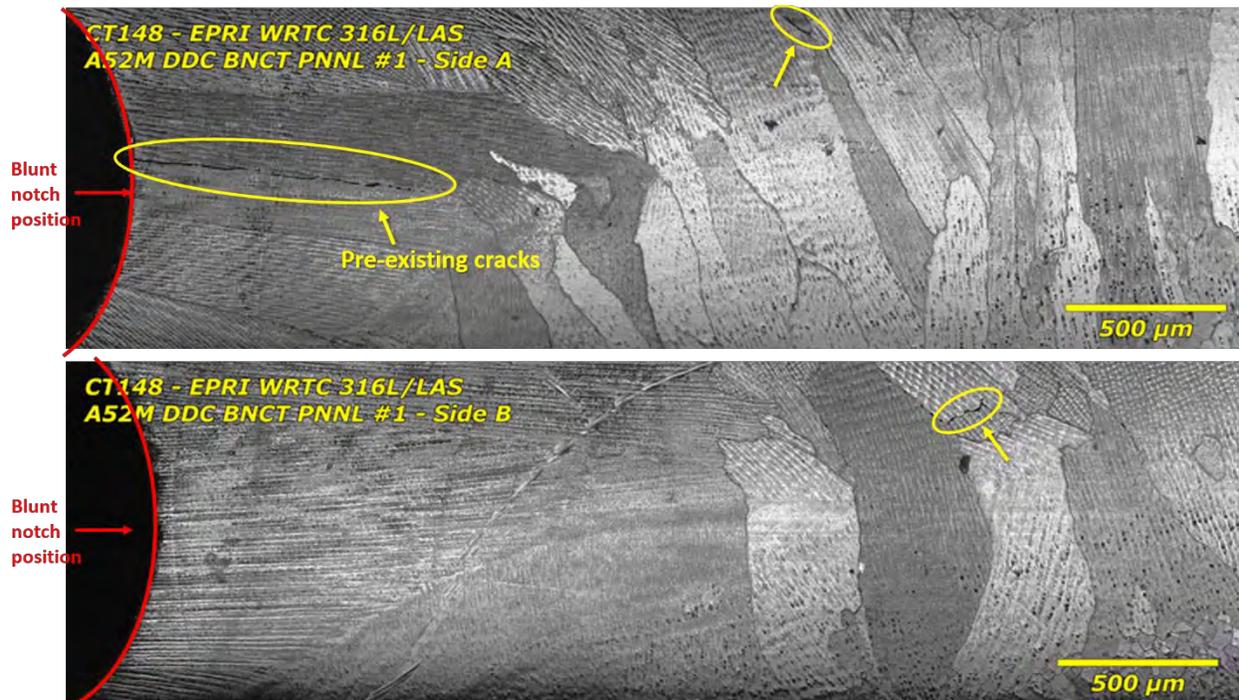
Figure 55. Micrographs revealing cracks identified in the side groove of CT148 just below the notch. The side groove surface was lightly etched for better visualization of solidification grain boundaries.

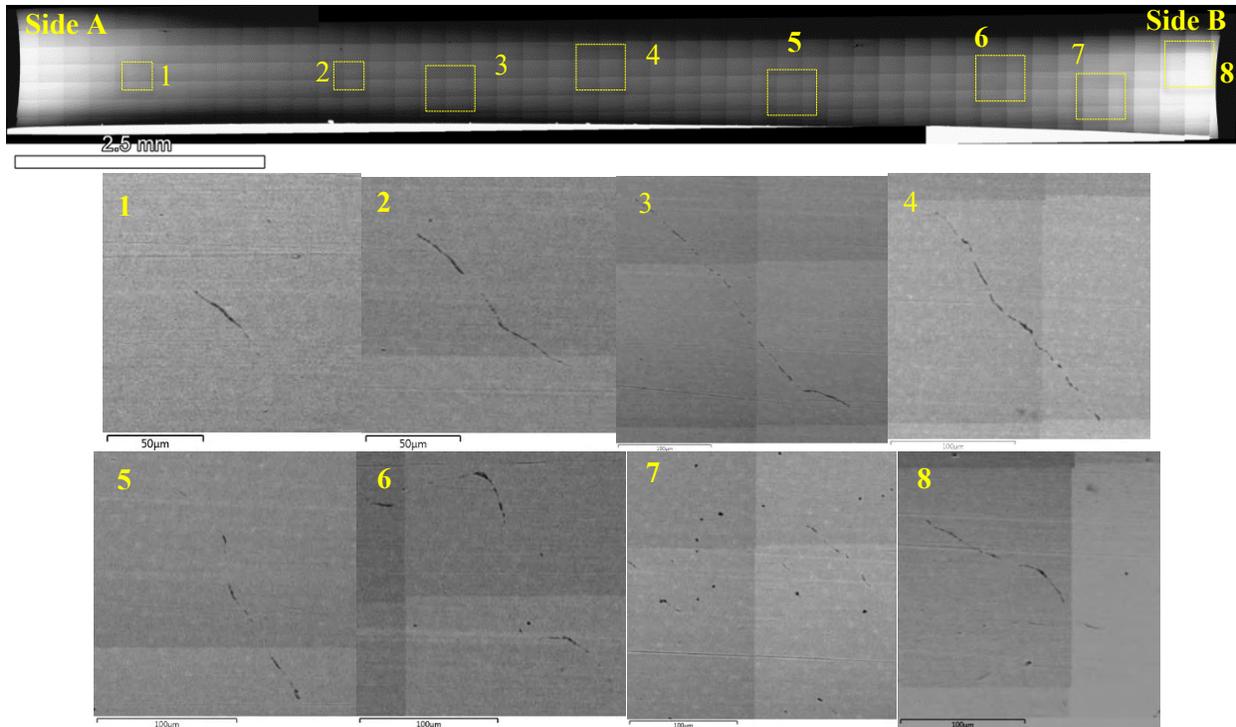
Figure 56. SEM-BSE low magnification montage image of the pre-test blunt notch surface of CT148 with examples of regions containing pre-existing DDC.

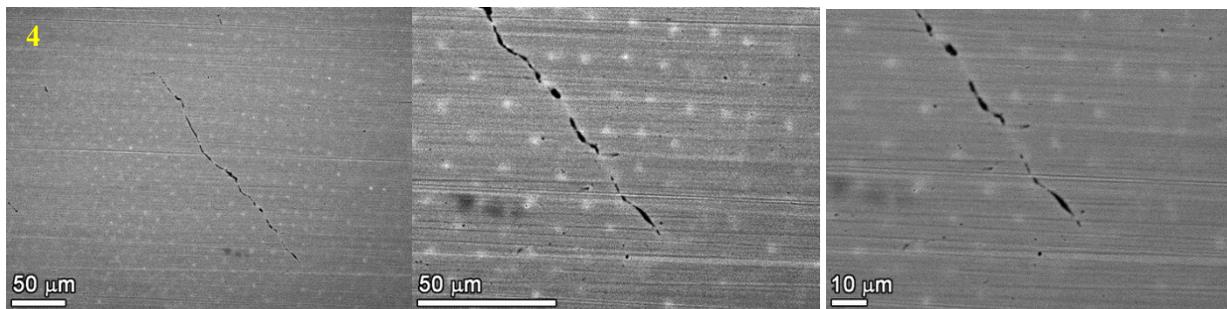
Figure 57. SEM-BSE high magnification micrographs of Region 4 in Figure 56 illustrating the DDC is along a solidification grain boundaries (SGBs). The bright intensity of the Nb signal segregation highlights two different grain orientations on either side of the crack.

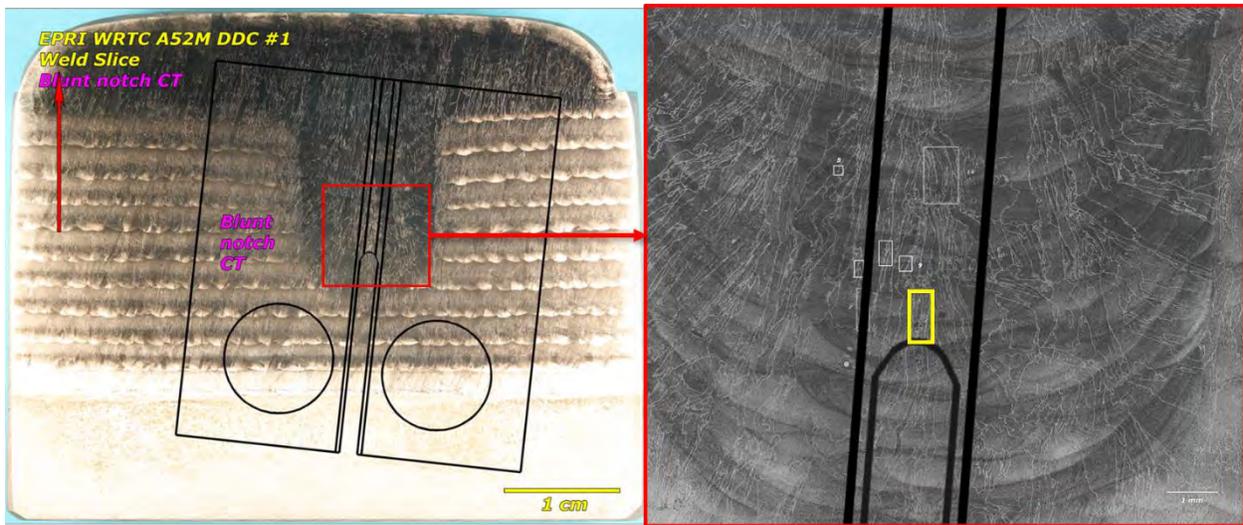
Figure 58. (a) Micrograph illustrating the blunt notch position for CT149, the EPRI WRTC Alloy 52M DDC Mockup specimen. (b) A zoom-in micrograph of the notch location.

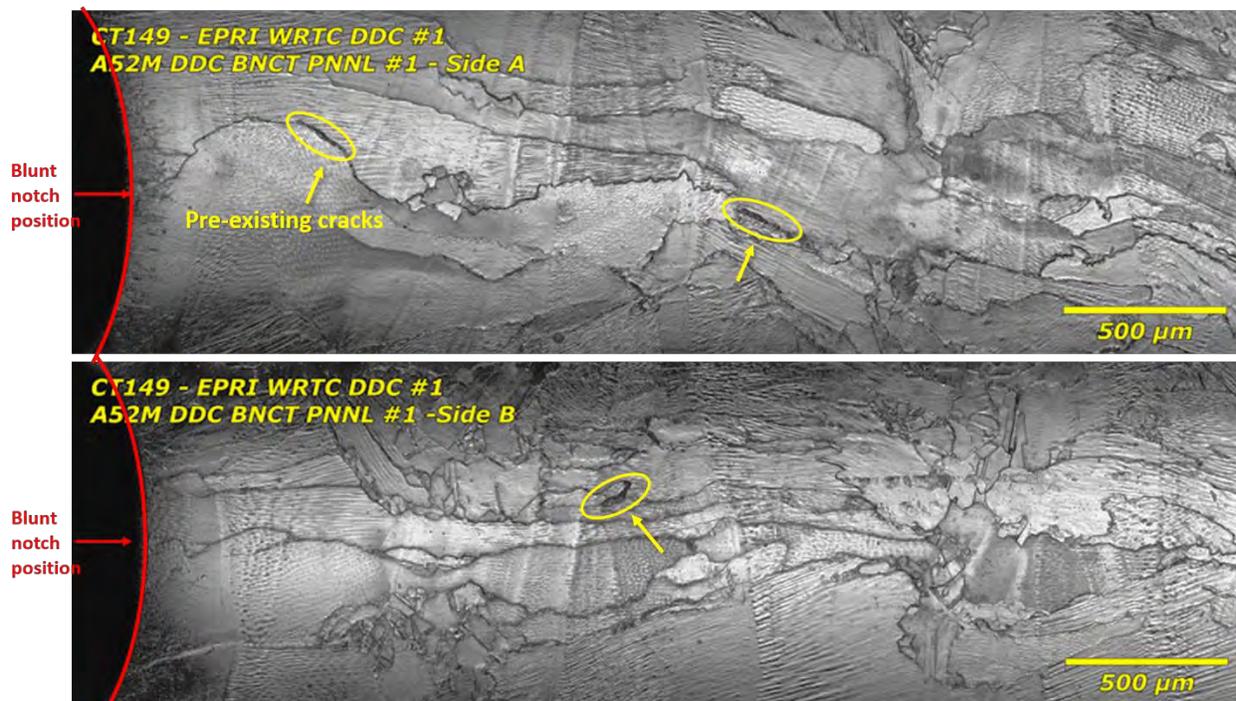
Figure 59. Micrographs revealing cracks identified in the side groove of CT149 just below the notch.

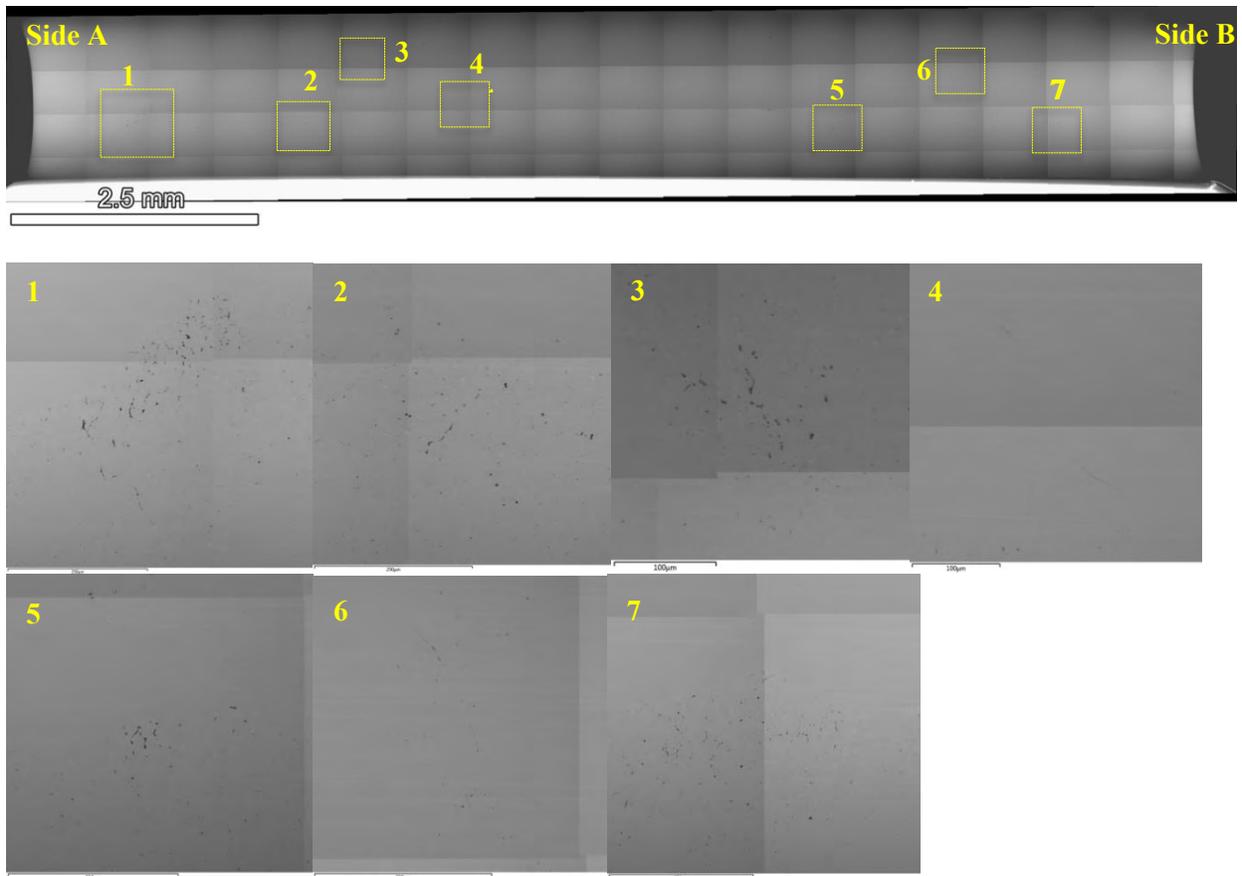
Figure 60. SEM-BSE montage image of the pre-test blunt notch surface of CT149 showing possible regions of pre-existing DDC cracking and defects intersecting the surface.

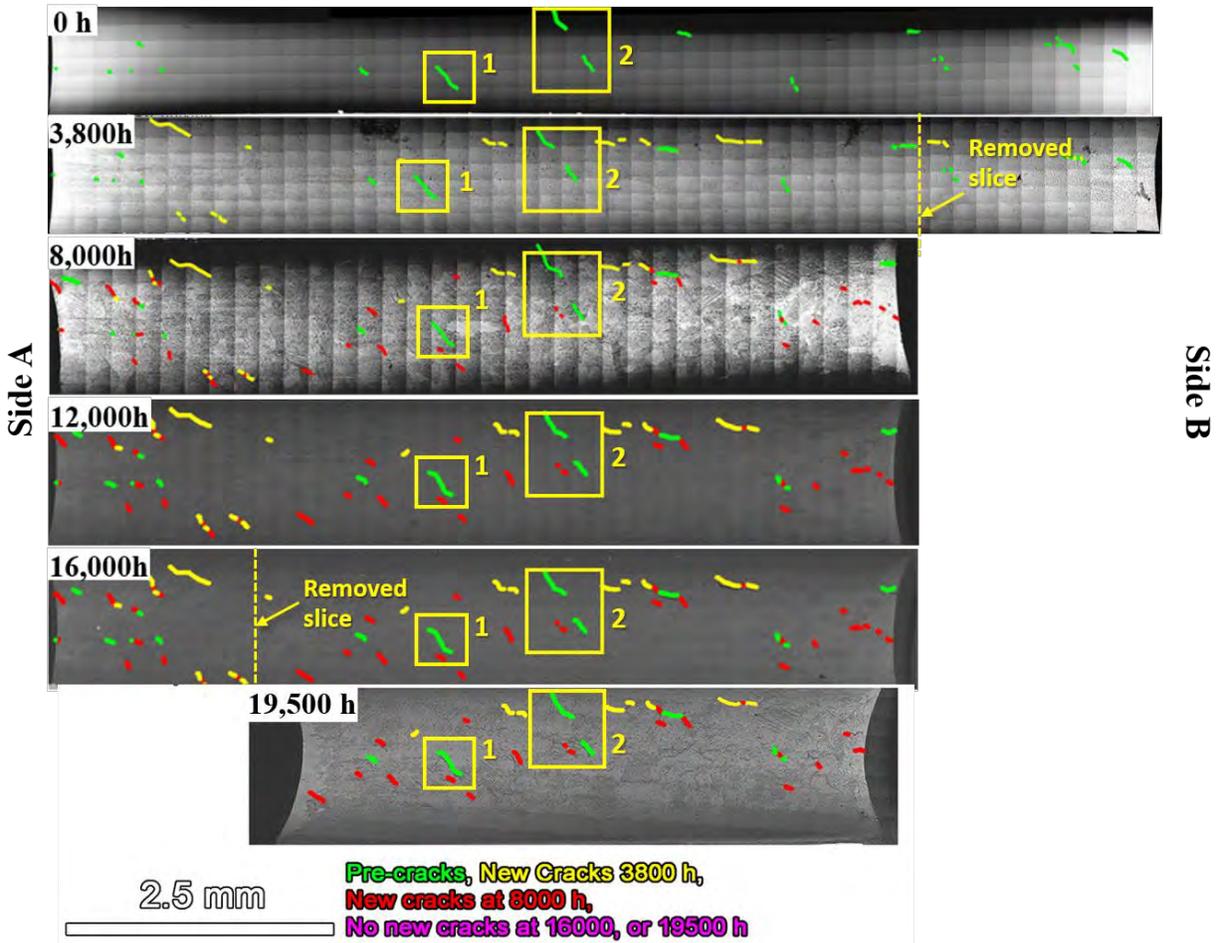
Figure 61. SEM-BSE montage imaging of the evolution of cracks on the blunt notch surface of CT148 from the EPRI WRTC A52M-316L-1 V-groove weld during the 19,500 hours of exposure at high stress in 360°C simulated PWR primary water. Side A is always presented on the left and side B on the right.

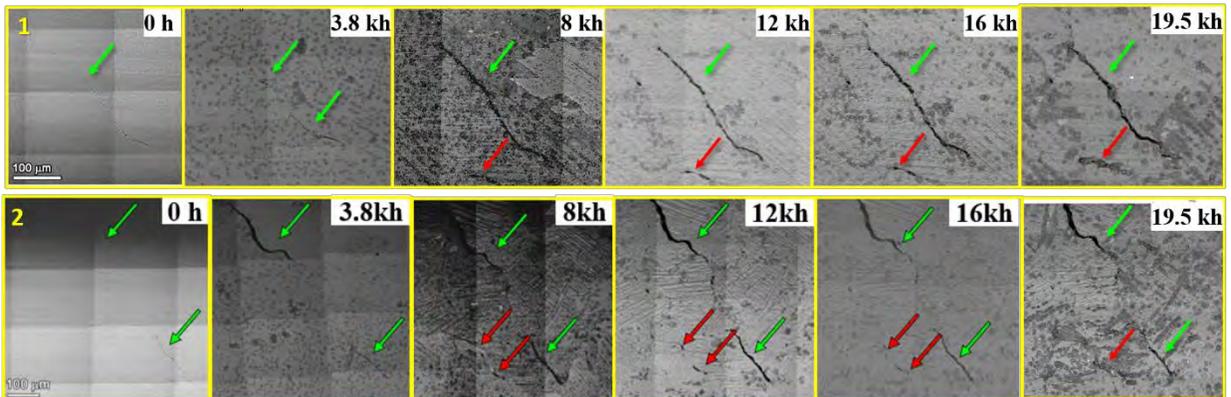
Figure 62. Higher magnification SEM-BSE image showing the evolution of cracks over ~16,000 hours of exposure in regions 1 and 2 highlighted in Figure 61 in the notch surface of CT148. Green arrows indicate pre-existing cracks and red arrows indicate cracks observed at 8,000 hours of exposure.
