Light Water Reactor Sustainability Program

Advanced microstructural and electrochemical quantification of irradiated stainless steels

September 2024

**Light Water Reactor Sustainability
Materials Research Pathway**

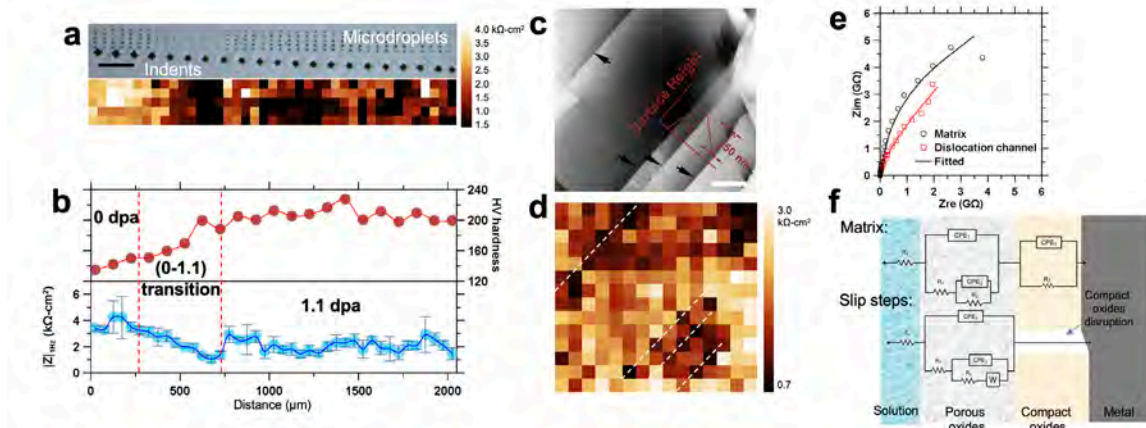
Figure 3 Scanning probe impedance analysis: constant frequency mapping of irradiated 304L. (a) An optical image showing matrices of microdroplets and Vickers hardness indents. From left to right, the microdroplets are 50 μm apart and the hardness indents are 100 μm apart. The scale bar is 200 μm in length. (b) AC-impedance at 1 Hz is consistent with hardness measurements, revealing the irradiated and unirradiated regions, the transition region is highlighted by red dashed lines. The error bars of $|Z|_{1\text{Hz}}$ show the standard deviation of five repeat measurements. In an irradiated and deformed (1% strain) 304L sample, dislocation channels (DCs) are evidenced by the surface height steps. (c) Surface topography and (d) $|Z|_{1\text{Hz}}$ maps acquired from the same area indicating the DCs feature a significantly reduced corrosion

resistance. The scale bar in (c) is 20 μm in length, and a 20 mM LiCl + 5 % HNO_3 solution was used in all impedance scans. (e) Full frequency spectra (1 Hz - 1 kHz) of the irradiated matrix and a dislocation channel, the data were fitted by equivalent circuit models indicated in (f). We noticed that the passive film formed on the matrix has a two-layered structure: a compact layer and a porous layer. However, only a porous layer was observed at the slip steps, indicating the disruption of compact layer during deformation.

When the irradiated sample is further subjected to mechanical deformation, a small strain (1%) can readily cause severe dislocation channeling in the irradiated lattice (see **Figure 3c**)^{23–25}. The dislocation channels (DCs) are signified by the 20-to-150 nm slip steps found on the sample surface. Evident corrosion susceptibilities of the DCs are revealed by the scanning AC-impedance measurements conducted via constant frequency and frequency sweeps (see **Figure 3d** and **3e**). Note that, an irradiation of 1.1 dpa alone can cause a 40% reduction in steel's oxidation resistance ($|Z|_{1\text{Hz}}$ from $3.7 \pm 0.6 \text{ k}\Omega\text{-cm}^2$ to $2.1 \pm 0.5 \text{ k}\Omega\text{-cm}^2$), and the resistance is further reduced to $1.2 \pm 0.2 \text{ k}\Omega\text{-cm}^2$ at DCs. Such significant reduction in charge-transfer resistance will result in fast corrosion of the surface steps, and has been confirmed by studies in simulated reactor environments^{23,26}. It is indicated that the high corrosion/oxidation tendency of DCs is attributed to the following: 1) the highly distorted lattice which stores elastic energy at defects such as dislocation networks, thereby elevating the chemical potential and reactivity of the alloying atoms.^{16,17} 2) DC formation leads to the formation of abrupt surface steps, which mechanically disrupt the original oxide film and expose the metal atoms directly to the corrosive environments. In fact, equivalent circuit fitting of the EIS spectra suggests the rupture of the oxide layer at the surface steps, leading to the reduced surface impedance values (see **Figure 3e** and **3f**). Moreover, the surface steps also disrupt stress flow and cause stress concentration, causing mechanical-chemical interplay (i.e., likely the root cause of IASCC initiation). Importantly, this study provides a non-destructive approach to locate and assess these detrimental features induced by irradiation and/or deformation.

In summary, the TEM-STEM results provide strong evidences that confirms the passive film disruption resulted in elevated corrosion activity as characterized by SECCM (**Figure 3**).

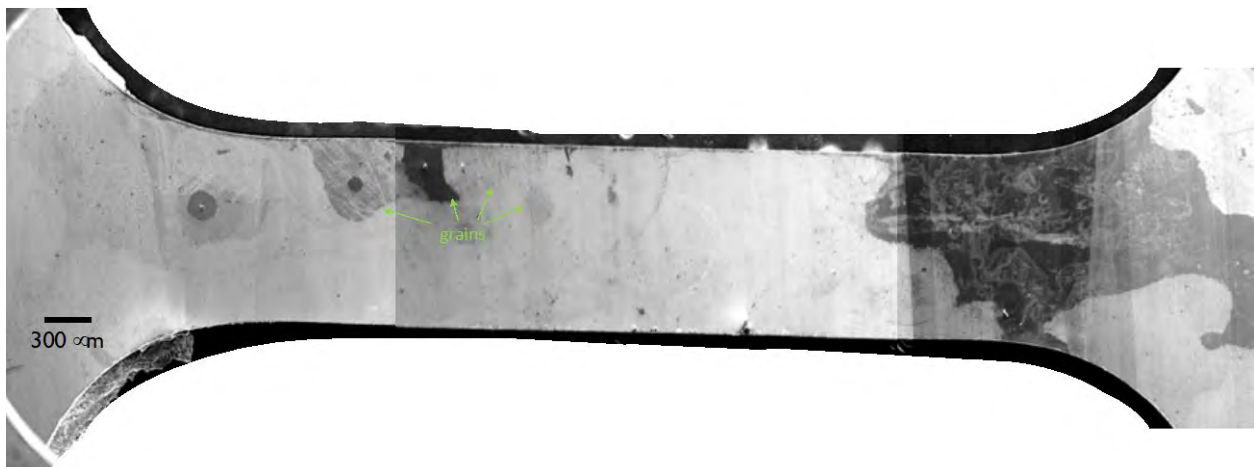
Figure 18 SEM characterization of the SS sample#3 tensile specimen. Only a few grains are visible within the gauge length (highlighted by green arrows).

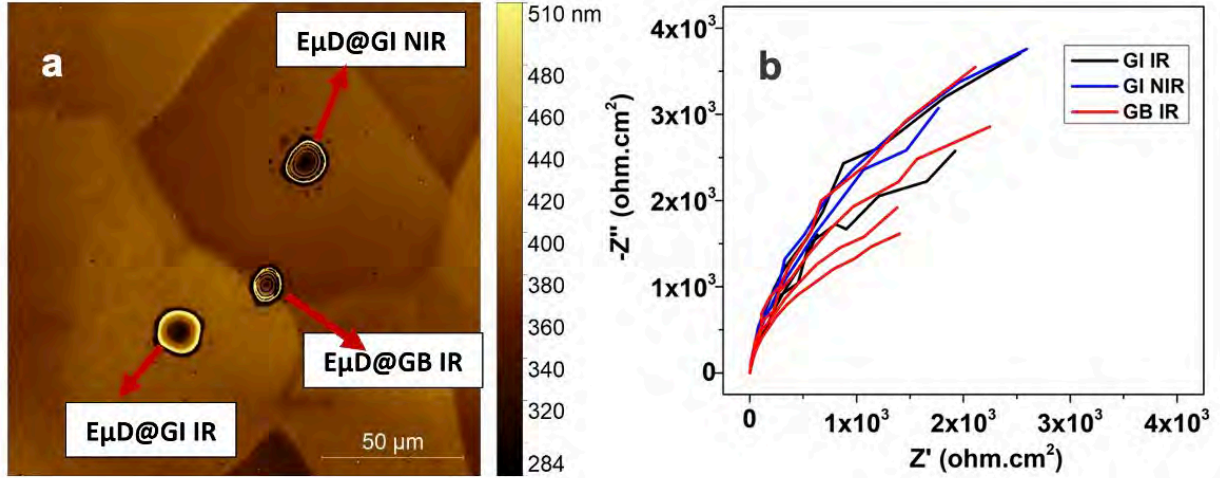
Figure 30 (a) Exemplary SECCM point analysis on grain boundaries (GB) and grain interiors (GI) of a 5 MeV Ni⁺⁺ ion irradiated (2 dpa) austenitic (316L) stainless steel. (b) Exemplary impedance spectra of

The insensitive corrosion activity at GBs is likely due to the Cr-depletion is not severe enough to induce passivity break down. To confirm, we have used the same approach to examine an austenitic (316L) stainless steel sample that was irradiated to 2 dpa by 5 MeV Ni^{++} ions. Consistently as shown in **Figure 30** and **Table 2**, SECCM can only reveal enhanced corrosion reactivity at GBs via statistical analyses. And no significant difference in corrosion activity was observed between grain interiors (GI) and grain boundaries (GB). This may be resulted from 1) not enough dpa or Cr depletion, and 2) GB characteristics, and not all GBs were subjected to irradiation-induced Cr depletion.

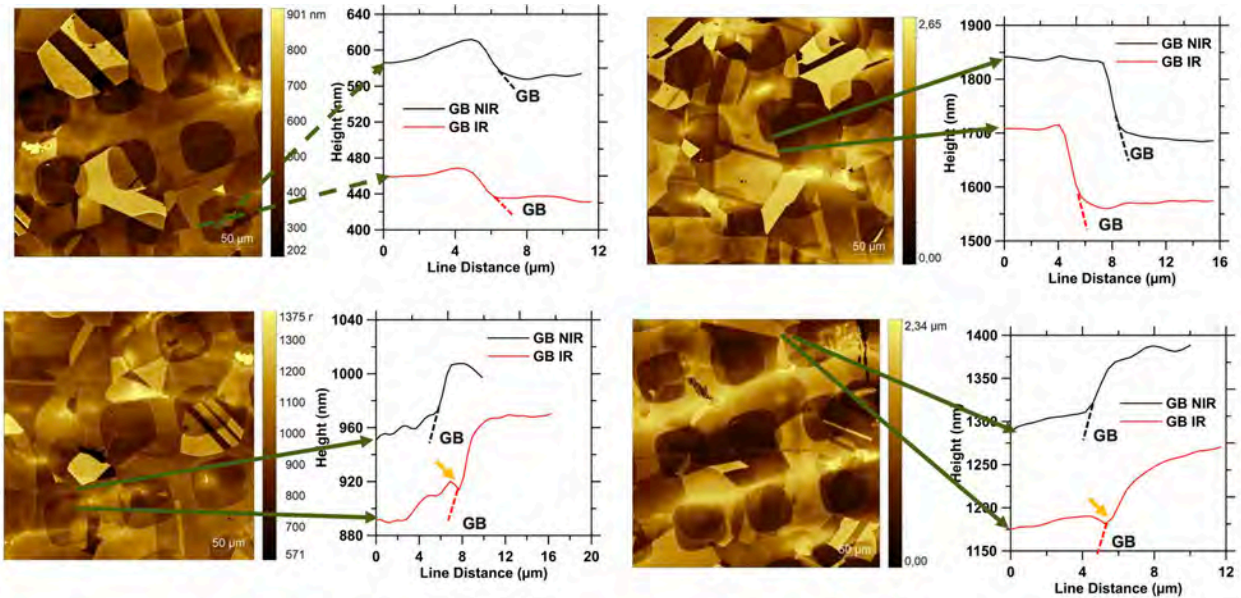
Figure 33 VSI topographical images and surface height line profiles across irradiated and non-irradiated grain boundaries.

are subjected to irradiation induced corrosion sensitivity, and GB characteristics play a determining role. This might explain why SECCM can only reveal a small difference in corrosion resistance only via statistical analysis. Nevertheless, VSI coupled with electrochemical etching could be an effective tool to investigate the radiation induced swelling and screen swell-resistant alloys as LWR components.
