Light Water Reactor Sustainability Program

Analysis of attenuation effects based on results from Zion beltline reactor pressure vessel

Light Water Reactor Sustainability Program
Materials Research Pathway
Milestone Report: M3LW-24OR0402015

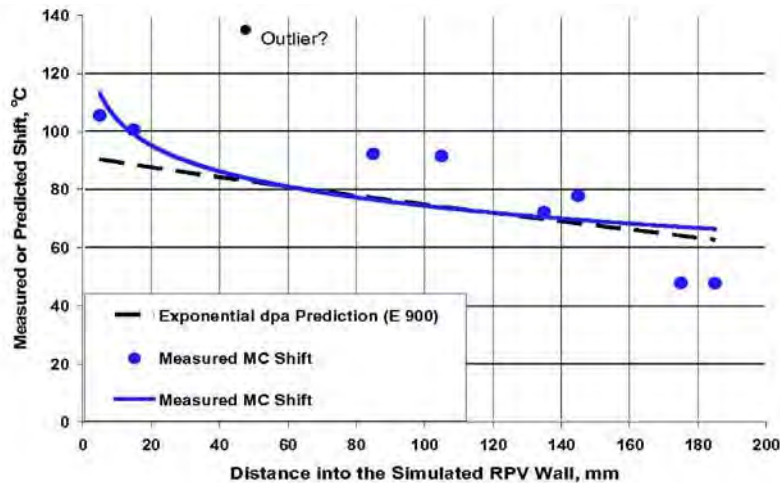
Figure 3. Predicted and measured values of Master Curve T_0 shift for the JRQ plate material [16].

Although the attenuation experiments listed in Table 2 permitted better opportunities for characterization of the unirradiated materials and control of the experimental variables, the results were not as definitive as planned. As discussed in Ref. [13], the data was confounded by unexpected behavior, which was variously attributed to experimental uncertainties, unexplained sensitivities to alloy chemistry and Charpy specimen orientation, and what has been referred to as “anomalous results” [16]. For example, although the master curve data for the JRQ plate material irradiated in the IAEA-NRI experiment shown in Fig. 3 is generally consistent with the dpa-based attenuation model in ASTM E900, it exhibits higher than expected shifts in the 0.3 to 0.5T region and an anomalously high shift at about 0.25-T, where T was the simulated thickness of the vessel wall.

Considering the data shown in Figs. 1-3, and other interpretational difficulties discussed in Ref. [13], it perhaps is not surprising that understanding the results of the current investigation of the Zion RPV remains a work in progress.

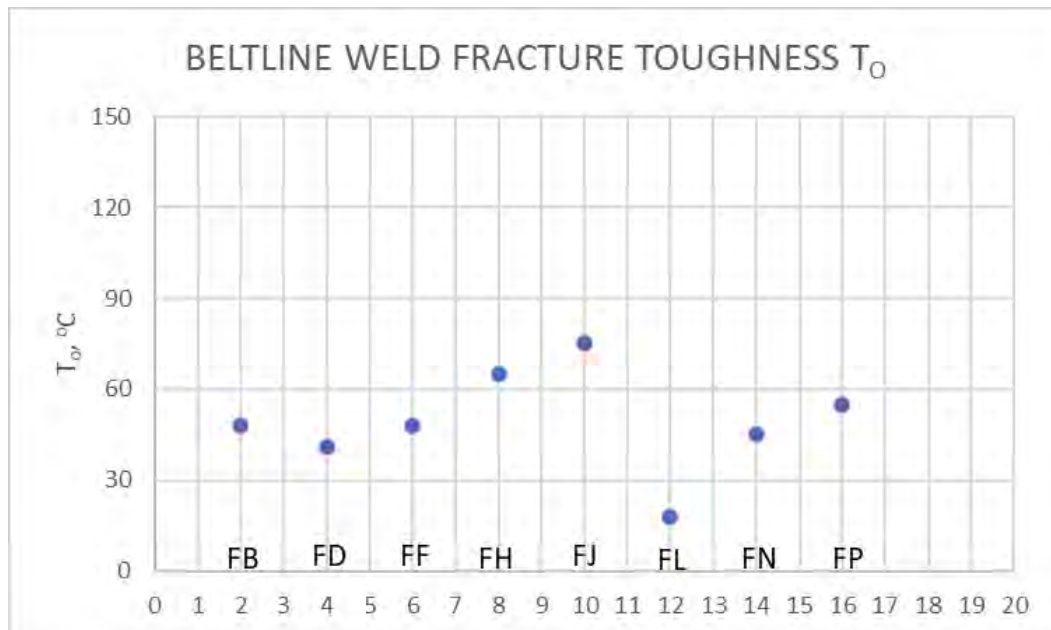
Figure 6. Distribution of the fracture toughness transition temperature, T_0 , of beltline weld metal through the thickness of the vessel wall. Layer 1 was closer to the reactor core.

Figure 6 illustrates the distribution of the fracture toughness transition temperature of the beltline weld, T_0 , through the thickness of the vessel. Like the Charpy 41-J transition temperature data shown in

Figure 5, the T_0 distribution did not exhibit a particular trend through the thickness of the vessel. Similarly to the Charpy layer 7 data, layers 8 and 10 exhibited higher fracture toughness T_0 values compared to other layers even though those layers are in the middle section of vessel wall.

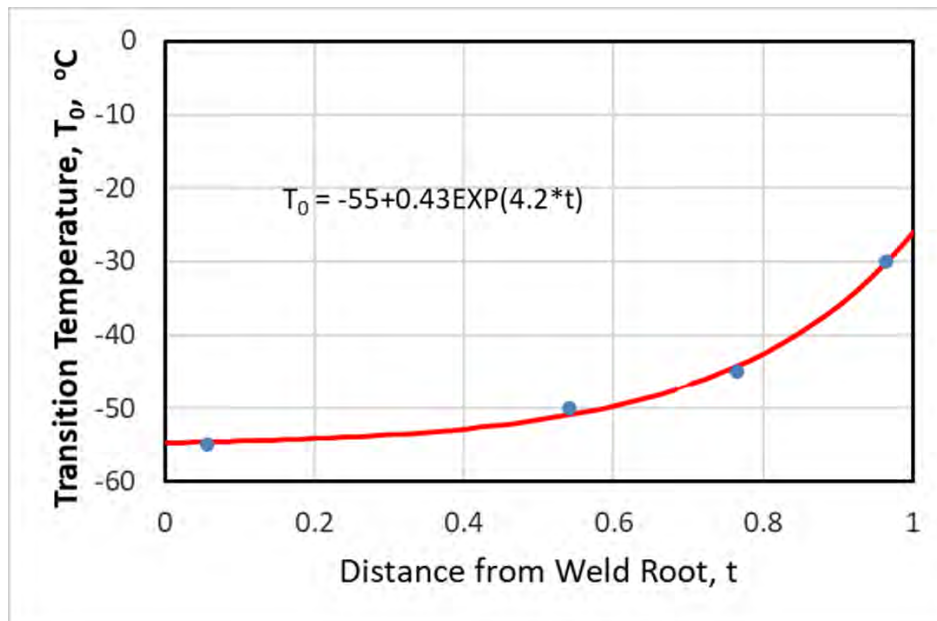
Figure 7. Through-thickness distribution of T_0 in the archived surveillance weld.

These unexpected “humps” in the transition temperature distributions were one of the main reasons to performed characterization of the archived material [8,9]. While the archive surveillance weld did not reveal any unusual behavior in the half-depth of the of the weld, it did show a very pronounced trend with T_0 distribution through the thickness of the weld, as seen in Fig. 7. This trend was used to calculate the shift of the fracture toughness transition temperature, T_0 , through the thickness of the weld. Since it is well accepted fact that harpy and fracture toughness transition temperatures are following approximately the same trend, the same through-thickness dependence was used to calculate through-thickness distribution of Charpy T_{41J} transition temperature in the unirradiated condition using reported T_{41J} values for surveillance weld at $\frac{1}{4}$ -thickness of the weld. Figure 8 represents the measured shift, ΔT , through the thickness of the vessel wall where blue points represent fracture toughness and red points represent Charpy transition temperatures, respectively.

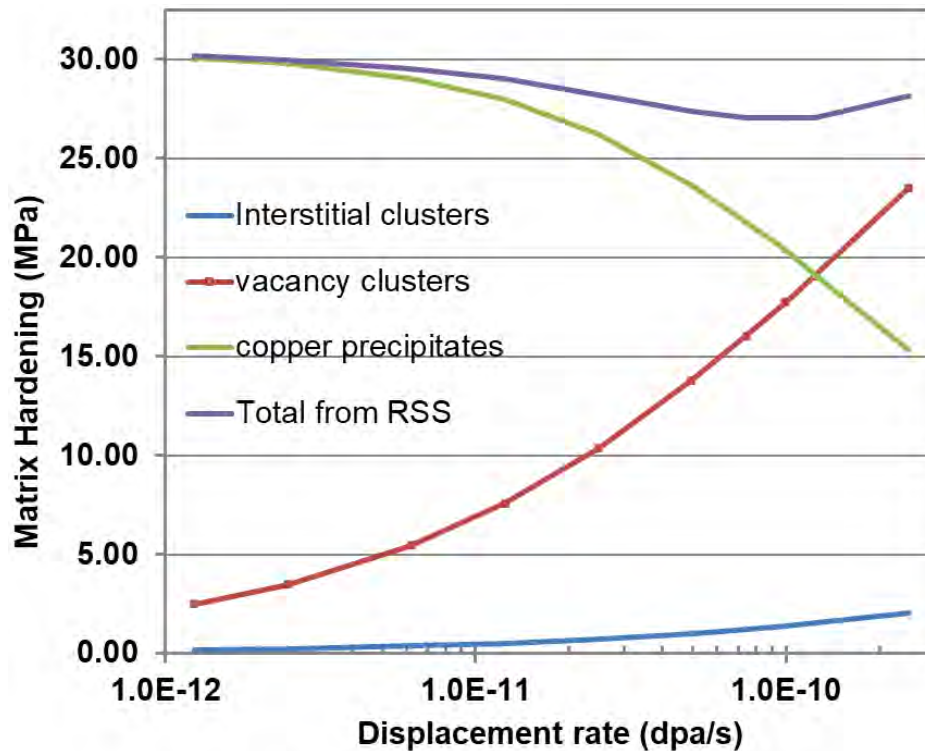
Figure 9. Predicted hardening for different microstructural defects for irradiation at 288°C to 0.01 dpa. Copper content is 0.3 atom-%.

As an example of the model behavior, Fig. 9 provides representative results from the model for matrix hardening as a function of displacement rate at 288°C at a total dose of 0.01 dpa, which is similar to the maximum does on the Zion RPV materials. The values shown in the figure can be converted to yield strength change and Charpy shift using standard conversions as discussed in [18], but it seems more suitable to focus on the parameters calculated directly by the model for the purpose of this illustration. Values are shown for the three defect types mentioned above, along the total hardening based on the root sum-of-squares (RSS) of the individual components. The potential impact of a reduced displacement rate (neutron flux) as a function of depth into the RPV can be inferred from this figure. For values typical of RPV materials, hardening from point defect clusters decreases and hardening from copper-rich precipitates increases as the displacement rate decreases. Because of the opposing effect of displacement rate on different types of defects, the total hardening can either increase or decrease with damage rate. The displacement rate at which the minimum in total hardening occurs will be a function of alloy composition and other material and irradiation parameters.

However, the results shown in Fig. 9 are for a constant total dose, which does not represent the through-thickness dose behavior obtained in an RPV. Fig. 10 shows the expected attenuation in an 8.8-inch thick RPV; the exponential attenuation formula from Regulatory Guide 1.99/2 [11] is compared with what is denoted as “real” dpa based on detailed transport calculations [19]. As pointed out previously [20], the dpa attenuation through the RPV is slower than that predicted by the NRC exponential model. However, attenuation is relatively strong in both cases and the relative attenuation is similar at the $\frac{3}{4}$ -T position.

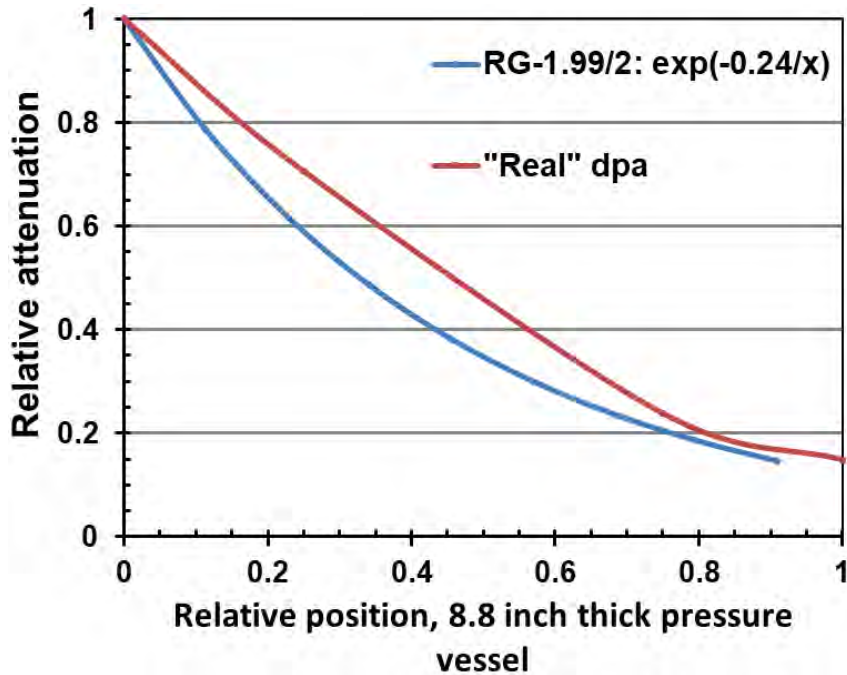
Figure 10. Relative attenuation of displacement rate through RPV. A comparison of the RG-1.99/2 attenuation model with neutron transport calculation (“real” dpa).

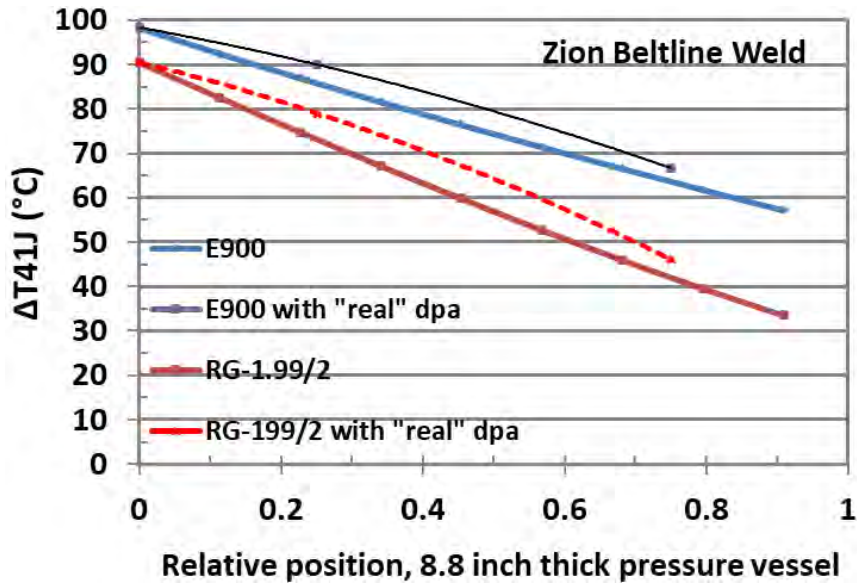
Figure 11. Attenuation of Charpy 41J transition temperature shift estimated for Zion beltline weld with different embrittlement trend curves.

It is important to point out that it is not proper to assume that the attenuation in mechanical properties will be the same as the attenuation in the primary damage term, i.e. the atomic displacement rate. This is another way of saying that damage accumulation is not simply linear in damage formation. The difference is clear when comparing the results from Fig. 10 with those in Fig. 11. Although Fig. 10 indicates that total dose is reduced to about 20% at the $\frac{3}{4}$ -T position, applying this reduction in the RG-1.99/2 embrittlement trend curve leads to ~40% of the predicted embrittlement. Application of the ASTM E900 embrittlement trend curve [12] with the same dose values indicates even less attenuation.

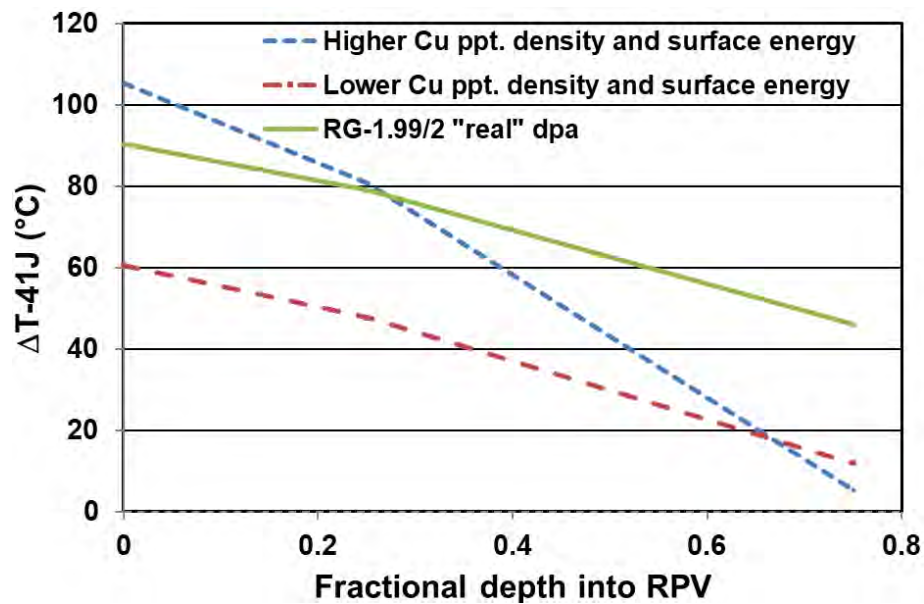
Figure 12. Comparison of Charpy 41J transition temperature shift estimated for the Zion beltline weld with microstructural model and the RG-1.99/2 embrittlement curve.

The predictions of the microstructural model are consistent with the experimentally based embrittlement trend curves. This is shown in Fig. 12 in which results of the RG-1.99/2 trend curve are compared with model predictions obtained using two alternate parameter sets. The case with the higher assumed copper precipitate density and surface energy favors leads to greater embrittlement near the inside surface and more rapid attenuation. The case with a lower precipitate density and surface energy has a lower maximum value of Charpy shift and slower attenuation. The cross-over in the two predicted curves at about 0.65-T is related to the displacement rate change and the balance between point defect hardening and precipitate hardening as discussed with respect to Fig. 8 above.
