# Microstructure and Mechanical Performance of the Friction Stir Welds Made on Neutron-Irradiated Steel with Helium

M. N. Gussev  
W. Tang  
N. Bibhanshu  
T. M. Rosseel

August 2021

Prepared under the direction of the  
U.S. Department of Energy  
Office of Nuclear Energy  
Light Water Reactor Sustainability Program  
Materials Research Pathway

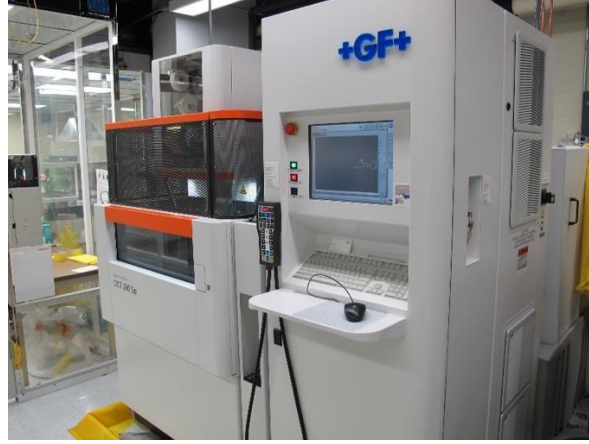
**Figure 6. EDM system installed in LAMDA to manufacture specimens from radioactive material.**

Miniature tensile specimens of the “SS-Teeny” geometry—a custom specimen geometry for mechanical testing of irradiated metals and alloys, as discussed below—were manufactured using the EDM system (Figure 6) installed in the LAMDA hot area. The system allows for handling, processing, and cutting the irradiated materials involved in this and other projects. The AgieCharmilles CUT 200 Sp commercial system was purchased ~3 years ago and allowed for multiple wire diameters, providing an accuracy level up to 3–5 µm. Cutting is performed on specimens fully submerged in water, which excludes any possibility of overheating.
