## Initial Characterization of Unirradiated Concrete and Summary of Stainless Steel Weld Harvesting from Ringhals Unit 2 in FY25

ORNL/SPR-2025/4216  
M3LW-25OR0407015

Light Water Reactor Sustainability Program  
Materials Research Pathway

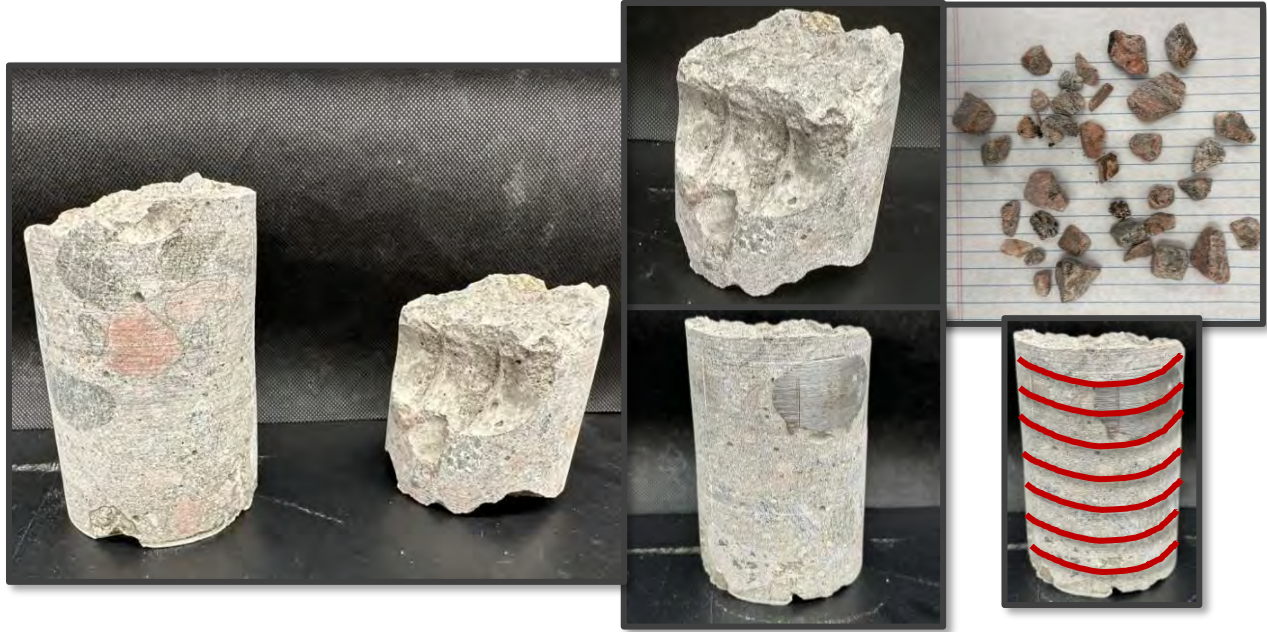
**Figure 1. Unirradiated concrete cores from Ringhals Nuclear Power Plant.** The smaller core was used to extract aggregates, and the taller core was sliced for analysis after running an XCT scan.

Vattenfall provided two cores of unirradiated concrete from Unit 2 of Ringhals nuclear power plant in Väröbacka, Sweden (Figure 1). The cores are approximately 7 cm in diameter and 12 and 8 cm tall, respectively.

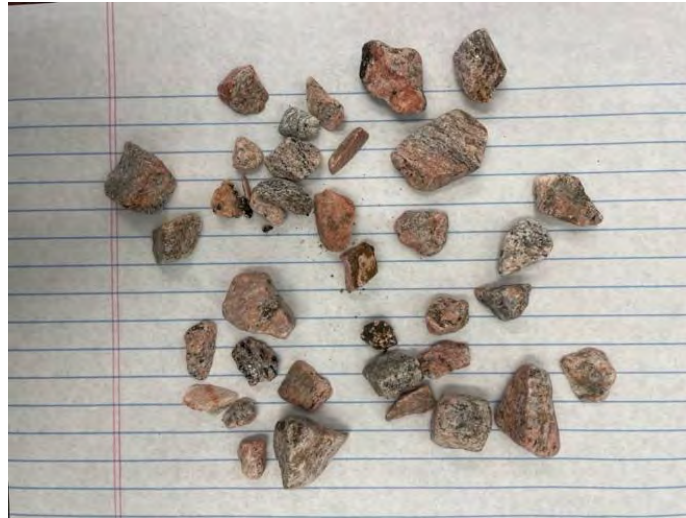
**Figure 5. Extracted aggregates from Core 2.**

The clean coarse aggregates confirm that the core contained a macroscopically homogeneous group of aggregates, exhibiting consistent texture and visible characteristics, while any mineralogical heterogeneity is analyzed and discussed at the microscopic level later in the text. Visually, aggregates are of similar shapes and colors, with few exceptions (Figure 5). The initial sorting was performed based on the color and texture (Figure 6). Five aggregates were cut, embedded in epoxy, and polished for micro XRF and quantitative evaluation of minerals by scanning electron microscopy mineralogical analysis. They were also cut into thin sections for petrography analyses (Figure 7). The remaining specimens were ground to fine powder for structural and chemical analyses using XRD and powder XRF.

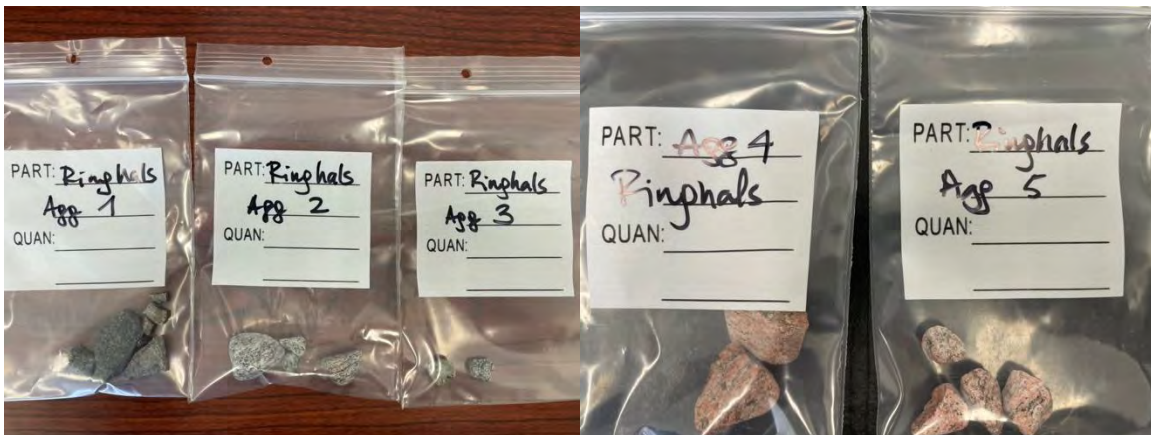
**Figure 6. Selected aggregates for detailed characterization.**
