## Nondestructive Evaluation Techniques for Nuclear Power Plant Concrete Structures

### Dwight Clayton

Materials Aging and Degradation Pathway

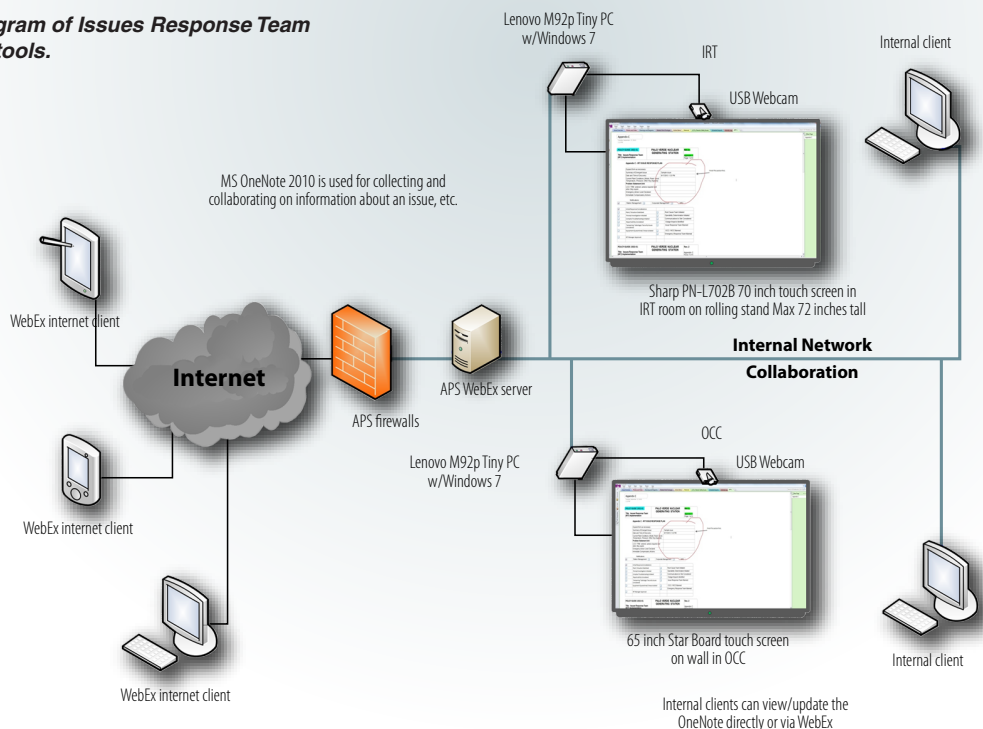
**Figure 10. Diagram of Issues Response Team collaboration tools.**

screen monitor for use in the IRT room. Video cameras for remote collaboration also were added to the IRT room and the OCC. Figure 10 provides a diagram of the hardware and software implementation.

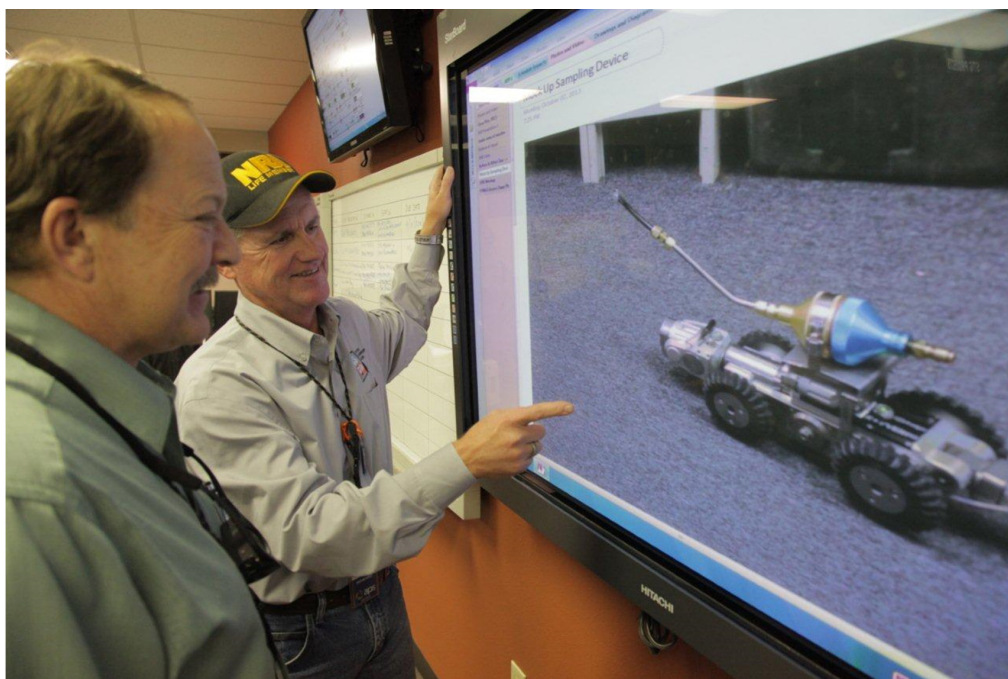
**Figure 13. Outage Control Center video wall planned for next refueling outage.**

In summary, the initial study of AOCC technology at the Palo Verde Nuclear Generating Station to support the IRT was well received. Palo Verde Nuclear Generating Station plans to permanently adopt the IRT process and technologies used during the fall 2013 refueling outage. Based on the advantages observed using the network accessible collaboration software, prior to their next refueling outage, Palo Verde Nuclear Generating Station intends to update their OCC with this technology to improve outage communication and collaboration. Figure 13 shows the planned OCC equipment upgrades.
